Facility: AltEn, LLC

5/3/2021

Site Visit Check list

Site Visit Report

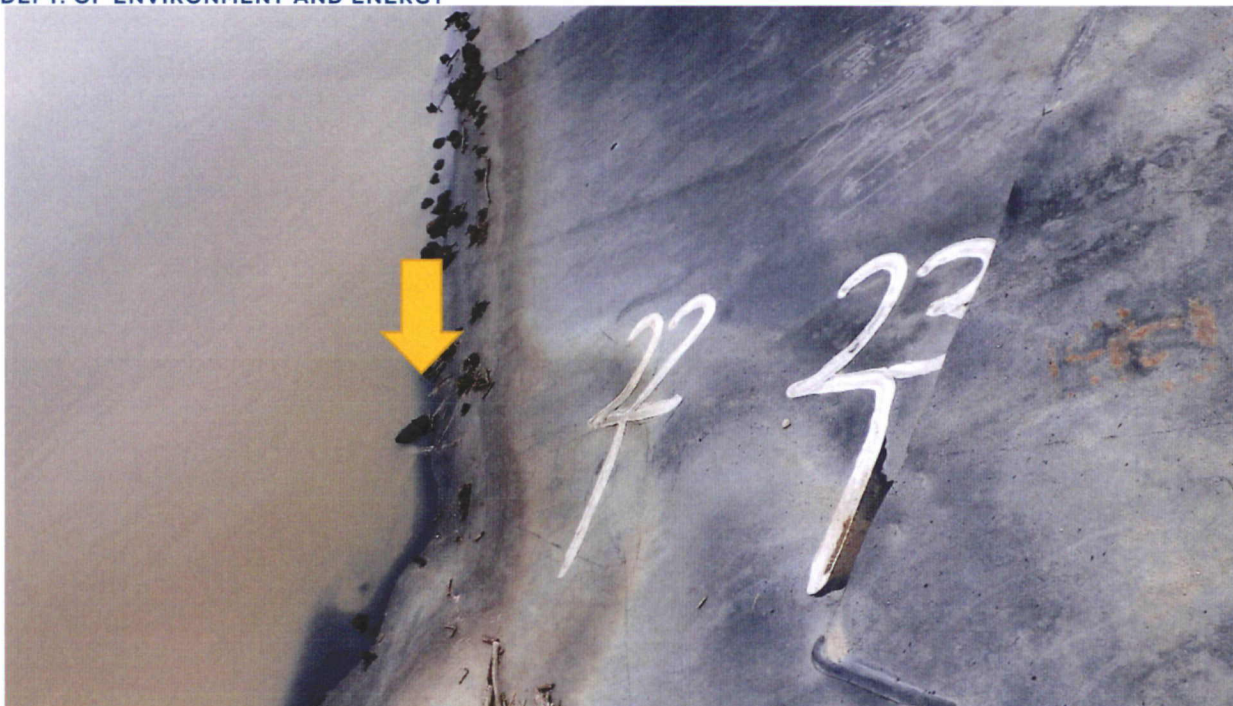
Photo: 26

Description: This photo depicts the south lagoon depth gauge. It appears to be just above 21 ft.

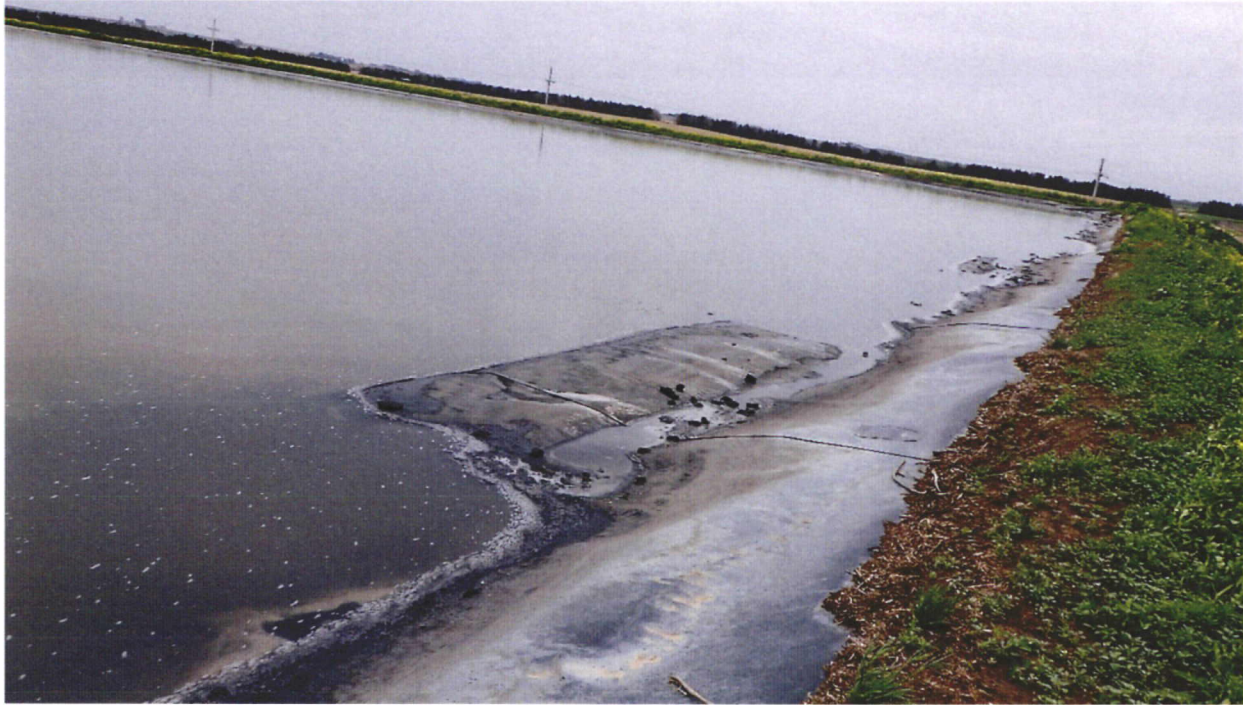
Photo: 27

Description: This photo depicts the south dike of the south lagoon. There is an area of floating liner.

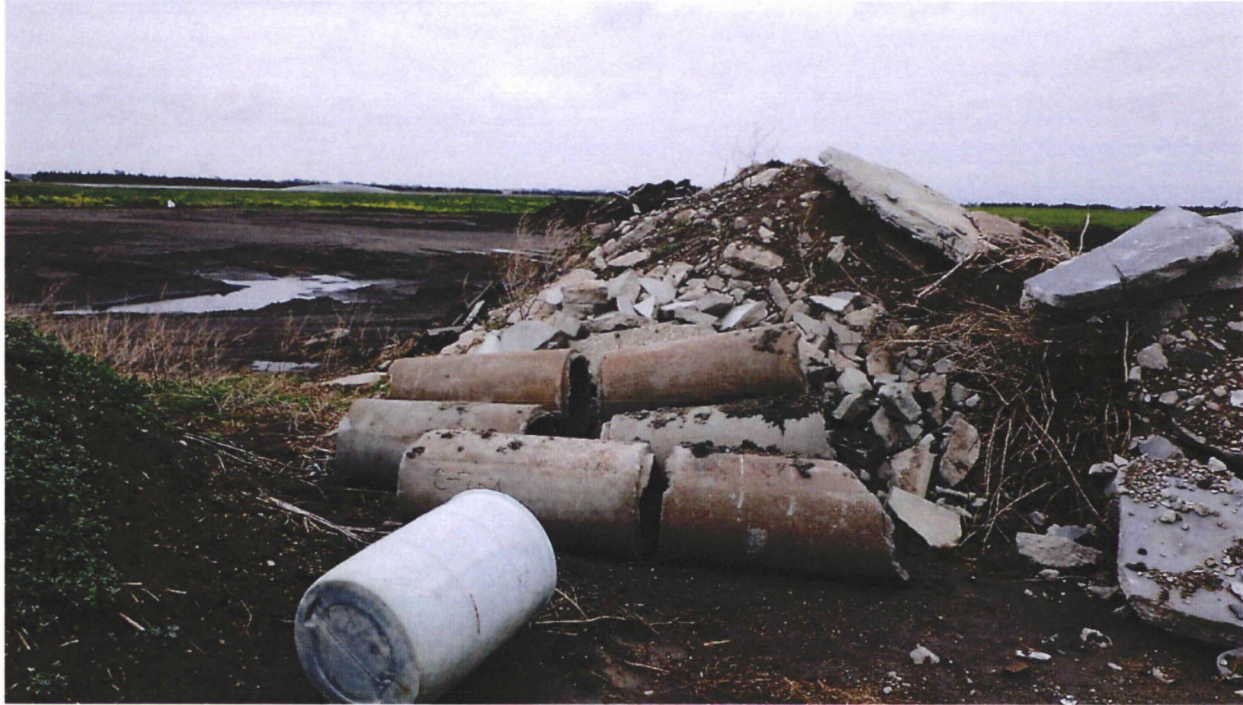
Photo: 28

Description: This photo depicts a pile of cement and plastic barrel.

- Remove Cont. pile
- Work on Housekeeping (Biochan)

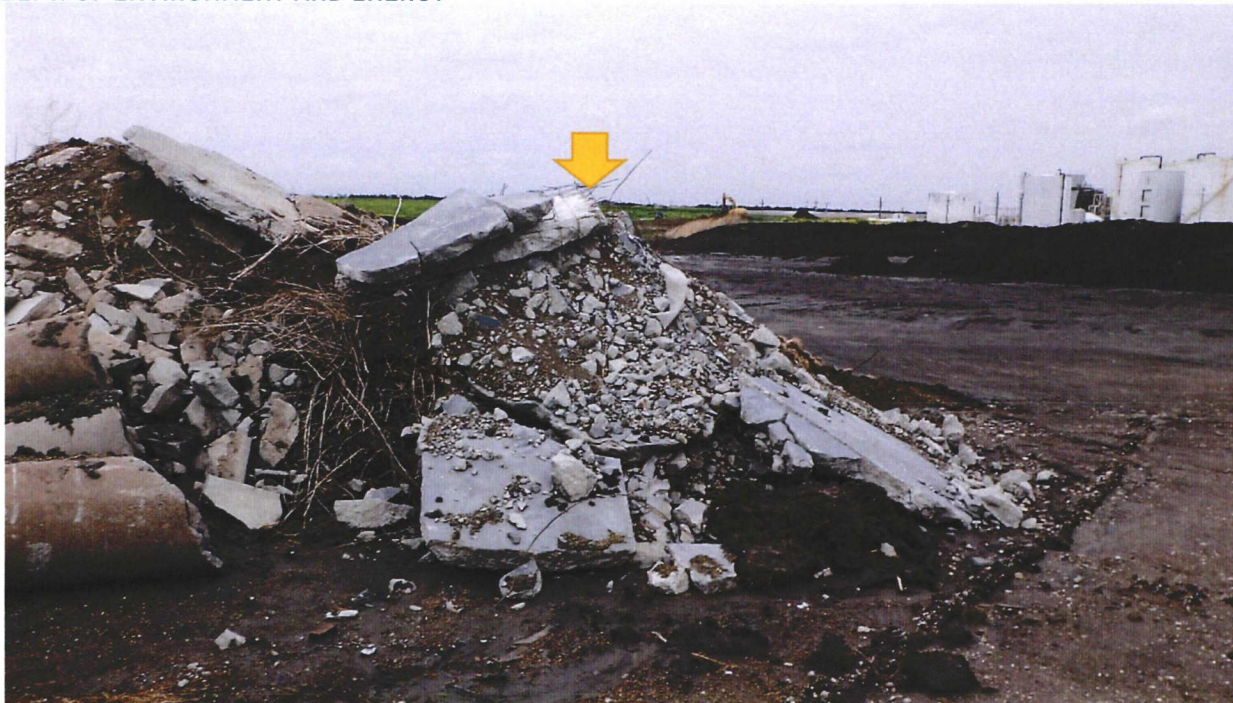
Photo: 29

Description: This photo depicts cement and rebar (arrow)

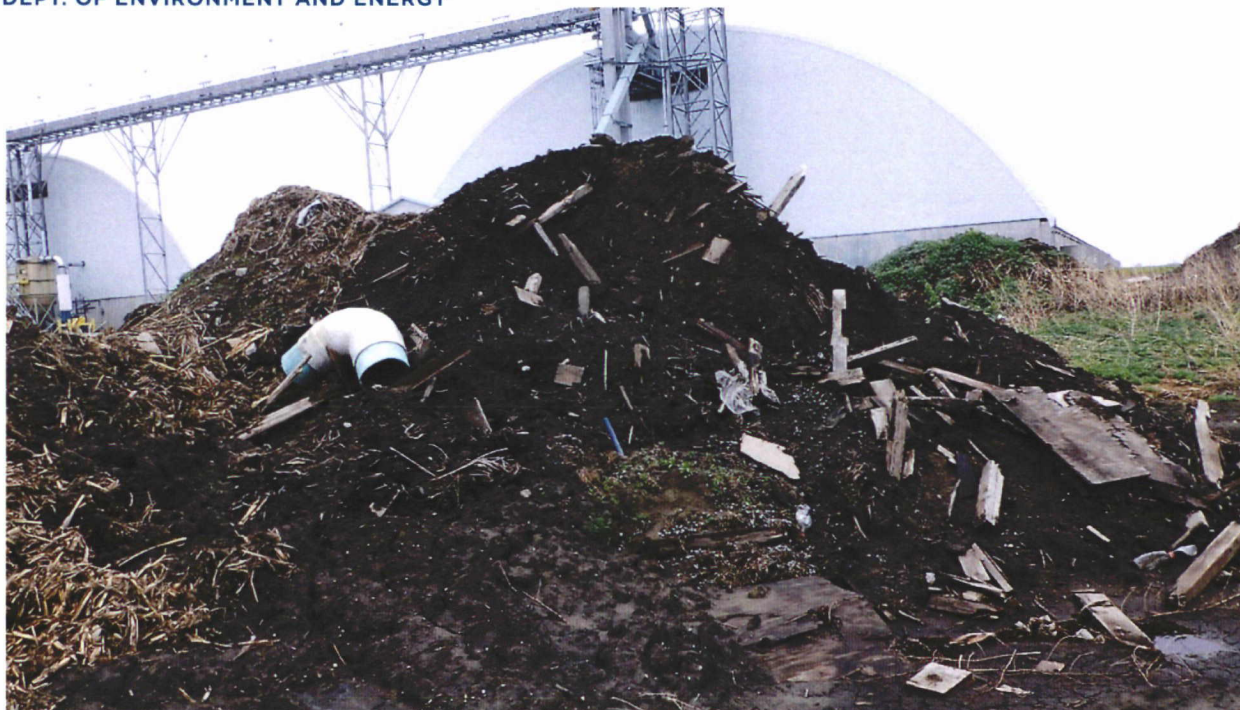
Photo: 30

Description: This photo depicts wood mixed with some plastic.
