Facility: AltEn, LLC

IIS: 84069

5/24/2021

## Site Visit / Sampling Event Report

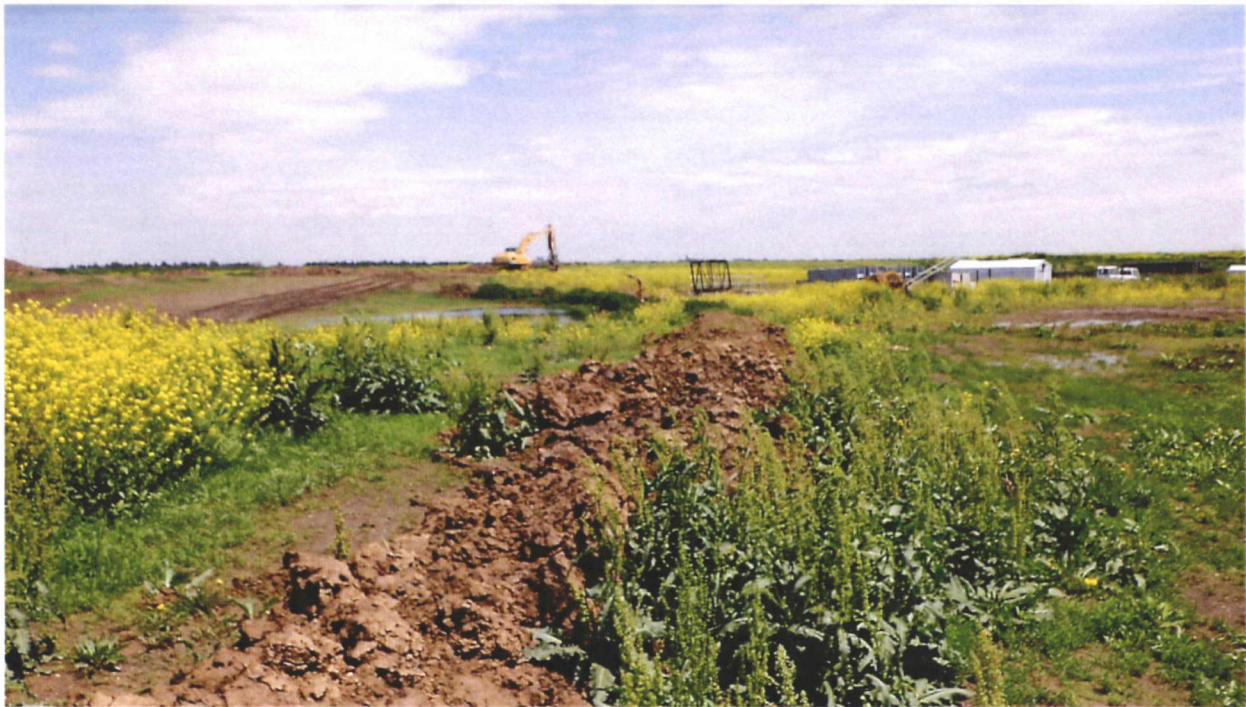
Photo: 1

Description: This is the original berm for area 1. The berm is becoming overrun with vegetation.

- Clean the biochar area and install proper BMPs
- Manage vegetation around the lagoons and the main facility.

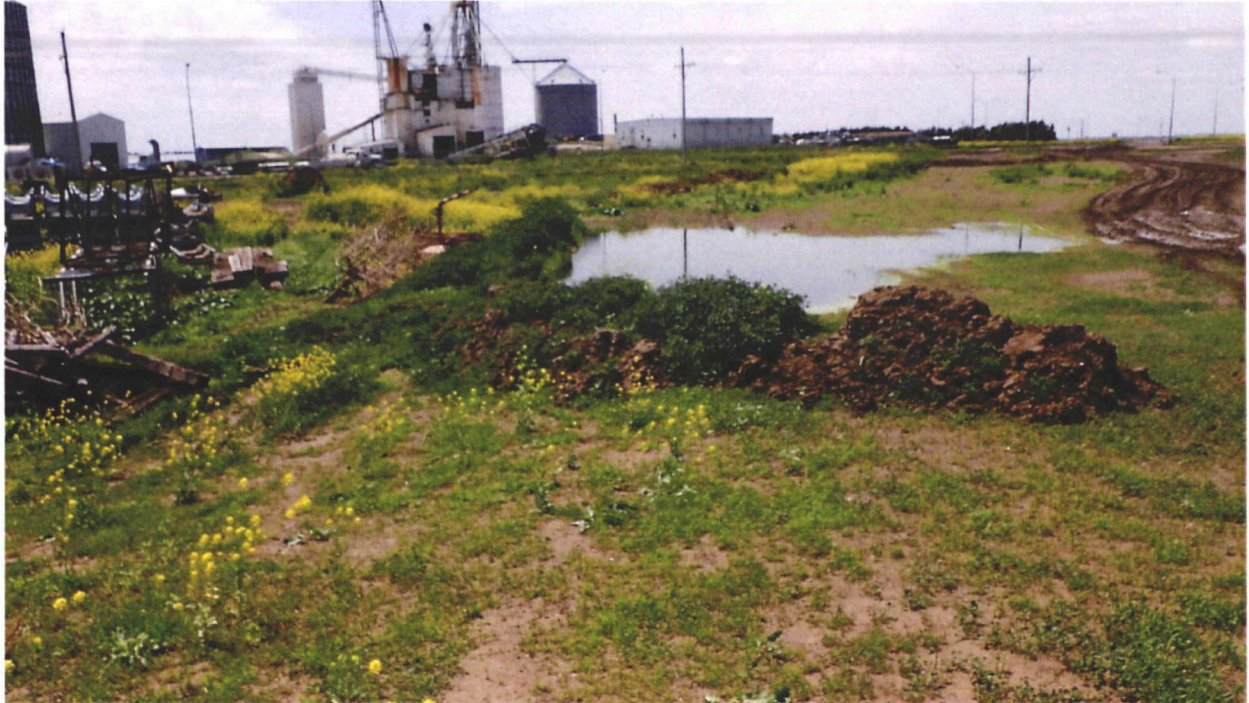
Photo: 2

- Area 1 contains two berms. The original east berm contains green water and needs to be pumped to make room for upcoming rain event
- Areas 2: The facility is currently pumping the berm to the emergency lagoon.
- Area 3 is in good condition. No seepage observed.
- Area 4 is in good condition. No seepage observed.
- Area 5 is in good condition. No seepage observed.
- Clean Harbors has finished the berm around the Area 6 pile. No seepage observed. Some totes used to transport water from area 6 are stained with corrosive chemical.

Description: This is the original berm for area 1. There is green water behind the berm. There is no signs of seepage.

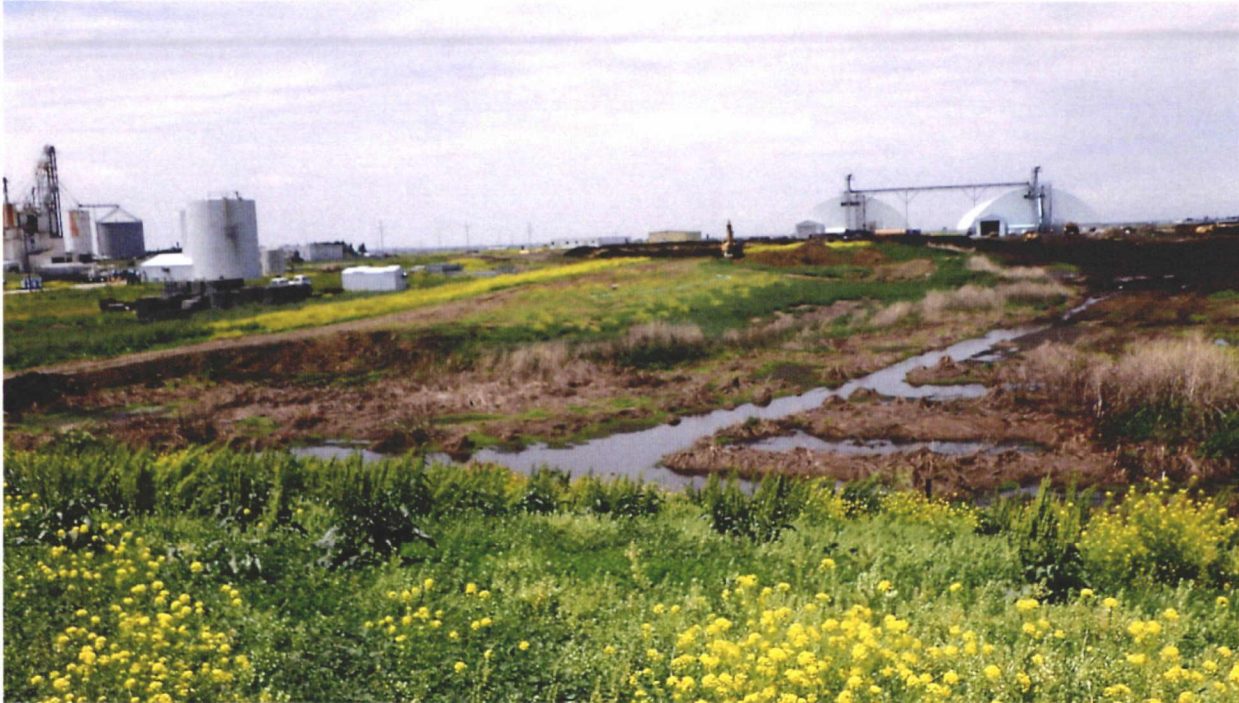
Photo: 3

Description: This photo depicts water accumulation. Water drains areas west which includes Area 5. Area 5 contains a trench that conveys water to area 2.

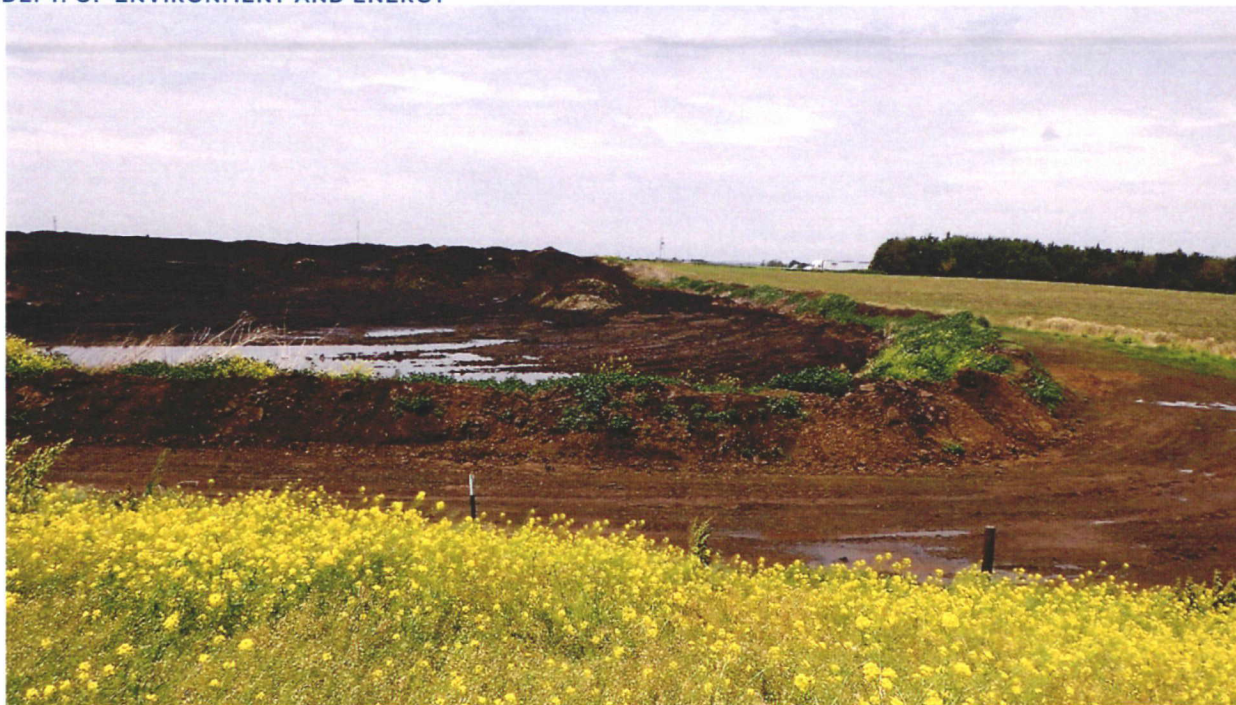
Photo: 4

Description: This photo depicts water accumulation. The water outside the berm is pooled rain water.

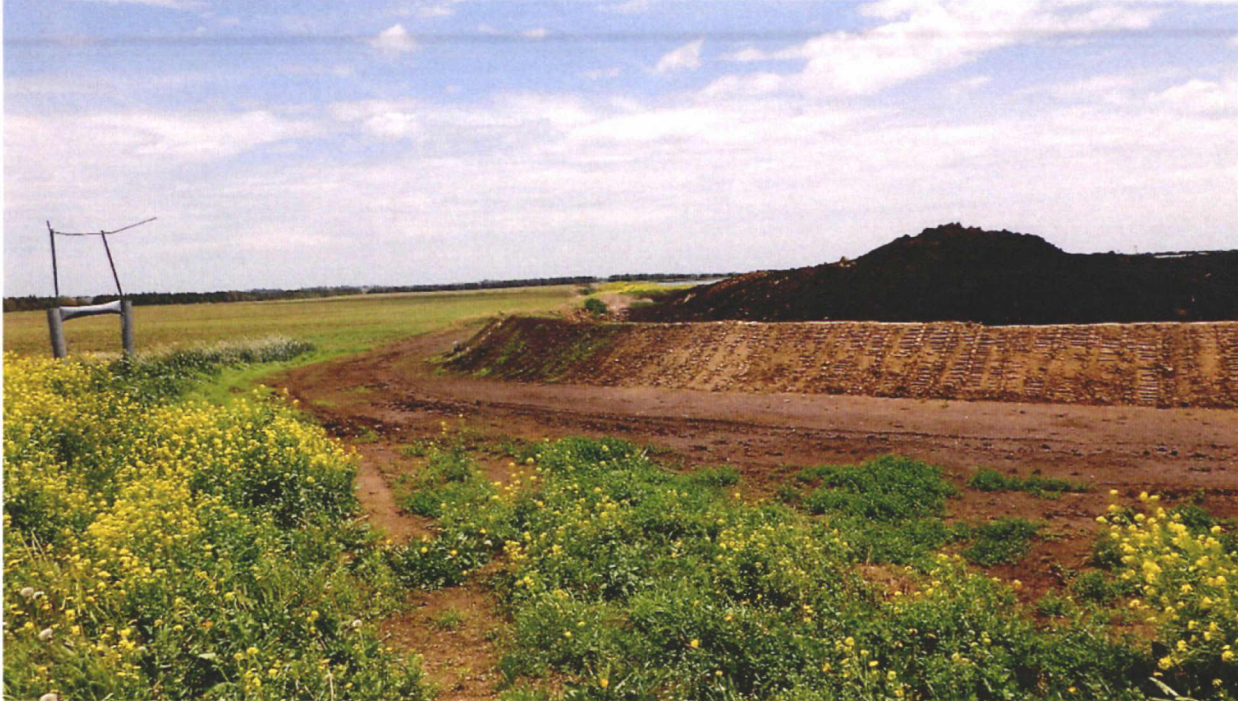
Photo: 5

Description: This photo depicts the new compacted berm. Area four connects to area 5, which is depicted in the next photo.

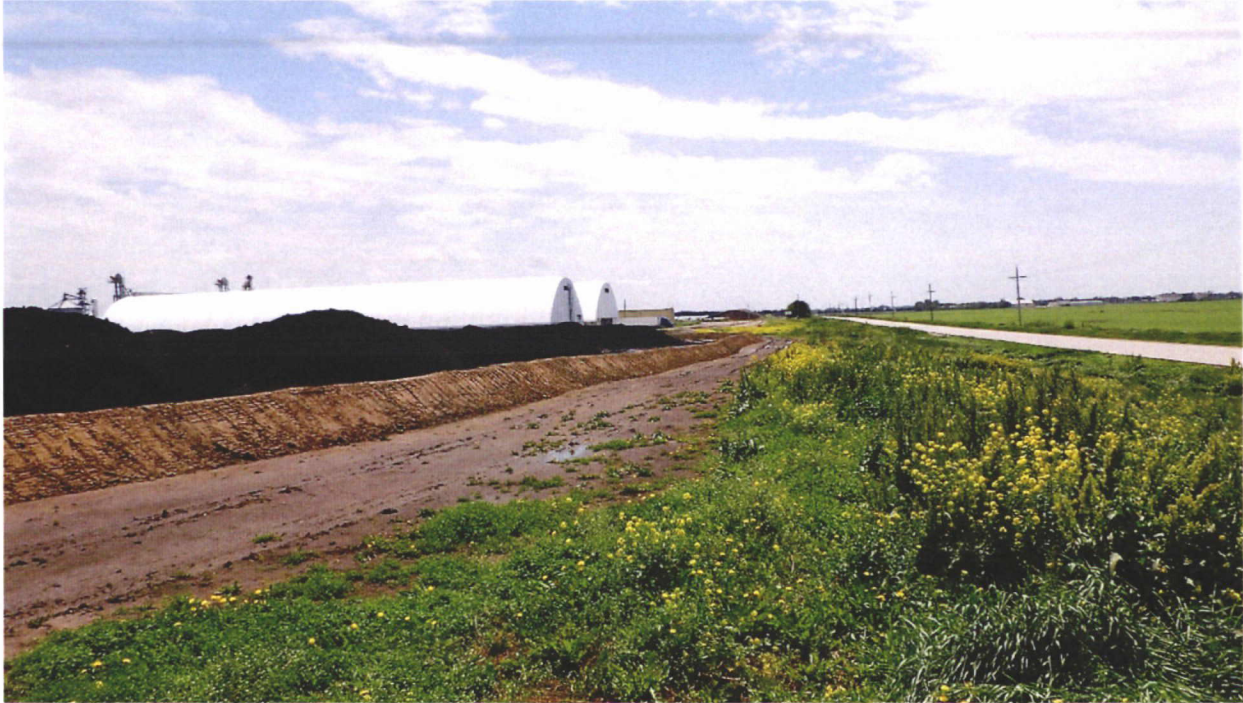
Photo: 6

Description: This photo depicts the connection between area 4 and 5.

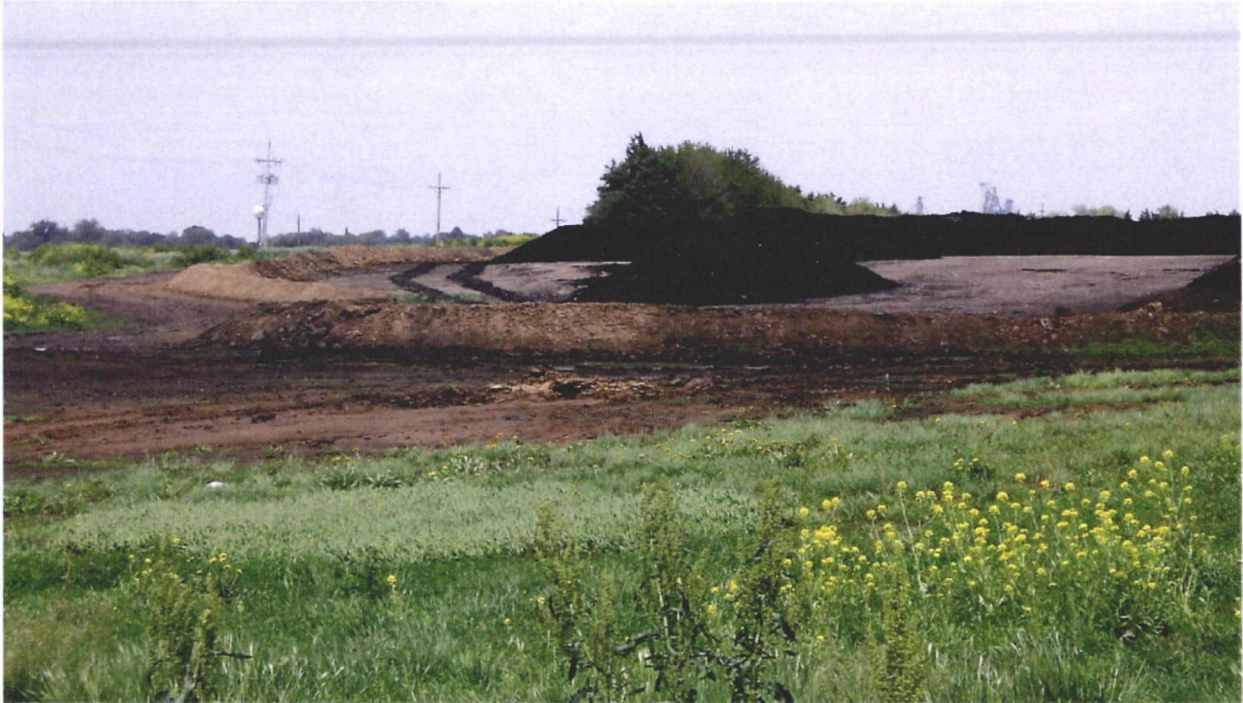
Photo: 7

Description: This photo depicts the area 5 berm. There are no signs of seepage.

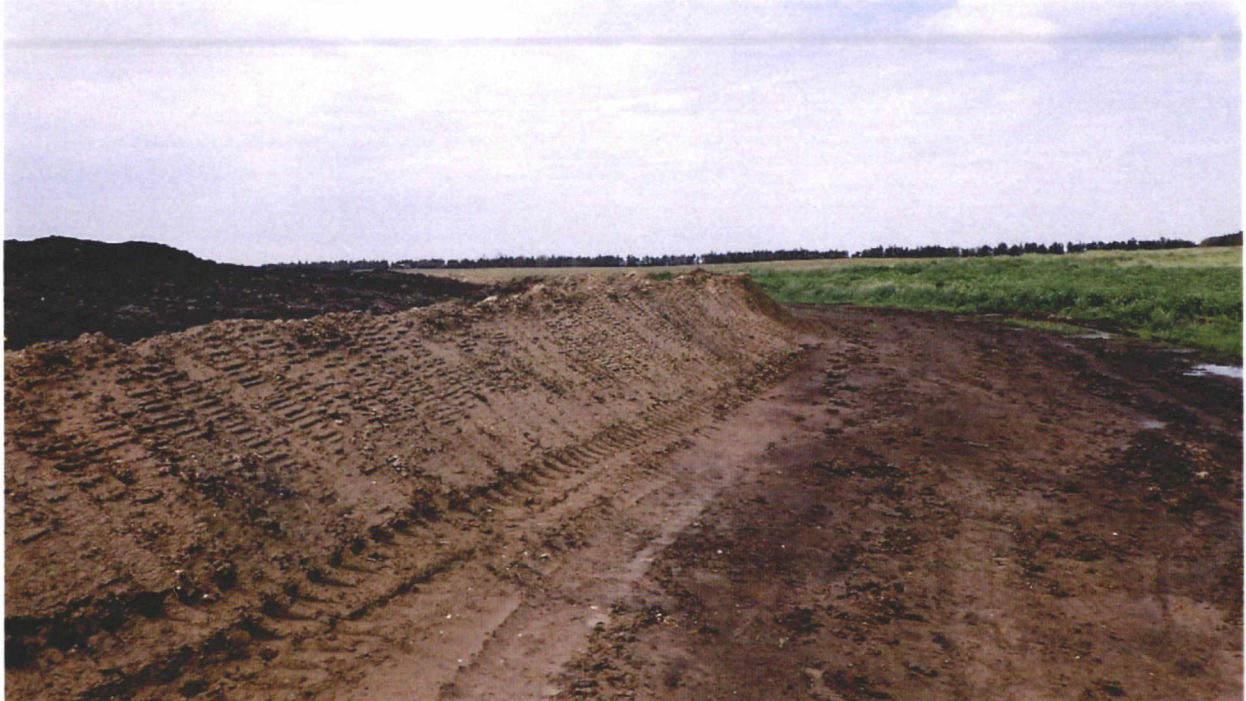
Photo: 8

Description: There is no signs of seepage.

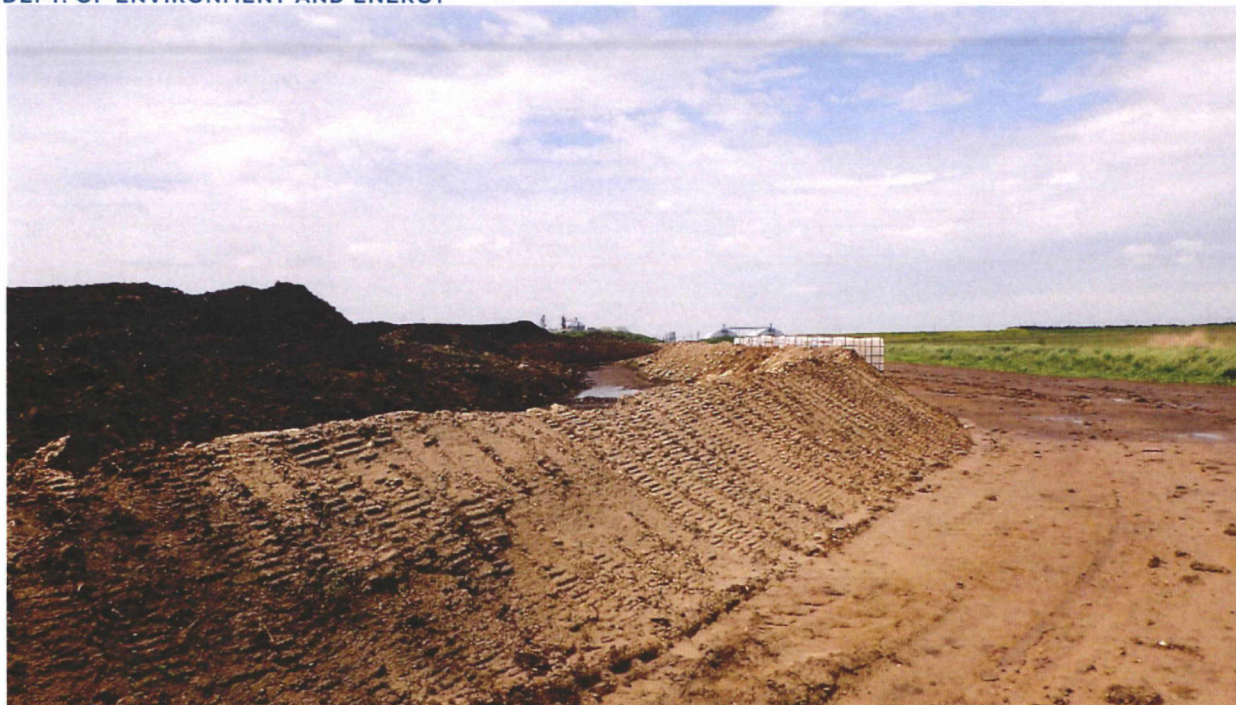
Photo: 9

Description: There is no signs of seepage.

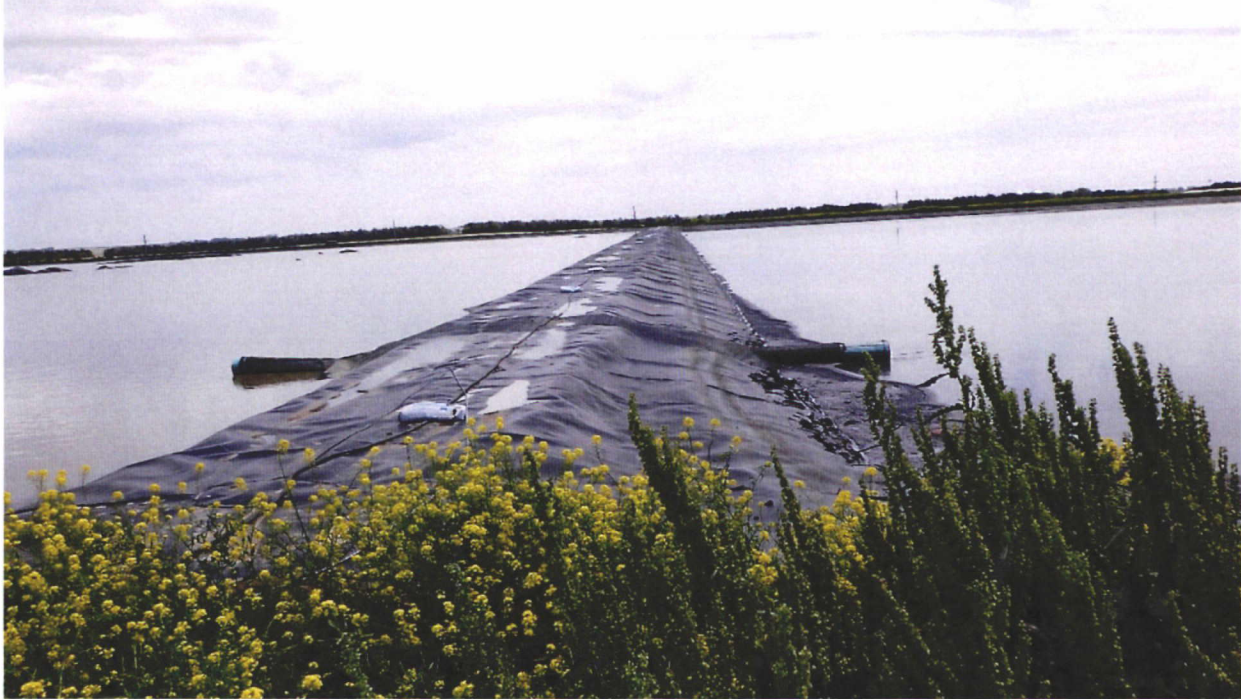
Photo: 10

Description: There is no change.

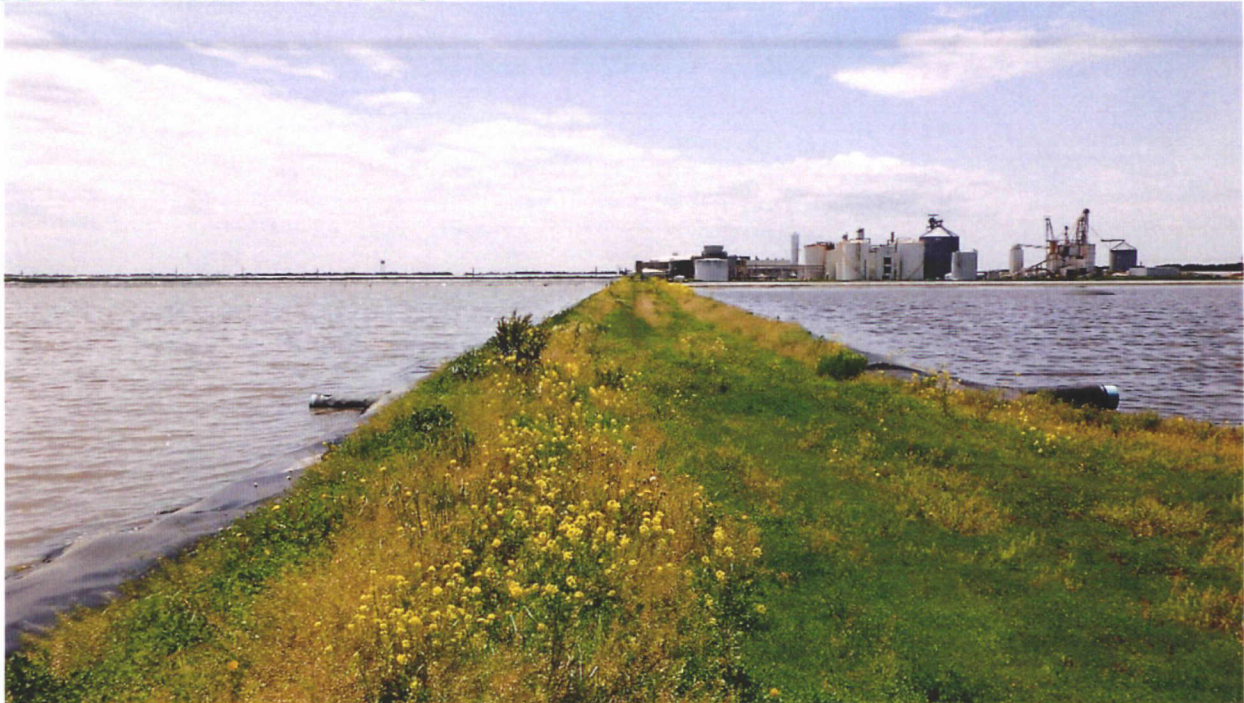
Photo: 12

Description: No change

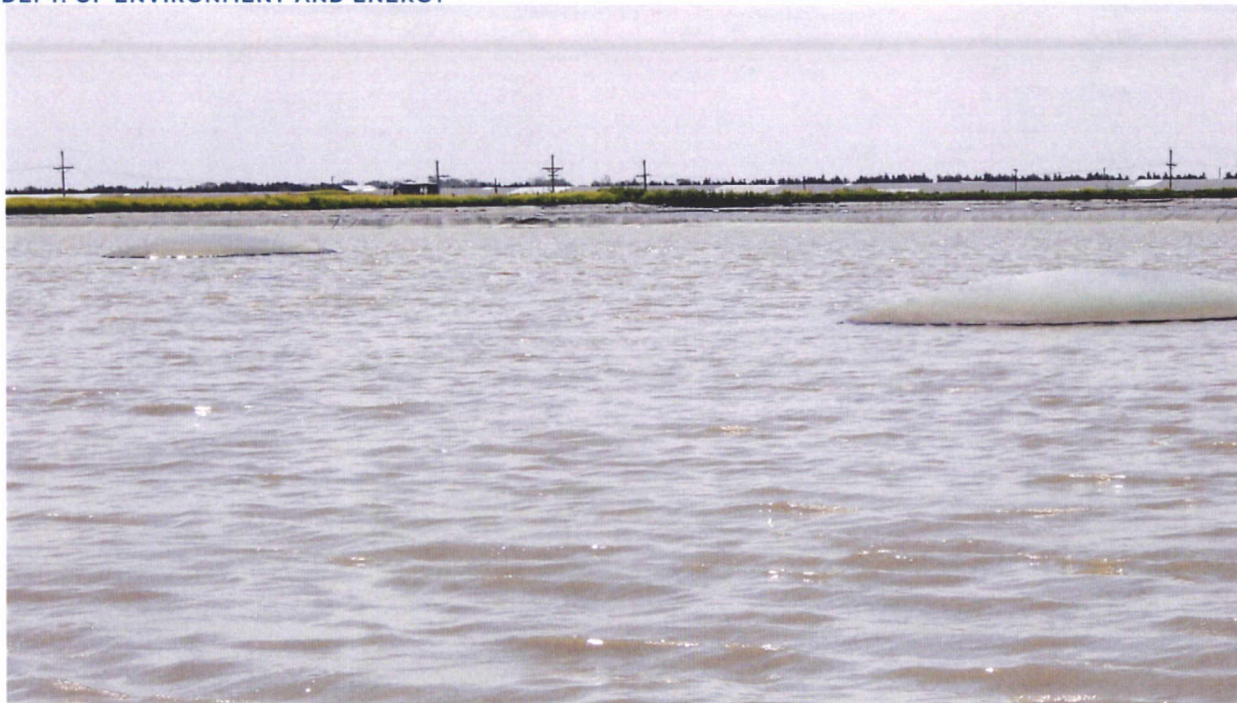
Photo: 13

- Northeast lagoon
  - No change with the liners. The lagoon is releasing gas in multiple locations.
  - The facility is recirculating water from the pumping station into the northeast lagoon.
  - Vegetation is growing fast around the lagoon. Vegetation is a possible tripping and falling hazard. There appears to be two near floating liner sections (whales).
- Northwest lagoon
  - Vegetation is growing fast.
  - No change in the liners.

Description: There appears to be new whales on the northeast lagoon.

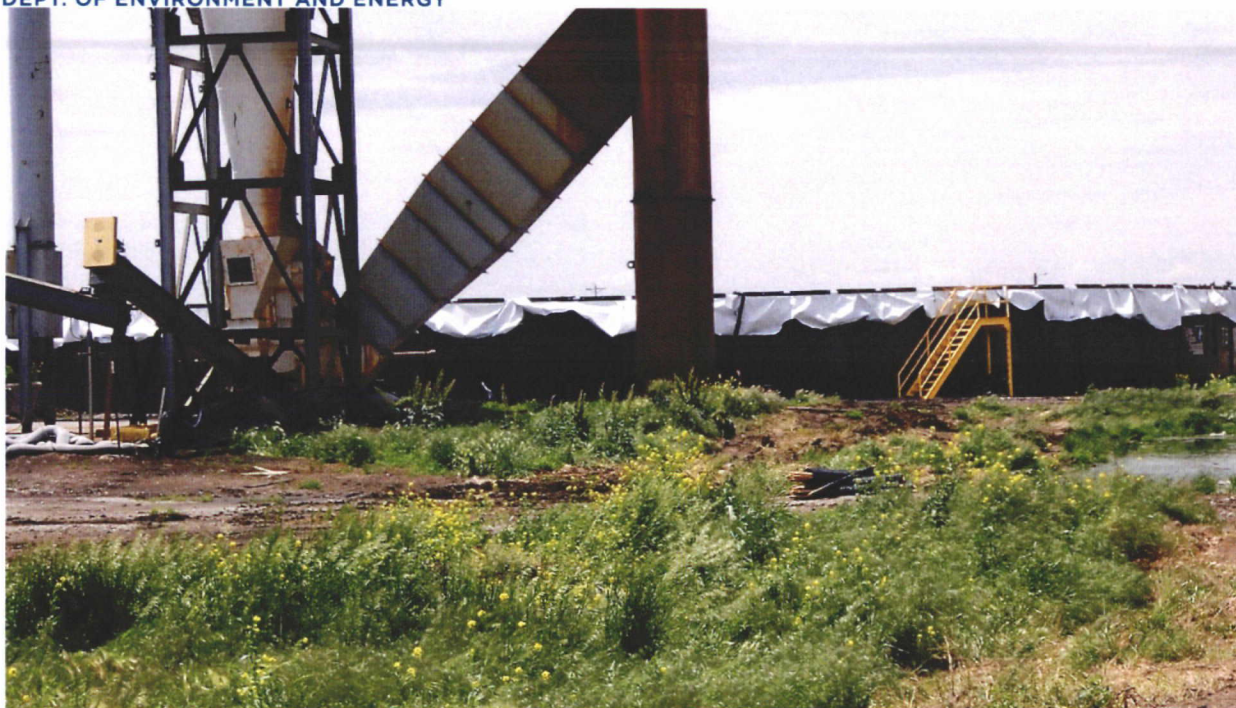
Photo: 16

- Clean Harbors has installed new silt fence. The silt fence does not contain all the spilled biochar product.
- The area continues to contain trash and debris.

Description: The facility has not installed BMPs.

x The Biochar area continues to have spilled product, trash and debris. The facility has not installed best management practices (BMPs).

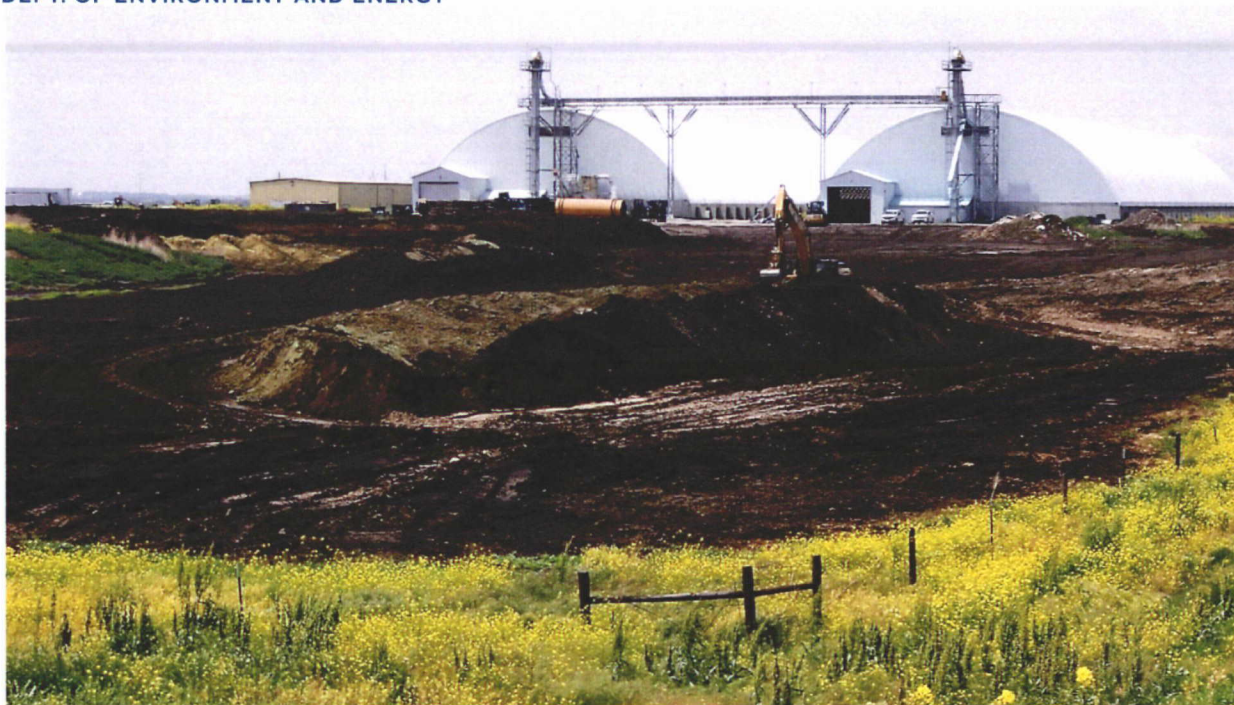
Photo: 17

Description: Clean Harbors is process of moving soil and wet cake to the west location. This is being done to make room for additional Poseidon Tanks.

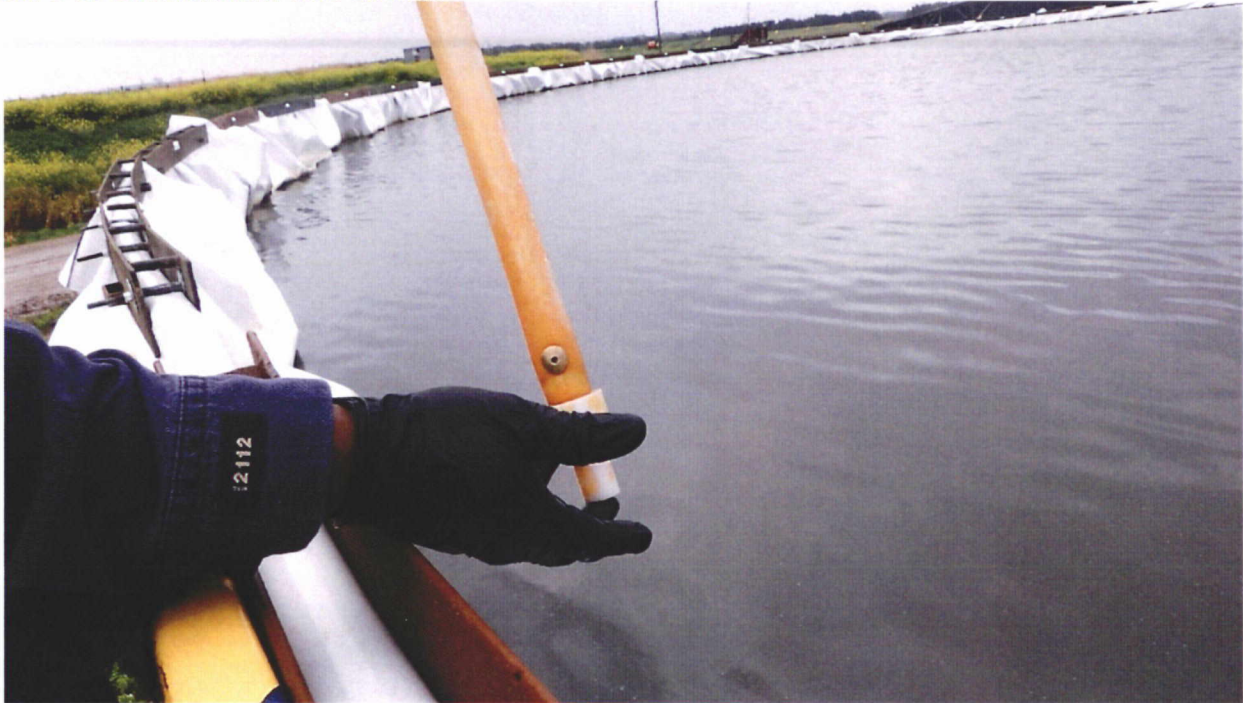
Photo: 19

1. Clean Harbors staff sampled each Poseidon tank using a sludge judge. Each tank varied of how many sludge judge draws were used. Tank #1 (East tank) 8 samples, Tank #2 (Middle Tank (9 samples) and Tank #3 (West tank) 12 samples. The sludge judge was not rinsed between tanks.

Description: This photo depicts the sludge judge used to collect samples. The sampler places the tube straight down of the platform until it reaches the bottom.

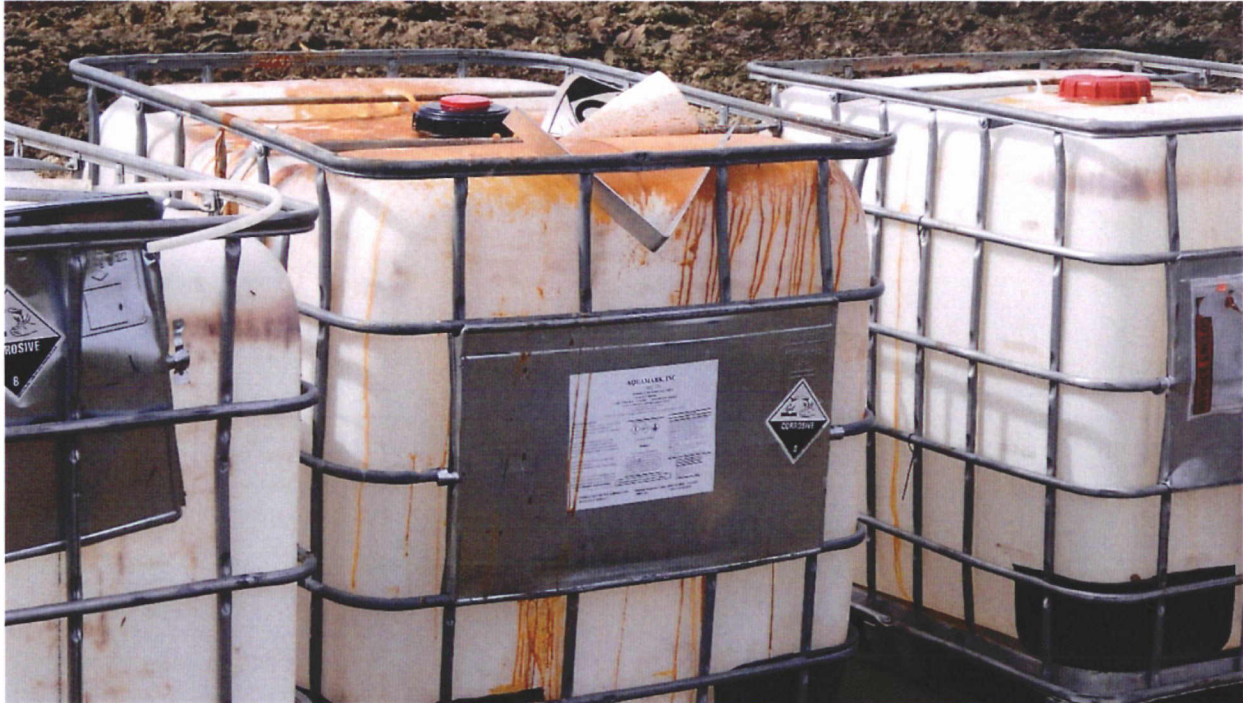
Photo: 30

Description: This photo depicts corrosive chemical staining a chemical tote used to transfer water from area 6.
