Facility: AltEn, LLC
IIS: 84069
PCS: NE0137634

Jason Windhorst
5/14/2021

Site Visit Check list

Site Visit Report

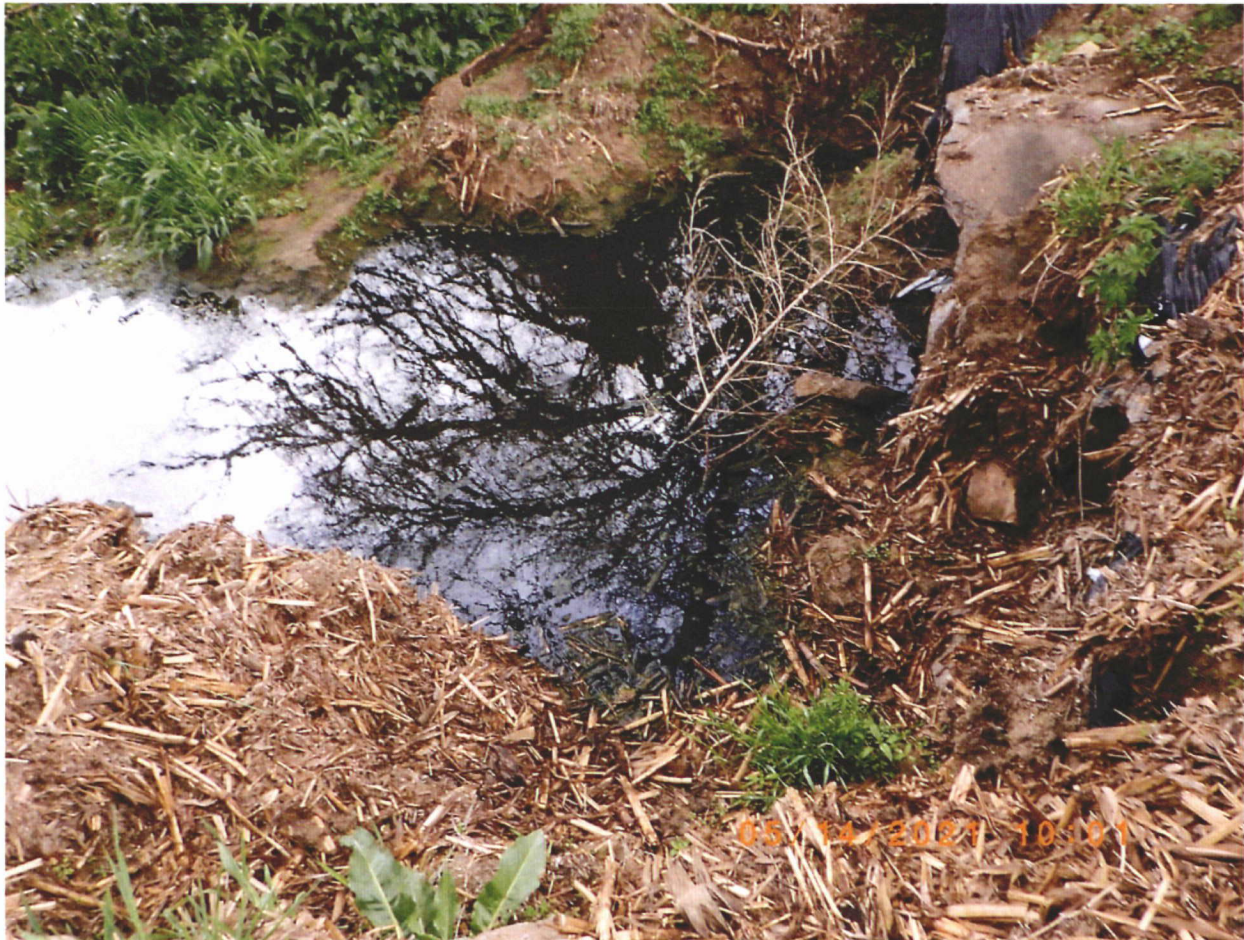
Photos: 1

Location: Culverts at CR 9 & J

Description: The water in the ditch has had periodic flow and appears slightly clearer than it was on the last site visit.

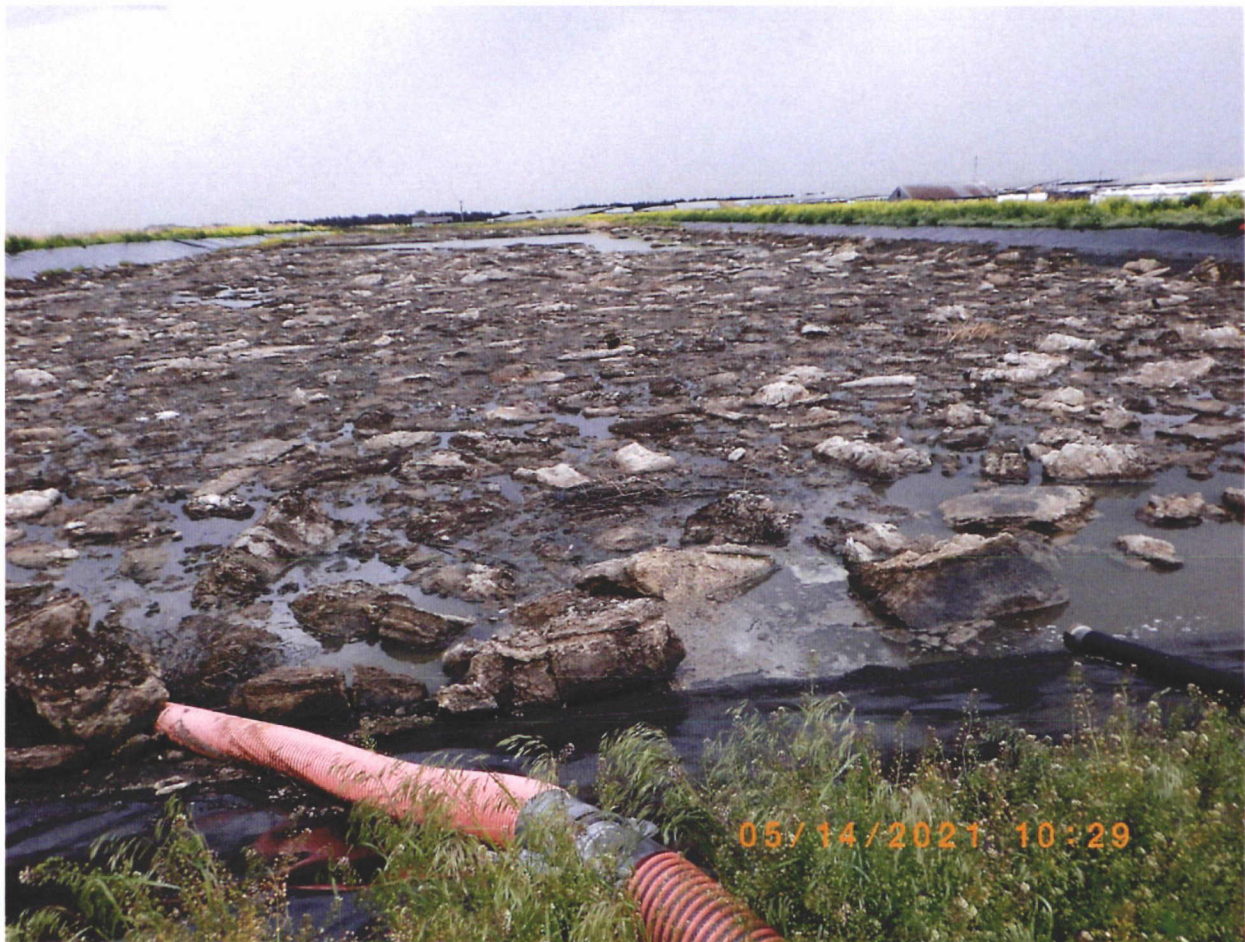
Photos: 2

Location: West edge of the emergency lagoon.

Description: No pumping was observed during the site visit, only additional solids floating over most of the lagoon.

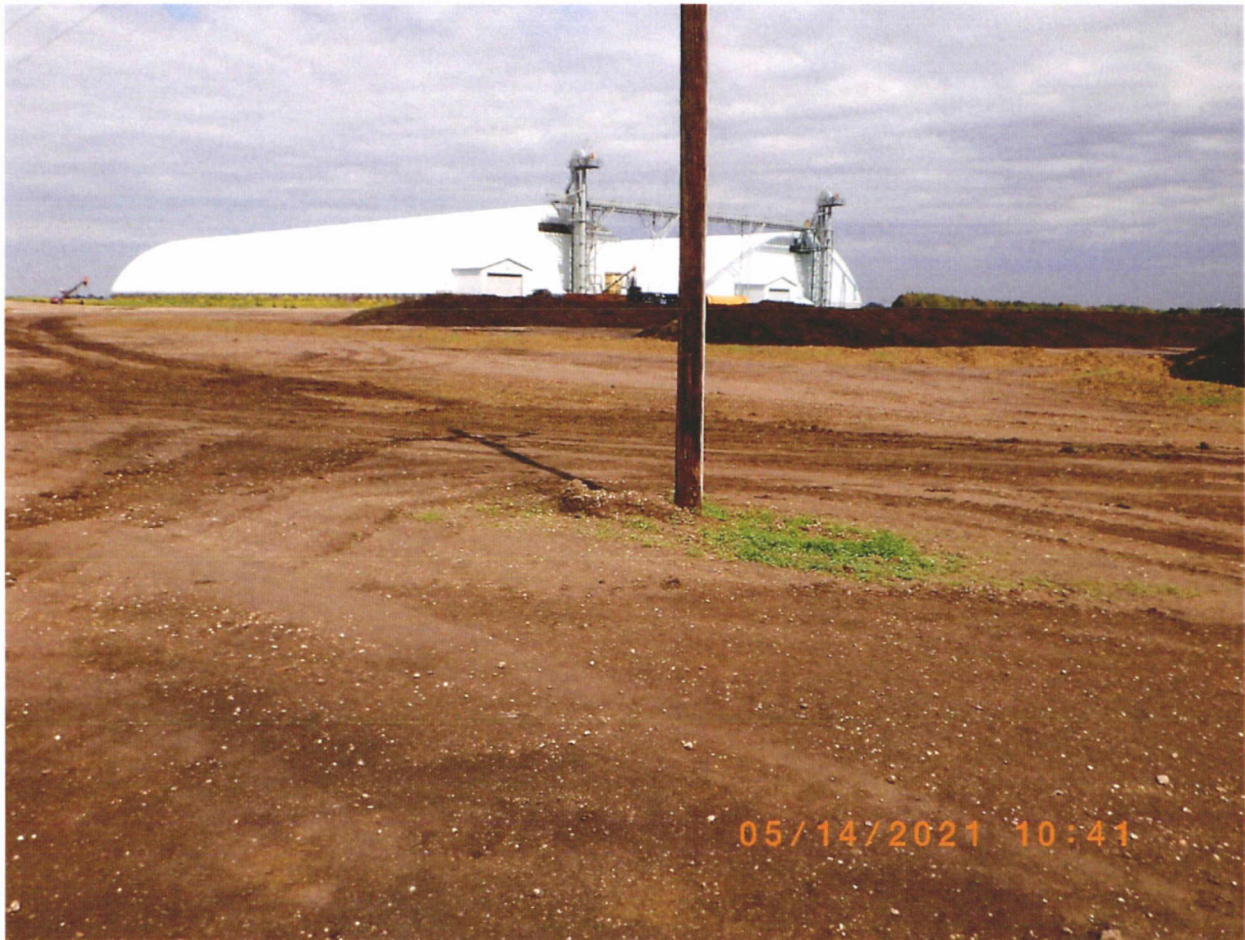
Photos: 3

Location: Area 1 on the site map.

Description: Area diverted from the first bermed section consisting of access roads and parking.

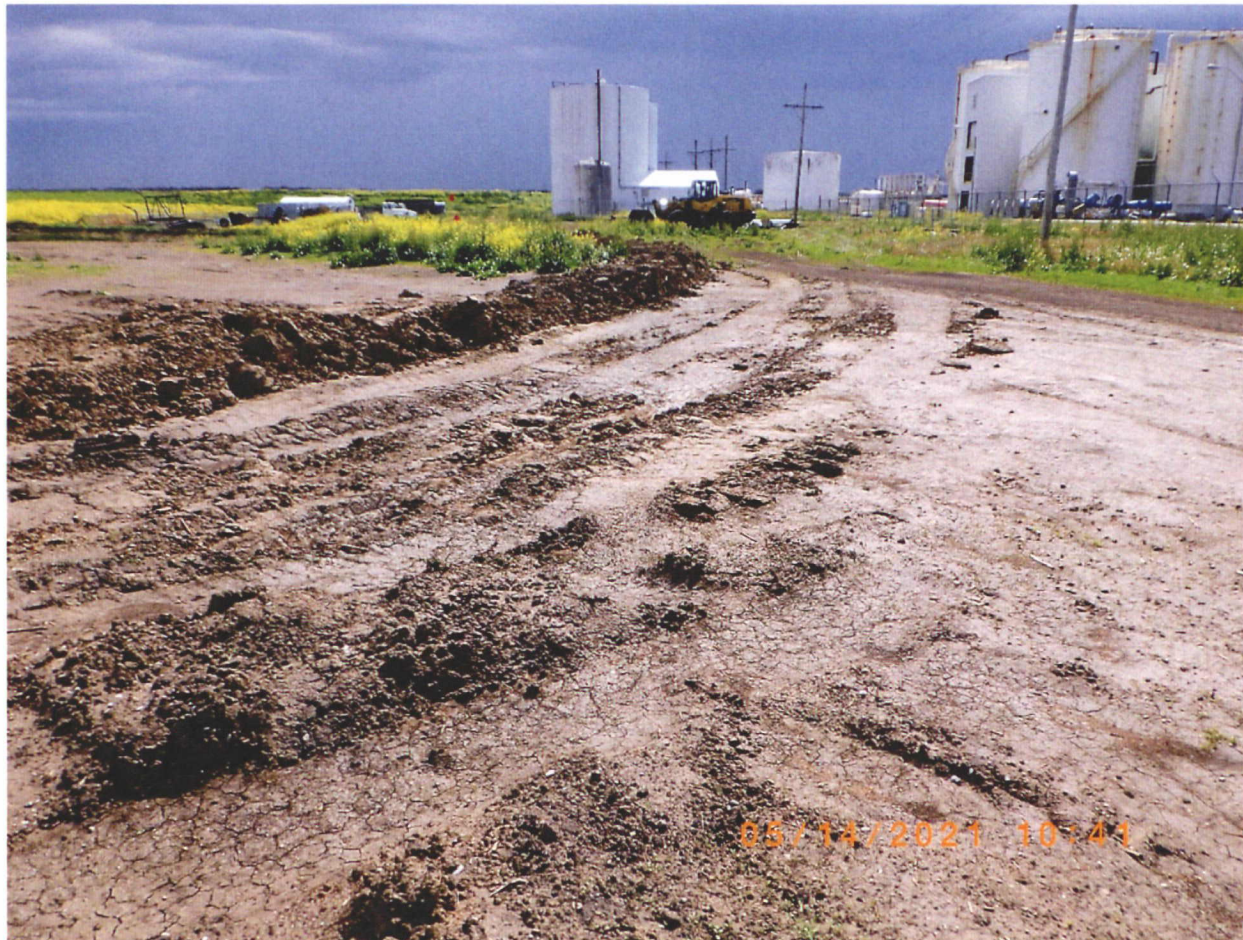
Photos: 4

Location: Area 1 on the site map.

Description: Berm diverting access road and parking lot runoff.

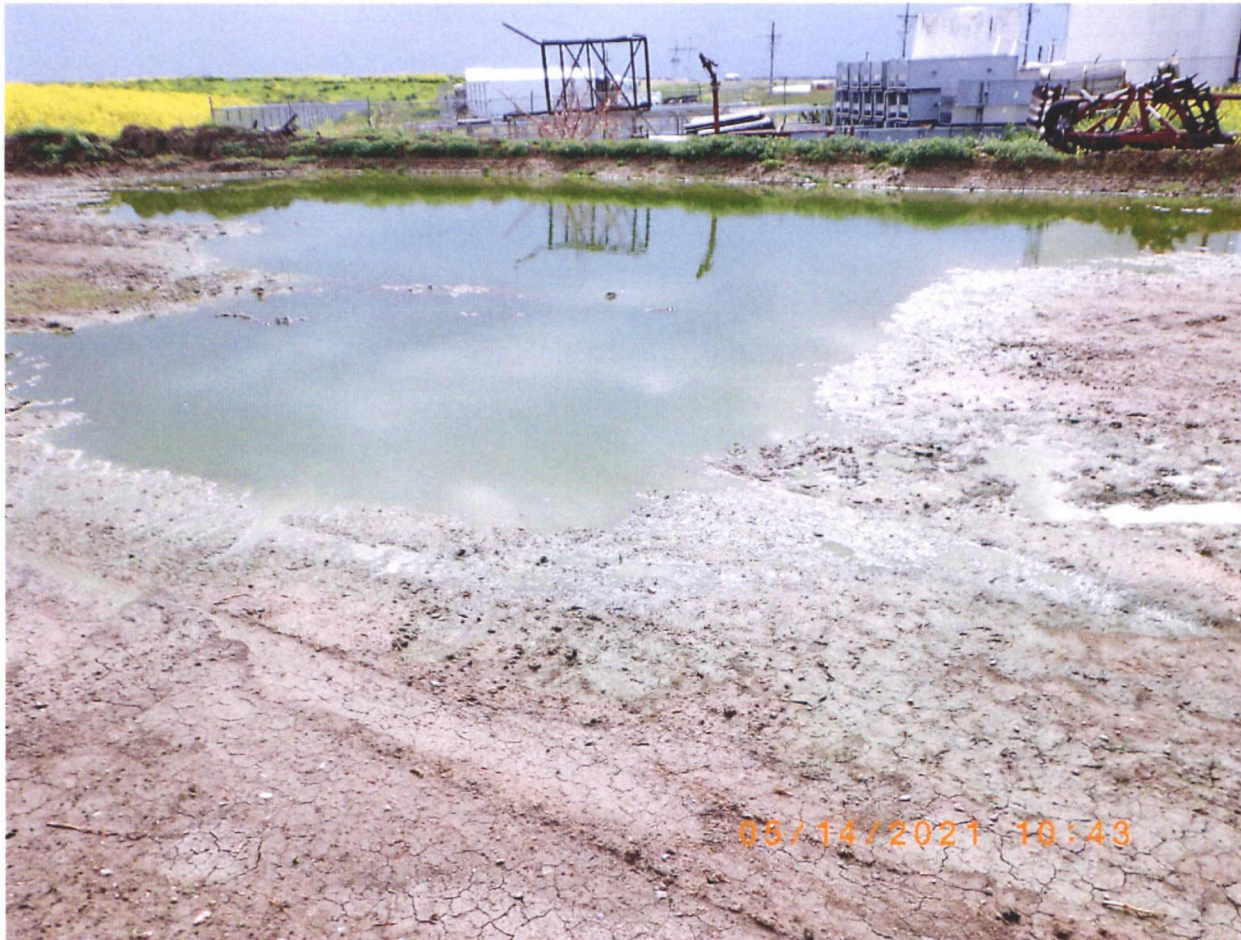
Photos: 5

Location: Area 1 on the site map.

Description: First bermed area holding excess runoff, ponded water and has a green hue.

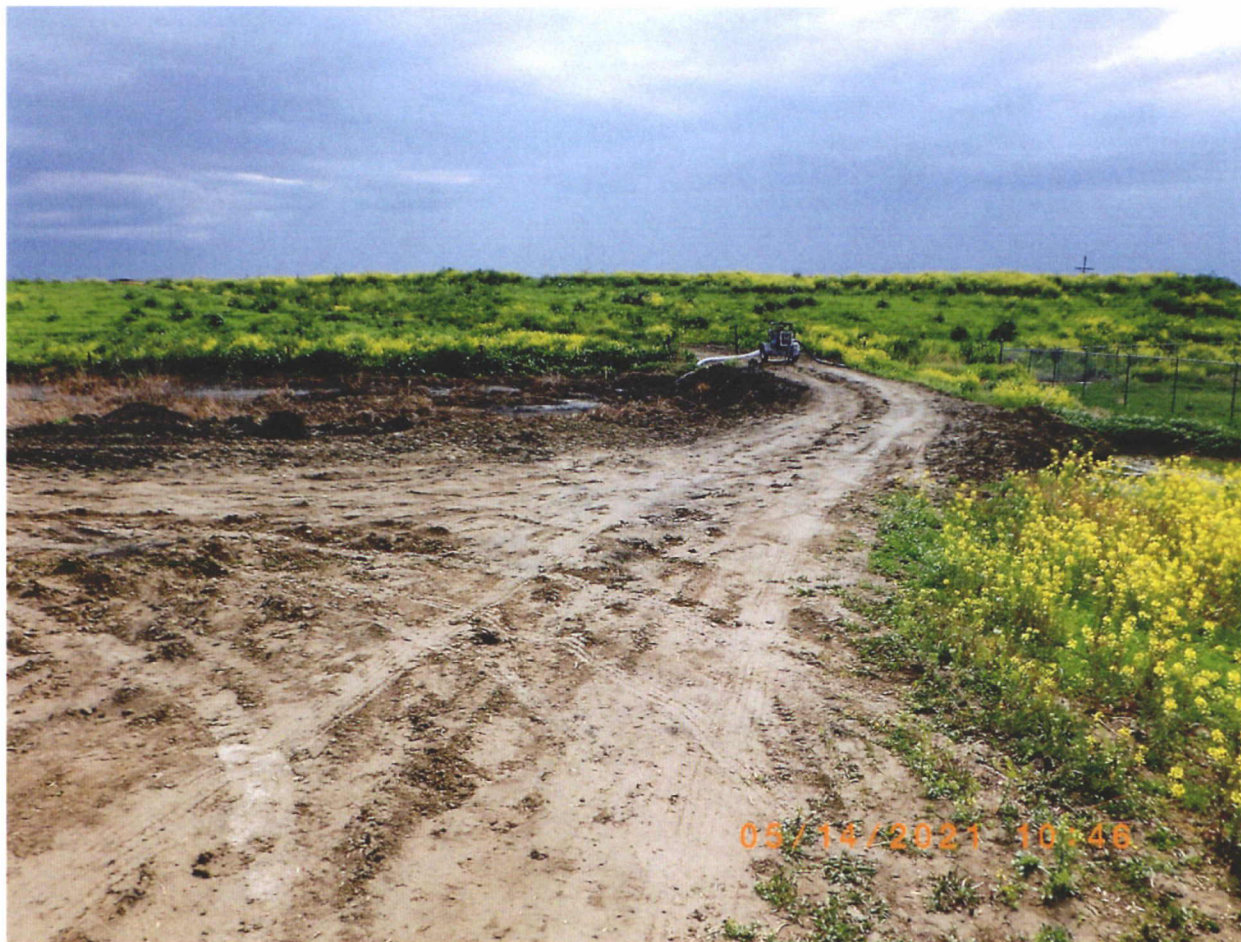
Photos: 6

Location: Area 2 on the site map.

Description: Bermed area was recently pumped and appears to be in good condition.

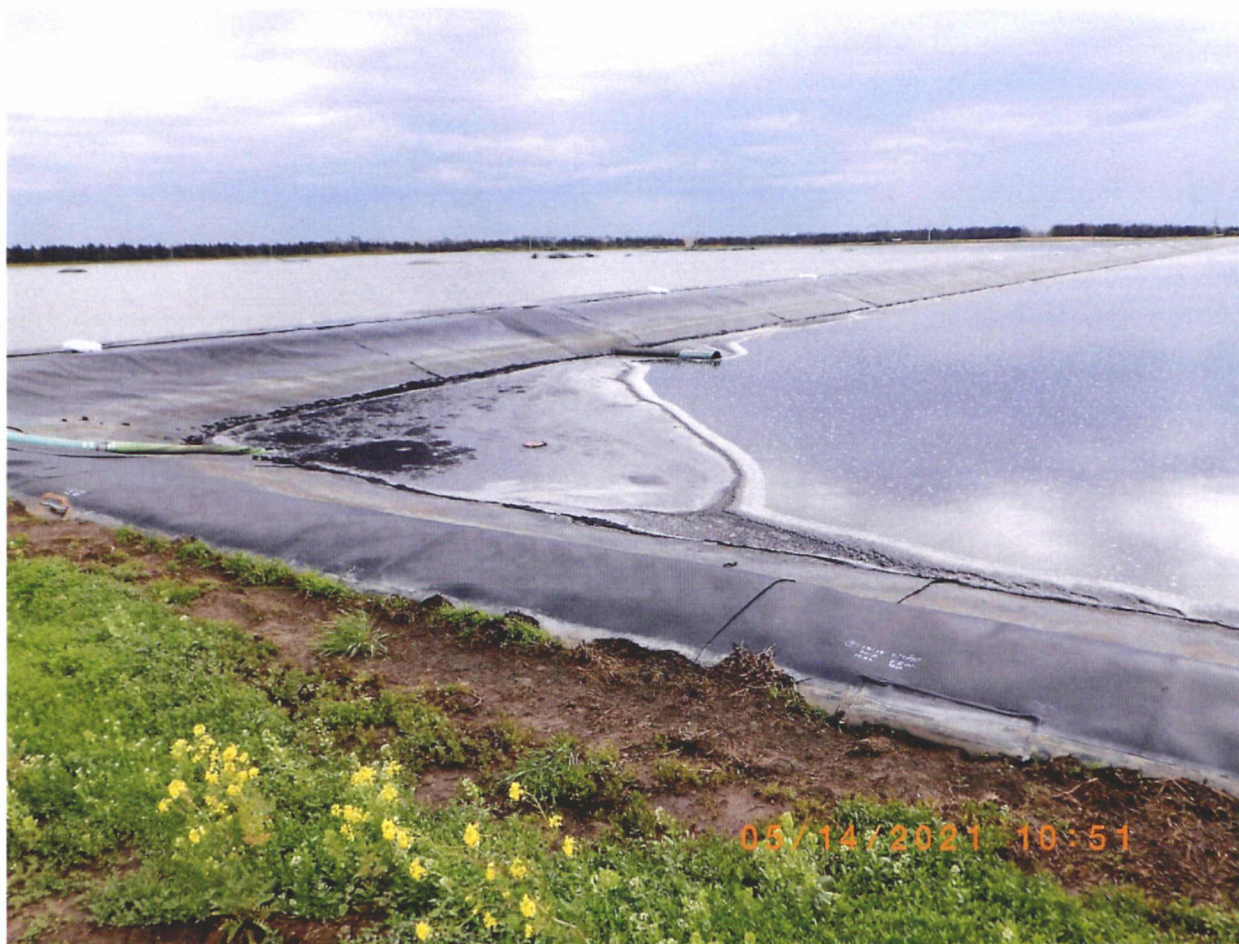
Photos: 7

Location: Northwest corner of the southeast lagoon.

Description: Lagoon is bubbling across the majority of the lagoon and black foam is accumulating along the edges again.

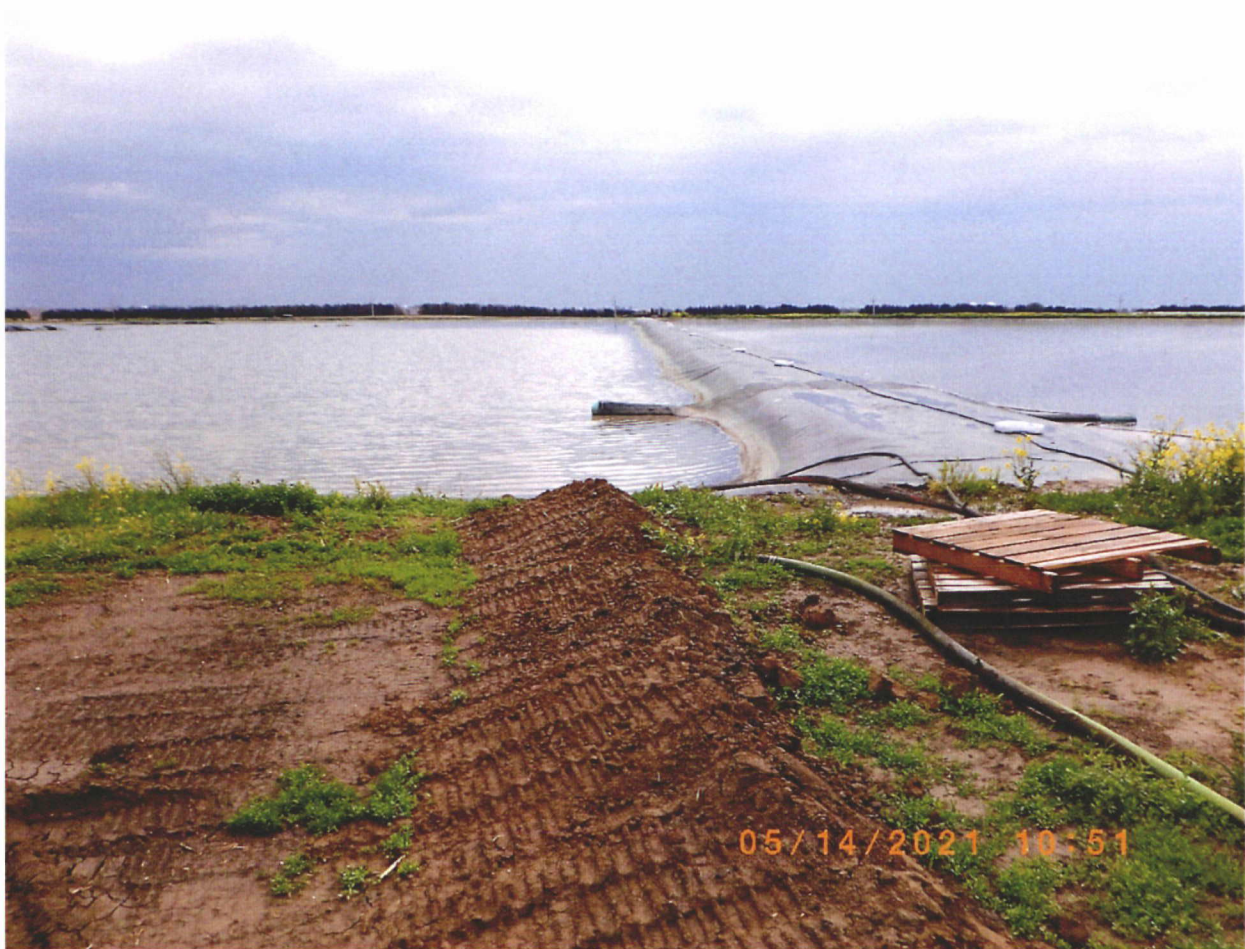
Photos: 8

Location: Southeast corner of the northwest lagoon.

Description: Small berm around the pumping operation at the lagoon area.

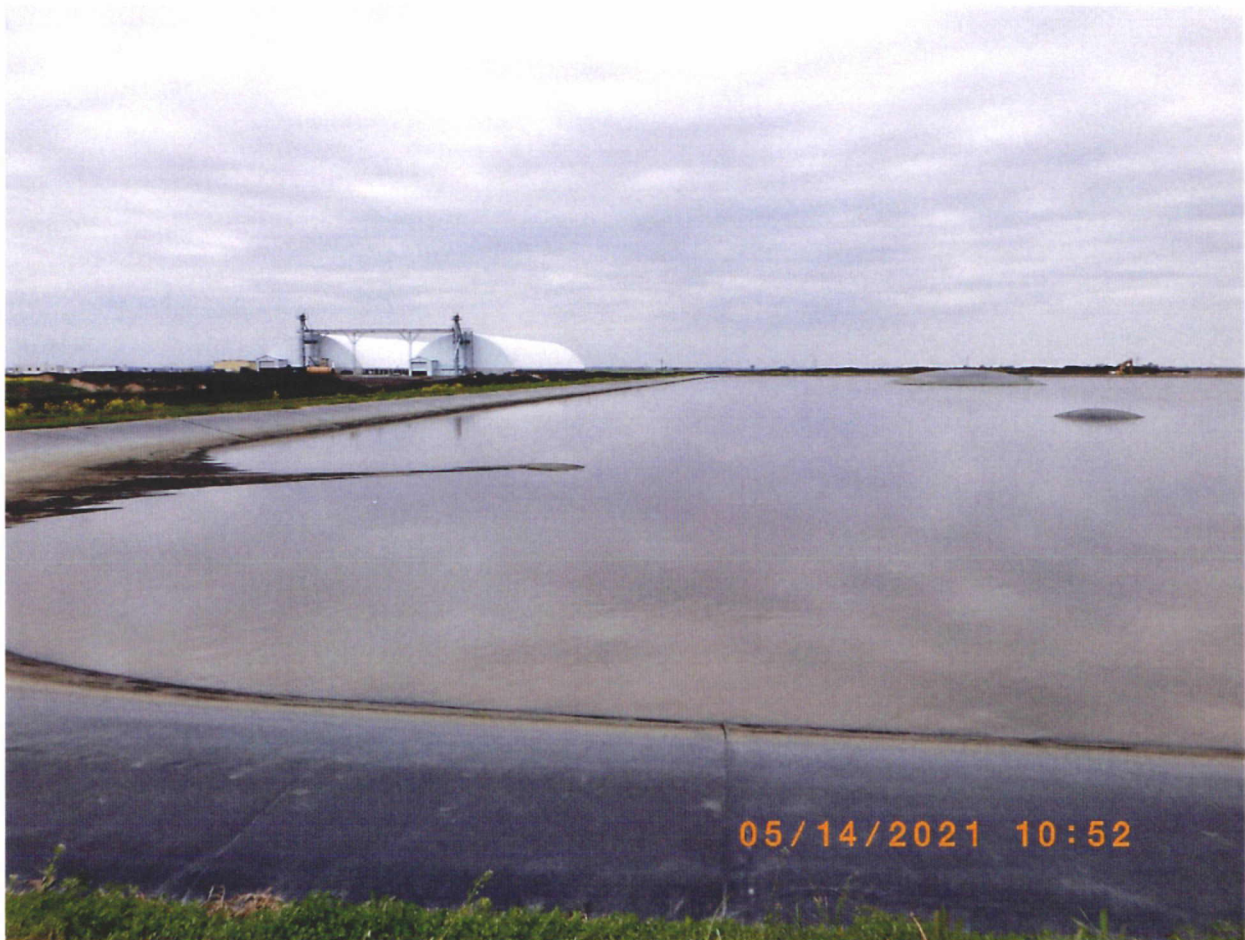
Photos: 9

Location: Southeast corner of the northwest lagoon

Description: Stretched section of the northeast lagoon liner and small whale that recently reemerged.

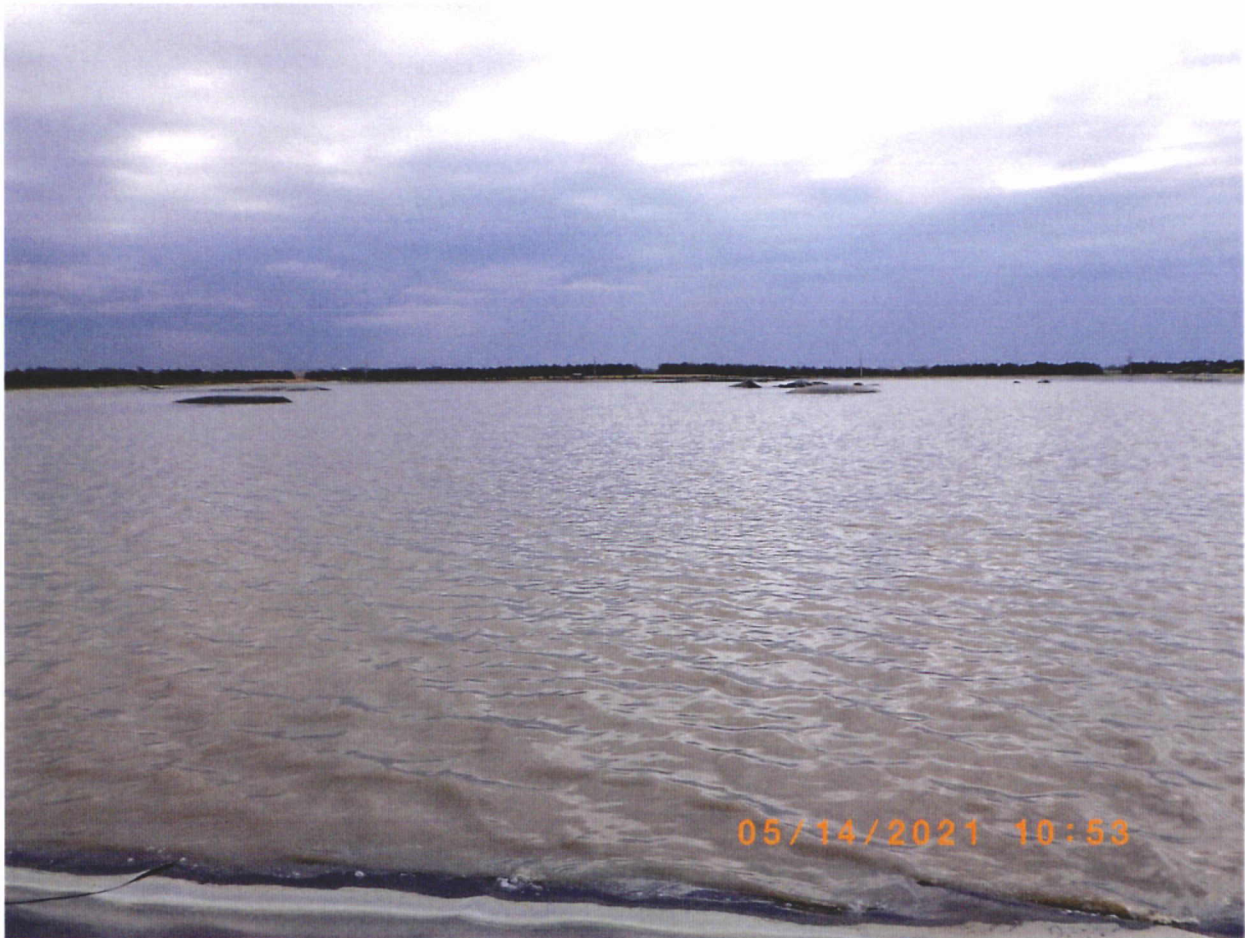
Photos: 10

Location: Midway along the west side of the northeast lagoon

Description: Little change observed in the northeast lagoon. The lagoon showed minimal degassing and liner movement. The lagoon level was higher than the last week due to the pumping from the emergency lagoon.

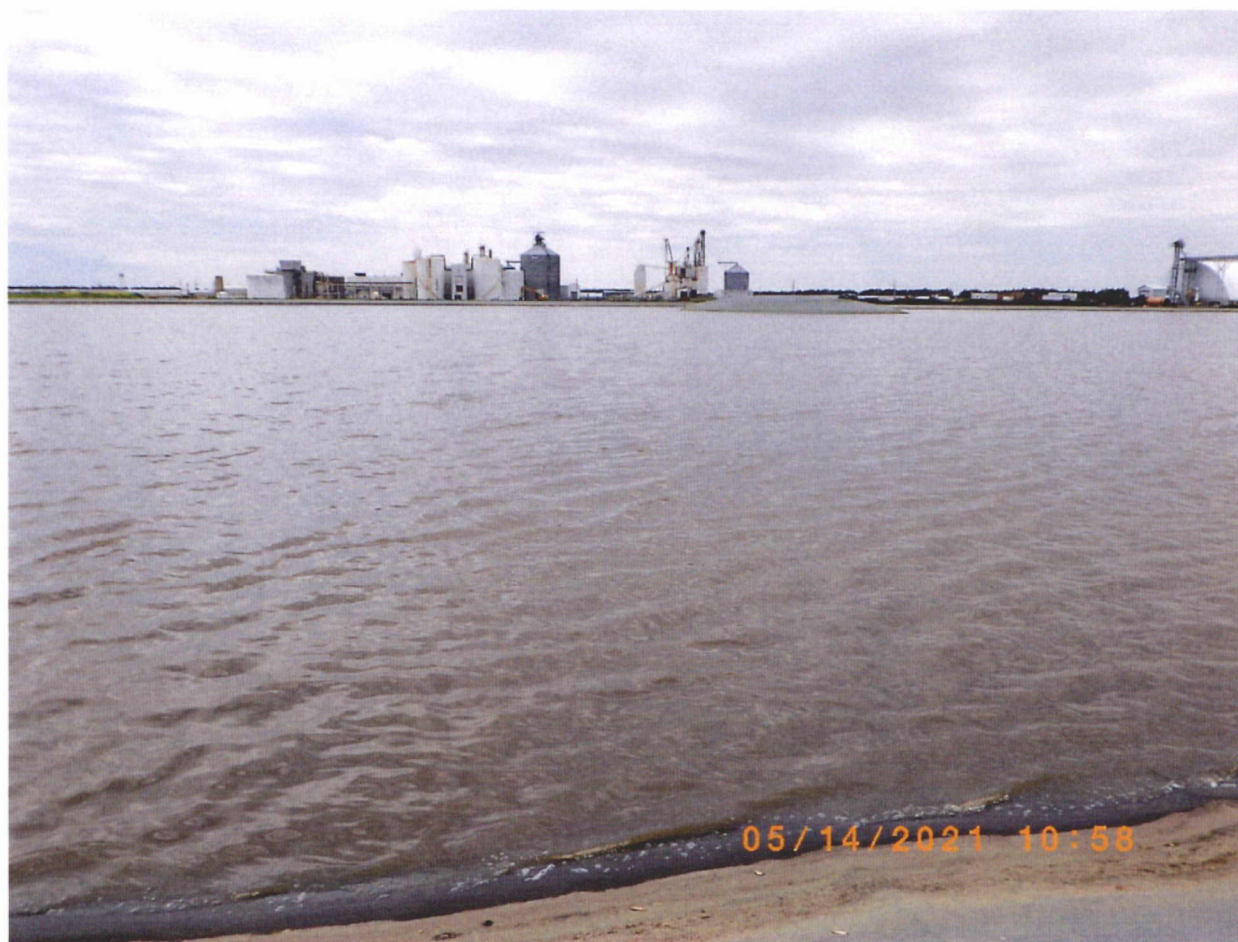
Photos: 11

Location: West of the northeast corner of the northwest lagoon.

Description: Persistent whale stationary along the south side of the lagoon.

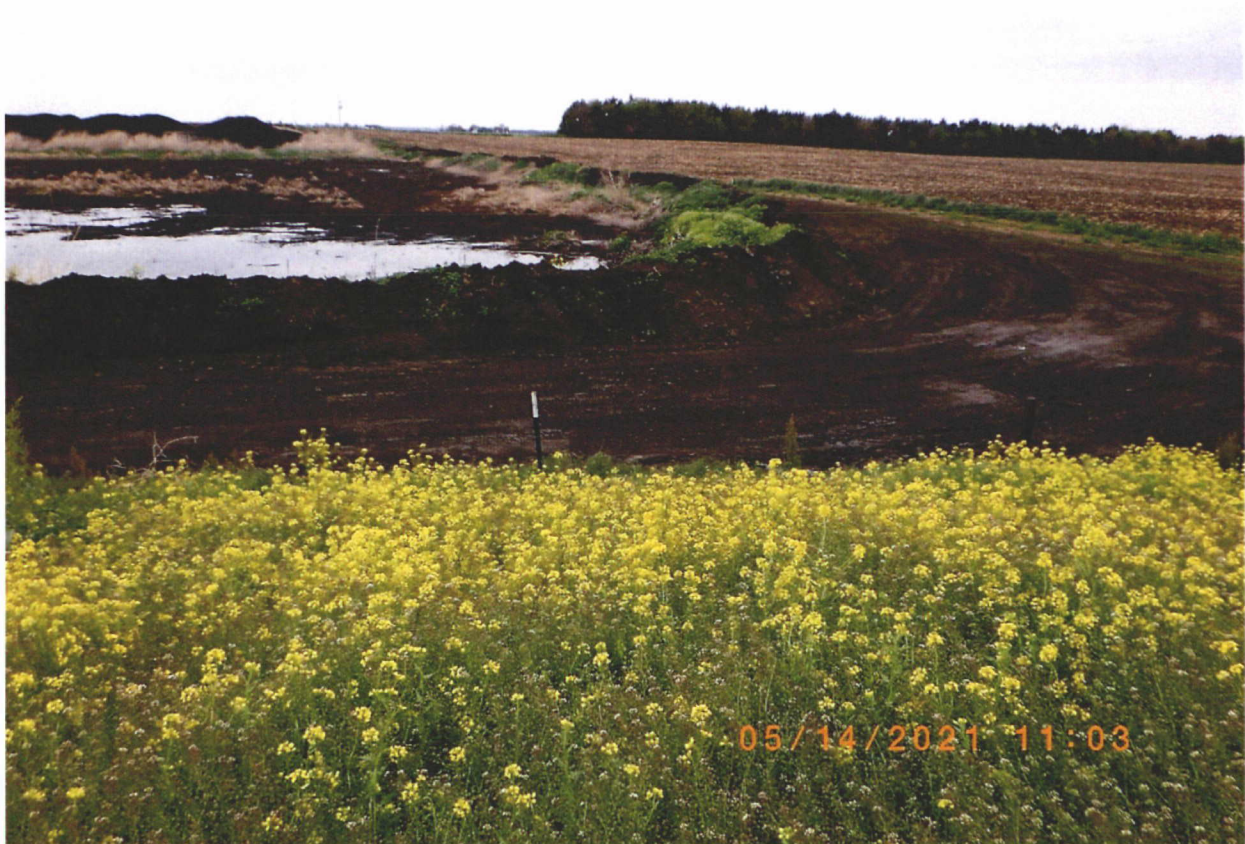
Photos: 12

Location: Area 3 on the site map.

Description: Berms are in good condition and have no evidence of seepage. Clean Harbor's is improving access around the northwest wet cake and maintaining any seepage points in the berm.

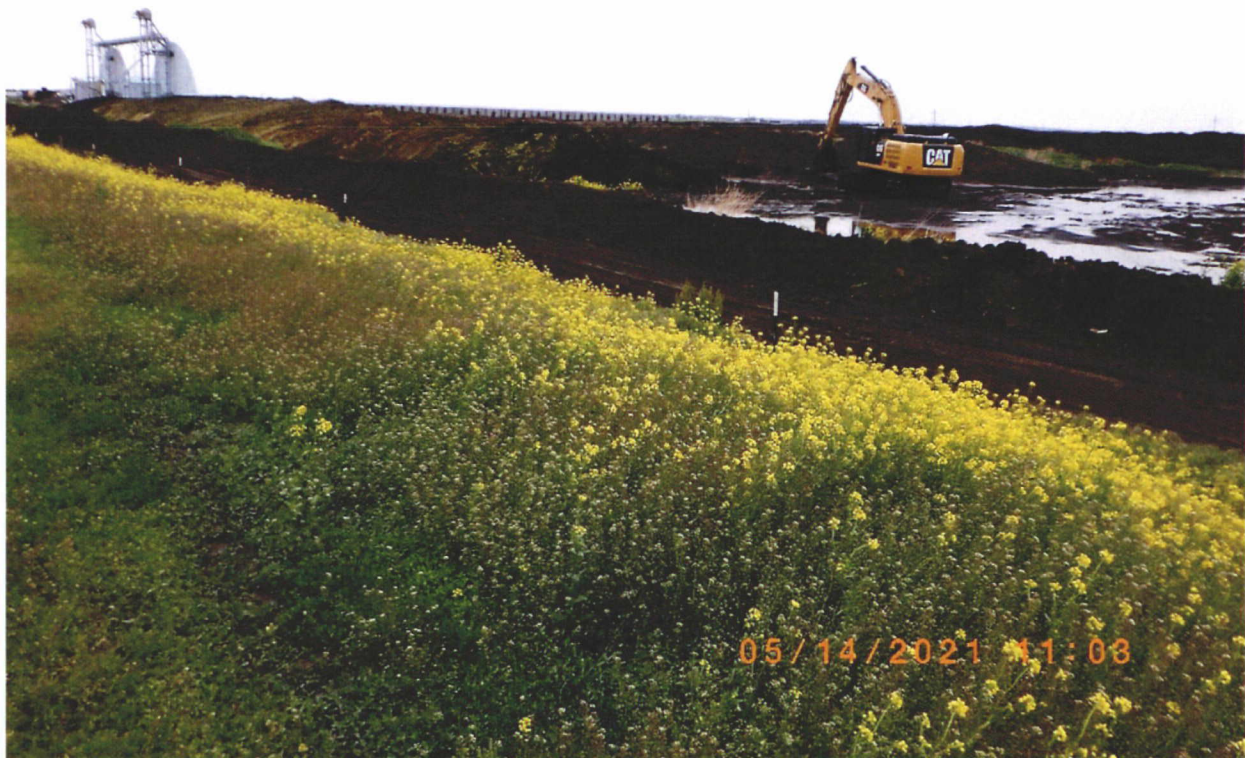
Photos: 13
Site Visit Report
Date Taken: 5-14-2021
Photographer: Jason Windhorst
Facility Name/ Project Name: AltEn LLC
Facility IIS number / Project identifier: IIS: 84069 / NE0137634
Location: Area 3 on the site map.
Direction Facing: Southwest
Description: Clean Harbor is using a backhoe to manage wet cake in order to increase drainage and consolidate material from the central storage area.

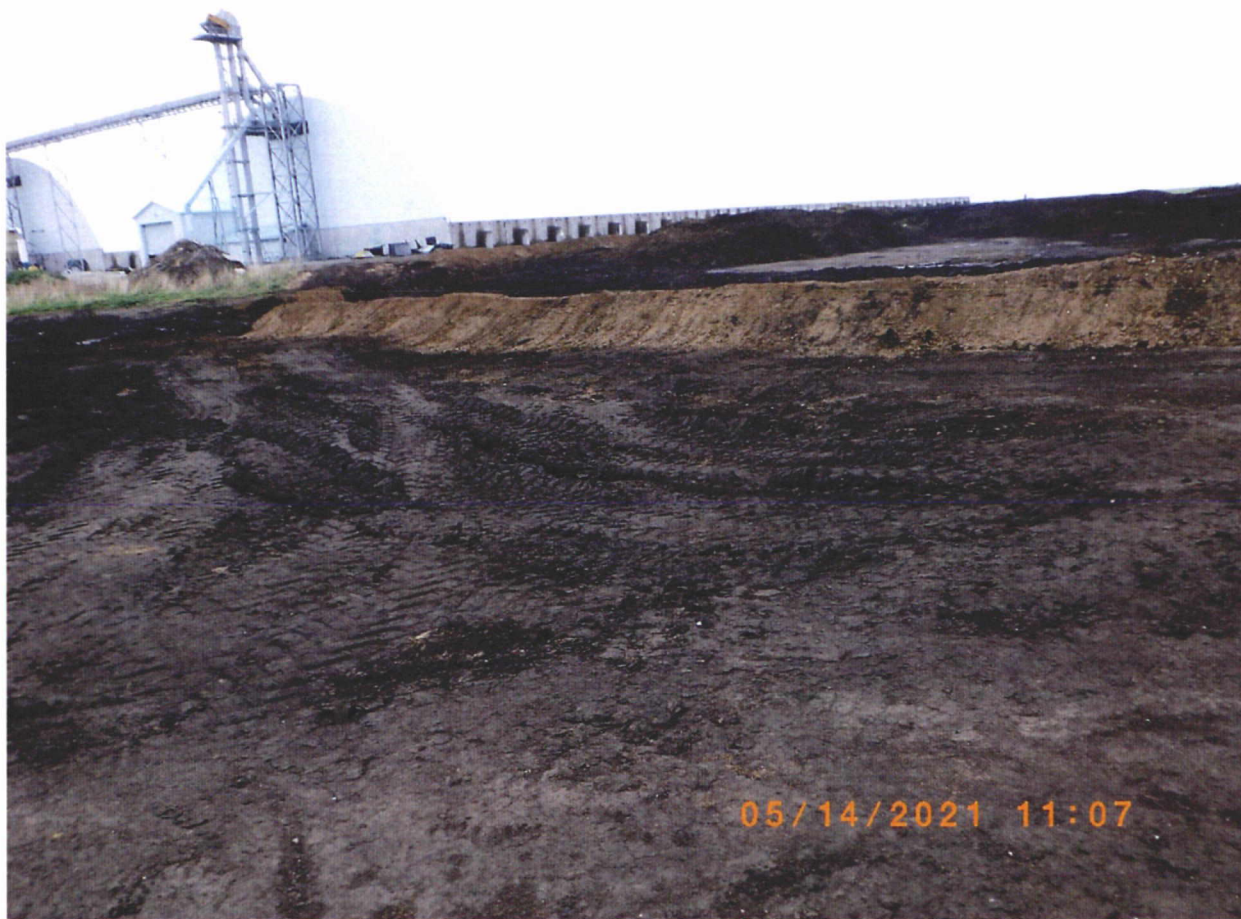
Photos: 14

Location: Southwest of the northwest lagoon.

Description: New berm being constructed enclosing the northwest wet cake storage area. Drainage is directed to the same area that area 5 was trenched to.

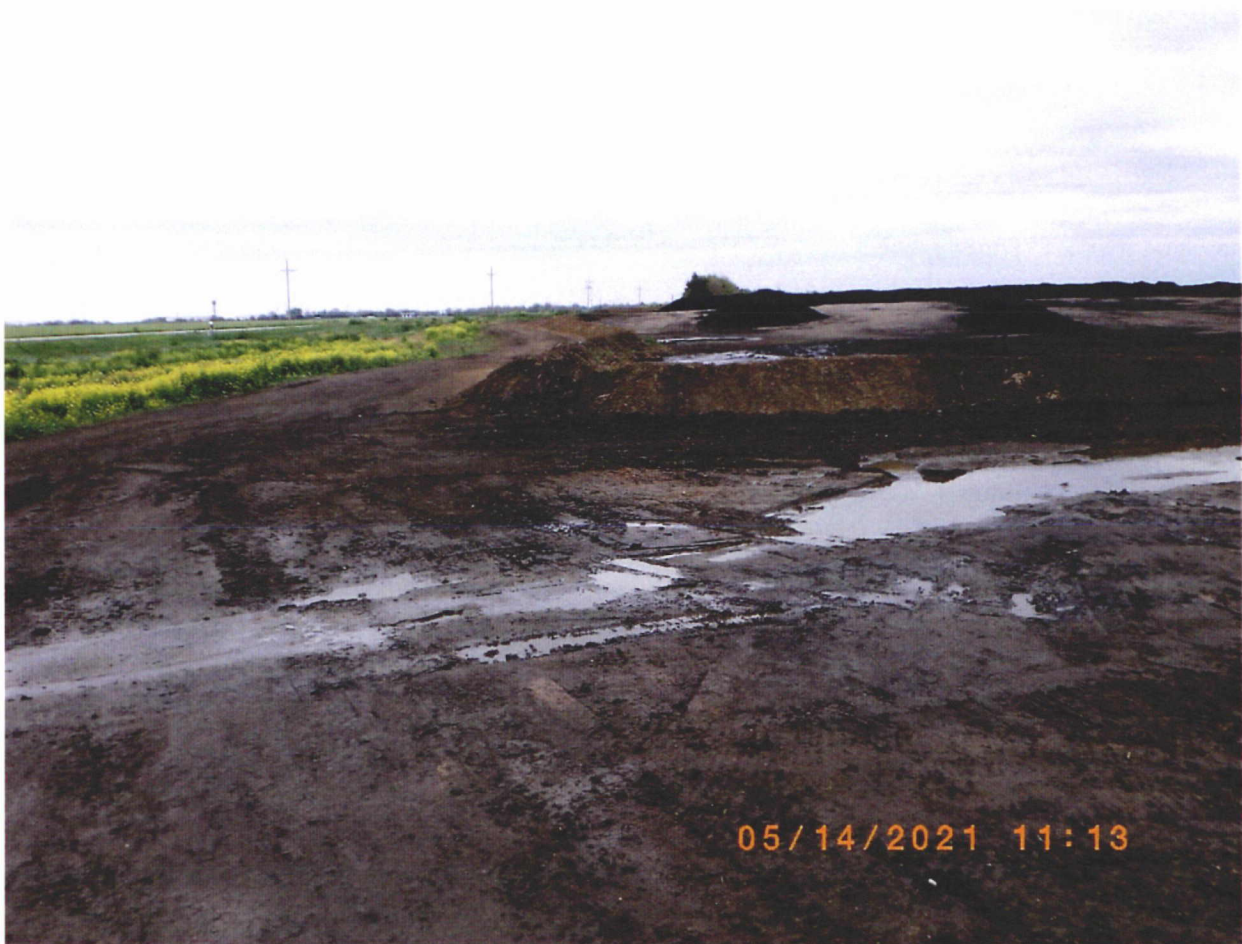
Photos: 15

Location: Area 5 on the site map

Description: Berm has been moved to the north and raised in order to decrease ponding. Water is diverted from the outside of the berm through regrading the area to drain to the west away from the wetcake area.

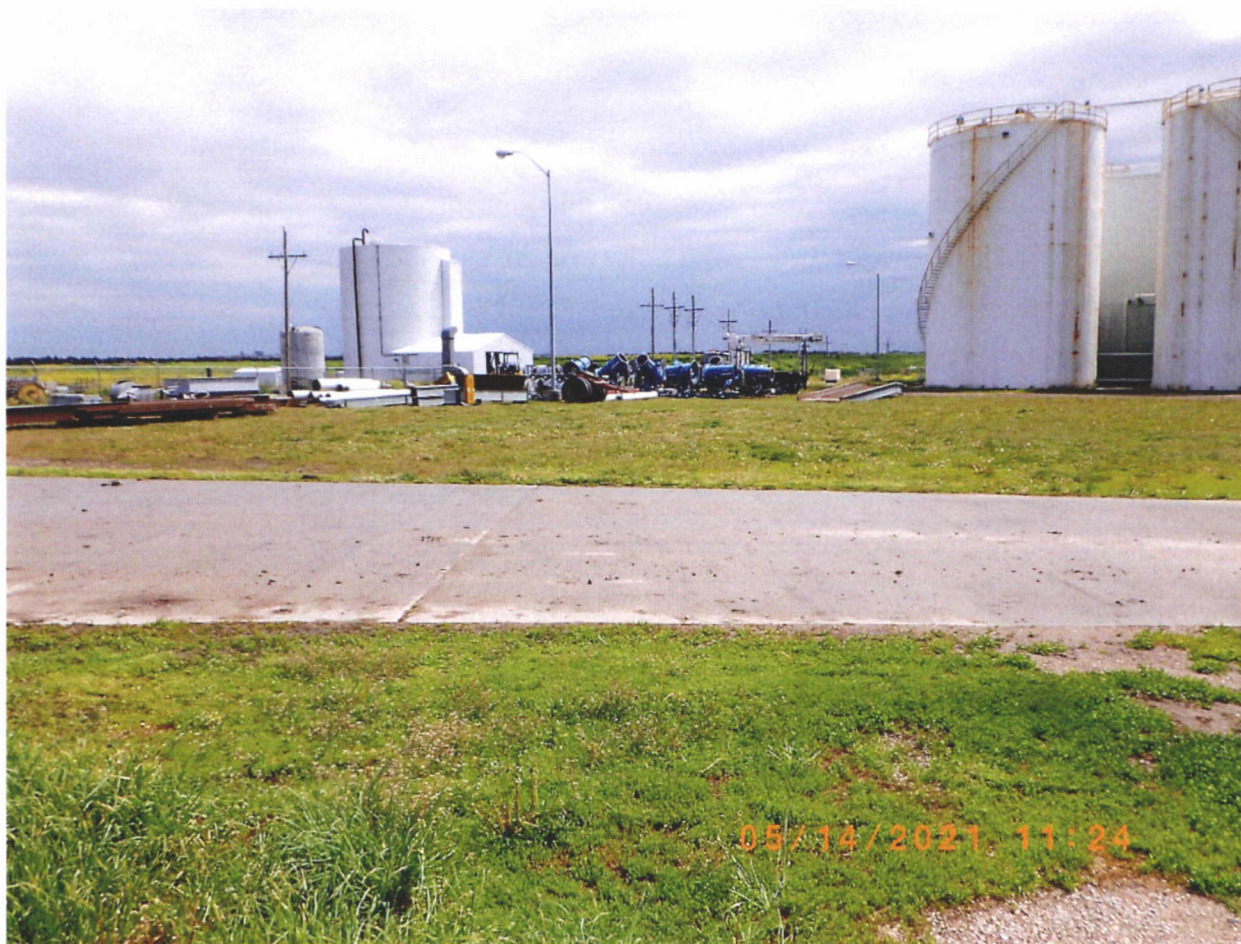
Photos: 16

Location: East side of the administration building

Description: Material being centralized for action in this area and southwest of the distillation pad.

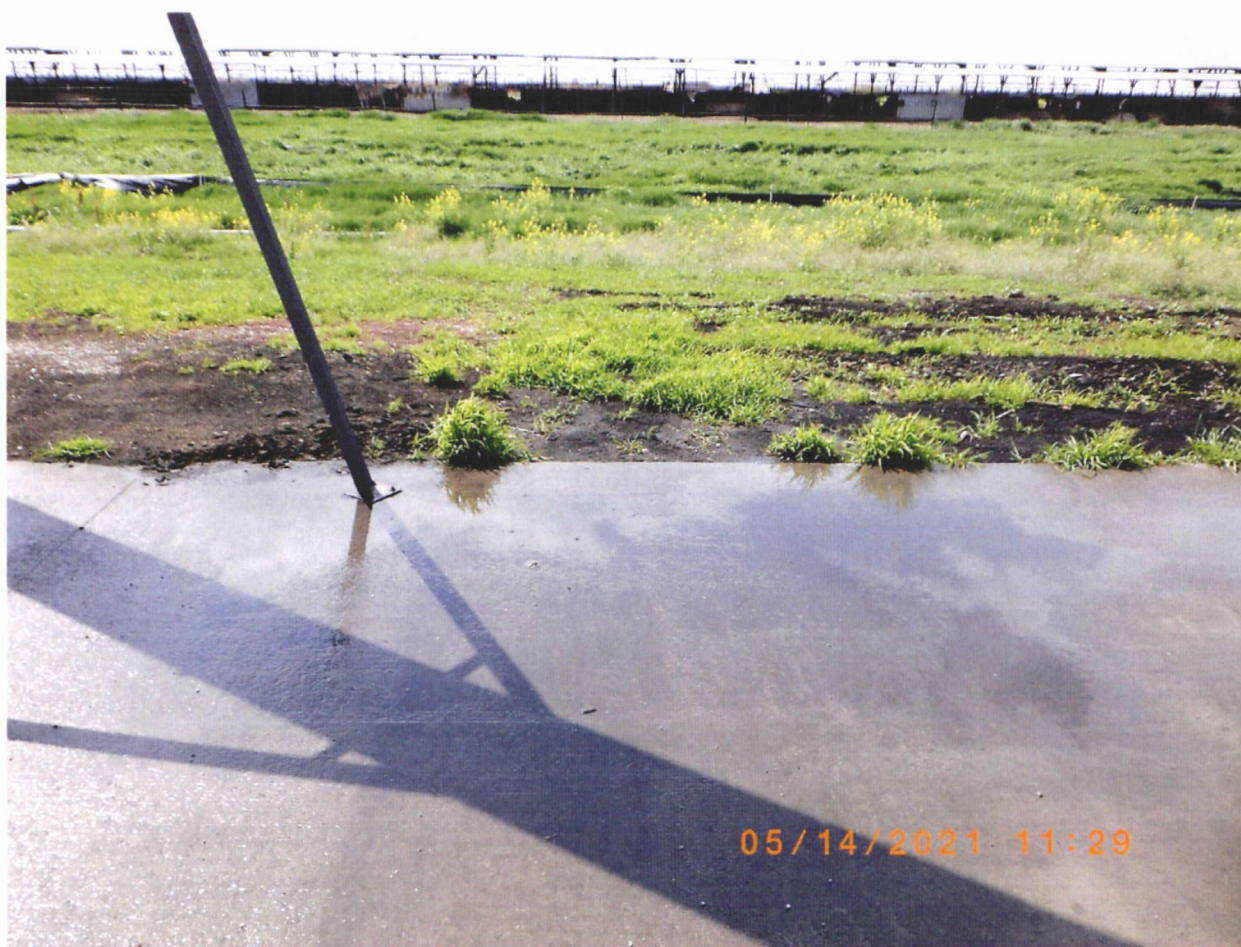
Photos: 17

Location: South side of the Biochar pad.

Description: The Biochar on the ground around the pad was pointed out to Clean Harbors in order to show what areas and material need to be cleaned up.

- Brokaw area in need of material removed from the ground ~~which~~ primarily on the south side.

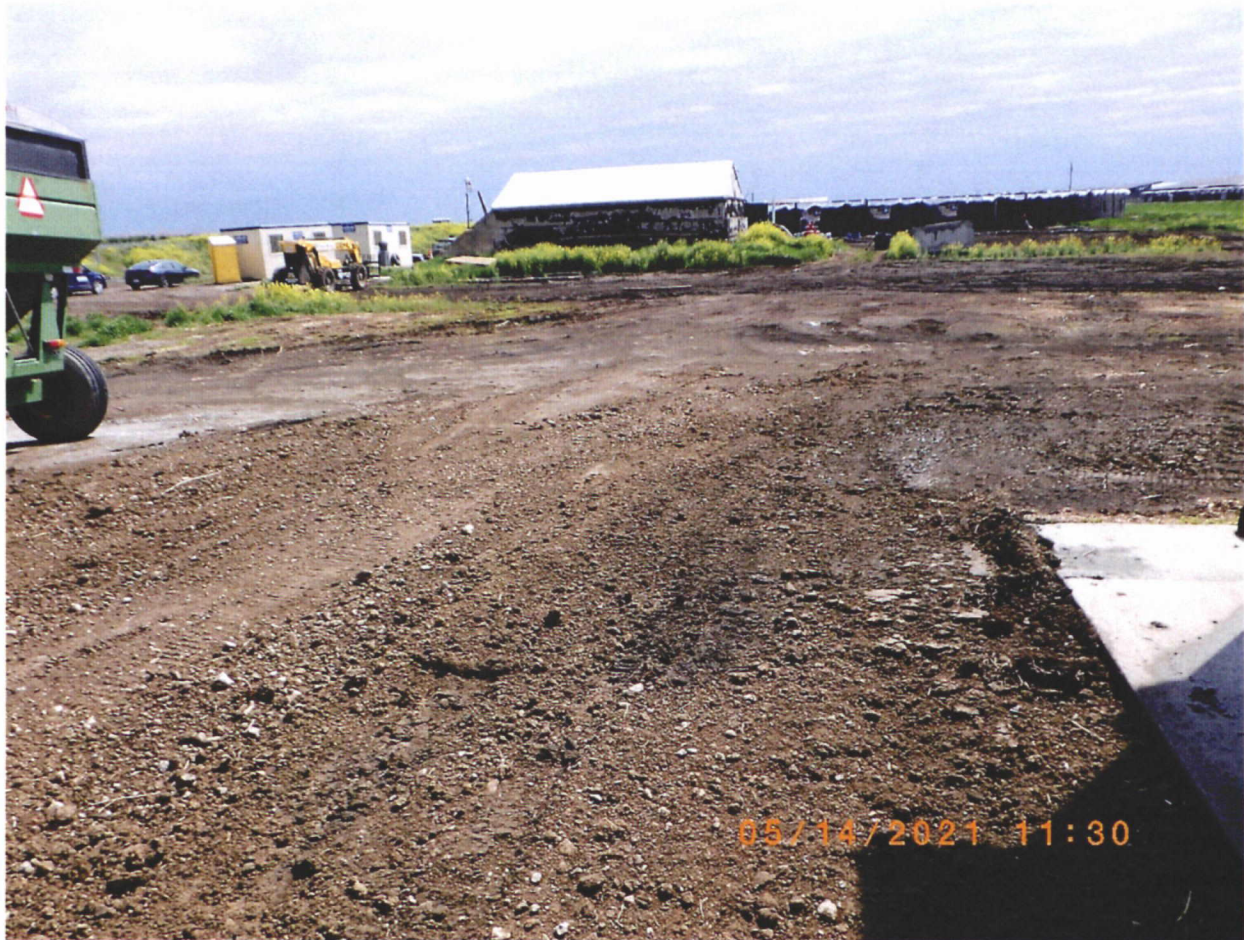
Photos: 18
Site Visit Report
Date Taken: 5-14-2021
Photographer: Jason Windhorst
Facility Name/ Project Name: AltEn LLC
Facility IIS number / Project identifier: IIS: 84069 / NE0137634
Location: East side of Biochar.
Direction Facing: East
Description: Area that has been cleaned up and had Biochar removed.

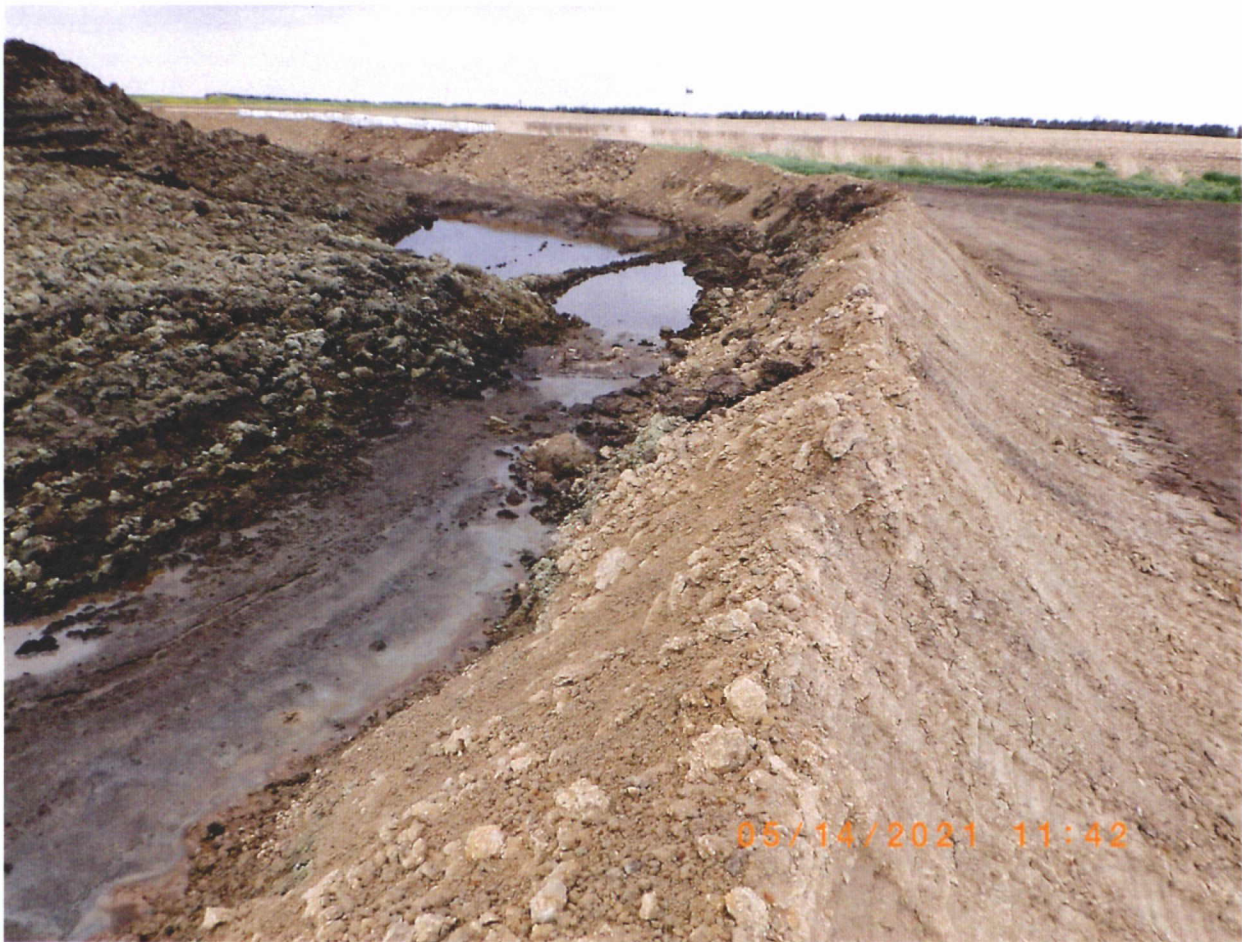
Photos: 19
Site Visit Report
Date Taken: 5-14-2021
Photographer: Jason Windhorst
Facility Name/ Project Name: AltEn LLC
Facility IIS number / Project identifier: IIS: 84069 / NE0137634
Location: Area 6 on the site map. (Northeast corner of wetcake)
Direction Facing: North
Description: Reinforced berm holding and not showing signs of seepage.
