Facility: AltEn, LLC
IIS: 84069
PCS: NE0137634

Jason Windhorst
5/14/2021

Site Visit Check list

Site Visit Report

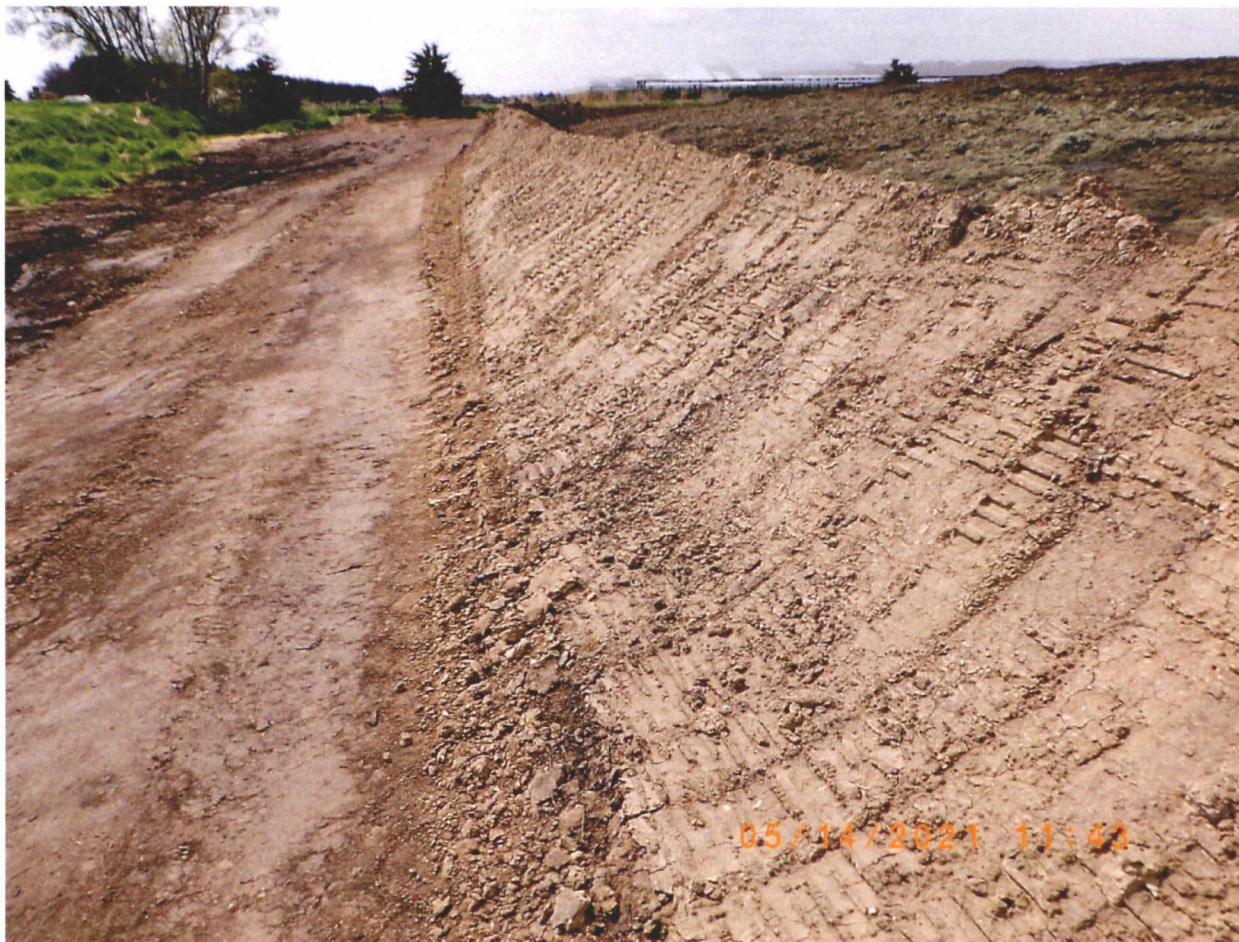
Photos: 20

Location: Same as photo 19.

Description: Clean berm showing no sign of seepage and most of material cleaned up from the lower berm.

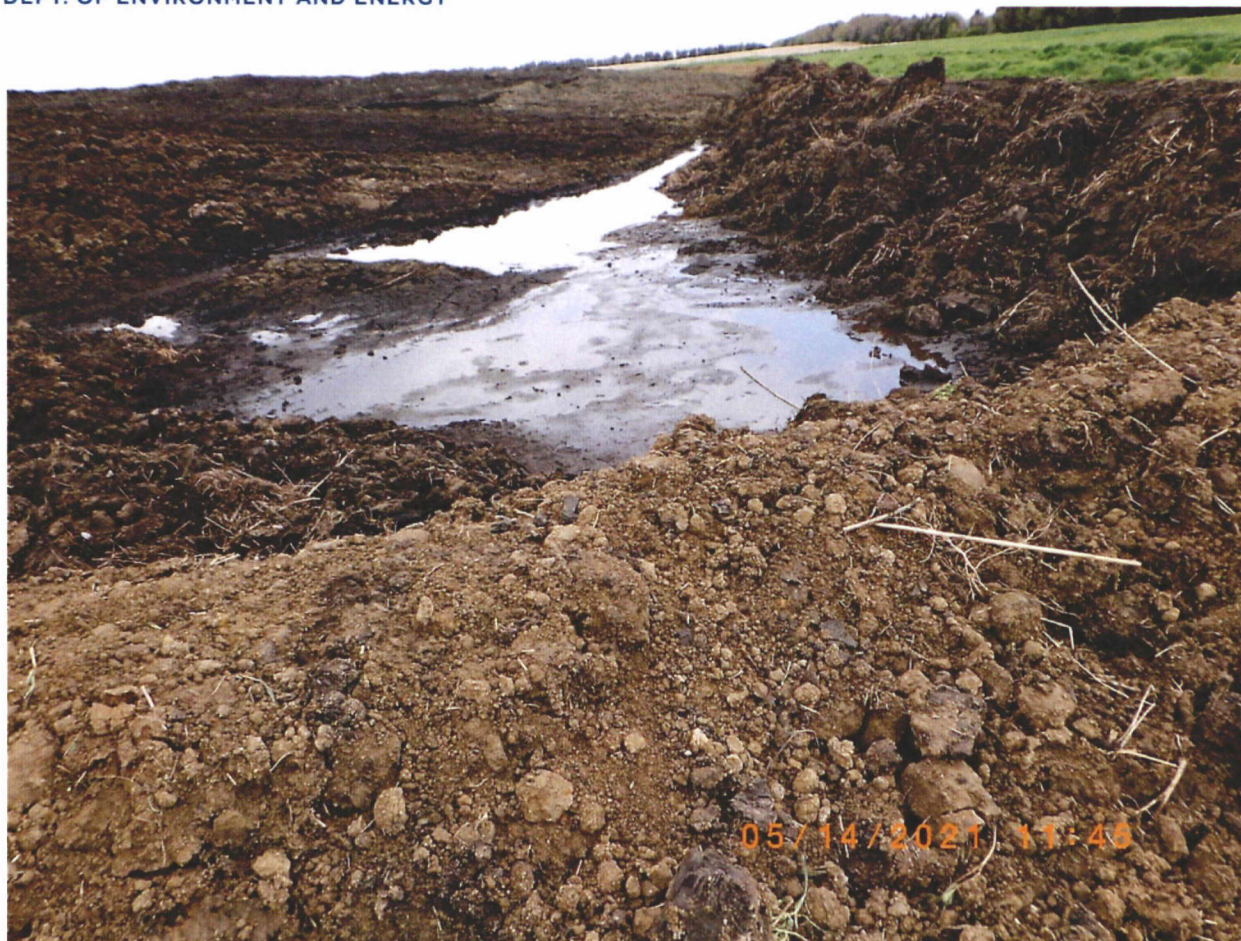
Photos: 21

Location: Area 6 on the site map. (southeast corner)

Description: Runoff beginning to pond behind the berm.

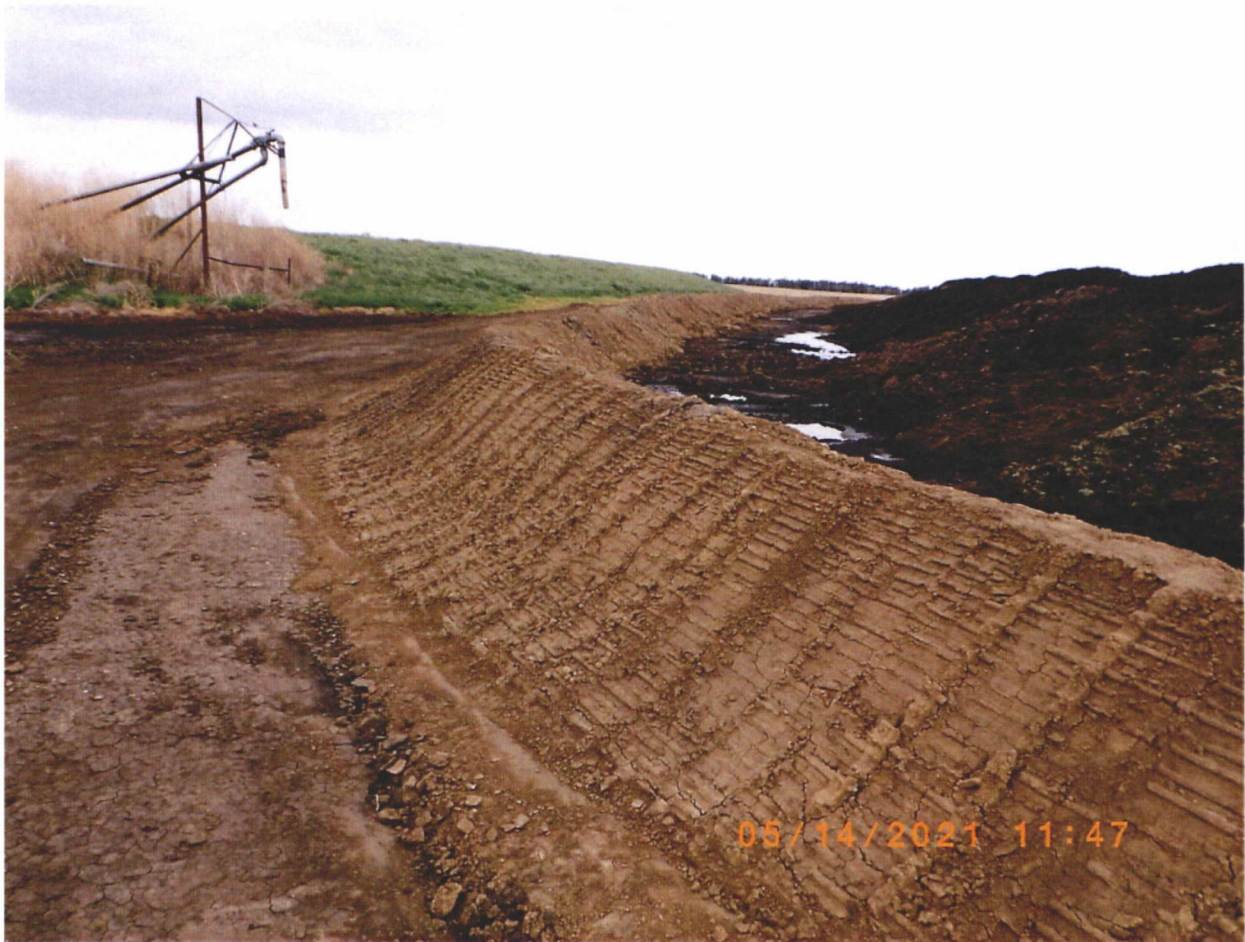
Photos: 22

Location: Area 6 on the site map. (southwest corner)

Description: Berm holding and no sign of seepage or ponding.

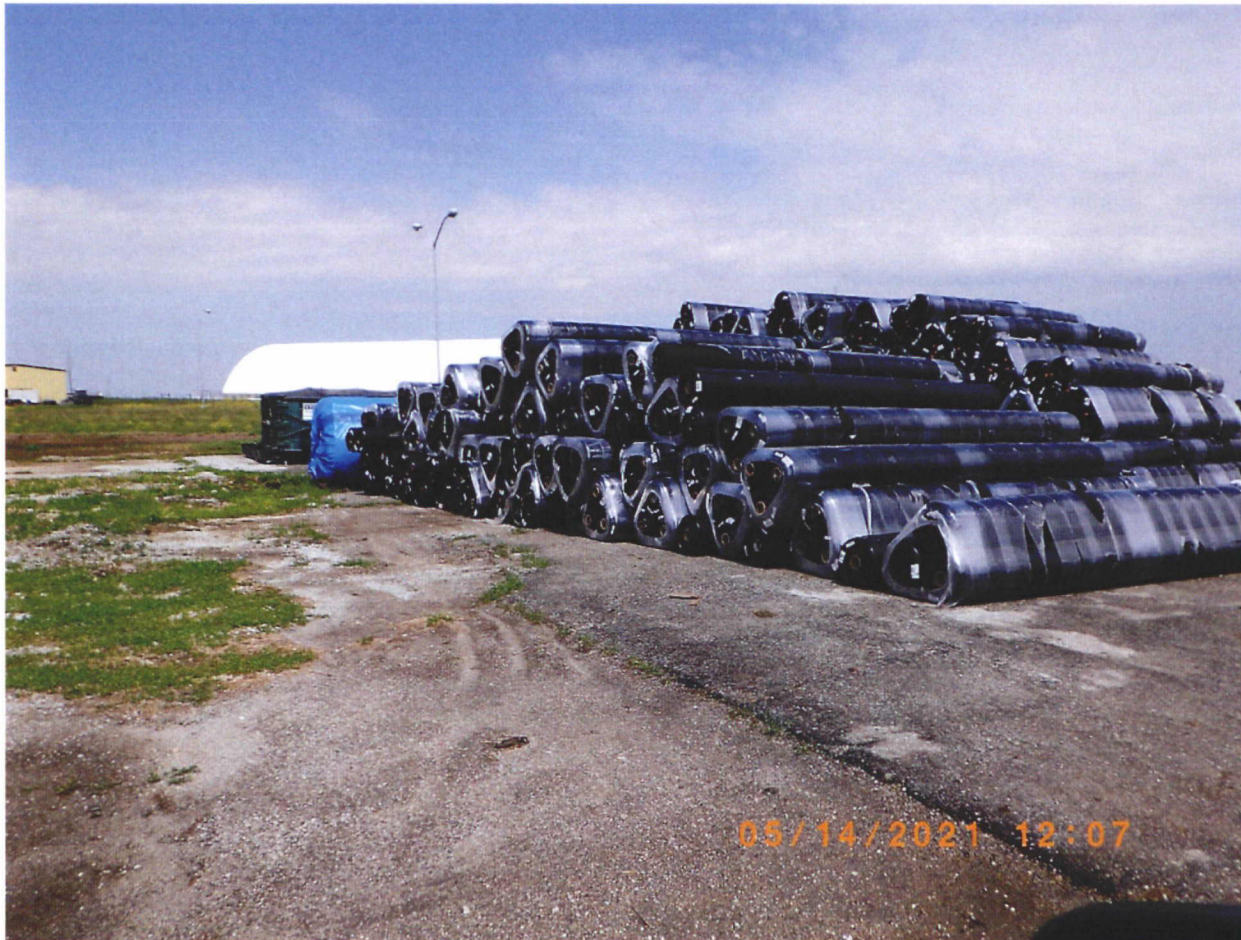
Photos: 23

Location: Administration building parking lot

Description: Geotextile fabric for soil stabilization at proposed Poseidon tank farm.
