Facility: AltEn  
IIS: 84069  
PCS: NE0137634

## Site Visit Check list

Site Visit Report

### Inspection and Assistance Exit Summary

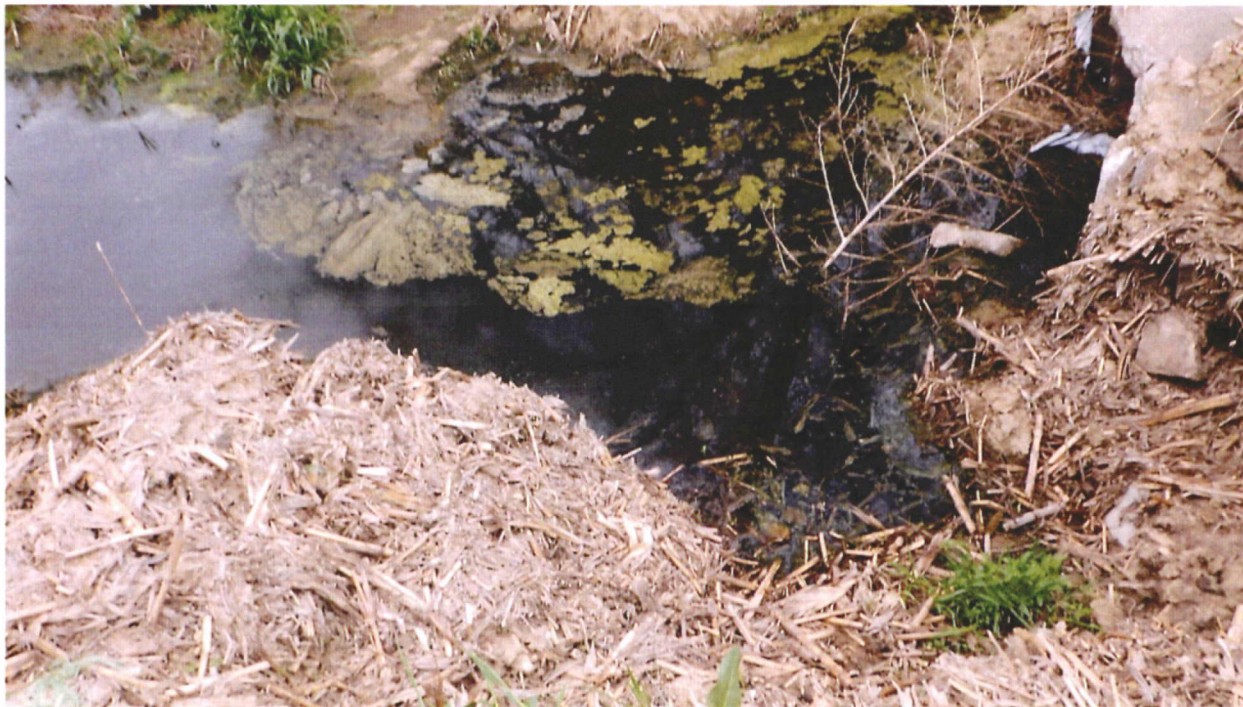
Photos: 1

Description: The water in the ditch slowly clearing up and the odor is less distinguishable from Mead Cattle.

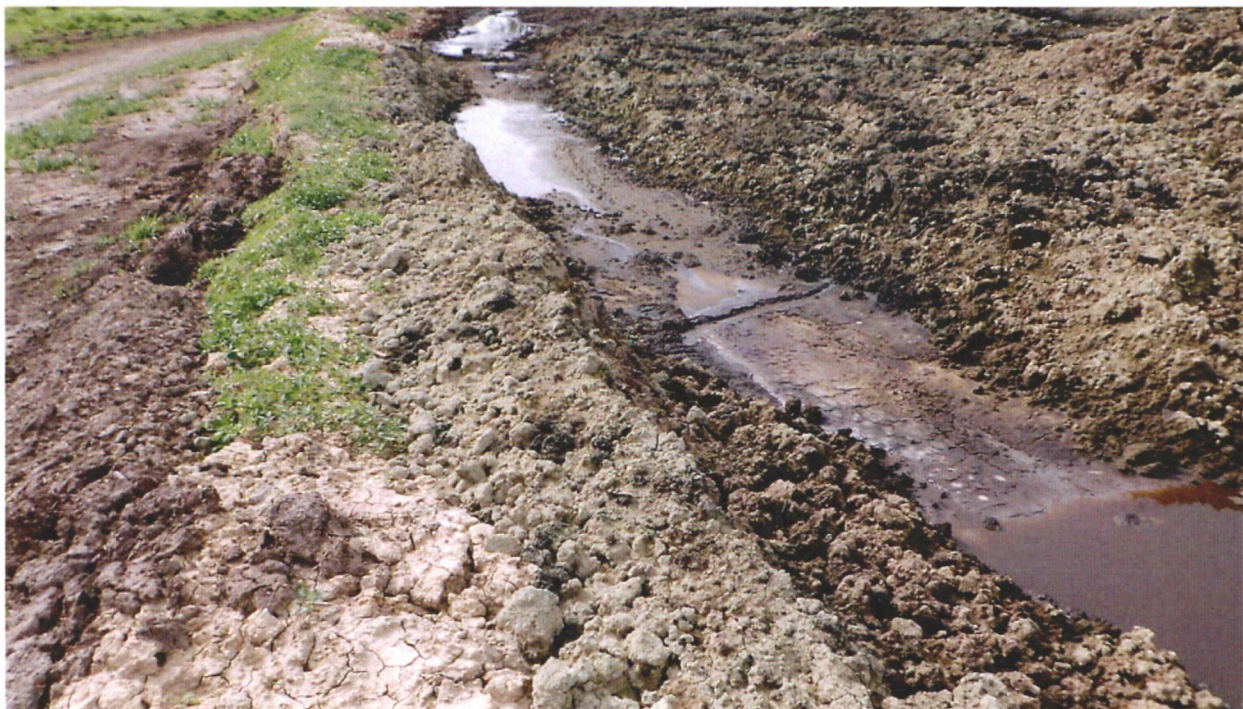
Photos: 2

- Clean Harbors has begun work on reinforcing and raising the berm in area 5 of the site map.
- Office space is slowly being cleaned out by Mary Tingelhoff with the exception of Matt O'Brien retaining his office.
- Area 6 or East wetcake storage area continues to seep through berms.
- Both hoop buildings have small leaks in the roof allowing materials to get wet which has caused sprouting and decomposition in the north building and potential decomposition of materials exposed in the south building.

Description: Northwest corner of the east wetcake storage area showing the extra storage for runoff after AltEn had pushed wetcake back into the pile.

- make sure bay doors are closed on North  
keep building when not in use.  
- Check electrical panel making noise between keep  
buildings  
- Address east wet catch berms & seepage must  
be pumped.

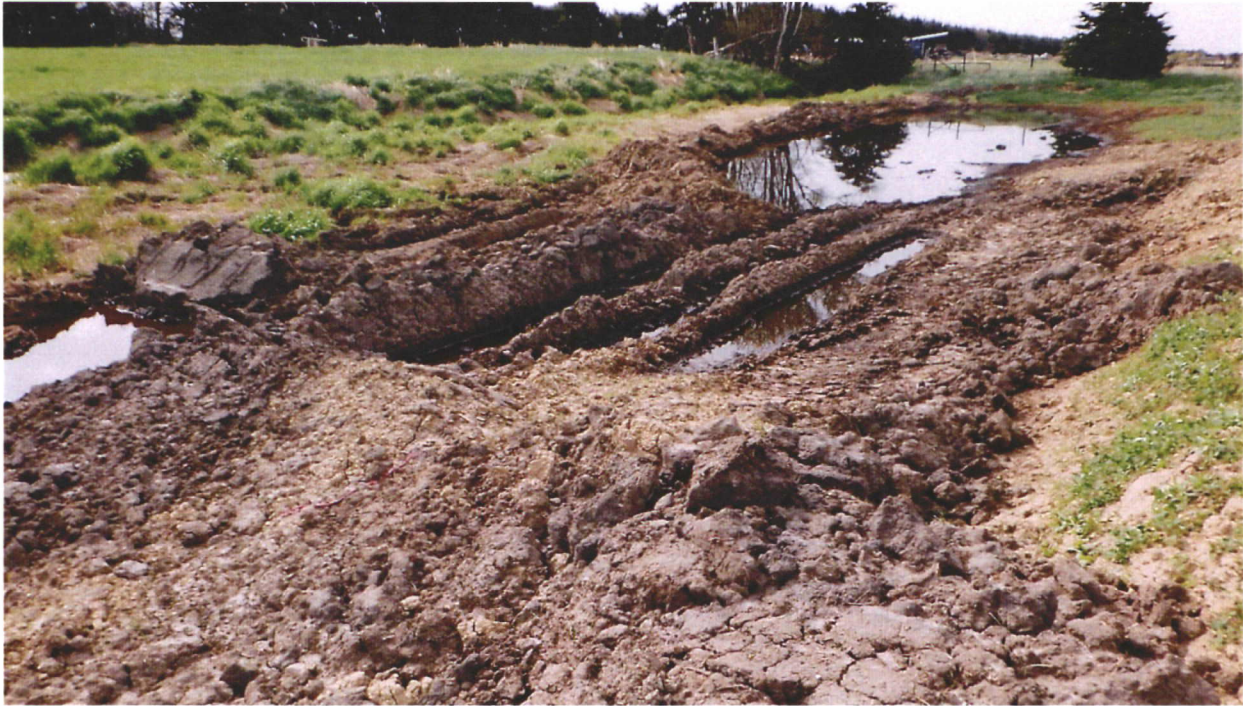
Photos: 3

Description: Lower bermed area containing the seepage from the upper berm. The upper berm is mostly empty of wetcake runoff currently.

Area 1 - Berm good condition & some water ponded  
2 - Berm good condition & can be pumped, No seepage  
3 - Berm good condition & can be pumped, no seepage  
4 - no concern  
5 - Berm holding & draining to the east  
6 - Berm has seepage in top & bottom berm, Bottom  
berm should be pumped ASAP

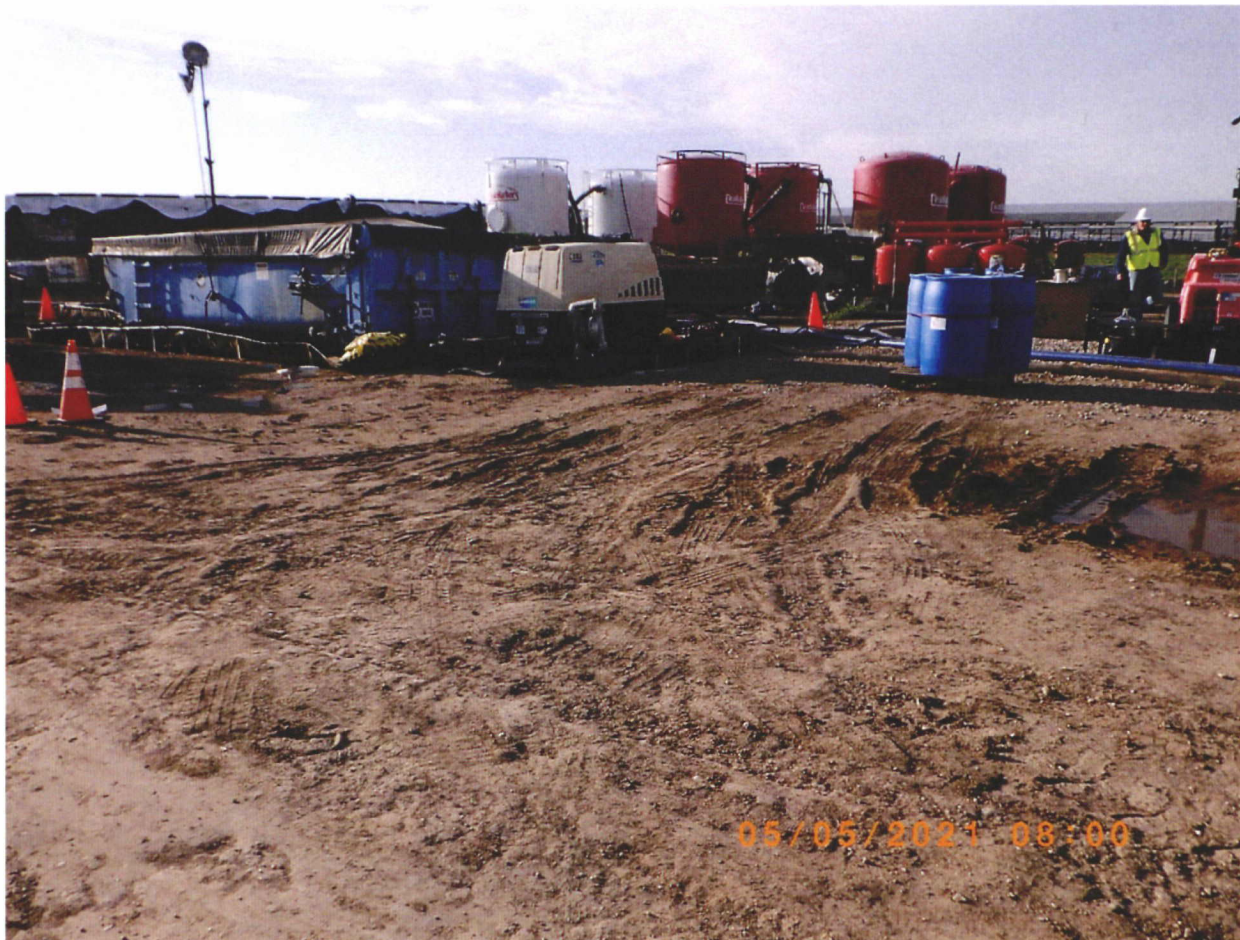
Photos: 4

Description: Clean Harbors wastewater treatment area. The water is being pumped from the AltEn system to theirs where it is further processed. They said that they are currently sending their treated water to Poseidon Tank 2.

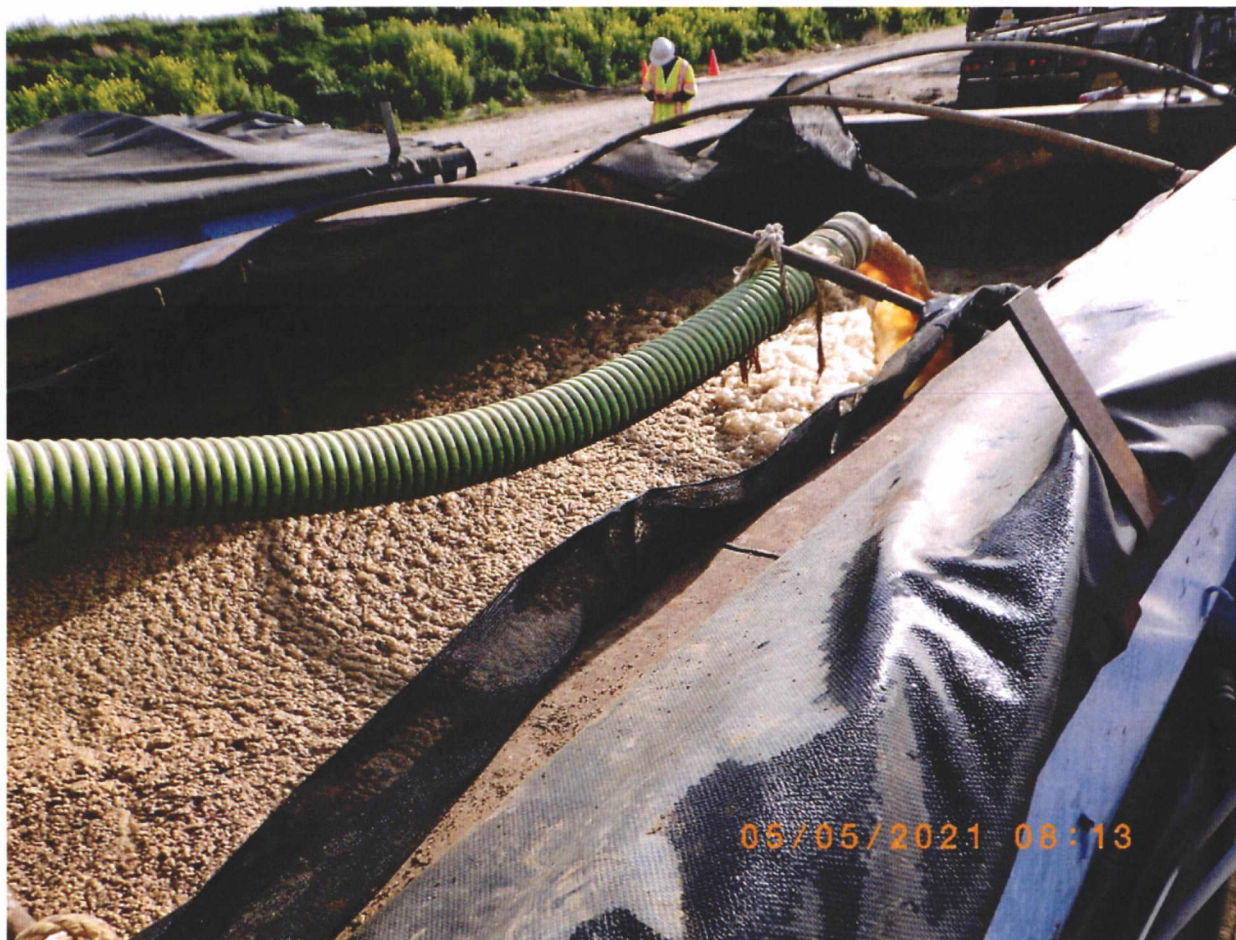
Photos: 5

Description: Influent from AltEn pumped to lined roll off dumpster for distribution to their system.

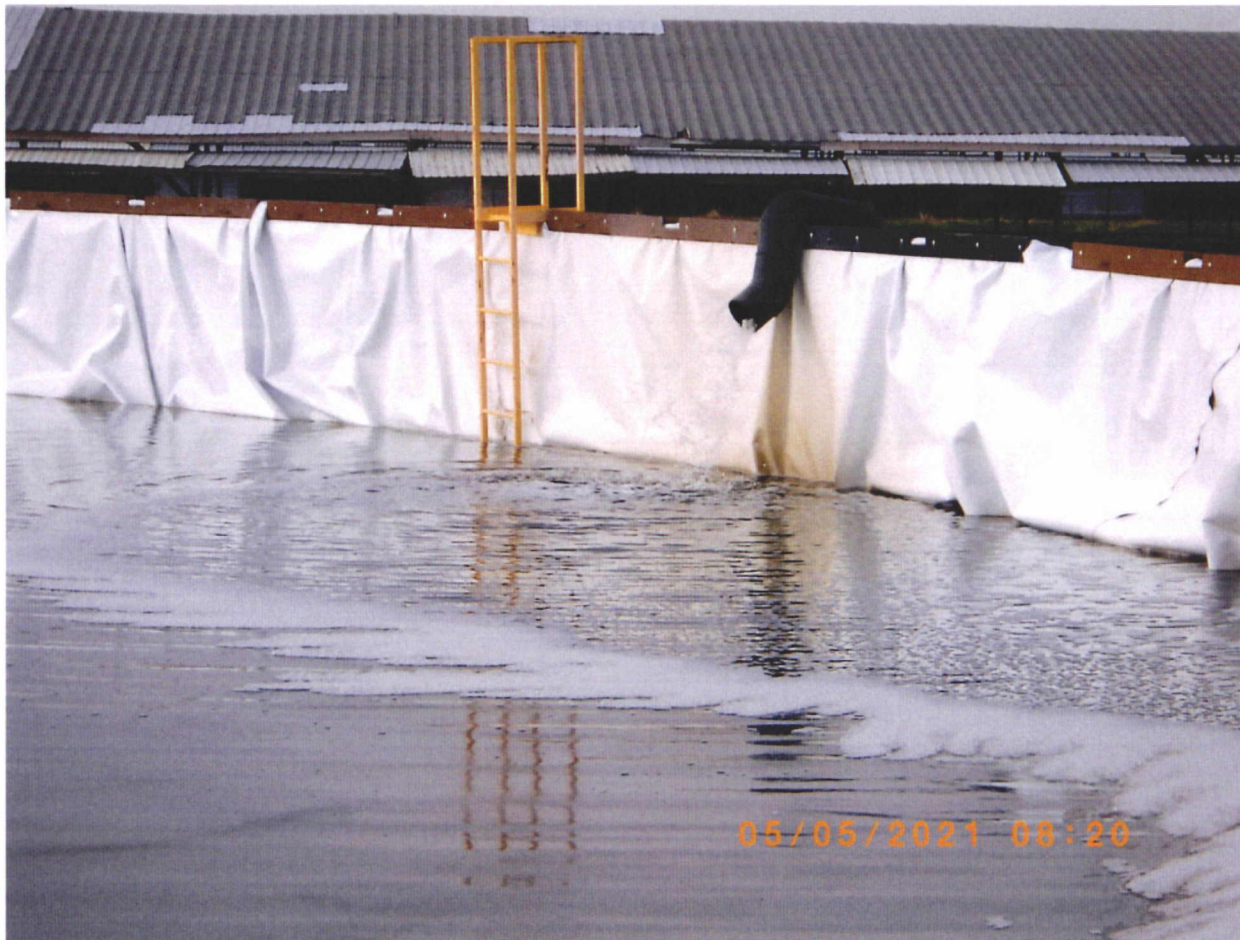
Photos: 6

Description: Clean Harbor effluent from treatment system pumped into Tank 2. Water in the tank is very dark with a strong odor but the water being pumped in at the time of the site visit was somewhat clear.

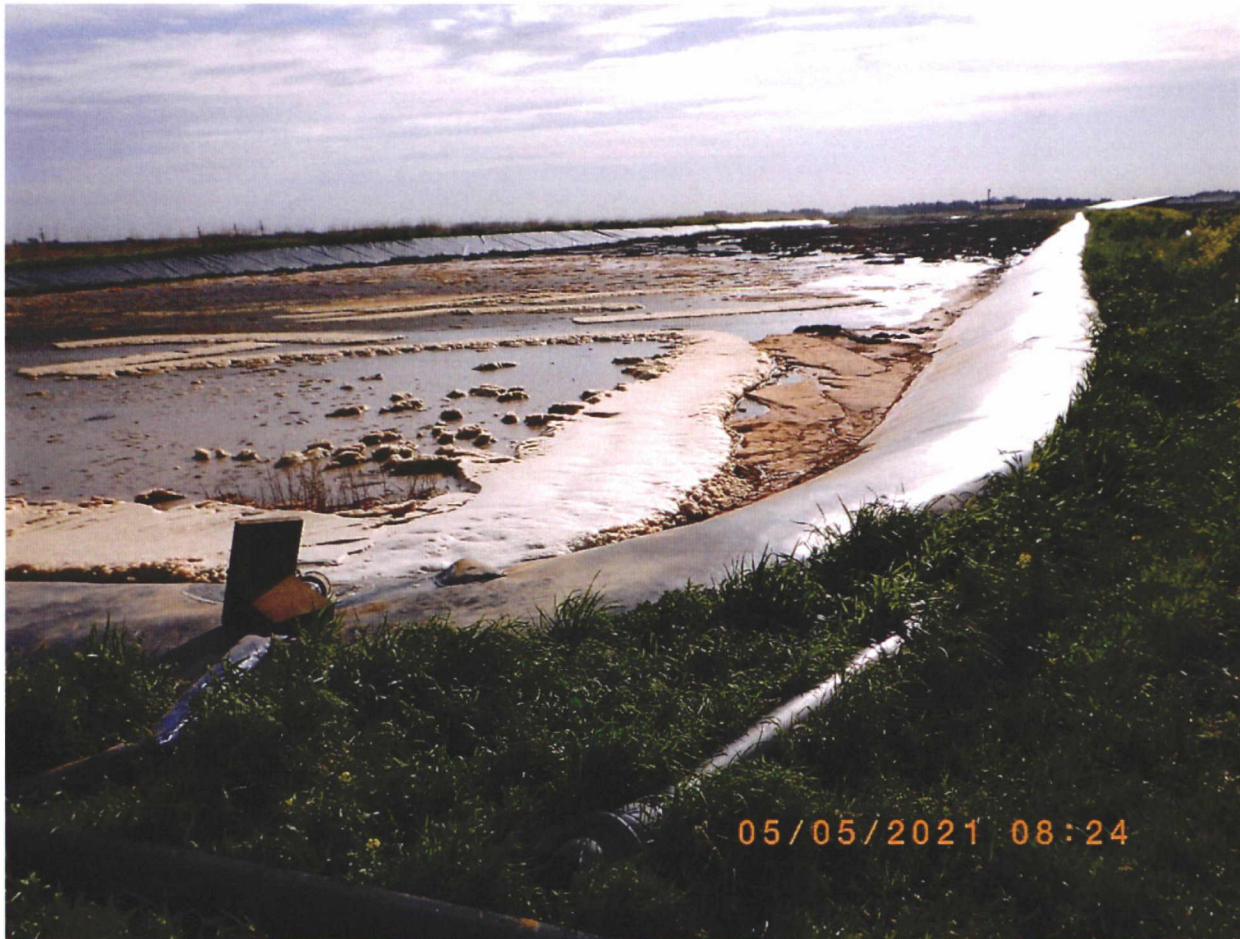
Photos: 7

Description: Solids and foam being pumped back to the emergency lagoon from Clean Harbors.

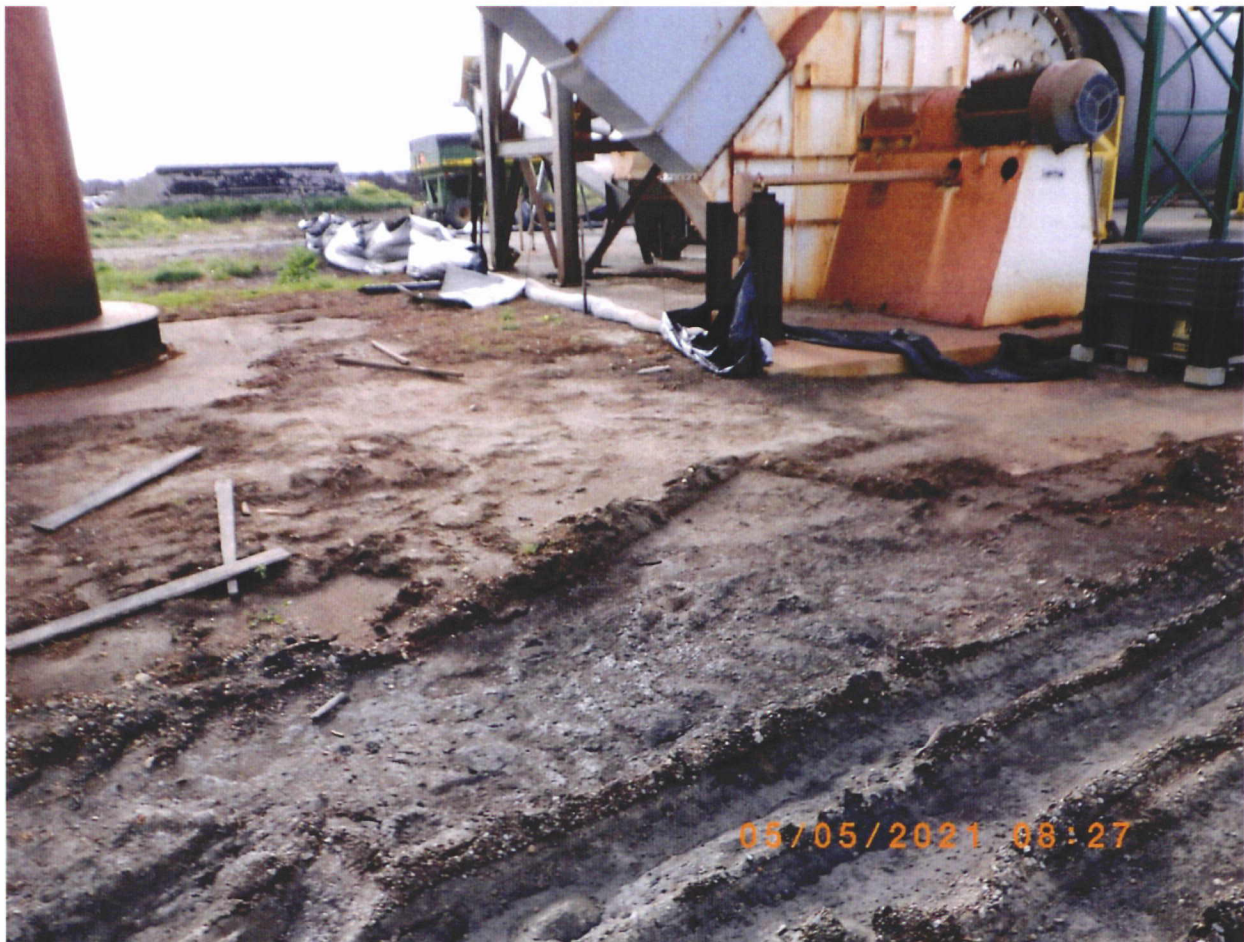
Photos: 8

Description: There is no change in the Biochar area since the last inspection.

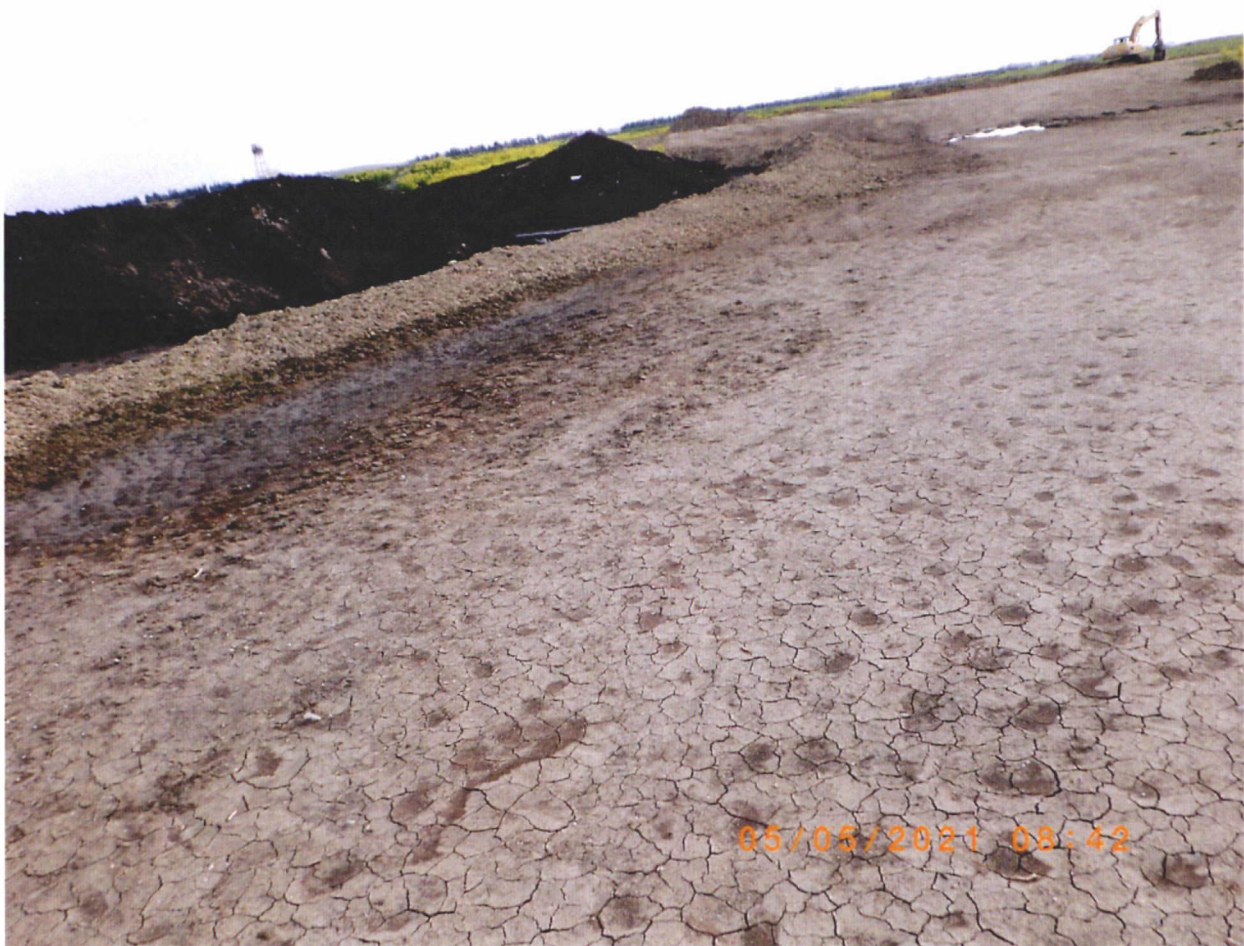
Photos: 9

Description: The small berms built to contain the wet cake and capture runoff are holding and show no sign of seepage.

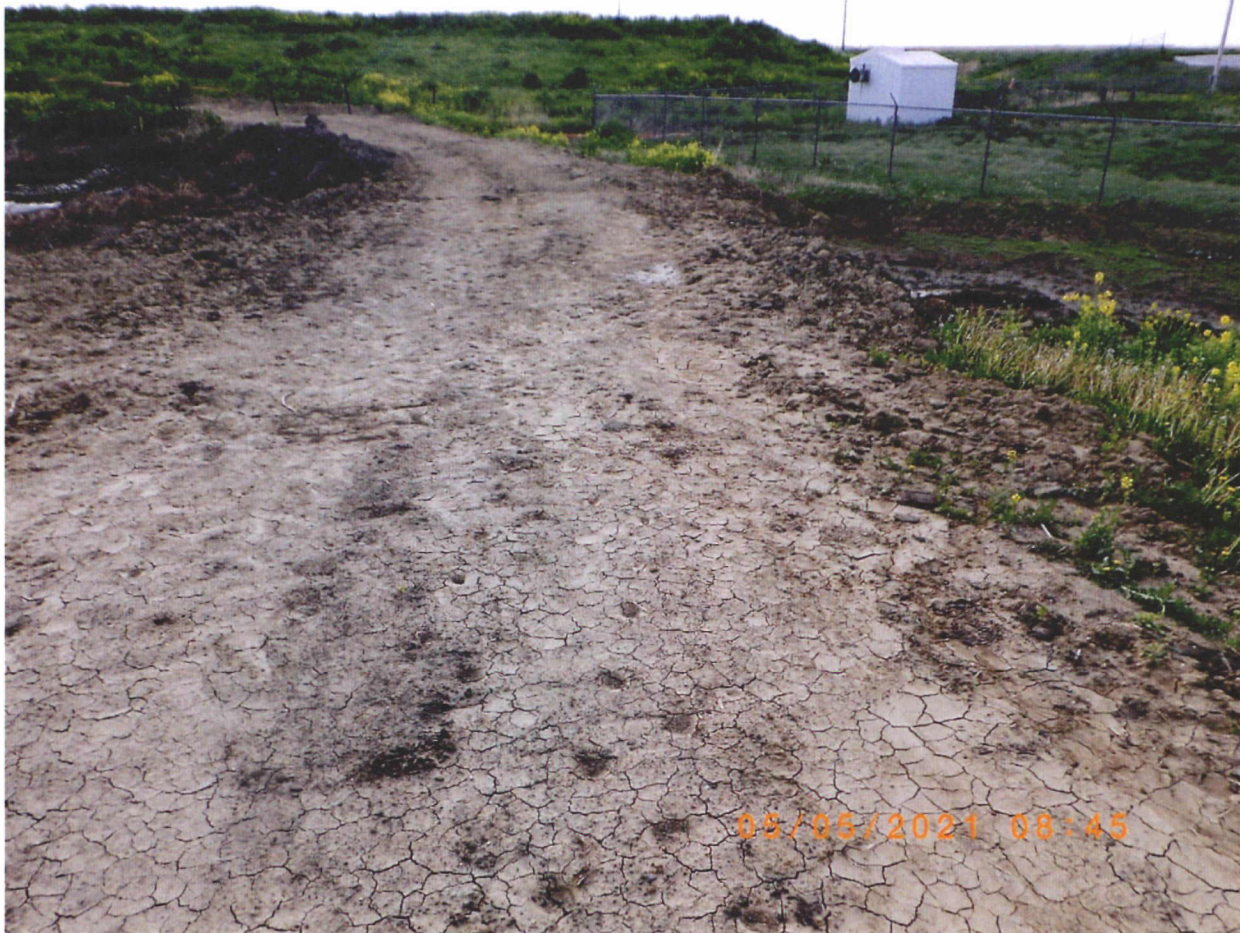
Photos: 10

Description: Berm is holding and show no sign of seepage, but could be pumped if there is measurable precipitation in the near future.

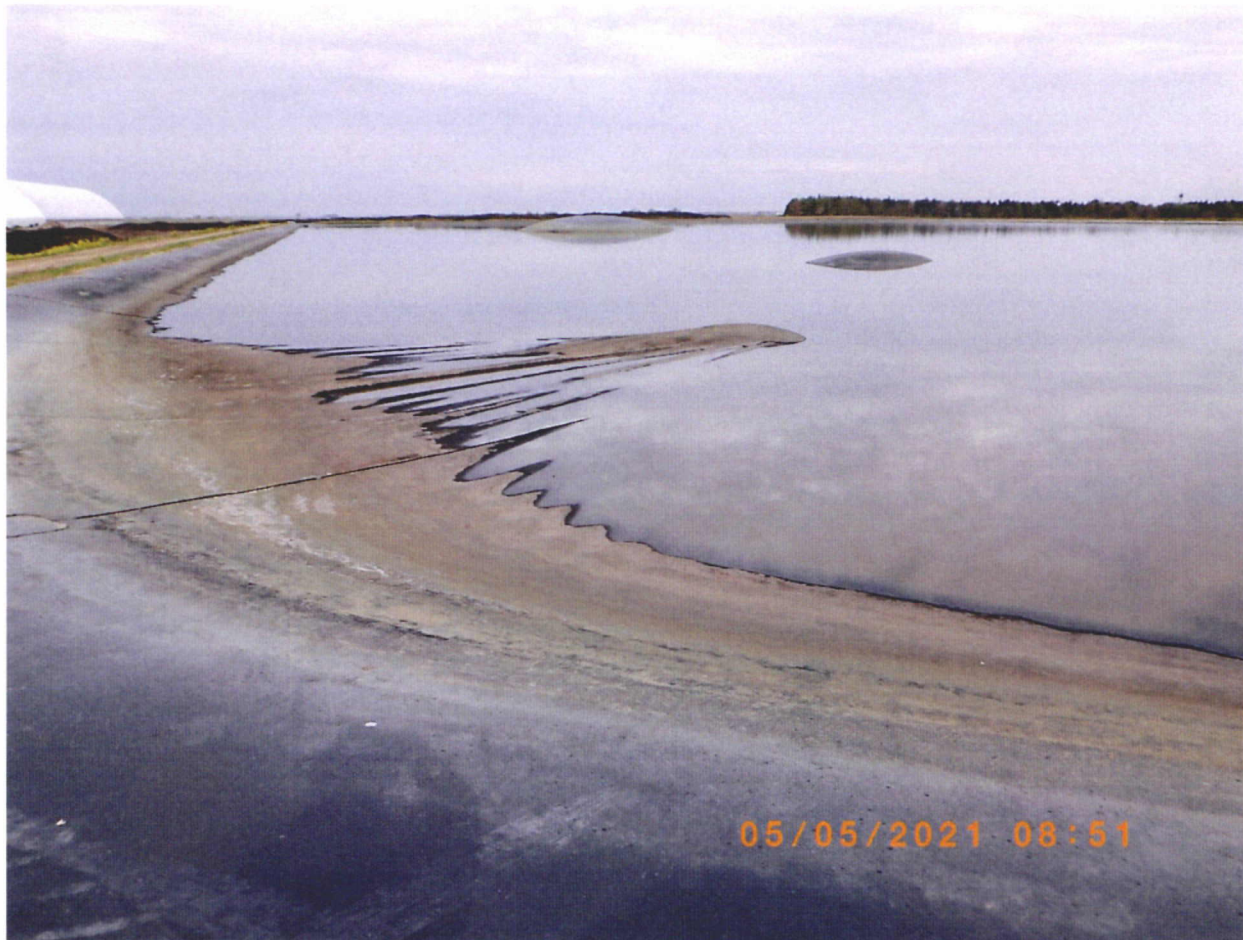
Photos: 11

- Northeast lagoon
  - No change in liner condition observed, but excessive degassing was taking place.
- Northwest lagoon
  - The whale on the east side of the lagoon has disappeared and one of the missing whales in the SE corner has reappeared. The liner is also stretching from the SE corner part way to the new whale. The equalization pipe between the NE and NW lagoon is no longer able to flow due lowered lagoon levels.
- South lagoon
  - No change in liner condition observed. Black sludge is now floating along edges of lagoon.

Description: Small whale rising with the corner section pulling the liner tight leaving void space underneath.

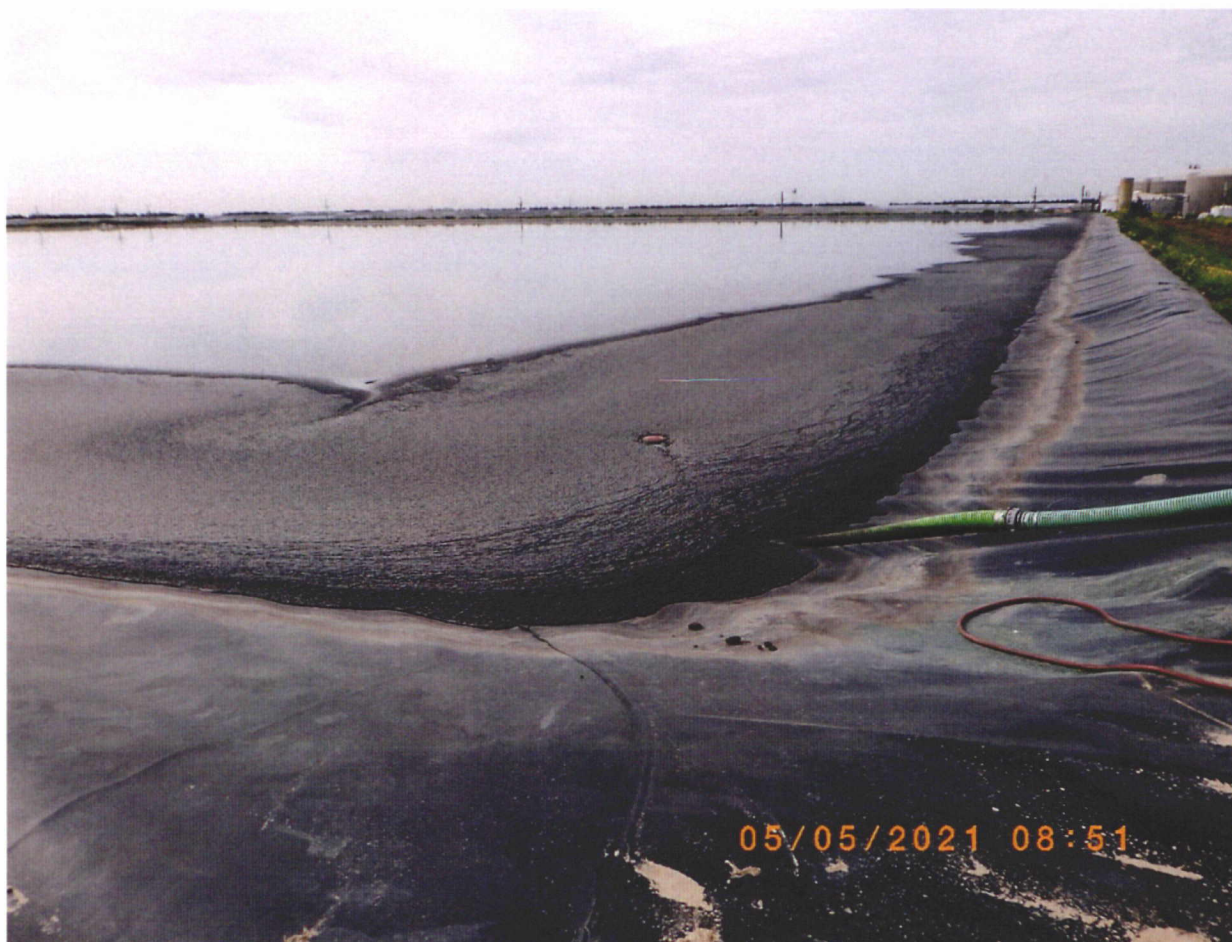
Photos: 12

Description: Thick black foaming sludge collecting along the edges with miscellaneous debris.

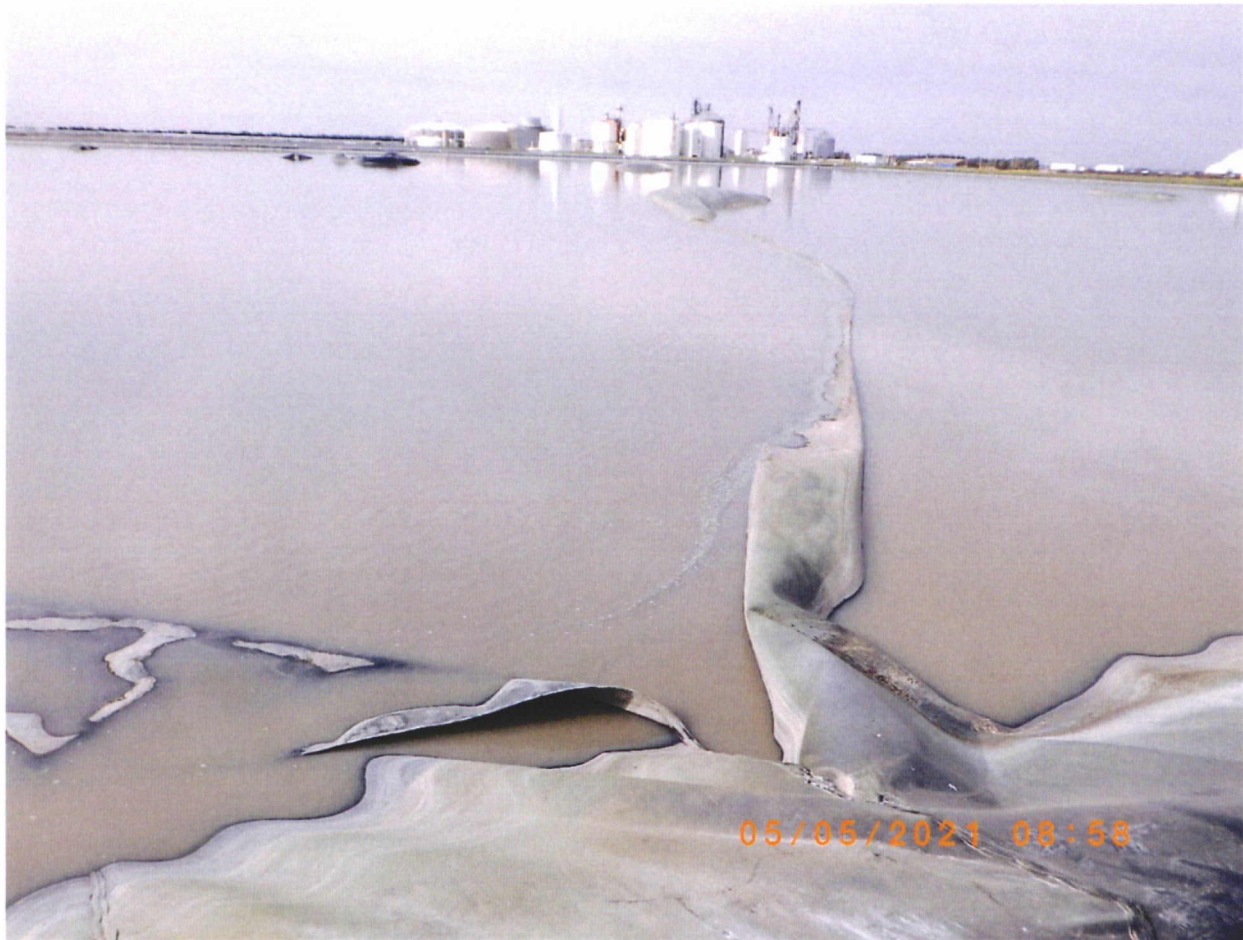
Photos: 13

Description: No major changes observed in this lagoon with the exception of green sludge continuing to rise and collect along the edges.

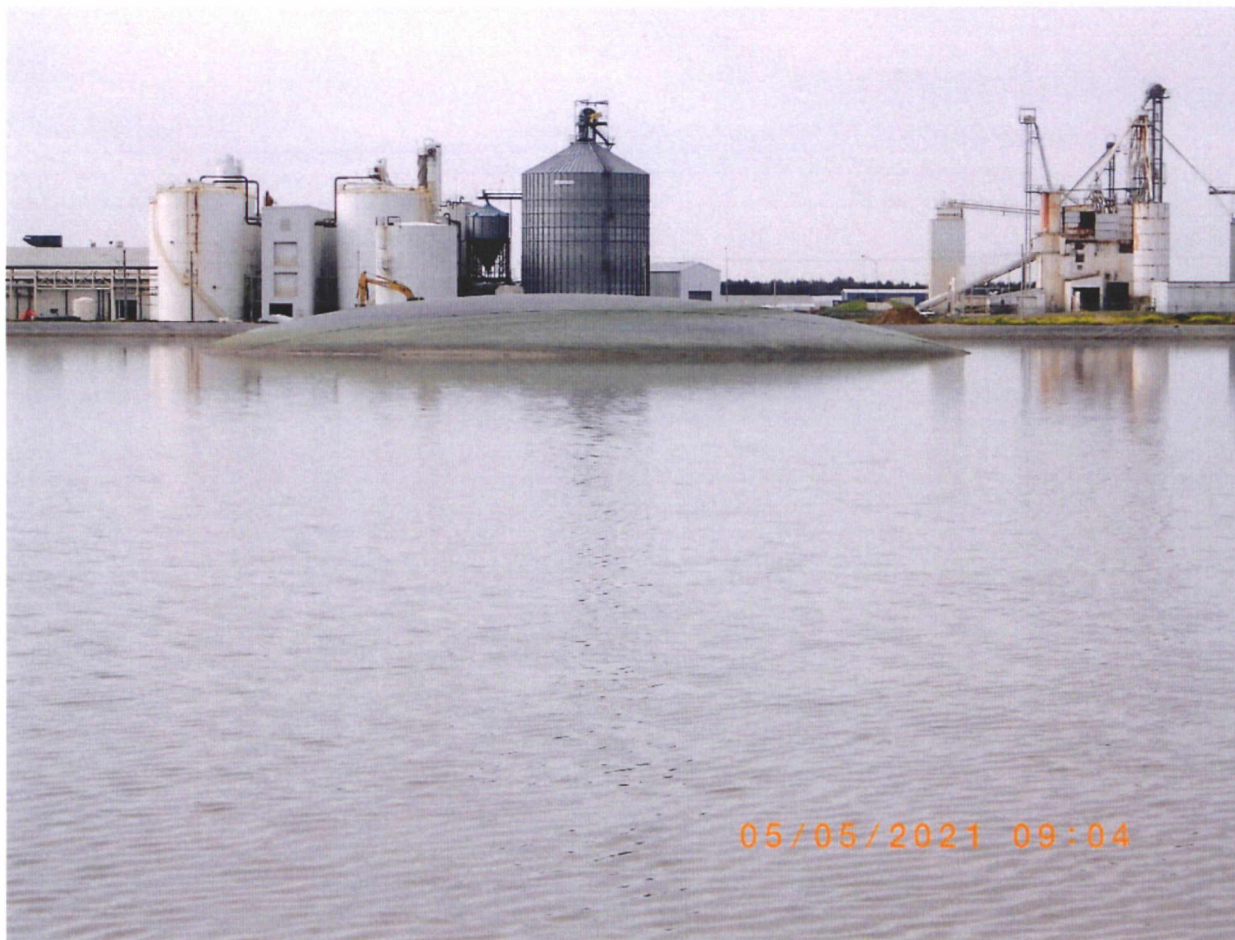
Photos: 14

Description: Persistent whale in the northwest lagoon.

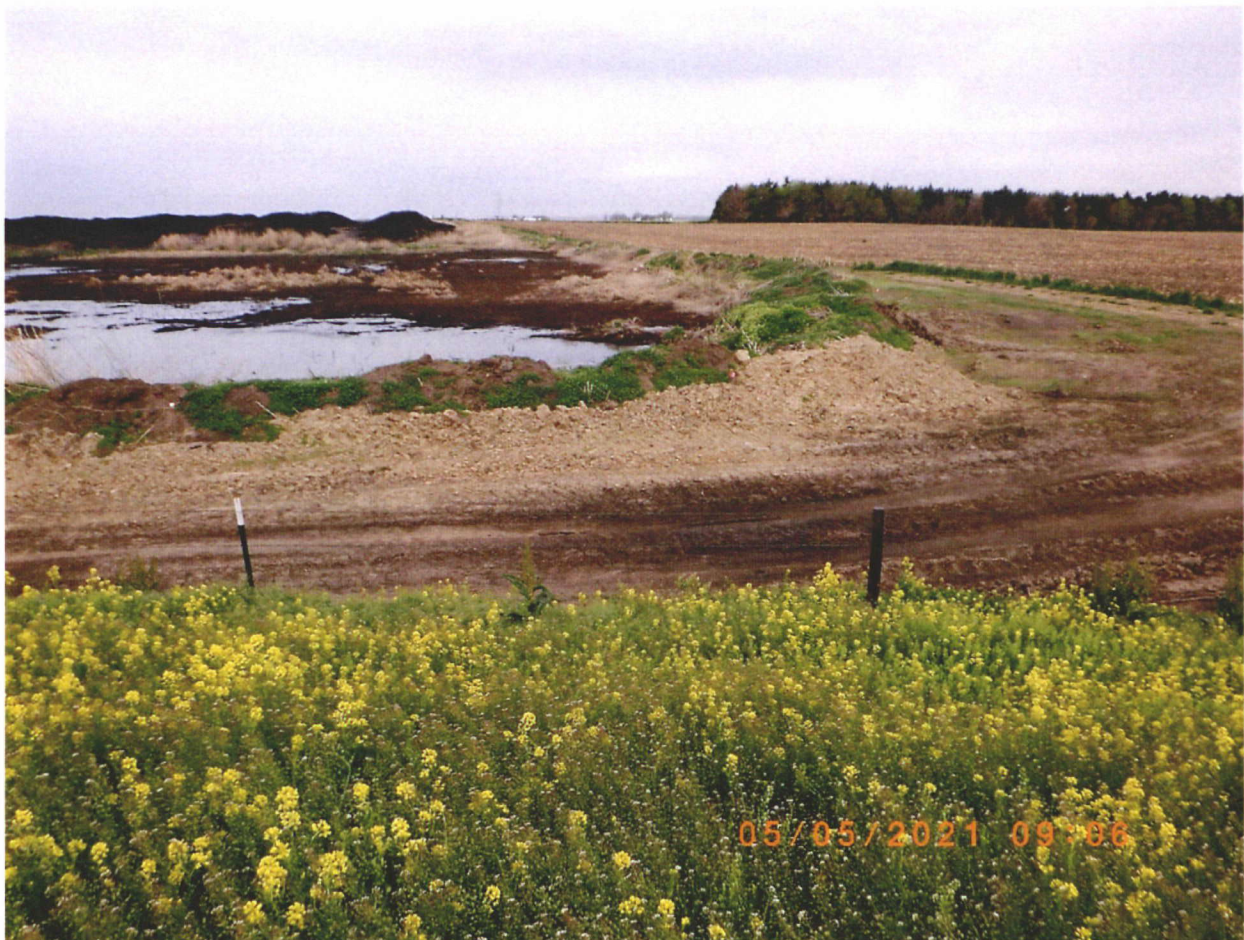
Photos: 15

Description: Berm is holding and no seepage was found.

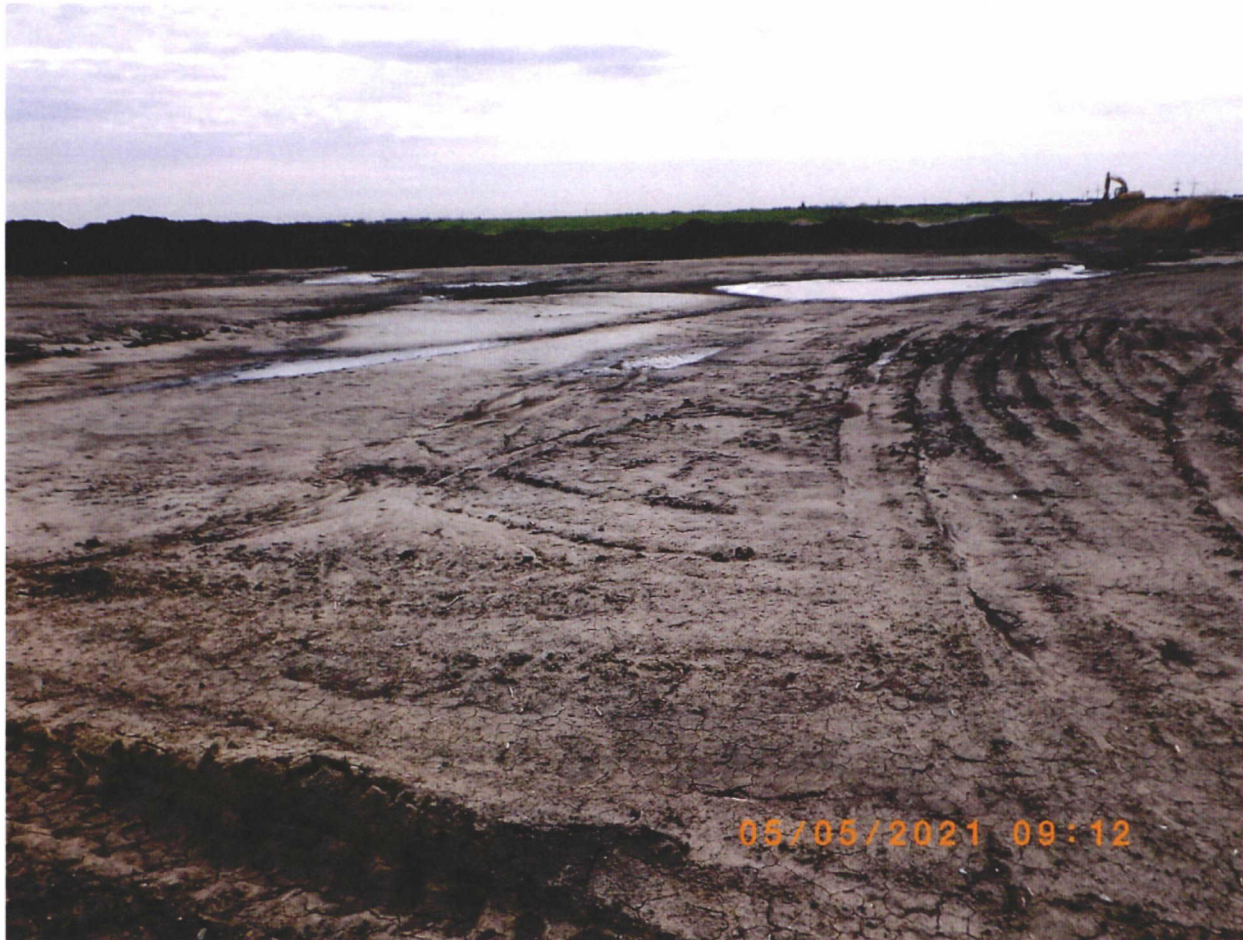
Photos: 16

Description: Main drainage path for the west wetcake storage area.

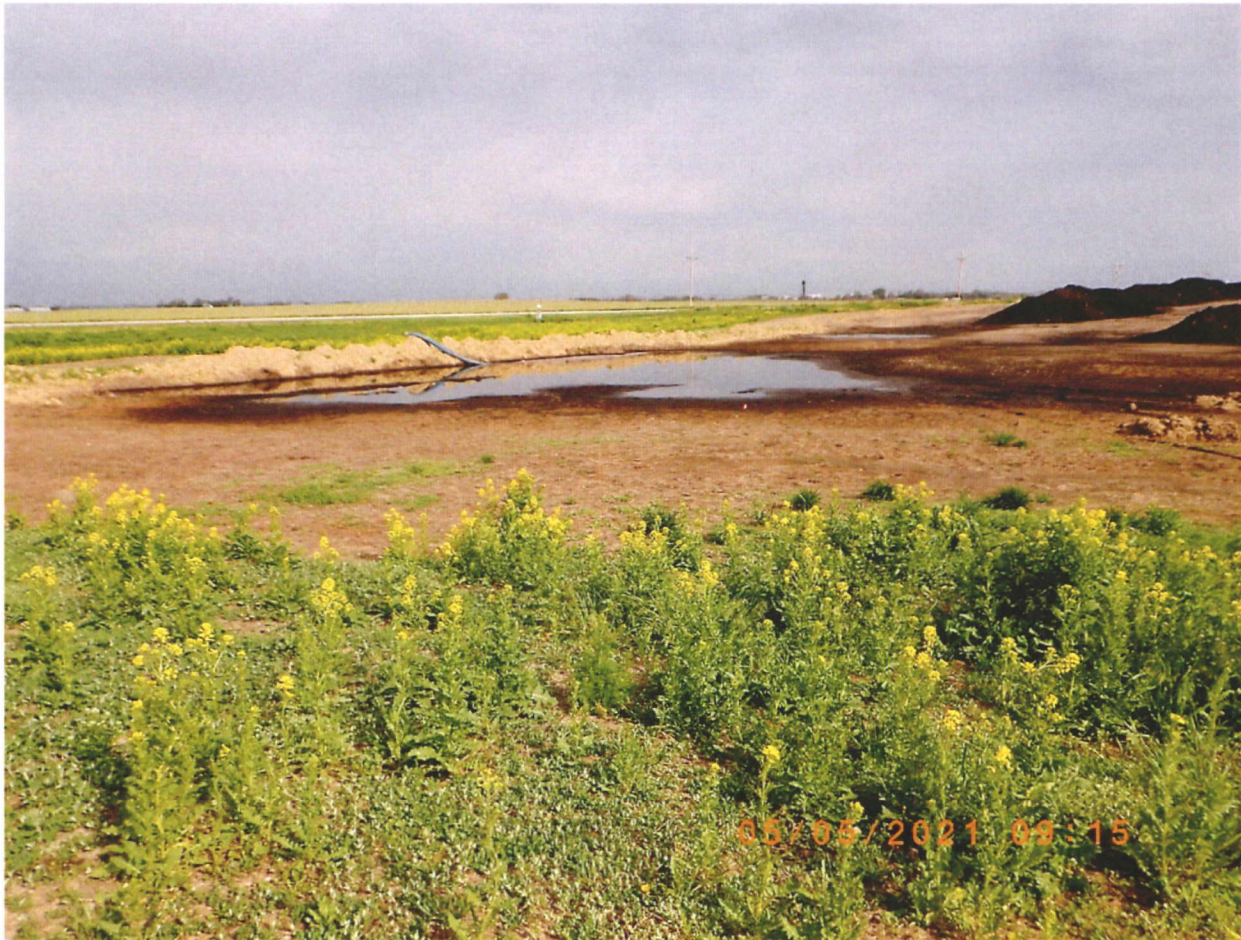
Photos: 17

Description: Berm is holding and has no seepage evident. Runoff continues to pond behind berm with the majority of the runoff flowing east via the ditch created by AltEn.
