Facility: AltEn, LLC

5/26/2021

Site Visit Report

AltEn LLC - Storm Water Temporary BMP Check Map

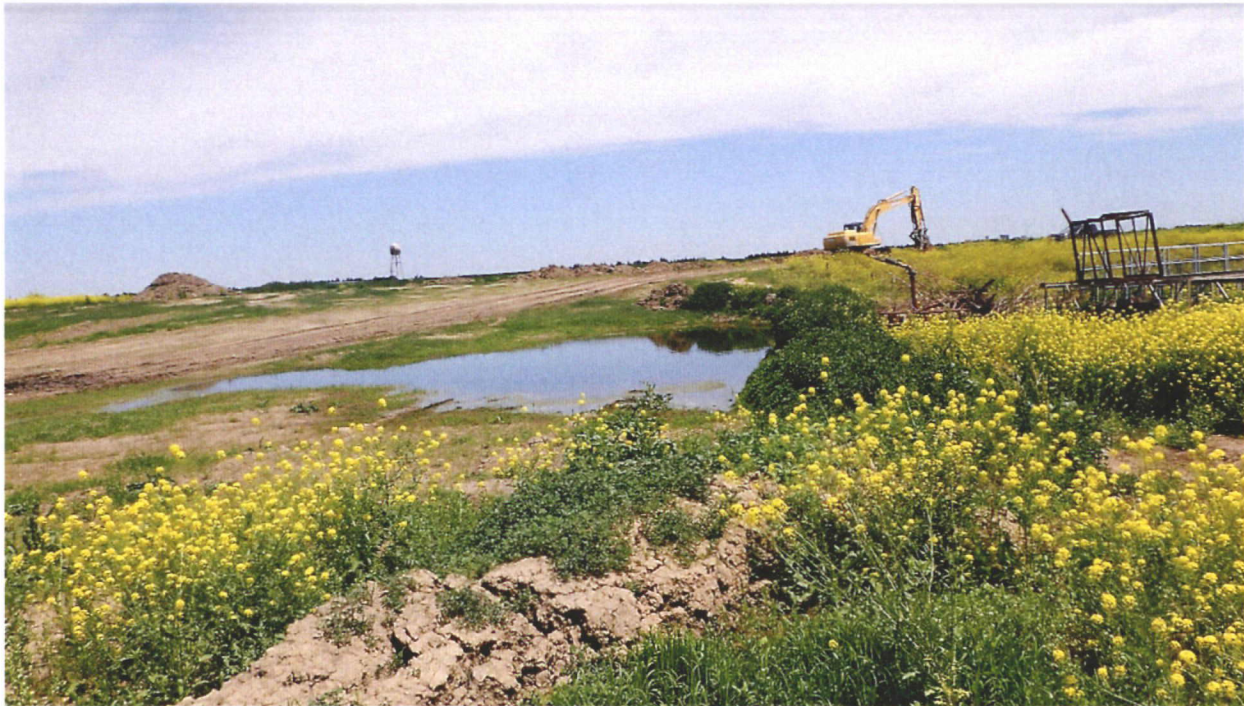
Photo: 1

- Area 1 contains two berms. The original east berm contains green water and needs to be pumped to make room for upcoming rain event
- Areas 2: The facility is currently pumping the berm to the emergency lagoon.
- Area 3 is in good condition. No seepage observed.
- Area 4 is in good condition. No seepage observed.
- Area 5 is in good condition. No seepage observed.
- Clean Harbors has finished the berm around the Area 6 pile. No seepage observed. Some totes used to transport water from area 6 are stained with corrosive chemical.

Location: Area 1 on the site map

Description: This is the original east berm. There is some water accumulation but no seepage observed. I mentioned to the facility that this needs to be pumped before the next rain event.

Area 1 – Water needs to be removed to prepare for the upcoming rain event.

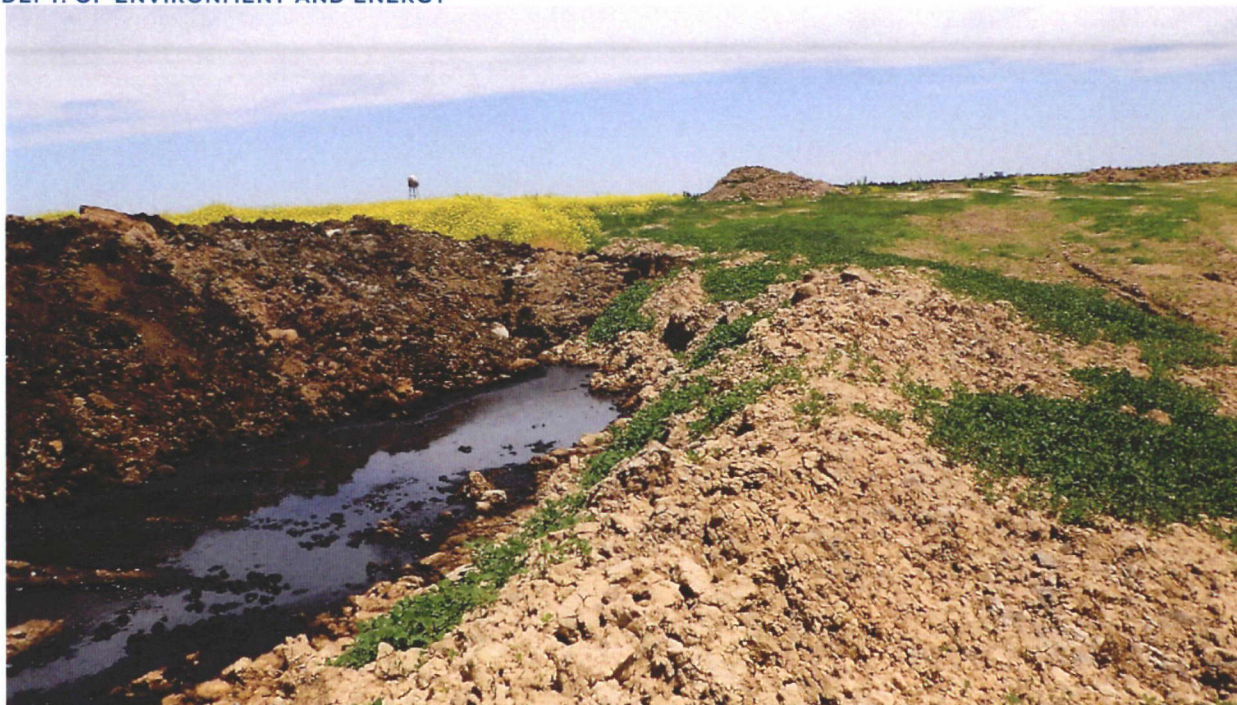
Photo: 2

Location: Area 1 on the site map

Description: This is the west berm in area 1. There is only minor water accumulation. There is no seepage observed.

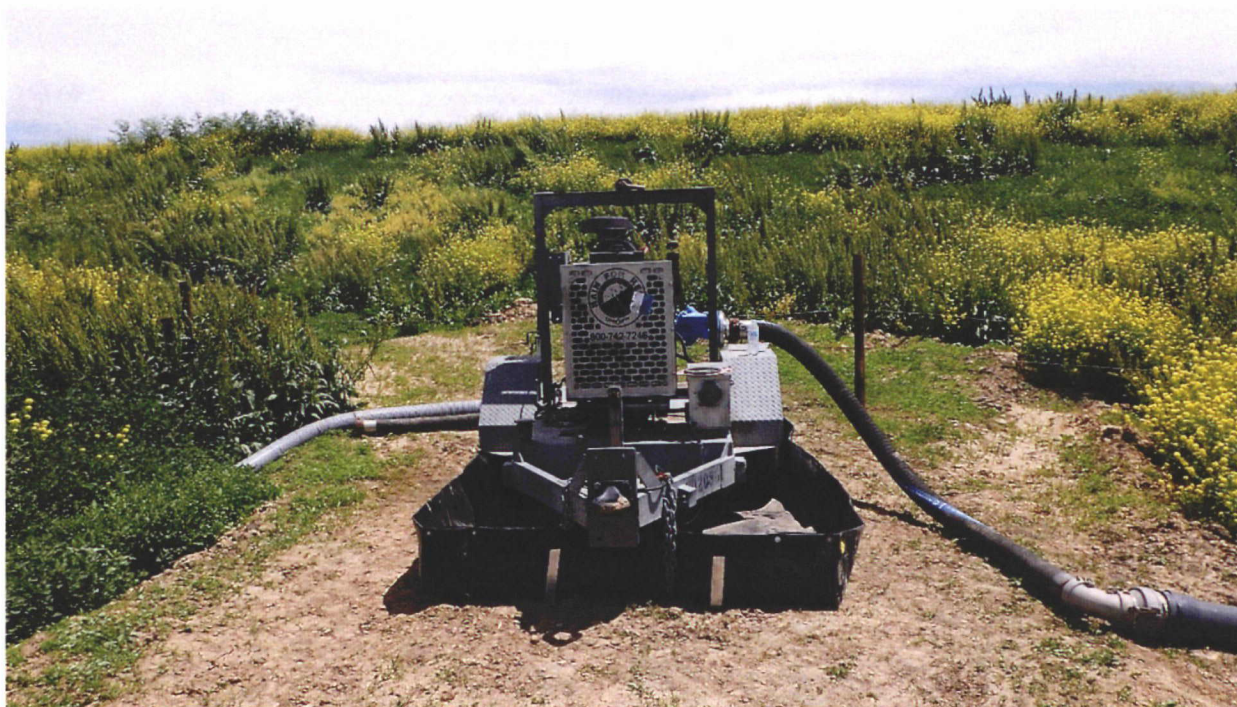
Photo: 3

Location: Area 2 on the site map

Description: This is the pump used to transfer water from area 2 to the emergency lagoon. The pump is running which is depicted on photo 4.

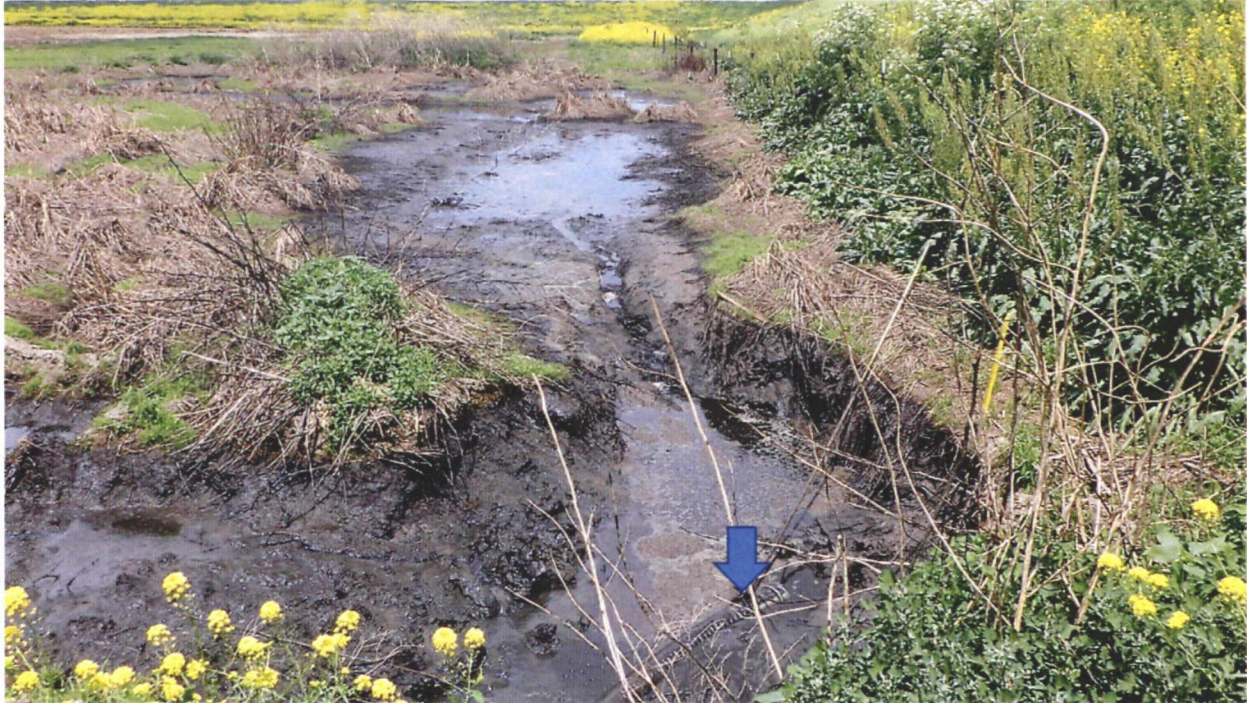
Photo: 4

Location: Area 2 on the site map

Description: Clean Harbors is actively pumping down area 2. This photo depicts the hose beginning to be above the water line (arrow).

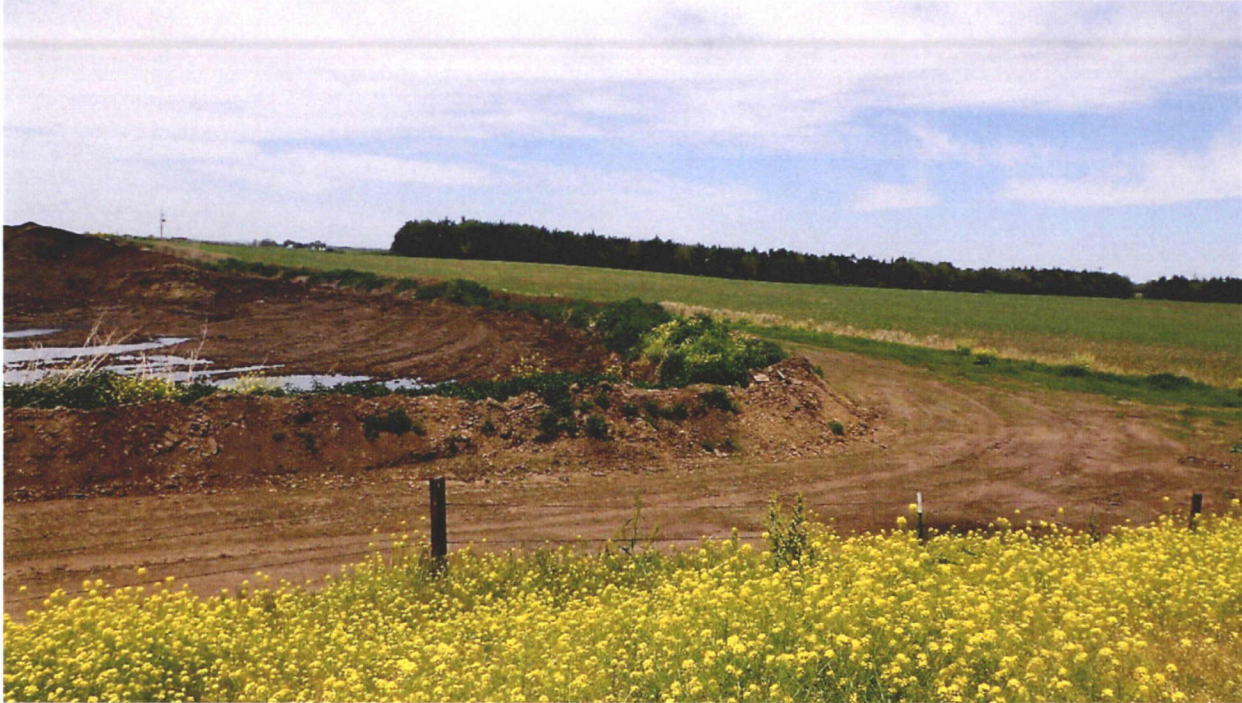
Photo: 5

Location: Area 3 on the site map

Description: No seepage observed.

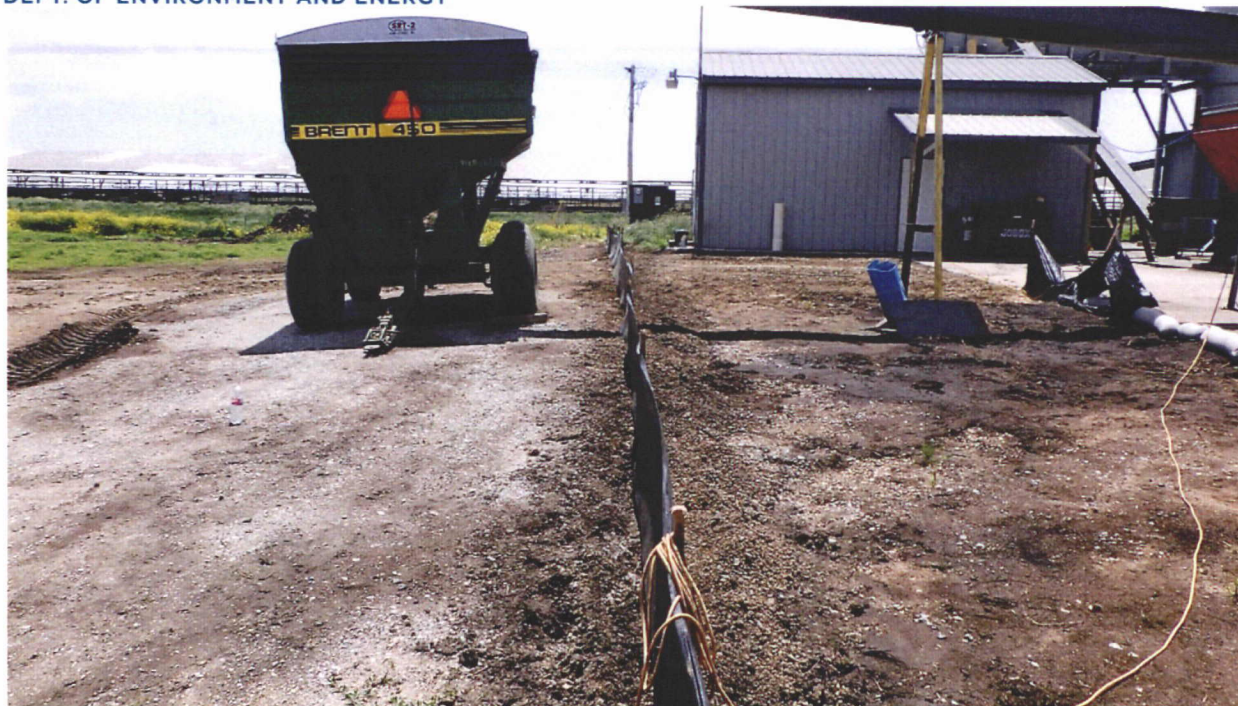
Photo: 6

- Clean Harbors has installed a new silt fence (trenched in). The silt fence does not contain all the spilled biochar product.

Location: Biochar

Description: This photo depicts the newly installed silt fence.

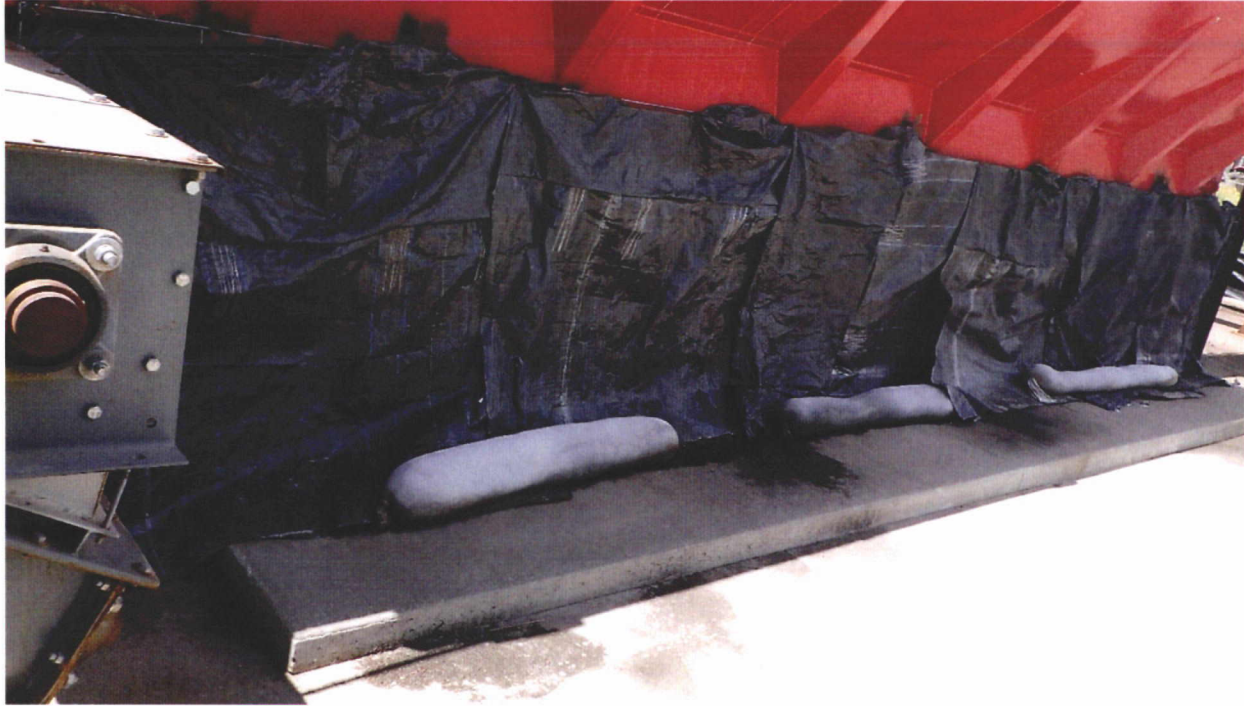
Photo: 7

Location: Biochar

Description: This photo depicts that workers installed silt fencing and absorbent socks around the biochar hopper to prevent runoff.

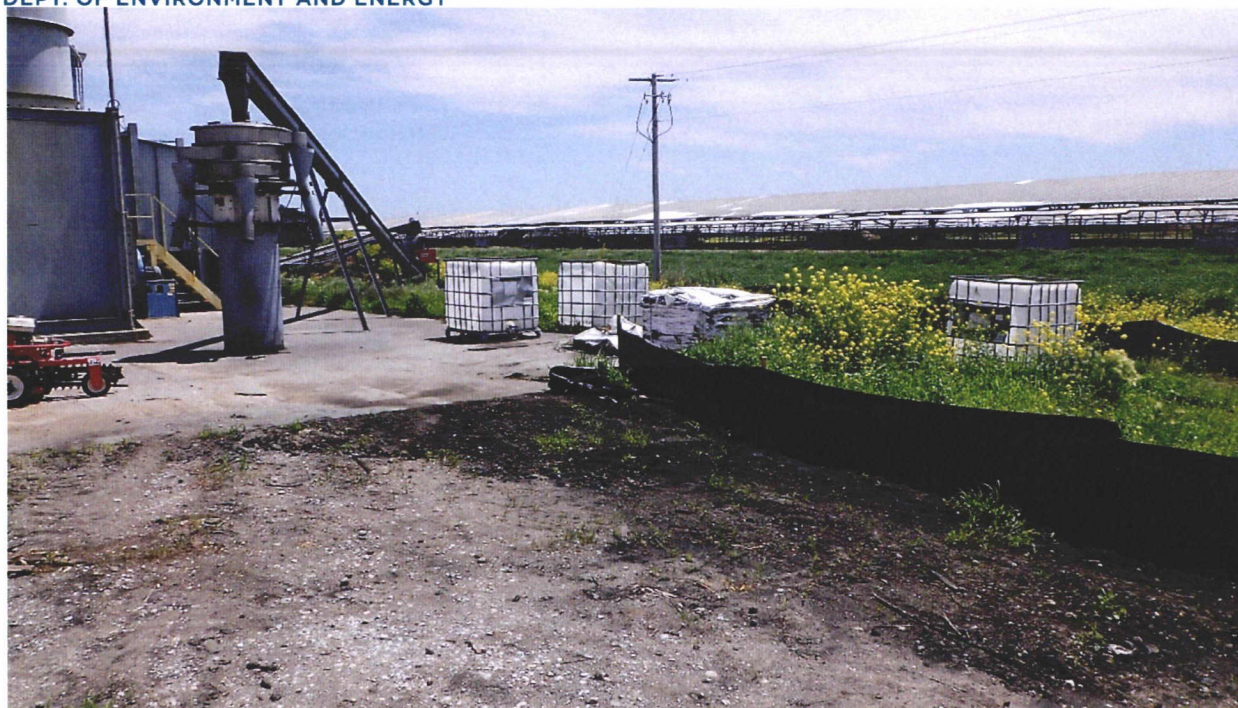
Photo: 8

Location: Biochar

Description: This photo depicts spilled biochar outside the silt fence. The silt fence does encompass all the spilled biochar in the area.

* **Biochar:** The facility has installed silt fencing, which is trenched in 3 to 4 inches. There is biochar product outside the containment. The original silt fence is in poor condition and needs to be replaced before the impending rain event.

- **Clean the biochar area and install proper BMPs.** The BMP needs to contain the spilled biochar.
- **Manage vegetation** around the lagoons and the main facility.

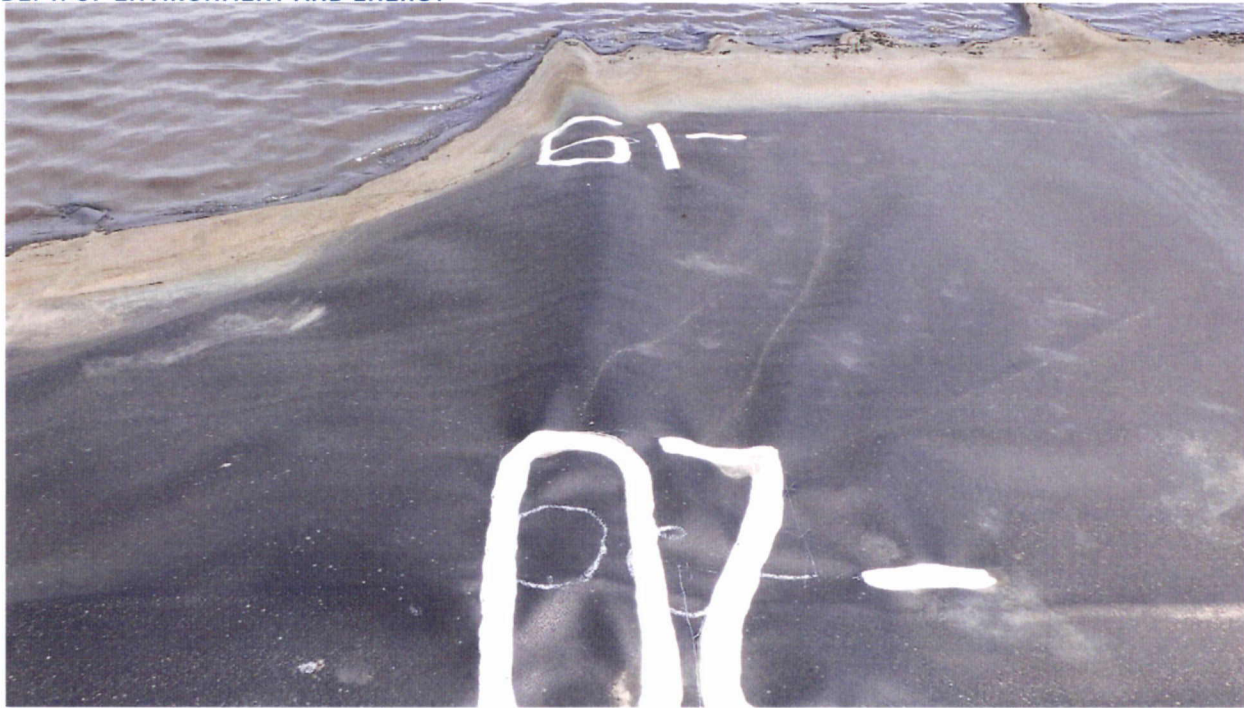
Photo: 9

Location: Northwest lagoon

Description: This photo depicts the depth gauge.

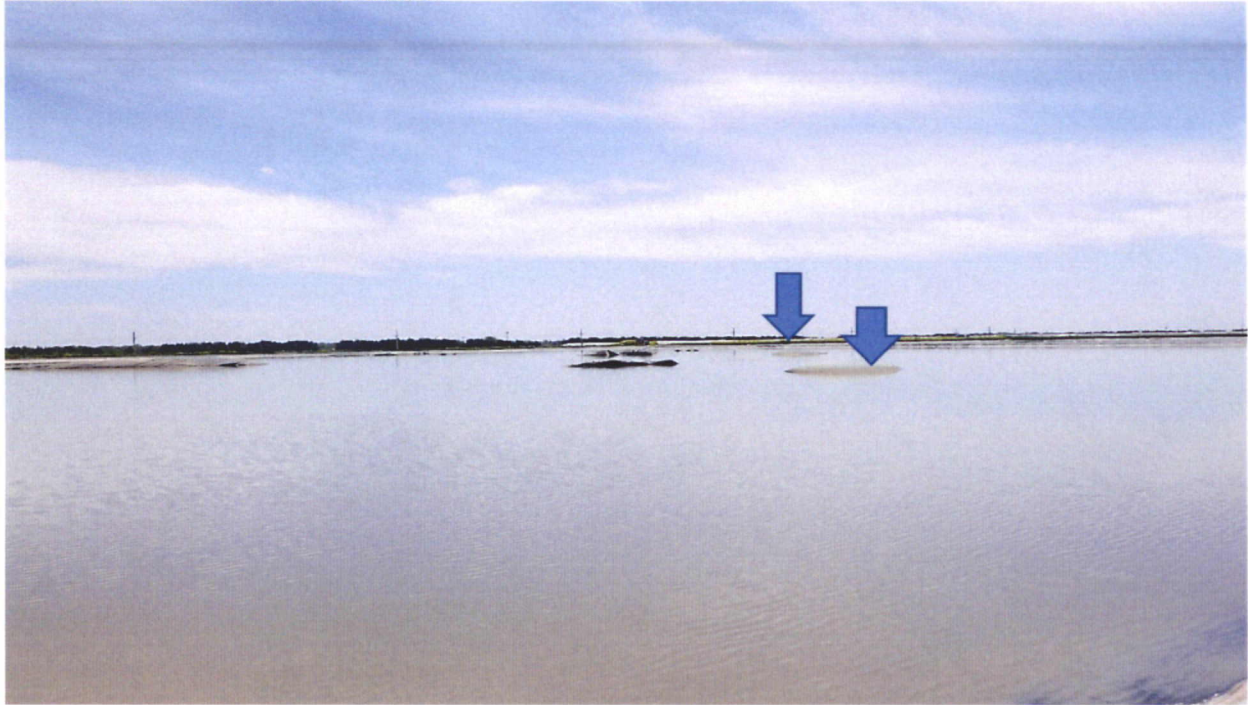
Photo: 10

Location: Northeast lagoon

Description: This photo depicts two additional whales in the northeast lagoon.

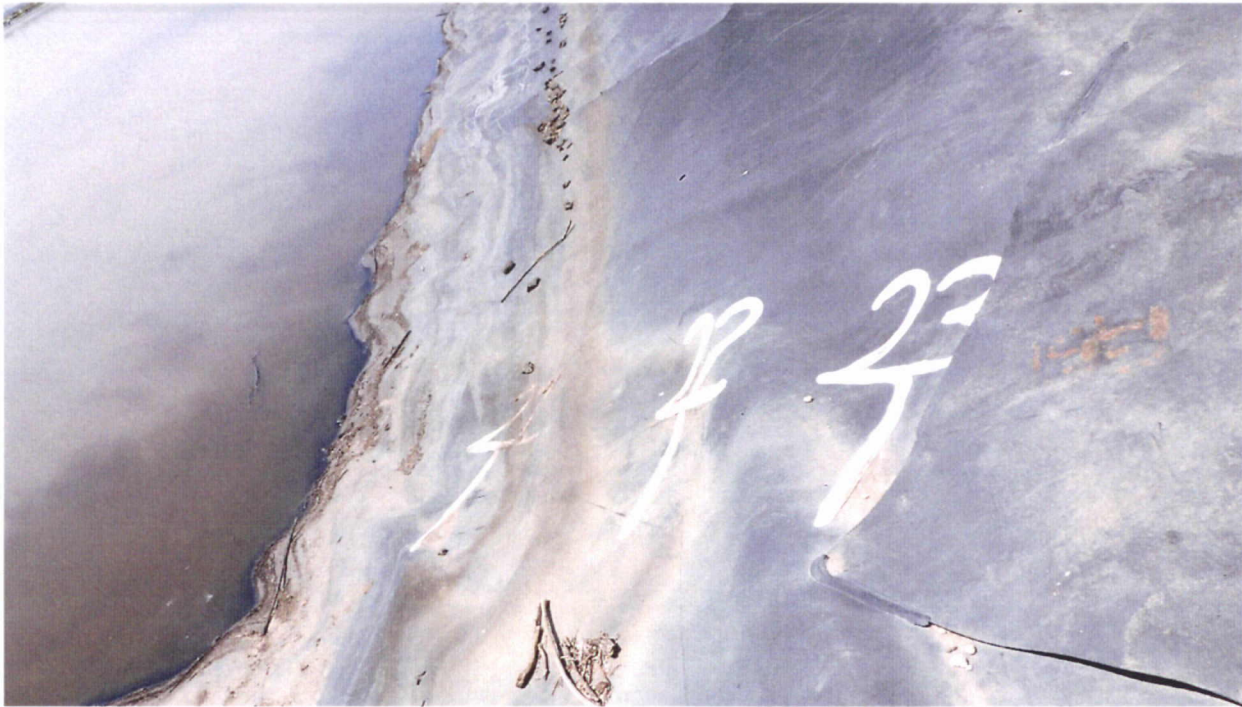
Photo: 11

Location: South lagoon

Description: This photo depicts the depth gauge.

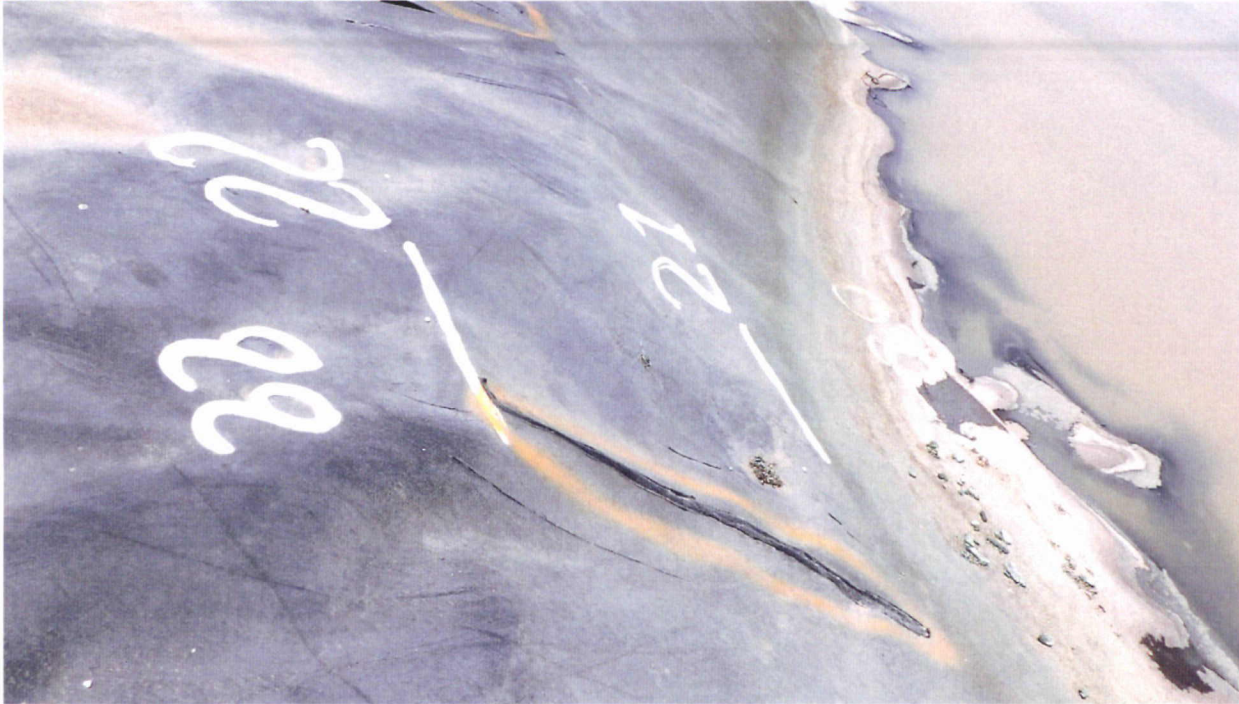
Photo: 12

Location: Northeast lagoon

Description: This photo depicts the depth gauge.

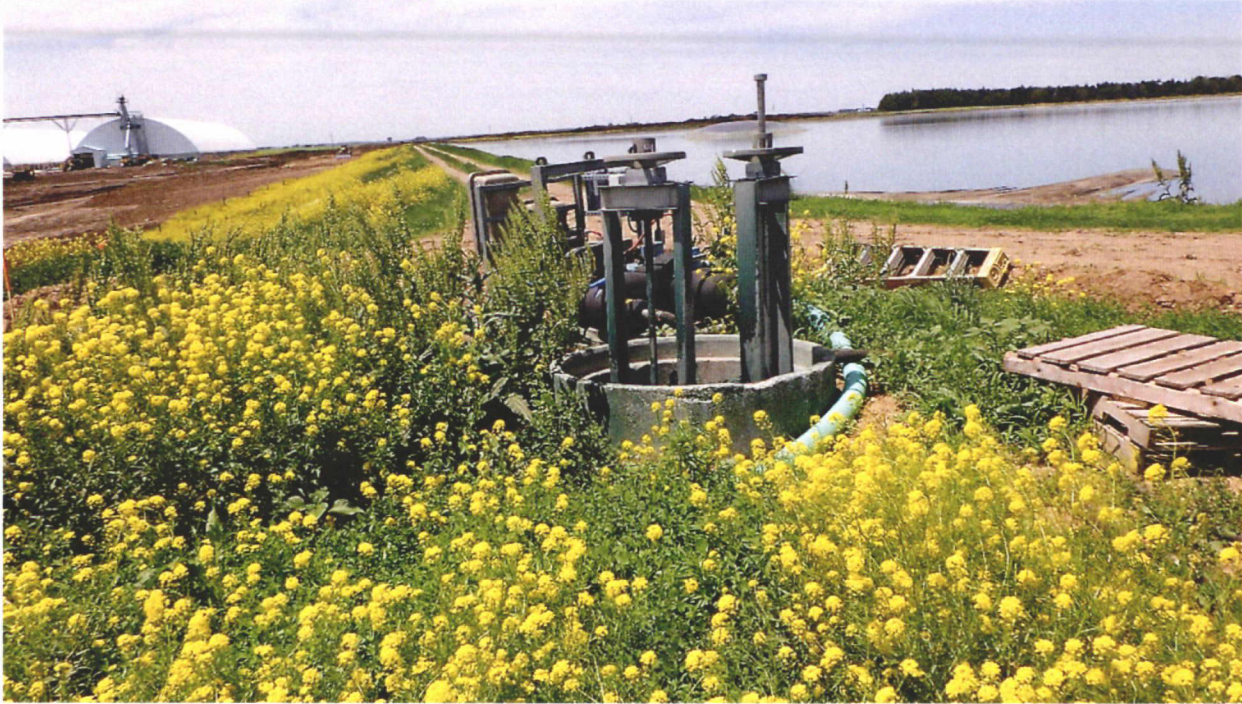
Photo: 13

Location: Pumping station

Description: This photo depicts the pumping station. Currently the station is not pumping.
