souNebraska Department of Environment and Energy (NDEE)

MEMORANDUM

RE: AltEn, LLC

Subject: Site Visit Report (Wastewater Aspects Only)

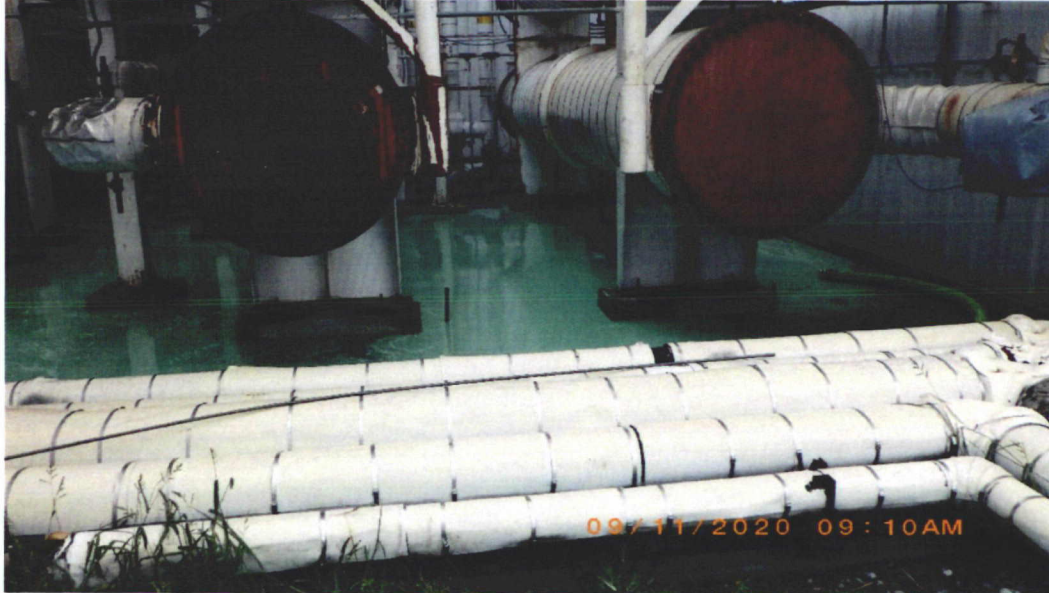
Photo 1

- Mr. Peterson and Mr. Tingelhoff estimated that the average daily flow to the lagoons is about 100,000 gallons per day.
- A wastewater (thin stillage) spill/overflow was observed at the facility during the visit (Photos 1-4, 6). Mr. Peterson stated that this was due to a pump failure, and it was being repaired while we were there. He said the spill had occurred that morning.

- A wastewater (thin stillage) spill was observed due to equipment failure. A wastewater spill was observed due to equipment failure during the last lagoon inspection, as well (November 2019). Proper maintenance and operation of wastewater equipment are essential to preventing these issues.

Description: Wastewater (thin stillage) spill due to pump issue.

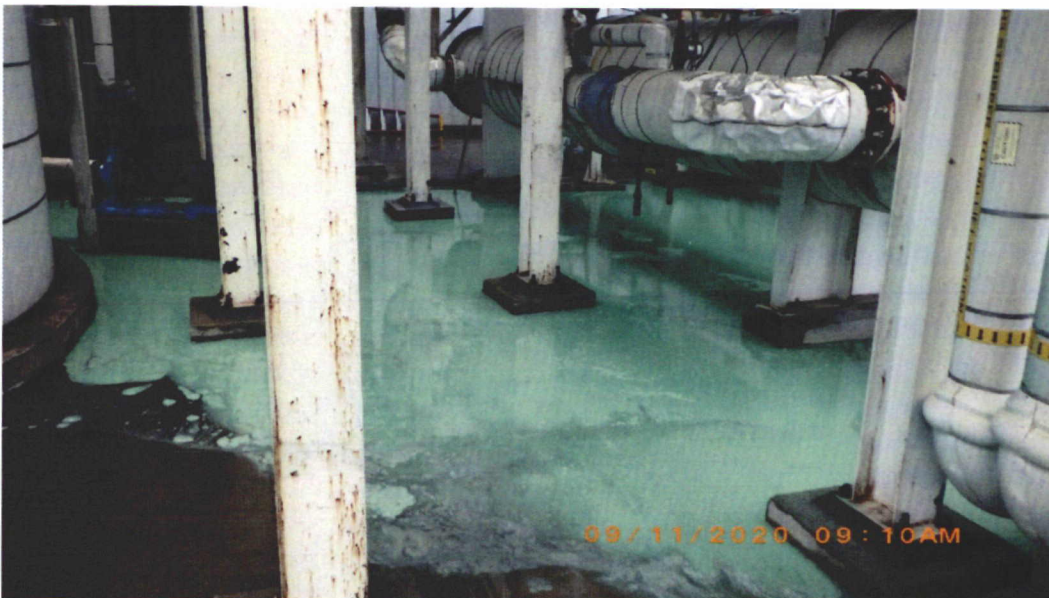
Photo 2

Description: Wastewater (thin stillage) spill due to pump issue.

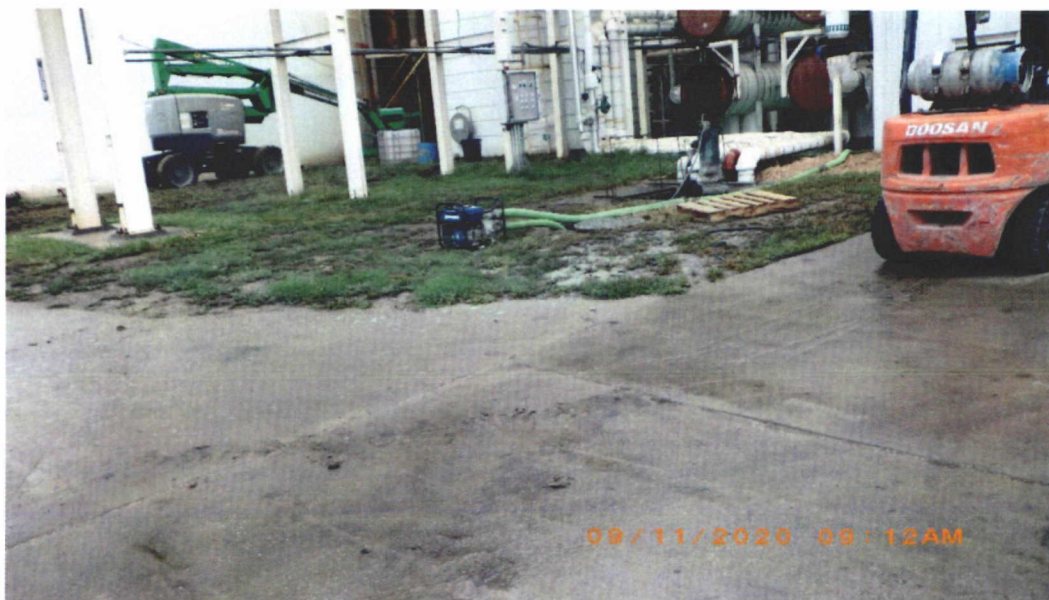
Photo 3

Description: Wastewater spill due to pump issue.

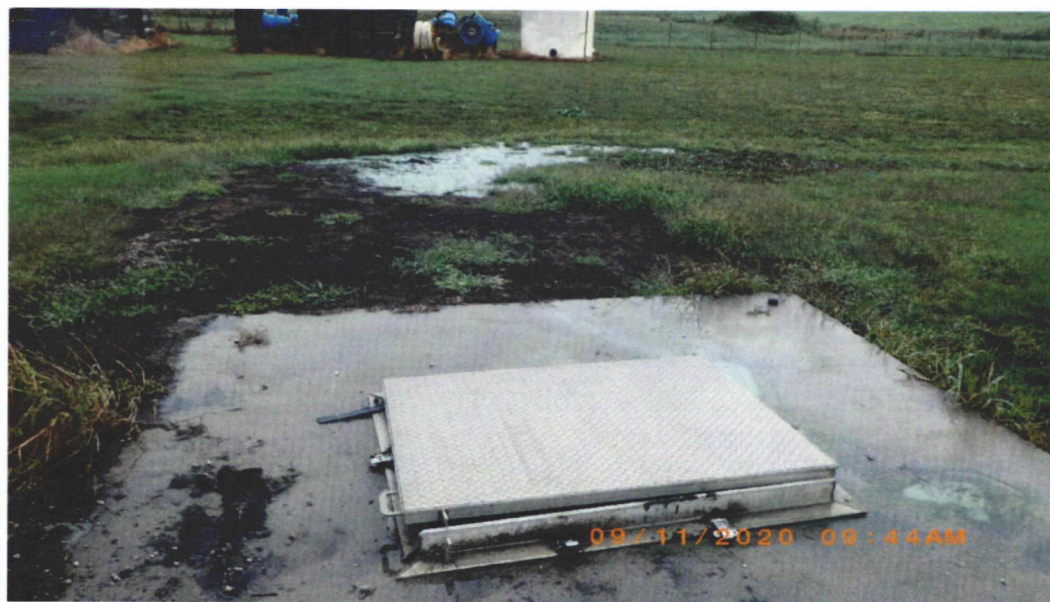
Photo 4

Description: Wastewater overflow due to pump issue near north manhole.

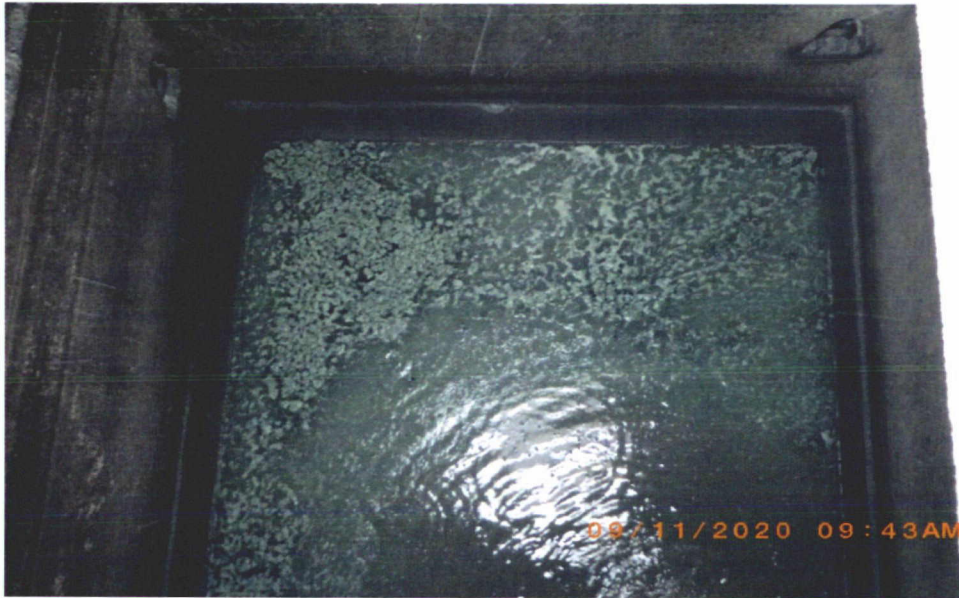
Photo 5

Description: Inside of manhole – no observable concerns about interior of manhole.

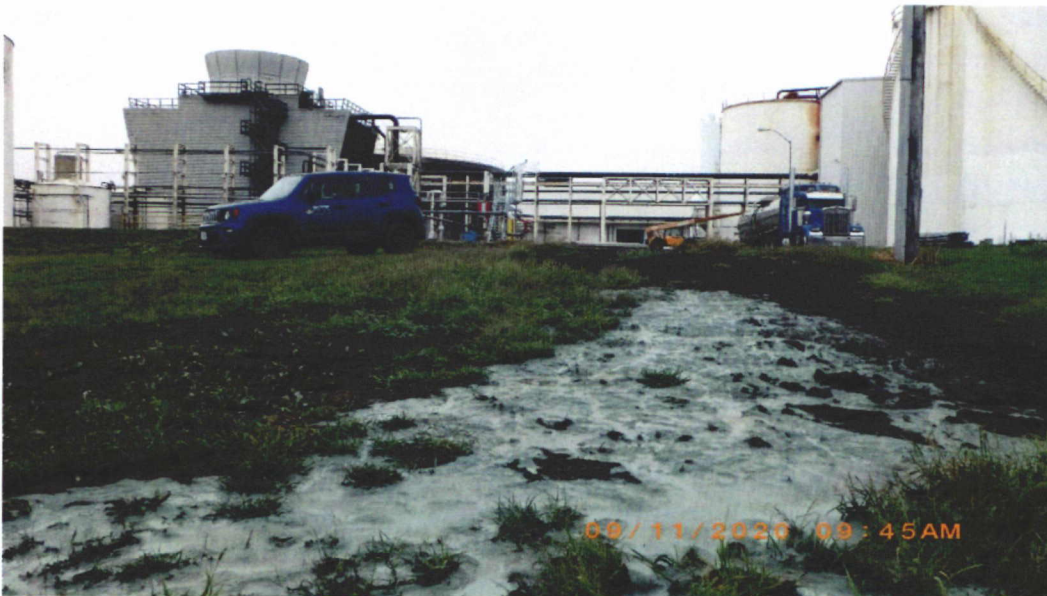
Photo 6

Description: Wastewater overflow due to pump issue near manhole.

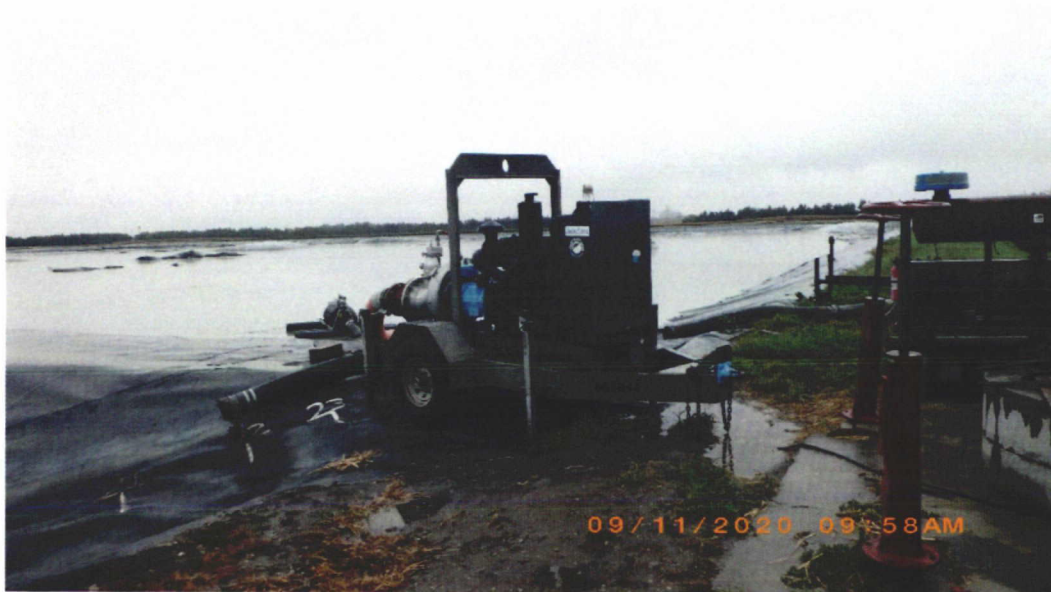
Photo 7

Description: Pump for moving wastewater from northeast lagoon to south lagoon for repairs.

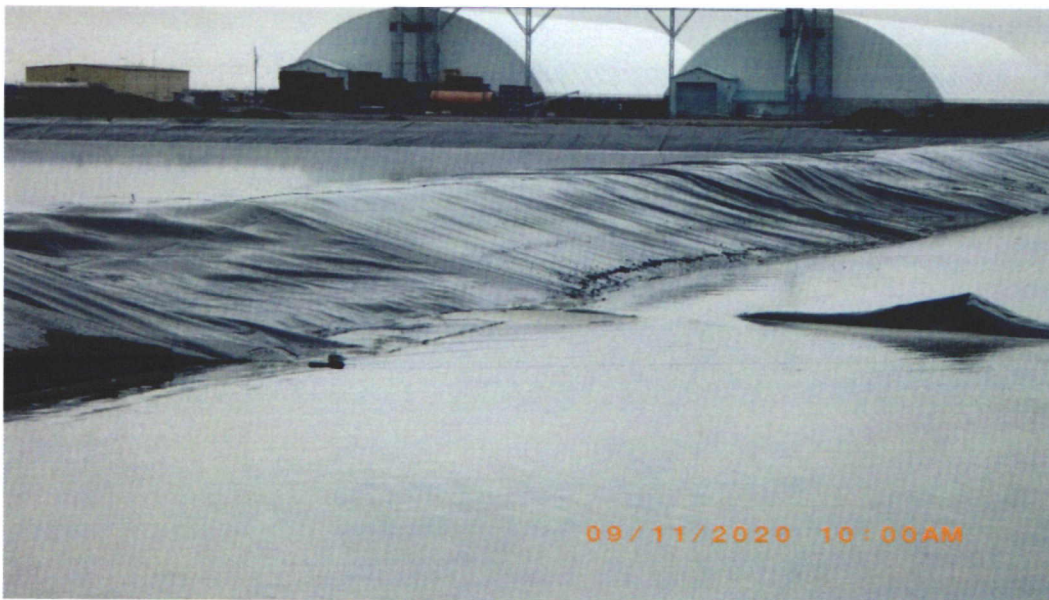
Photo 8

- The northeast lagoon liner continues to have many large “whales” and tears (Photos 8-19, 23, 24, 28). The condition has seemed to worsen over time.
- The northwest lagoon still has two “whales” (Photos 20, 32). It also has a couple small liner tears (25, 26, 33). There are a couple locations where the edge of the liner, which is supposed to be buried at least two feet under the ground (anchor trench), is visible from the ground surface (Photos 21, 22).

- The northeast lagoon liner is still significantly damaged. The condition of the liner has seemed to worsen over time. In some locations, the liner is completely torn and the ground underneath the liner is visible.

Description: Apparent tear in northeast lagoon liner. The liner between the south and northeast lagoons was too slick to observe the south side of the northeast lagoon up close.

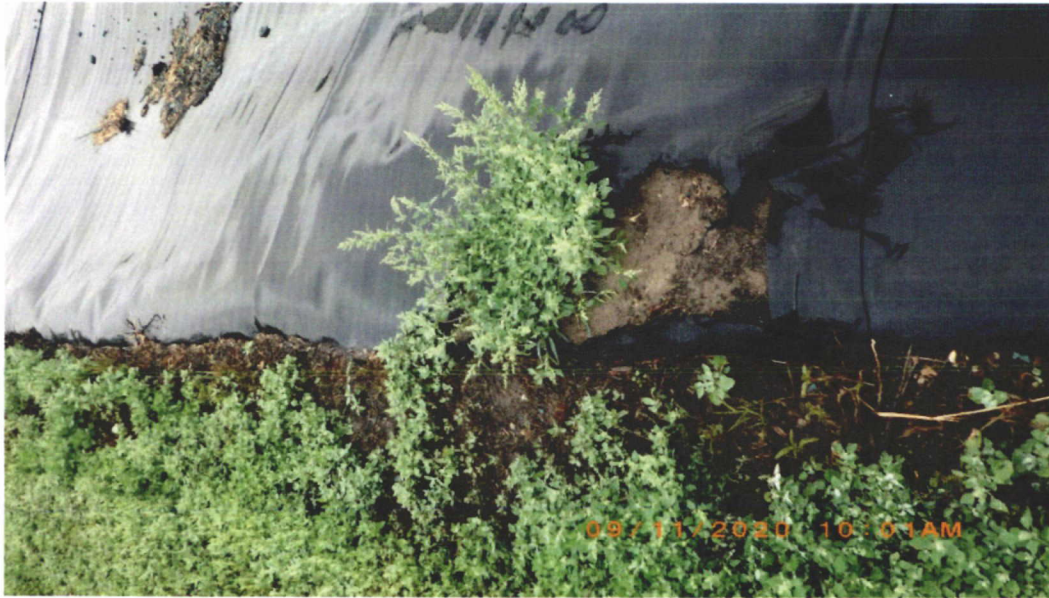
Photo 9

Description: Vegetation/liner damage on east side of northeast lagoon.

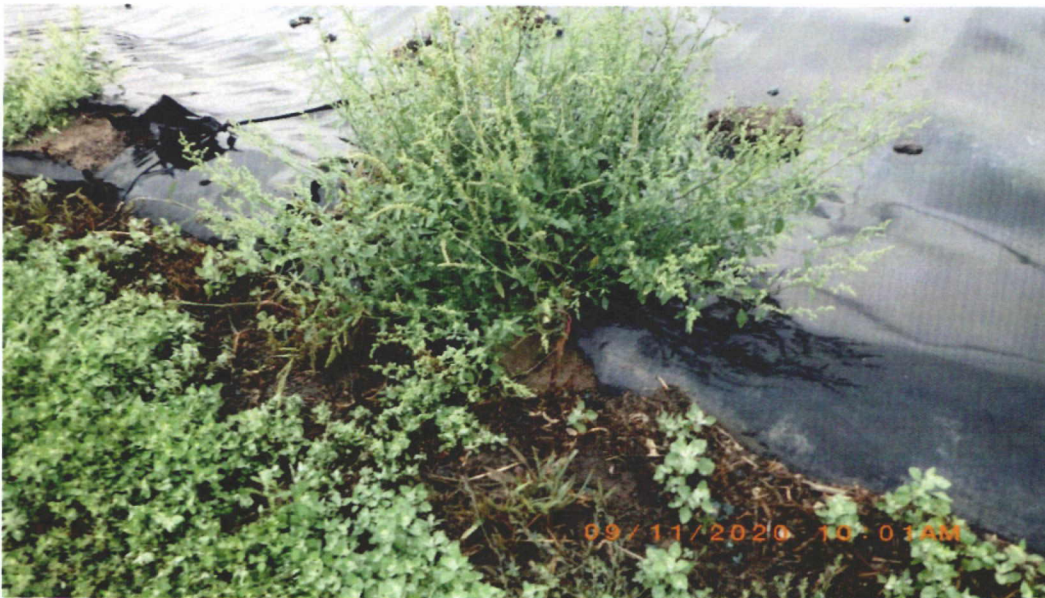
Photo 10

Description: Vegetation/liner damage on east side of northeast lagoon.

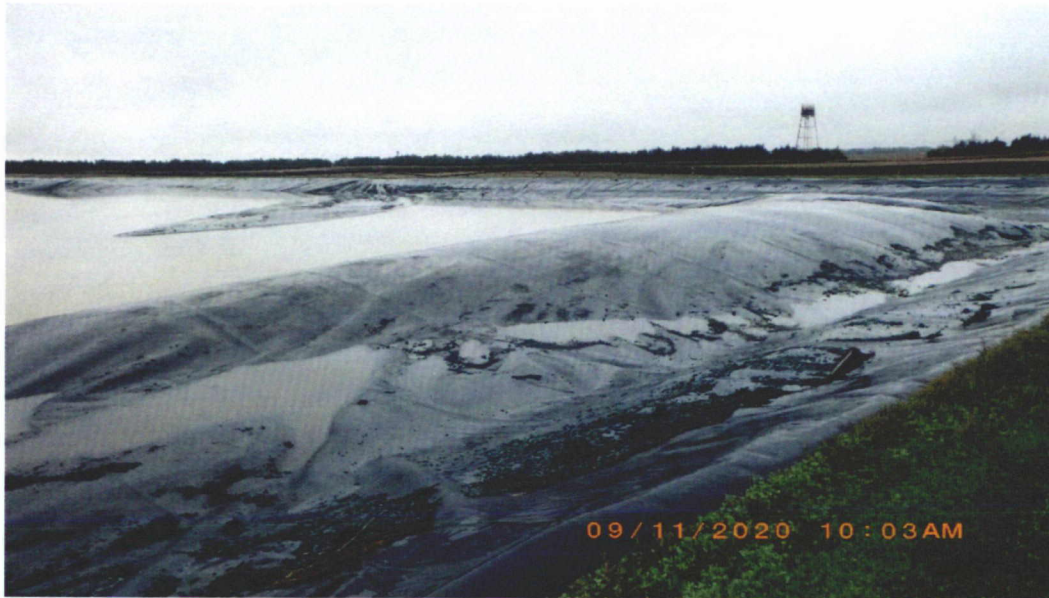
Photo 11

Description: Liner on east side of northeast lagoon.

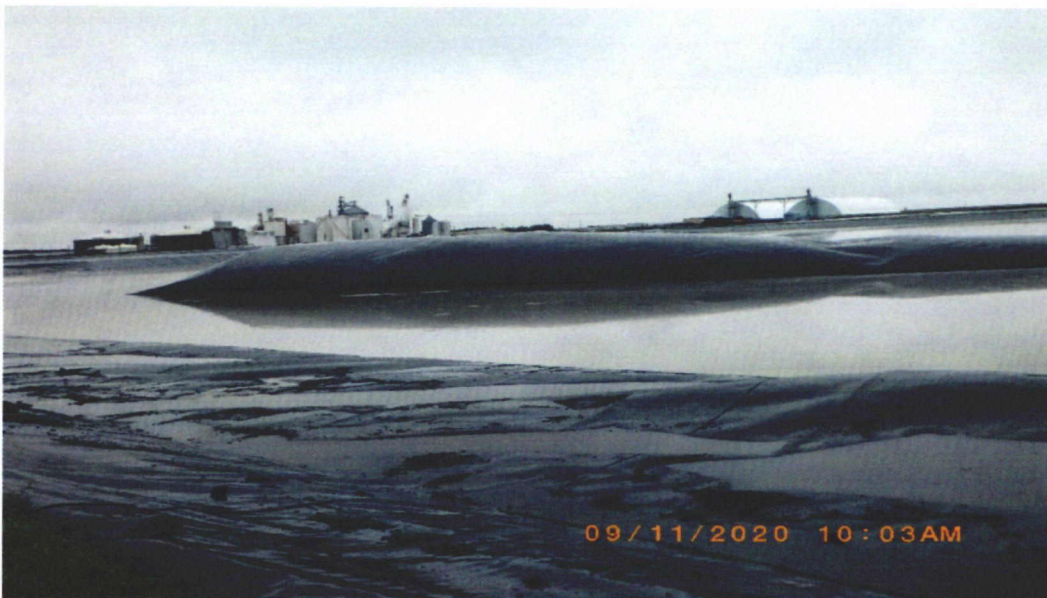
Photo 12

Description: Liner on east side of northeast lagoon. Large "whale" is visible.

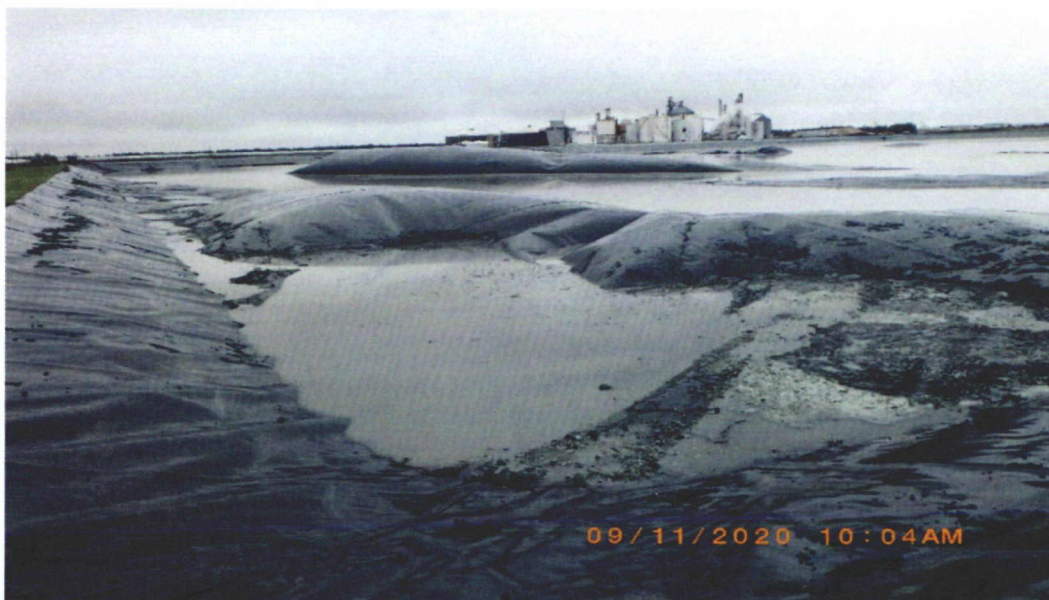
Photo 12

Description: Liner at northeast corner of northeast lagoon. "Whales" are visible.

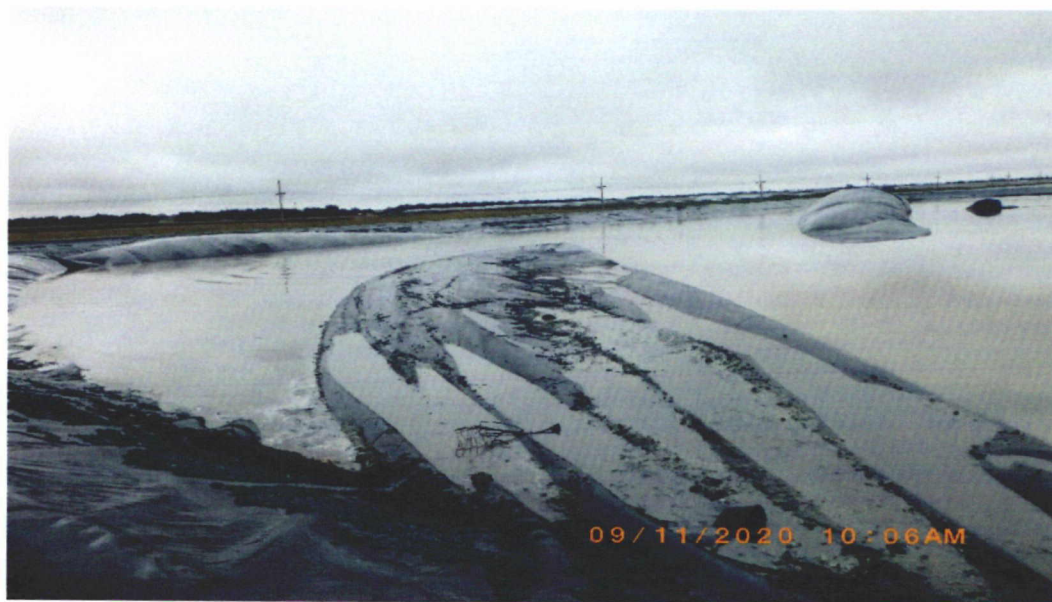
Photo 13

Description: View of liner damage from north side of northeast lagoon. Large liner tear is visible.

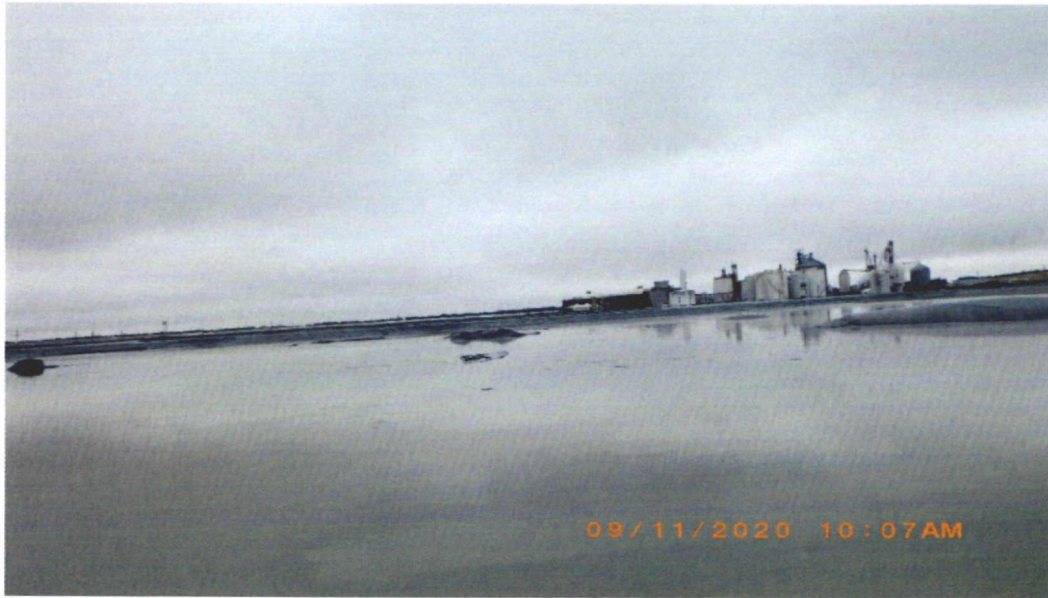
Photo 14

Description: View of liner damage from north side of northeast lagoon.

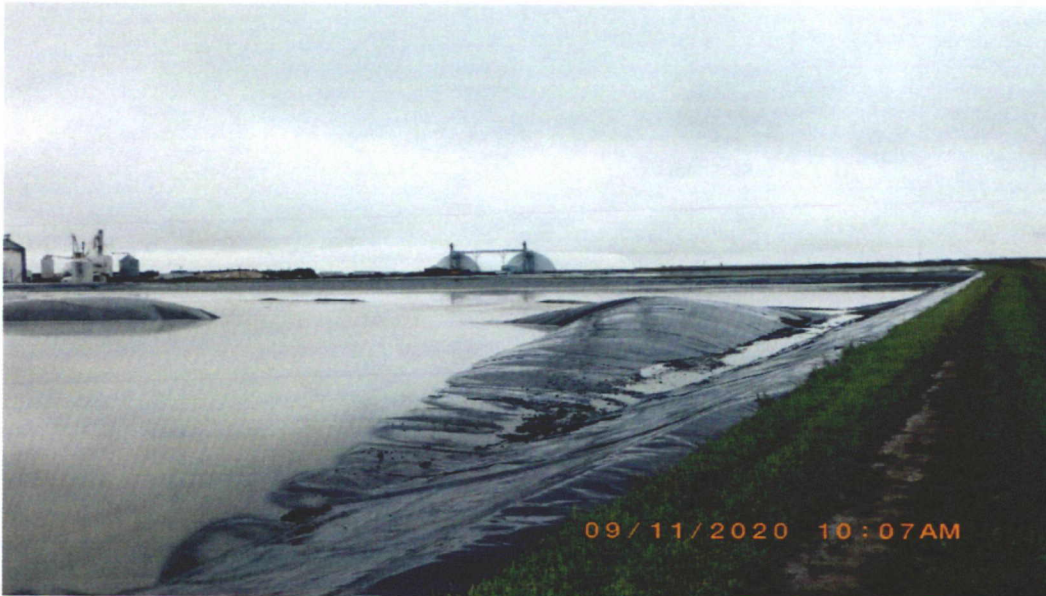
Photo 15

Description: View of liner damage from north side of northeast lagoon. Liner "whales" and tears are visible.

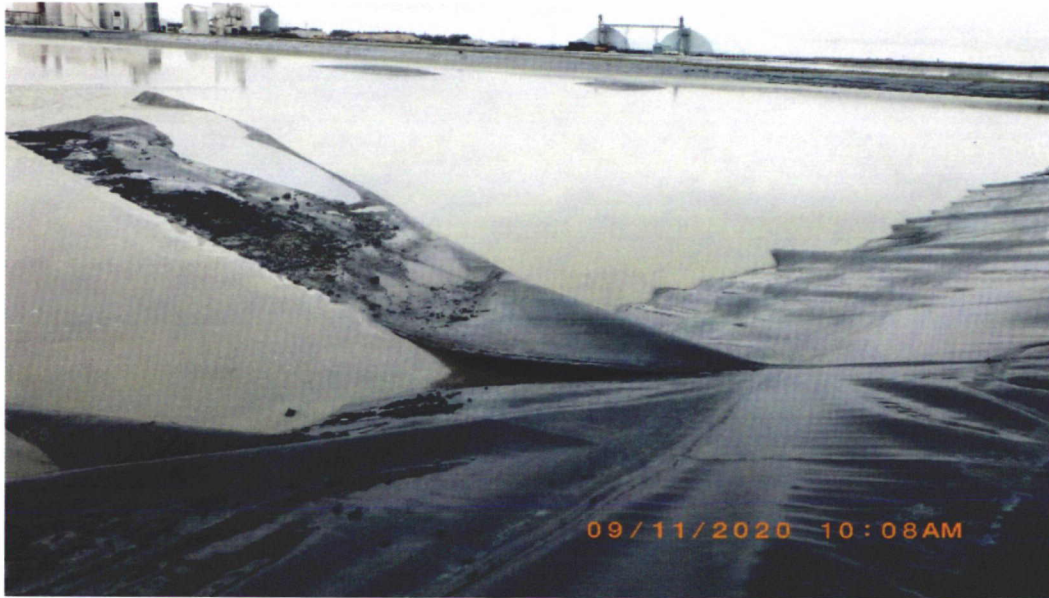
Photo 16

Description: Liner damage/tear on north side of northeast lagoon. The ground underneath the liner is visible.

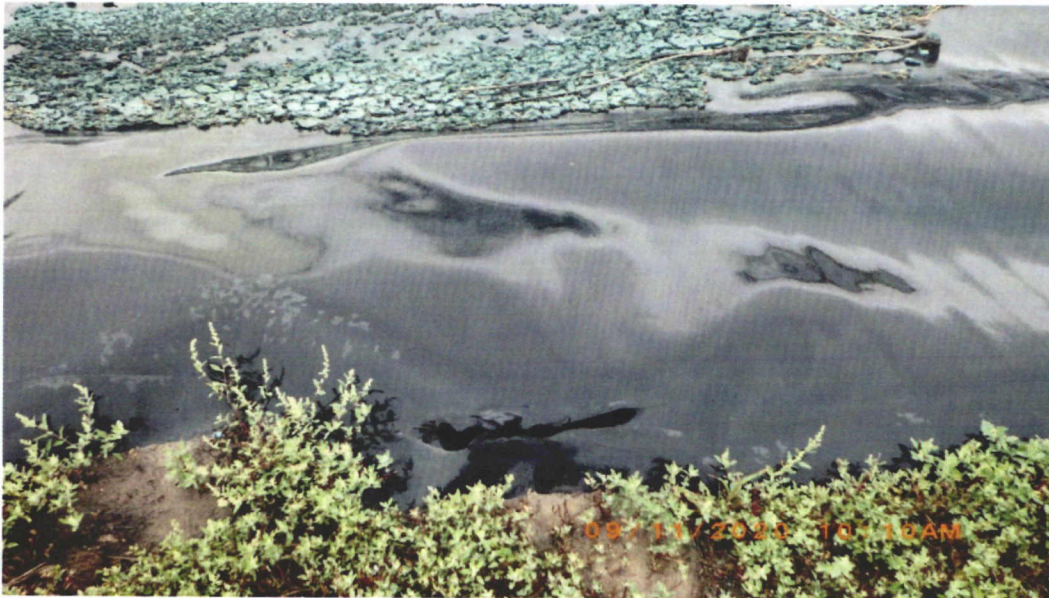
Photo 17

Description: Liner damage near northwest corner of northeast lagoon.

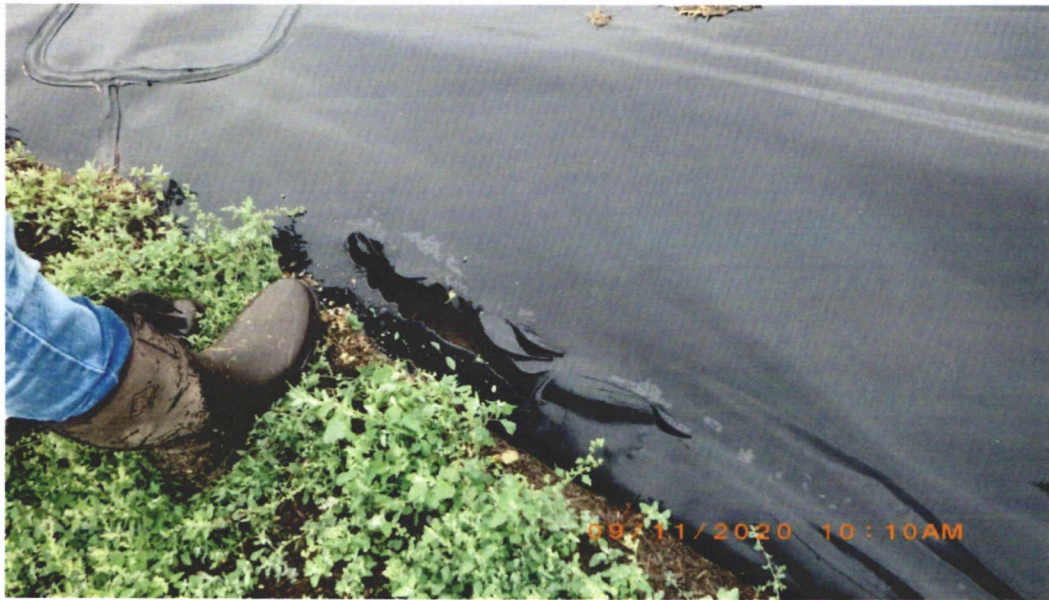
Photo 18

Description: Liner damage near northwest corner of northeast lagoon.

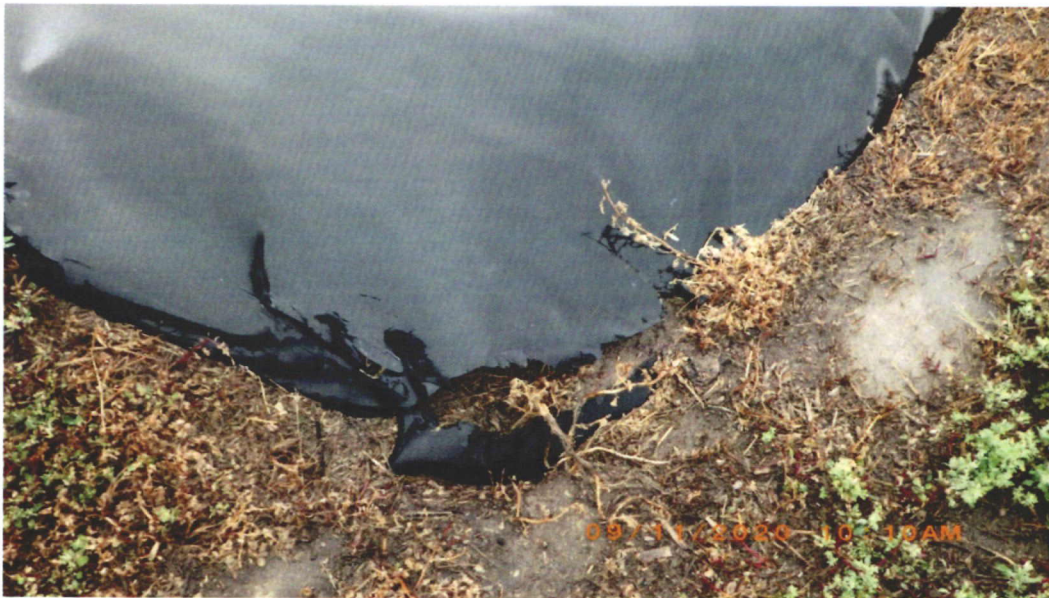
Photo 19

Description: Liner damage near northwest corner of northeast lagoon.

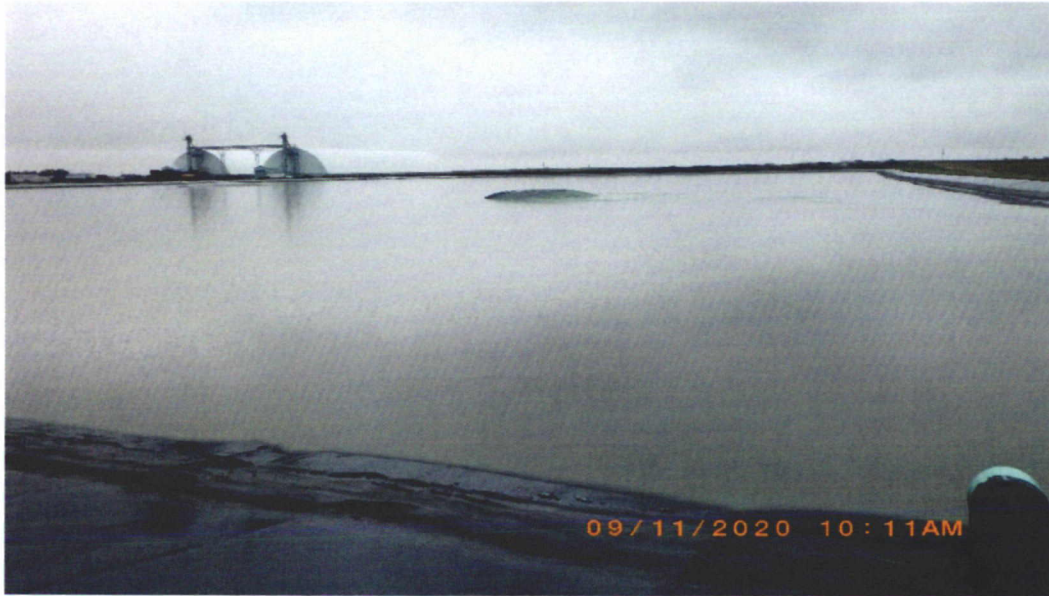
Photo 20

- The northwest lagoon still has “whales” that need to be repaired. If these are not repaired in a timely manner, further damage could occur to the liner. Moreover, in addition to the “whales”, there are small liner tears (photos referenced above). The edge of the liner is also visible from the ground surface in several areas. The edge of the liner is supposed to be at least two feet below the ground (anchor trench). In addition to repairing the “whales” in the northwest lagoon, these concerns should also be evaluated and addressed.

Description: "Whale" in northwest lagoon from east side of northwest lagoon.

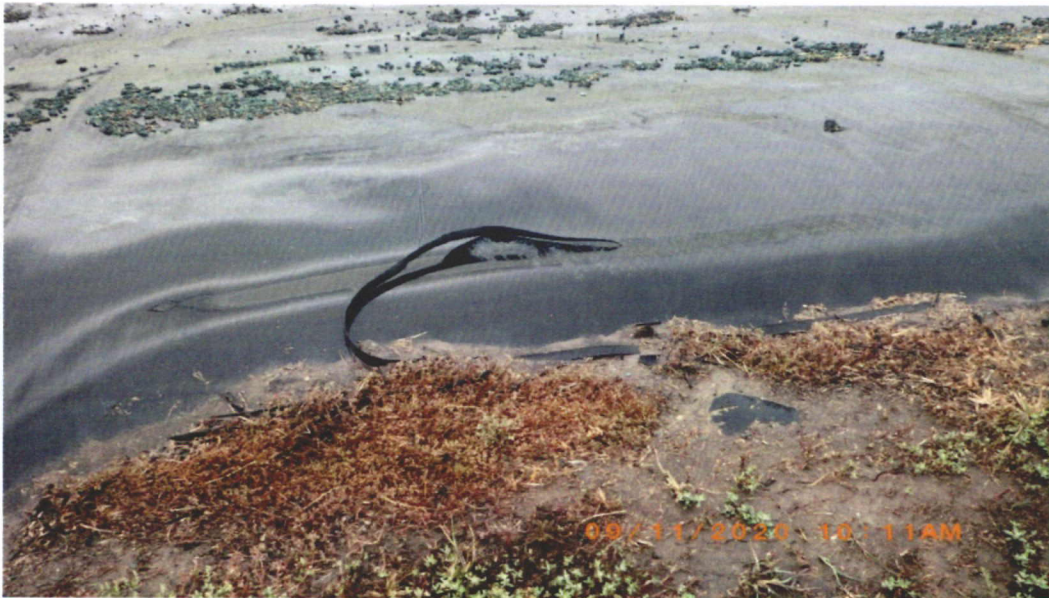
Photo 21

Description: Liner visible under backfill on east side of northwest lagoon. This should be adequately anchored underground.

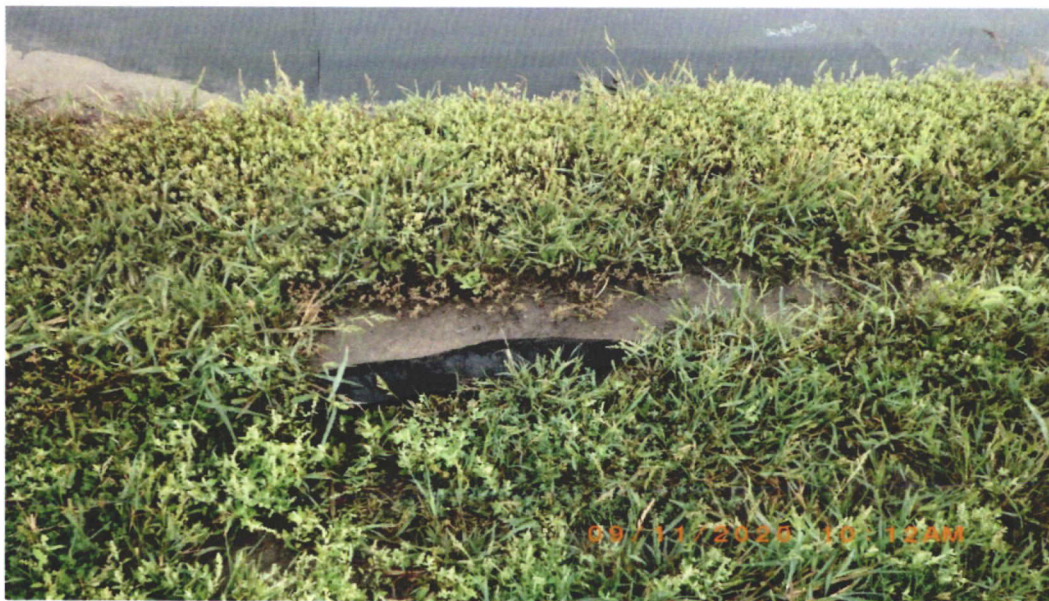
Photo 22

Description: Edge of liner visible under backfill on east side of northwest lagoon. This should be anchored underground.

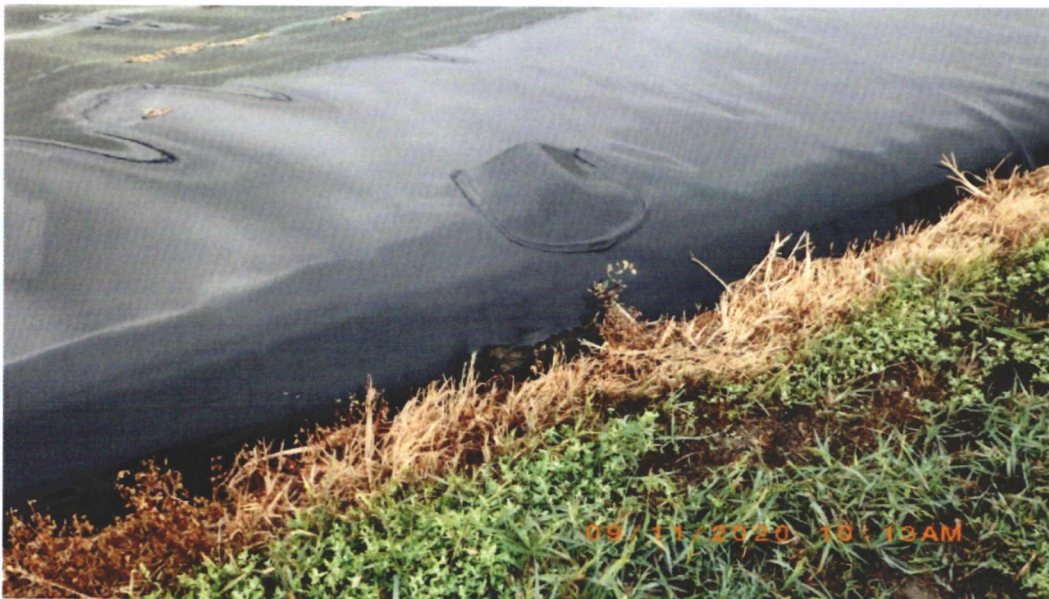
Photo 23

Description: Liner damage on west side of northeast lagoon.

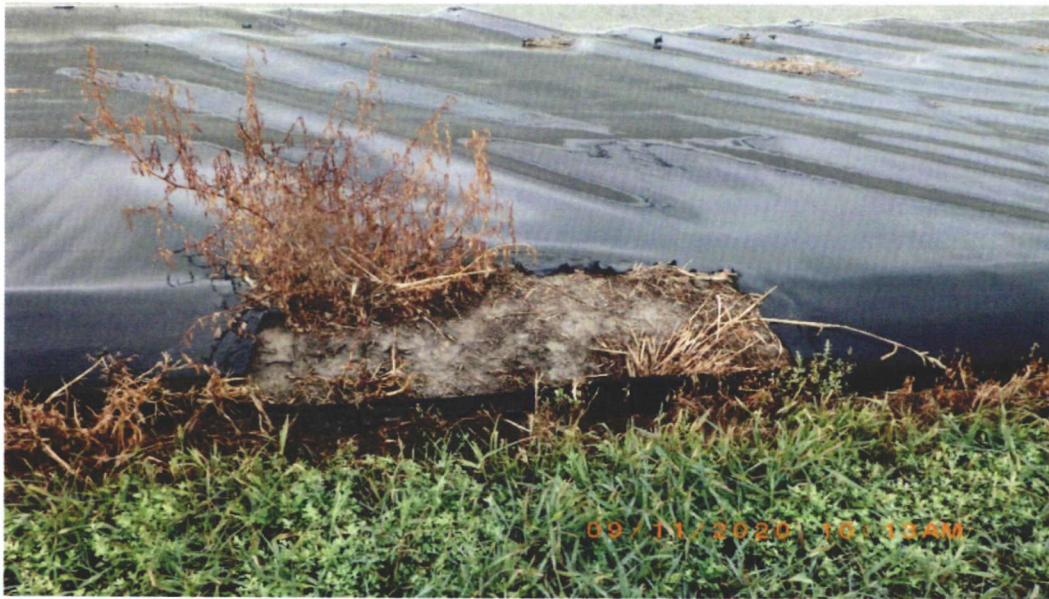
Photo 24

Description: Liner damage on west side of northeast lagoon.

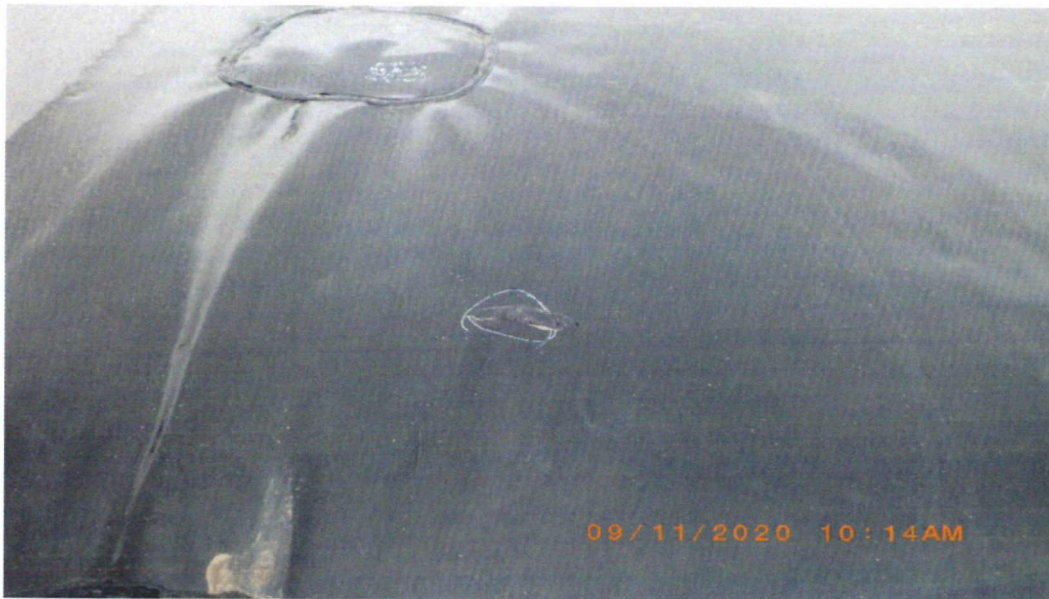
Photo 25

Description: Small liner tear on east side of west lagoon.

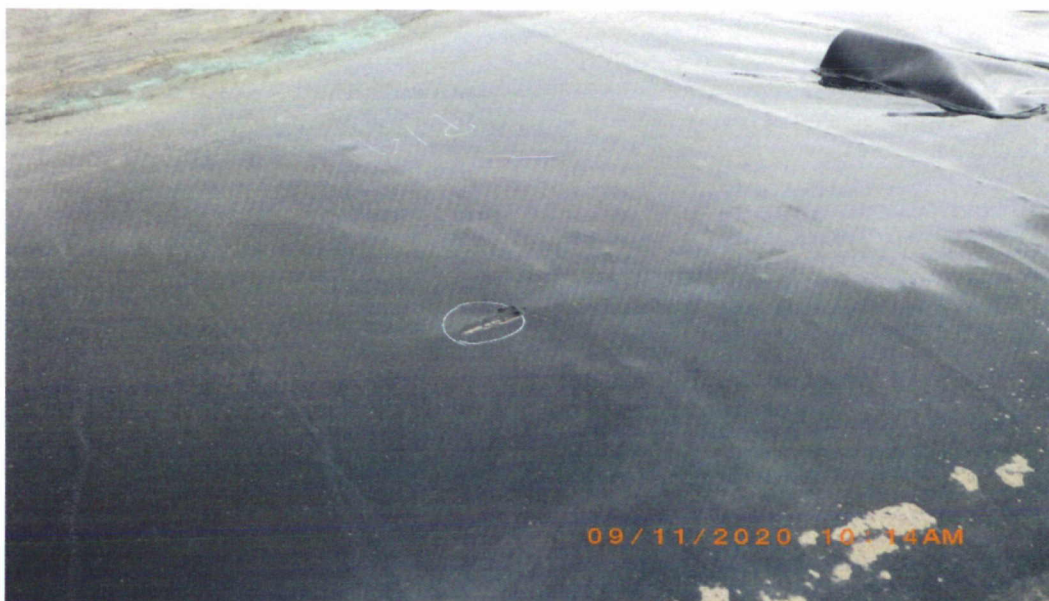
Photo 26

Description: Small liner tear on east side of west lagoon.

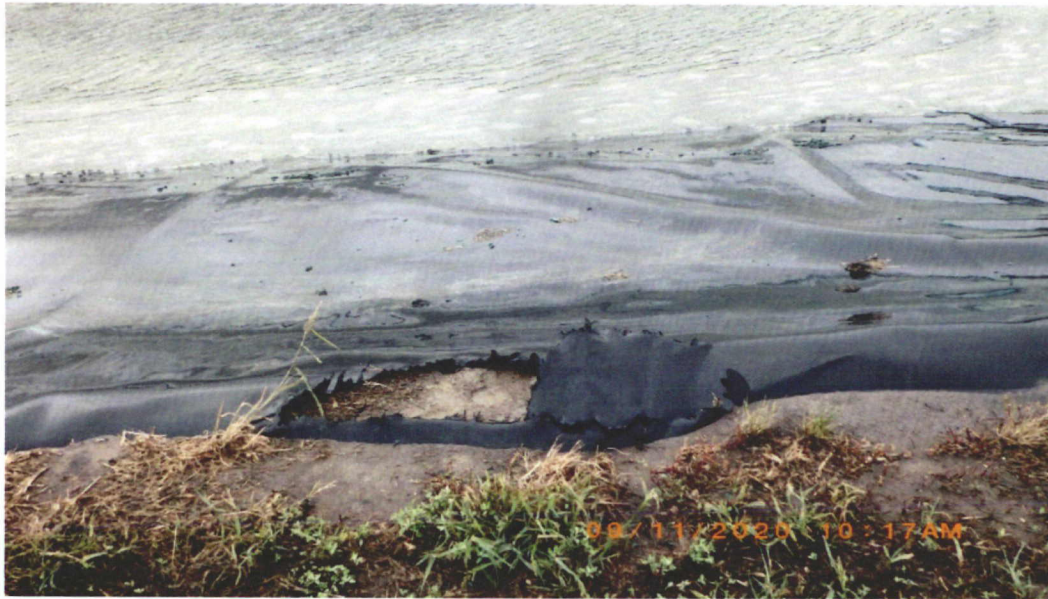
Photo 28

Description: Liner damage on west side of northeast lagoon.

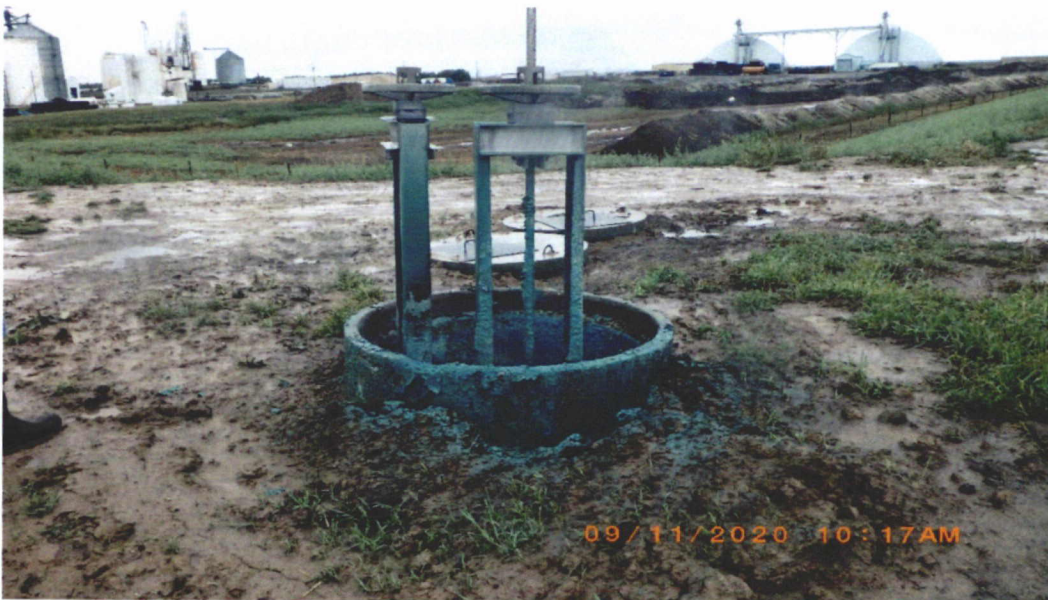
Photo 29

- The facility was in the process of completing a wastewater construction project while we were there. This involved moving the pipe that transports wastewater to the northwest lagoon. The pipe was moved from the toe of the lagoon dike to closer to the top of the lagoon dike. Moreover, a junction box and air relief valve appear to have been moved

Description: Junction box with pipes entering the northeast and south lagoons.

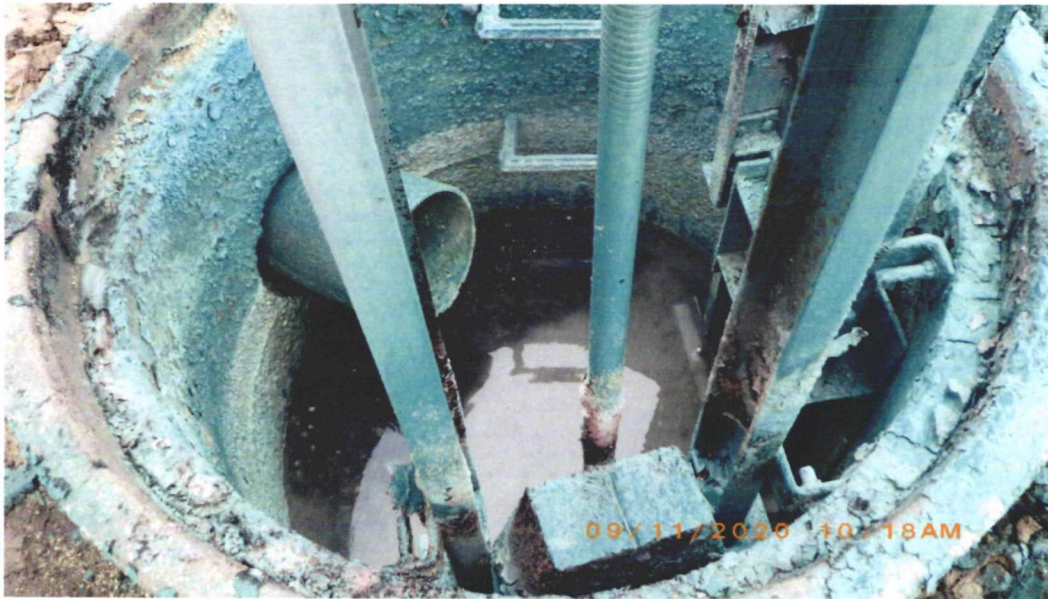
Photo 30

Description: Inside of junction box (sand and gravel accumulation in bottom).

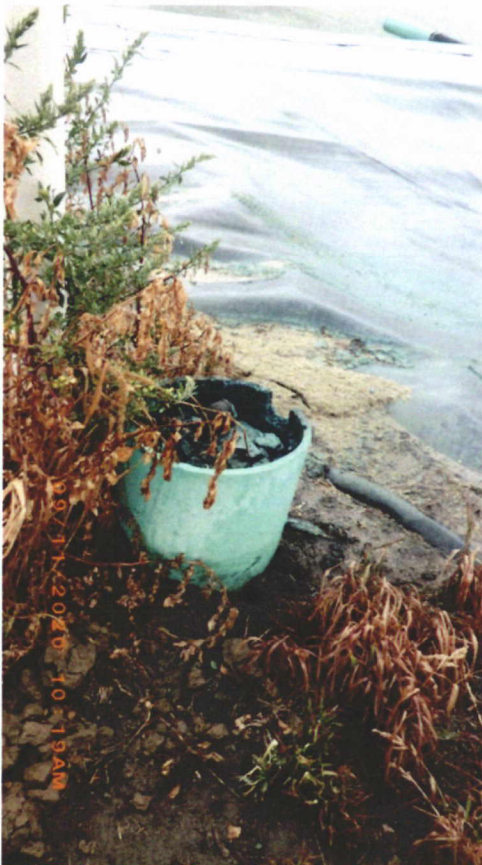
Photo 31

Description: Air relief valve near south lagoon.

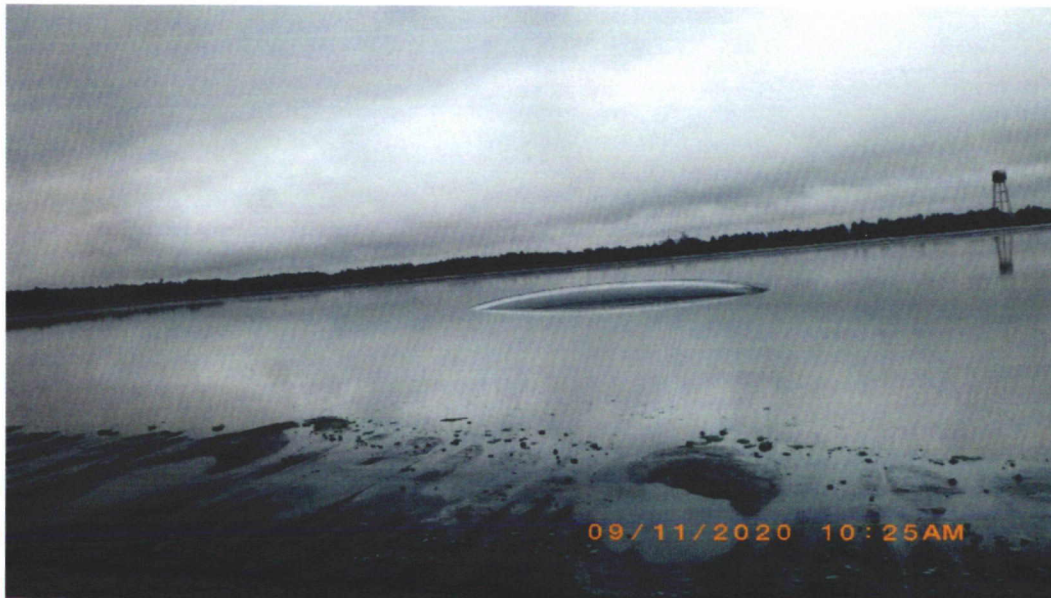
Photo 32

Description: Liner "whale" in northwest lagoon.

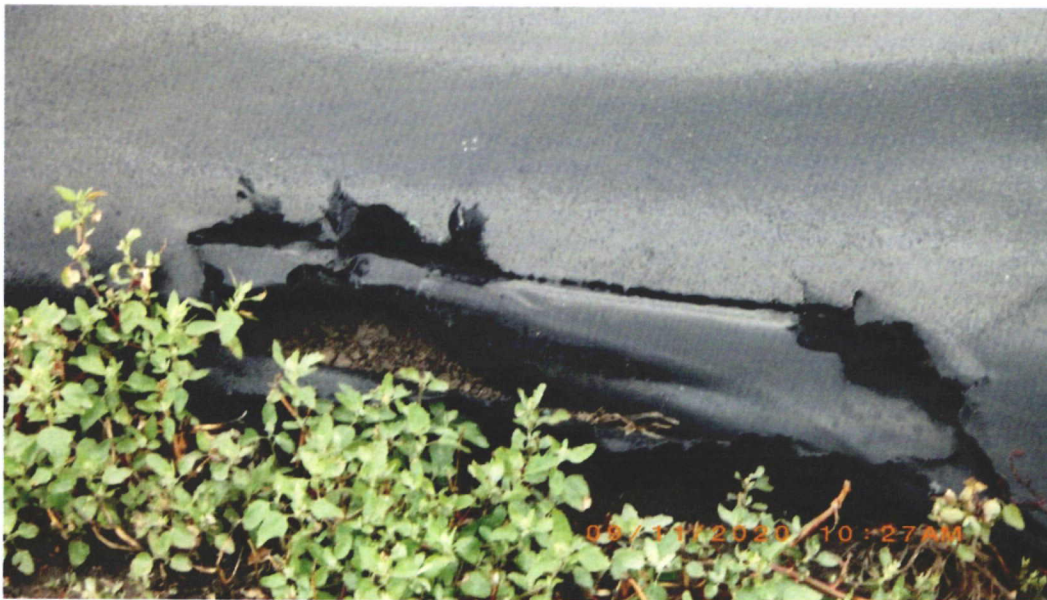
Photo 33

Description: Liner tear near southwest corner of northwest lagoon.
