## DEPT. OF ENVIRONMENT AND ENERGY

### MEMORANDUM

RE: Site visit – Jason Windhorst & Jason Holsten (NDEE)

NDEQID: 84069 (AltEn LLC)

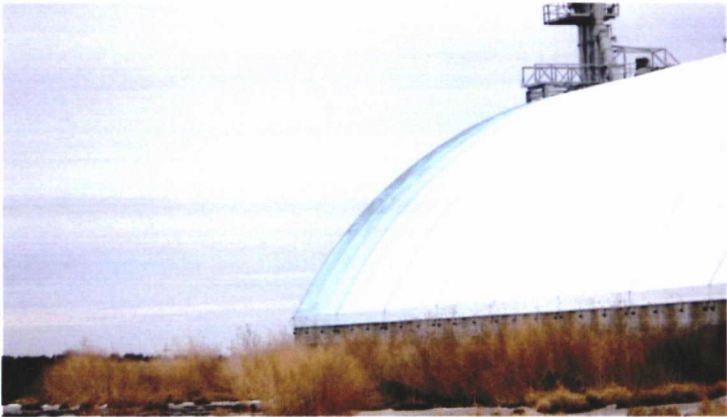
<p>Photograph # 07 Date: 2/12/2020 Photographer: Jason Windhorst Camera: RICOH WG-60 Facility Name: AltEn LLC Facility IIS number / Program ID: <b>IIS# 84069, NER910444</b> Direction Facing: Southeast Description: Blue dust coating the east edge of the north hoop barn. The camera was not able to capture evidence of dust blowing out of the building due to light conditions, but was visible to us.</p>

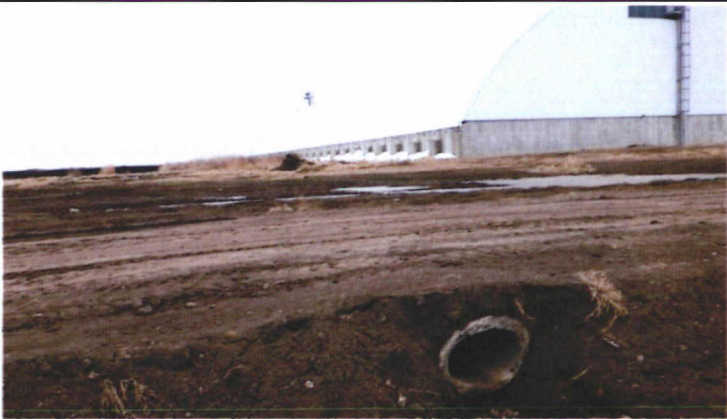
<p>Photograph # 08 Date: 2/12/2020 Photographer: Jason Windhorst Camera: RICOH WG-60 Facility Name: AltEn LLC Facility IIS number / Program ID: <b>IIS# 84069, NER910444</b> Direction Facing: East Description: Culvert draining portions of the wet cake storage area north of the north hoop barn. This culvert discharges to the ditch next to road 10.</p>

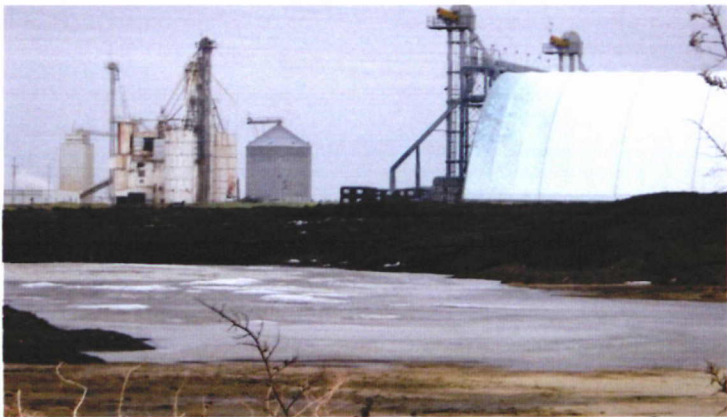
<p>Photograph # 09 Date: 2/12/2020 Photographer: Jason Windhorst Camera: RICOH WG-60 Facility Name: AltEn LLC Facility IIS number / Program ID: <b>IIS# 84069, NER910444</b> Direction Facing: South Description: Stormwater/wet cake liquids storage area at the northeast corner of the north wet cake storage area. The blue coating of the north hoop barn is evident at this location.</p>

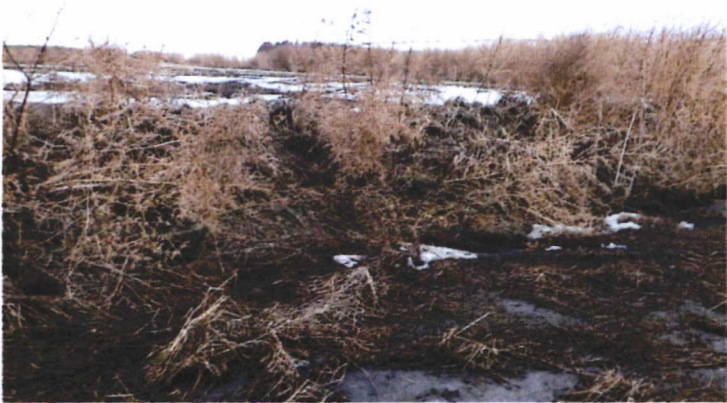
<p>Photograph # 10 Date: 2/12/2020 Photographer: Jason Windhorst Camera: RICOH WG-60 Facility Name: AltEn LLC Facility IIS number / Program ID: <b>IIS# 84069, NER910444</b> Direction Facing: West/Northwest Description: Material that overflowed from the northeast corner of the liquid containment area of the north wet cake storage area.</p>

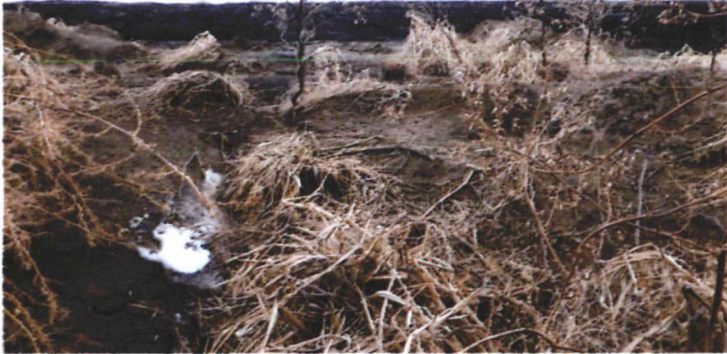
<p>Photograph # 11 Date: 2/12/2020 Photographer: Jason Windhorst Camera: RICOH WG-60 Facility Name: AltEn LLC Facility IIS number / Program ID: <b>IIS# 84069, NER910444</b> Direction Facing: West Description: Second area where liquid has overflowed/topped the containment dike of the wet cake storage area. Discharges from the liquid containment drain to north side of the wastewater lagoons.</p>

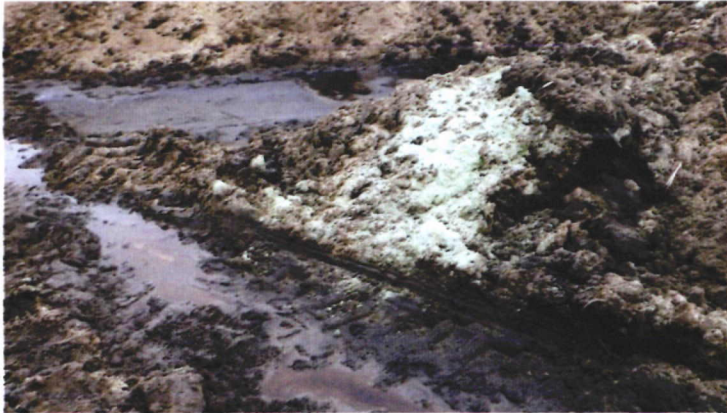
<p>Photograph # 12 Date: 2/12/2020 Photographer: Jason Windhorst Camera: RICOH WG-60 Facility Name: AltEn LLC Facility IIS number / Program ID: <b>IIS# 84069, NER910444</b> Direction Facing: Southwest Description: Liquids discharging from the southeast corner of the north wet cake storage area. Discharges in this area flow to the south side of the south lagoon.</p>

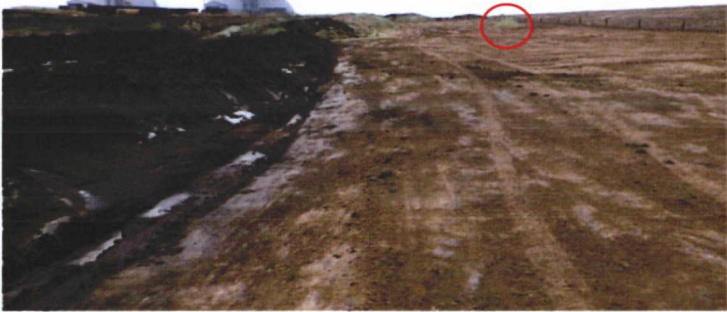
<p>Photograph # 13  Date: 2/12/2020  Photographer: Jason Windhorst  Camera: RICOH WG-60  Facility Name: AltEn LLC  Facility IIS number / Program ID:  <b>IIS# 84069, NER910444</b>  Direction Facing: West  Description: Recently cleared area south of the west lagoon. Wet cake was being placed in this area while we were onsite. The fence line on the right side of the photo is the south edge of the west lagoon berm.</p>

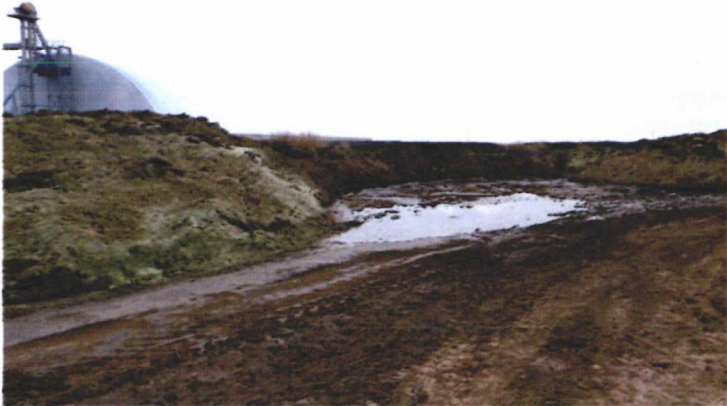
<p>Photograph # 14  Date: 2/12/2020  Photographer: Jason Windhorst  Camera: RICOH WG-60  Facility Name: AltEn LLC  Facility IIS number / Program ID:  <b>IIS# 84069, NER910444</b>  Direction Facing: Northwest  Description: In this area the north wet cake storage area connects to additional storage areas and discharge from the north concentrates at this point.</p>

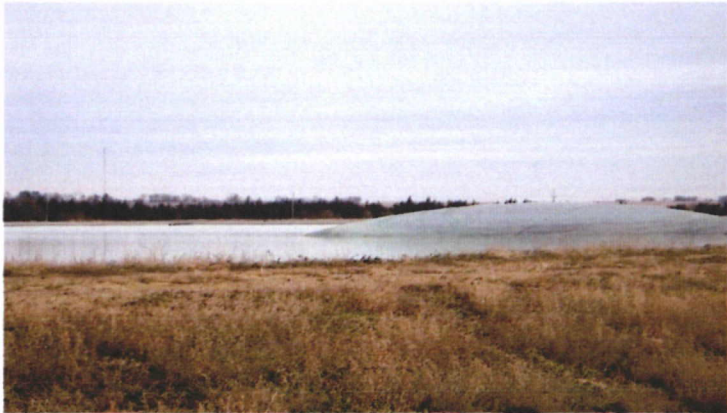
<p>Photograph # 15  Date: 2/12/2020  Photographer: Jason Windhorst  Camera: RICOH WG-60  Facility Name: AltEn LLC  Facility IIS number / Program ID:  <b>IIS# 84069, NER910444</b>  Direction Facing: East  Description: While at the location of photo 14, a photo was taken of the west lagoon at the south west corner. The large area on the right side of the photo is the liner protruding above the lagoon surface filled with gases.</p>

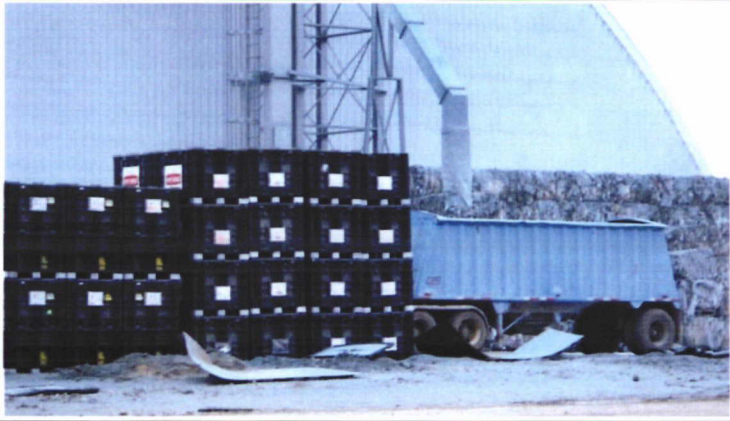
<p>Photograph # 16  Date: 2/12/2020  Photographer: Jason Windhorst  Camera: RICOH WG-60  Facility Name: AltEn LLC  Facility IIS number / Program ID:  <b>IIS# 84069, NER910444</b>  Direction Facing: West  Description: North hoop building loading area for grain taken to the ethanol plant. Note the blue coloring of the building and truck trailer.</p>

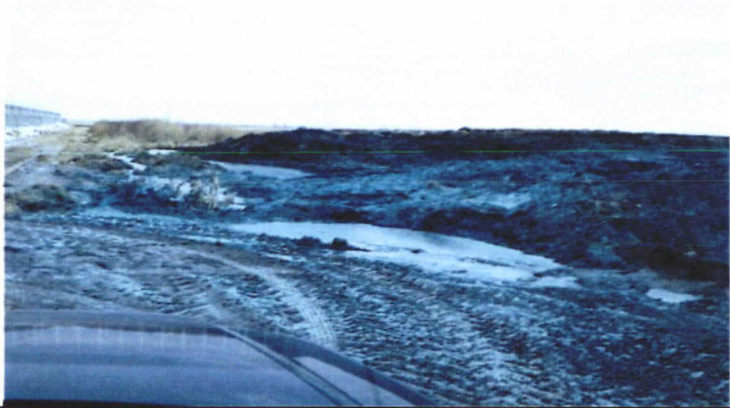
<p>Photograph # 17  Date: 2/12/2020  Photographer: Jason Windhorst  Camera: RICOH WG-60  Facility Name: AltEn LLC  Facility IIS number / Program ID:  <b>IIS# 84069, NER910444</b>  Direction Facing: Northeast  Description: at the northeast corner of the north hoop barn showing blue dust coating the black wet cake and runoff.</p>

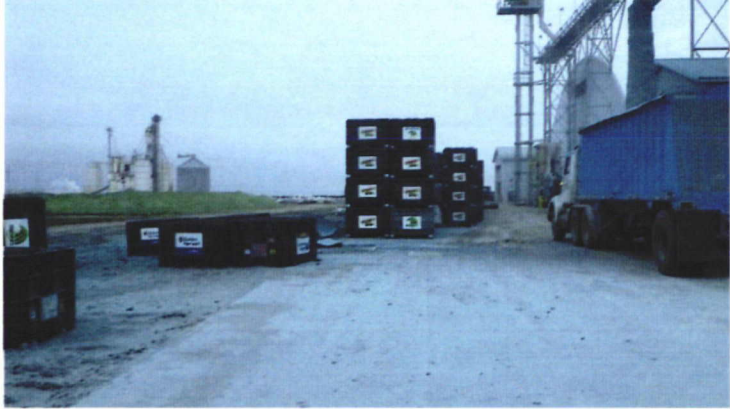
<p>Photograph # 18  Date: 2/12/2020  Photographer: Jason Windhorst  Camera: RICOH WG-60  Facility Name: AltEn LLC  Facility IIS number / Program ID:  <b>IIS# 84069, NER910444</b>  Direction Facing: South  Description: Same location as photo 17, showing blue dust on the ground, black totes, fixed equipment, and white (now blue) truck.</p>
