Nebraska Department of Environment and Energy (NDEE)

MEMORANDUM

RE: AltEn, LLC

Subject: Site Visit Report

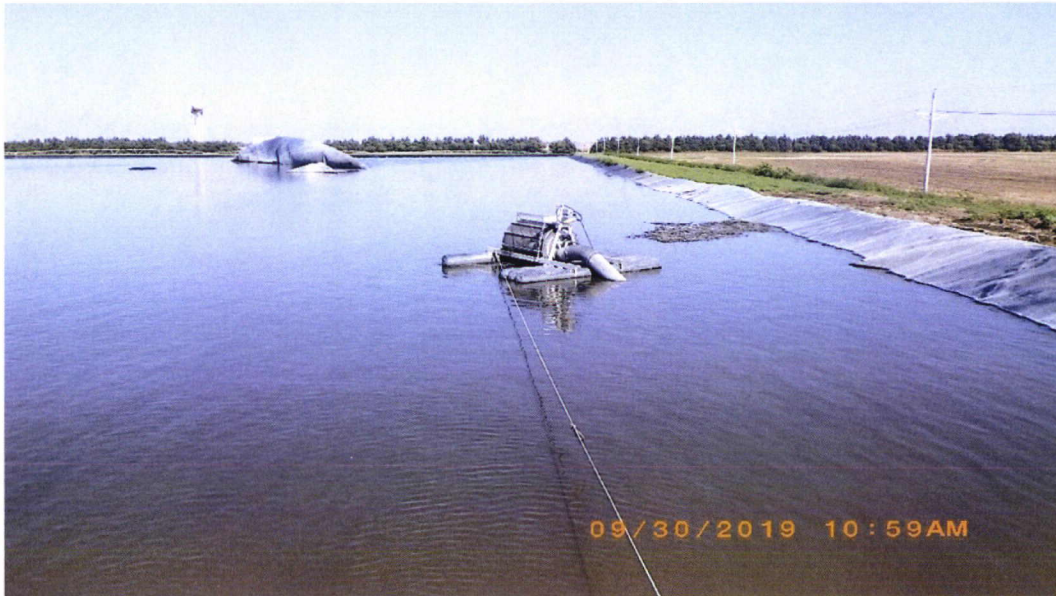
Photo 1

Description: Rotary drum in north lagoon that is not currently being used

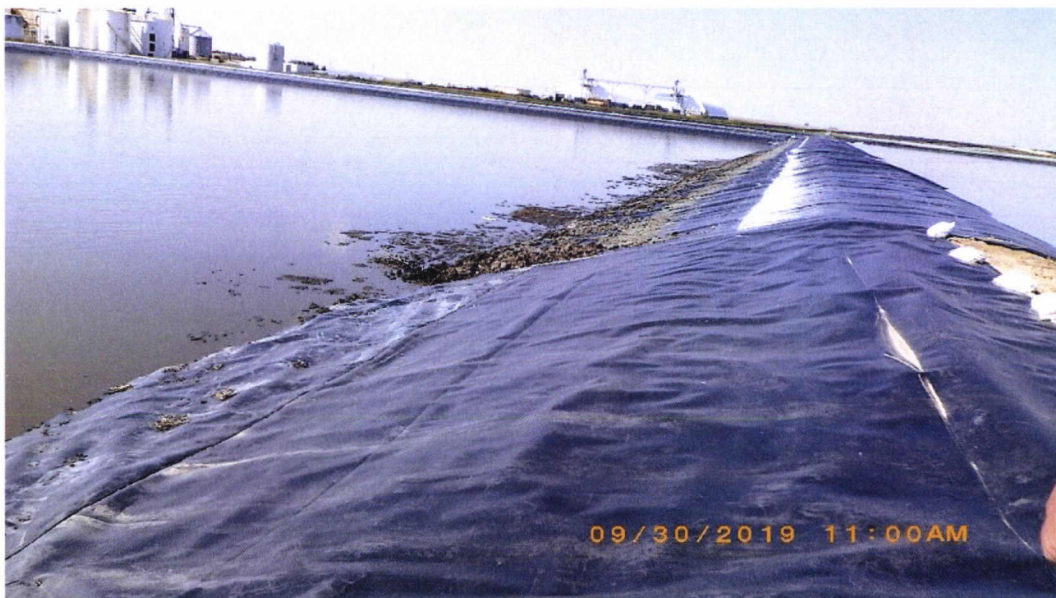
Photo 2

Description: South lagoon liner repair area

- The south lagoon liner dike is repaired (Photos 2-8).
- The storm water berm along the west lagoon is repaired; berm is also repaired on the southwest corner of lagoon system (Photo 17).
- The facility is not land applying wastewater from the lagoon system.
- The facility has stopped using the rotary drum screen with aerial jetting of wastewater until DEE approval.
- The air relief valve has been repaired (between the south and north lagoons) (Photos 15, 16).

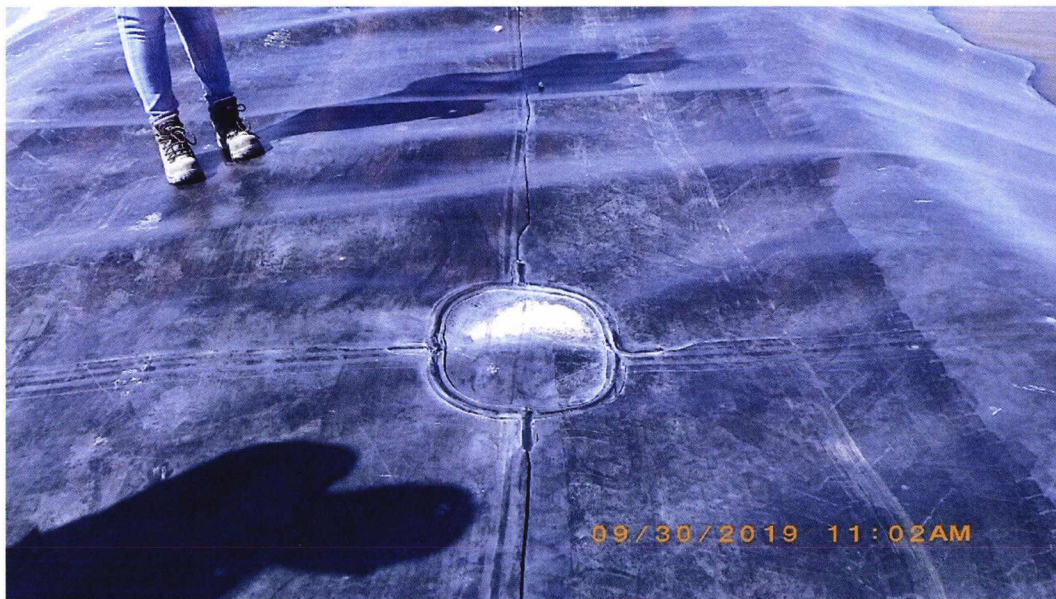
Photo 3

Description: South lagoon liner repair

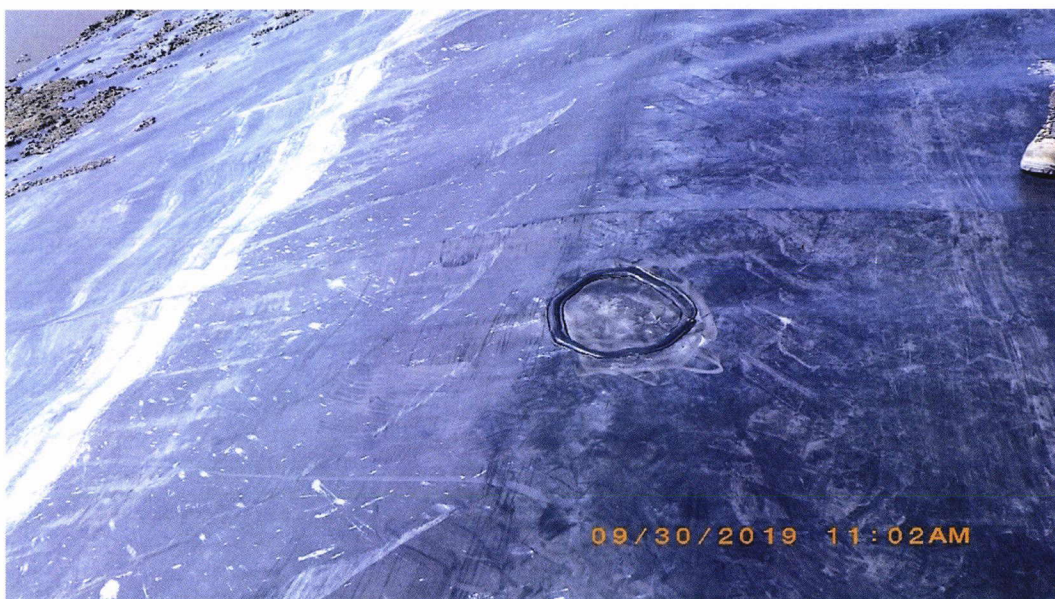
Photo 4

Description: South lagoon liner repair

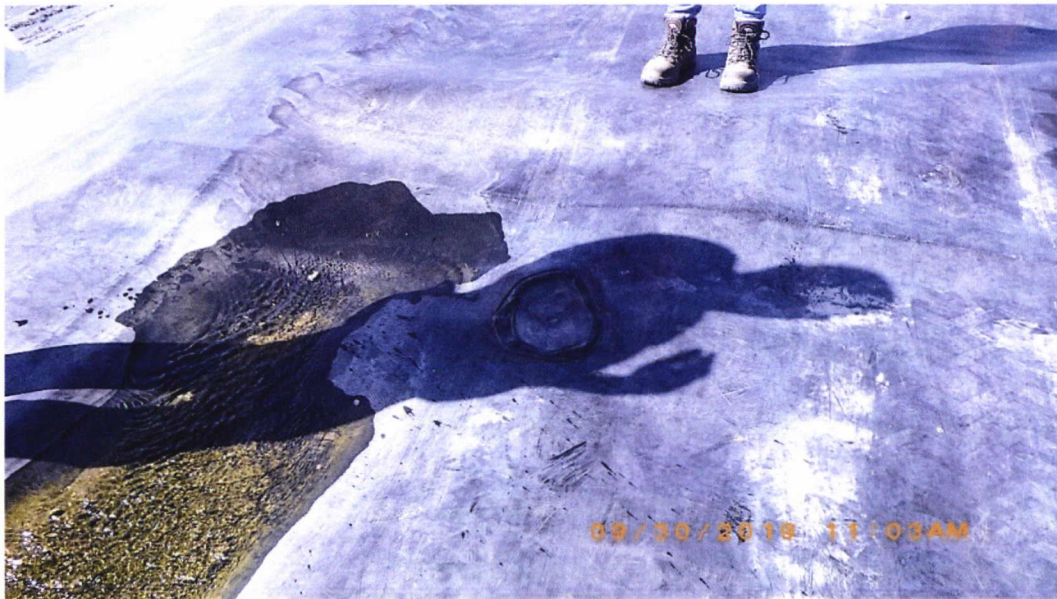
Photo 5

Description: South lagoon liner repair

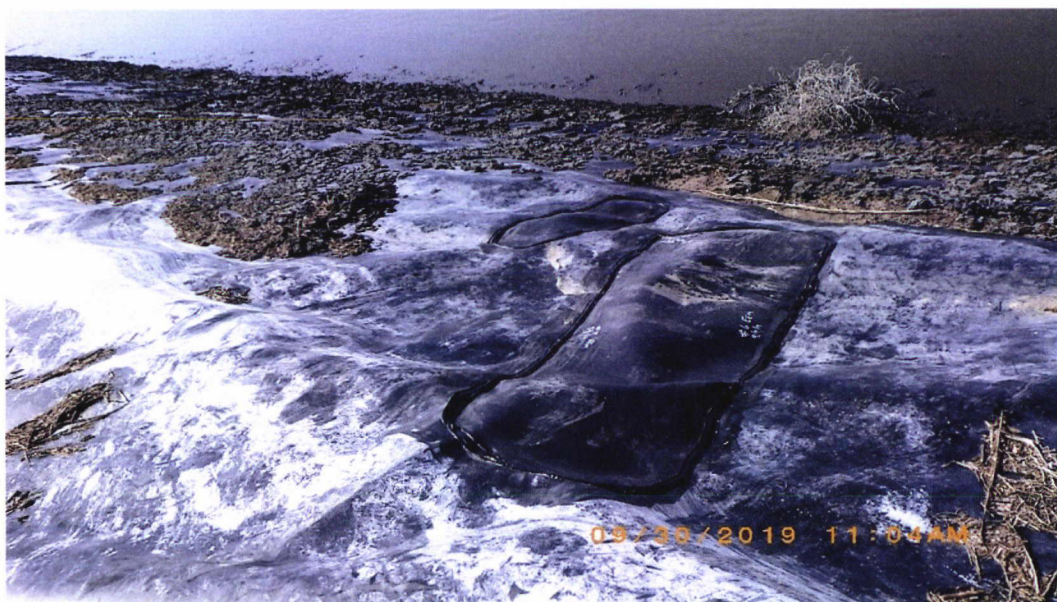
Photo 6

Description: South lagoon liner repair

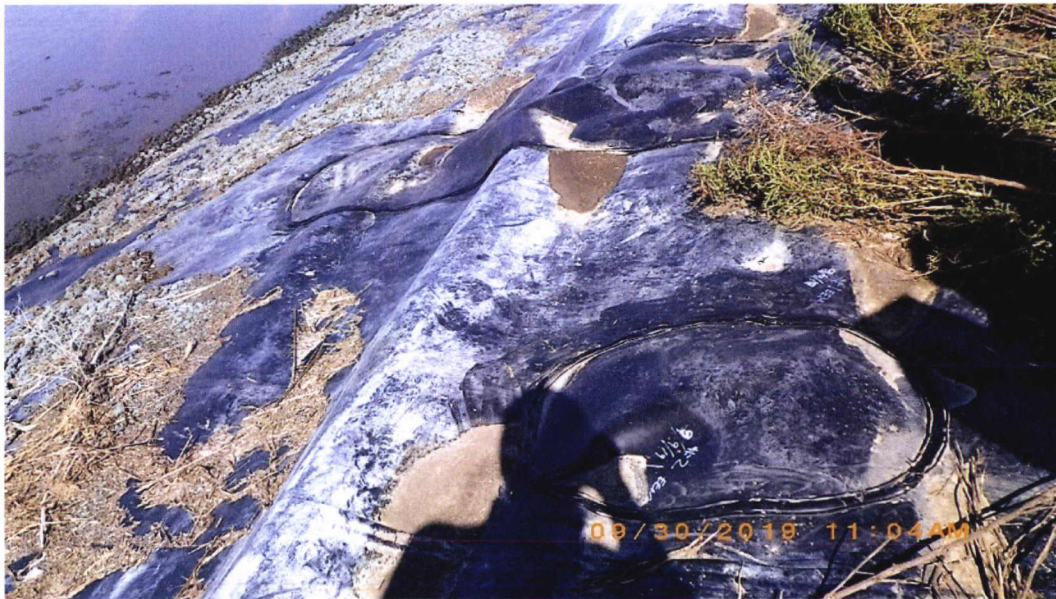
Photo 7

Description: South lagoon liner repair

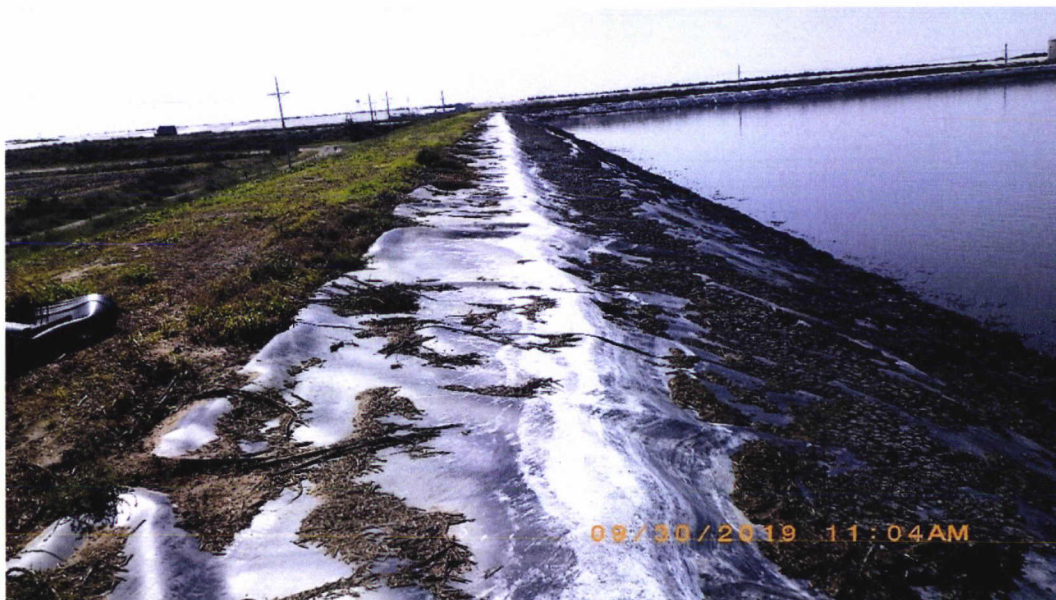
Photo 8

Description: South lagoon

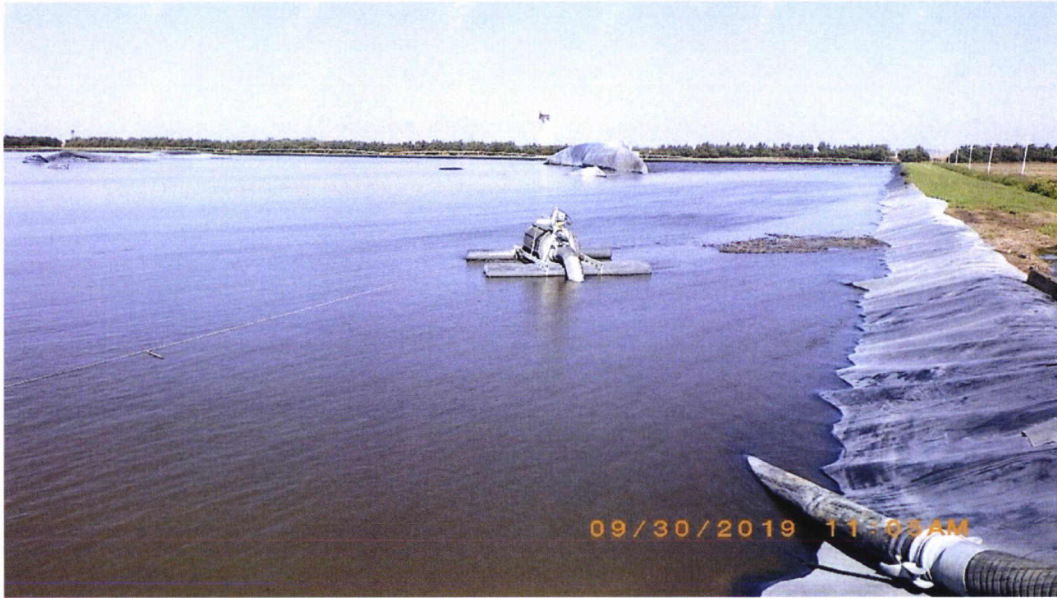
Photo 9

- The west and north lagoons are operating near the area designed for freeboard.
- The west lagoon now has three "whales" (floating liners). Only one "whale" was documented in April 2019.
- There is facility fence damage on the east side of the south lagoon.
- Monitoring wells are not installed.

Description: North lagoon; rotary drum (not in use), leaking liner "whales", and approaching designated freeboard range

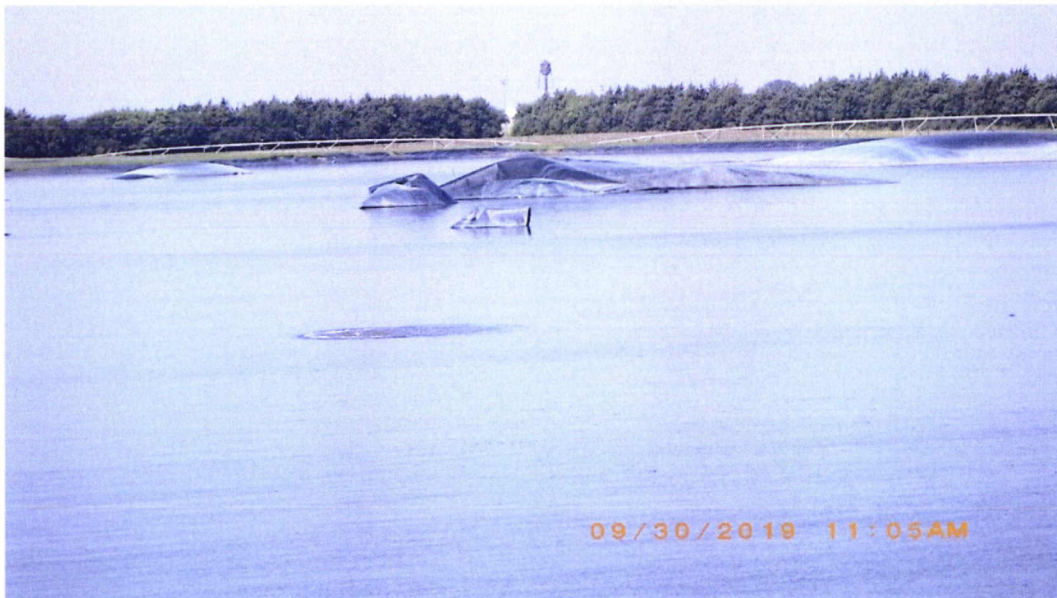
Photo 10

Description: North lagoon; liner "whales"

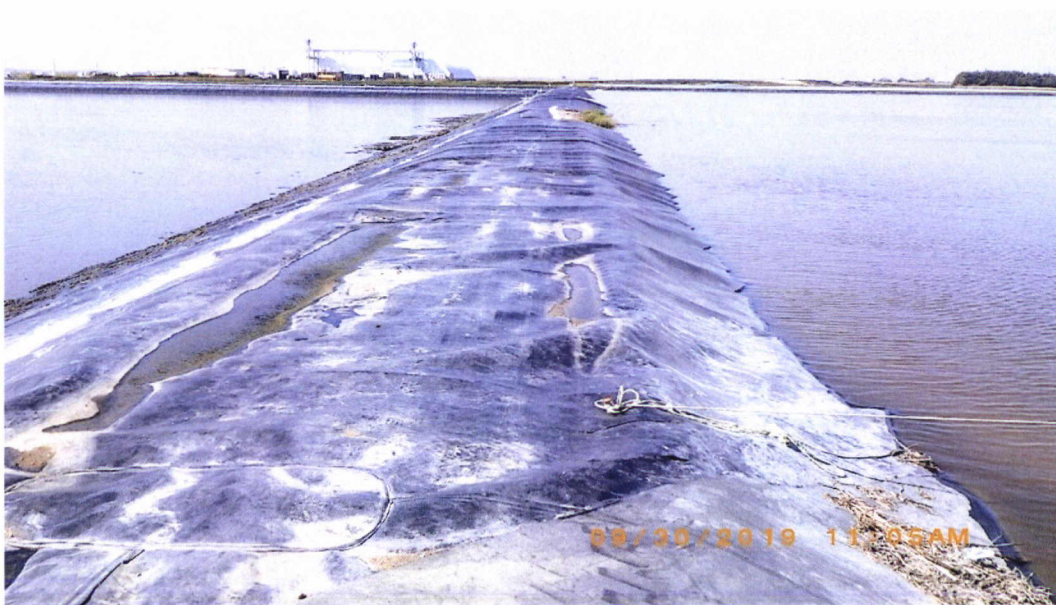
Photo 11

Description: Dike between north and south lagoons; liner repair area

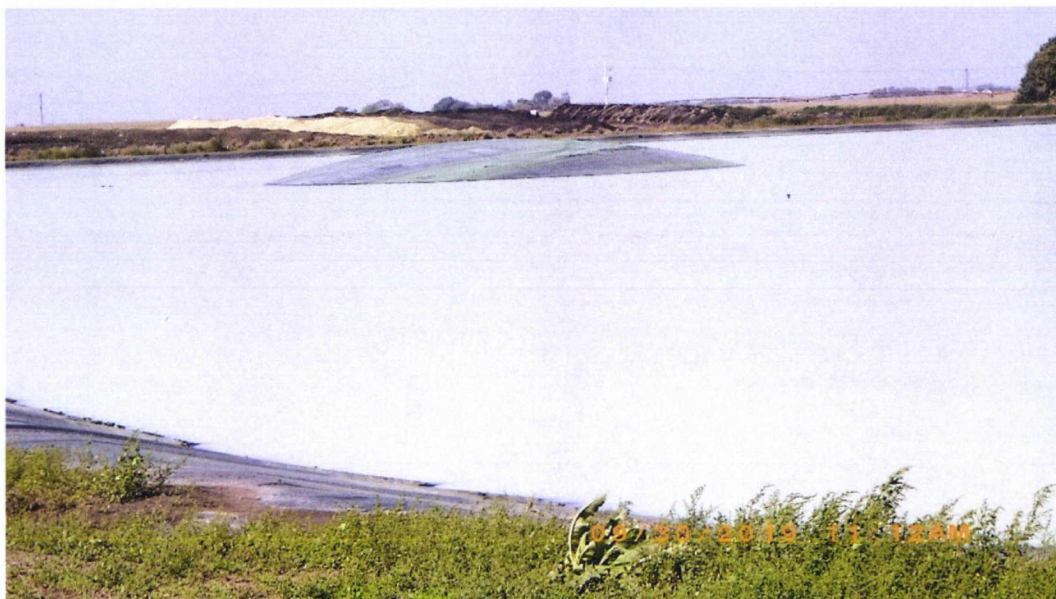
Photo 12

Description: West lagoon liner "whale"

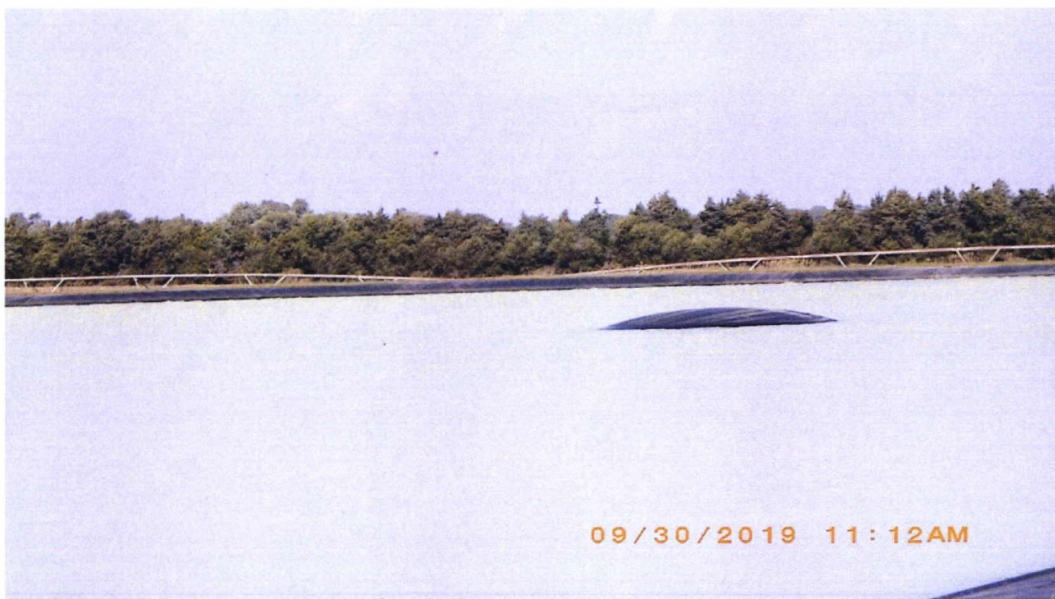
Photo 13

Description: West lagoon liner "whale"

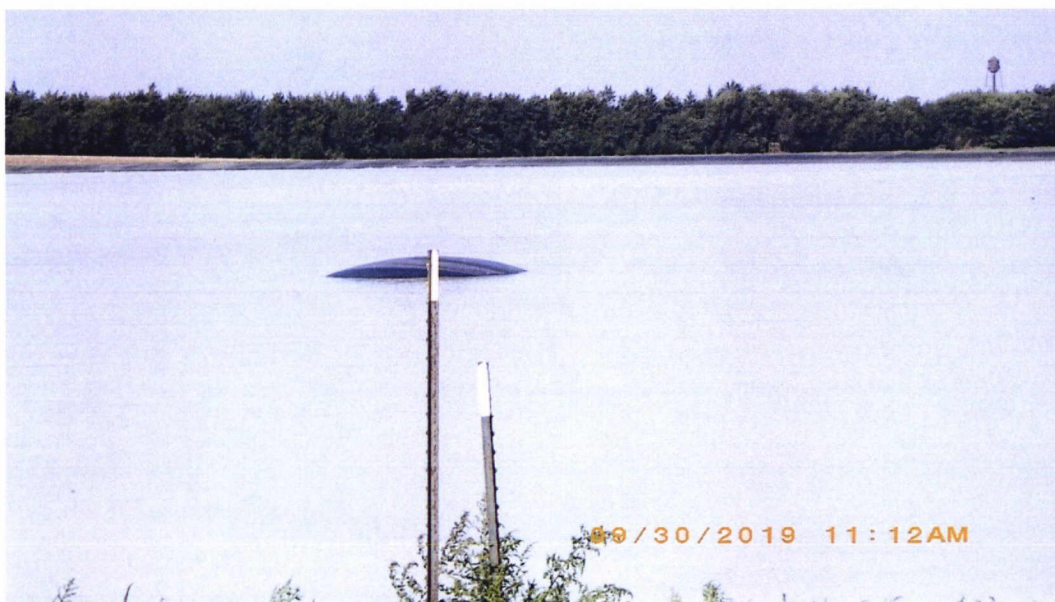
Photo 14

Description: West lagoon liner "whale"

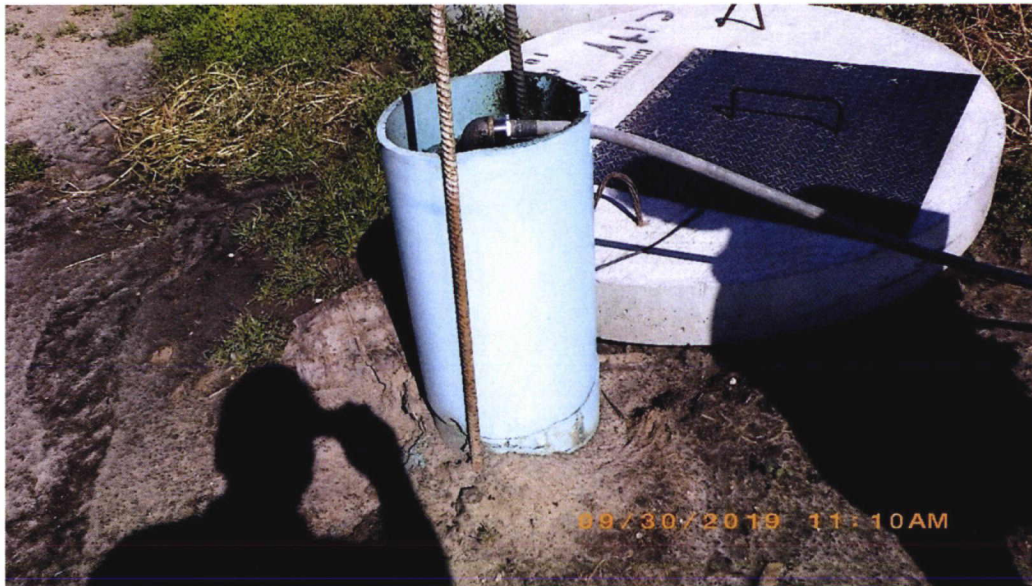
Photo 15

Description: Air relief valve system repaired between the south and north lagoon system. When the system surges, the relief valve discharges to the south lagoon.

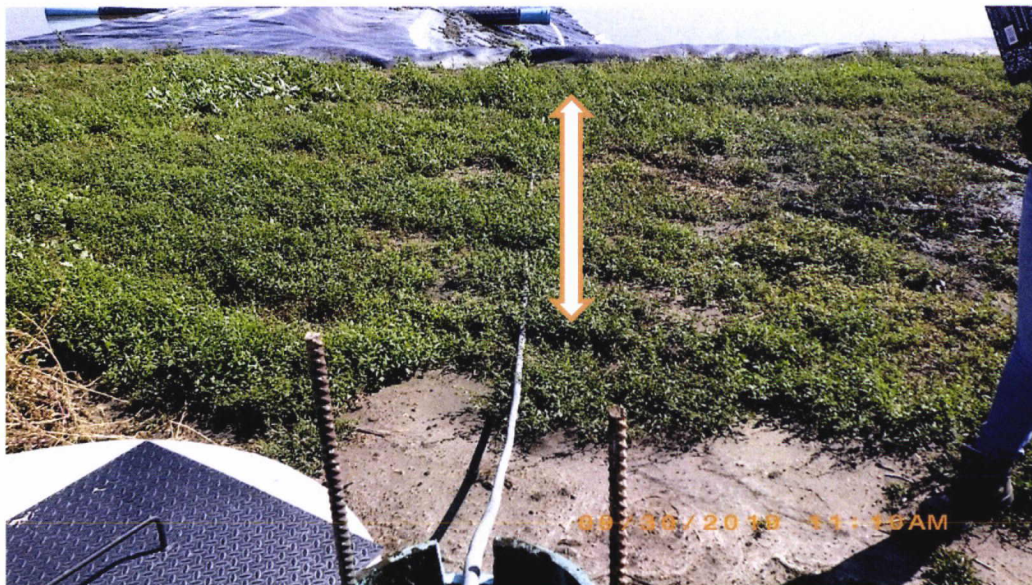
Photo 16

Description: This photo depicts the hose connected from the air relief valve to the lagoon system (arrow).

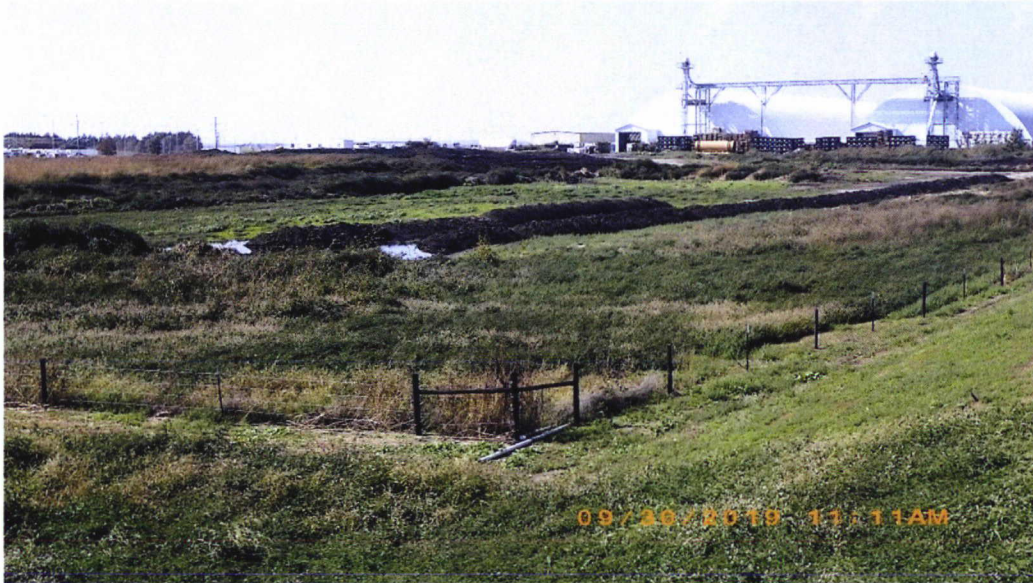
Photo 17

Description: This photo depicts the newly installed berm used to control storm water runoff from the wet cake storage area.

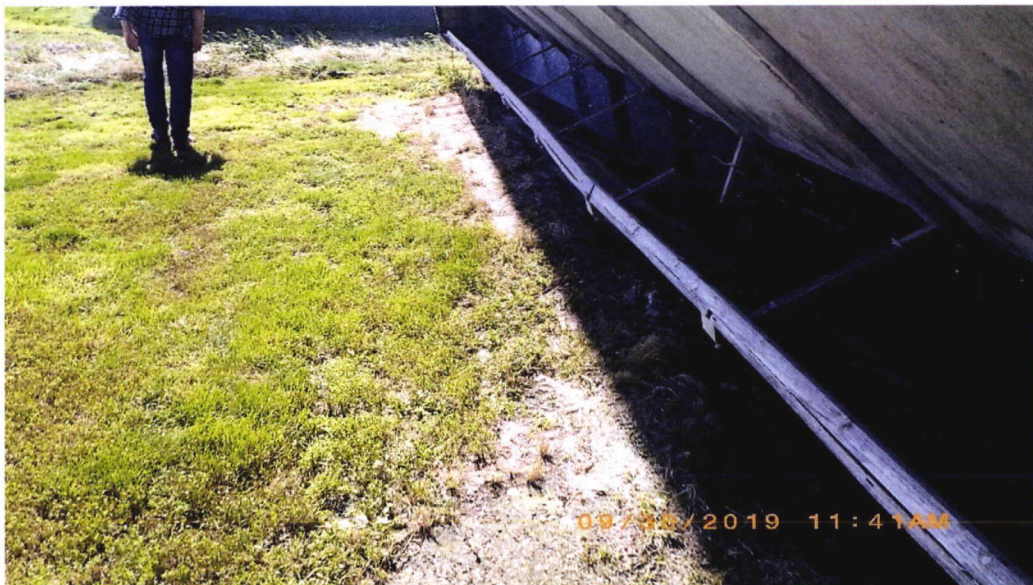
Photo 18

Description: This photo depicts the repaired cooling water tower.

- The cooling water tower has been repaired (Photos 18, 19).
- Starch bags have been moved to one central location; the facility is working on landfilling unusable starch.
- Beer and pop totes are empty and stored in one location (Photo 20).
- Previous starch bag storage locations are clean.
- Seed corn unloading area is clean. Auger system is repaired and has stopped leaking corn (Photo 22).
- Starch unloading area is clean (Photos 23, 24).

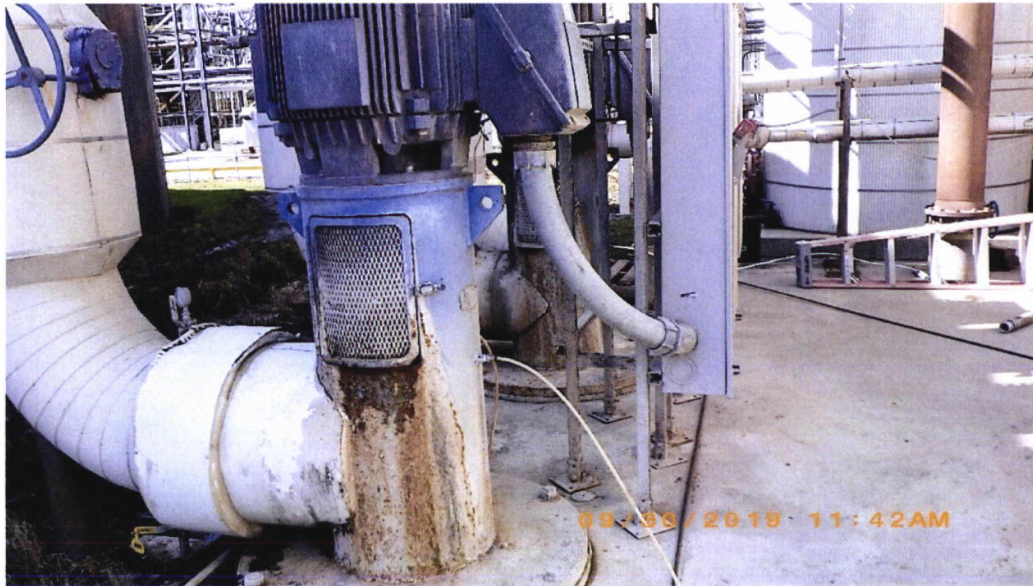
Photo 19

Description: This photo depicts the repaired cooling water tower.

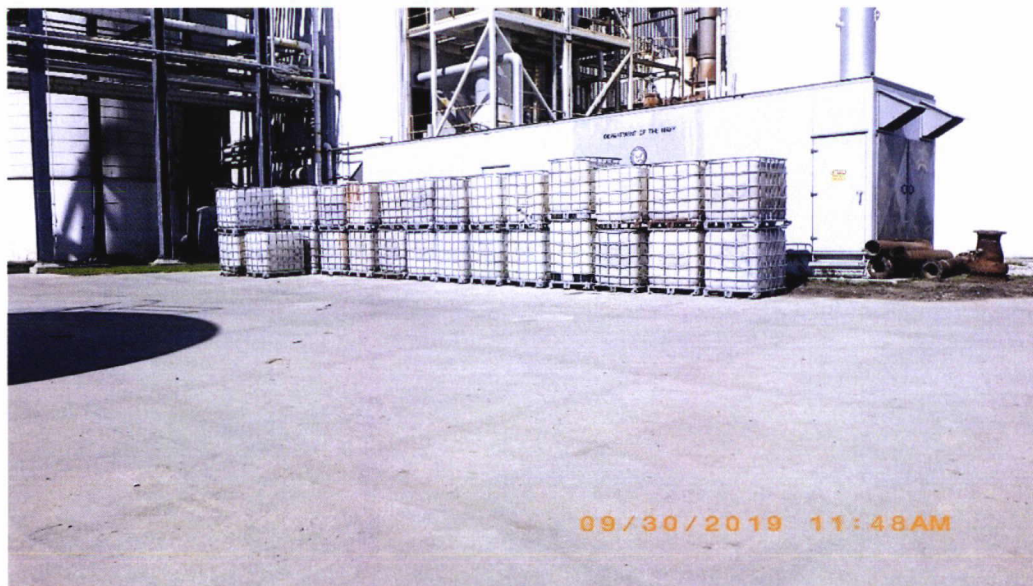
Photo 20

Description: These are empty beer/pop totes. The previous inspection noted that beer and pop were introduced into the lagoon system. Ken Pedersen today stated it was placed in a surge tank south of this photograph and depicted in Photo 21.

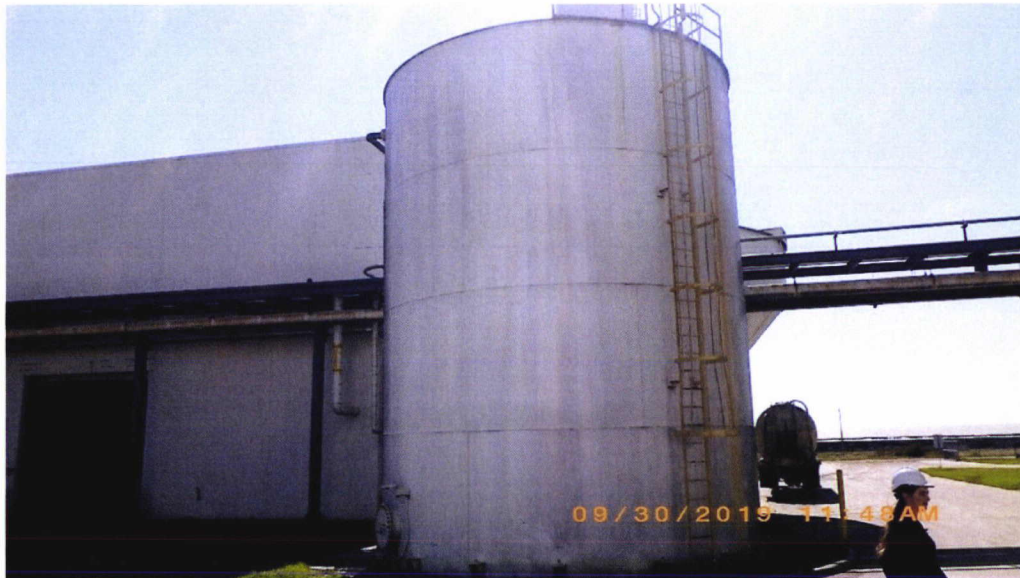
Photo 21

- Beer and pop previously thought to be in lagoon system is now in a surge tank (Photo 21).
- Centralized starch storage area does not have storm water controls (Photos 30-32).
- Track out observed along the wet cake storage area (Photo 29).
- Bio-Char operation area has no storm water controls (Photos 25-28).
- Bio-Char is not included in the facility's storm water pollution prevention plan (SWPPP).

Description: This is the surge tank that is storing beer/pop described in Photo 20.

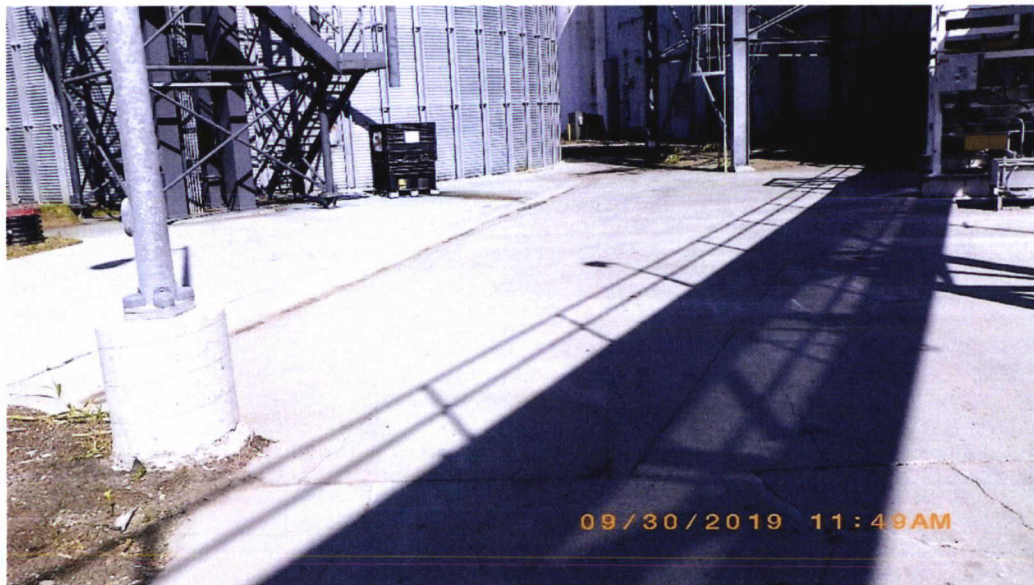
Photo 22

Description: This is the area below the grain receiving area and wet cake load out. According to Mr. Pedersen, the facility recently fixed the grain auger system, which previously leaked corn.

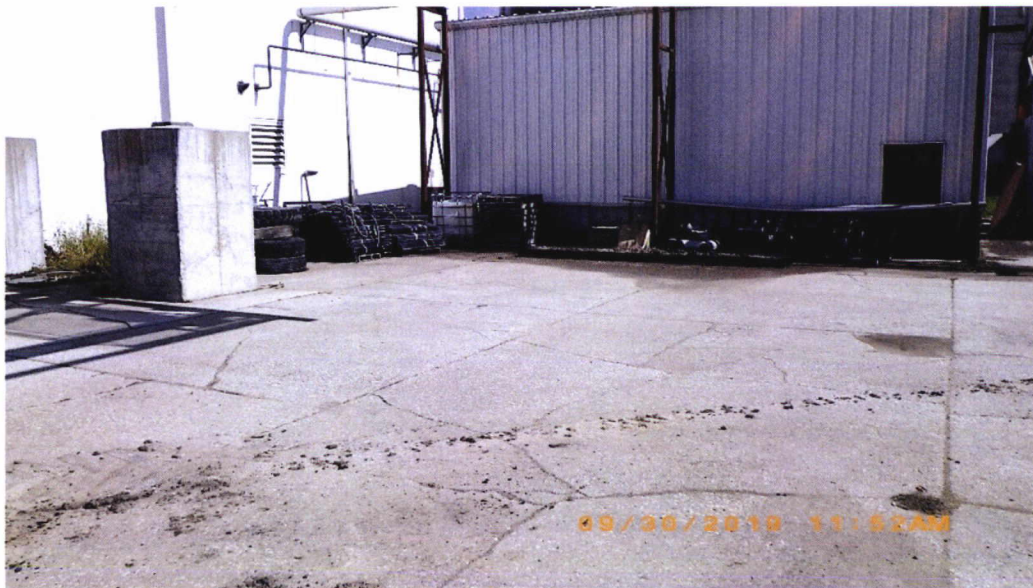
Photo 23

Description: The previous inspection noted torn and spilled starch bags. This photo depicts that the bags have been removed and placed in a centralized location.

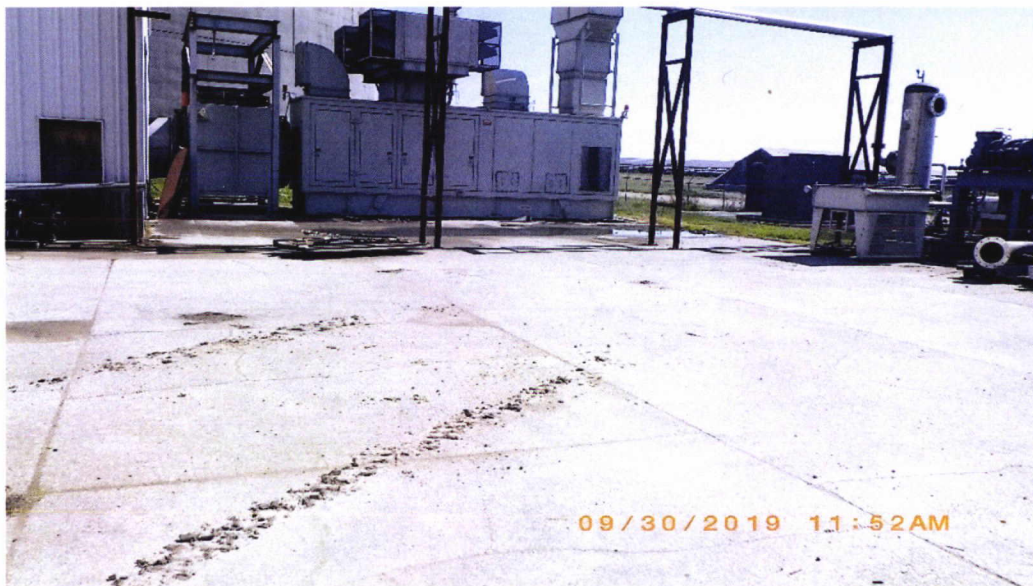
Photo 24

Description: The previous inspection noted torn and spilled starch bags. This photo depicts that the bags have been removed and placed in a centralized location.

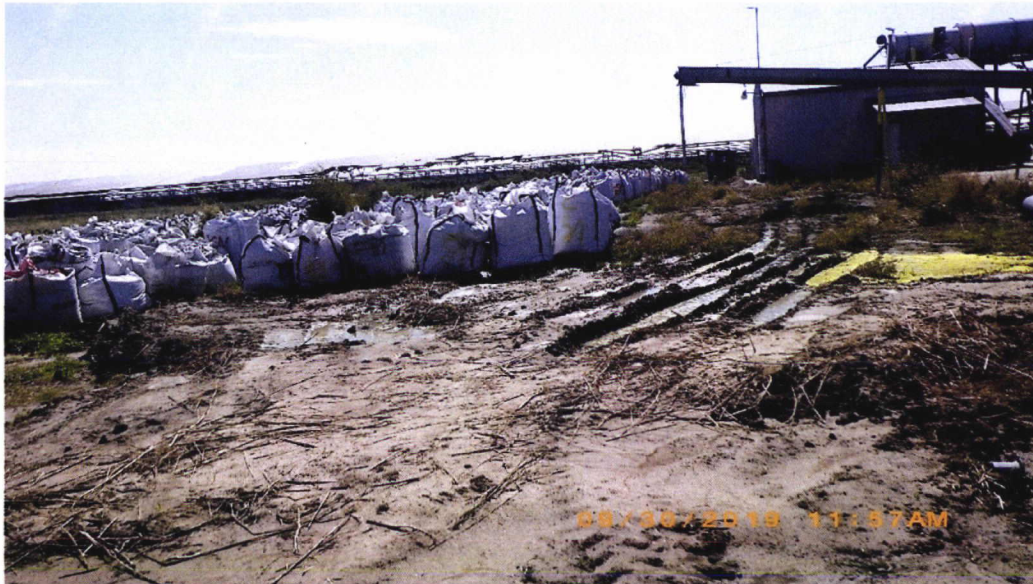
Photo 25

Description: This is the Bio-Char location. The photo depicts unused starch. The area is not listed in the facility SWPPP.

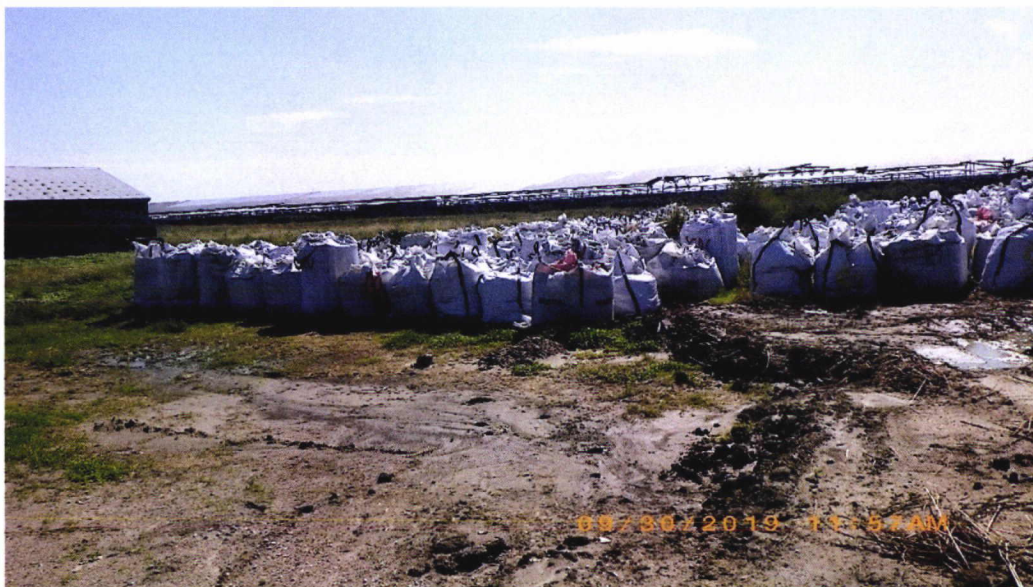
Photo 26

Description: This is the Bio-Char location. The photo depicts unused starch. The area is not listed in the facility SWPPP.

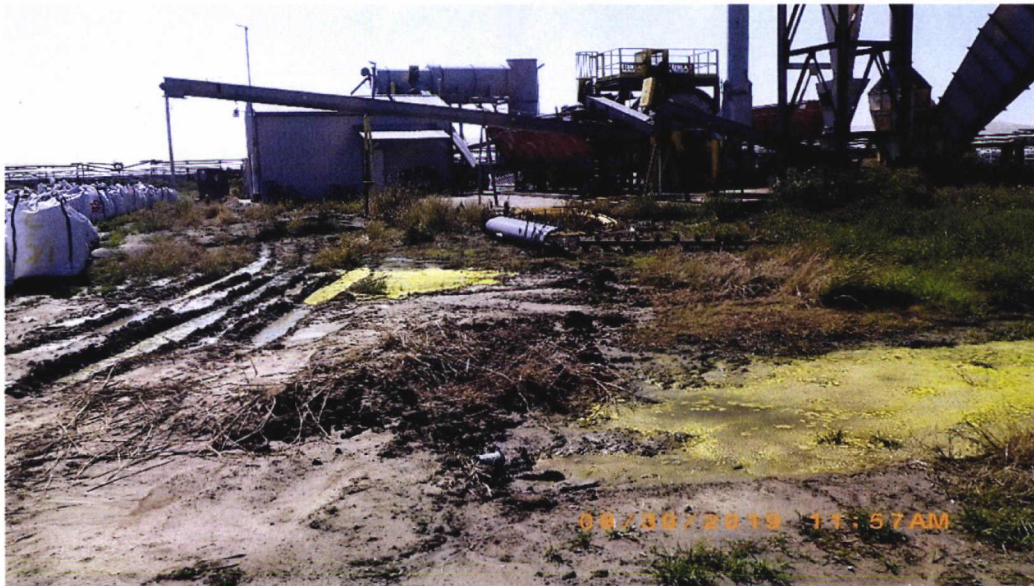
Photo 27

Description: This is the Bio-Char location. The photo depicts unused starch. The area is not listed in the facility SWPPP.

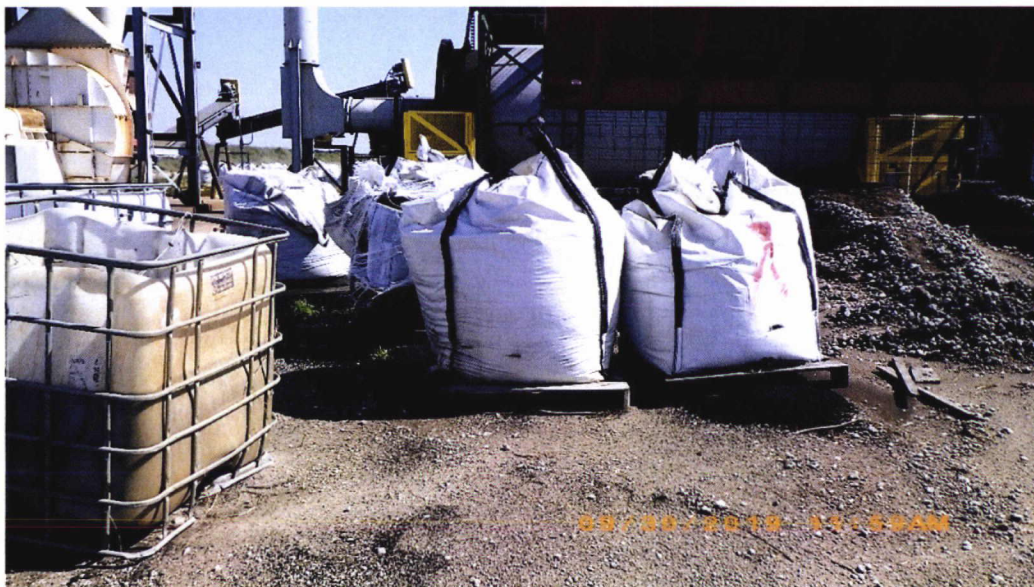
Photo 28

Description: This is the Bio-Char location. The photo depicts unused starch. The area is not listed in the facility SWPPP.

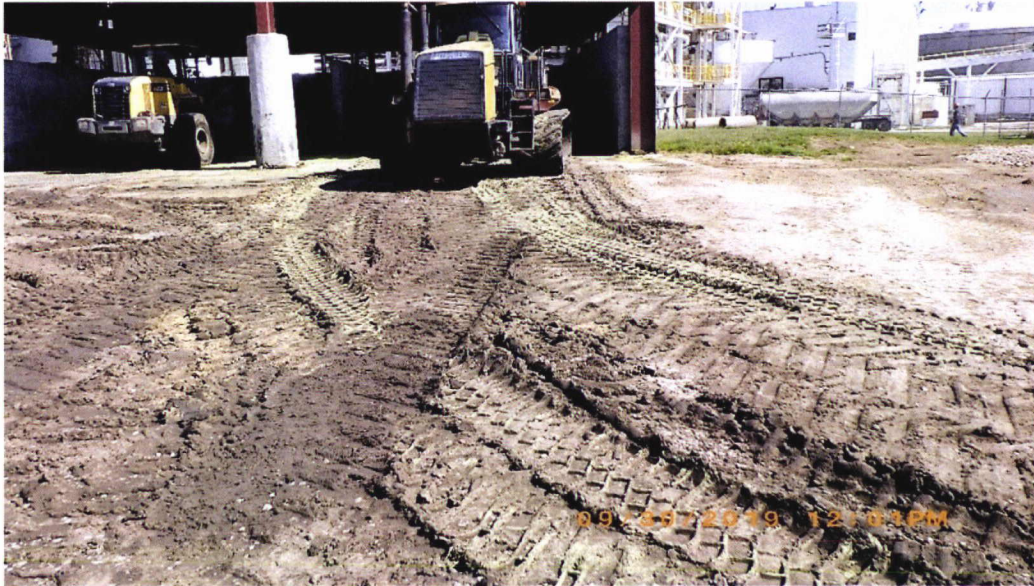
Photo 29

Description: This photo depicts track out from the wet cake storage area. The facility does not have installed BMPs to control track out.

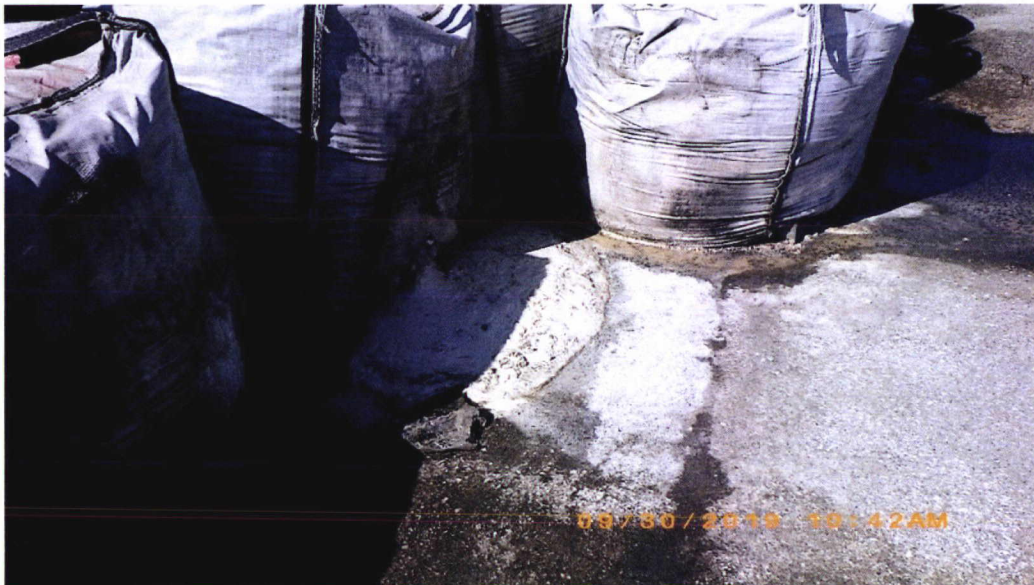
Photo 30

Description: This is the centralized location for starch. This is located south of the main office building. This photo depicts spilled starch with no installed controls.

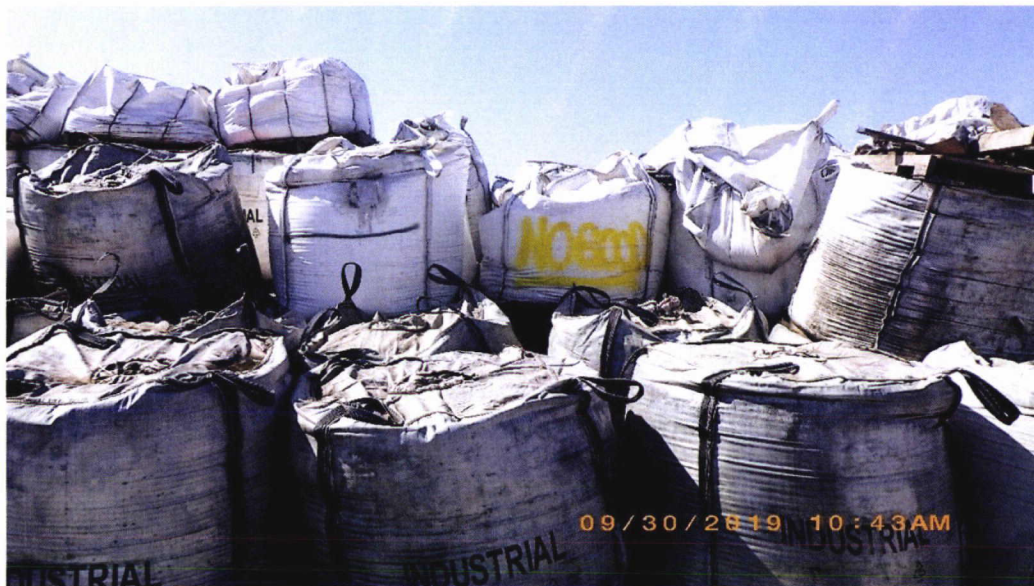
Photo 31

Description: This is the centralized location for starch. This photo depicts starch bags that are stacked and torn, which makes it difficult to control runoff.

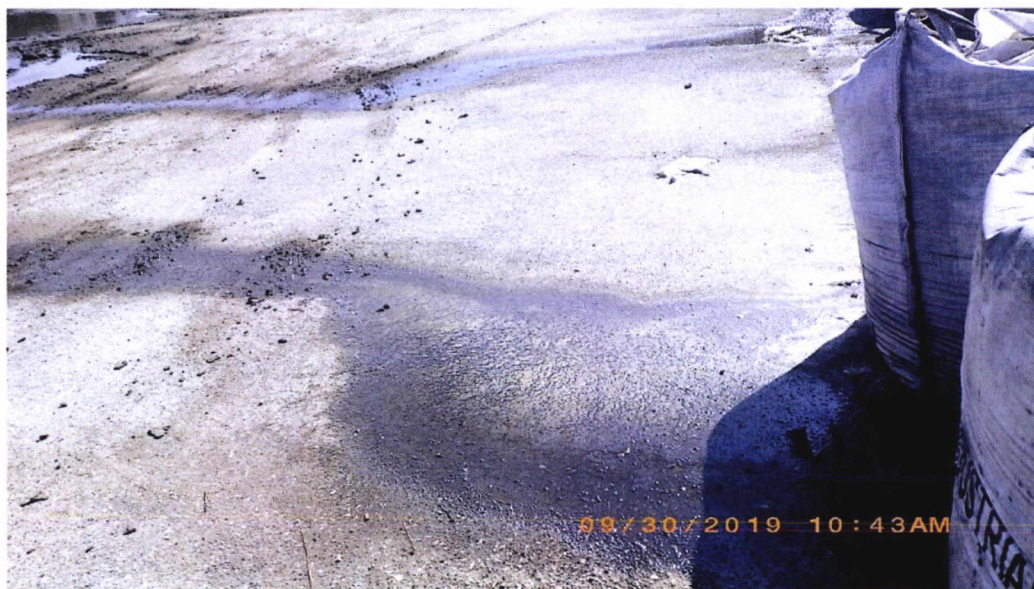
Photo 32

Description: This is the centralized location for starch. Drainage patterns indicate starch transport in the direction of the parking lot north of this photograph.
