MEMORANDUM

RE: AltEn, LLC

Subject: Site Visit Report (Stormwater Aspects Only) from Inspection – Mark Pomajzl, Hillary Stoll, and Jason Holsten Present

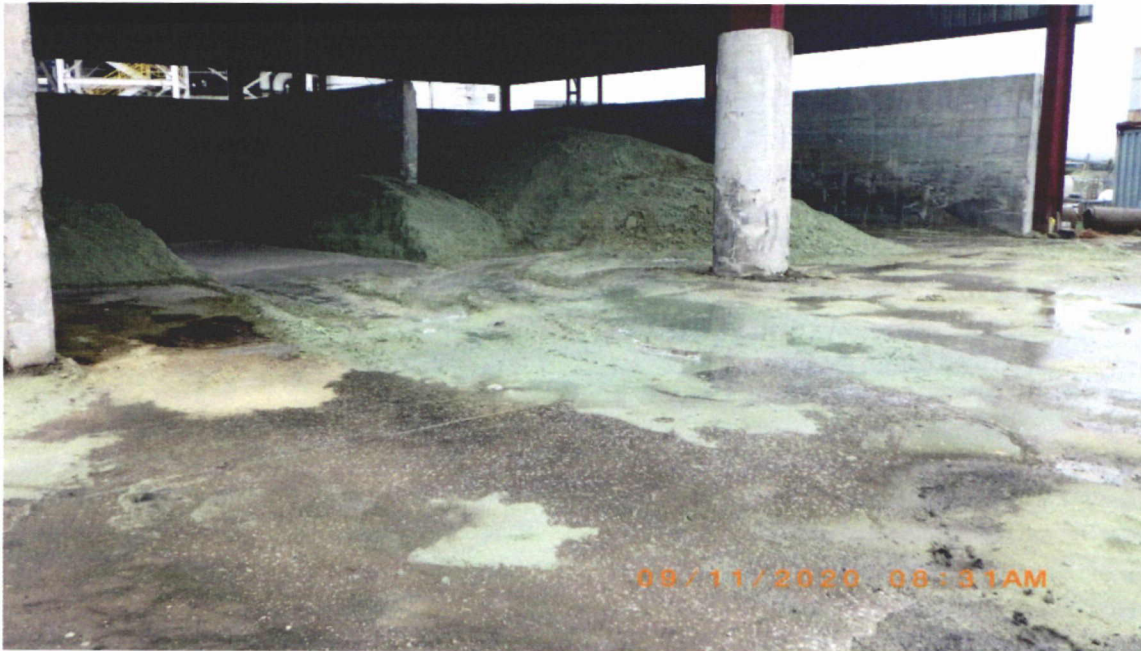
Photo 1

OA1 is the distiller's grains staging area. Solids are conveyed to a collection area where they are loaded onto trucks and transported to various areas for storage. The pad used to load wet distiller's grains contains residue that is being washed into an area that drains to a ditch leading to storm water outfall 001 (photos 1, 2).

Description: The structure pictured in the photo is the wet cake load out area for the facility. The solids are conveyed to a collection area where they are loaded onto trucks and transported to various storage locations.

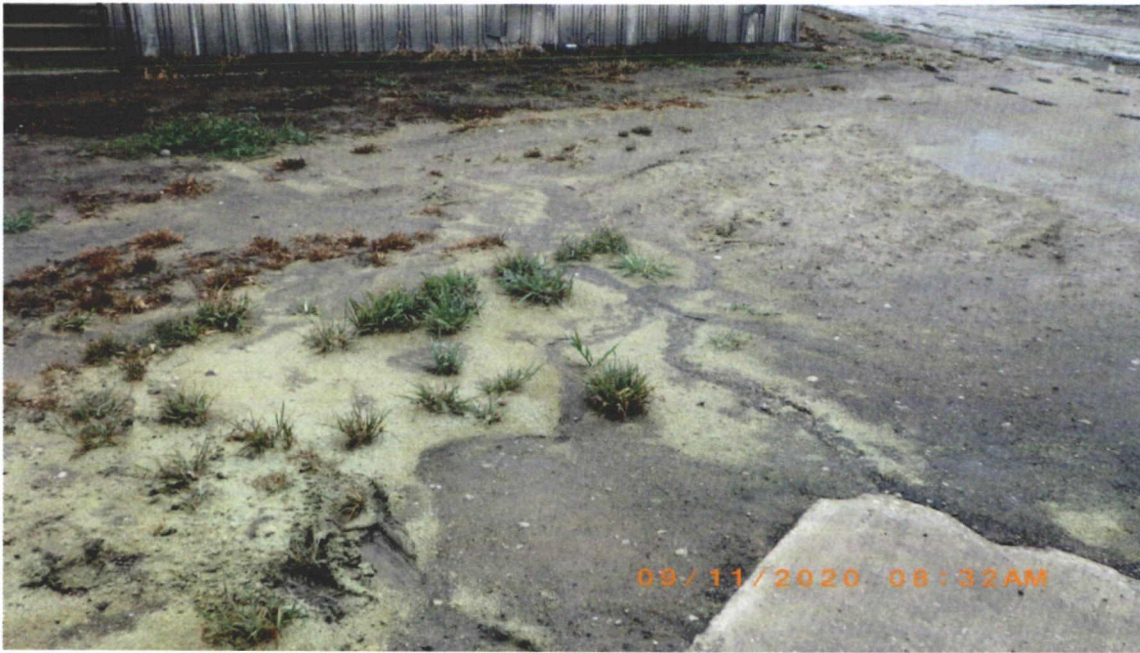
Photo 2

- 1) There are no best management practices (BMPs) installed to control runoff from the wet cake load out area. There is no mention of BMPs in the SWPPP to control potential runoff from this area.

Description: The photo depicts wet cake runoff from the southwest portion of the distiller's grain storage.
There are not BMPs installed to control these discharges.

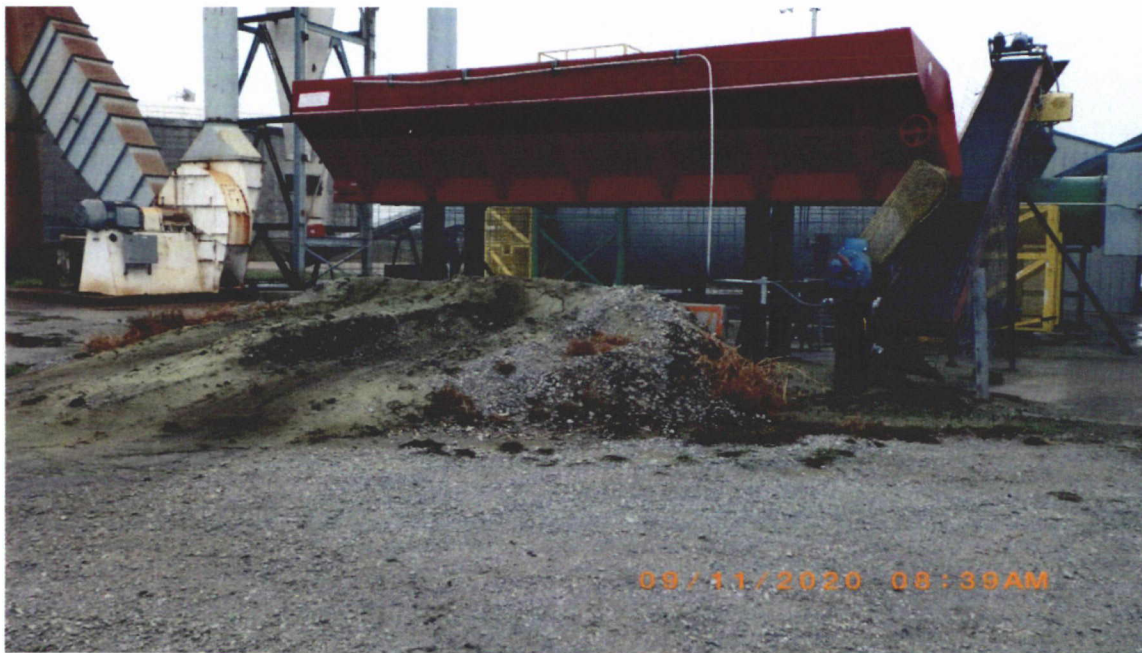
Photo 3

OA2 is the biochar process area, which is located south of the main ethanol production plant. The area west of the biochar unit is used to store final product. There is residual wet distiller's grain and chaff observed below the wet distiller's grain unloading conveyance system (photo 3). There is biochar product spilled along the final product auger system (photo 4). Some bags are torn, dispersing product (photo 5). Wet cake residue is observed discharging into the conveyance system on the west side of the biochar unit (photos 5, 6). A culvert conveys water to storm water outfall 001, south and east of this area. A review of the storm water pollution prevention plan (SWPPP) notes that the facility installed silt fencing to control runoff. There was no silt fence observed (photo 7). I asked Mr. Tingelhoff about the missing silt fence. Mr. Tingelhoff stated

Description: This photo depicts the Biochar process. There is wet cake in the forefront and on the right hand side. The facility is not conducting good housekeeping.

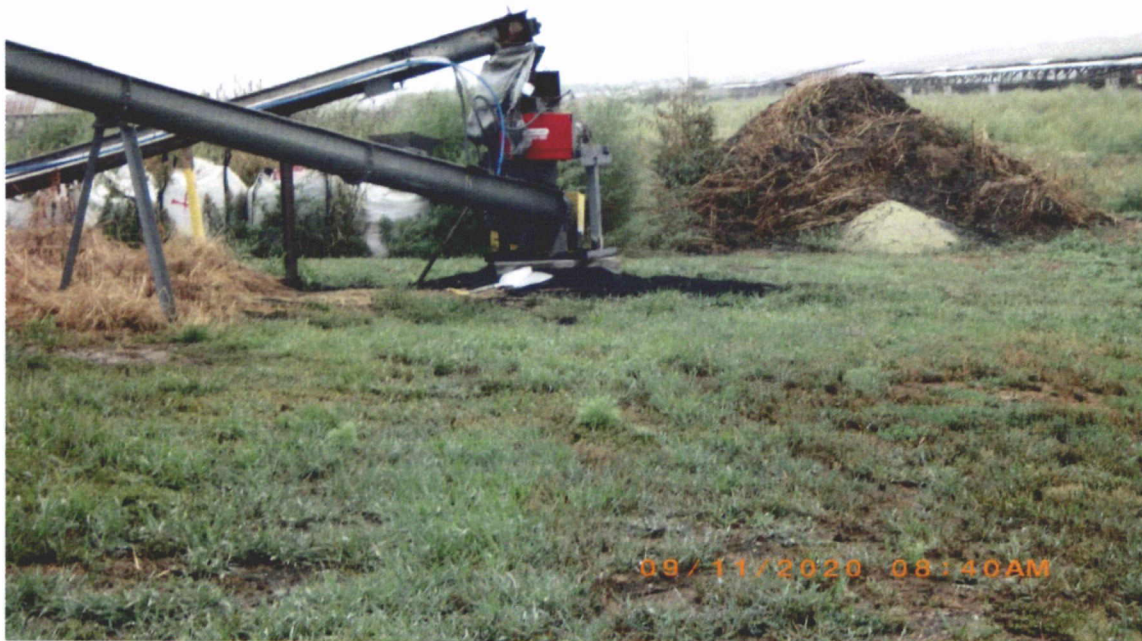
Photo 3

Description: This photo depicts the final product loadout. There is observed biochar product on the ground with no installed BMPs.

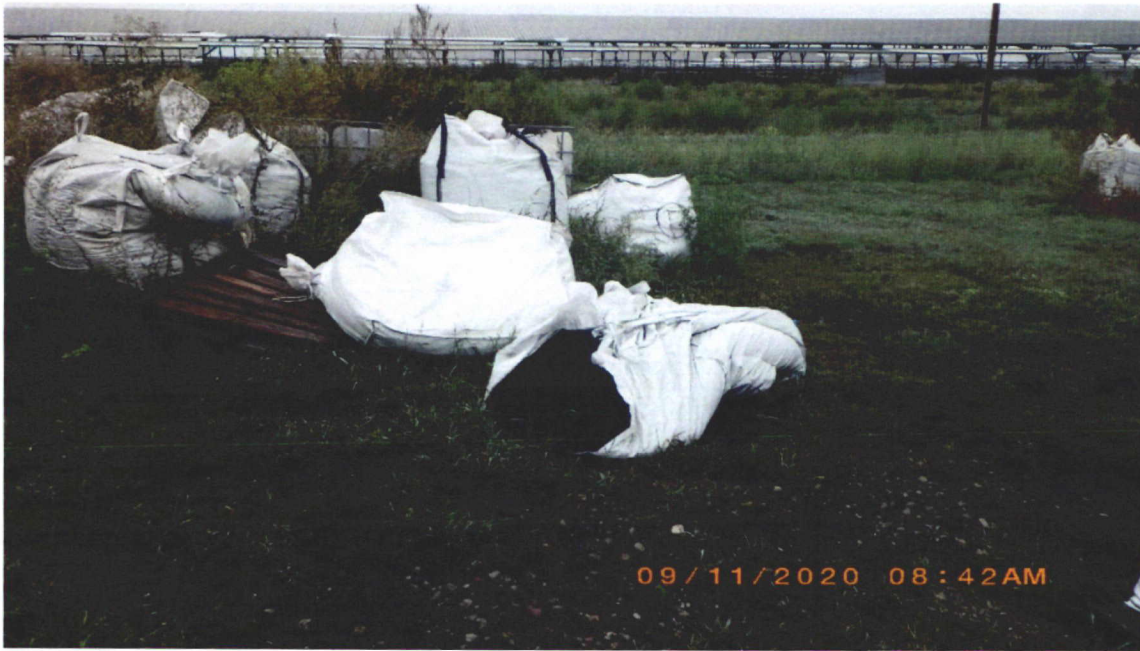
Photo 4

- 4) There are spilt and dispersing biochar super sacks in and around the biochar process. In addition there is storm water runoff containing wet cake residue entering the storm water conveyance system.

Description: This is photo depicting a torn bag of biochar super sack. There is no good housekeeping measures or BMPs being employed to contain the spilled product.

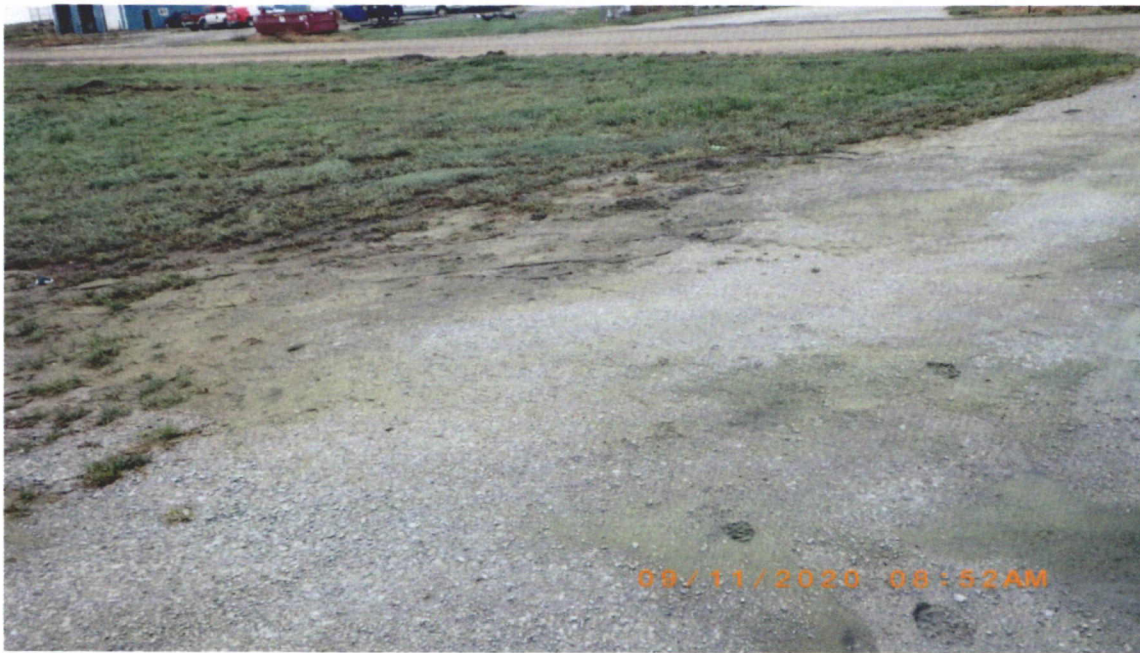
Photo 5

Description: This photo depicts residual wet cake. Wet cake is unloaded into the Biochar for processing, excess wet distiller's grain and chaff disperses and accumulates on the ground. Rain causes the residue to concentrate and discharges into the conveyance system, which leads to outfall 001.

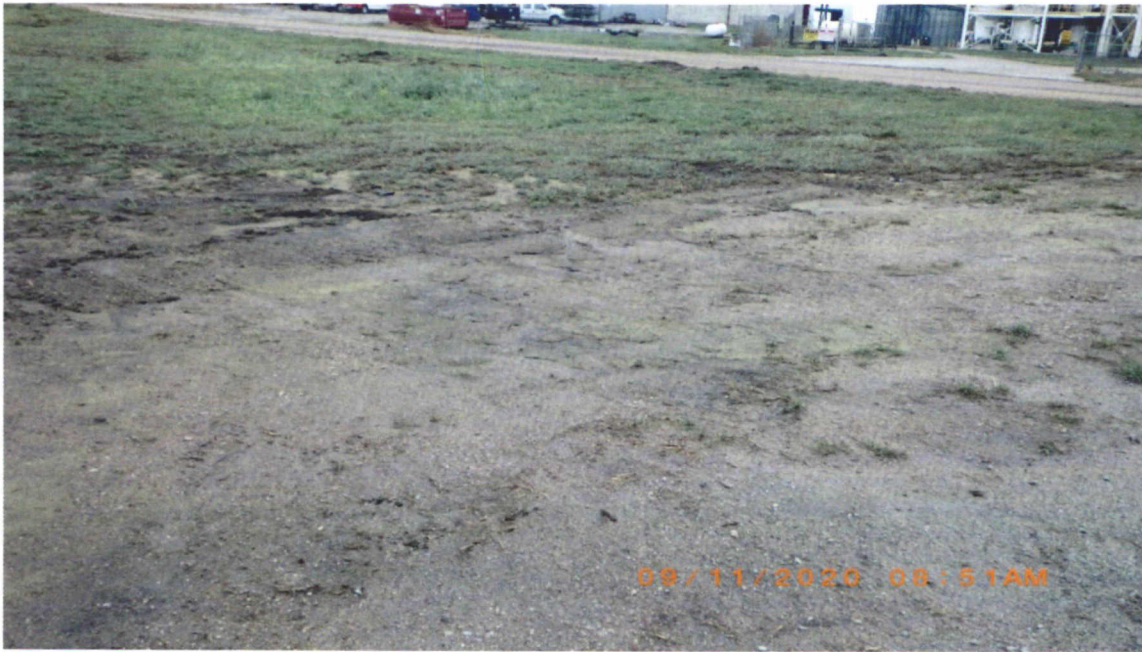
Photo 6

Description: This photo depicts residual wet cake. Wet cake is unloaded into the Biochar for processing, excess wet distiller's grain and chaff disperses and accumulates on the ground. Rain causes the residue to concentrate and discharges into the conveyance system, which leads to outfall 001. This photo depicts apparent sheet erosion, which conveys to outfall 001.

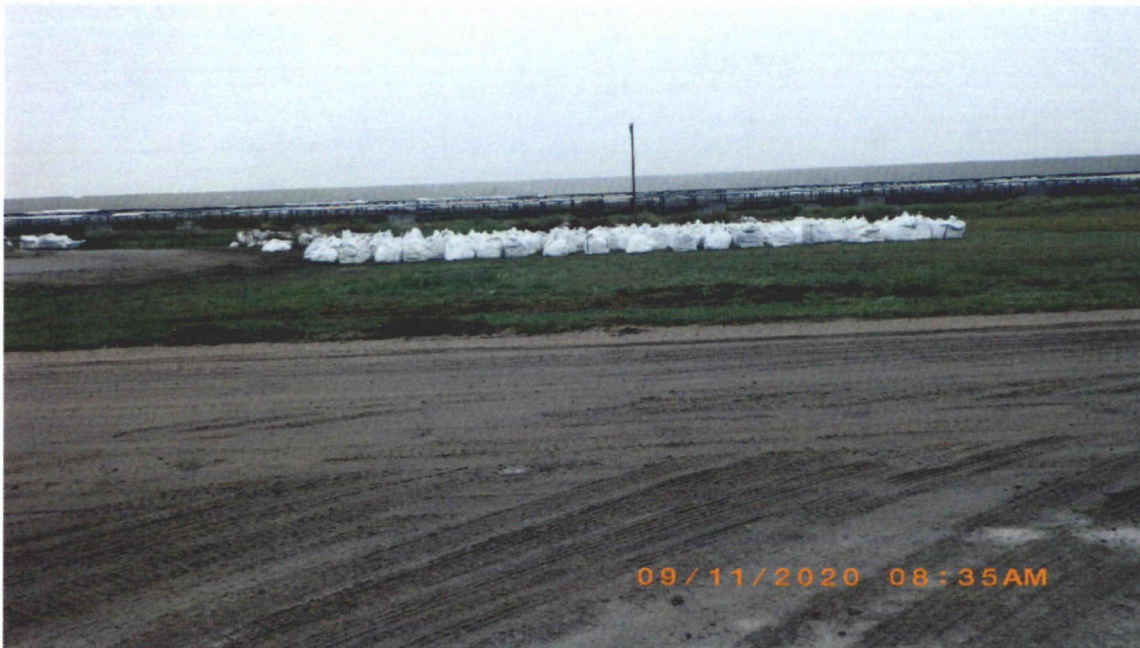
Photo 7

- 1) It was observed during the inspection that there is no silt fencing around the biochar process and super stacks storage. The SWPPP states that as a "Best Management Practice, AltEn has installed silt fencing around the biochar process to reduce the likelihood of any pollutants to admixture with storm water."

Description: This photo depicts the missing silt fence. The facility SWPPP states that a silt fence had already been installed.

Following the site visit and tour, we met with Mr. Tingelhoff and Mr. Peterson to discuss the findings and provide the exit summary. I expressed concern that the biochar process didn't contain a silt fence as described in the SWPPP. I read to Mr. Tingelhoff the sentence in the SWPPP that states that the silt fence had been installed. Mr. Tingelhoff stated they thought it was

for starch, but will reinstall the silt fence immediately. We explained that the lagoons are lower than we expected and asked how they are being managed. Mr. Tingelhoff stated that they are conducting business as usual and irrigation. We asked him if they have irrigated from the lagoon system. Mr. Tingelhoff stated they have been irrigating. We stated that the notice of violation (NOV) has not been closed and that they shouldn't be land applying. Mr. Tingelhoff stated that communication has been difficult due to multiple departments and that he hadn't received an answer from their recent submittal. We informed Mr. Tingelhoff and Mr. Peterson that we discovered a thin stillage spill north of the manhole/access for the force main (photos 15, 16, and 17). Mr. Peterson stated that he is aware of the spill and that the area will be cleaned. We also informed them the air vent and valve control system had spilled thin stillage, which they agreed to clean up the spill. We expressed concern about the southeast berm used to control the north wet distiller's grain storage area. We stated that we did not visually see the berm. Mr. Tingelhoff stated the berm is there, but is covered with grasses and vegetation. After the discussion, we provided Mr. Tingelhoff with the exit summary form.

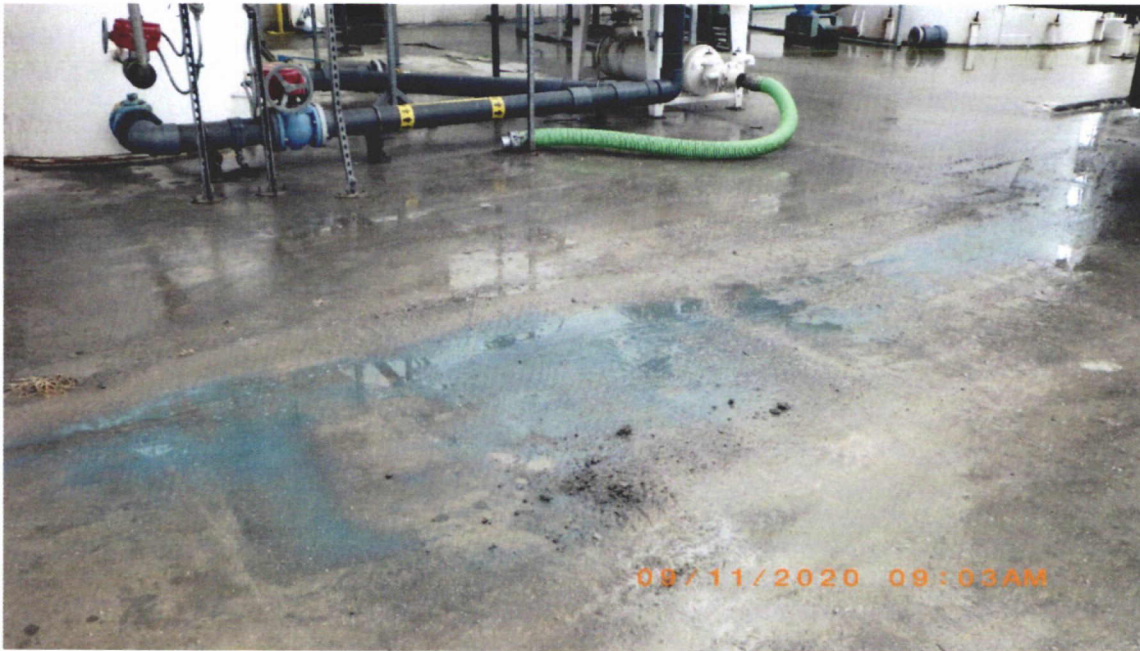
Photo 8

OA3 is east of the grain receiving area. In this area, an unknown teal-colored substance is observed (Photo 8). I asked Mr. Tingelhoff of the substance identity, but the substance was never identified. The facility has not contained the spill with absorbent socks or other spill prevention method. Above the spill, a green hose is observed attached to a pumping system. The end of the hose is not in containment. In the same area, there is an unlabeled tote of unknown liquid along with uncontained and unidentified hoses and a fuel tank (Photos 9, 10, 11). Mr. Tingelhoff stated that the facility is currently shut down and the hoses are not connected.

Description: This photo depicts an unknown teal liquid, which is located east of the grain unloading area. Mr. Tingelhoff could not identify its origin or its content. The green hose above is connected to a pumping system, it is unknown if the teal liquid came from this hose.

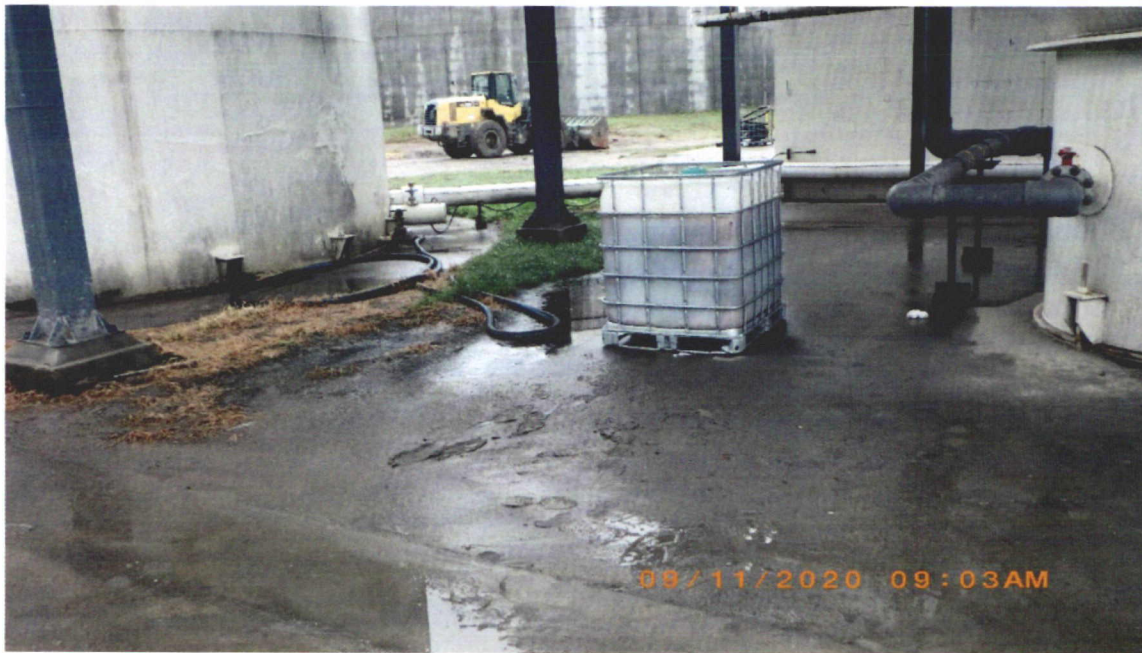
Photo 9

Description: This photo depicts an unlabeled chemical tote. Next to the tote are hoses of unknown origin. It is unknown if the hoses contain pollutants.

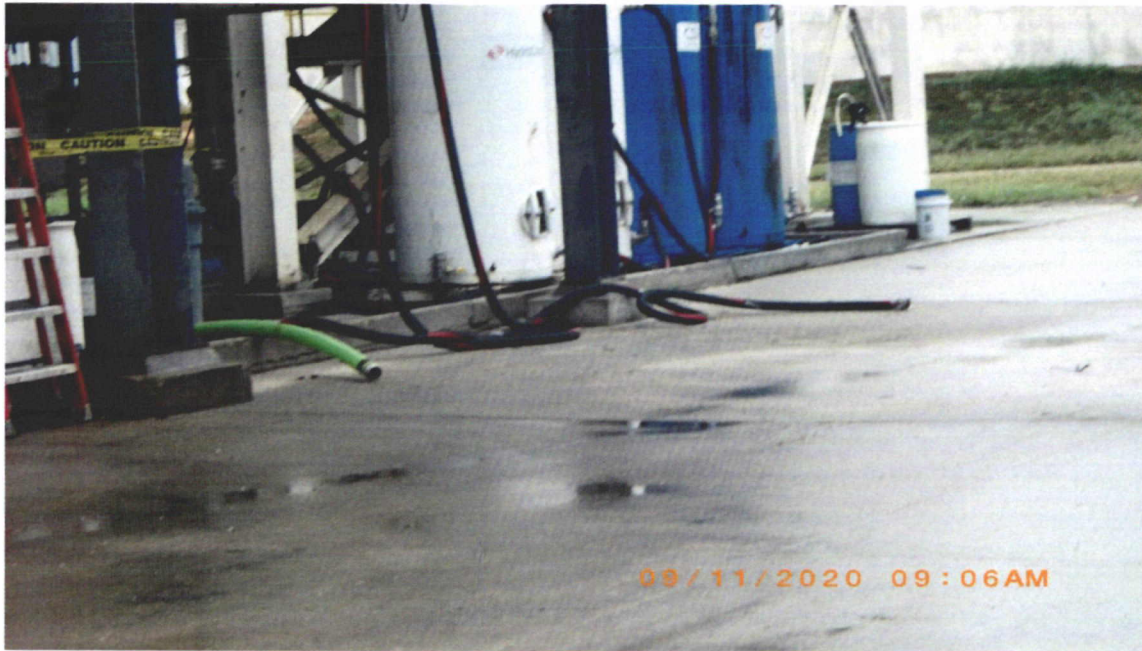
Photo 10

- 2) There are hoses attached and unattached to pumps in various locations. Depending on location, hoses can contain chemical/product. The residual chemical/product could escape into the storm water conveyance system.

Description: This photo depicts a series of unlabeled hoses. It is unknown if these hoses contain chemical or product.

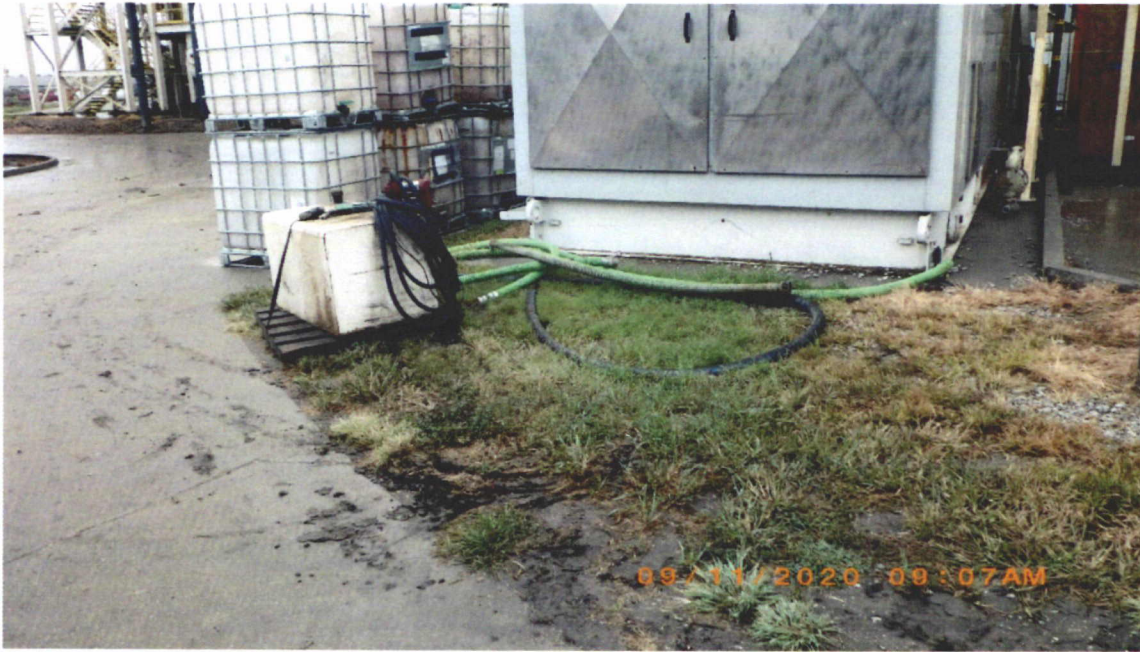
Photo 11

Description: This photo depicts a series of hoses dispersed along the grass and a possible fuel tank. The tank is not labelled.

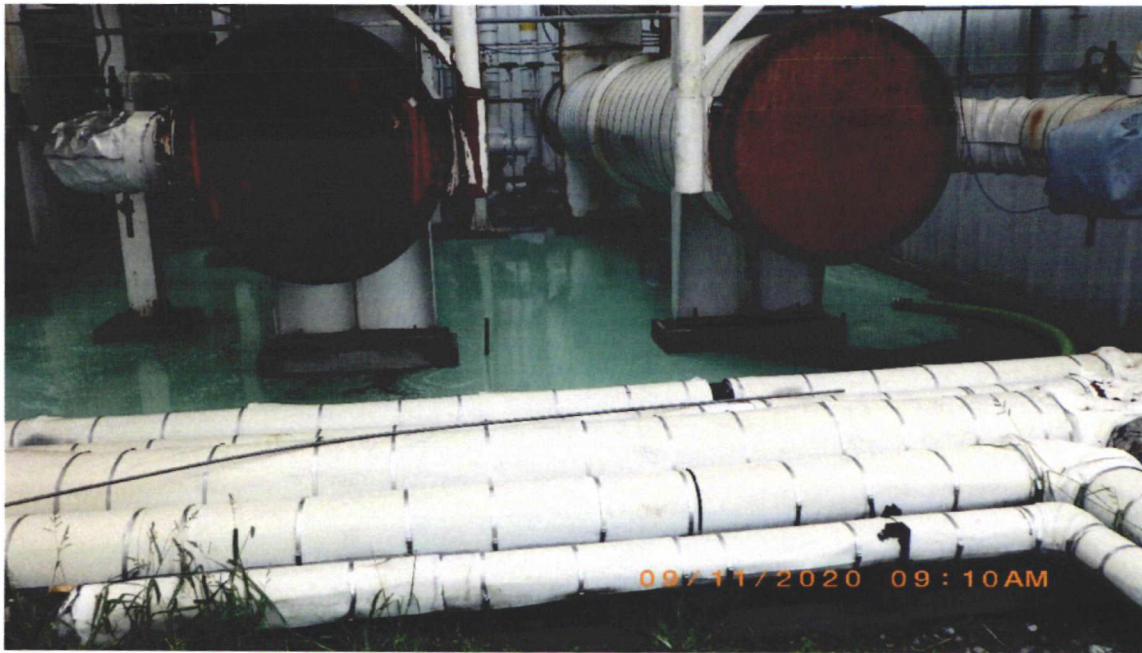
Photo 12

OA4 is the urea storage area. Temporarily, the facility has pumped thin stillage into the urea containment (photo 12). The facility is replacing a pump used to transport thin stillage to the wastewater lagoons and some stillage has dripped near the pump (photo 13). The facility has not employed absorbent socks or any spill control measures.

Description: This photo depicts thin stillage that has been temporarily discharged into the urea containment.

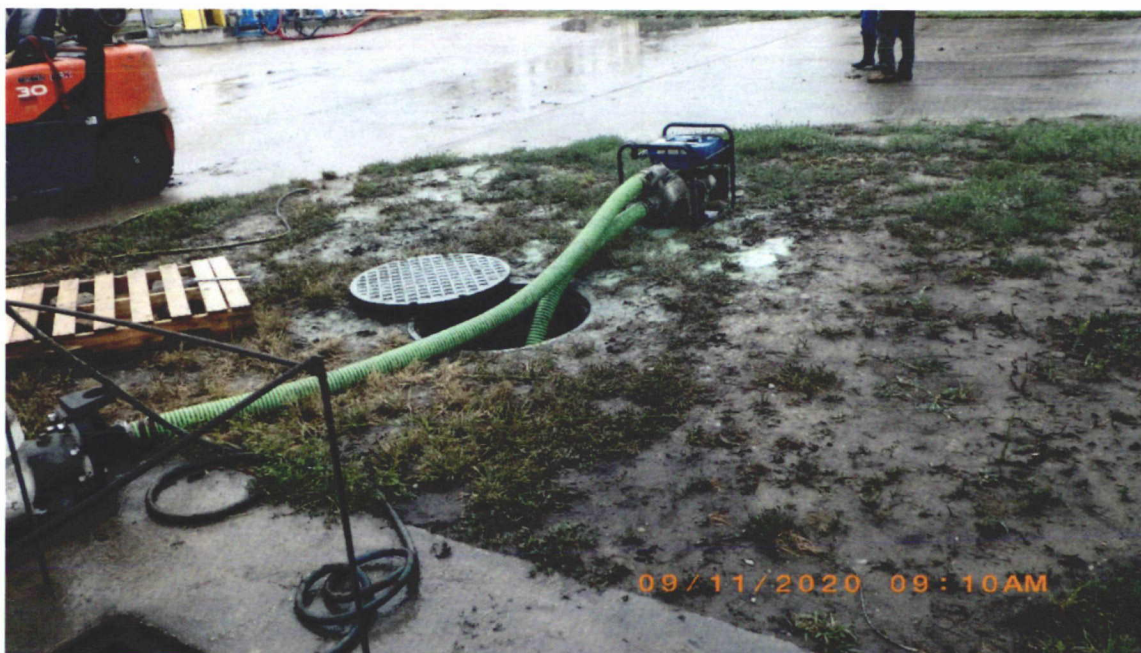
Photo 13

Description: This photo depicts thin stillage staining the ground surrounding the transfer pump. The facility is not using spill/leak prevention controls.

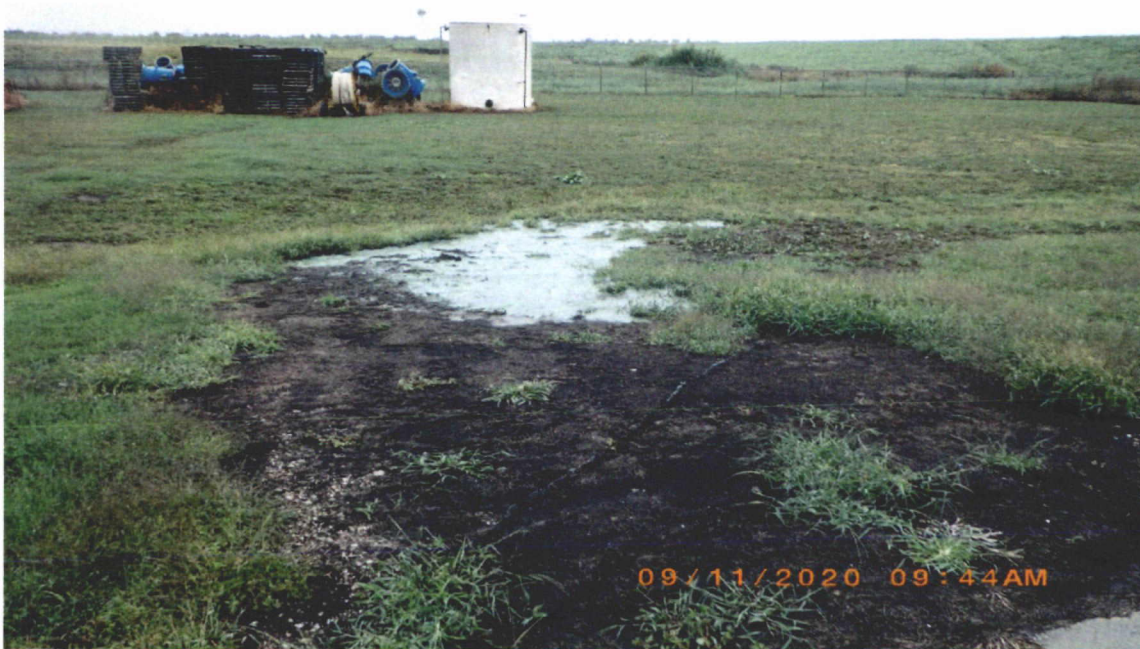
Photo 14

OA5 is the manhole/access point for the force main used to transfer thin stillage from the facility to the lagoon system. On the north side, the facility has spilled thin stillage into the swale which drains to the storm water outfall 001. Due to the unstained area between the thin stillage and the manhole, it appears that the facility may have pumped the thin stillage into the swale area, which is depicted in photos 14, 15, and 16.

- 1) There is a thin spillage spill near the manhole/access point for the force main used to transfer thin stillage to the wastewater lagoons. The SWPPP specifically states that "AltEn requires that all employees, representatives and contractors work to prevent spills." There is also a spill of unknown teal colored material east of the grain storage

Description: This photo depicts a thin stillage spill that apparently came from the manhole/force main. There is a large area free of thin stillage, which indicates the manhole may have been pumped out. The facility did not implement spill prevention procedures. This spill flows into a swale which leads to storm water outfall 001.

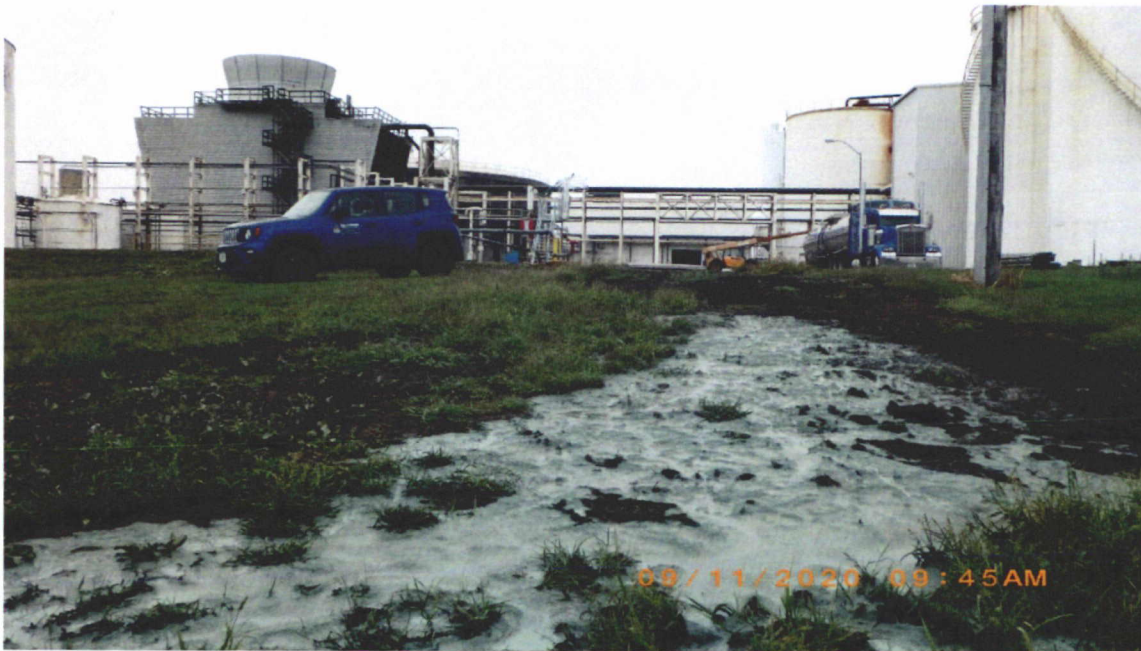
Photo 15
Site Visit Report
Observation Area: 5
Date Taken: September 11, 2020
Photographer: Mark Pomajzl
Facility Name/Project Name: AltEn, LCC
Facility IIS Number/Project Identifier: NER910444, IIS: 84069
Direction Facing: North
Description: This photo depicts the spill facing south.

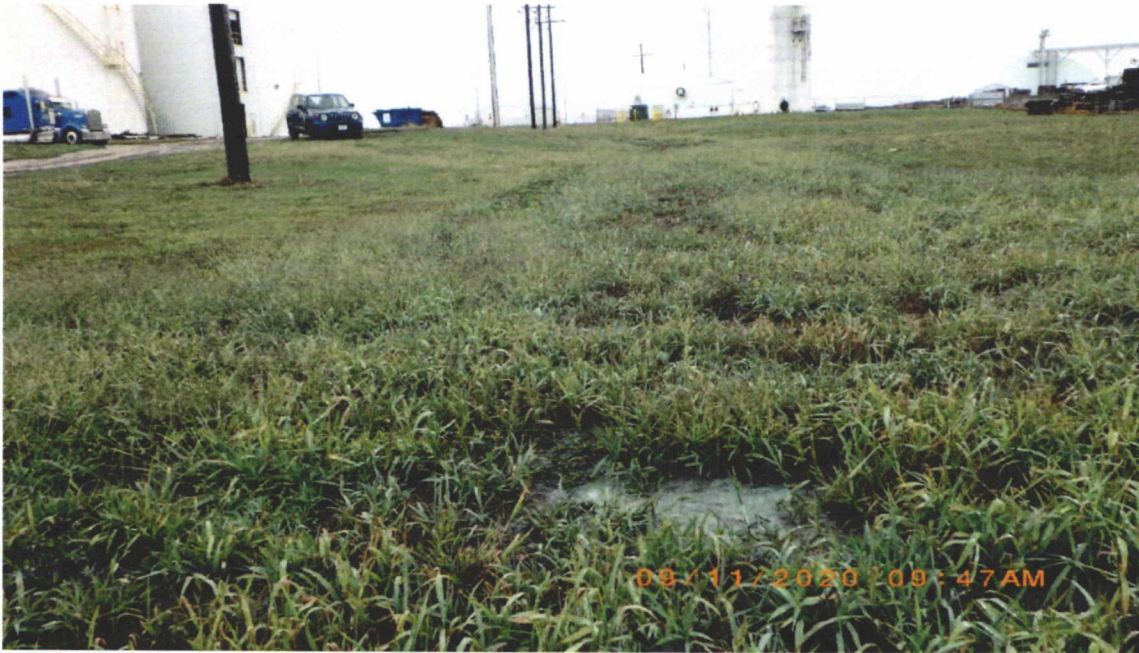
Photo 17

Description: This photo depicts the area that we last noticed thin stillage.

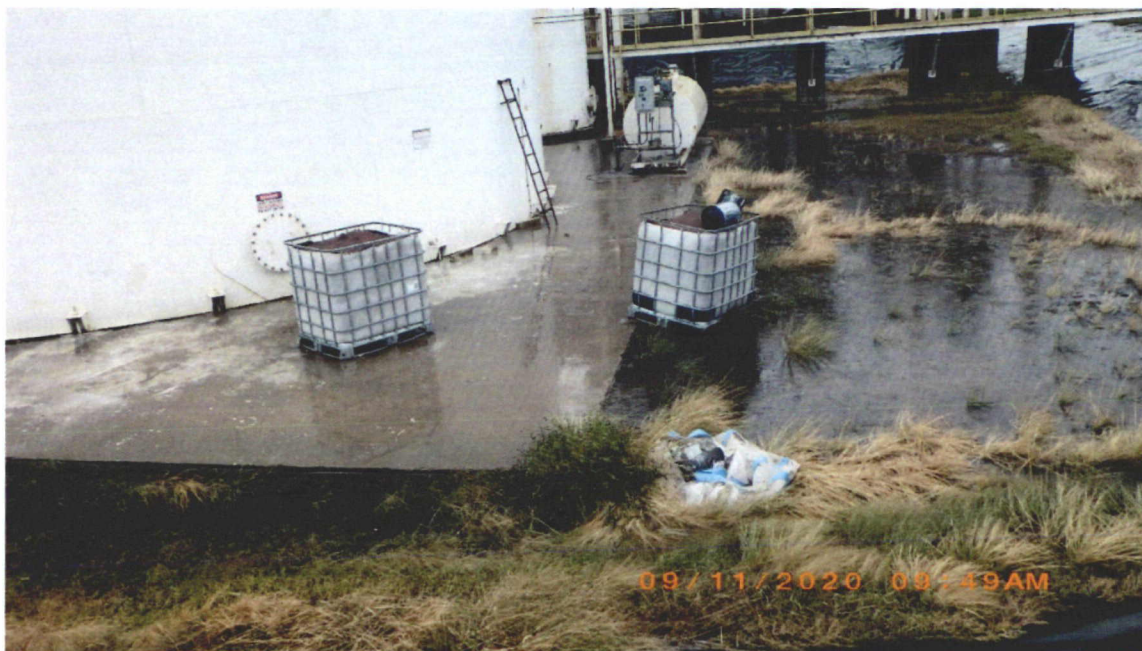
Photo 17

OA6 is the tank farm depicted in photo 17. Inside the tank farm berm are two totes of unlabeled and unknown material along with some trash. On the north side of the berm is spilled red granular material, which is depicted in photo 18. This material is similar to the material observed in the totes.

- 3) The tank farm berm contains two unlabeled totes, which contain an unknown red granular material. There is also unknown red granular material spilled on the north side of the tank farm berm. The SWPPP states that "a visual inspection is performed to note the absence of a sheen – indicating the presence of oil." The SWPPP does not state that it is an area used for tote storage.

Description: This photo depicts the tank farm. There are two unlabeled totes with red granular material. This berm is periodically discharged into the conveyance leading to outfall 001.

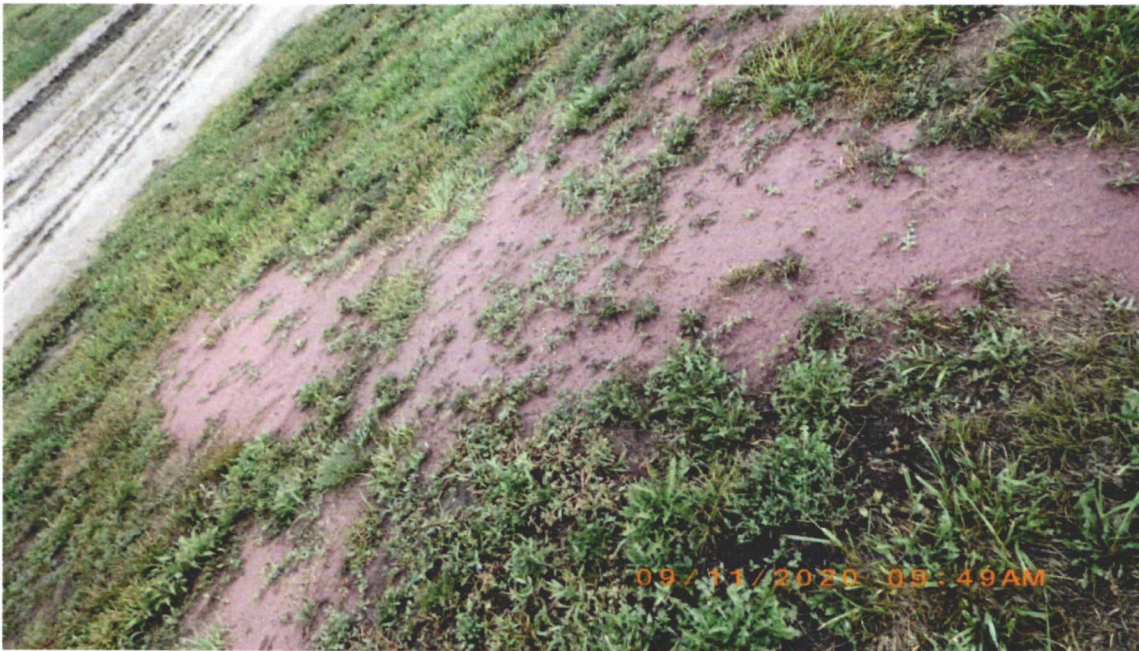
Photo 18

Description: This photo depicts spill of red granular material similar the totes in the above photo. This is located on the north side of the tank farm berm.

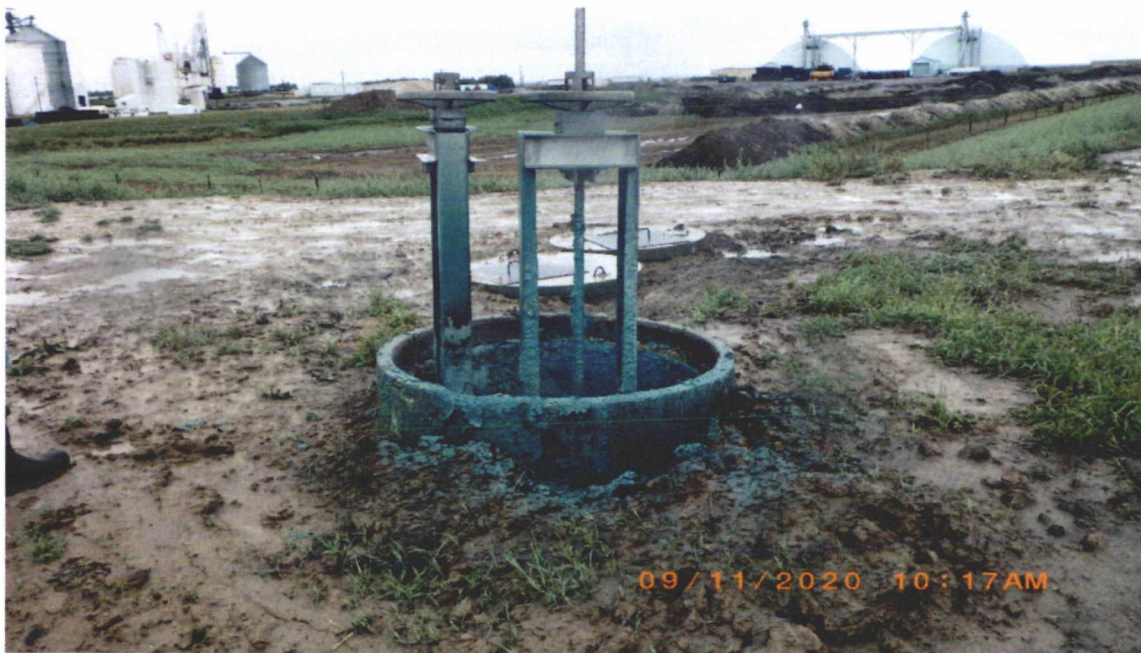
Photo 19

OA7 is located on the northwest corner of the south lagoon. This area contains an air relief vent and valve control system for the three lagoon system. The vent system has recently moved but the system has spilled thin stillage, which is depicted in photo 19. The facility has not contained the spill with countermeasures. The manhole contains rocks and sand, which is depicted in Photo 20.

Description: This photo depicts a thin spillage leakage on and around the junction box between the south and northeast lagoon.

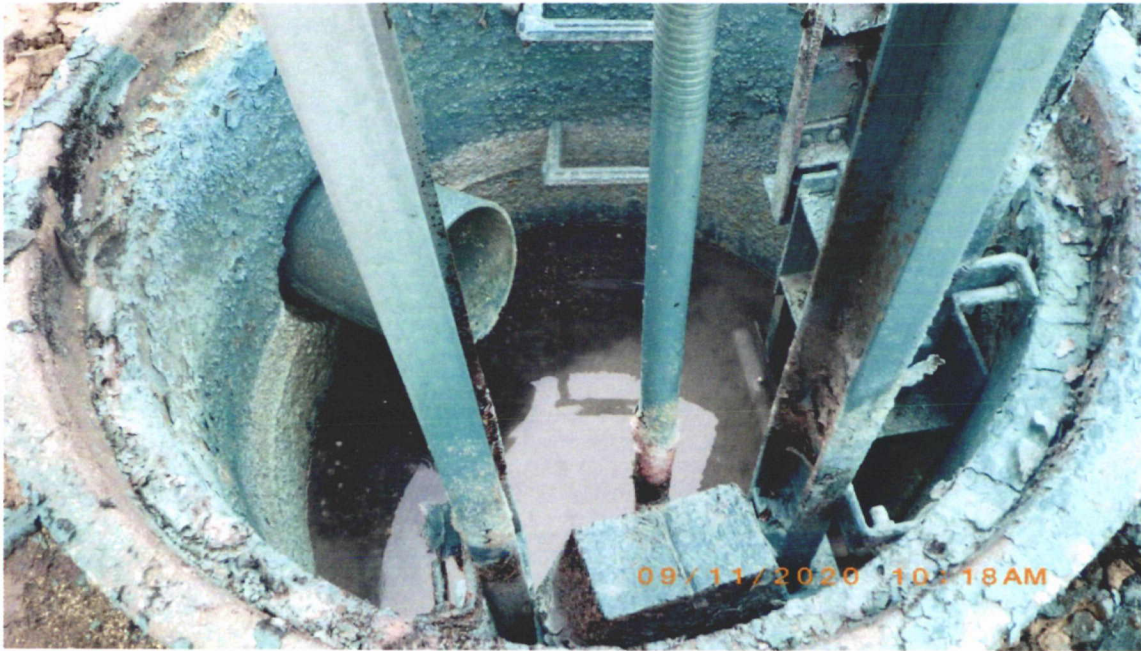
Photo 20

Description: This photo depicts that the junction box filled with gravel and sand. The photo also depicts the lack of spill prevention and storm water controls.
