MEMORANDUM

RE: AltEn, LLC, Mead, Nebraska

Subject: Wastewater Sampling Report

Wastewater Sampling Event on November 12, 2019

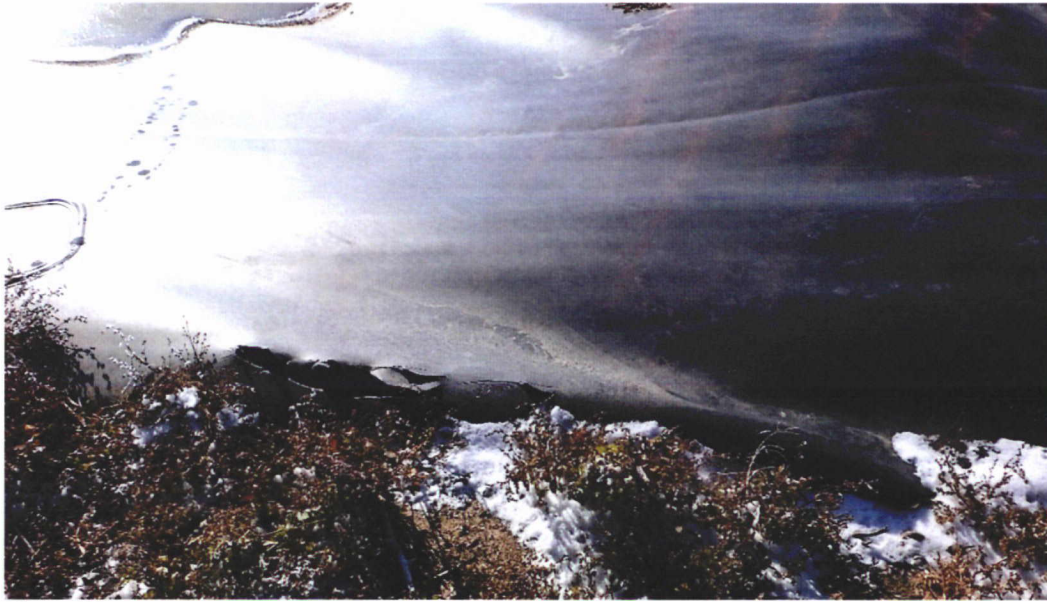
Photo 15
 Date Taken: November 12, 2019
 Photographer: Hillary Stoll
 Facility Name/Project Name: AltEn, LLC, Mead, NE
 Facility IIS number/Project Identifier: IIS #84069, PCS NE0137634, NER910444
 Direction Facing: N/A
 Description: Tear on North lagoon liner (middle of north side)

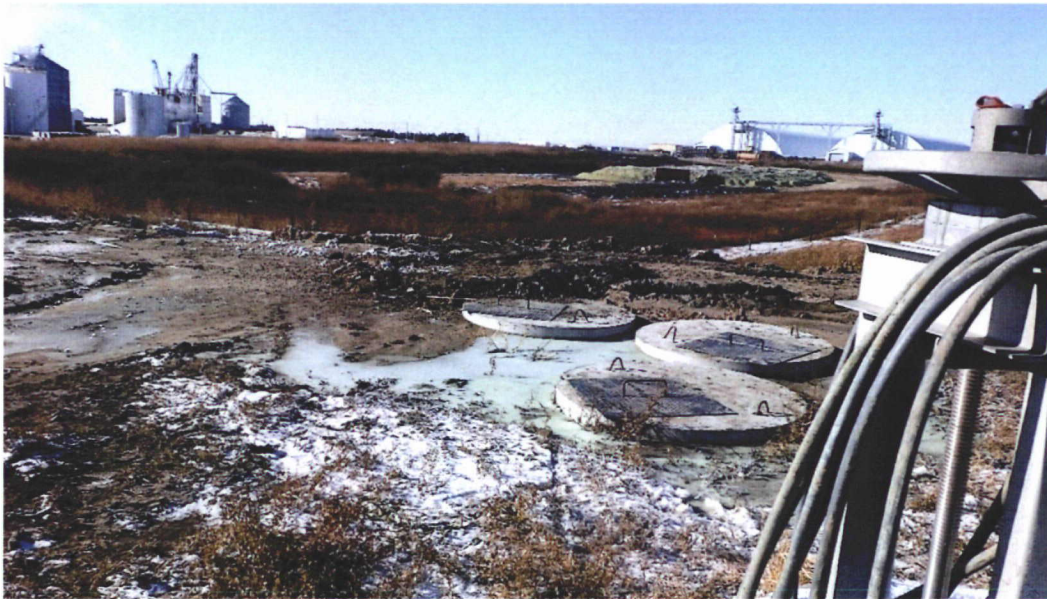
- Mr. Egr notified us that there was a wastewater spill on November 11, 2019 (documented in photos). He used our visit as an opportunity to report the spill, which was still within 24 hours of the spill. The facility will be sending in a report for the spill. Based on Mr. Egr's description of the spill, it seemed to be caused by a failure of the connecting hose between the air relief valve and the South lagoon.

Photo 16
 Date Taken: November 12, 2019
 Photographer: Hillary Stoll
 Facility Name/Project Name: AltEn, LLC, Mead, NE
 Facility IIS number/Project Identifier: IIS #84069, PCS NE0137634, NER910444
 Direction Facing: Southwest
 Description: Spilled wastewater on lagoon dike

Inspection Date: 11/12/19 Start Time: 9:45am End Time: 12:39pm☐ No concerns observed☐ Further agency discussion needed☒ Concerns observed:SPILL From Air Vent Valve Cause green water to Exit behind
South Lagoon☒ Actions to be performed immediately or as soon as reasonably practical:Keep her up to date on the progress on Air Vent Valve**Please notify the Inspector when the above actions are completed.**

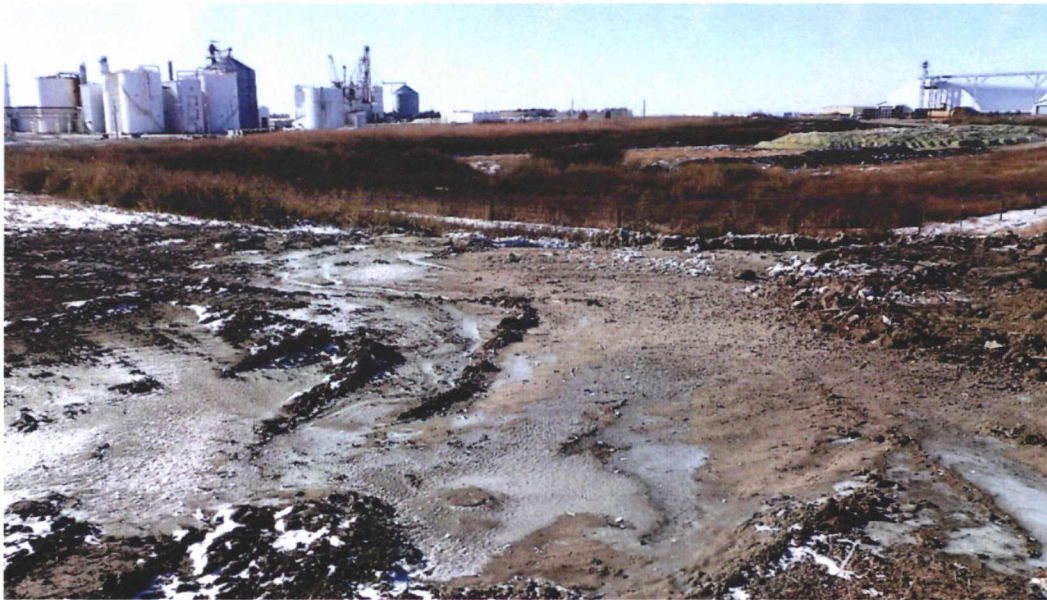
Photo 17

Description: Spilled wastewater on lagoon dike

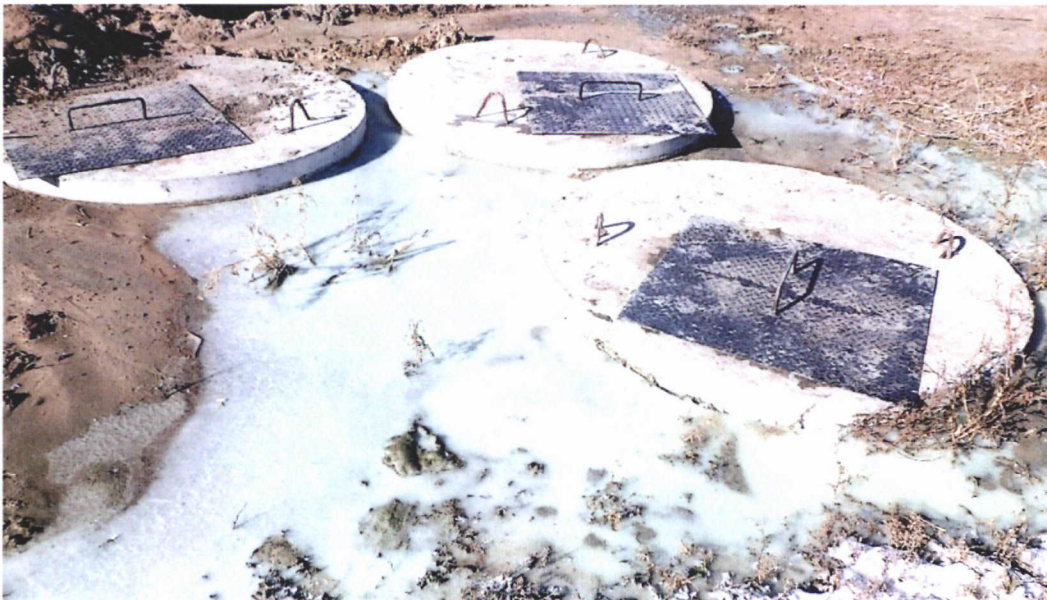
Photo 18

Description: Spilled wastewater on lagoon dike

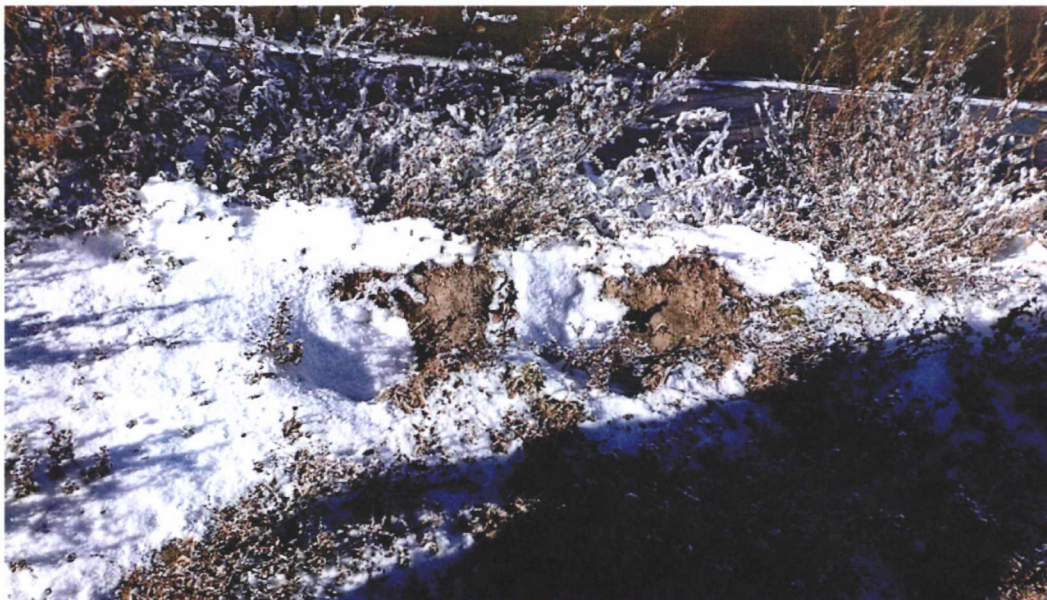
Photo 19

Description: Animal burrow near North lagoon liner (east side)

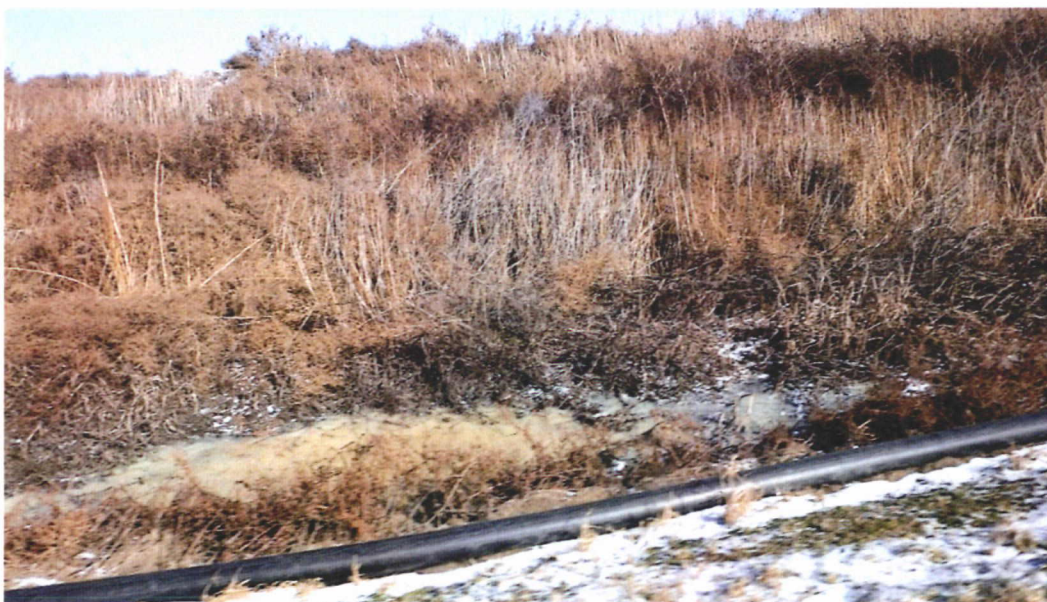
Photo 20

Description: Spilled wastewater on south side of South lagoon dike

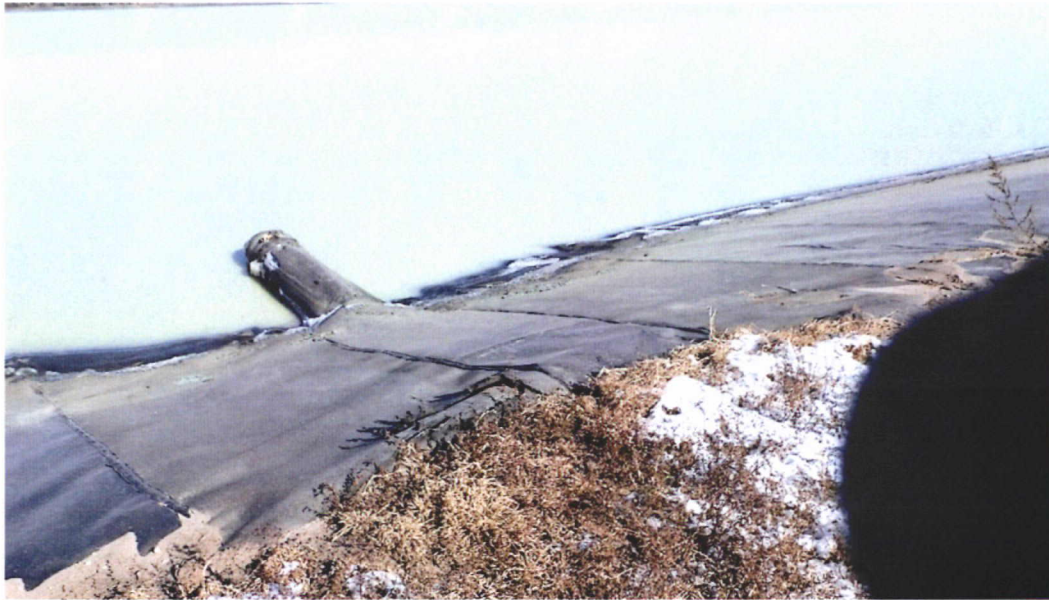
Photo 21

Description: Tear in West lagoon liner (south side)

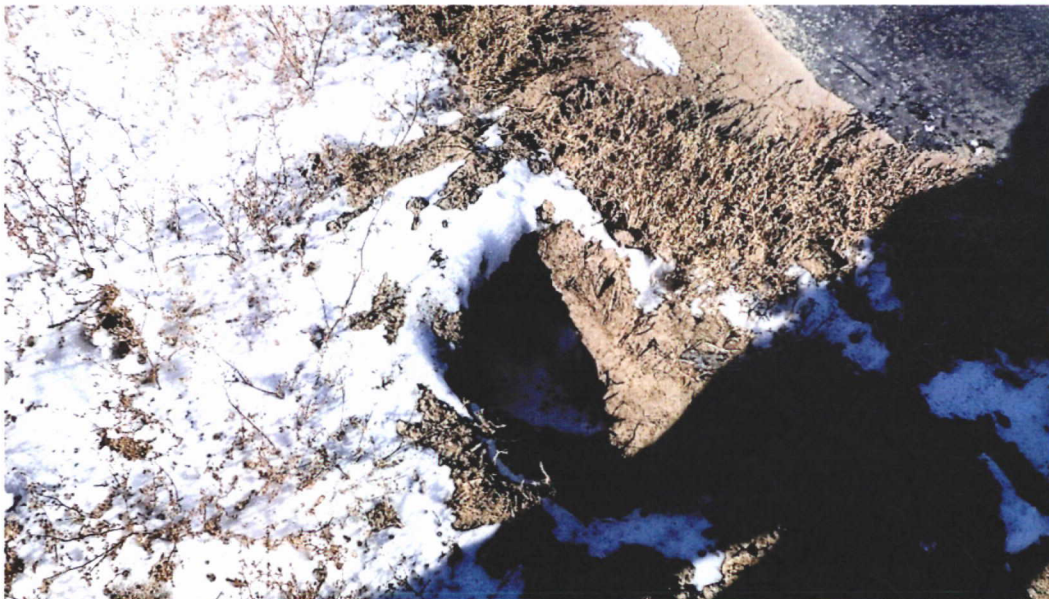
Photo 22

Description: Animal burrow near West lagoon liner (south side)

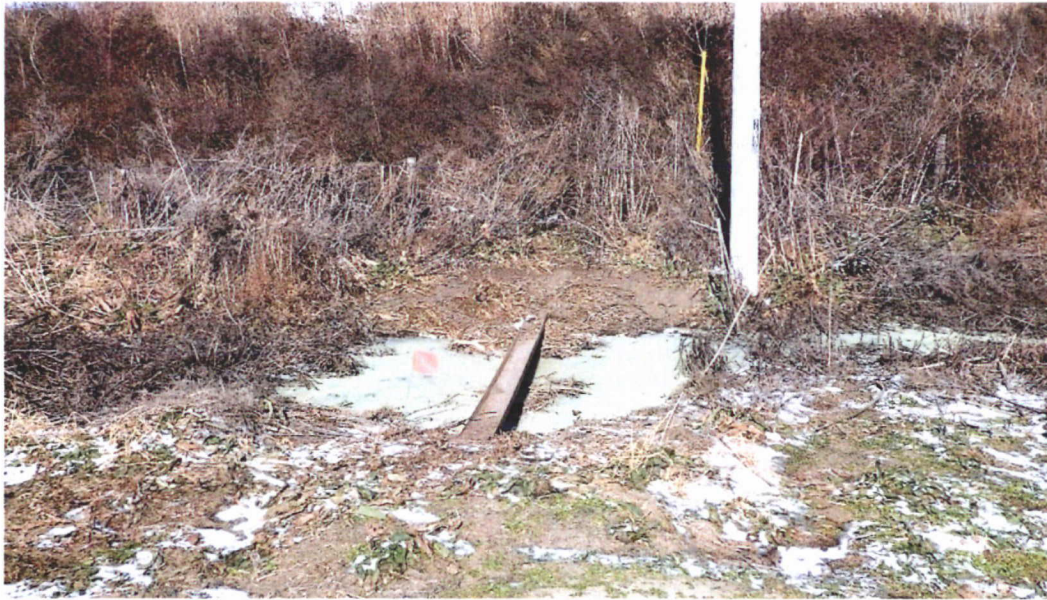
Photo 23

Description: Spilled wastewater on south side of South lagoon dike

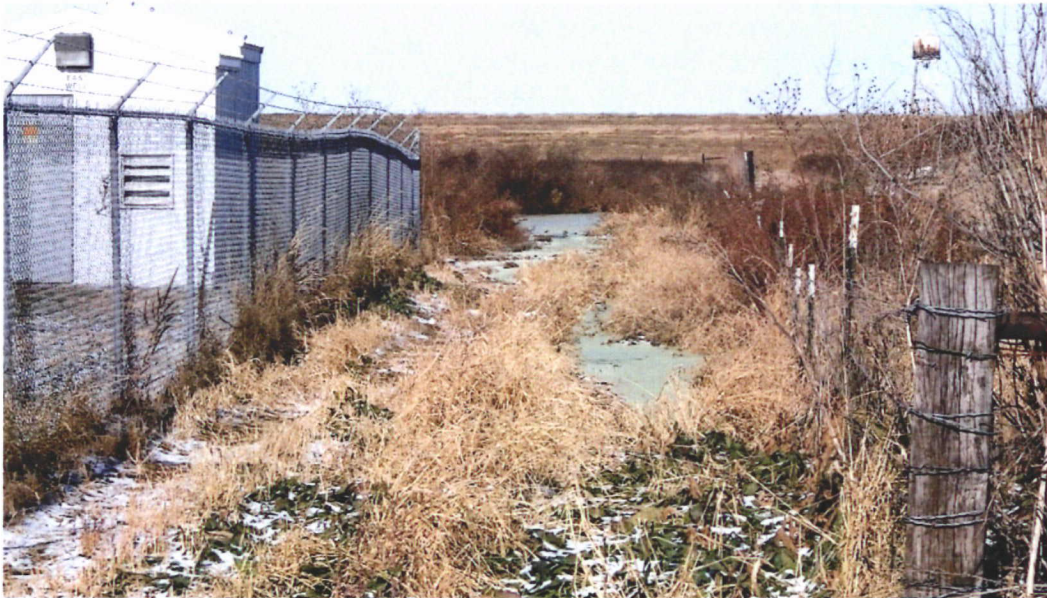
Photo 24

Description: Spilled wastewater on east side of South lagoon dike
