**MEMORANDUM**

From: AltEn, LLC, Mead Nebraska

Date: July 31, 2019 (12:00 pm – 4:36 pm)

RE: Inspection – Mark Pomajzl, Jason Windhorst, Jason Holsten, Hillary Stoll

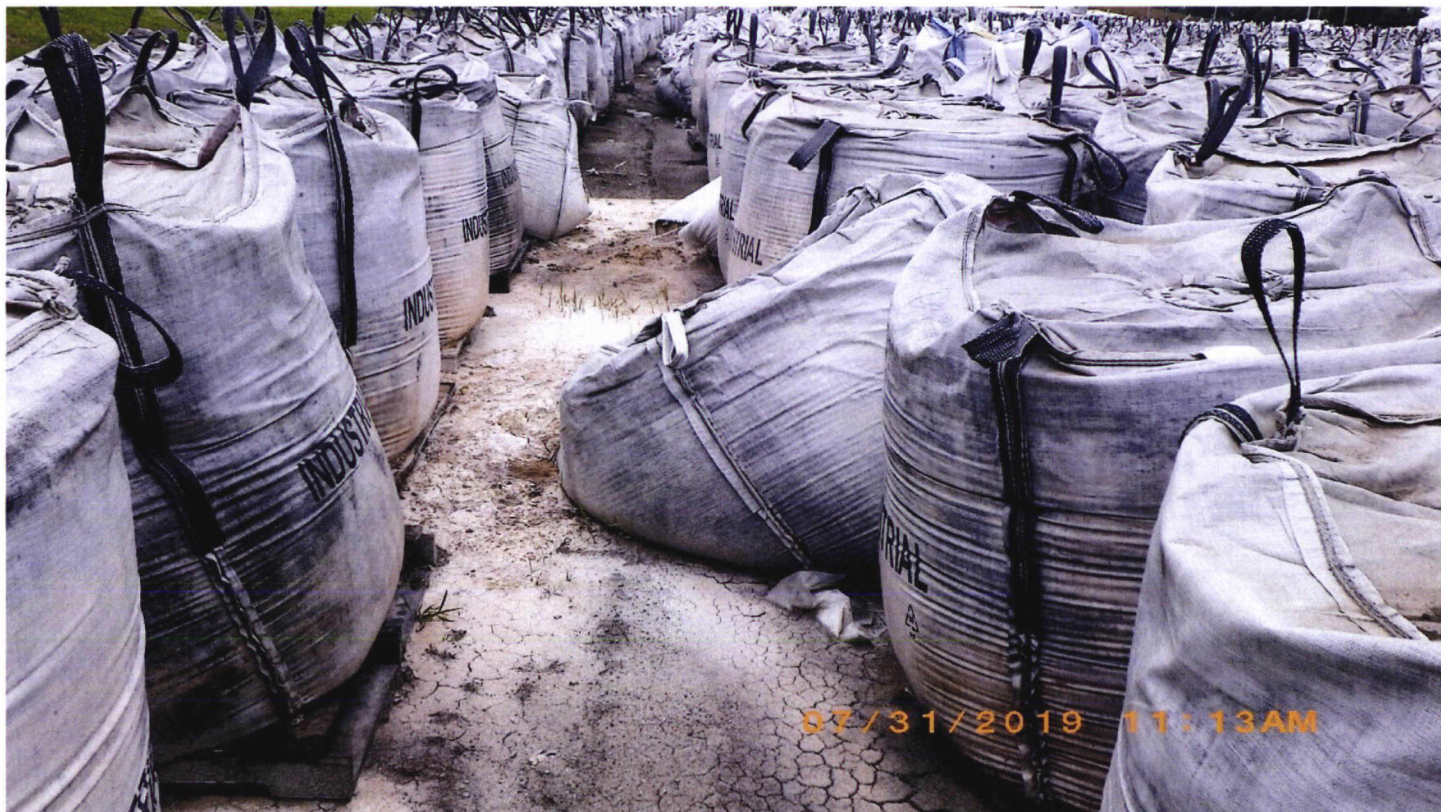
Photo 1

OA1 is the area southwest of the Administration building that is used to store pallets of starch (Photos 1, 2). I asked Mr. Pederson about how much starch is onsite. He did not know this information. There are torn and leaking bags of starch exposed to precipitation. Evidence of starch transport is observed in the employee parking lot (Photo 3). I asked Mr. Pederson of the best management practices (BMPs) used for this area. Mr. Pederson was not aware of the BMP used in this location.

Description: Bags of starch stored on the north side of the facility exposed to precipitation for an undetermined time period. Some of the bags have burst, torn, and spilled onto the ground where precipitation has transported starch into drainage areas onsite. Evidence of starch transport is evident in the employee parking area north of the office building.

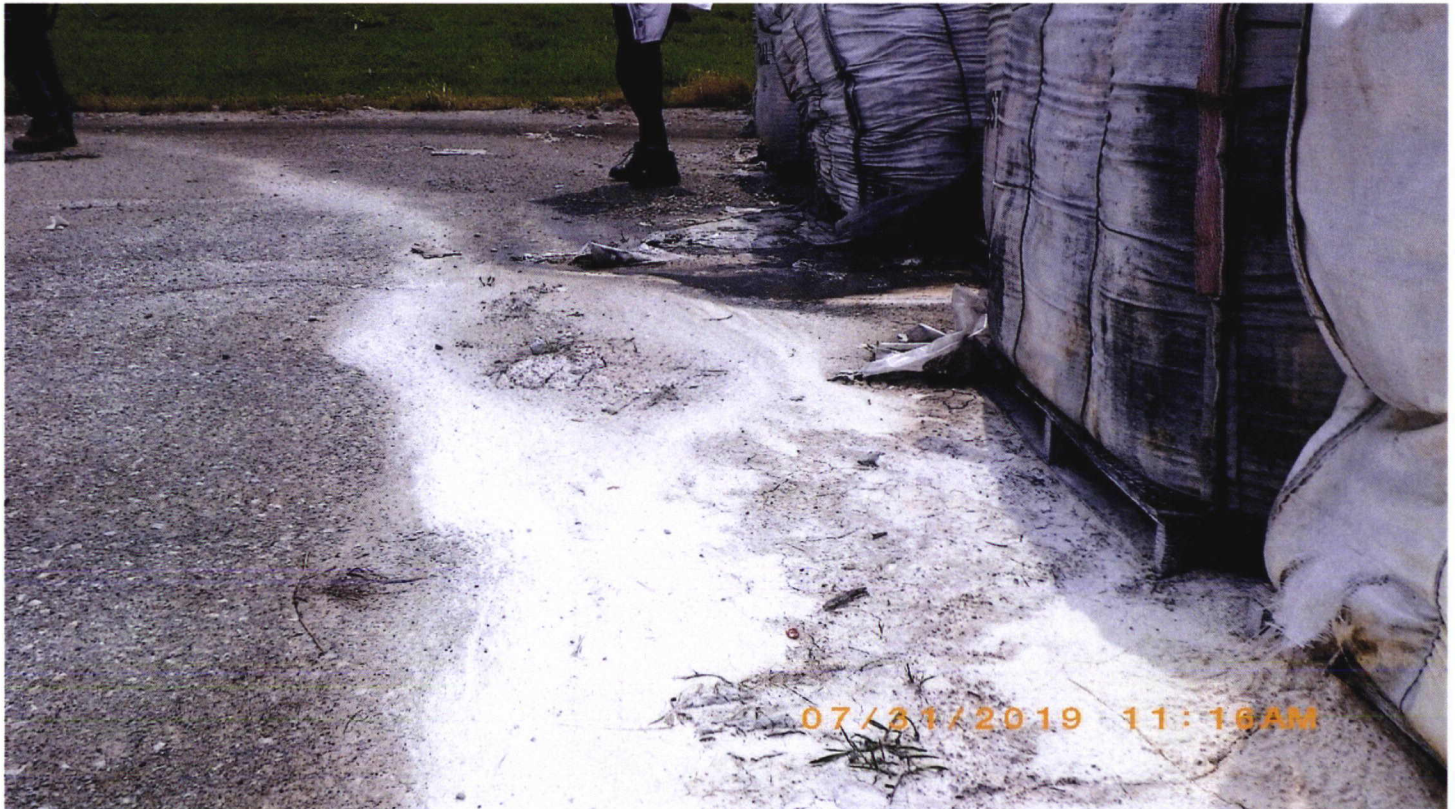
Photo 2

Description: The east edge of the primary starch storage area shows visual evidence of the material migrating via precipitation into drainage areas.

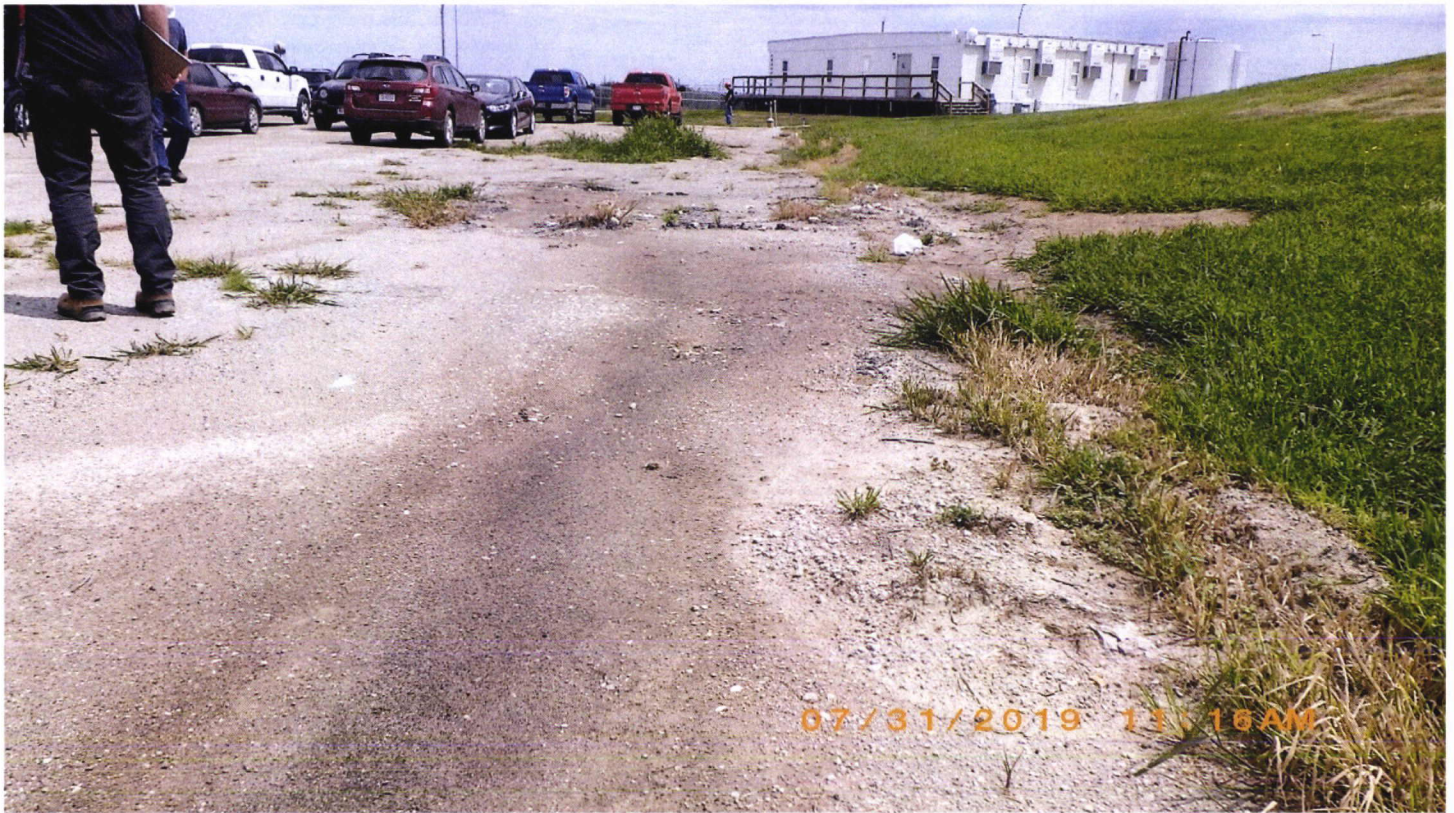
Photo 3

Description: The photo taken at the southeast edge of the primary starch storage area. Starch is comingled with sediment and discharging to the employee parking lot.

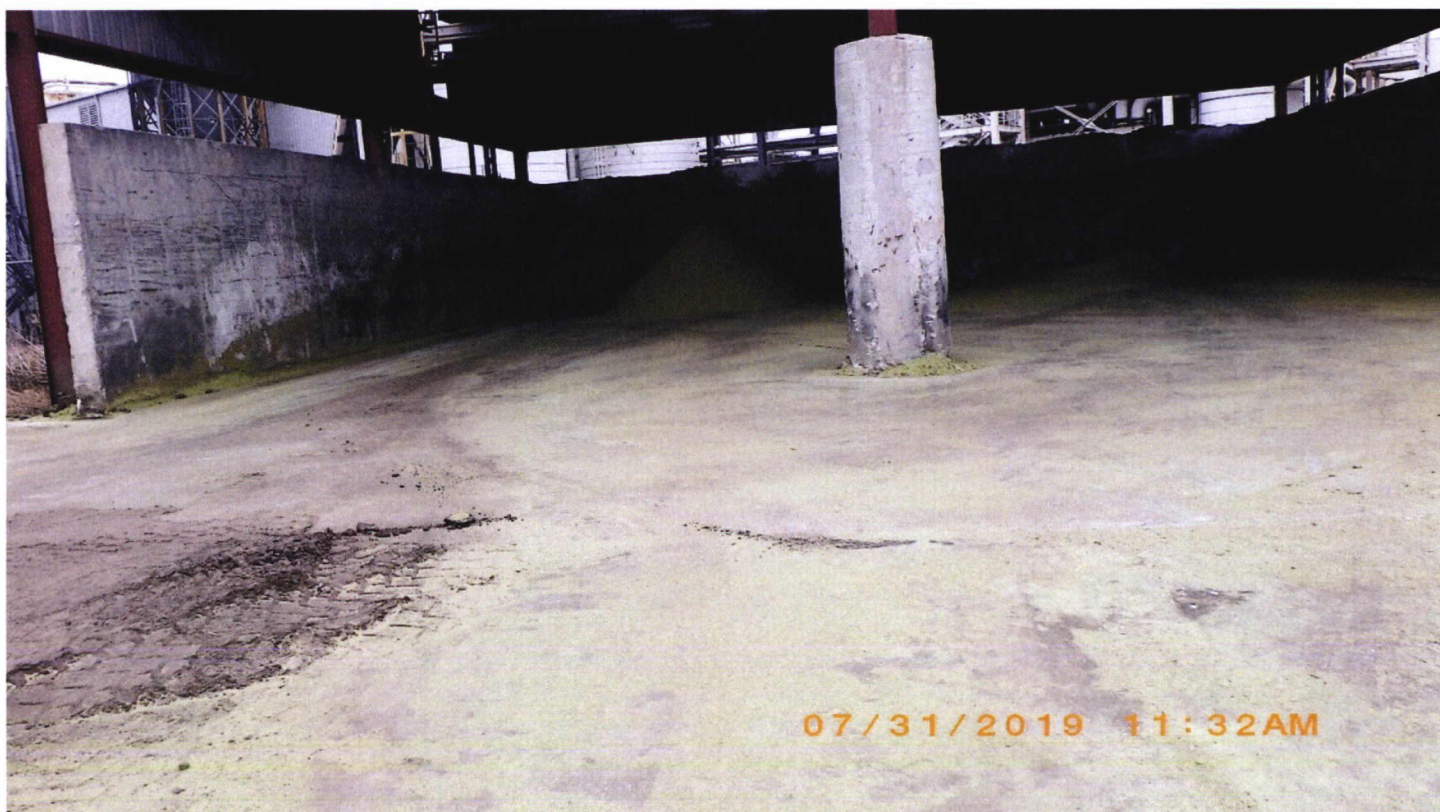
Photo 4

Description: The structure pictured in the photo is the wet cake load out area for the facility. The solids are conveyed to the collection area where it is loaded onto trucks and transported to the wet cake storage areas northwest portion of the facility. Wet cake observed tracked out for several feet onto the haul road. The haul road crosses internal roads within the facility that are used by traffic entering and exiting the facility.

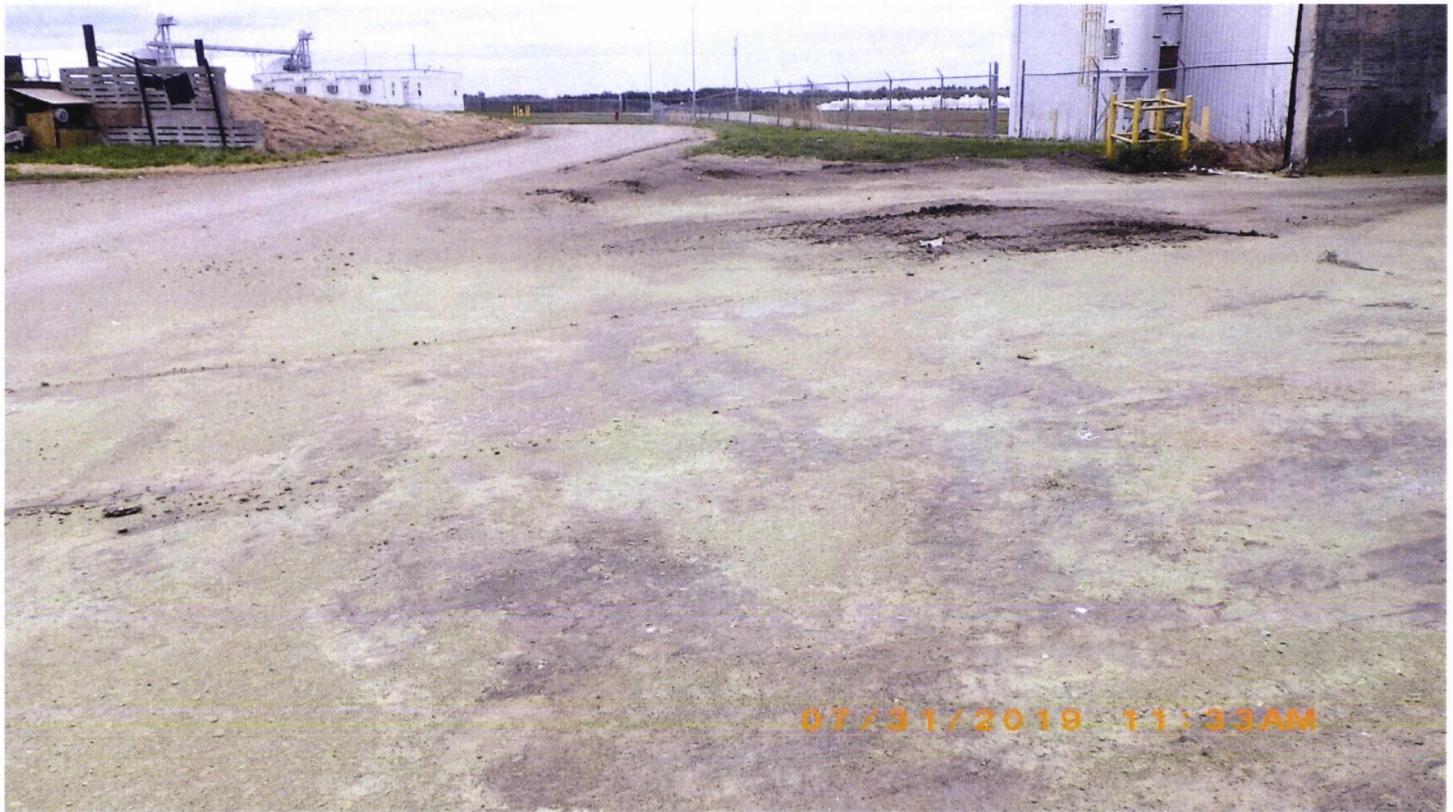
Photo 5

Description: The photo depicts the west edge of the wet cake loading area with the Mead Cattle mill in the background. The road is observed being used frequently by trucks loading material from the mill and tracking through the wet cake on the road on its way to the feed lot area of Mead Cattle.

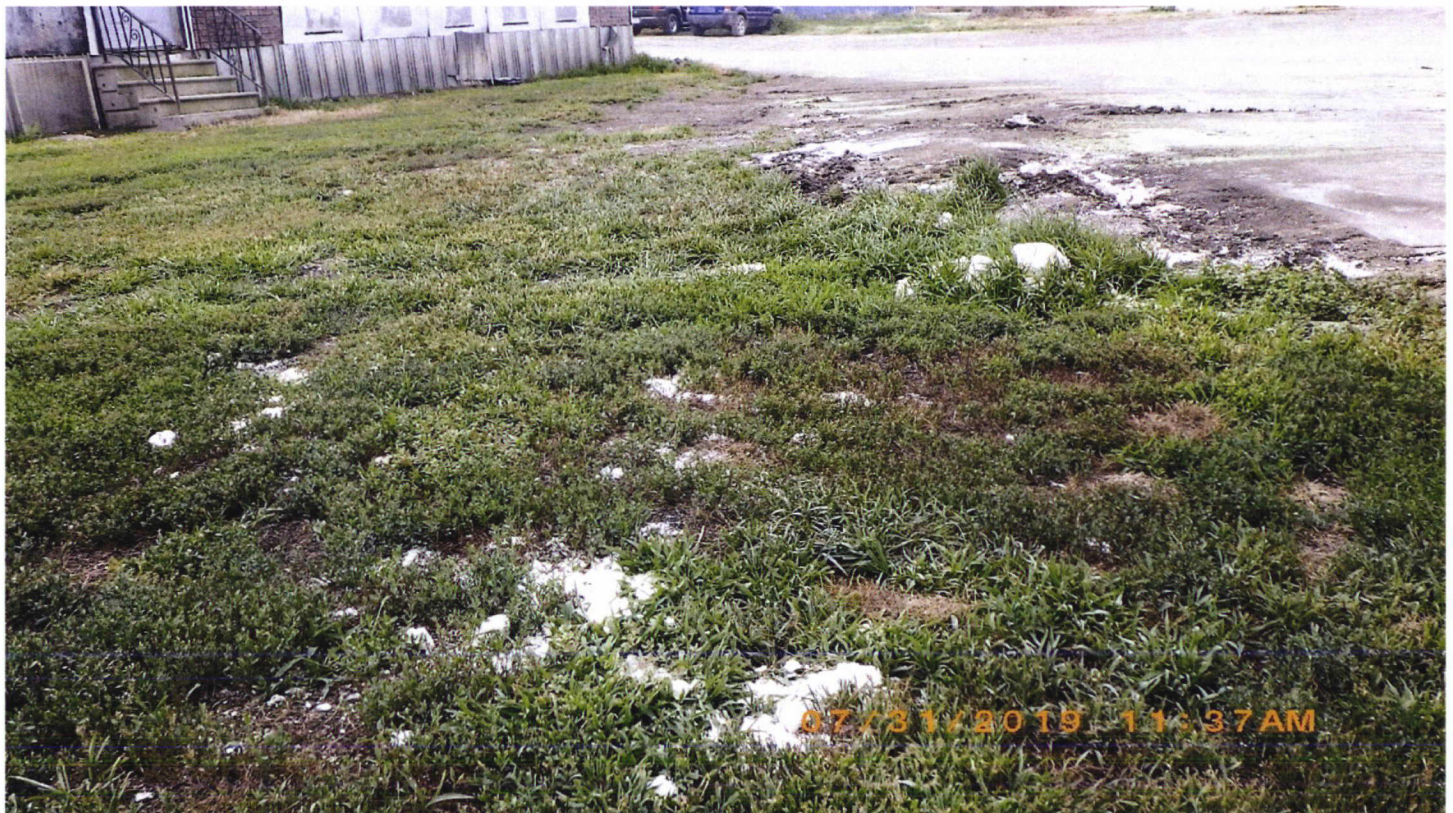
Photo 6

Description: The grass area to the west of the wet cake load out structure evidence of starch was present in several areas. Upon questioning, Mr. Pederson with AltEn, he said that they were mixing some of the unusable starch with the wet cake prior to hauling it to the storage area. He said they break up the starch and mix it on the concrete pad before loading it onto the trucks.

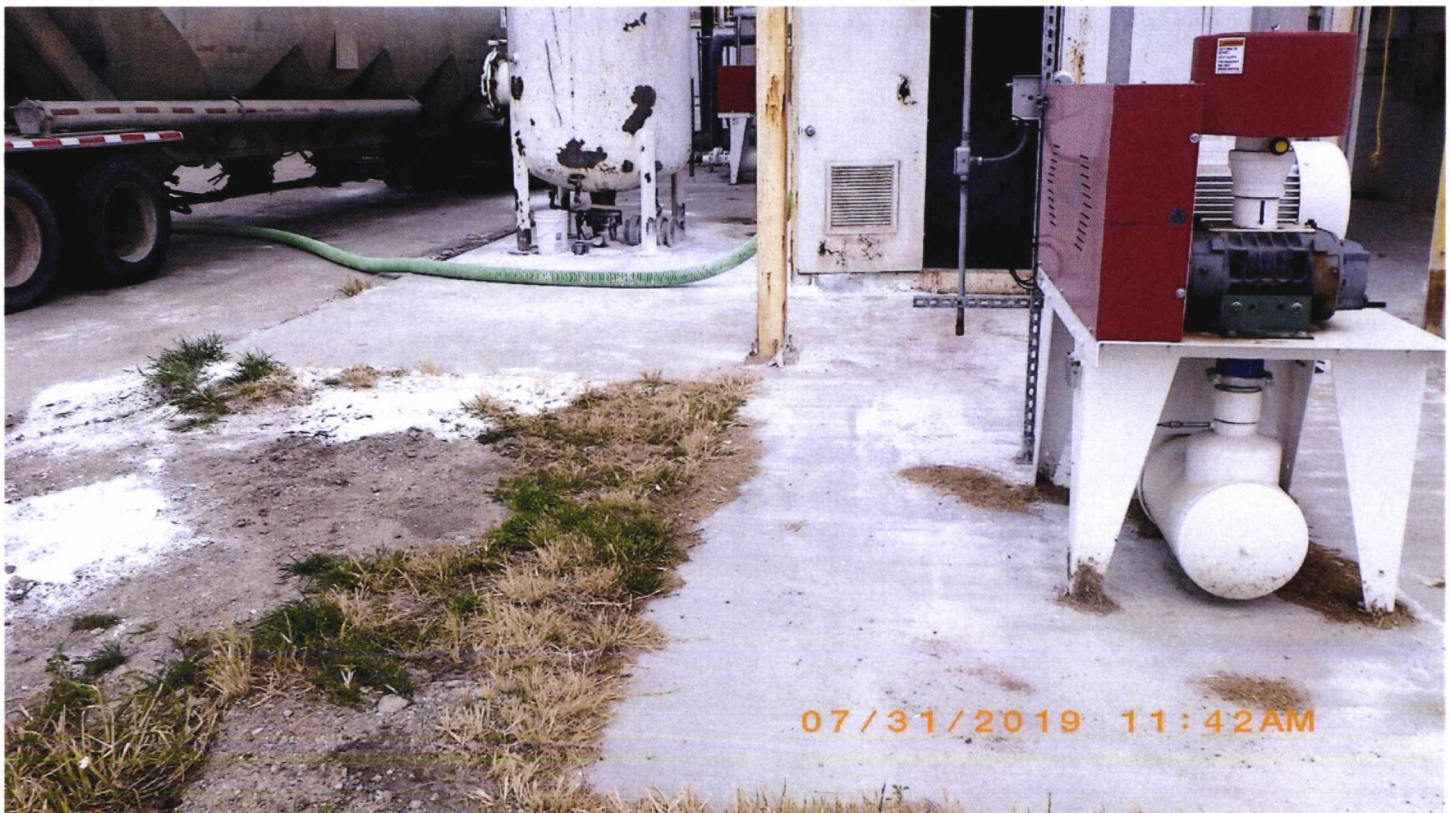
Photo 7

Description: In this area, the facility receives loads of starch to be used in the fermentation process. The facility primarily uses starch based upon the ease of use and storage. The receiving area appeared to have problems with housekeeping based upon evidence of corn starch found around the area used to unload the product. This area has a similar problem to the bagged storage area, where precipitation appears to have transported starch from the unloading area to the adjacent drainage area.

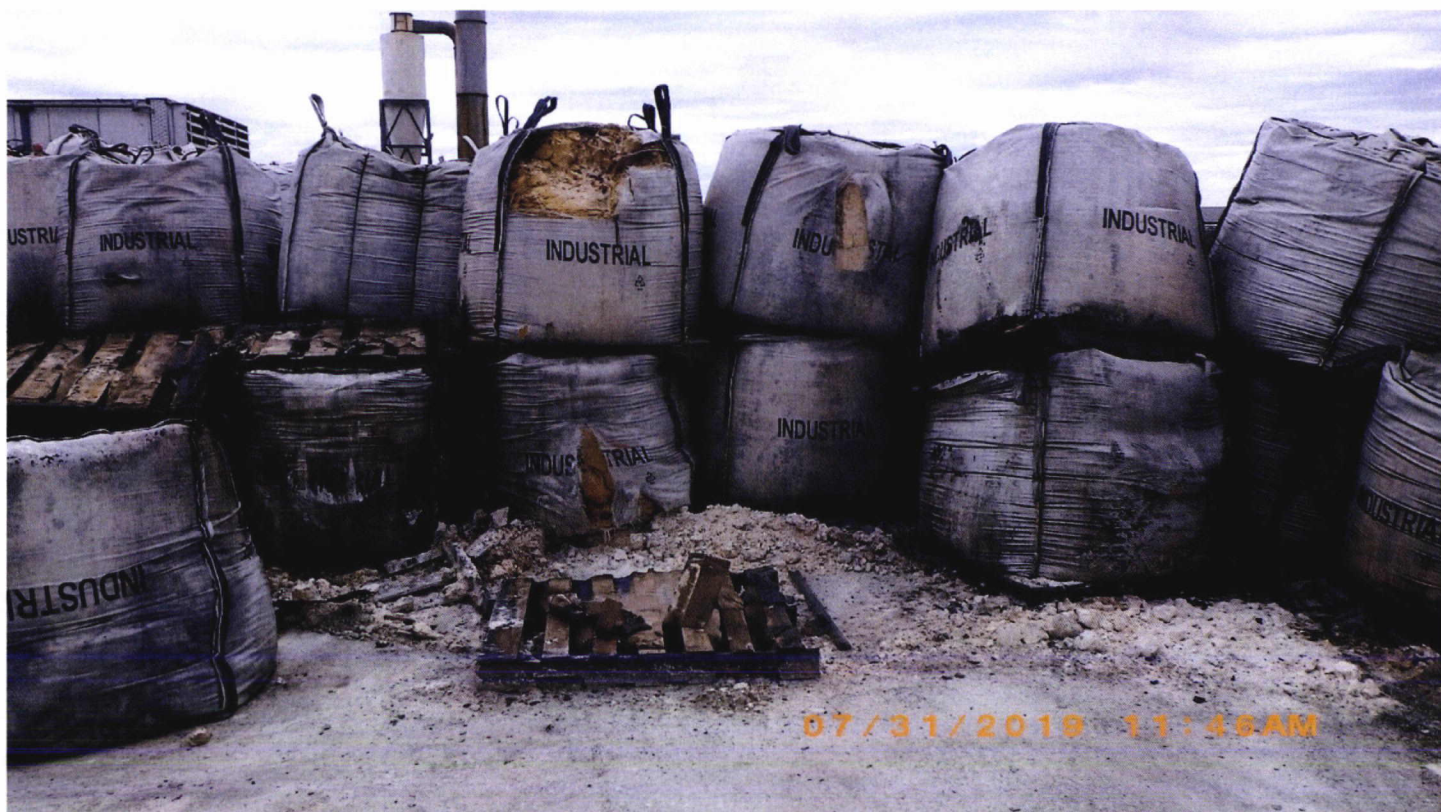
Photo 8

Description: South of the NR System building where bags of starch are found continued to be stored. This area was requested to be cleaned up on the October 2018 sampling site visit. Based upon photo 9, there appears to be more material stored in this area. The bags that were stored to the north of this photo location has had material removed, but appears that it may have been moved to the south side of the concrete pad as illustrated above.

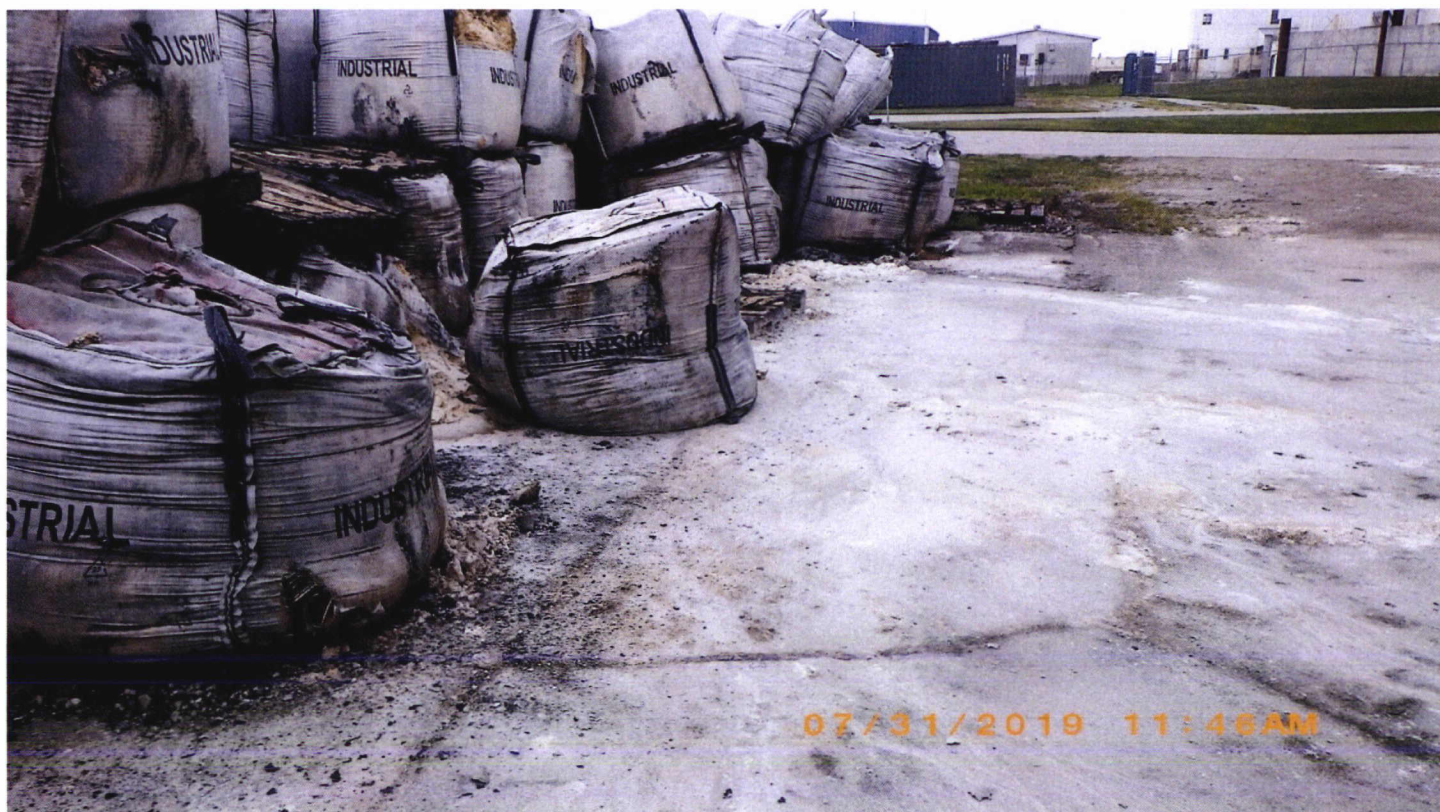
Photo 9

Description: Same area as photo 8 showing damaged bags of starch and starch on the ground. Precipitation events show that the migration of material away from storage area is not maintained or prevented. The majority of this area has starch present on the ground and is evident in the vegetated area adjacent to the starch bags.

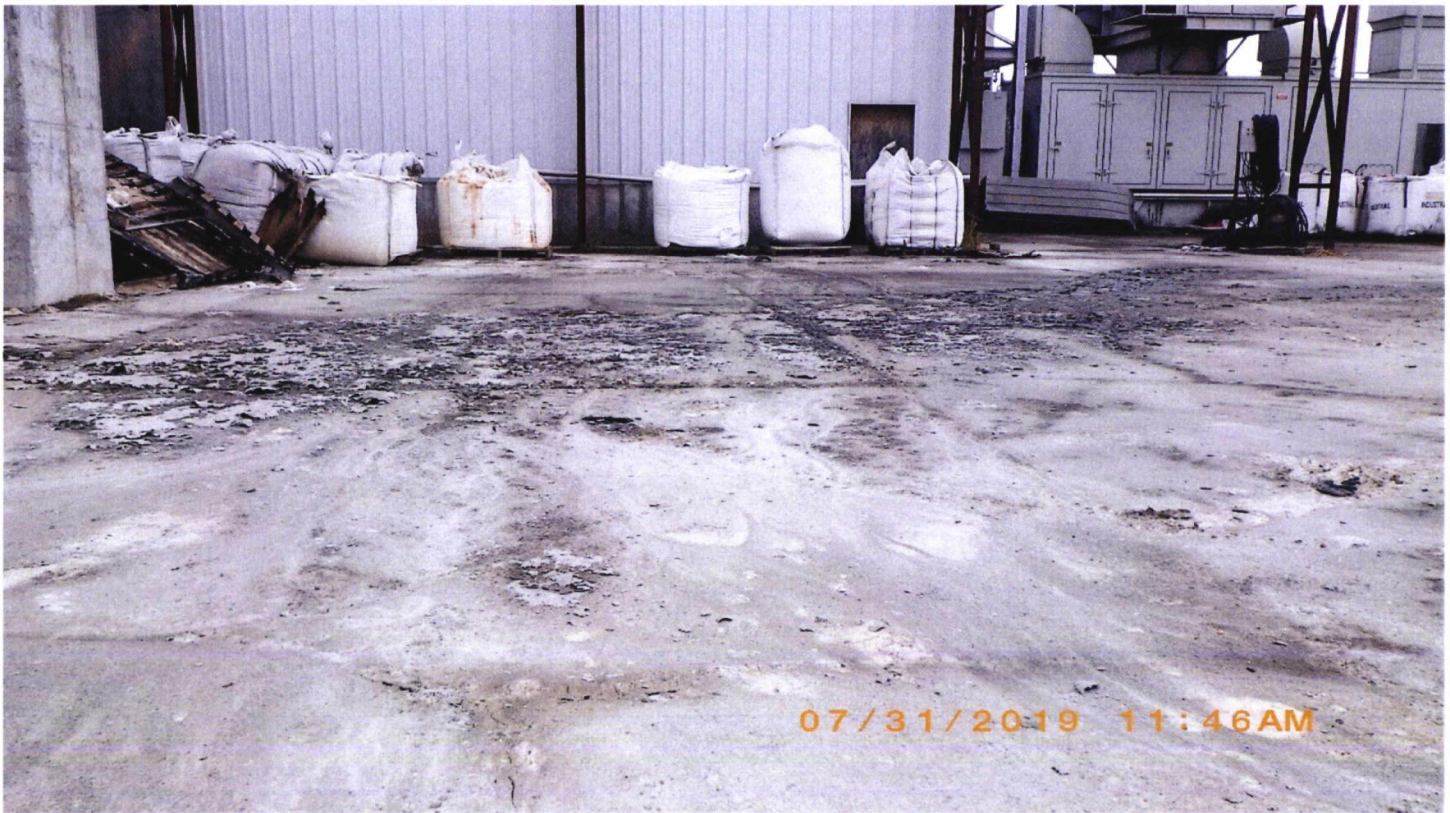
**Photo 10**

**Description:** This area had in 2018, bags of starch that were requested to be cleaned up. The bags have been removed, but not the material that had leaked from the starch bags. Drainage patterns from the area depicted in photo 8 (to the right of this photo) are visible with evidence of starch transport in the direction of the facilities west property line.

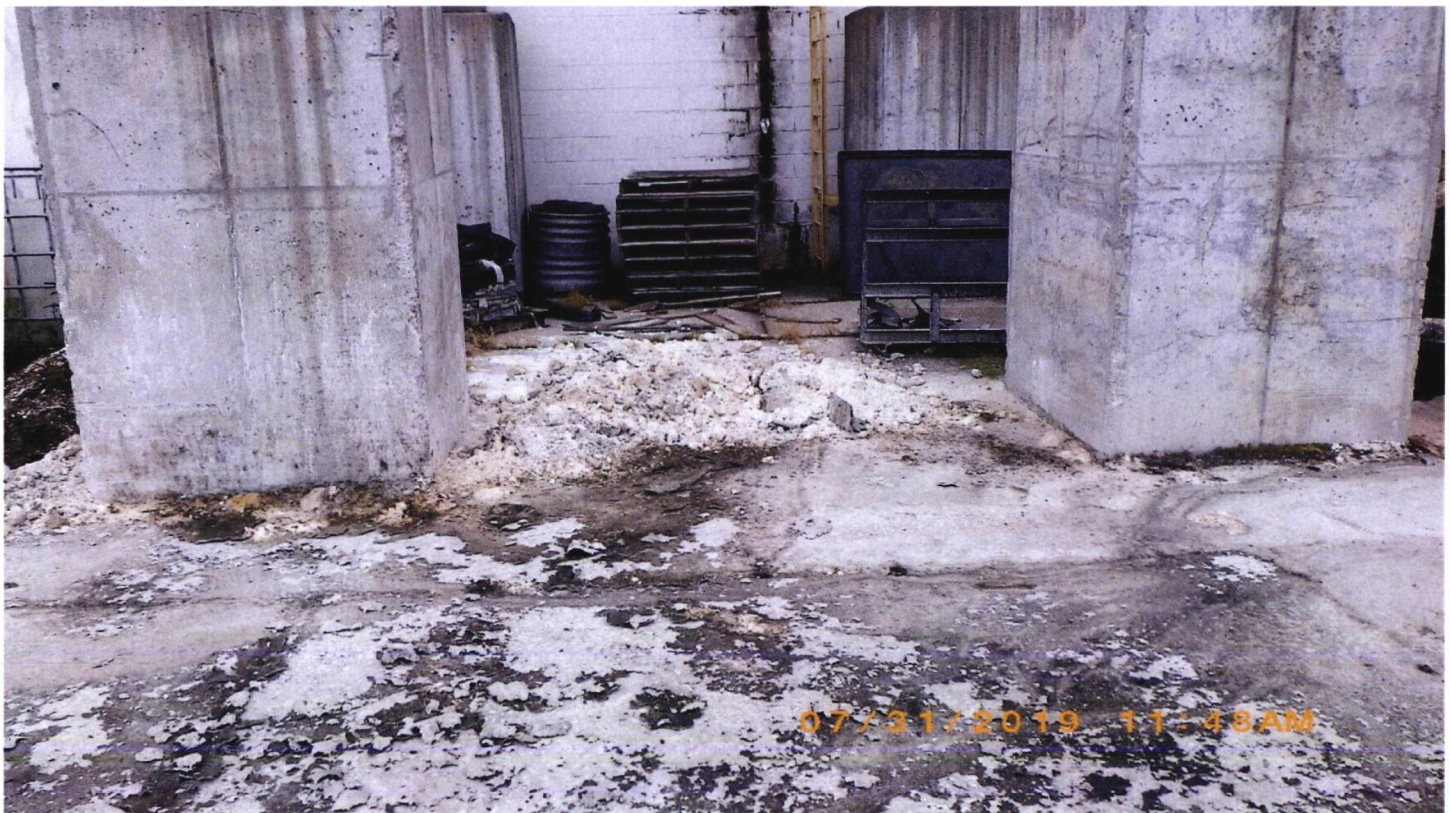
Photo 11

Description: Area depicted in photos 8-11. Loose starch is present across this concrete paved area.

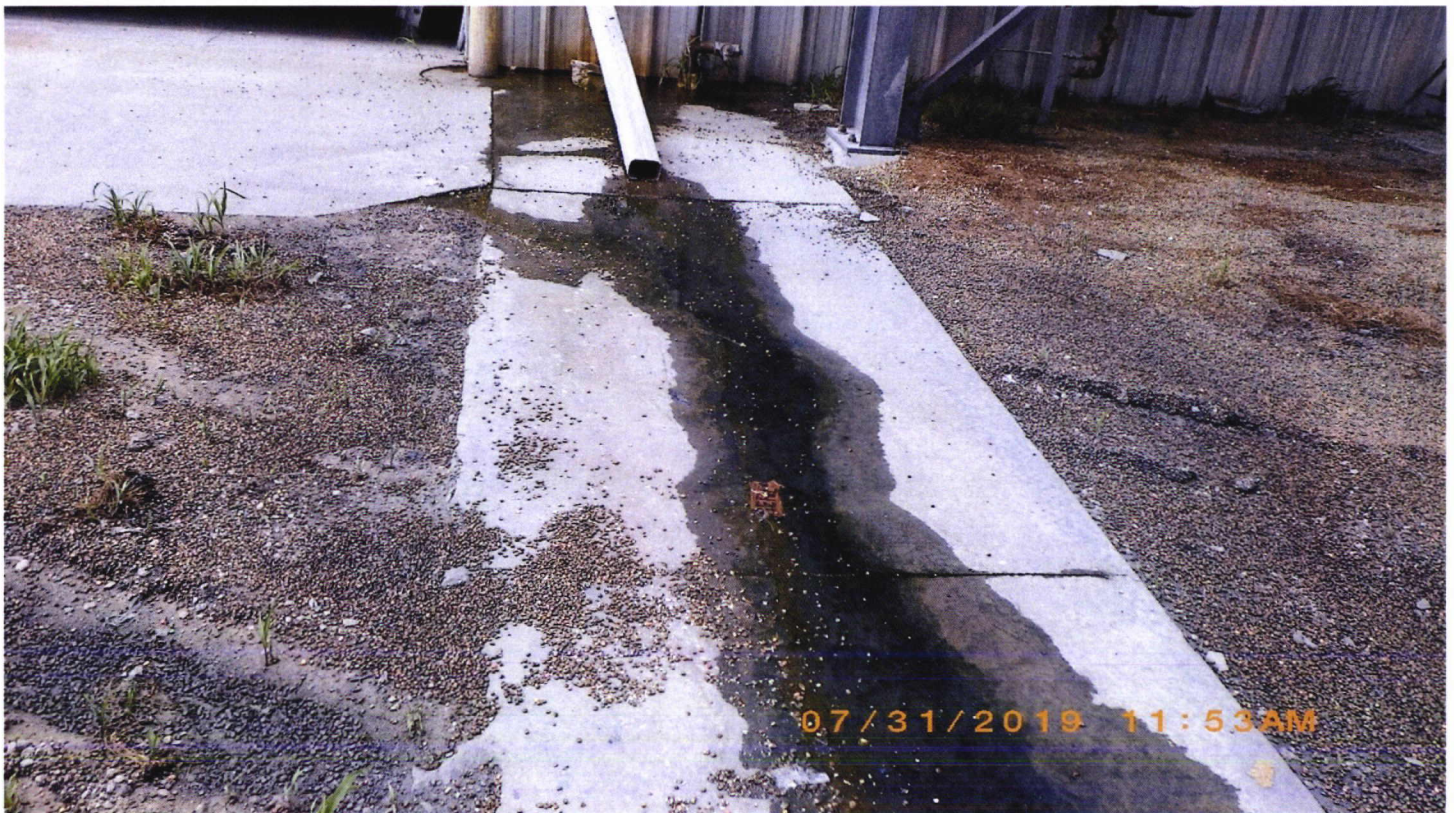
Photo 12

Description: Area between the grain receiving building and the process building. Condensate appears to be discharging from the process building, but is in contact with treated seed corn. The condensate is then drained via flume to a collection area adjacent to the wet cake load out structure.

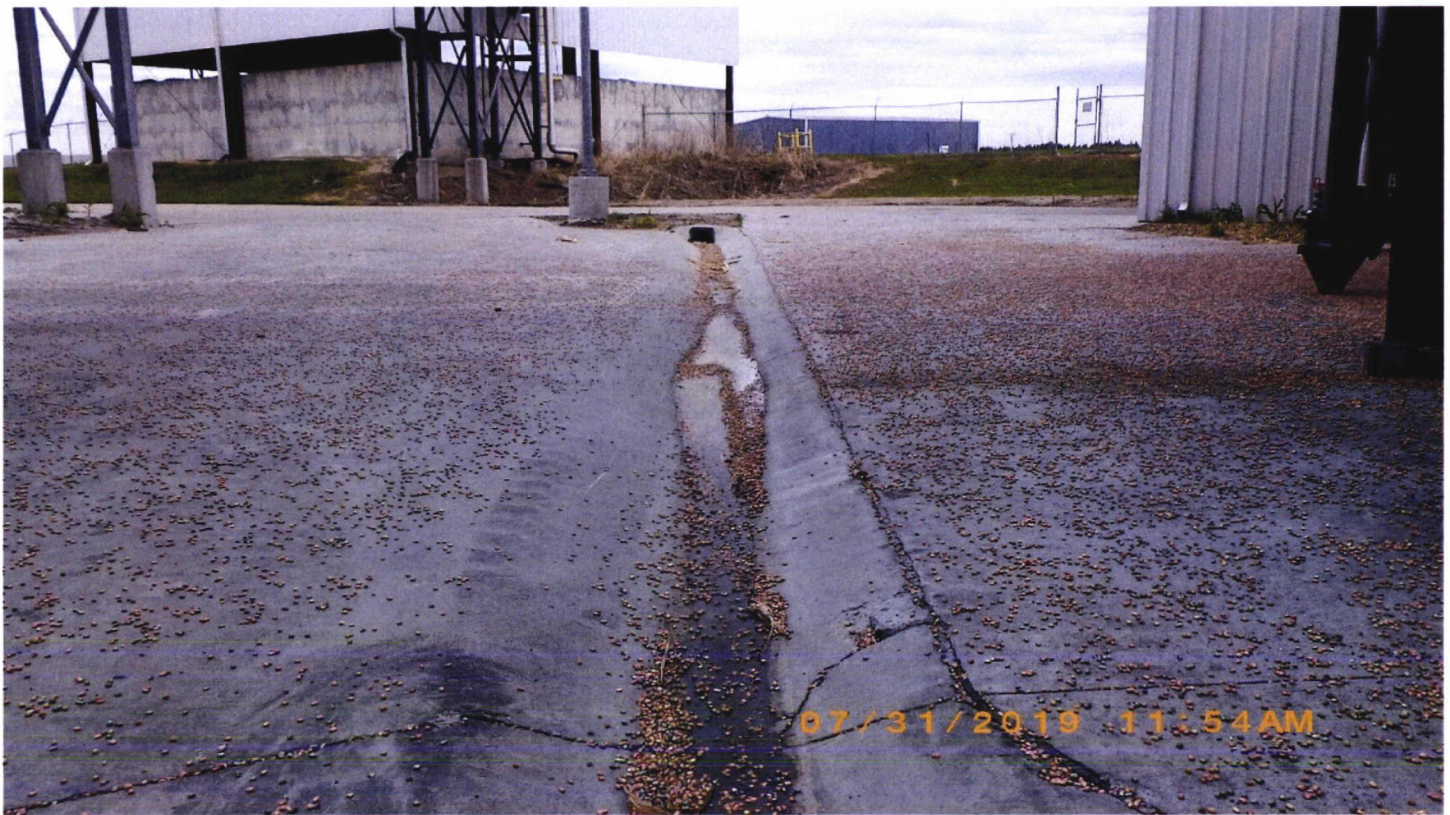
Photo 13

Description: Flume between the process building, grain receiving, and wet cake load out. According to AltEn staff, this area is problematic in regards to grain spillage and requires daily cleanup.

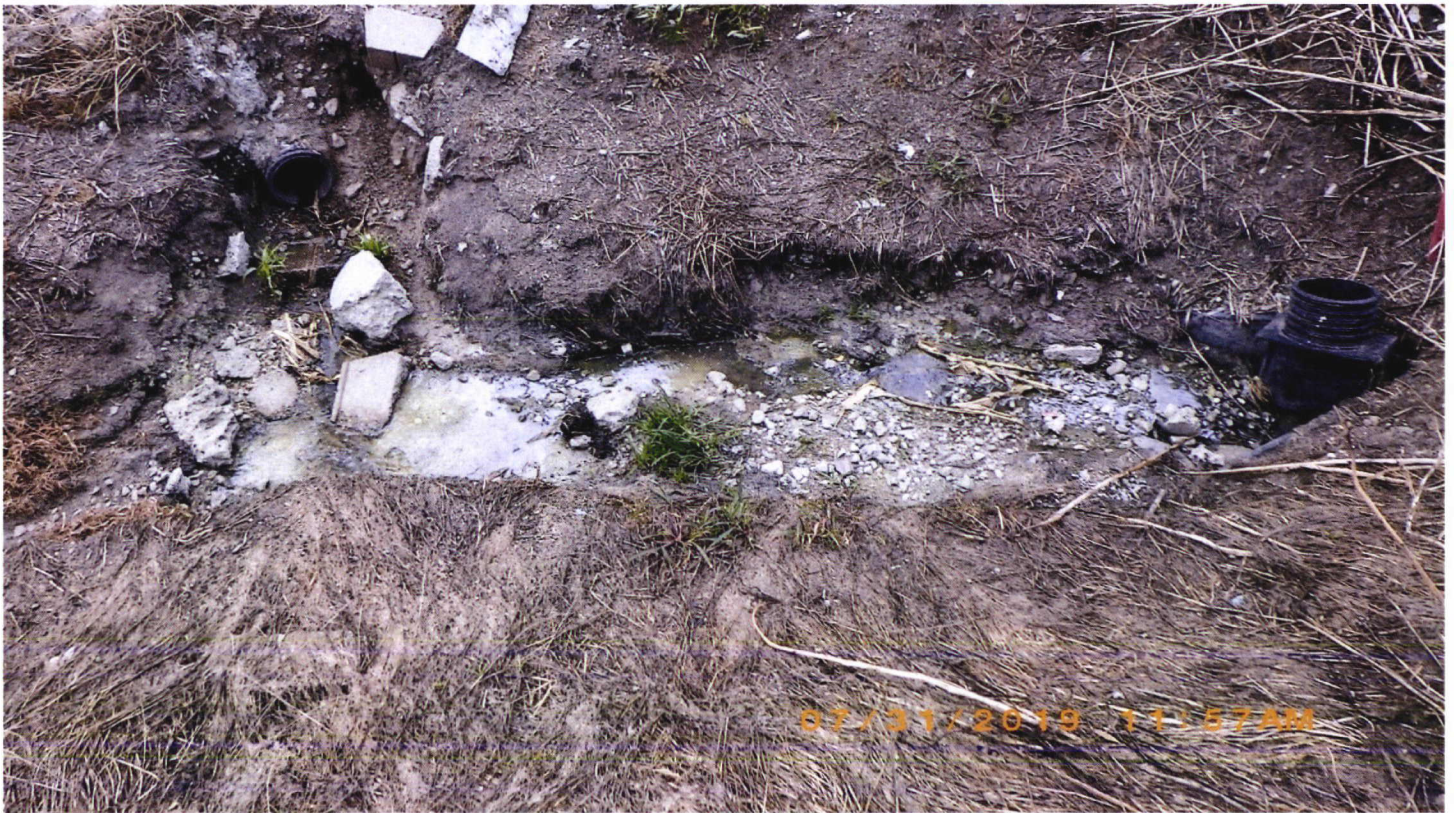
Photo 14

area (Photo 14). Next to the drainage area, the wet cake conveyer is leaking, creating a pile that is exposed to precipitation (Photo 15).

Description: Confluence of drainage from the area depicted in photos 13 & 14, and north of the wet cake load out building. The runoff is viscous in appearance with a slight sheen and opaque. This material is discharged to the west edge of the facility property's west edge. It is unknown what the volume of discharge is from this area, but appears to be several gallons daily if flow remains constant without precipitation.

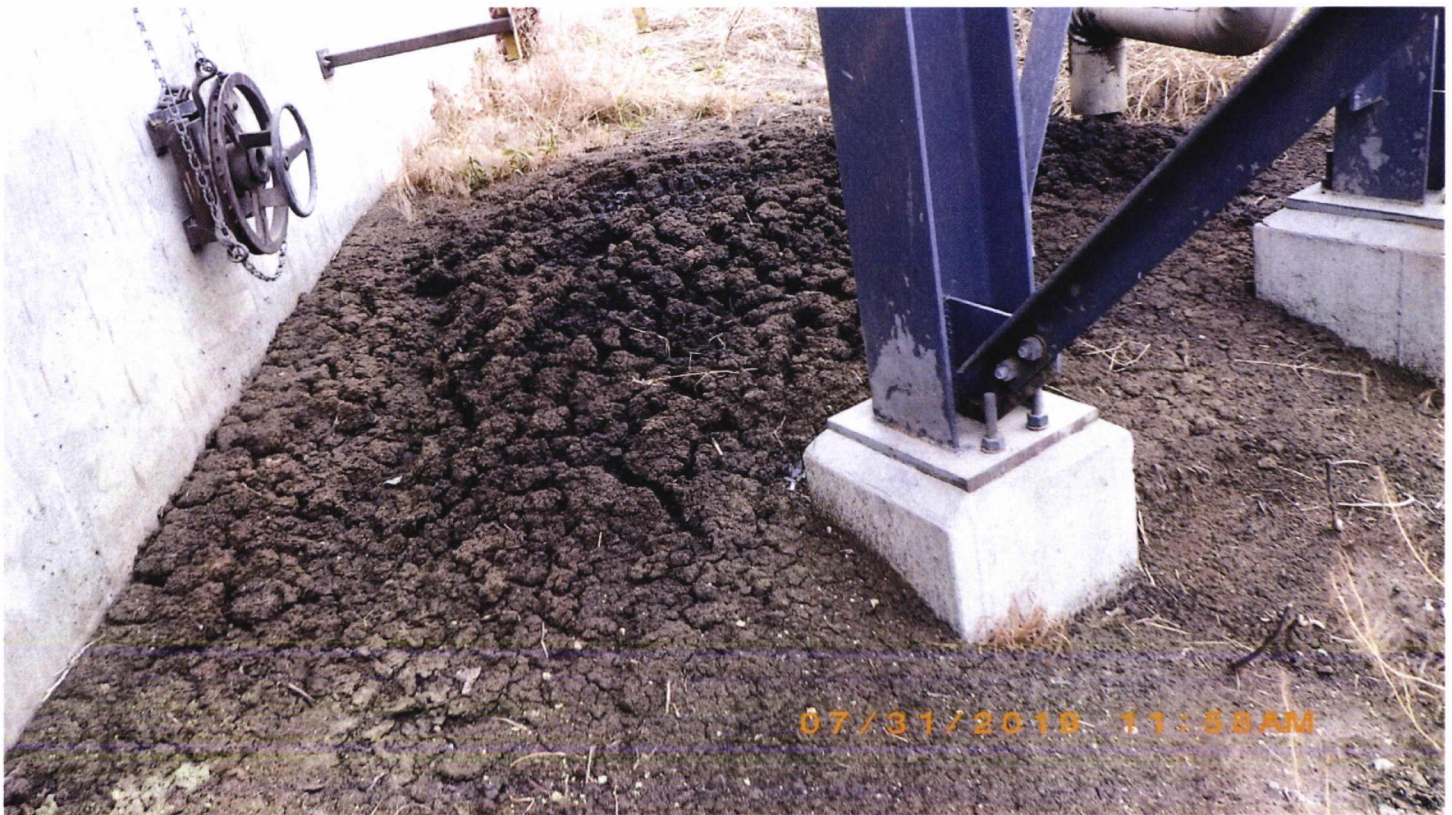
Photo 15

Description: Wet cake overflow from conveyance system adjacent to the wet cake load out building. This area is adjacent to the west of the area depicted in photo 15 and has potential to enter the flow discharge.

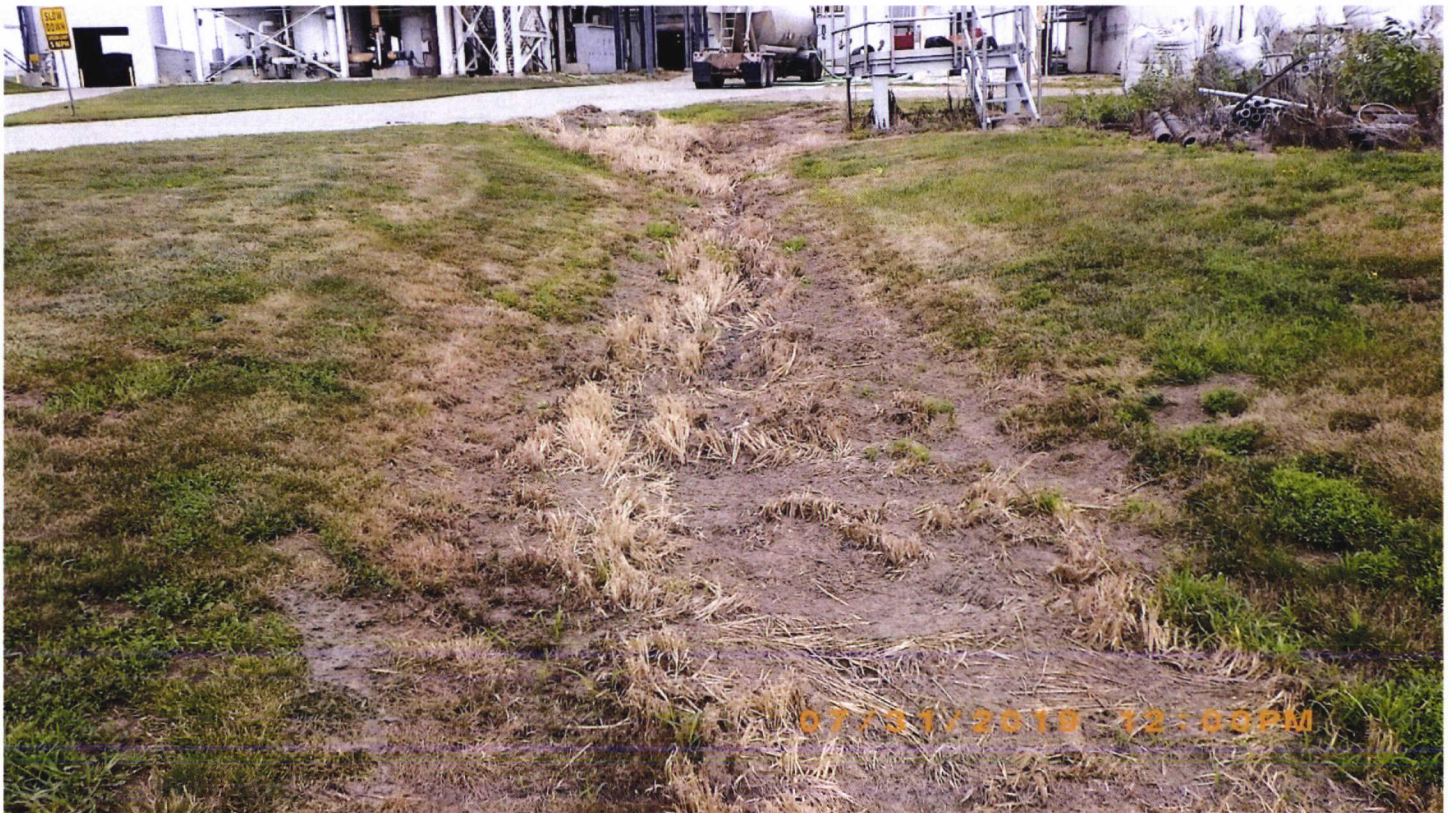
Photo 16

Description: Swale to the southeast of the grain receiving area and process building. There are two additional pipe conveyances for storm water/non-storm water buried in this area, which discharge to a common outfall location adjacent to an access drive southeast of the NR System building.

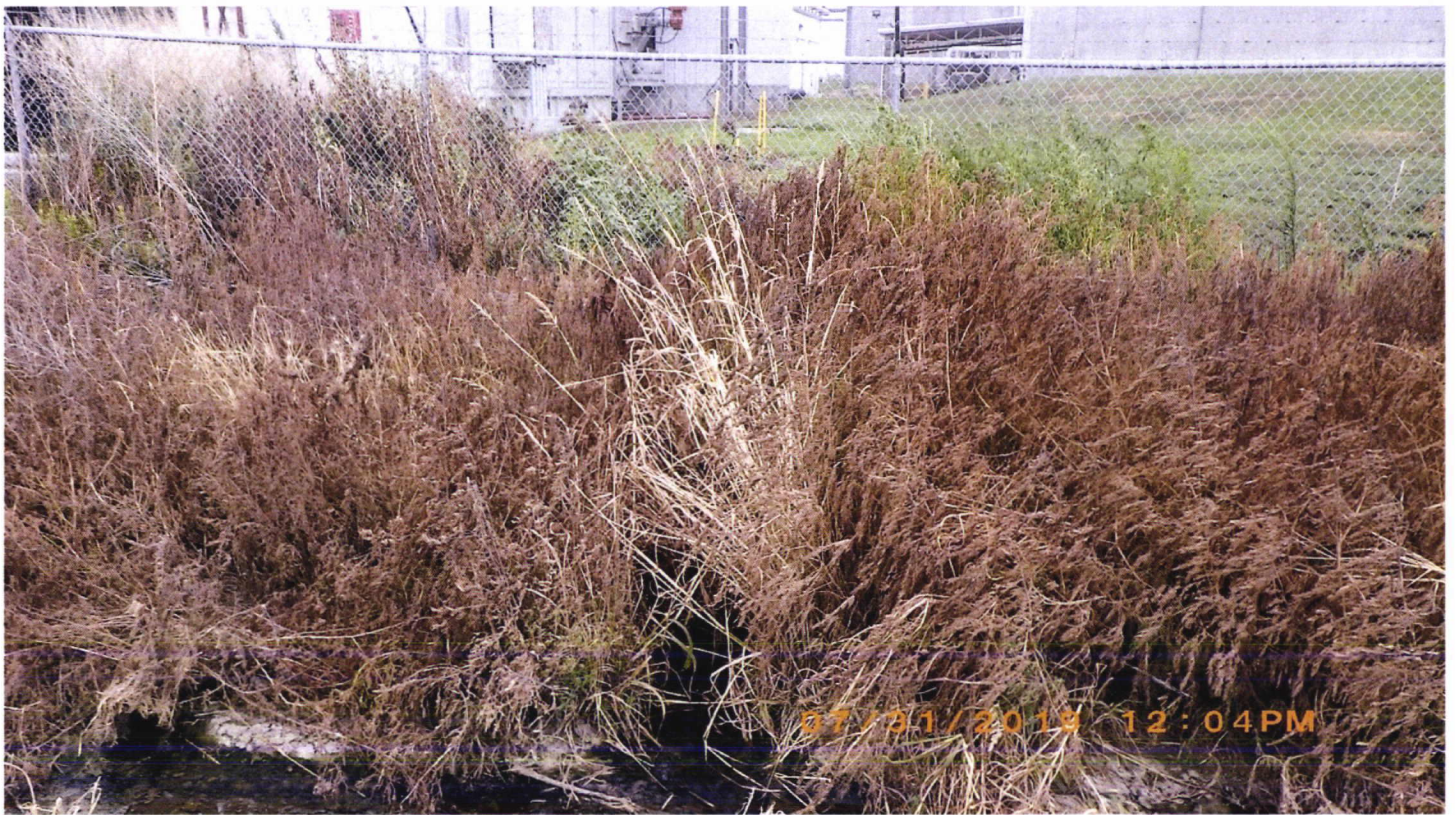
Photo 17

Description: Outside of the facility grounds where the swale pictured in photo 17 and a buried pipe discharge to the ditch outside the fence on the south edge of facility grounds. The vegetation is said to have been sprayed recently causing the brown vegetation. Water discharged at this point from the pipe is dark colored and slightly cloudy with a slight sheen. Discharges in this ditch are comingled with discharge from an unknown source from Mead Cattle.

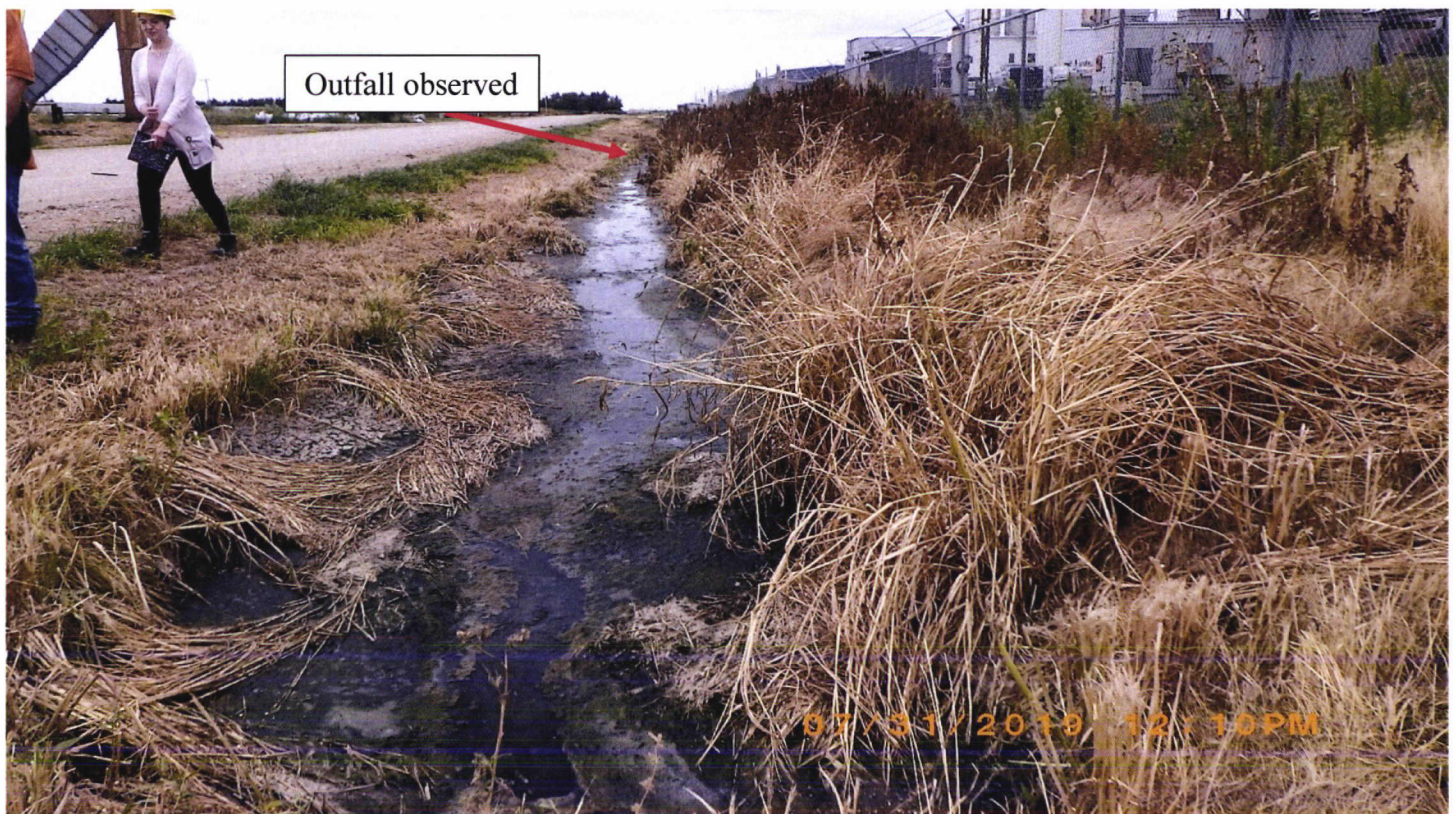
Photo 18

Description: Facing upstream along the south edge of the facility grounds showing non-storm water discharges from AltEn & Mead Cattle Company. There is significant discharge from both facilities that are not originated from storm water, which allow substantial algal growth in the ditch. At the outfall upstream from this photo
