**MEMORANDUM**

From: AltEn, LLC, Mead Nebraska

Date: July 31, 2019 (12:00 pm – 4:36 pm)

RE: Inspection – Mark Pomajzl, Jason Windhorst, Jason Holsten, Hillary Stoll

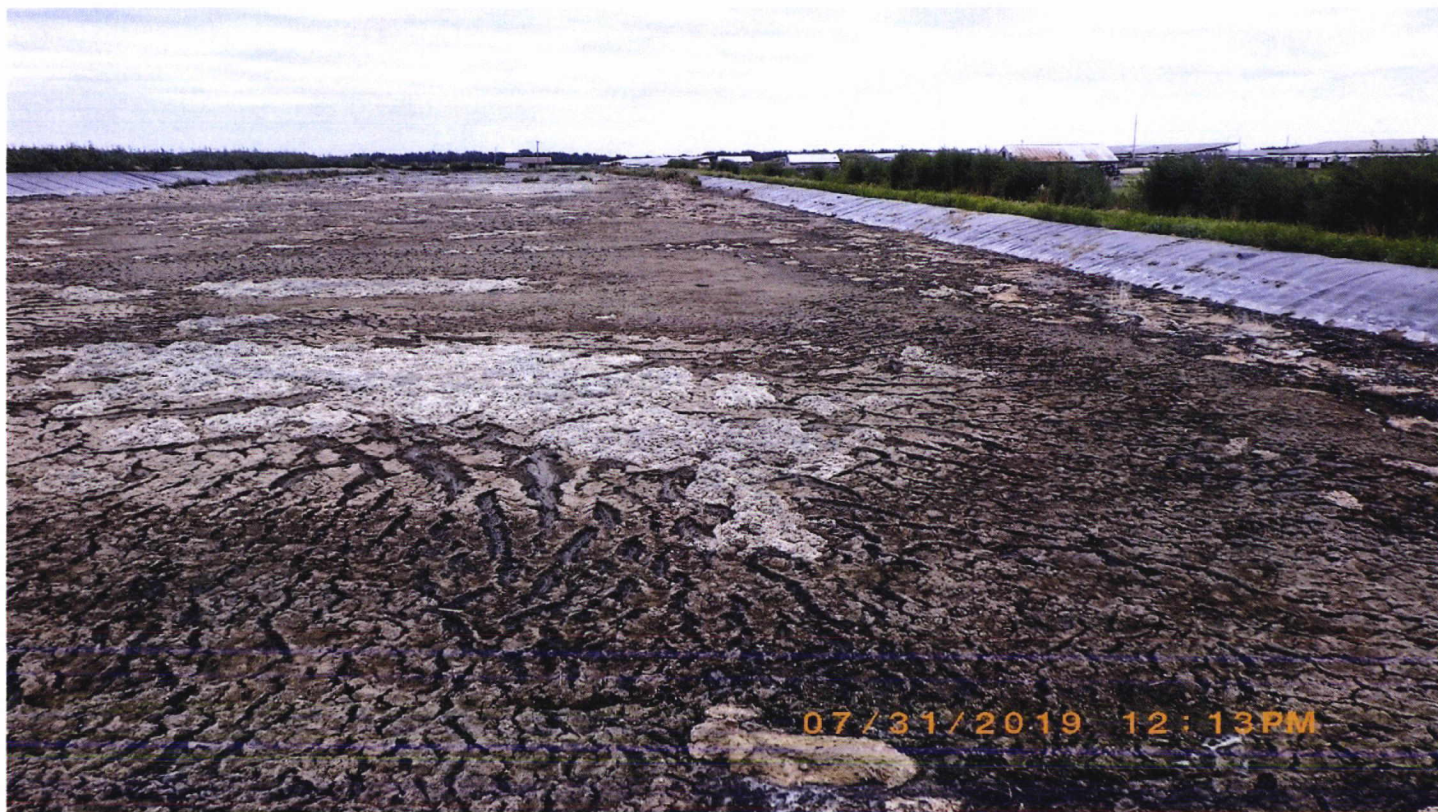
Photo 19  
Inspection Report  
Observation Area: 7  
Date Taken: July 31, 2019  
Photographer: Mark Pomajzl  
Facility Name/ Project Name: AltEn, LLC  
Facility IIS number / Project identifier: NER910444, IIS: 84069  
Direction Facing: East  
Description: Over flow lagoon adjacent to the south digester.

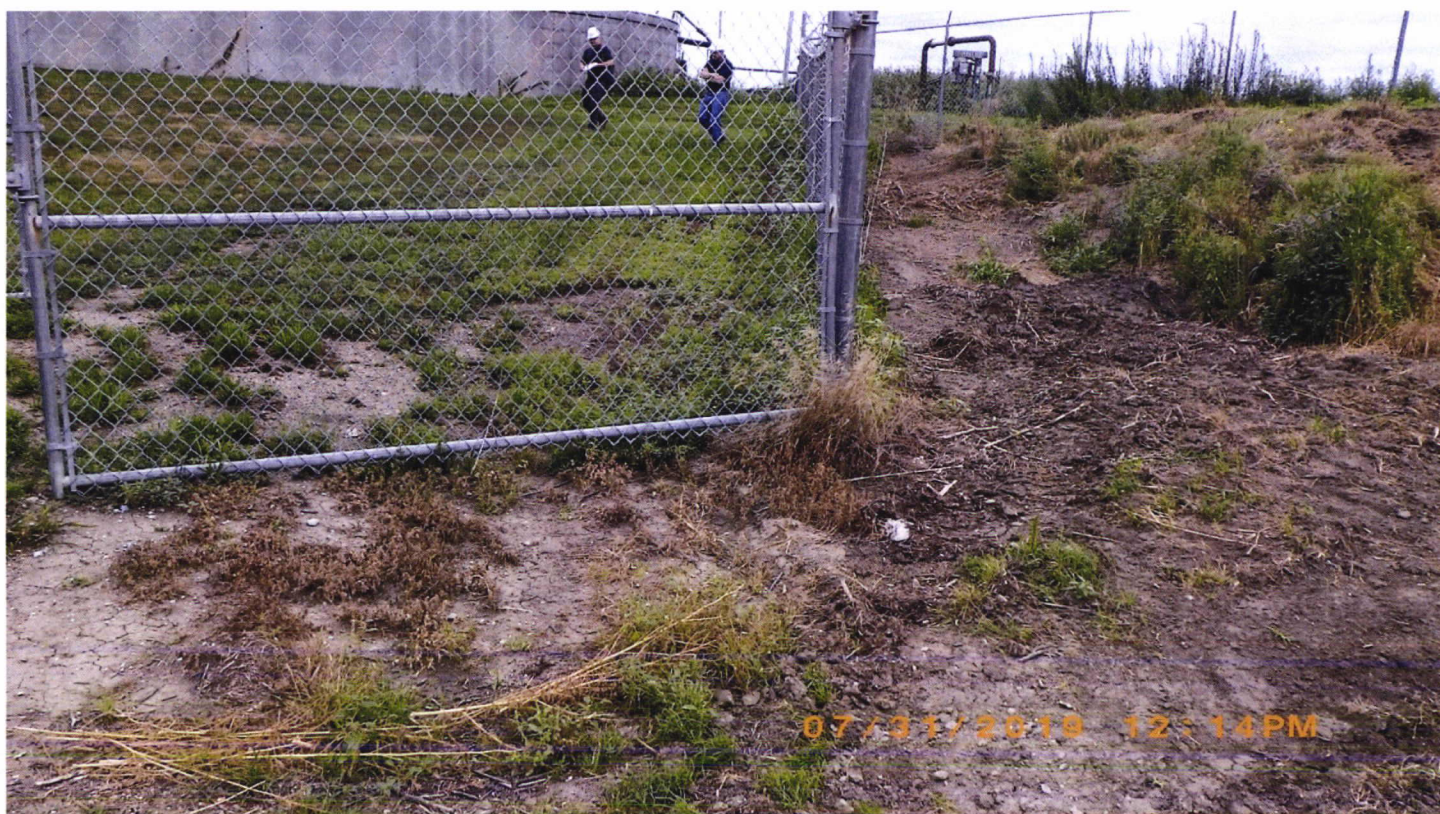
Photo 20

Description: This area is directly south of the south digester and adjacent to the overflow lagoon. This corner is also a potential outfall location for storm water discharge. At the time of the inspection, there is no discharge from precipitation, but there is visible evidence of discharge based on drainage patterns visible on the ground surface.

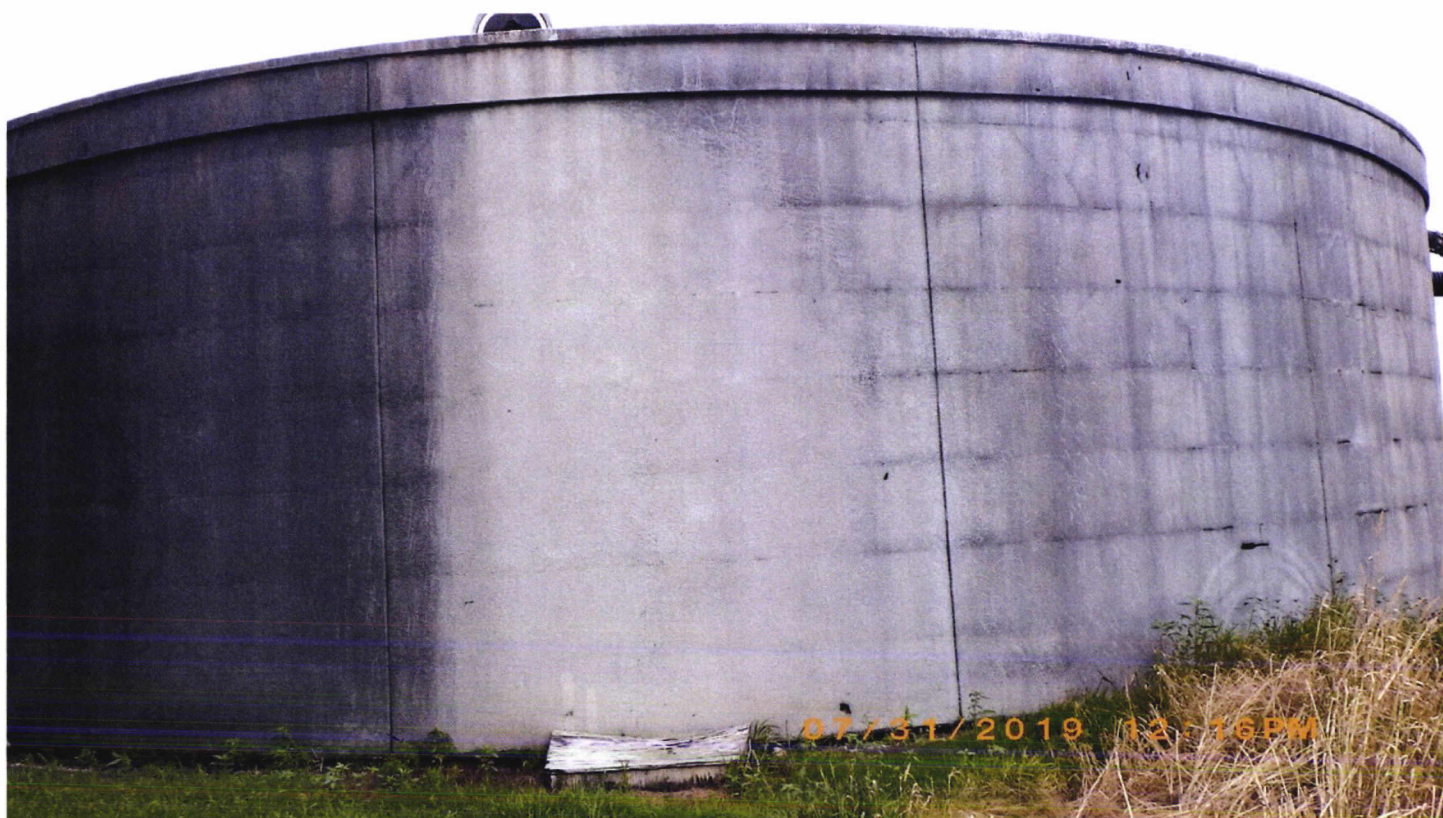
Photo 21

Description: Looking at the south side of the Influent tank. There is white staining that appears to have originated from an overflow in the past from the port on top. The area adjacent to the right/south (photo 23) appears to be remnants of a previous overflow event.

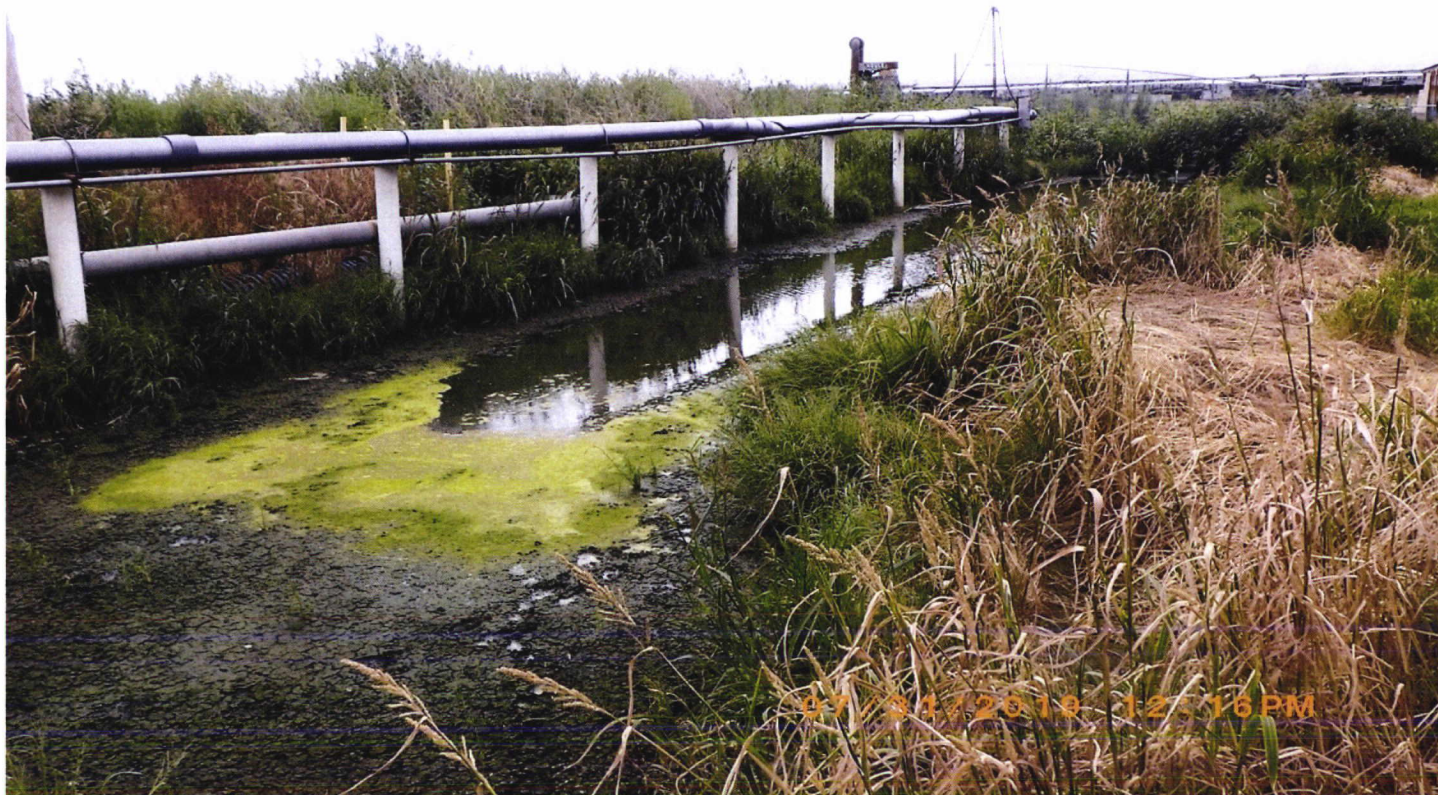
Photo 22

Description: Low area adjacent to the Influent tank structure. The material in the ponded is full of dark organic material with thick algal growth along the edges.

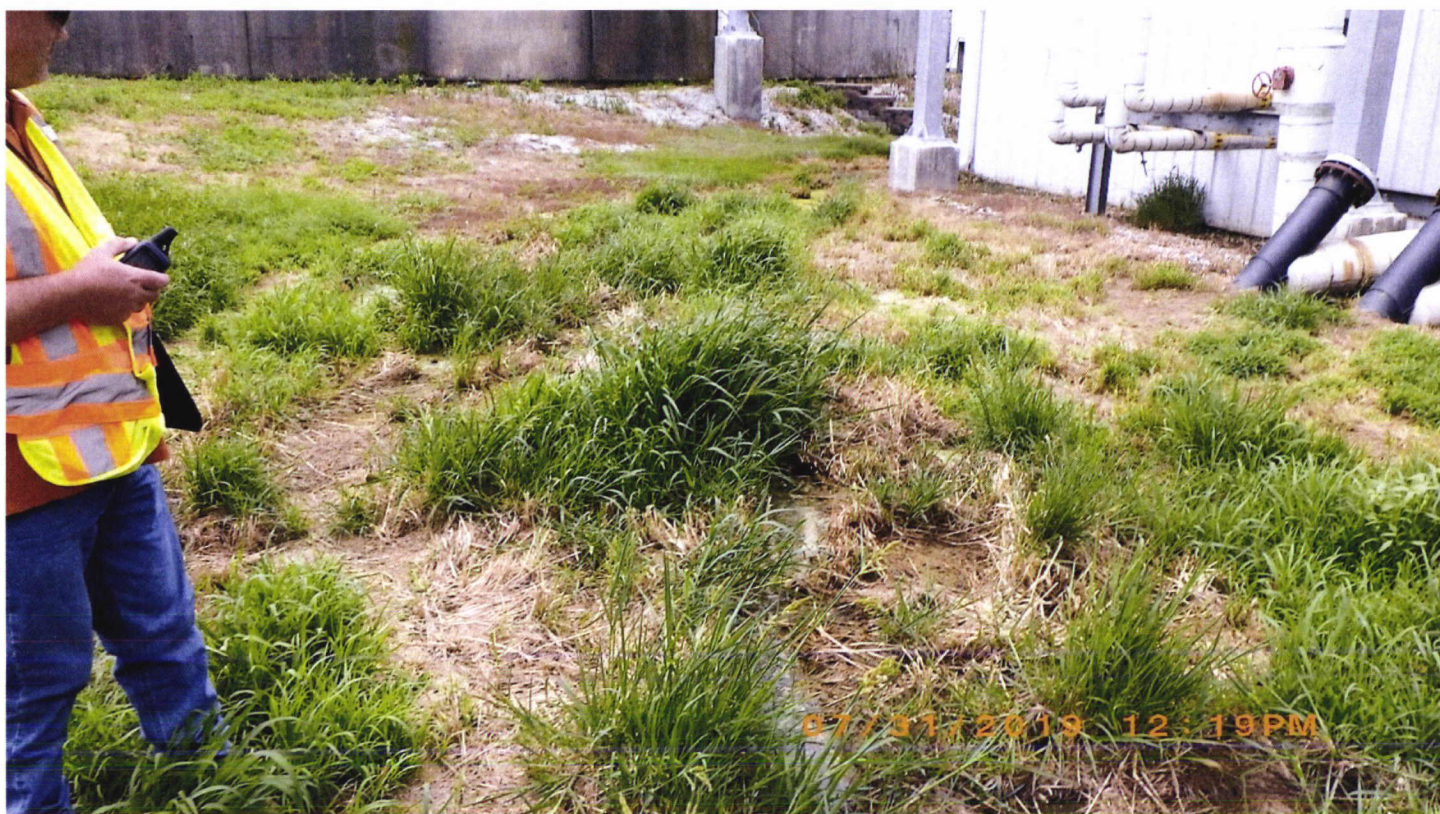
Photo 23

Description: Opaque discharge from the south side of the cooling tower. The water discharging is foaming and showed evidence of filamentous bacteria along the discharge path. This discharge stream follows a path from the south side of the cooling tower through the facility west of the digesters to the facility's west boundary.

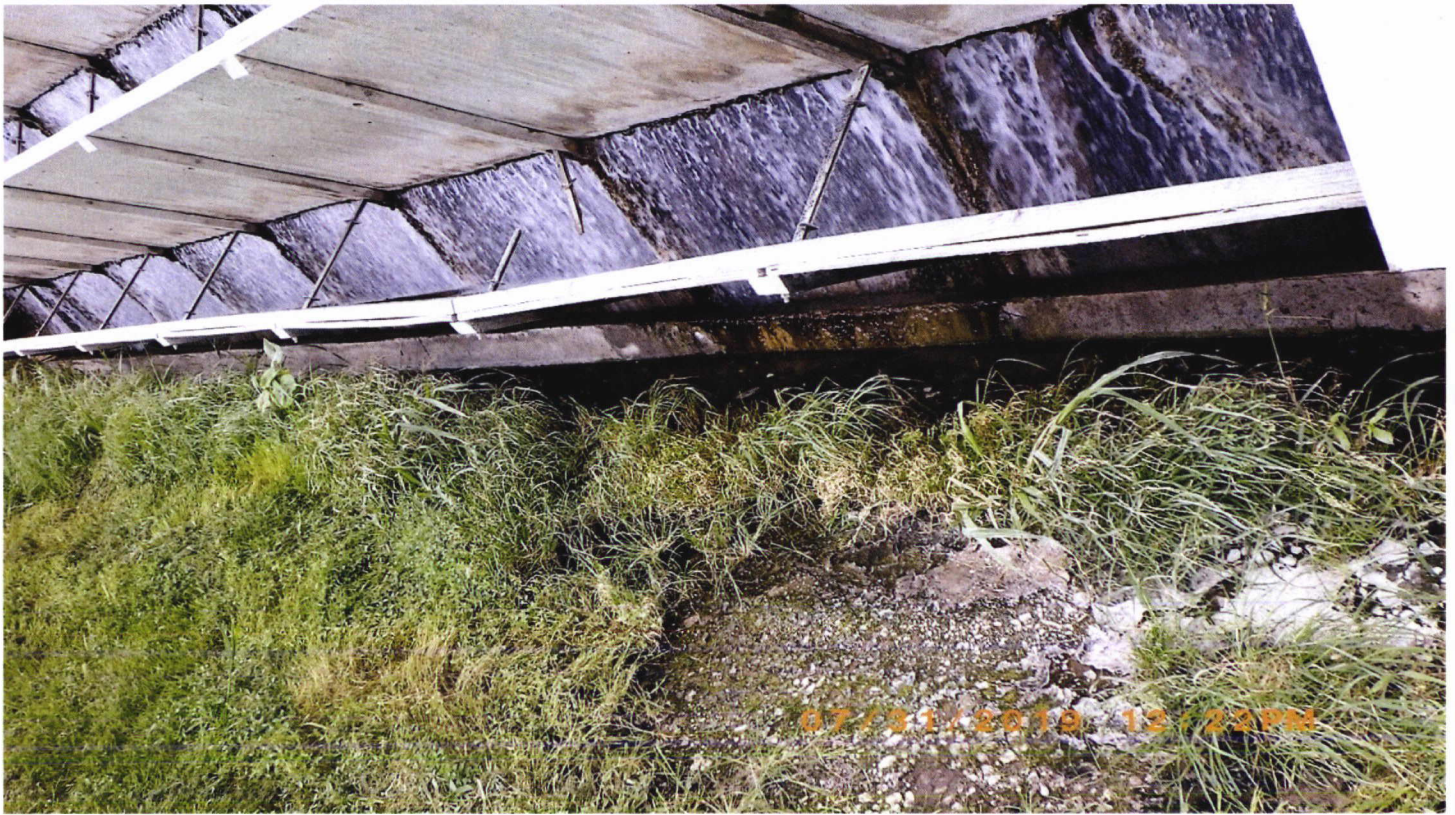
Photo 24

Description: Looking down into the south edge of the cooling tower baffles. The cooling water is discharging from the base of the tower where it joins another area where discharge is taking place at the southeast corner of the cooling tower.

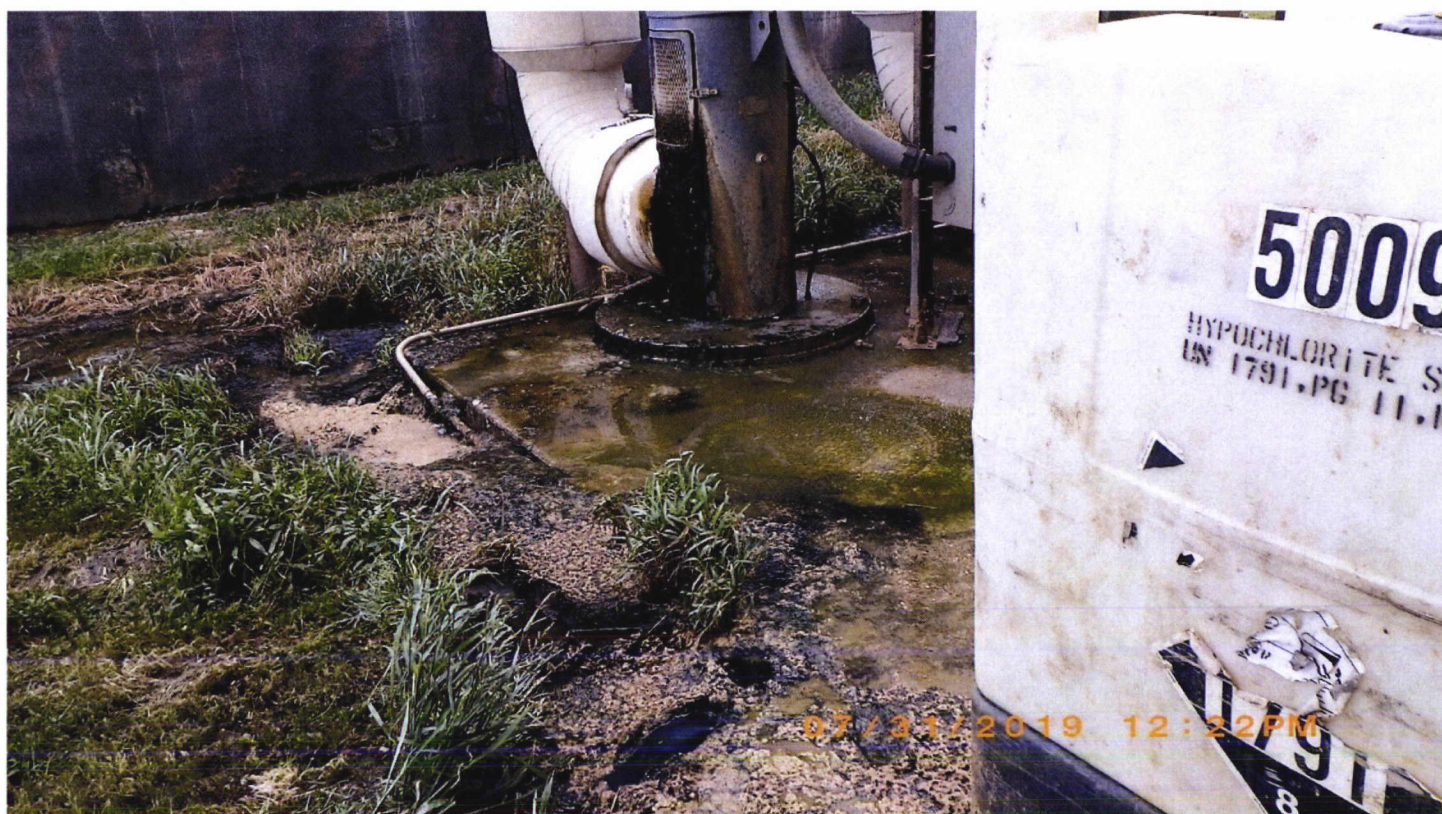
Photo 25

Description: Looking at what appears to be a return line from the cooling tower to the make-up water tank. The cooling water is surging from the pipe to the ground around the tank. Thick bacterial and algal growth is visible over much this area. A tote of Hypochlorite solution is also stored in the area unprotected.

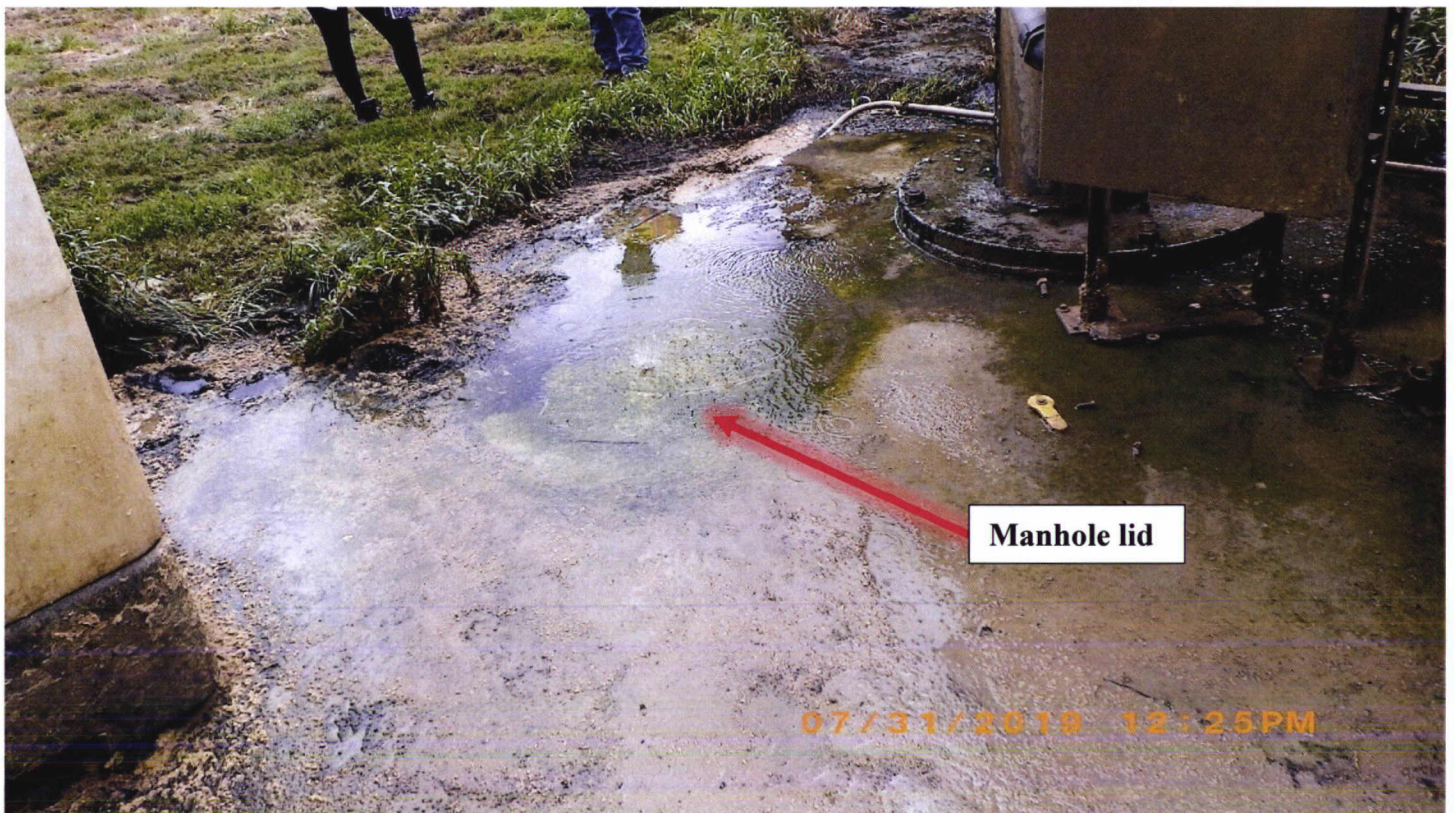
Photo 26

Description: Looking at the area depicted in photo 26 from a different angle showing the electrical control boxes adjacent to surging pipe behind them. The red arrow shows the location of the manhole lid where water is ejecting out of when the water is surging. The hypochlorite solution tote is to the left of the manhole.

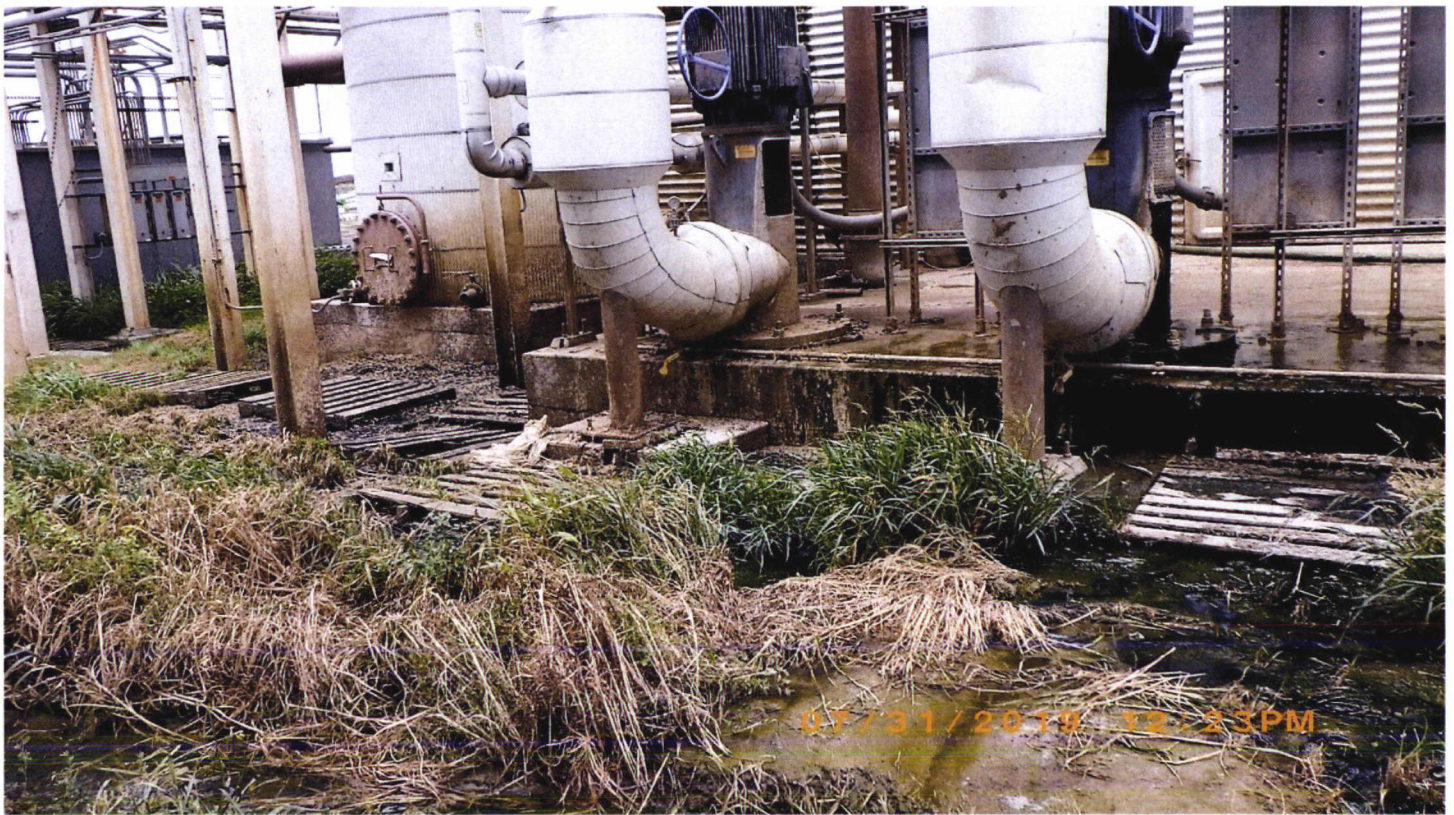
Photo 27

Description: Looking at the northwest corner of the pump area for the cooling tower. Cooling water is actively discharging from the pumps and make-up water tank structure. The grounds around the tank area is saturated and covered with thick bacterial and algal growth. Based upon visual assessment, the degree of saturation and organic growth in this area indicate that the discharge may have been taking place for a substantial amount of time.

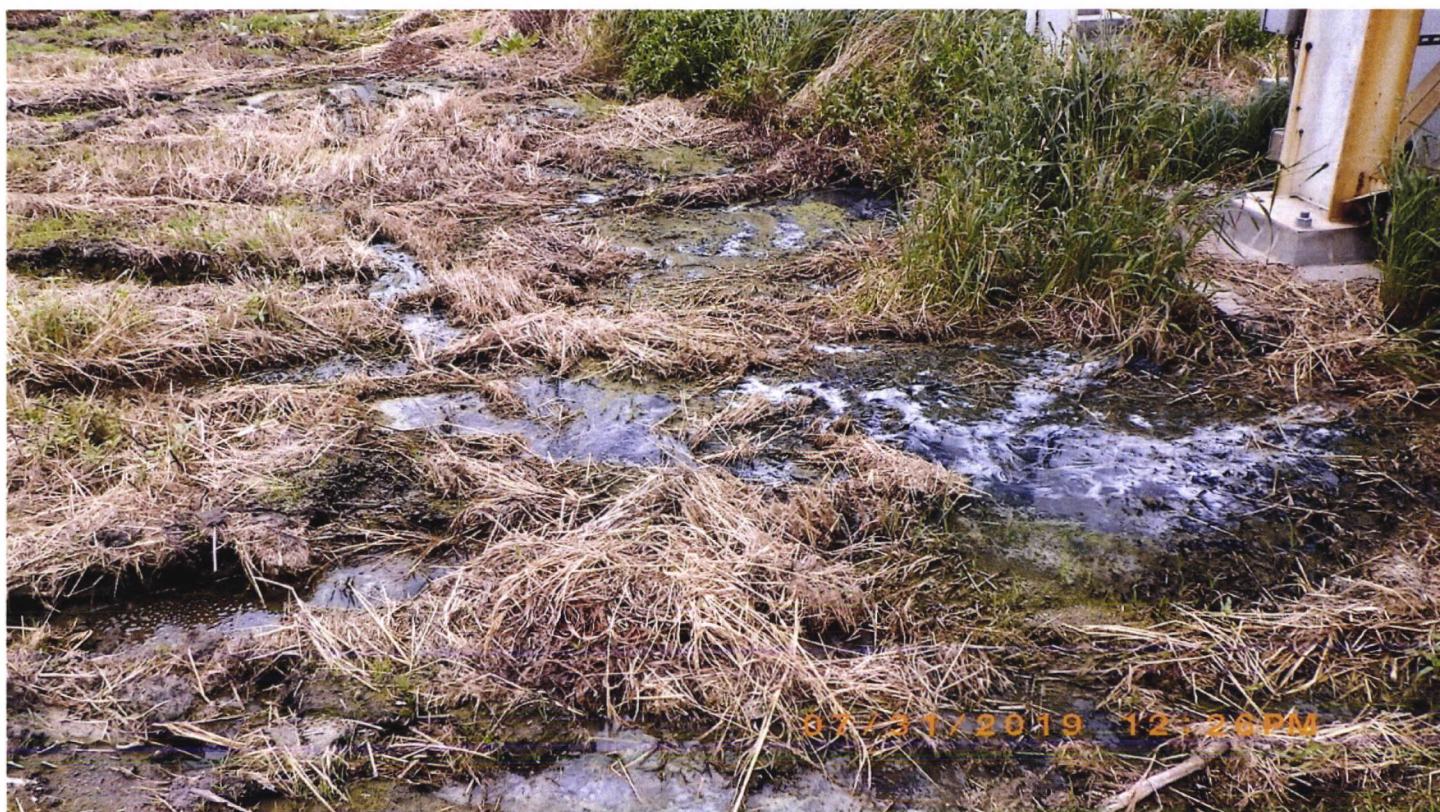
Photo 28

Description: Saturated ground near the cooling tower showing filamentous bacteria growth in a portion of the discharge.

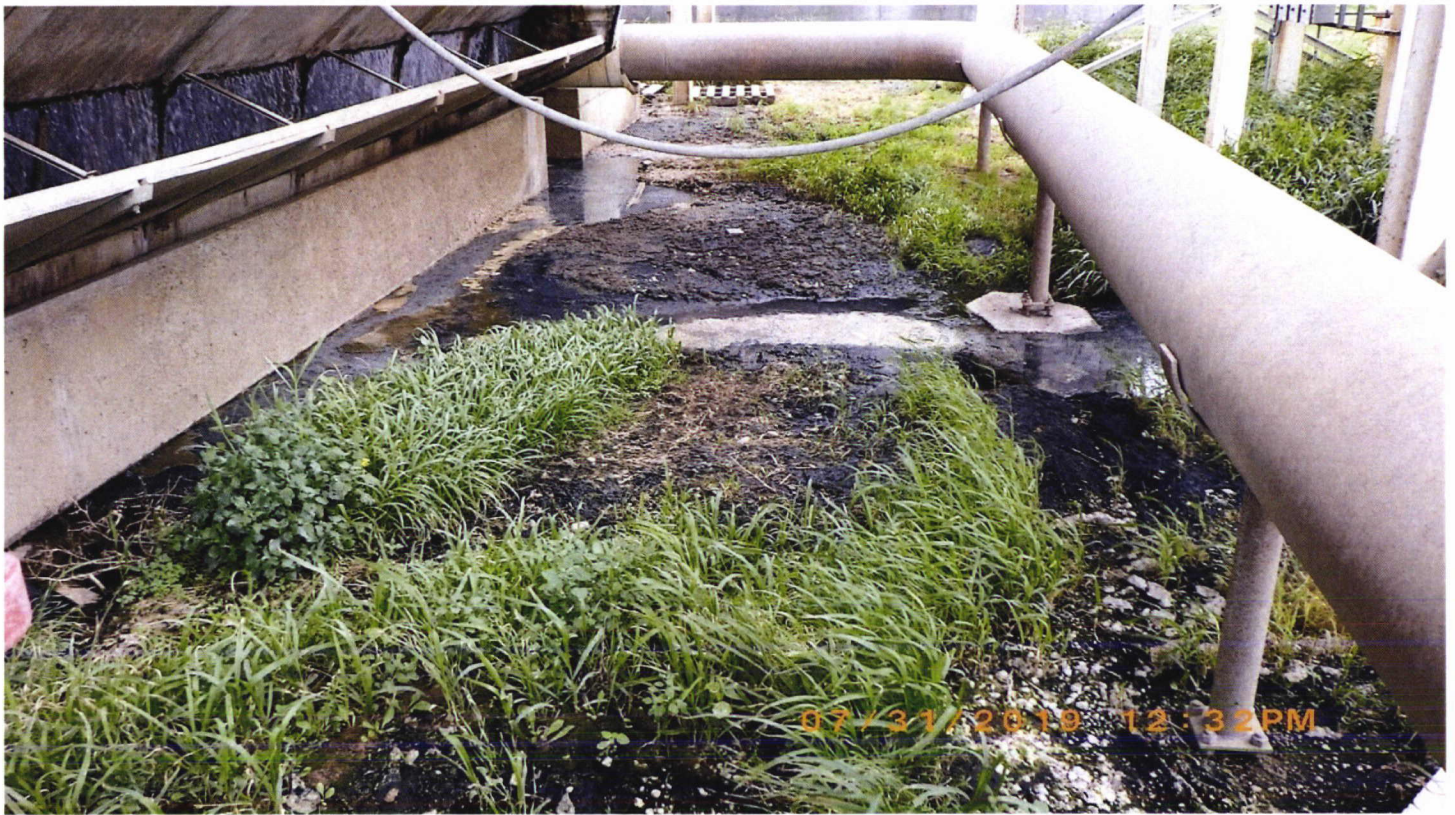
Photo 29

Description: Cooling water discharge on the north side of the cooling tower. The water discharged is opaque and had an odor of hypochlorite. The discharge on this side of the structure appears to be several gallons a minute and discharges on the ground where it flows through the plant to the west boundary ditch. This is the source of the cloudy opaque water observed in photo 19.

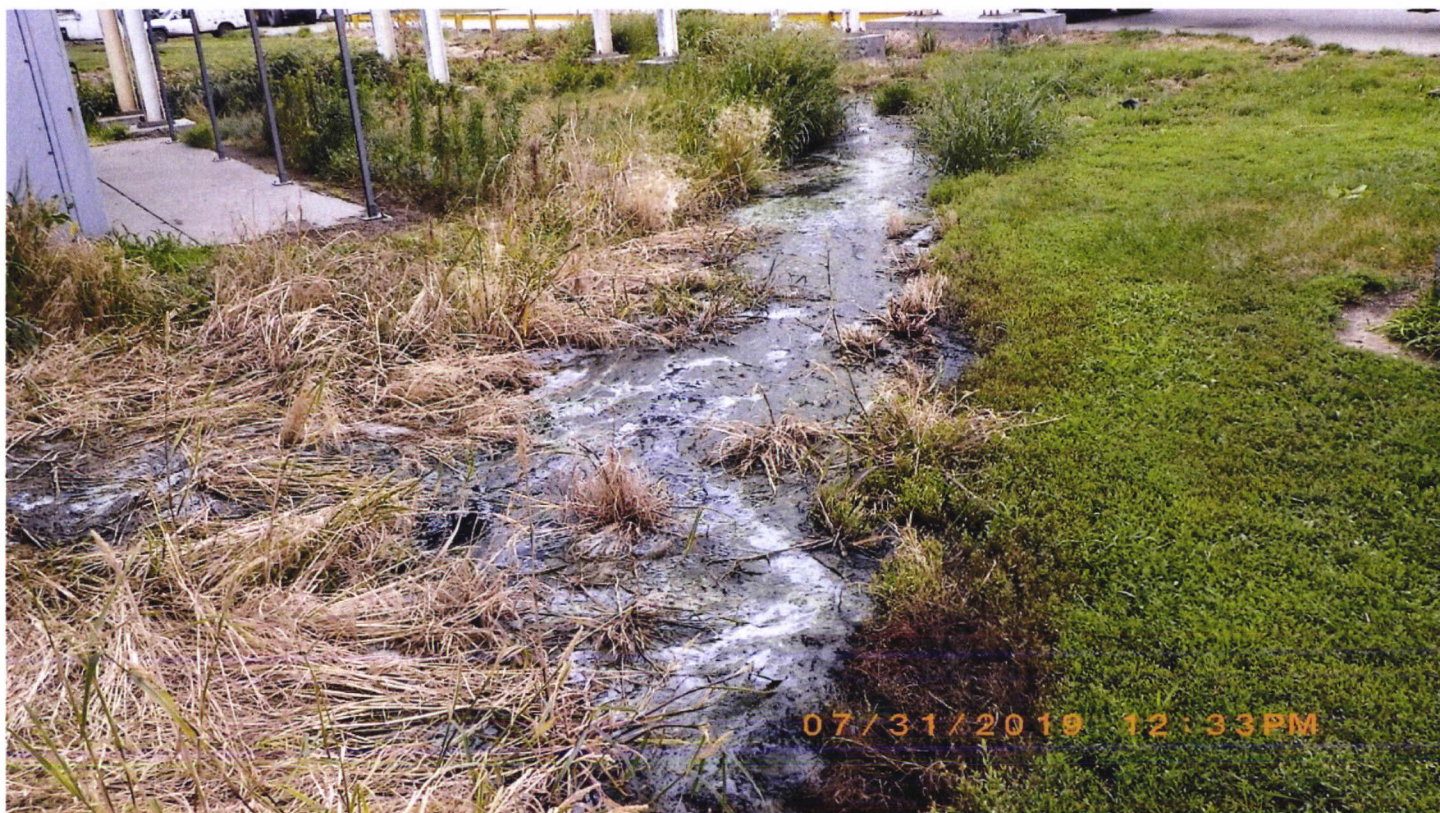
Photo 30

Description: This area is adjacent to the cooling tower to the west and is where several of the smaller discharges from the north side of the cooling tower combine before draining to the west boundary of the facility. This area has substantial white filamentous bacteria visible in photo.

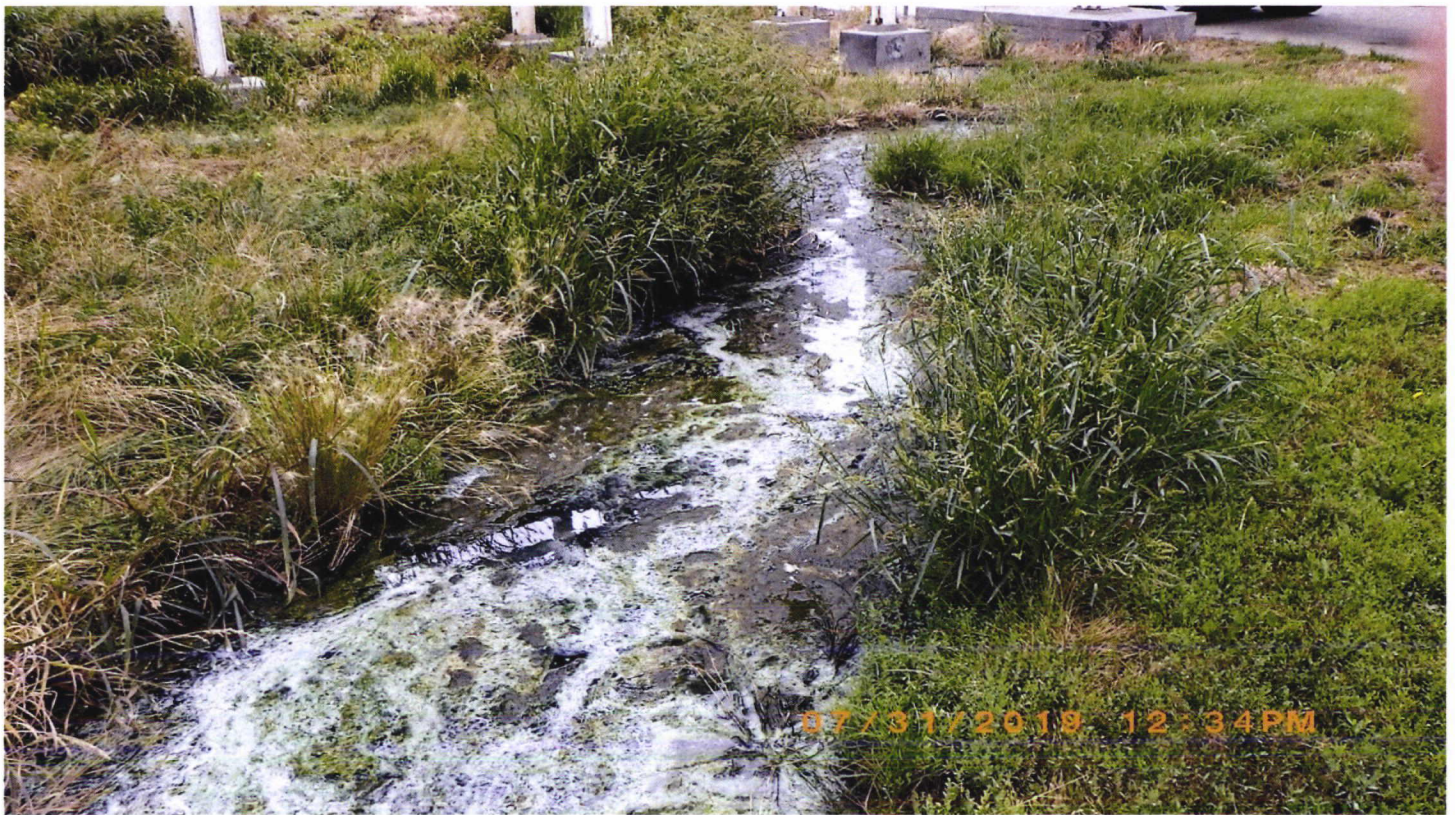
Photo 31

Description: This is the same area as photo 31, but further southwest. The close up shows the degree of bacterial growth in the discharge.

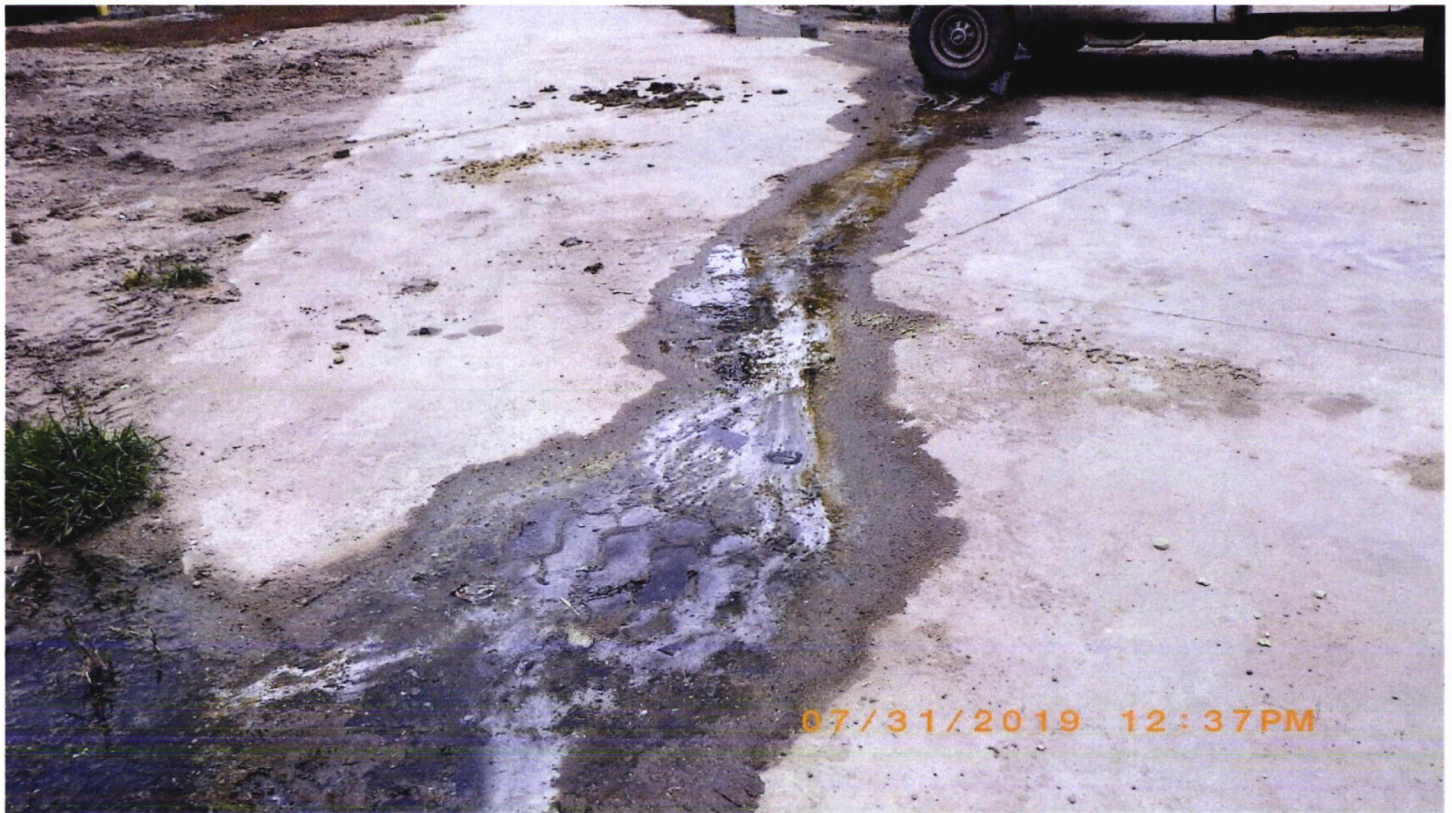
Photo 32

Description: The same discharge from the north side of the cooling tower depicted in photo's 30-32. This is approximately 160' east of the discharge to the southwest of the north digester. The filamentous bacteria is present at this location growing on the pavement.

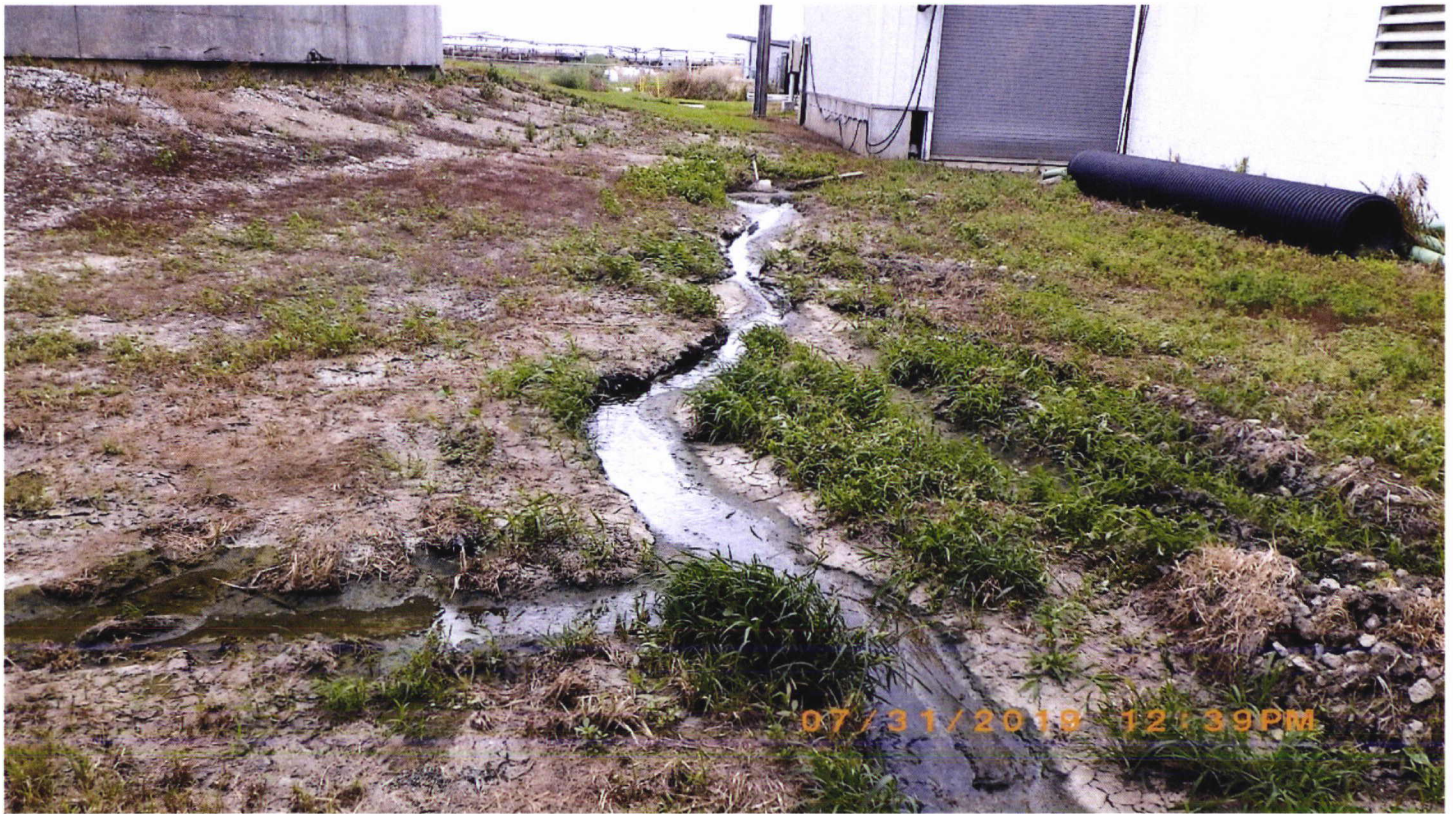
Photo 33

Description: In this area the discharges from the north and south side of the cooling tower converge into one discharge stream prior to discharging at the west boundary of the facility. This is between the GCS building and the AD area building noted on the SWPPP map.

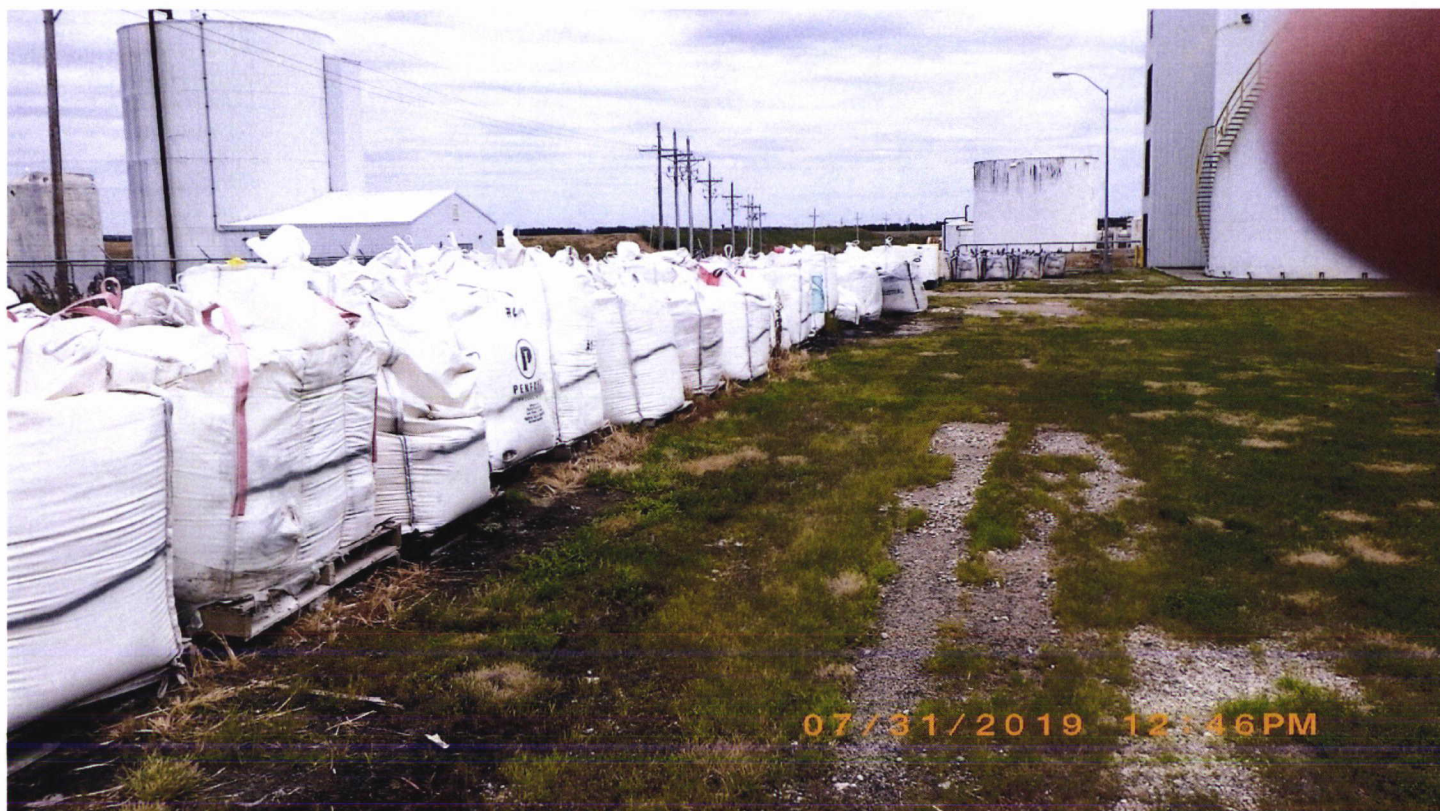
Photo 34  
Inspection Report  
Observation Area: 10  
Date Taken: July 31, 2019  
Photographer: Mark Pomajzl  
Facility Name/ Project Name: AltEn, LLC  
Facility IIS number / Project identifier: NER910444, IIS: 84069  
Direction Facing: East  
Description: Starch stored along the north access road.

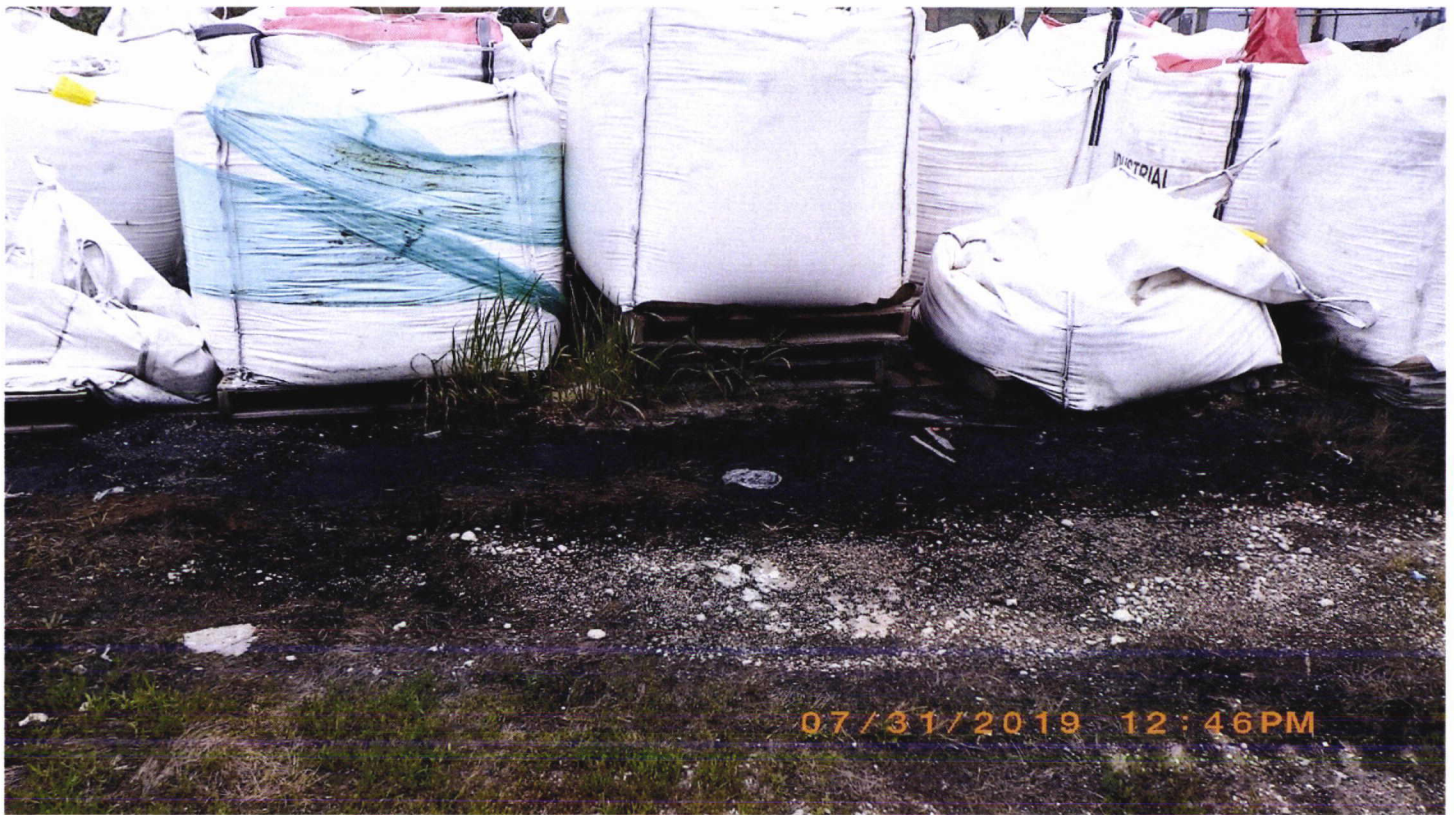
Photo 35

Description: Contaminated ground surface adjacent to north starch storage area.

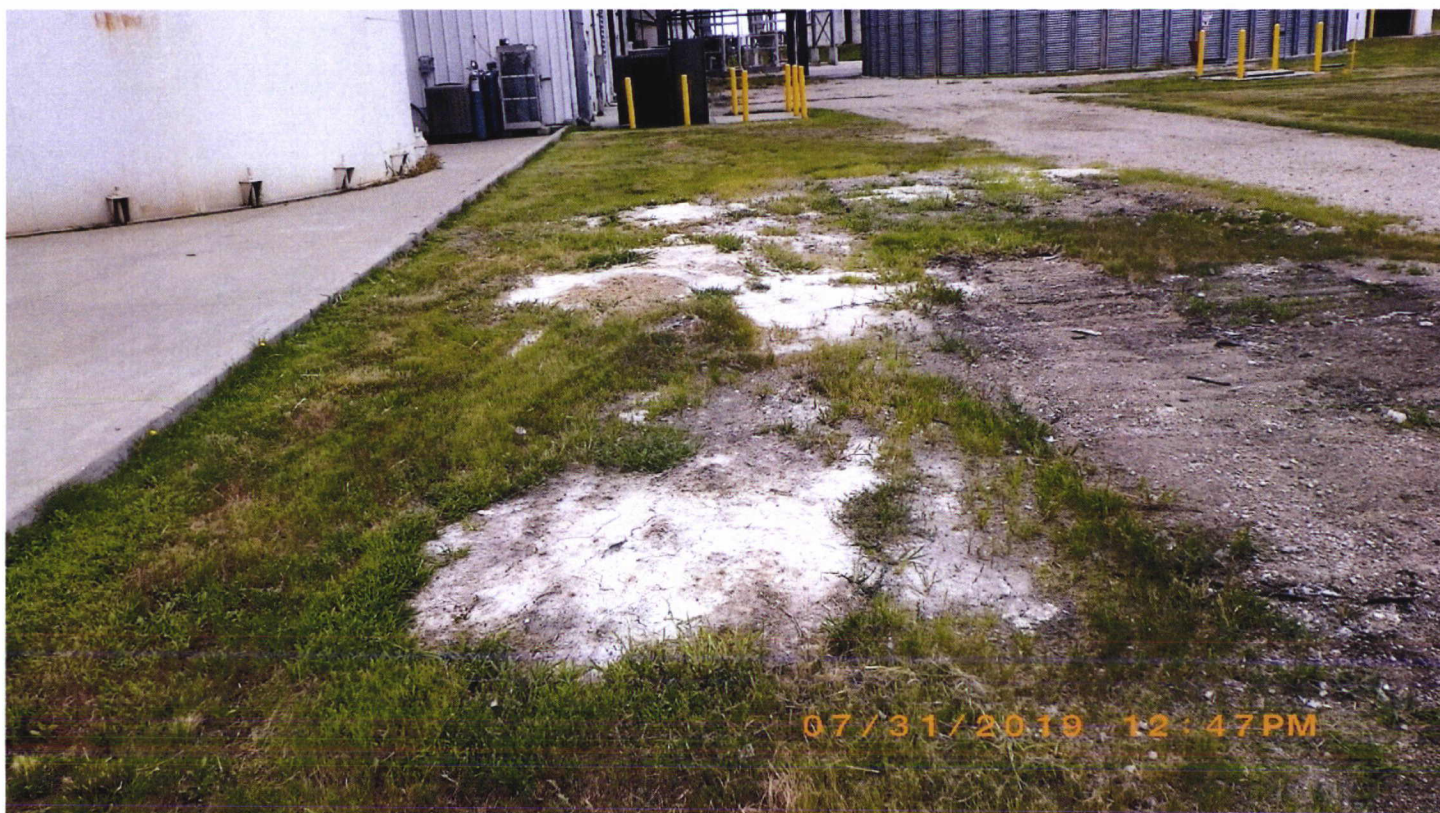
Photo 36

Description: Starch observed on the ground west of the distillation area.
