**MEMORANDUM**

From: AltEn, LLC, Mead Nebraska

Date: July 31, 2019 (12:00 pm – 4:36 pm)

RE: Inspection – Mark Pomajzl, Jason Windhorst, Jason Holsten, Hillary Stoll

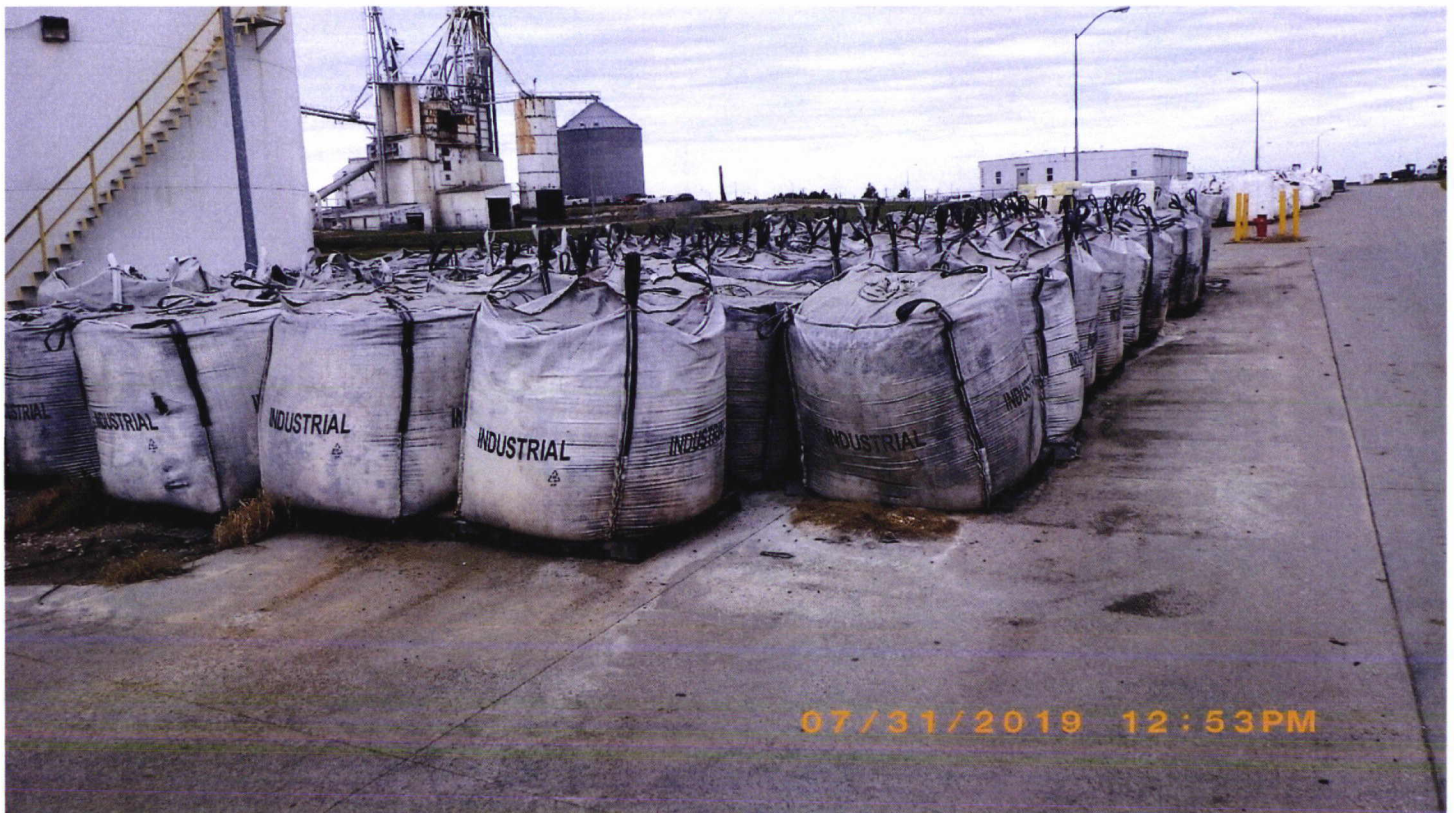
Photo 37

Description: Starch bags leaking on north drive north of the distillation area.

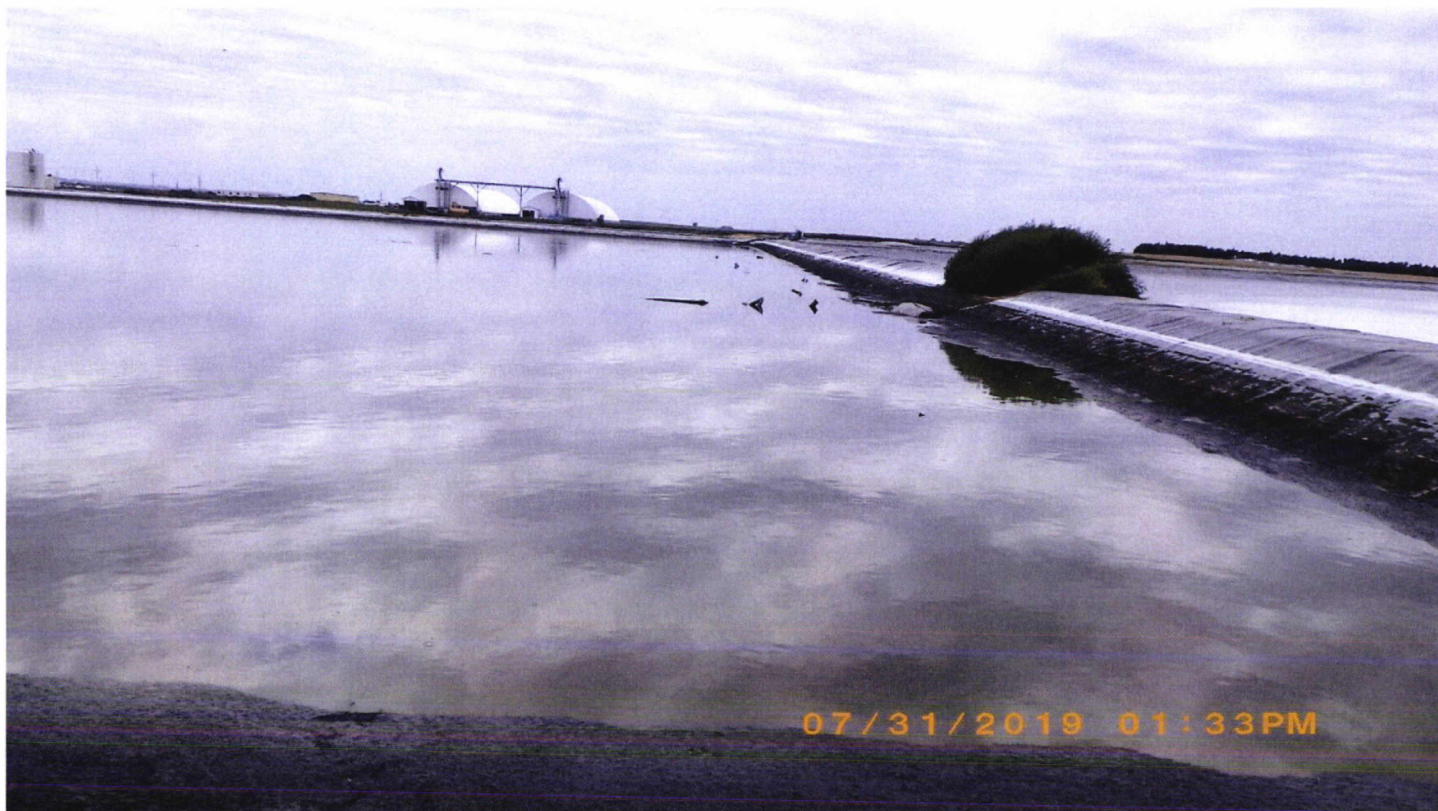
Photo 38

Description: The lagoon berm between the north and south lagoons on the east side of the lagoon area. The lagoon is being drawn down for liner repair. The lagoon appeared to be more than 3' lower from the last site visit.

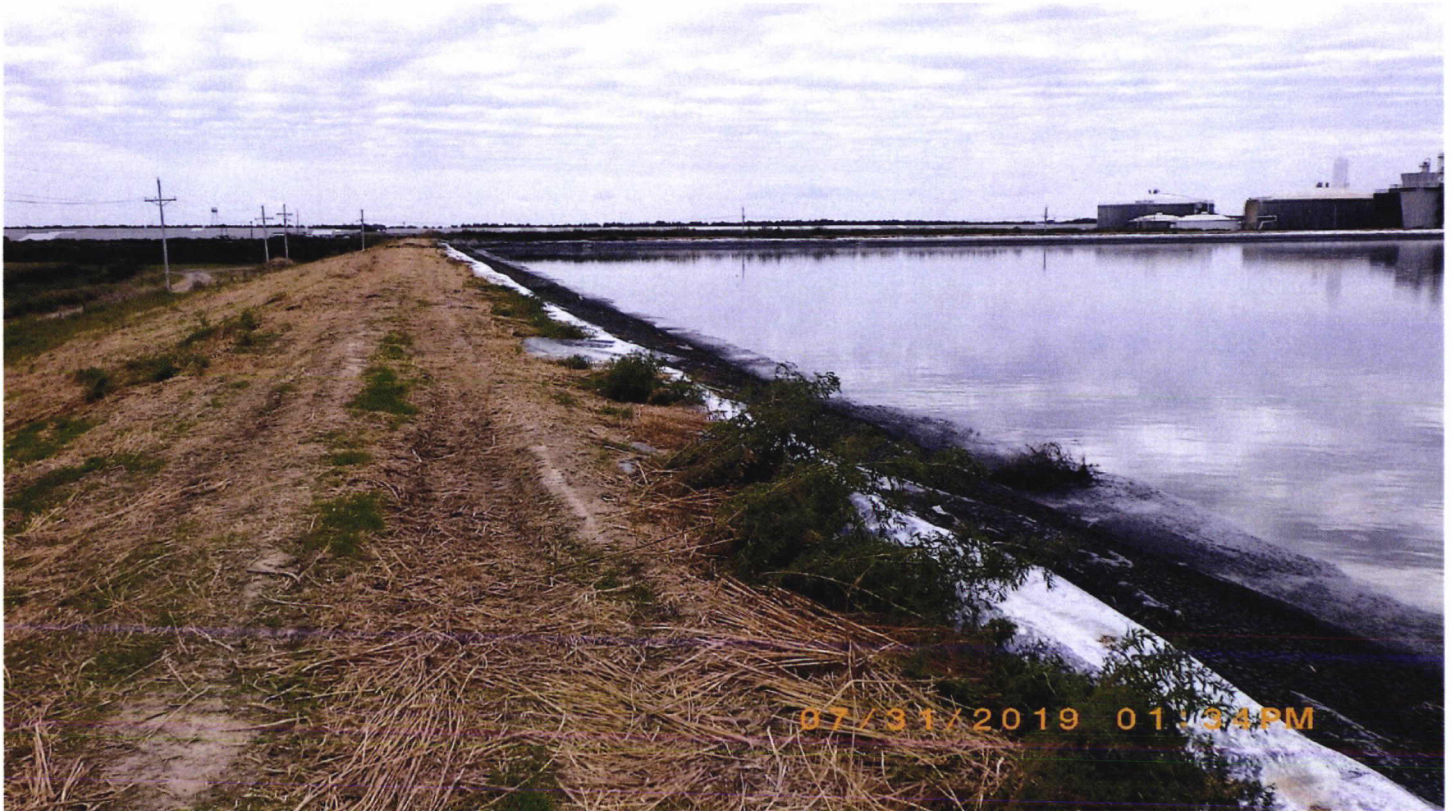
Photo 39

Description: The east edge of the southeast lagoon where most of the vegetation is removed from the 2018 request. It appeared that AltEn is also actively spraying to control the weeds along the lagoons.

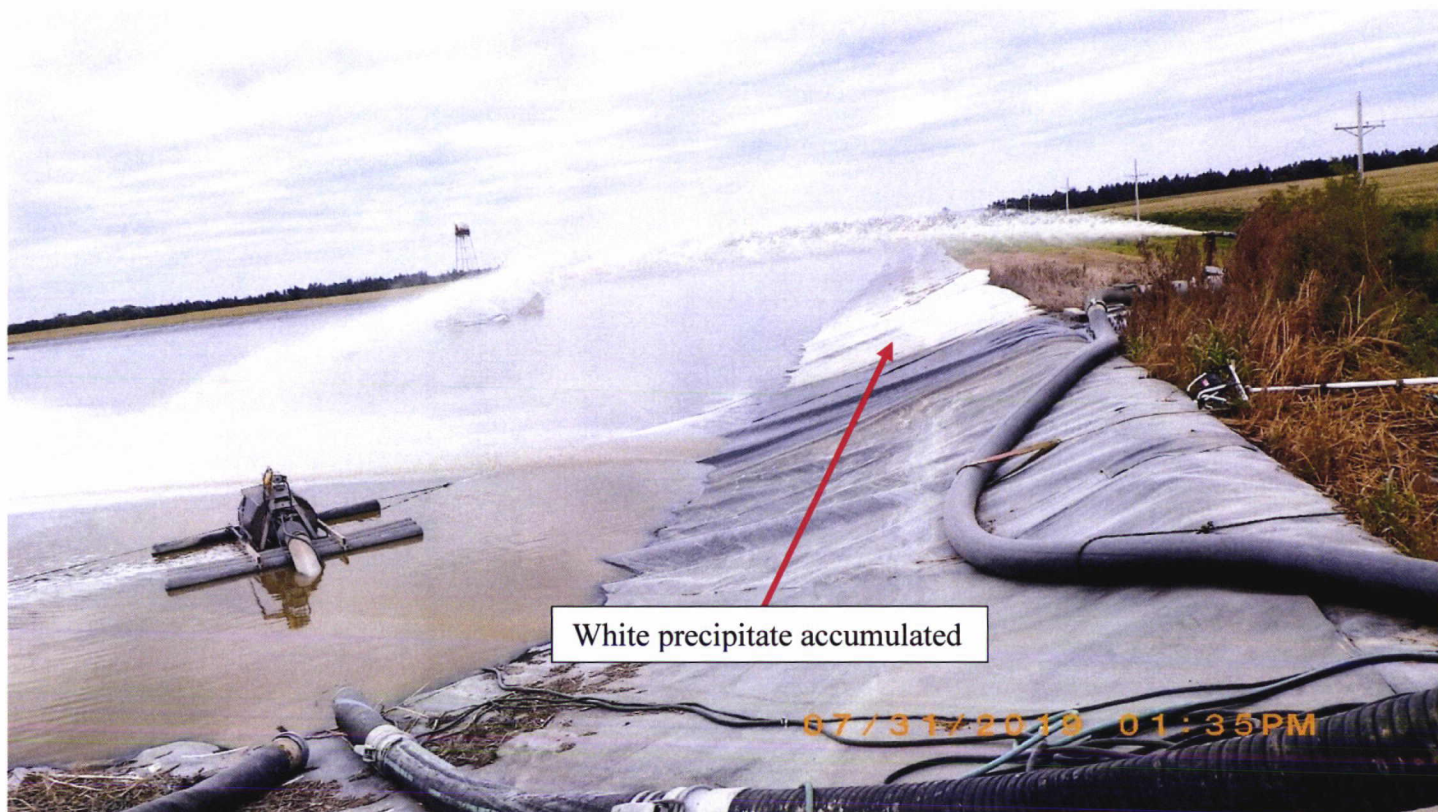
Photo 40

Description: At the southeast corner of the northeast lagoon where the facility stated they are removing solids from the wastewater via rotary drum prior to land applying. The water is sprayed back into the lagoon where it atomizes partially and is carried offsite by the wind. Downwind of the spray white precipitate is observed on the liner and vegetation adjacent to the liner. The odor from this is observed from county road 10 (wind direction is from the East).

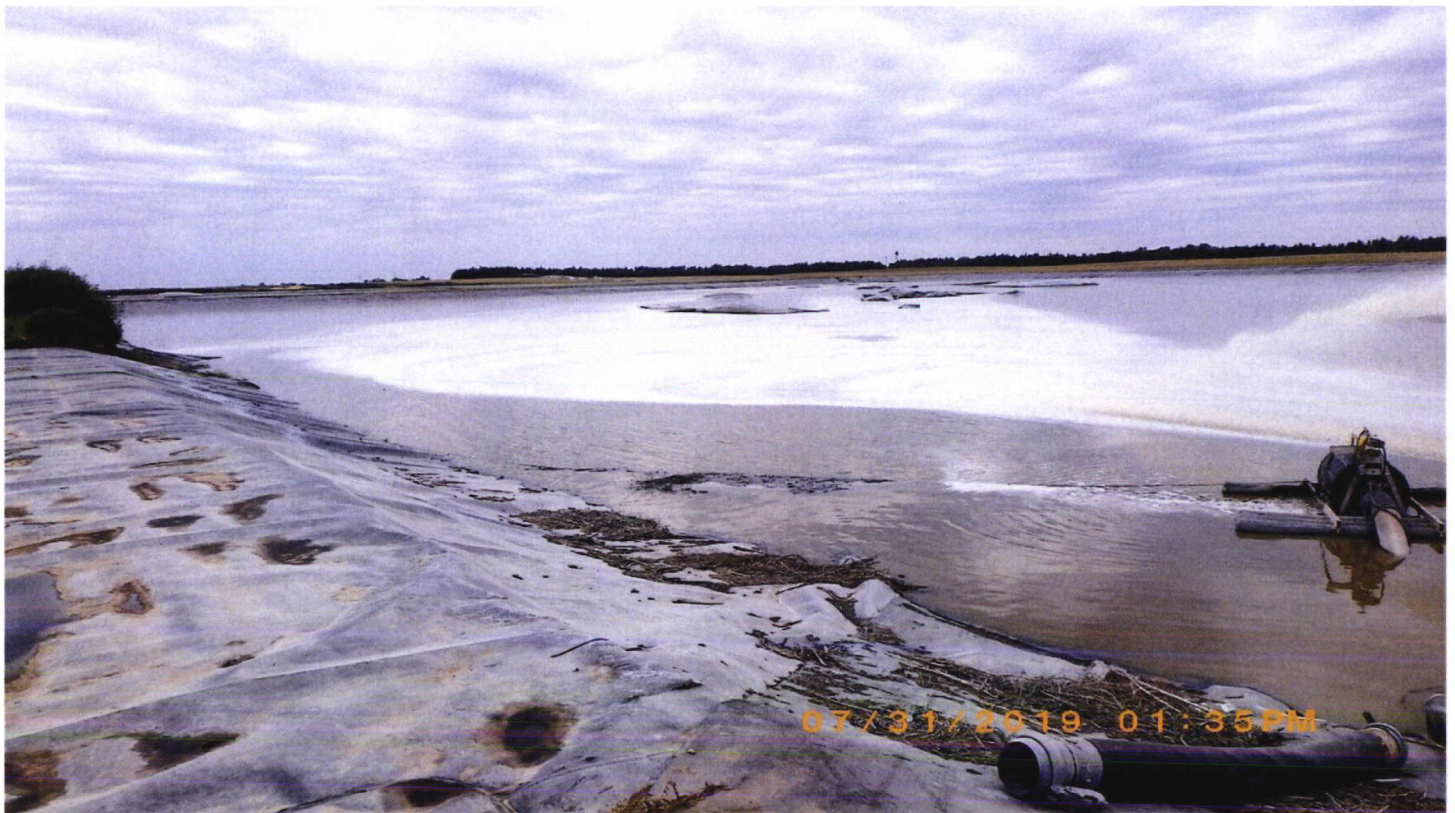
Photo 41  
Inspection Report  
Observation Area: 11  
Date Taken: July 31, 2019  
Photographer: Mark Pomajzl  
Facility Name/ Project Name: AltEn, LLC  
Facility IIS number / Project identifier: NER910444, IIS: 84069  
Direction Facing: West  
Description: Same as photo 41 showing the degree of foaming from the operation.

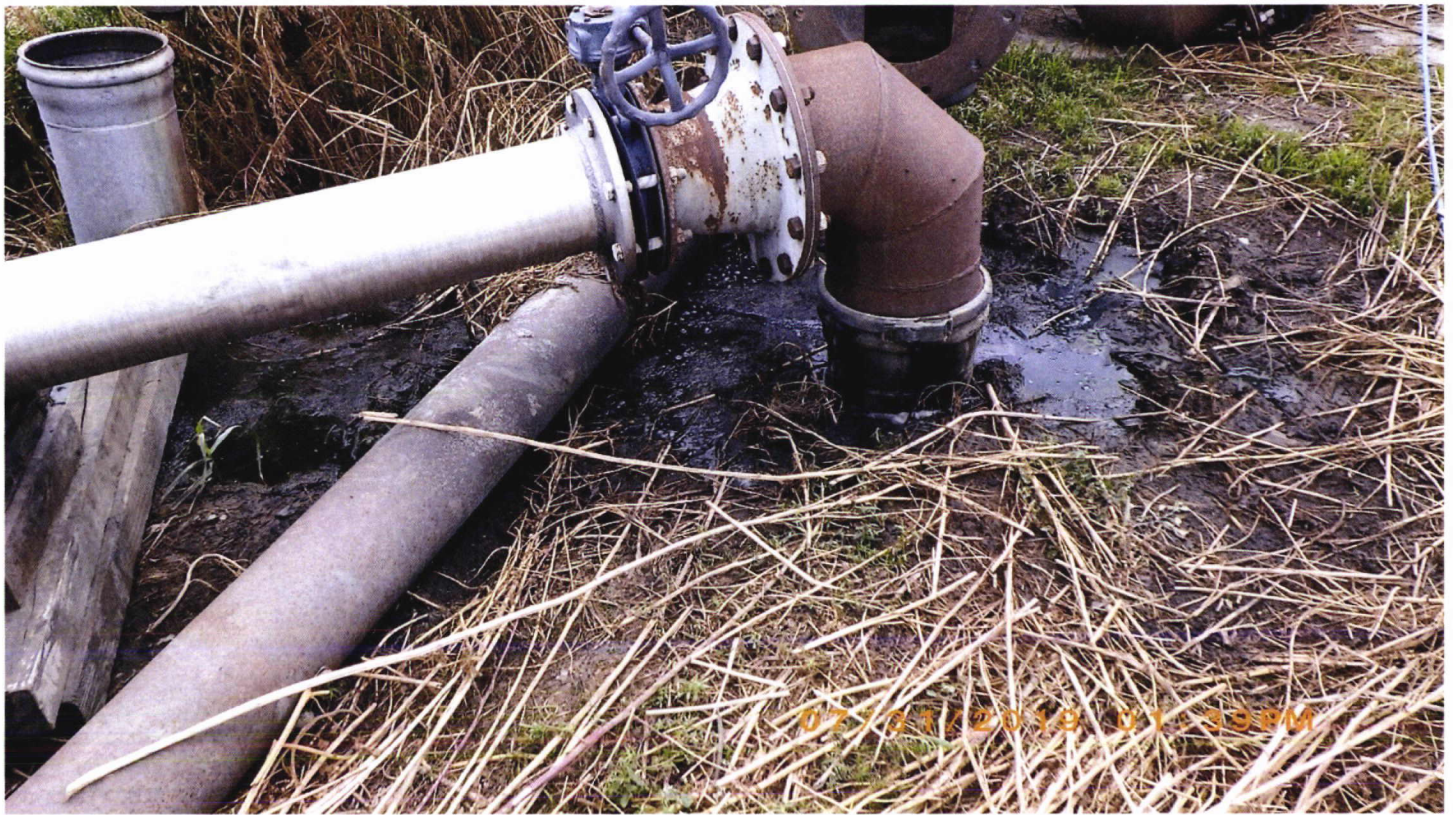
Photo 42

Description: Pump connection for the operation depicted in photos 41-42. Some leaking is observed at the pipe connections.

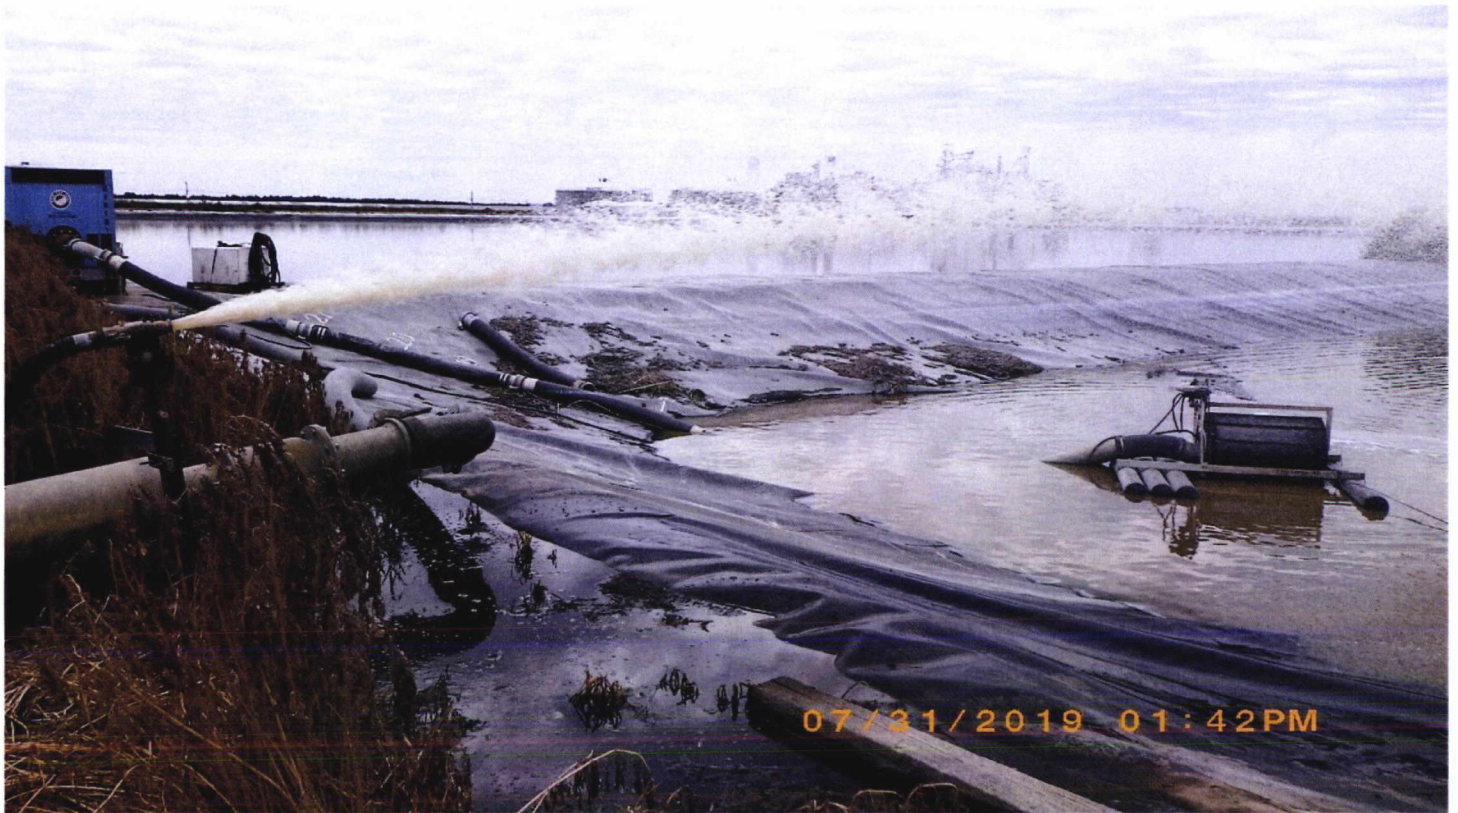
Photo 43

Description: Same as photos 41-43. Rotary screen is shown in the right portion of the photo.

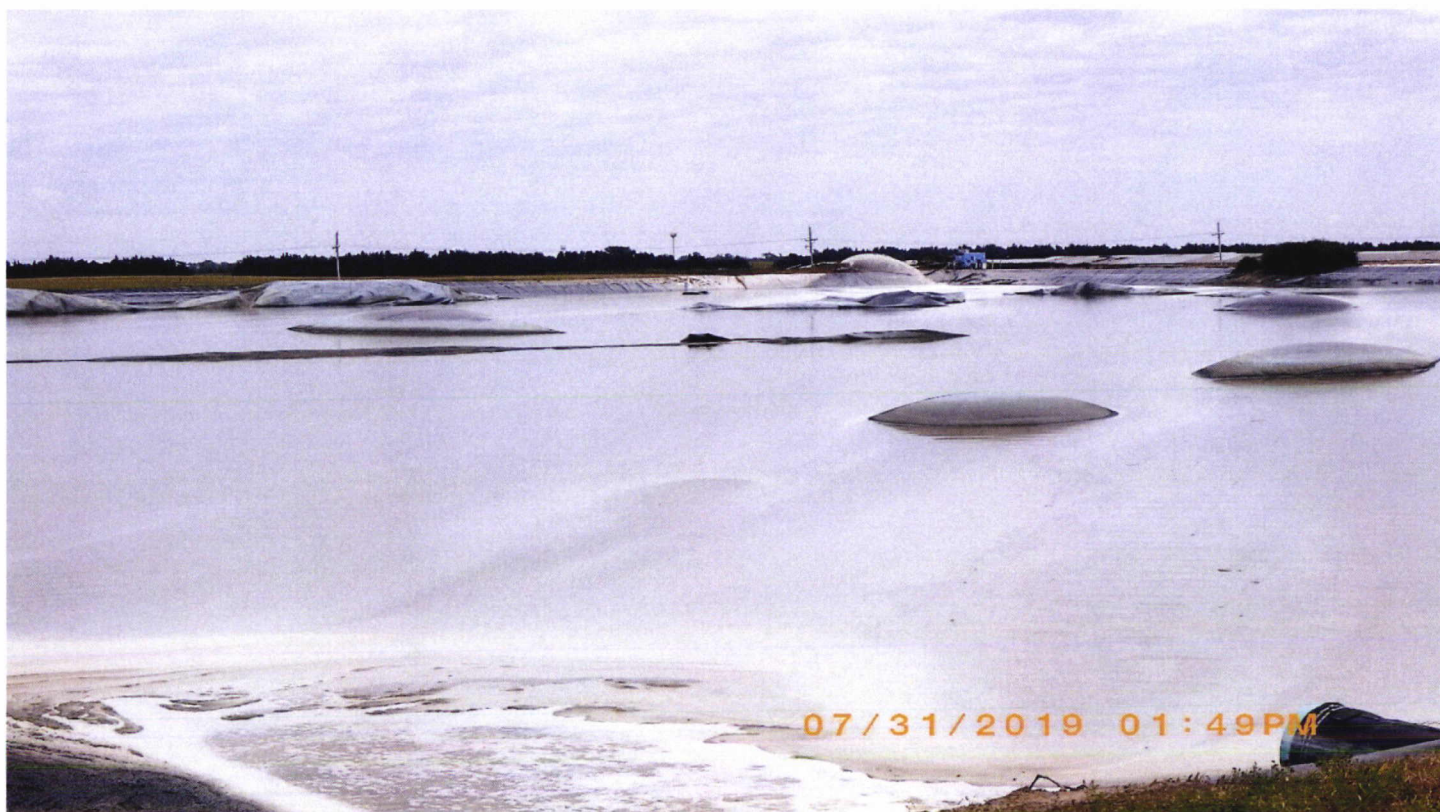
Photo 44

Description: Vantage point shows several section of the liner of the northeast lagoon at the surface with the screening operation in the background.

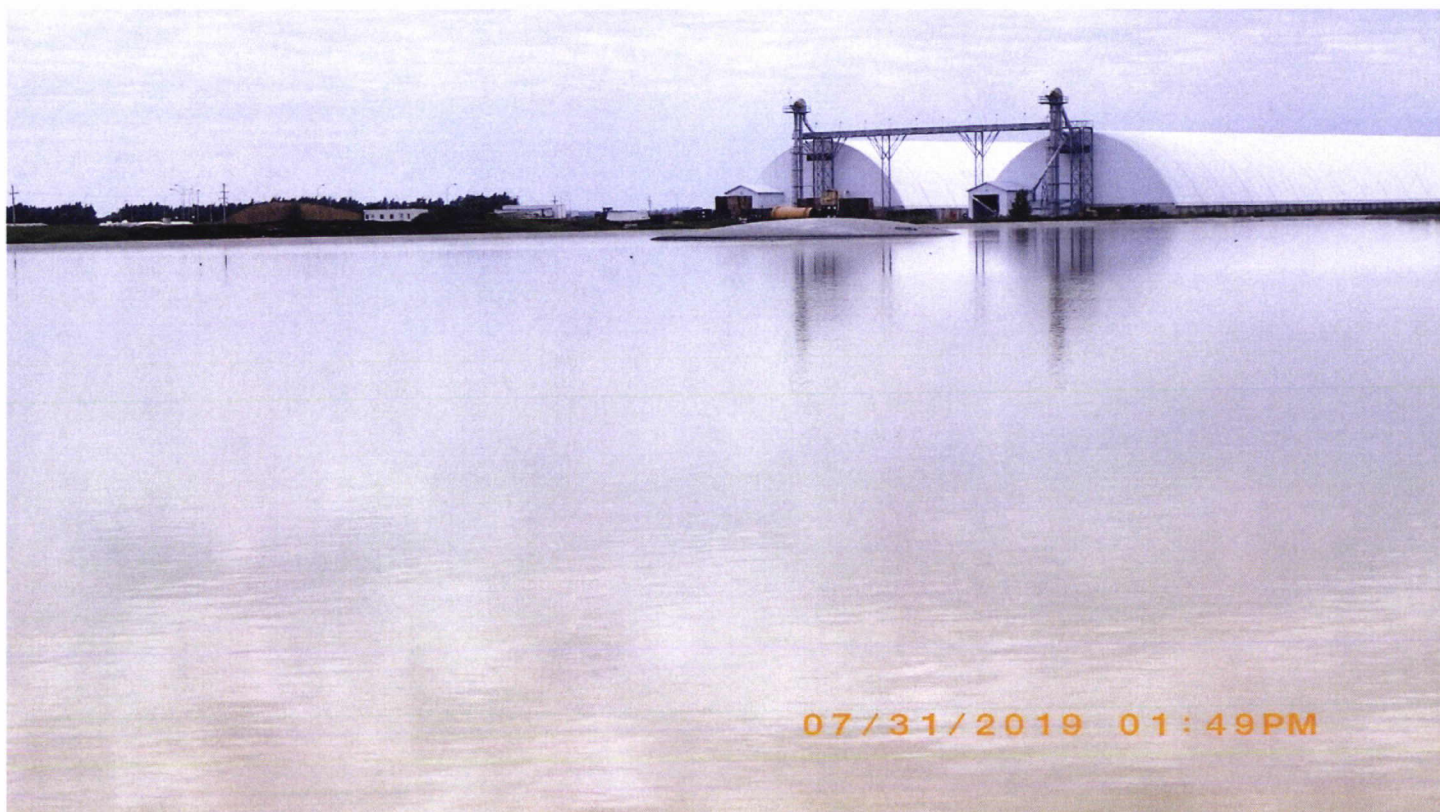
Photo 45

Description: Looking across the northwest lagoon showing a failed section of the liner pushed up to the surface.  
Green Cycle Solutions is visible in the background.

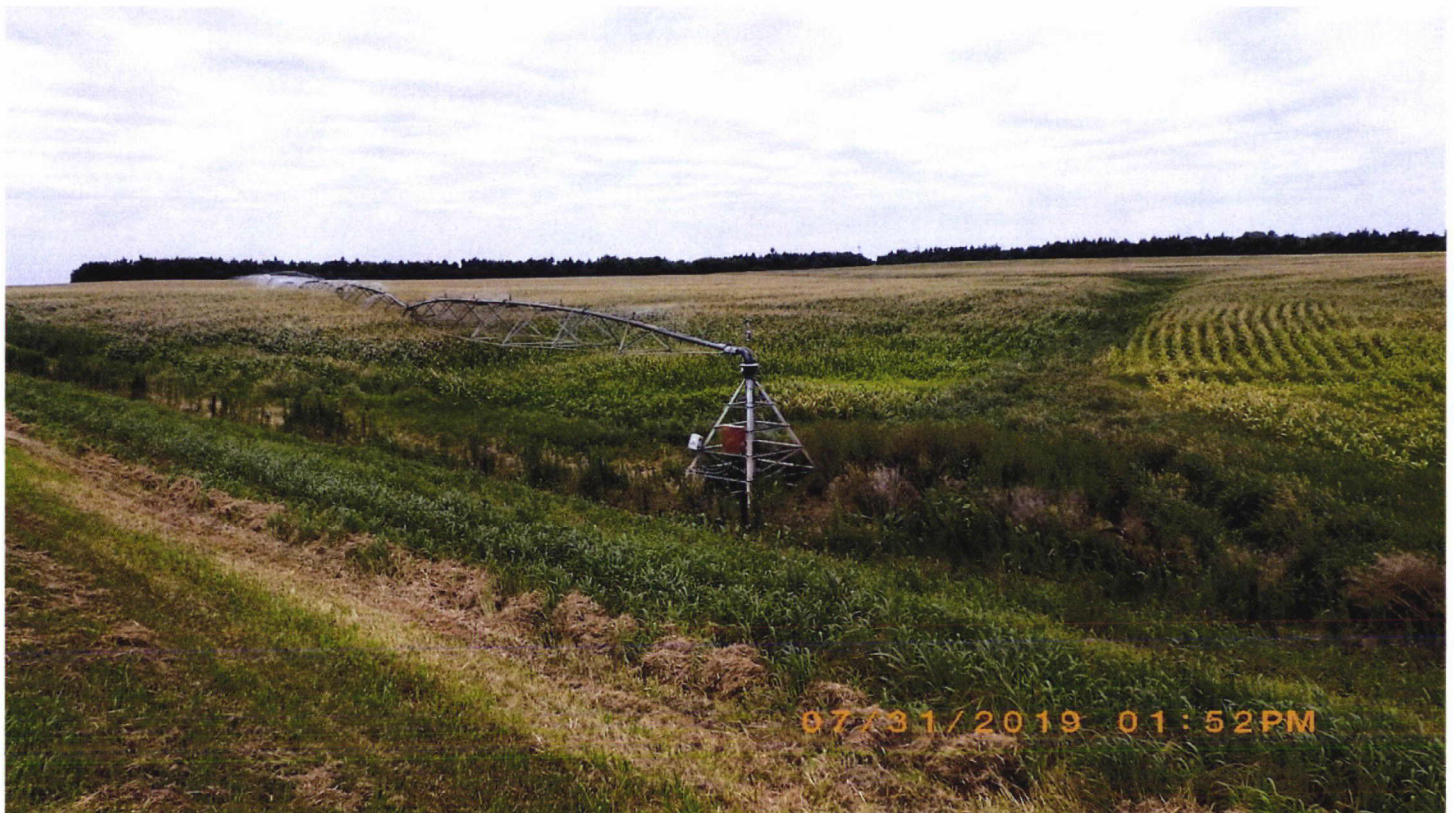
Photo 46

Description: Pivot adjacent to the northwest lagoon. AltEn stated that they were not current irrigating from their lagoons. They stated that they had very recently irrigated from the lagoons in order to draw down the east lagoons.

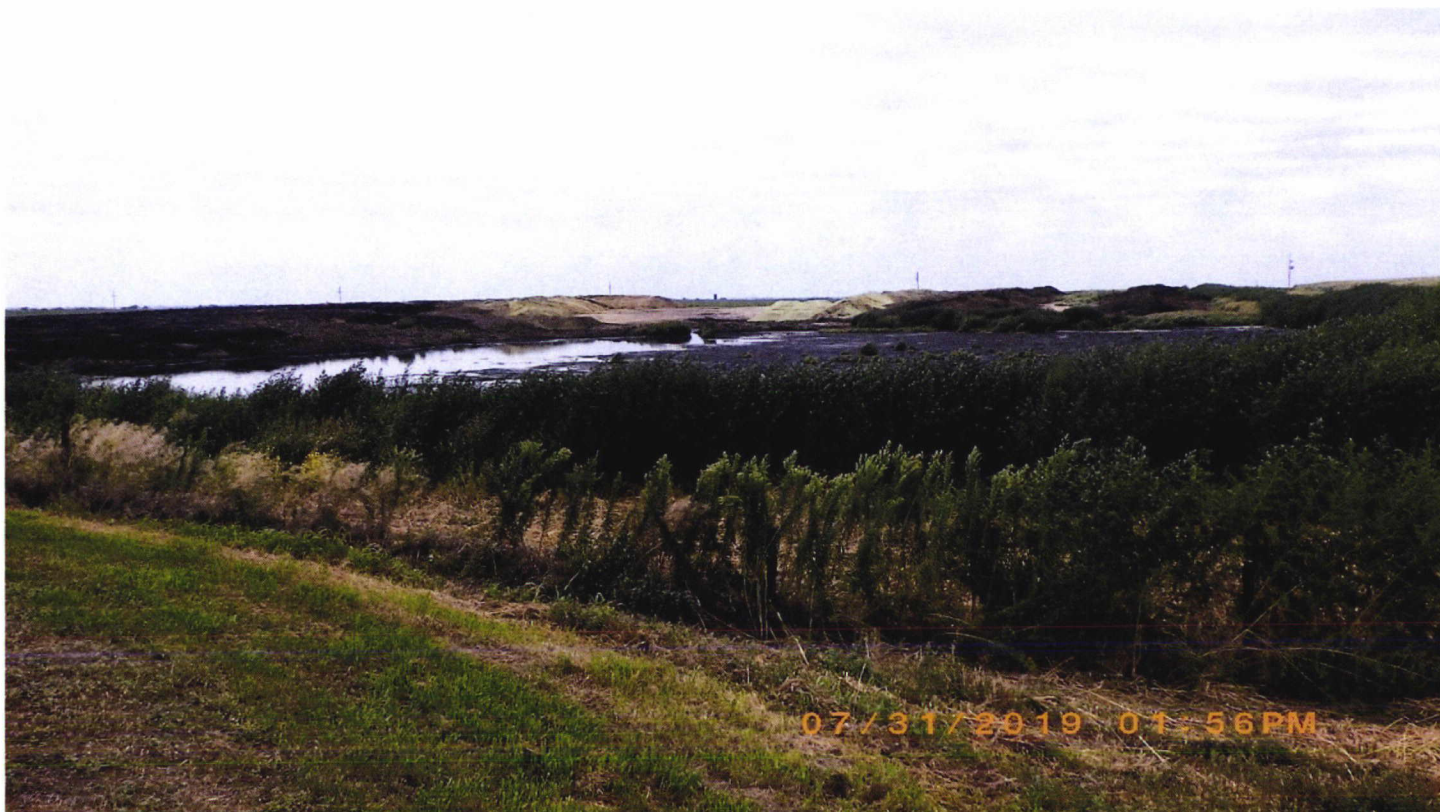
Photo 47

Description: From the northwest corner of the northwest lagoon looking at the detention pond for runoff from the wet cake storage area. A small berm contains the liquid according to AltEn. This is an area that qualifies as a potential storm water outfall.

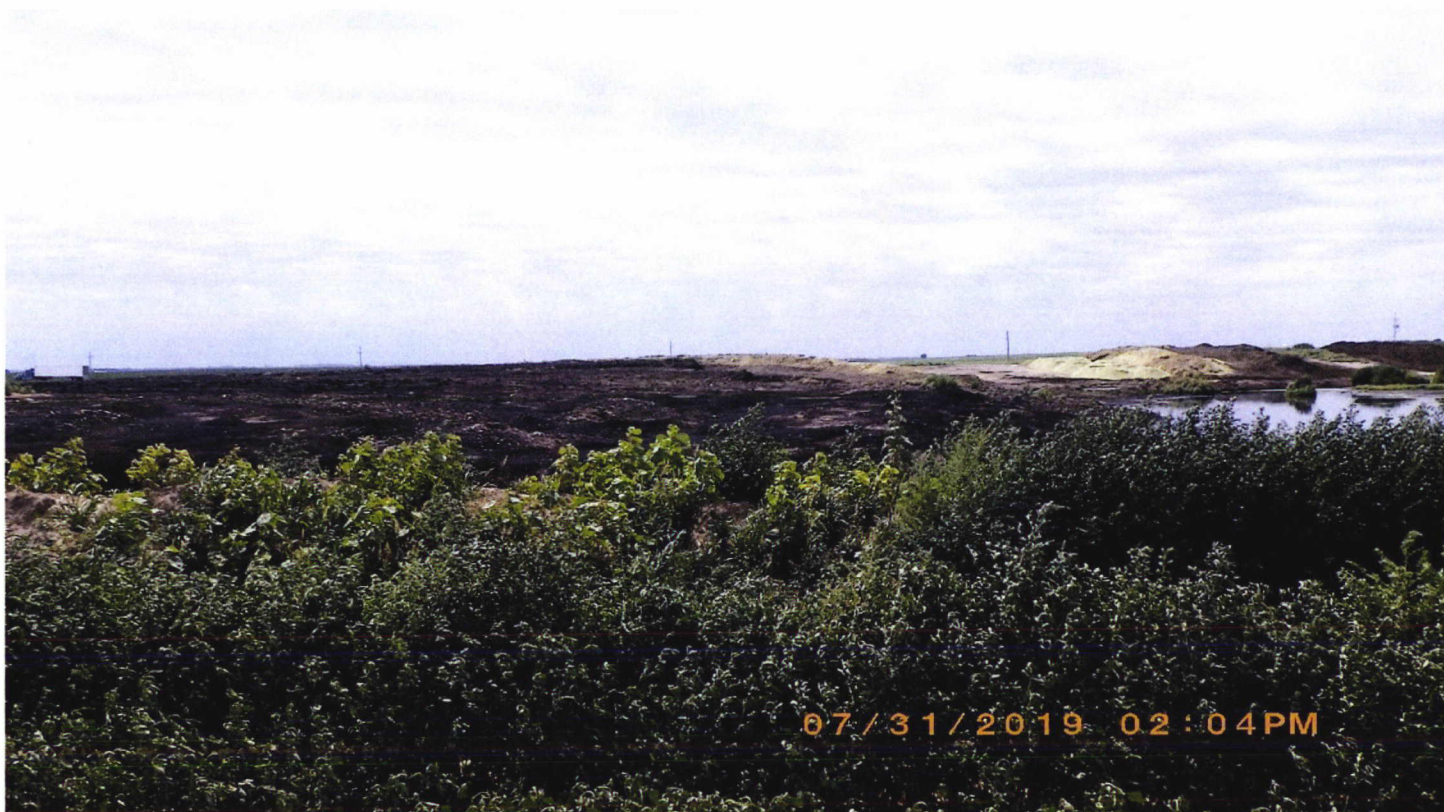
Photo 48  
Inspection Report  
Observation Area: 13  
Date Taken: July 31, 2019  
Photographer: Mark Pomajzl  
Facility Name/ Project Name: AltEn, LLC  
Facility IIS number / Project identifier: NER910444, IIS: 84069  
Direction Facing: West  
Description: Wet cake storage west of the northwest lagoon.

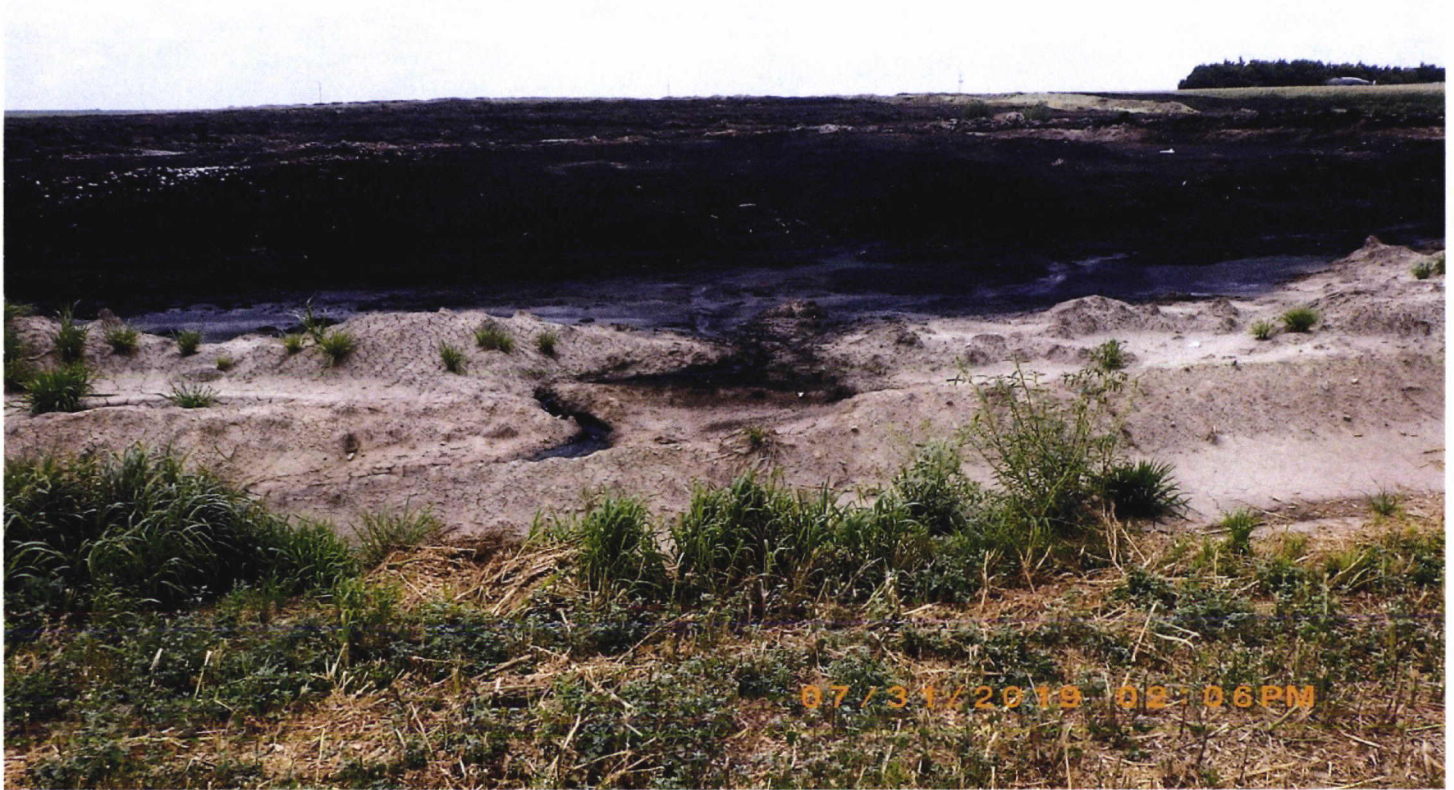
Photo 49

Description: Looking at the wet containment berm at the southwest corner of the northwest lagoon. The wet cake detention berm has breached and could discharge at the area between the wet cake detention pond and the northwest lagoon. This area is noted and conveyed to AltEn while at this location.

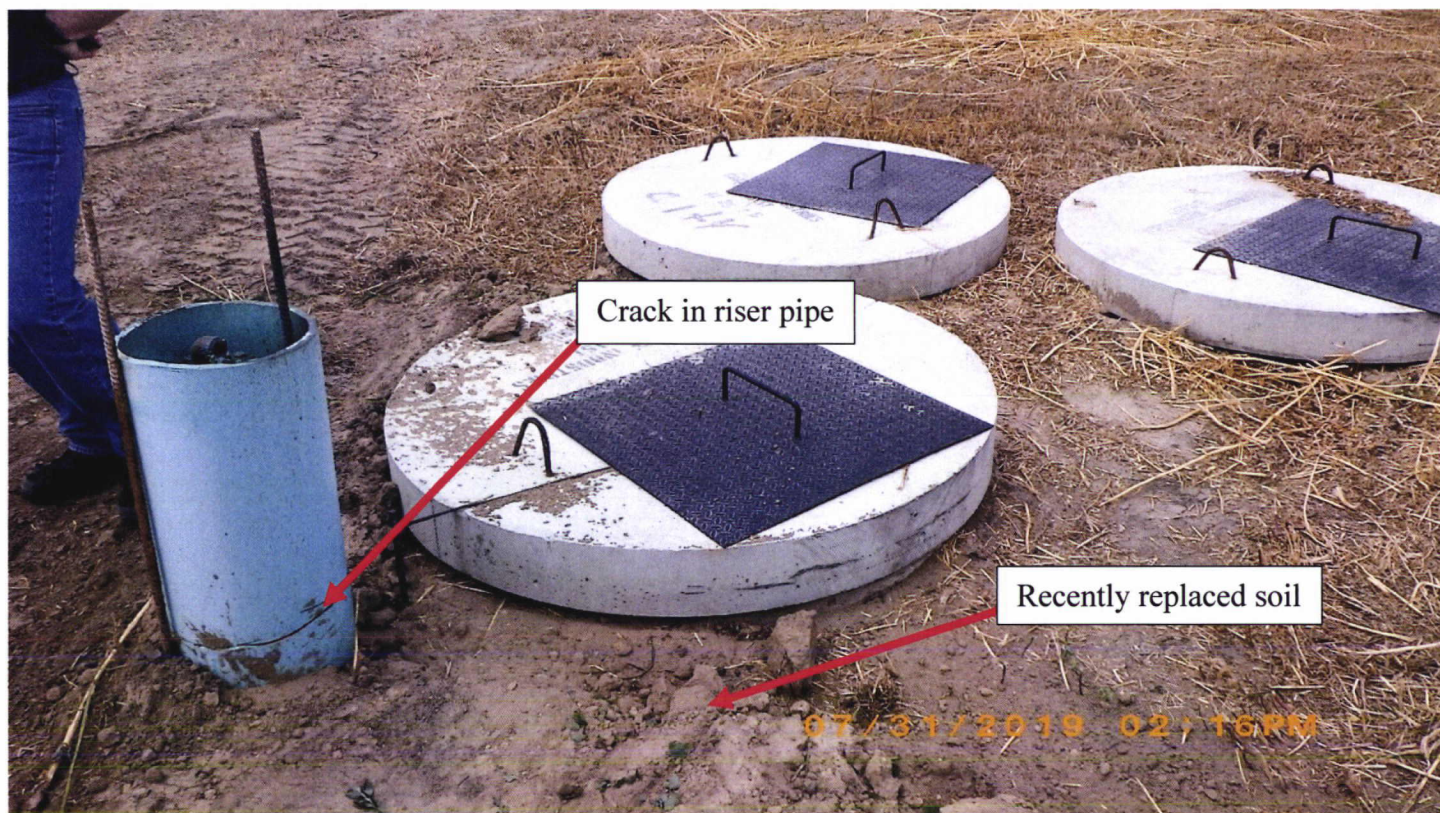
Photo 52

OA16 is on the northwest corner of the south lagoon. In this area, there is a valve control system and air relief vent. The air relief vent is damaged and has discharged thin stillage to the ground. There is a crack on the riser pipe, which could have been recently leaking due to observed green material. The area appears to be recently cleaned. (Photo 52). Across the southeast lagoon, looking west, the wet cake

Description: Looking at the air relief vent (inside green pipe) and the valve control system for the three lagoon. The riser pipe for the air relief vent is damaged and appears to be a source of thin stillage leaking to the ground prior to entering the lagoon system. A large crack is visible near the bottom of the green pipe and the ground to the south had been recently replaced from potential cleanup. Upon stepping on the fresh soil, green liquid is observed mixed with soil.

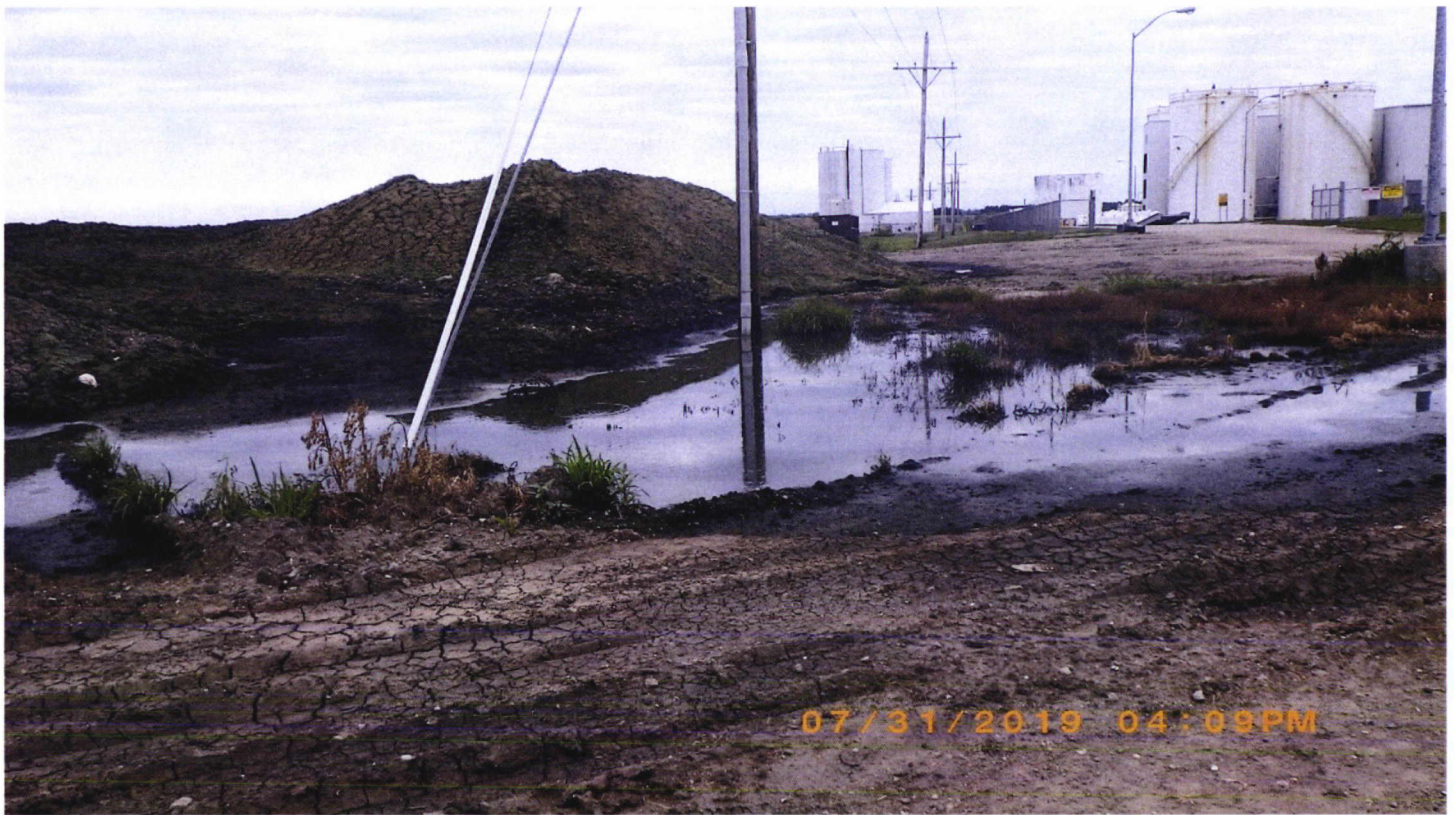
Photo 57

OA17 is on the southwest corner of the south wet cake storage area. In this area, water is pooled with no containment. This area shows signs of vehicle track out based on tire tracks observed in this area. (Photo 58).

Description: Looking at the west edge of the wet cake storage area showing no containment for runoff. It is evident that vehicle traffic has tracked through the ponded runoff based upon the ruts observed in this location.
