MEMORANDUM

RE: Site visit – Mark Pomajzl and Dan LaMaistre

NDEQID: 84069

Program ID: NE0137634, NER910444

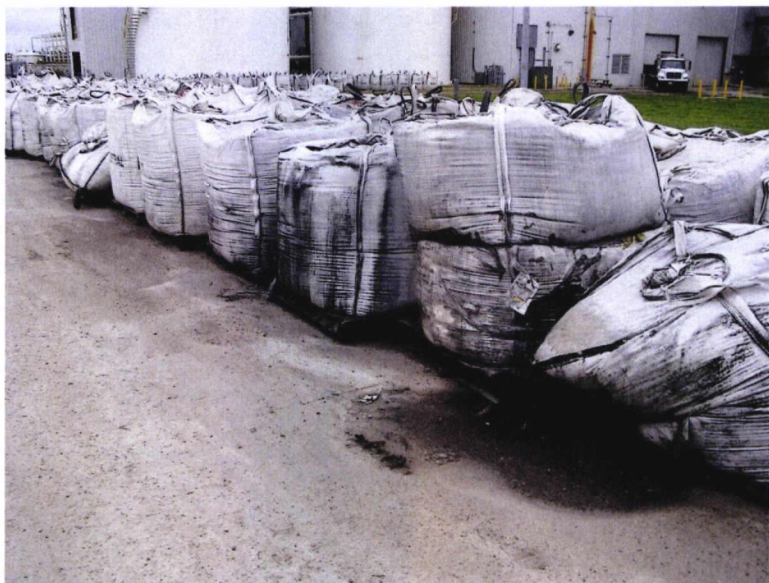
Photo #: 1

9. There are numerous pallets of bagged starch located throughout the facility (photos 1, 2, 13, 14). The facility labeled these bags as "Industrial". This labeling is not consistent with Section 5.4 Spill Prevention. The section states that all potential containers susceptible to spillage be plainly labeled to encourage handling and rapid response if spills occur. The current means of determining the content of these pallets is by closely examining the bags or asking facility staff.

Description: One of the starch storage areas. This batch is located south of the ethanol production area.

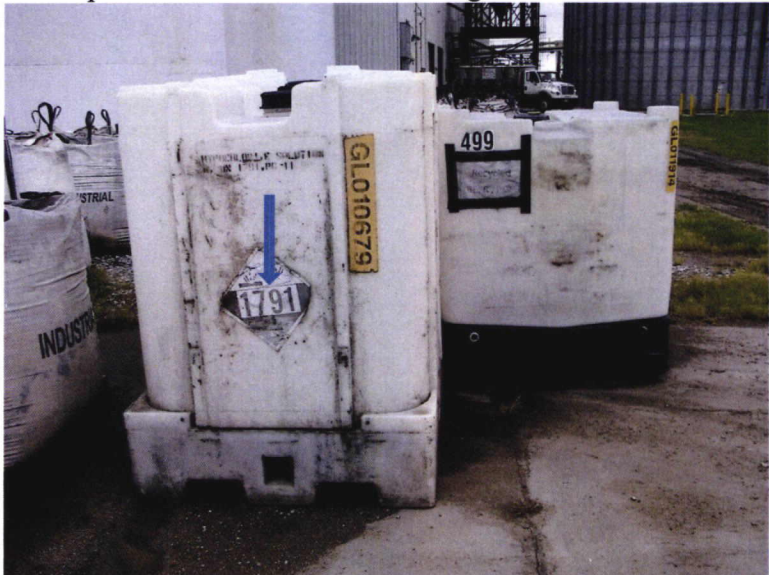
Photo #: 2

Description: Beer and pop totes stored in cleaned chemical totes. The labeling does not clearly indicate that beer and pop are stored in these totes (notice the placard)

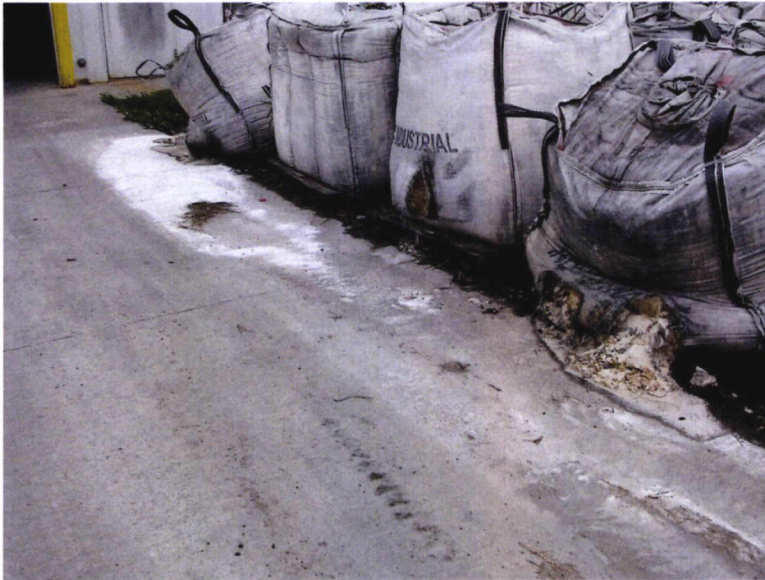
Photo #: 3

Description: Stored starch north of the ethanol plant. Three bags are broken and discharging along the cement pad.

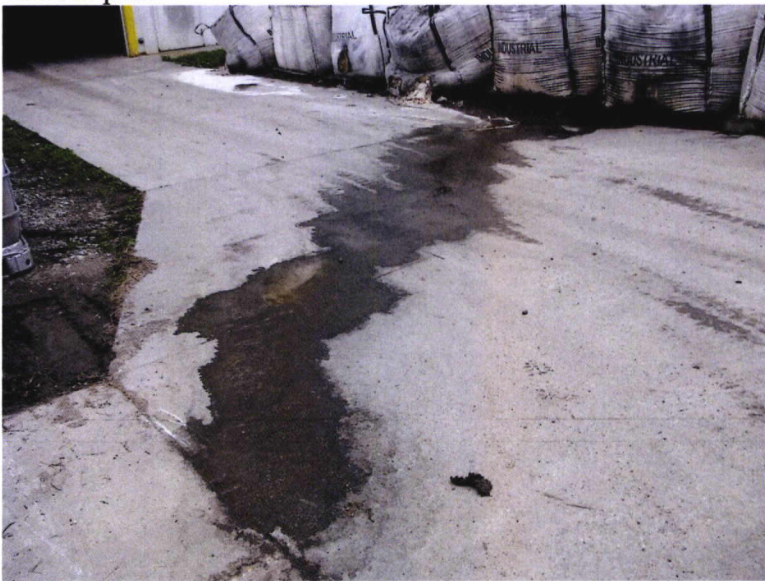
Photo #: 4

Description: Stored starch north of the ethanol plant. This is the same bags as the above photograph. The facility did not attempt to contain or clean the area during the inspection.

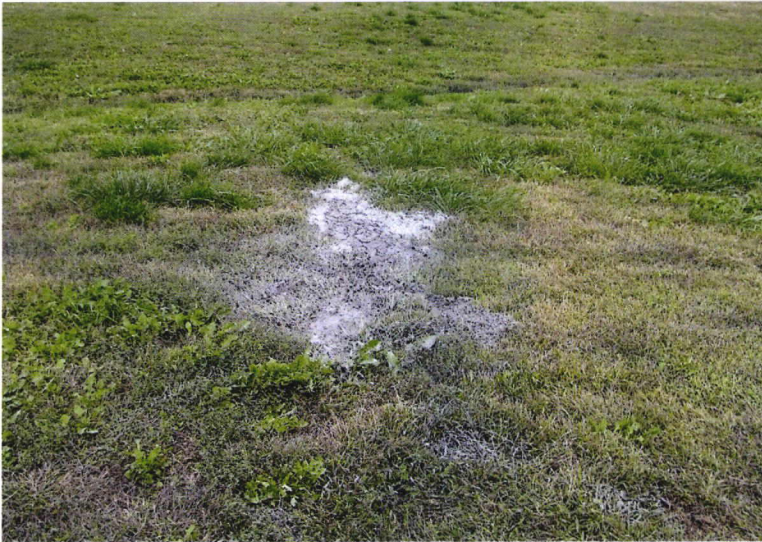
Photo #: 5

Description: Wastewater spilled north of the ethanol plant. North of the spillage is the beginning of the intermittent tributary of Clear Creek. The area was not clean during the inspection.

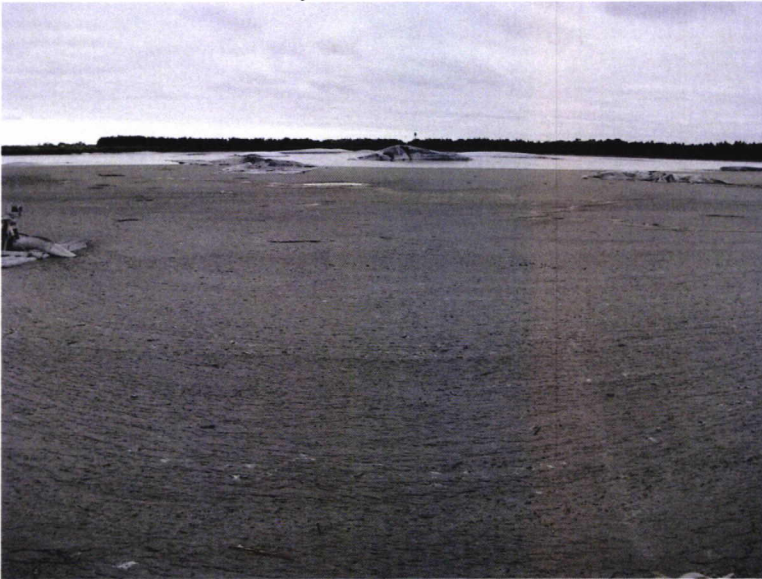
Photo #: 6

11. The facility employs a three cell non-discharging system with land application. The west cell is new construction and finished less than two months ago. The original two-cell system has liner damage from a tornado. Liners are torn and are bubbled in places due to wastewater seeping behind the liner (photos 6, 7, 8). The south cell has recently been above freeboard and some erosion in exposed areas (photos 8, 9).

Description: Cell liner bubbling on the north cell.

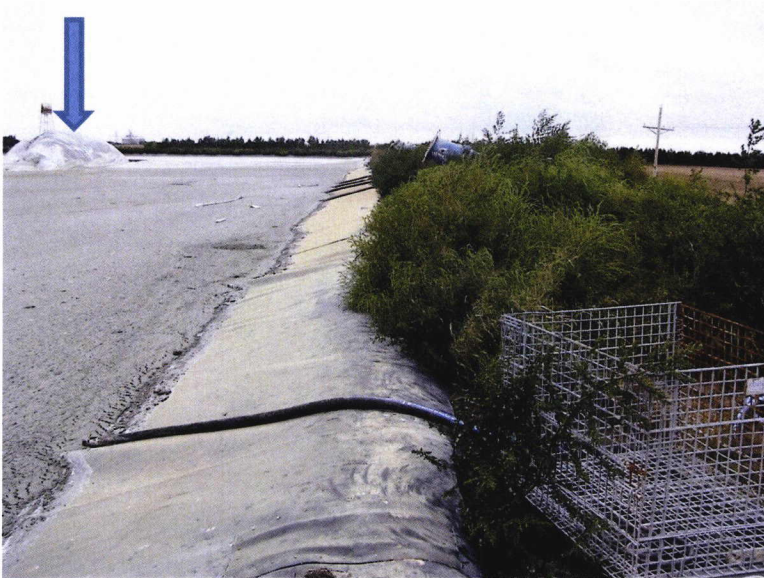
Photo #: 7

Description: Cell liner bubbling on the north cell.

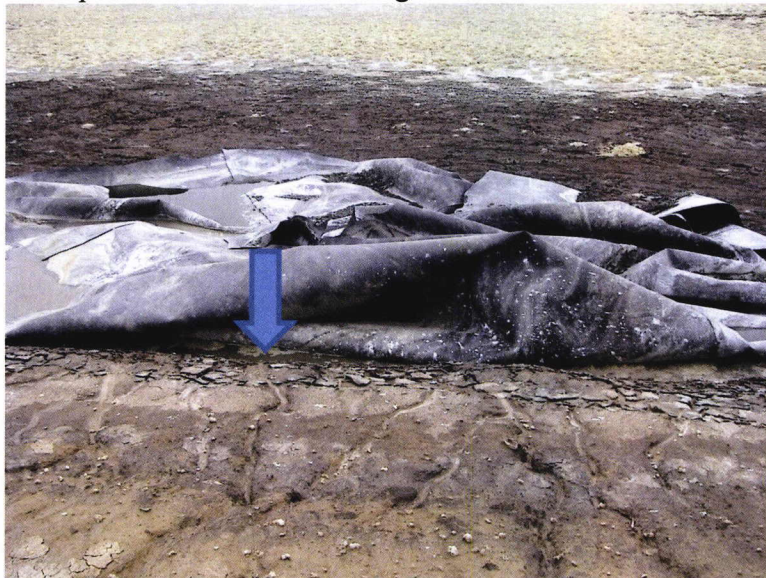
Photo #: 8

Description: Part of the liner torn and laying the south Cell. There is water pooled on the backside of the liner (arrow). There is also rill erosion noted.

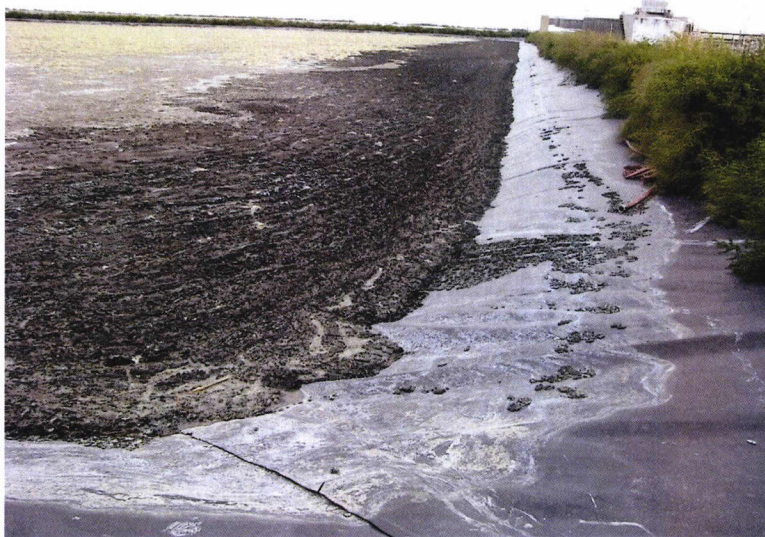
Photo #: 9

Description: West side of the original Cell system. There is indication of the recent water levels above freeboard and nearly overflowing dikes.

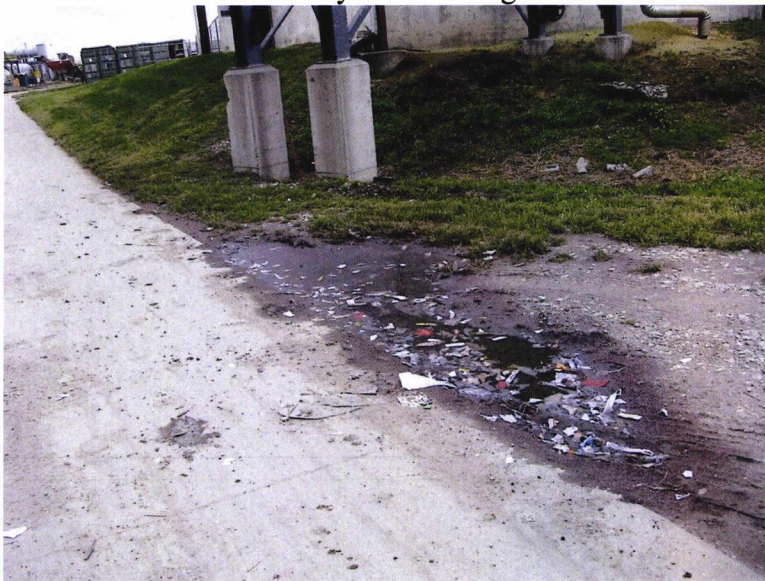
Photo #: 10

5. The seed unloading area noted seed bag trash (photo 10). Section 5.1 Good House Keeping Practices states that the facility practices frequent garbage, rubbish and sanitary waste disposal and proper storage and disposal of materials.

Description: Trash located along the seed unloading area.

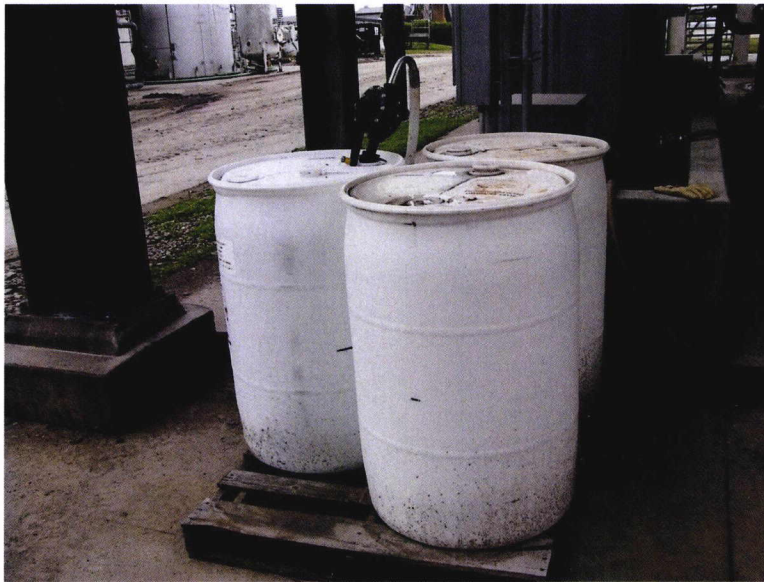
7. The facility uses Ethylene Glycol for lubrication for some motors and valves. The noted barrels are not in containment (photo 11). There are potential for spills and leaks.

Photo #: 11
 Photo date: 10-12-2018
 Project Name: AltEn, LLC
 Photographer: Mark Pomajzl
 Direction facing: South
 GPS/Site location: N41.19557, W 96.47807
 Description: Ethylene Glycol used but not in containment.

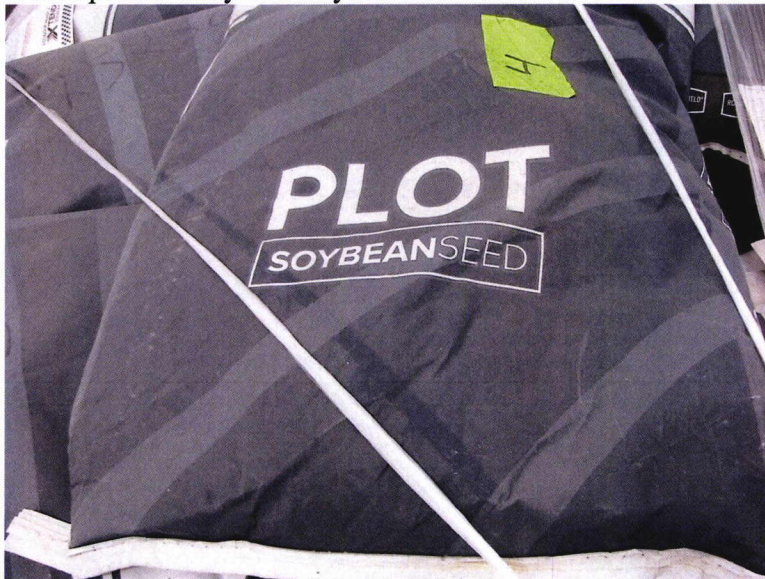
12. Soybeans bags noted in the grain storage structure. Please report any process change to the Air Quality Unit at 1-402-471-4141.

Photo #: 12
 Photo date: 10-12-2018
 Project Name: AltEn, LLC
 Photographer: Mark Pomajzl
 Direction facing: South
 GPS/Site location: Not recorded
 Description: Soybeans located in the corn storage building. Mr. Egr stated that soybeans would not cause problems with the process.

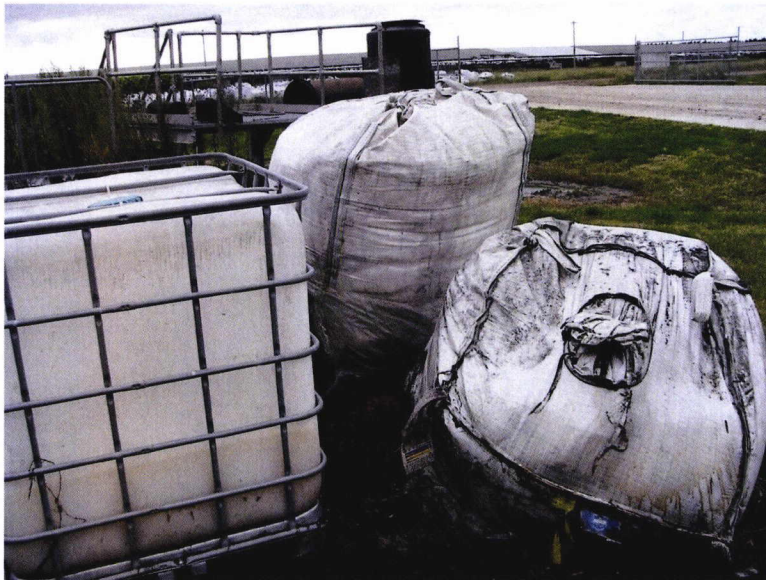
Photo #: 13

Description: Speared bags of starch on the north side of the ethanol production area.

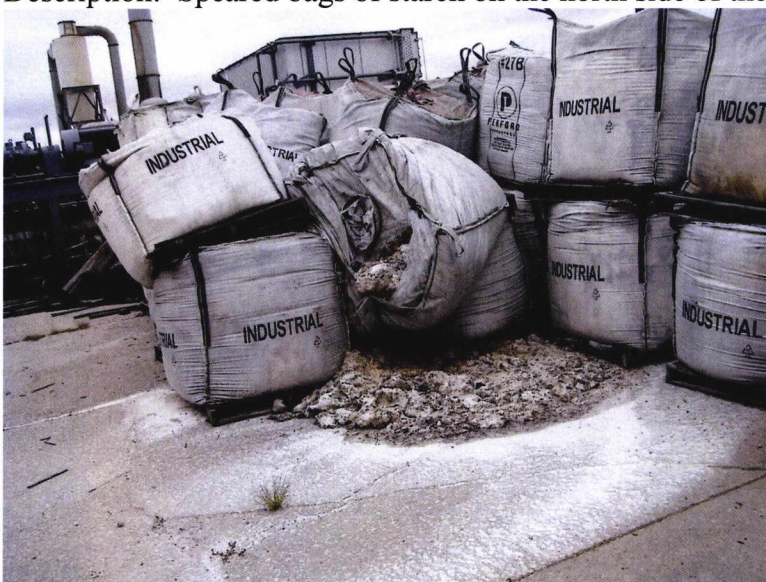
Photo #: 14

Description: Speared bags of starch on the north side of the production area.

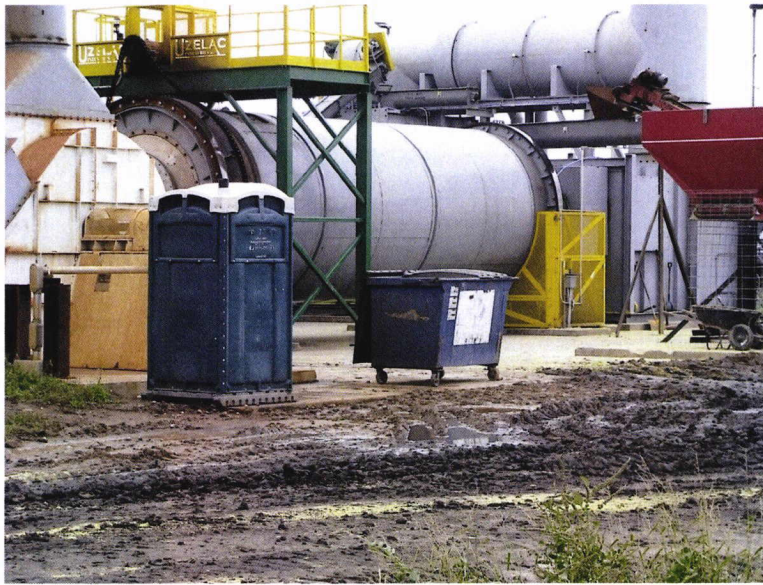
Photo #: 15

2. The SWPPP does not mention the wet cake storage area and BMPs used to contain runoff. Staff stated this wet cake is outdated or unsold seed corn and is not used for cattle feed but is used for a new process called BioChar. BioChar is the reduction of wet cake to charcoal like material, and used for plant fertilizer. The SWPPP does not mention this technology nor how to control potential spills.

Description: BioChar system.
