Nebraska Department of Environment and Energy (NDEE)

MEMORANDUM

RE: AltEn, LLC

Subject: Site Visit Report (Wastewater Treatment System Only)

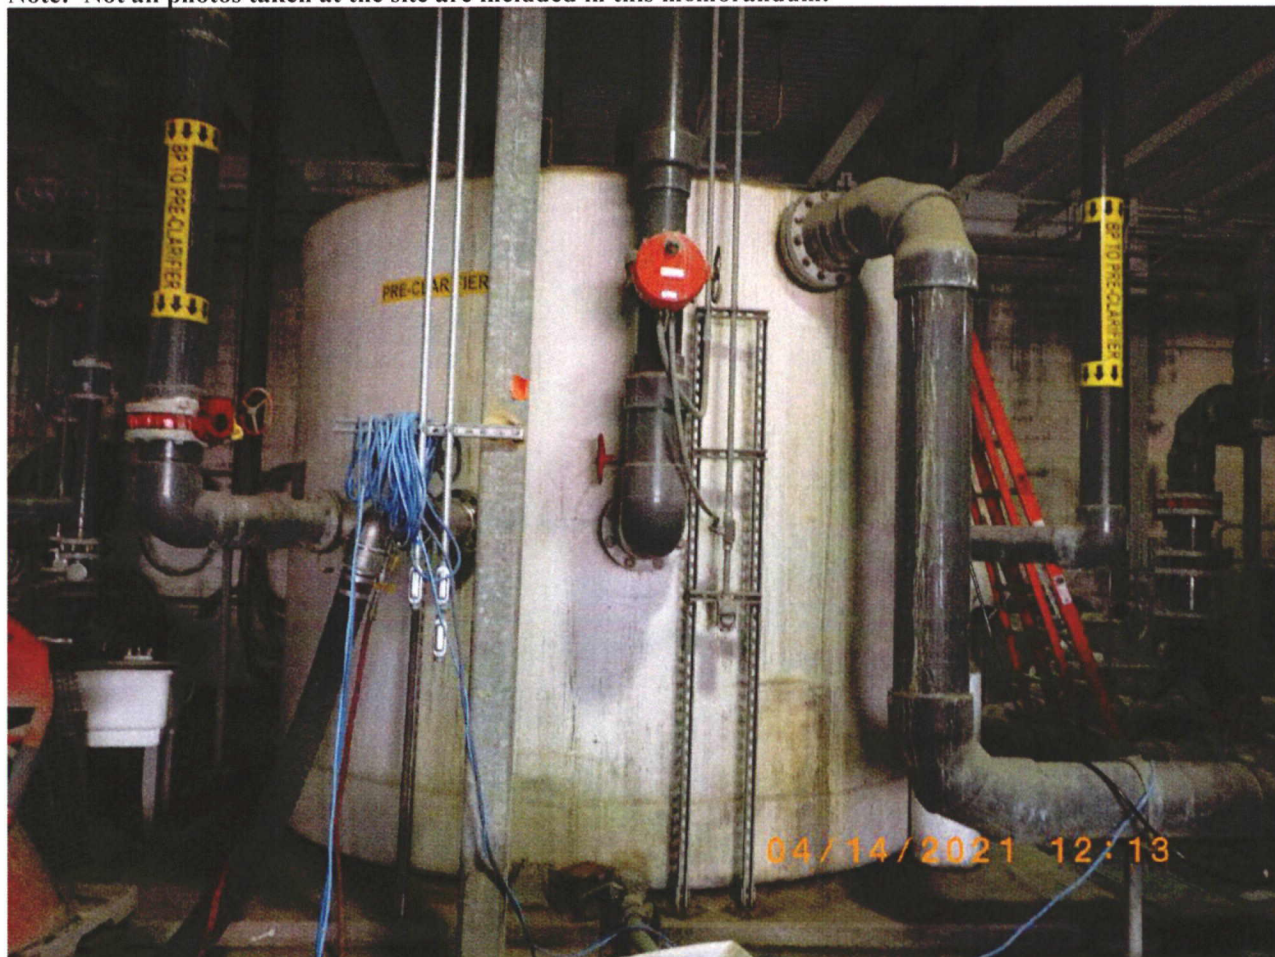
Photo 1

Description: Pre-clarifier tank where ferric chloride is added to the raw wastewater (first step in the treatment process).

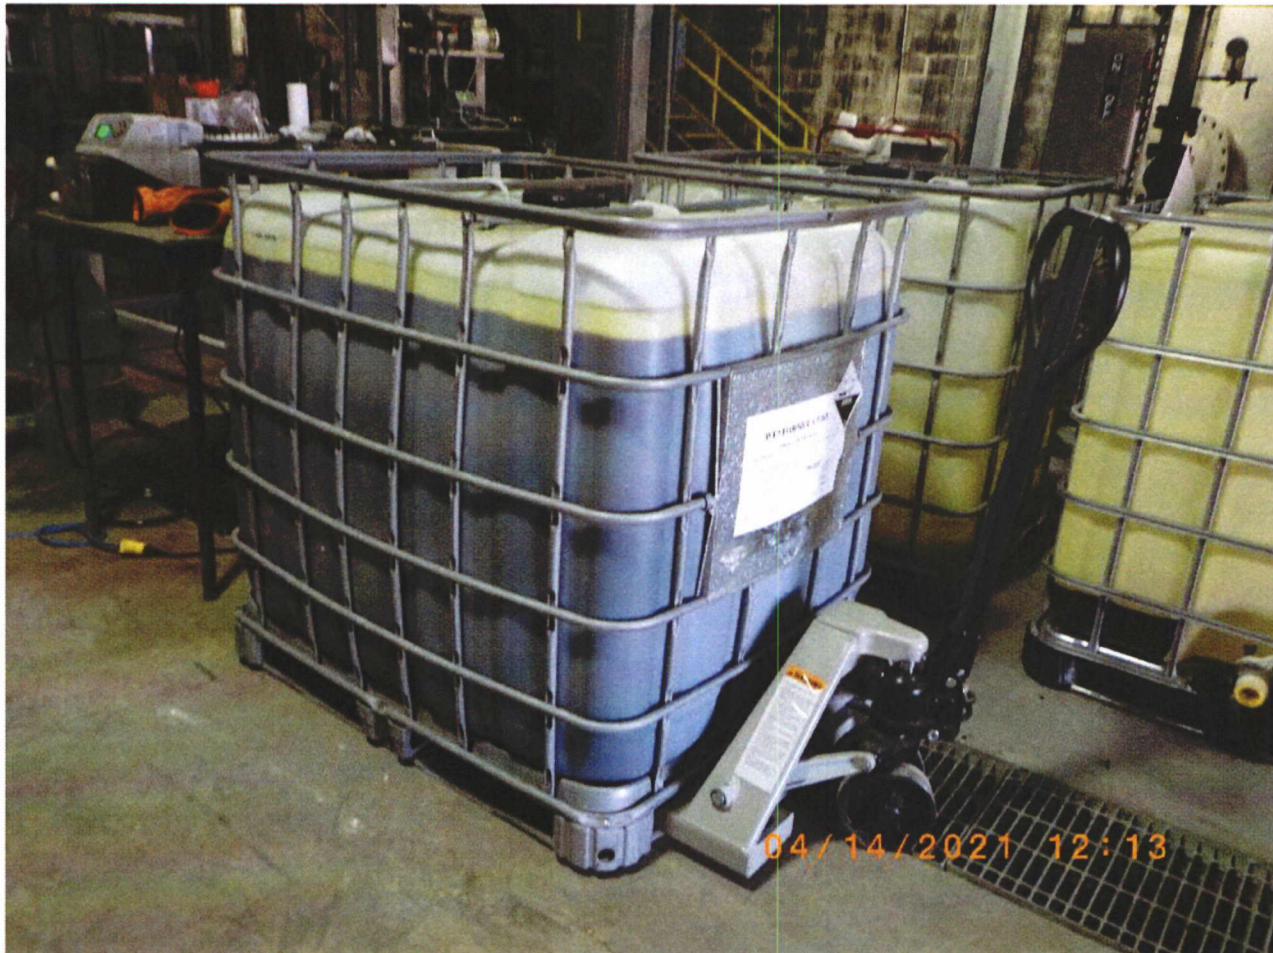
Photo 2

Description: Ferric chloride chemical tank, for addition to the pre-clarififier tank.

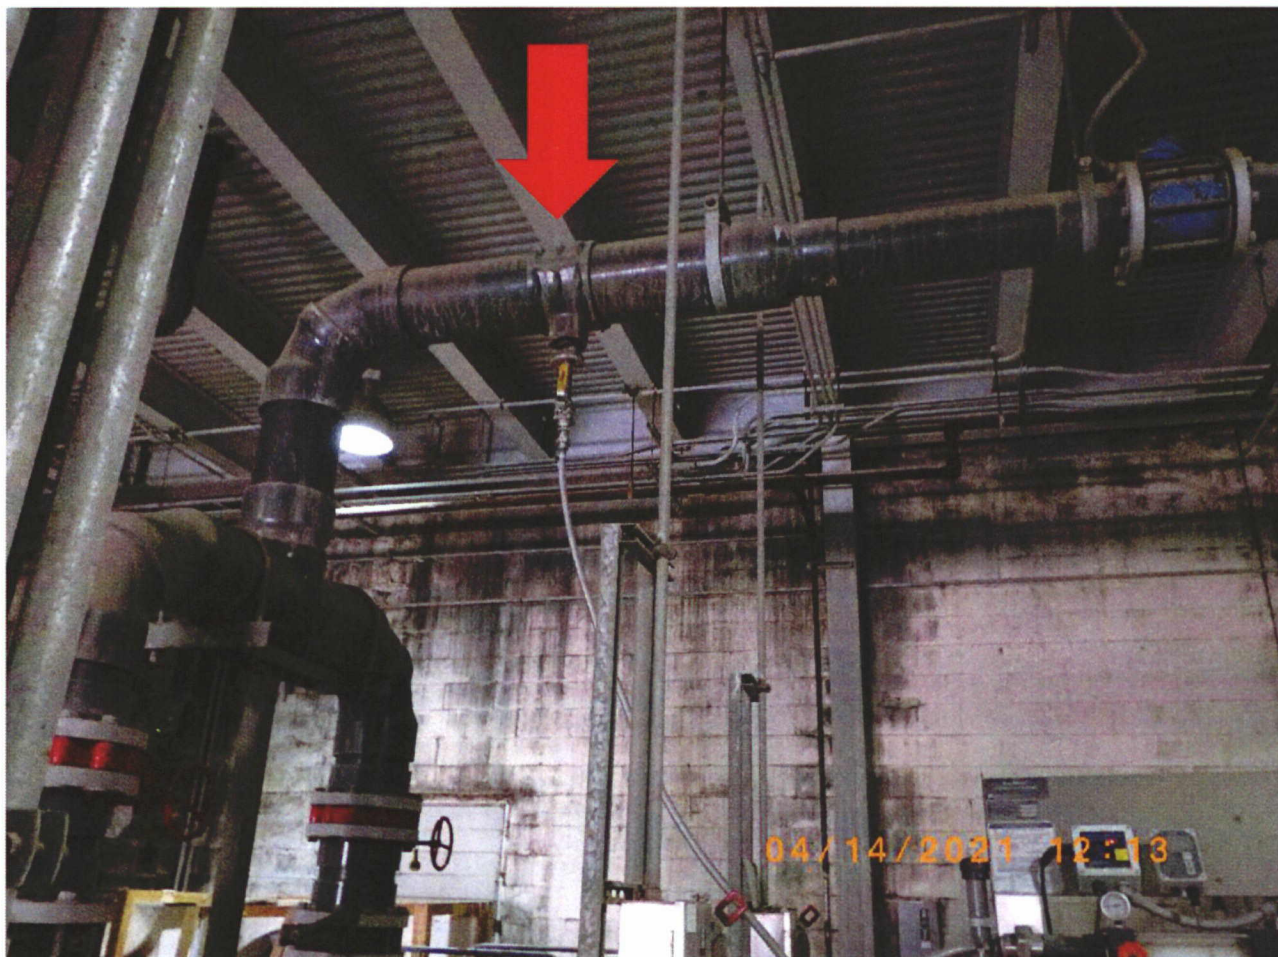
Photo 3

Description: Injection of polymer into pipe transporting wastewater from the pre-clarifler to the clarifier.

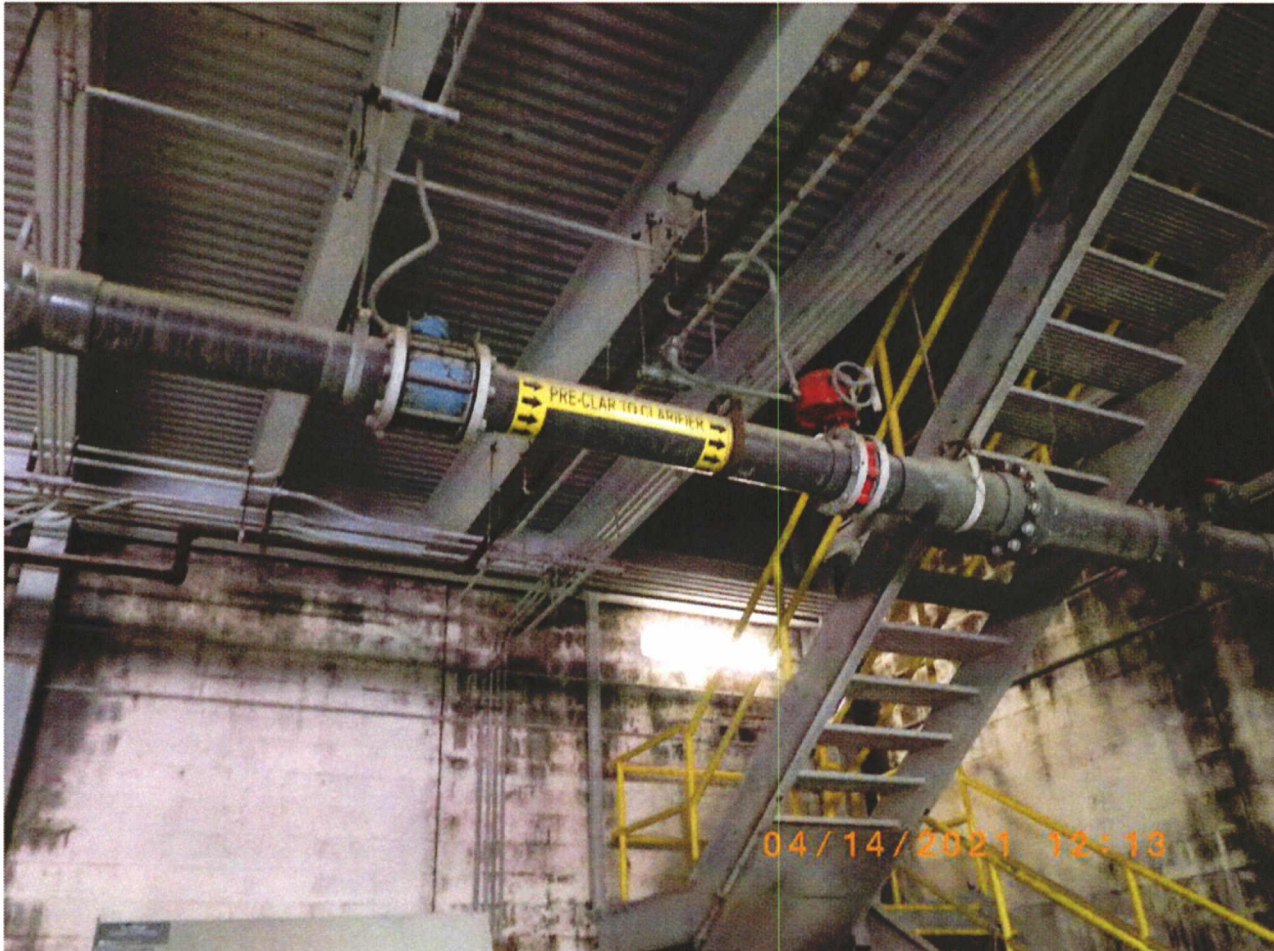
Photo 4

Description: Pre-clarifier to clarifier pipe.

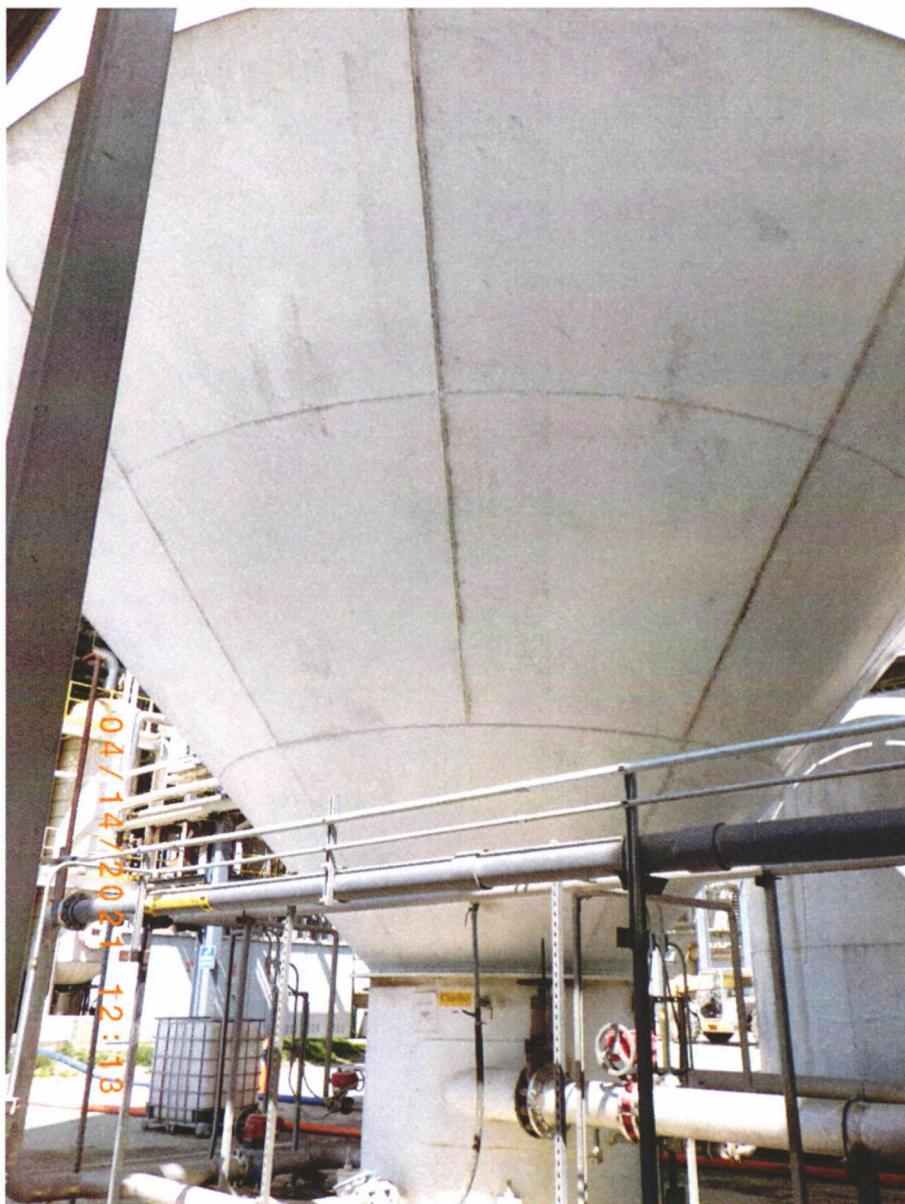
Photo 5

Description: Clarifier (second step in the treatment process).

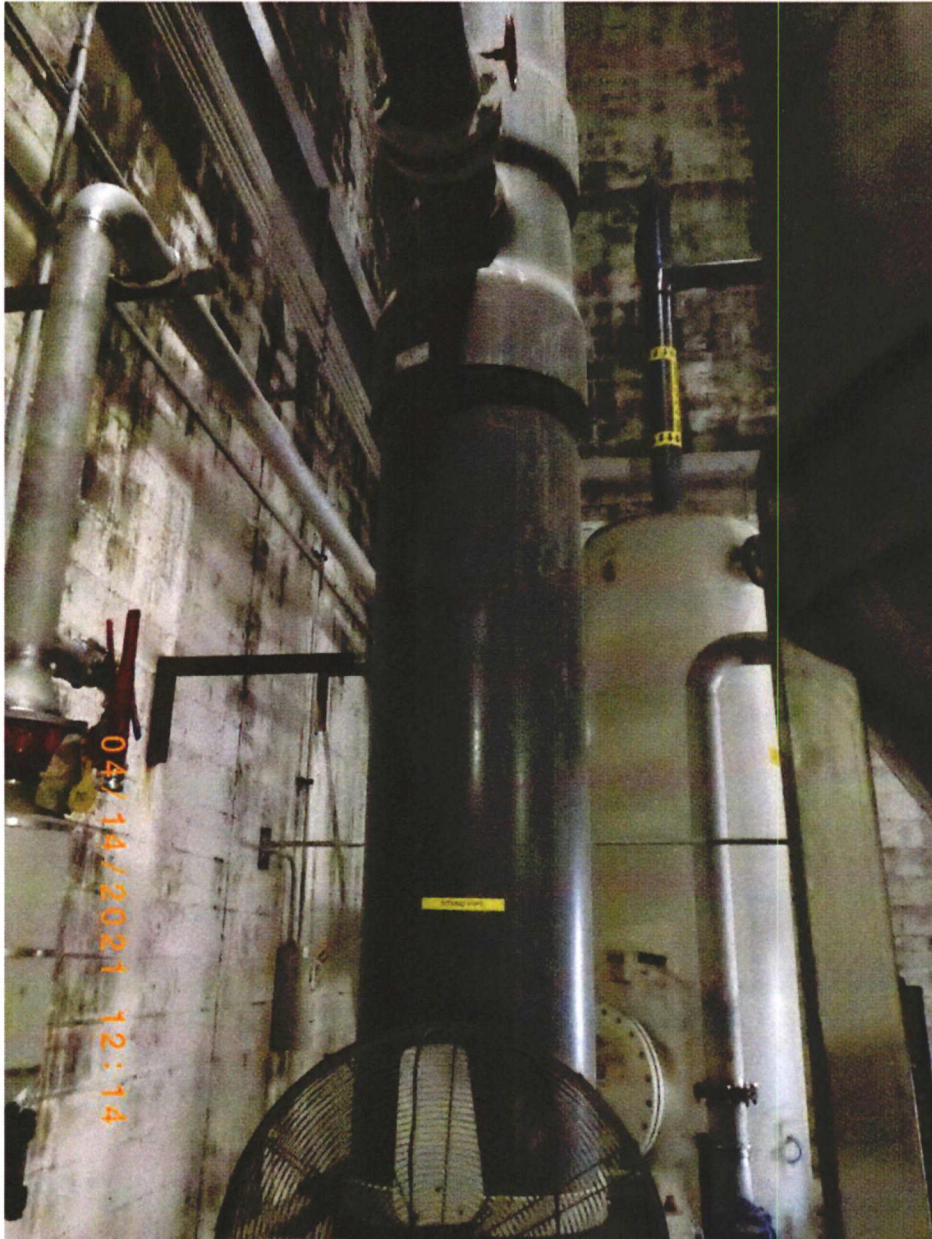
Photo 6

Description: Standpipe following the clarifier, prior to the first sand filter.

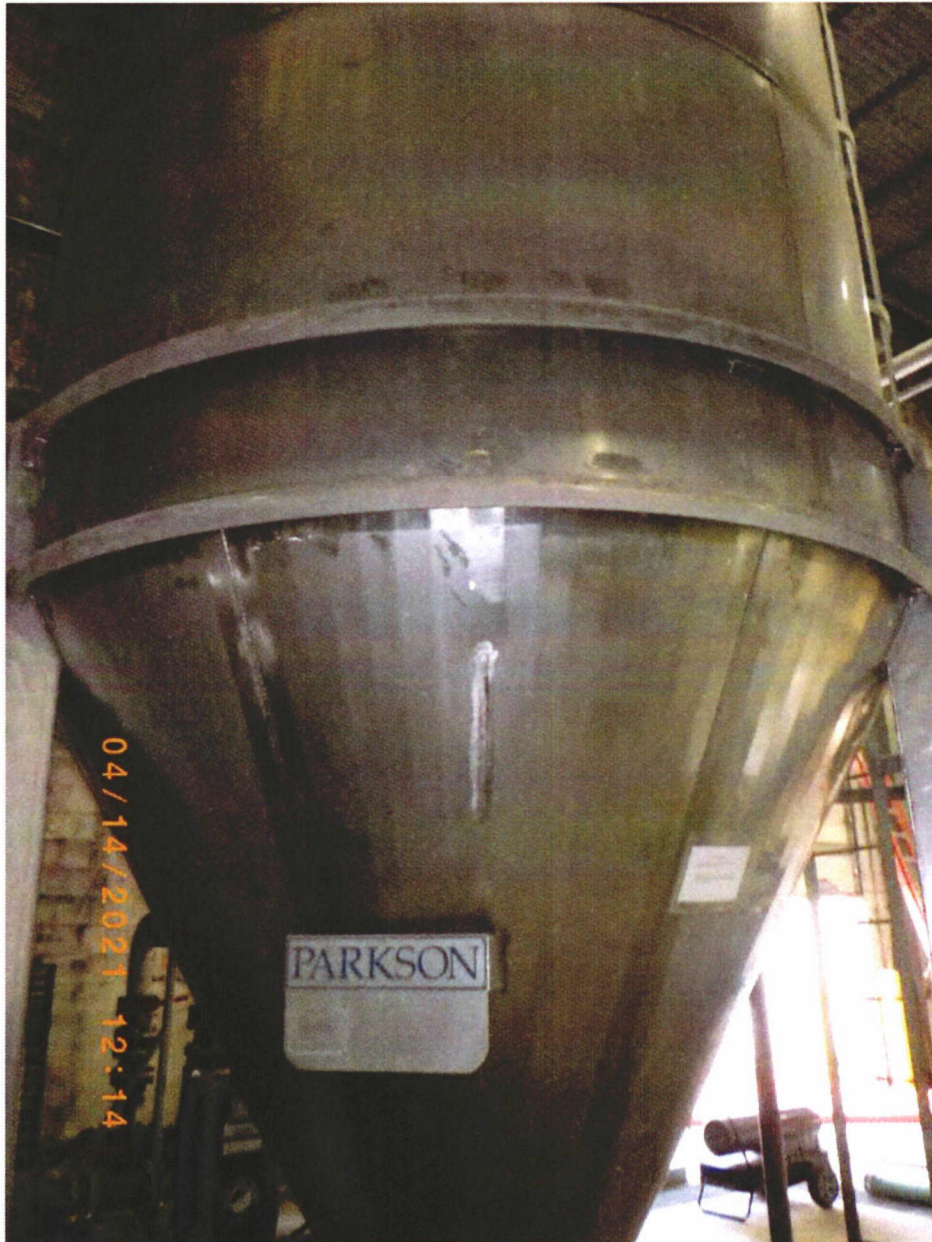
Photo 7

Description: Parkson upflow sand filter (first sand filter in the treatment process, third step of the treatment process).

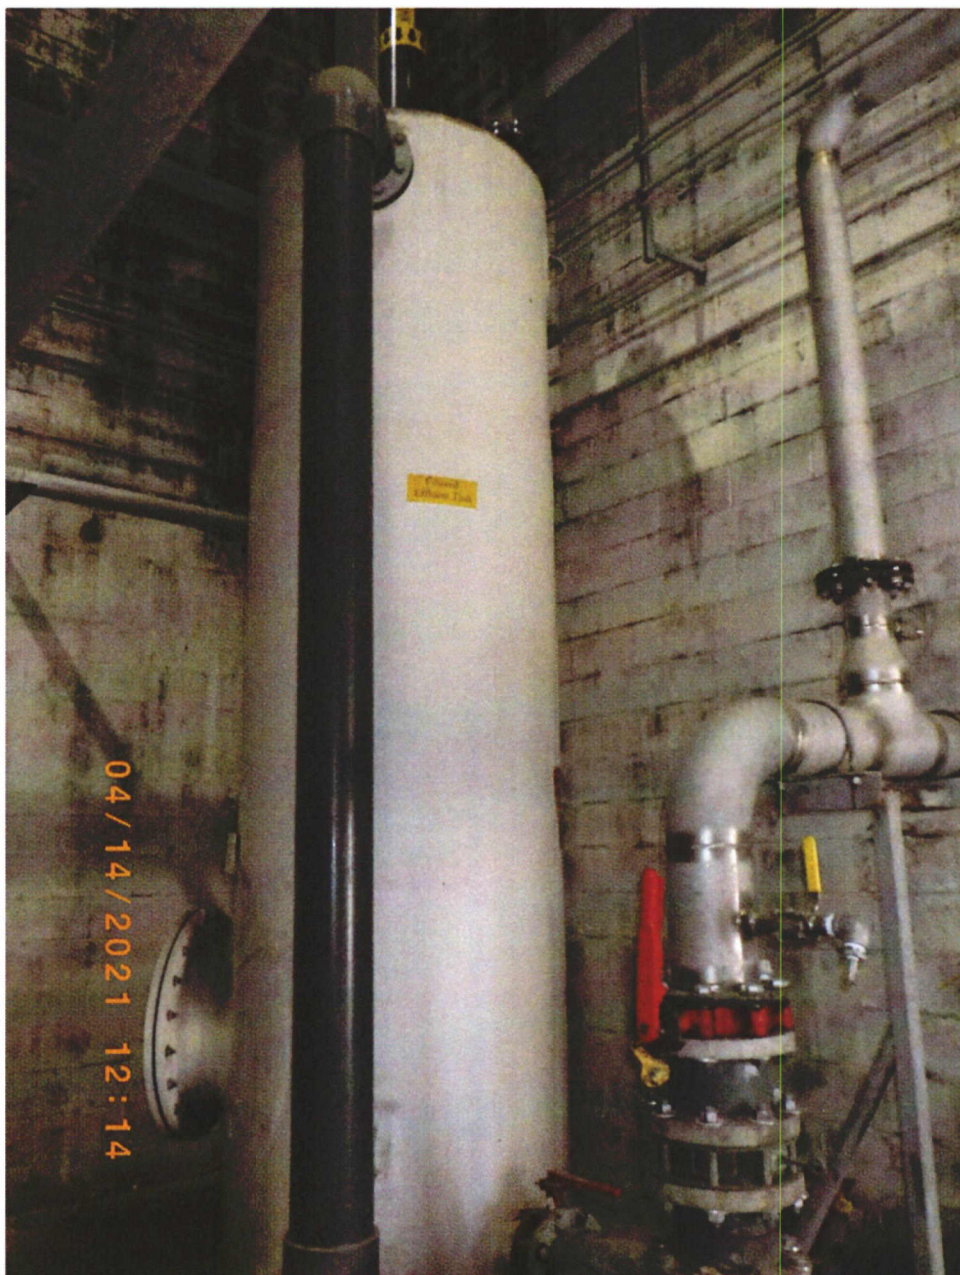
Photo 8

Description: Filtered effluent tank (following the sand filter).

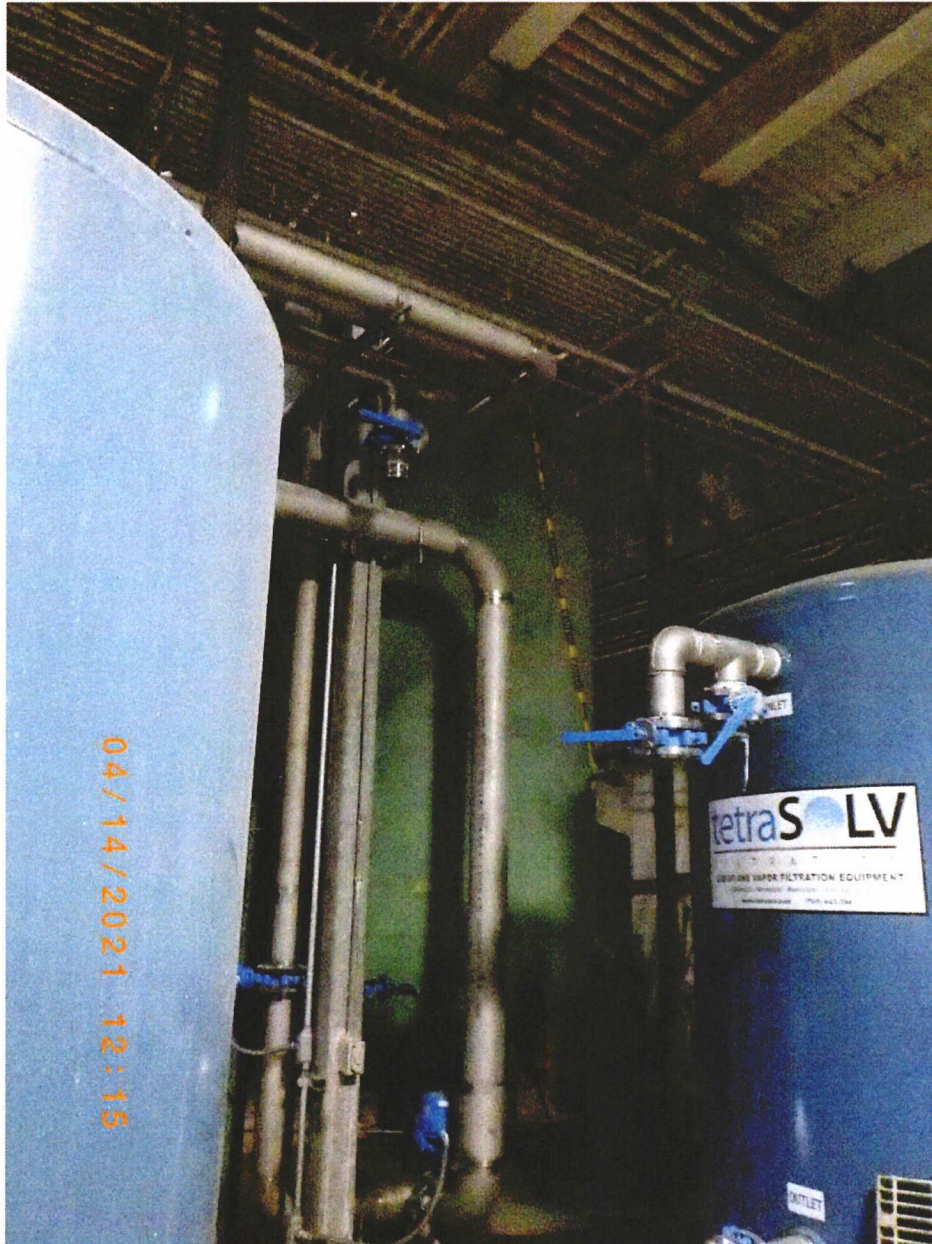
Photo 9

Description: Second sand filter (green tank). This is the fourth step in the treatment process. Water flows from the filtered effluent tank into this filter. The blue tanks in front are not currently in use, but are additional, unused filters.

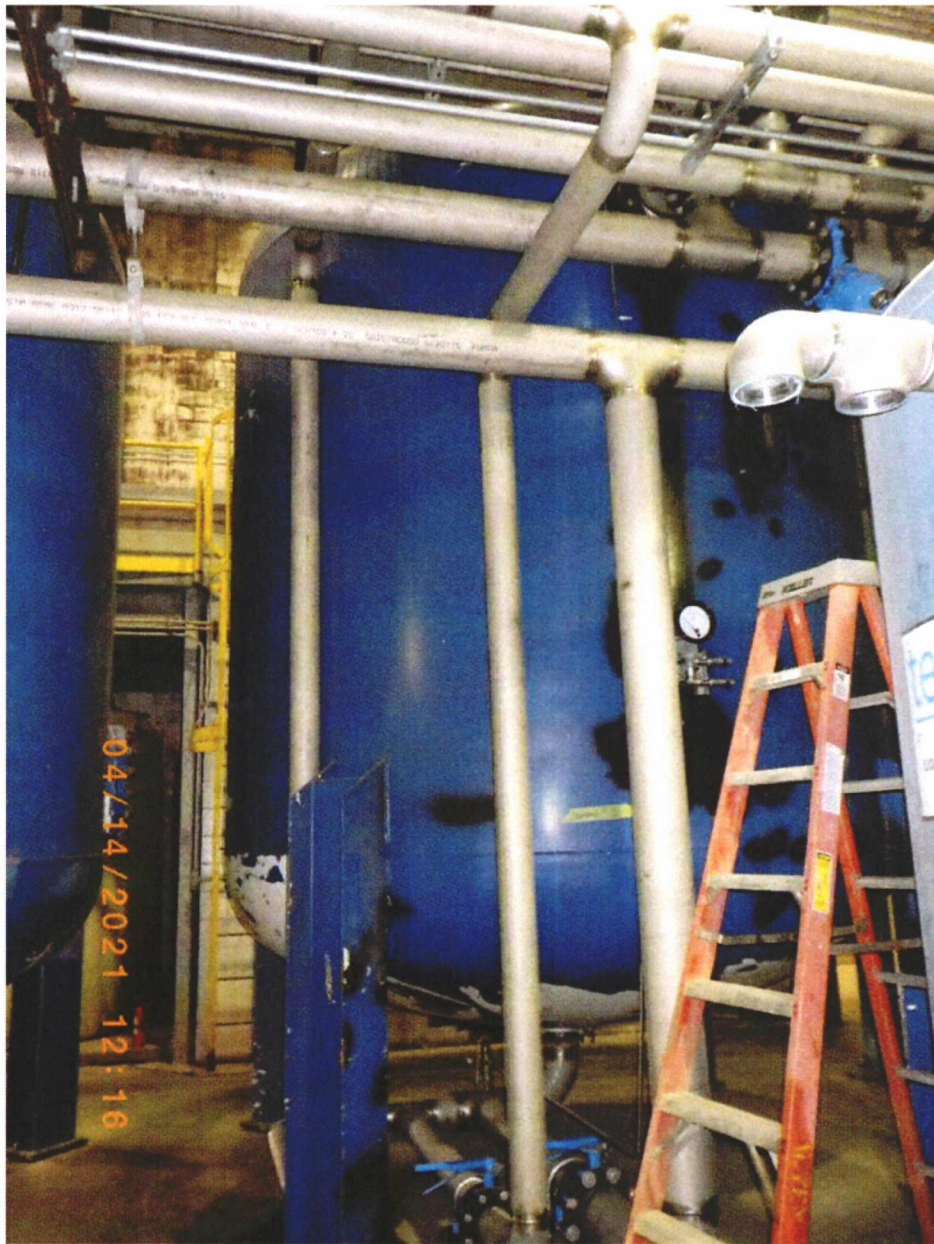
Photo 10

Description: First (right) and second (partly shown left) carbon filters, which are operated in series following sand filtration. These are the fifth and sixth steps in the treatment process. The second carbon filter (partly shown left) is the final step in AltEn's wastewater treatment system and is identical to the first carbon filter (right).
