Facility: AltEn  
IIS: 84069  
PCS: NE0137634

Mark Pomajzl  
4/28/2021

### Site Visit Check list

Facility Name/ Project Name: AltEn LLC

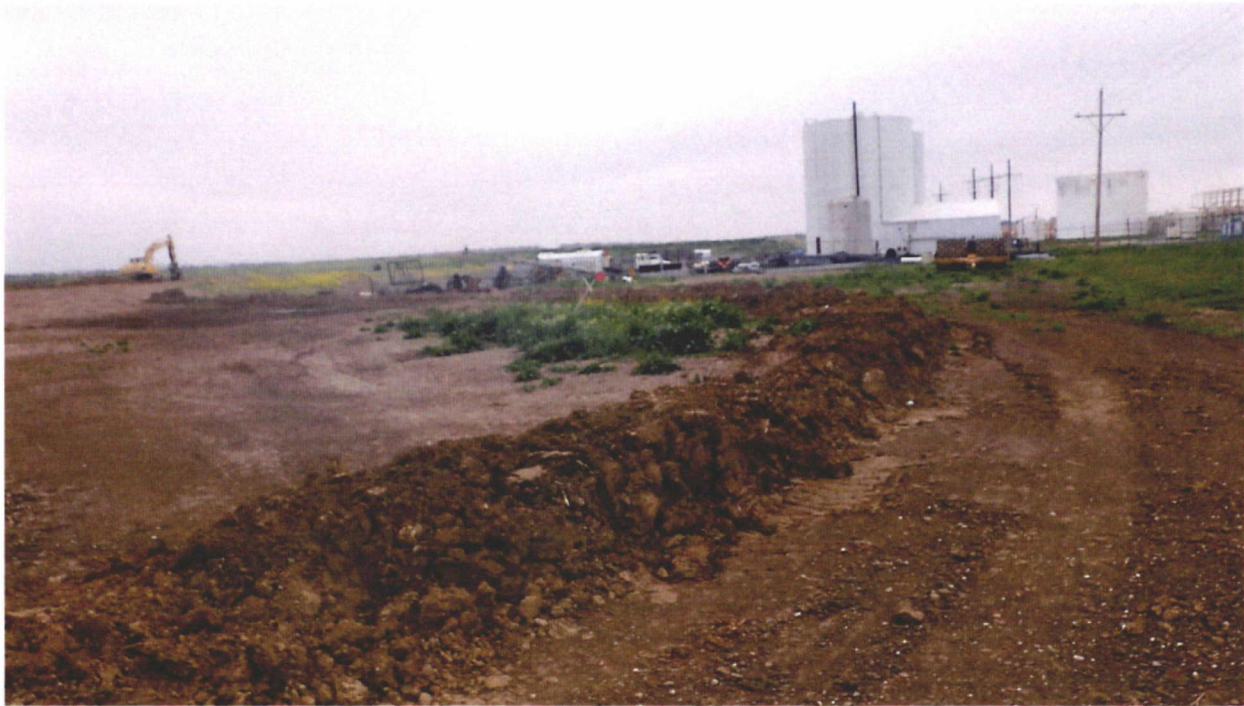
Photo: 1

Description: This is the east berm. The berm has been extended south to reduce storm water from the parking lot. The berm is not compacted.

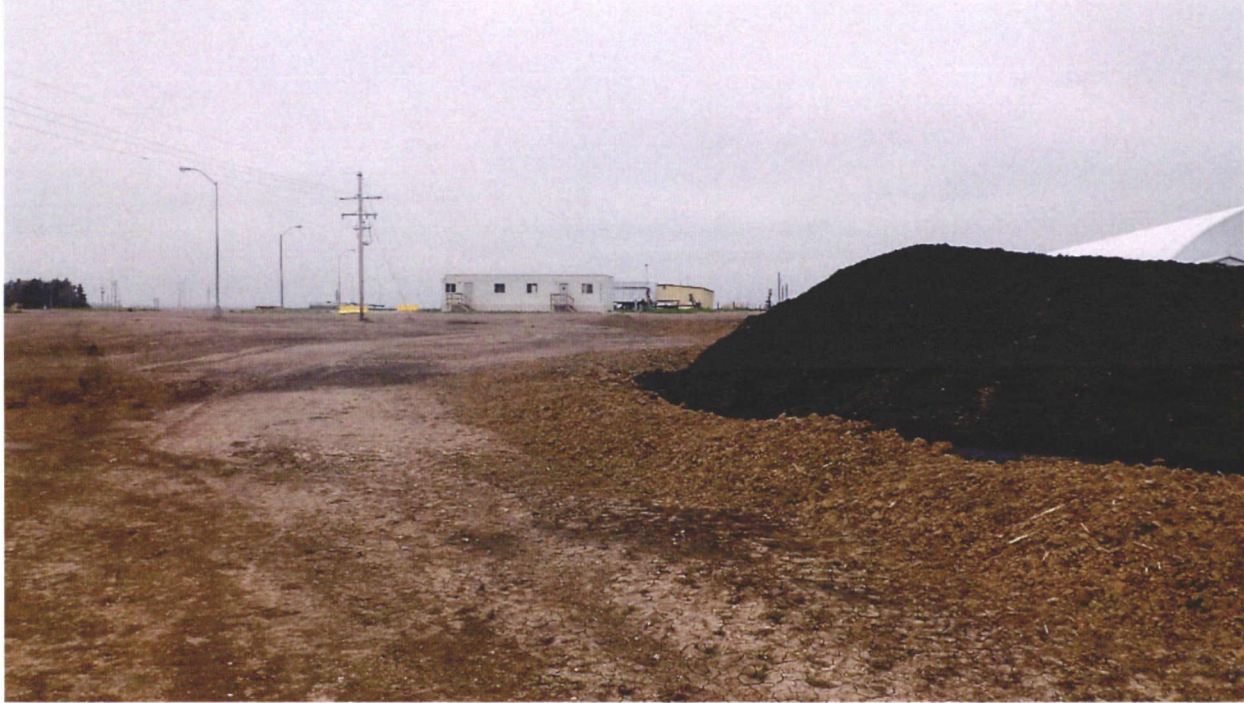
Photo: 2

Description: This photo depicts the west berm. This berm surrounds the south wet cake pile.

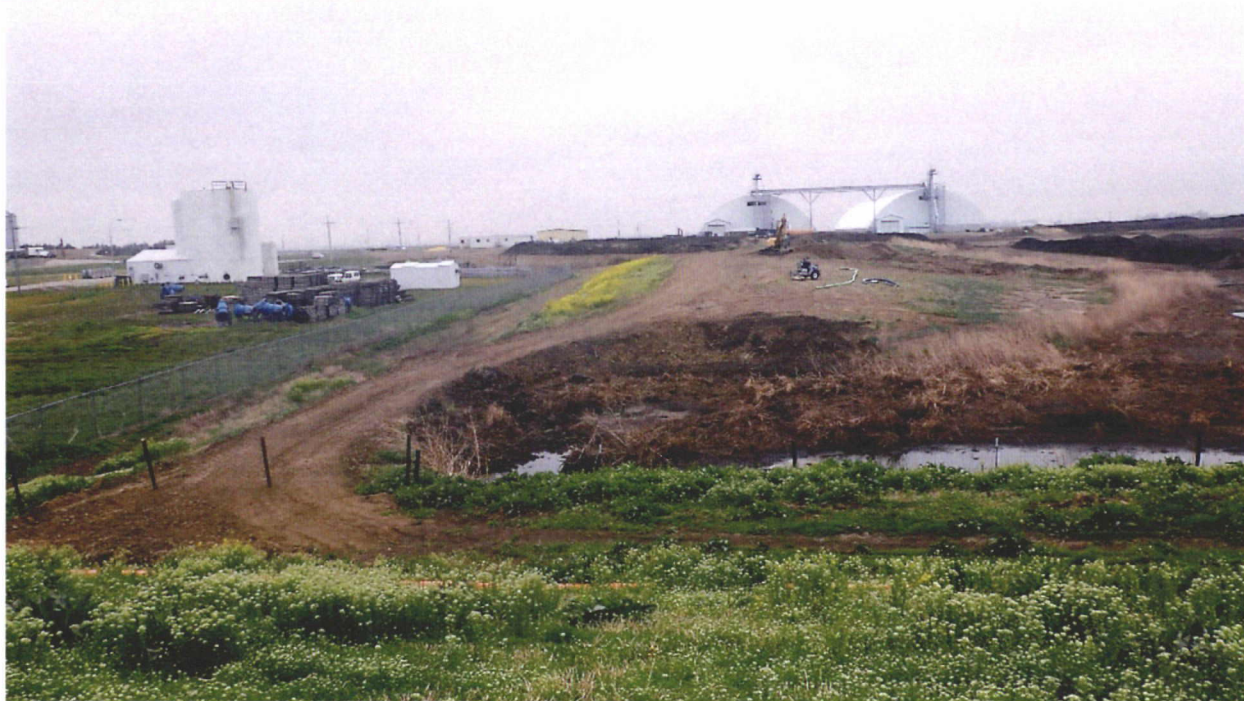
Description: This photo depicts Area 2. There is some accumulated water and no signs of seepage.

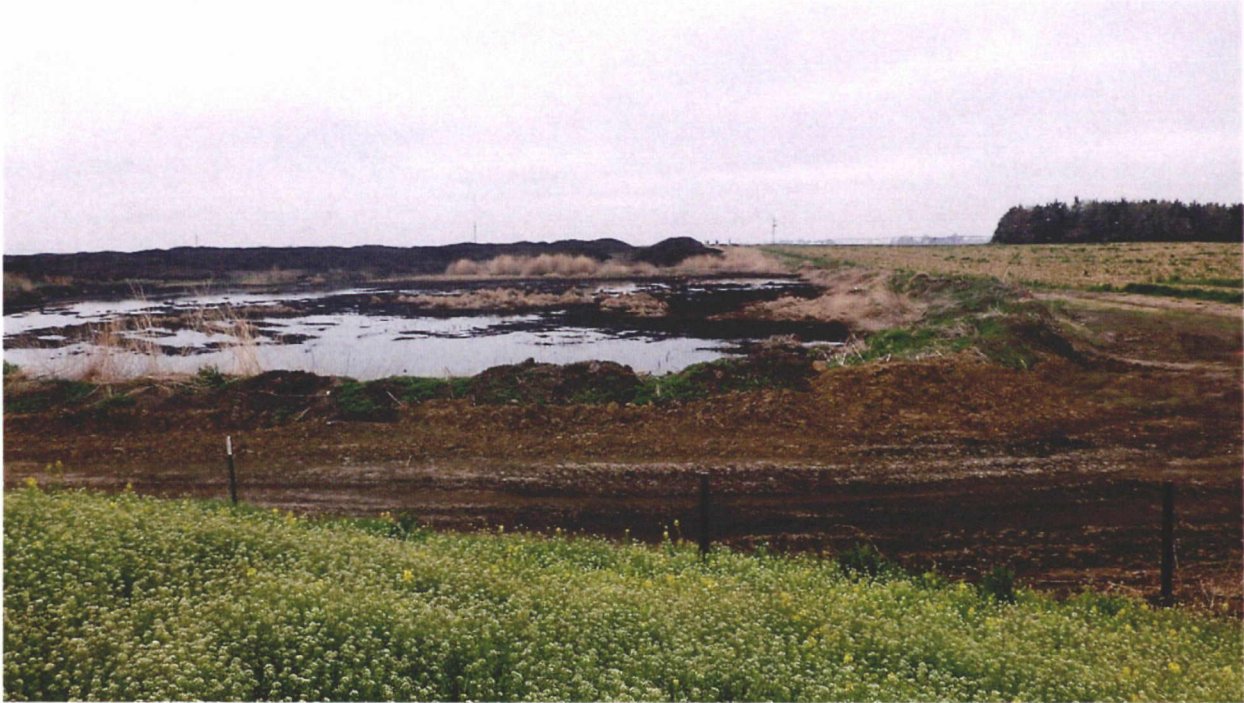
Photo: 4

Description: This photo depicts Area 3. There is some accumulated water. The facility added dirt to prevent seepage.

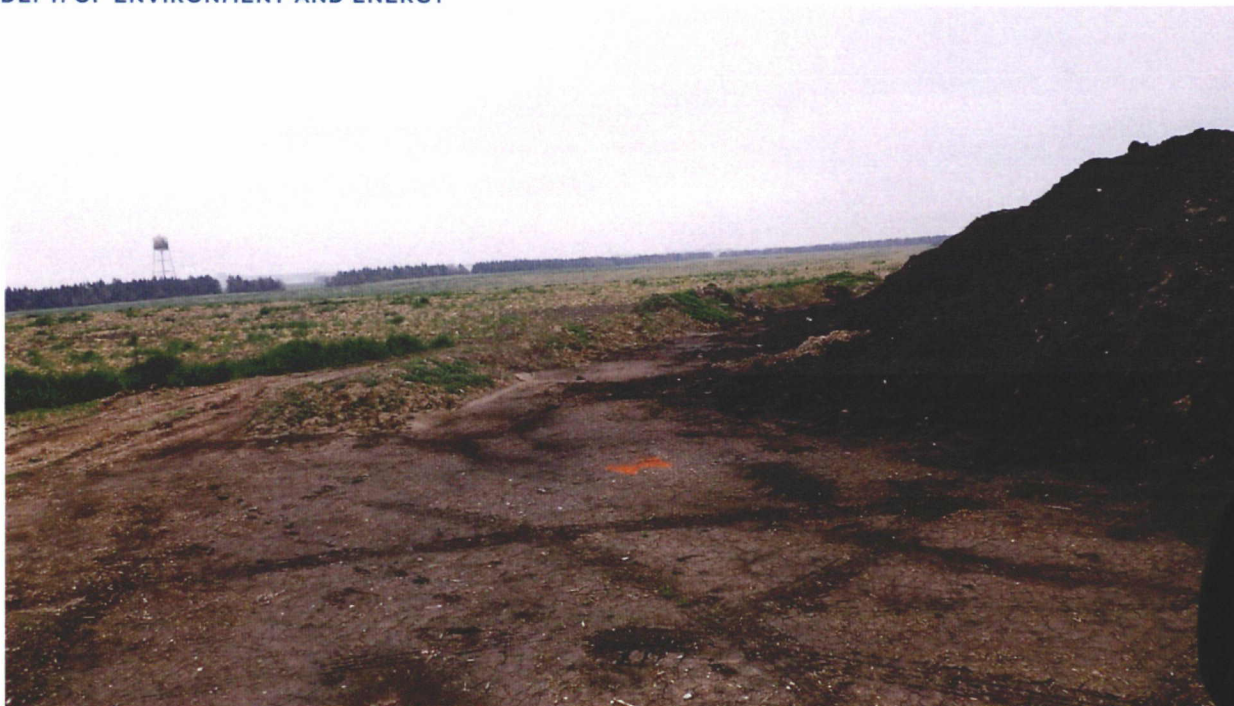
Photo: 5

Description: There is no water accumulation.

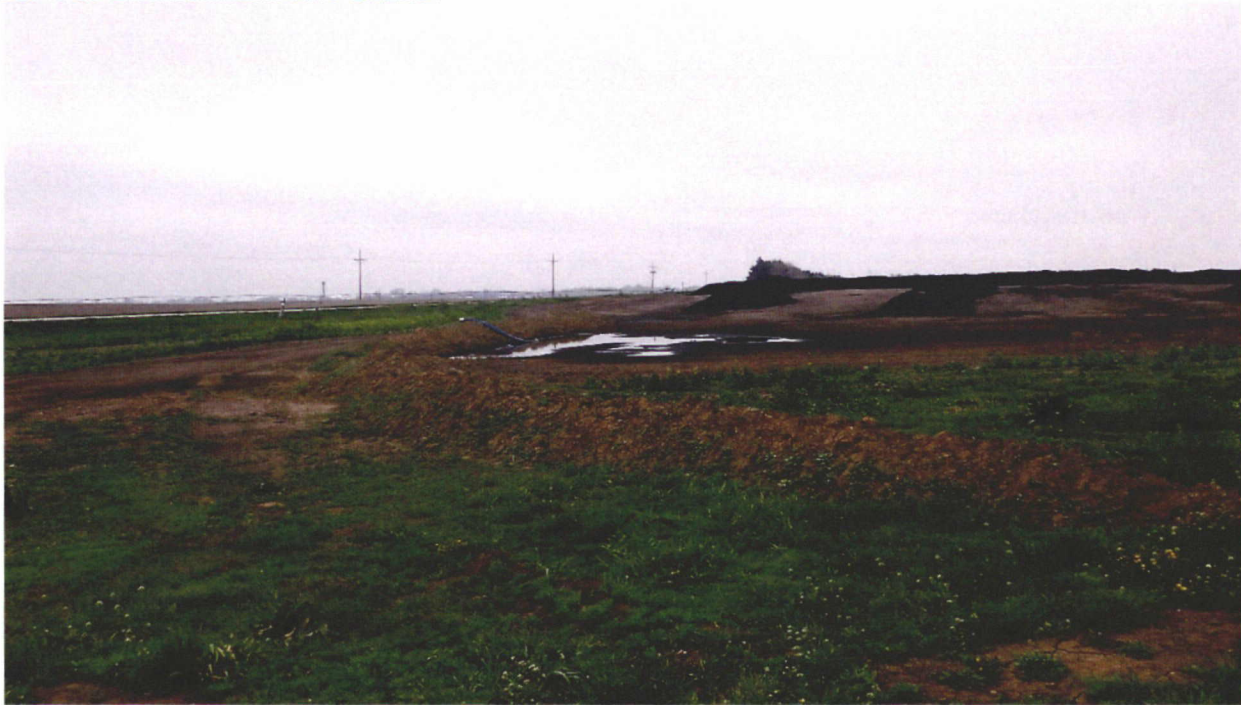
Photo: 6

Description: There is some remaining water behind area 5. There are no signs of seepage.

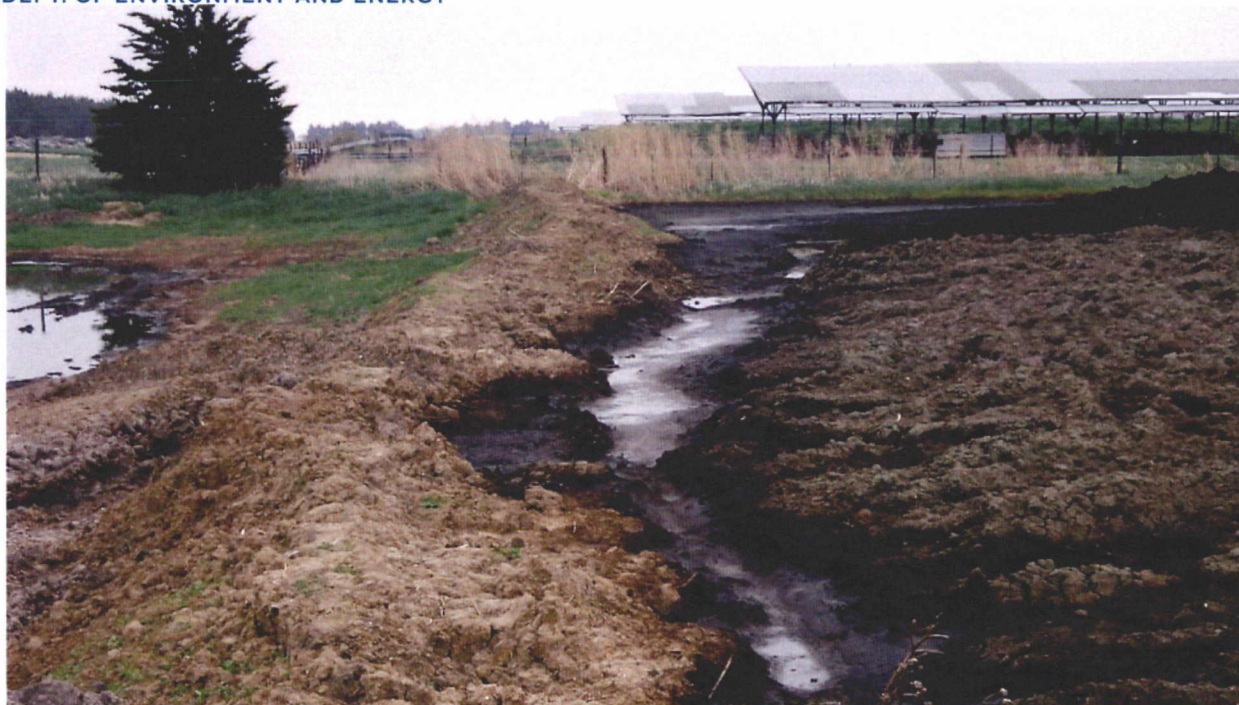
Photo: 7

Description: This photo depicts that the water level has lowered considerably. There are no signs of seepage.

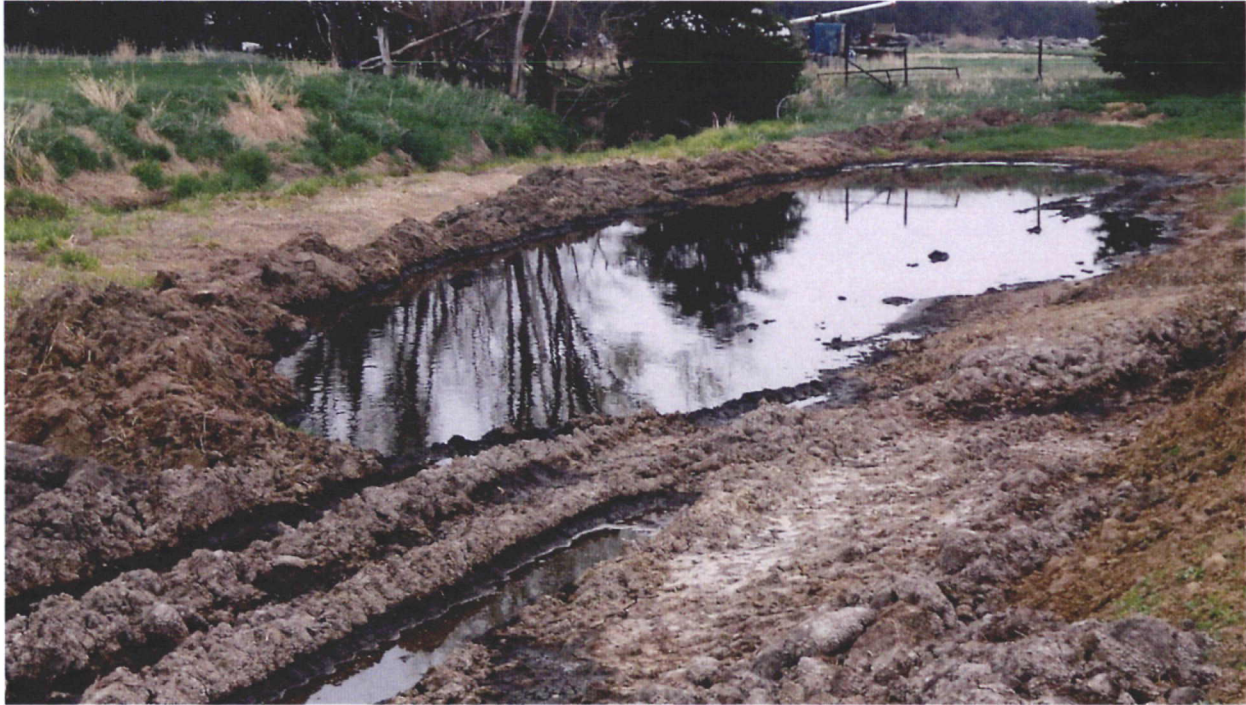
Photo: 8

Description: Area 6 contains a secondary berm. The berm was placed to provide additional storage prior to the waterway.

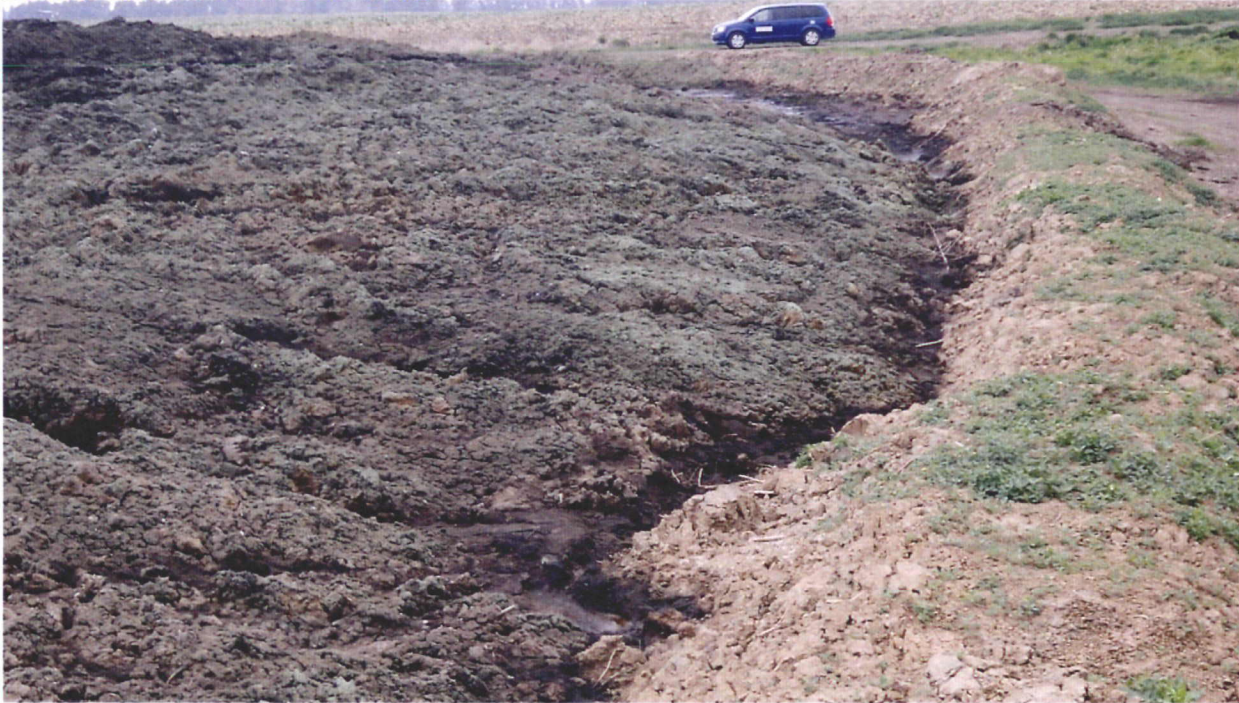
Photo: 9

Description: This photo depicts wet cake up against the berm.

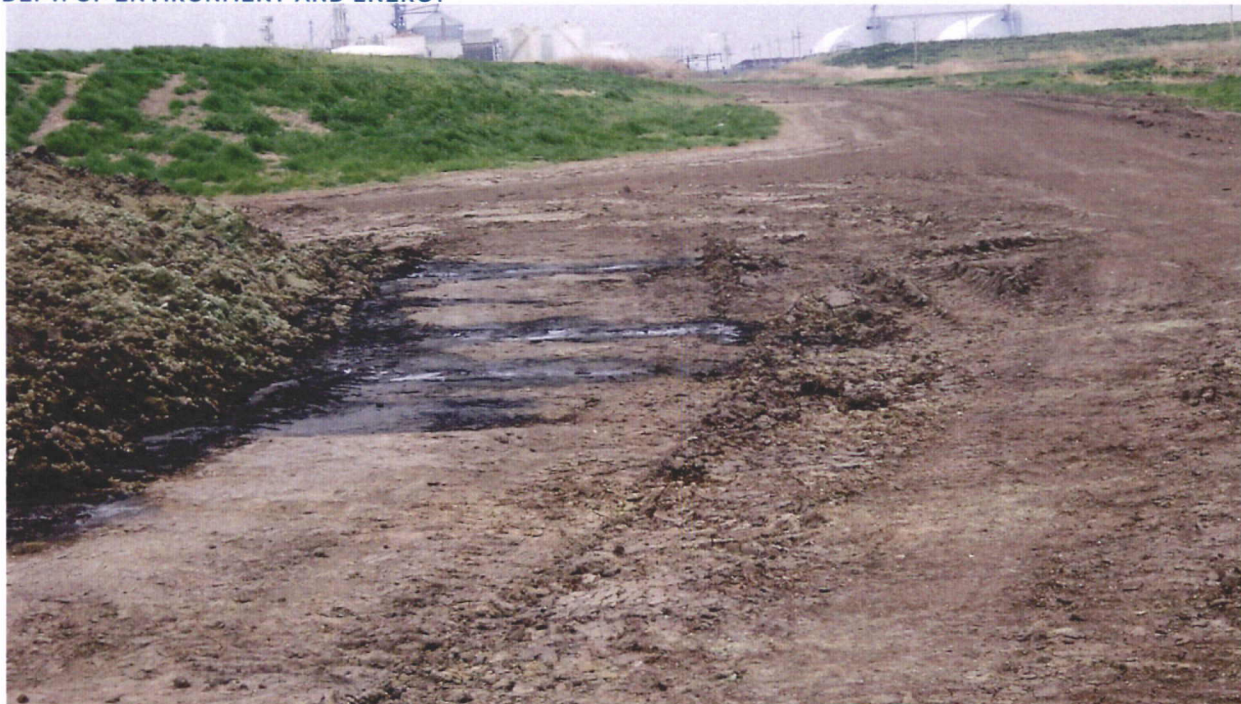
Photo: 10

- Area 1 contains two berms. The east berm has been expanded to prevent parking lot water from entering the berm area. I observed no seepage from the east or west berm.
- Areas 2, 3, 4 and 5 show no seepage.
- Area 6 shows signs of seepage along the northwest corner of the pile. There is no berm in place to contain runoff.

Description: This photo depicts wet cake seepage. It appears that wet cake is seeping north of the wet cake pile. There is no berm in this area.

Area 6 - Seepage observed on the Northwest Corner of the pile - Beam is needed to prevent stormwater discharge

- Add Beam on Northside of Area-6
- Work on Housekeeping Concerns
- Provide Daily Checks of Beams (or as often as you can)

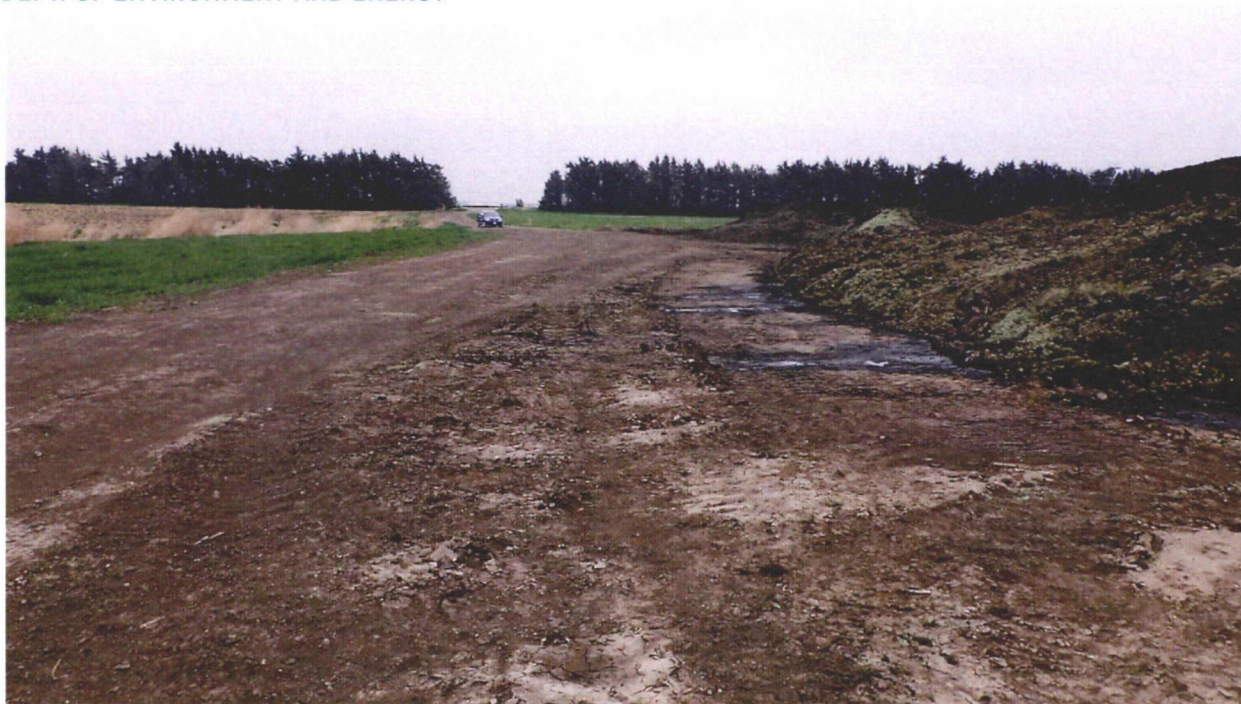
Photo: 11

Description: This photo depicts wet cake seepage. It appears that wet cake is seeping north of the wet cake pile. There is no berm in this area.

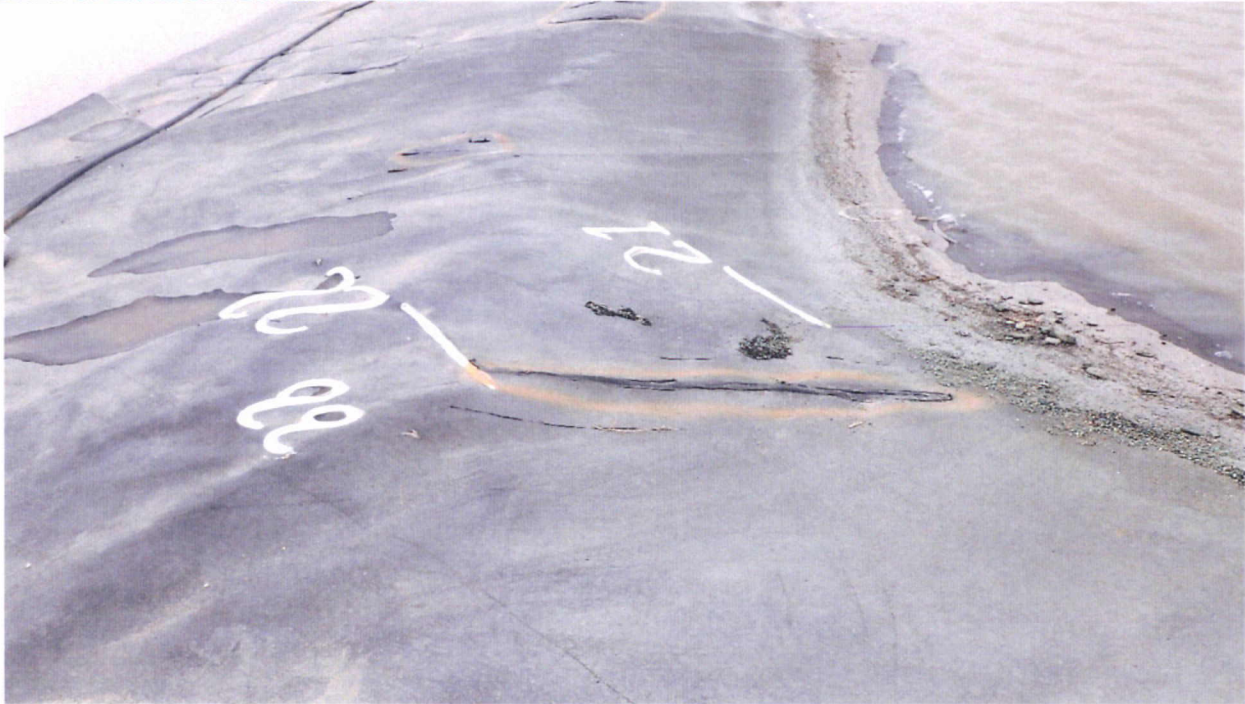
Photo: 12

- The liners note no change.
- The water level continues to lower.

Description: This photo depicts the northeast lagoon depth marker.

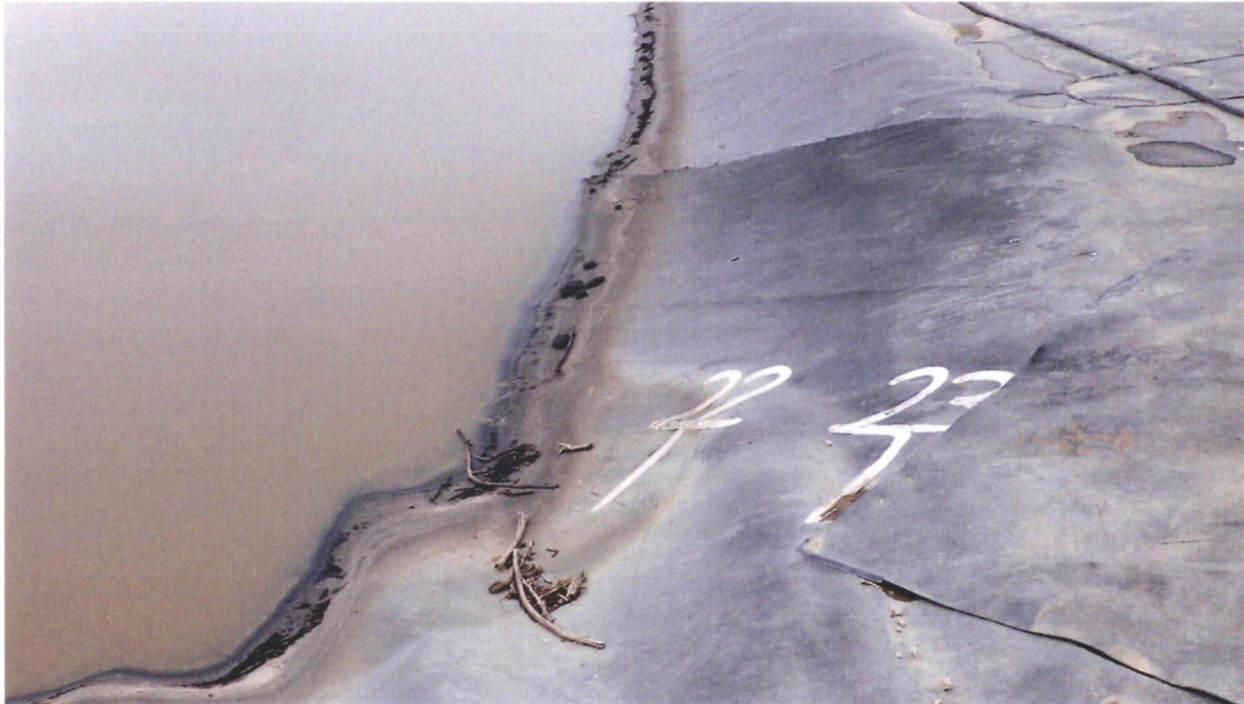
Photo: 13

- The water level continues to lower.

Description: This photo depicts the south lagoon depth marker.

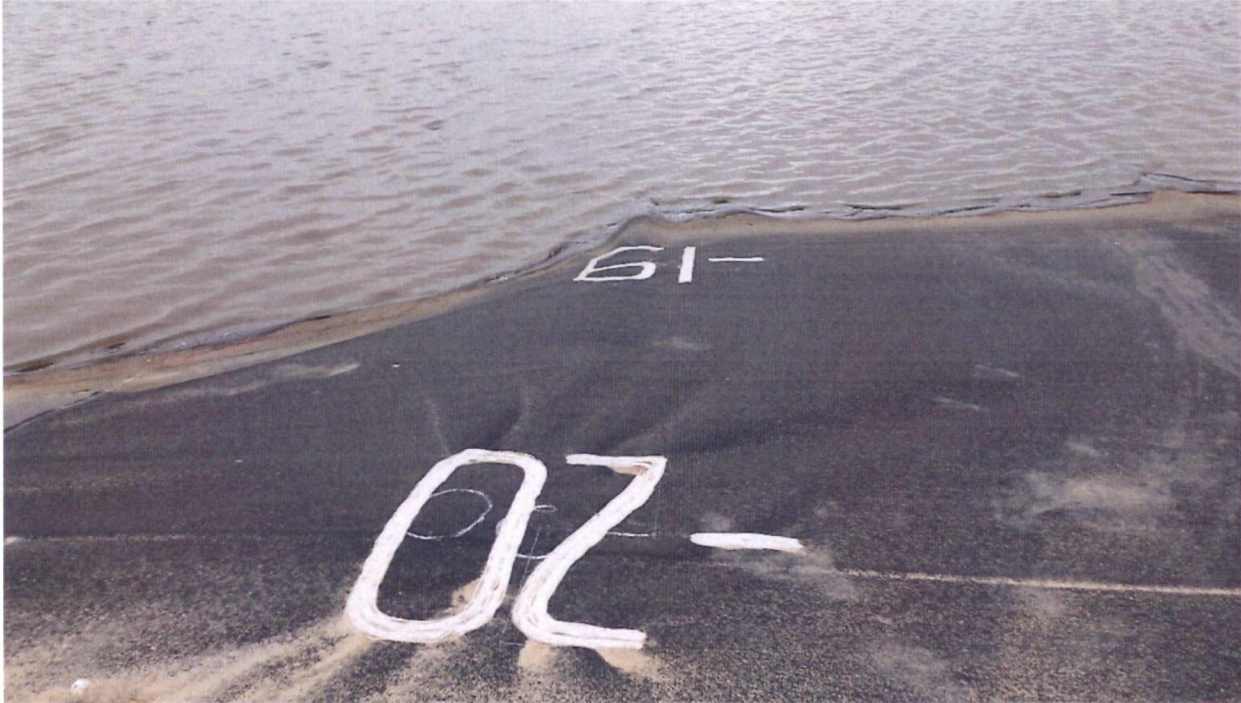
Photo: 14

Description: This photo depicts the northwest lagoon depth marker.

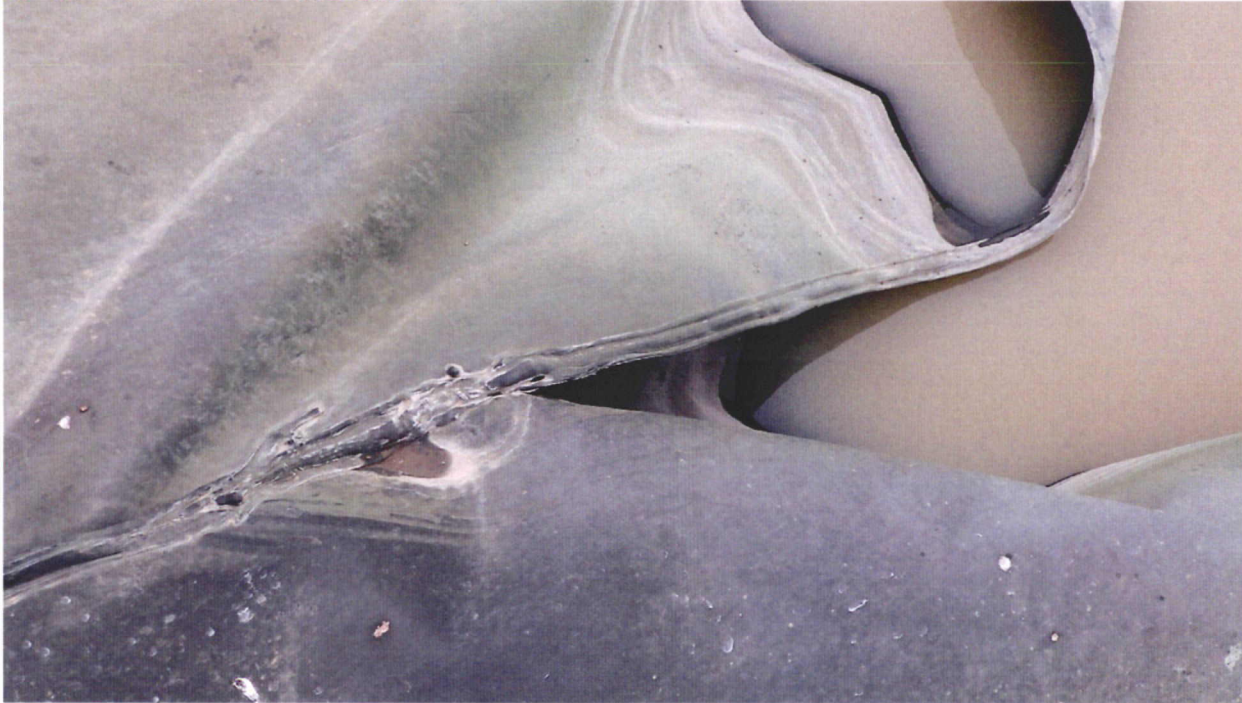
Photo: 15

Description: This photo depicts a tear in north dike of the south lagoon.

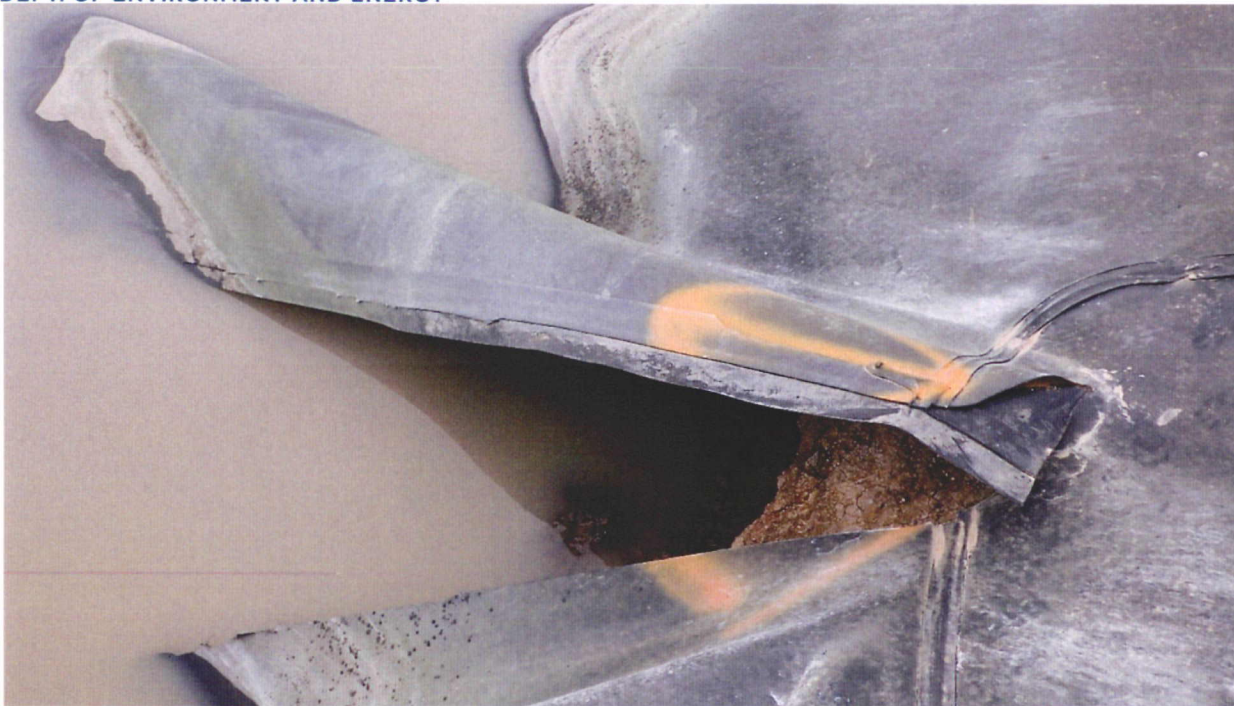
Photo: 16

Description: This photo depicts a tear in north dike of the south lagoon. This tear is west of the above photo.

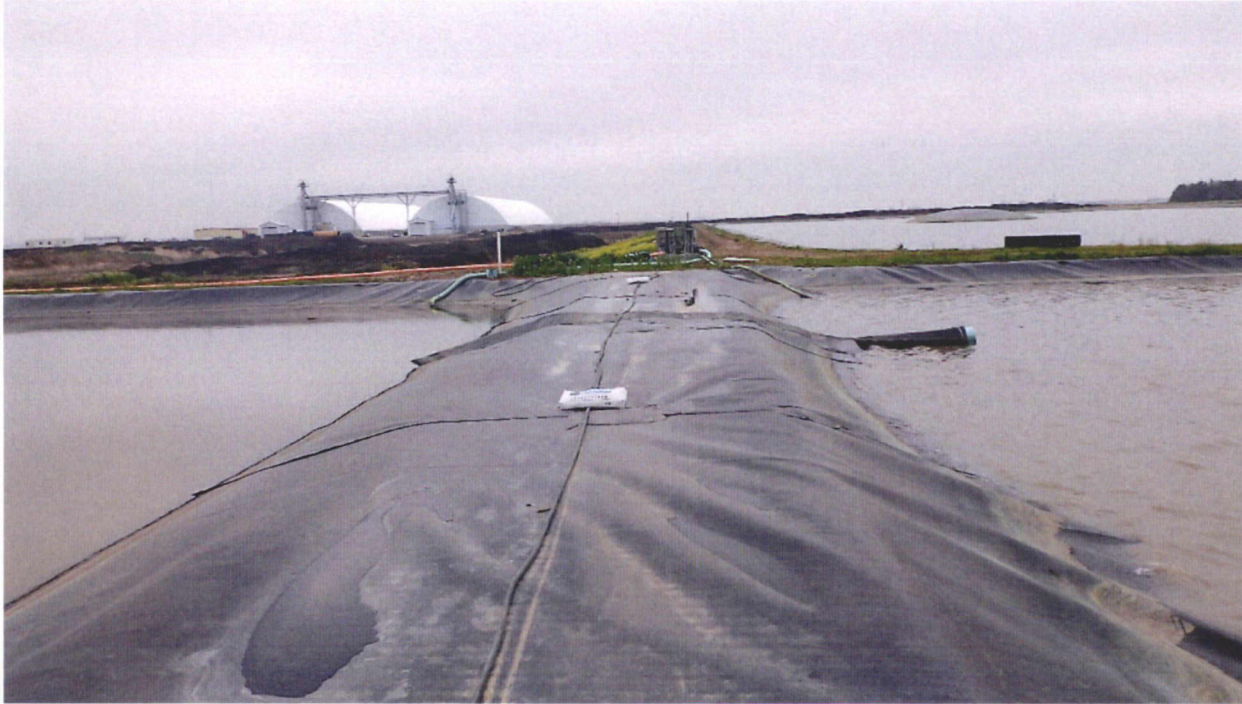
Photo: 17

Description: This photo depicts the equalization pipe between the two lagoons.

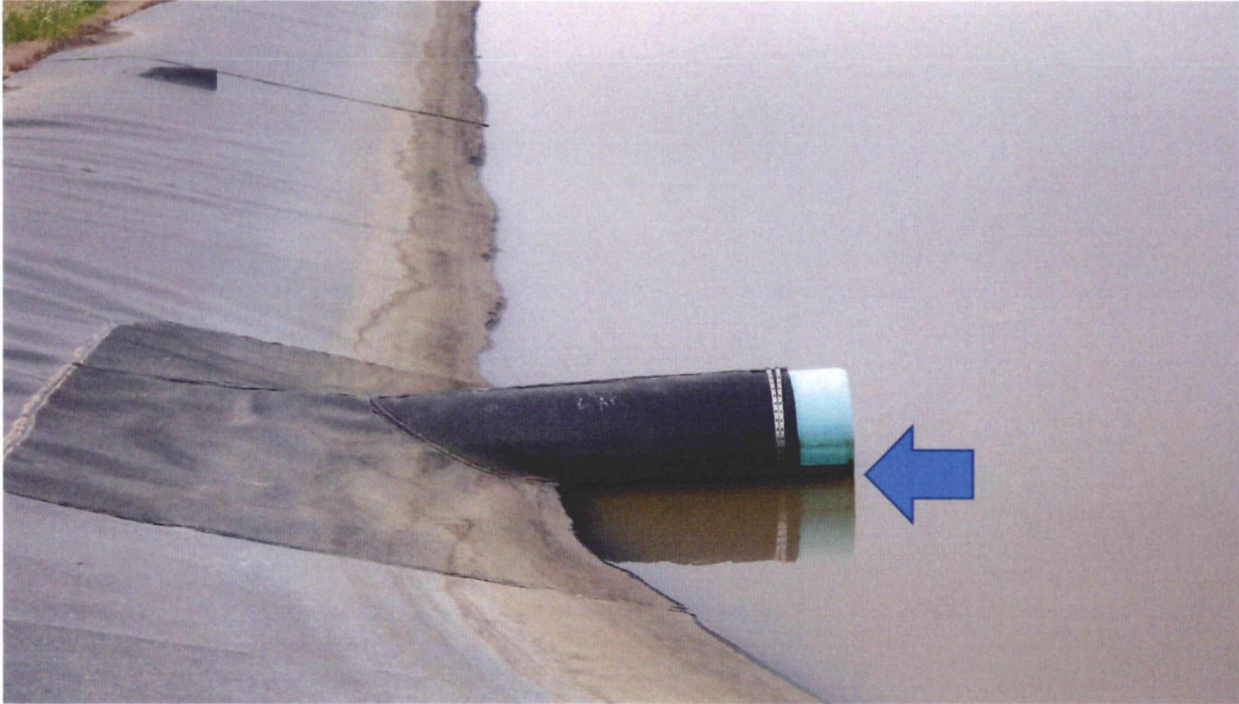
Photo: 18

- The water level is starting to drop below the equalization pipe.

Description: This photo depicts the equalization pipe between the northeast and northwest lagoon. This photo depicts that the water level is nearly below the pipe.

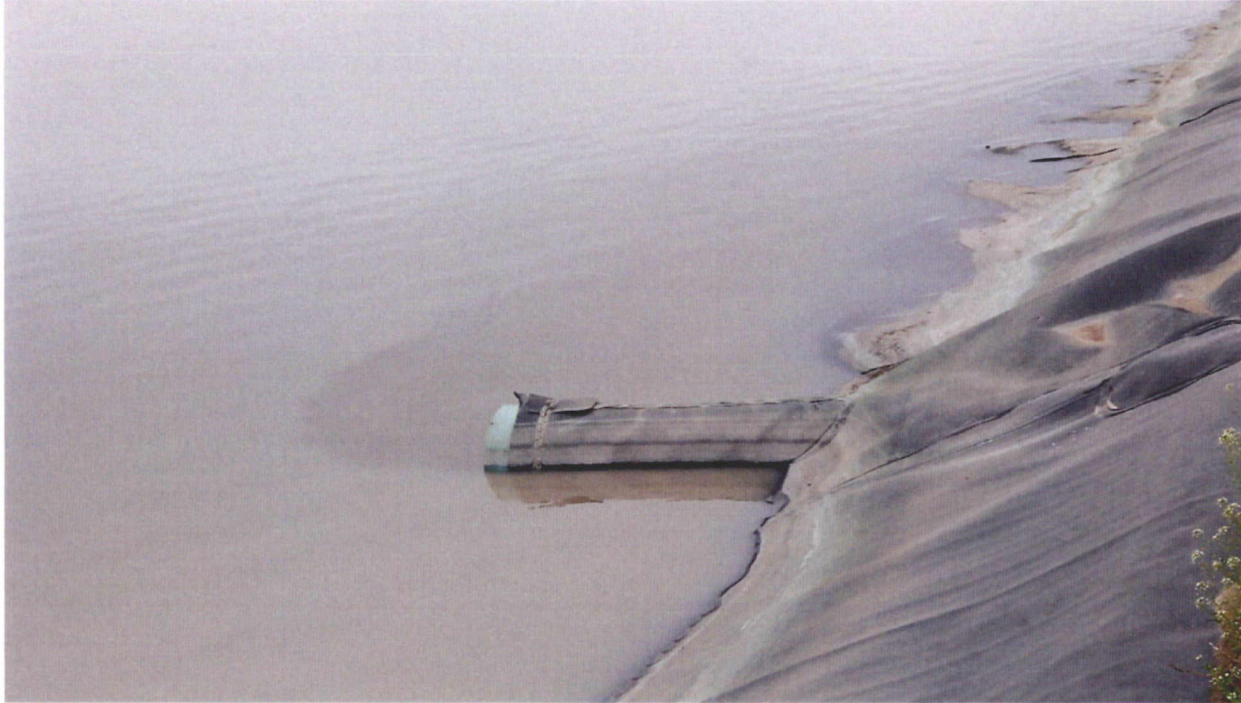
Photo: 19

Description: This photo depicts water from the northwest lagoon entering the northeast lagoon.

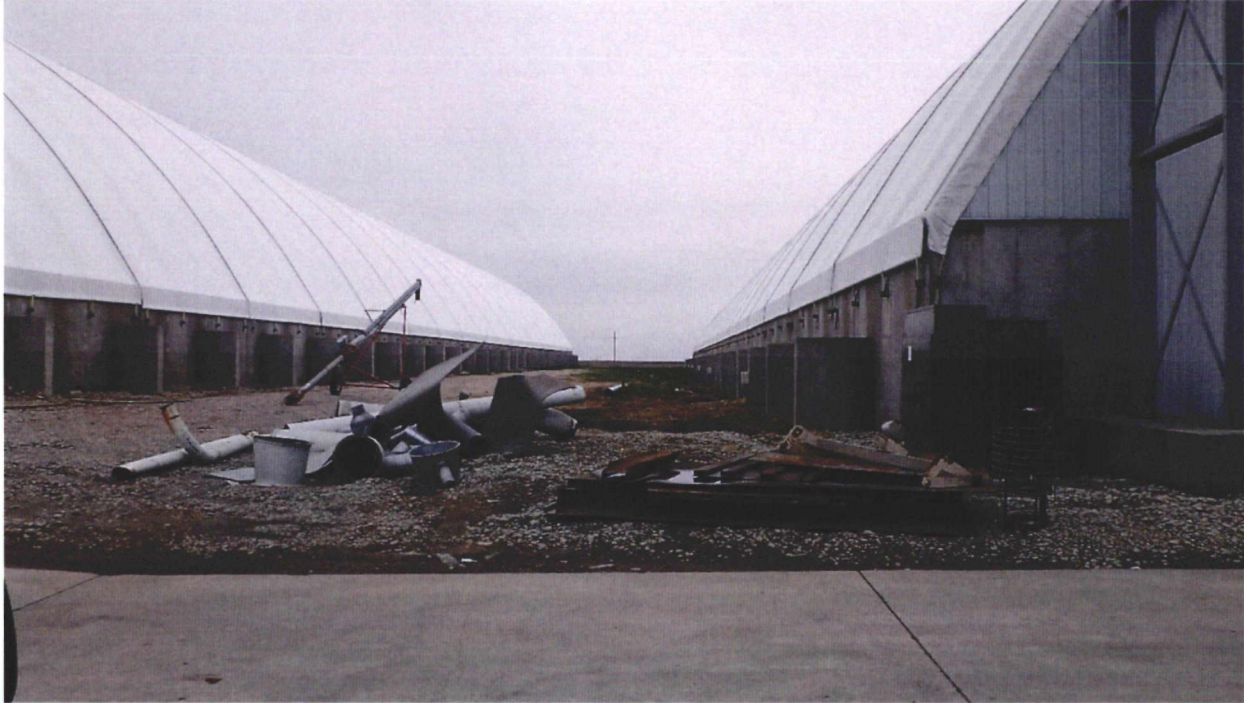
Photo: 20

- There is trash and debris observed at the hoop building.

Description: This photo depicts stored metal. There is residual grain dust observed on the metal.

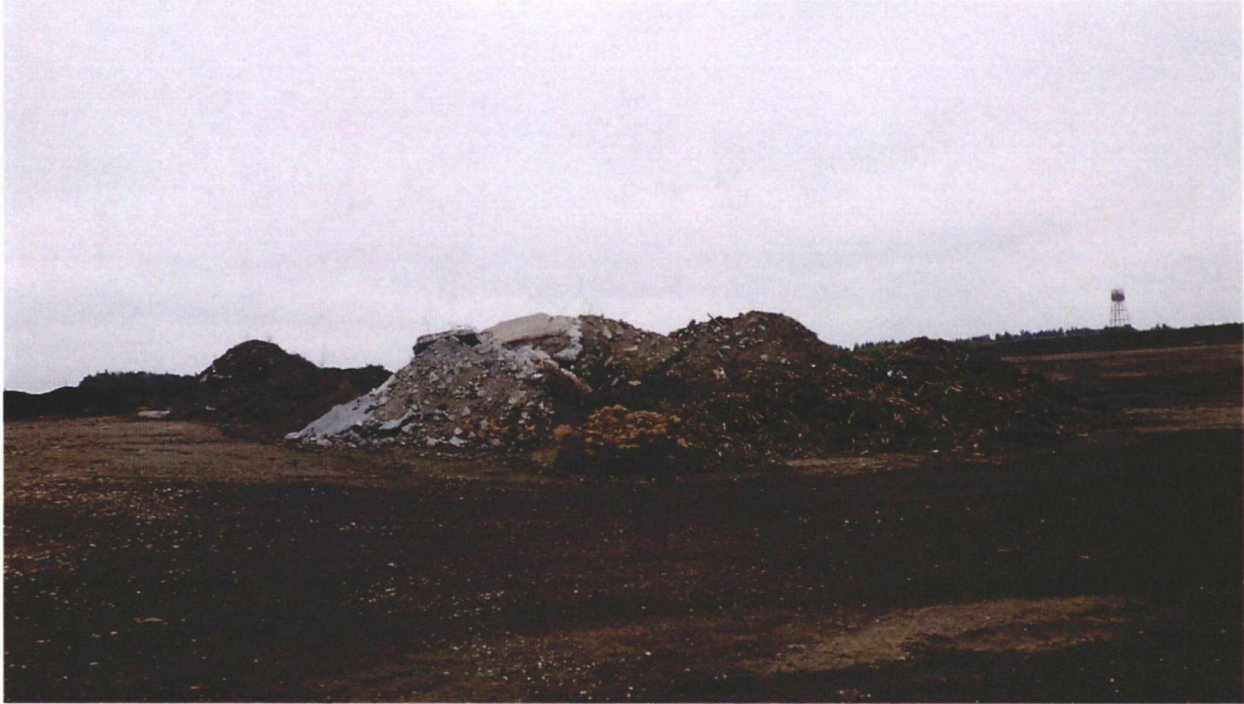
Photo: 21

Description: This photo depicts concrete waste piled north of the hoop building.

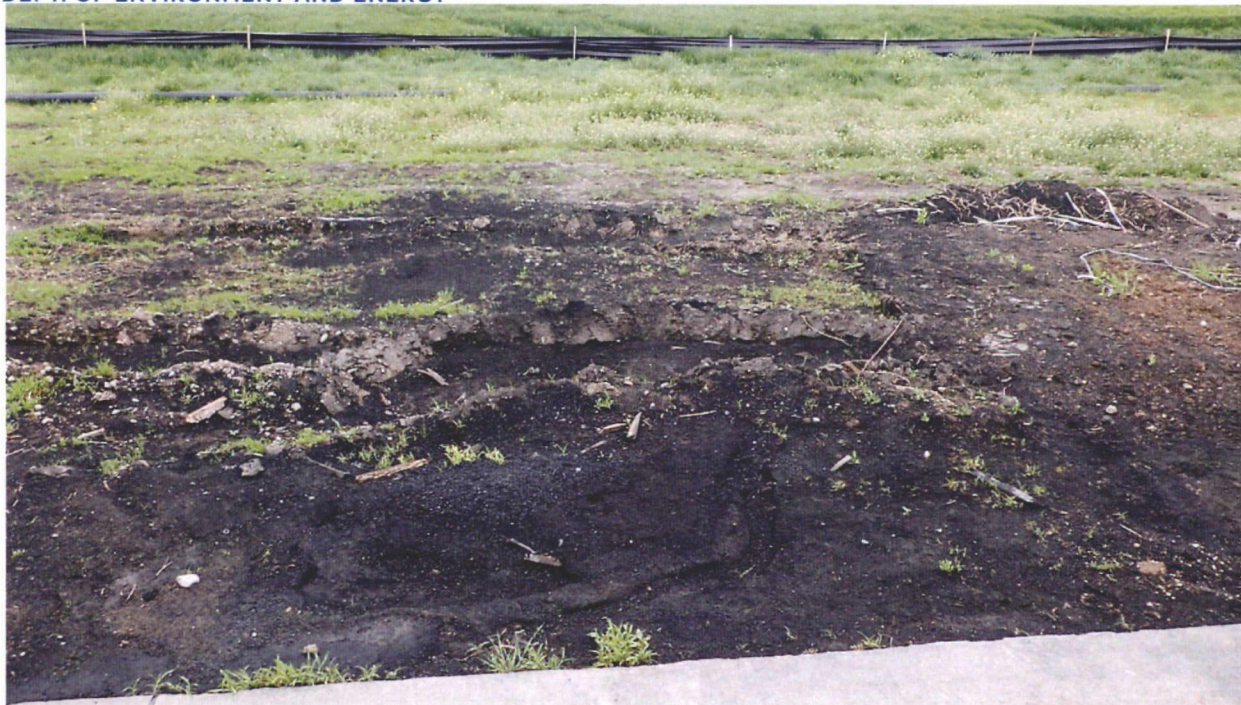
Photo: 22

- Spilled biochar product.
- Trash and debris observed.

Description: This photo depicts biochar spillage. Biochar will wash into the waterway south of the biochar unit.

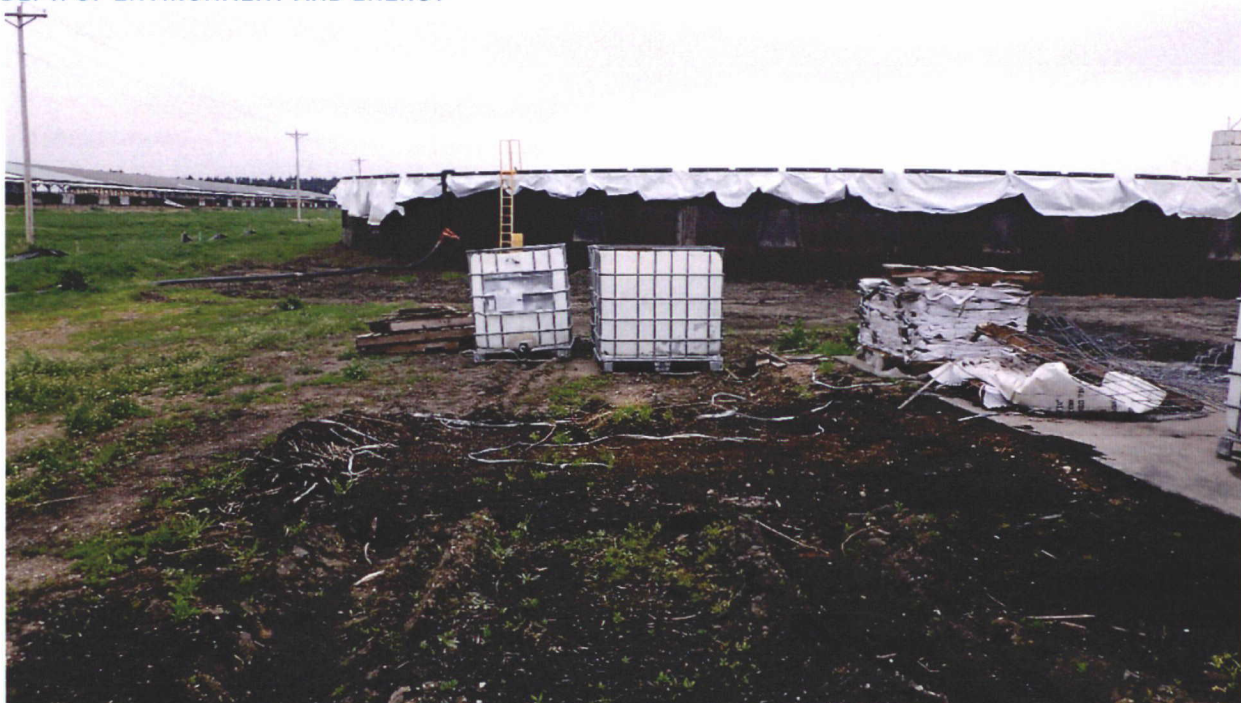
Photo: 23

Description: This photo depicts empty chemical totes, trash and spilled biochar product.

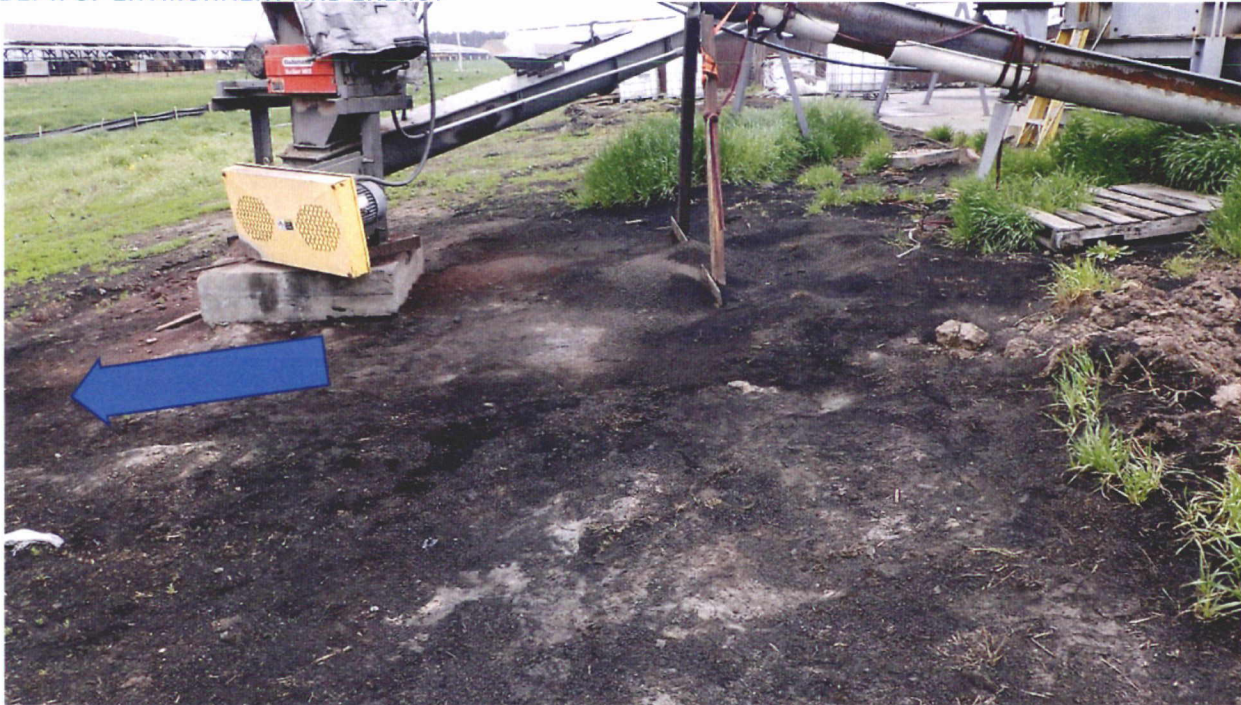
Photo: 24

Description: This photo depicts spilled biochar product. This area also slopes south to a waterway (arrow).

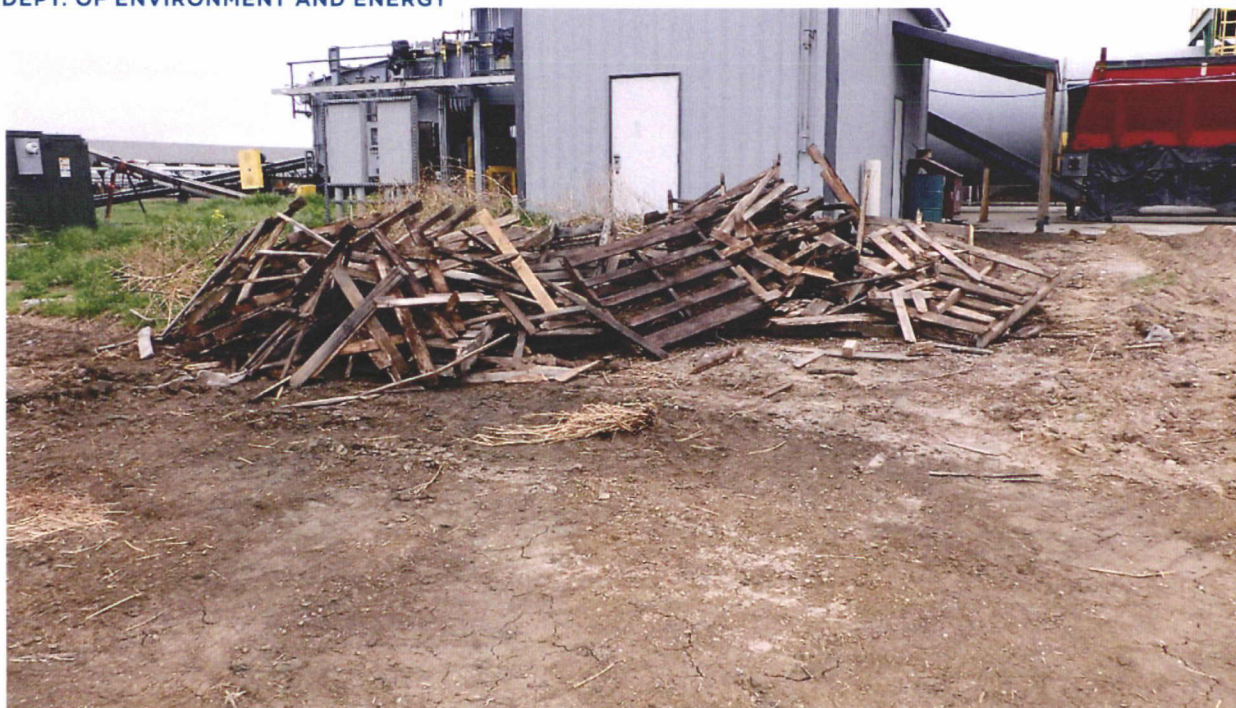
Photo: 25

Description: This photo depicts trashed pallets.
