Facility: AltEn  
IIS: 84069  
PCS: NE0137634

Mark Pomajzl  
4/28/2021

### Site Visit Check list

Facility Name/ Project Name: AltEn LLC

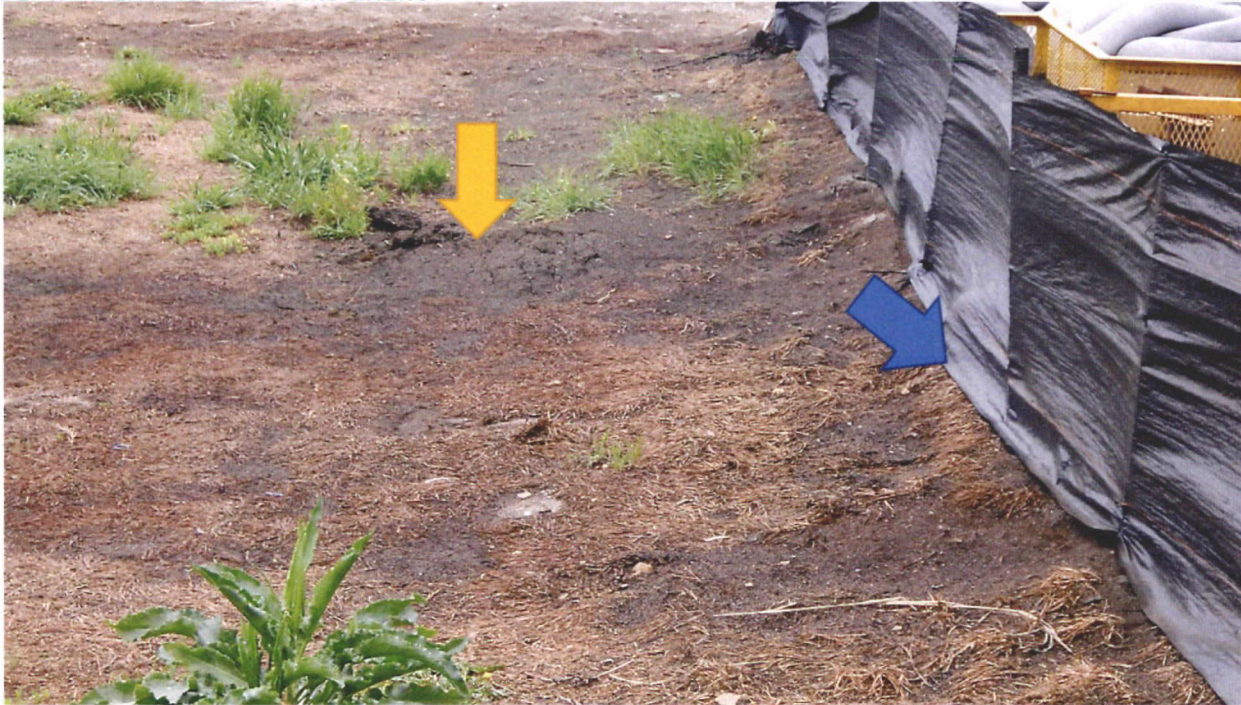
Photo: 26

Description: This photo depicts an incorrectly installed silt fence (blue arrow). The silt fence is not trenched in which causes undercutting. The silt fence has allowed sludge material to discharge (yellow arrow).

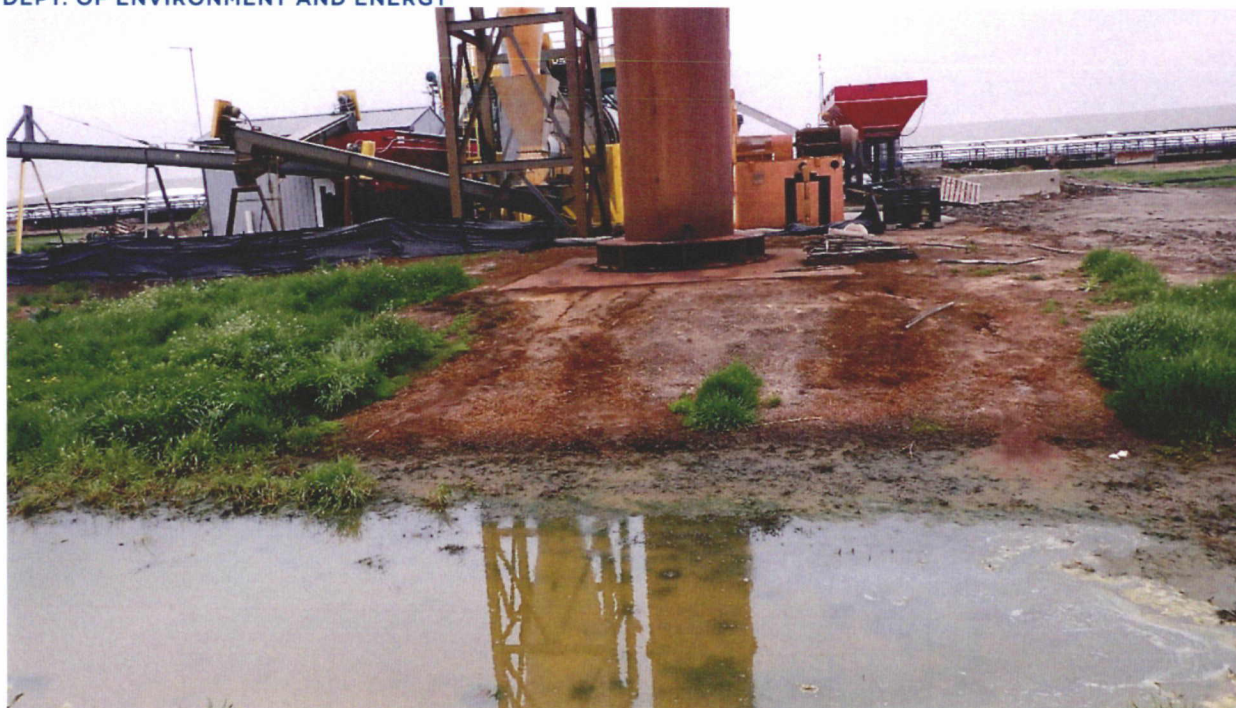
Photo: 27

Description: This photo depicts staining and dead vegetation from the biochar unit. Stormwater runoff enters the ditch north of the unit.

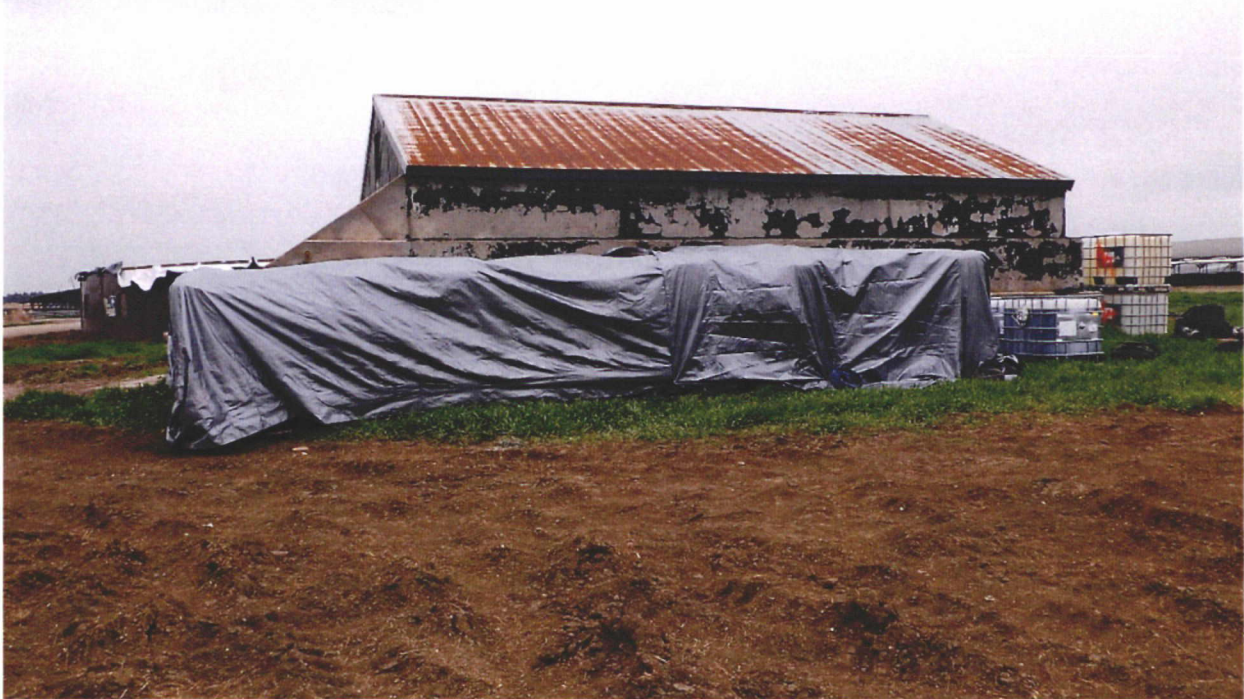
Photo: 28

Description: Clean Harbors has covered the granular chemical totes. The inspection on April 23 noted spilled chemical. This inspection noted that the facility has cleaned the area.

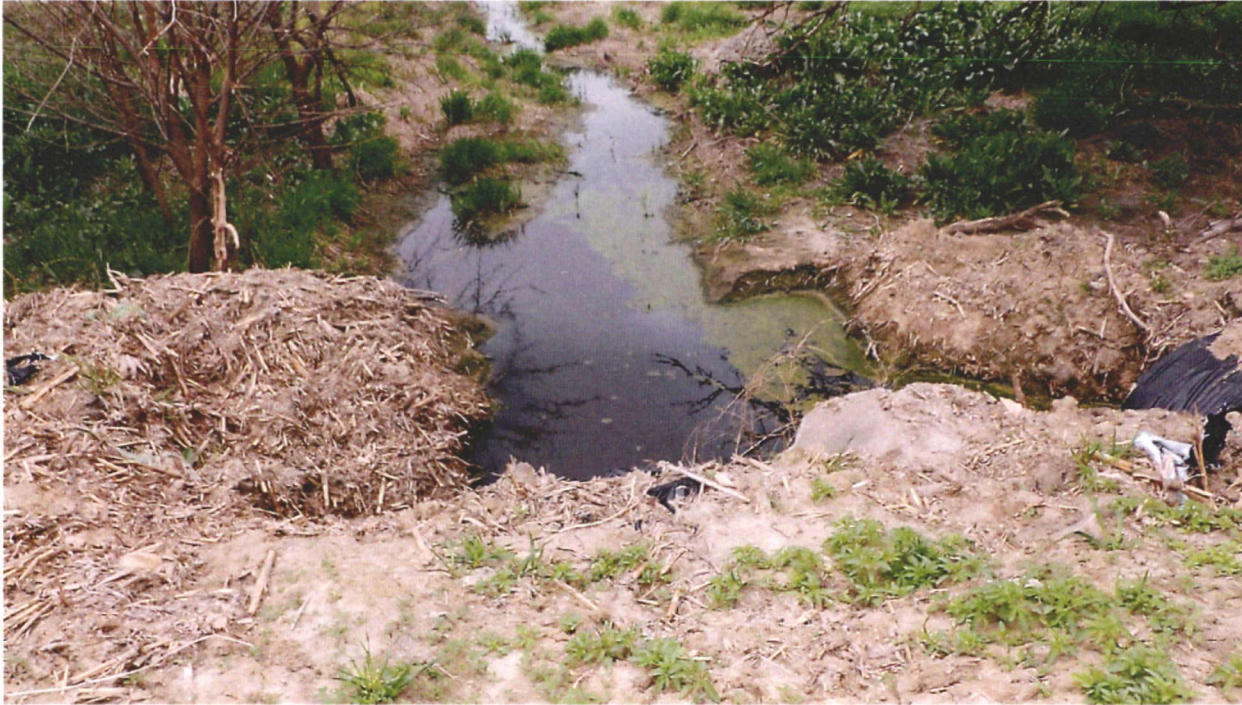
Photo: 29

Description: The water in the ditch is becoming cloudy and has some algae growth.
