RE: ALT EN LLC
MEAD, NEBRASKA

NDEE FAC ID: 84069

PROGRAM ID: 021221-NH-0845

DATE: February 21, 2021

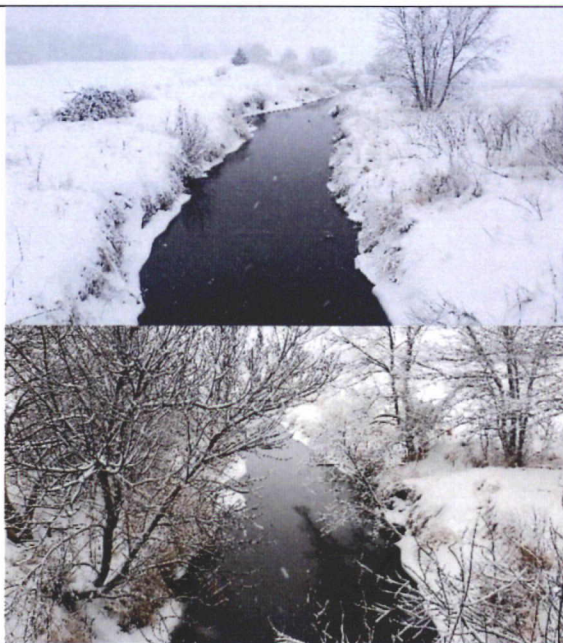
**STOP 1 – HIGHWAY 66 WEST of
ASHLAND GUN CLUB**

Current heavy snow and fog.
No noticeable discolored water or odor.

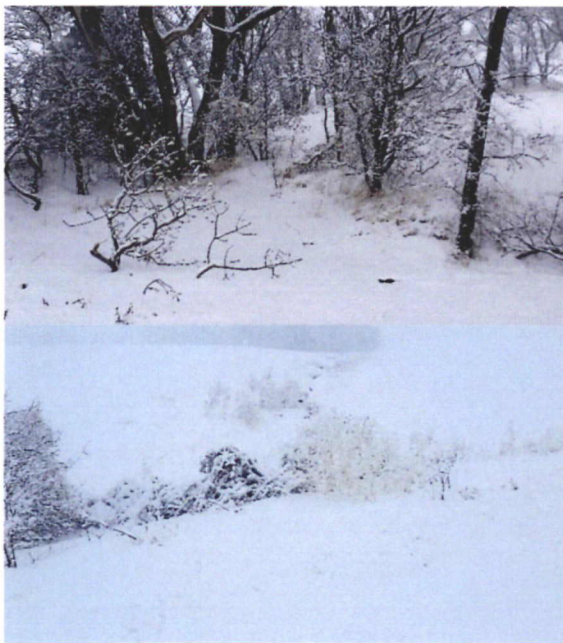
**STOP 2 – North of the Intersection of
COUNTY ROADS 6 & F**

Stream covered in snow/ice.

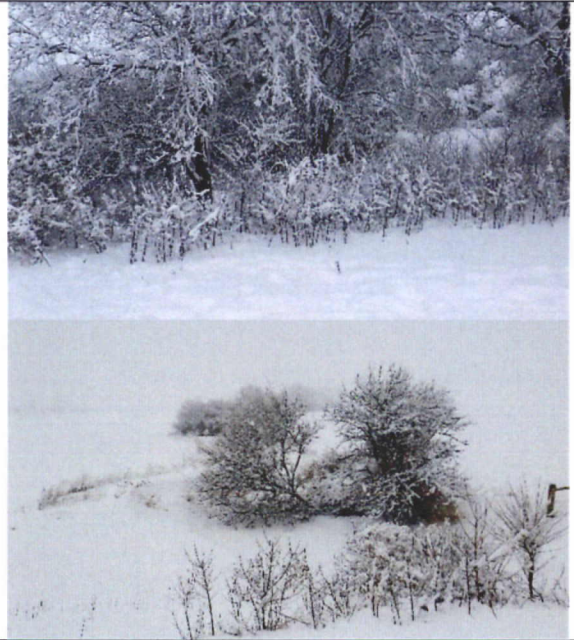
STOP 3 – Road 7/Highway 66

Did not want to pull too far off the road as slick conditions would have allowed vehicle to slide down the side slope. Also, due to very heavy fog, did not want to leave vehicle on the road while out taking pictures as possible oncoming cars may have been coming and visibility was less than 1/8 to 1/4 mile. Pictures taken very rapidly while getting out of the vehicle momentarily.

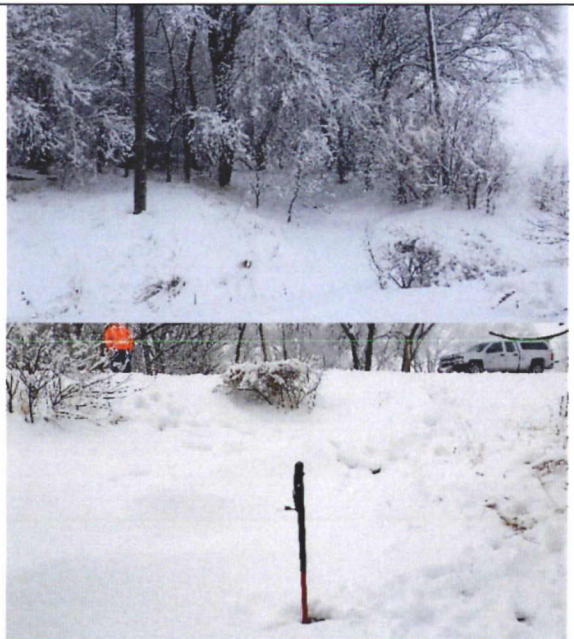
STOP 4 – County Road 8, North of Road H

There had been a hole in the ice from a previous investigation done by G. Michl. Chopped the new ice out of the hole with a chipper. Ice was likely 15 inches thick. Water was no more than an inch or two in the bottom of the hole. Some livestock smell in the hole and on the ice chisel.

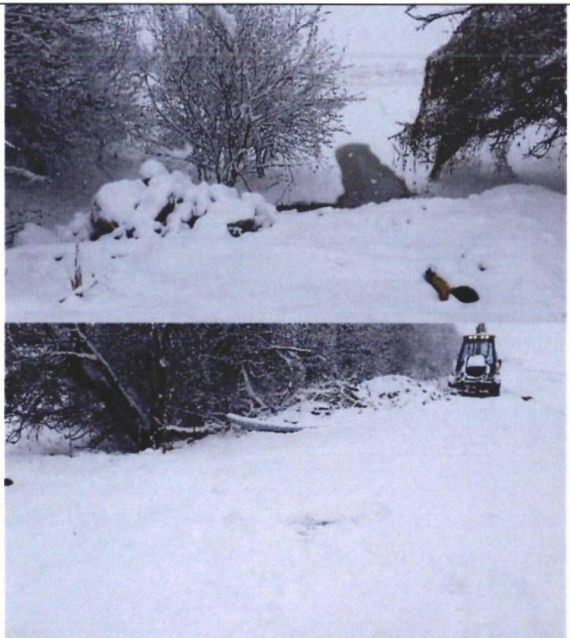
**STOP 5 – UN-L Eastern Extension – North
of County Roads 9 & J**

Water is open to slush covered upstream.
Water appeared to be dark.

Tractor/PTO set up to pump water from the
stream.

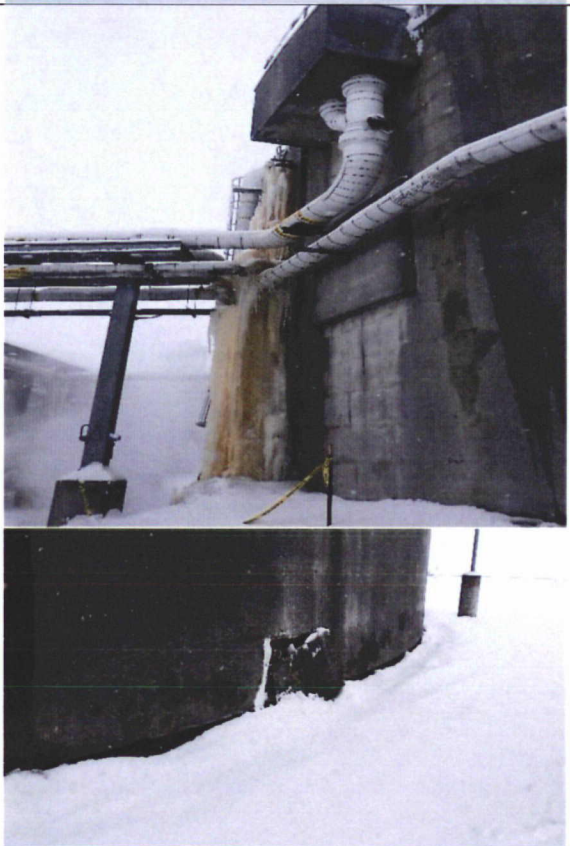
**STOP 6 – ALTEN LLC FACILITY
DIGESTERS**

Water trickling from a digester causing a
large ice cycle.

Damage to insulation on one of the digesters.

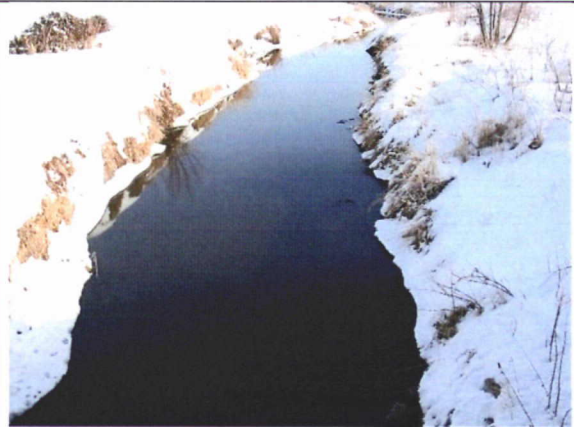
**STOP 1 – HIGHWAY 66 WEST of
ASHLAND GUN CLUB**

Water/liquid present. No unusual odors noted.

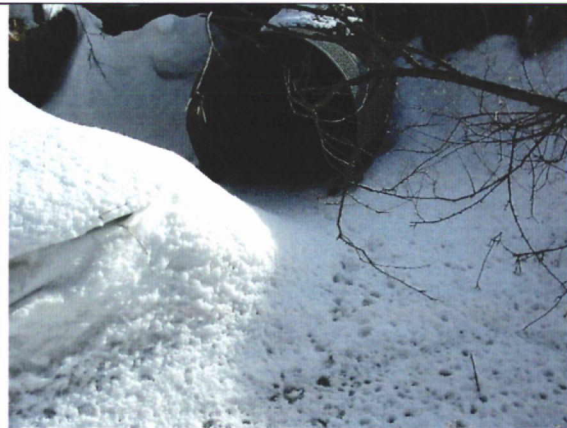
**STOP 2 – North of the Intersection of
COUNTY ROADS 6 & F**

Fresh snowfall and ice observed upstream from culvert. No flow observed entering culvert. No flow observed leaving downstream opening of culvert.

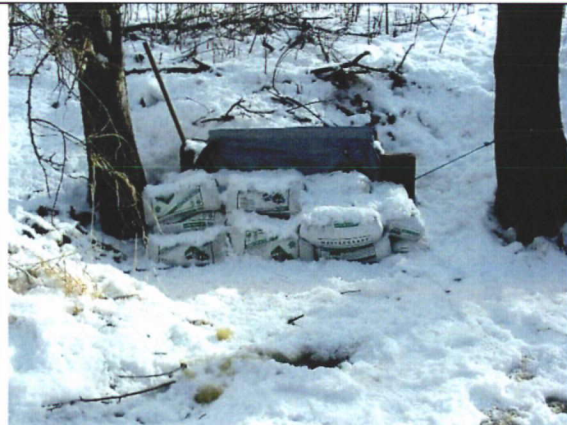
STOP 3 – Road 7/Highway 66

Please note that at the area of Road 7/Highway 66 ("Stop 3") the team observed the spilled material beyond the constructed containment (i.e. immediately east of the highway). This information was immediately shared, on site, with the Clean Harbors work crew.

It is not yet clear if this new area of contamination resulted from migration prior to Saturday's introduction of a "packer device" into the culvert, or if the barrier construction is not capable of stopping water flow in its entirety. At present, I would expect that the barrier should, at a minimum, severely restrict water flow through this new area of discovered contamination and slow the migration further downstream.

Sandbags rearranged since my previous visit and blue nylon rope leading into entrance to culvert. Brownish liquid observed in hole chopped into ice prior to my visit. Called Brad Pracheil to advise liquid presumed to be spilled material present at this location.

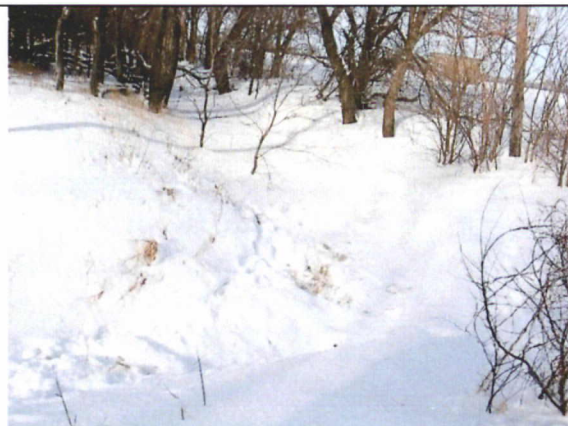
STOP 4 – County Road 8, North of Road H

Brownish-colored ice present below fresh layer of snow; same as previous visit.

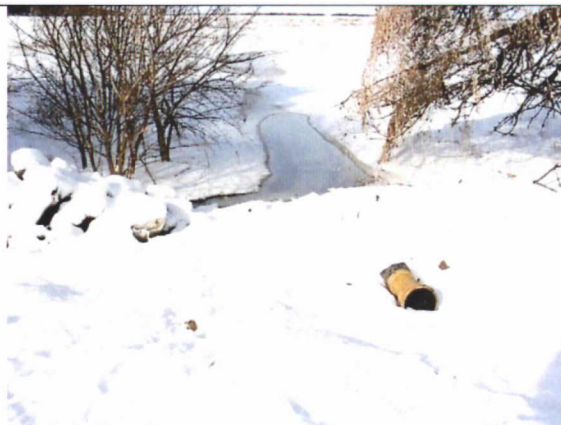
STOP 5 – UN-L Eastern Extension – North of County Roads 9 & J

Liquid observed upstream of road. Downstream snow-covered. Generator present, but not running. Hoses present, but not connected to anything.

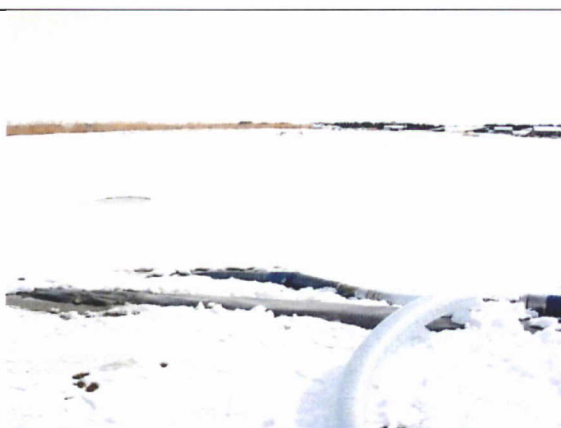
STOP 6 – ALTEN LLC FACILITY DIGESTERS

Truck with “Bucklin” on door and three workers present at south digester. Using gasoline-powered pump to pump from digester piping vault to lagoon immediately east of south digester. Lagoon contains liquid within 5-10 feet of top of berm. I was told no flow out of south digester. North digester as before (no observed leaks). Several workers using hose emitting steam to melt large ice structure on south side of north digester.

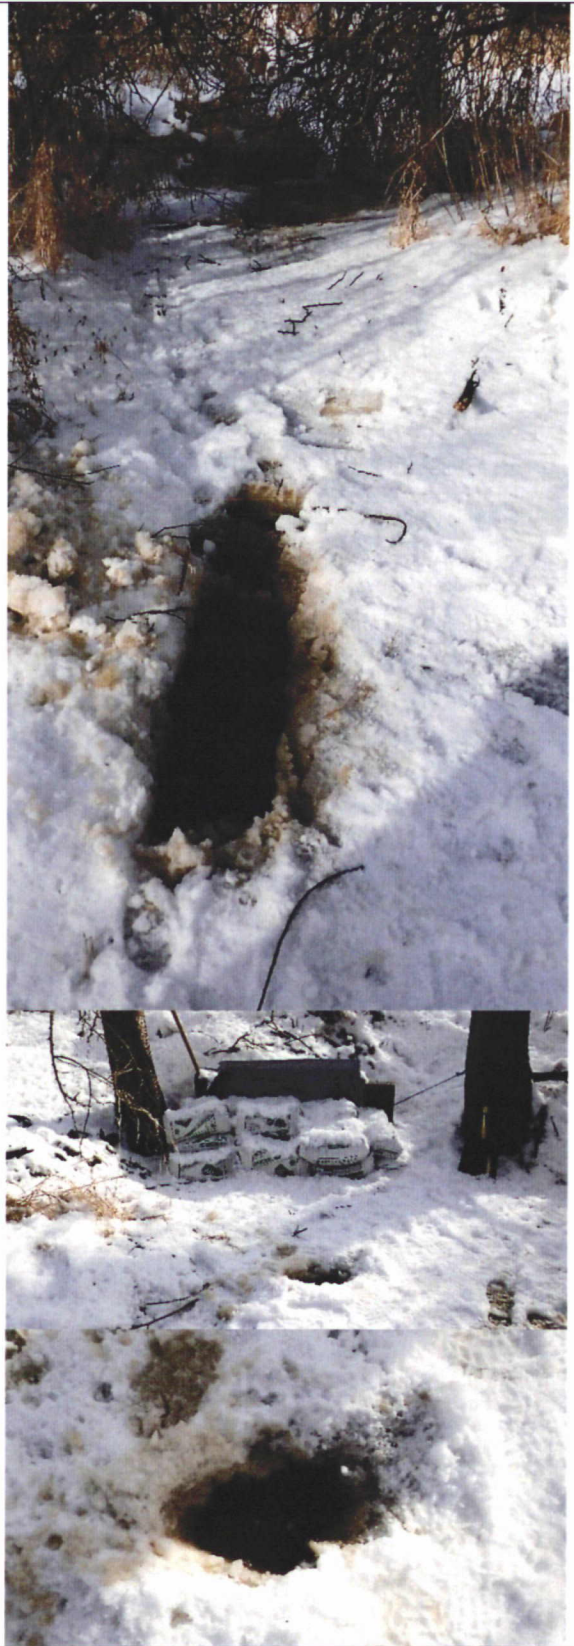
STOP 3 – Road 7/Highway 66 – Upstream

The AltEn thin stillage discharge water has now reached this location. The discolored surface ice/snow can be viewed in the top portion of photo and the lower part of the photo is where we shoveled the snow from the surface of the ice. The odorous, darker colored waste water rapidly filled the void on top of the ice surface.

In the second and third photo's you can view the hole I had chopped to the channel's mud substrate on 2/19/21. This hole was void of any water on 2/19/21, but is now full of the odorous, dark colored water.

Temperature: 0.6 ° Celsius
Dissolved Oxygen: 3.05 mg/l
pH: 8.07 su
Conductivity: 11,955.0 $\mu\text{mhos/cm}$
Turbidity: 211.6 NTUs

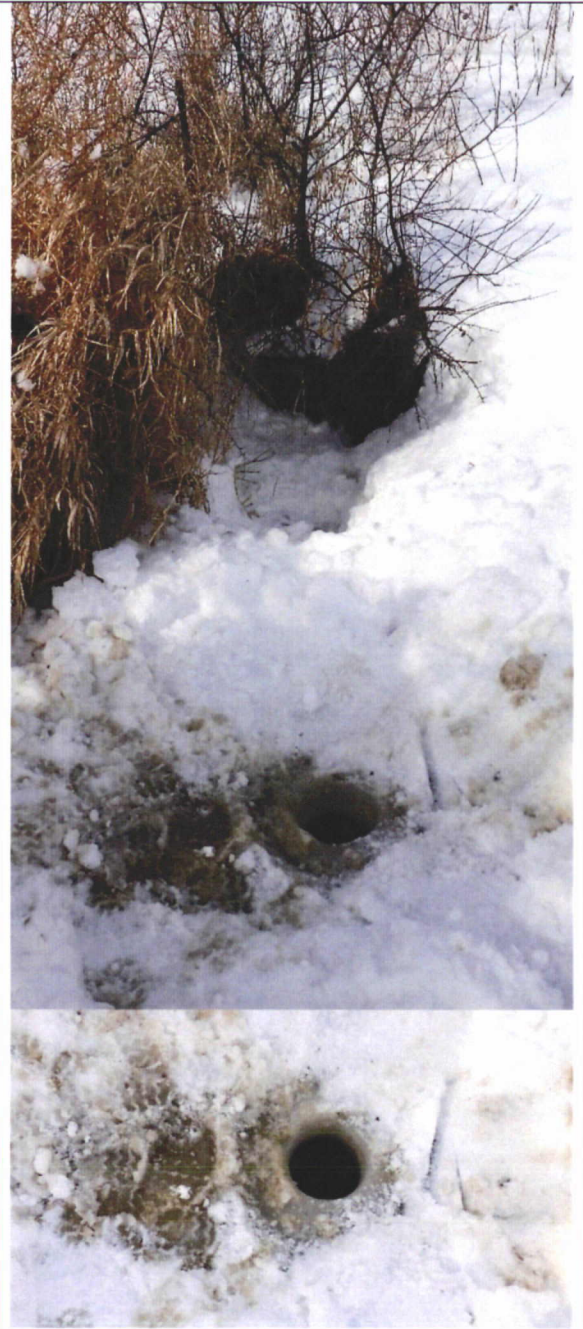
**STOP 3 – Road 7/Highway 66 –
Downstream**

The AltEn thin stillage discharge water has also moved through the Hwy 66 culvert and is now present in the plunge pool on the downstream side (east). There was no discolored surface ice/snow, but when we drilled a hole through the ice it was immediately evident in the water below. The odorous, darker colored waste water rapidly filled the drilled hole. The plunge pool was estimated to be 2.5-3 ft deep at this location.

Temperature: 0.9 ° Celsius
Dissolved Oxygen: 0.54 mg/l
pH: 7.68 su
Conductivity: 9,593.0 umhos/cm
Turbidity: 189.0 NTUs

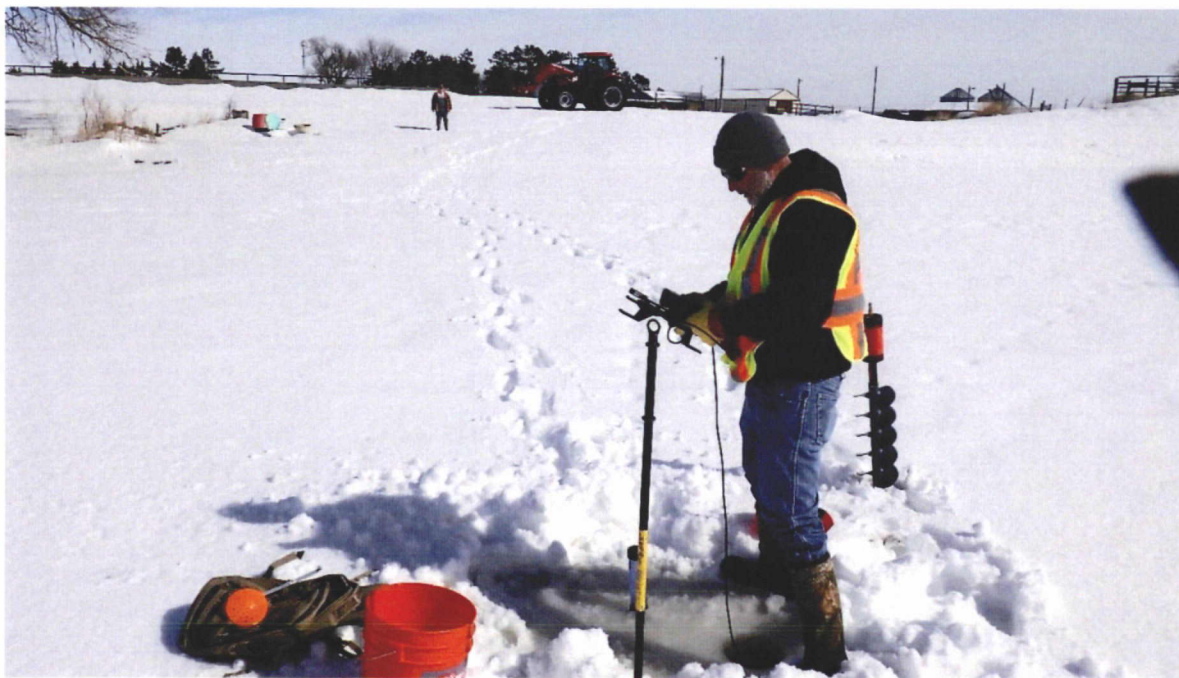
At 11:20 we collected a downstream “background” water sample from the Stan Kizer pond located approximately 1.5 miles southeast of the “Stop 3” location. This small reservoir is located on the same stream channel, but we do not believe the AltEn thin stillage has reached this location. The purpose of this sampling was to document the current water quality conditions

Dissolved Oxygen: 38.2 mg/l (*reservoir was exhibiting super-saturated conditions at 283%; likely due to heavy algal growth/photosynthesis occurring under the ice*)
