Nebraska Department of Environment and Energy (NDEE)

MEMORANDUM

RE: AltEn, LLC

Subject: Site Visit Report (Stormwater only)

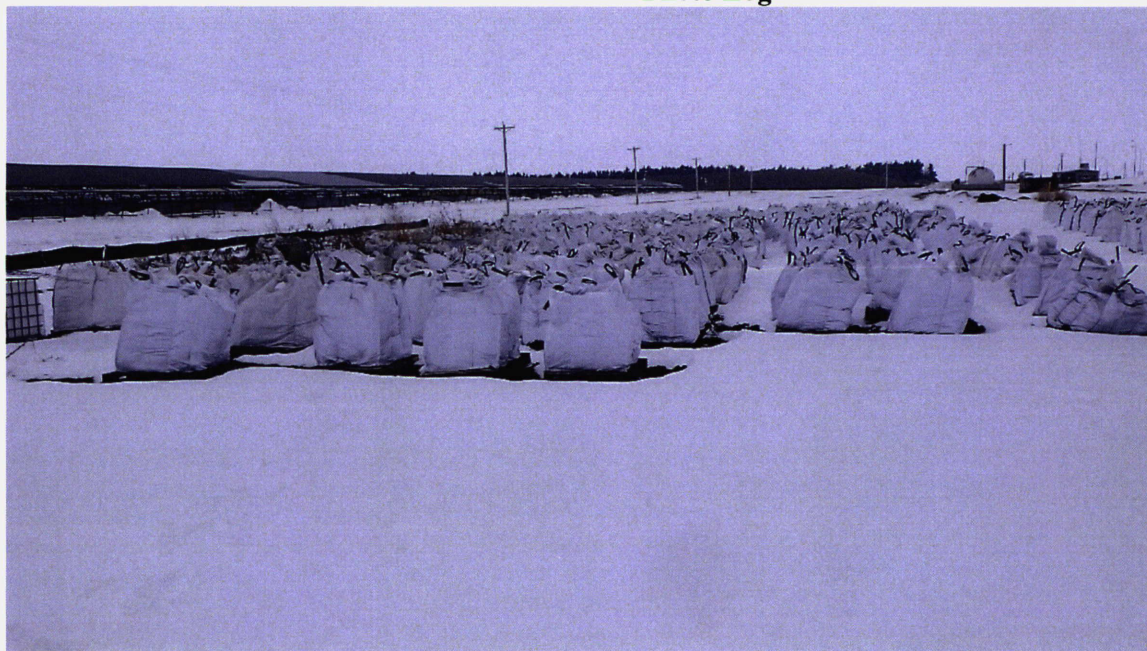
Photo 1

OA1 is the Biochar Process, which is located south of the main ethanol production plant. The area west of the Biochar is used to store super sacks of process biochar, photos 1 and 2. In accordance with the storm water pollution prevention plan (SWPPP), the facility installed a silt fence around the Biochar Process, photos 3 and 4.

Description: This photo depicts biochar super sack storage area.

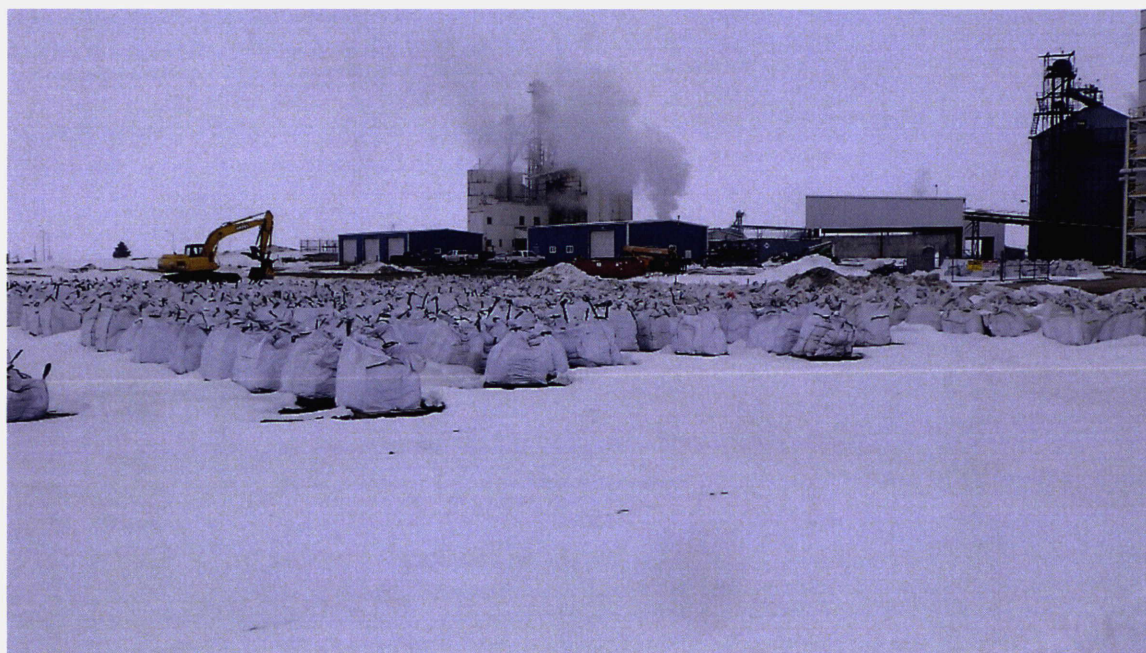
Photo 2

Description: This photo depicts biochar super sacks.

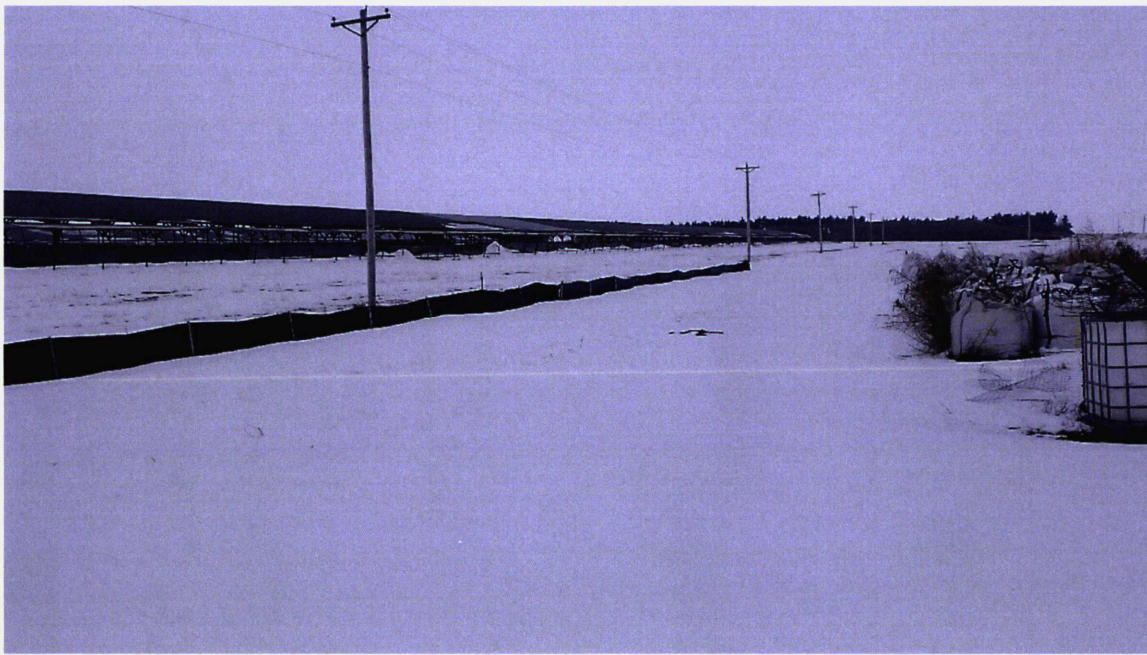
Photo 3

Description: This photo depicts the recently installed silt fence. The fence is a requirement found in the storm water pollution prevention plan (SWPPP).

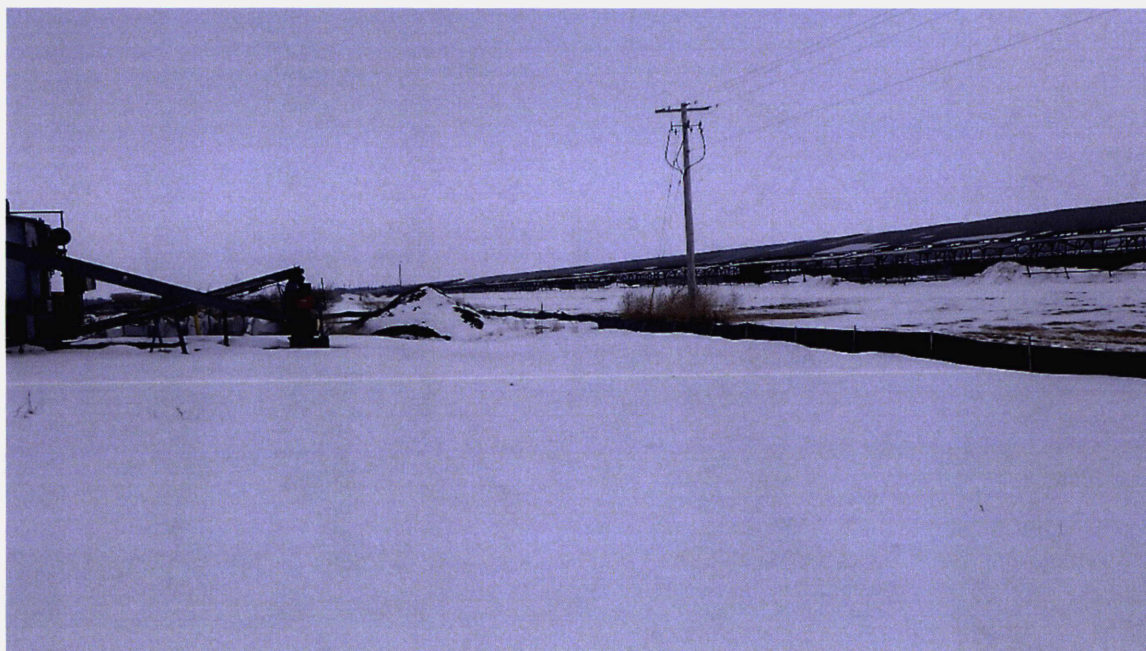
Photo 4

Description: This photo depicts the recently installed silt fence southeast of biochar process.

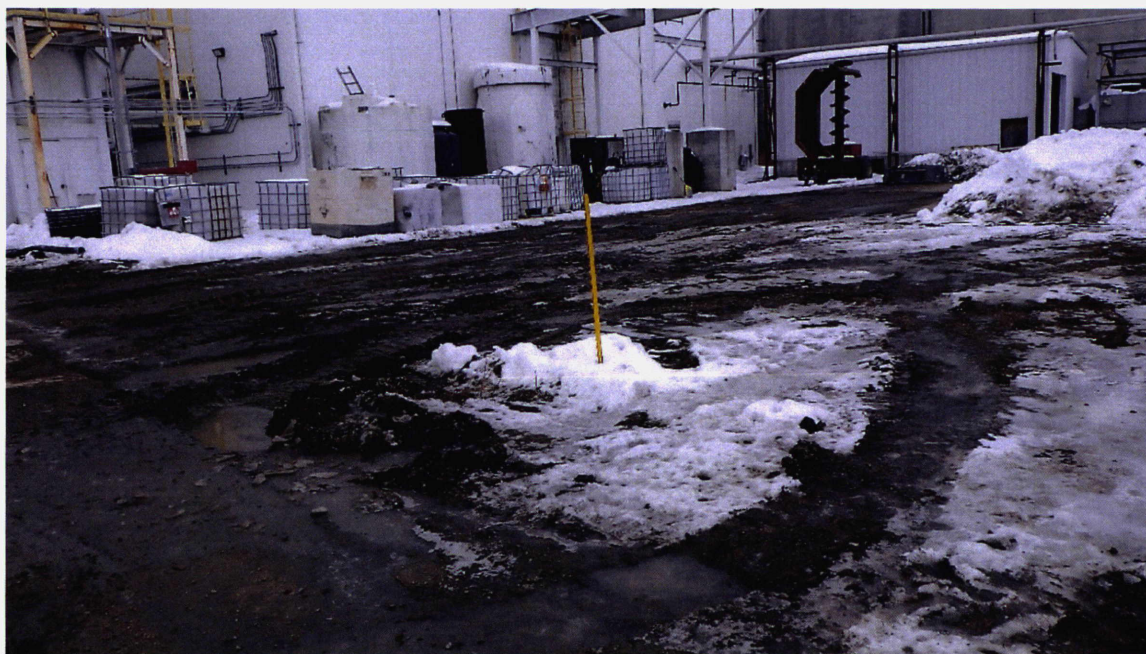
Photo 5

OA2 is north of the Biochar Process. There are unlabeled empty chemical totes stored in this area. Mr. Peterson stated that they are waiting on vendor pick up. It is unknown how much residual chemical is contained in these totes and if they are leaking. There is evidence of track out of mud from this area, which could contain residual chemical, photo 5.

- 4) There are unlabeled chemical totes in various locations. **SWPPP section 5.4 Spill Prevention states that “containers be plainly labeled that could be susceptible to spillage or leakage”.**

Description: This photo depicts unlabeled empty chemical totes. It is unknown if residual chemicals are leaking in the exposed muddy area depicted in the photograph. The SWPPP states that all chemical totes are to be labeled.

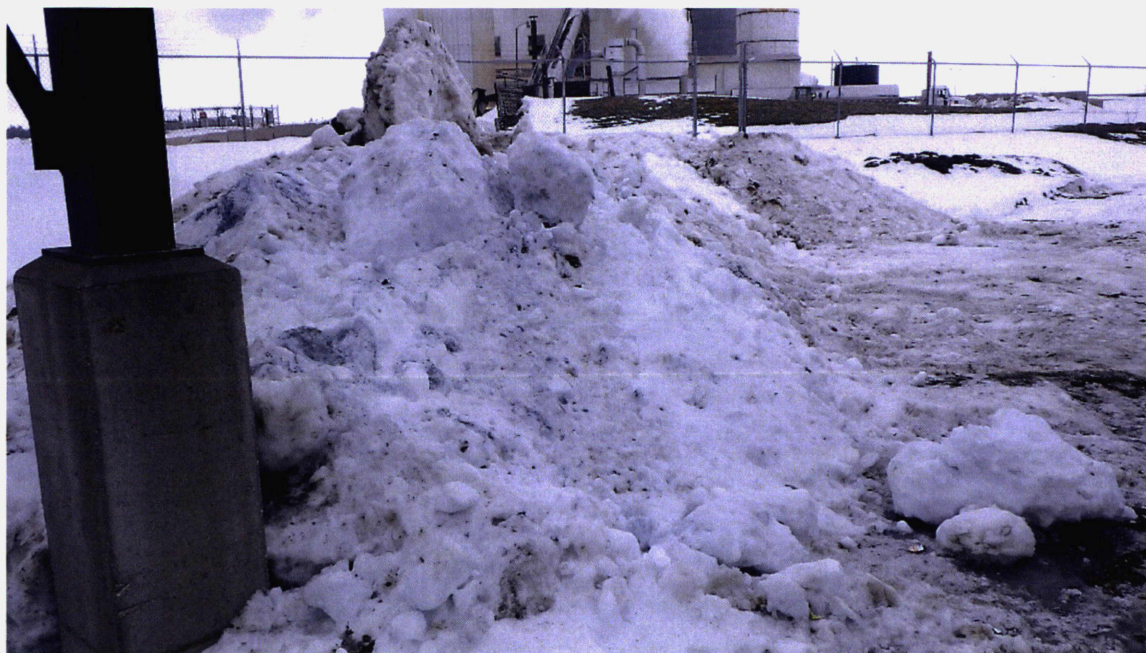
Photo 6

OA3 is the grain receiving conveyance system. Grain is unloaded via truck where it is conveyed to additional storage prior to production. Snow banks surrounding the receiving area are stained green with grain dust/chaff, photo 6. The area leading to the grain unloading area is also stained with green grain dust/chaff, photos 7 and 8. There is loose grain and blue stained ice under the conveyance system, photo 9. I asked Mr. Peterson if he knows how often this area is inspected for storm water. Mr. Peterson stated storm water is not his department.

- 3) In the seed unloading area, there is green dust/chaff staining snow and spilled seed. It is unknown if dust/chaff contain pesticides. There are no best management plan (BMP) installed to prevent dust/chaff or treated seed latent stormwater from entering the waterway. **SWPPP section 5.1 Good Housekeeping Practices states that the facility will “promptly cleanup minor spills and conduct oversight of product transfer”.**

Description: This photo depicts grain dust staining the a snow bank directly south of the grain unloading area.

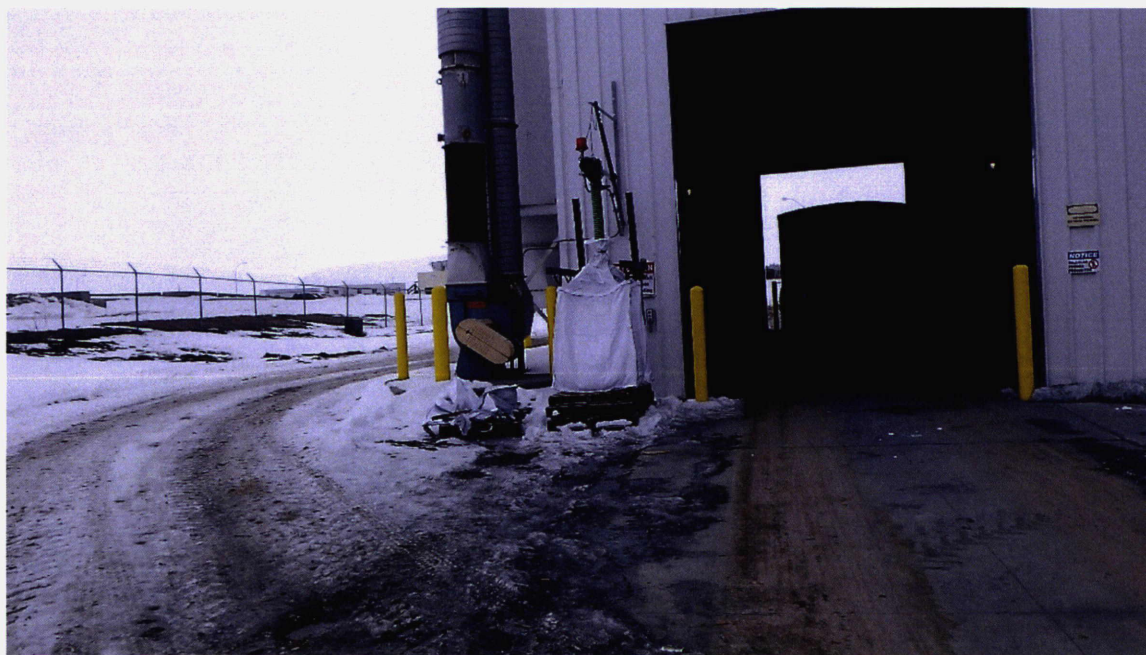
Photo 7

Description: This photo depicts residual chaff and grain dust. Grain dust and chaff are not considered to be a pollutant of interest in the SWPPP.

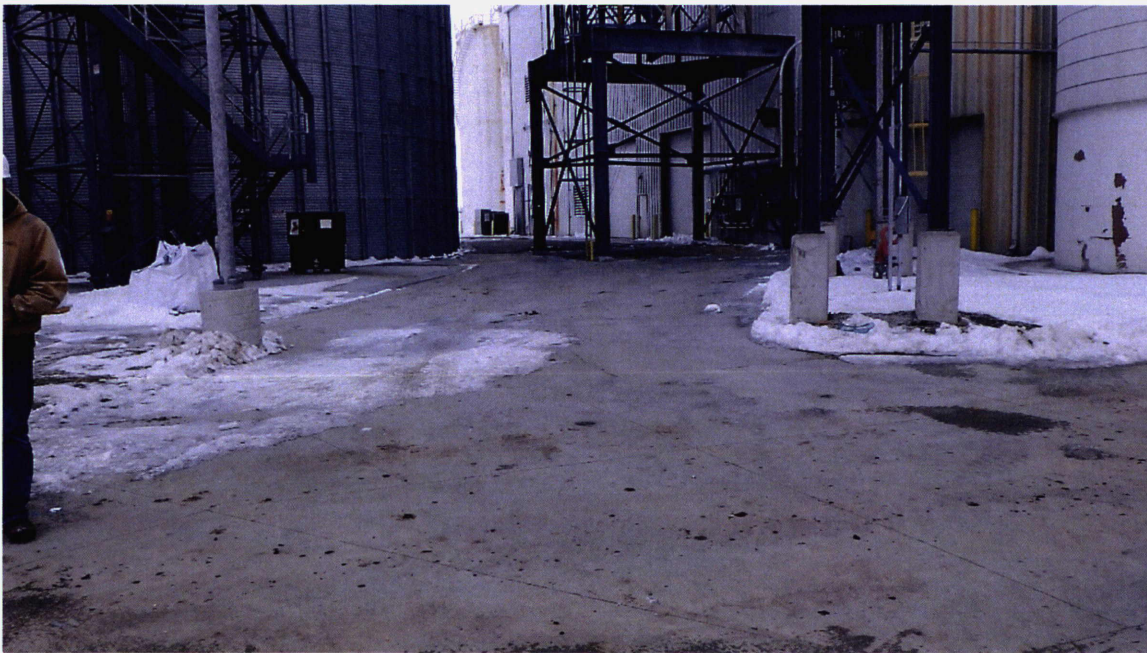
Photo 8

Description: This photo depicts additional grain dust and chaff near the grain unloading area.

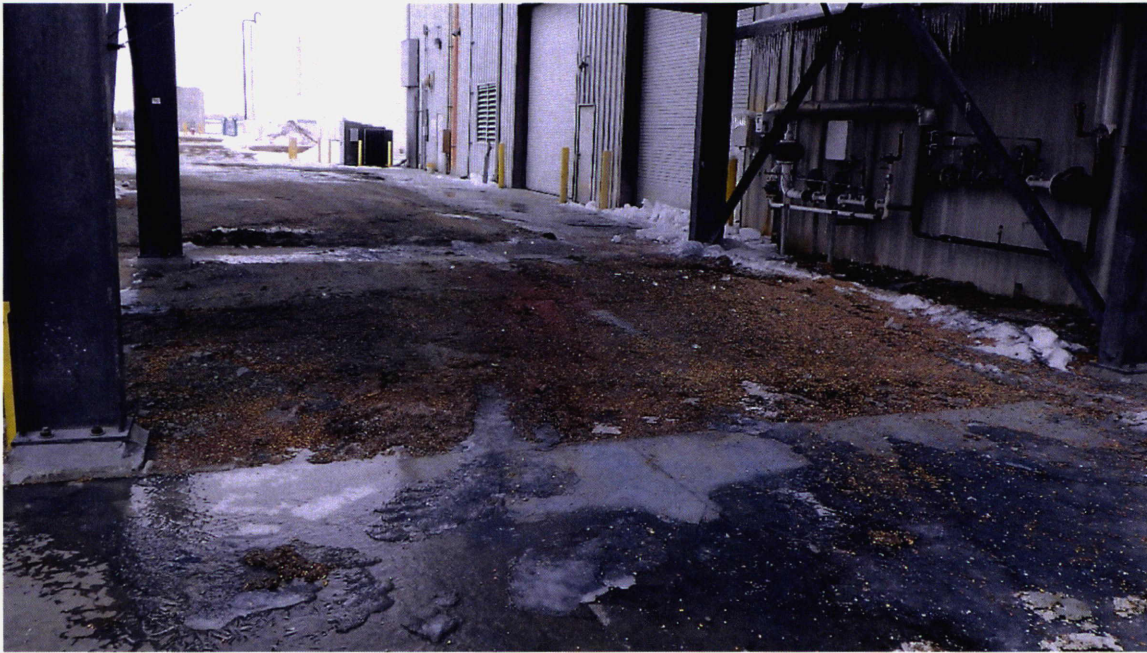
Photo 9

Description: This photo depicts loose grain and stained ice under the conveyance system.

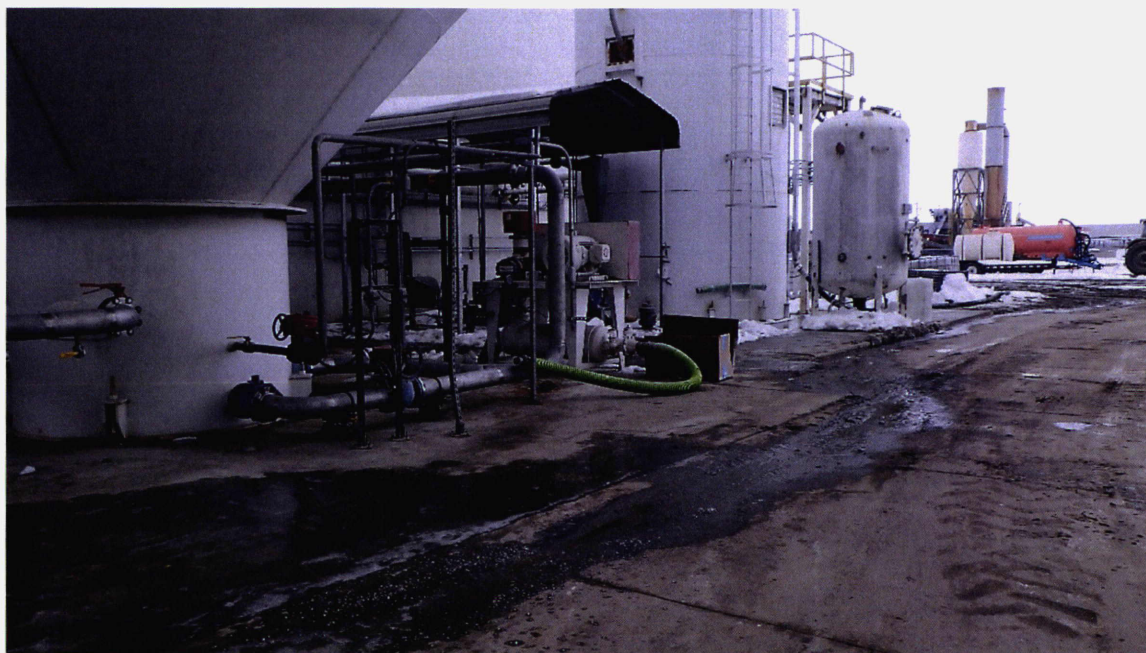
Photo 10

OA4 is east of the grain receiving area near the stair tower. In this area, a series of hoses are depicted, photos 10, 11 and 12. These hoses are not in containment or identified. It is unknown if they contain pollutants. Mr. Peterson stated that a sump pump had failed. This failure caused the facility to haul solids to the lagoons. Mr. Peterson stated the hoses are associated with pumping activities.

Description: This photo depicts an unlabeled chemical tote. Next to the tote are hoses of unknown origin. It is unknown if the hoses contain pollutants.

- 1) There are hoses attached to pumps and unattached in various locations. Depending on location, hoses can contain chemical/product. The residual chemical/product could escape into the storm water conveyance system. Facility staff stated the hoses are being used to transfer solids due to a sump pump failure. To prevent leaks, hoses should to be placed in containment between use.

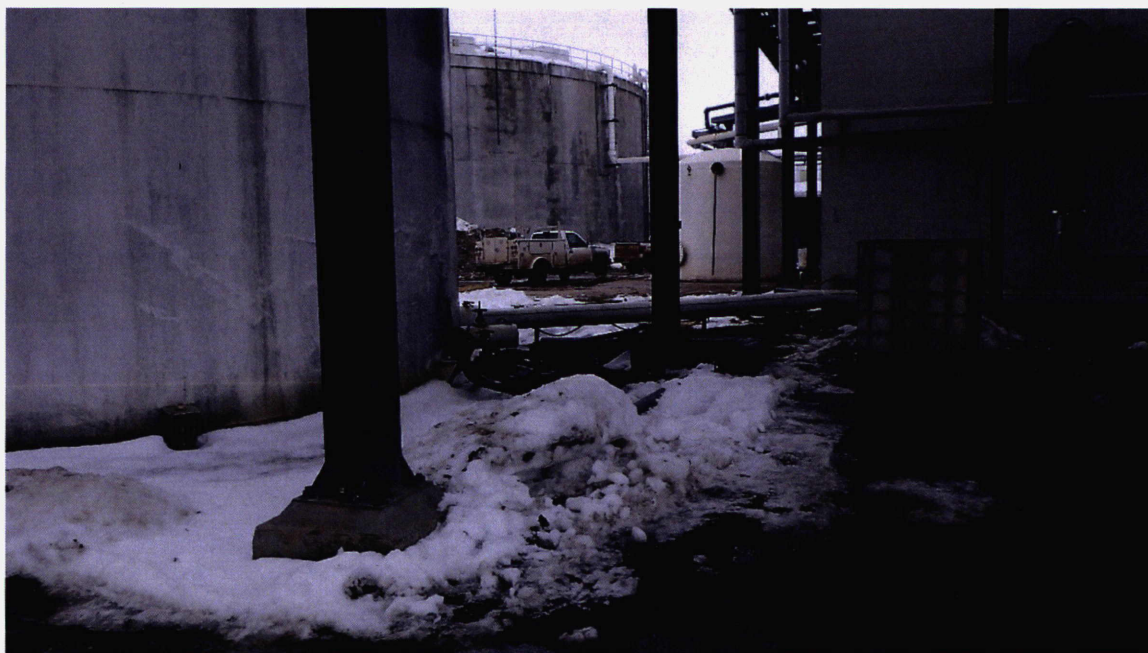
Photo 11

Description: This photo depicts a coiled black hose (arrow) and unlabeled tote.

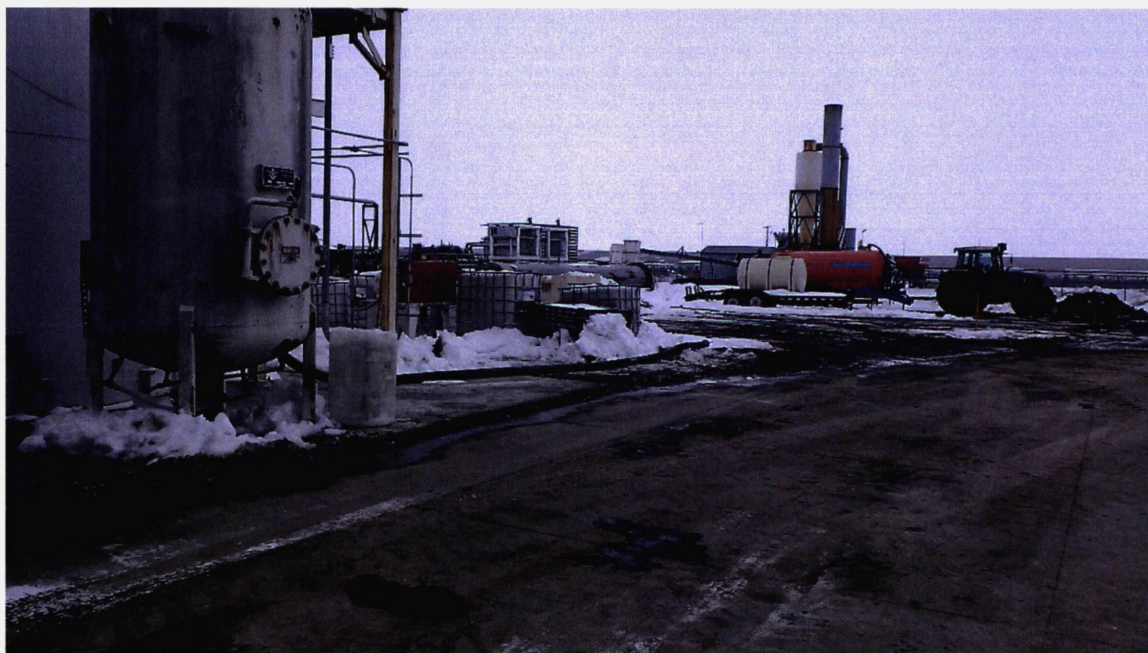
Photo 12

Description: This photo depicts a long black hose. The hose is not in containment and is unknown if it contains pollutants of concern. The photo also depicts track out of mud which could contain pollutants.

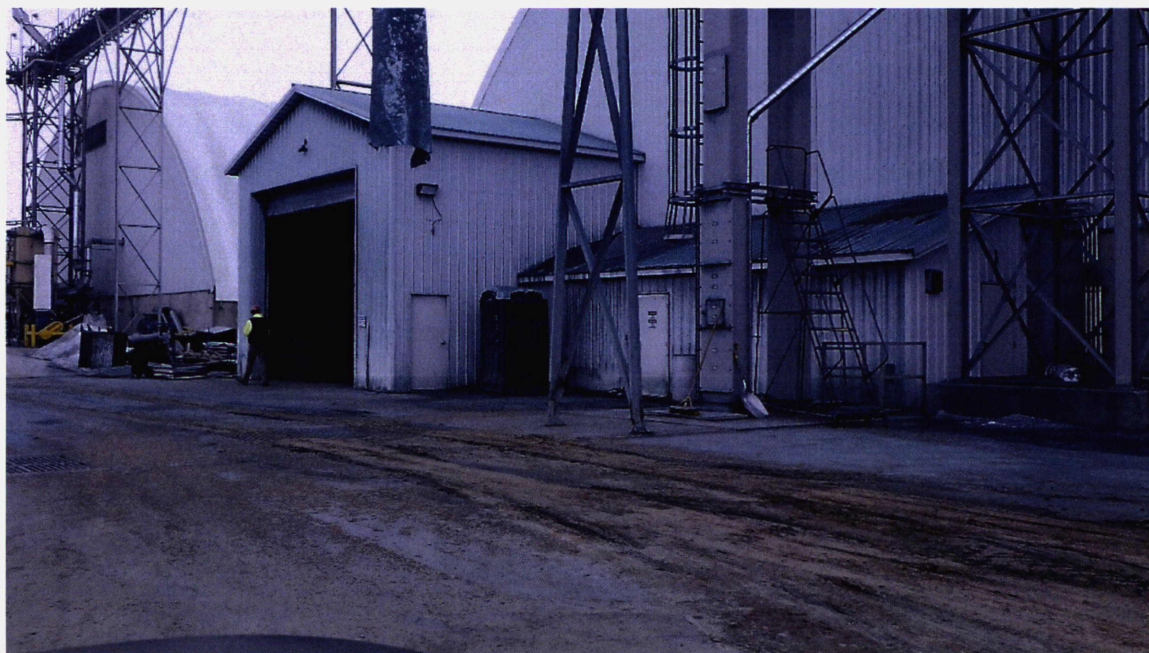
Photo 13

OA5 is the hoop building which is used to store, unbag and clean seed prior to processing. The area outside is stained with green dust/chaff. There is spilled seed, green dust/chaff along the truck path depicted in photos 13, and 14.

Description: This photo depicts green dust/chaff along with spilled seed.

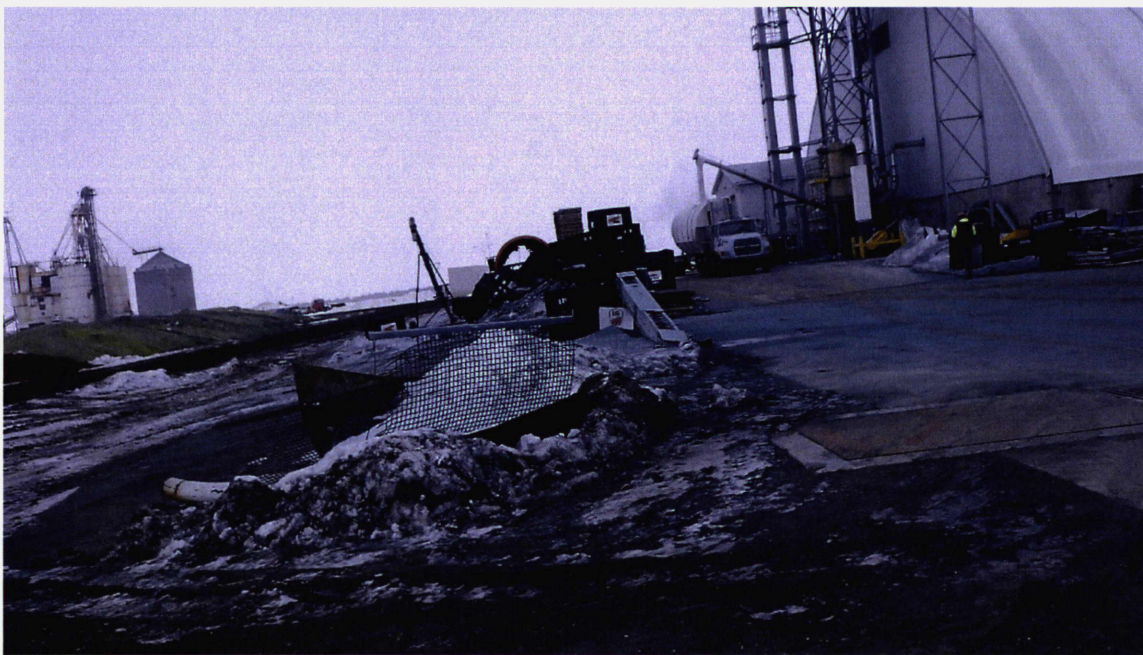
Photo 14

- 2) There is treated seed, green dust/chaff observed on the east side of hoop building. **SWPPP section 4.1, Feedstock Storage state the two-hoop buildings have an “impervious concrete base”, and specifically states that AltEn “minimizes the potential for pollutants from leaving the building by utilizing good housekeeping measures”.**

Description: This photo depicts additional dust/chaff and spilled seed on the east side of the hoop building.

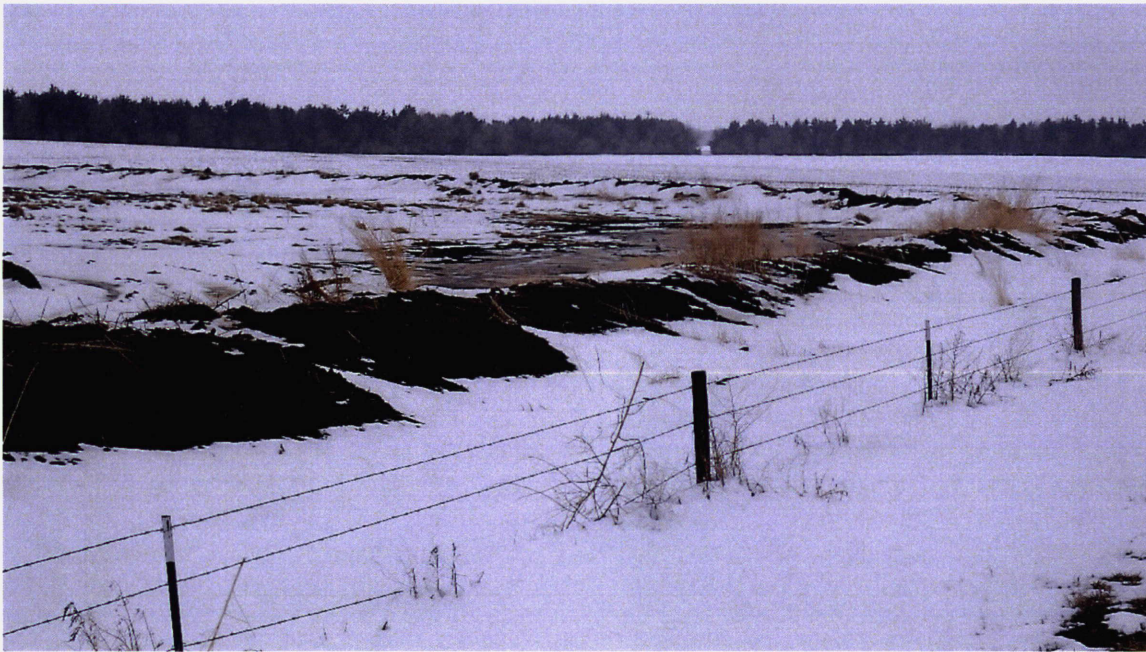
Photo 15

OA6 is located on the northwest corner of the northwest lagoon. This area contains an earthen berm which is used to contain runoff water, photos, 15, 16, and 17. There is no evidence of breaching or overtopping. It appears that the level is about half capacity.

Description: This photo depicts the earthen berm constructed to contain runoff from the wet cake pile. There is no evidence of breaching or leaching.

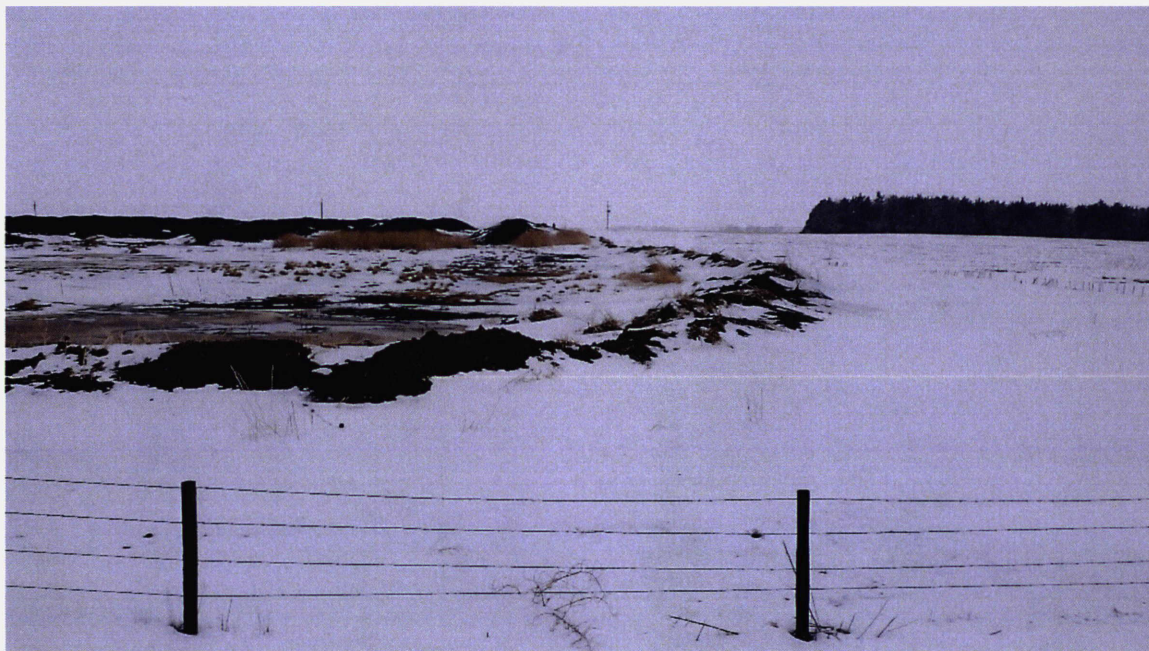
Photo 16

Description: This photo depicts the north side of the constructed berm. It is estimated that the berm is approximately half full.

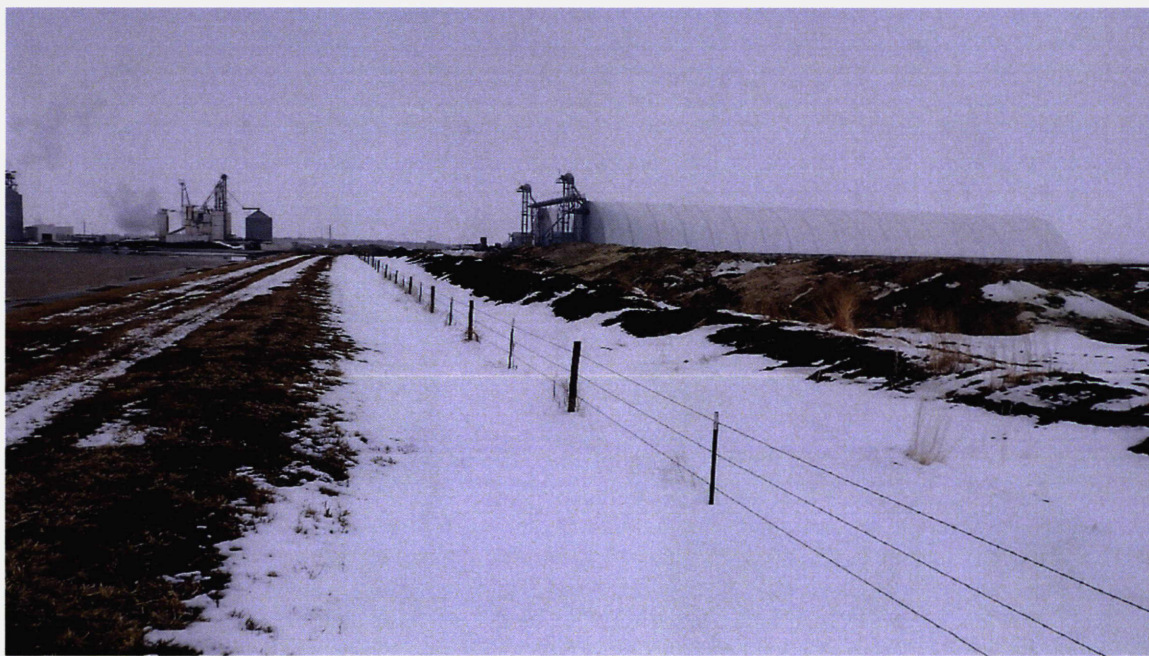
Photo 17

Description: This photo depicts the earthen berm looking south along northwest lagoon boundary fence.

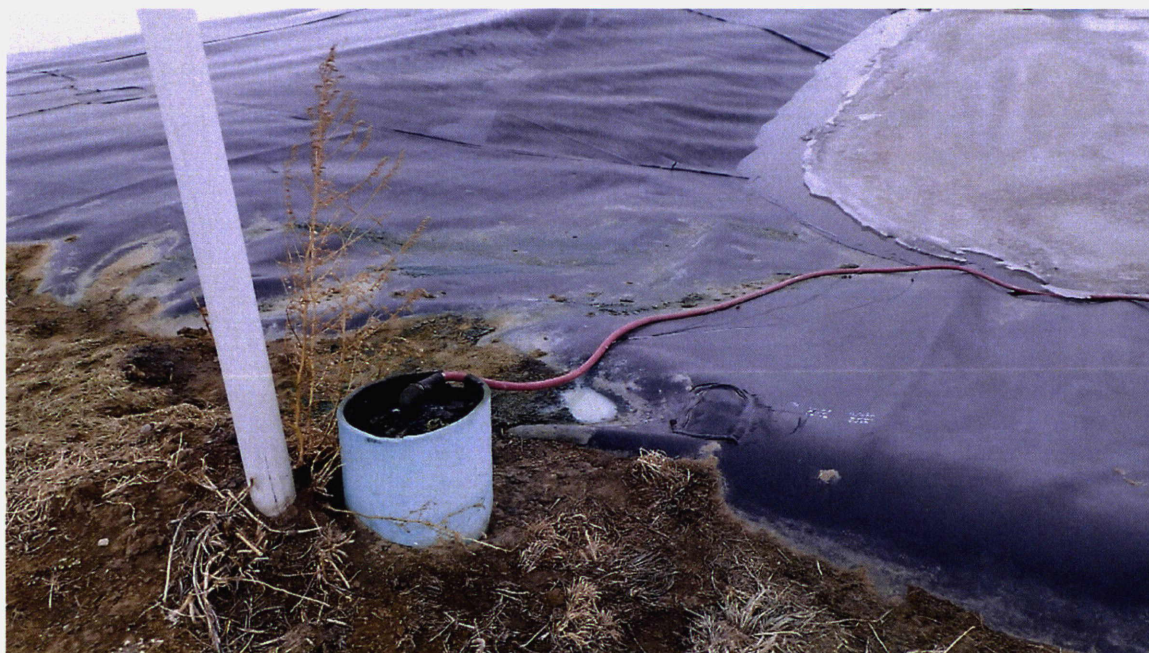
Photo 18

OA7 is the air relief valve located along the northwest corner of the south lagoon. There is minor leakage of thin stillage along lagoon liner, photo 18.

Description: This photo depicts a small leak of thin stillage from the air relief hose entering the south lagoon.

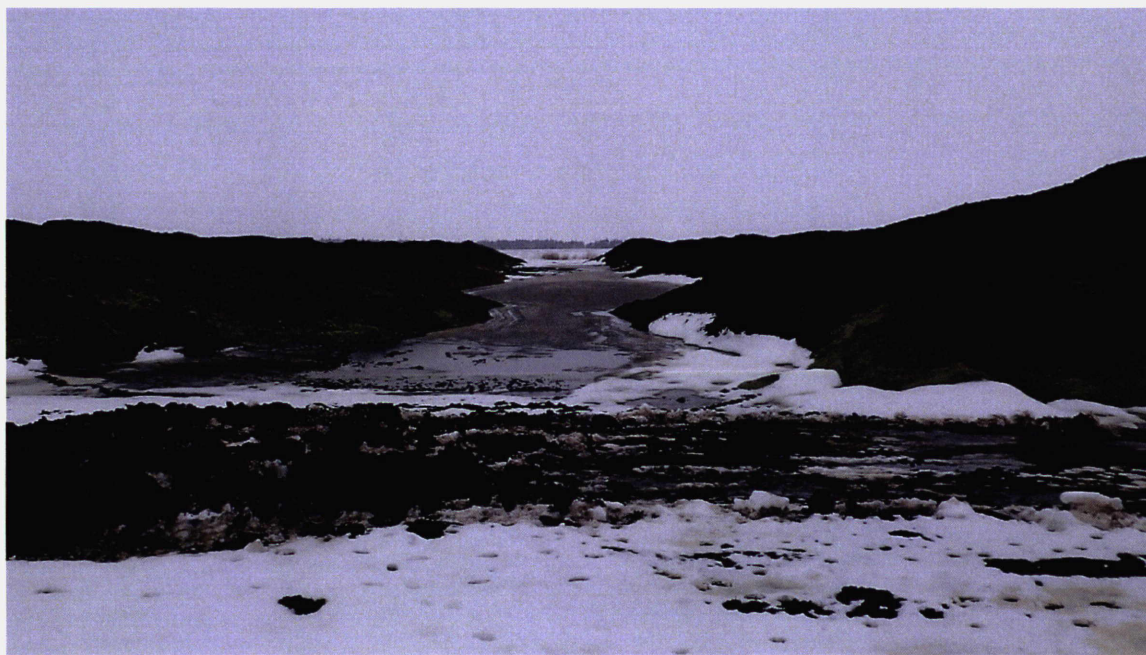
Photo 19

OA8 is the east wet cake storage area depicted on Map 3. There are multiple uncontained wet cake piles that contain water accumulation, depicted in photos 19, 20, 21 and 22. The waterway that drains AltEn property meanders east of the wet cake pile and then south through a culvert, photos 23, 24, and 25.

Description: This photo depicts the east wet cake pile facing north. In between the pile is accumulated stormwater and snow melt.

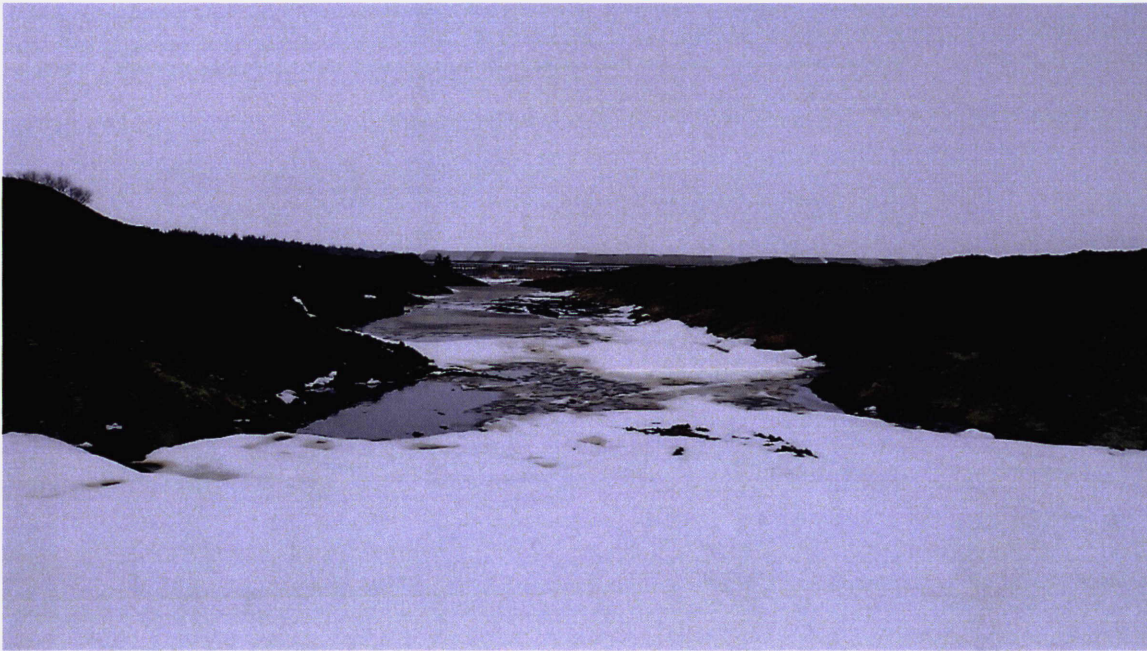
Photo 20

Description: This photo depicts the runoff facing south. This water drains south along the south side of the pile to the waterway and culvert.

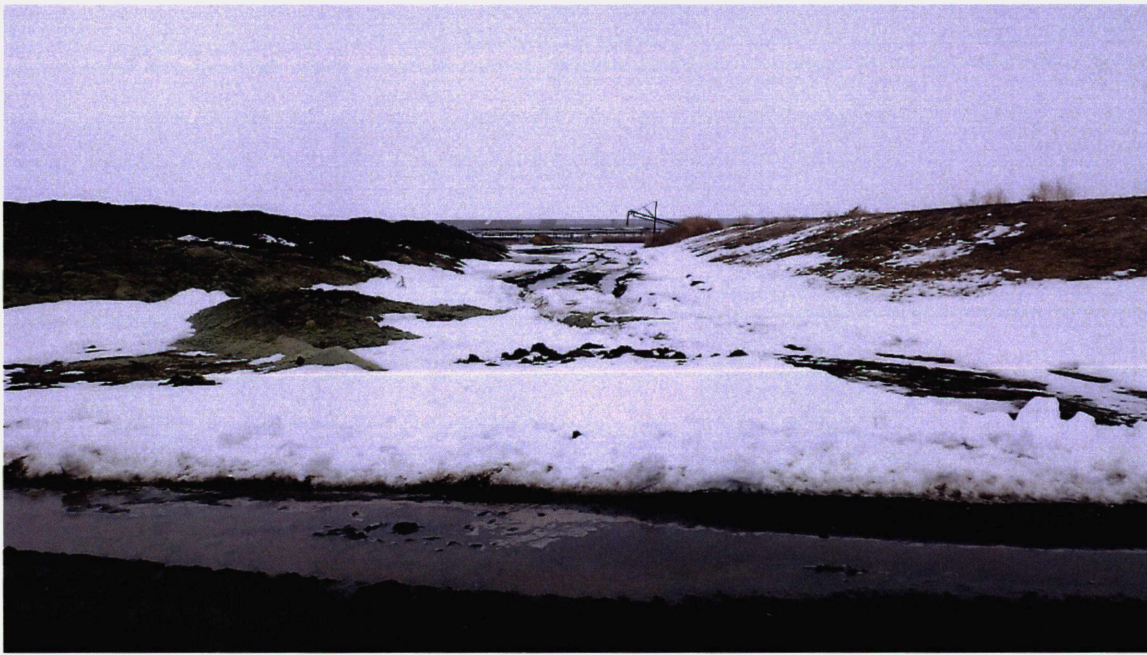
Photo 21

Description: This photo depicts the north side of the wet cake pile. The water in this area drains north along the side of pile to an uncontained area that discharges to a waterway.

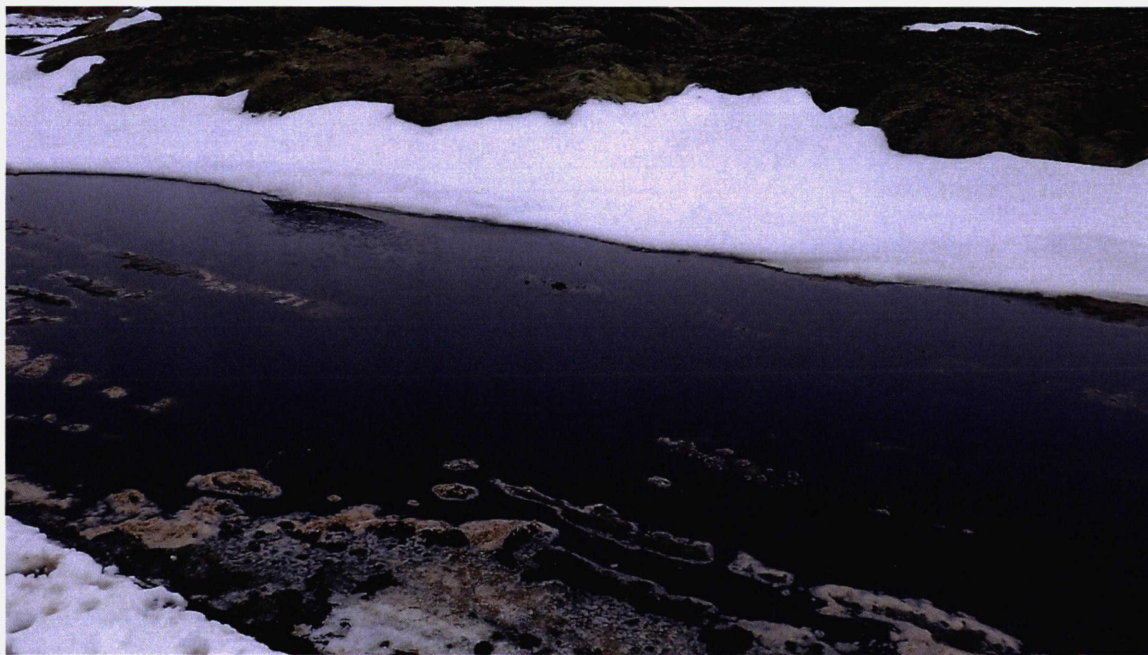
Photo 22

Description: This photo depicts the southeast side of the wet cake pile. Water has accumulated into small swale. The waterway and containment are depicted on the next photo.

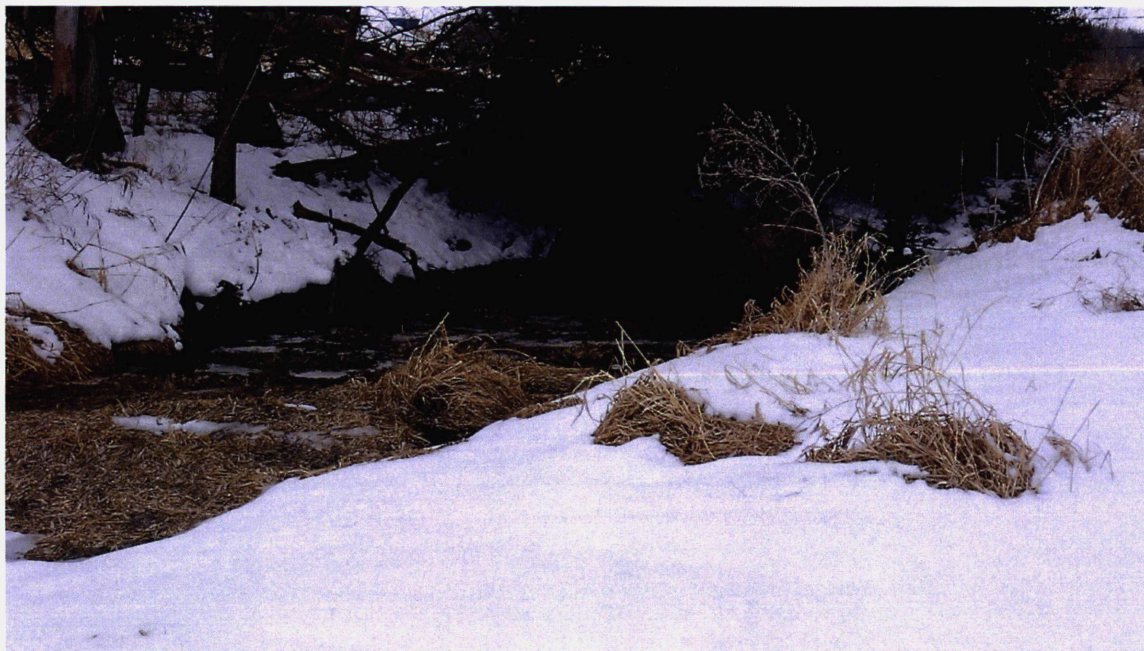
Photo 23

Description: This photo depicts a culvert located southwest of the wet cake pile depicted in the previous photos.

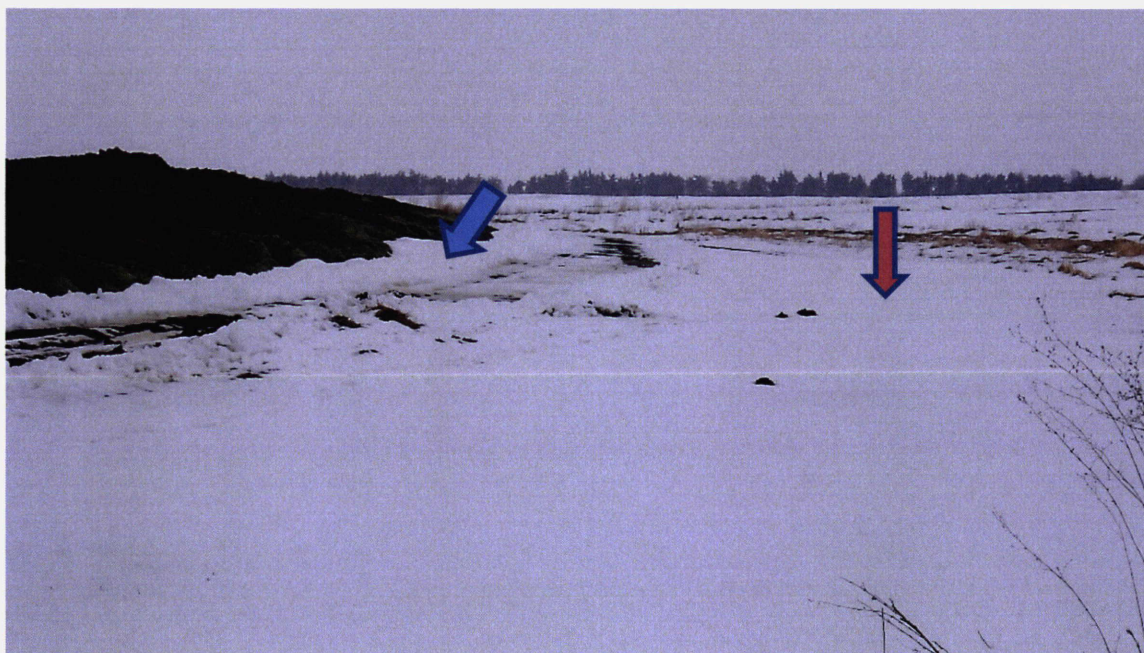
Photo 24

- 5) We could not confirm that the east wet cake pile is contained by a berm. The east storage site is located next to a waterway that connects to Clear Creek. **SWPPP section 4.1 Storm Water Generation, wet cake loadout and storage areas states “to prevent any storm water that has contacted WDG from leaving the property, AltEn uses natural topography and has built and maintains earthen berms around these holding areas where necessary to contain any runoff from the WDG.**

Description: This photo depicts the location of the wet cake to the waterway. We did not observe a berm in the area depicted by the blue arrow. The red arrow depicts the waterway location.

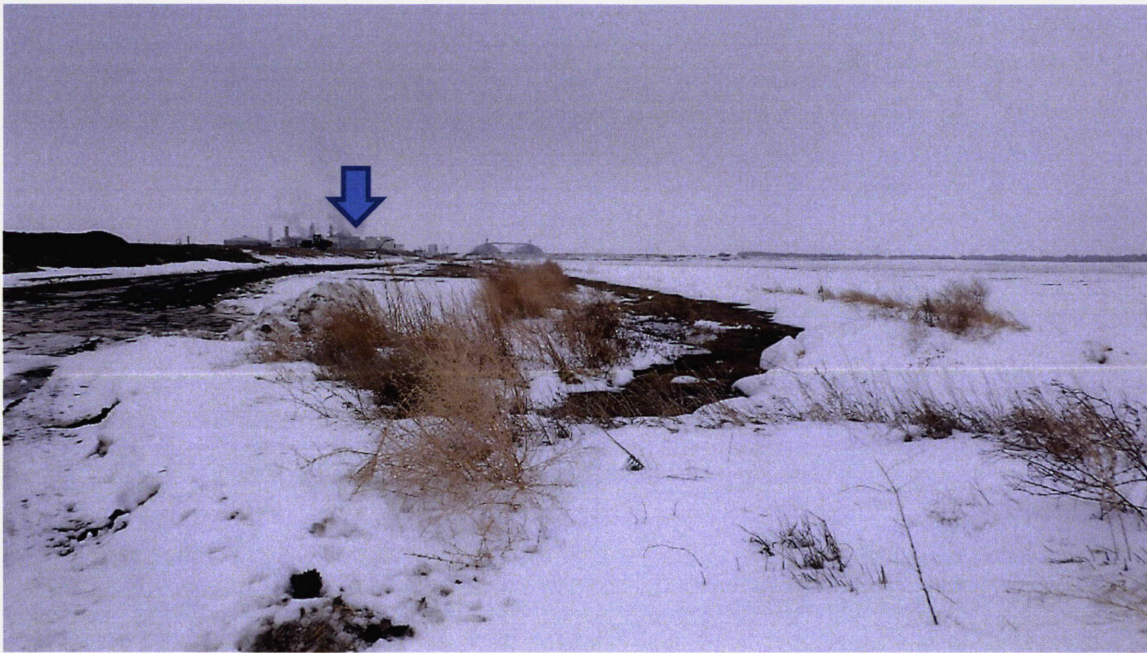
Photo 25

Description: This photo depicts the water way north of the wet cake pile. The arrow depicts AltEn west of this location
