Nebraska Department of Environment and Energy (NDEE)

MEMORANDUM

RE: AltEn, LLC

Subject: Site Visit Report to Observe the Lagoons

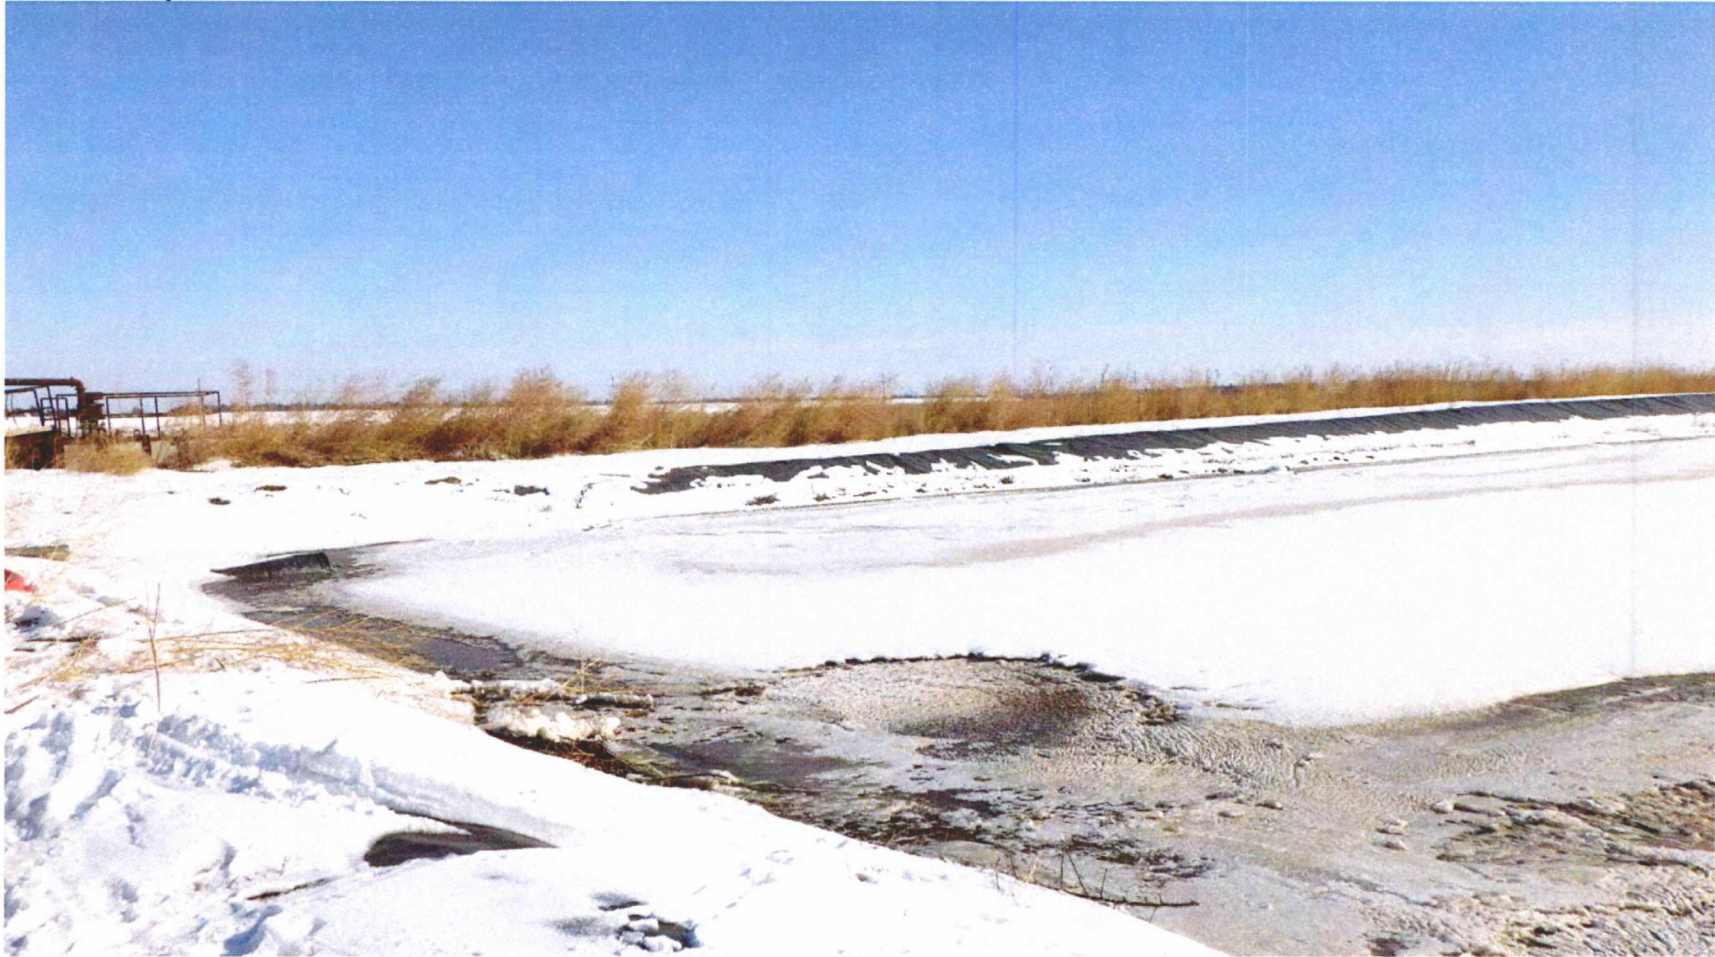
Photo 1

Description: Northwest corner of the Emergency Overflow lagoon.

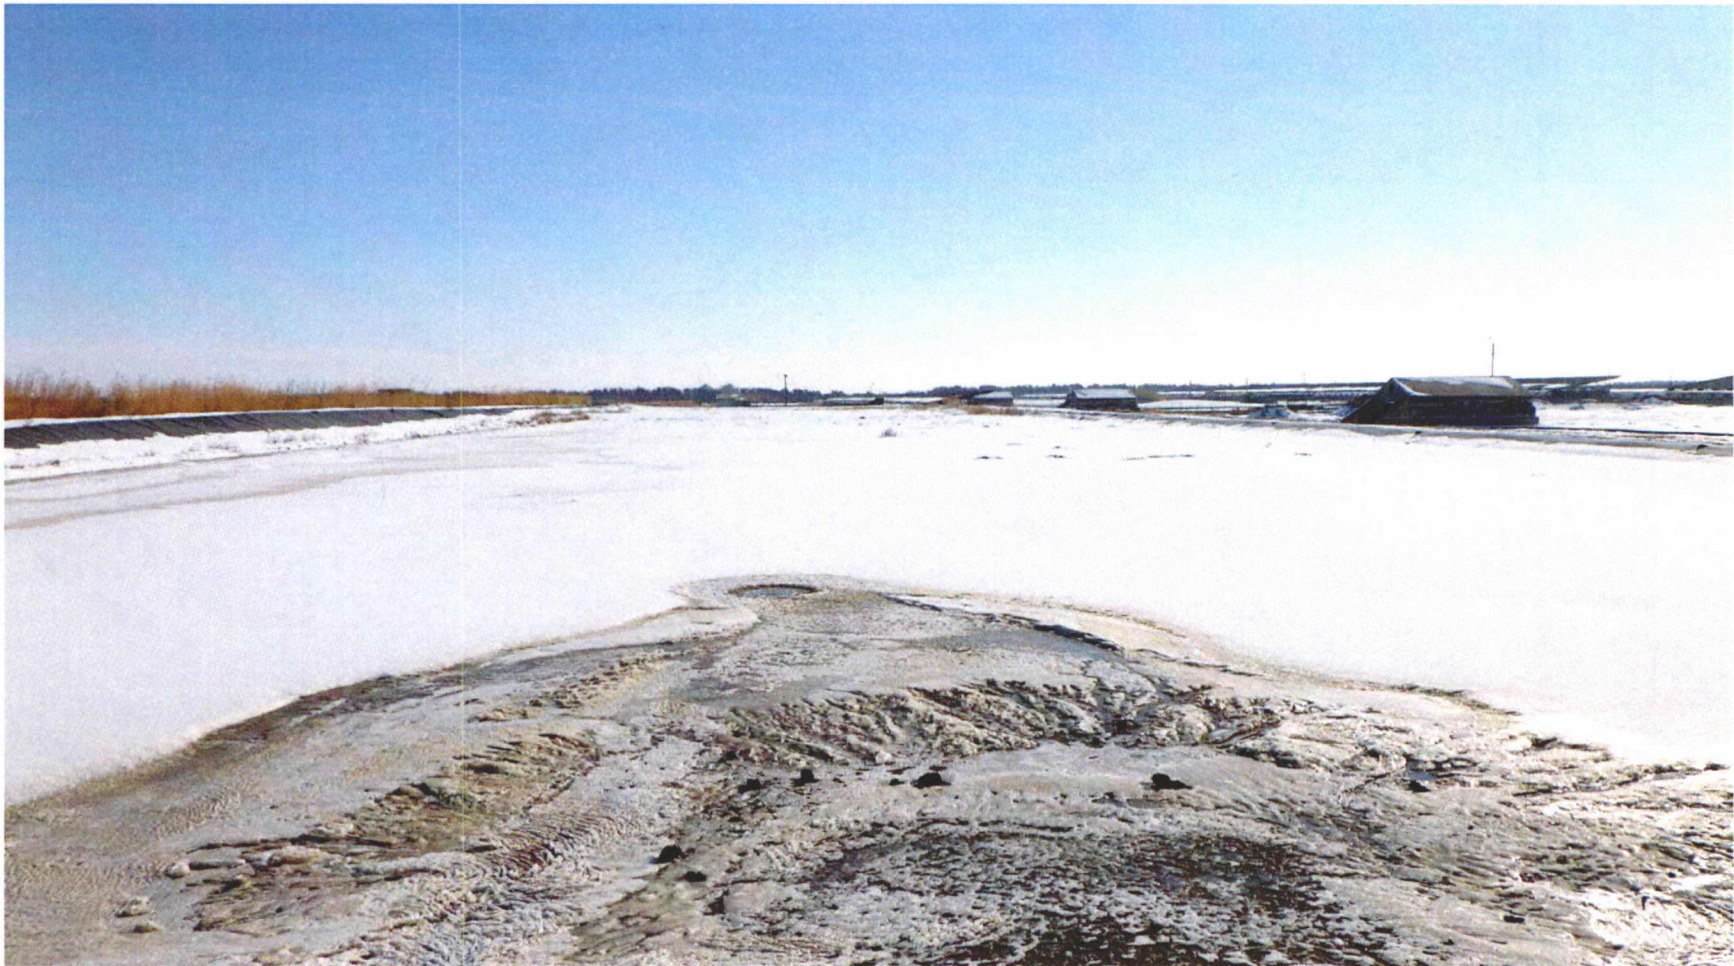
Photo 2

Description: Overview of the Emergency Overflow lagoon.

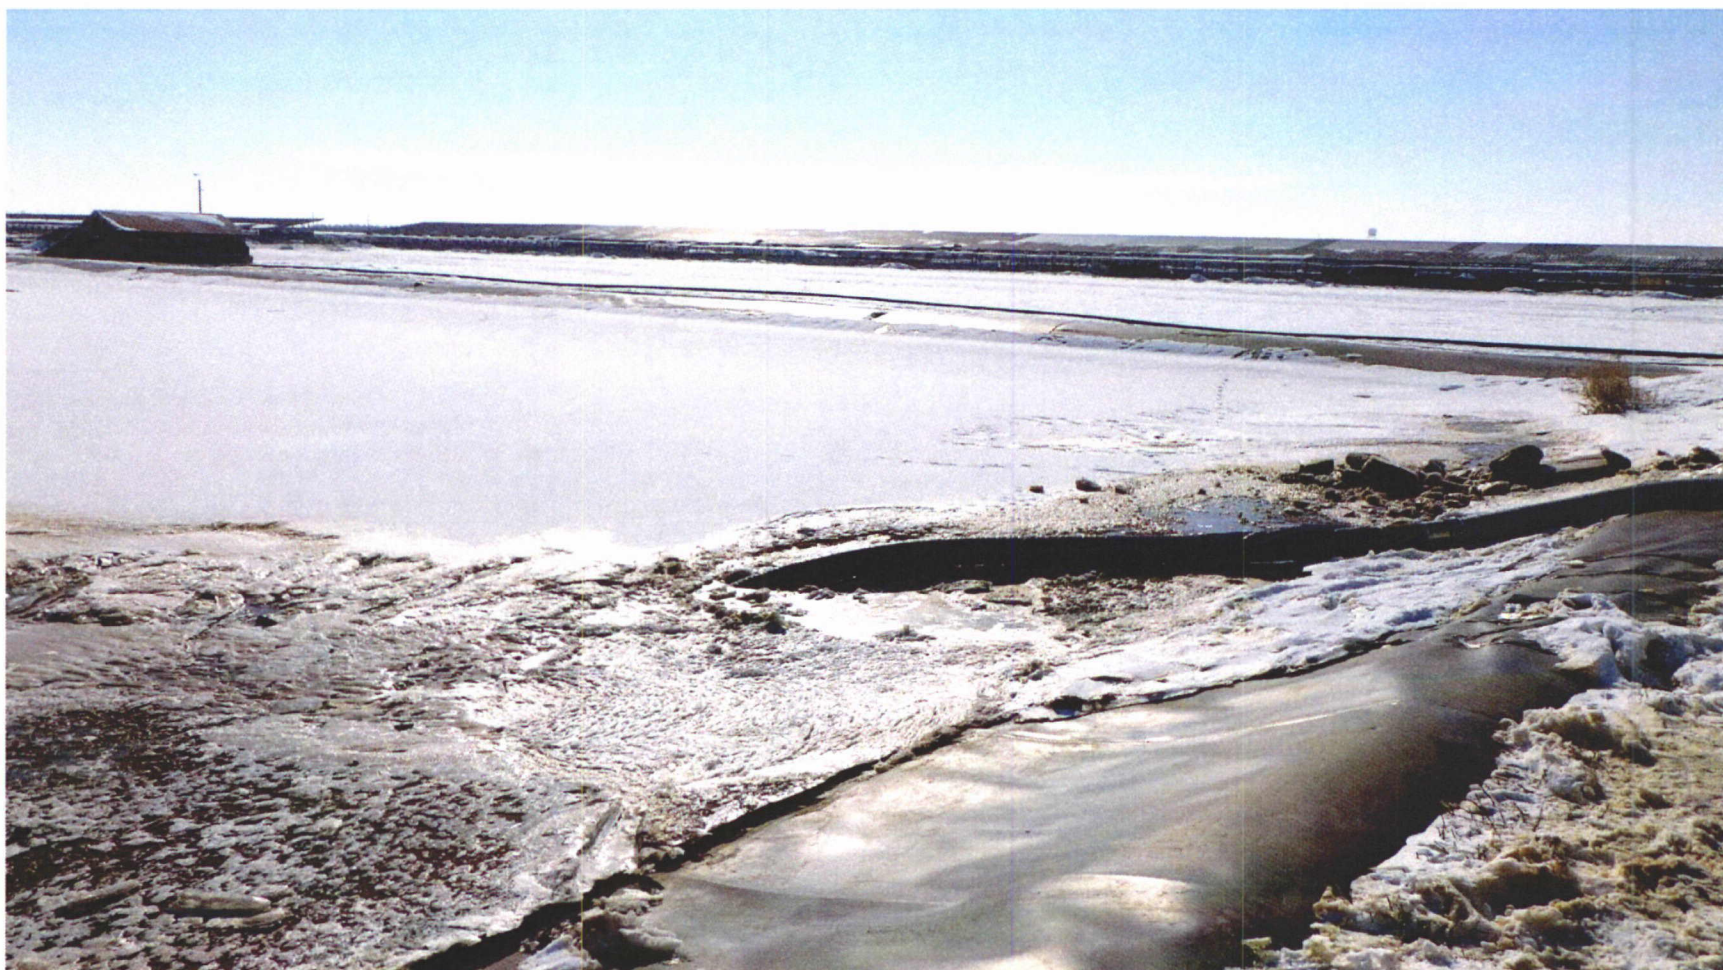
Photo 3

Description: Southwest corner of the Emergency Overflow lagoon. A black suction pipe for a pump (Photo 4) is observed.

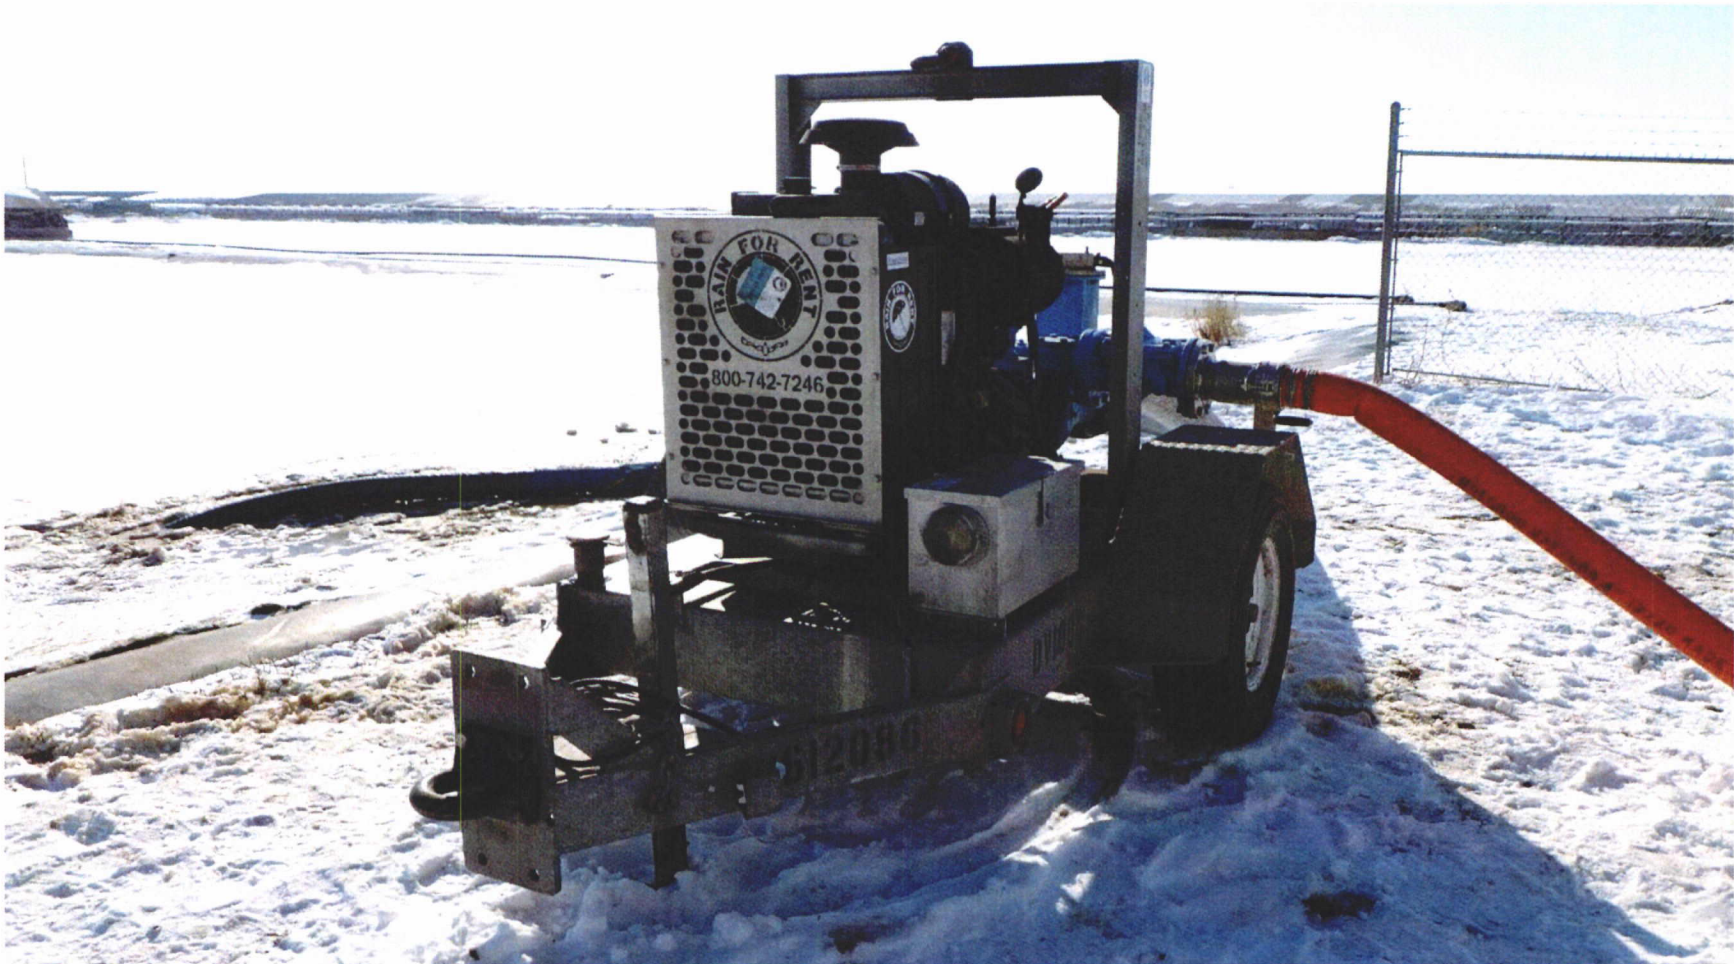
Photo 4

Description: Pump that is being used to pump wastewater from the Emergency Overflow lagoon into the Northwest lagoon (see Photo 5).

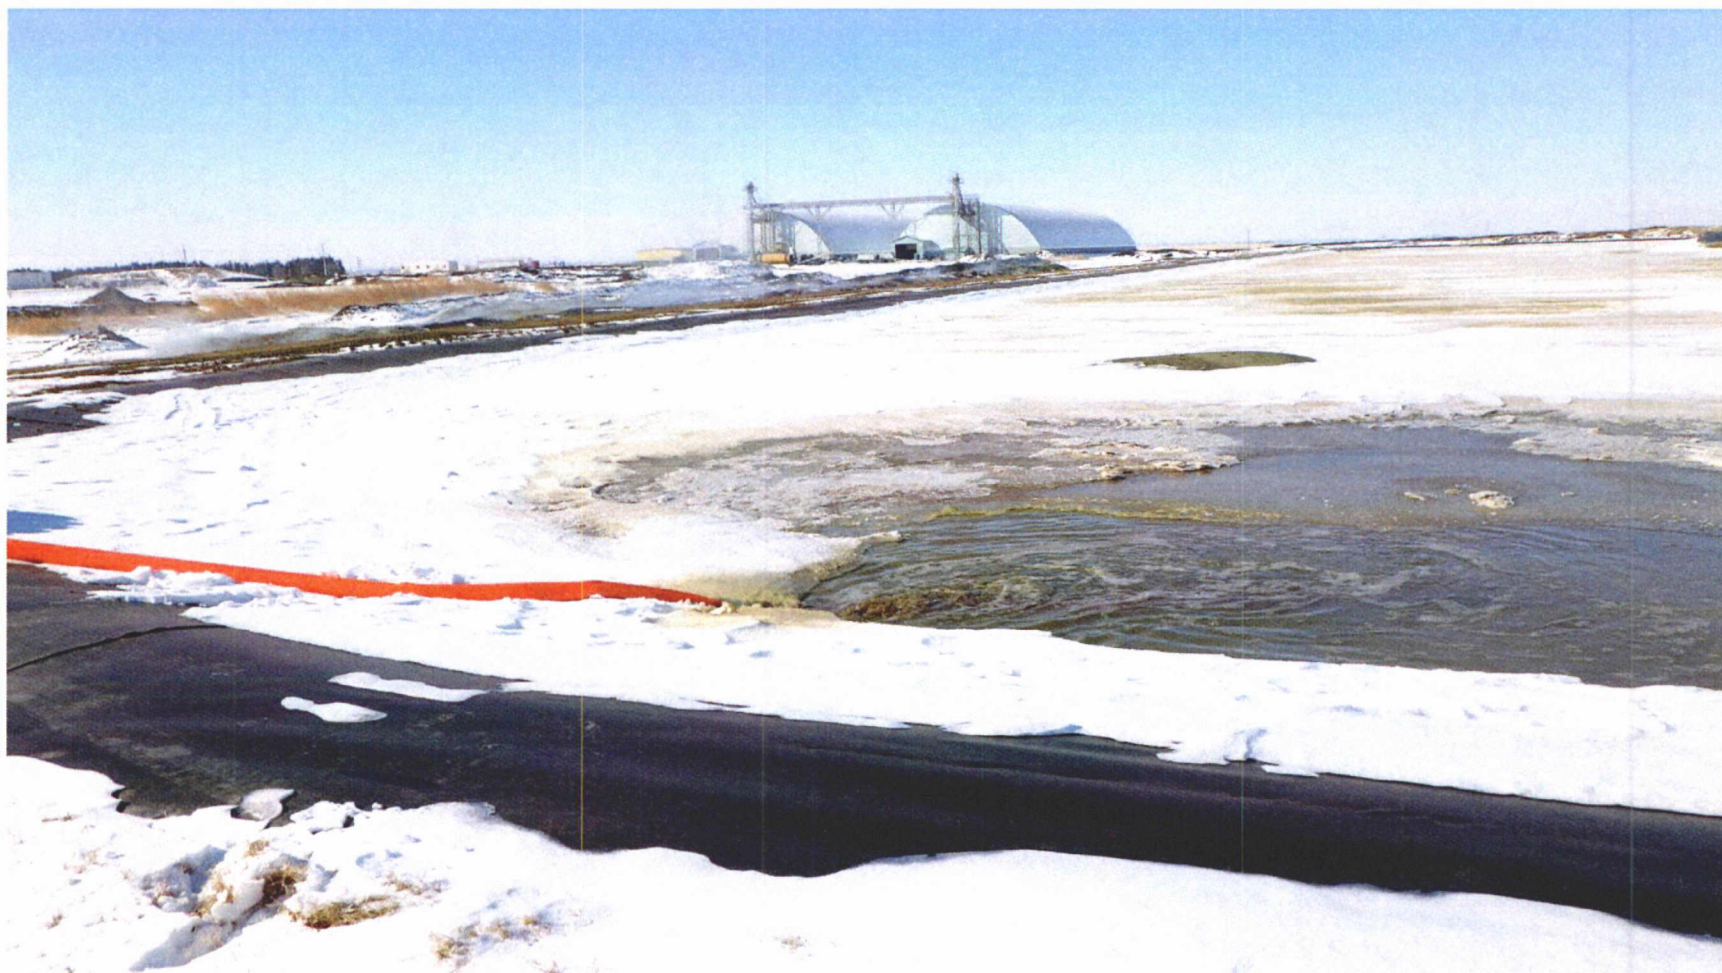
Photo 5

Description: Southeast corner of the Northwest lagoon. The orange hose conveys wastewater that is being pumped into the Northwest lagoon from the Emergency Overflow lagoon.

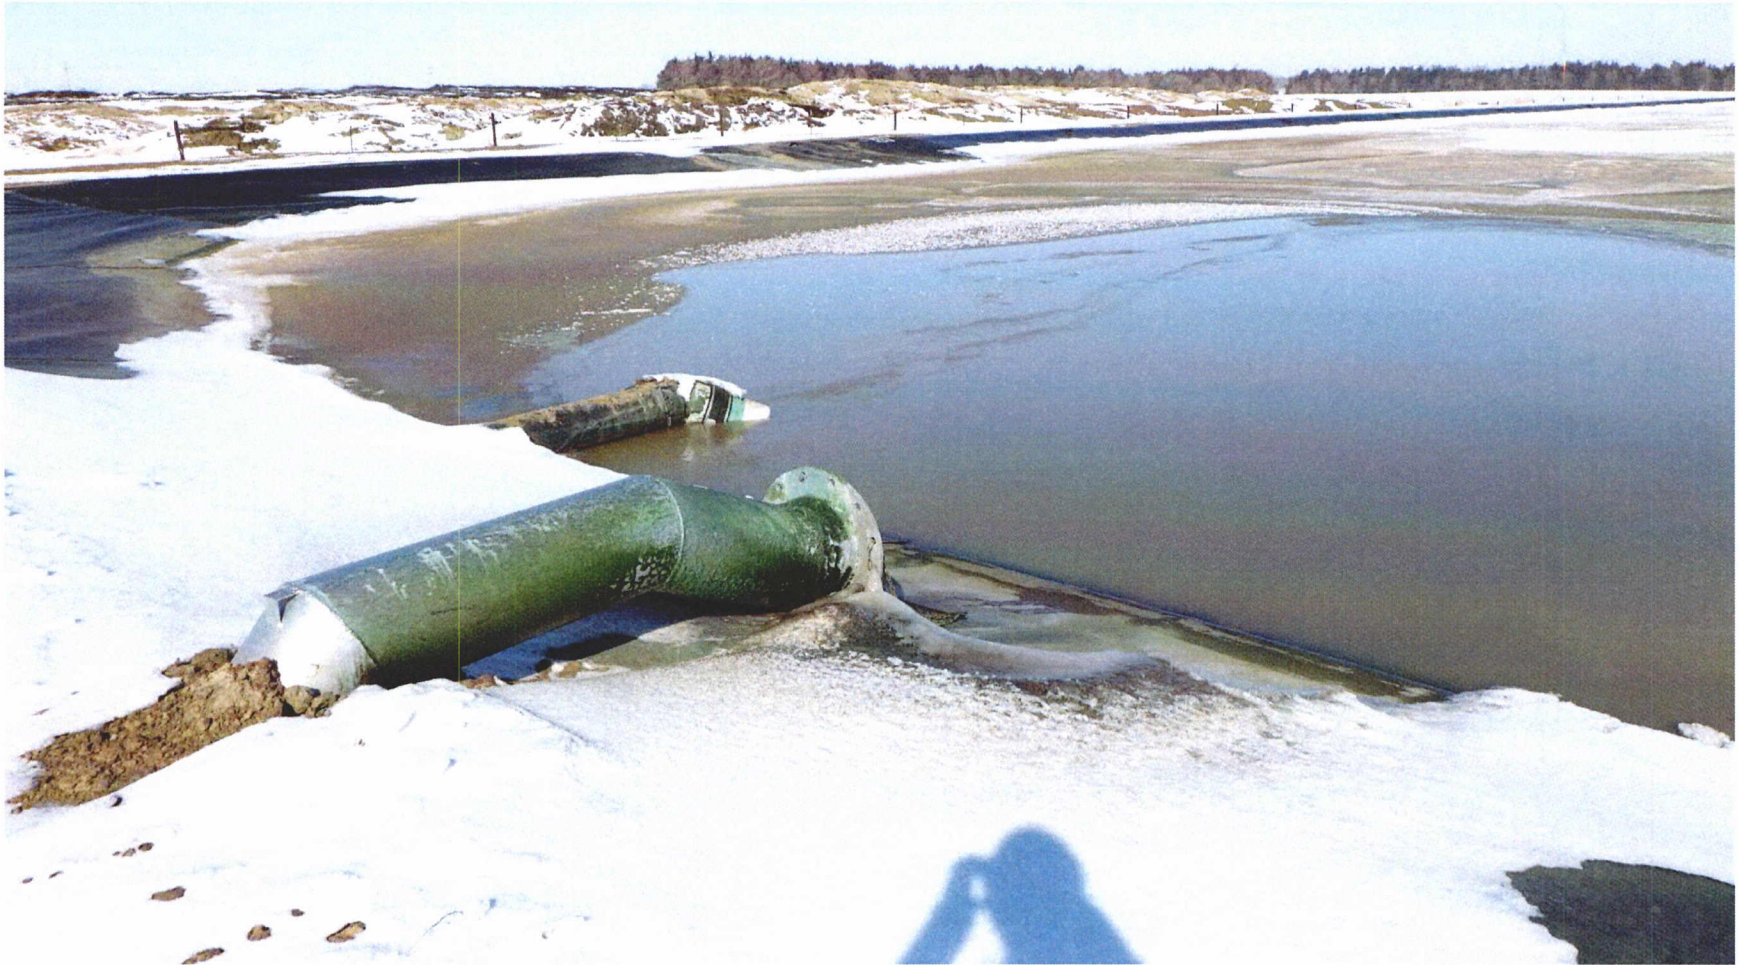
Photo 6

Description: Southwest corner of the Northwest lagoon. The pipe shown is the influent pipe used to convey wastewater from the facility. There was no evidence of wastewater discharging into the lagoon from this pipe since the facility is currently shutdown and not producing wastewater.

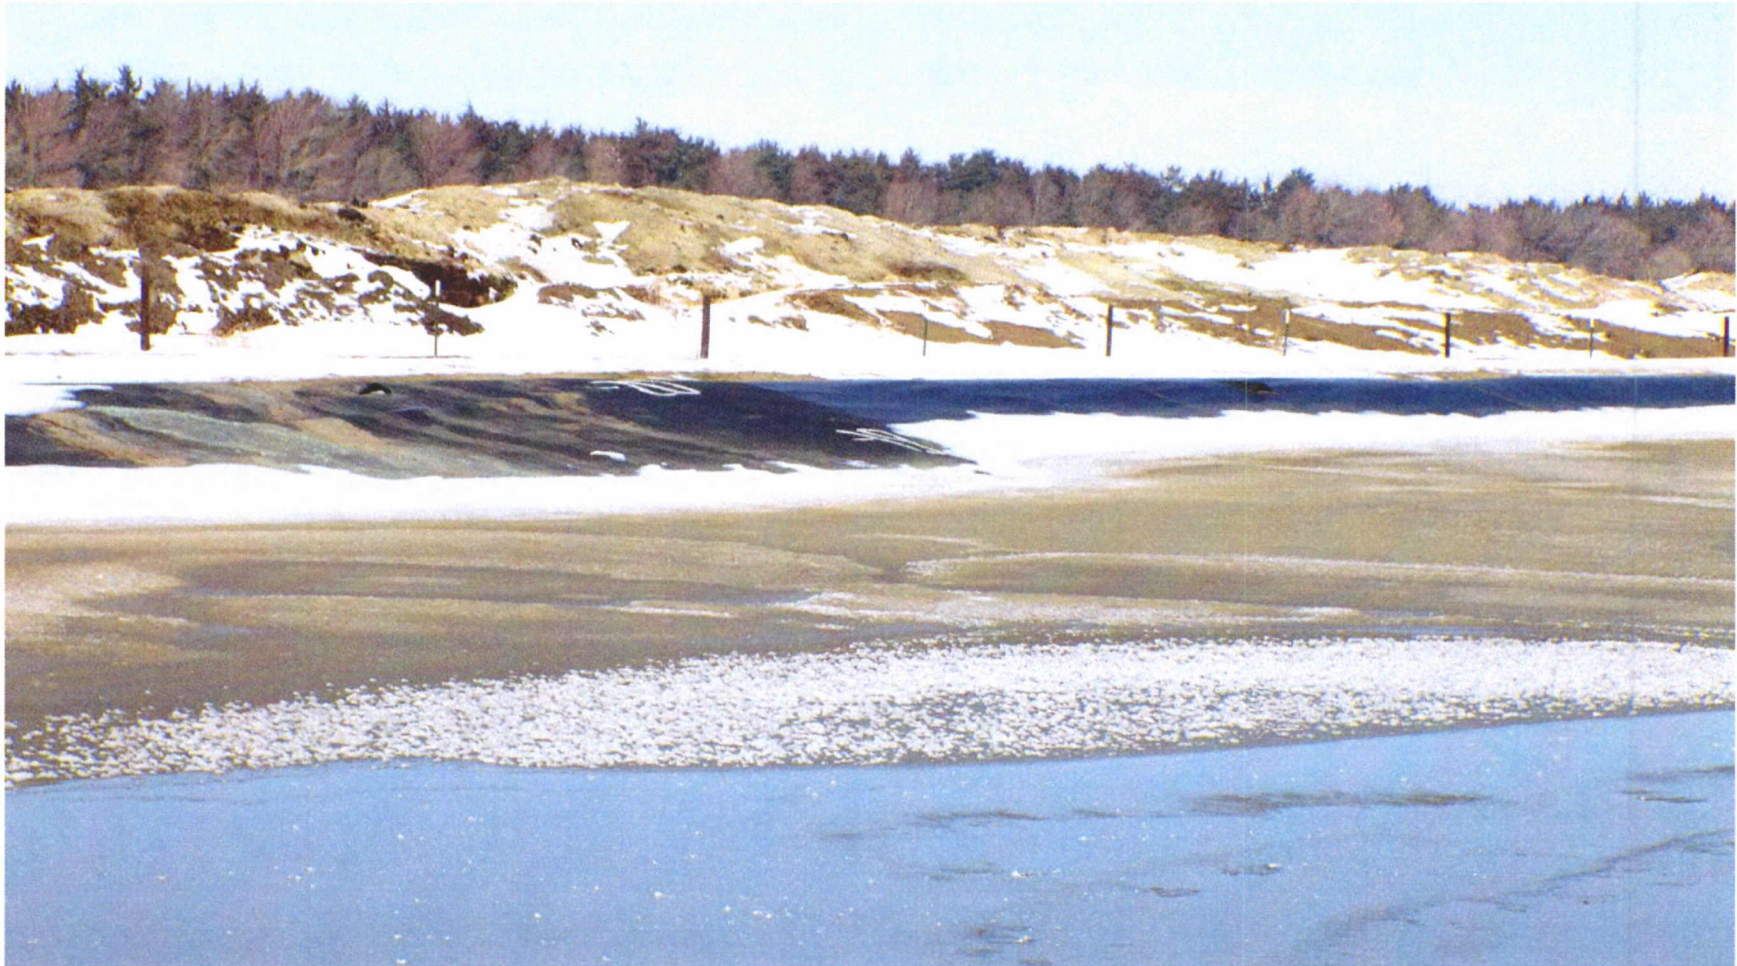
Photo 7

Description: Depth marker near the southwest corner of the Northwest lagoon. The top number is "20" and the bottom number is "19".

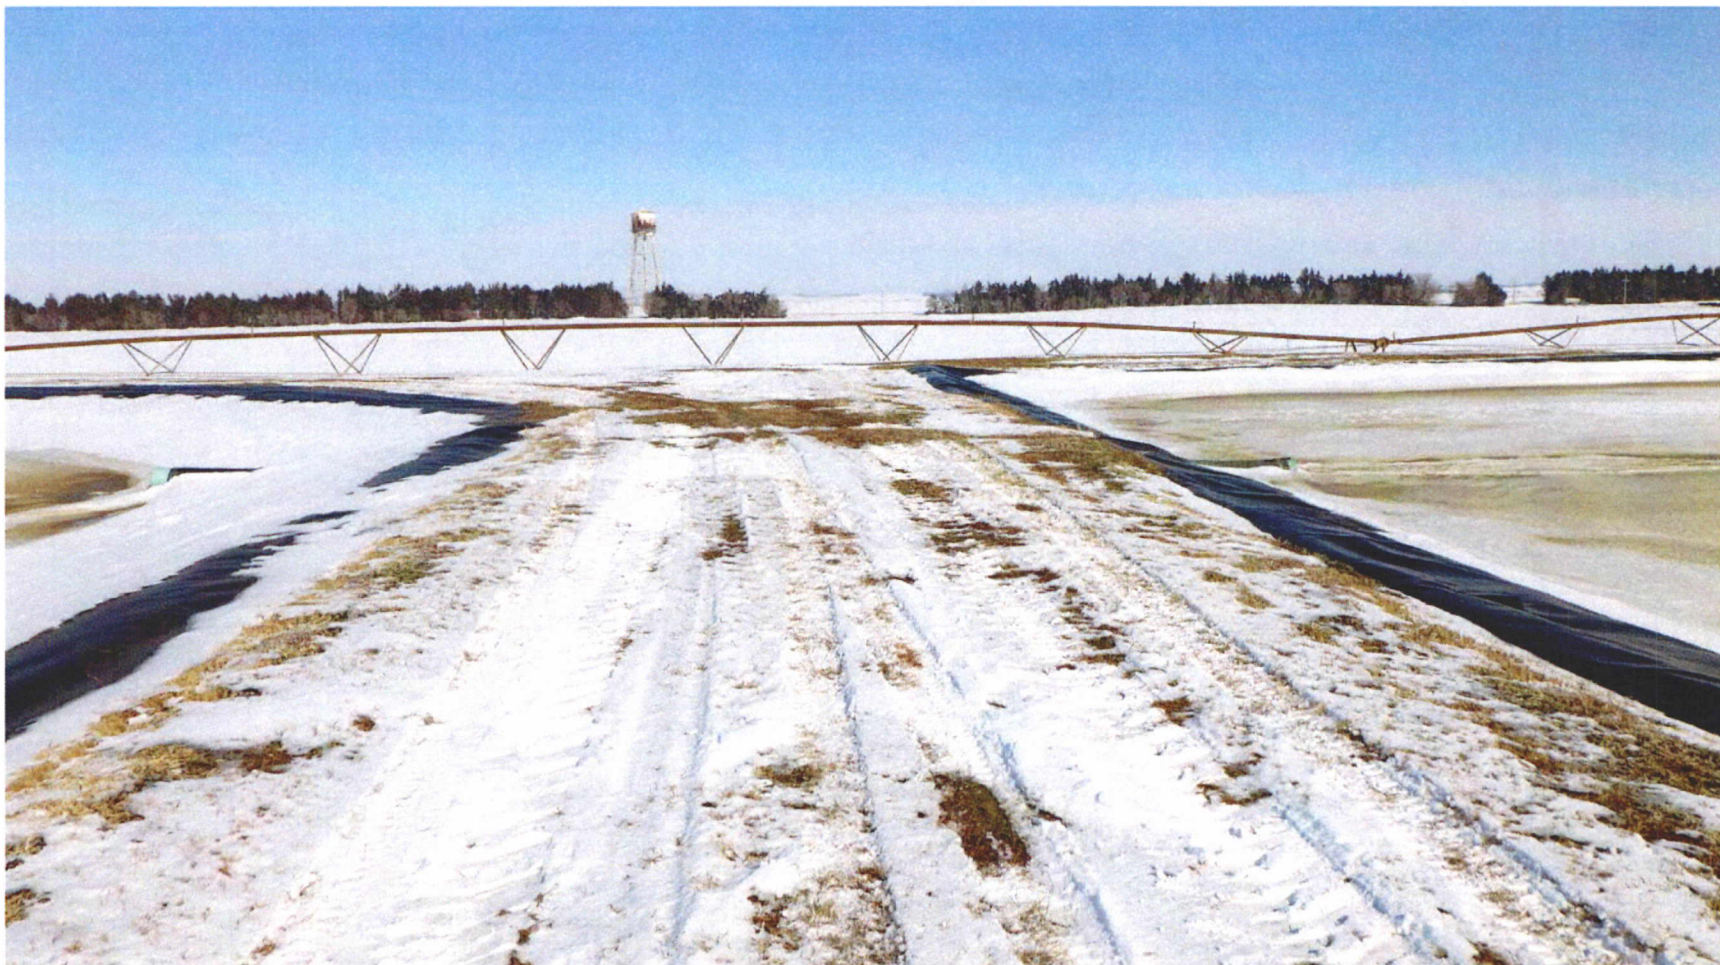
Photo 8

Description: Overflow pipe from the Northwest lagoon (left) to the Northeast lagoon (right).

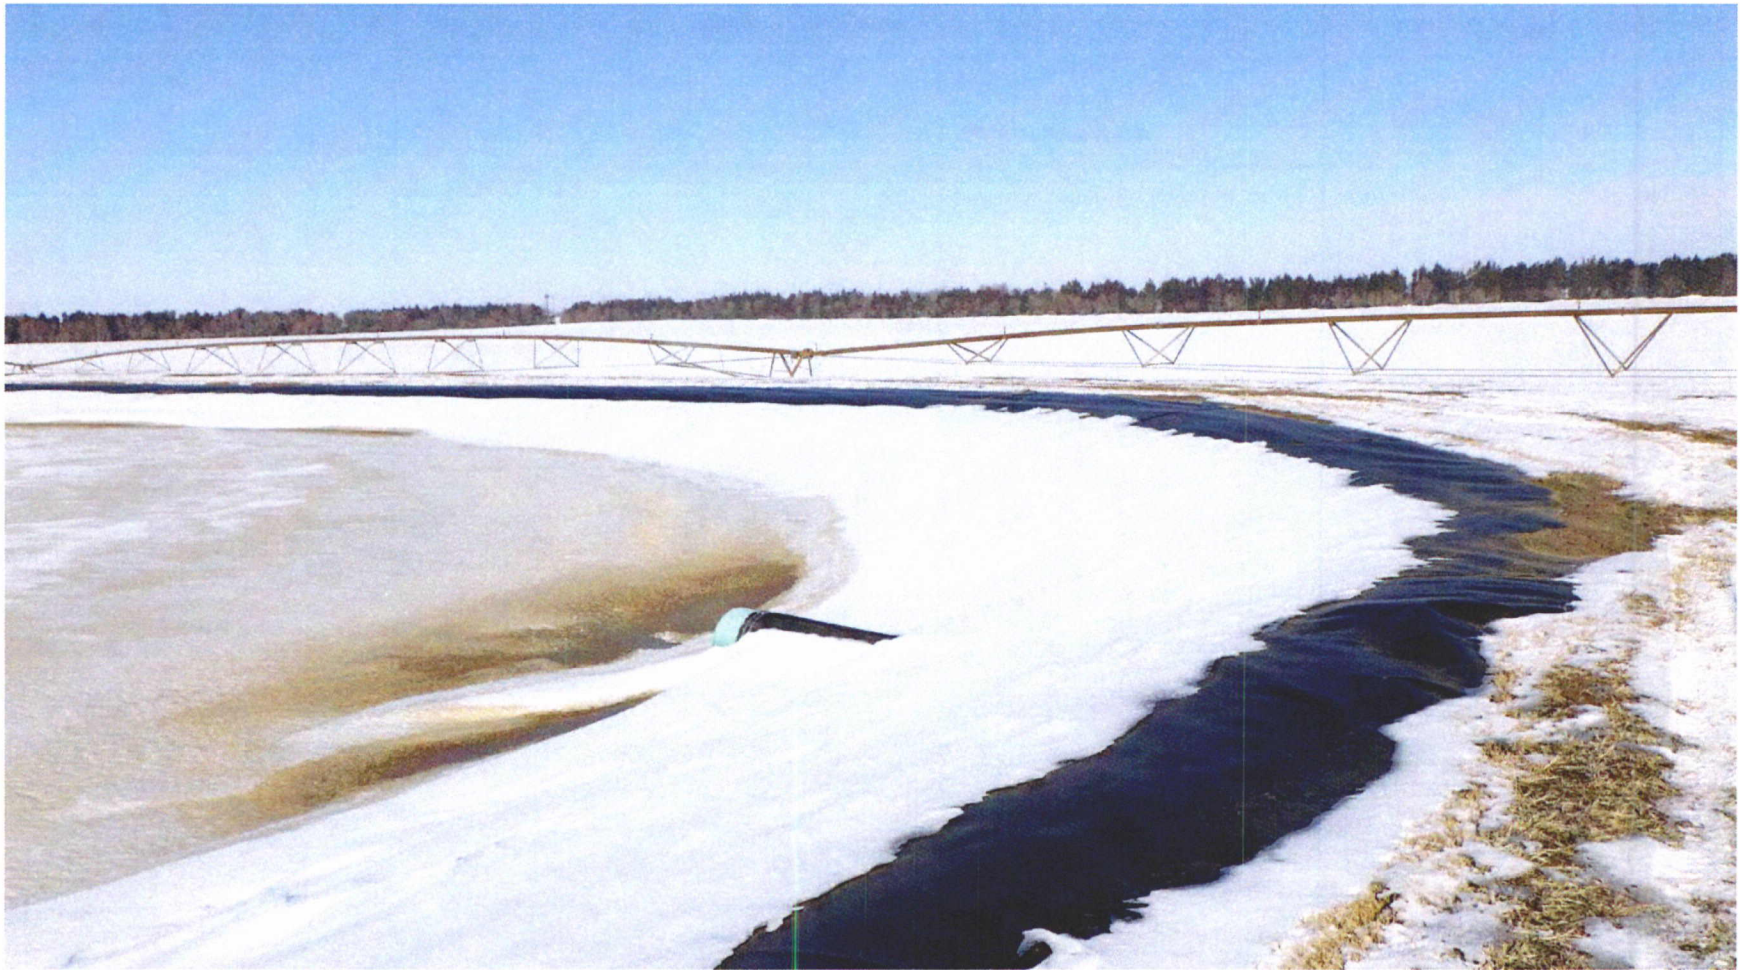
Photo 9

Description: Overflow pipe exiting the Northwest lagoon (flows to Northeast lagoon – see Photos 8, 11, and 12).

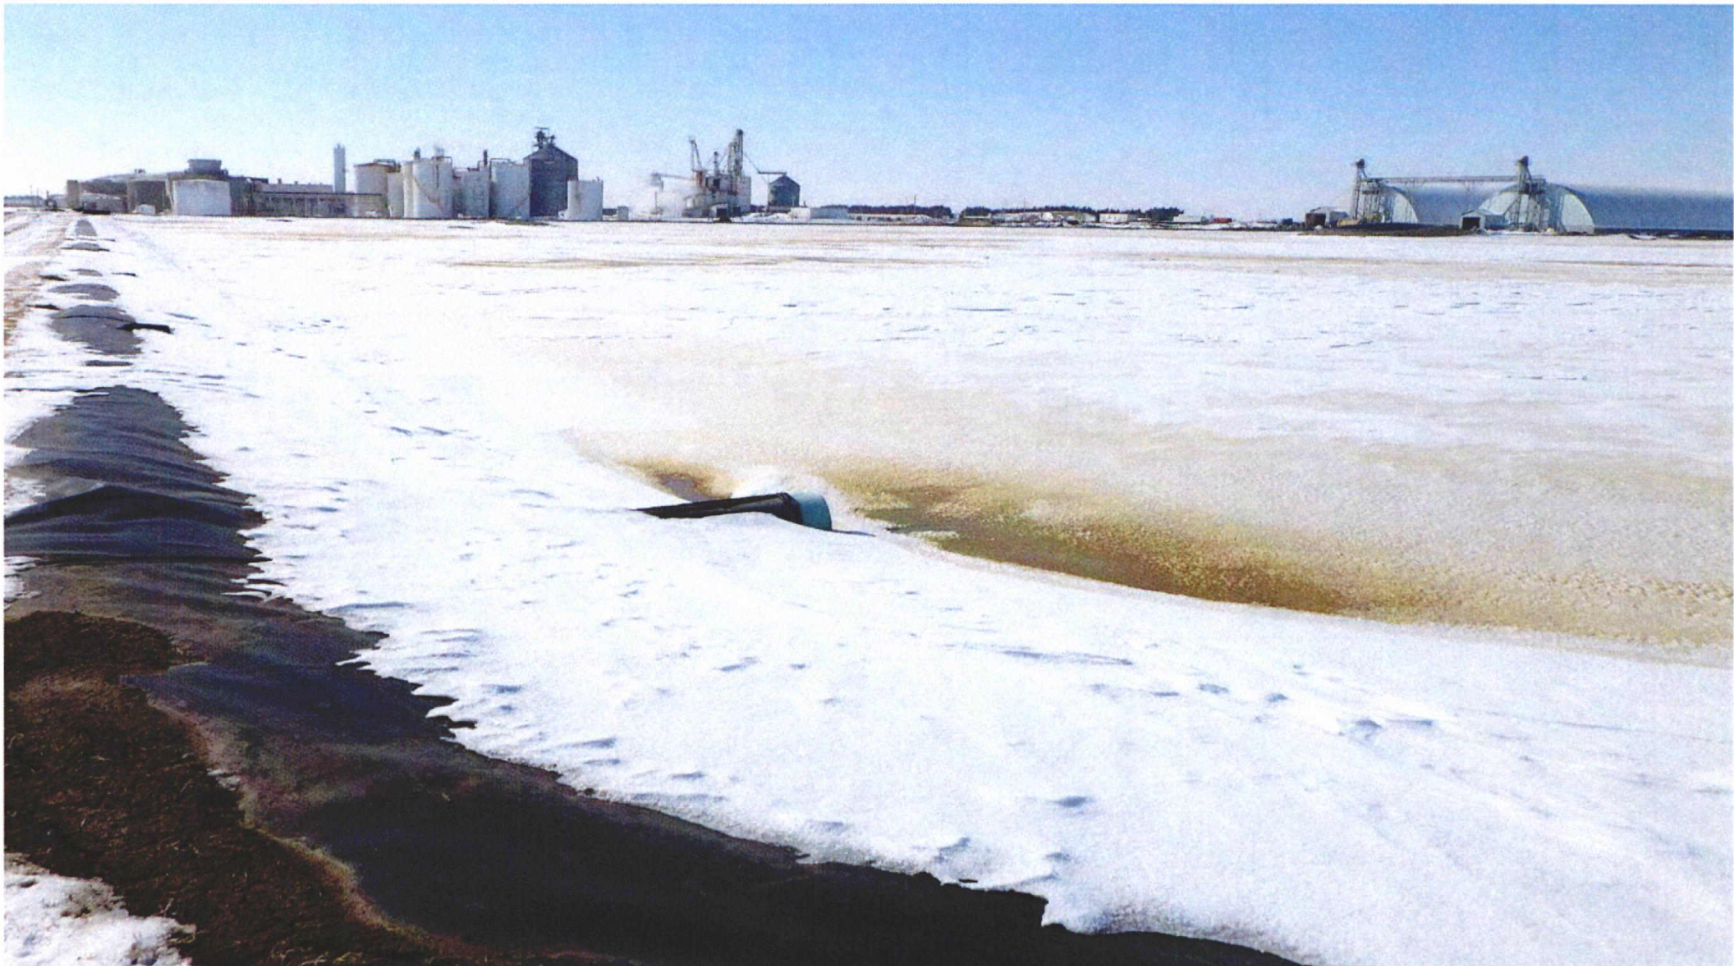
Photo 10

Description: Overflow pipe exiting the Northwest lagoon (flows to Northeast lagoon – see Photos 8, 11, and 12).

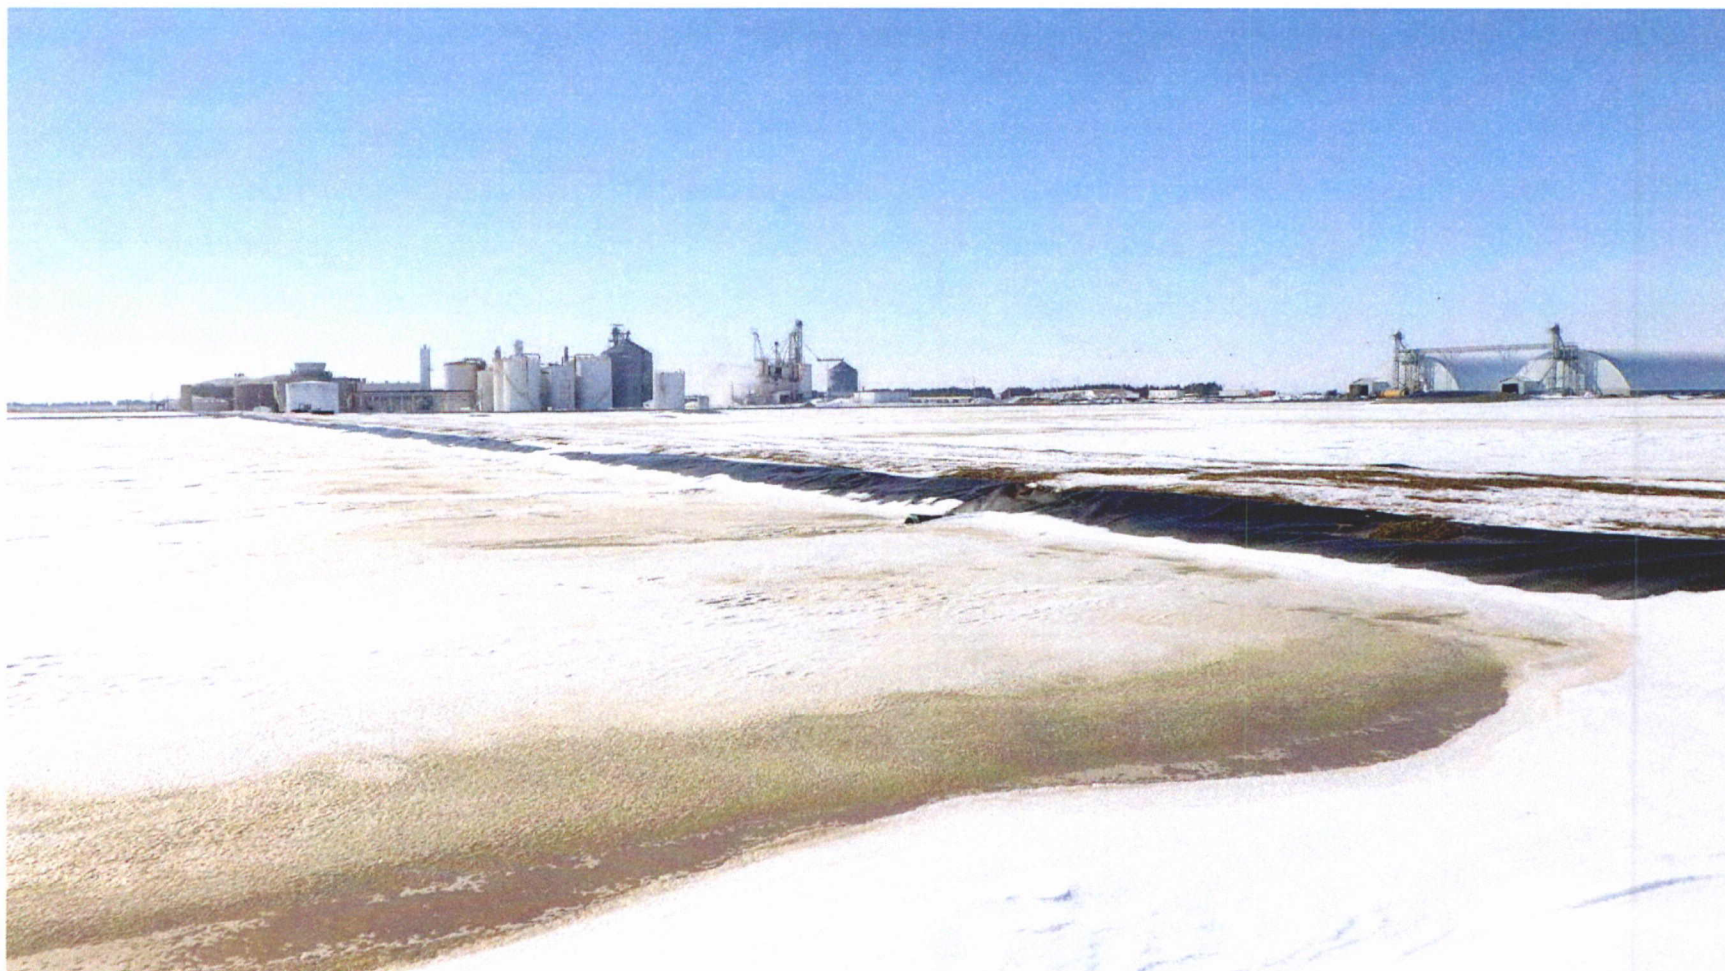
Photo 11

Description: Overflow pipe entering the Northeast lagoon from the Northwest lagoon.

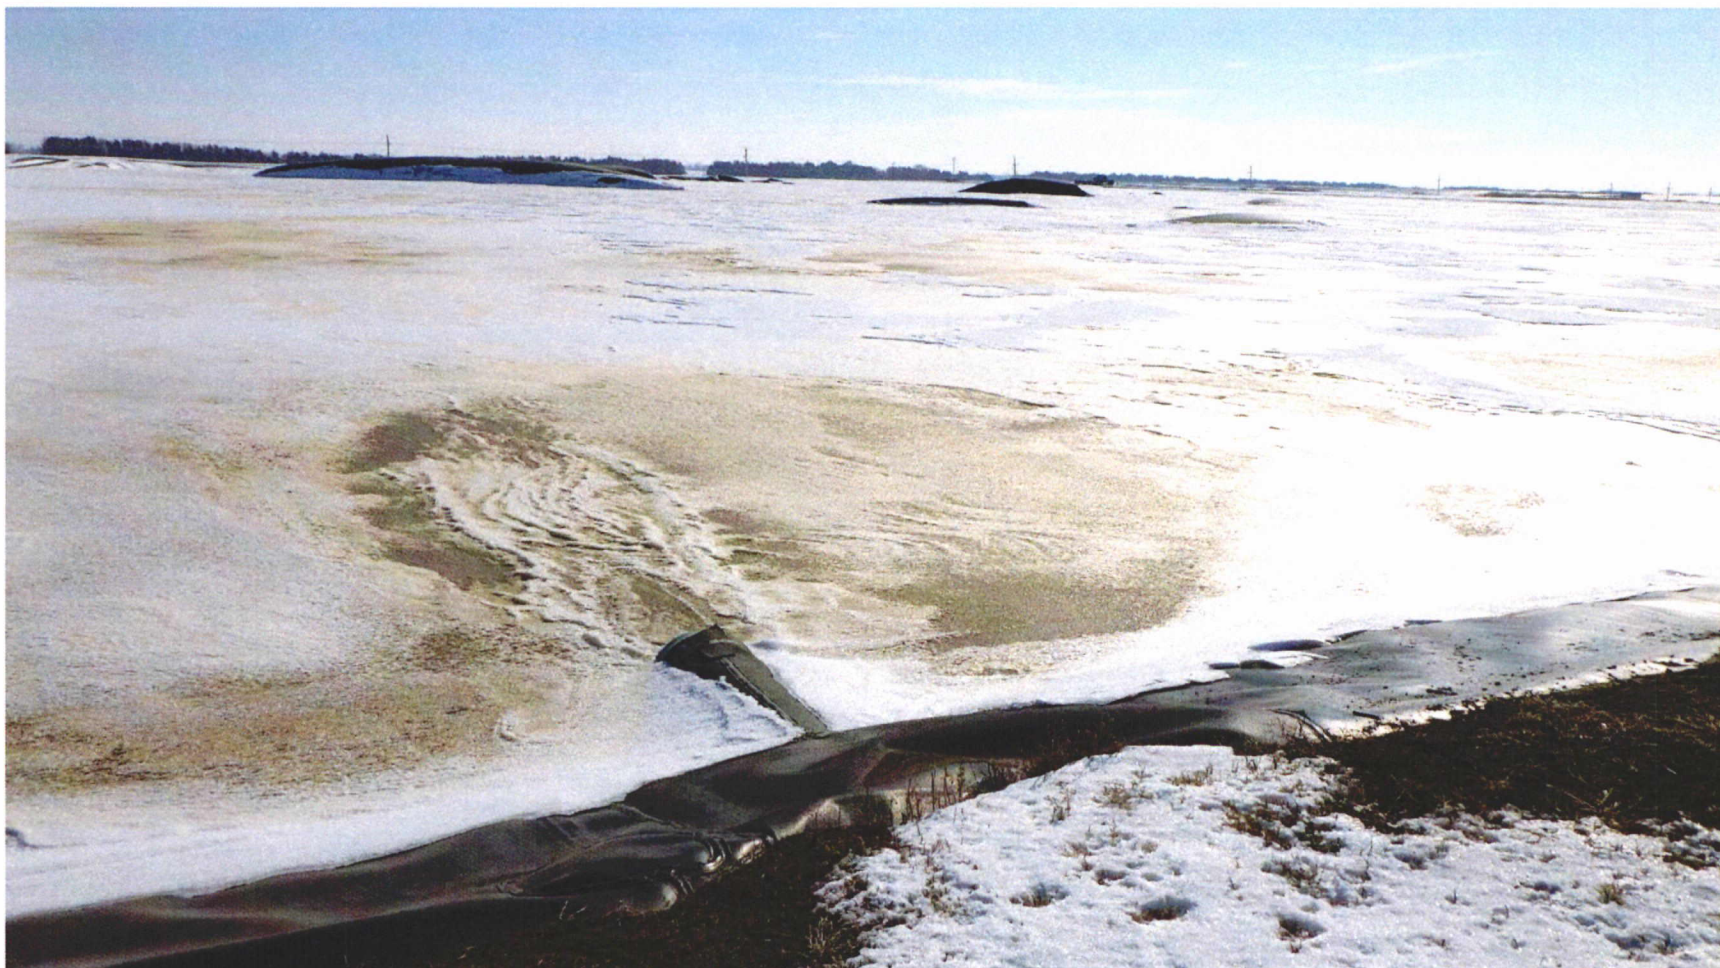
Photo 12

Description: Overflow pipe entering the Northeast lagoon from the Northwest lagoon.

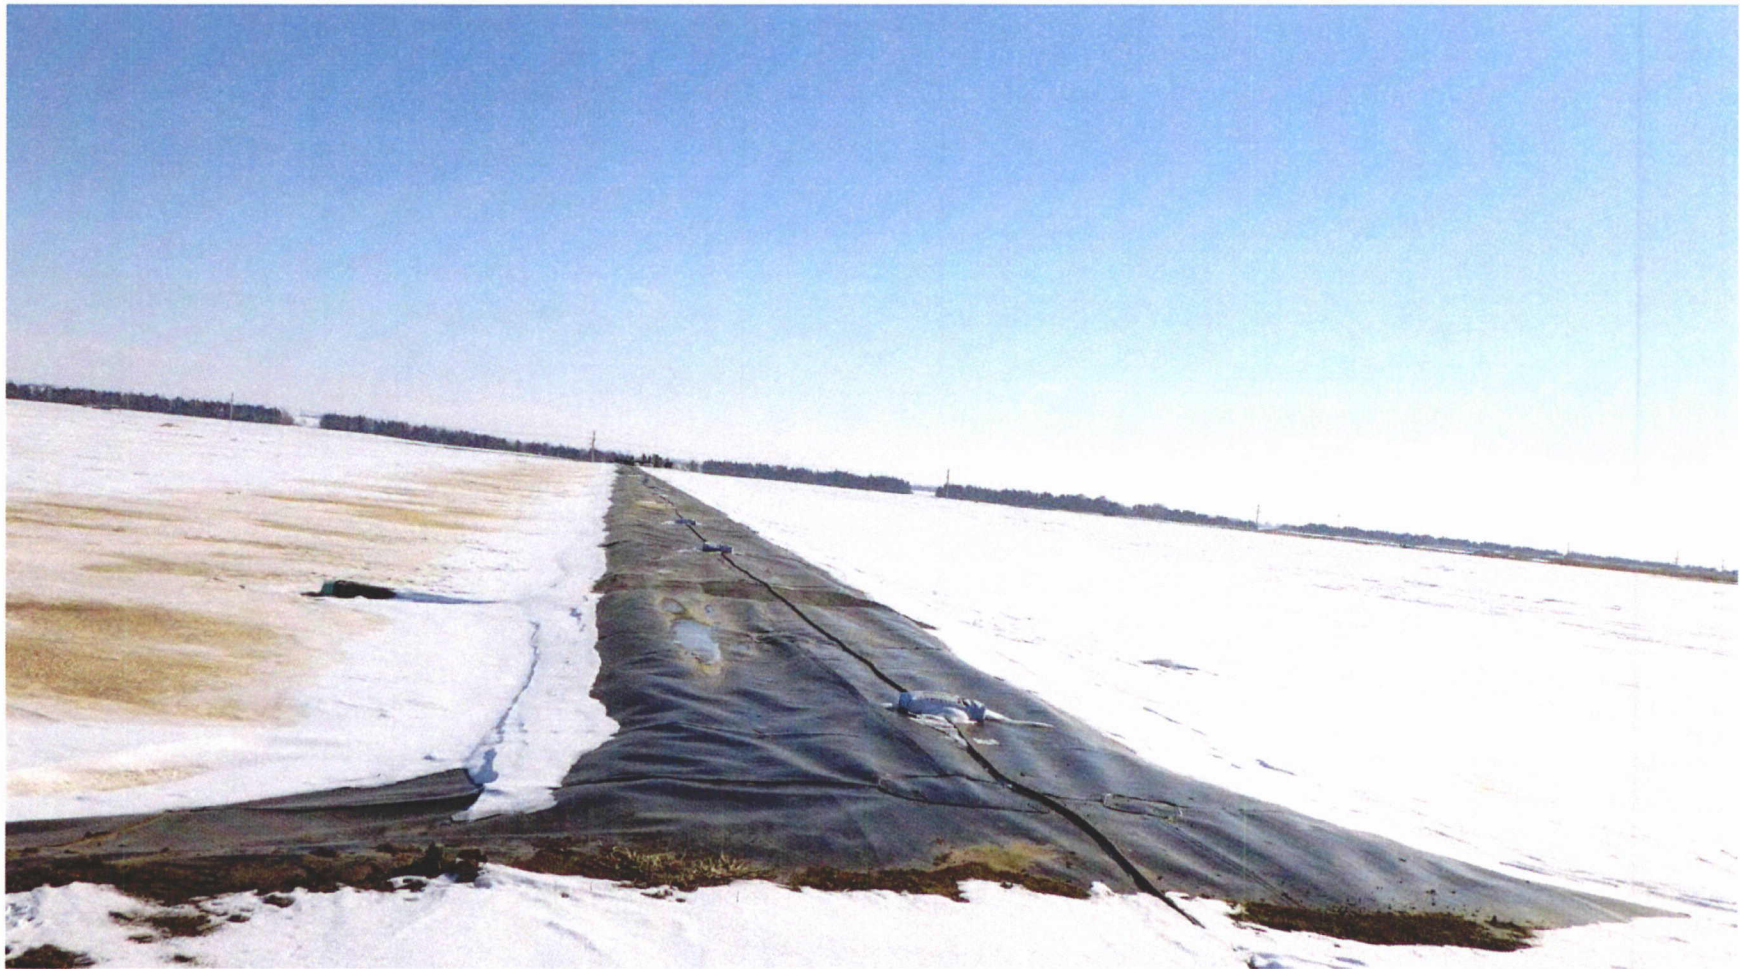
Photo 13

Description: Overflow pipe from the Northeast lagoon (left) to the Southeast lagoon (right).
