Nebraska Department of Environment and Energy (NDEE)

MEMORANDUM

RE: AltEn, LLC

Subject: Site Visit Report to Observe the Lagoons

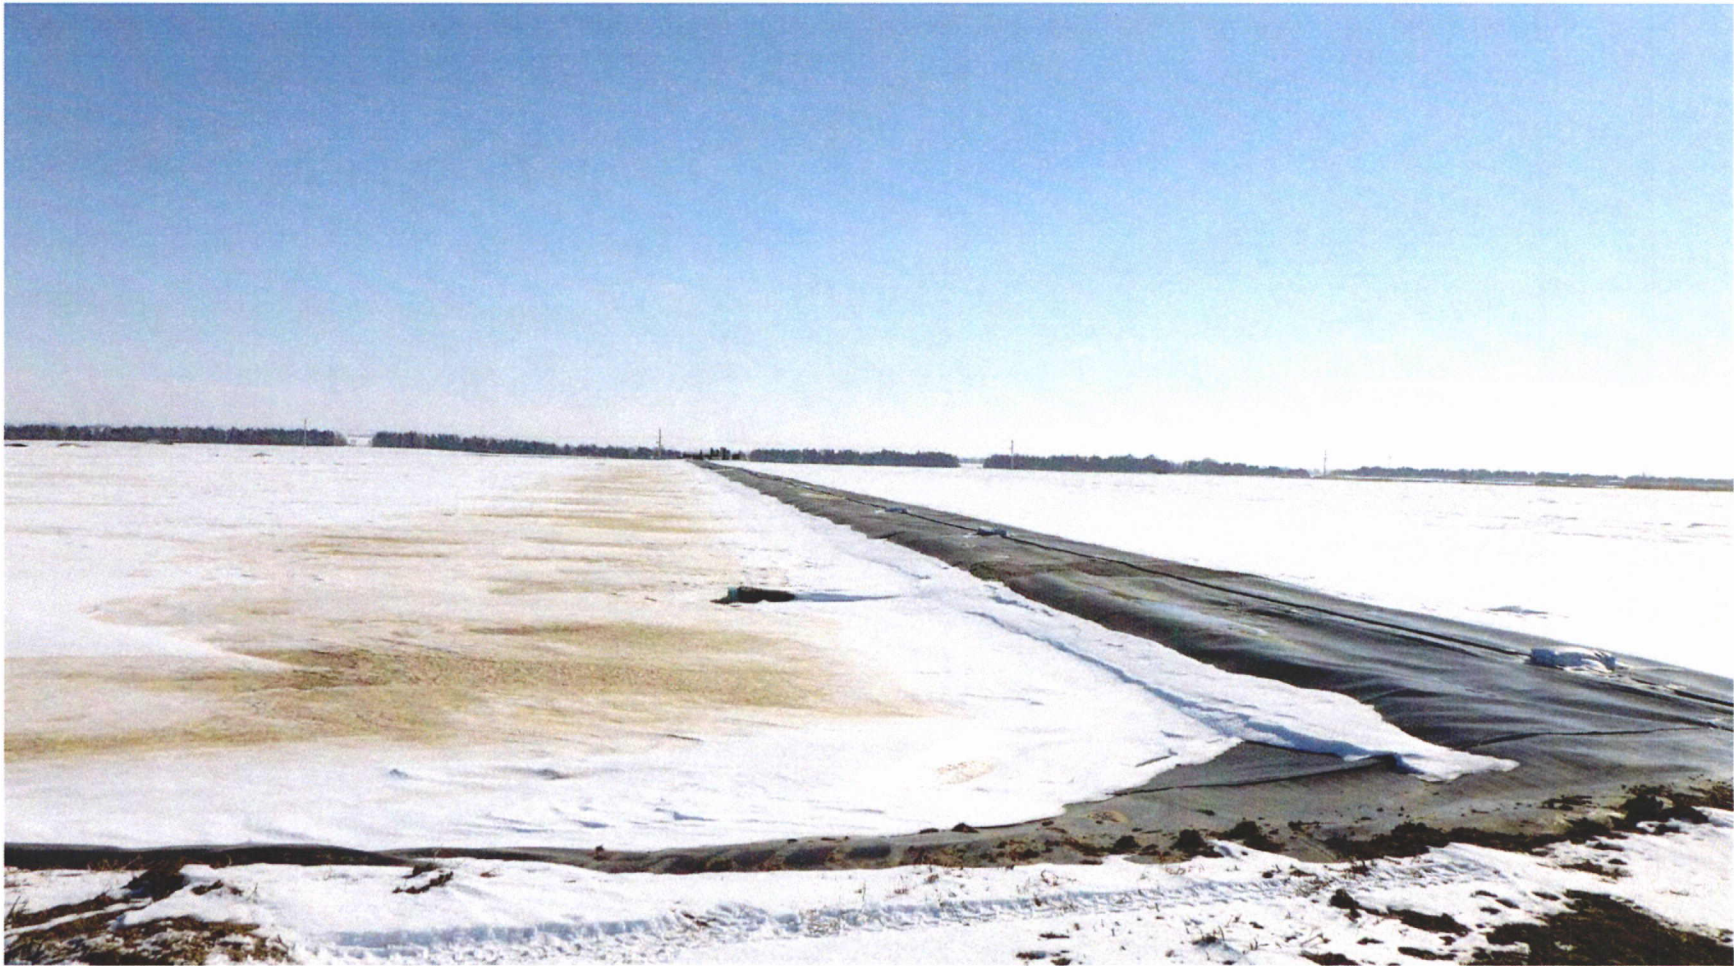
Photo 14

Description: Overflow pipe from the Northeast lagoon (left) to the Southeast lagoon (right).

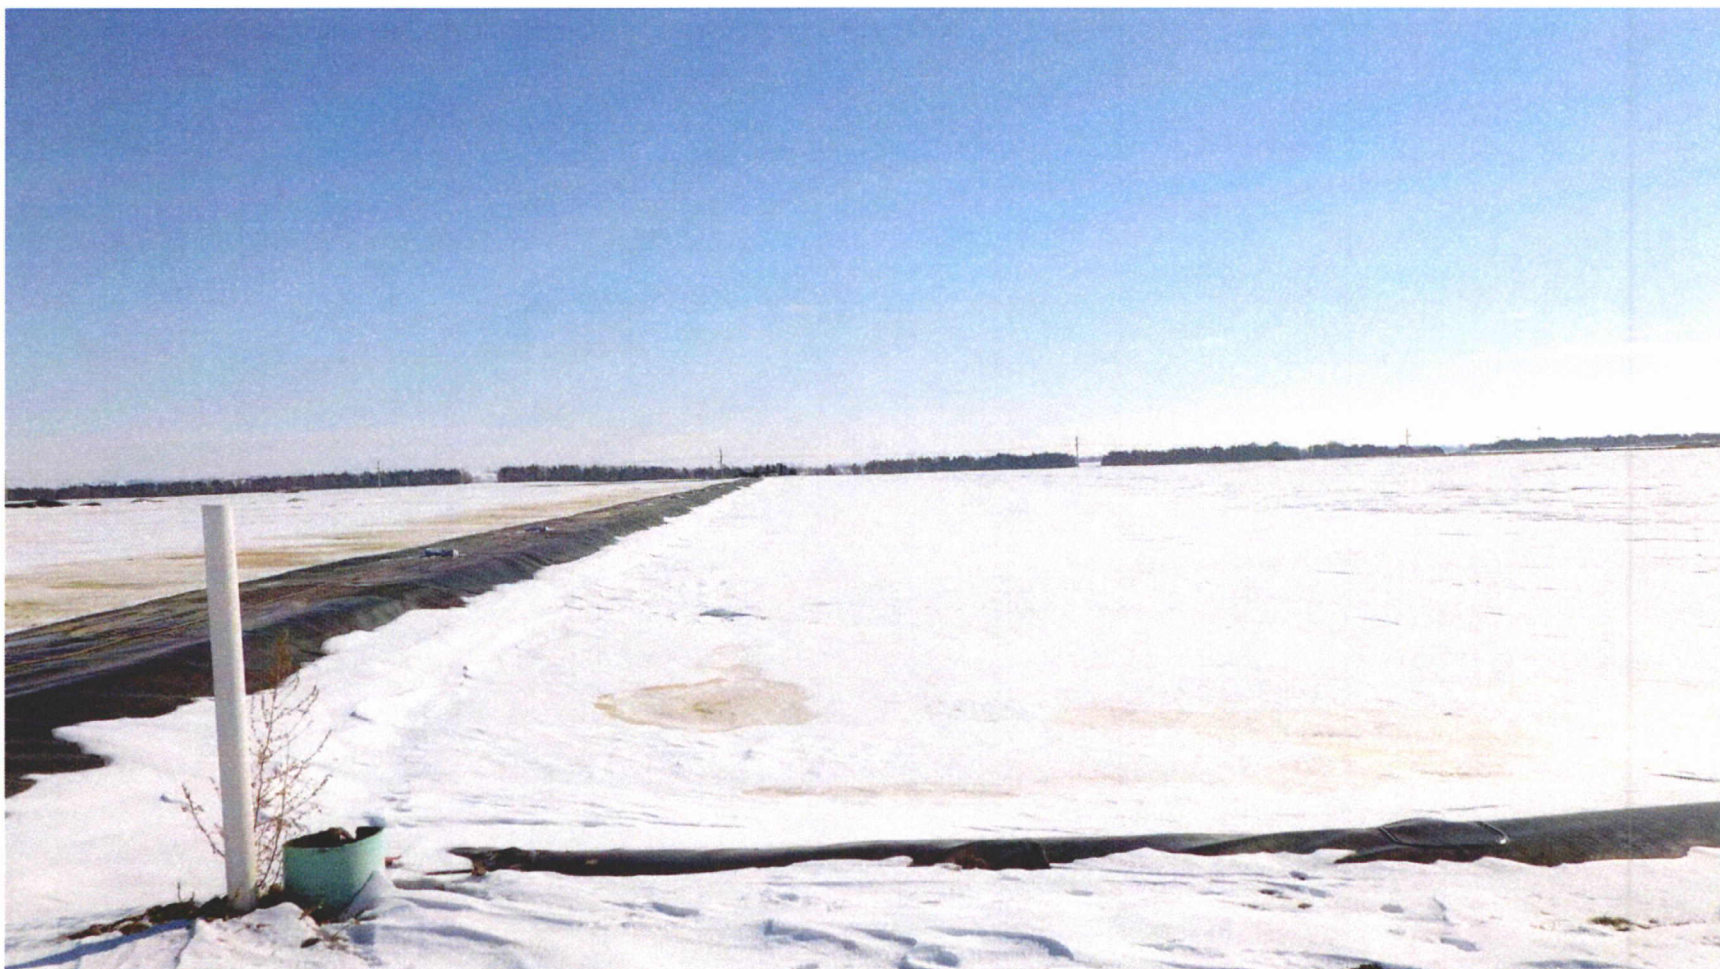
Photo 15

Description: Overflow pipe from the Northeast lagoon (left) entering the Southeast lagoon (right). The pipe in the Southeast lagoon is mostly covered with ice/snow.

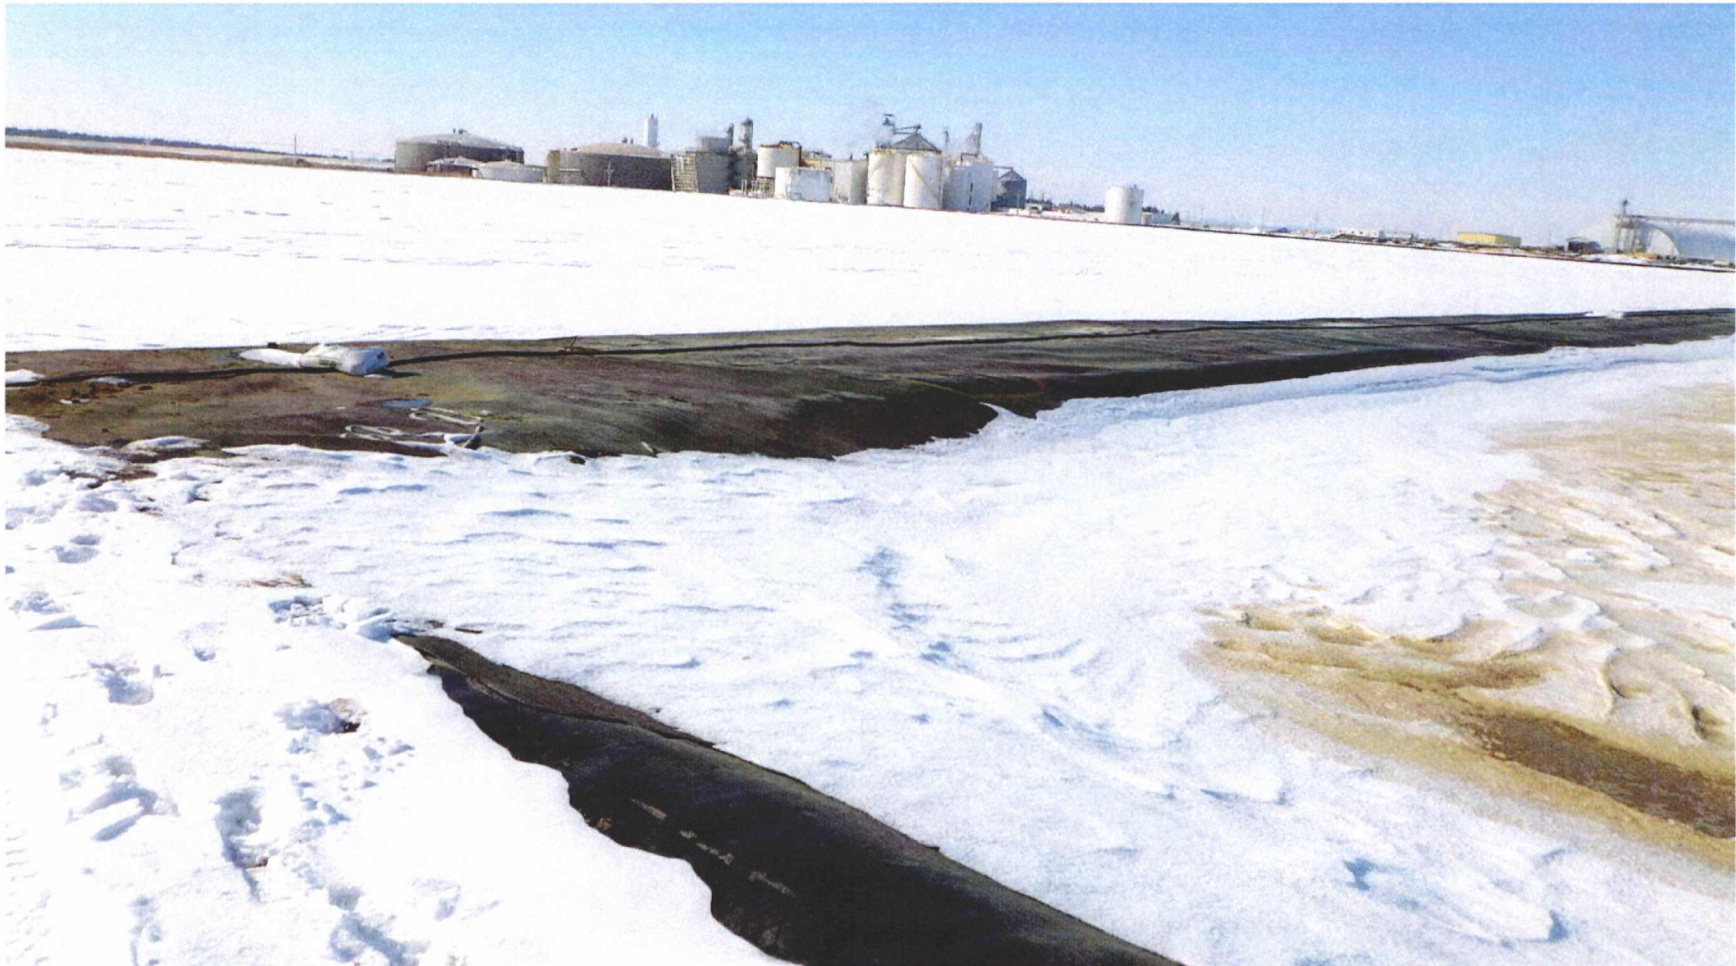
Photo 16

Description: Southeast corner of the Northeast lagoon. The depth marker for the Northeast lagoon is somewhat visible. The top number is "22". The "1" from "21" is barely visible under the snow.

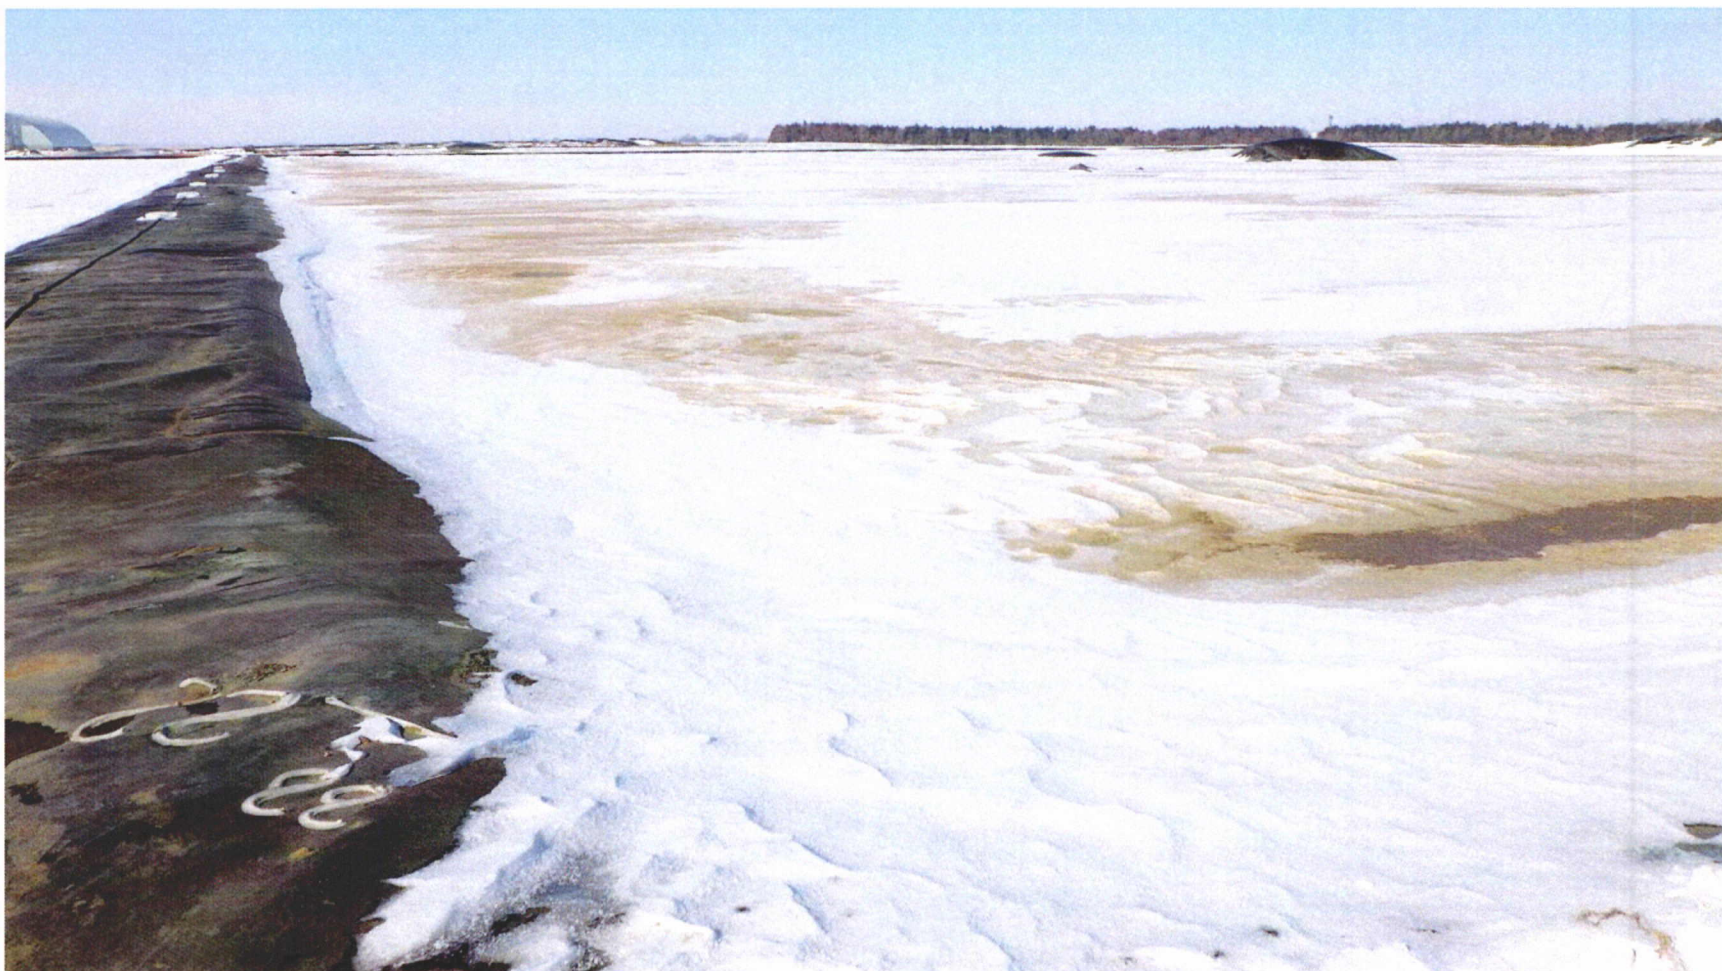
Photo 17

Description: Southeast corner of the Northeast lagoon. The depth marker for the Northeast lagoon is somewhat visible.

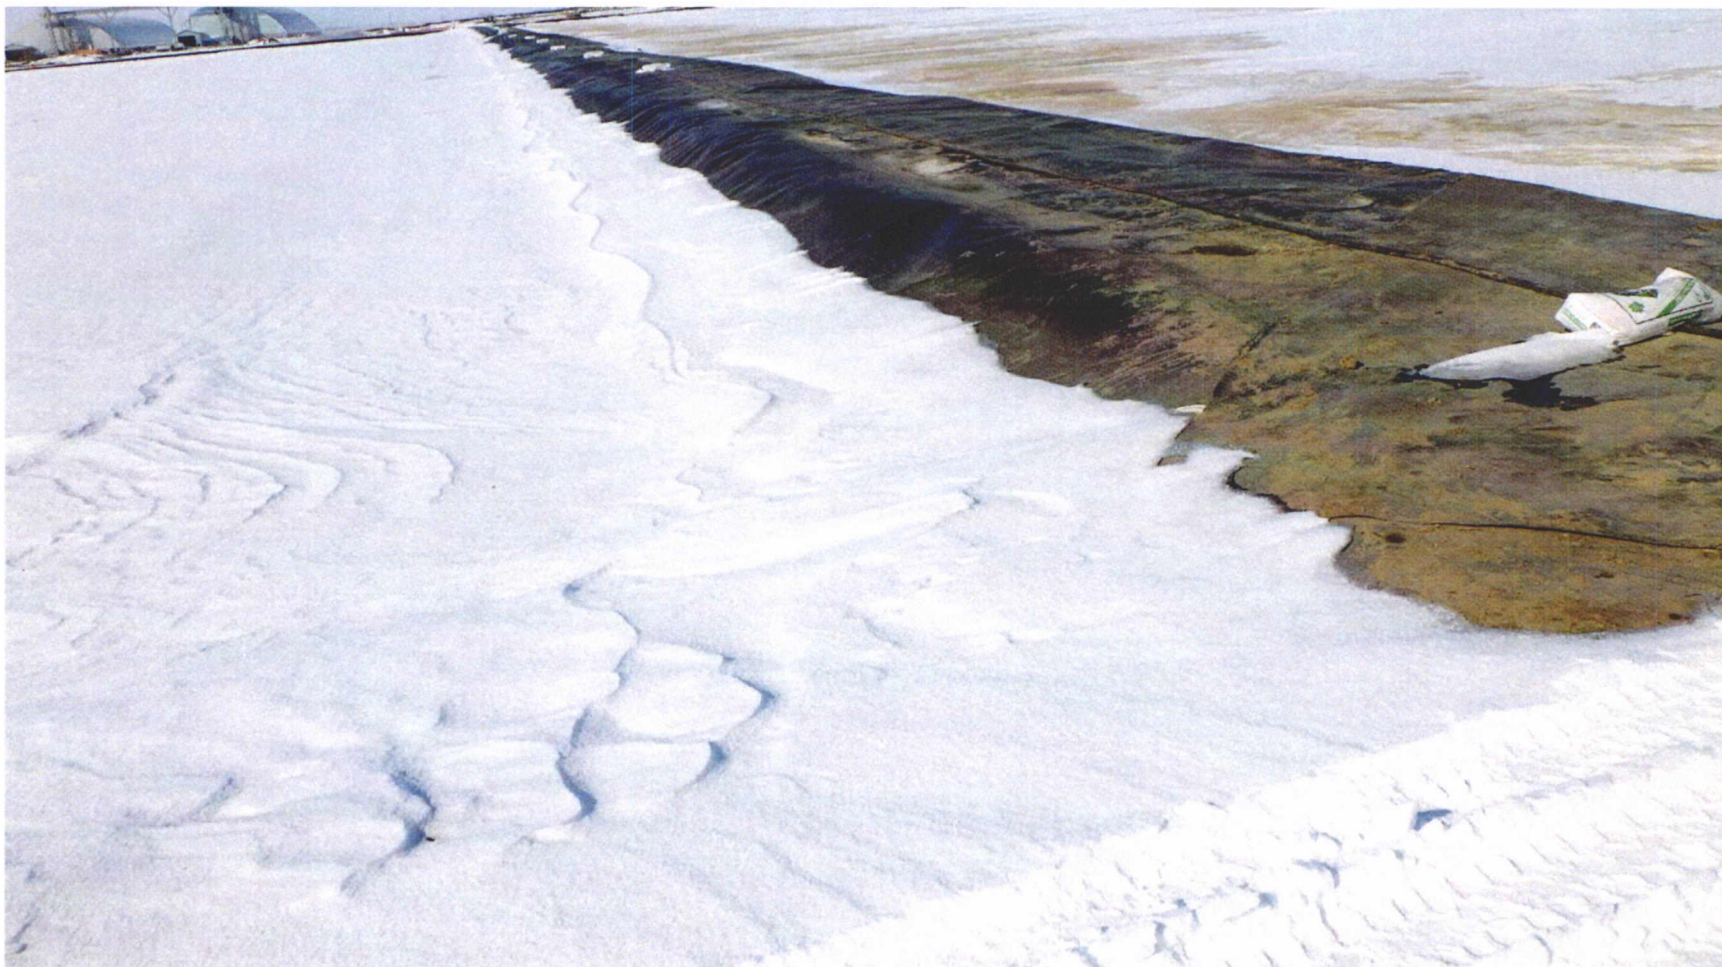
Photo 18

Description: Northeast corner of the Southeast lagoon. The depth marker is not visible due to the snow.

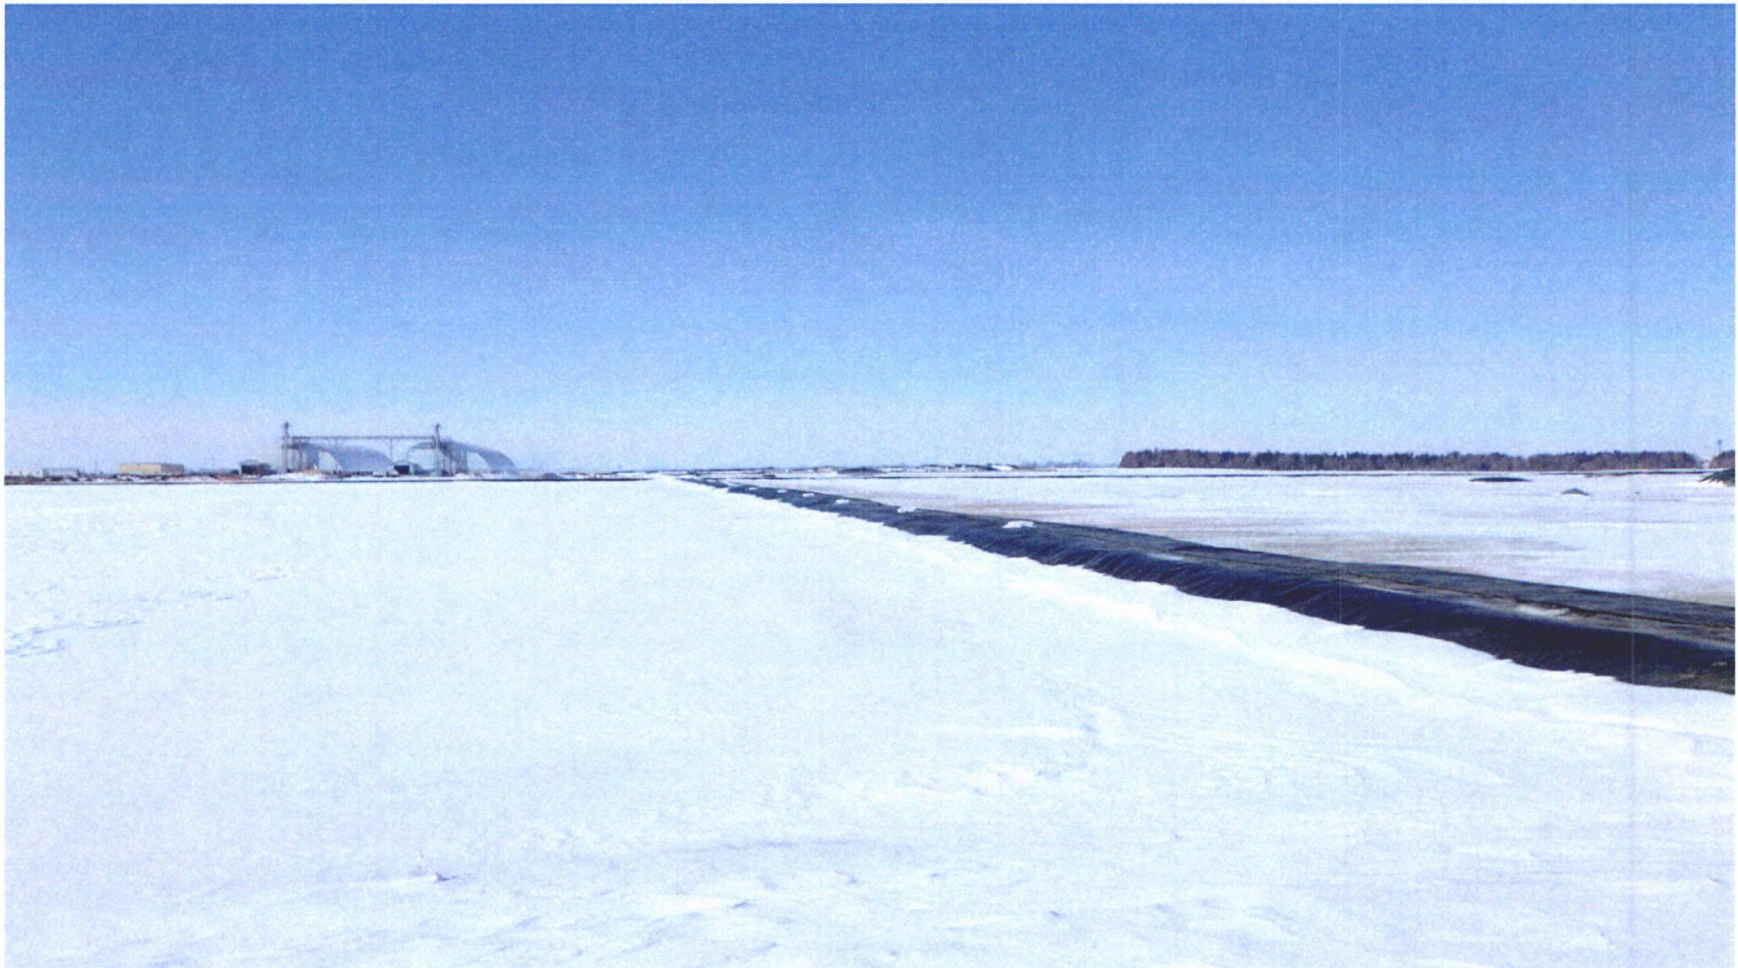
Photo 19

Description: Overview of the Southeast lagoon (left) and the Northeast lagoon (right).

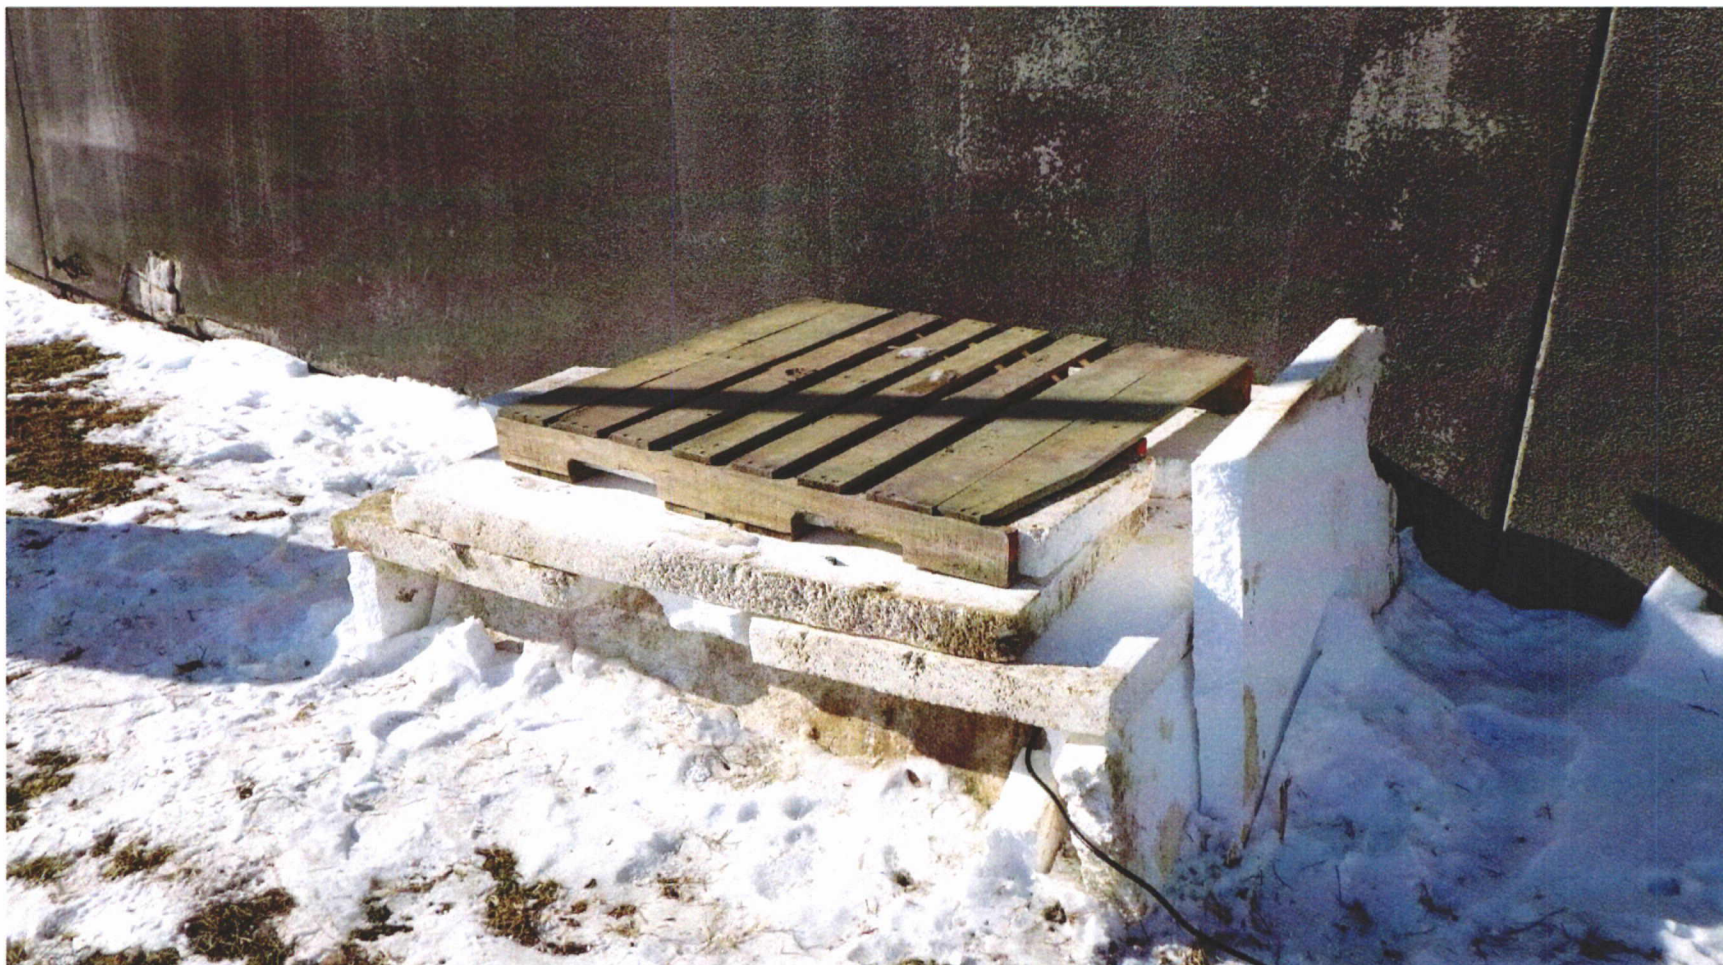
Photo 20

Description: Insulation and heating lamp in place to help prevent a pipe on the North digester (currently full – not part of the spill) from freezing.
