From: Morrow, Kirk
Sent: Saturday, February 20, 2021 6:45 PM
To: Scott Tingelhoff
Cc: kpeterson@mrgkc.com; dzalesky2@unl.edu; mtingelhoff@mrgkc.com; Doug Ferguson (Ferguson.Doug@epamail.epa.gov); Buell, Thomas; Pracheil, Brad
Subject: RE: DAILY OBSERVATIONS (FEB 20 (PM))
Attachments: ALTEN OBSERVATIONS (Capps PMFEB20).pdf

RE: ALT EN LLC
MEAD, NEBRASKA

NDEE FAC ID: 84069

PROGRAM ID: 021221-NH-0845

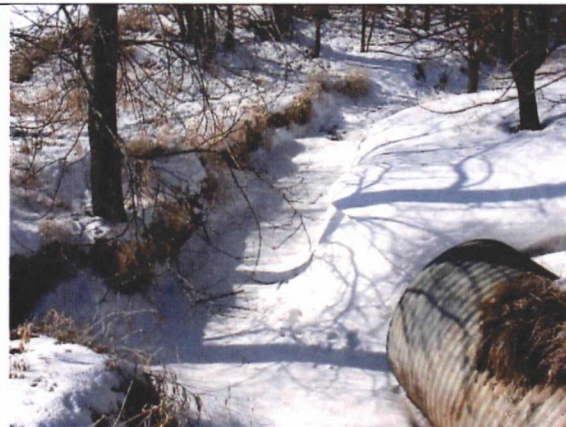
No change from previous reports

Photo facing up stream to the Northwest

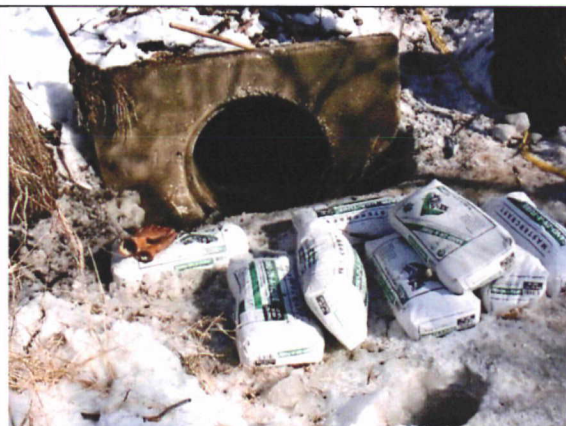
No contamination present. Water standing at the entrance of the culvert.

Steve explained they had removed sandbags, plywood and tarp from the culvert. They dug out all of the ice at the culvert and were in the process of inflating the packer, with generator at the truck, to place in the culvert.

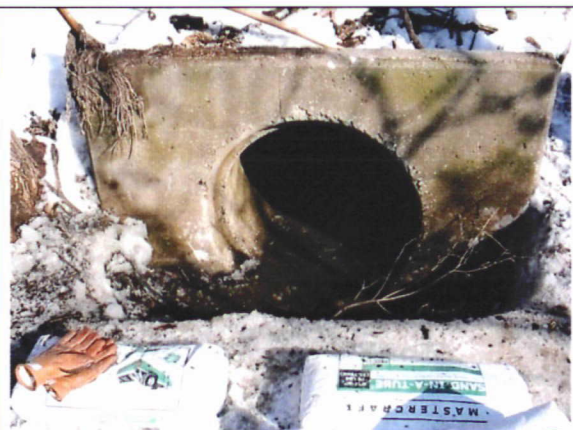
Photo: Entrance of culvert.

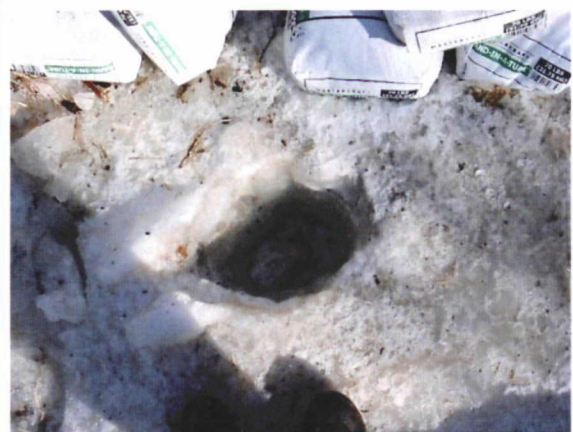
Hole G. Michl chipped into ice on 2/18/21

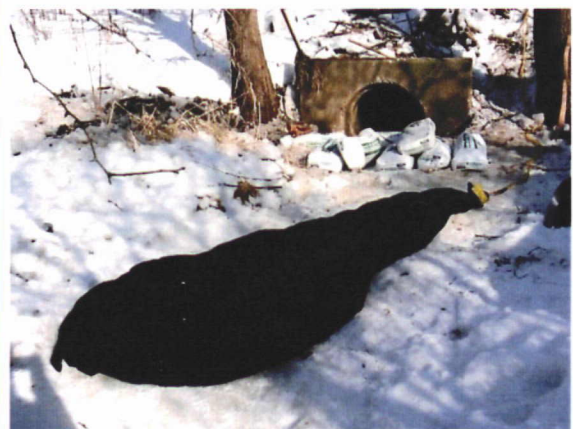
Photo: Packer being inflated.

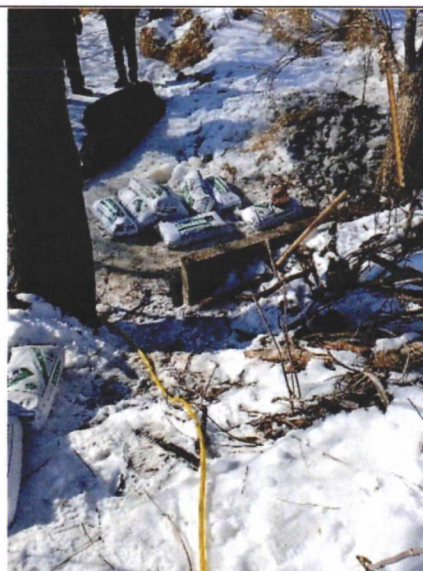
Photo: Taken upslope from culvert

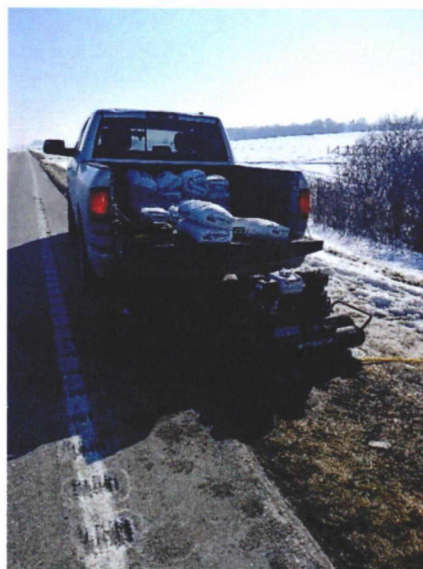
Photo: Clean Harbors truck with sandbags and generator used to air up packer.

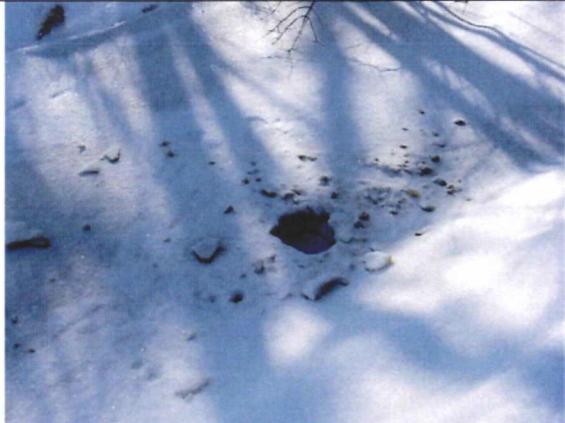
Photo: Hole in ice. No standing water in hole

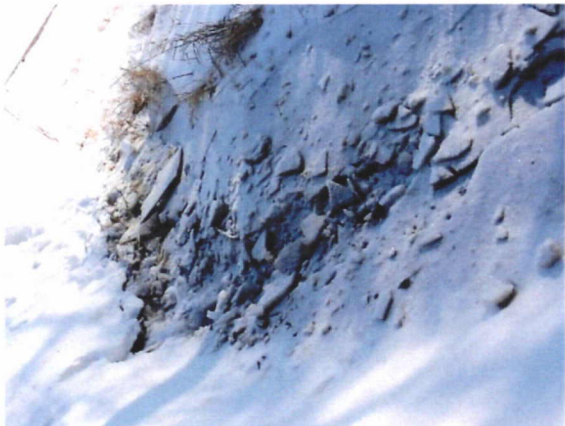
Photo: Discolored ice chunks

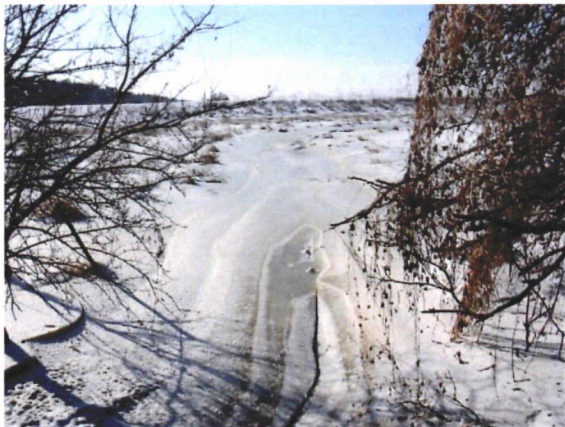
Photo: Ice beginning to thaw. Facing upstream.

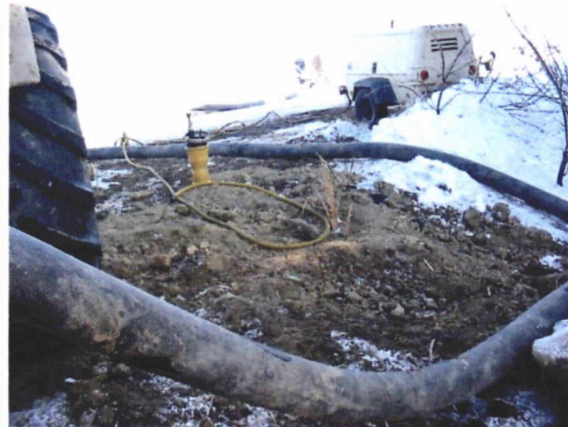
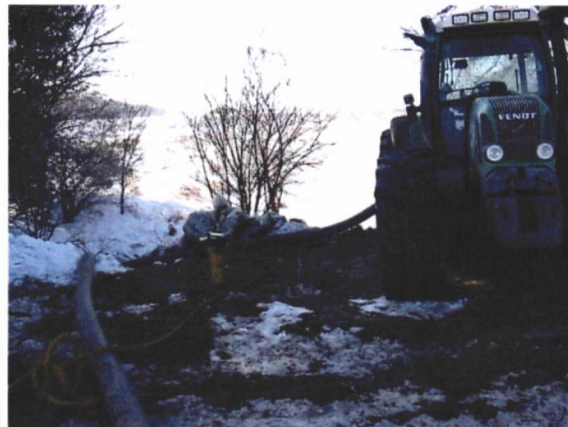
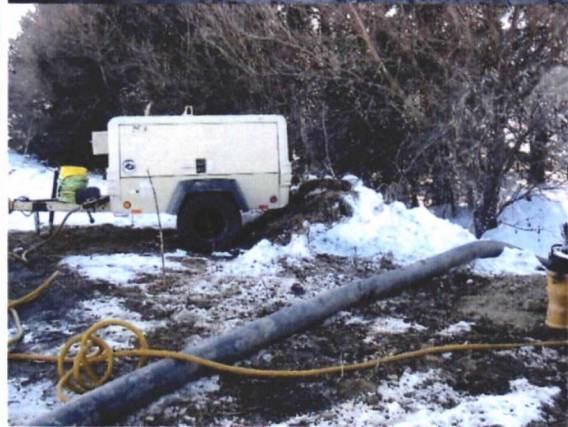
Photos: Various angles showing set up for to complete pumping.

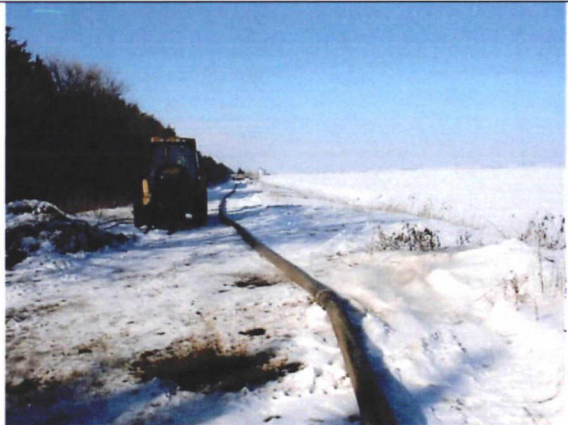
Photo: Hose laid to the north. Terracon said that it went to AltEn lagoon.

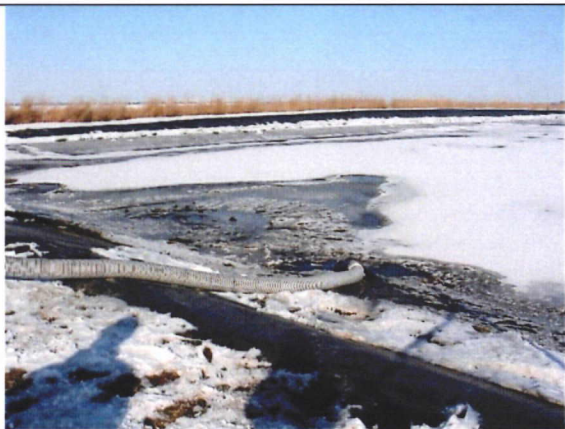
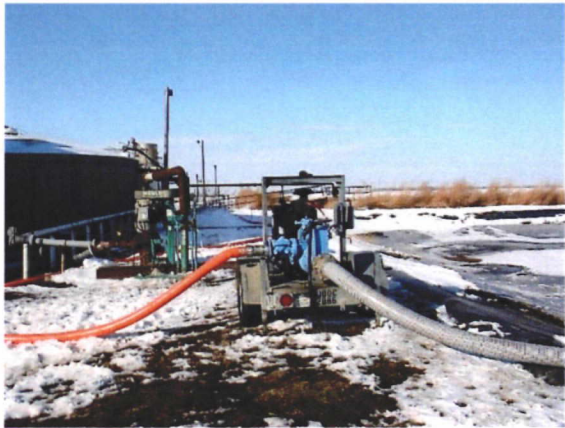
Photo: Hose pumping out of emergency lagoon.

Photo: Pump at emergency lagoon.

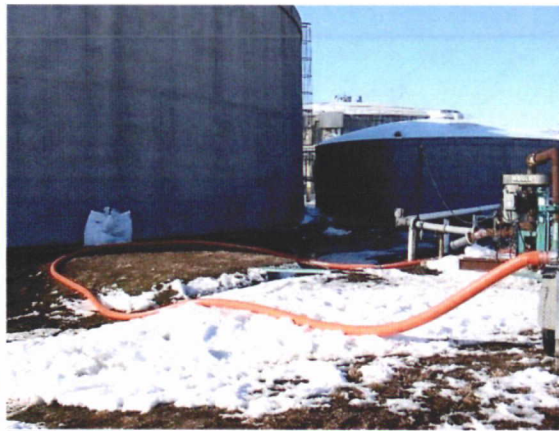
Photo: Hose coming off of pump.

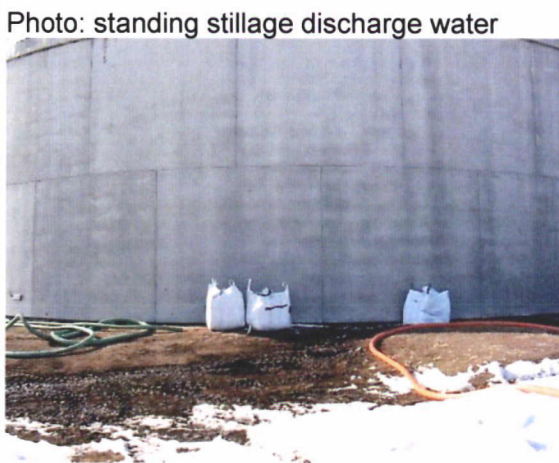
Photo: Area near Digester 1

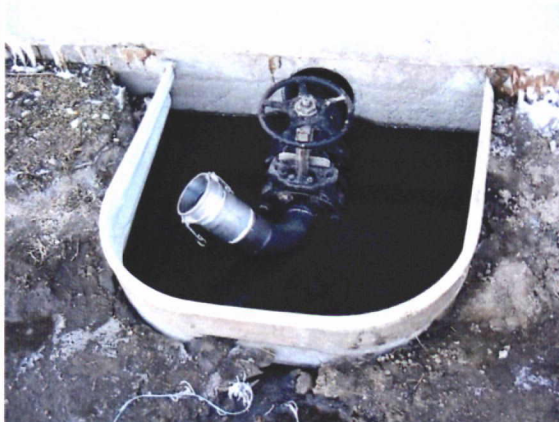
Photo: Digester 1 pipe/valve with standing stillage discharge water.

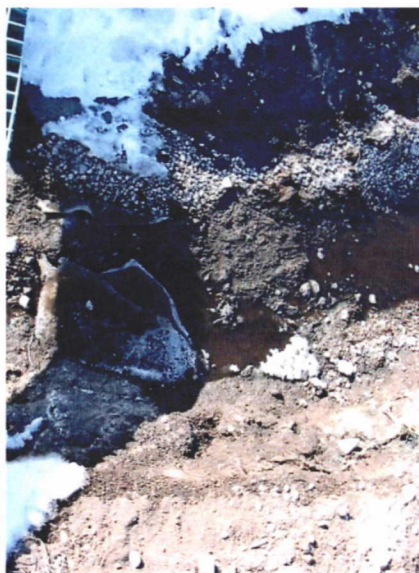
Photo: Standing stillage discharge water on ground between Digester 1 and Digester 2

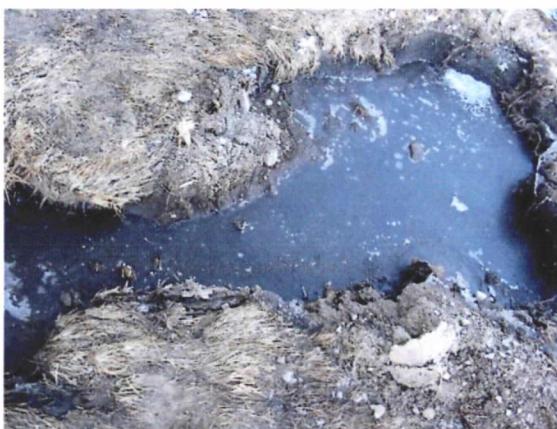
Photo: More standing stillage discharge water on ground between Digester 1 and Digester 2

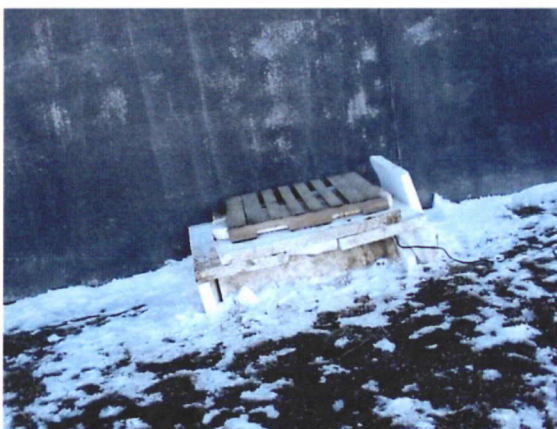
Photo: Covered pipe/valve on Digester 2

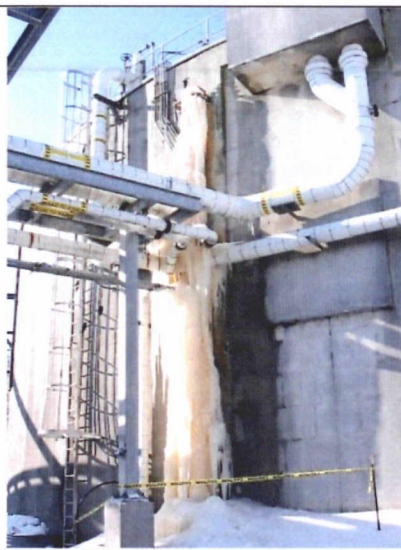
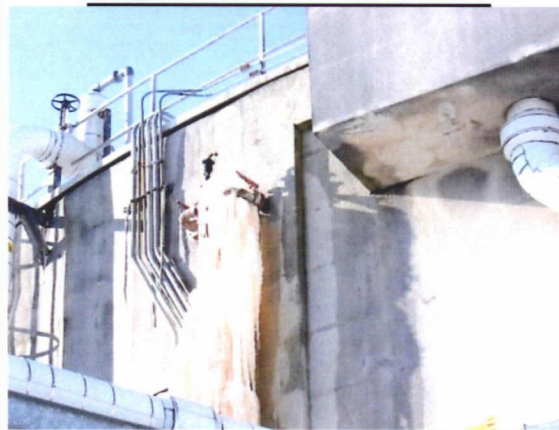
Photos: Continuous leak on Digester 2

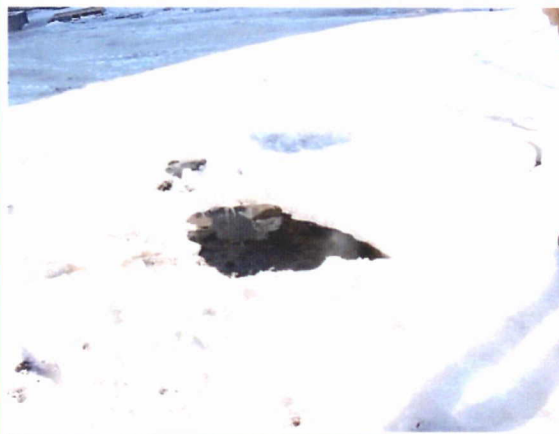
Photo: Area behind Digester 2 with significant ice build up. Several inches thick.

Large area behind Digester 2 was observed while walking to the road to leave site. Ice was several inches thick. It had large cracks and holes because of thawing. Ken Peterson said that all of the ice was from the initial release of stillage discharge water.
