Nebraska Department of Environment and Energy (NDEE)

Date: February 1, 2021

RE: AltEn, LLC

Subject: Site Visit Report (Wastewater Aspects Only)

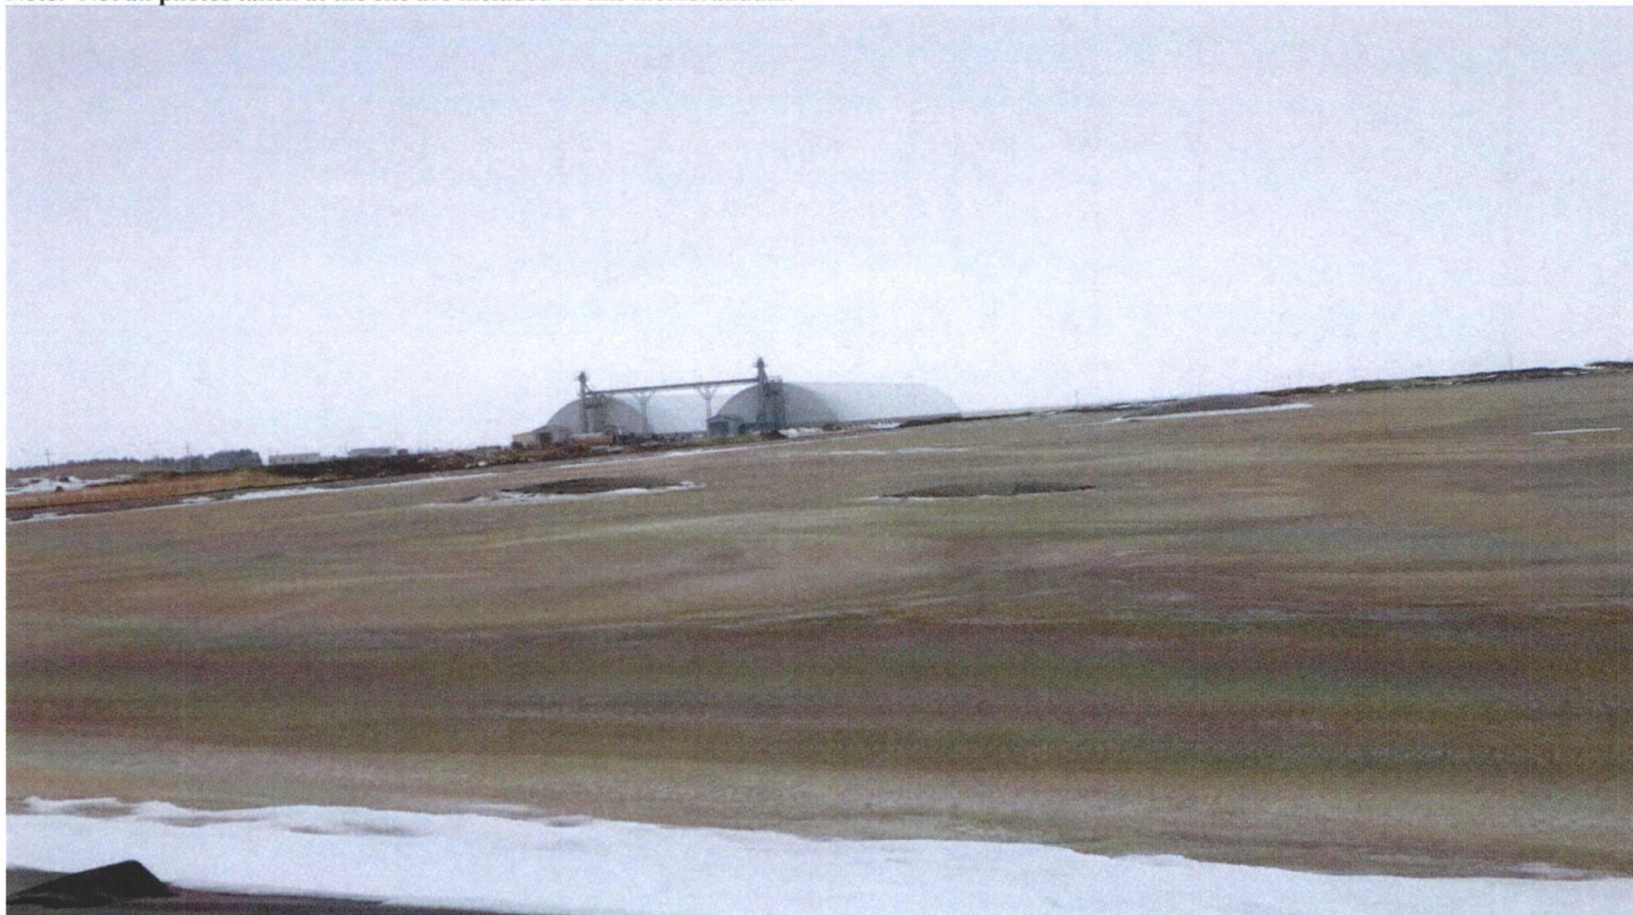
Photo 1

Description: Overview of Northwest lagoon cell (influent cell)

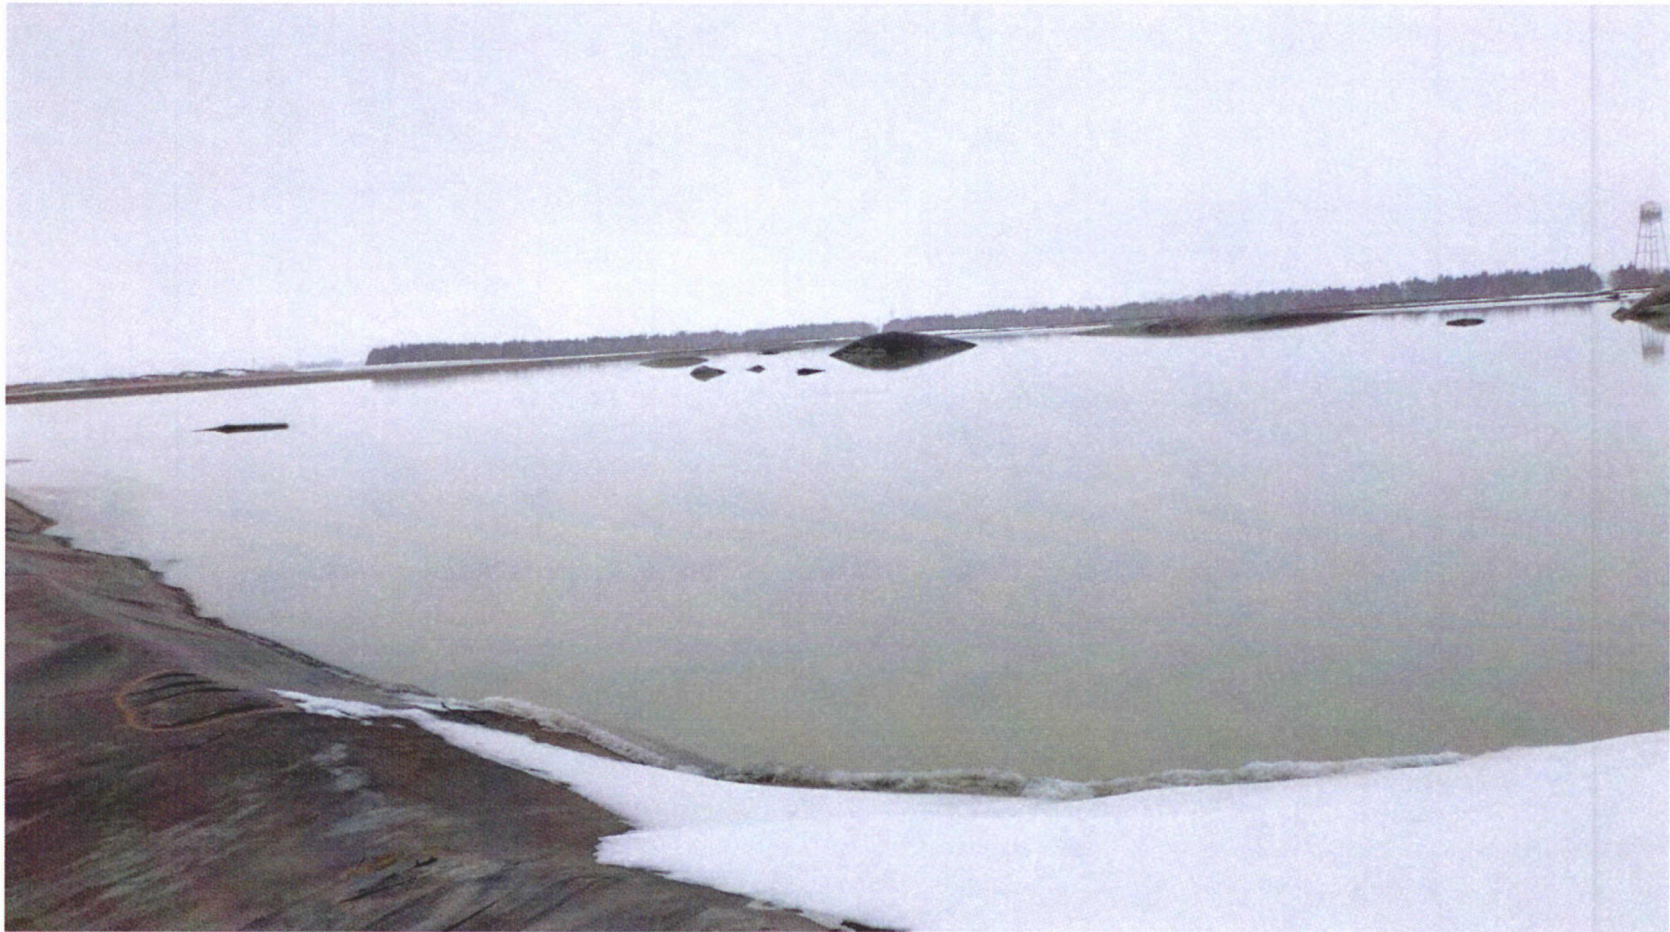
Photo 2

Description: Overview of Northeast lagoon cell (second cell)

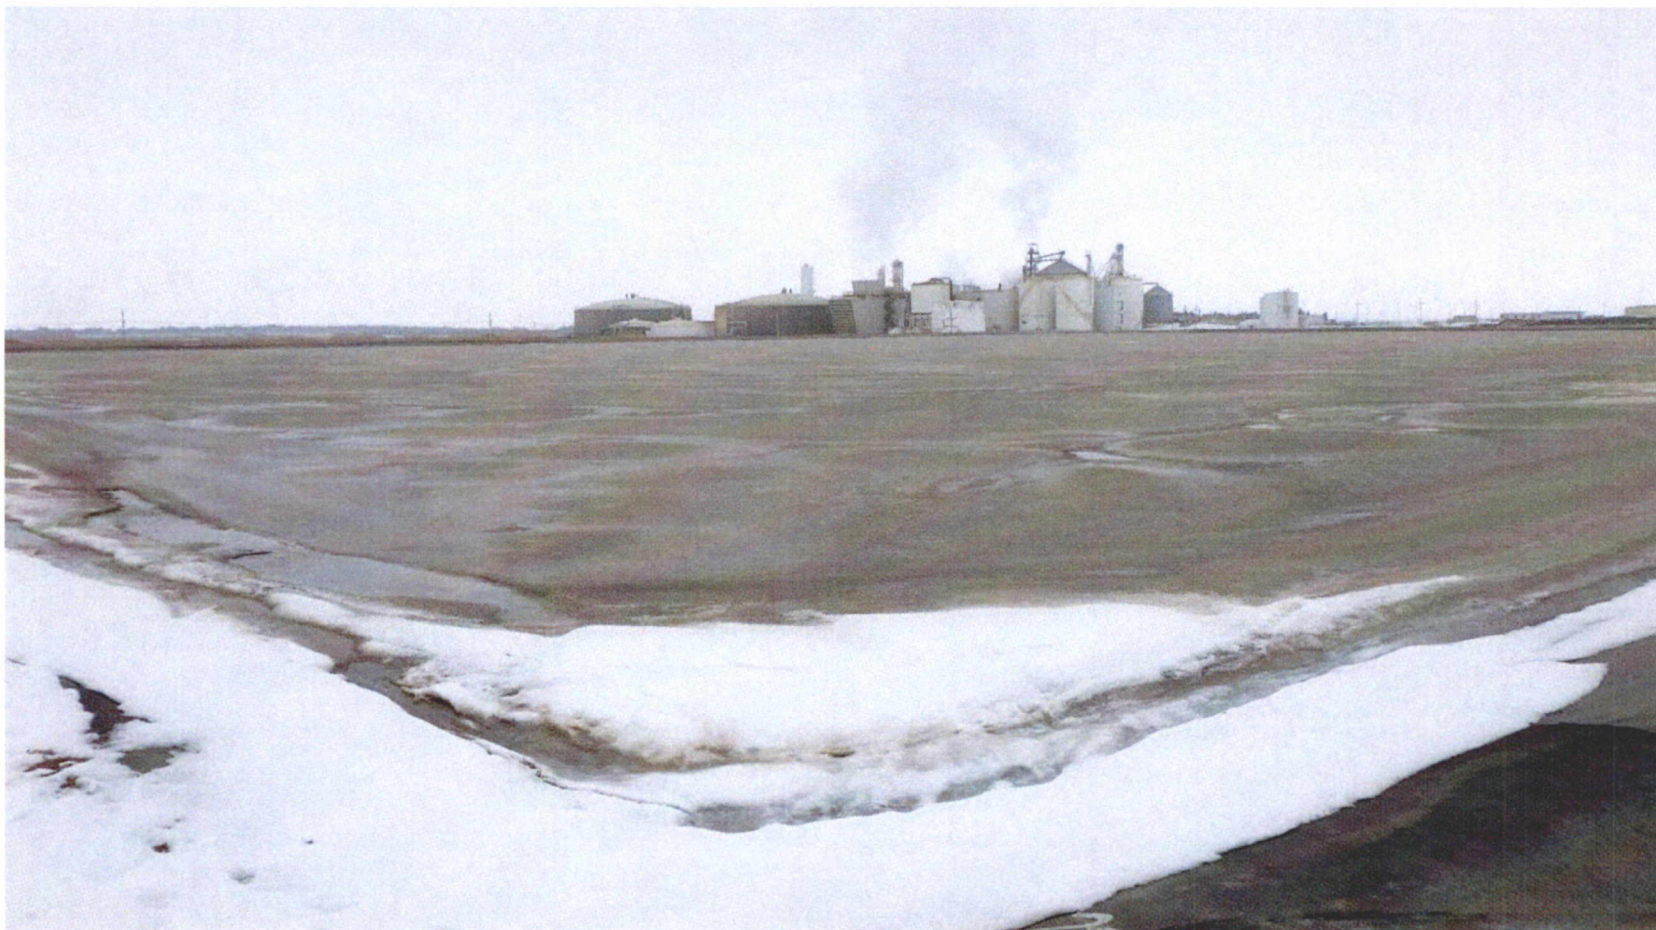
Photo 3

Description: Overview of Southeast lagoon cell (final cell)

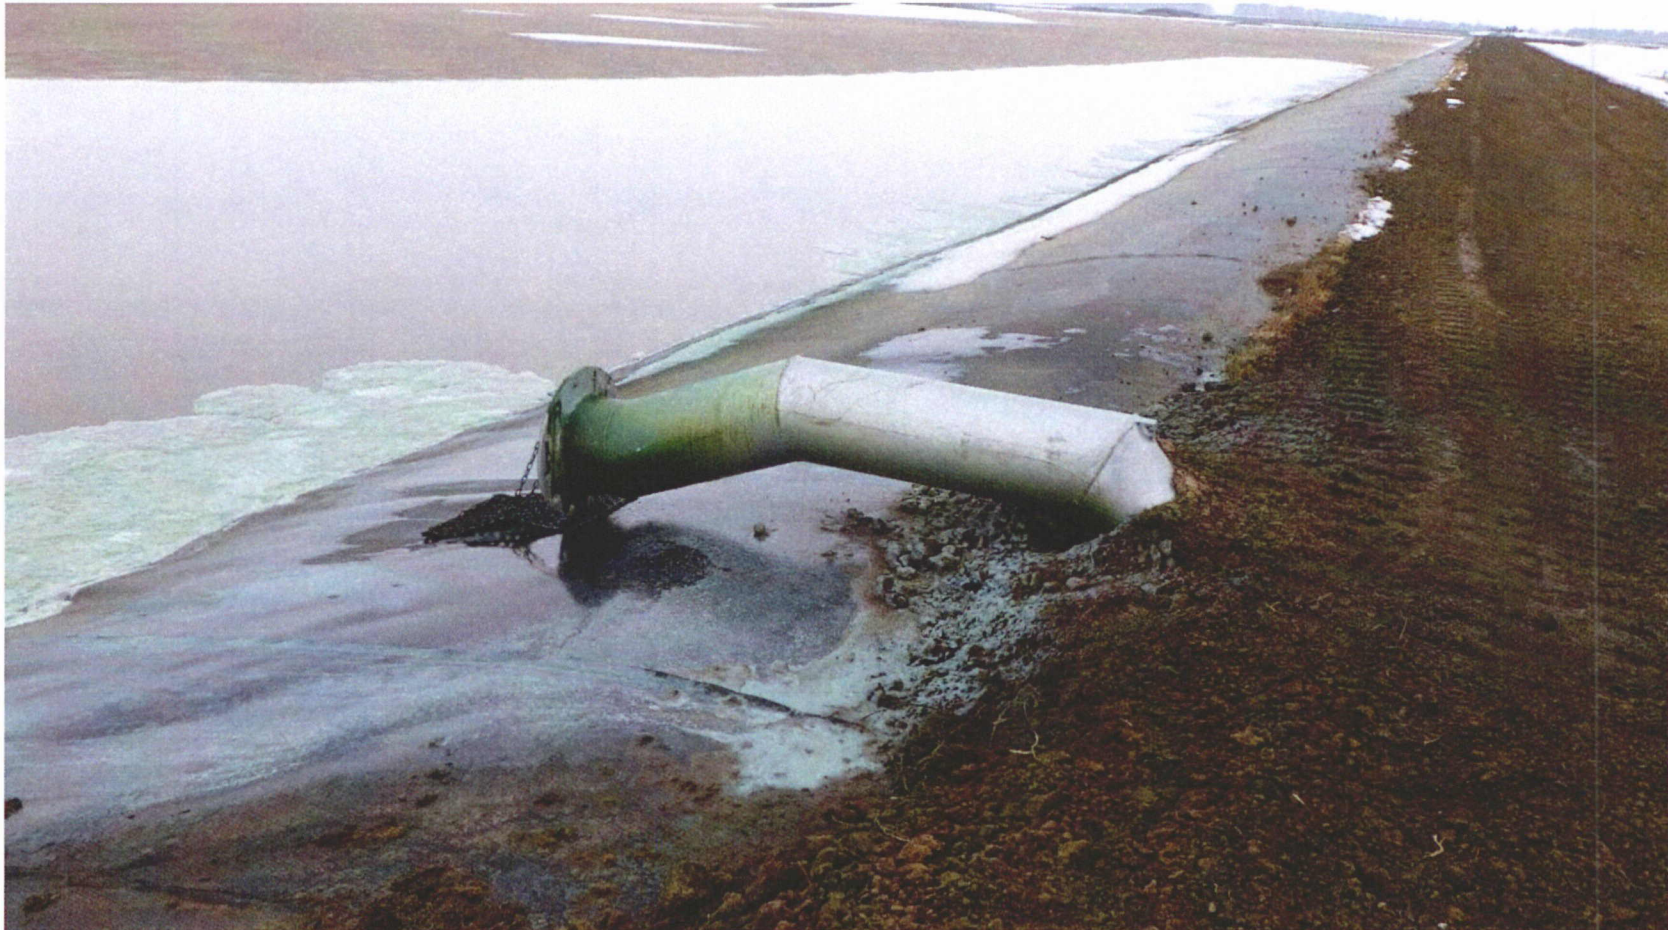
Photo 4

1. Mr. Dean Egr confirmed that the facility completed an approved wastewater construction project (NDEE Document ID 20200085932) to help reduce excessive air in the force main that transports wastewater to the Northwest (also known as "West") lagoon cell. This involved constructing a new force main that discharges wastewater into the Northwest lagoon cell. According to Mr. Egr, this project was completed last week (Photos 4 and 6).

Description: Newly constructed influent pipe into the Northwest lagoon cell

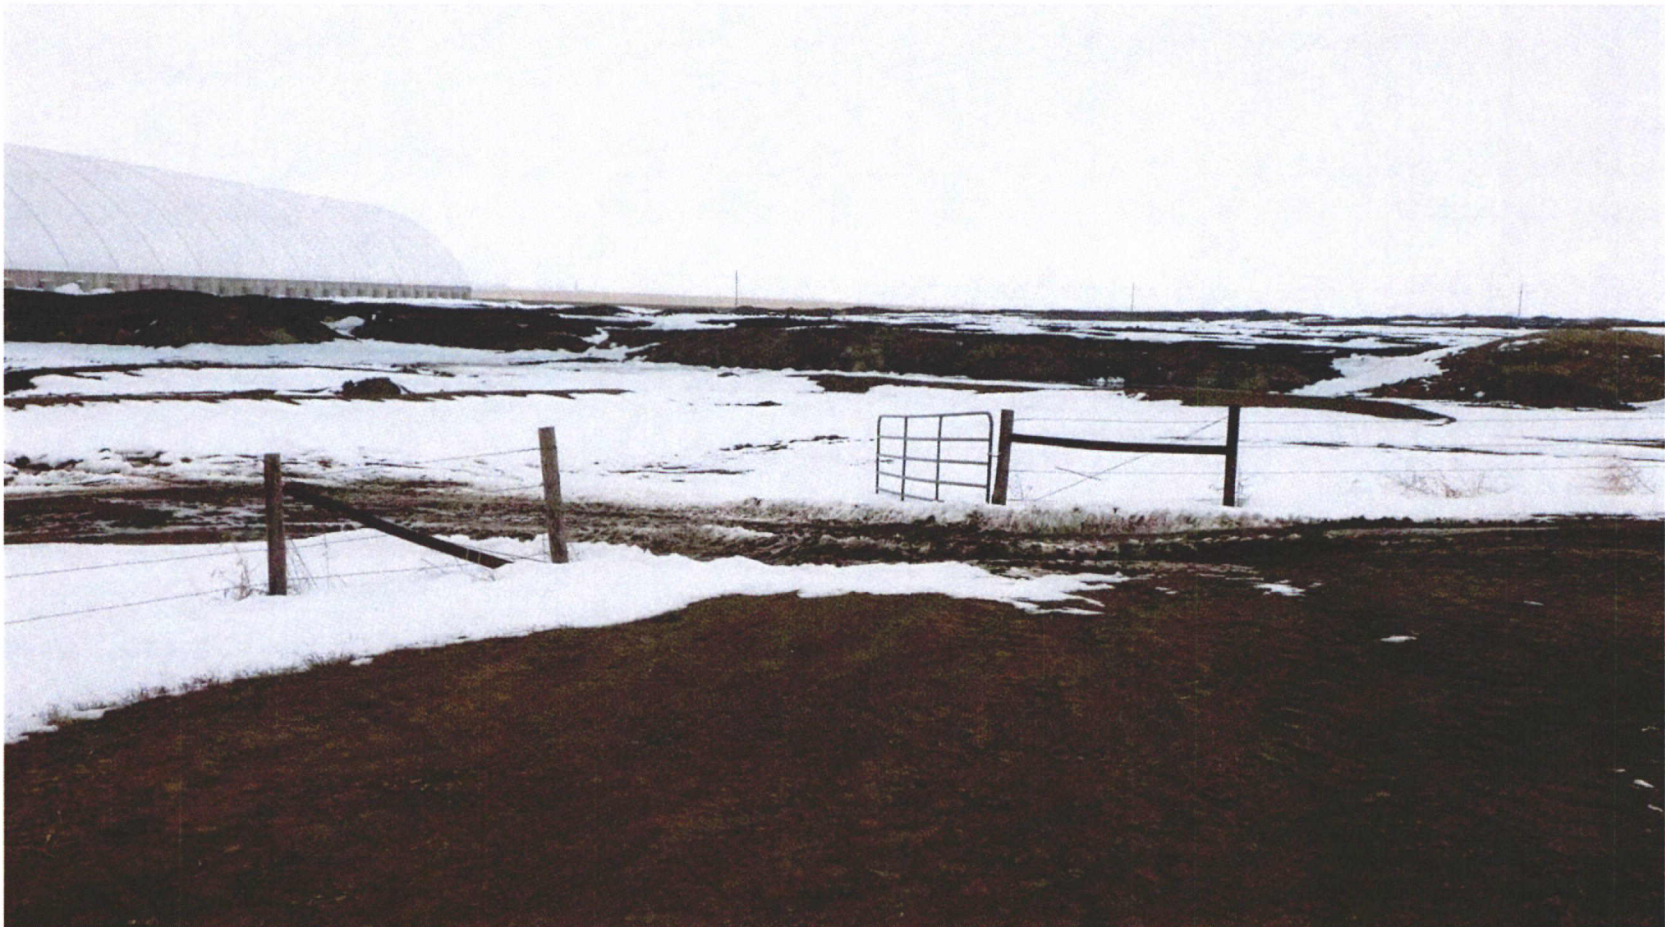
Photo 5

8. One of the fences enclosing the wastewater lagoons was left open (Photo 5).

1. One of the gates to the wastewater lagoons was opened. This is a violation of Title 123, Chapter 11-008.03.
2. The Northeast and Northwest lagoons remain unrepaired and have damaged liners. This is a violation of Title 123, Chapter 11-008.06.

Description: Open gate south of the Northwest lagoon cell

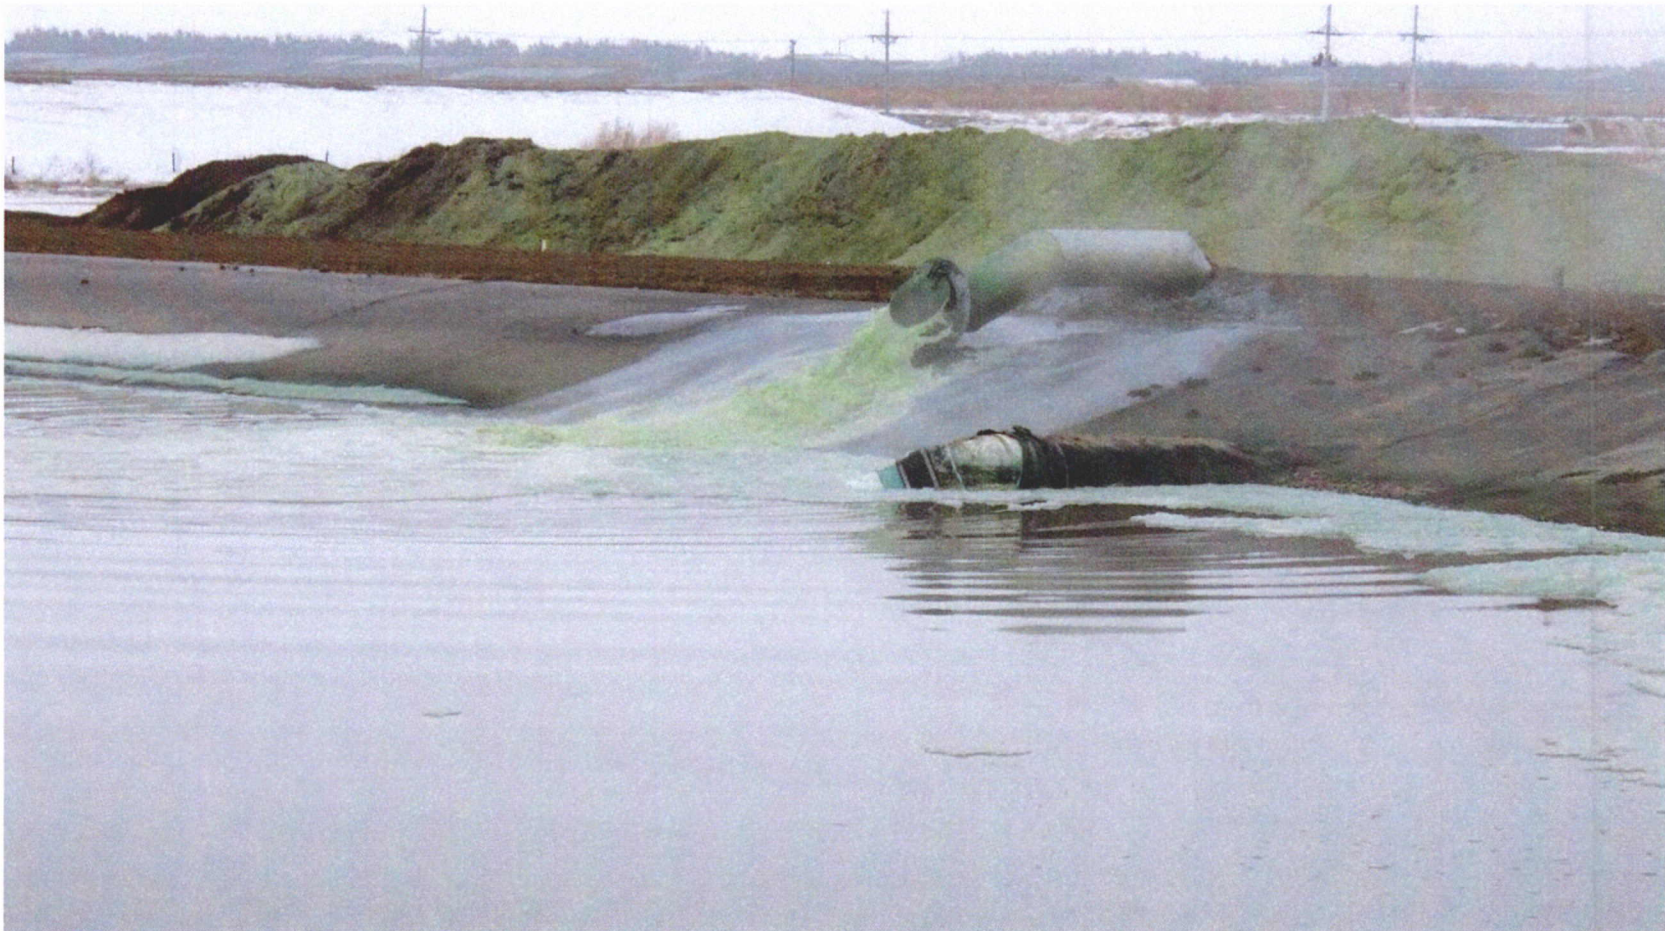
Photo 6

Description: Influent pipe into the Northwest lagoon cell

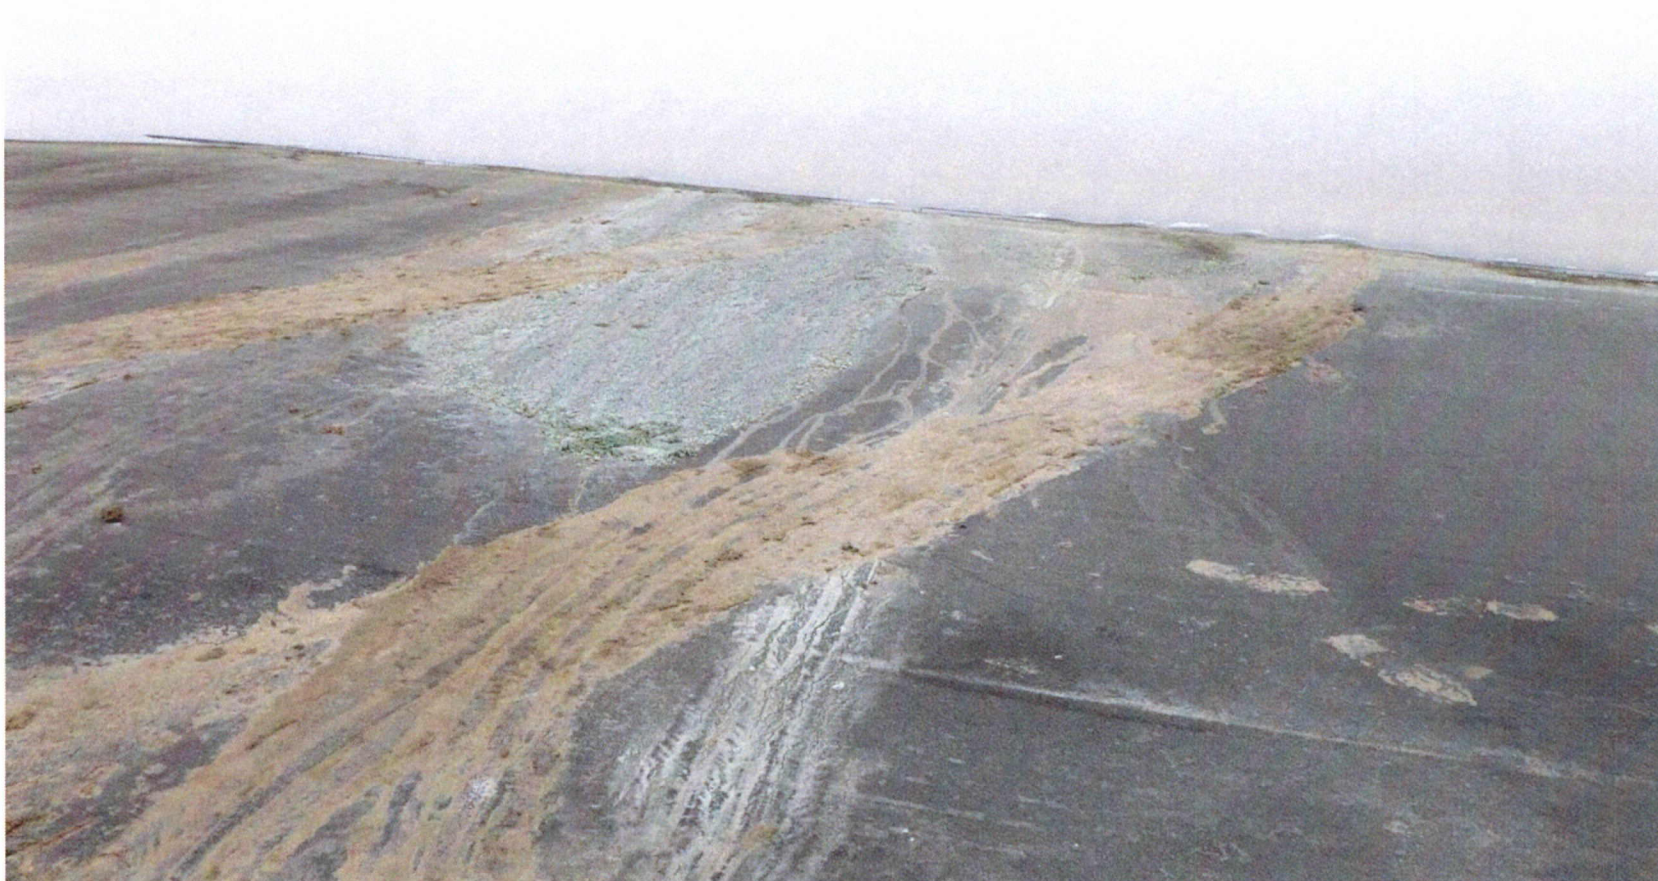
Photo 7

2. Mr. Dean Egr confirmed that a sump pump failed so they manually transported sump waste into the Northwest lagoon cell via a honeywagon (Photo 7).
3. The water levels in each of the three lagoon cells have exceeded the maximum operating depths and are operating in the area designed for freeboard. The maximum operating depths, according to the approved plans and specifications for the construction of the Northwest lagoon cell, as well as modifications to the Northeast and Southeast lagoon cells, are included in Table 1. The pipe invert elevations for the overflow pipes between the lagoon cells are included in Table 2.

Description: Tracks from a honeywagon used to transport wastewater from the sump into the Northwest lagoon cell

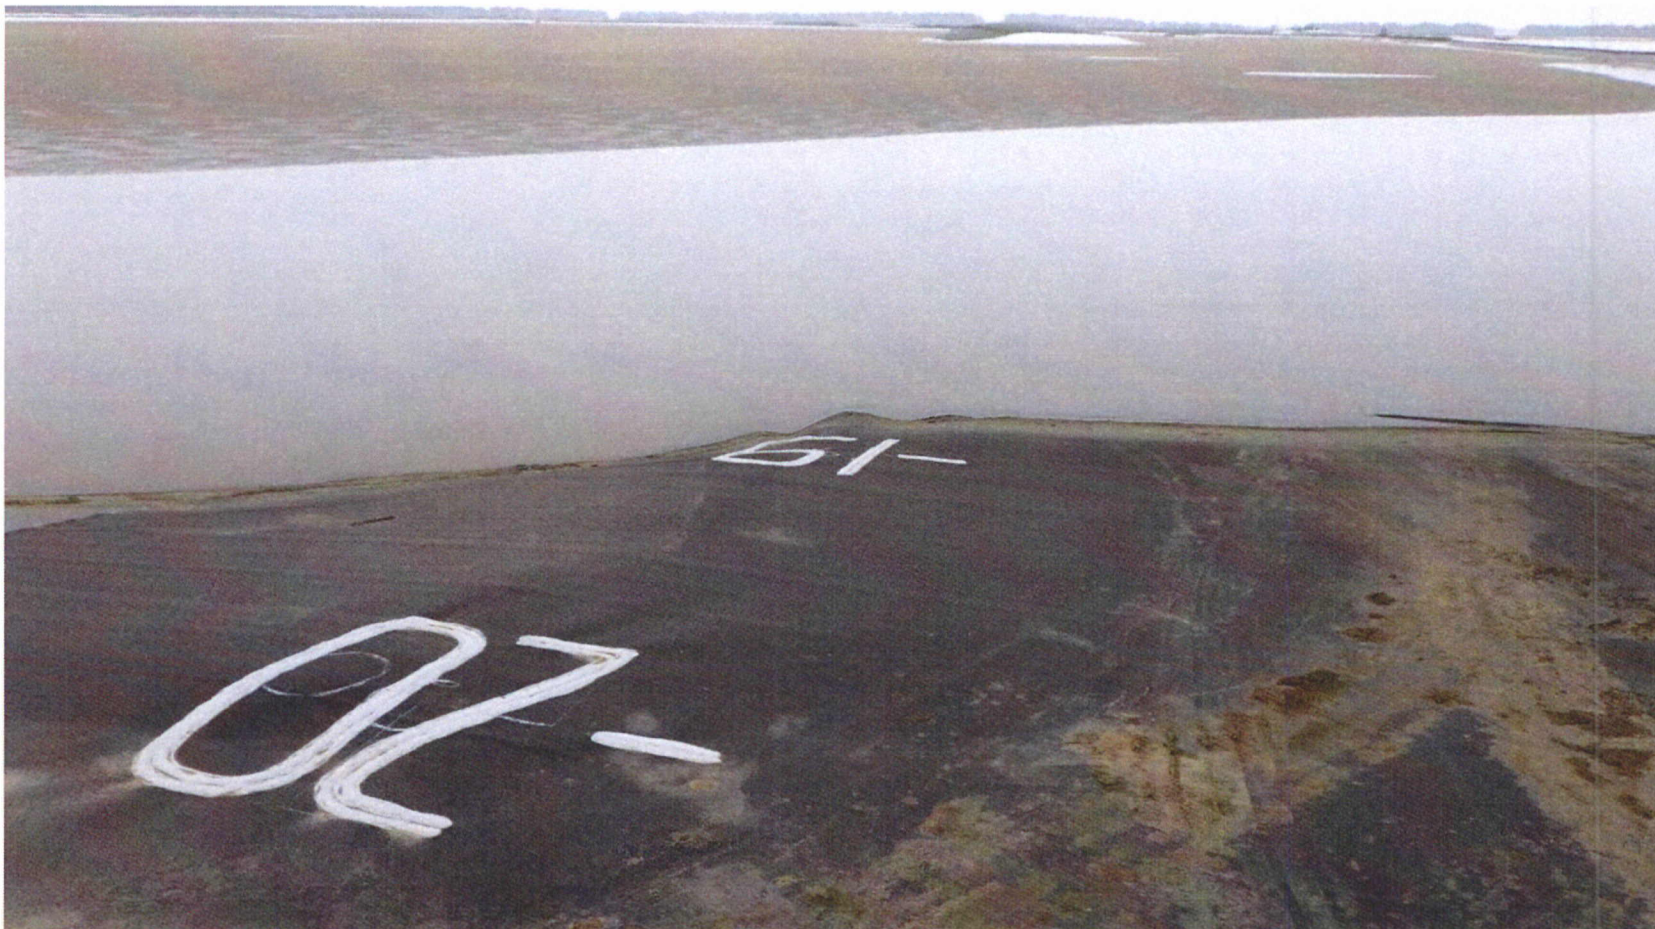
Photo 8

4. From a visual observation of the depth marker, the Northwest cell is operating at a depth of about 18.5 feet, which is above the maximum operating depth and within the area designed for freeboard (Photos 8 and 9).

3. Operating a wastewater lagoon in the area designed for freeboard is a violation of Title 123, Chapter 11-008.07. The purpose of freeboard is to protect the lagoons against exceptional storms and associated winds, heavy rain/snowfall, and damage to the integrity of the lagoon from wave action and potential erosion. Freeboard protects the property and waters of the State from wastewater overflows. Damaged lagoon liners with whales are also susceptible to further damage from wind and high water levels in the lagoons. The Northeast and Northwest lagoons remain unrepaired; using the lagoons without adequate freeboard could subject the lagoons to additional damage. Moreover, per a Notice of Violation dated September 13, 2019, the facility is not able to apply the wastewater to land due to the presence of pesticides. Therefore, the only way that wastewater can “leave” the lagoons currently is through seepage and evaporation. The lagoons were designed for zero seepage and evaporation is minimal during the winter months. According to a site visit on September 11, 2020, the facility estimated that the average wastewater flow to the lagoons is 100,000 gallons per day. Therefore, if the facility continues to discharge wastewater to the lagoons without any acceptable method approved by the Department to dispose of the wastewater, the water level in the lagoons will continue to rise and be susceptible to overflowing the dikes as precipitation increases in the spring.

Description: Depth marker for Northwest lagoon cell

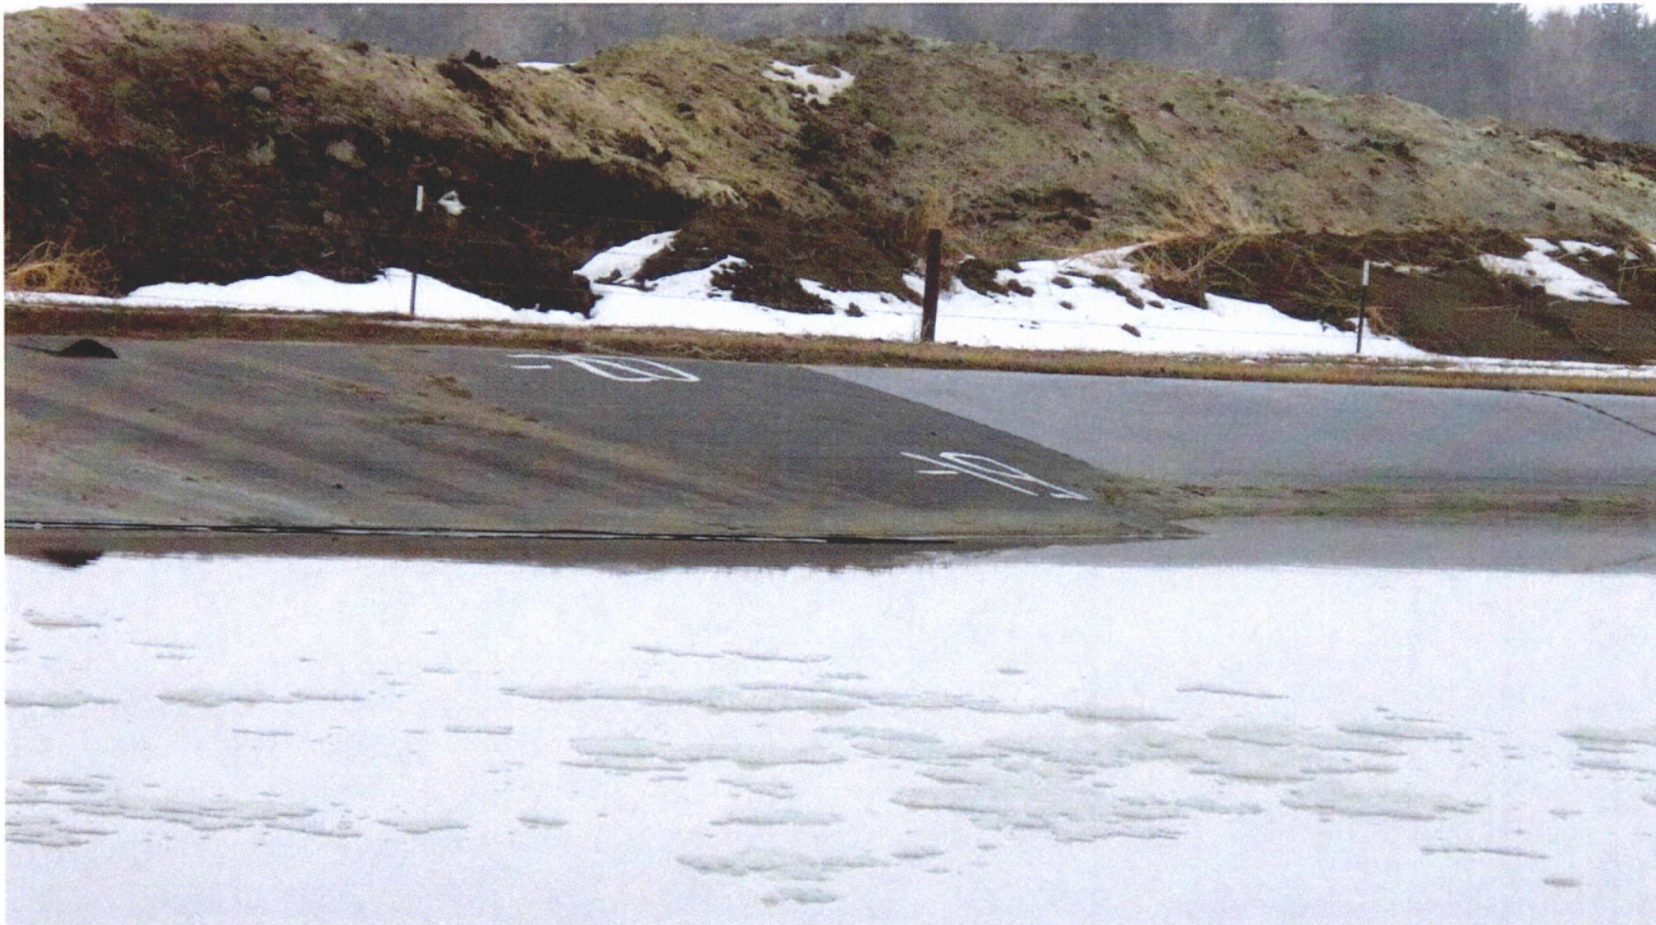
Photo 9

Description: Depth marker for Northwest lagoon cell

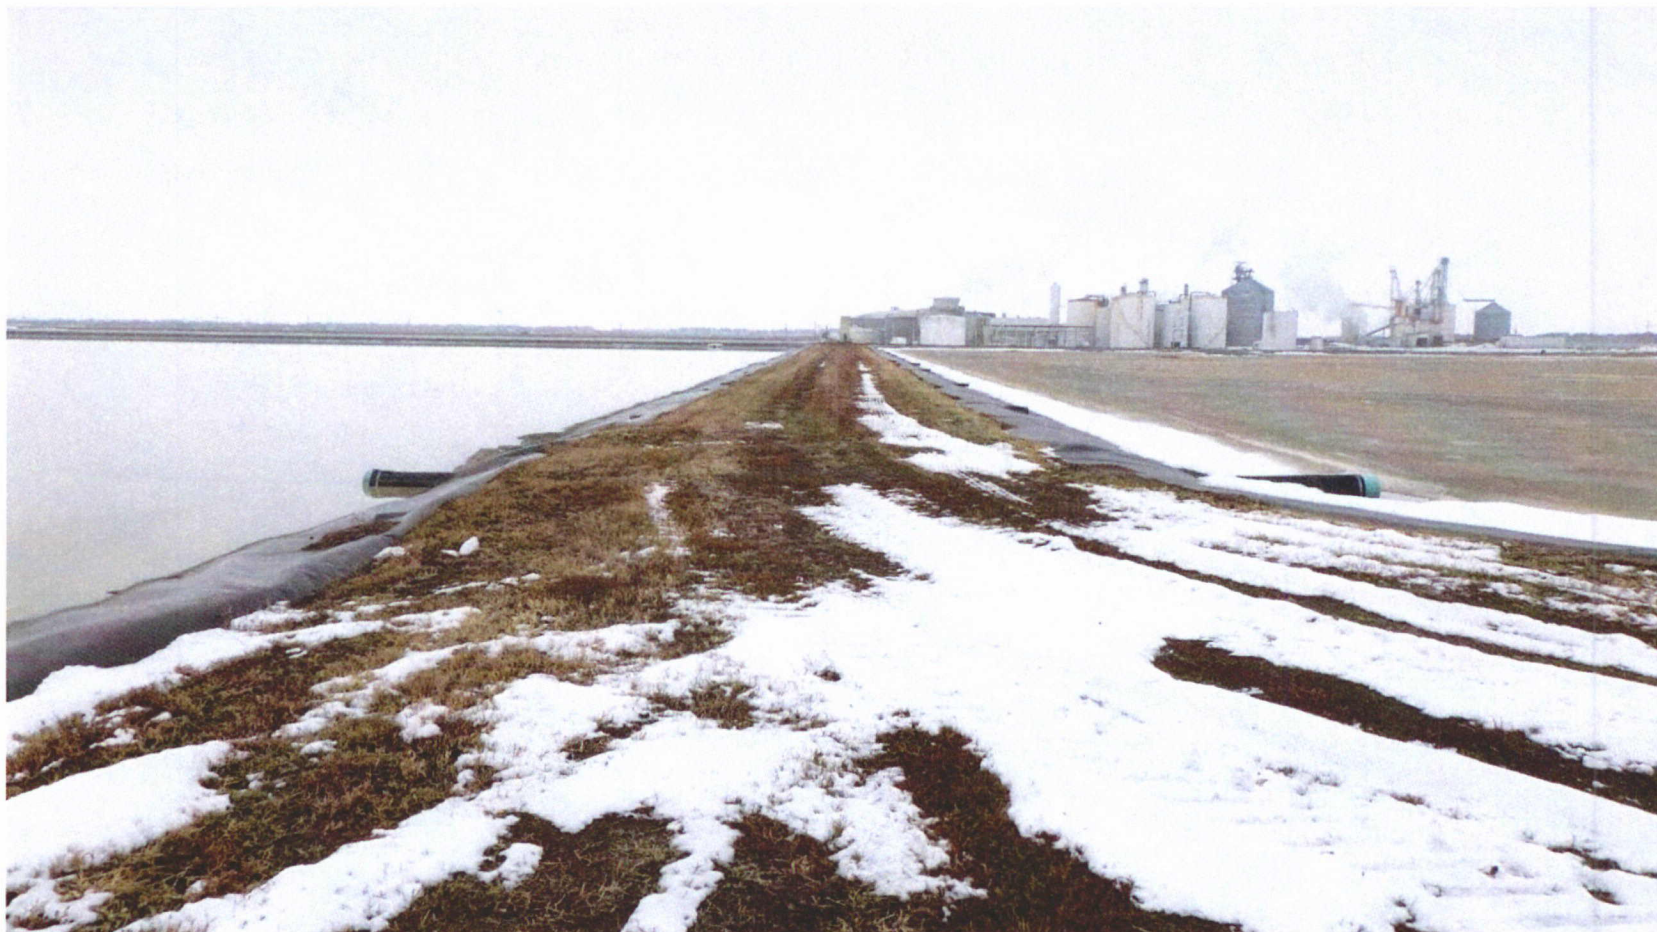
Photo 10

Description: Overflow pipe from Northwest lagoon cell (right) to Northeast lagoon cell (left)

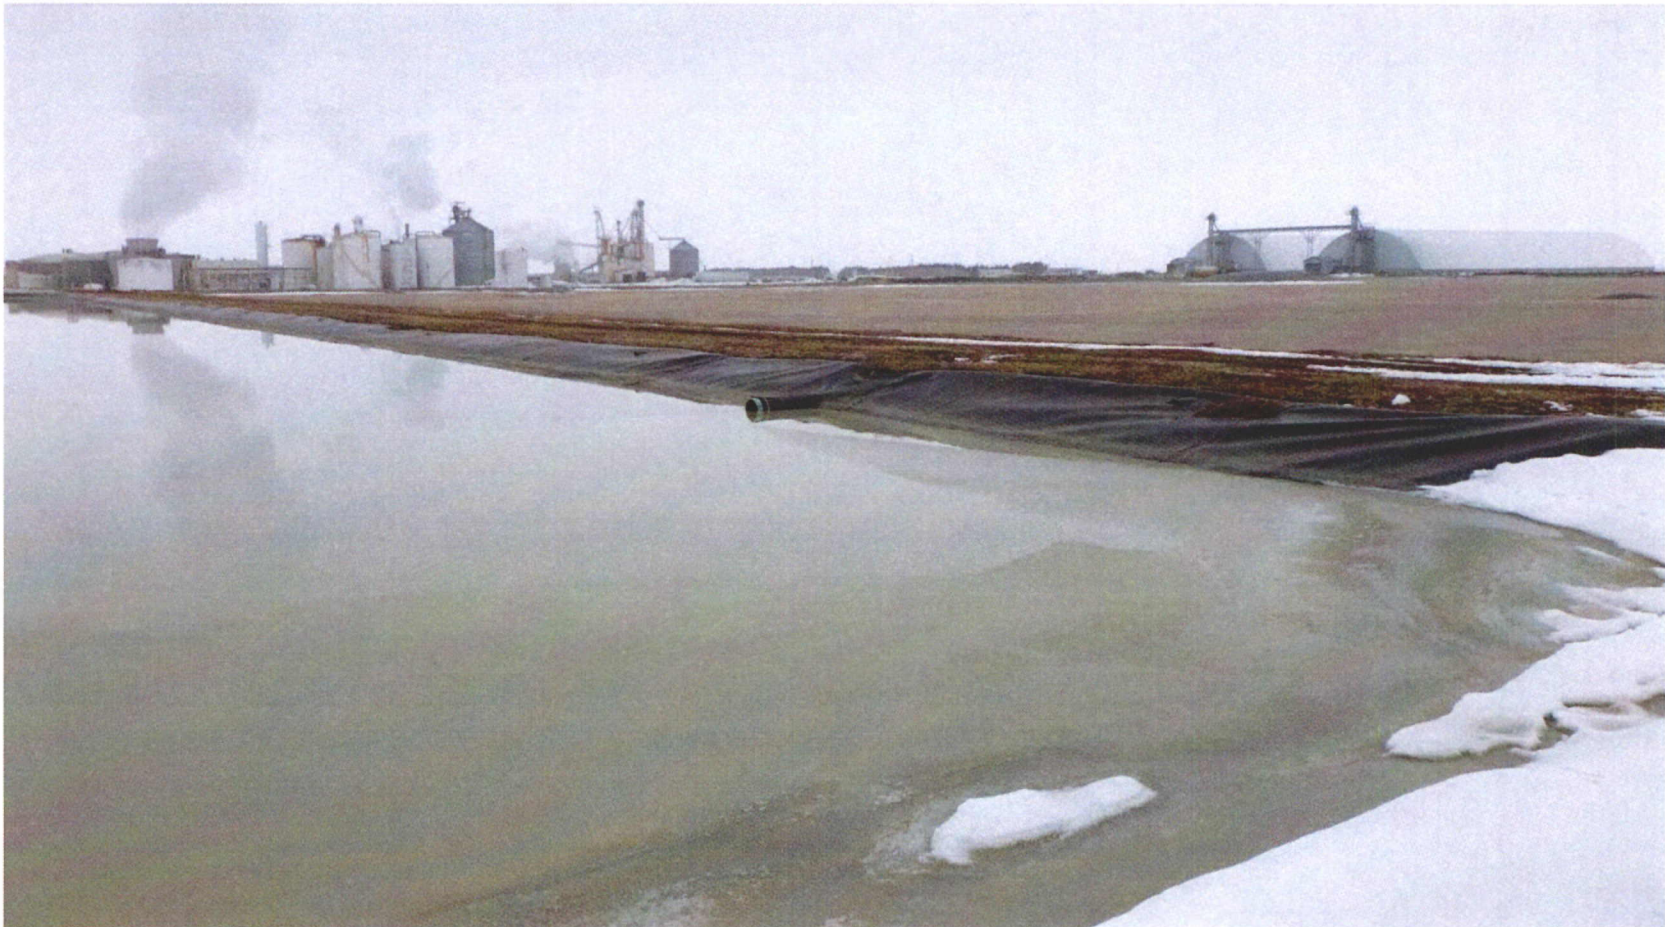
Photo 11

Description: Overflow pipe between the Northwest lagoon cell (right) and the Northeast lagoon cell (left)

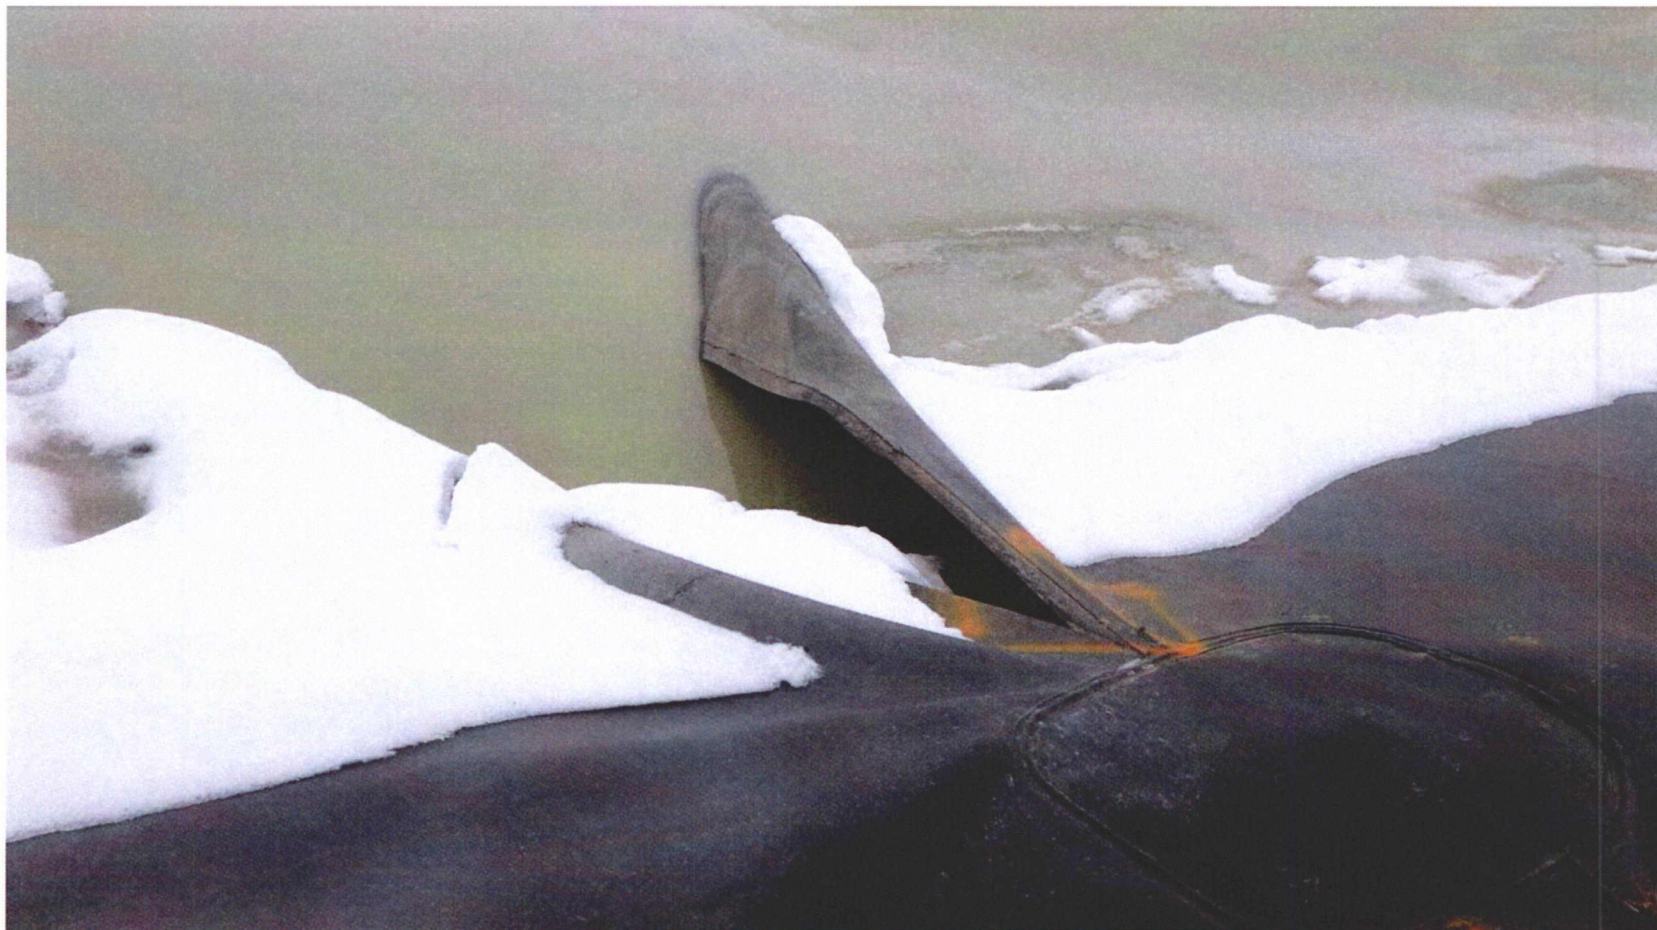
Photo 12

7. The Northeast lagoon cell liner has not been repaired and is still badly damaged (Photos 12-14). The multiple "whales" in the Northwest lagoon cell liner have also not been repaired.

Description: Liner tear in Northeast lagoon cell

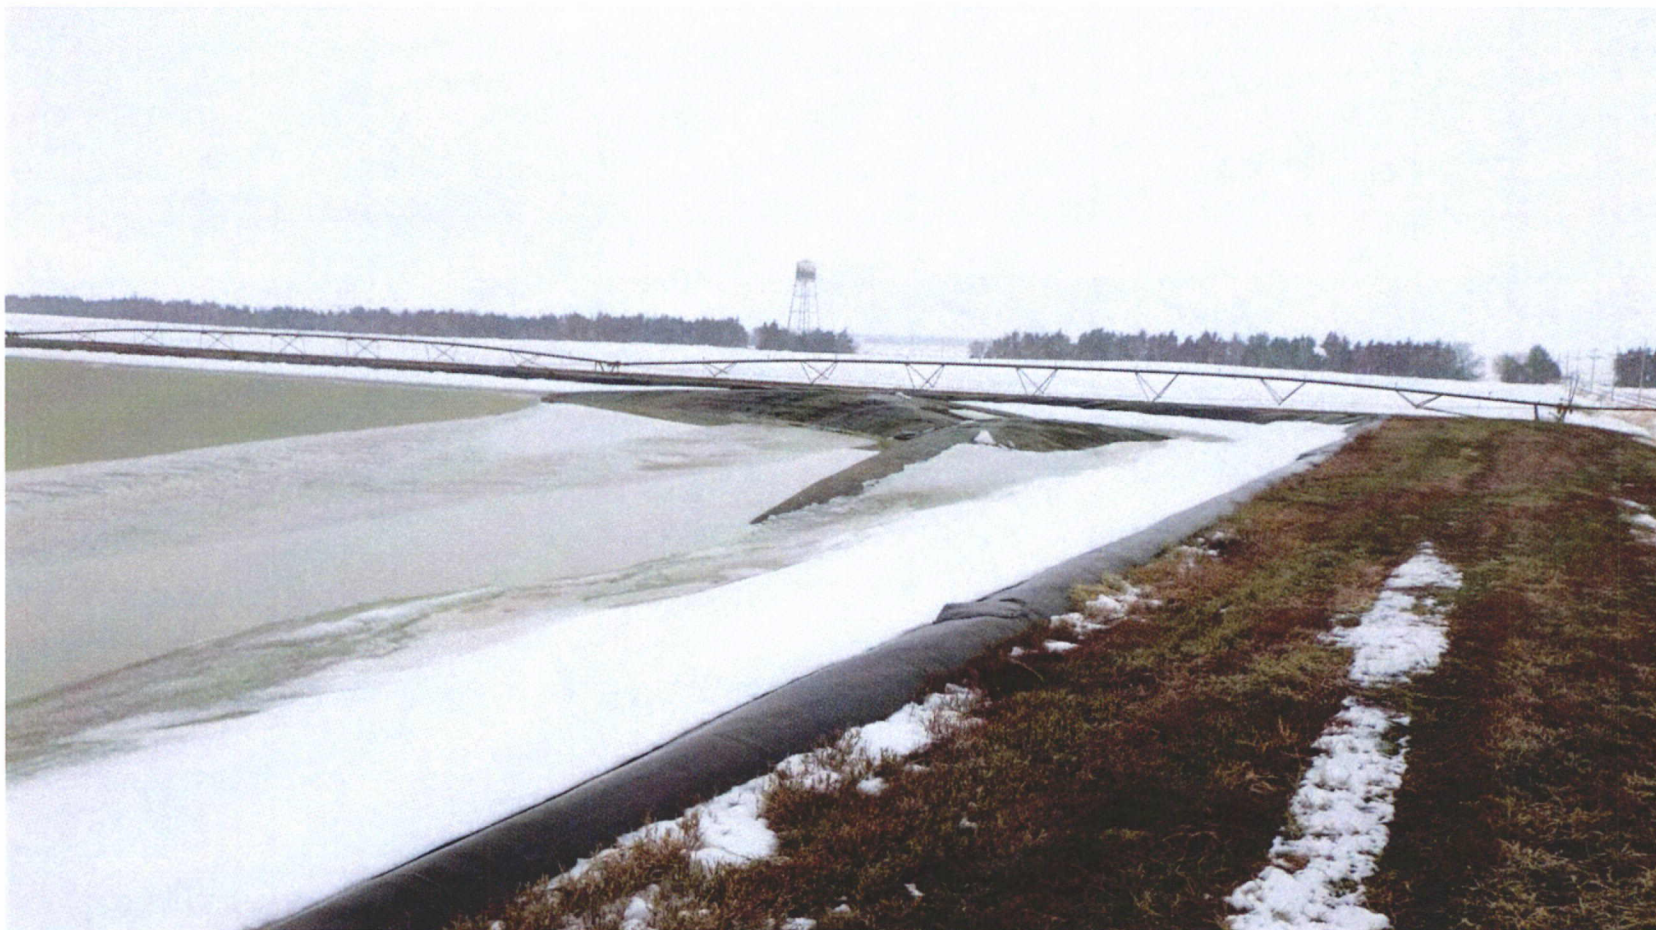
Photo 13

Description: Liner "whale" in Northeast lagoon cell

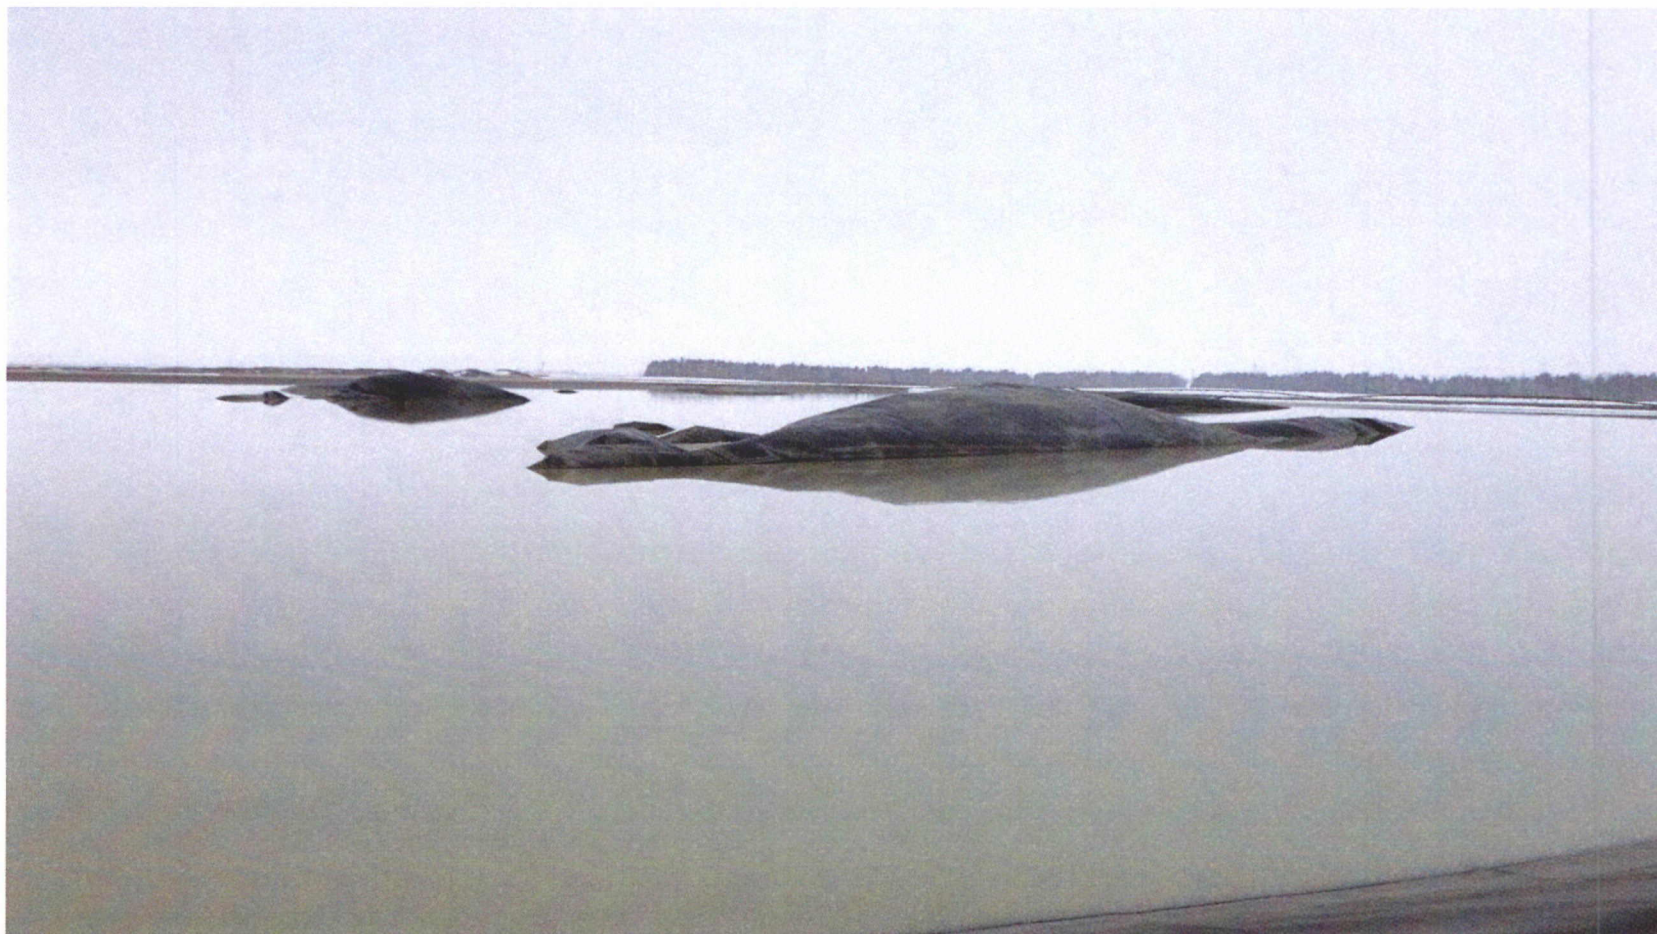
Photo 14

Description: Liner "whales" in Northeast lagoon cell
