Nebraska Department of Environment and Energy (NDEE)

Date: February 1, 2021

RE: AltEn, LLC

Subject: Site Visit Report (Wastewater Aspects Only)

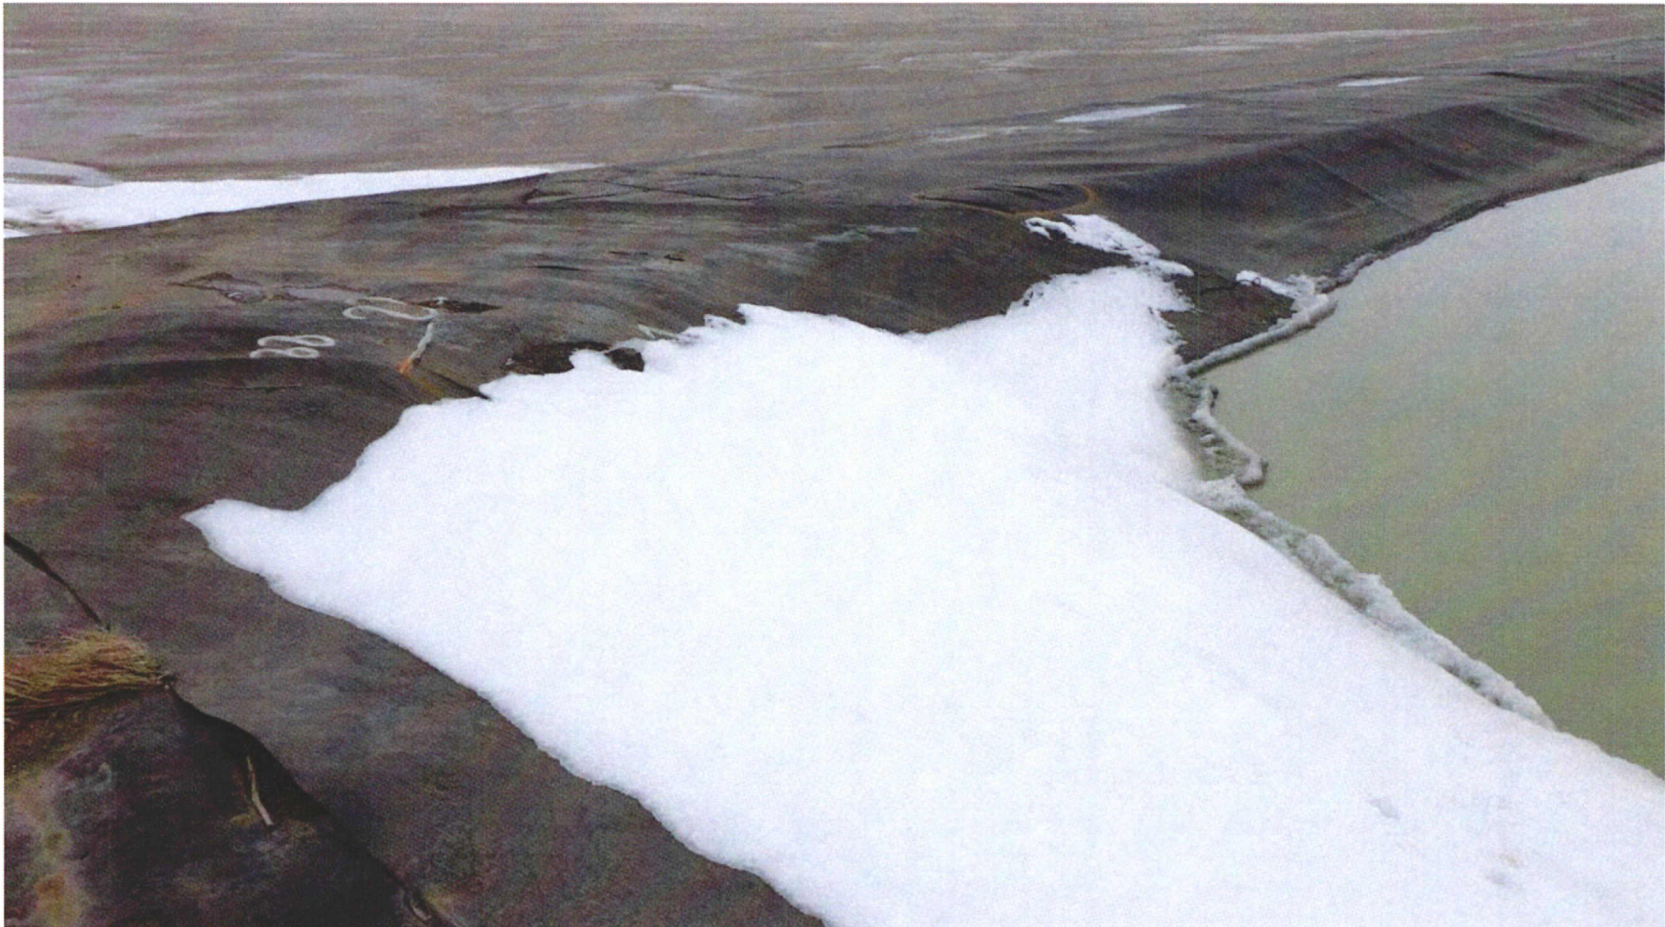
Photo 15

5. From a visual observation of the depth marker, the Northeast cell is operating at a depth of about 19 to 19.5 feet. It was difficult to determine the operating depth based on the depth marker due to snow (Photo 15). The invert elevation of the overflow pipe entering the Northeast lagoon cell from the Northwest lagoon cell is 116.0', per the approved plans and specifications (Table 2). The water surface in the Northeast lagoon was above this invert, suggesting that it was above the maximum operating depth and within the area designed for freeboard (Photos 10 and 11). The Northeast lagoon is designed to drain into the Southeast lagoon when it reaches its maximum operating depth. Wastewater was flowing from the Northeast lagoon to the Southeast lagoon during the site visit (Photos 16-18).

Description: Depth marker for Northeast lagoon cell. The top line is 22 feet. The "1" for 21 feet is just visible above the snow.

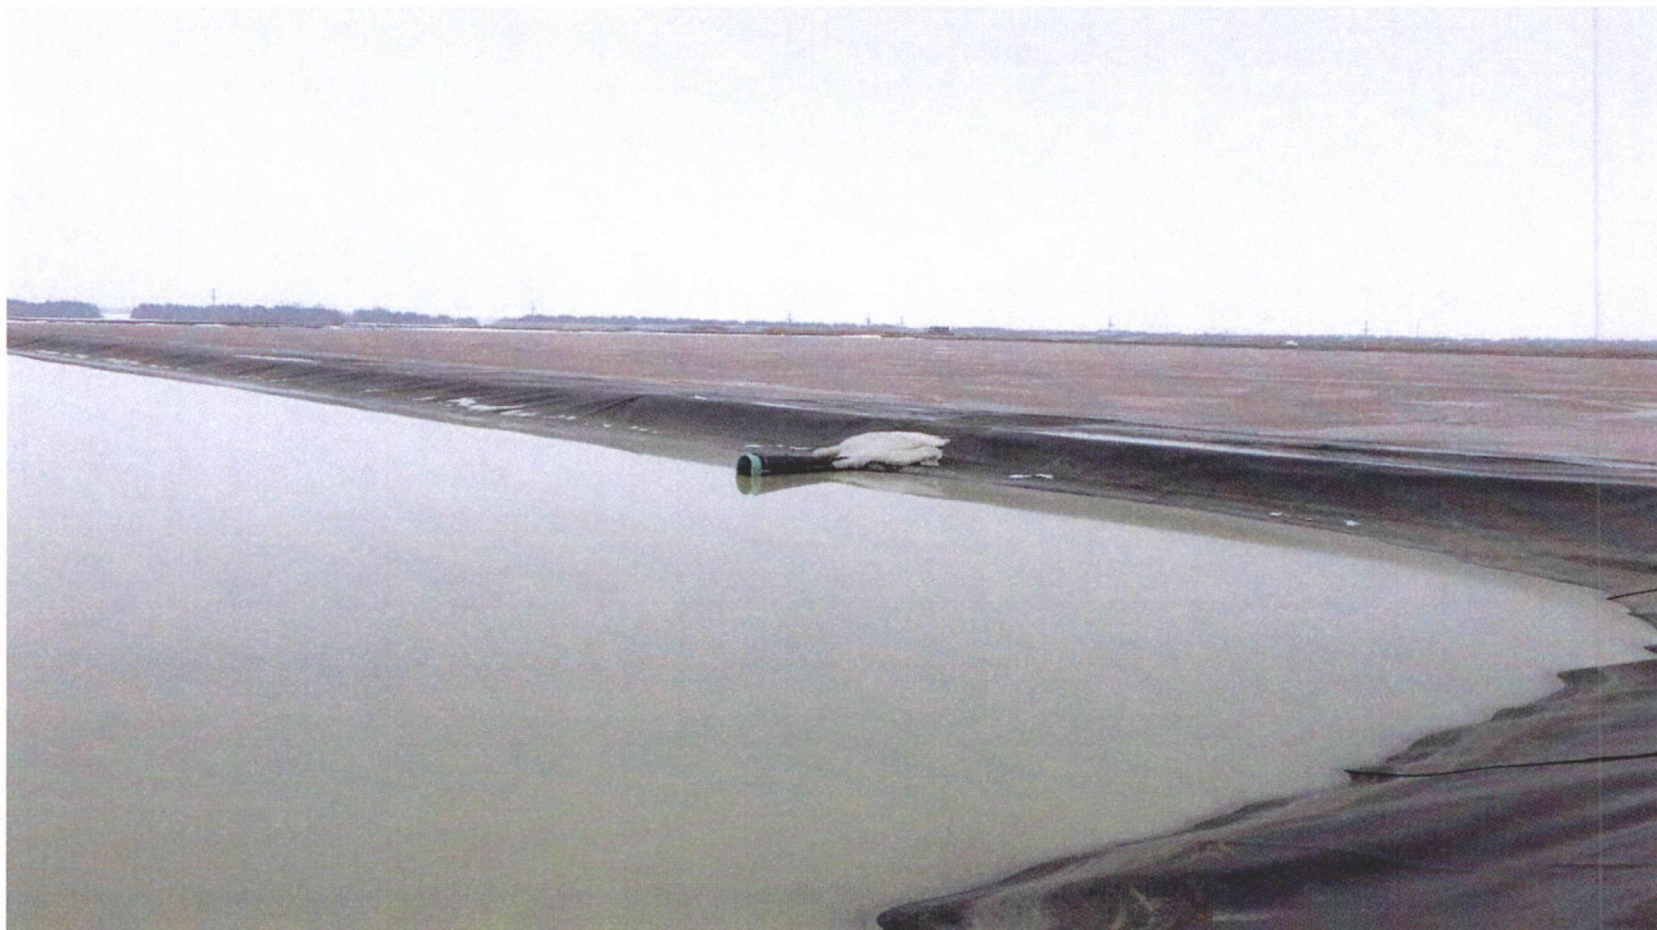
Photo 16

Description: Overflow pipe from Northeast lagoon cell (left) into Southeast lagoon cell (right)

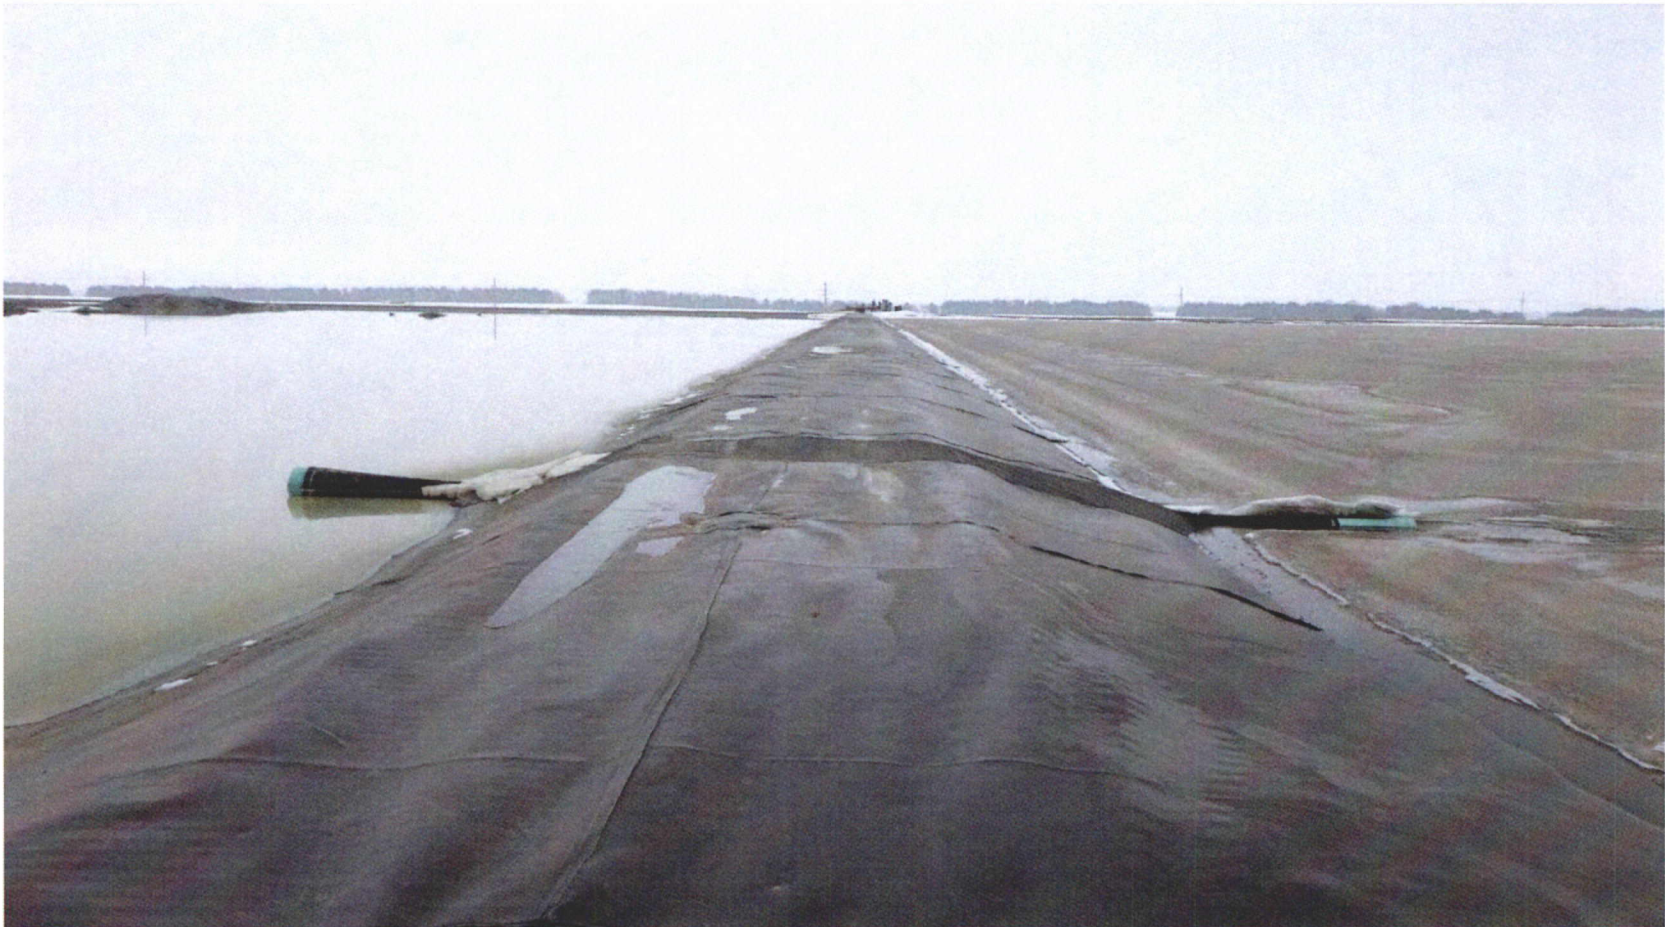
Photo 17

Description: Overflow pipe from Northeast lagoon cell (left) to Southeast lagoon cell (right)

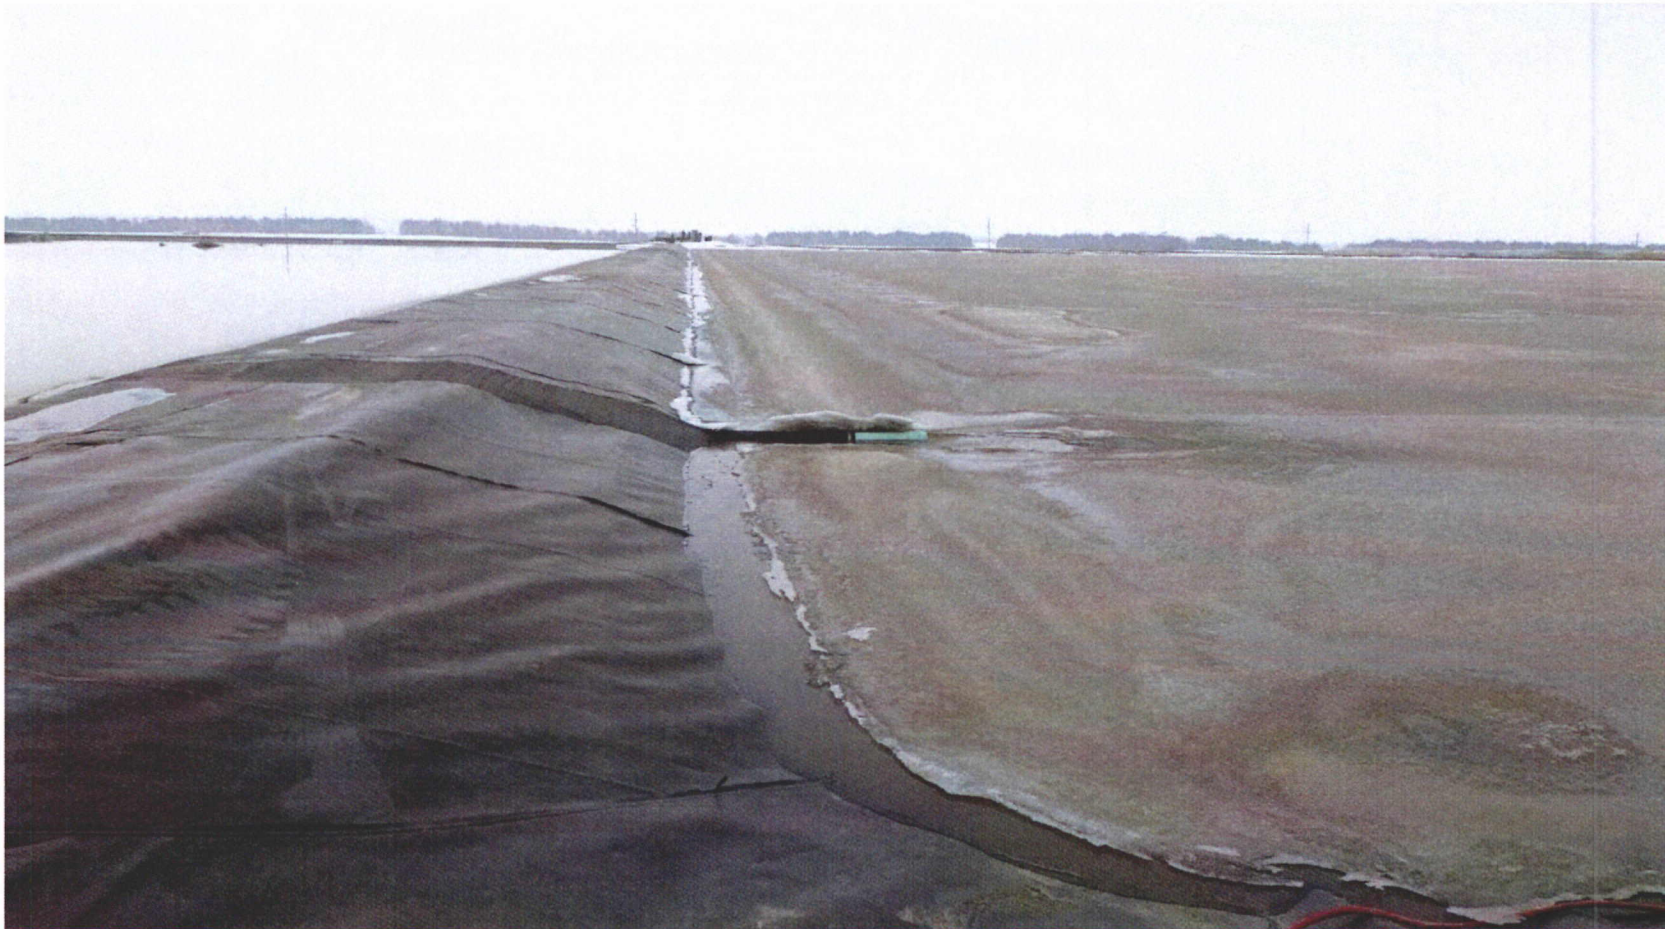
Photo 18

Description: Overflow pipe from Northeast lagoon cell (left) entering the Southeast lagoon cell (right)

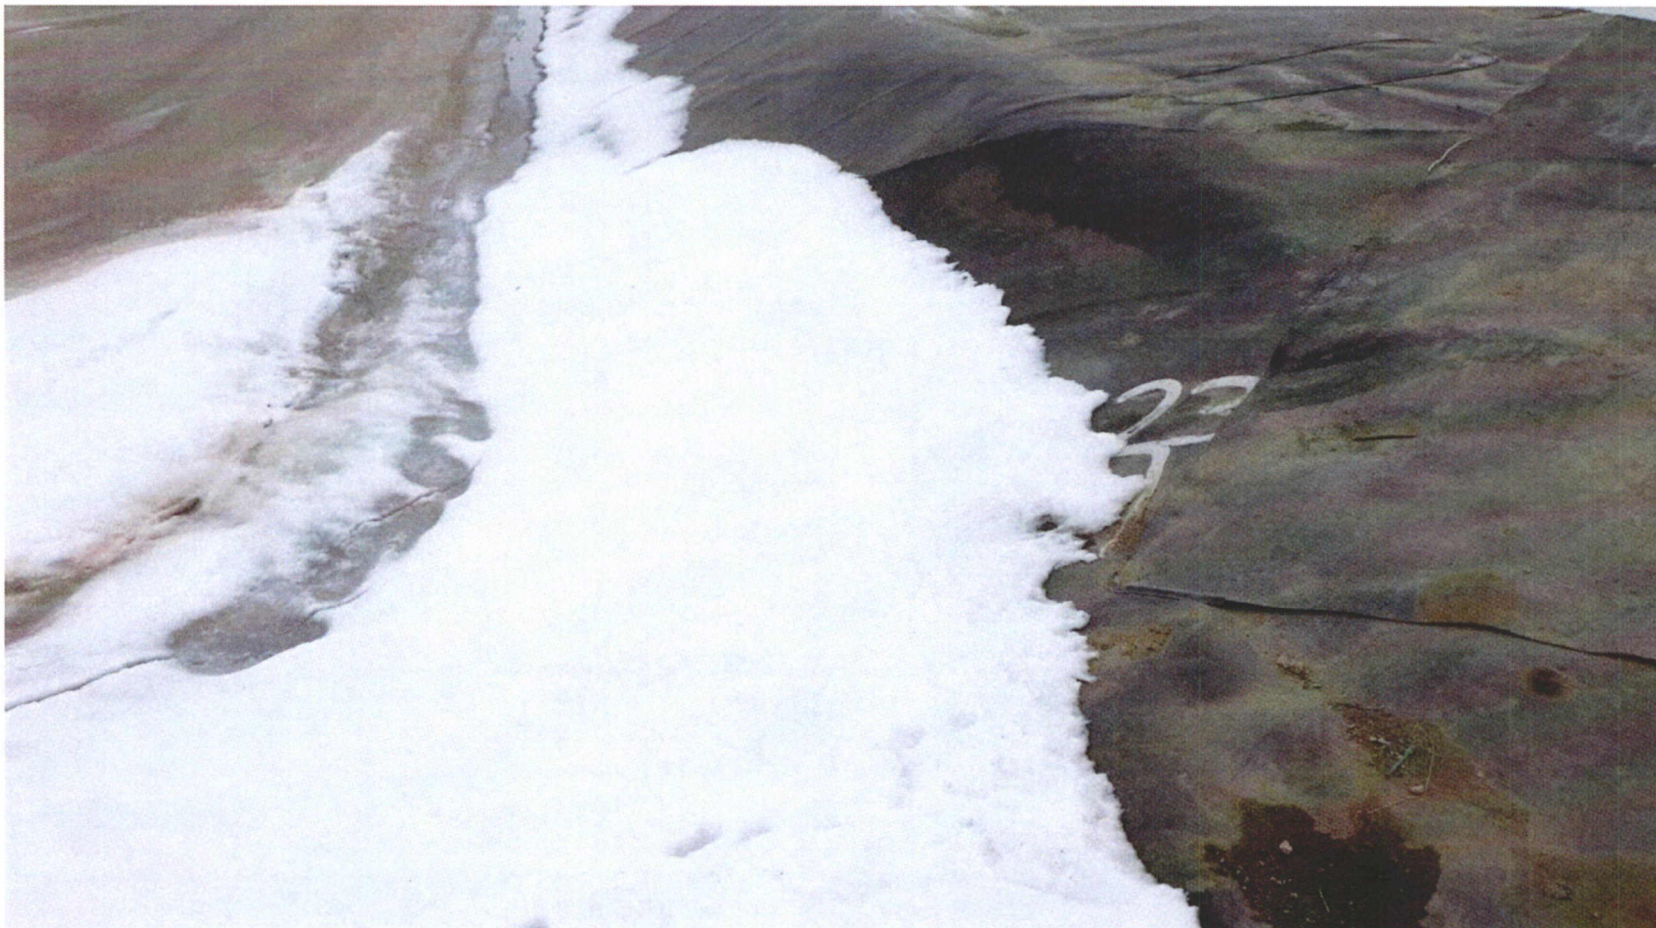
Photo 19

6. From a visual observation of the depth marker, the Southeast cell is operating at a depth of about 19 to 19.5 feet. It was difficult to determine the depth based on the depth marker due to snow (Photo 19). The invert elevation of the overflow pipe entering the Southeast cell from the Northeast cell is 115.3', per the approved plans and specifications (Table 2). The elevation of the water in the Southeast cell appeared to be greater than the elevation of the middle of the overflow pipe (Photos 17 and 18). Per the approved plans and specifications, the overflow pipe is fifteen inches in diameter. Since the overflow pipe is fifteen inches in diameter, this suggests that the elevation of the water in the Southeast cell was at least 115.925' ($115.3' + 0.625'$), which is greater than the maximum operating depth and within the area designed for freeboard.

Description: Depth marker on Southeast lagoon cell. The top line is 23 feet (right above the snow).
