RE: ALT EN LLC
MEAD, NEBRASKA

NDEE FAC ID: 84069

PROGRAM ID: 021221-NH-0845

DATE: February 19, 2021

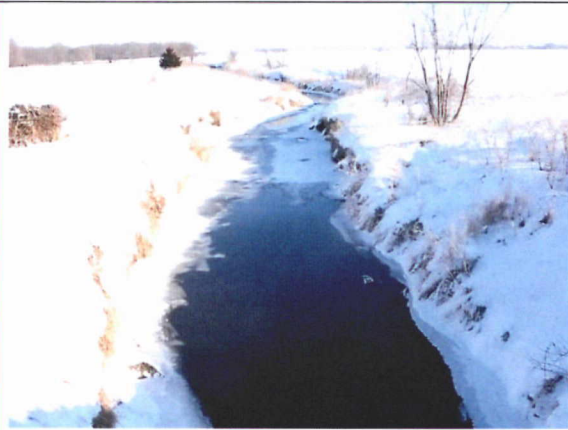
**STOP 1 – HIGHWAY 66 WEST of
ASHLAND GUN CLUB – 0835 hrs.**

Nothing to see here other than water and ice;
no apparent impacts.

Photo looking north from Highway 66 bridge.

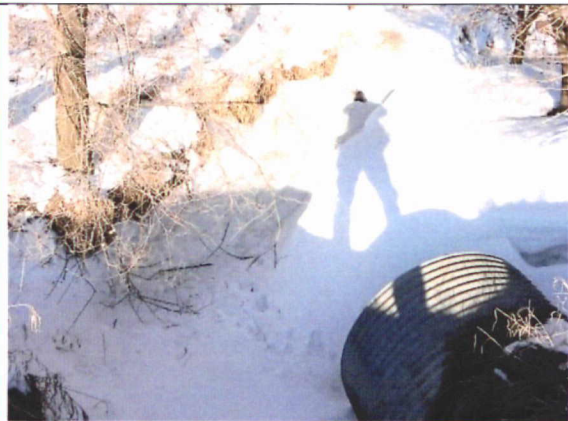
**STOP 2 – North of the Intersection of
COUNTY ROADS 6 & F – 0845 hrs.**

No apparent contamination; same as
described by Greg Michl 2-18-21.

Photo looking west.

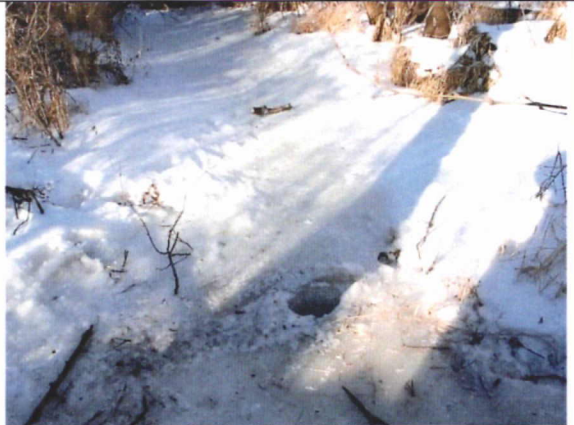
STOP 3 – Road 7/Highway 66 – 0850 hrs.

Same as reported by Greg Michl 2/18/21, no contamination apparent.

Top photo looking west.

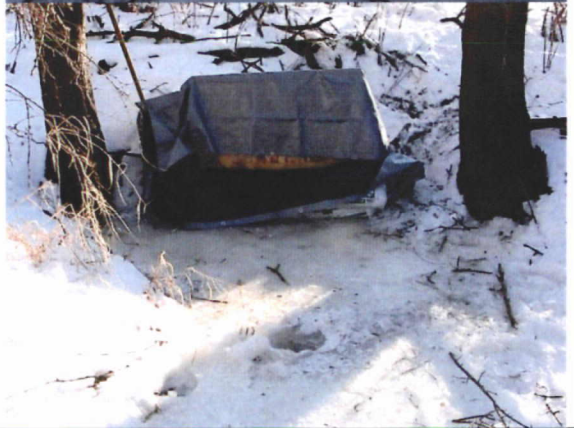
Bottom photo looking east at containment structure.

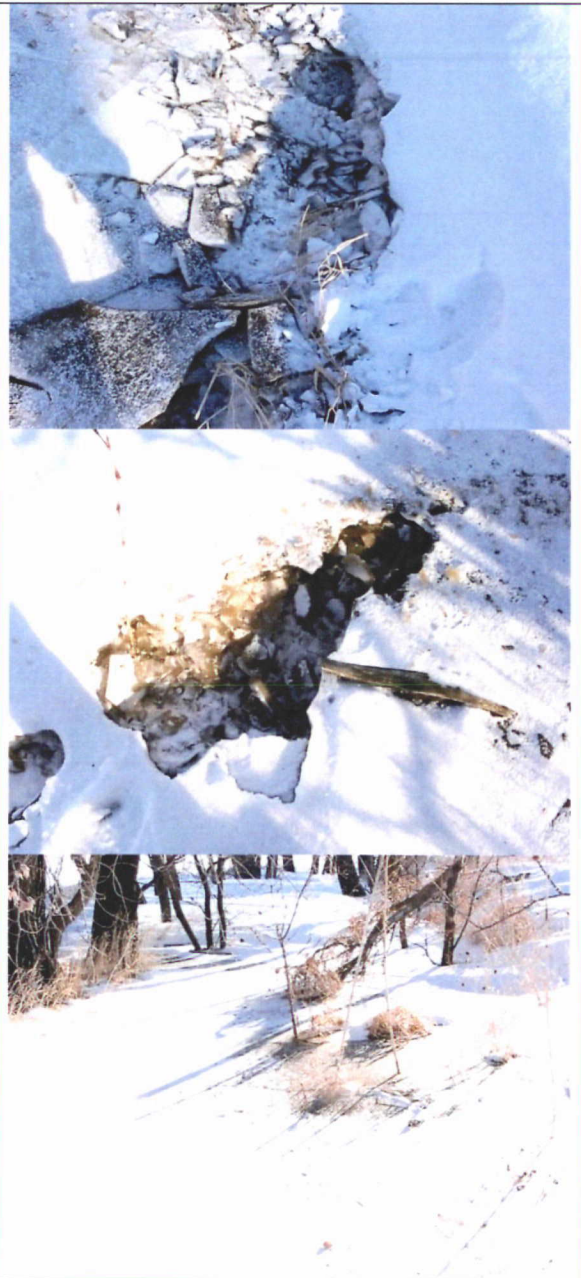
STOP 4 – County Road 8, North of Road H
– 0905 hrs.

Appears to be as described by Greg Michl on 2-18-21. Contamination evident.

Top two photos looking down at frozen contamination on west side of county road.

Bottom photo looking east from east side of county road.

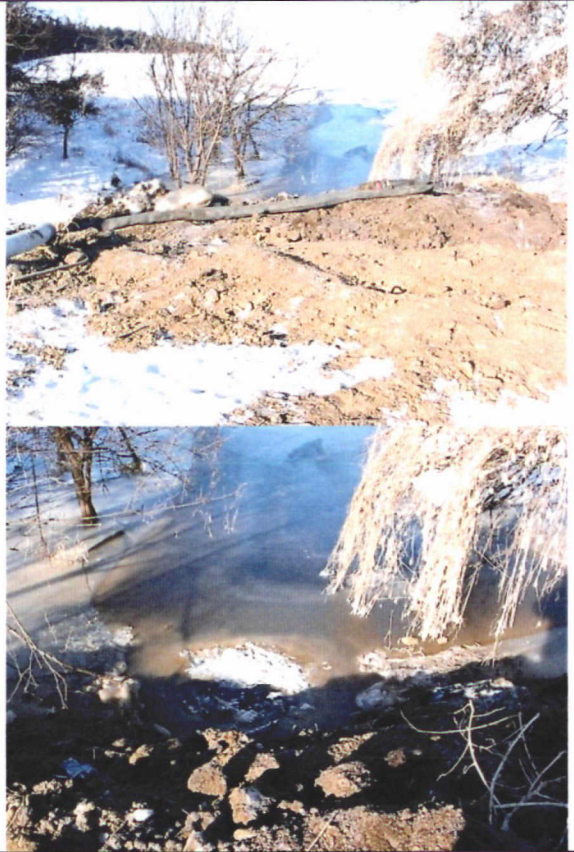
**STOP 5 – UN-L Eastern Extension – North
of County Roads 9 & J – 0915 hrs.**

Generator and piping present, but no pumping going on.

Top photo (page 4) looking west at constructed dam.

Bottom photo (page 4). Looking down from top of constructed dam.

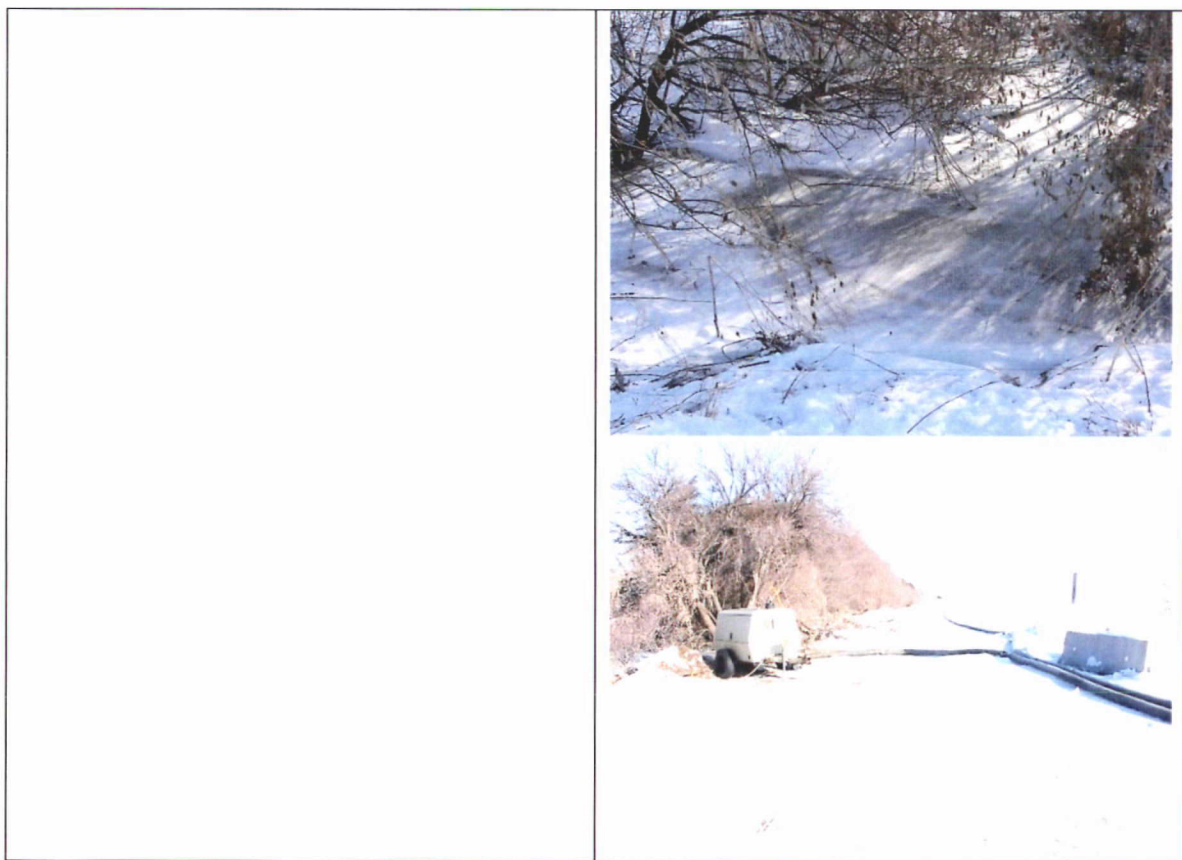
Top photo (page 5). Looking east at frozen contamination.

Bottom photo (page 5). Looking north at overview of generator (not operating) and piping.

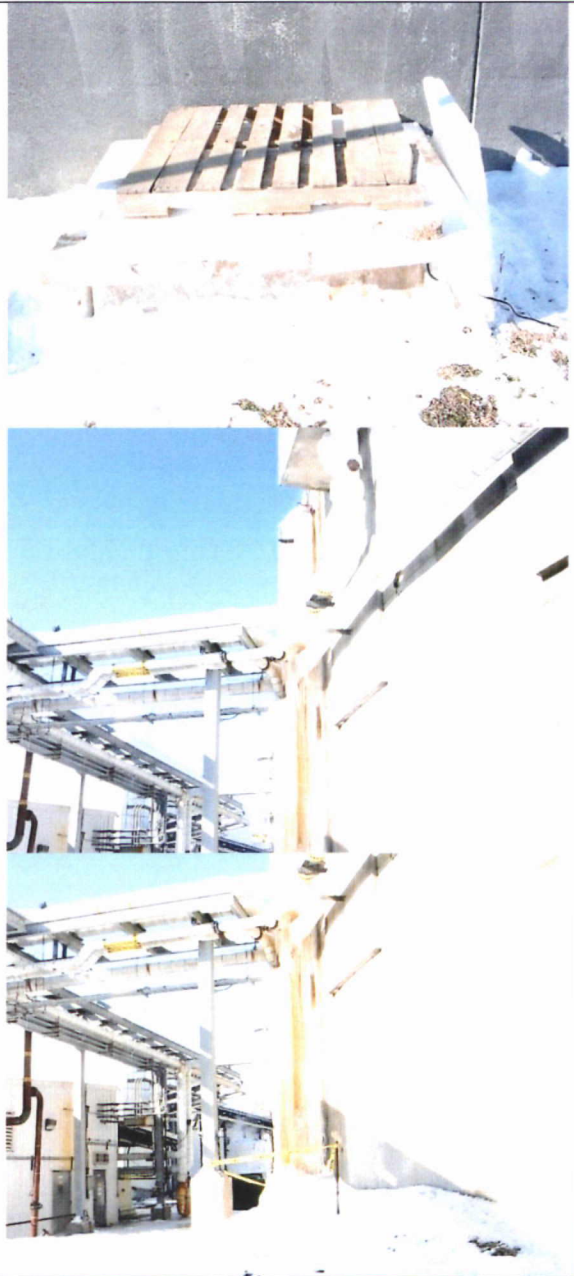
STOP 6 – ALTEN LLC FACILITY
DIGESTERS – 0932 hrs.

Same observed by Greg Michl 2-18-21.

Top photo. Looking at piping well associated with north digester. Chord on right side leading into well is associated with heating lamp for piping.

Bottom two photos. Looking at ice accumulation on side of north digester.

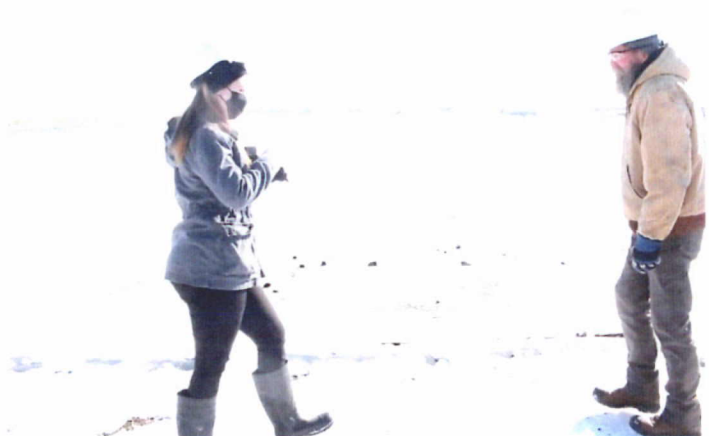
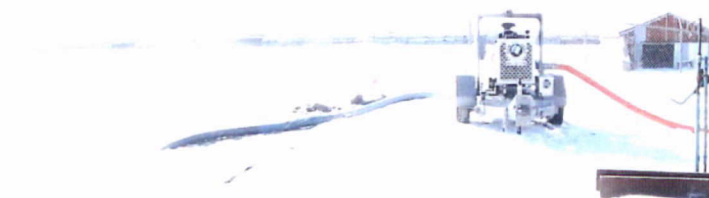
Facility pumping water from emergency lagoon to active wastewater lagoons in preparation for pumping material from north digester. NDEE Inspector Hillary Stoll on-site for inspection of emergency lagoon (see Photos below). Top photo looking east across "emergency lagoon." Bottom photo (looking south) shows water from "emergency lagoon" being pumped north to site wastewater lagoons.
