Nebraska Department of Environment and Energy (NDEE)

Date: February 10, 2021

RE: AltEn, LLC

Subject: Site Visit Report to Confirm Facility Shutdown/Cessation of Discharge to Wastewater Lagoons

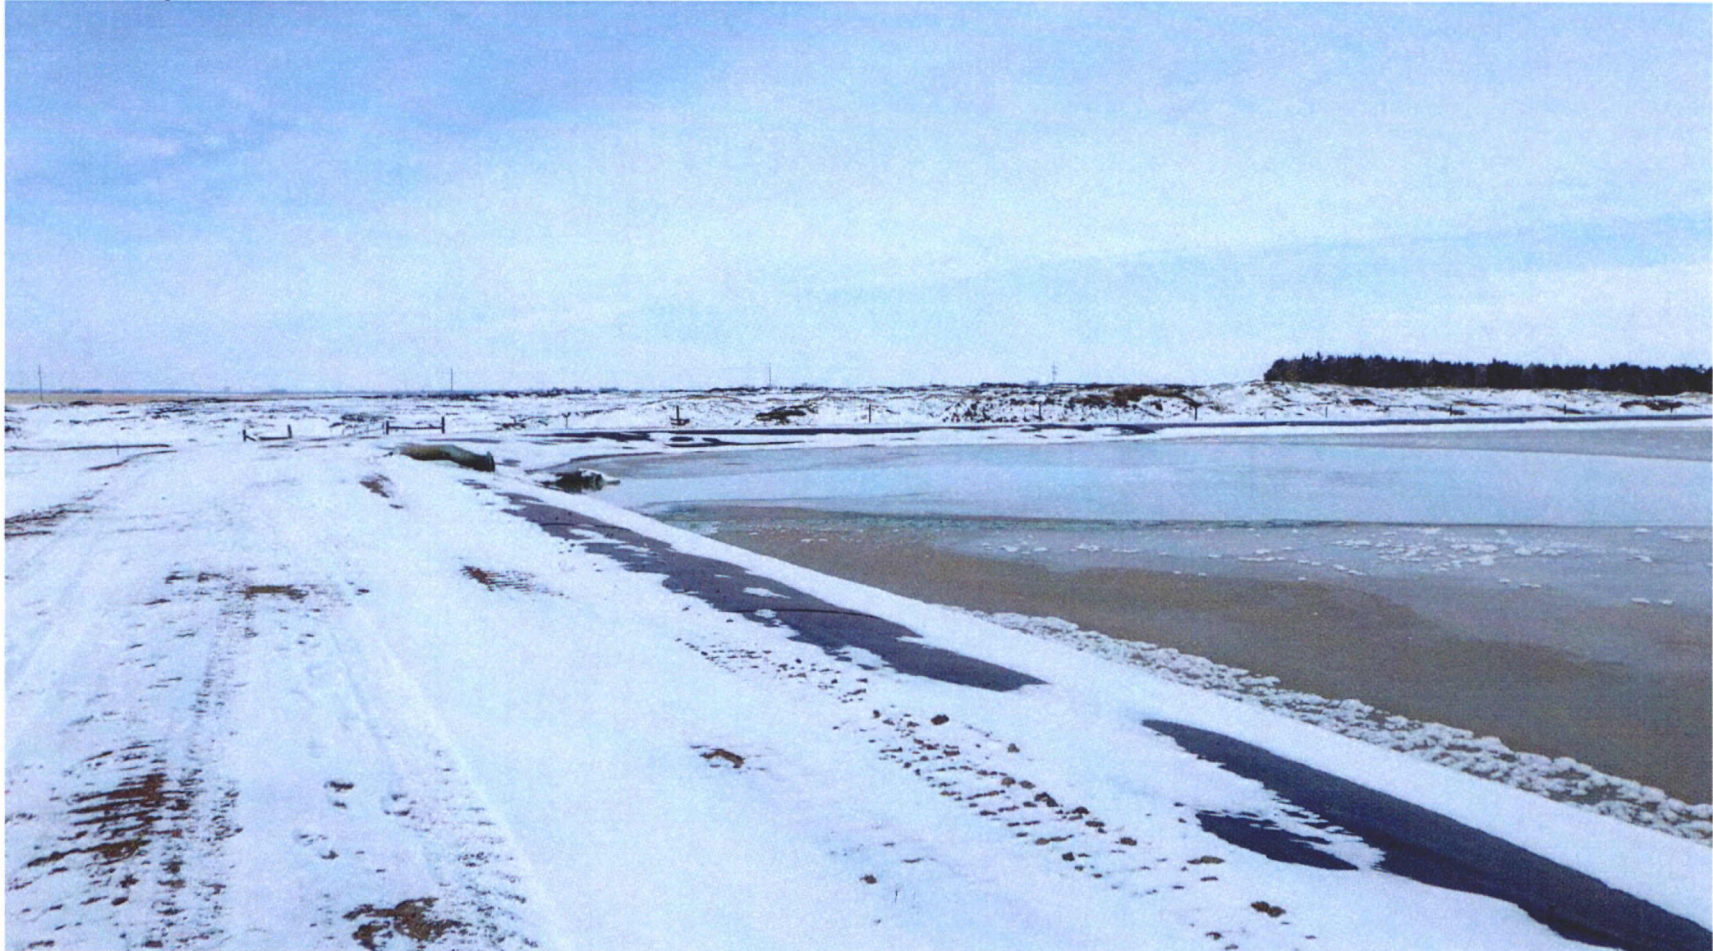
Photo 1

Description: Influent pipe into the Northwest lagoon. No discharge into the lagoon was observed.

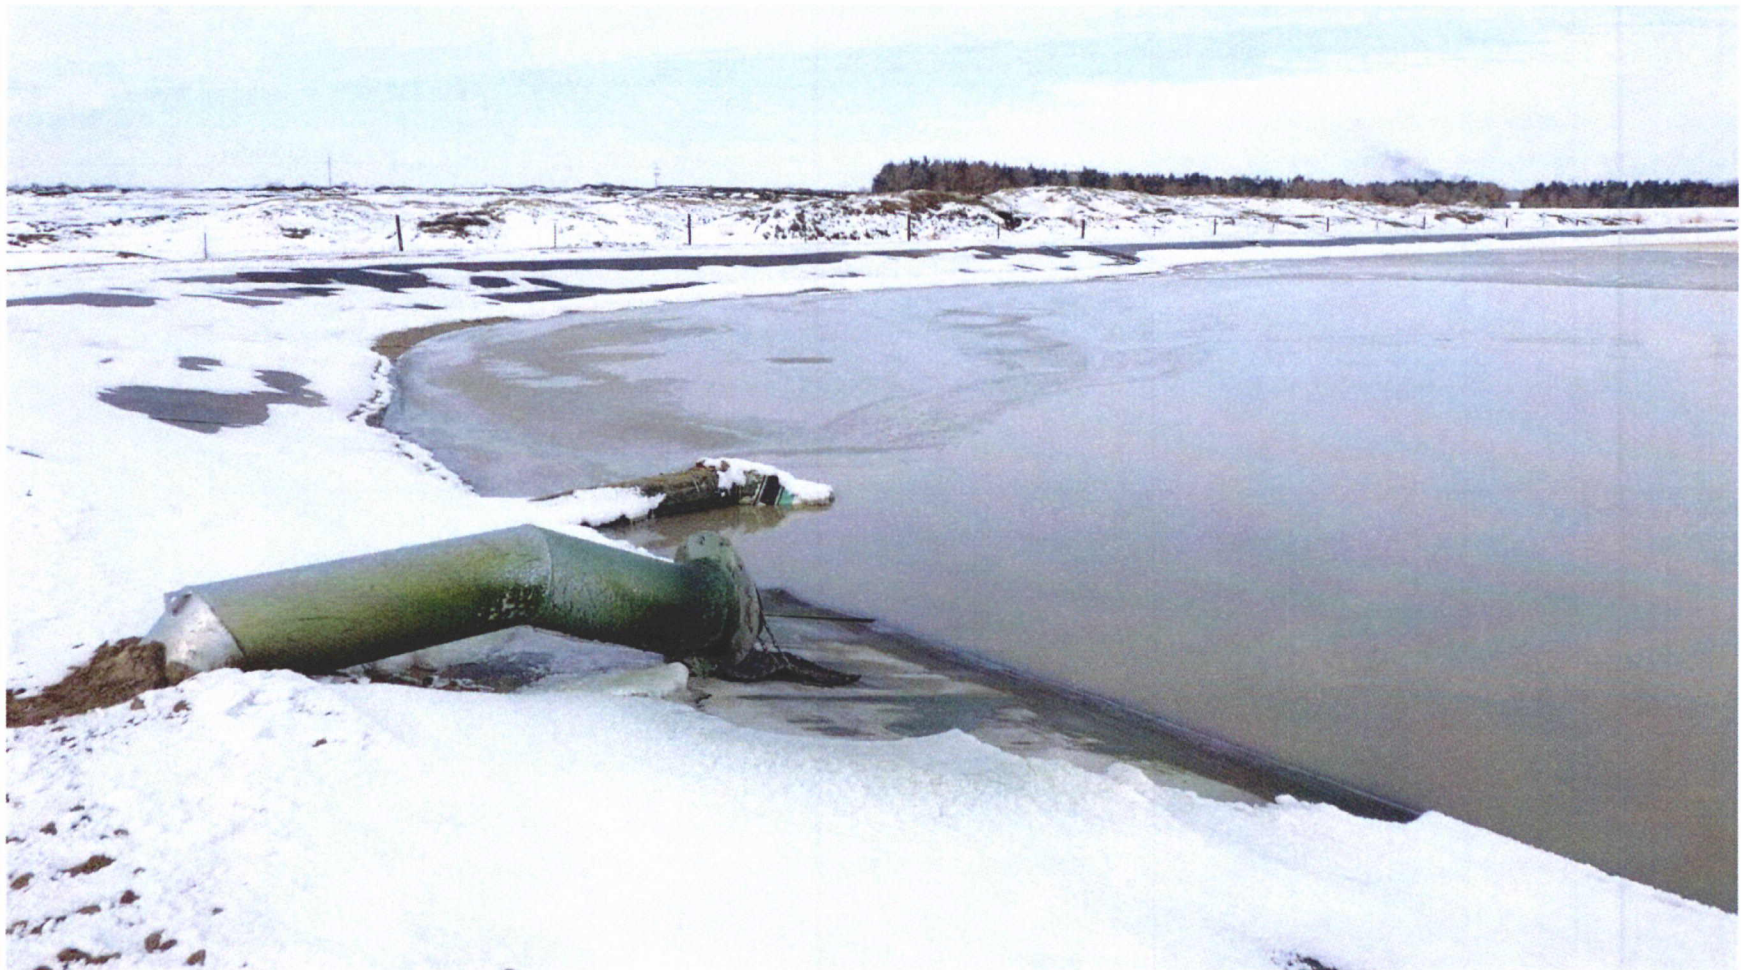
Photo 2

Description: Influent pipe into the Northwest lagoon. No discharge into the lagoon was observed.

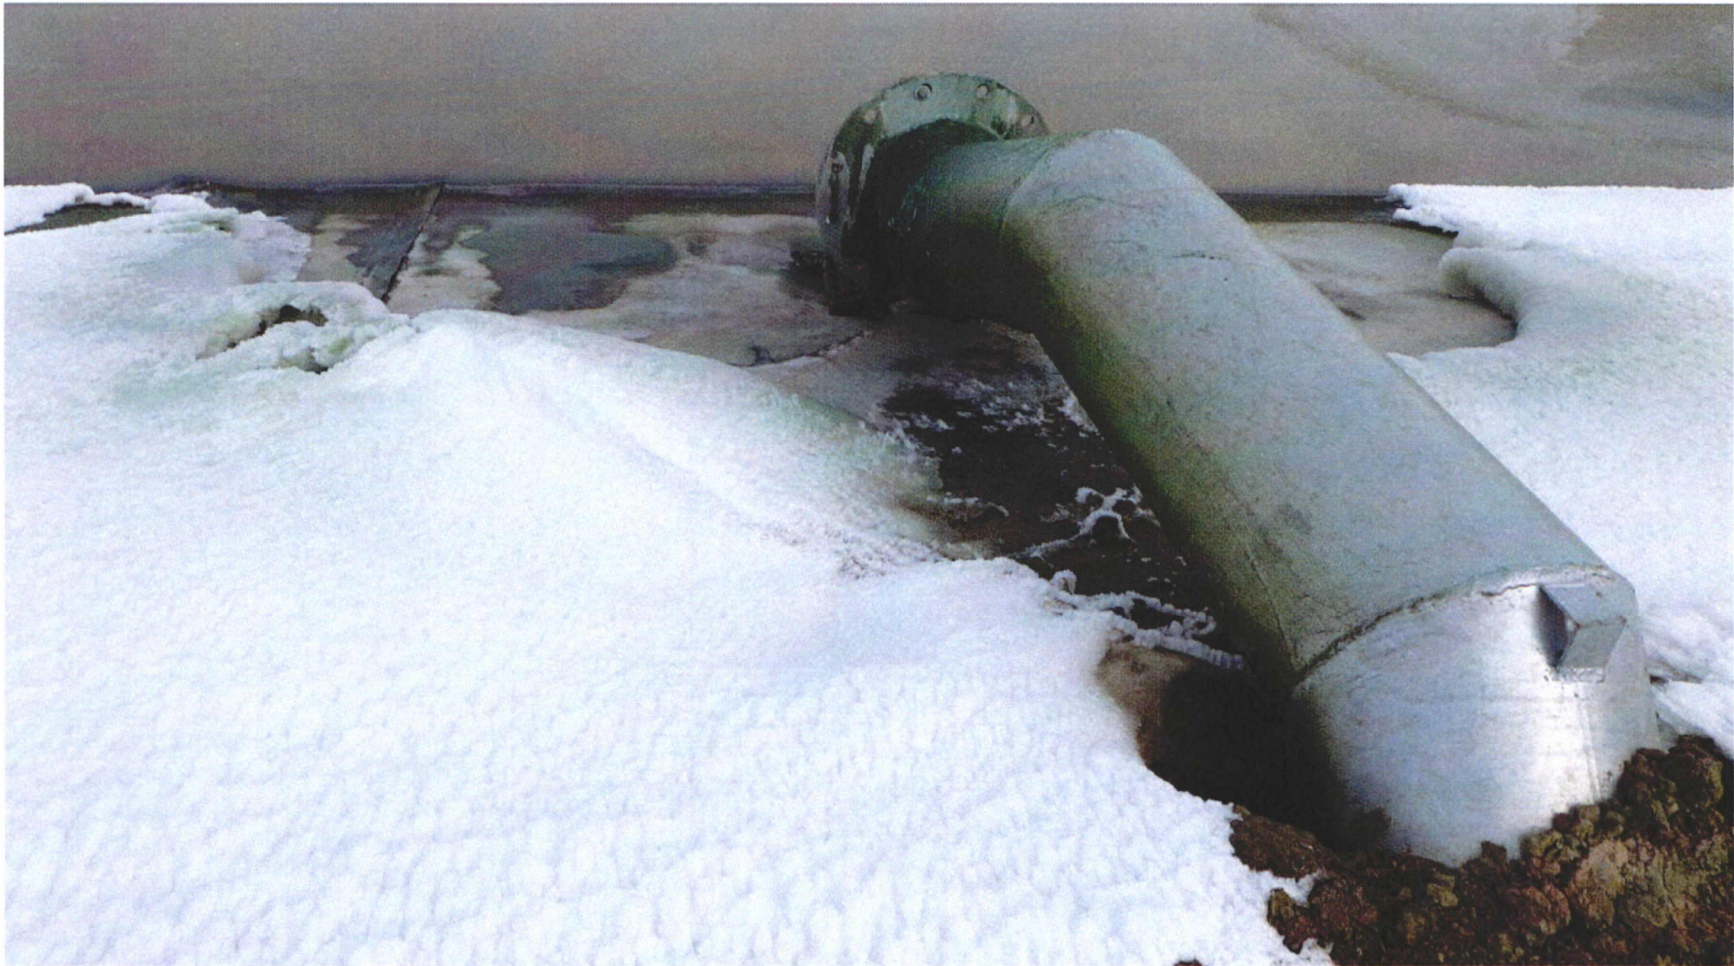
Photo 3

Description: Influent pipe into the Northwest lagoon. No discharge into the lagoon was observed.

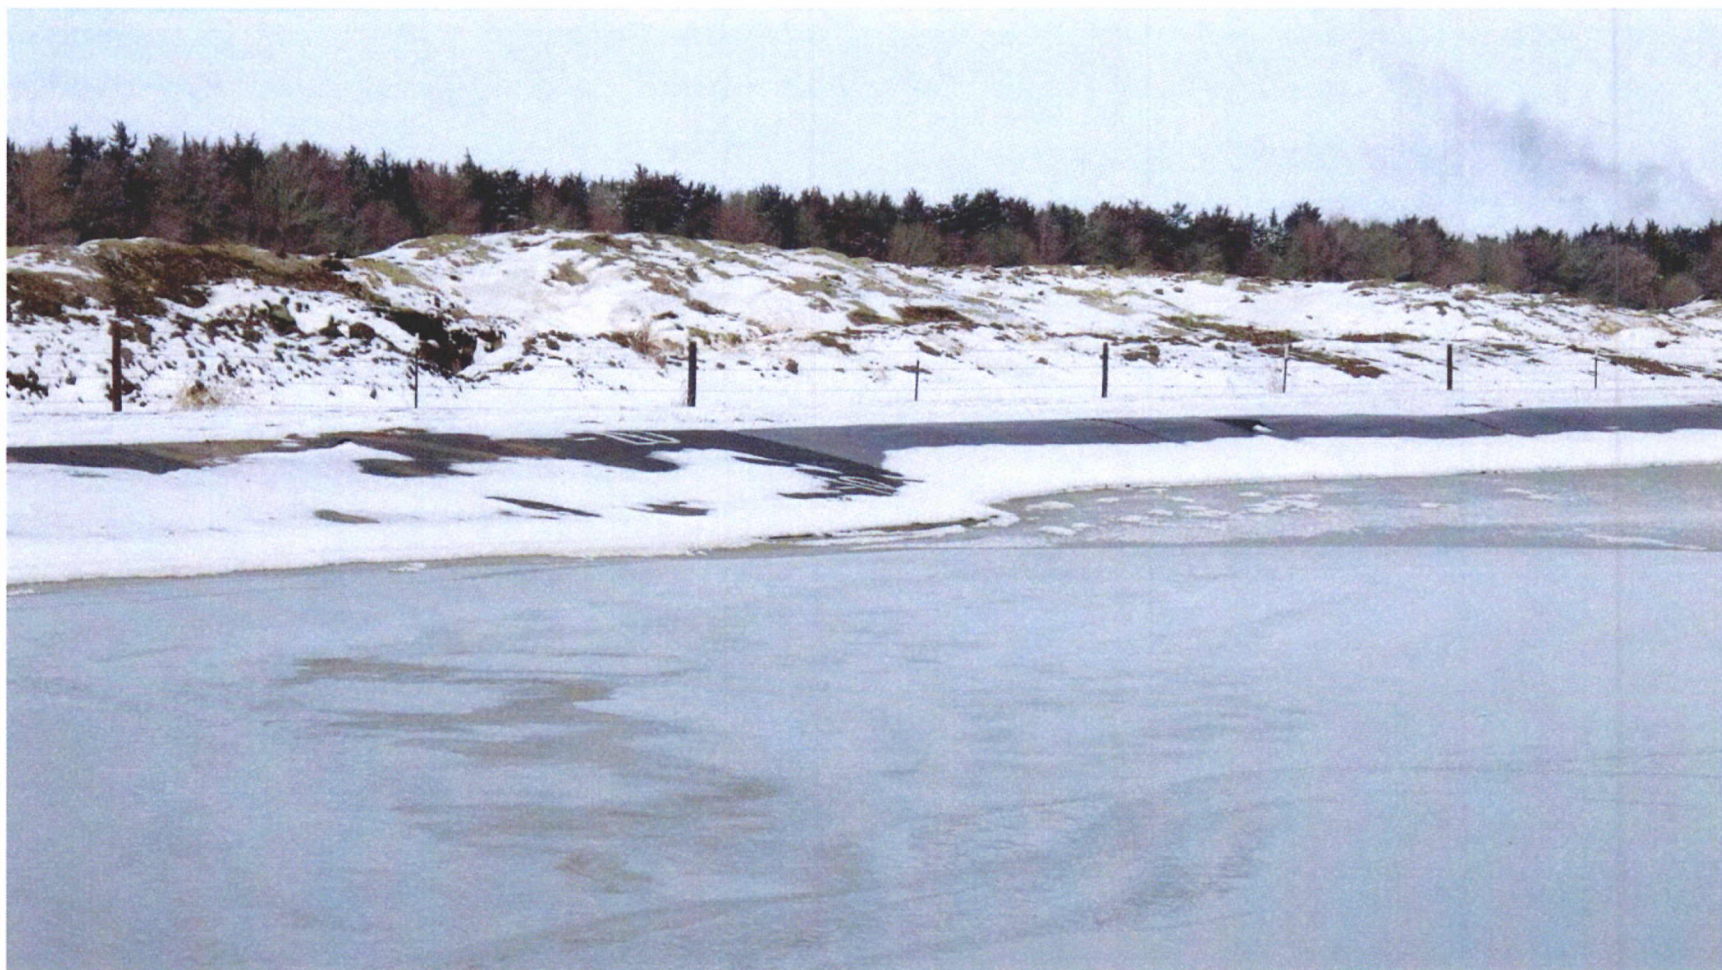
Photo 4

Description: Depth marker for Northwest lagoon cell.

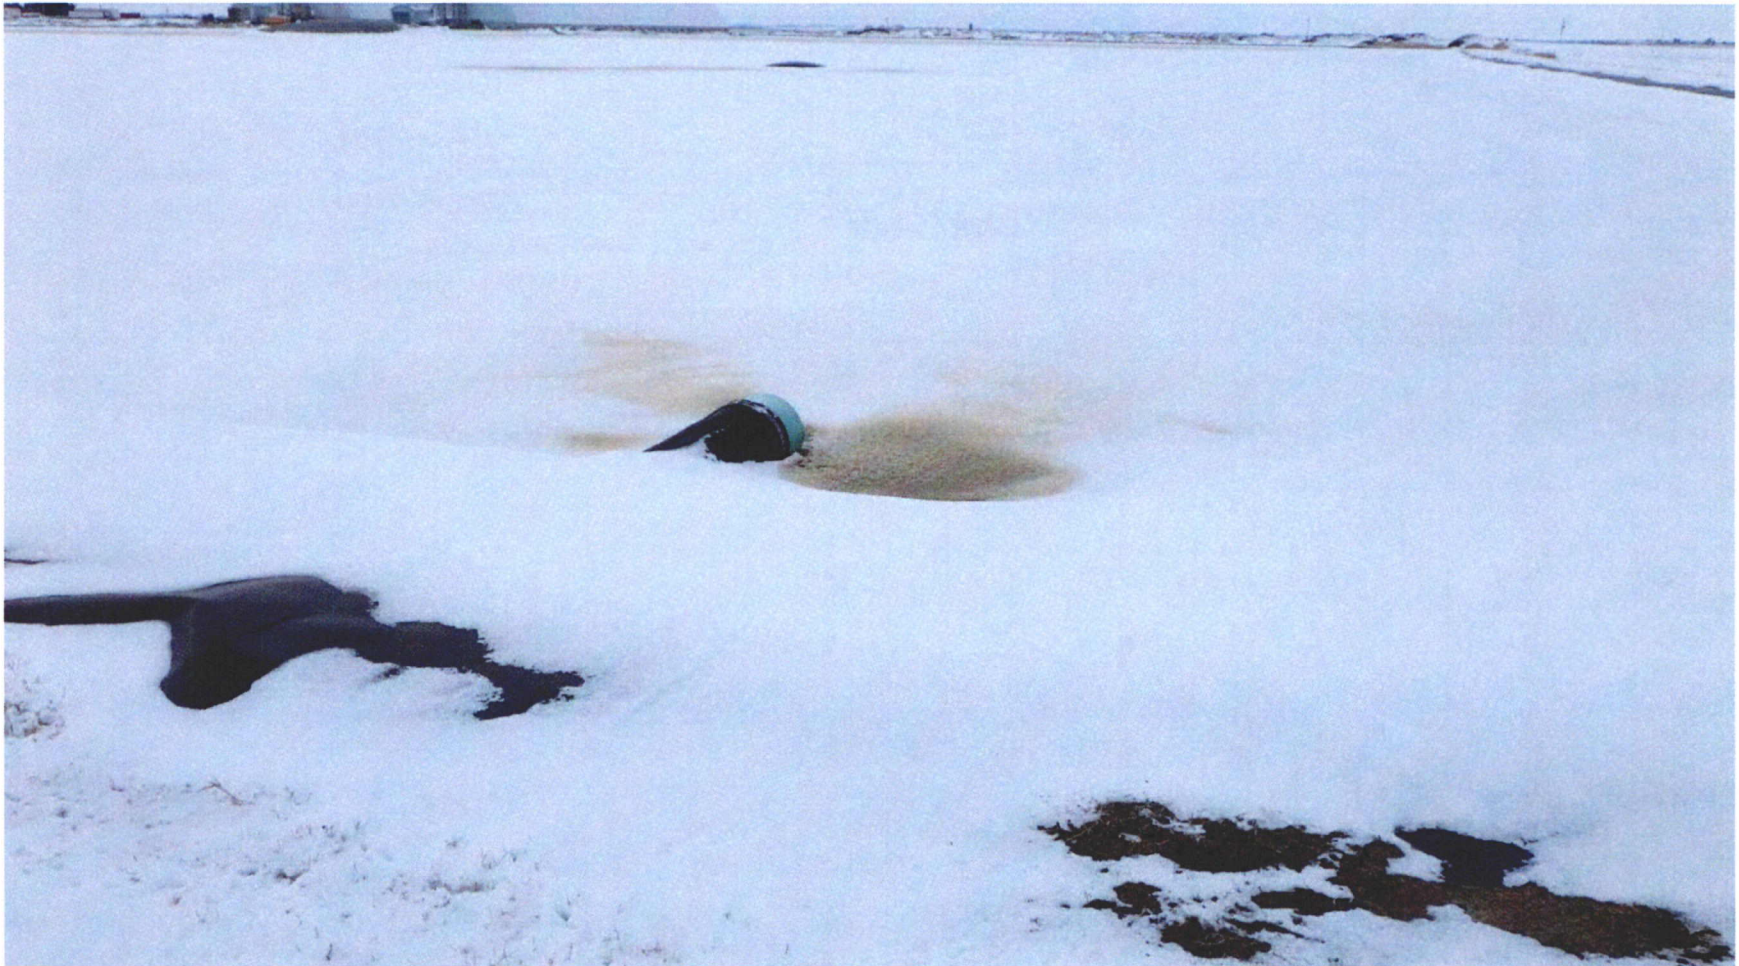
Photo 5

Description: Overflow pipe in Northwest lagoon (flows into Northeast lagoon which is not visible in this photo – see Photo 6).

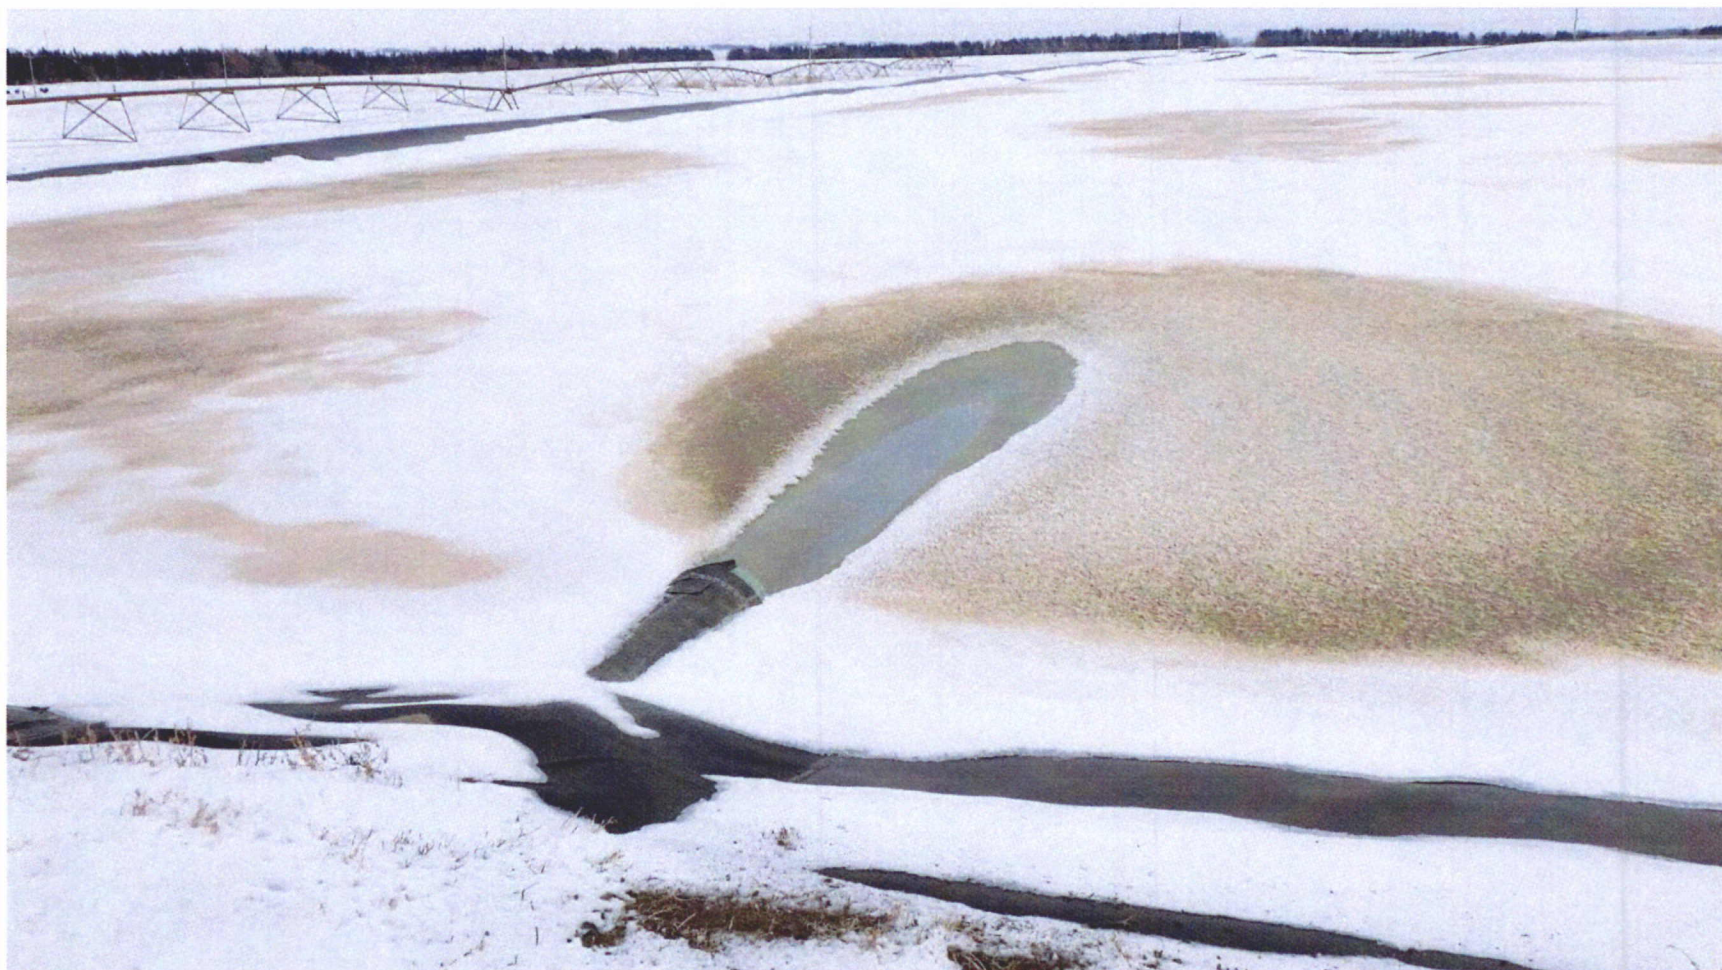
Photo 6

Description: Overflow pipe entering the Northeast lagoon (flows from Northwest lagoon which is not visible in this photo – see Photo 5).

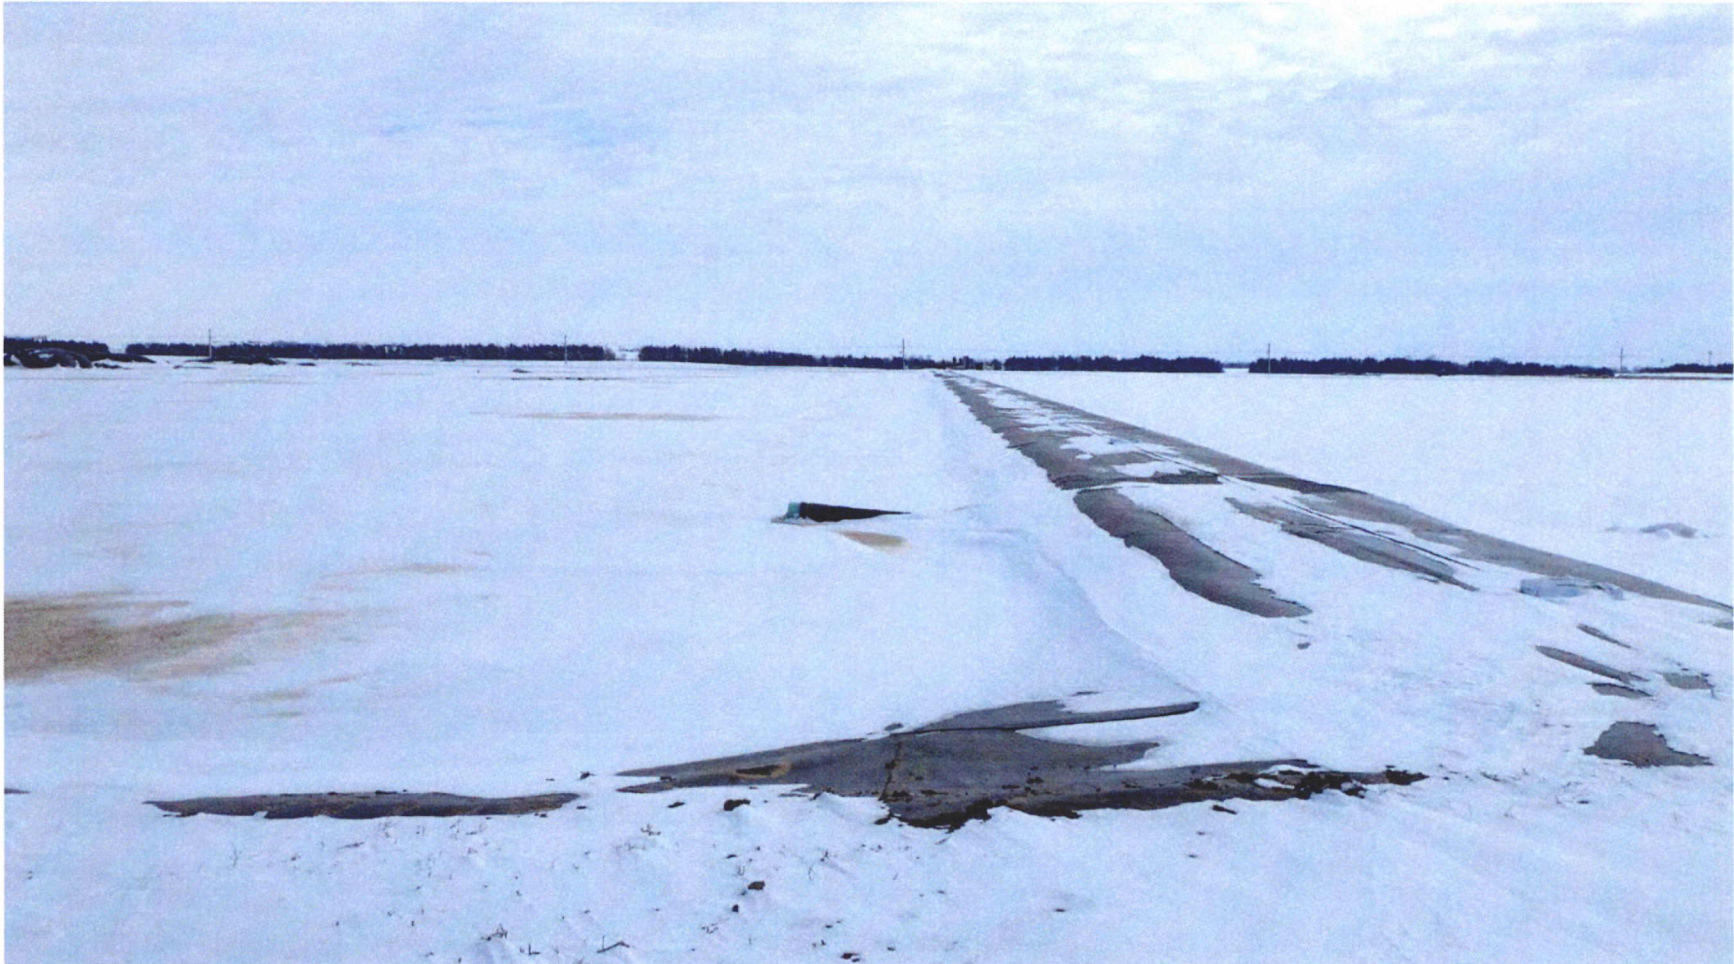
Photo 7

Description: Overflow pipe in Northeast lagoon (left) flows into the Southeast lagoon (right).

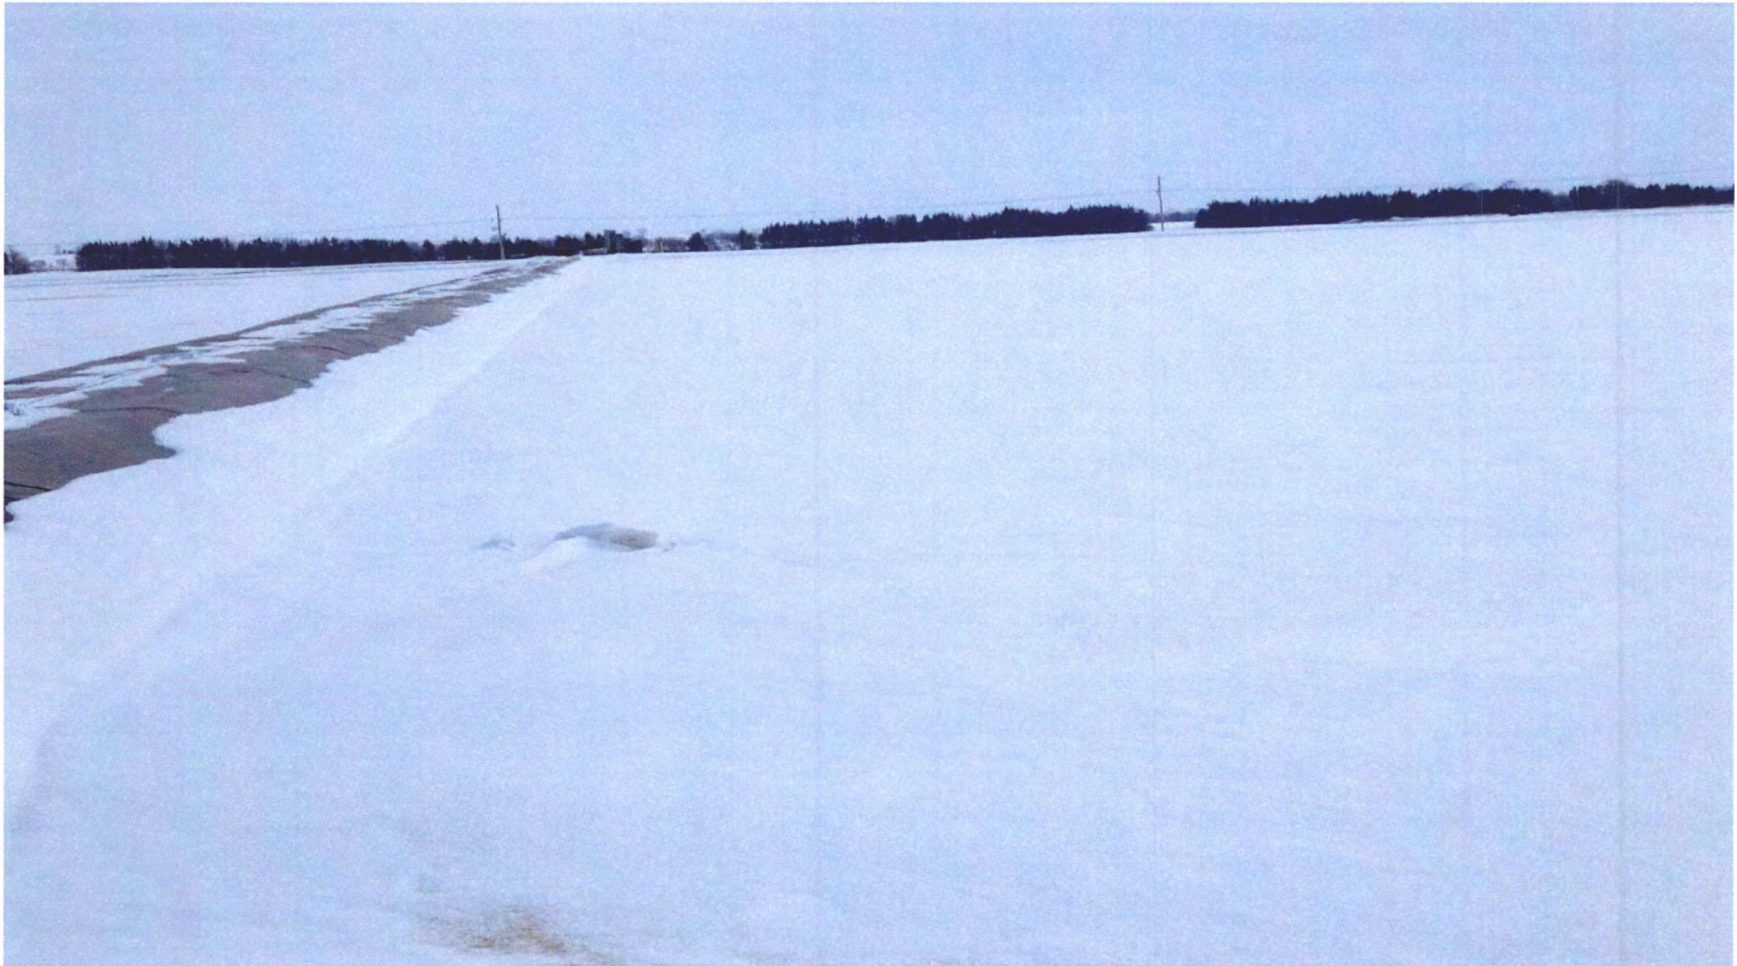
Photo 8

Description: Overflow pipe in the Southeast lagoon is mostly covered with ice/snow.

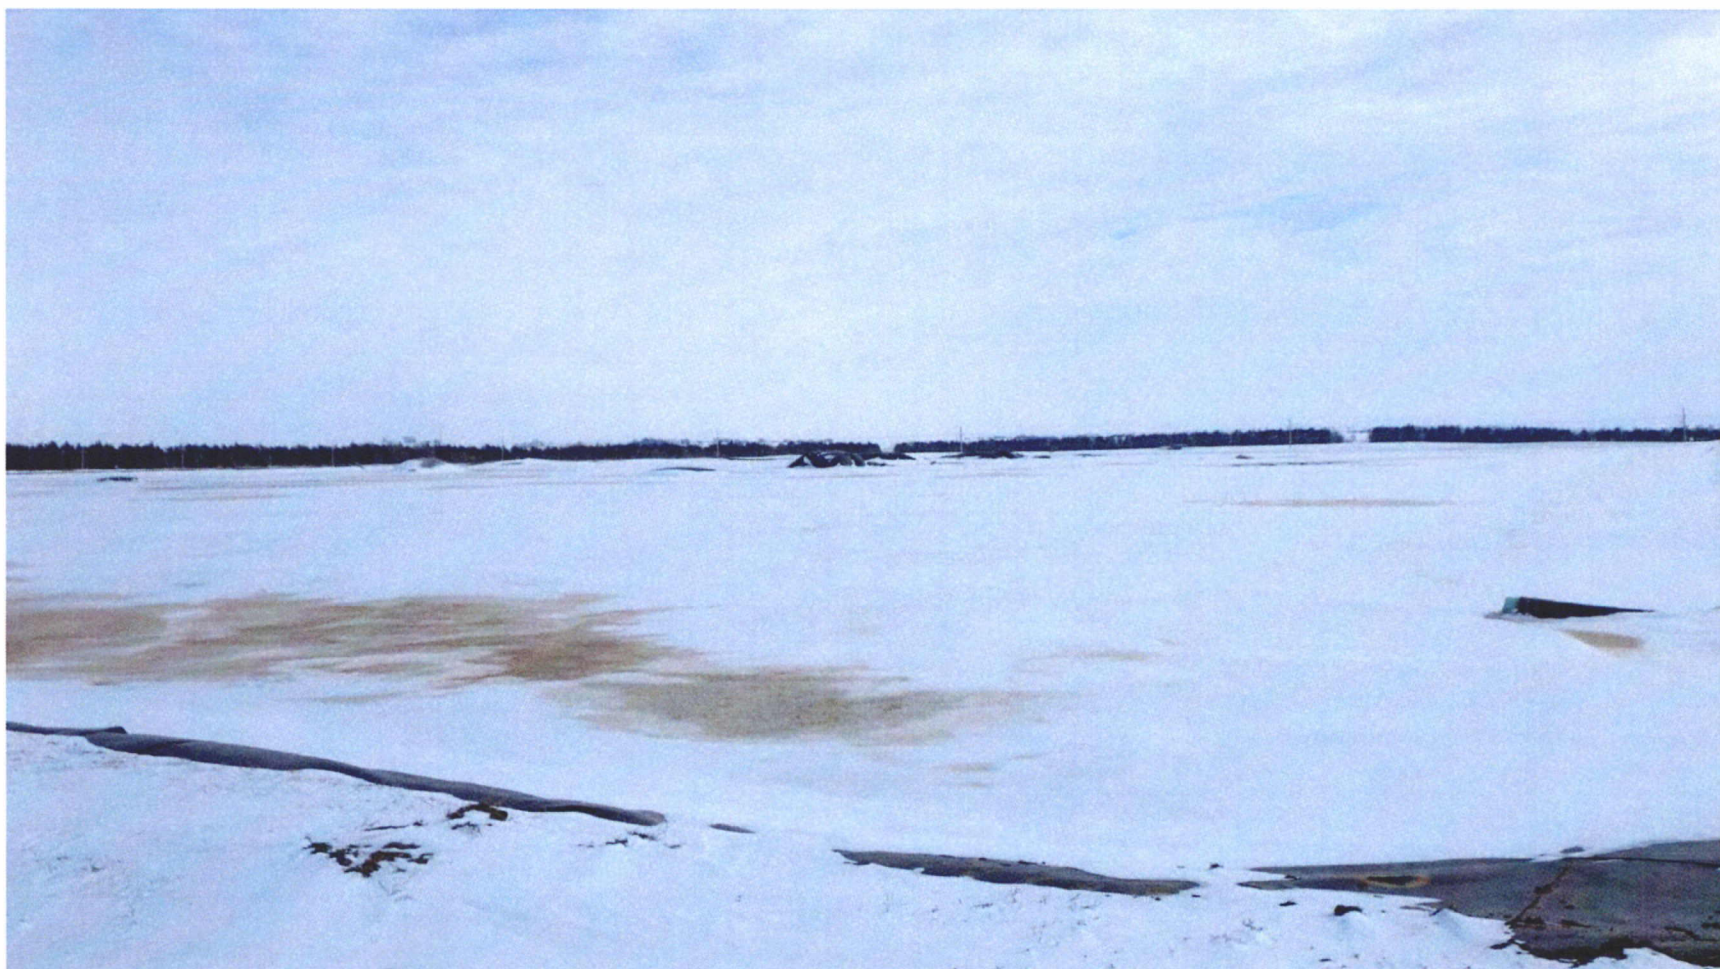
Photo 9

Description: Overview of Northeast lagoon.

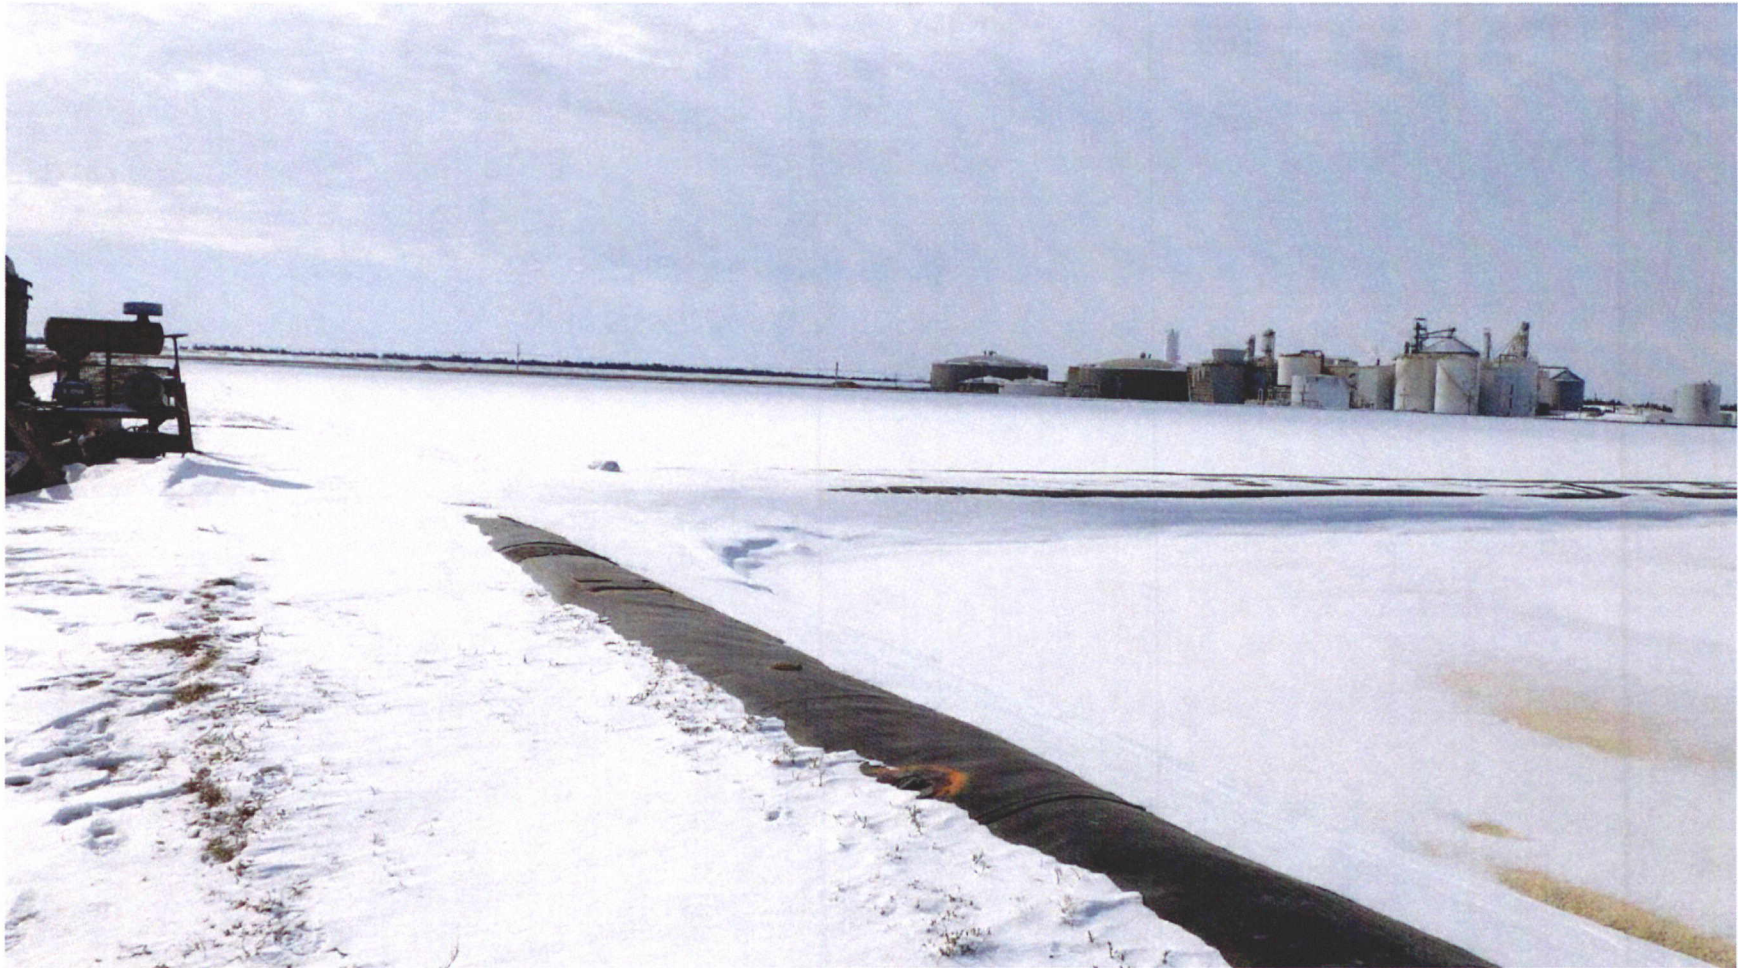
Photo 10

Description: Southeast corner of the Northeast lagoon. The depth marker is not visible due to the snow.

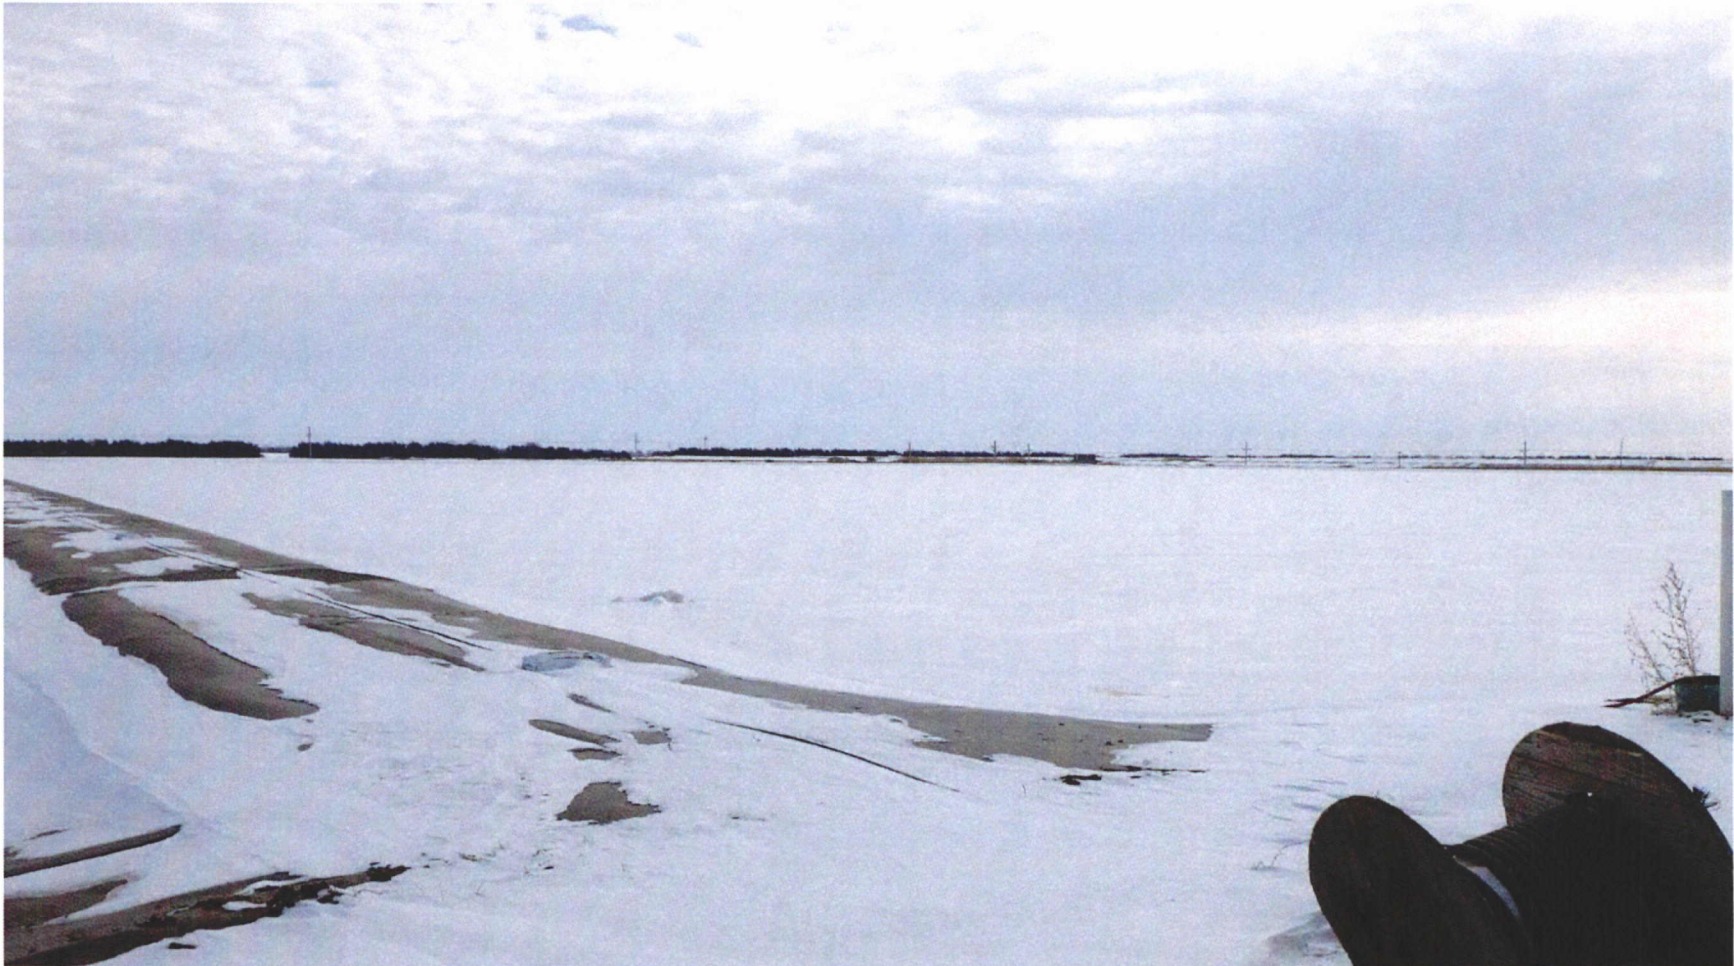
Photo 11

Description: Overview of the Southeast lagoon.

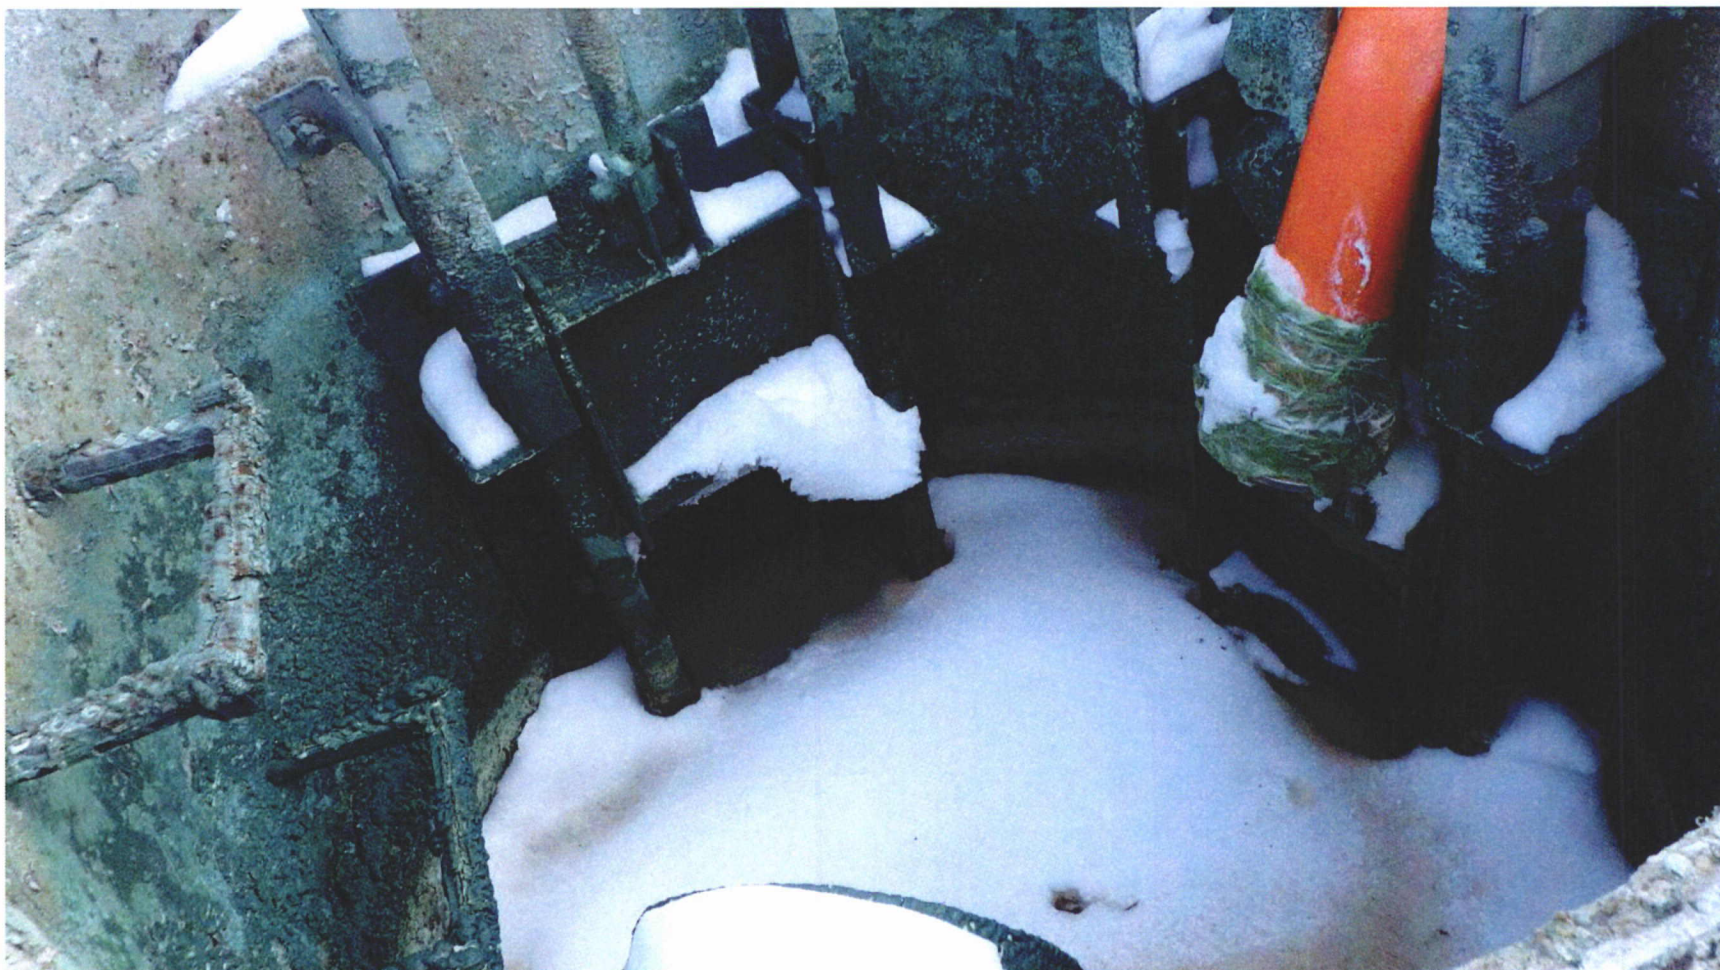
Photo 12

Description: Splitter box that used to split influent flow between the Northeast and Southeast lagoons prior to the construction of the Northwest lagoon. The orange hose is not usually present, but was put in place to convey water used to test the new filters that are being constructed. No discharge from this hose into the splitter box was observed.

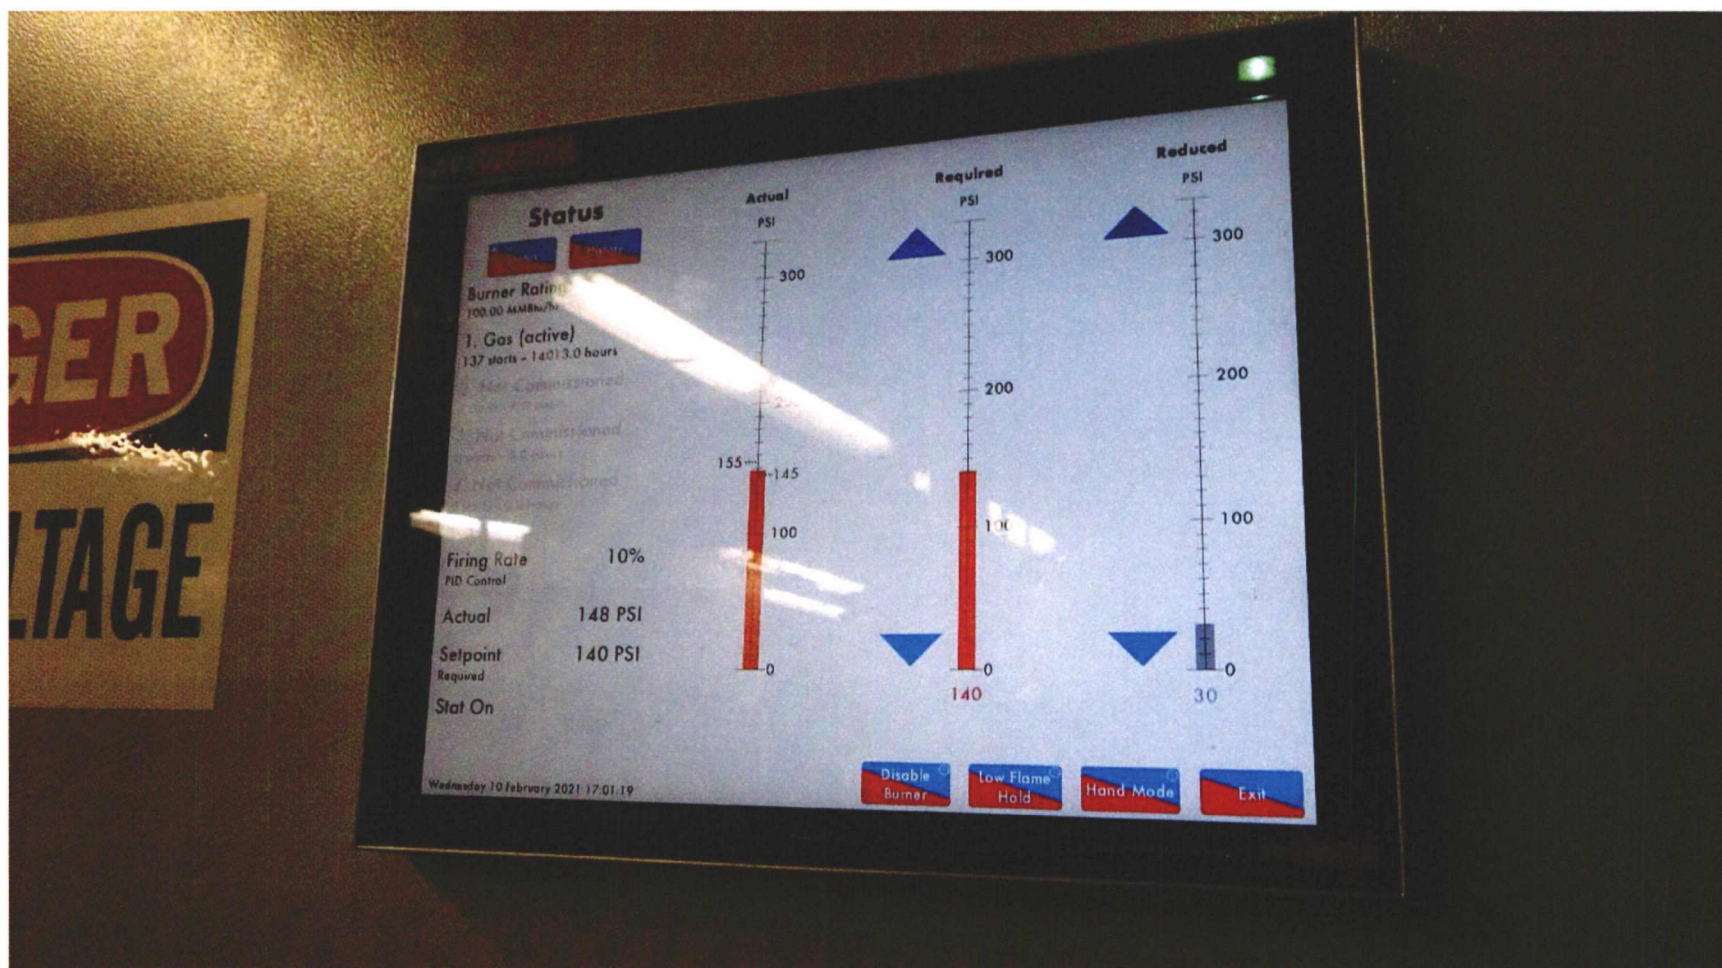
Photo 13

Description: Status for the one boiler that has been left on. Mr. Ken Peterson stated that the 10% firing rate is the lowest rate possible.
