Nebraska Department of Environment and Energy (NDEE)

Date: February 10, 2021

RE: AltEn, LLC

Subject: Site Visit Report to Confirm Facility Shutdown/Cessation of Discharge to Wastewater Lagoons

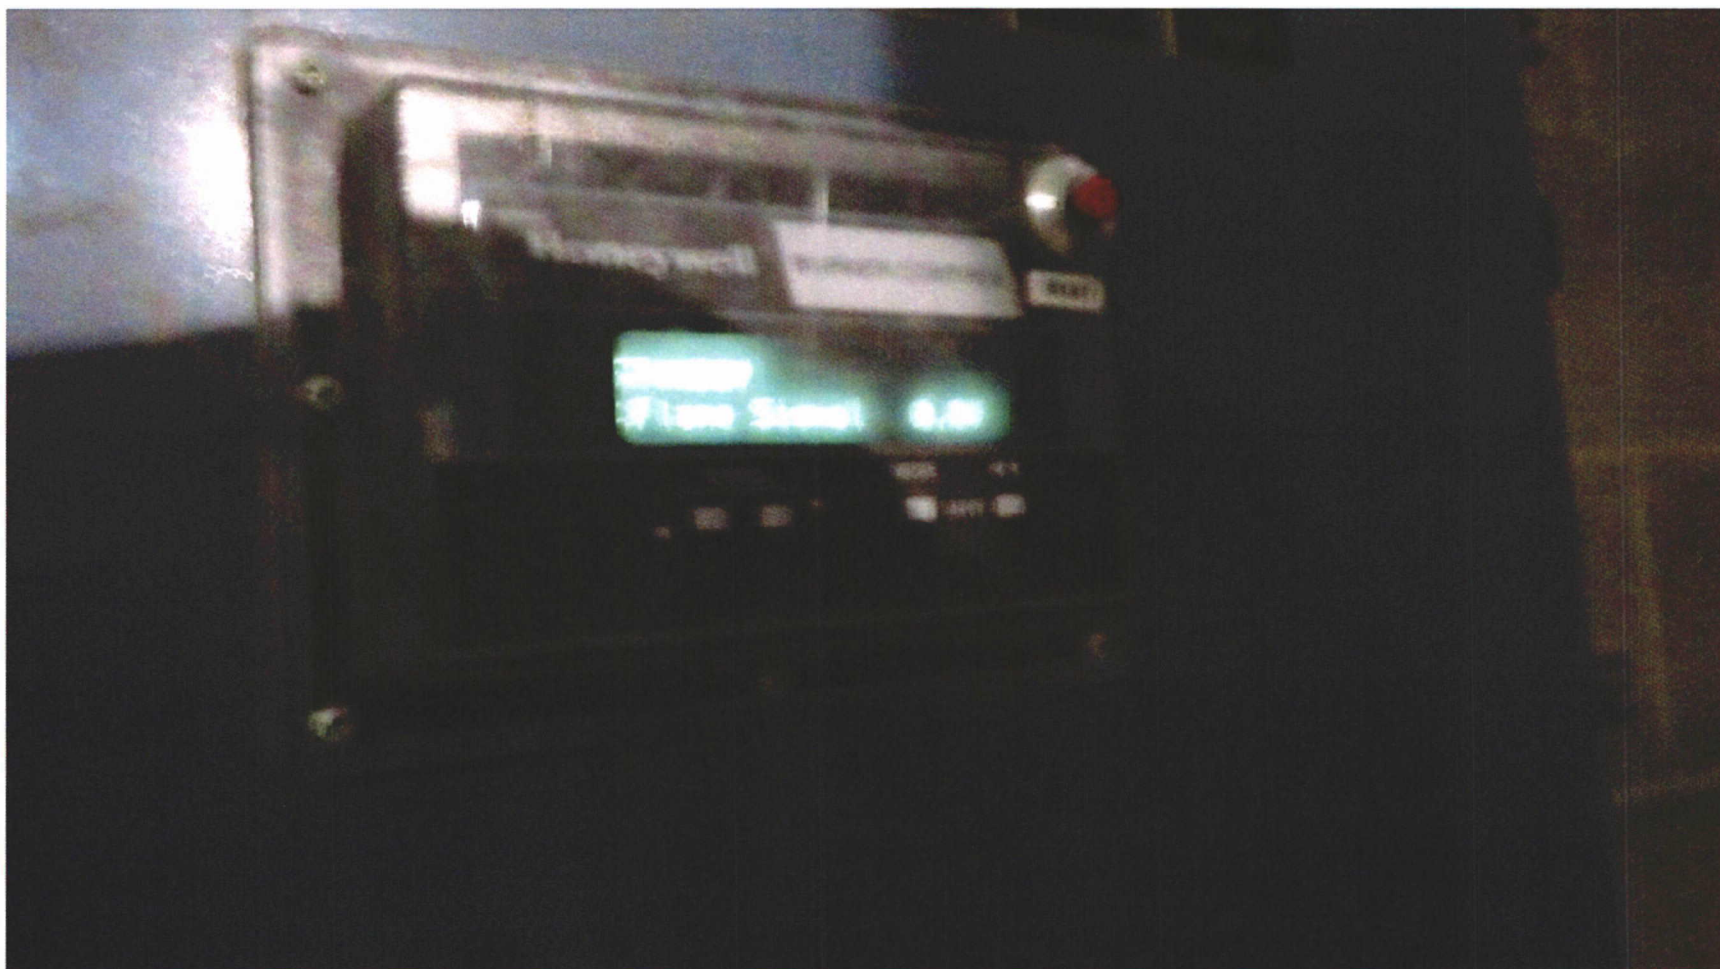
Photo 14

Description: Documentation that another boiler is off. The panel says "Standby Flame Signal 0.0 V". The boiler was visually observed and there was no noise or flame and it was not operating.

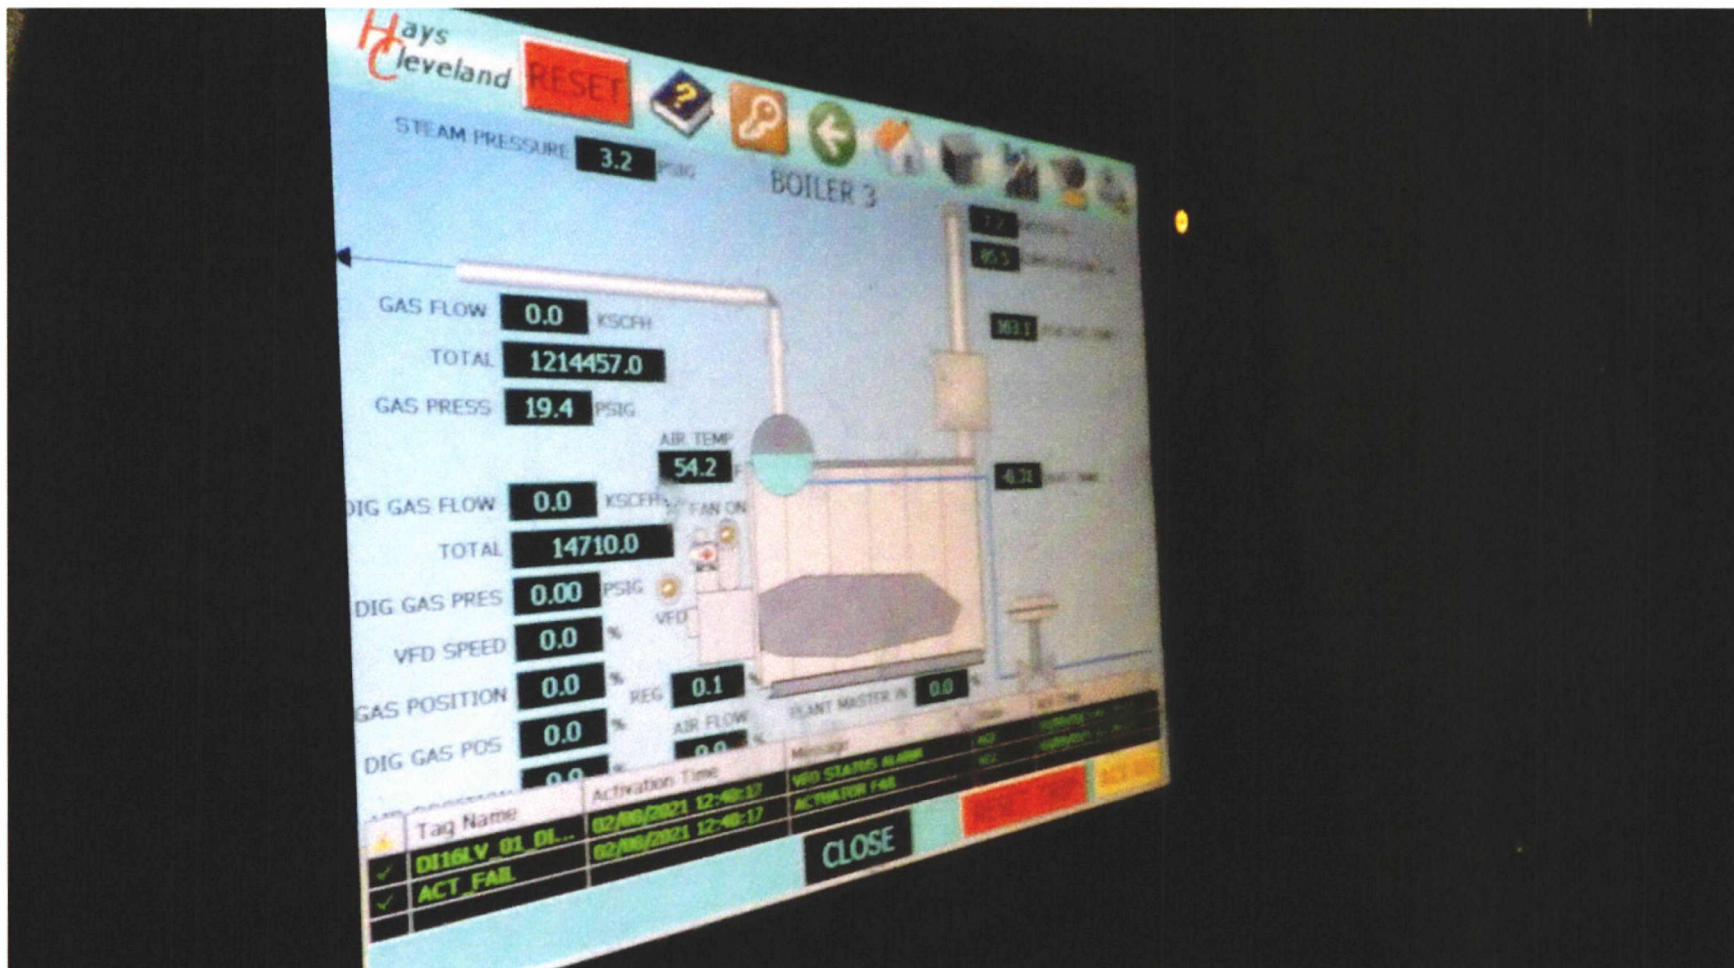
Photo 15

Description: Documentation that another boiler is off. The boiler was visually observed and there was no noise or flame and it was not operating.

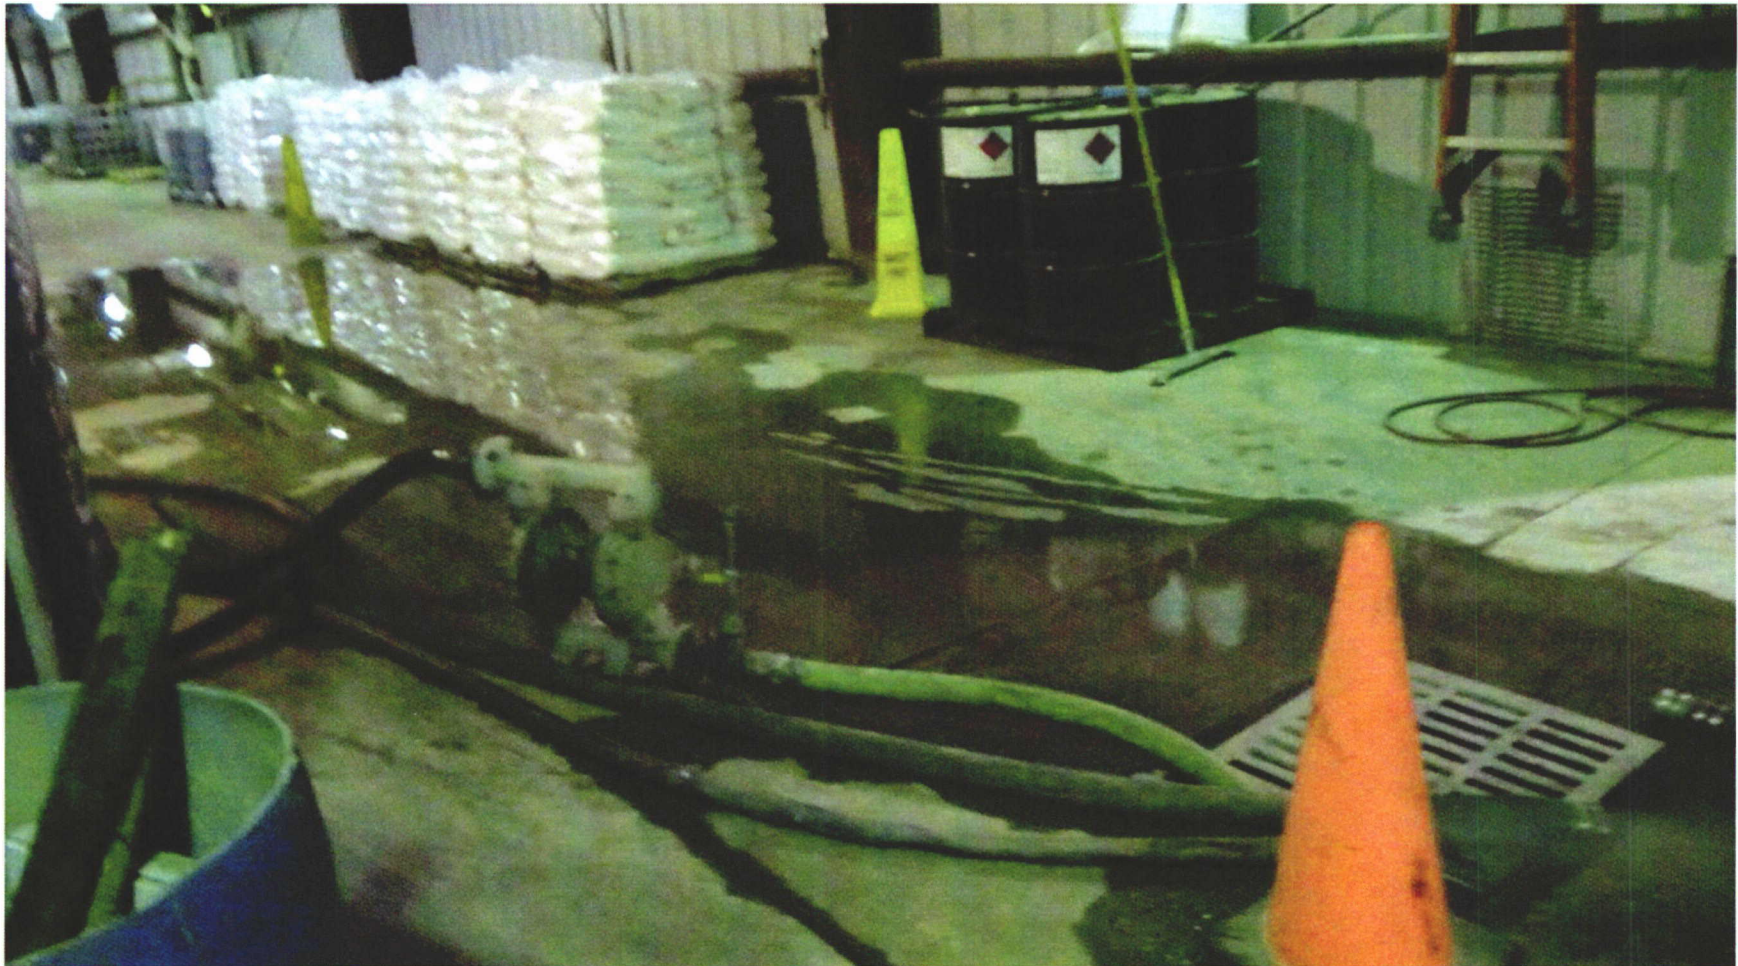
Photo 16

Description: Steam condensate from the boiler.
