MEMORANDUM

DATE: February 22, 2021
TO: AltEn
THRU: Brad Pracheil
FROM: Josh Wilhelm
RE: University of Nebraska Lincoln, Agricultural Research and Development Center Site Visit

FACILITY ID: 84069

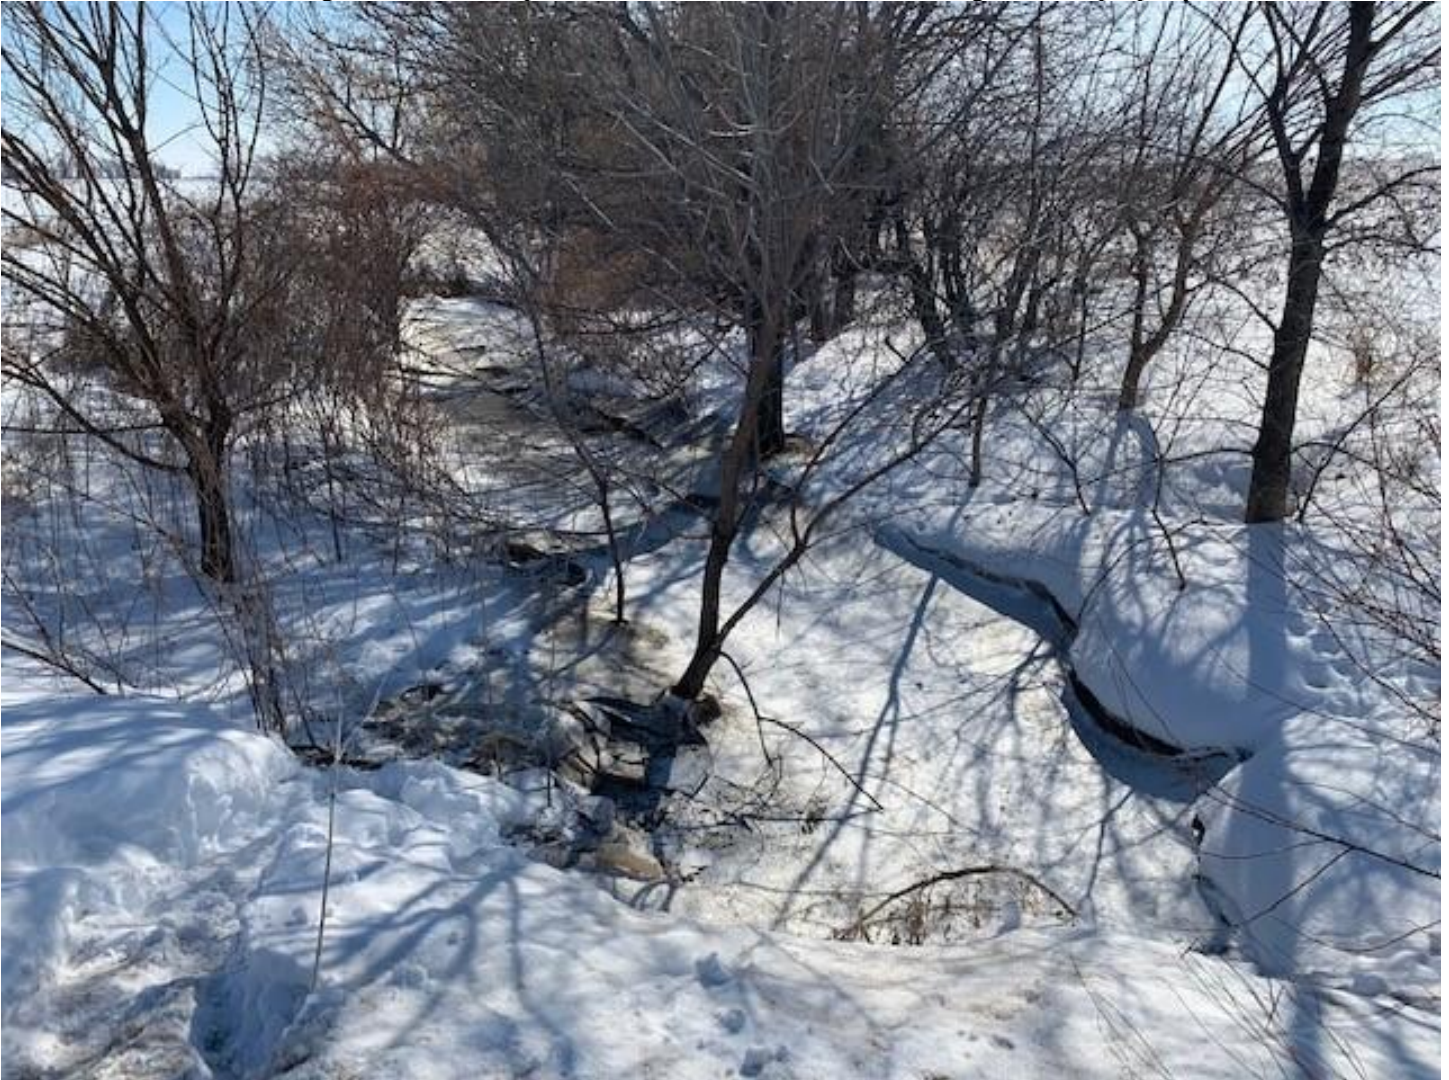
ATTACHMENT B

Downstream of road crossing near UNL dam site – 2/19/2021

Staining in ice and on top of ice south of dam and road crossing on UNL property.

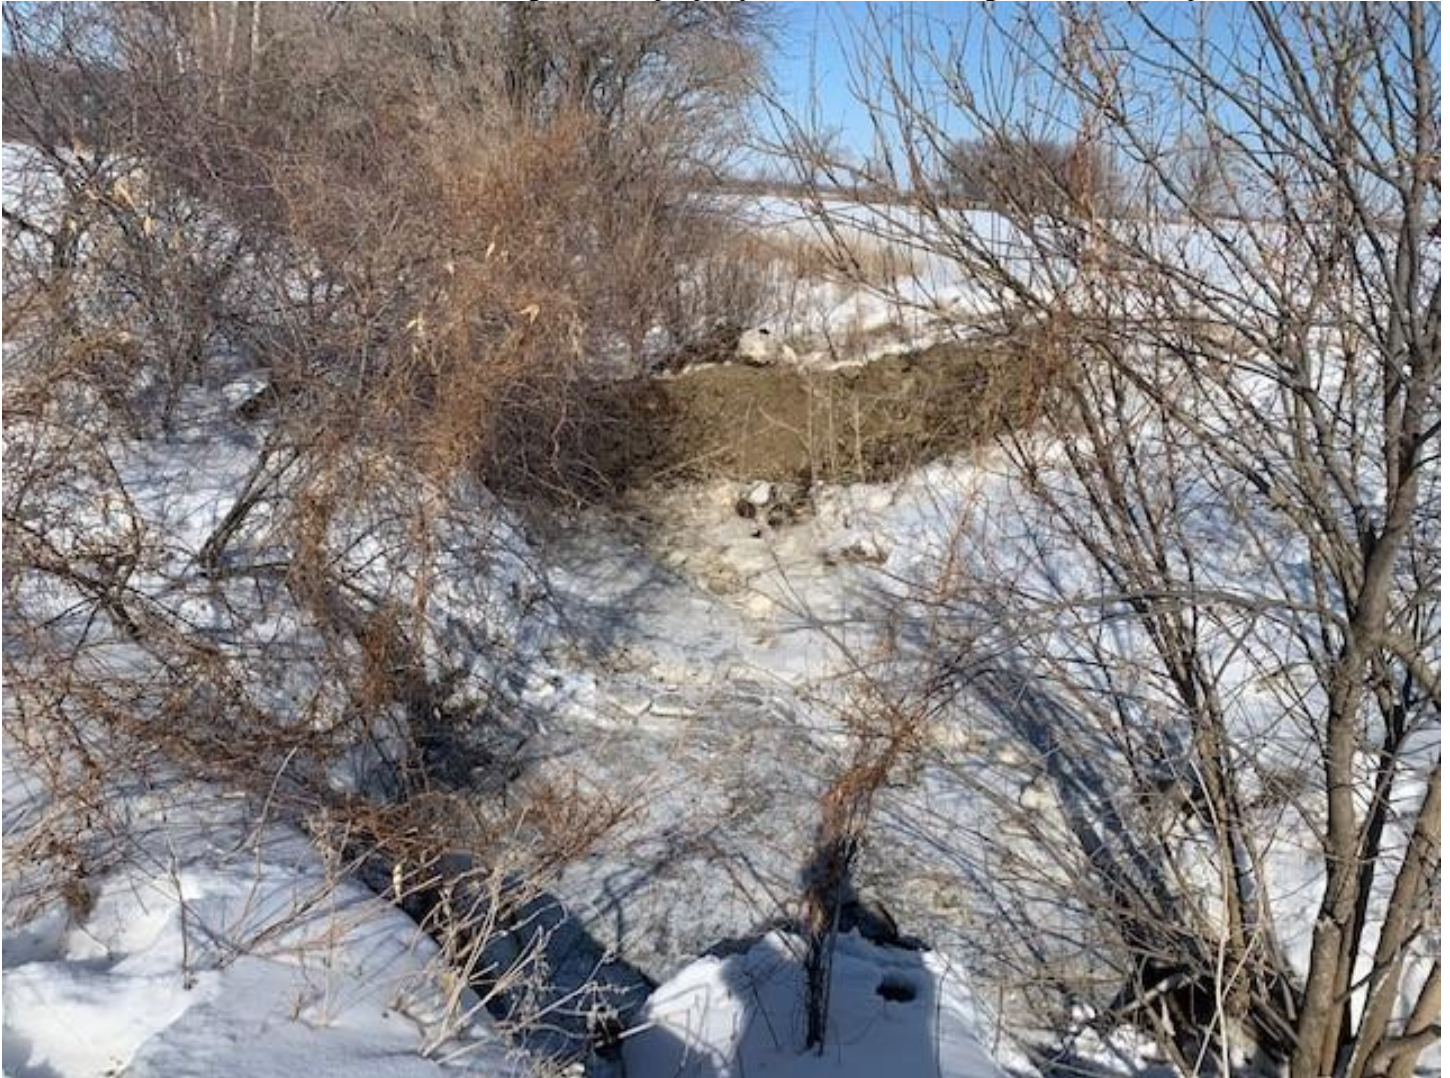
ATTACHMENT C

Dam built on UNL property – 2/19/2021

View of dam from road crossing on ULN property with visible staining in ice and on top of ice.

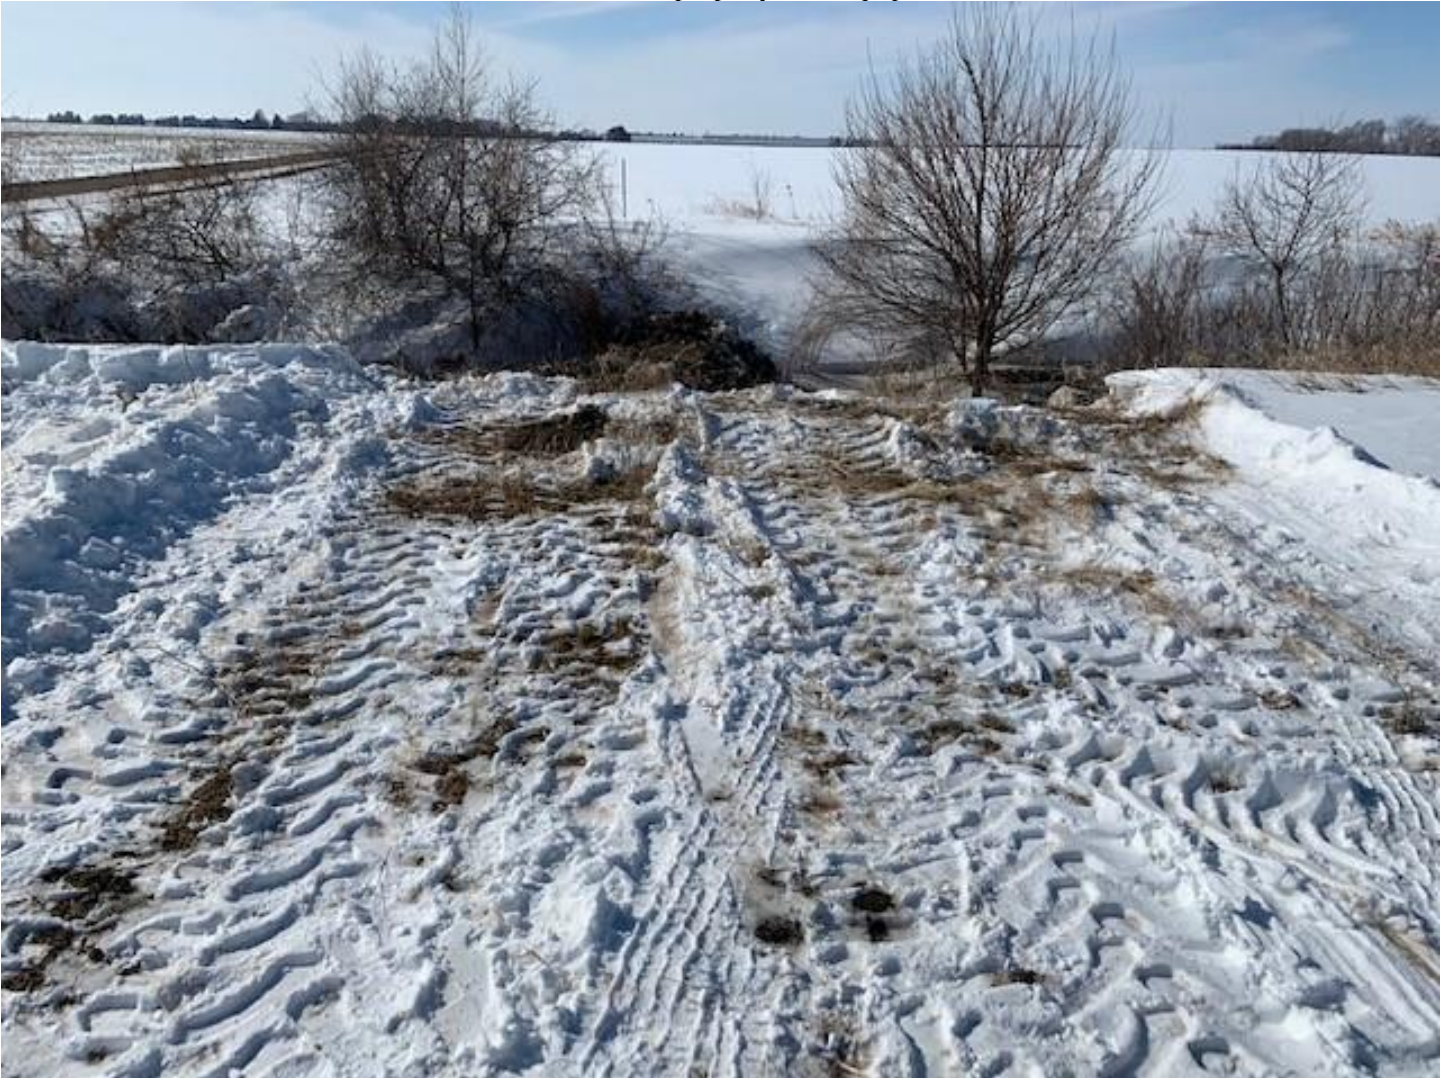
ATTACHMENT D

Dam built on UNL property – 2/19/2021

View of dam from the east on ULN property with equipment tracks in the snow.

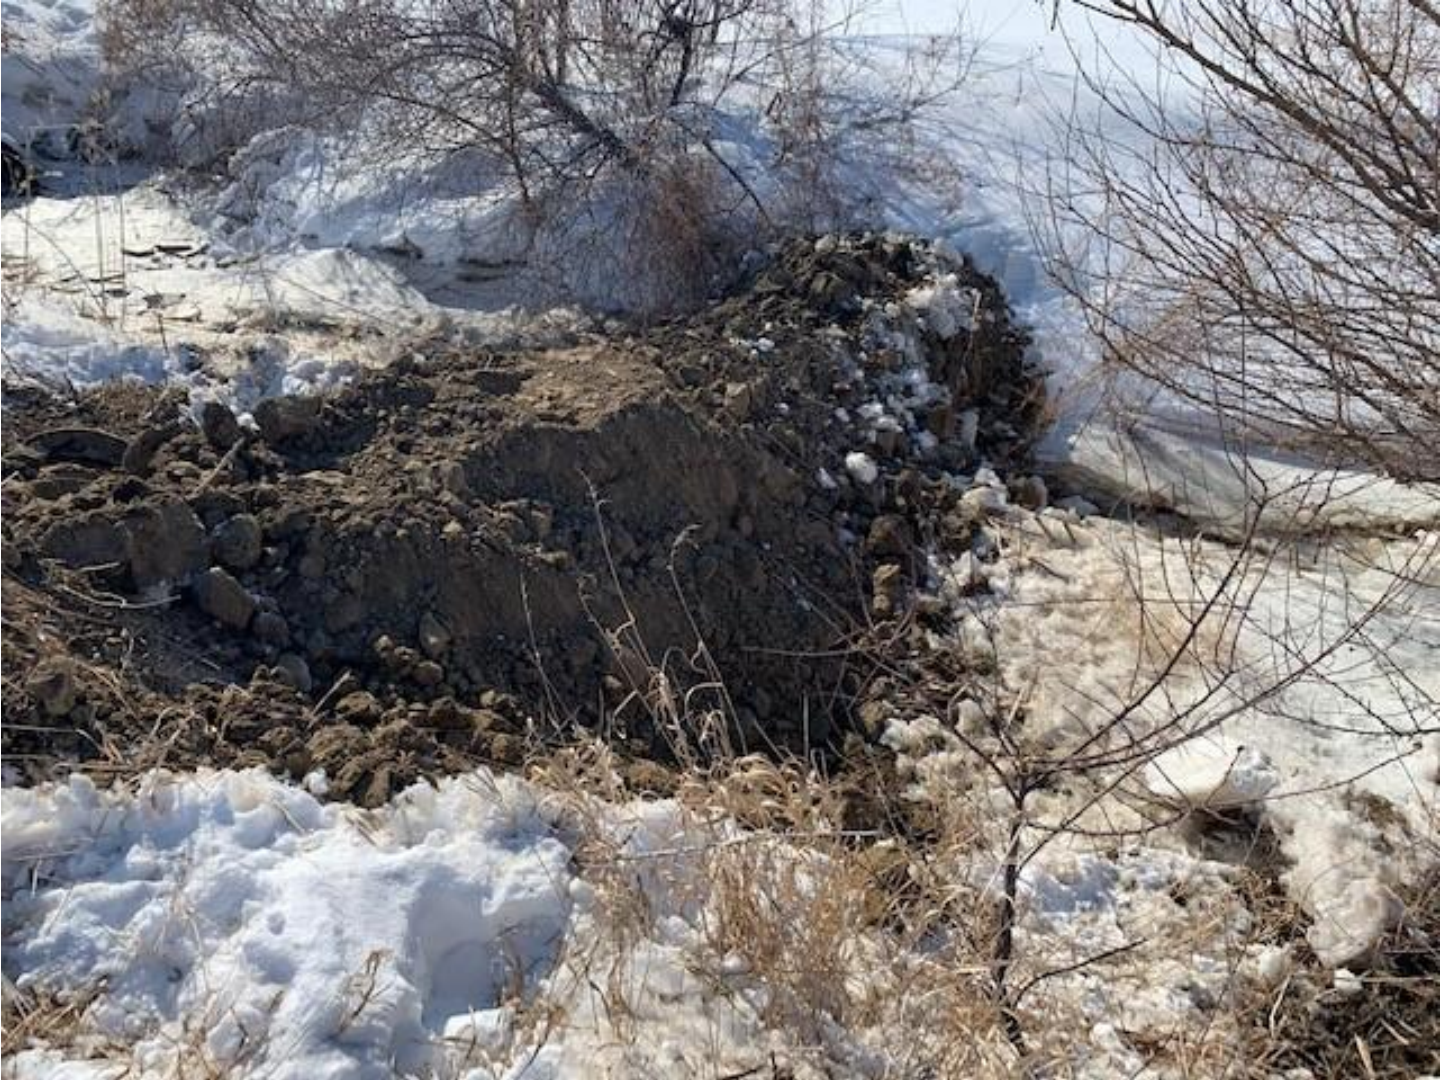
ATTACHMENT E

Dam built on UNL property – 2/19/2021

Upstream side of dam on ULN property with visible staining in ice and on top of ice. No sign of liquids flowing or backing up behind the dam were observed.

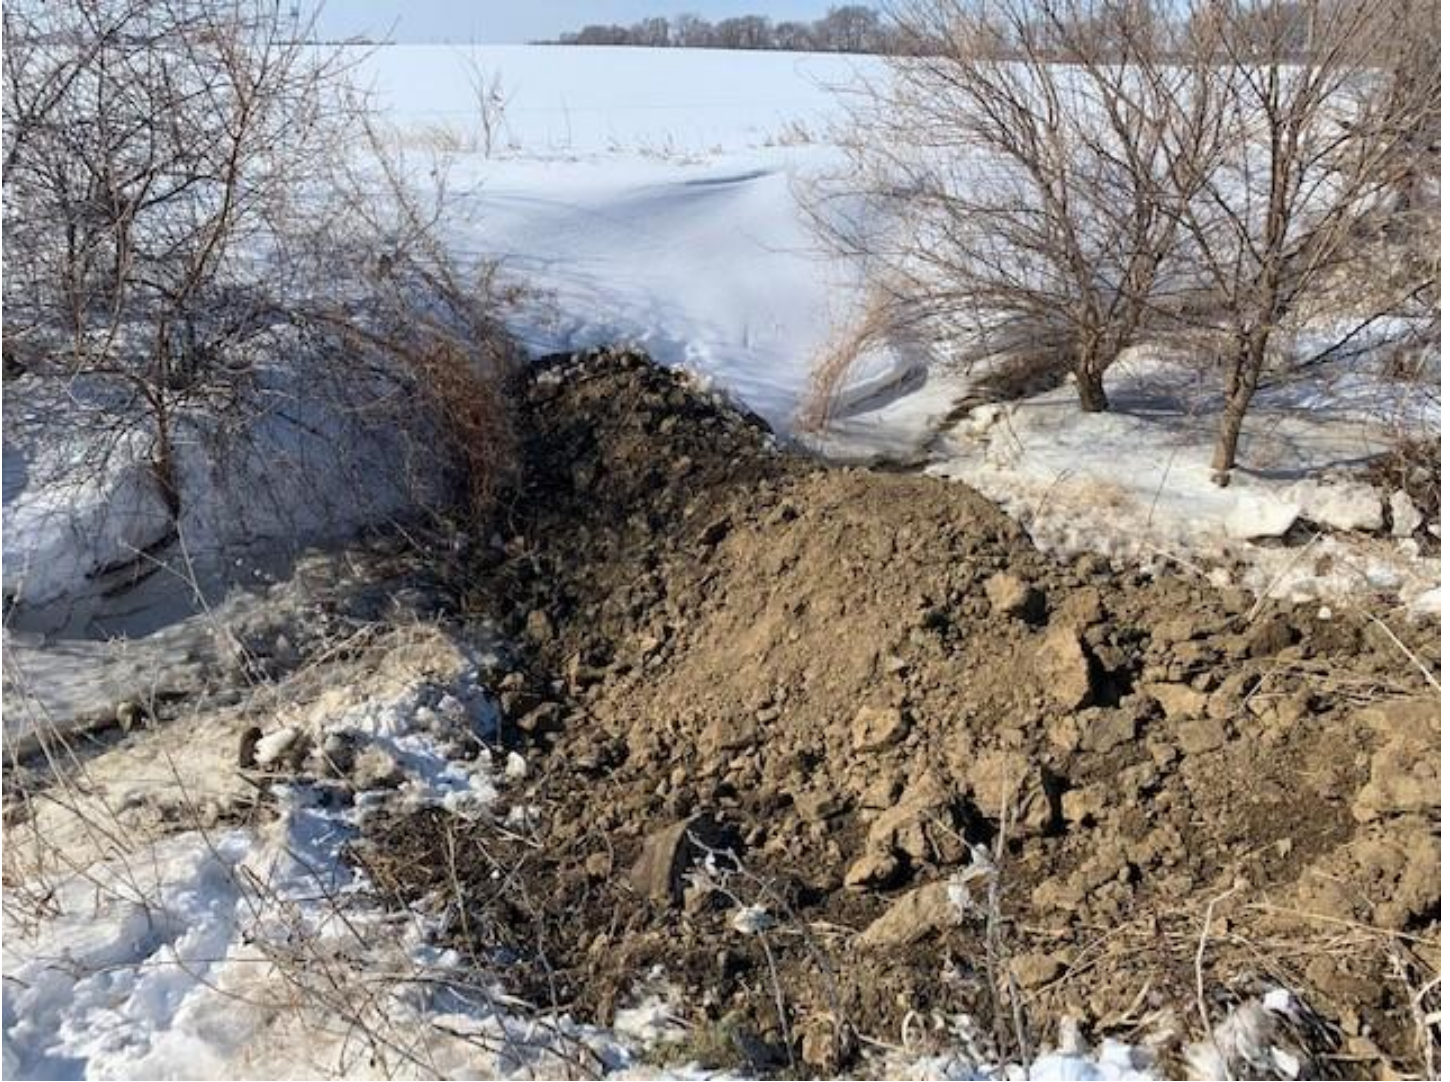
ATTACHMENT F

Dam built on UNL property – 2/19/2021

Downstream side of dam on ULN property with visible staining in ice and on top of ice. No signs of flowing liquids were observed below the dam.
