RE: ALT EN LLC  
MEAD, NEBRASKA

NDEE FAC ID: 84069

PROGRAM ID: 021221-NH-0845

**DATE: 2-22-21**

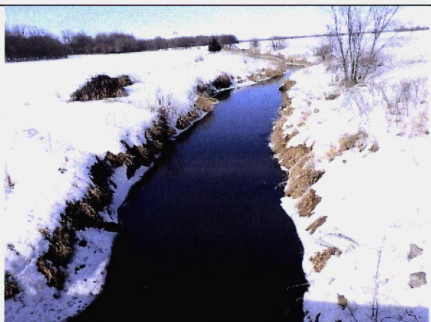
**STOP 1 – HIGHWAY 66 WEST of  
ASHLAND GUN CLUB**  
1425 Hours

Looking North. Open water, fairly clear. Can see creek bottom. Water was flowing slowly. No odor noted.

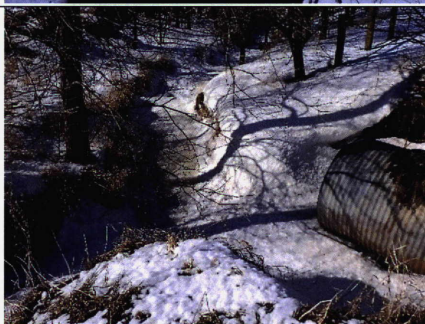
**STOP 2 – North of the Intersection of  
COUNTY ROADS 6 & F**  
1441 Hours

Looking west at creek and culvert. Creek is ice-covered. No open water.

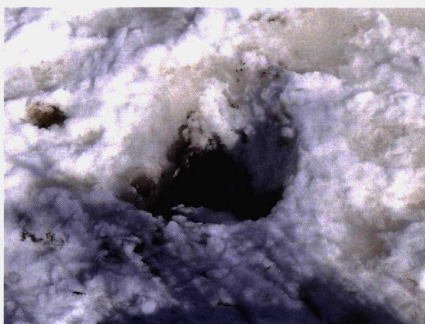
West side of culvert – hole chipped in the ice shows no sign of free liquid or water flow.

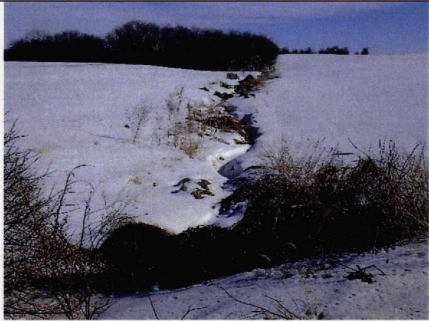
**STOP 2 – North (continued)**

Looking east – Creek is frozen over, no sign of flowing water.

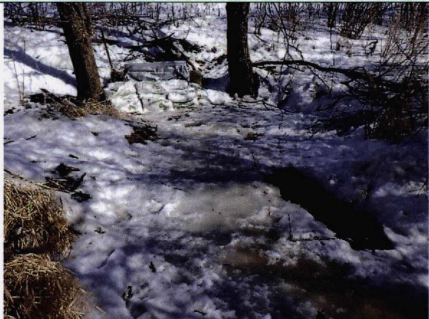
**STOP 3 – Road 7/Highway 66**

Photo taken on west side of culvert looking east. Holes cut in the ice have water in them. No obvious water flow. Water is a turbid brown in color. The culvert is blocked with sandbags and a tarp. Some liquid was on the surface of the ice, slightly brown in color.

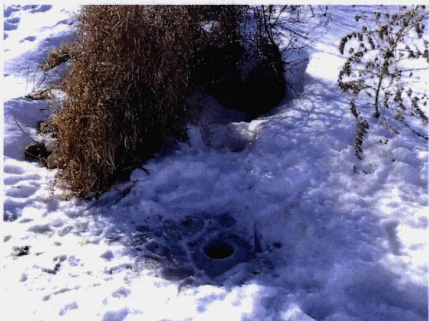
Photo shows the culvert on the east side of the road. A hole drilled in the ice contains a murky brown water. No obvious water flow.

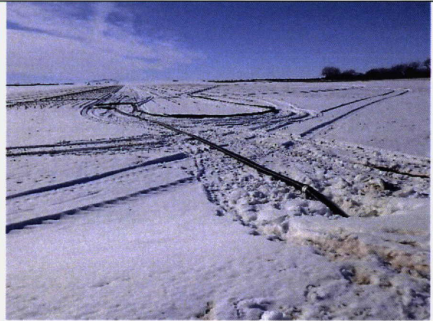
**STOP 4 – County Road 8, North of Road H**  
1515 Hours

Photo is looking east from a culvert just south of the creek. A hose had been laid out through the culvert under Road 8. No liquid was being pumped at the time of this observation.

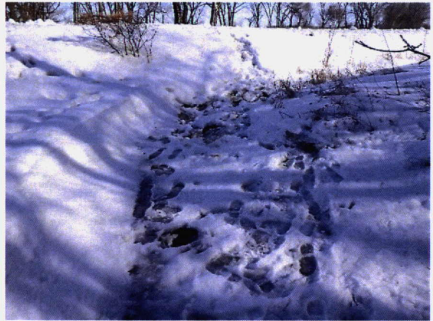
Photo was taken looking east at the culvert on the west side of Road 8. The creek is iced over. No open water is visible on the surface or in the hole drilled in the ice.

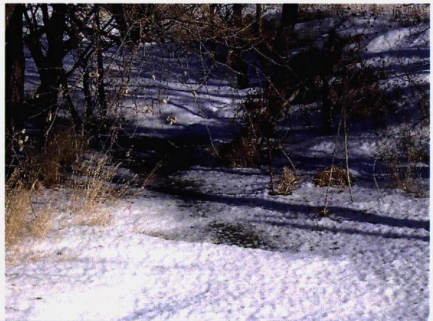
Photo is looking east on the east side of Road 8. Some water is sitting on top of the ice. No obvious discoloration in the water.

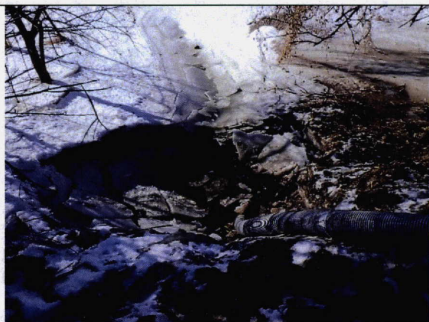
**STOP 5 – UN-L Eastern Extension – North  
of County Roads 9 & J**

Photo taken looking at the west side of Road 9 just before the culvert. A PTO-driven pump and hose was actively pumping water from this location during my observation. Slightly turbid water was flowing into this ponded area from the west under the ice.

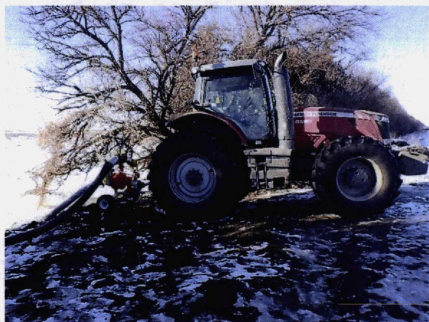
Photo shows the tractor and the PTO-driven pump being used to pump water from the creek. Brian Jacob of Lagoon Pumping & Dredging was on-site at the time of my observation.

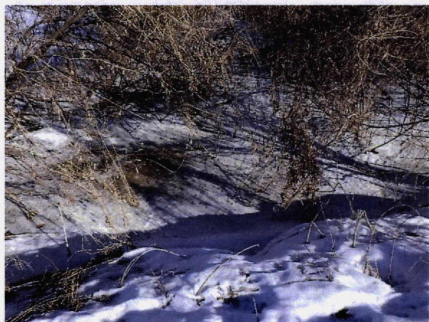
Photo shows the creek on the east side of Road 9. There was no visible water and the creek was ice covered.

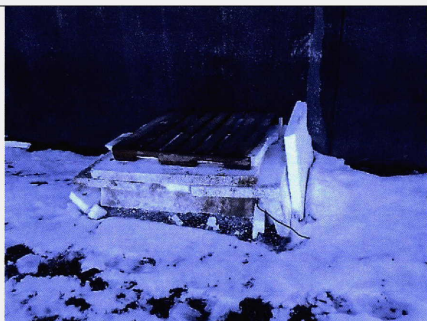
**STOP 6 – ALTEN LLC FACILITY****DIGESTERS**

I was accompanied by Ken Peterson. This photo shows the drain on the north digester. The drain has been covered, insulated, and has a heat lamp inside according to Mr. Peterson. No contents have been drained from the north digester yet.

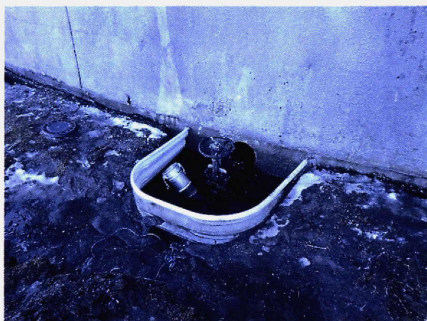
Photo shows the south digester drain that failed.

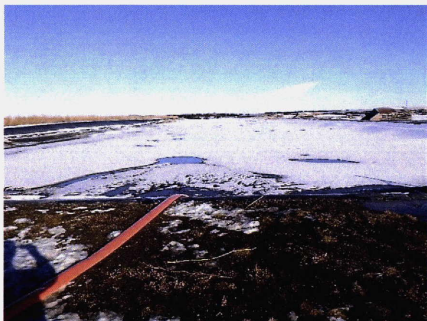
Photo shows the emergency lagoon looking east. Mr. Peterson said they had stopped pumping liquid from this lagoon to the main lagoons. He said the liquid being pumped from Stop 5 was being pumped into the main lagoons, not the emergency lagoon as of the date and time of my observation.
