PCS 84069

AltEn Field Observations.

February 27, 2021

NDEE

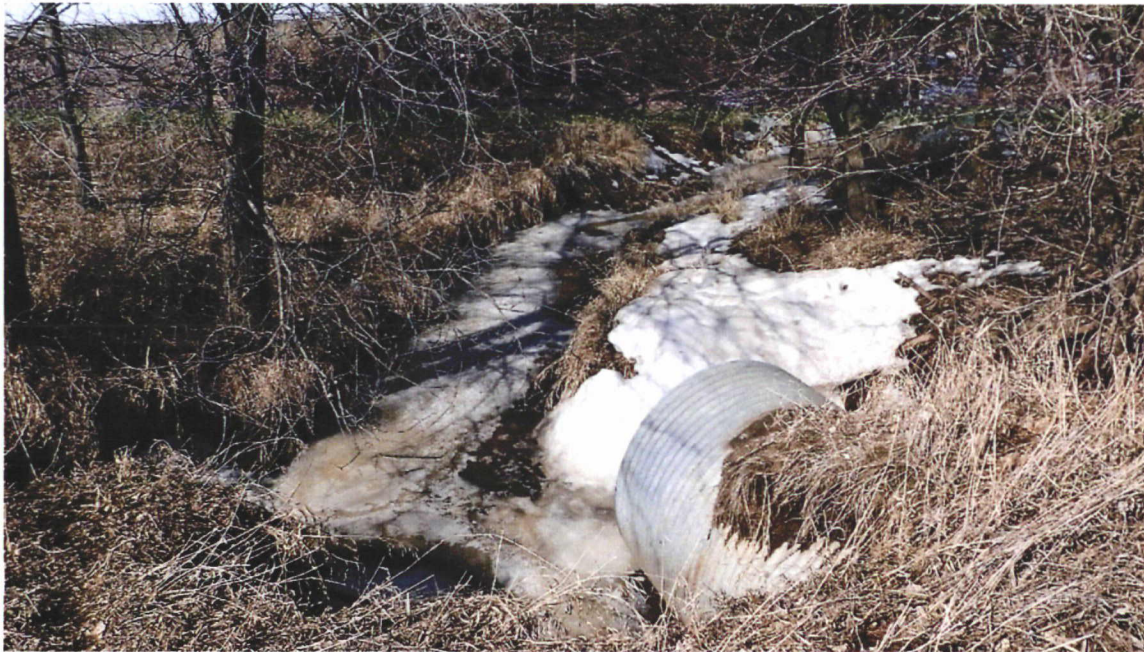
Site 2, west side of county road, facing west. Approximately 95 percent frozen with some free water over surface of ice and some ice-free areas along bank. One sample collected here for HHS Laboratory analysis with an additional pesticide sample. Water temperature: 0.2 degrees C, Dissolved oxygen: 5.6 mg/l, pH: 8.0 St.Units, Conductivity: 2,134 Umhos/cm, Turbidity: 91.7 NTU's, Dissolved oxygen (percent saturation) 40 percent. Air temperature: 45 degrees F, clear, calm.

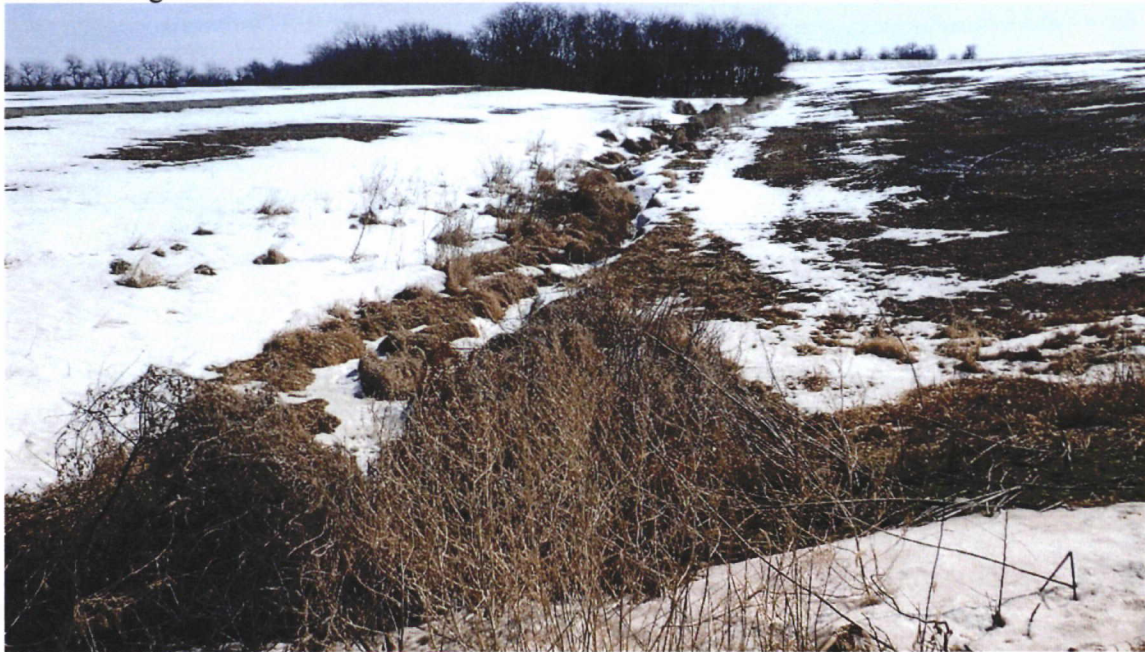
Site 2 facing east. 100 % ice and snow-covered.

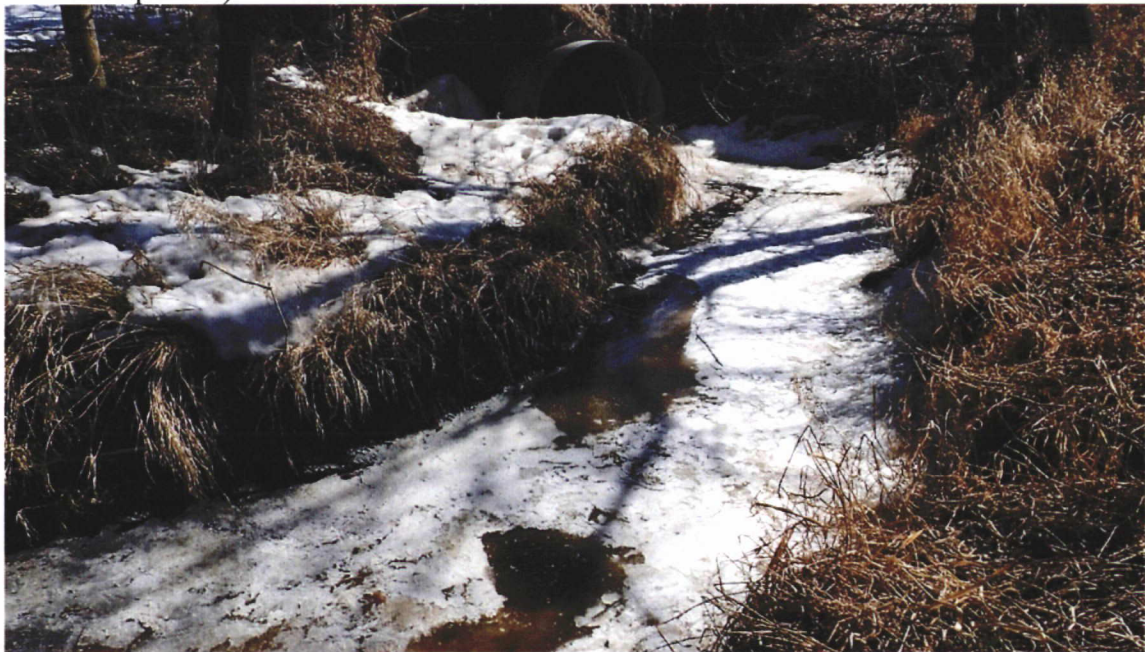
Site 2, west side of the county road facing east. Sample site in the foreground (bottom-middle of picture).

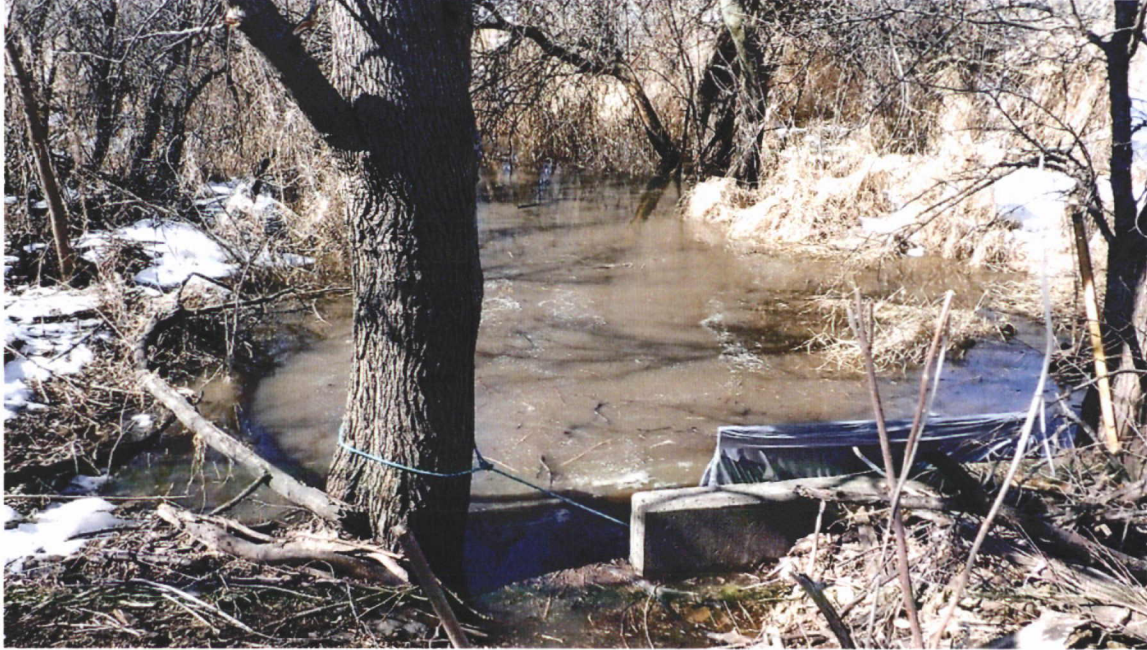
Site 3, west side of Hwy 66, facing west. No ice and pooled above culvert. One sample collected here for HHS Laboratory analysis with an additional pesticide sample. Water temperature: 1.0 degrees C, Dissolved oxygen: 1.5 mg/l, pH: 8.0 St.Units, Conductivity: 1,699 Umhos/cm, Turbidity: 98.5 NTU's, Dissolved oxygen (percent saturation) 10 percent. Air temperature: 45 degrees F, clear, calm.

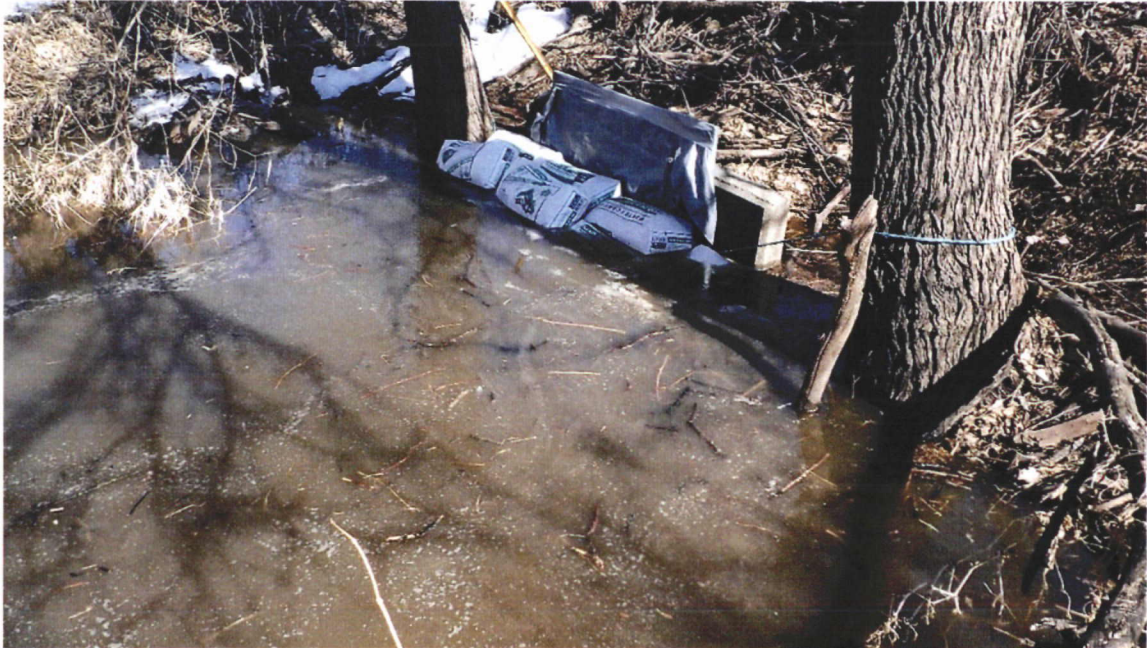
Site 3, west side of Hwy 66, facing northeast. Note water level in comparison to culvert. Water can be heard leaking from the behind the sandbags.

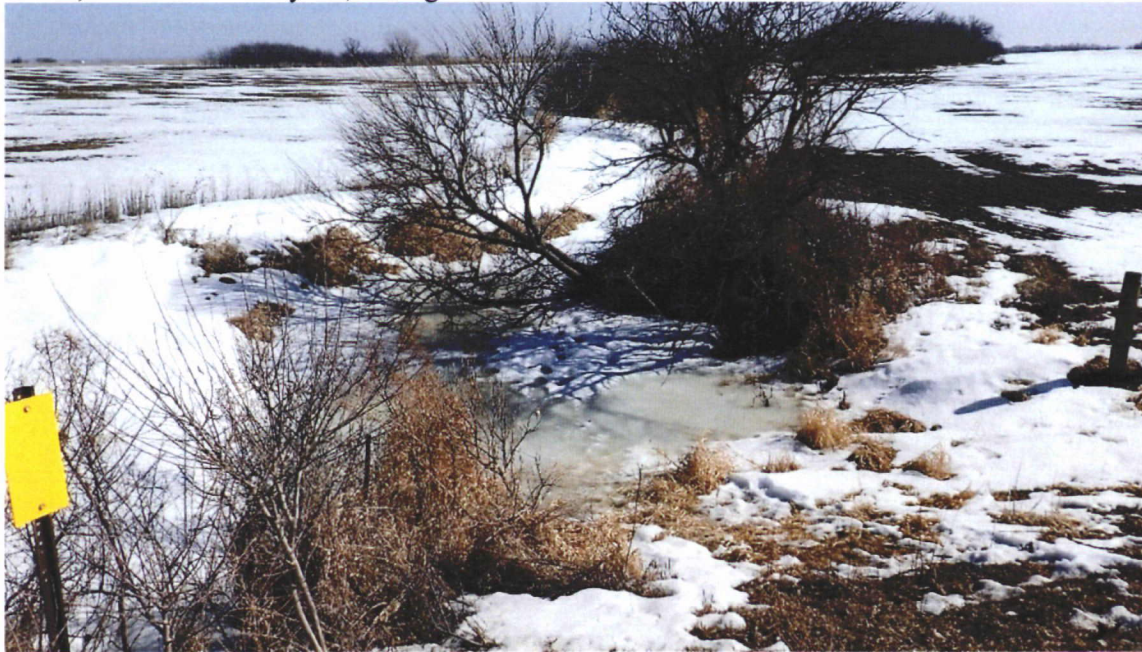
Site 3, east side of Hwy 66, facing east. 100% frozen and snow-covered.

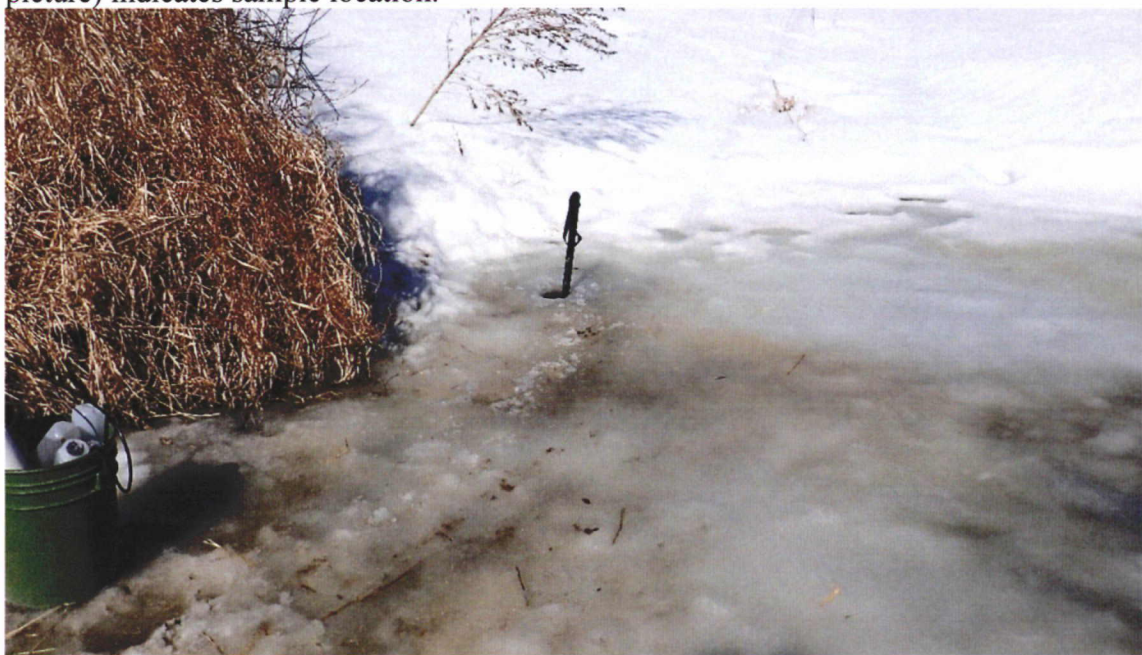
Site 3, east side of Hwy 66, facing north/northeast. One sample collected here for HHS Laboratory analysis with an additional pesticide sample. Water temperature: 0.9 degrees C, Dissolved oxygen: 0.5 mg/l, pH: 7.7 St.Units, Conductivity: 8,950 Umhos/cm, Turbidity: 384 NTU's, Dissolved oxygen (percent saturation) 3 percent. Air temperature: 45 degrees F, clear, calm. Ice is 3-4 inches thick. Ice chisel (black handle, middle of picture) indicates sample location.

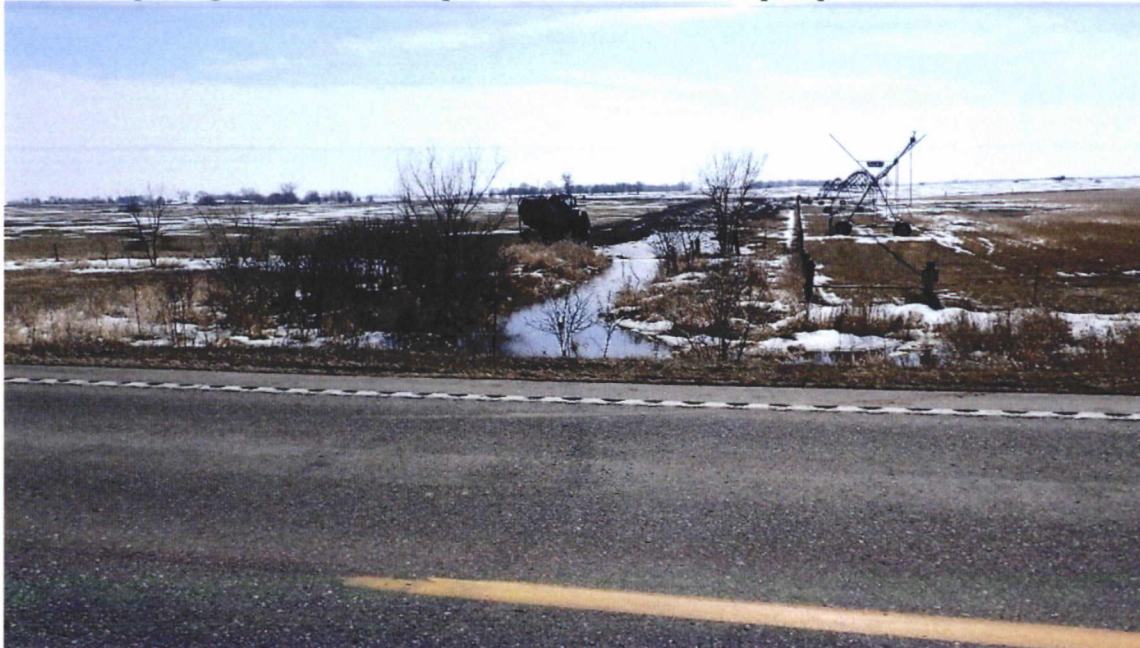
Between Sites 3 and 4 facing south from Hwy 66. Much of stream has been dredged. Tractor is pulling trailer with collapsible hose to be used to pump contents of stream.

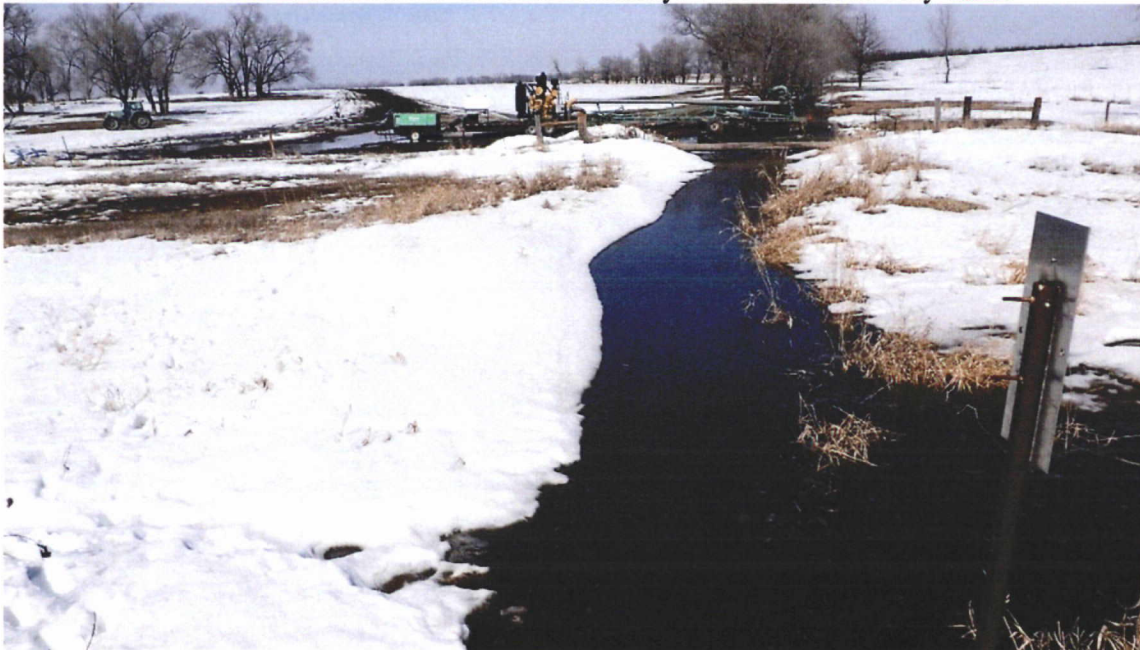
Same site as above but facing north. Pump being used to pump some of stream's contents back towards the north/northeast to the AltEn facility. Water color is very dark.

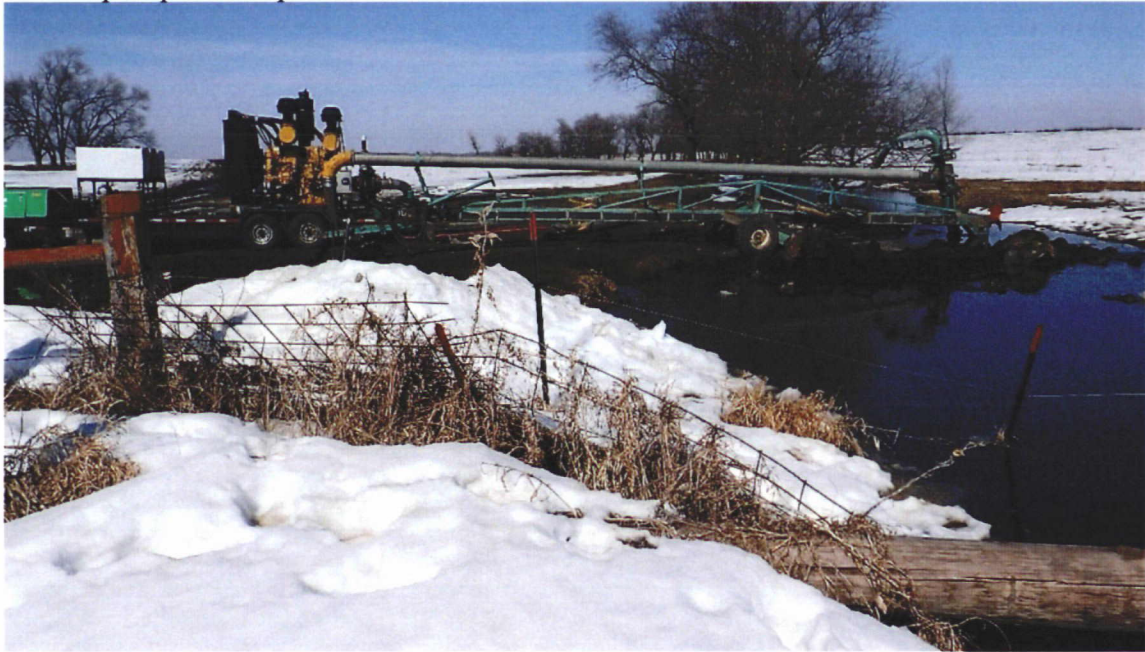
Close-up of previous photo.

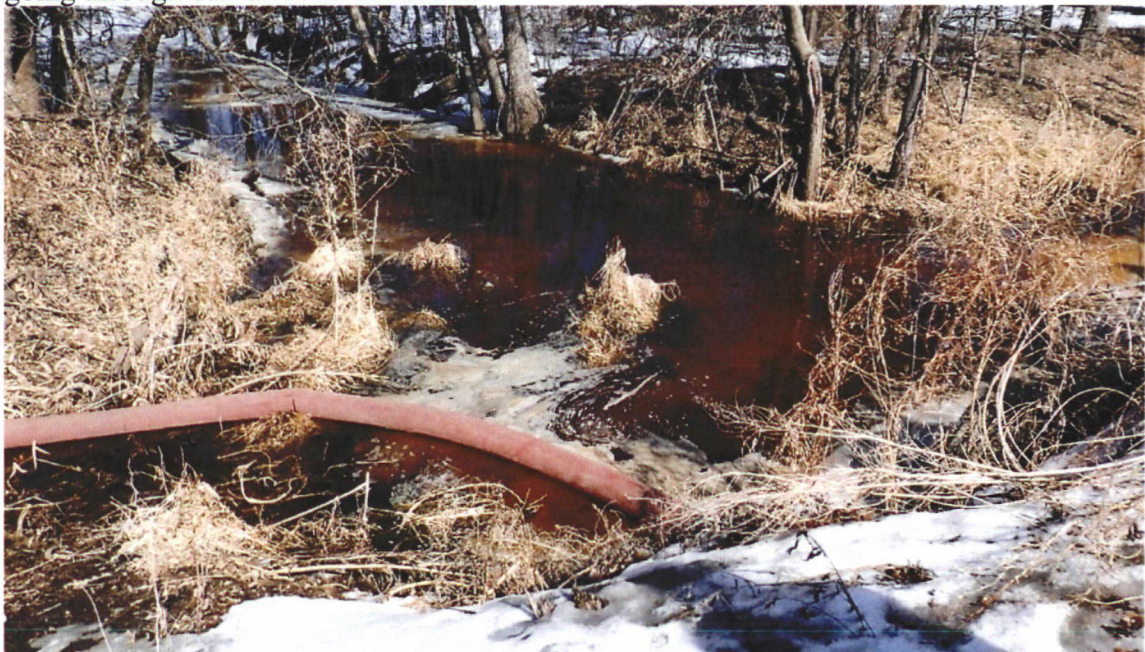
Facing north/northeast on Avenue H, approximately 1/3 mile east of Road 8. Between previous picture site and Site 4. Water has an orange, or tannic stain appearance to it. Clean Harbors truck was at this location. Reddish/orange tube, lower part of picture, going through culvert from the south.

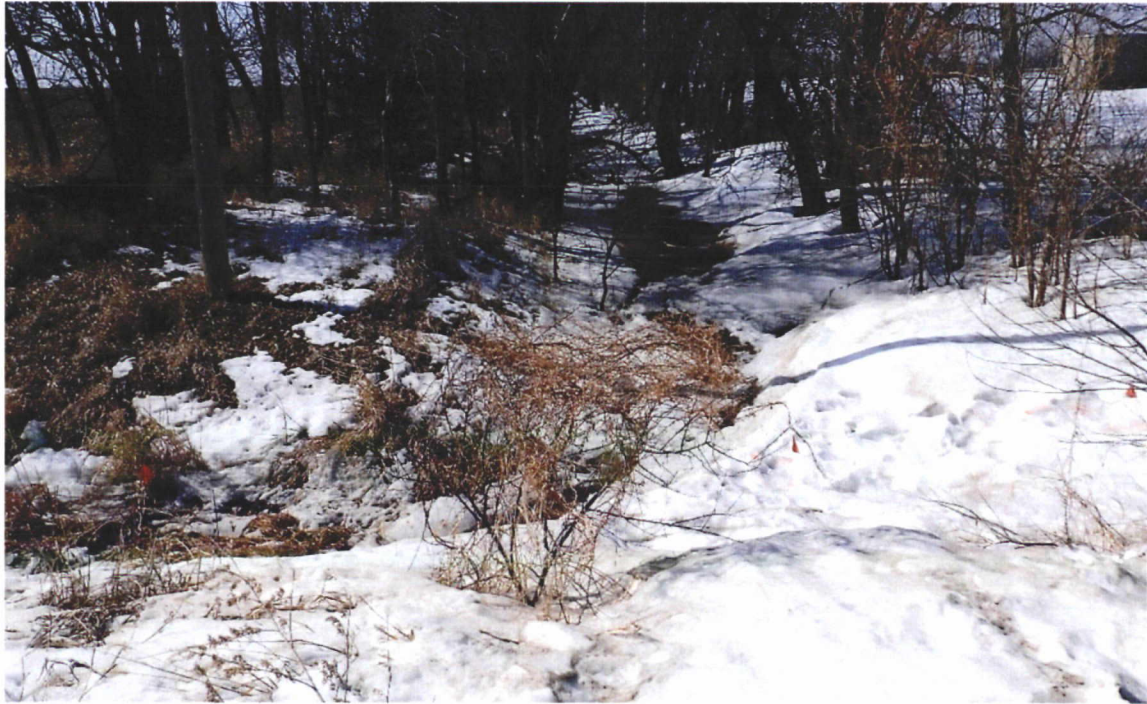
Site 4 facing west. Approximately 80 percent frozen with water flowing over ice. Dark-colored water.

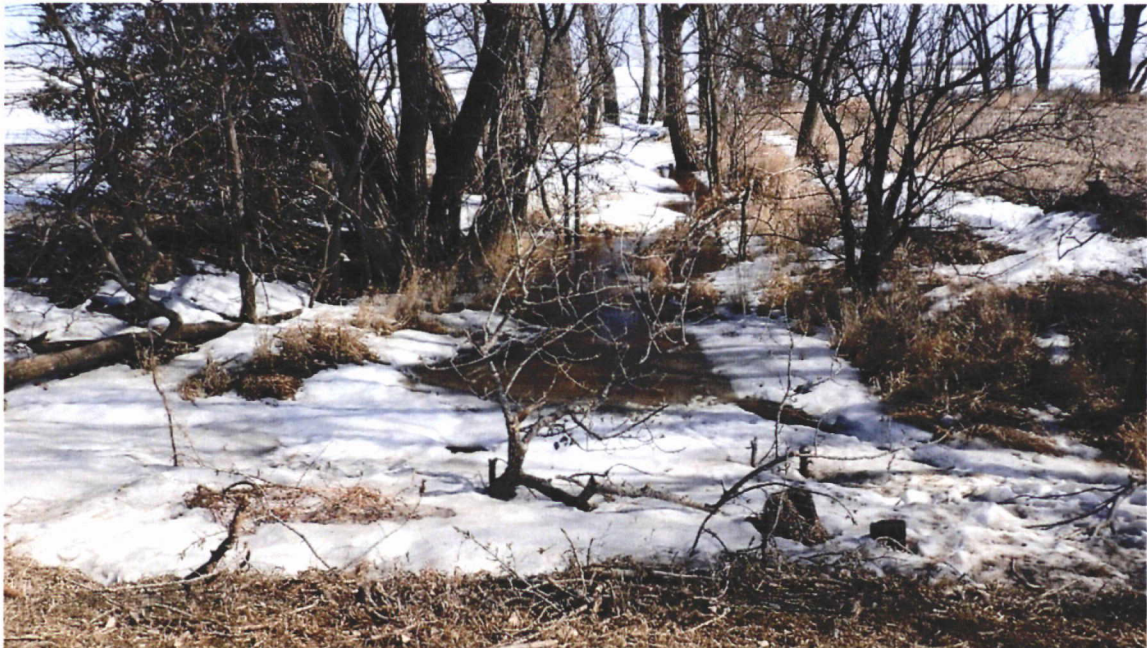
Site 4 facing east. Stream has some open water with much subsurface ice.

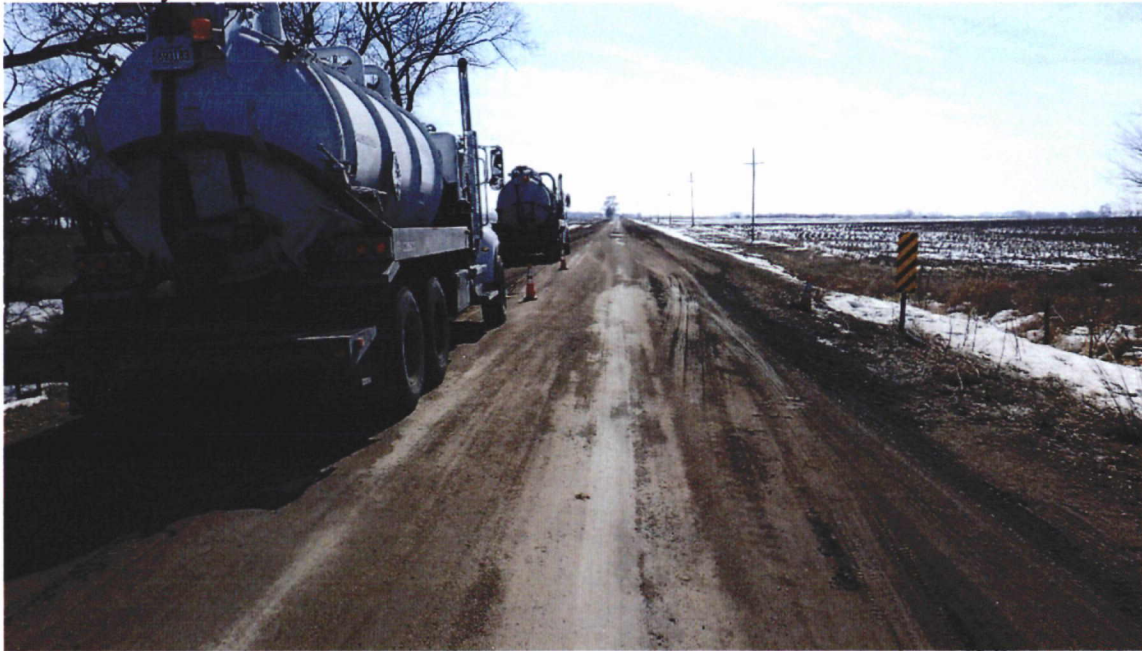
Two trucks from Clean Harbors ready to pump water from the stream at Site 4 however, at the time of this picture, the operators were waiting for instructions as the lagoons at the AltEn facility were full.

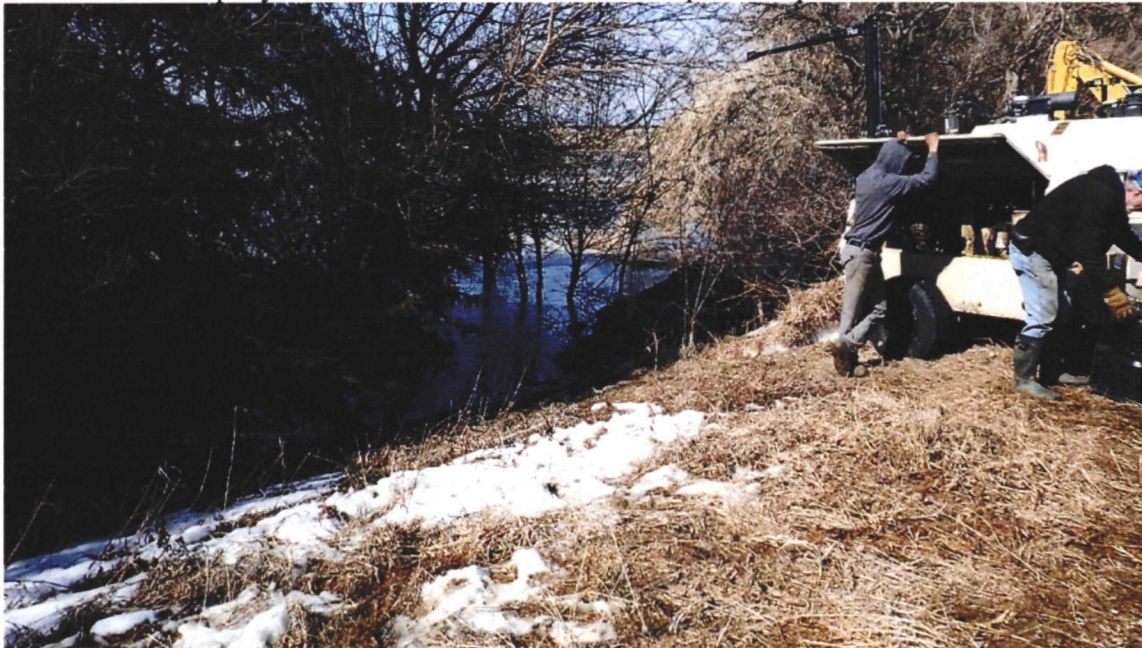
Site 5, facing northwest. Tractor and PTO set up at this location by Lagoon Pumping and Excavation Company. Area to the west of this site is pooled up.

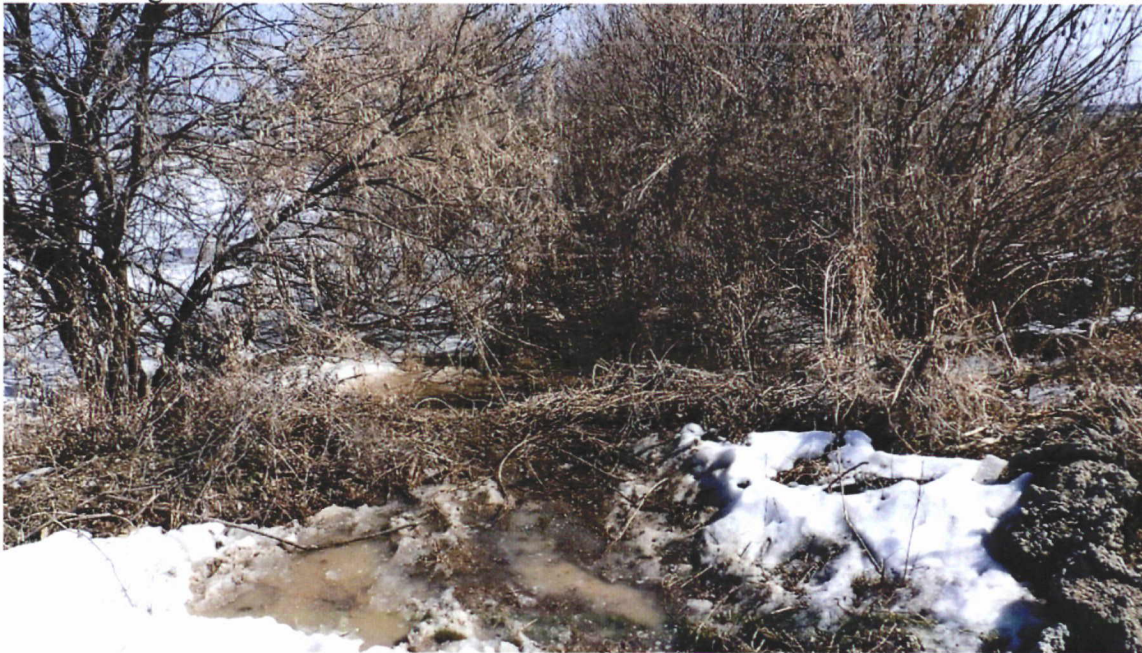
Site 5 facing east.

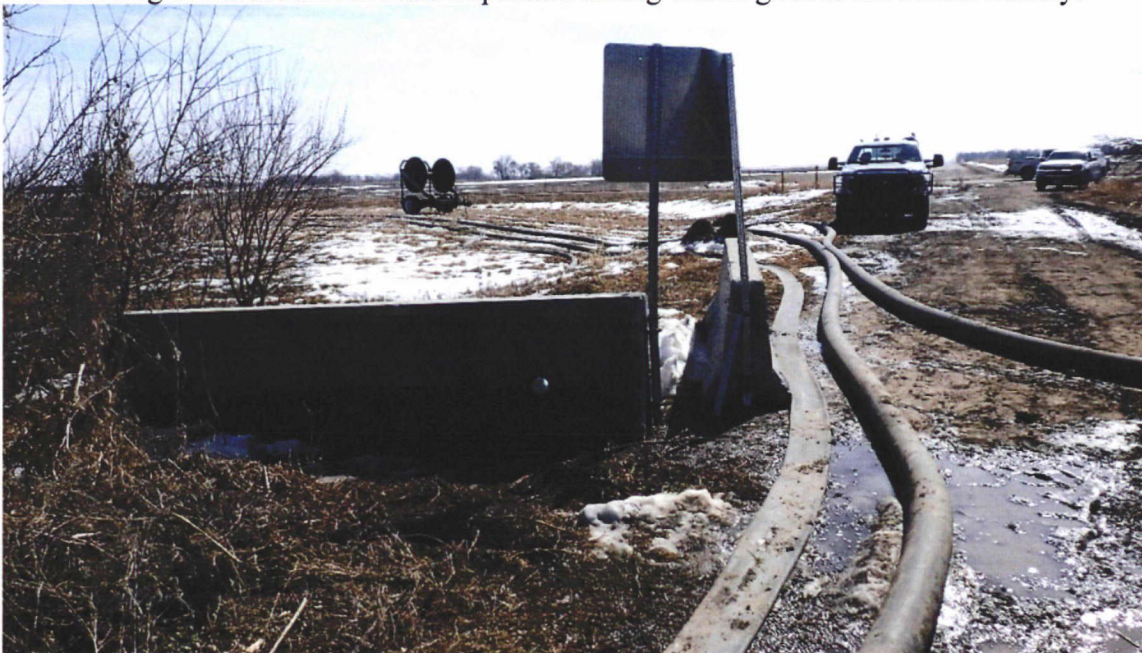
Site 5 facing south/southeast. Note expanded tubing which goes to the AltEn facility.

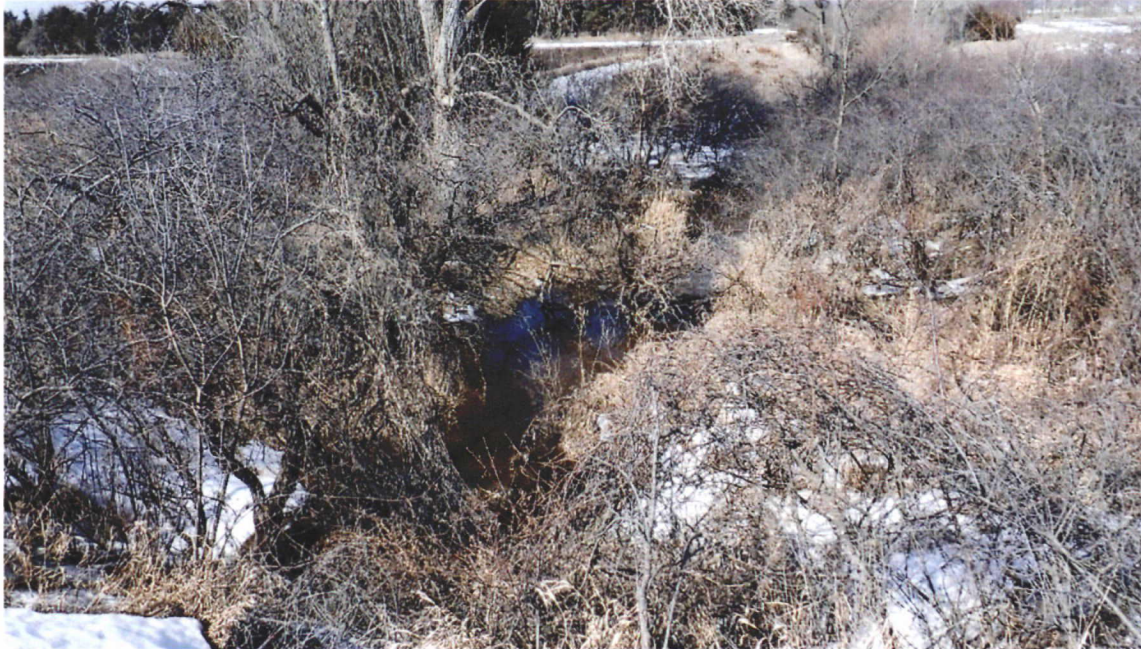
Unnamed tributary to Silver Creek facing north from Hwy 66 approximately 1/10 mile west of Road 10. One sample collected here for HHS Laboratory analysis with an additional pesticide sample. Sample site is on the west side of the stream approximately 20 feet upstream from the outfall structure. Air temperature was 45 degrees F, 50% cloud cover and an east/southeast wind at 15 to 20 mph. I met James Koehler, Environmental Technician with Terracon, at this location.
