AltEn Field Observations.

February 24, 2021

Dave Bubb

NDEE

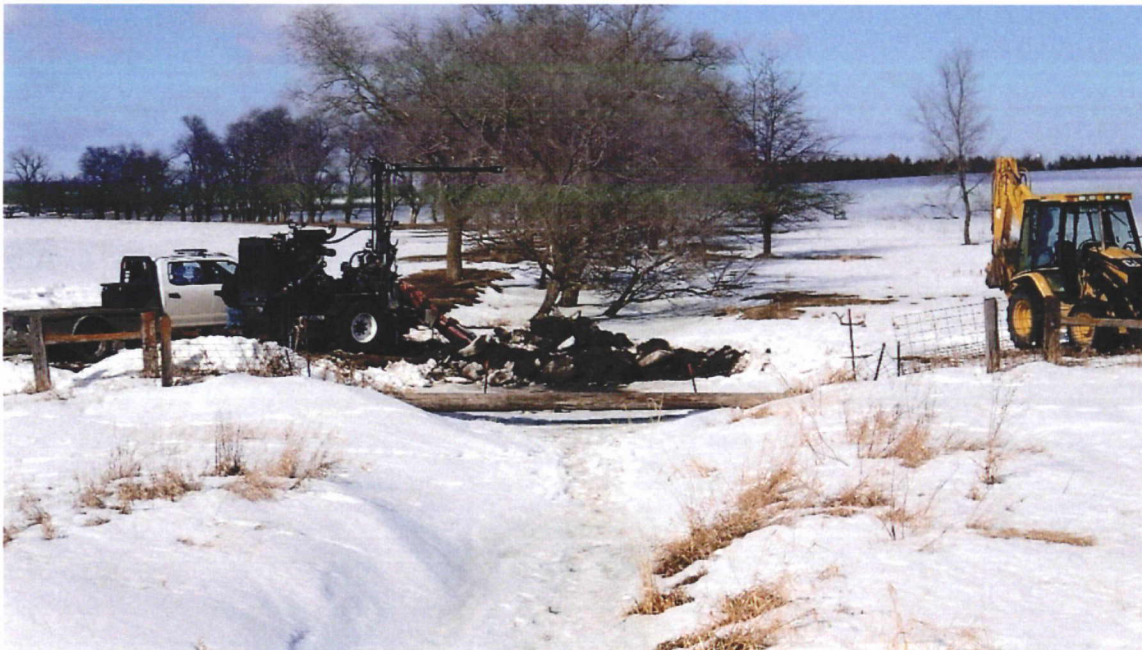
Looking north from Highway 66 northwest of Site 3. Lagoon Pumping and Excavating Company pumping fluid from ditch.

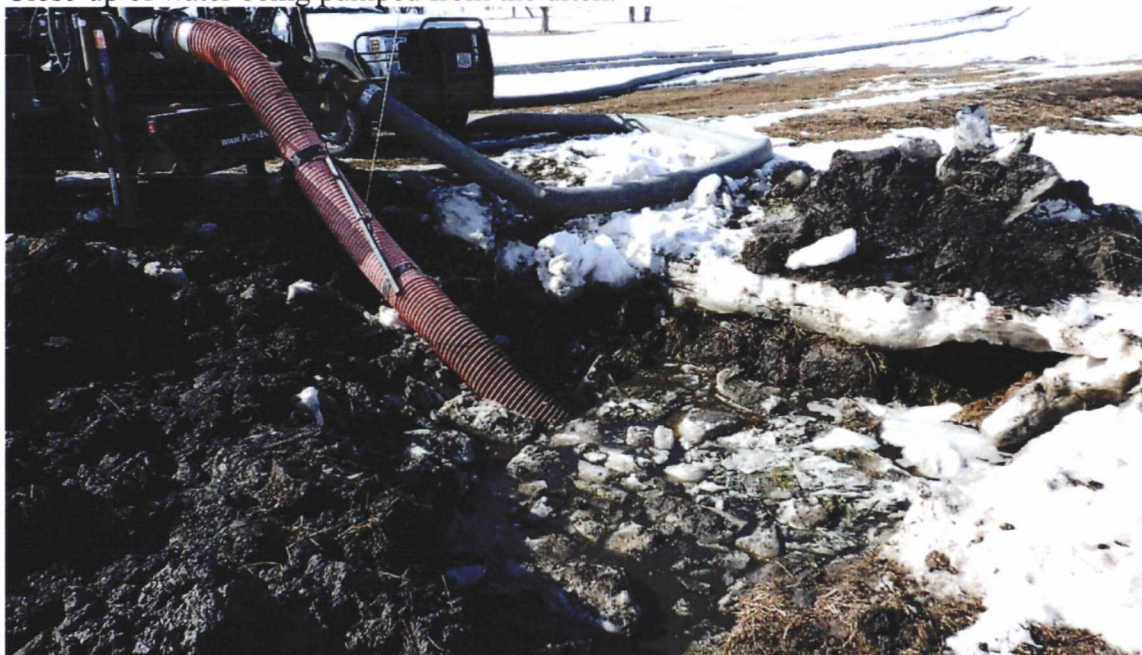
Close-up of water being pumped from the ditch.

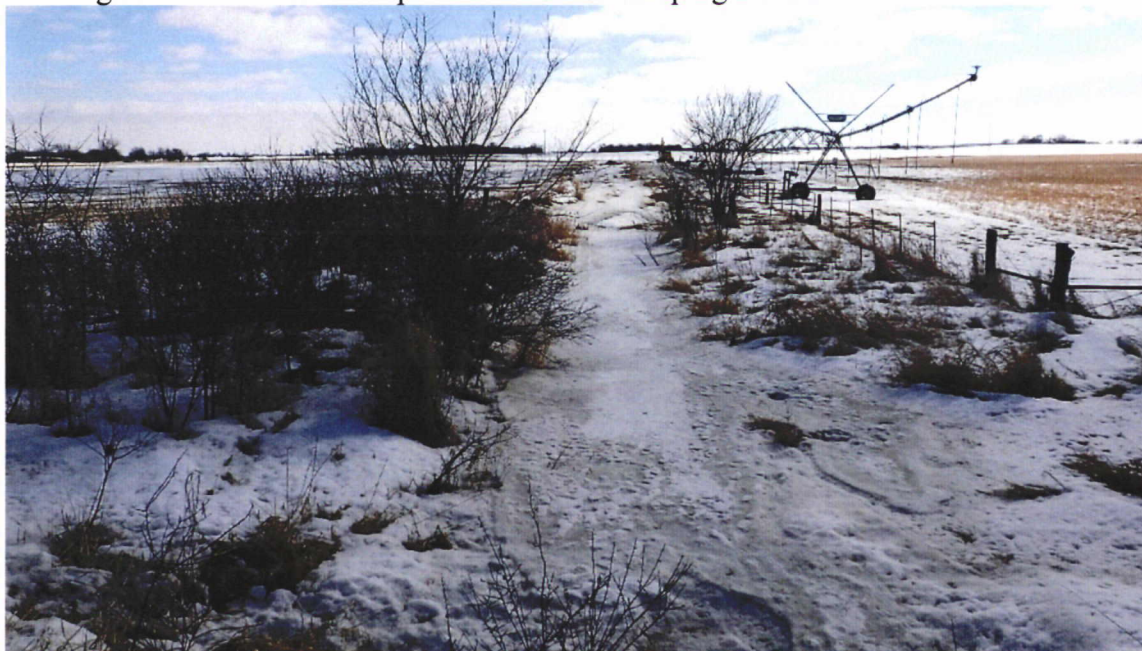
Looking south from the above picture. Backhoe scraping the ditch.

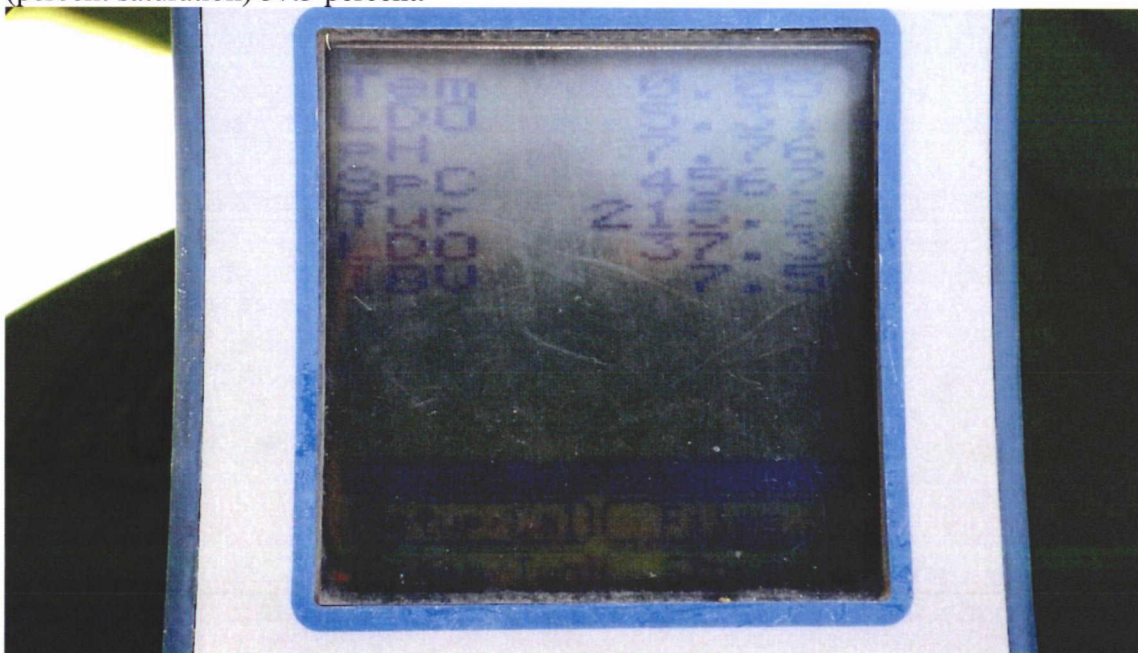
Water quality meter determining field parameters at Site 2. Water was melting on top of the ice. Water Temperature: 0.05 degrees C, Dissolved oxygen: 5.31 mg/l, pH: 7.76 St.Units, Conductivity: 4,567 Umhos/cm, Turbidity: 215.6 NTU's, Dissolved oxygen (percent saturation) 37.3 percent.

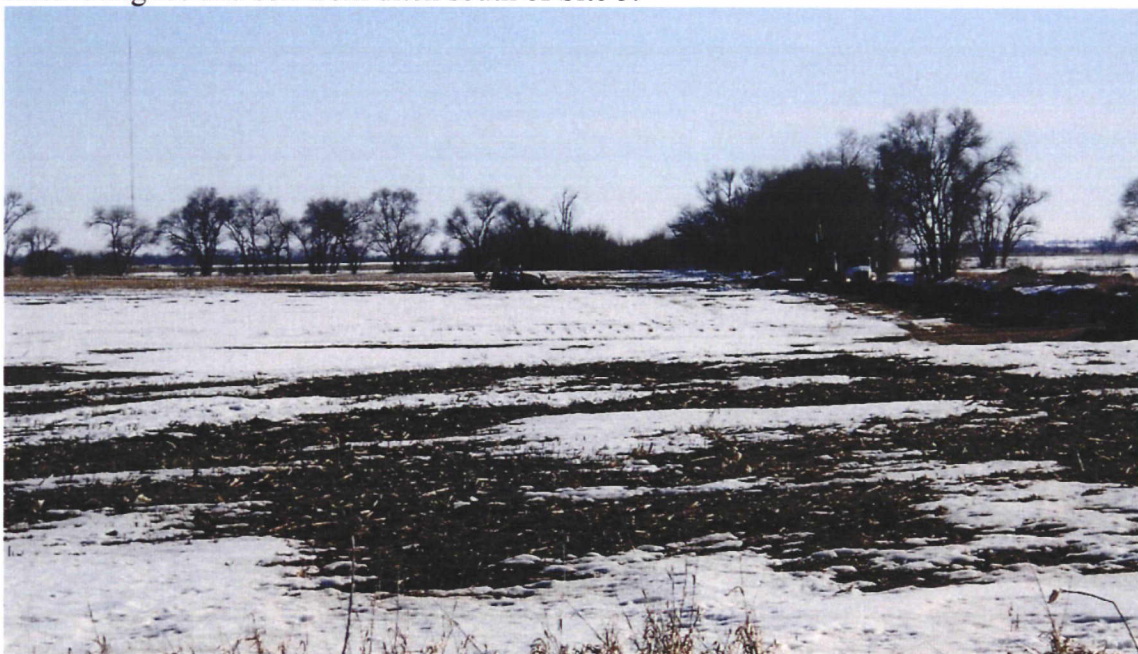
Excavating ice and soil from ditch south of Site 5.

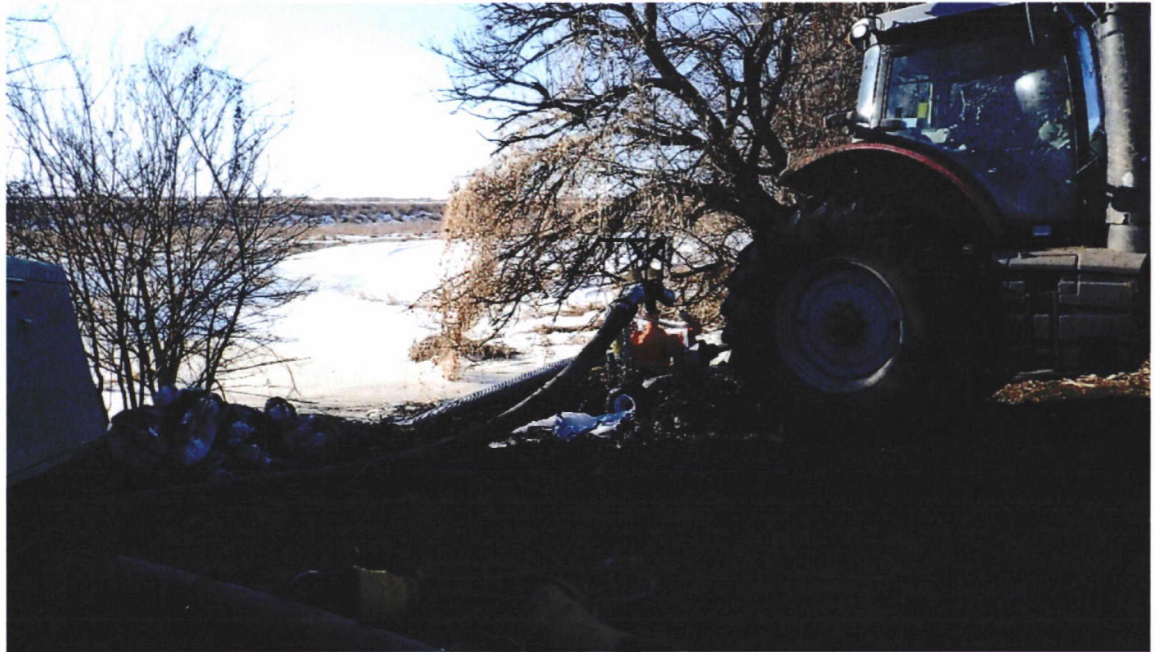
PTO from tractor at Site 5.

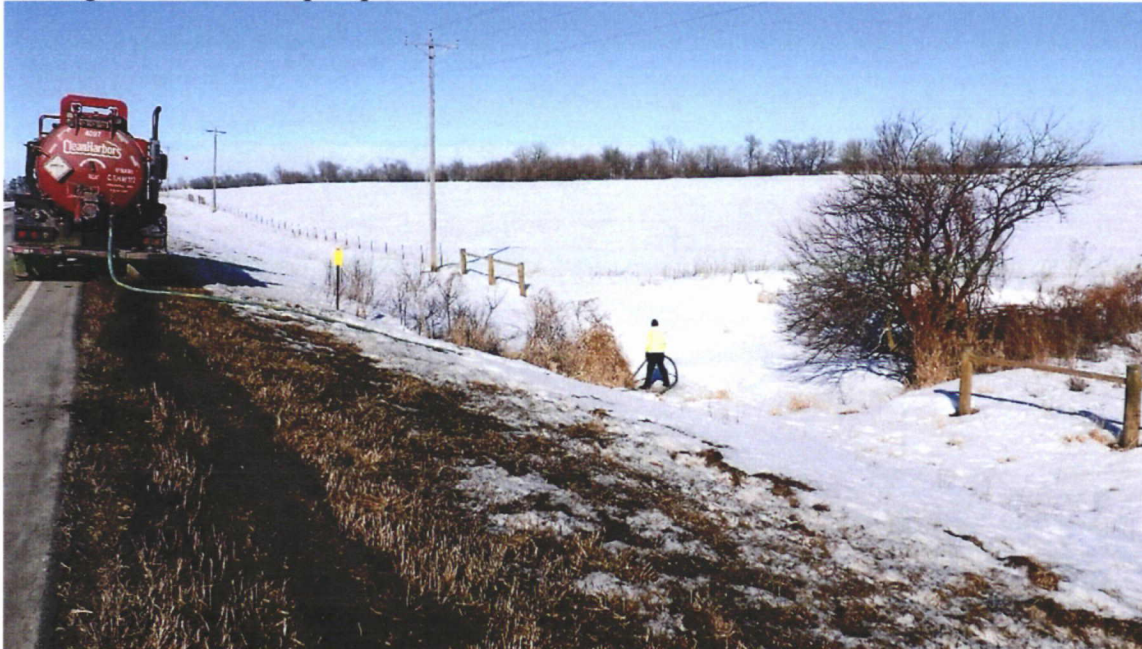
Site 3, east side of Highway 66. Pumping waste from stream. As of 1630 approximately 7,500 gallons had been pumped from stream.

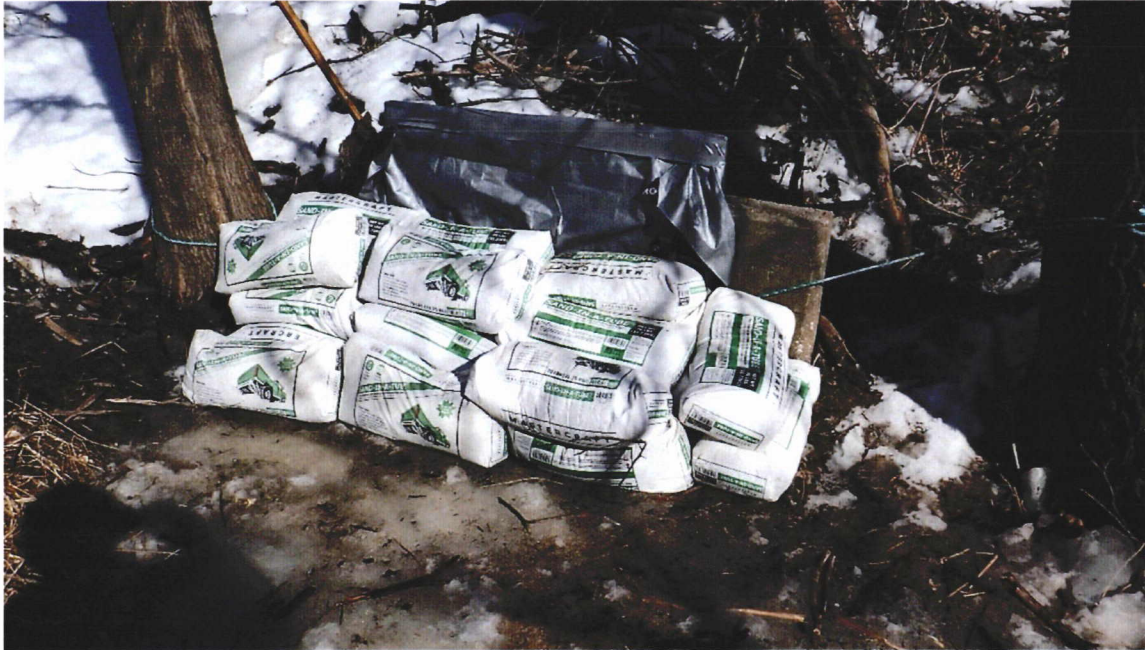
Site 3, west side of Highway 66. Sandbags and tarp-covered plywood blocking the culvert. There is also an inflated packer in the culvert.

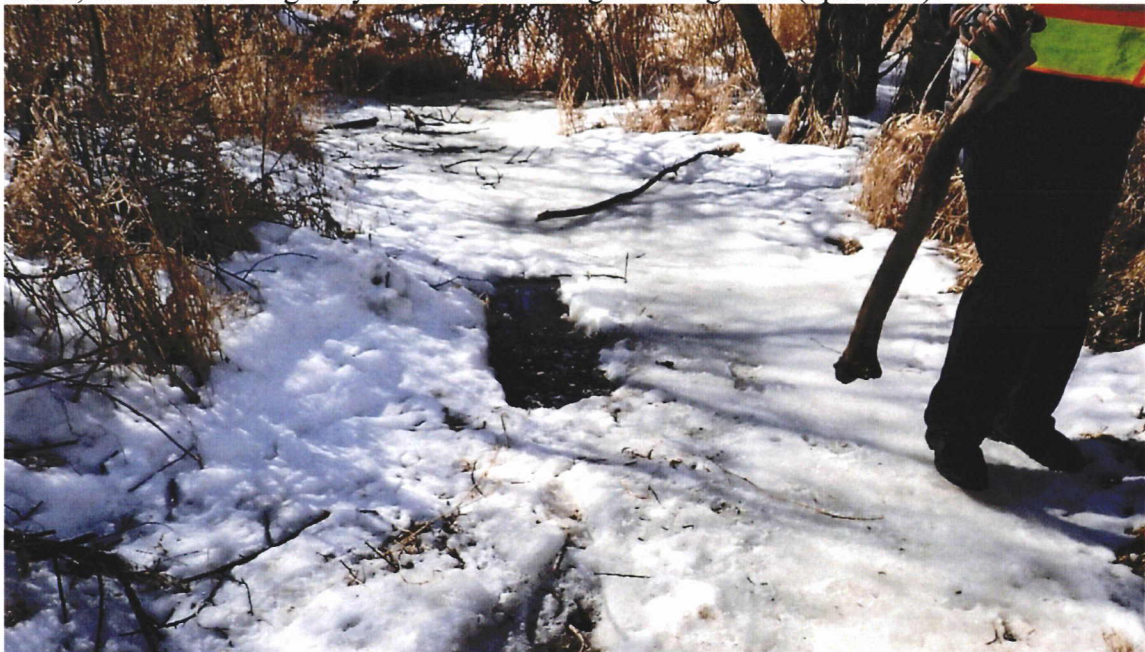
Site 3, west side of Highway 66 above sandbags looking west (upstream).

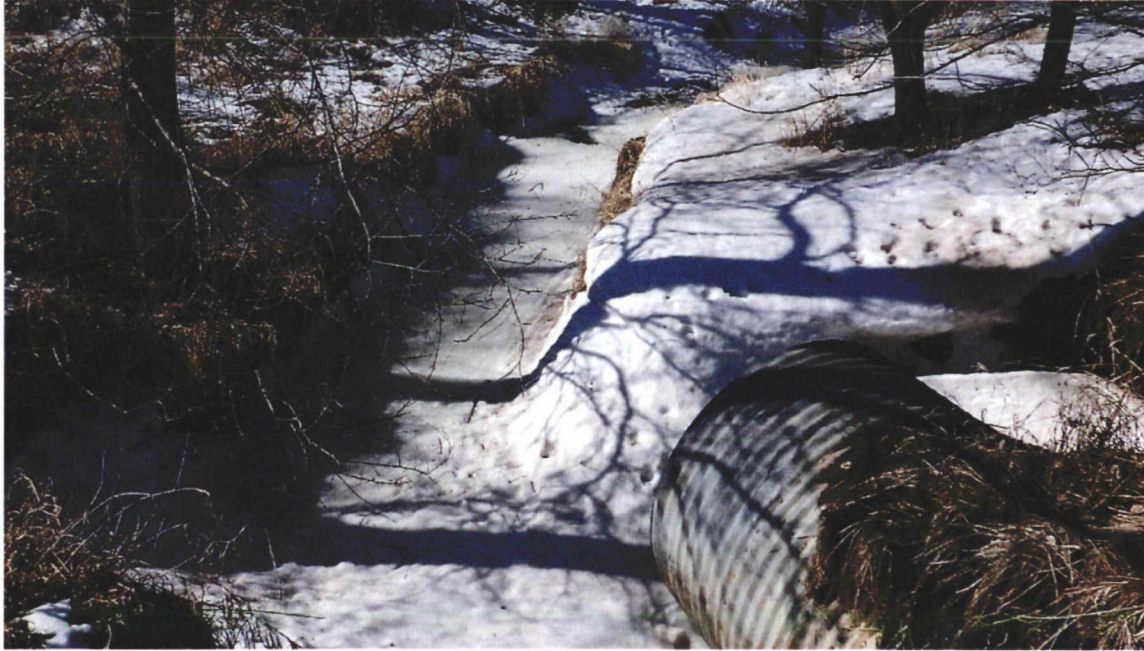
Site 2, west side of road. Note hole in ice toward top of picture.

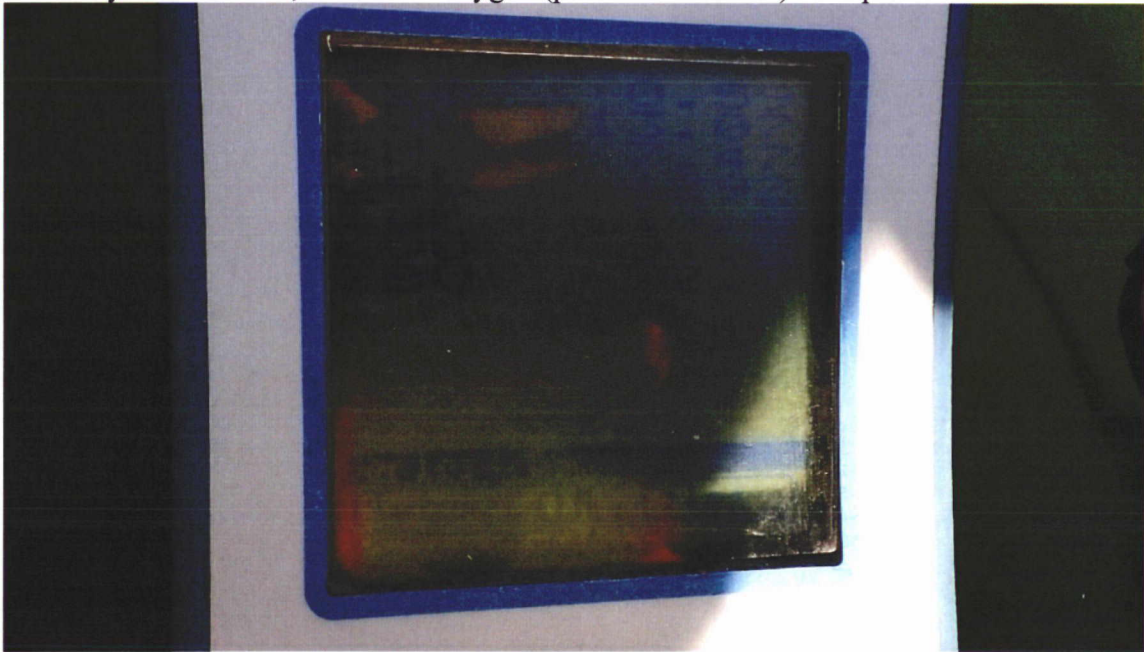
Site 2, west side of road. Hydrolab Surveyor showing results of field parameters from probe being deployed in hole on previous picture. Water Temperature: 0.59 degrees C, Dissolved oxygen: 13.07 mg/l, pH: 7.47 St.Units, Conductivity: 1,292 Umhos/cm, Turbidity: 14.0 NTU's, Dissolved oxygen (percent saturation) 91.5 percent.

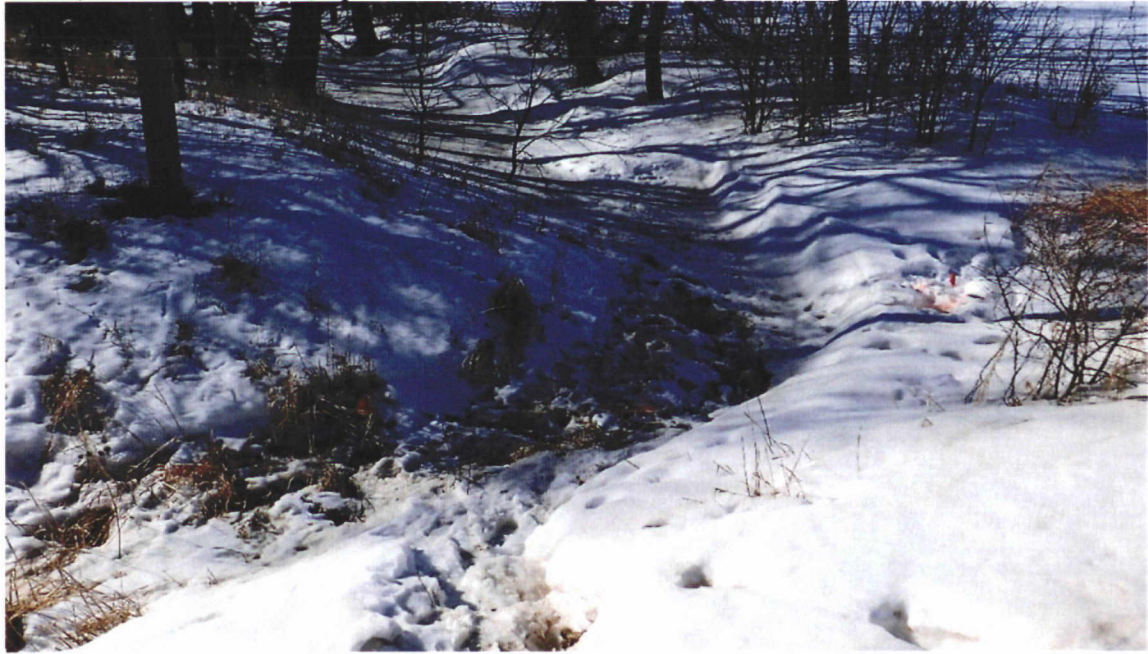
Site 4, west side of road, upstream. Note orange markings and flags.

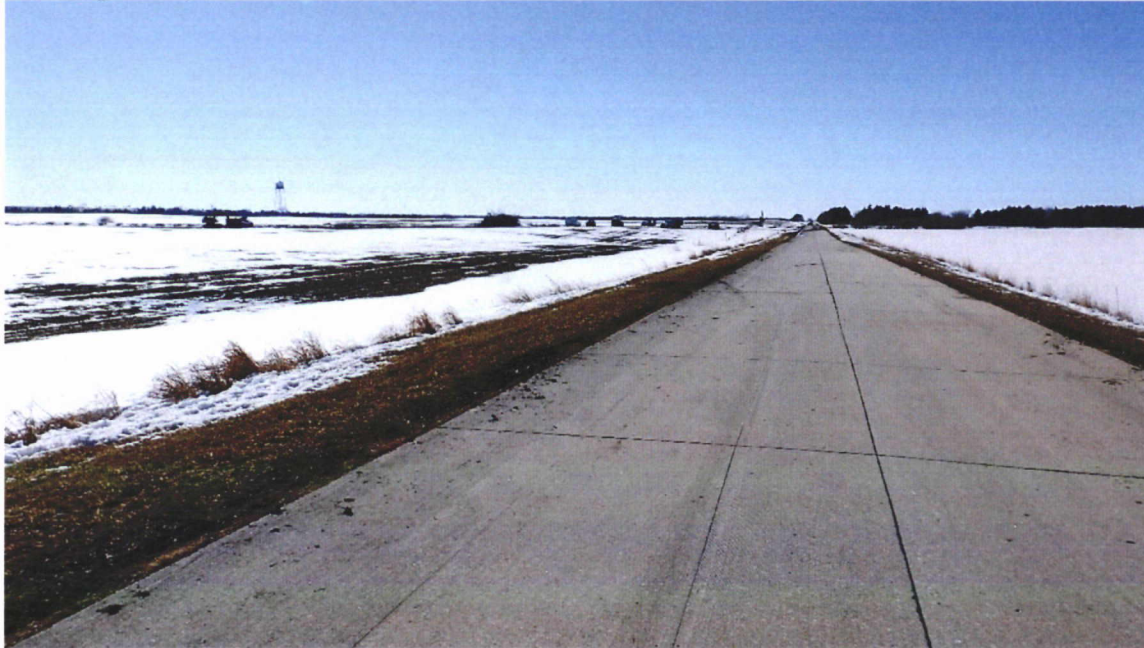
East of Site 5, looking west toward Site 5 (upper right-hand corner). Note dump trucks and backhoes in the distance removing ice and soil from stream southeast of Site 5 (left side of picture).

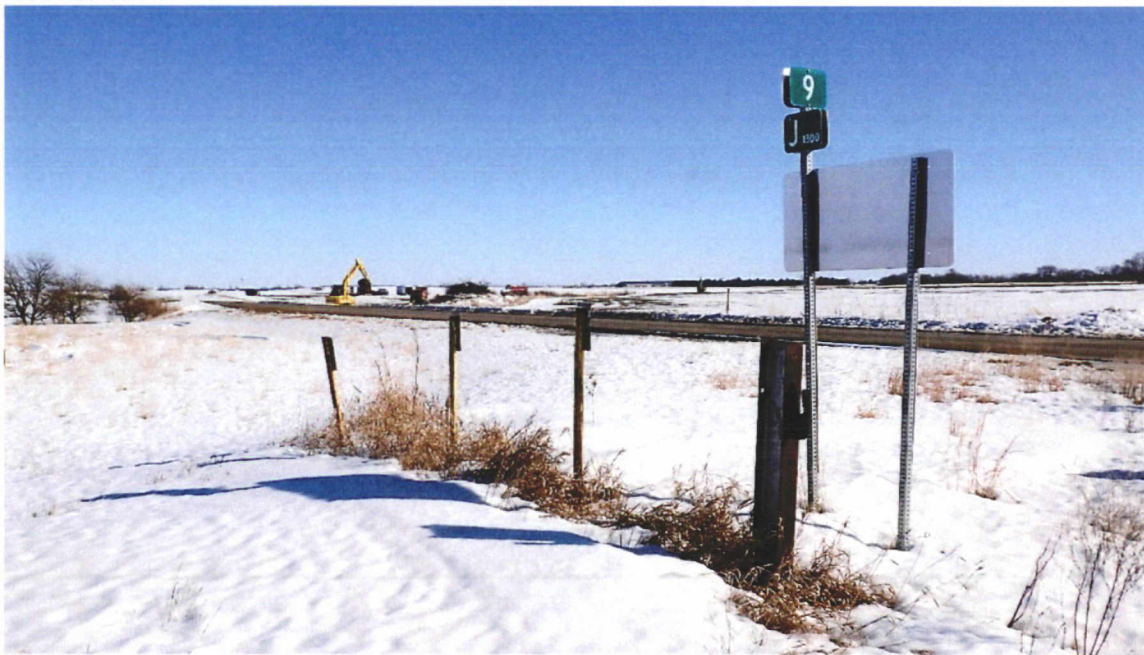
Looking east/southeast from Site 5. Dump trucks and backhoes removing ice and soil from stream.

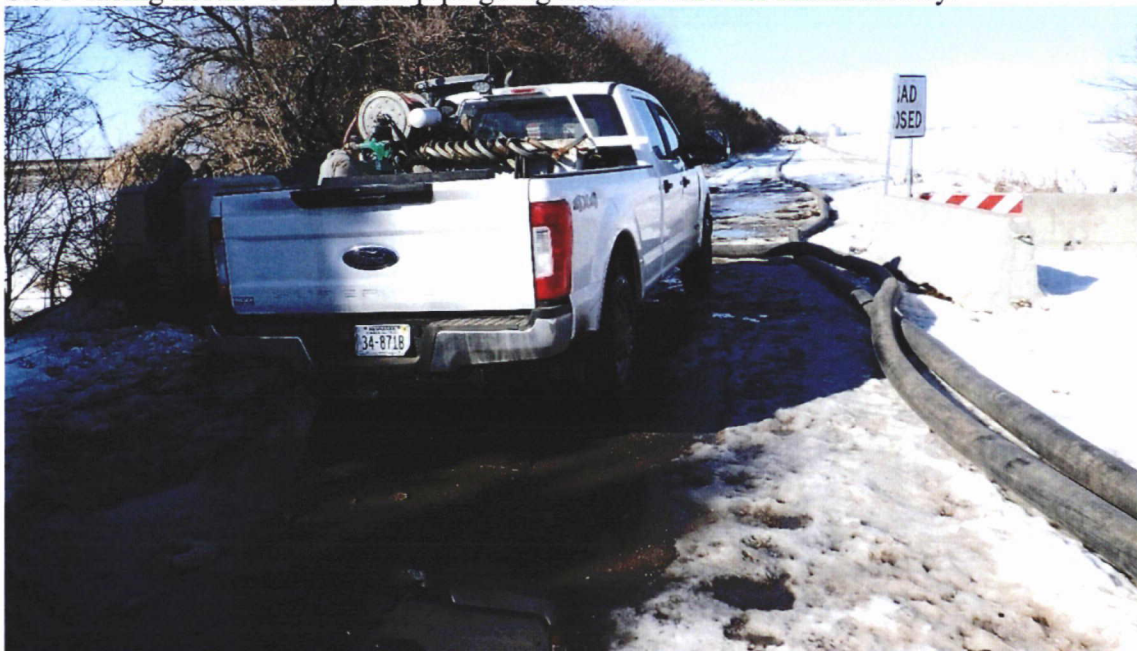
Site 5 facing north. Collapsible pipe going north toward the AltEn facility.

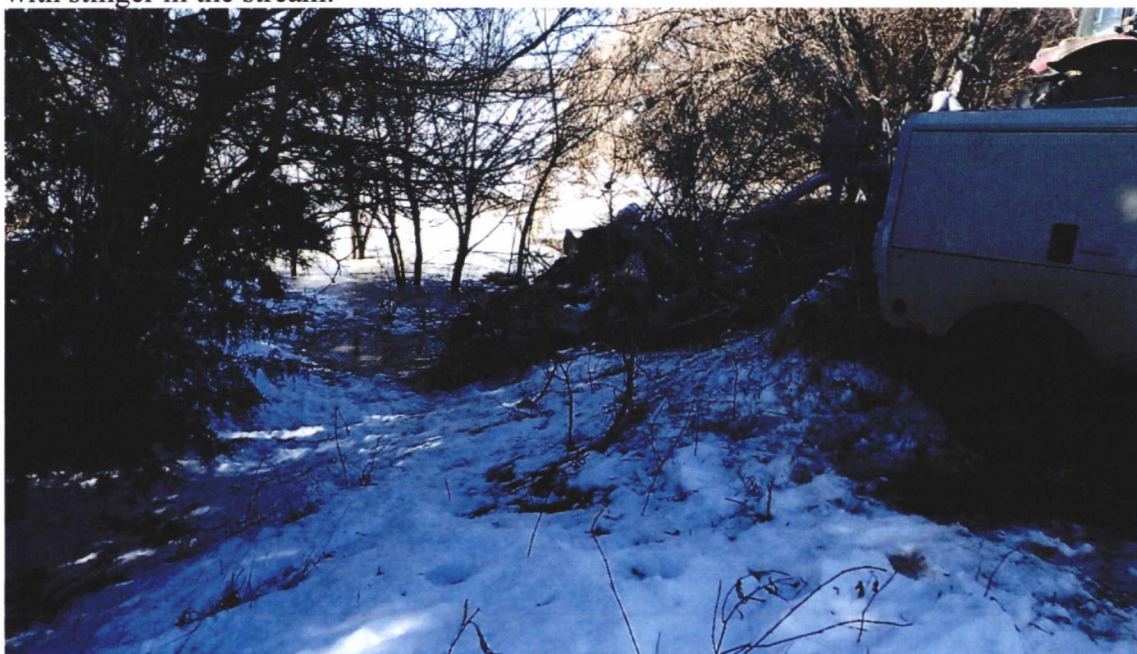
Site 5, at roads 9<sup>th</sup> and J facing northwest. PTO from tractor (above white generator) with stinger in the stream.
