AltEn Field Observations.  
February 26, 2021  
Jim Borovich  
NDEE

PCS 84069

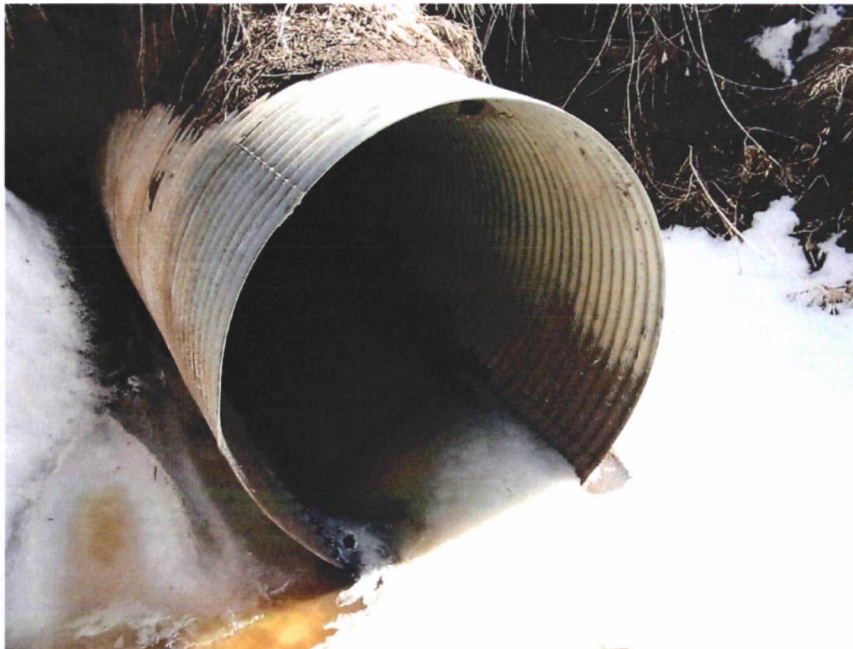
Photo 1. Looking east at culvert on west side of Road 6. No odors. Water in drainage way discolored.

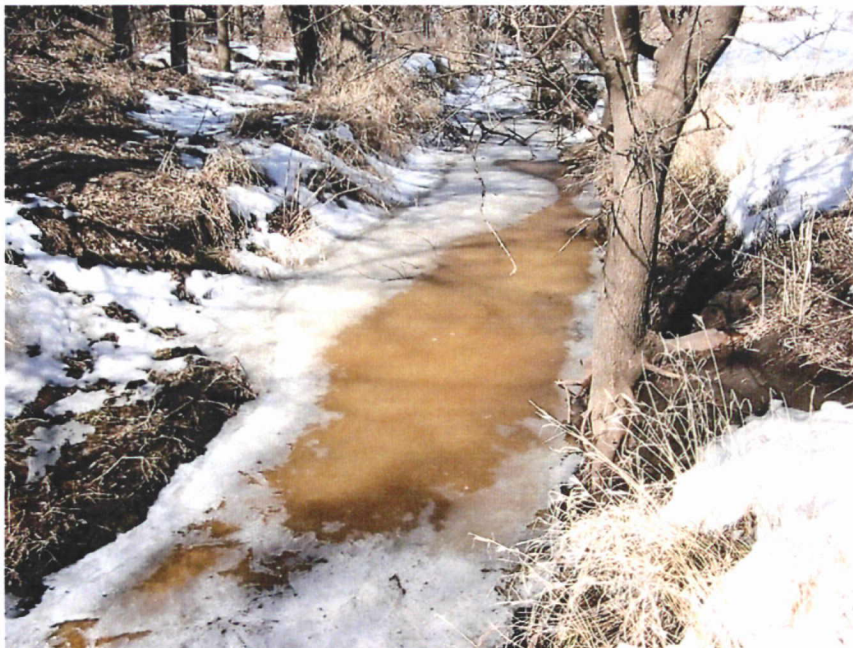
Photo 2. Looking west from culvert shown in Photo 1 at discolored water. No odors.

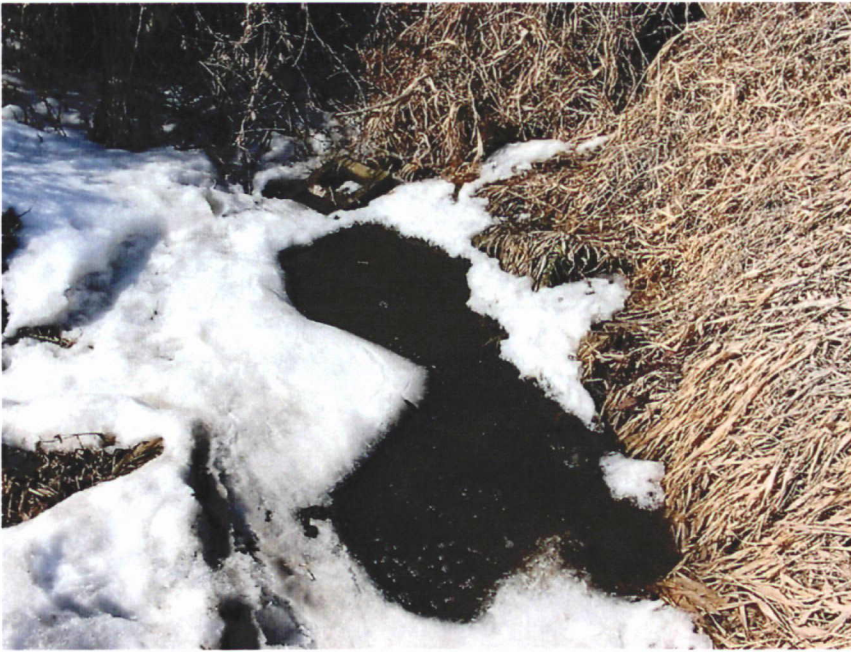
Photo 3. Looking down at water in drainage way on east side of Road 6. No discoloration of water as noted in Photos 1 and 2.

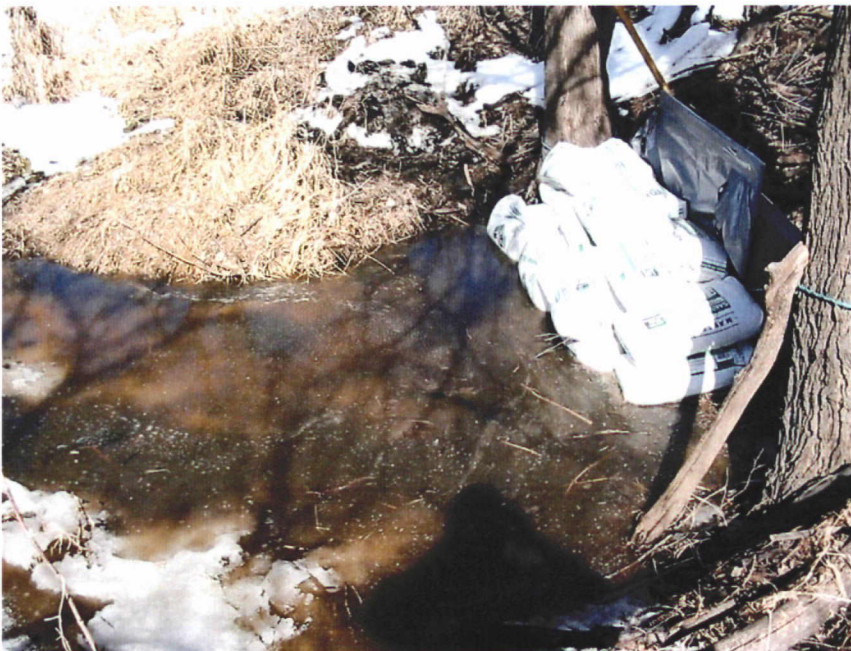
Photo 4. Looking at culvert and make-shift dam. Note melting of ice compared to previous site observation. Water discolored. No odors.

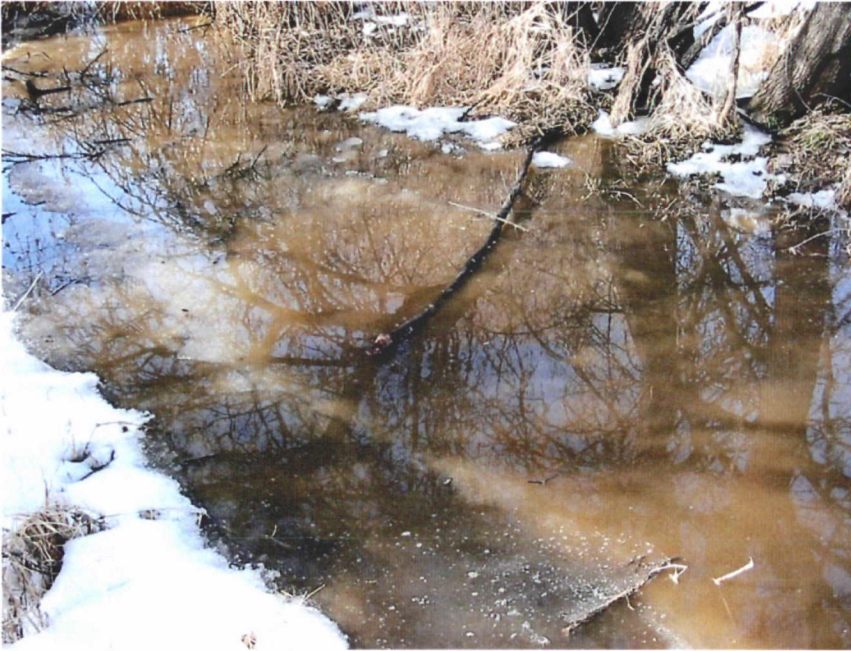
Photo 5. Looking northwest at drainage way 25 feet west of makeshift dam. Water appears discolored.

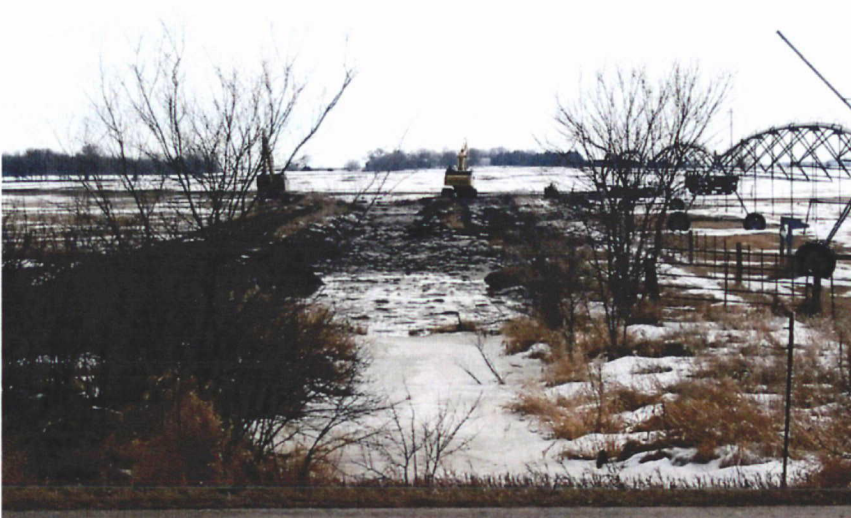
Photo 6. Looking south across Highway 66 at Heimes Excavation working.

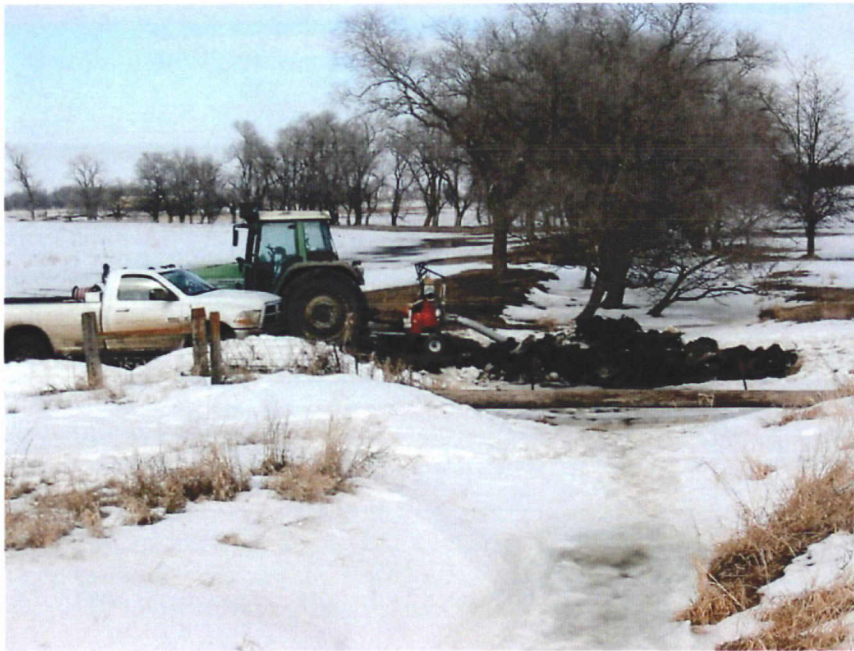
Photo 7. Looking north at pumping of liquid from drainage way by Lagoon Pumping, Inc.

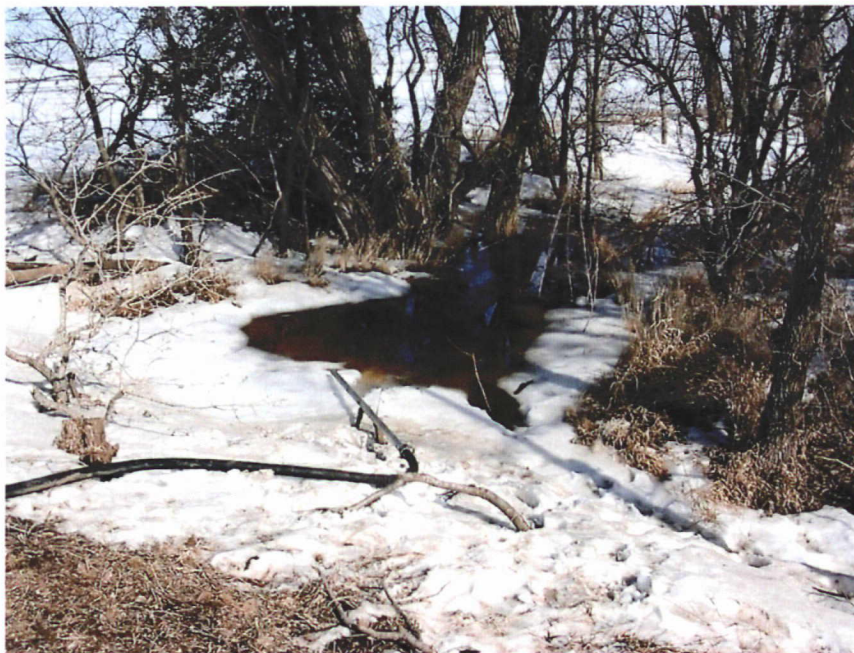
Photo 8. Looking northeast at drainage way on east side of Road 8. Note piping in foreground being used (see Photo 10) to pump liquid from drainage way into a vacuum truck.

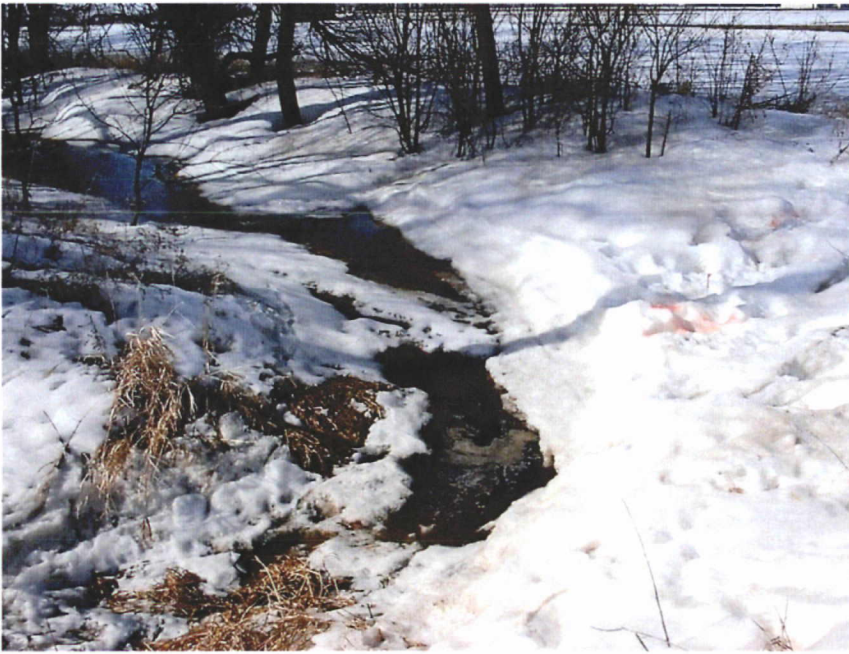
Photo 9. Looking west at drainage way on west side of Road 8. Water is discolored.

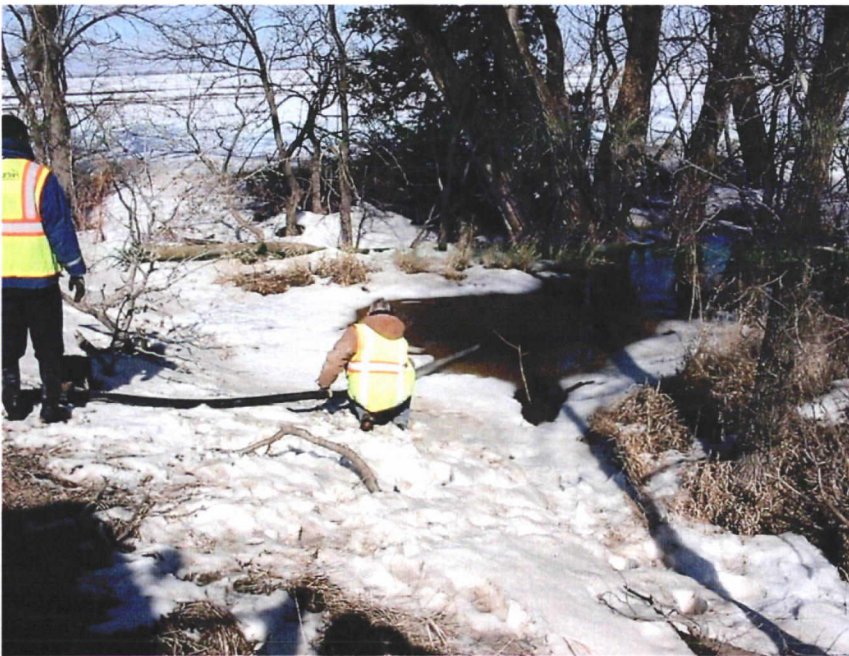
Photo 10. Clean Harbors personnel pumping liquid from east side of drainage way to vac truck.

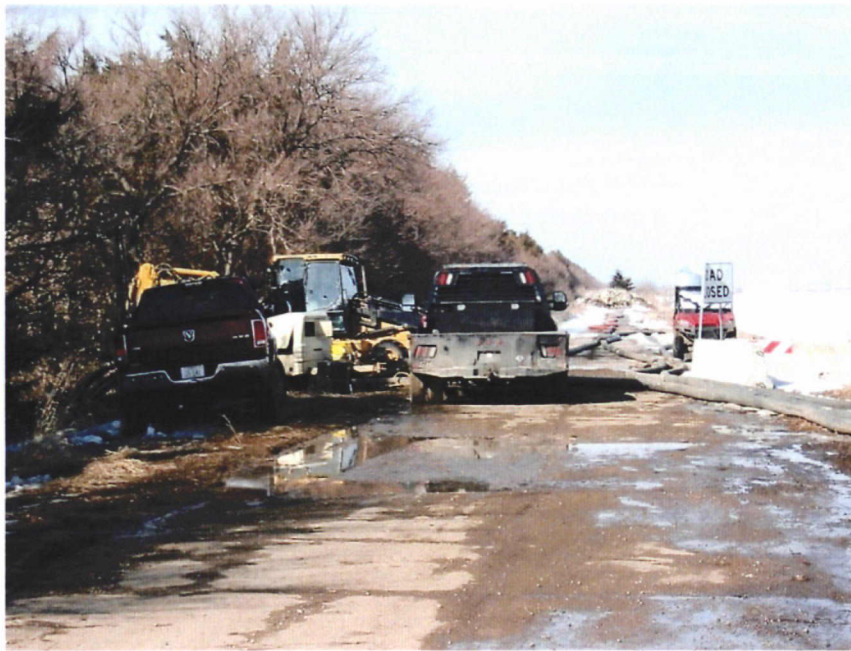
Photo 11. Looking north at equipment apparently pumping from the earthen dam on the west side of Road 9. No personnel were present, but equipment was running.

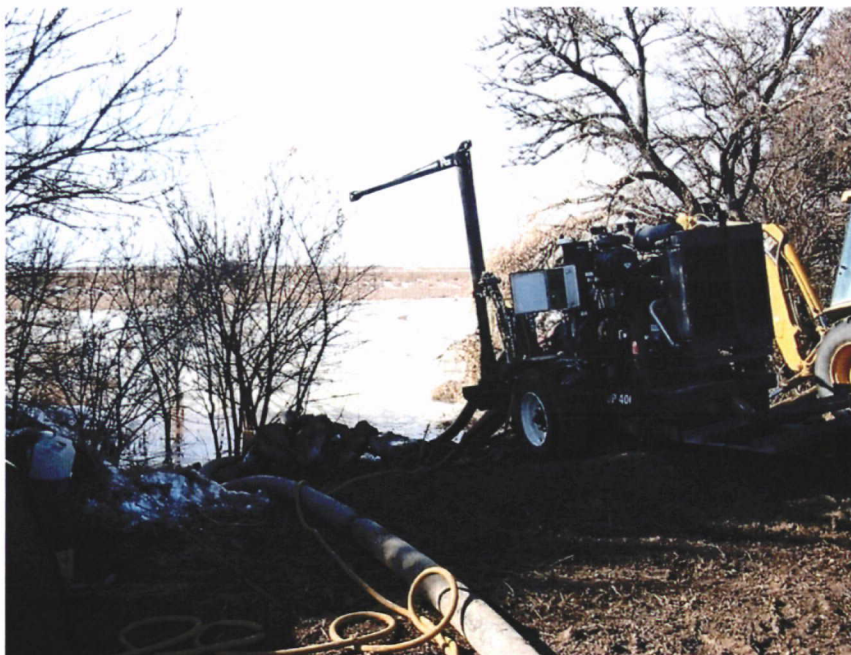
Photo 12. Looking west at earthen dam and impoundment on west side of Road 9.
