DATE: 2-28-21

INVESTIGATOR: Rachel Neisius

**STOP 1 – HIGHWAY 66 WEST of
ASHLAND GUN CLUB**

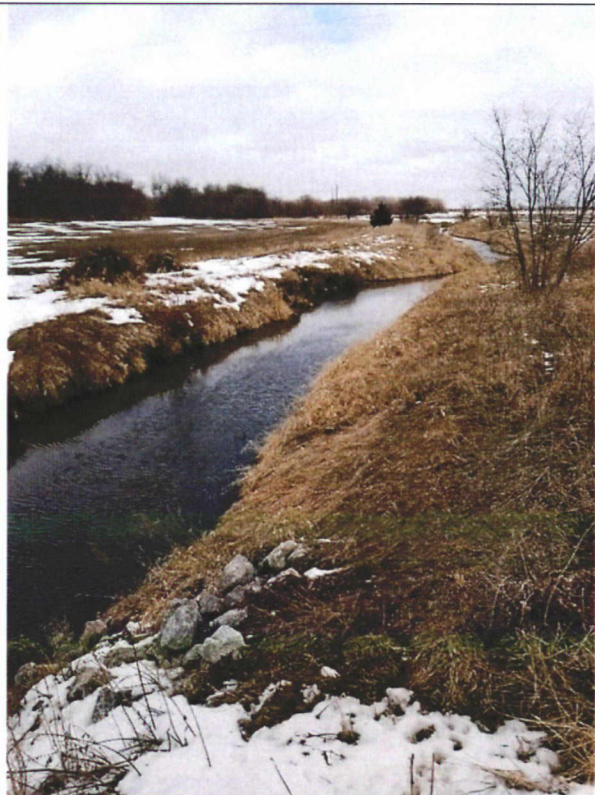
Looking North. Open water, cannot see the bottom- too turbid. Water was flowing slowly. No odor noted.

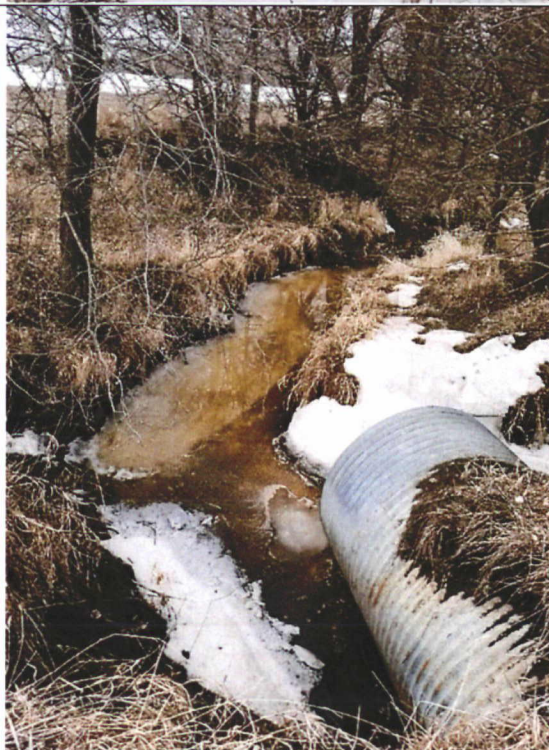
**STOP 2 – North of the Intersection of
COUNTY ROADS 6 & F**

Looking west at creek and culvert. Creek is partially ice-covered. Water looks murky yellow/brown. No odor.

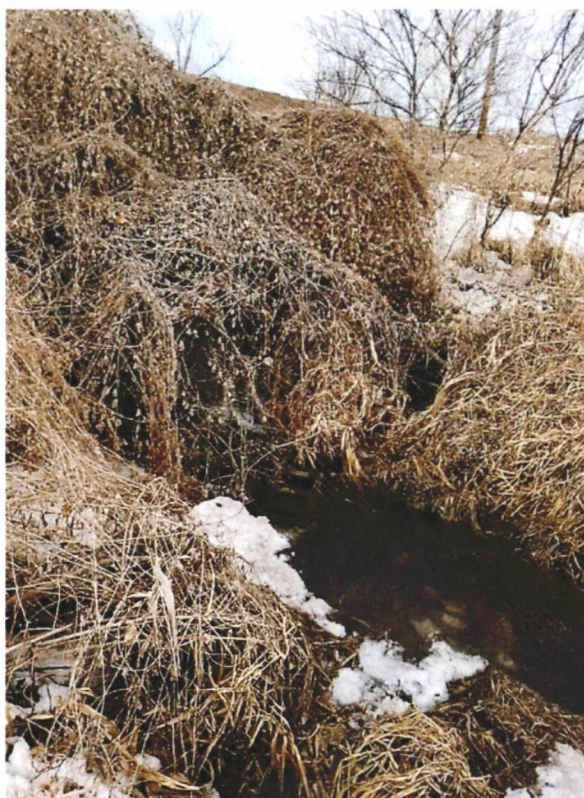
West side of culvert – south side of creek, looking north towards culvert. Partly ice covered. Fairly clear, brown tinted water, can see bottom. No odor.

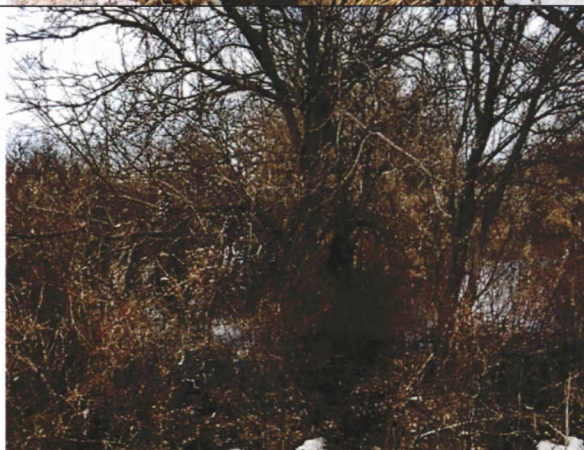
STOP 3 – Road 7/Highway 66
1358 Hours

Photo taken on west side of culvert looking east. Area has flooded out of the banks. Water is flowing from west to east. Water is turbid and brown. Culvert was not visible. No odor.

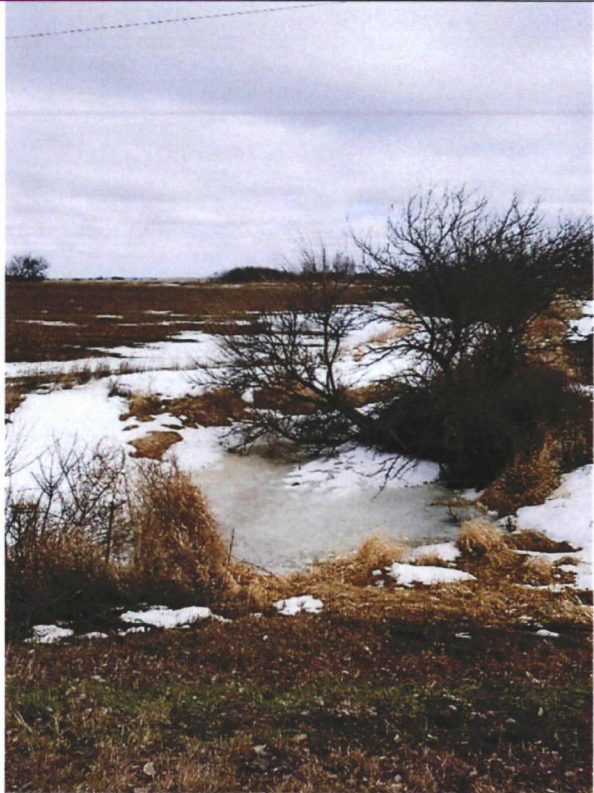
Photo shows the creek on the east side of the road, looking east. No obvious water flow. Mostly ice covered. No odor.

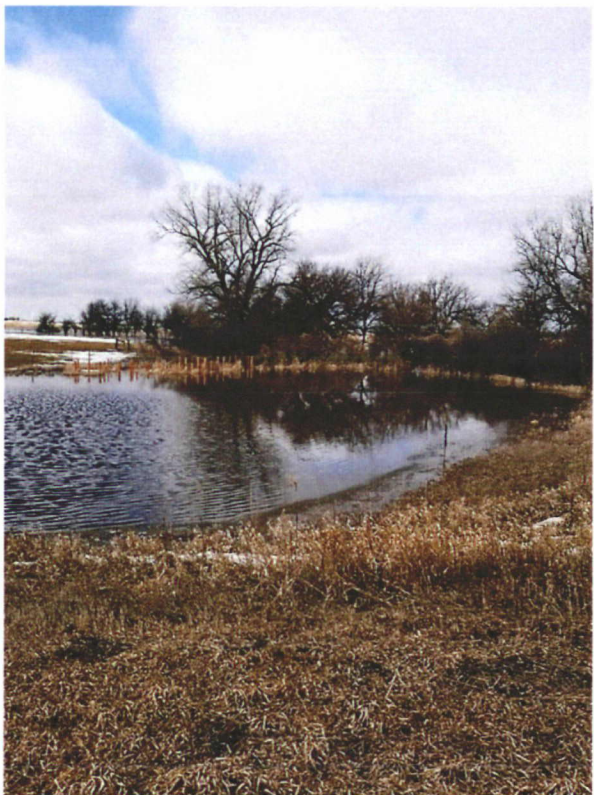
Photo shows additional flooding to the south of the creek on the west side of the road, looking northwest.

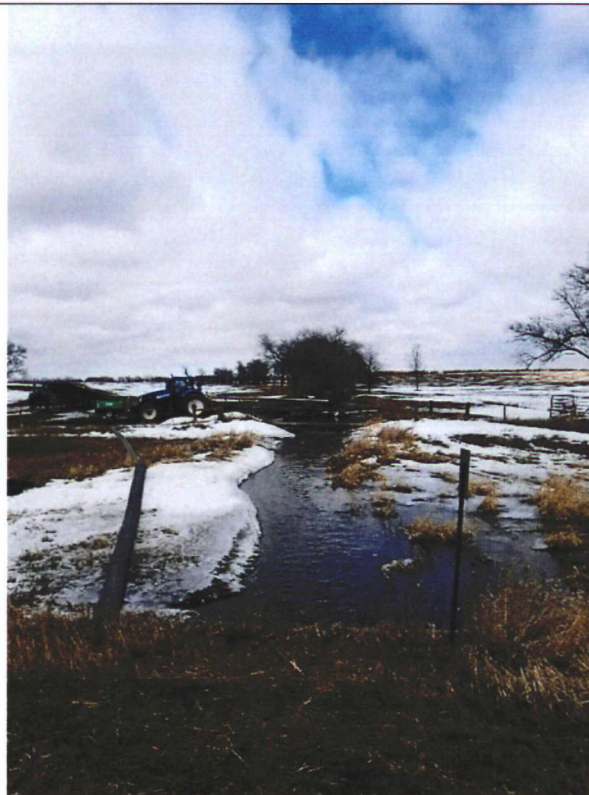
Second Sample Site, West of Site 3, on Hwy 66

Photo is looking north from Hwy 66 at the creek. Water was flowing through culvert. Tractor and hose visible in photo. Water is turbid. Mr. Ken Peterson took two samples in area showed in picture. No odor.

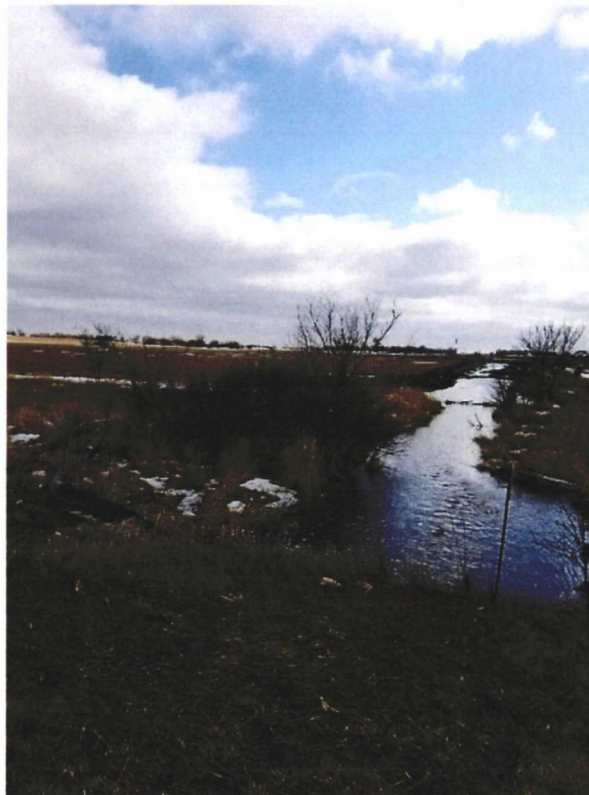
Photo is looking south from Hwy 66 at the creek. Hose is visible. No odor.

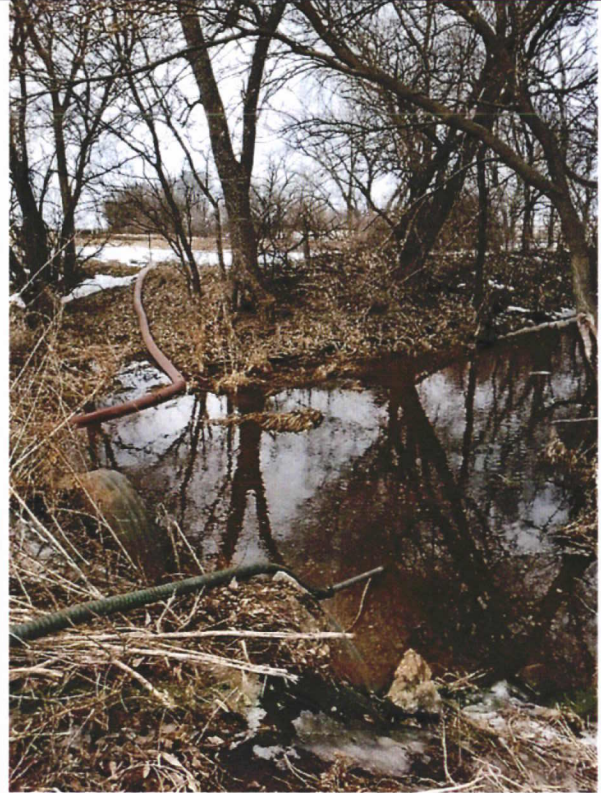
**Sample Site East of County Road 8 and H
at the Creek.**

Photo is looking north at the creek and culvert from County Road H. Water is brown and turbid. No odor. Clean Harbors on site. Hose is visible in photo. Mr. Ken Peterson took the samples in the area shown.

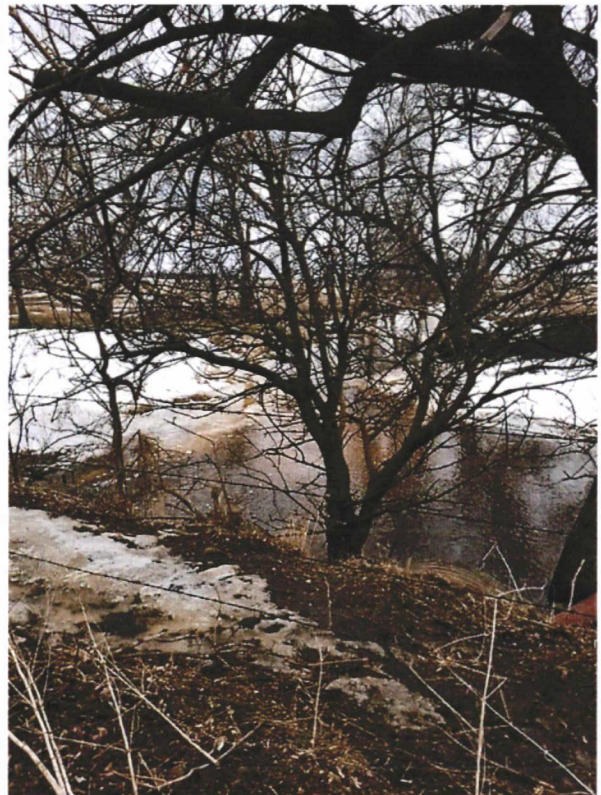
Photo is looking south at the creek and culvert from County Road H. Water is brown and turbid. No odor.

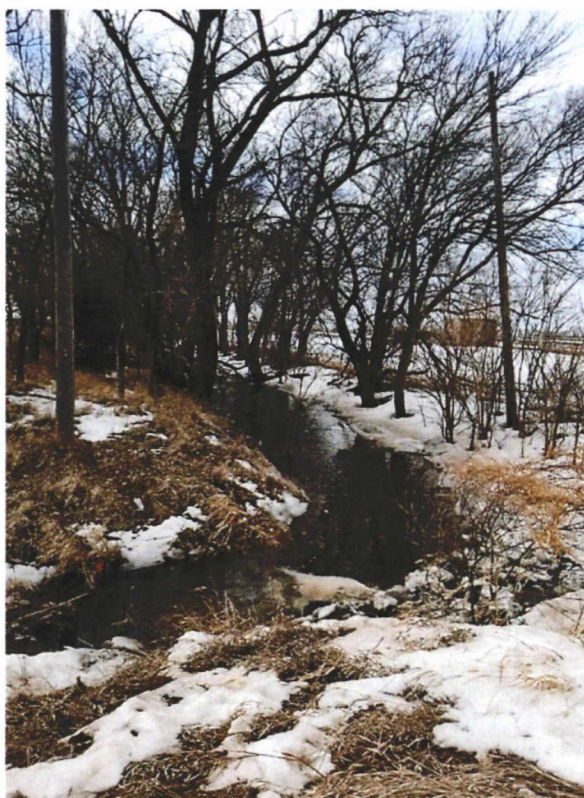
STOP 4 – County Road 8, North of Road H
1424 Hours

Photo was taken looking west at the creek from Road 8. The creek is mostly open water. Water is flowing and turbid. Some noticeable odor. Mr. Ken Peterson took his samples from the area shown.

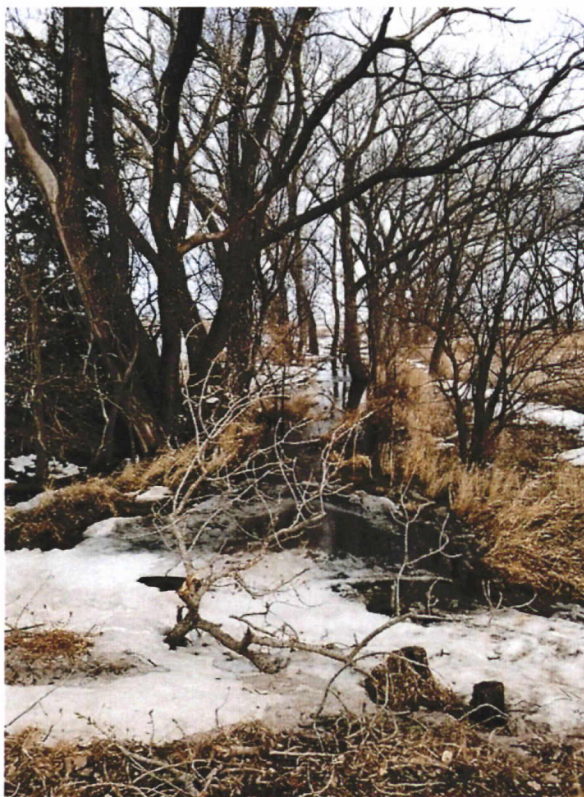
Photo is looking east at the creek on the east side of Road 8. Creek is partially ice covered.

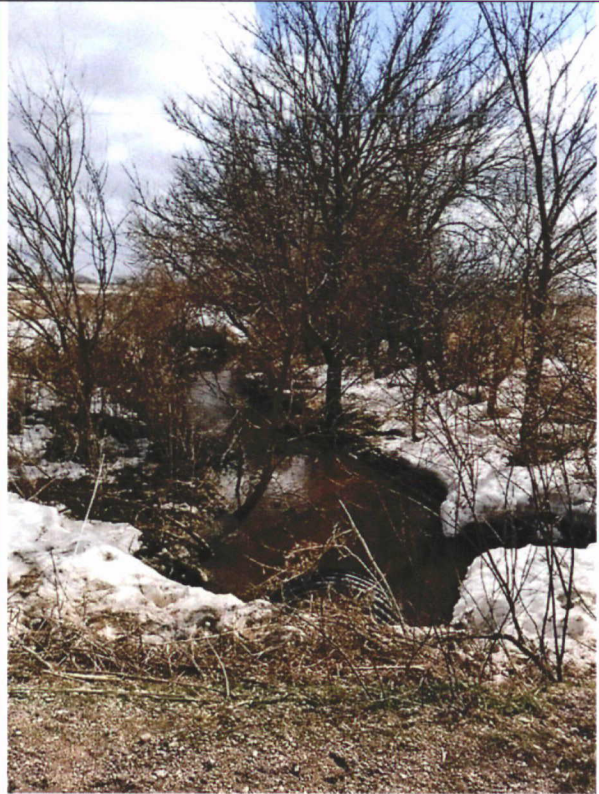
Sample site-West of UNL-ENREC
Foundation Seed between County road 8
and 9, and between county road J and H
1436 Hours

Photo was taken looking south at the creek and culvert from the road. Water was flowing and turbid. Bottom of the creek was visible. Mr. Ken Peterson took samples in the area shown.

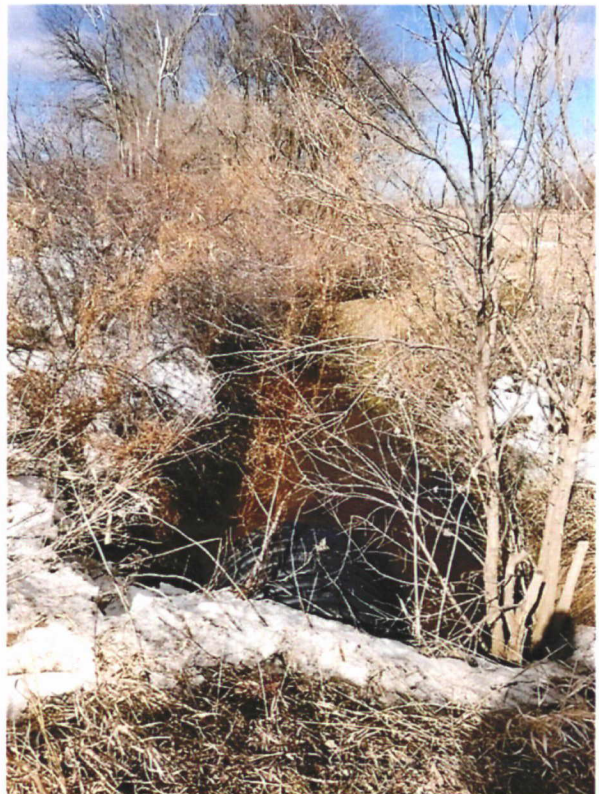
Photo was taken looking North at the creek and culvert from the road. A manmade dirt 'dam' is visible. It showed partial erosion on the west-hand side.

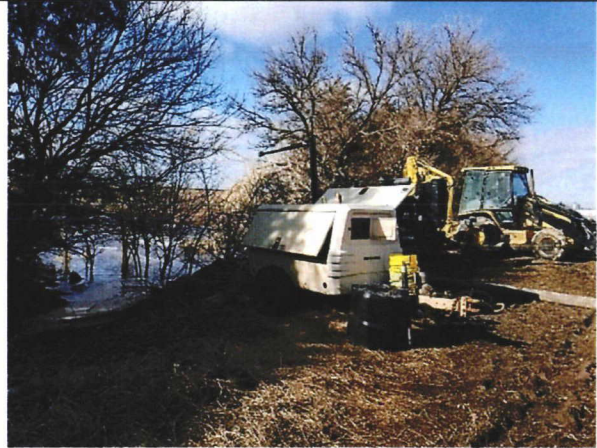
**STOP 5 – UN-L Eastern Extension – North
of County Roads 9 & J**

Photo taken looking at the west side of Road 9 just before the culvert. A PTO-driven pump and hose was actively pumping water from this location during my observation. Slightly turbid water was flowing into this ponded area from the west. Water was actively pumping. Clean Harbors was on site. Foul odor was noticeable.

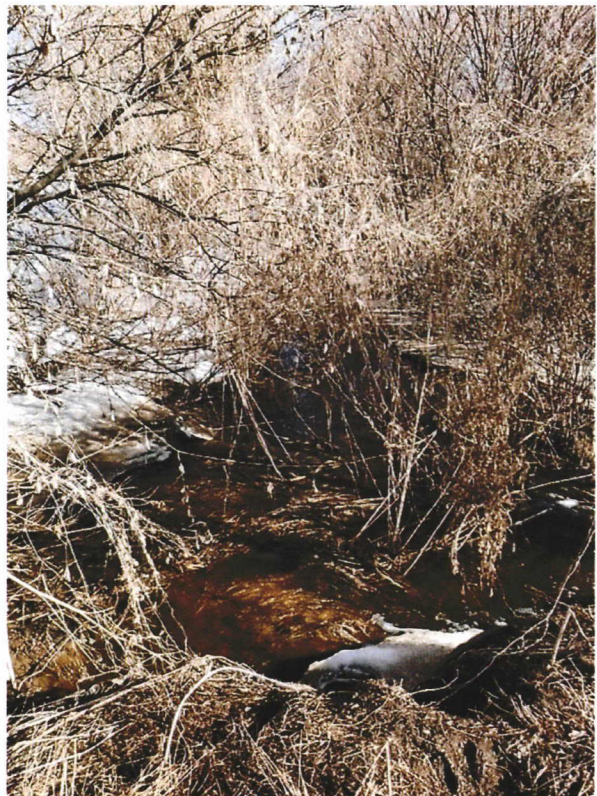
Photo shows the creek on the east side of Road 9. The creek was open with some ice noticeable. Mr. Ken Peterson took samples from area pictured.

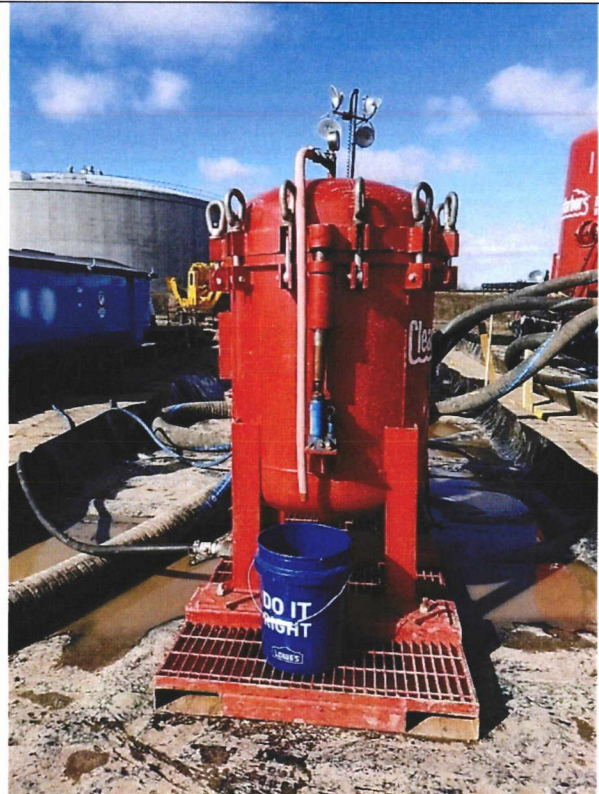
STOP 6 – ALTEN LLC FACILITY

Photo shows the influent area of the Clean Harbors Filtration system, looking north. The influent samples were taken from the hose hanging over the blue bucket in the photo. Sampling was performed by Mr. Ken Peterson. Foul odors were noticeable.

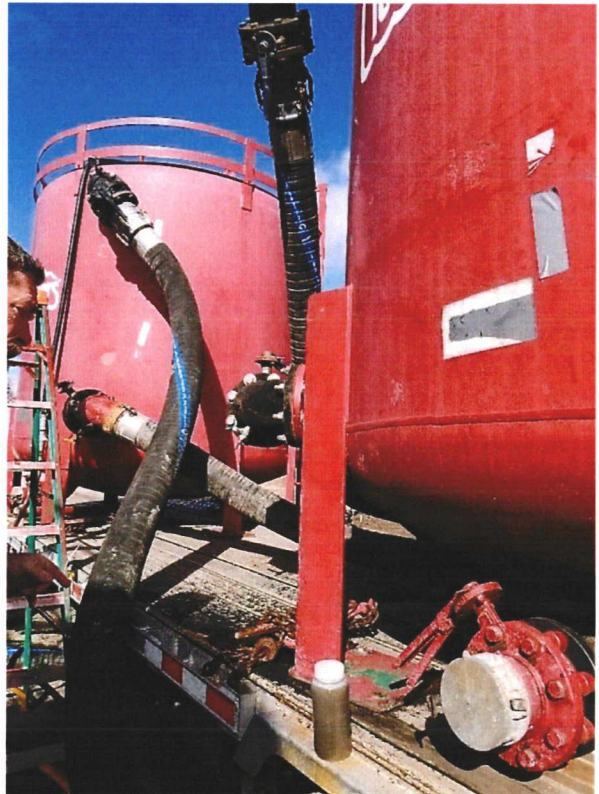
Photo shows the Clean Harbors filtration system with the spout where Mr. Ken Peterson took the filtered water samples. Sample appeared murky and green/brown.
