## **Nebraska Department of Environment and Energy (NDEE)**

### **MEMORANDUM**

**RE:** AltEn, LLC

**Subject:** Site Visit Report (Stormwater only)

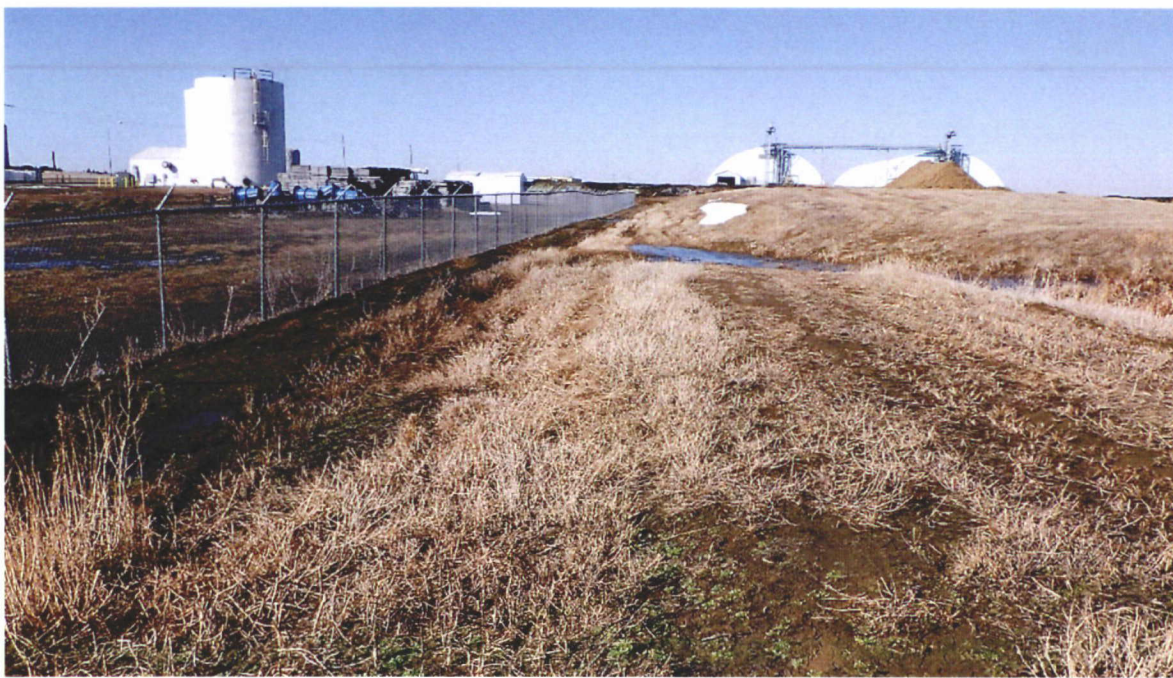
Photo: 1

OA1 is the berm located on the southwest corner of the southeast lagoon, photo 1. There is water accumulation observed due to recent snow melt and rain event. Mr. Egr stated that this area captures water from the west and northwest wet cake piles, photos 2 and 3. I stated I was concerned about the low area depicted in photo 1. Mr. Egr stated that this is where runoff from the west pile enters the berm. I suggested that the berm be built up. Mr. Egr stated that if the berm was built up, runoff flowing from the west pile would not enter the berm. Mr. Egr also stated the berm has a depth of approximately three feet. I asked how they manage collected runoff. Mr. Egr stated depending on weather will pump it down whenever they notice the area becoming full.

Description: This photo depicts the southwest berm. This berm is used to capture water from the west and north west wet cake storage area.

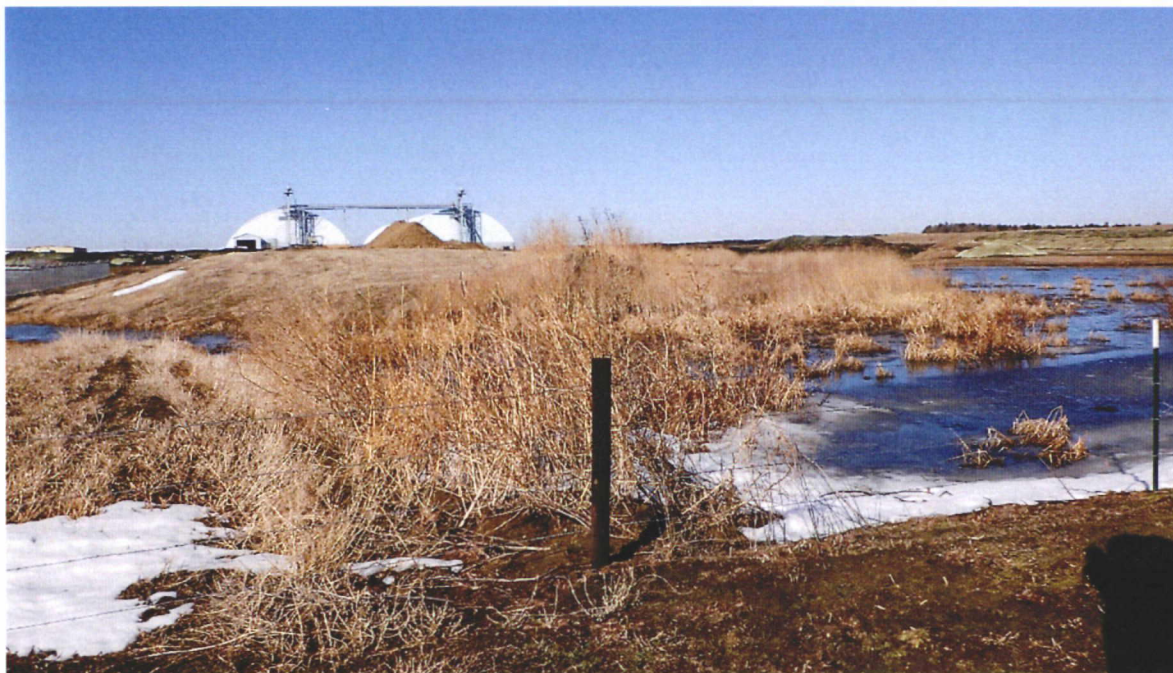
Photo: 2

Description: This photo depicts the southwest berm. This photo depicts captured water in the area of the berm.

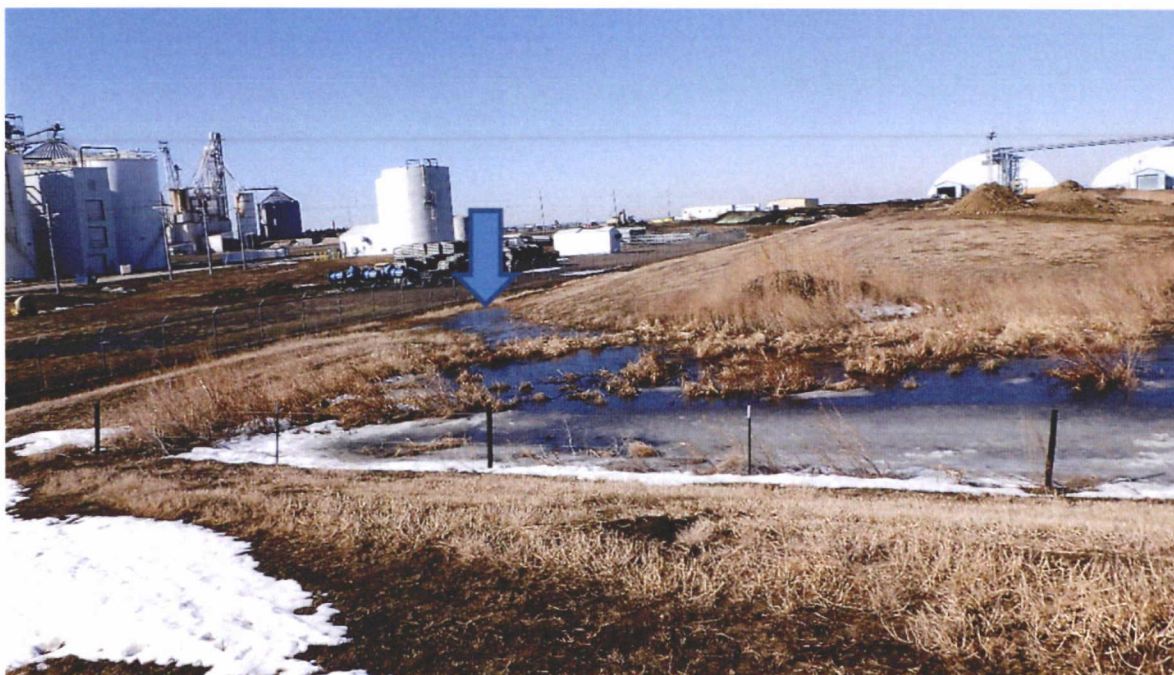
Photo: 3

Description: This photo depicts captured runoff inside the southwest berm. Notice that the southwest corner appears to be at capacity (arrow).

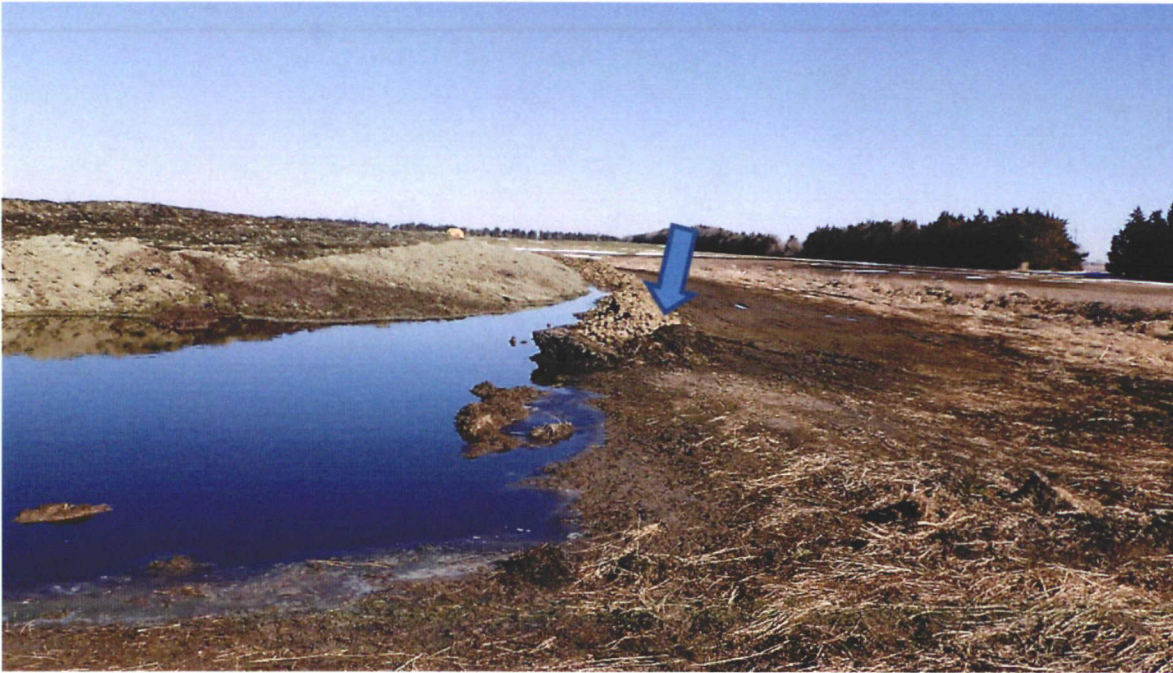
Photo: 4

OA2 is the east wet cake storage area. This area was recently part of letter of noncompliance (LNC) issued on February 16, 2021. The LNC requested that AltEn install a berm around the east wet cake pile as required in the storm water pollution prevention plan (SWPPP). Mr. Egr stated that he finished the berm late last week. The berm surrounds the pile from the southwest corner to the northeast side and is not compacted, photos 4, 5 and 6. The berm does not completely surround the wet cake pile. There is water accumulation behind the berm and does not appear to be seeping through, photo 7. Mr. Egr stated they will be using a honey wagon to transfer water to the lagoon system.

Description: This photo depicts the east wet cake pile. The facility recently installed a berm which starts near the southeast corner of the pile (arrow).

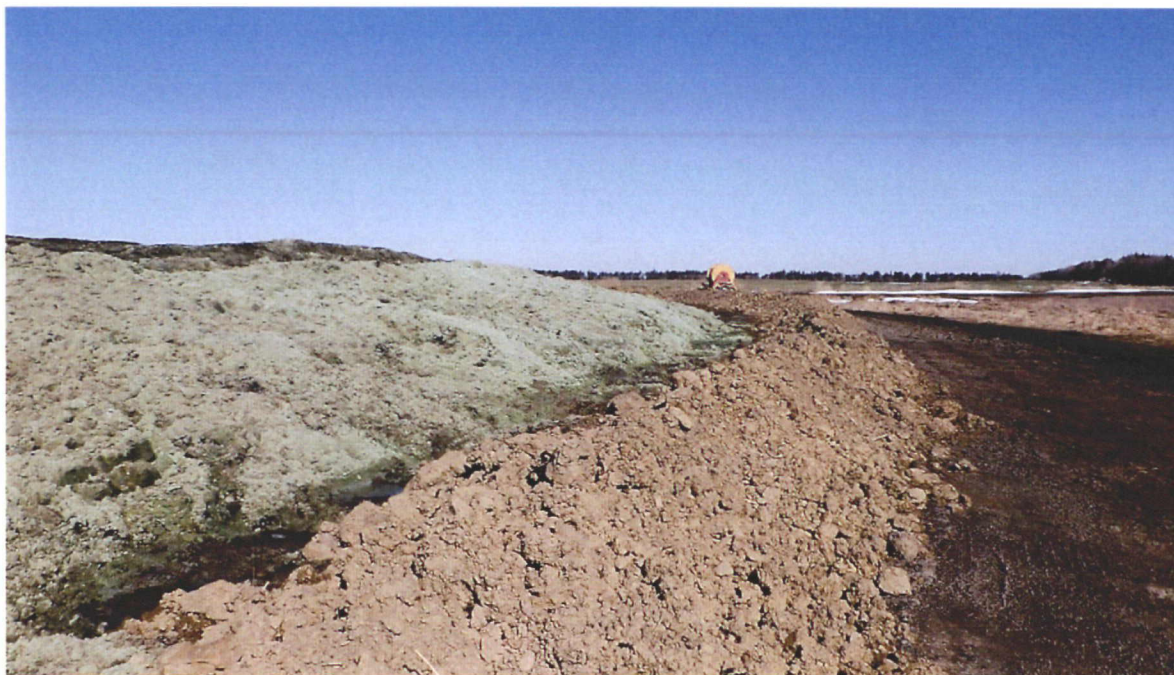
Photo: 5

Description: This photo depicts the berm. The berm is constructed of clay and is approximately 3 to 4 foot tall.

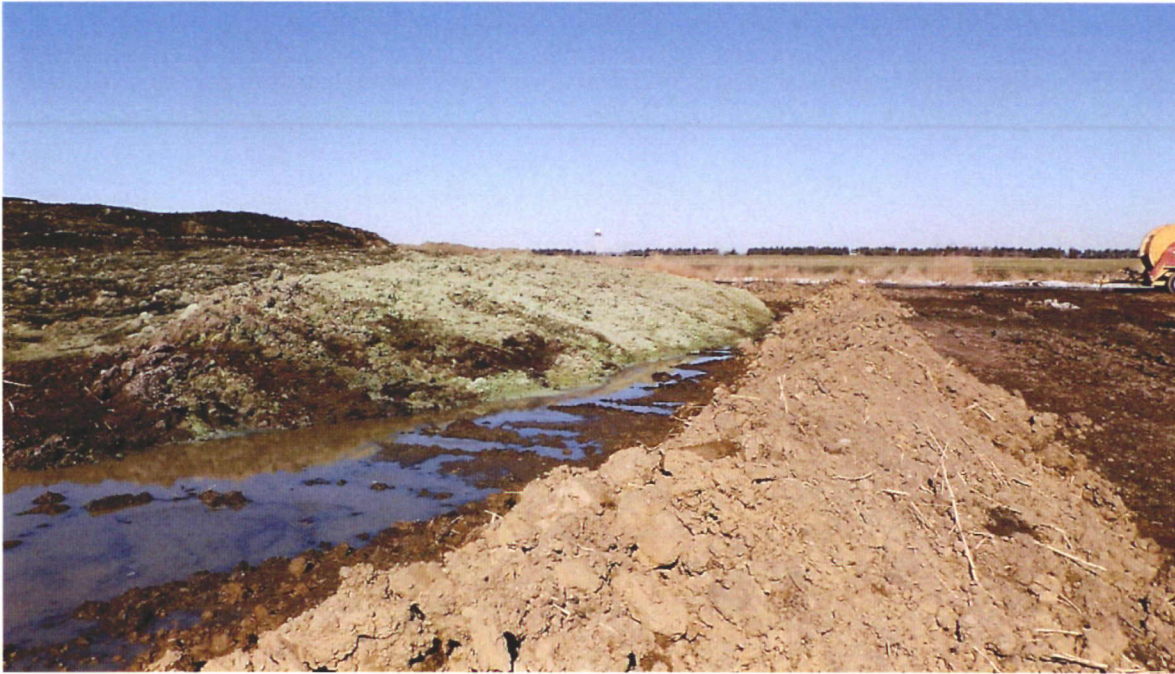
Photo: 6

Description: This photo depicts water accumulation on the west of the berm. There is no water seepage noted.

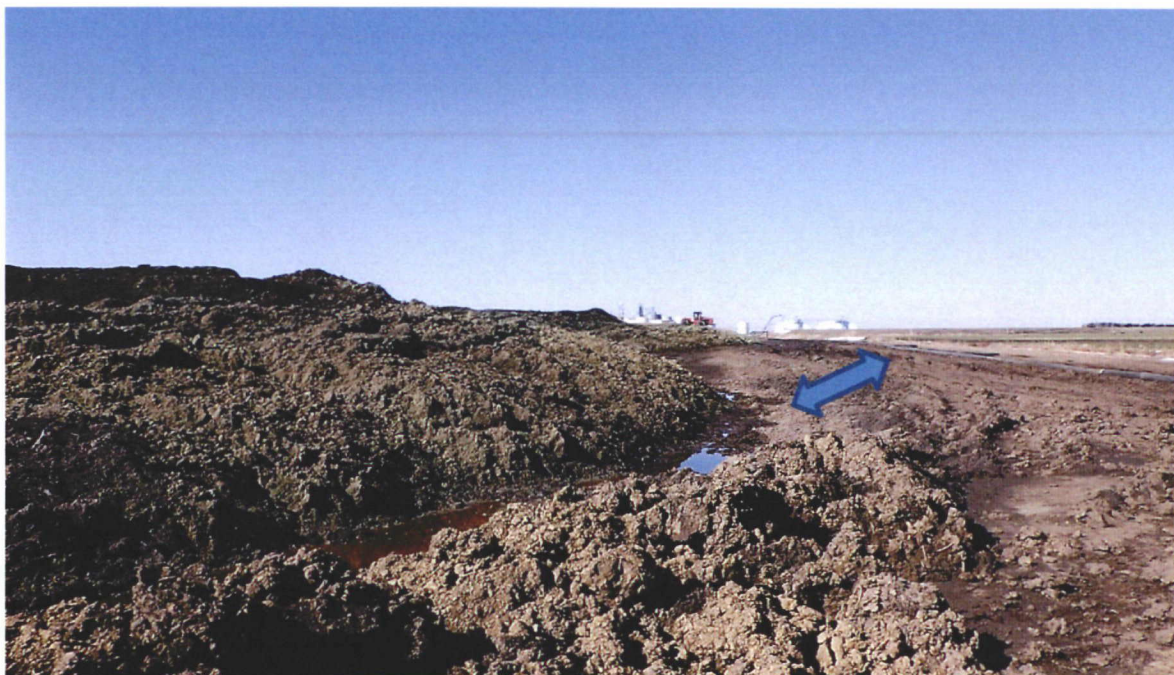
Photo: 7

Description: This photo depicts the end of the constructed berm. The elevation on the north side does not allow for water to flow north (arrow).
