## Nebraska Department of Environment and Energy (NDEE)

### MEMORANDUM

**RE:** AltEn, LLC

**Subject:** Site Visit Report (Wastewater Aspects Only)

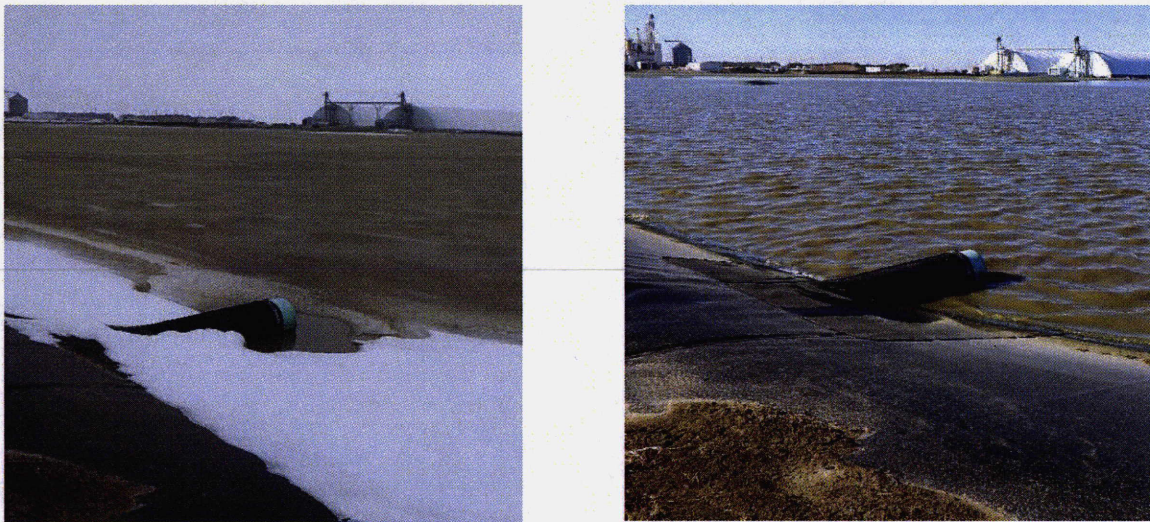
**Figure 1. Overflow Pipe in Northwest lagoon on February 1, 2021 (left) and on March 2, 2021 (right).**

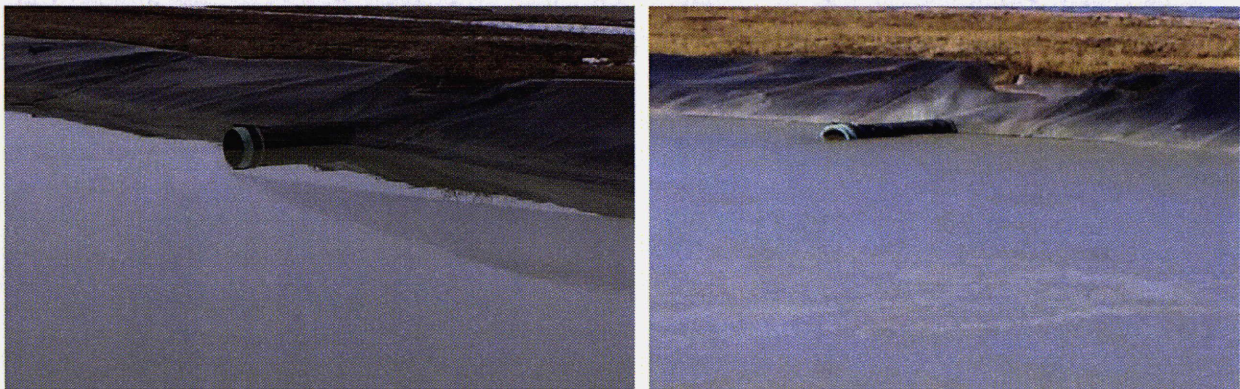
**Figure 2. Overflow Pipe from Northwest lagoon entering the Northeast lagoon on February 1, 2021 (left) and on March 2, 2021 (right).**

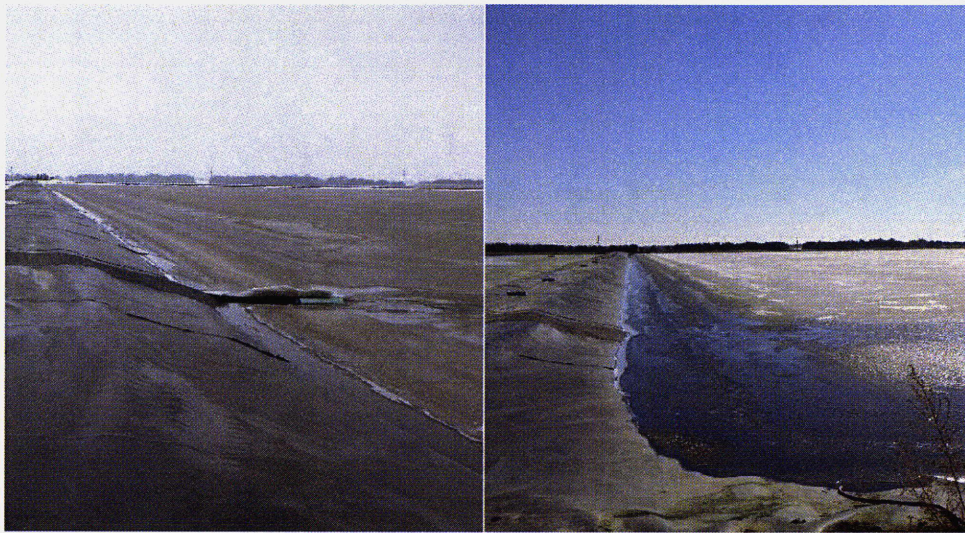
**Figure 3. Overflow Pipe entering the Southeast lagoon from the Northeast lagoon on February 1, 2021 (left) and on March 2, 2021 (right).**

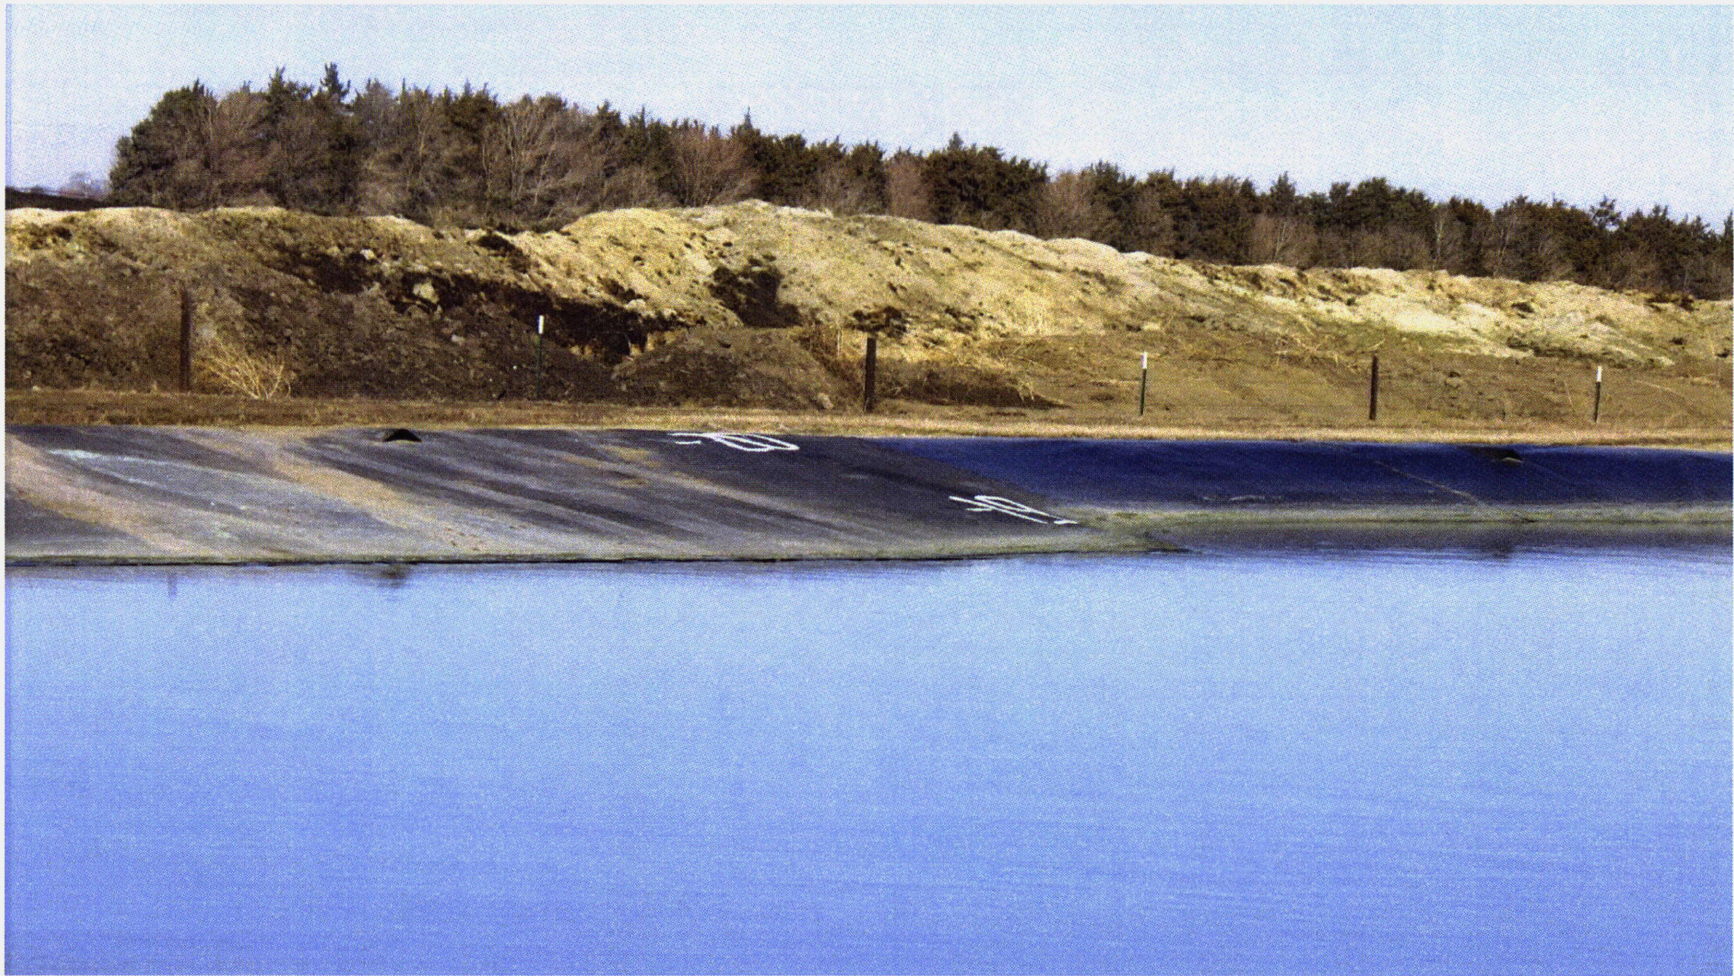
Photo 2

- From a visual observation, the depth of the Northwest lagoon appeared to be about 18.5 feet, based on the depth marker (Photo 2). The maximum depth (top of berm) based on the depth marker is 20 feet. Thus, there was about 1.5 feet of freeboard observed in the Northwest lagoon.

Description: Depth marker for the Northwest lagoon.

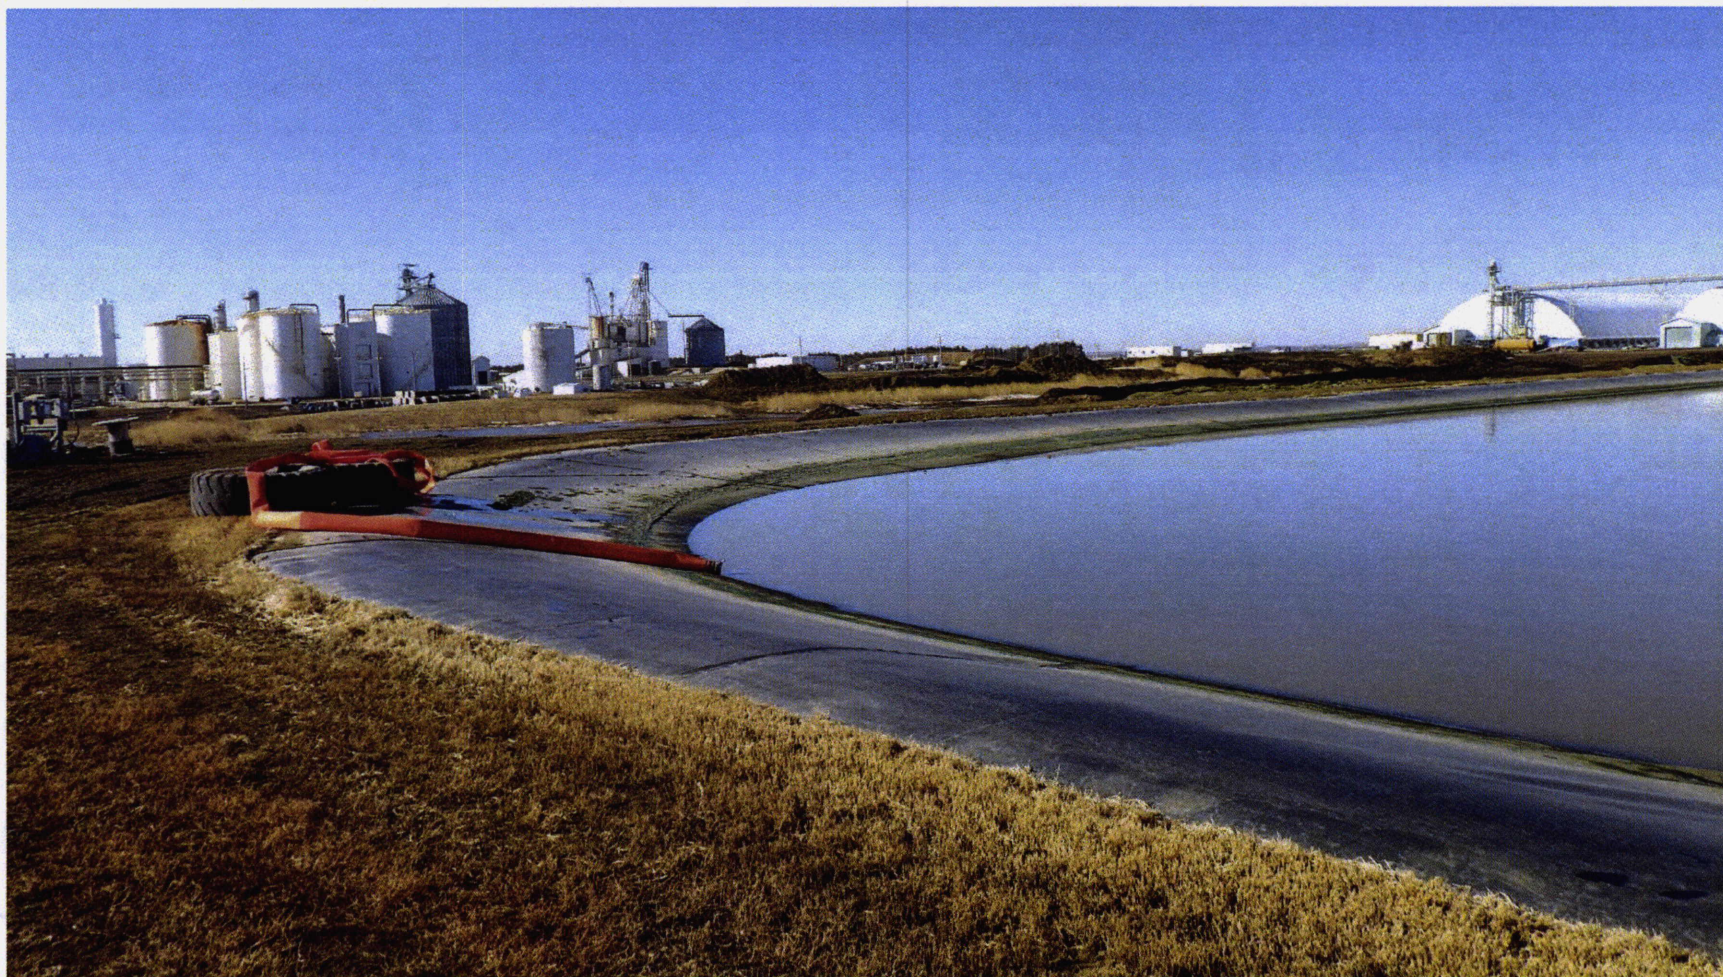
Photo 3

- The facility was not pumping wastewater from the emergency overflow lagoon into any of the three wastewater lagoons during the site visit (Photos 3 and 17).

Description: Hose that was used to pump wastewater from the emergency overflow lagoon into the southeast corner of the Northwest lagoon. No wastewater was observed being pumped into the lagoons while we were there.

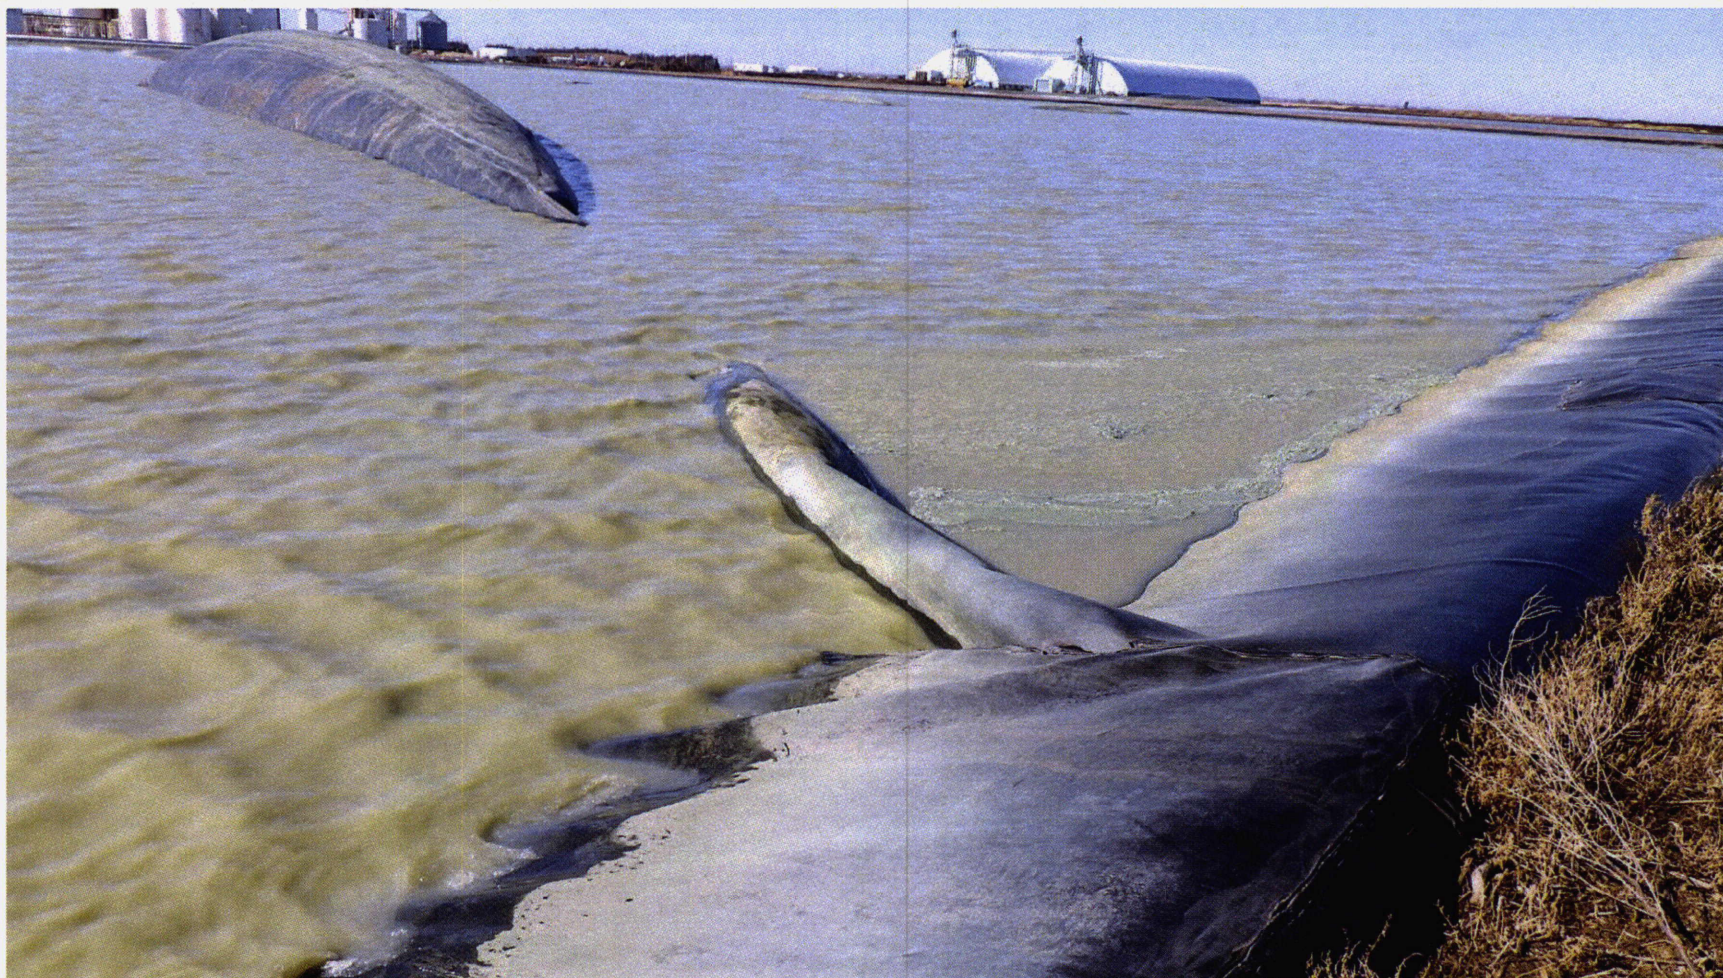
Photo 9

- The Northeast lagoon cell liner has not been repaired and is still badly damaged (Photos 9 and 10). There were also numerous animal burrows observed on the north side of the dike north of the Northeast lagoon (Photo 11).

Description: Liner tear on the north side of the Northeast lagoon.

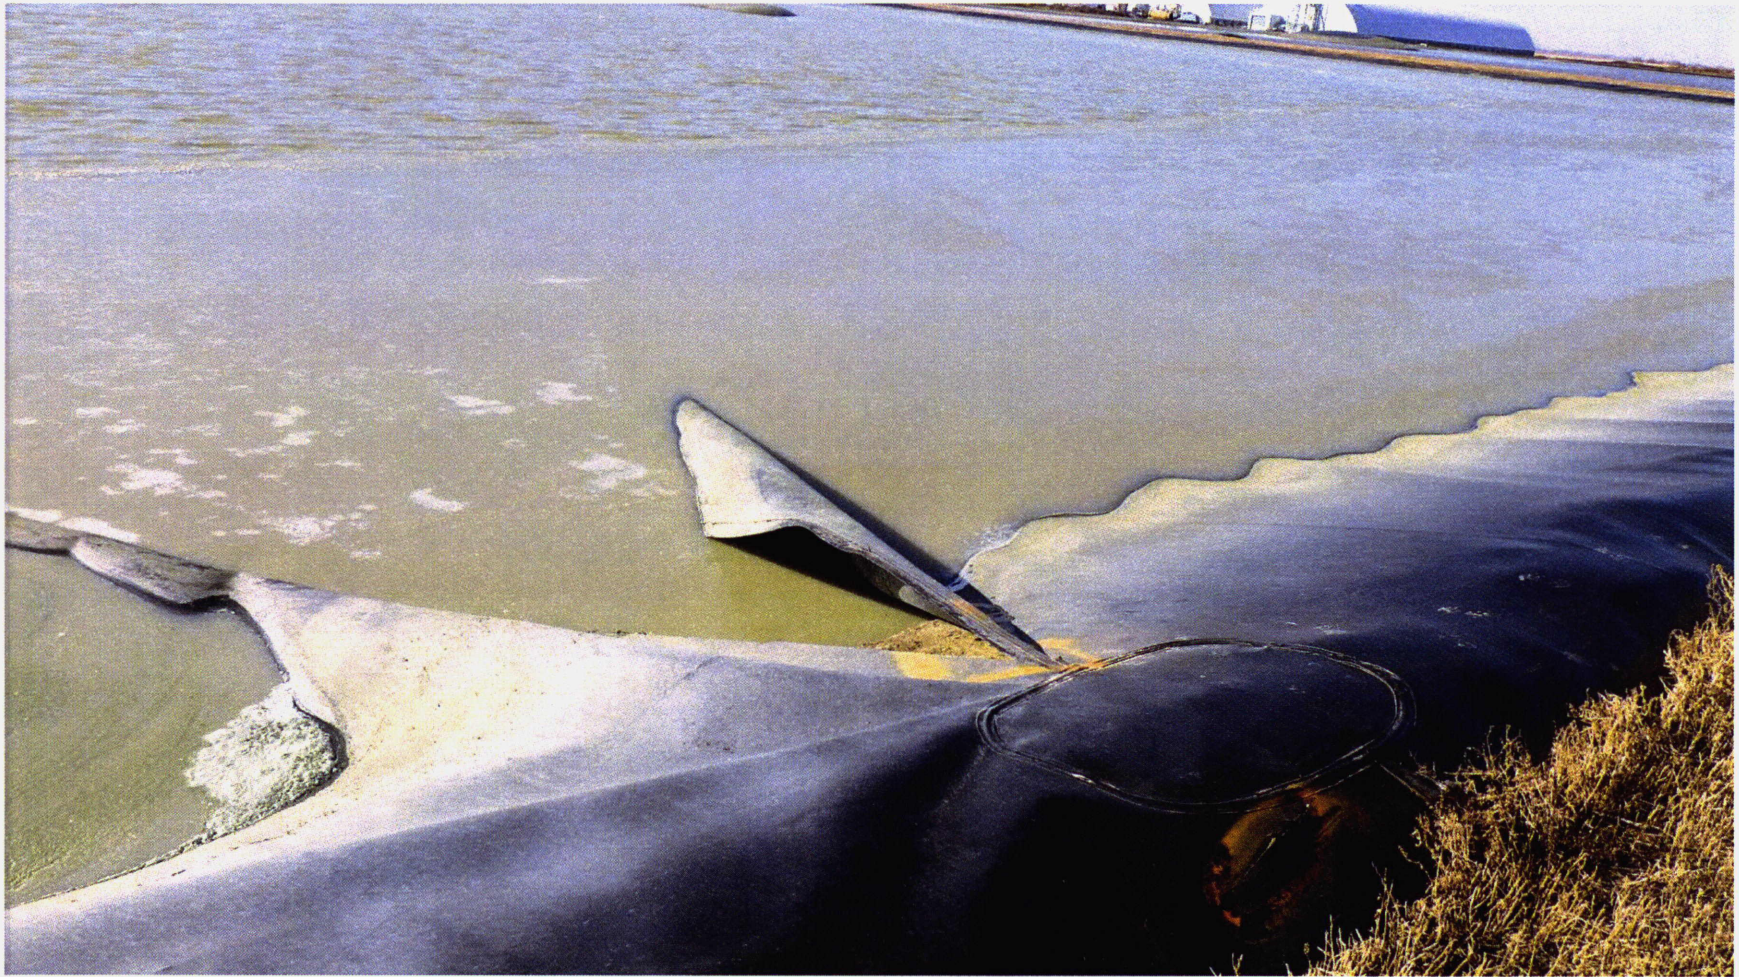
Photo 10

Description: Liner tear on the north side of the Northeast lagoon.

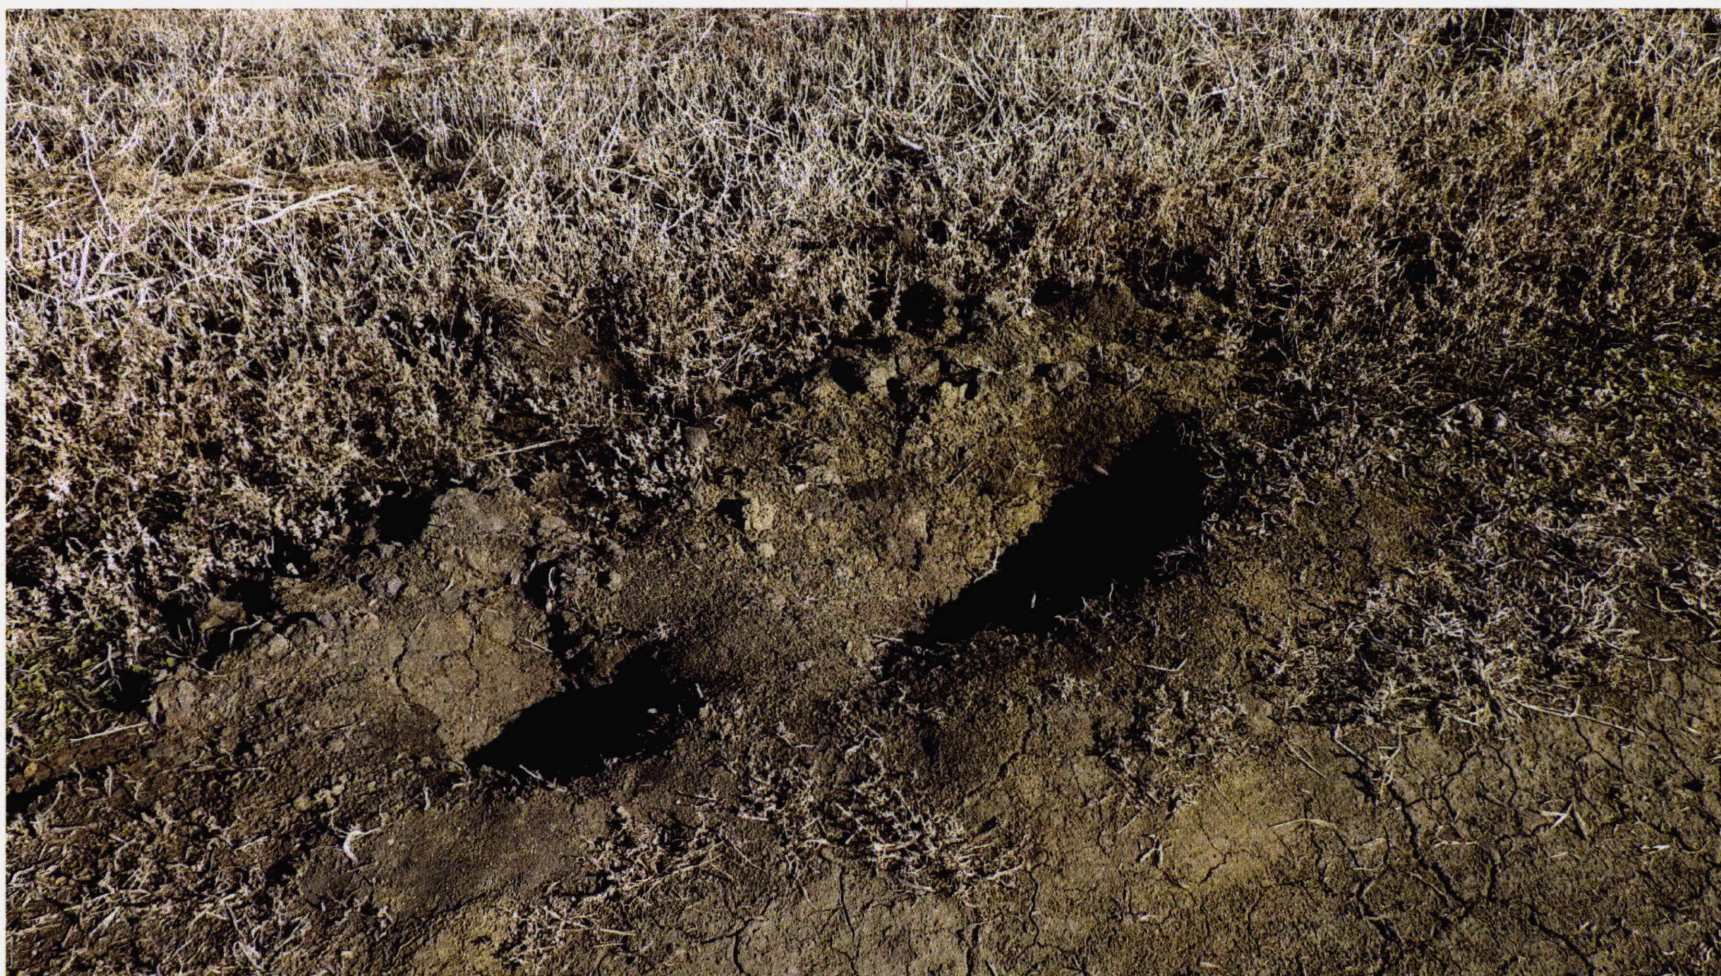
Photo 11

Description: Animal burrows on north side of the dike north of the Northeast lagoon.

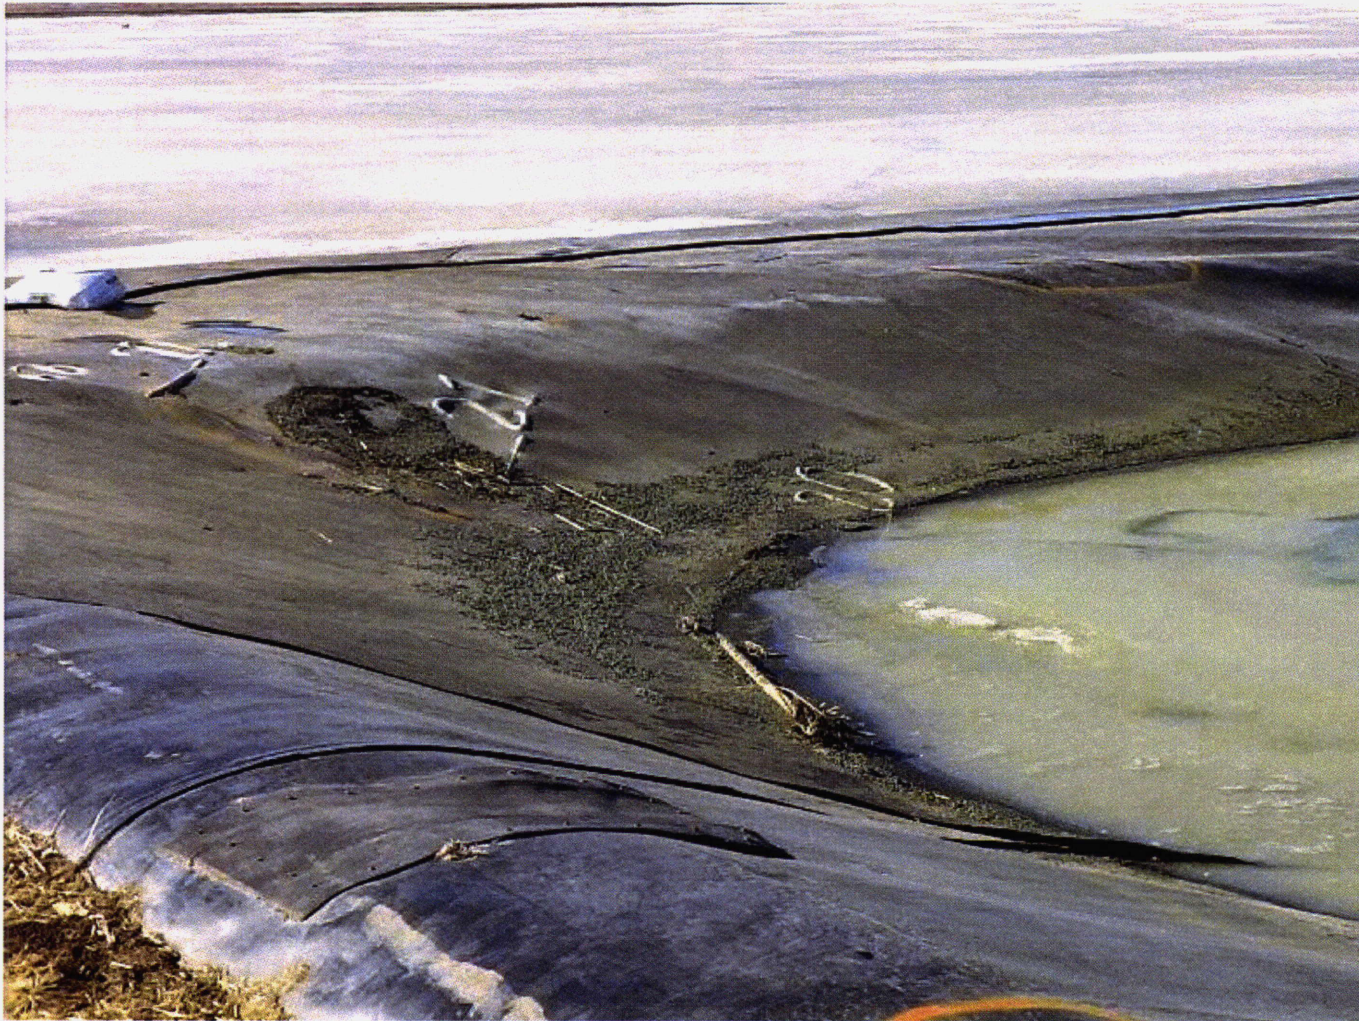
Photo 12

- From a visual observation, the depth of the Northeast lagoon appeared to be about 20 feet, based on the depth marker (Photo 12). The maximum depth (top of berm), based on the depth marker, is 22 feet. Thus, there was about 2.0 feet of freeboard observed in the Northeast lagoon.

Description: Depth marker for the Northeast lagoon (Southeast corner). The water level appears to be at about 20 feet (number at top of dike is 22 feet).

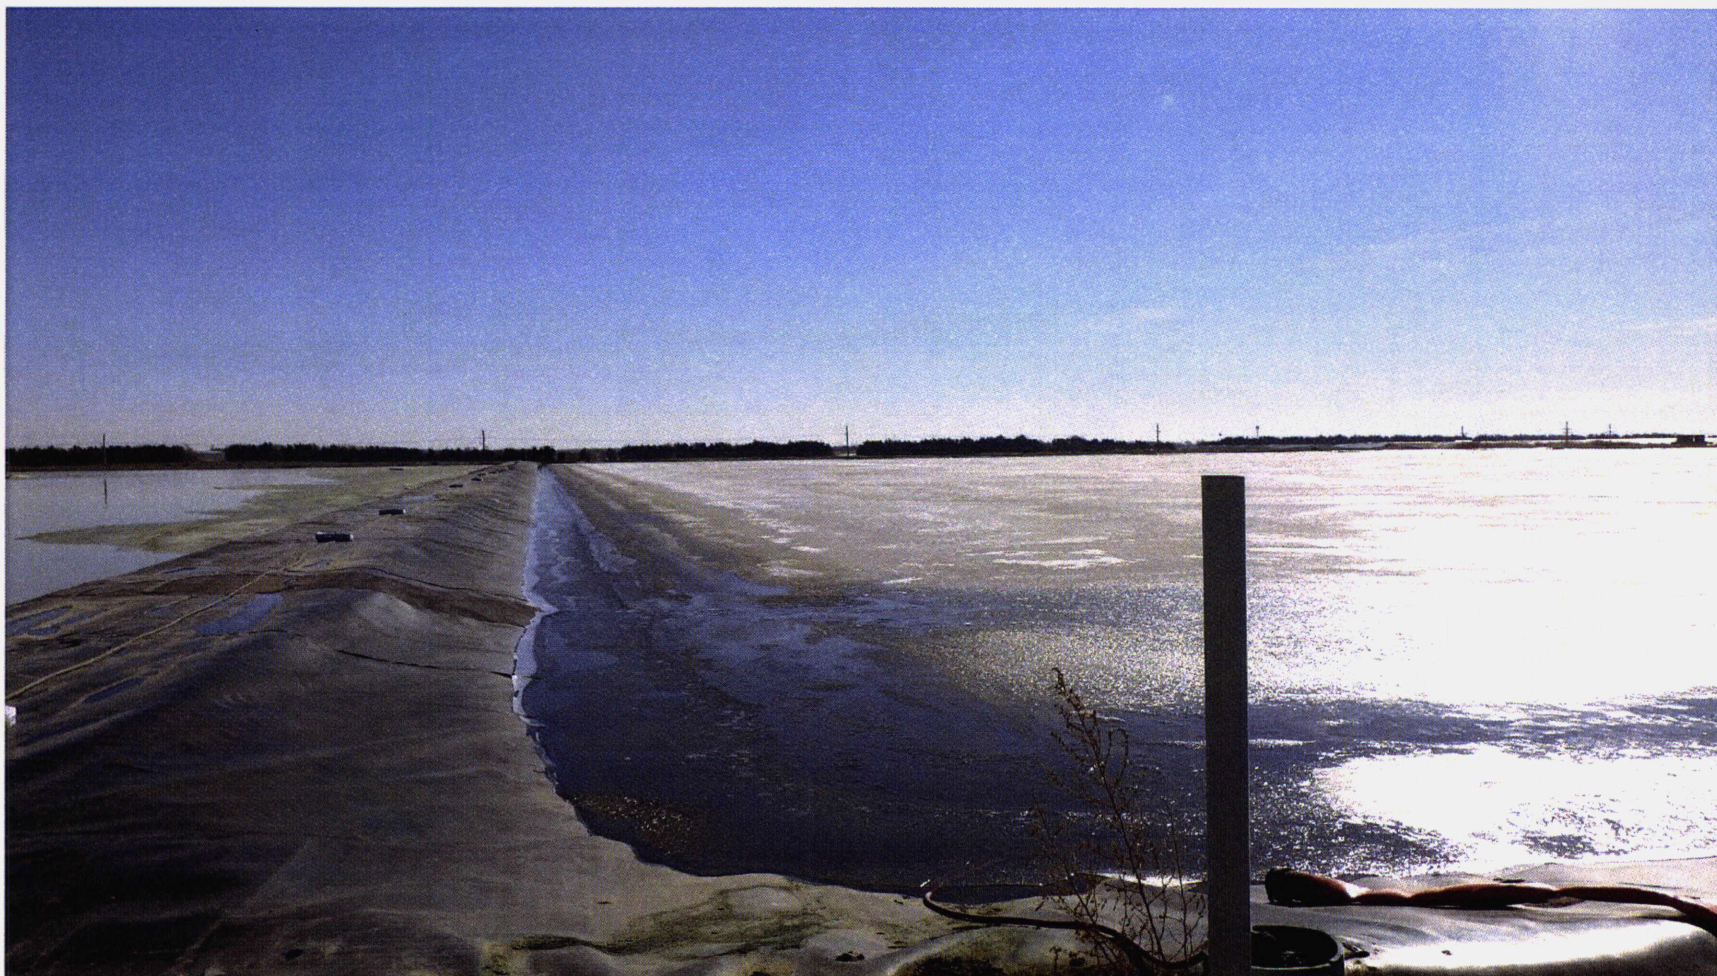
Photo 16

Description: Overflow pipe entering the Southeast lagoon (right) from the Northeast lagoon (left). The overflow pipe in the Southeast lagoon is submerged.

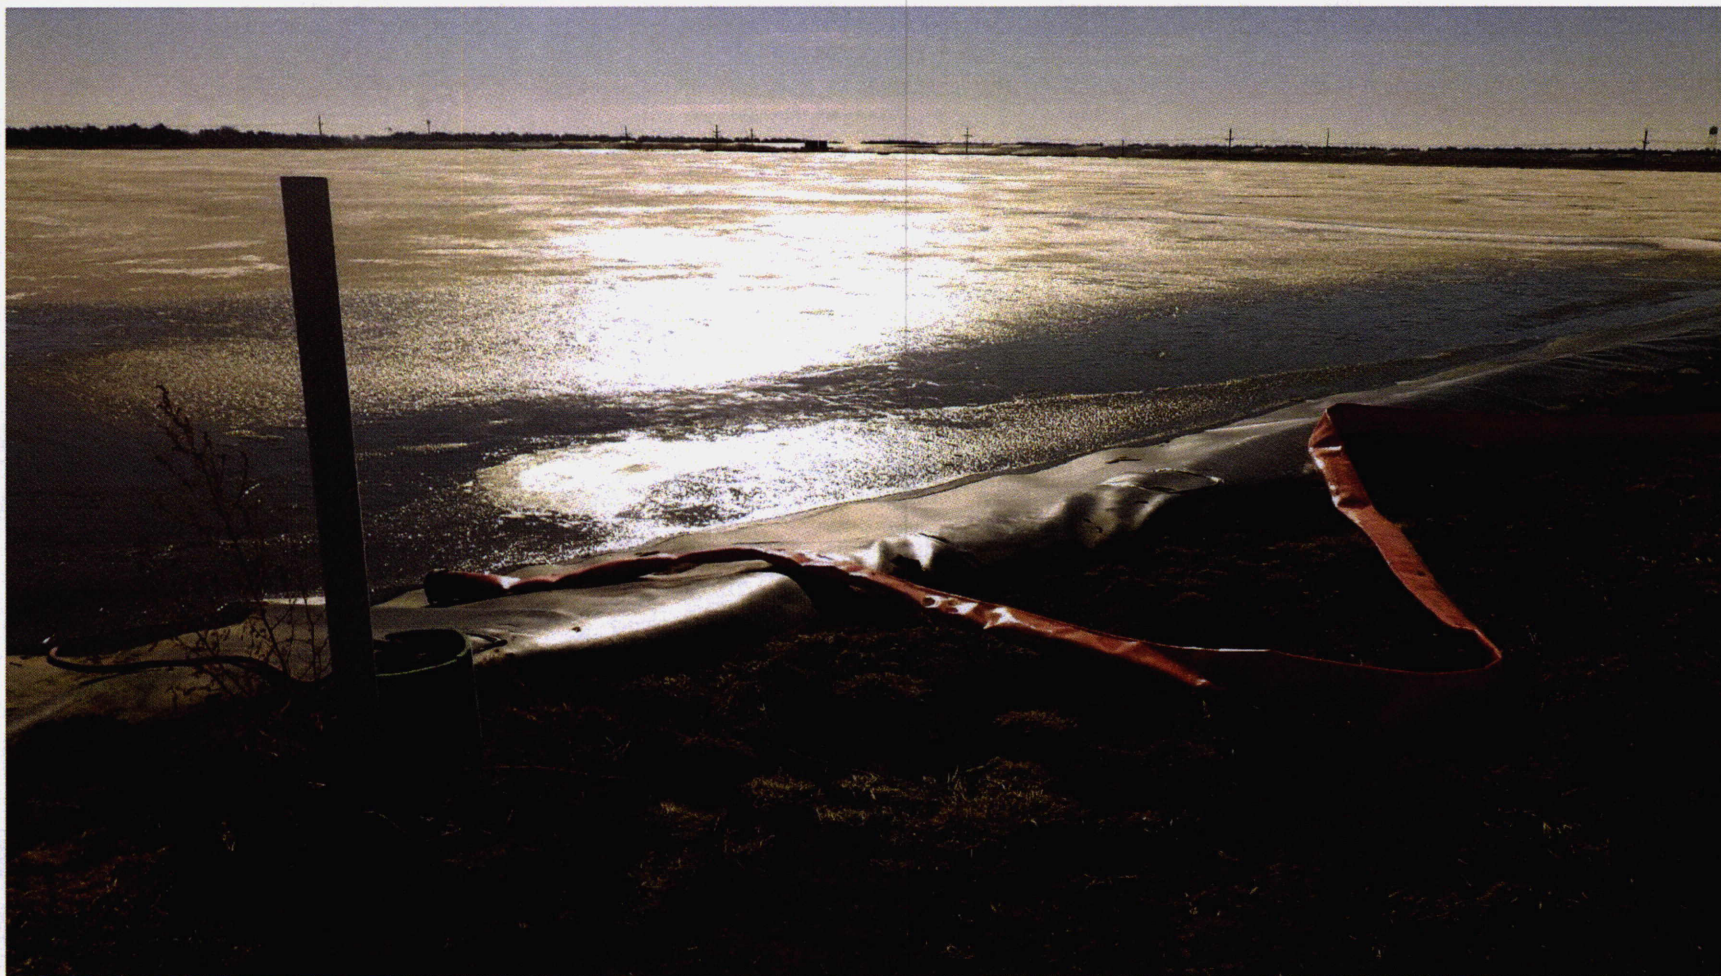
Photo 17

Description: Hose that was used to pump wastewater into the Southeast lagoon. No wastewater was observed being pumped into the lagoons during the site visit.

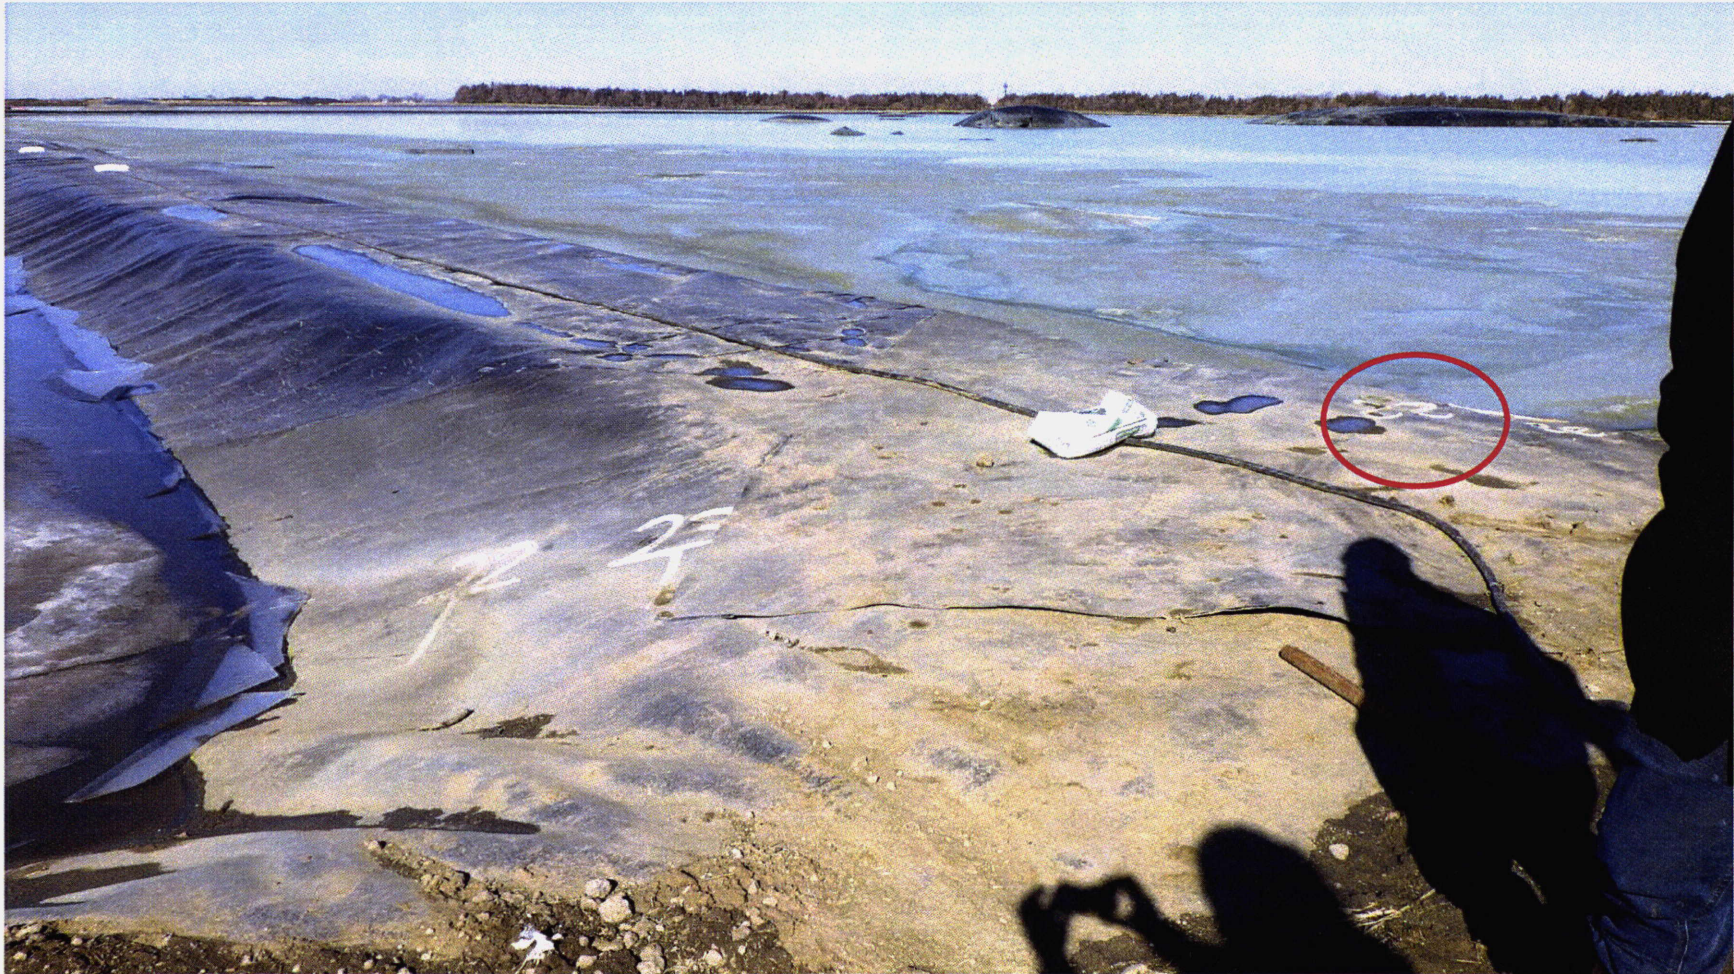
Photo 18

- From a visual observation, the depth of the Southeast lagoon appeared to be a little over 21 feet, based on the depth marker (Photos 18 and 19). The maximum depth (top of berm), based on the depth marker, is 23 feet. This provides about 1.8 feet of freeboard. According to information obtained from plans and specifications for the addition of the Northwest lagoon (Document ID 20180034184), the maximum depth of the Southeast lagoon is 22 feet. The reason for the variation between the Southeast lagoon depth marker

and the referenced engineering document is unclear. Regardless, there was about 1.8 feet of freeboard observed in the Southeast lagoon.

Description: Depth marker for the Southeast lagoon (northeast corner). The water level appears to be a little over 21 feet (based on depth marker numbers). According to the depth marker, the maximum depth is 23 feet, which means there is a little less than 2 feet of freeboard. According to the depth marker, the maximum depth for the Northeast lagoon is 22 feet. This number can be seen in this photo, as well (circled in red).

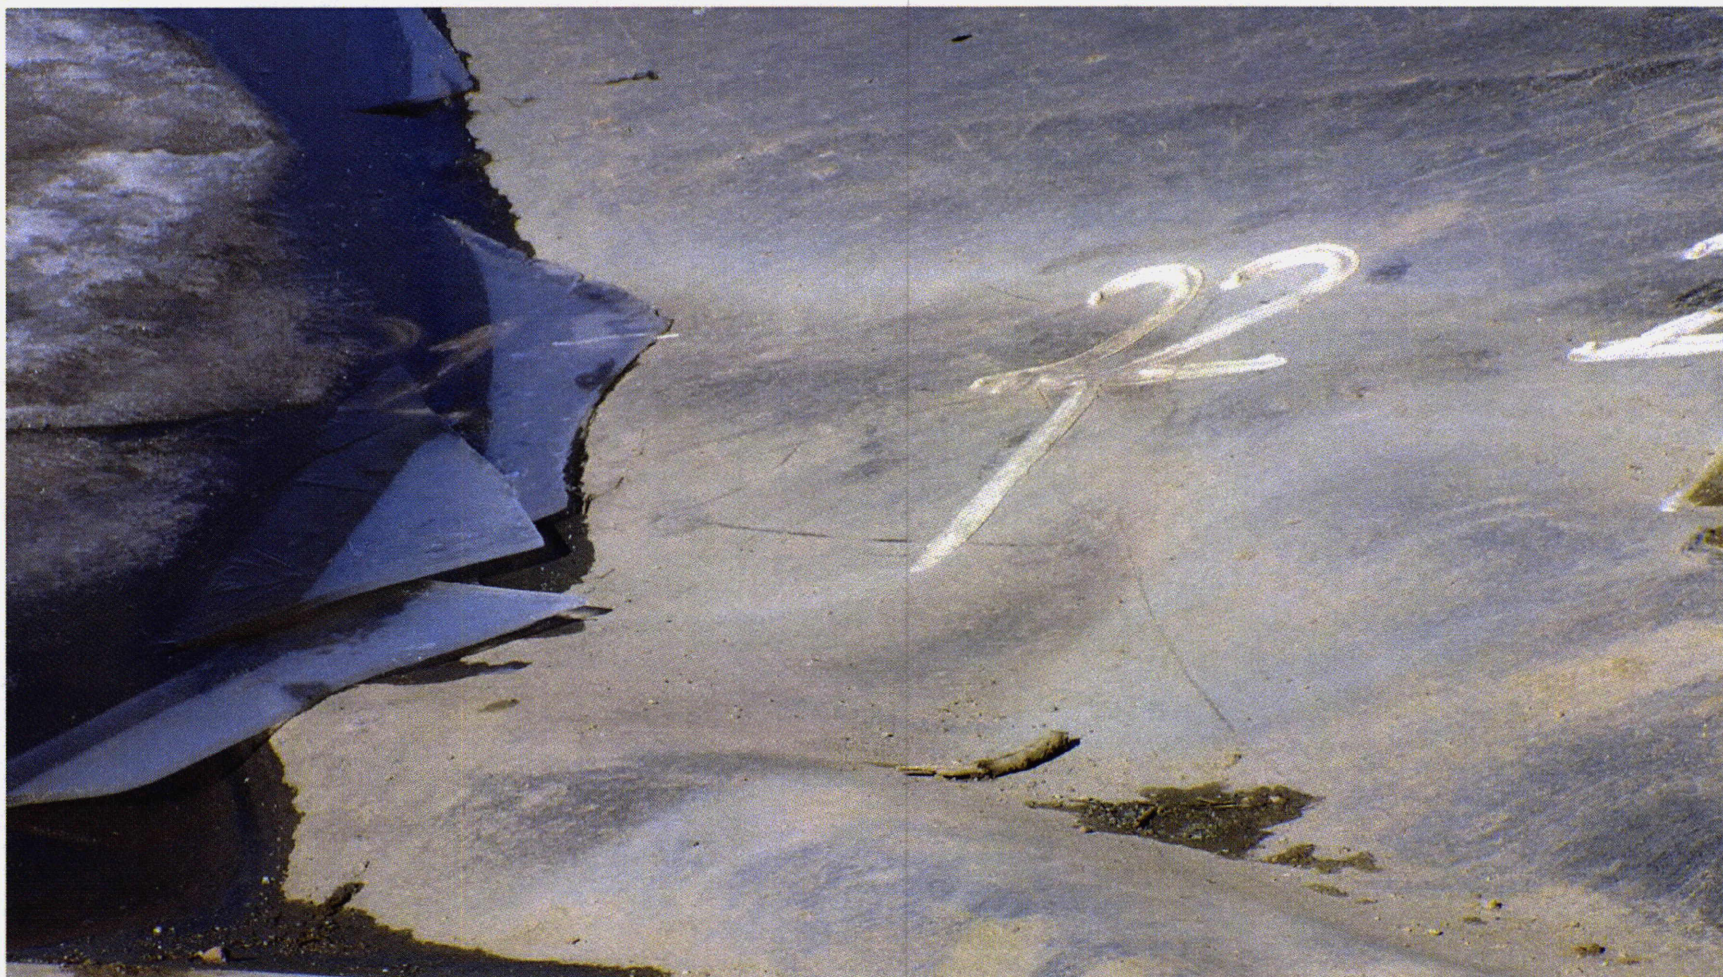
Photo 19

Description: Depth marker for the Southeast lagoon (northeast corner). The water level appears to be a little over 21 feet (based on depth marker numbers).

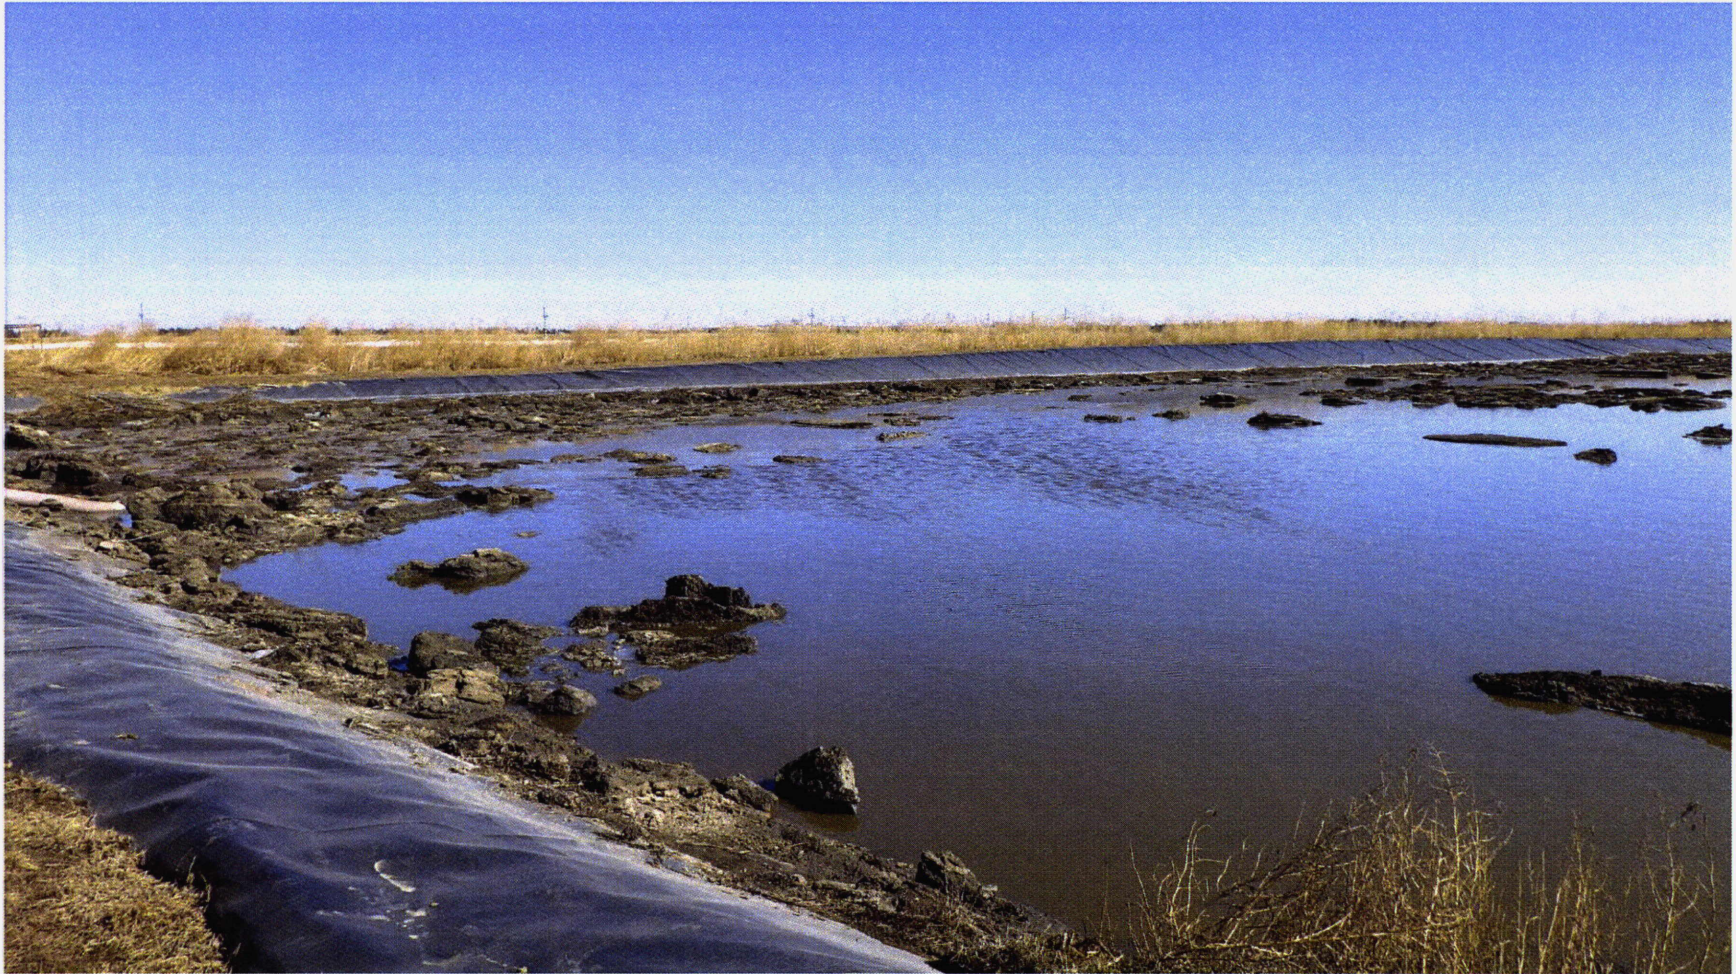
Photo 22

Description: Overview of the emergency overflow lagoon. Excavated soil/ice are floating in the lagoon from the spill.

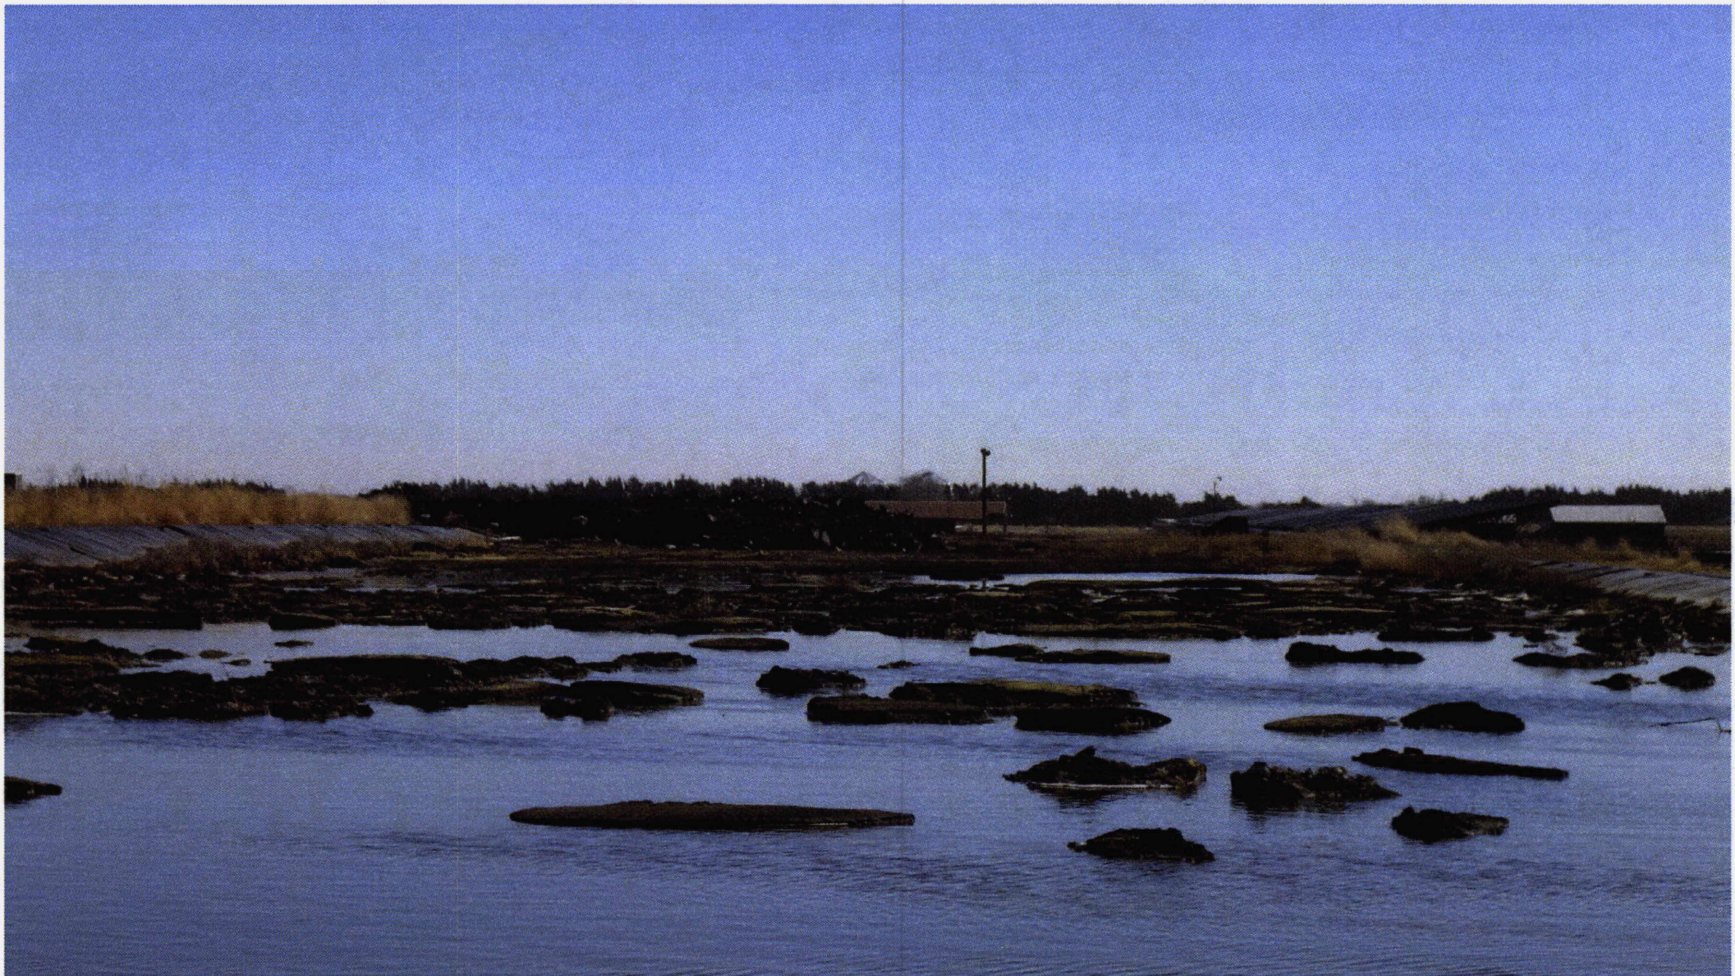
Photo 23

- There is a stockpile of ice and soil that were excavated as part of the spill clean-up process on the east side of the emergency overflow lagoon (Photos 23 and 27).

Description: Overflow of the emergency overflow lagoon. Excavated soil/ice are floating in the lagoon from the spill.
