## Nebraska Department of Environment and Energy (NDEE)

### MEMORANDUM

**RE:** AltEn, LLC

**Subject:** Site Visit Report (Wastewater Aspects Only)

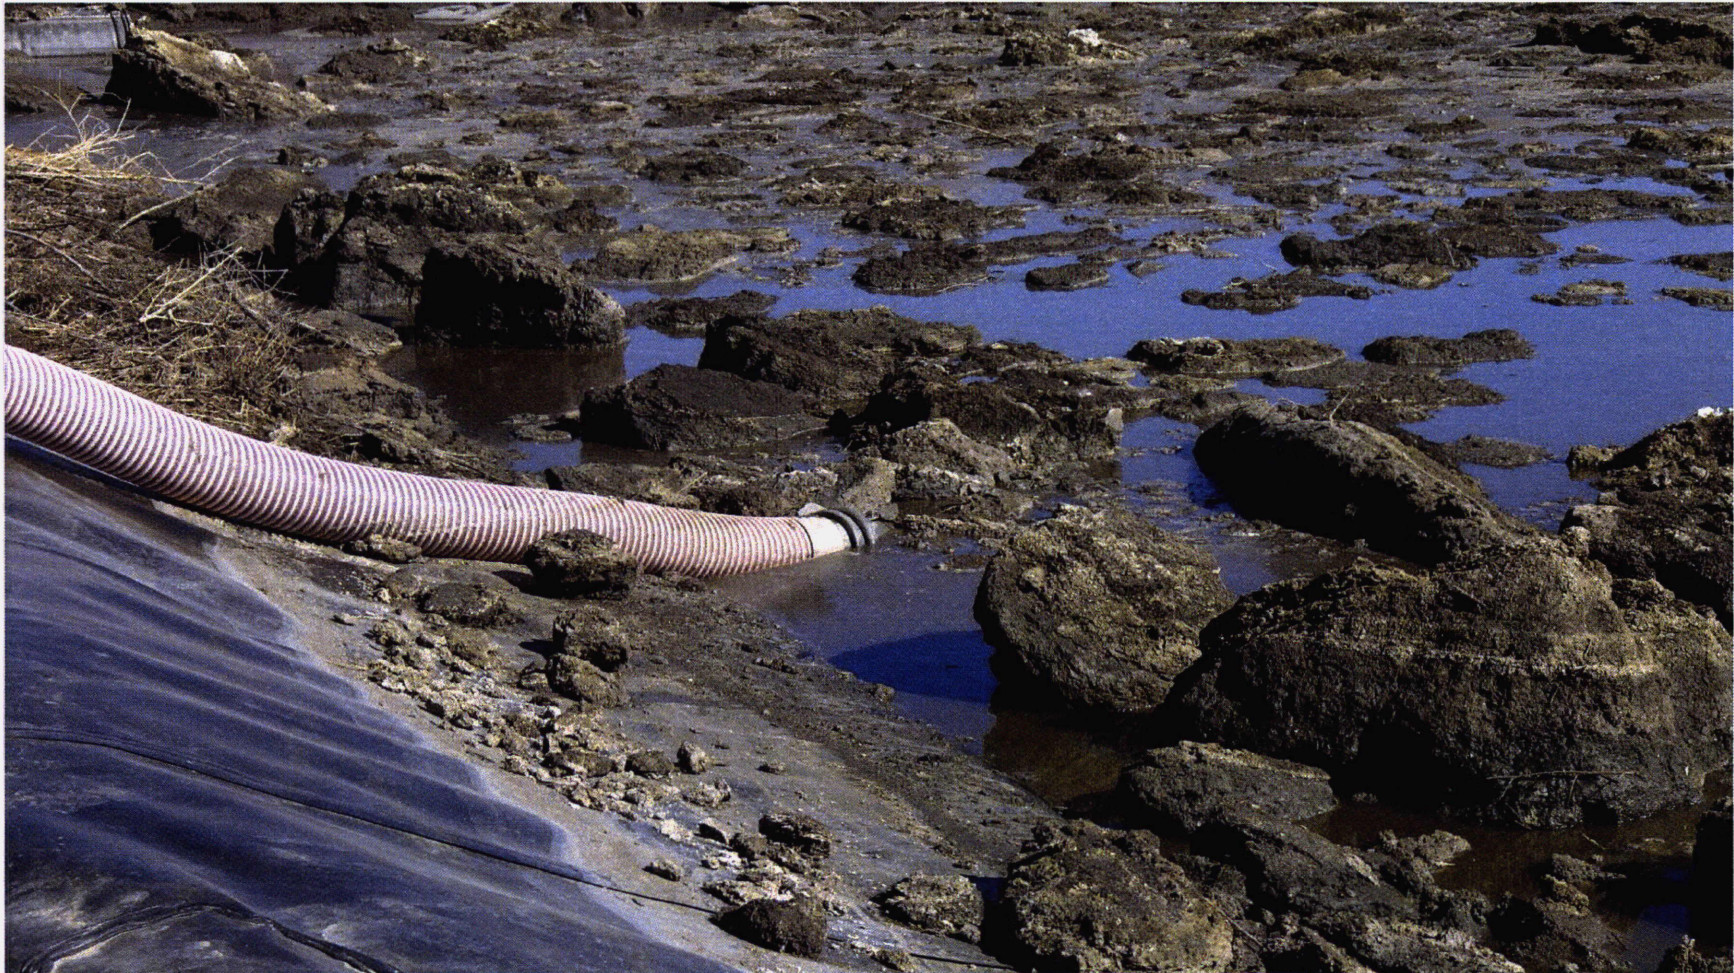
Photo 24

- The facility is currently pumping wastewater from the emergency overflow lagoon to a portable filtration unit provided by Clean Harbors. This water is then being stored in a portable holding structure. It was confirmed that this is what was occurring during the March 2, 2021 site visit via a phone call with Mr. Scott Tingelhoff and Mr. Ken Peterson on March 3, 2021 (Photos 24-26).

Description: Suction end of pump that appeared to be pumping wastewater from the emergency overflow lagoon to a portable filtration treatment system (Photo 25) and a portable holding tank (Photo 26).

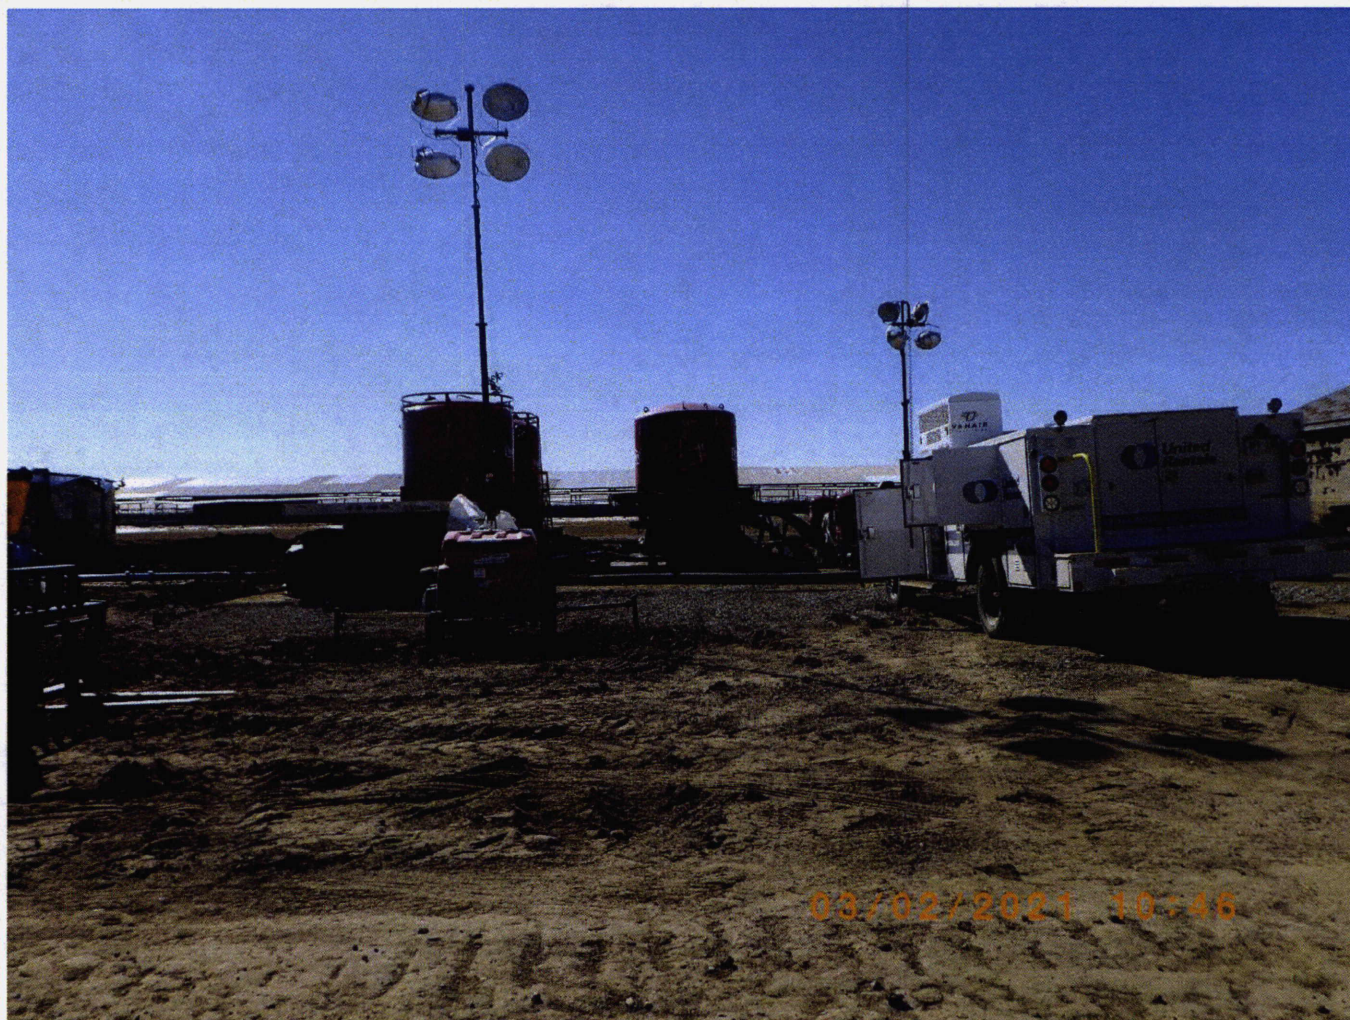
Photo 25

Description: Portable filtration treatment system provided by Clean Harbors.

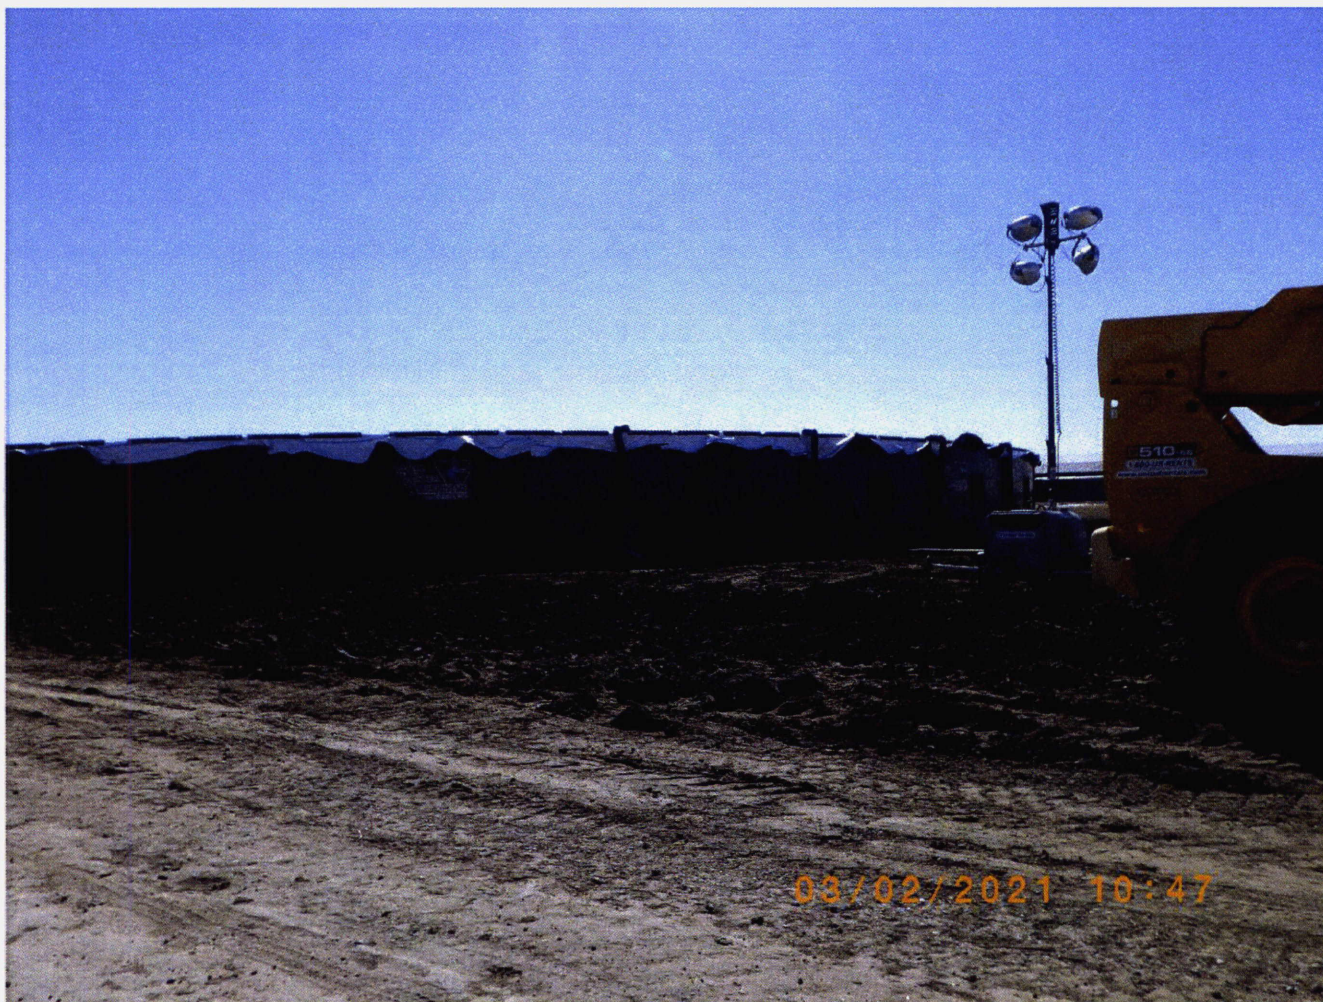
Photo 26

Description: Temporary wastewater holding tank provided by Clean Harbors.

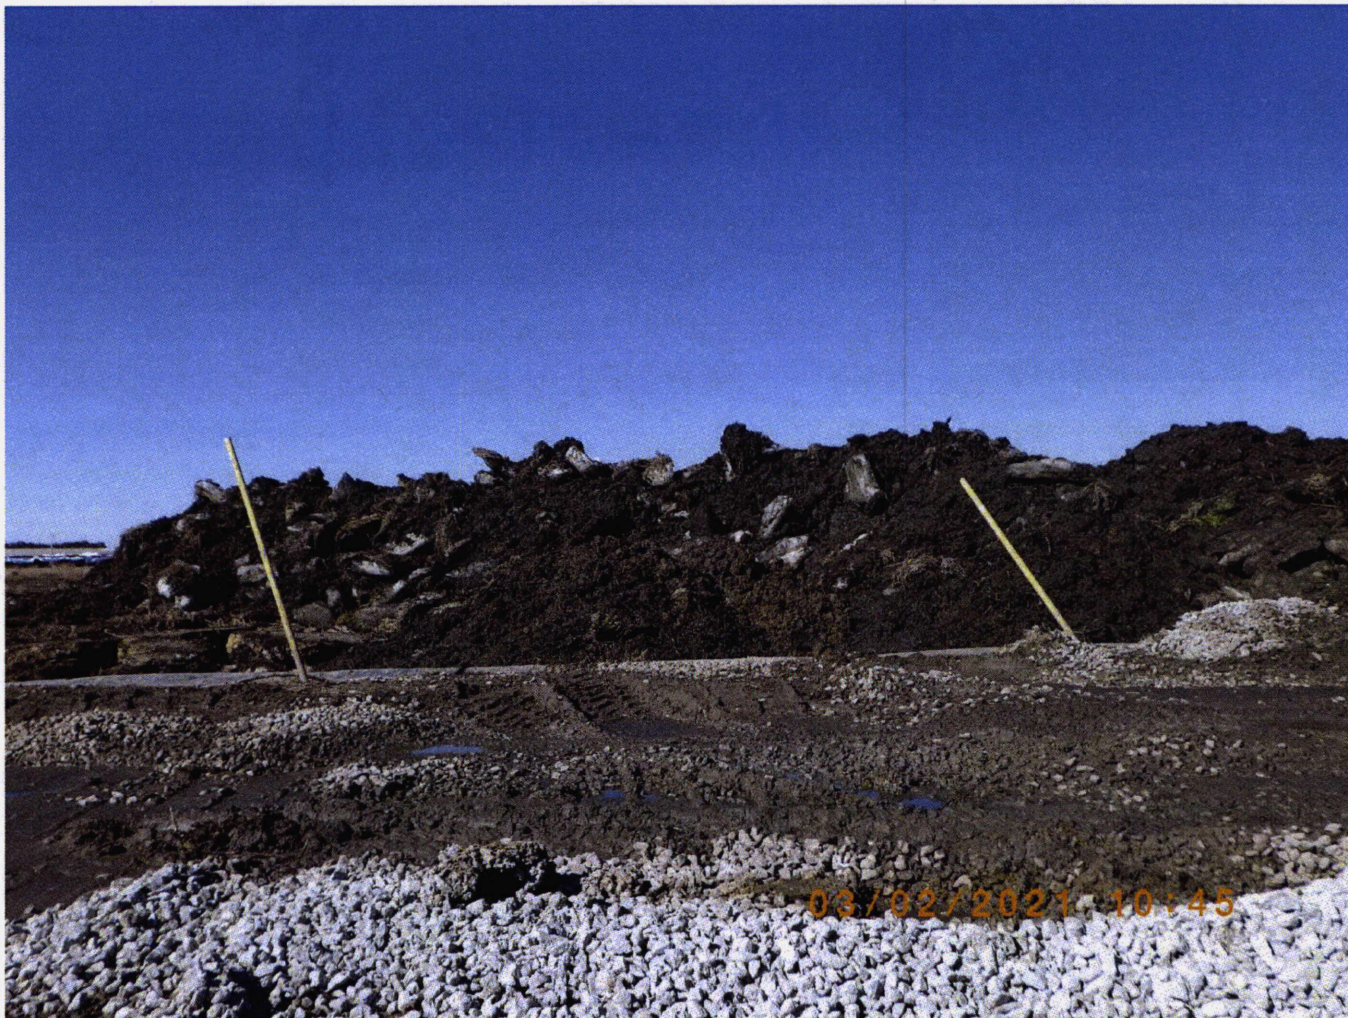
Photo 27

- There is a stockpile of ice and soil that were excavated as part of the spill clean-up process on the east side of the emergency overflow lagoon (Photos 23 and 27).

Description: Pile of ice/soil excavated from the spill. This pile is on the east side of the emergency overflow lagoon.
