AltEn Field Observations

March 3, 2021

NDEE

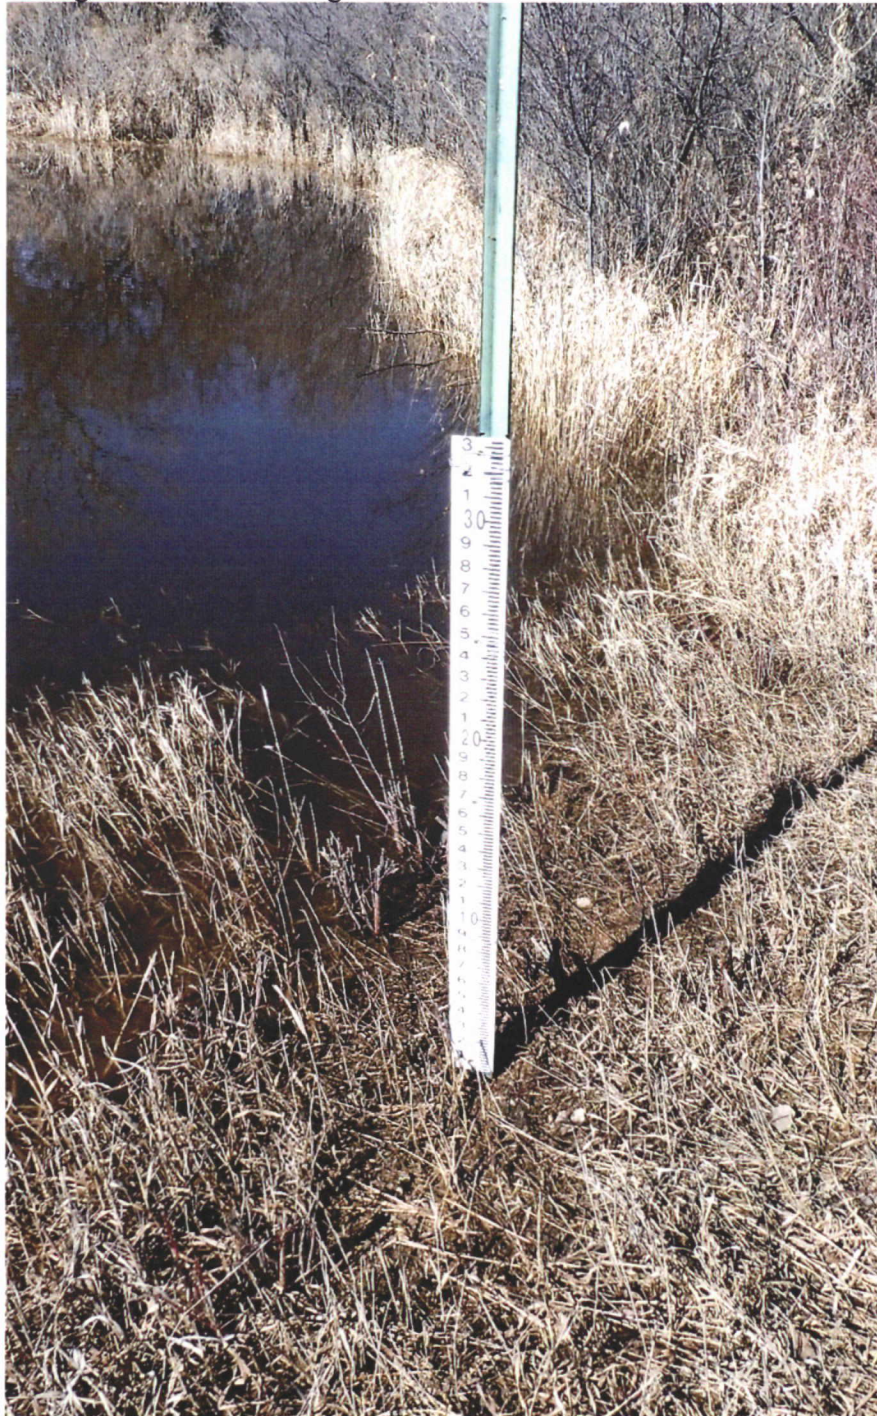
Gage staff installed on March 2, 2021, at water's edge on the surface. Water level had dropped over night and was receding.

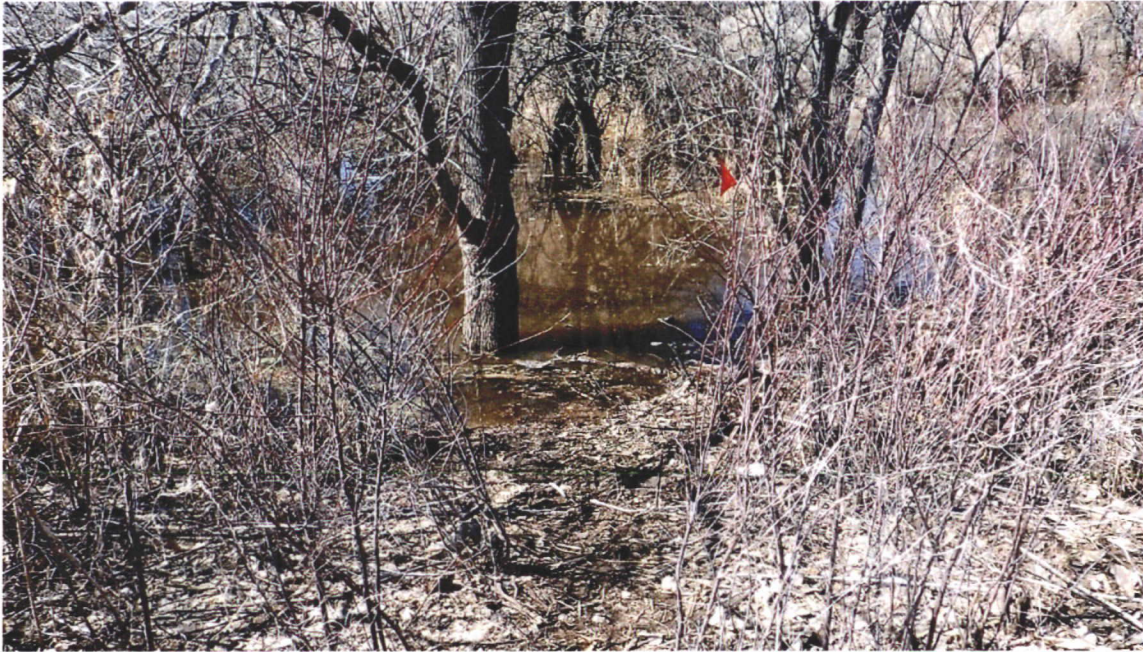
Site 3, west side of Highway 66, facing west. Cement culvert is under water between the larger tree and under the orange flag. AltEn employee collected sample at this location. Water temperature: 3.7 degrees C, Dissolved oxygen: 1.4 mg/l, pH: 7.6 St.Units, Conductivity: 472 Umhos/cm, Turbidity: 30.4 NTU's, Dissolved oxygen (percent saturation) 9 percent. Air temperature: 64 degrees F, clear, calm.

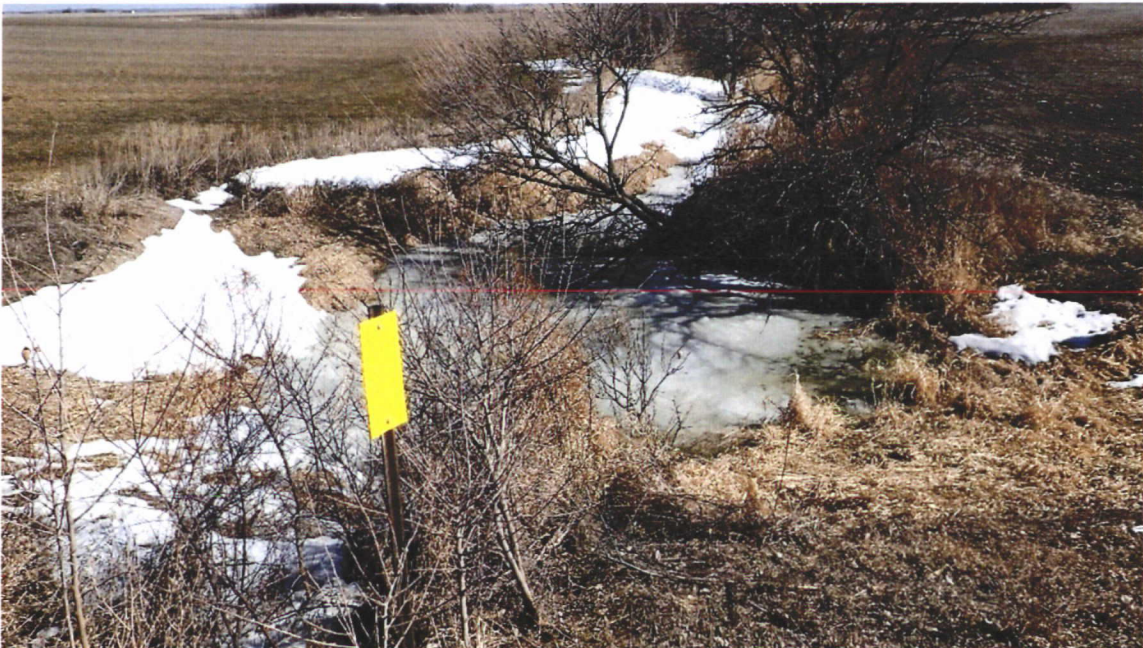
Site 3, east side of Highway 66 facing east. Note the plunge pool and stream are still frozen.

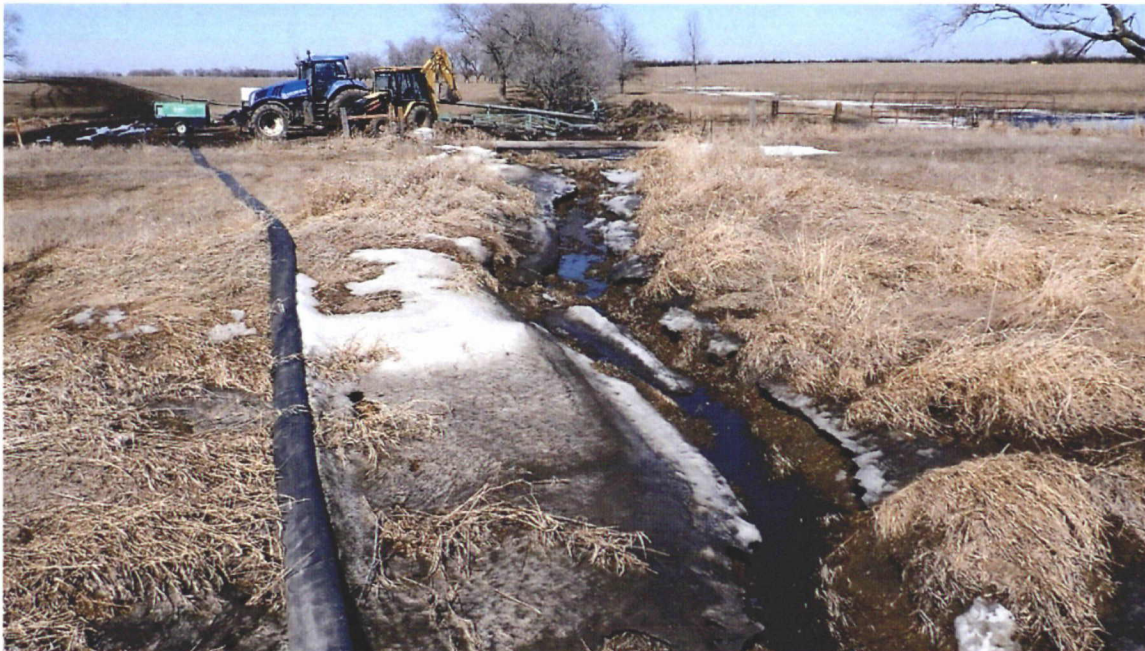
This site is just above Site 3 on the north side of Highway 66. Green device from the back of the tractor is an agitator designed to stir up the water so the pump doesn't become plugged with debris. Agitator is attached to the PTO from the blue tractor. The yellow backhoe is used to maintain a small berm. The berm is used to back up the stream which makes it possible for the pump to have enough water to pump out of. Note collapsed flexible tubing going north and south on left side of photo. This was installed in the event that site 3 had to be pumped. An AltEn employee collected a sample in a pool above the agitator. Water temperature: 0.6 degrees C, Dissolved oxygen: 7.0 mg/l, pH: 7.7 St.Units, Conductivity: 358 Umhos/cm, Turbidity: 37.2 NTU's, Dissolved oxygen (percent saturation) 48 percent.

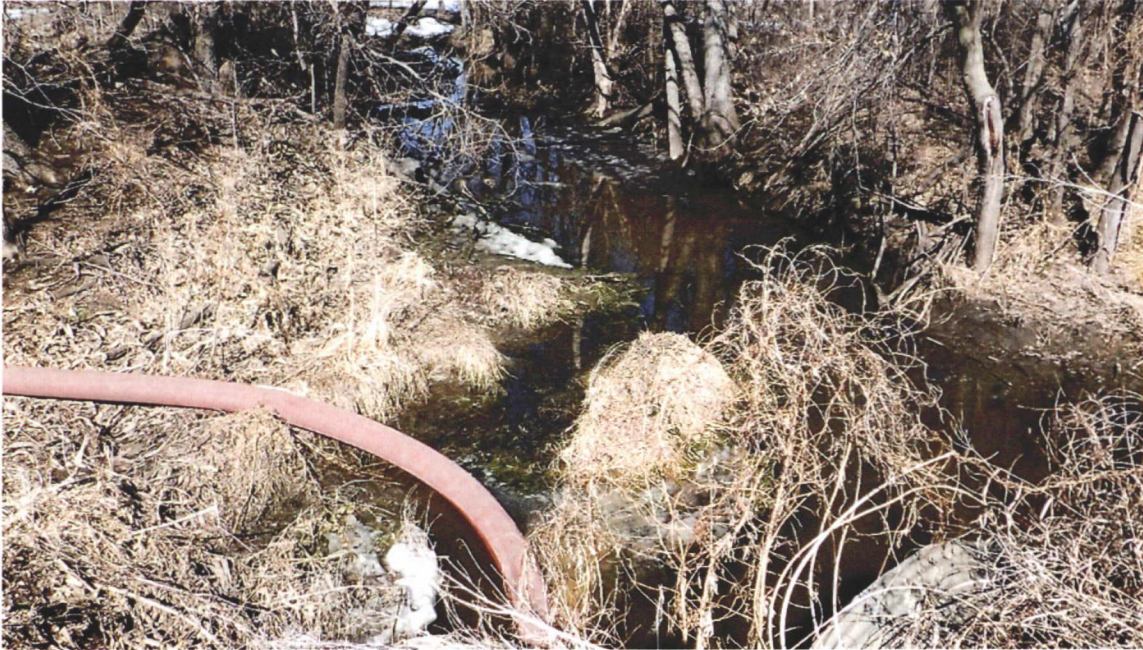
This site is 0.3 miles east of Roads 8 and H facing north. An AltEn employee collected a water sample at this location. Water temperature: 2.0 degrees C, Dissolved oxygen: 1.9 mg/l, pH: 7.9 St.Units, Conductivity: 668 Umhos/cm, Turbidity: 40.6 NTU's, Dissolved oxygen (percent saturation) 14 percent. Red hose, bottom left-hand corner of photo, is from the area where the previous photo was from. Water is being pumped to the AltEn facility.

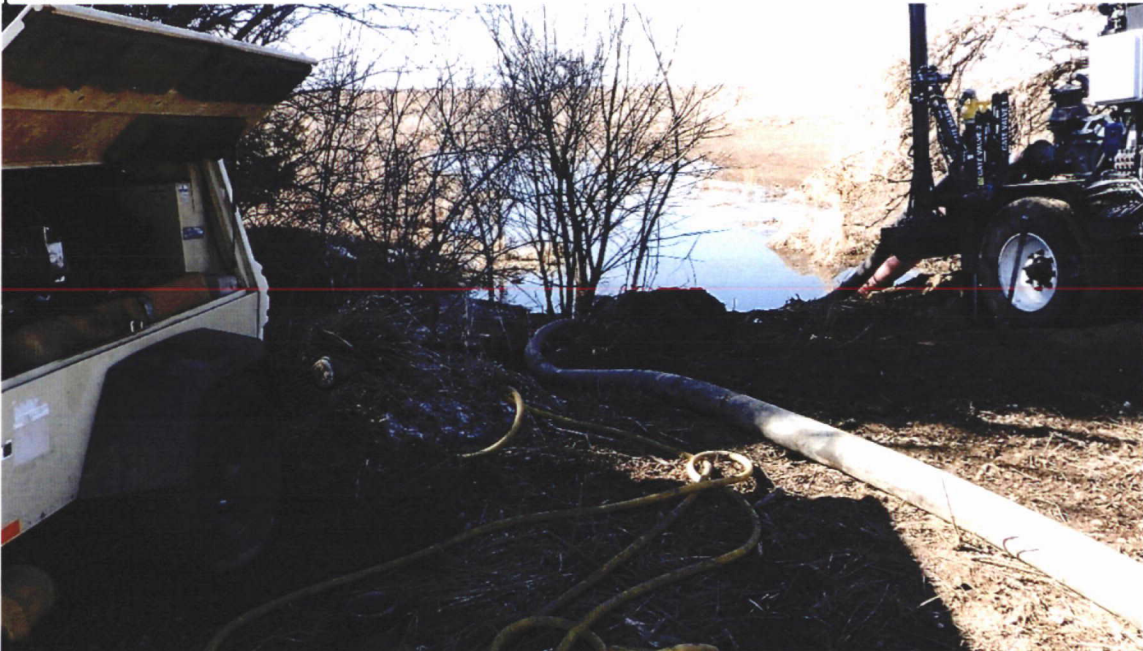
Site 5 facing west. An AltEn employee collected a water sample at this location. Water temperature: 5.6 degrees C, Dissolved oxygen: 1.6 mg/l, pH: 7.7 St.Units, Conductivity: 1,026 Umhos/cm, Turbidity: 102 NTU's, Dissolved oxygen (percent saturation) 12 percent.

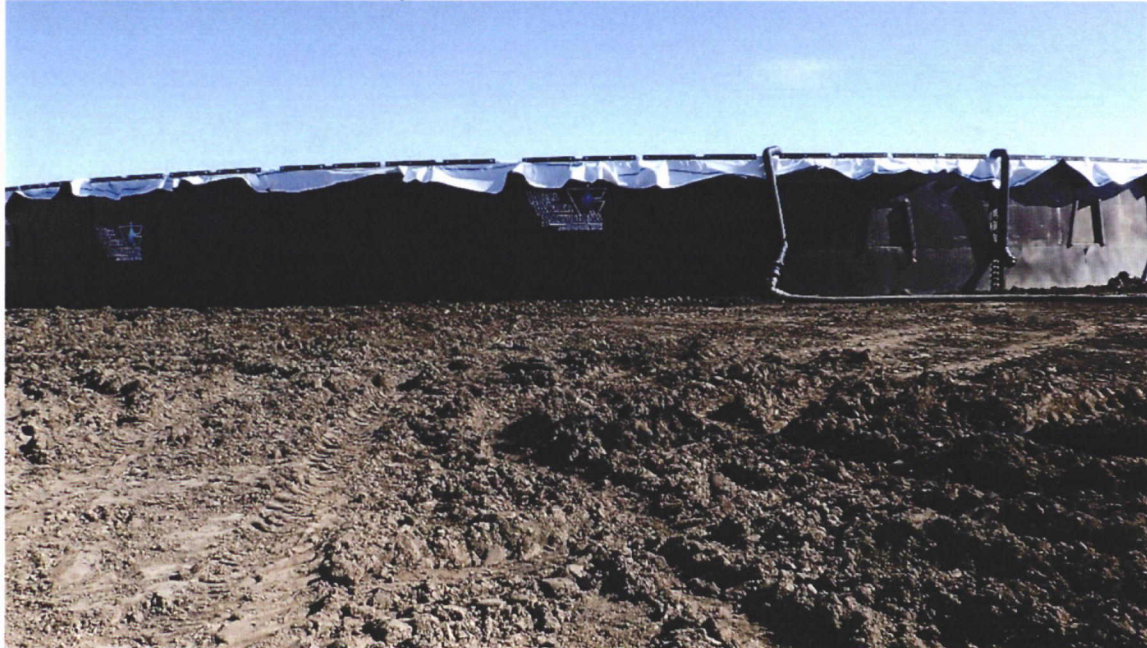
Treated water containment structure on the AltEn property. Structure is just to the south of the large lagoon which is located just on the east side of the digester which was compromised. Note: Tube towards the right side of the photo transfers treated water from Clean Harbors treatment facility into the containment structure.

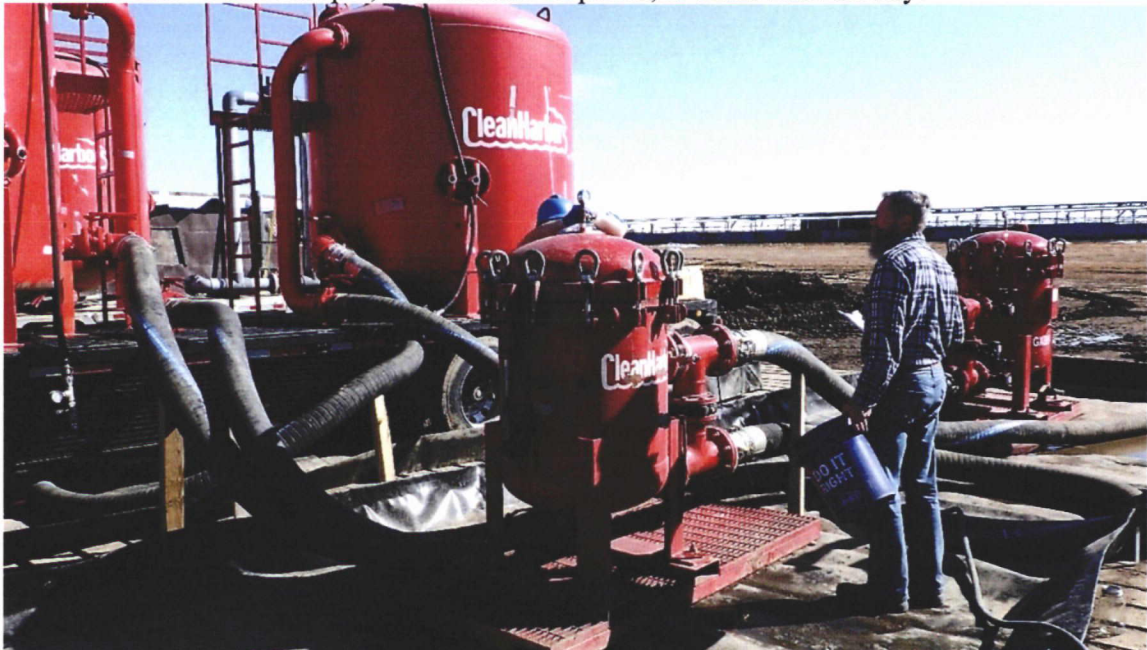
Clean Harbors water treatment equipment at the AltEn facility. Water sample is being collected by an AltEn employee towards the center of the photo. Employee is wearing blue hard hat. Water sample, near middle of photo, is somewhat cloudy.

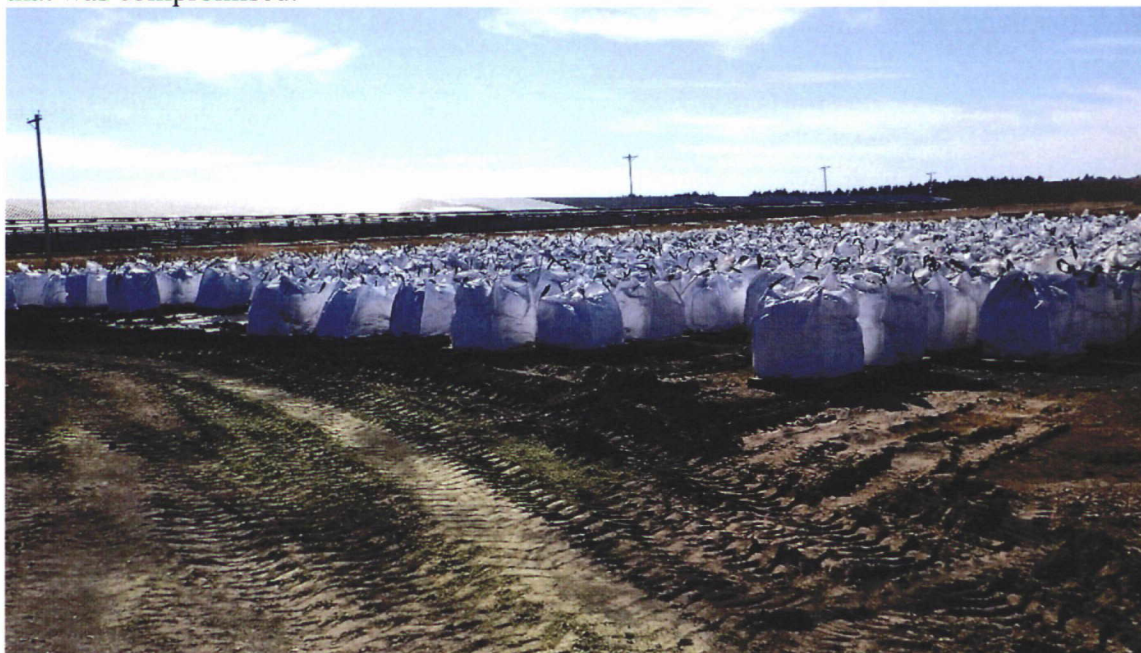
Large bags of Bio Char being stored at the AltEn facility. These are located across a dirt road, which runs through the facility, and are to the south and southwest of the digester that was compromised.

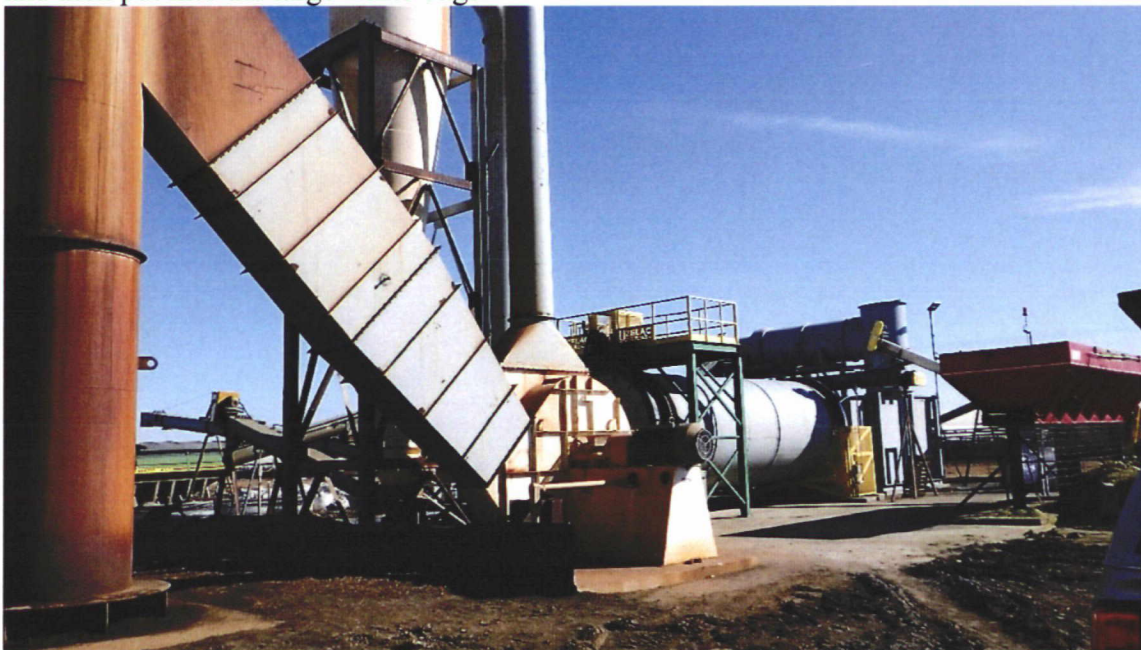
Furnace and tumbler where Bio Char is made and put into the large white bags. On the right side of the photo is the hopper where wet cake is dumped into with a front-end loader. The wet cake goes through the tumbler and furnace where it is heated and dried and then put into the large white bags.

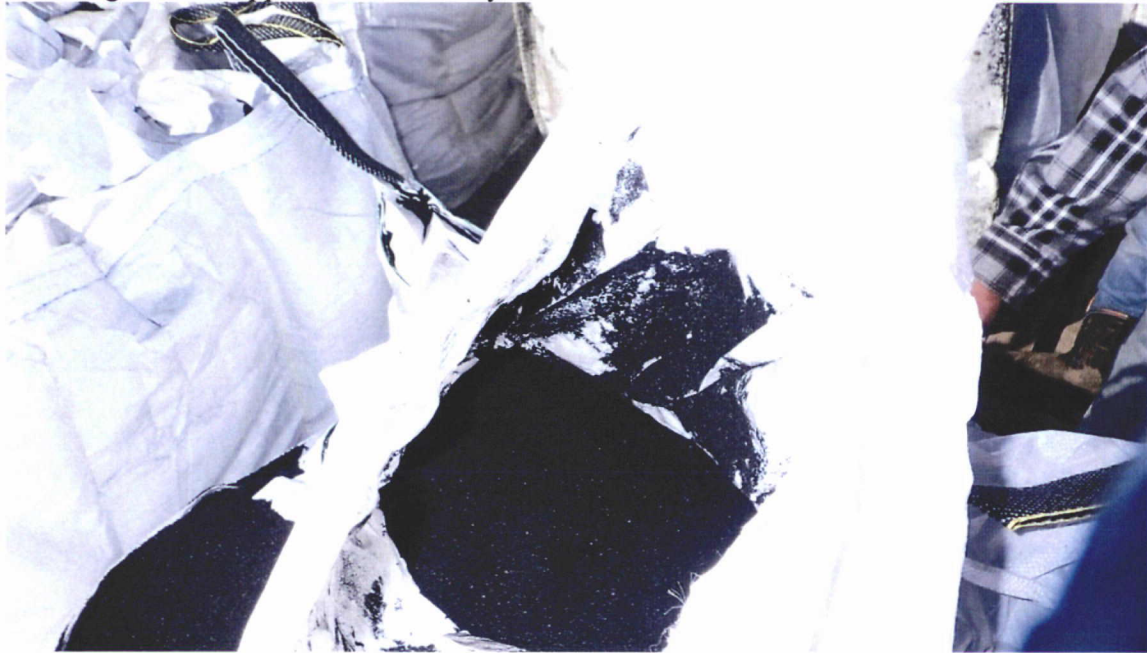
Close-up of Bio Char in a large white bag. Finished product looks similar to coffee grounds. A composite sample was collected in a Ziploc type bag from 5 different Bio Char bags to be shipped to a laboratory.

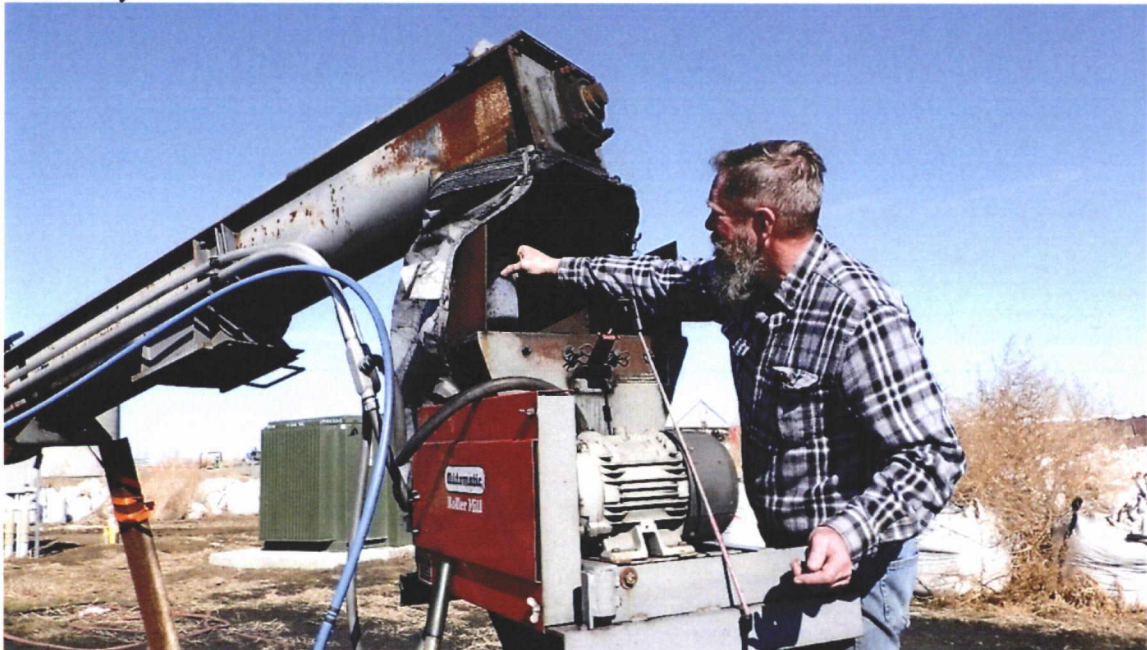
An AltEn employee collecting a sample of Bio Char in an NDEE supplied sample container. This was a second sample in addition to the sample collected from the large white bags. This sample was collected below an auger where product is being put into the large white bags. Sample was then transferred to a Ziploc type bag for shipping to a laboratory.

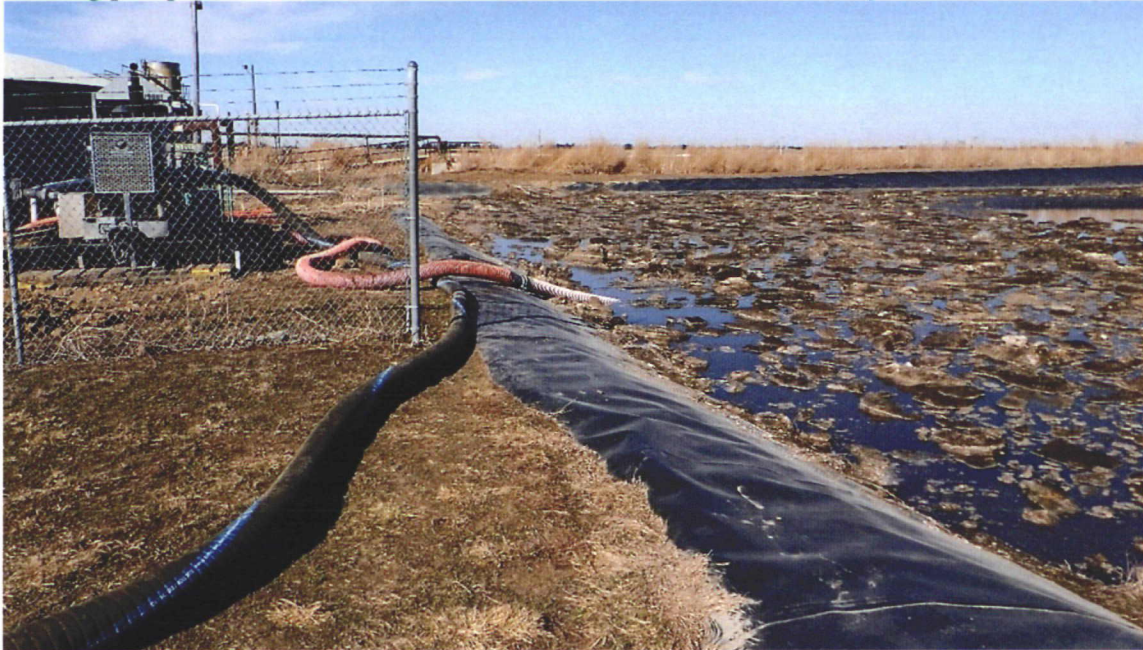
Emergency lagoon at the AltEn facility. Located directly east of the compromised digester. Note the pink/orange tube coming from the lagoon. Water from lagoon bottom is being pumped to the on-site Clean Harbors water treatment facility.

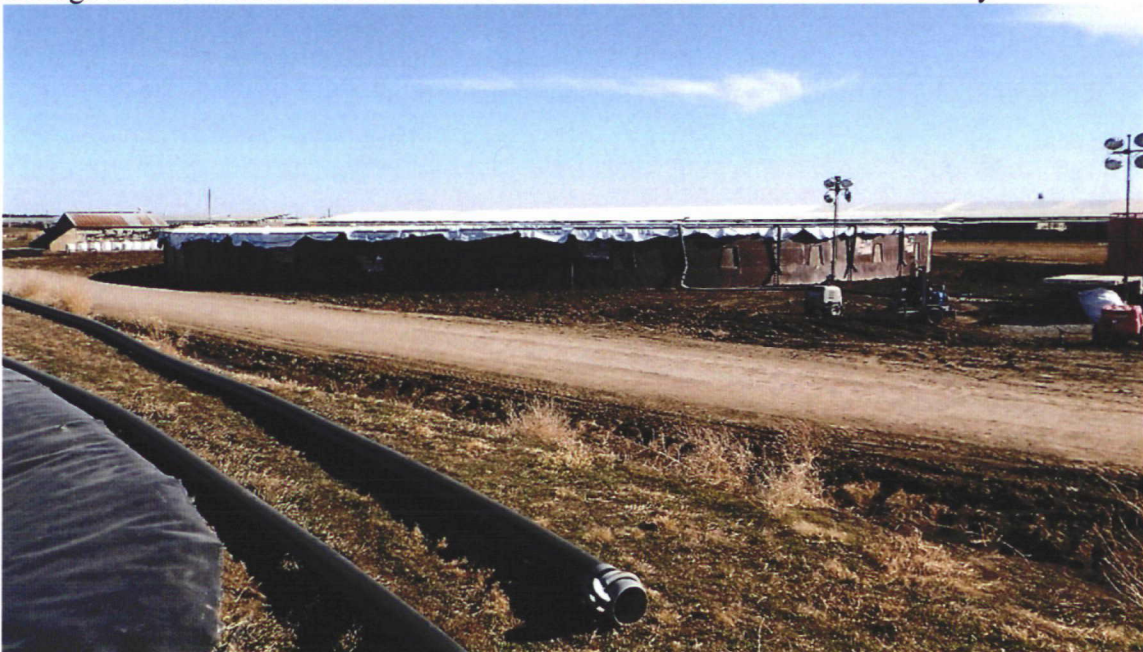
Storage tank for treated water from the Clean Harbors water treatment facility.

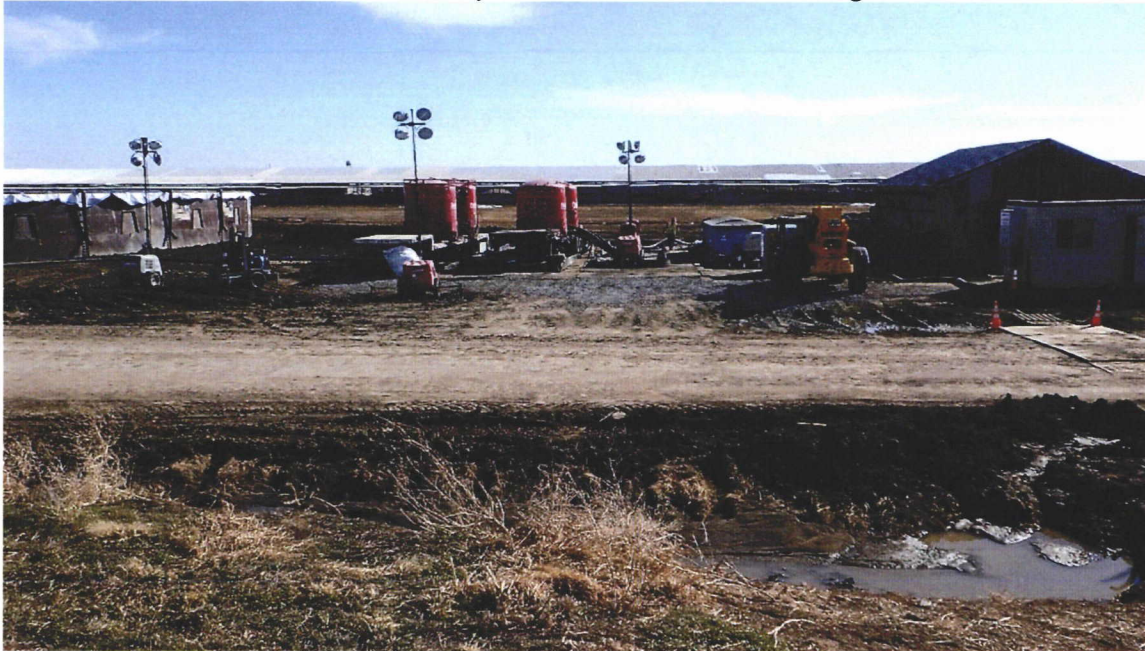
Clean Harbors water treatment facility next to treated water holding structure.

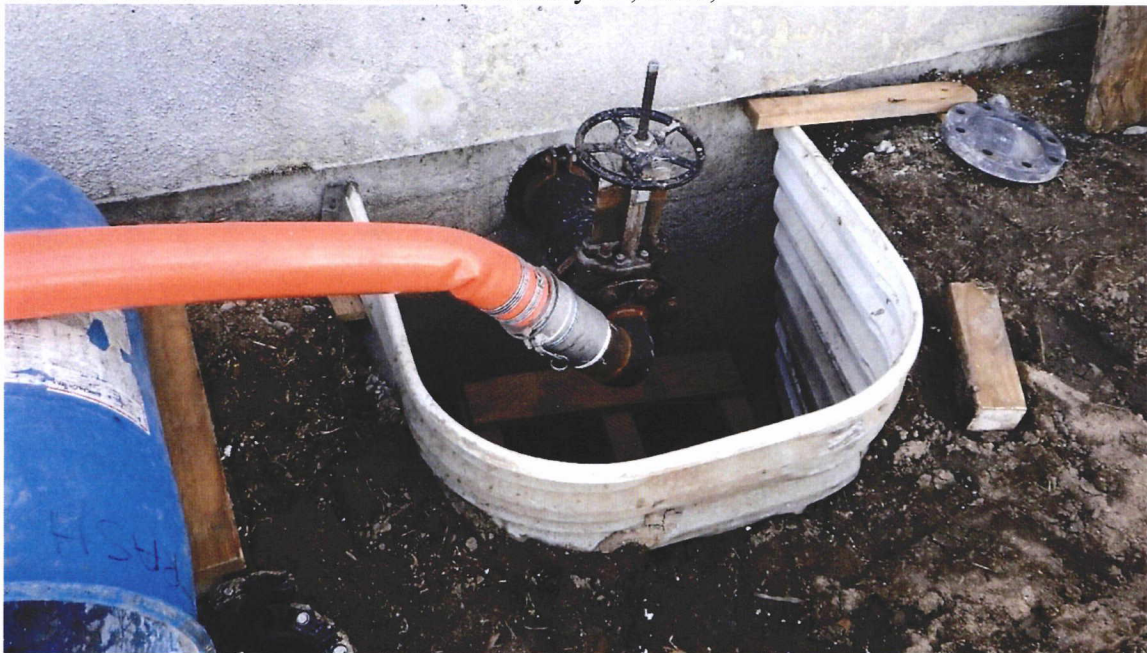
Tube from pump putting water from the lagoon back into the compromised digester. This is where the valve was that failed on February 12, 2021,

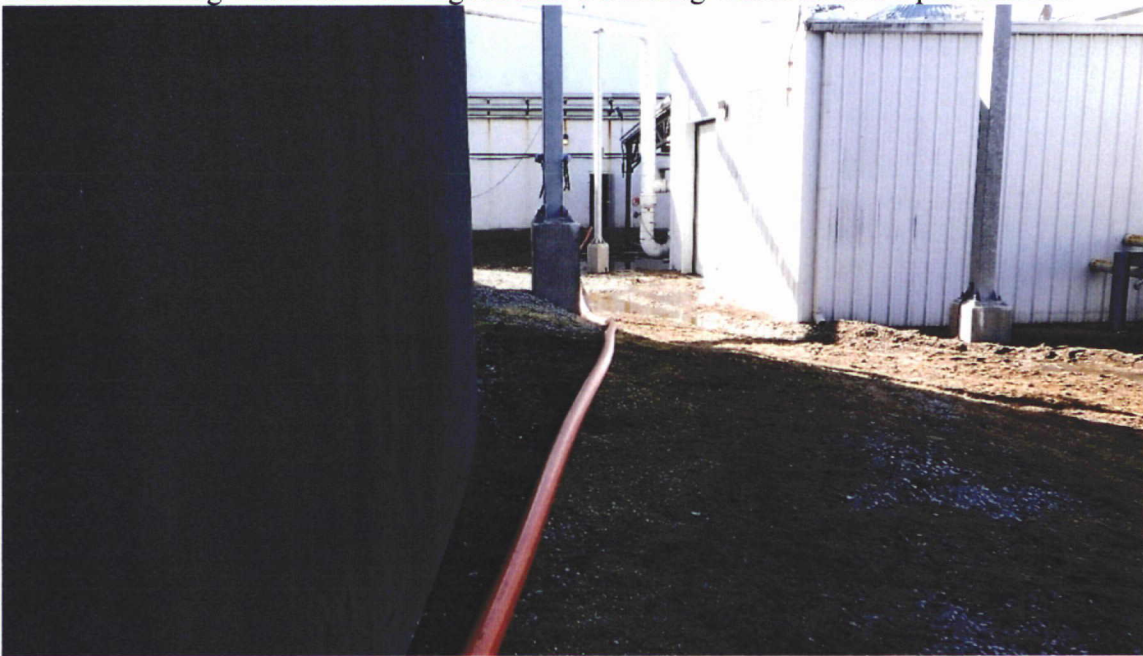
Tube transferring water from the lagoon into a building which houses a pre-clarifier.

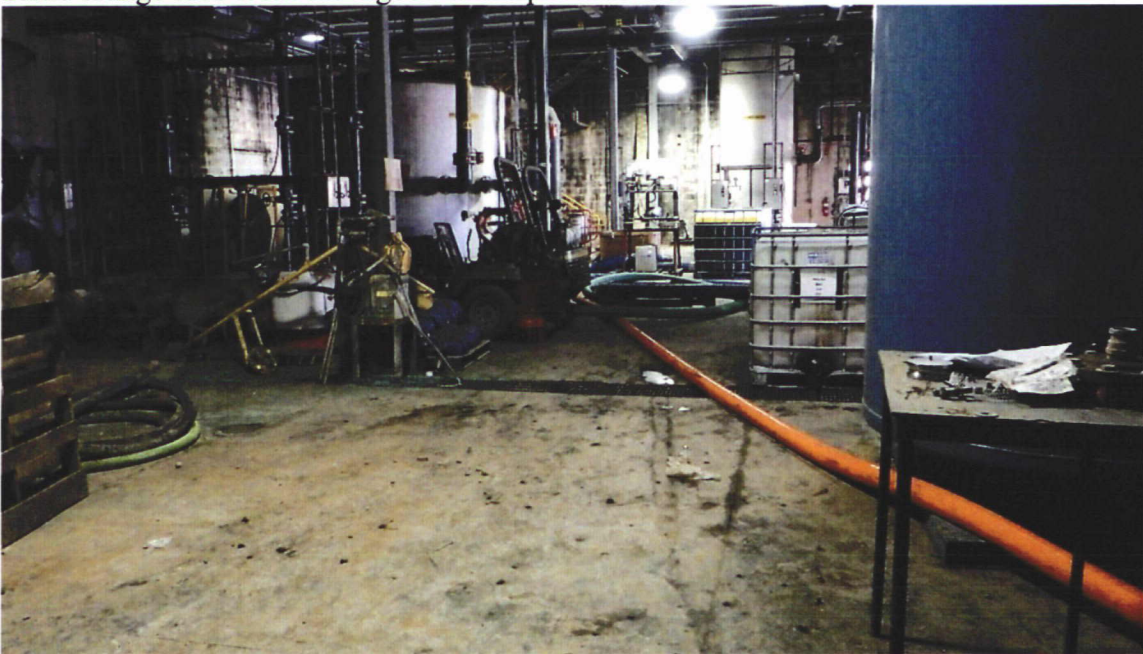
Same orange tube from the lagoon to the pre-clarifier.

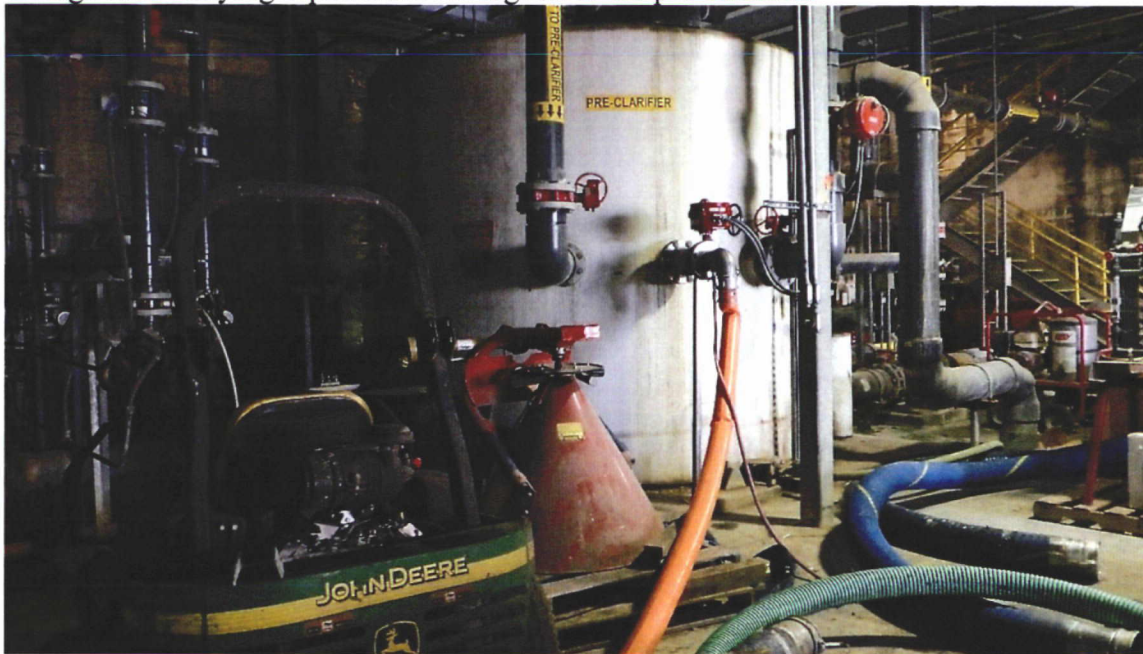
Orange tube carrying liquid from the lagoon to the pre-clarifier.

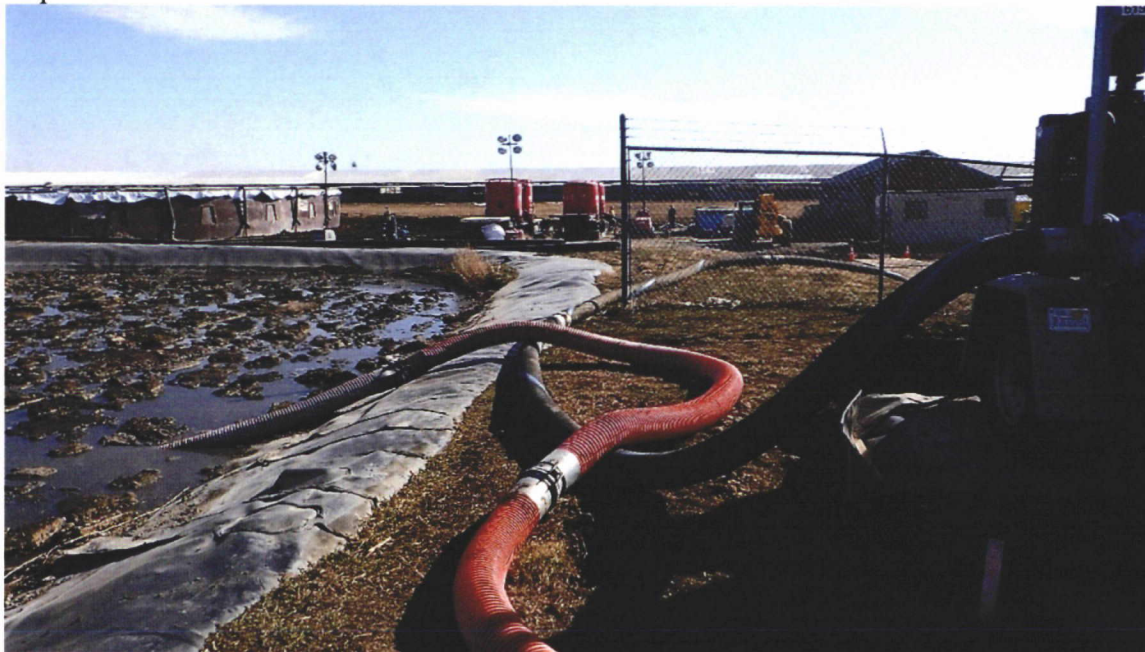
Pink/orange tube pulling liquid from the bottom of lagoon through pump, on the right side of photo, back through a black tube to the Clean Harbors water treatment facility, red tanks in center of photo. Treated water then goes to the holding structure to the left side of photo.

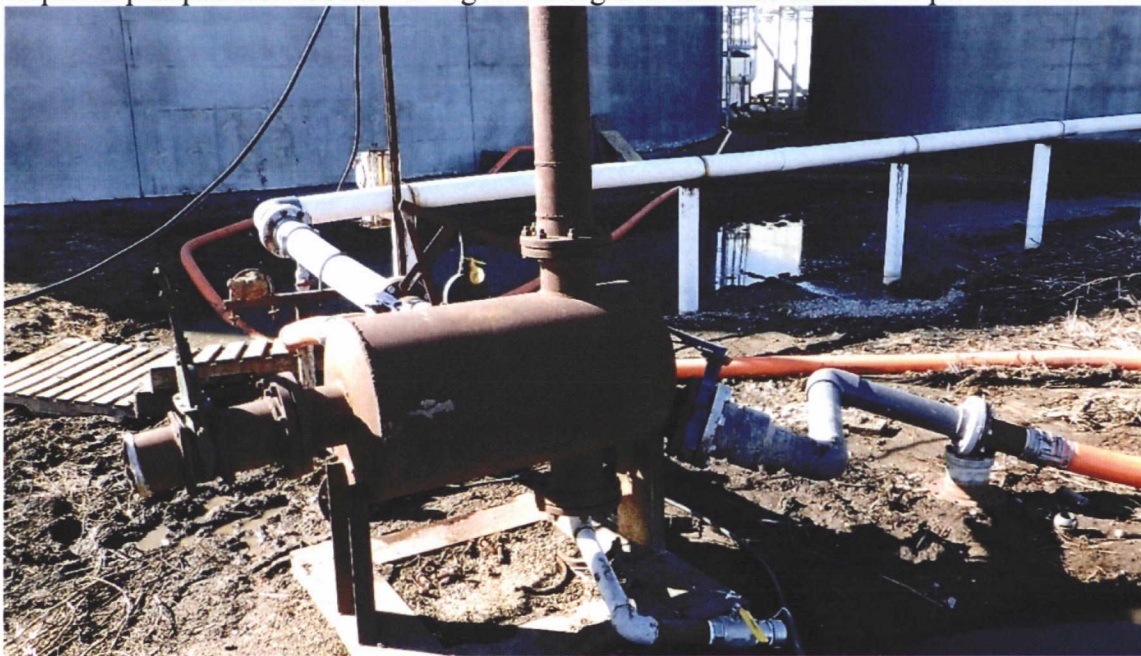
Liquid is pumped from bottom of lagoon to digester tank and also to the pre-clarifier.

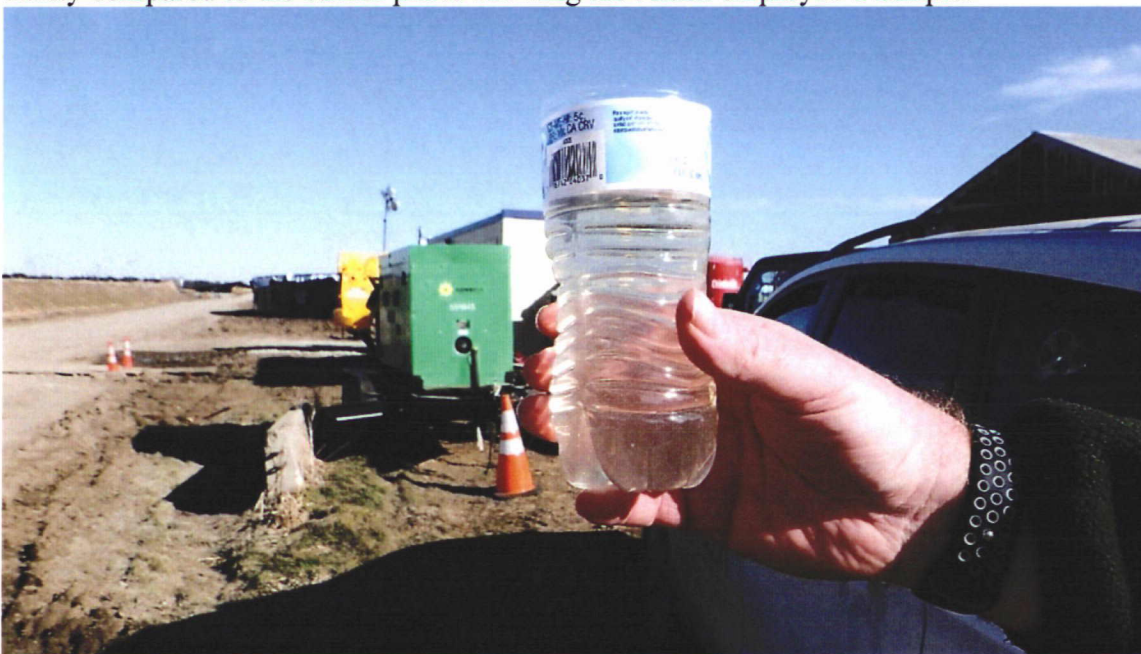
Clean Harbors Supervisor holding a sample of water that has been treated with a polymer (1 to 2 mg/l) after going through their on-site water treatment facility. He also indicated that the water can be run through carbon for additional cleaning if necessary. Note the clarity compared to the earlier photo showing the AltEn employee's sample.

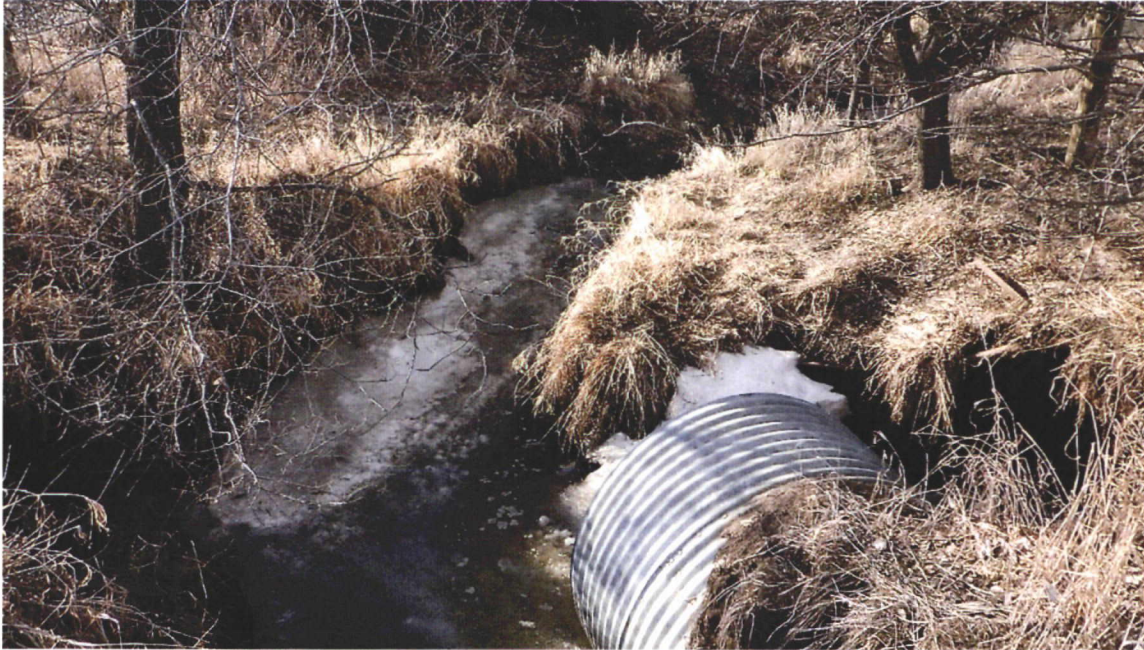
Site 2. This is the last stop on the stream before the private pond. Water is still mostly frozen with a small stream of open water to right of photo. Water temperature: 0.6 degrees C, Dissolved oxygen: 12.5 mg/l, pH: 7.6 St.Units, Conductivity: 428 Umhos/cm, Turbidity: 45 NTU's, Dissolved oxygen (percent saturation) 86 percent.
