AltEn Field Observations.
March 1, 2021
Jim Borovich
NDEE

PCS 84069

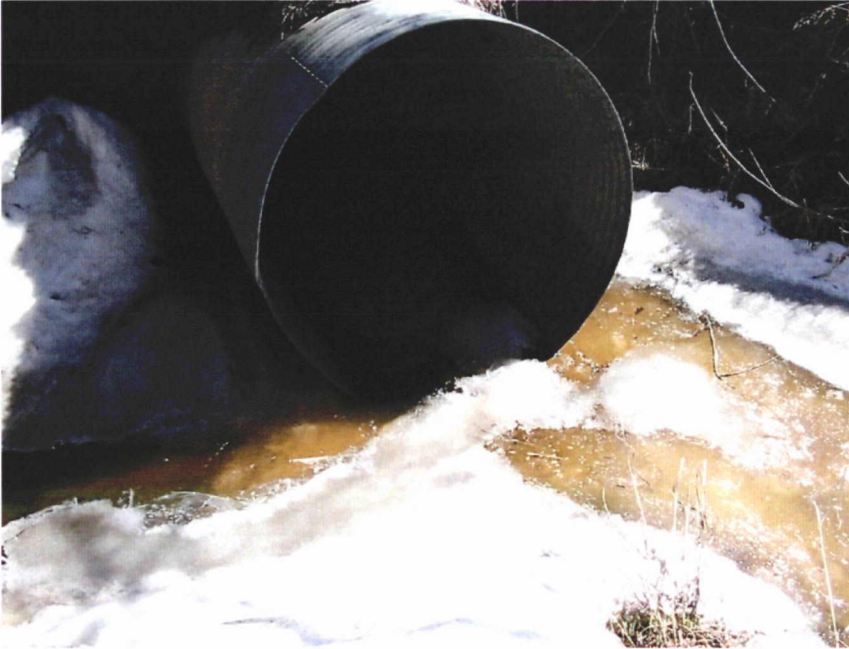
Photo 1. Looking east at culvert on west side of Road 6. No odors. Water in drainage way discolored and murky.

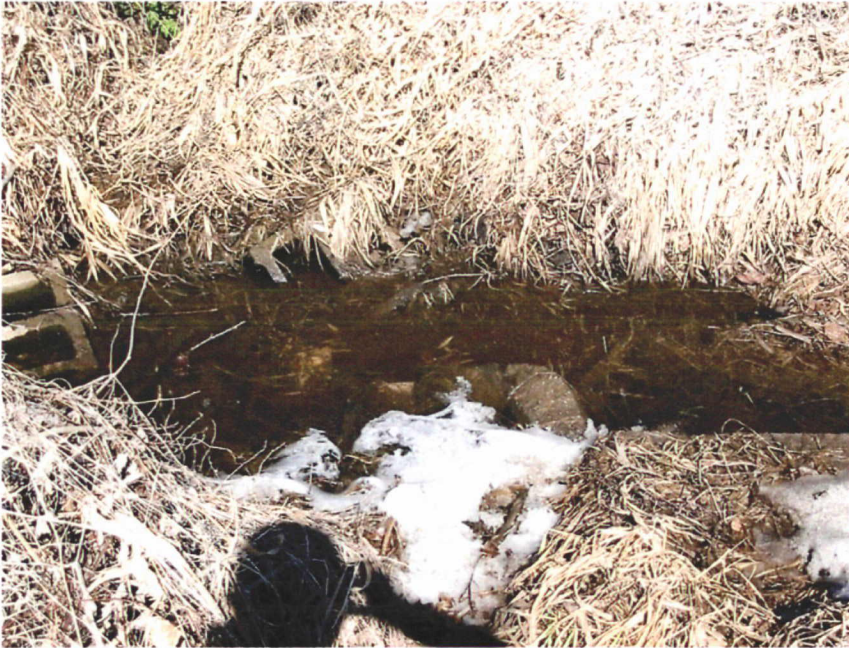
Photo 2. Looking down at drainage way on east side of Road 6. Water clear. No odors.

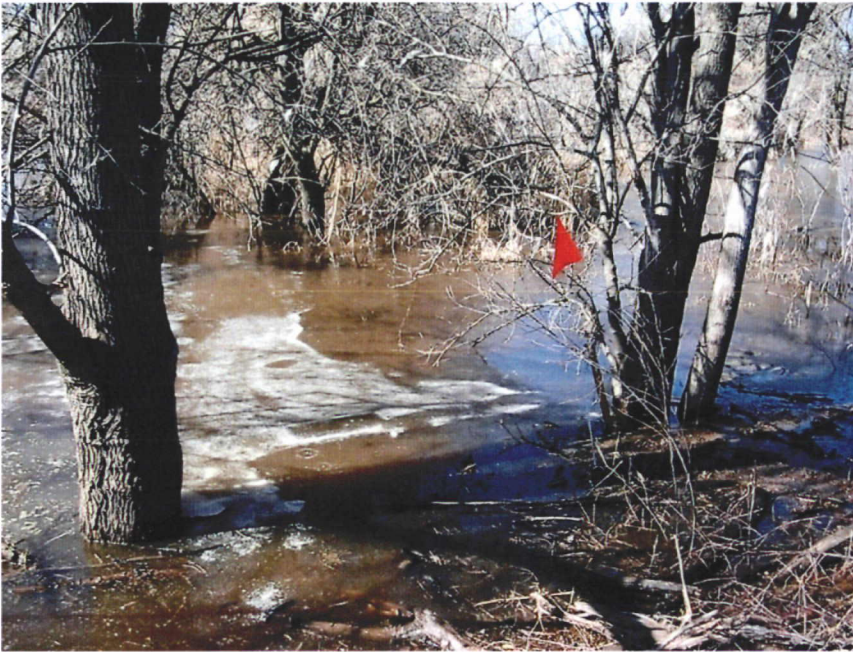
Photo 3. Looking west from west side of Highway 66. Area inundated with water. Water discolored. Red flag marks general position of culvert and makeshift dam.

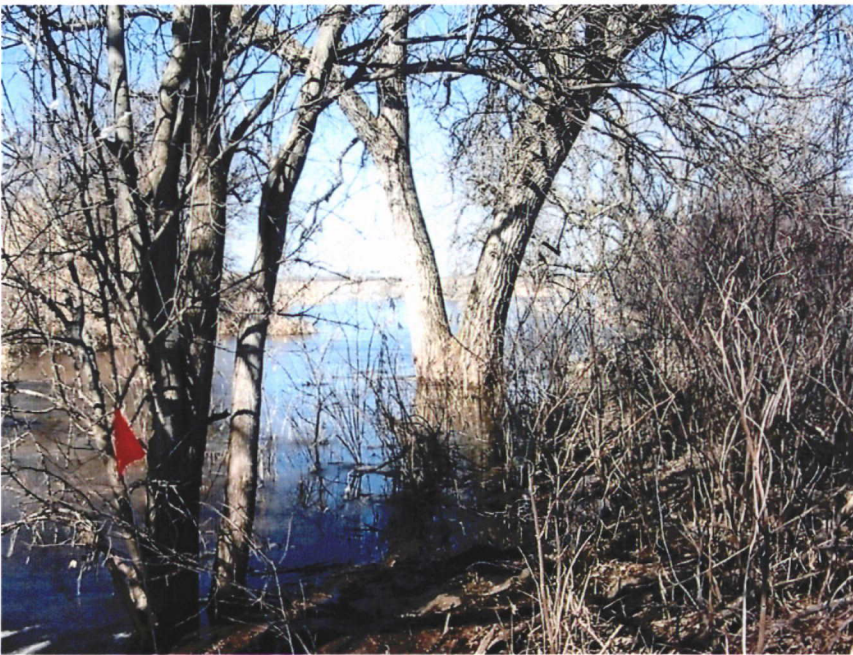
Photo 4. Looking northwest from same location as Photo 3 at inundation of area on west side of Stop #3.

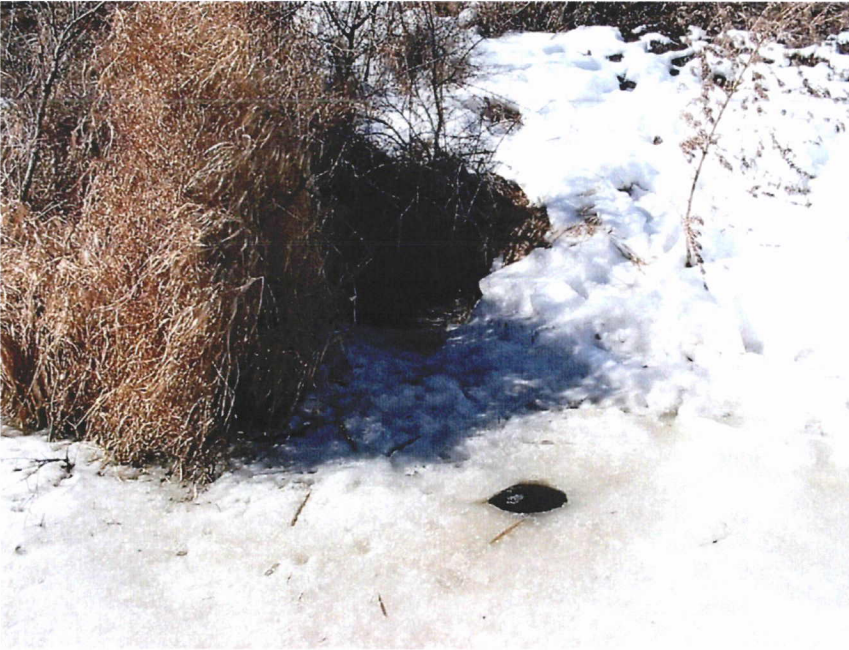
Photo 5. Looking west at culvert/drainage way on east side of Highway 66. Water appears discolored. Note auger hole in foreground of apparent recent, but unspecified date/origin.

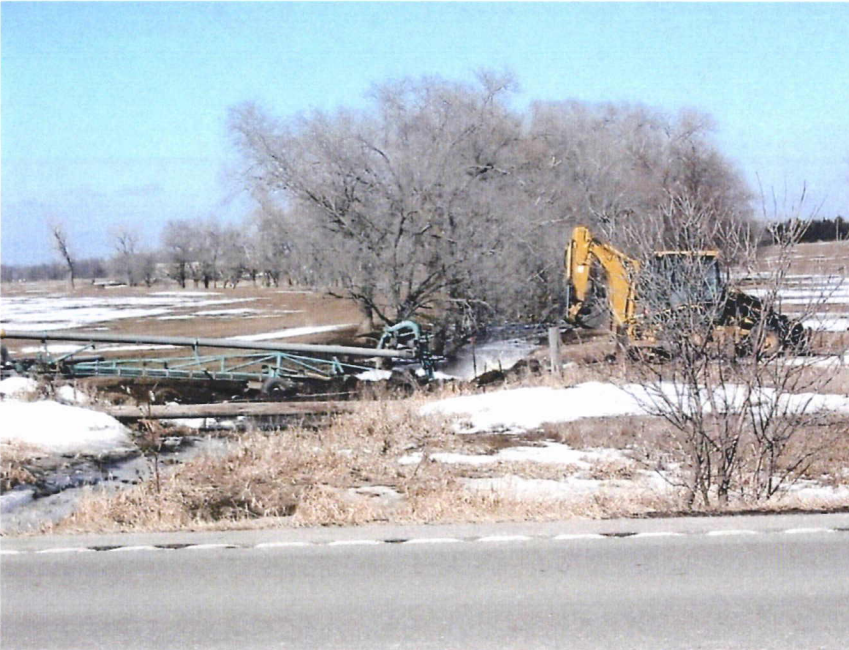
Photo 6. Looking north at Lagoon Pumping, Inc. activity. Water appears “frothy” behind dam in midground.

At this location, I met James Koehler and associate Ms. Nichols of Terracon. After some time of observation, we walked over to this work for a closer inspection. We were informed that liquid was being pumped from this location back to the AltEn facility at approx. 500 gallons/minute, but to pump from this location they also had to be injecting air to create an excavation deep enough to pump from.

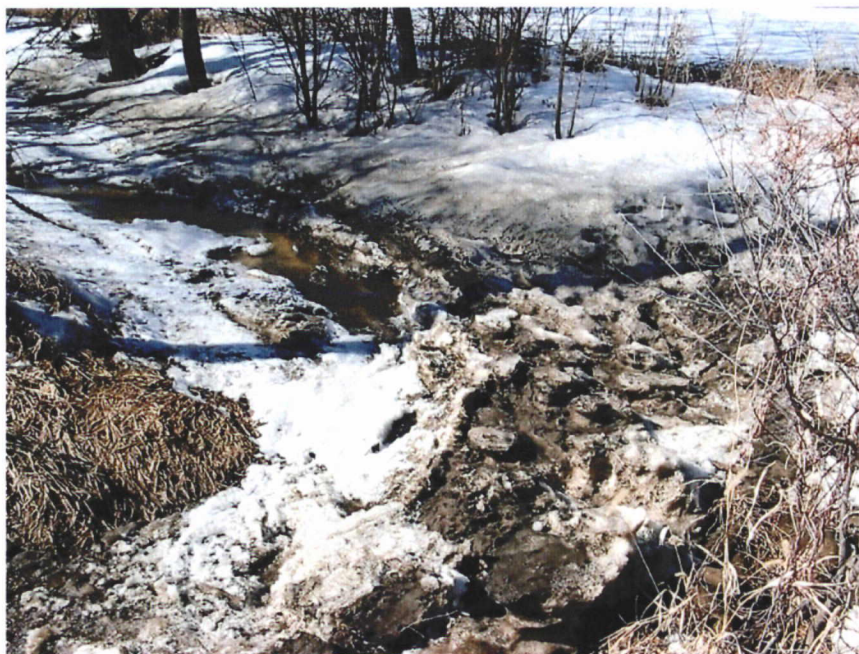
Photo 7. Looking down and west from west side of culvert on Road 8.

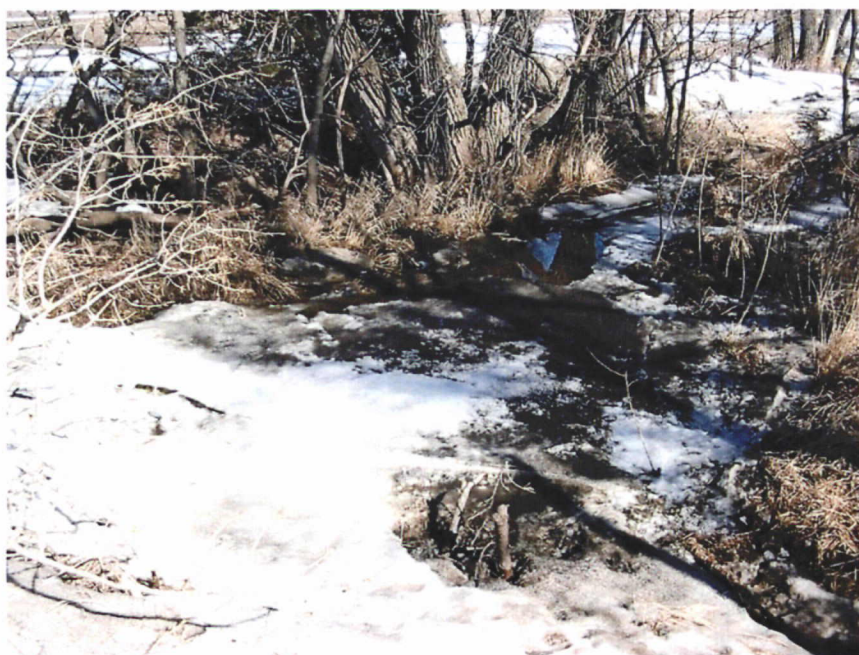
Photo 8. Looking east at drainage way on east side of Road 8.

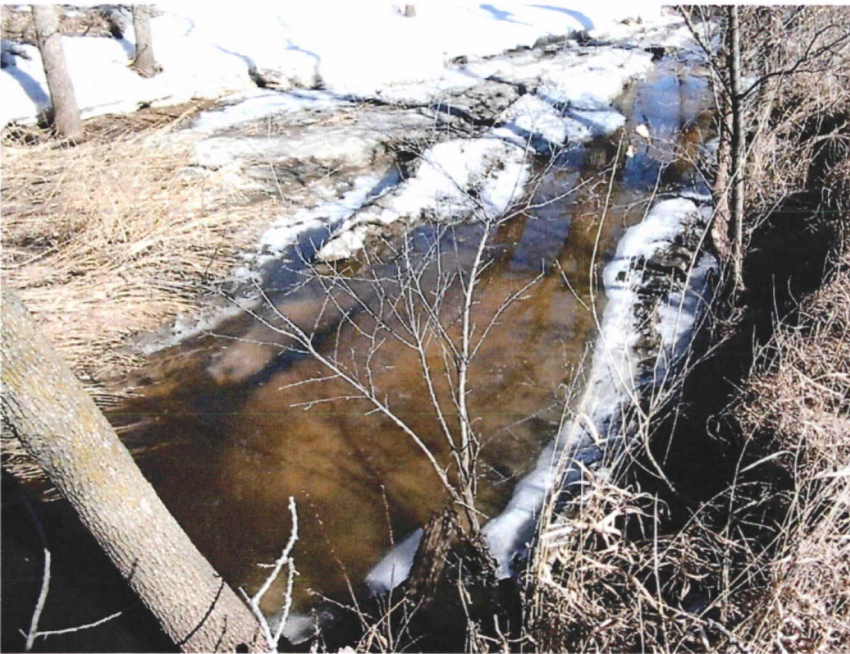
Photo 9. Looking east from point approx. 50 feet from Road 8 east-side culvert. Water looks brown, but appears clear.

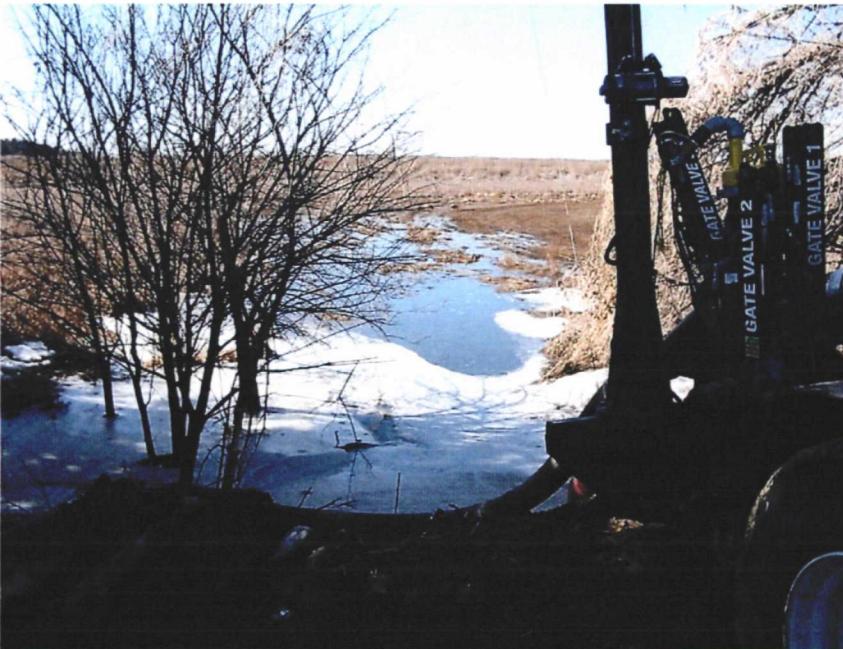
Photo 10. Looking west from west side of Road 9. Pumping of liquid taking place. Liquid at this location appears to have been pumped down a great extent compared to previous observations at this location.

At this stop, I met Mr. Randy Ross, Crew Foreman for Lagoon Pumping, Inc. While there had been a hiatus of pumping at this location on Saturday, pumping had resumed on Sunday. Pumping was occurring at a rate of approx. 450 gallons/minute to one of the wastewater lagoons at the AltEn facility.
