PCS 84089

AltEn Field Observations

March 2, 2021

NDEE

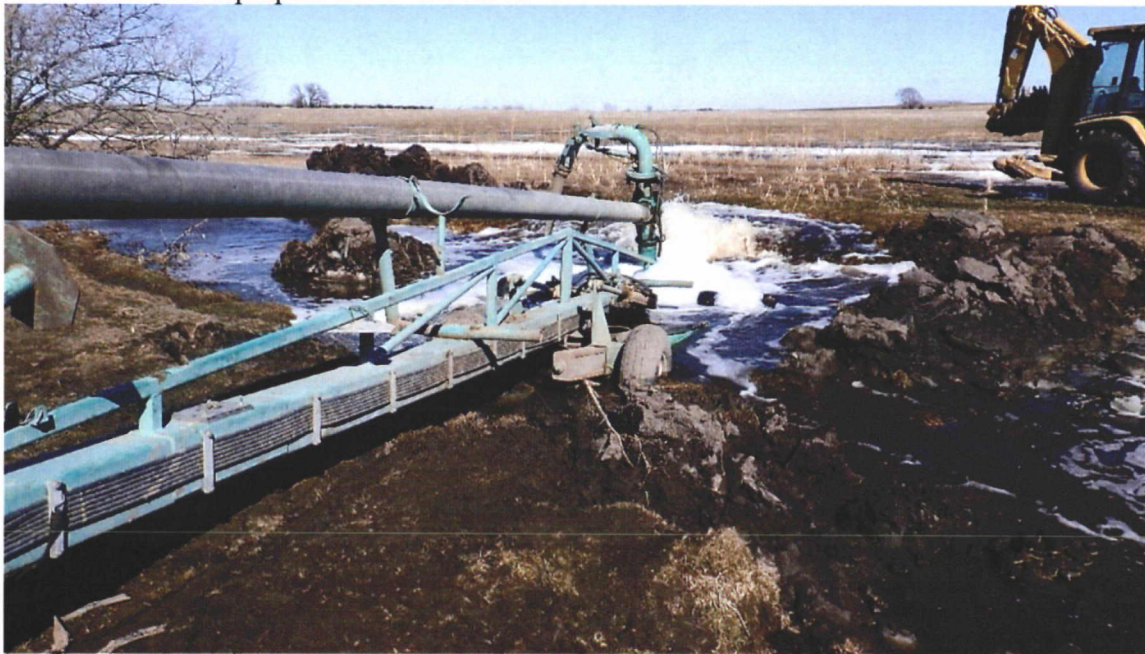
Site just above Site 3 on the north side of Highway 66 facing northeast. Foam and water bubbling near the green vertical pipe is caused by a subsurface agitator on the end of the pump. The agitator is designed to prevent the pump from pulling debris and mud into the pump. The operator said that he is pumping 800 gallons per minute back to the AltEn facility. The small earthen berm to the right side of the picture was compromised during the previous evening and allowed water to escape as the flow had increased overnight. He indicated that the day before he was able to nearly pump the stream dry and very little water was pooling behind the earthen berm. The pump is running 24 hours a day and wasn't able to keep up with the increased runoff.

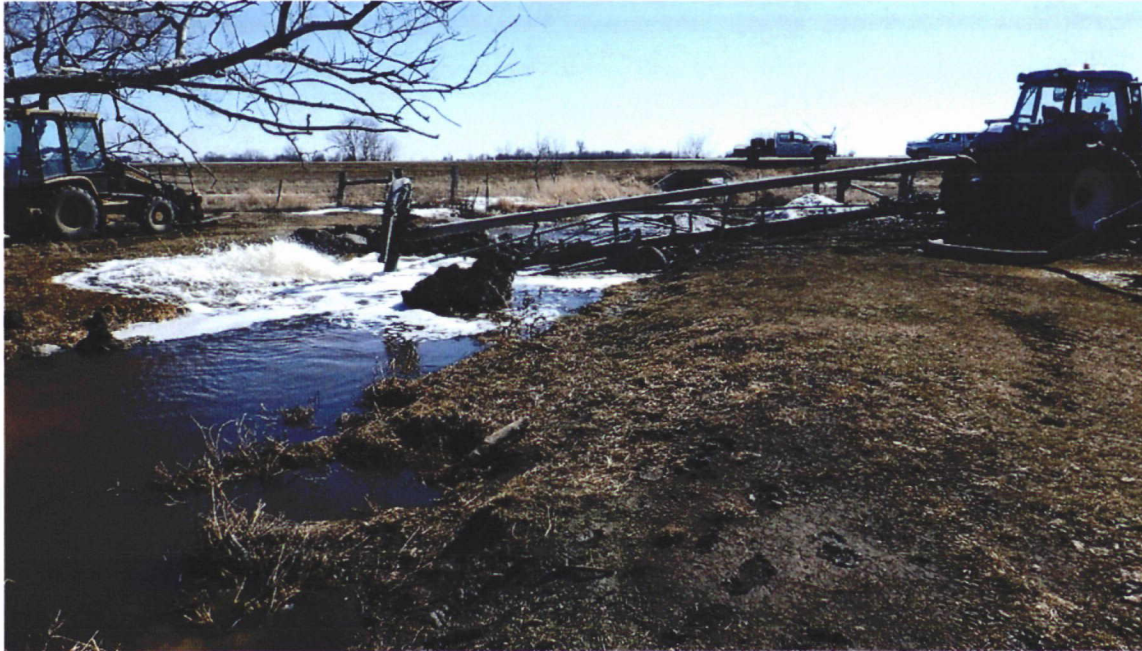
Same site as the previous picture but facing back towards the south toward Highway 66 towards top of the picture. Note water color has a tannic stain to it.

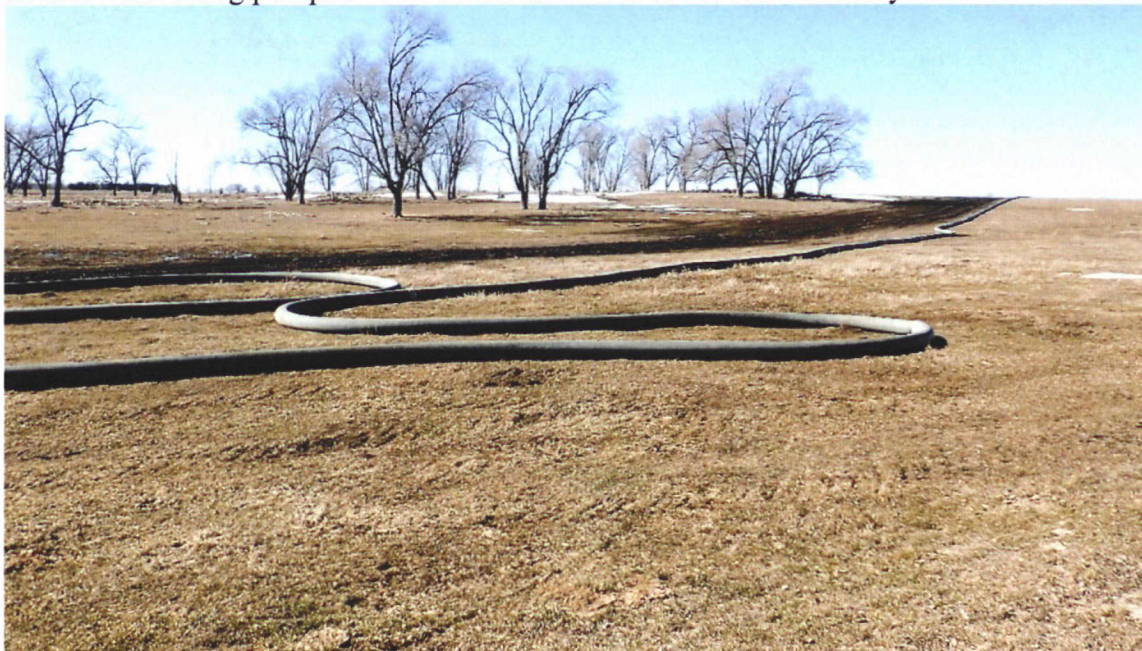
Same location as previous picture, facing northwest, showing collapsible pipe full of stream water being pumped towards the northwest to the AltEn facility.

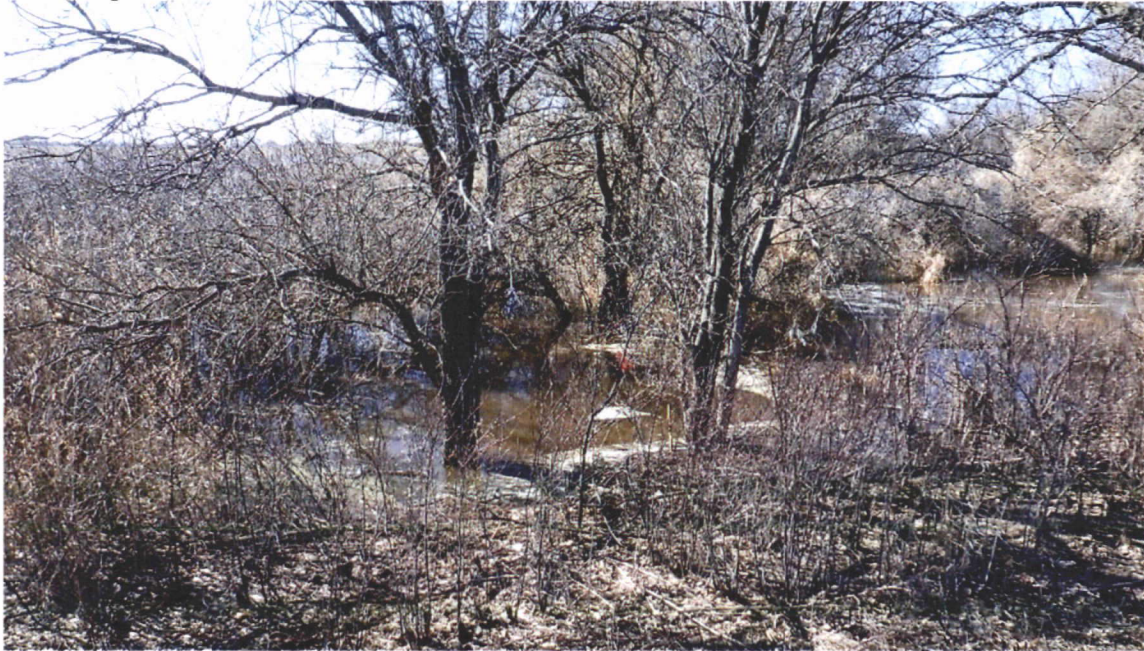
Site 3 facing west on the west side of Highway 66. Cement culvert is underwater and is located between the two larger trees and below the orange flag. The sandbags which were in front of the tarp-wrapped plywood have been removed and the water is holding the plywood in place. Water temperature: 2.6 degrees C, Dissolved oxygen: 0.8 mg/l, pH: 7.5 St.Units, Conductivity: 491 Umhos/cm, Turbidity: 44.7 NTU's, Dissolved oxygen (percent saturation) 6 percent. Air temperature: 61 degrees F, clear, southwest wind at 20-25 mph.

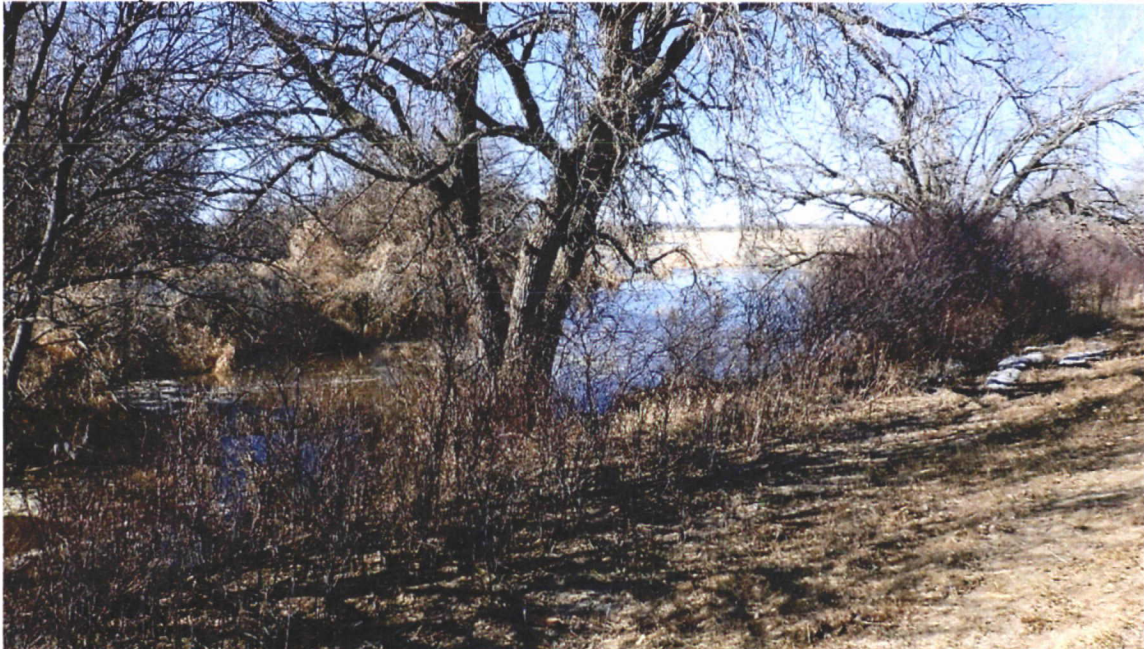
Site 3 facing northwest on the west side of Highway 66. Cement culvert is just to the left of the photograph. Photo shows how much water is building behind the blocked culvert and has expanded beyond the normal stream channel.

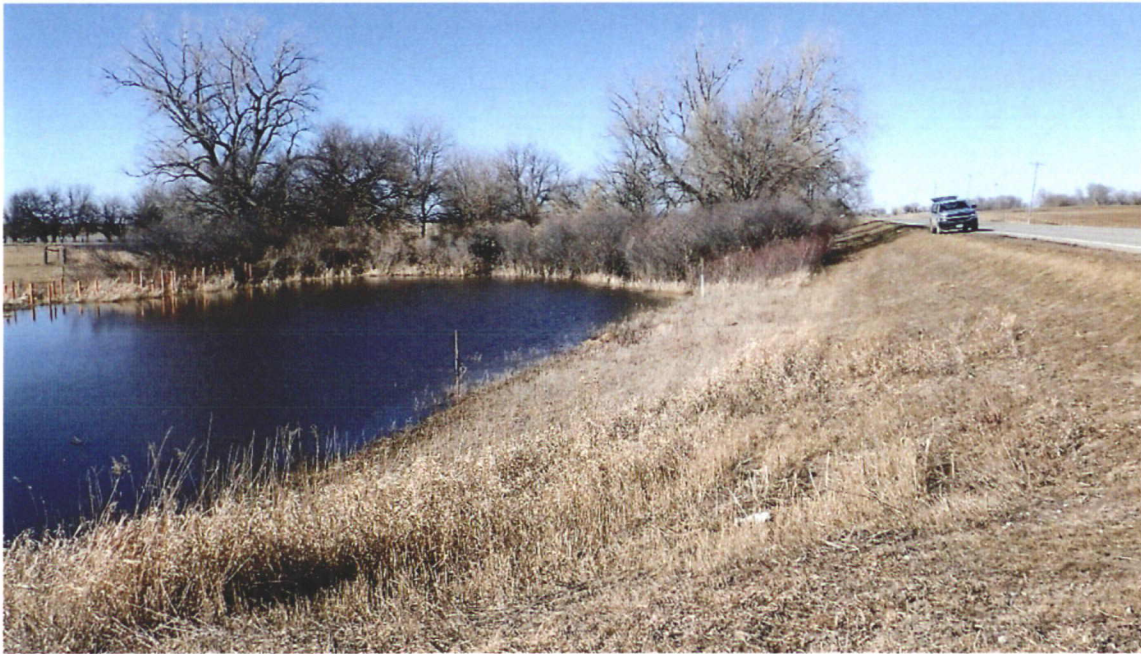
Site 3 facing north on the west side of Highway 66. Photo shows water in ditch from recent melting snow and some backed-up water from the stream just on the opposite side of the brush. Note the two markers near the water line. The pole in the foreground was placed there by someone else. The one towards the right, at the edge of the water, has 1/10th of a foot increments on a metal 3.3-foot gage height marker and placed there by the NDEE.

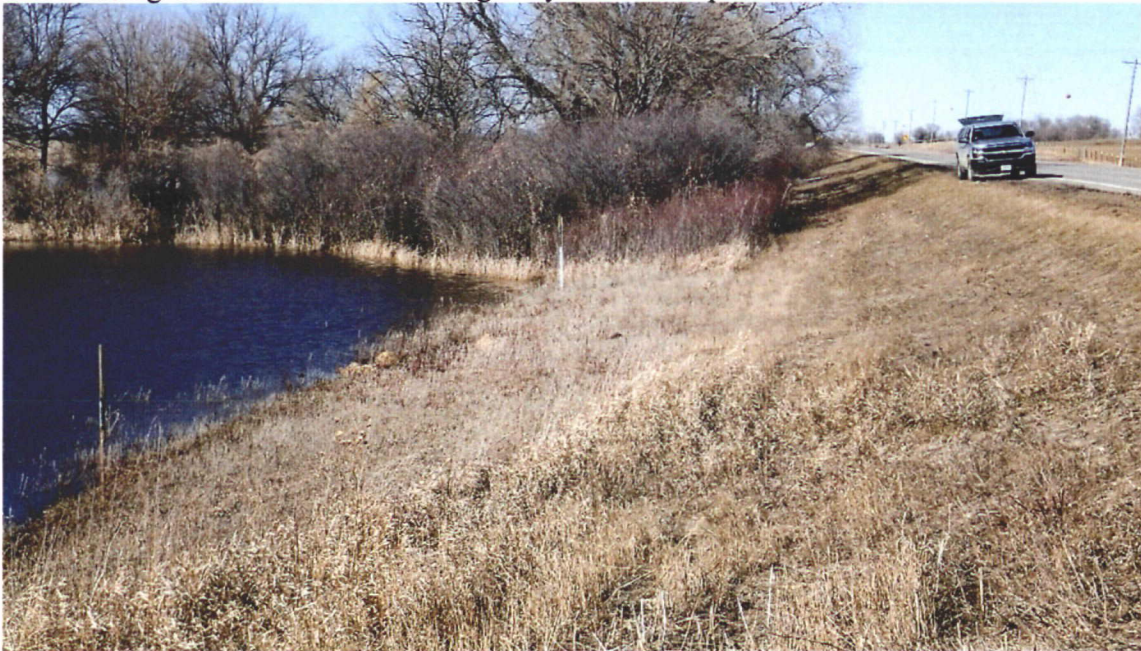
Site 3 facing north on west side of Highway 66. Closer photo of the NDEE marker.

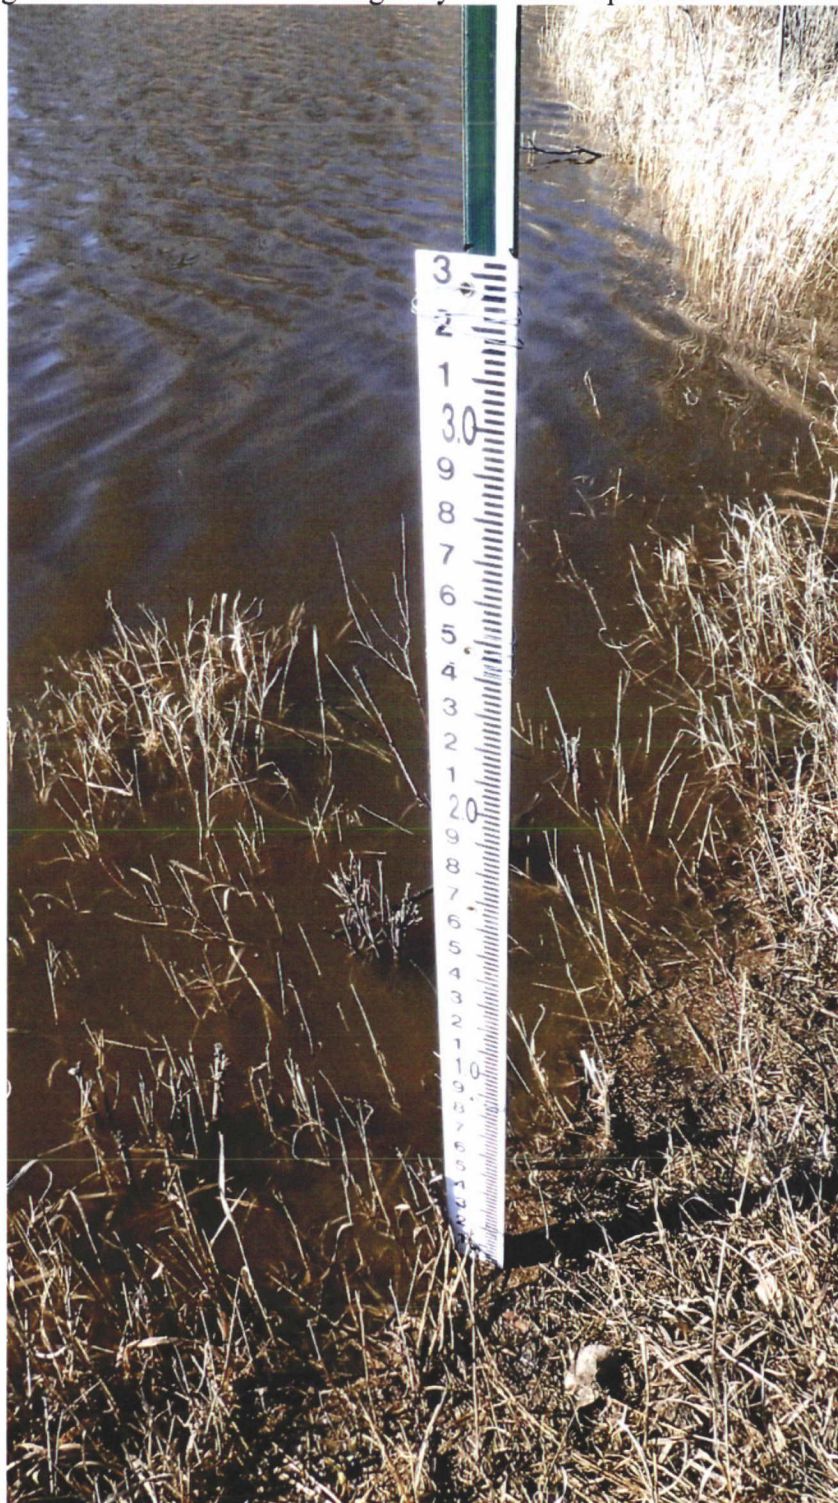
Site 3 facing west on the west side of Highway 66. Close-up of the NDEE marker.

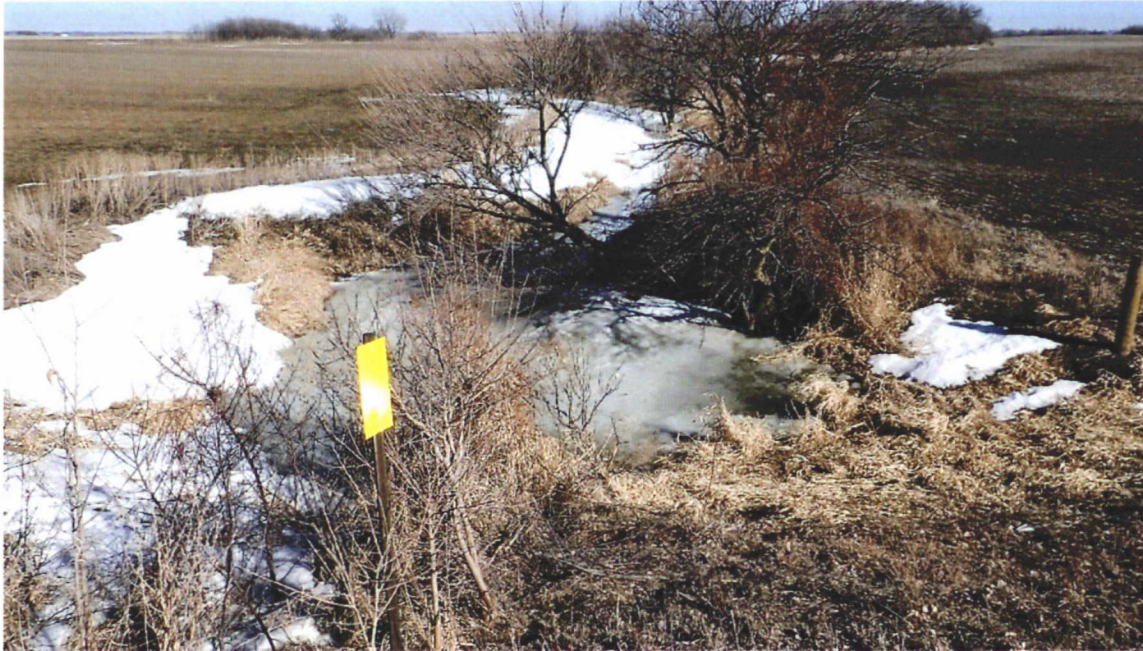
Site 3 facing east on the east side of Highway 66. Stream below culvert is still mostly frozen with some surface water over ice.

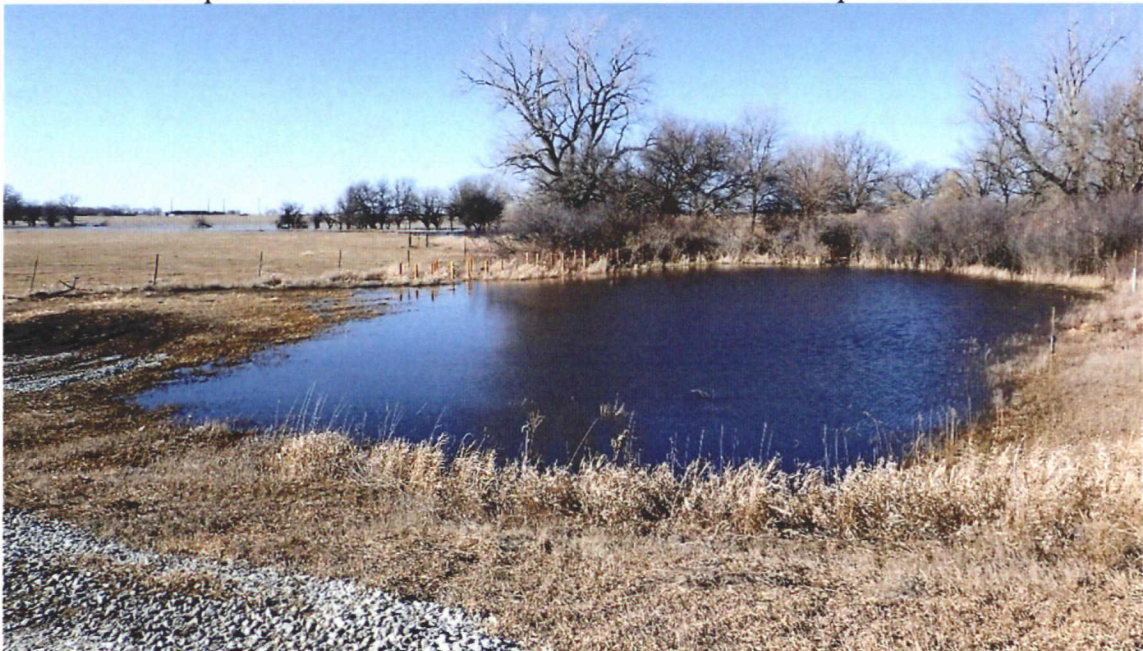
Site 3 facing northwest on the west side of Highway 66. Photo shows flooded ditch as well as flooded pasture from runoff from snow melt and backed up water in the stream.

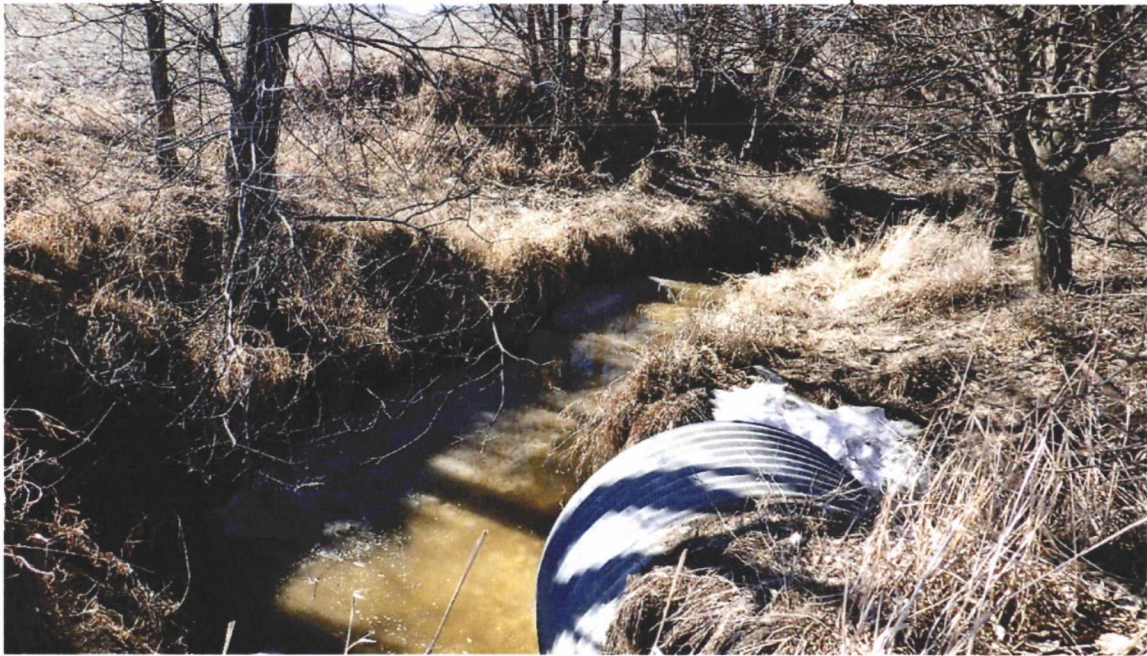
Site 2 facing west on the west side of the county road. Water on top of ice.

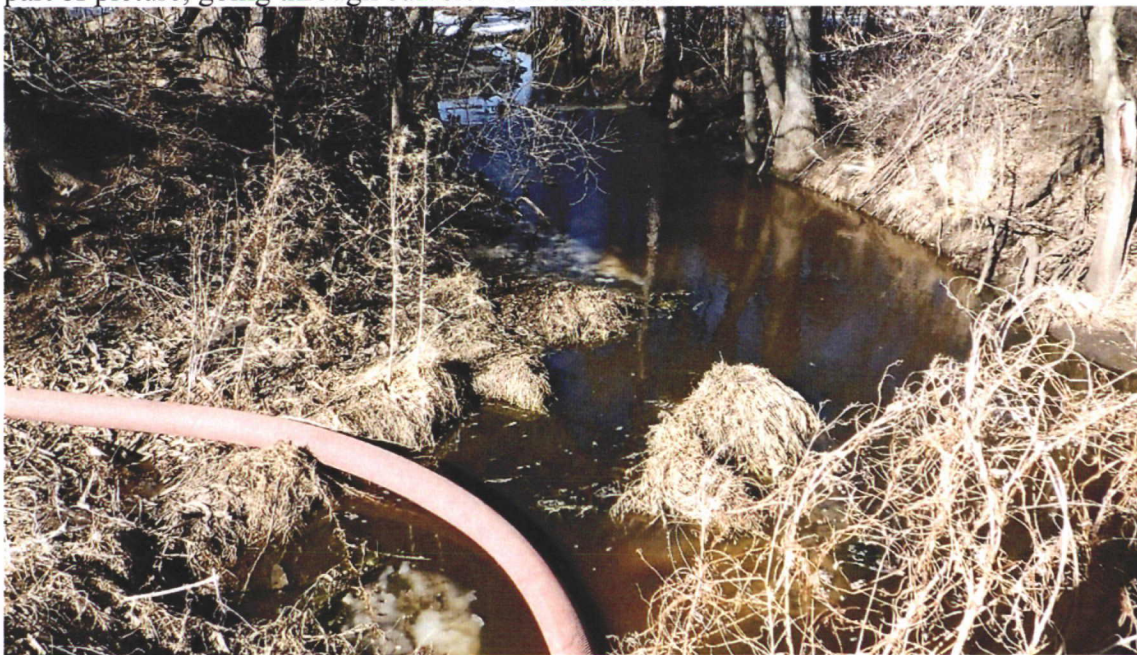
Facing north/northeast on Avenue H, approximately 1/3 mile east of Road 8 to the southeast of Site 4. Water has a tannic stain appearance to it. Reddish/orange tube, lower part of picture, going through culvert from the south.

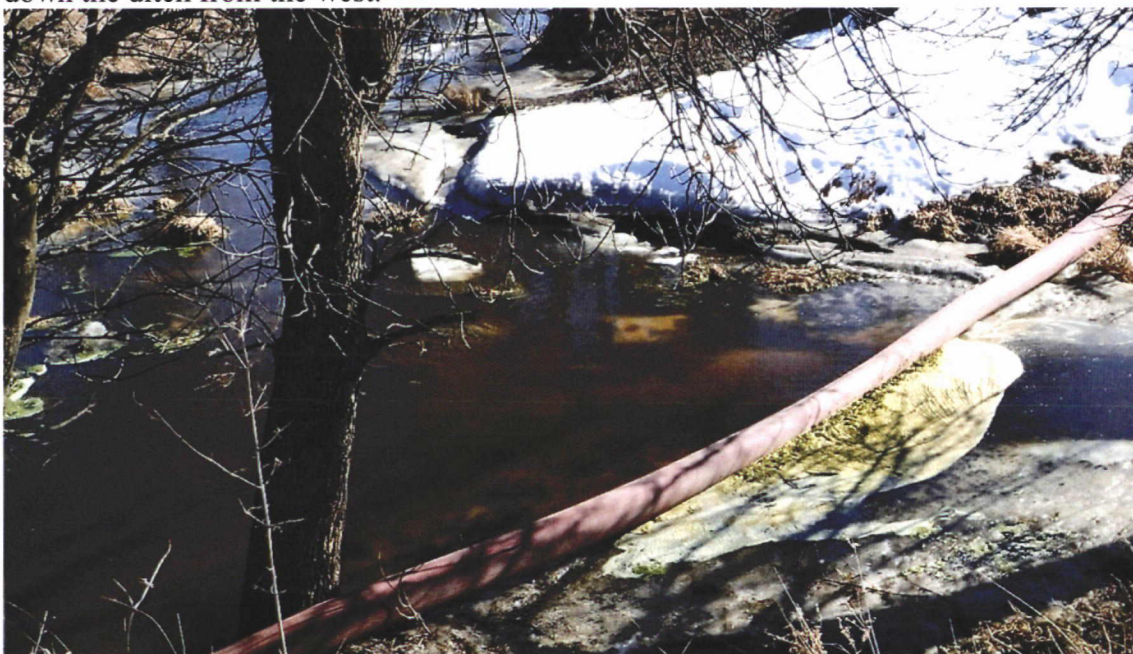
Facing south and on south side of the county road from the previous photo. Note green debris accumulate on the collapsible tubing. Water on the right side of photo is flowing down the ditch from the west.

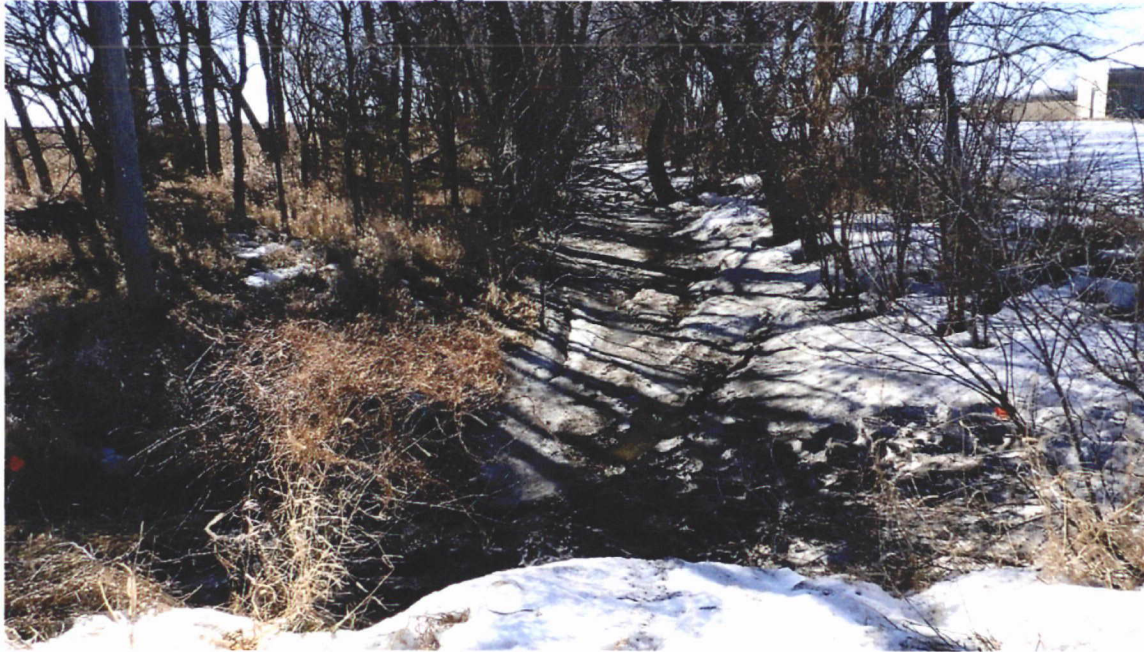
Site 4 facing west on west side of county road. Mostly frozen as there is considerable tree cover and not allowing sun to fully penetrate to the ground.

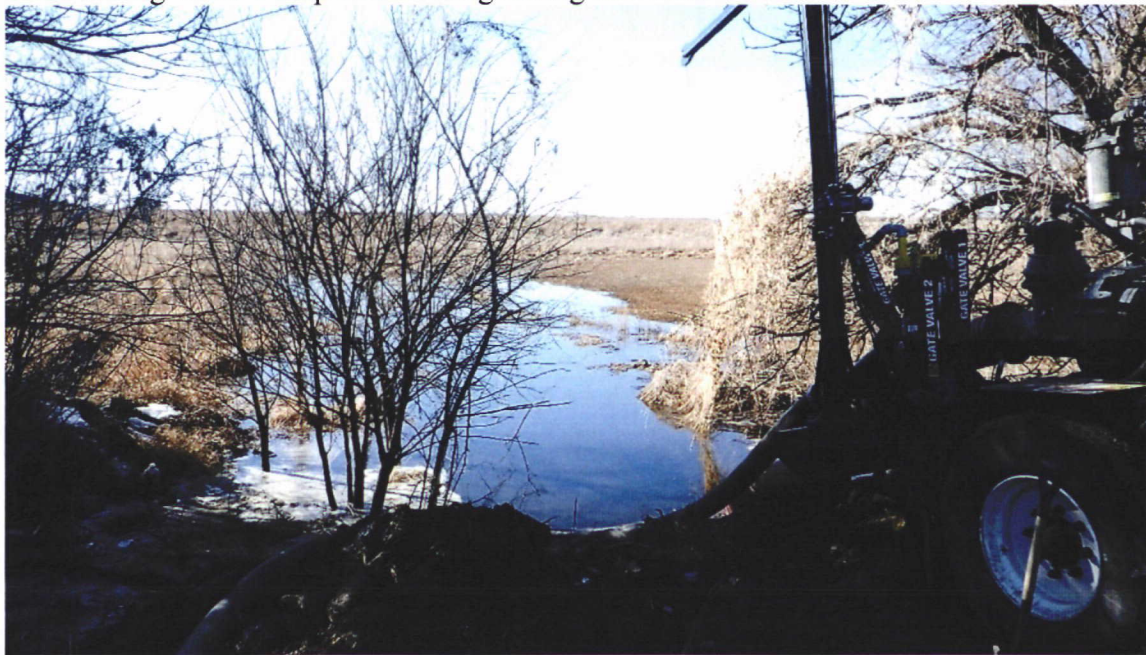
Site 5 facing west. Pump was running during this visit.
