From: Pomajzl, Mark
Sent: Thursday, March 18, 2021 2:28 PM
To: Pracheil, Brad; Anderson, Reuel; Ugai, Susan; Stoll, Hillary; Valentine, Kara; Goans, Steve; Windhorst, Jason
Subject: AltEn Site visit (Wednesday)
Attachments: AltEn daily (wednesday).docx

Facility: AltEn
IIS: 84069
PCS: NE0137634

Mark Pomajzl
3-17-2021

Site Visit Check list

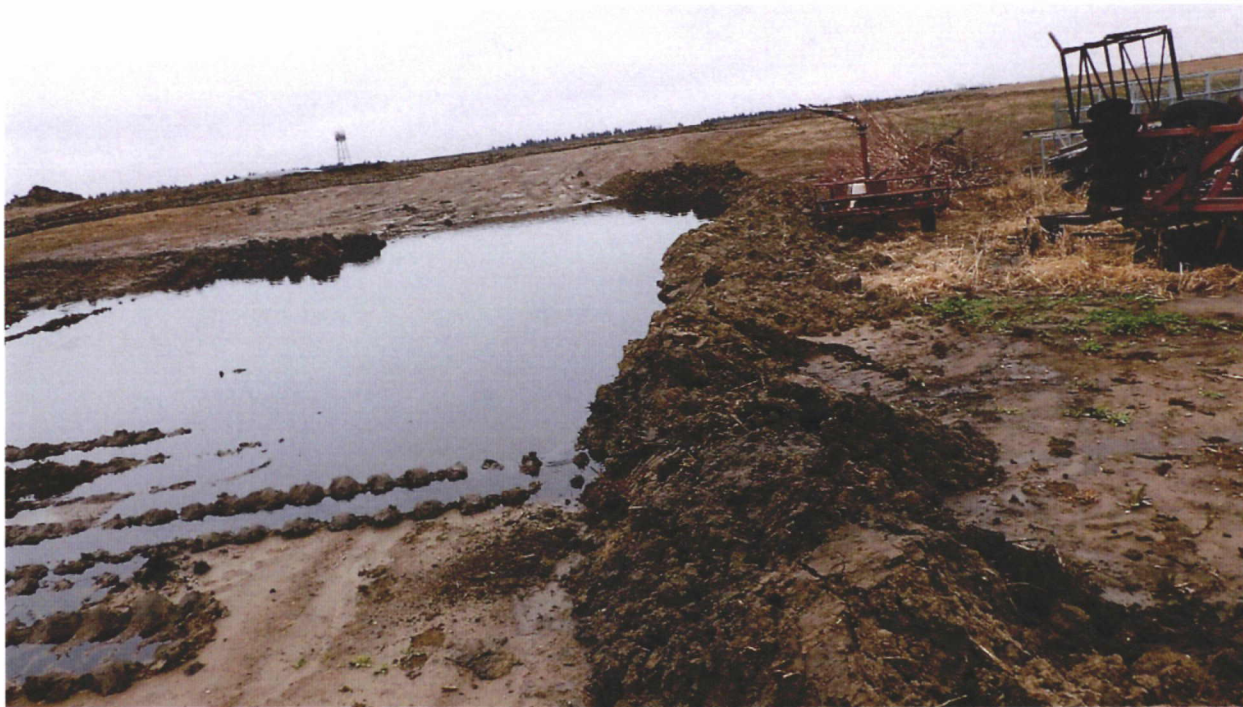
Photo: 1

Description: This photo depicts the area northeast of the administration building. The facility installed a berm along a low area which conveys to the southwest side of the south lagoon. The berm does not appear to be leaking.

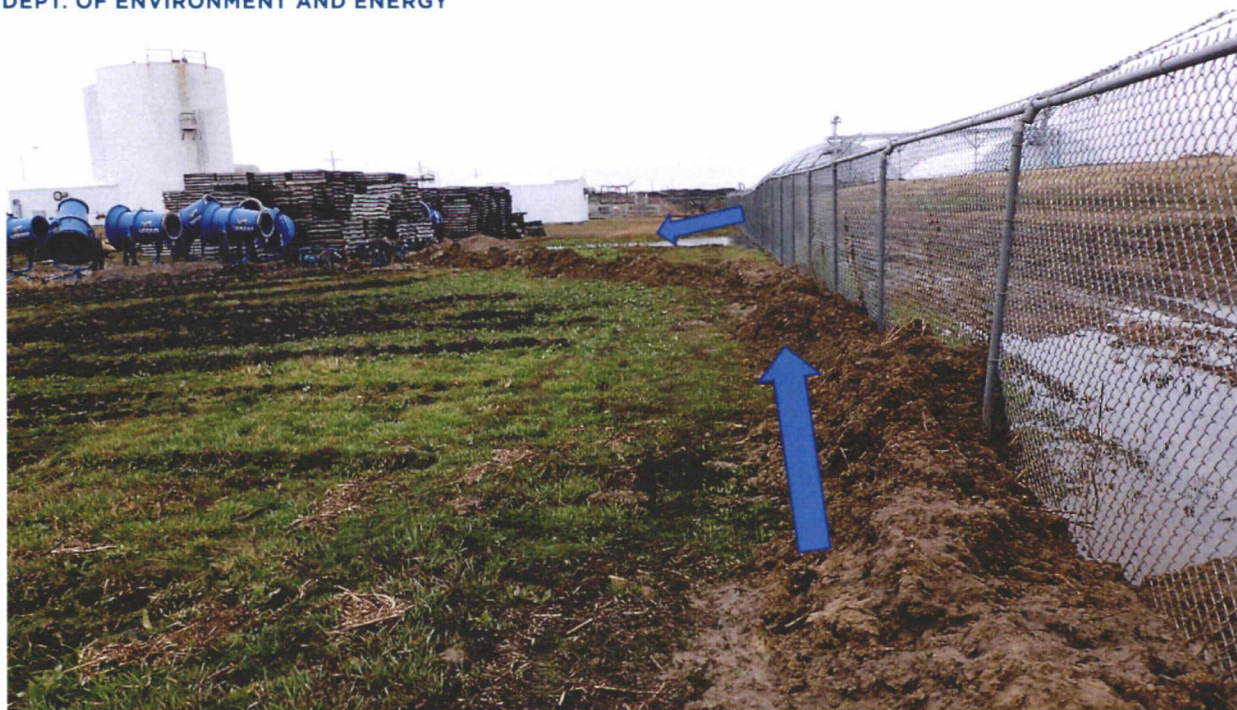
Photo: 2

Description: This photo depicts the berm southwest of the south lagoon. The facility extended the berm south and west along the fence (arrow). There is no evidence of leaking.

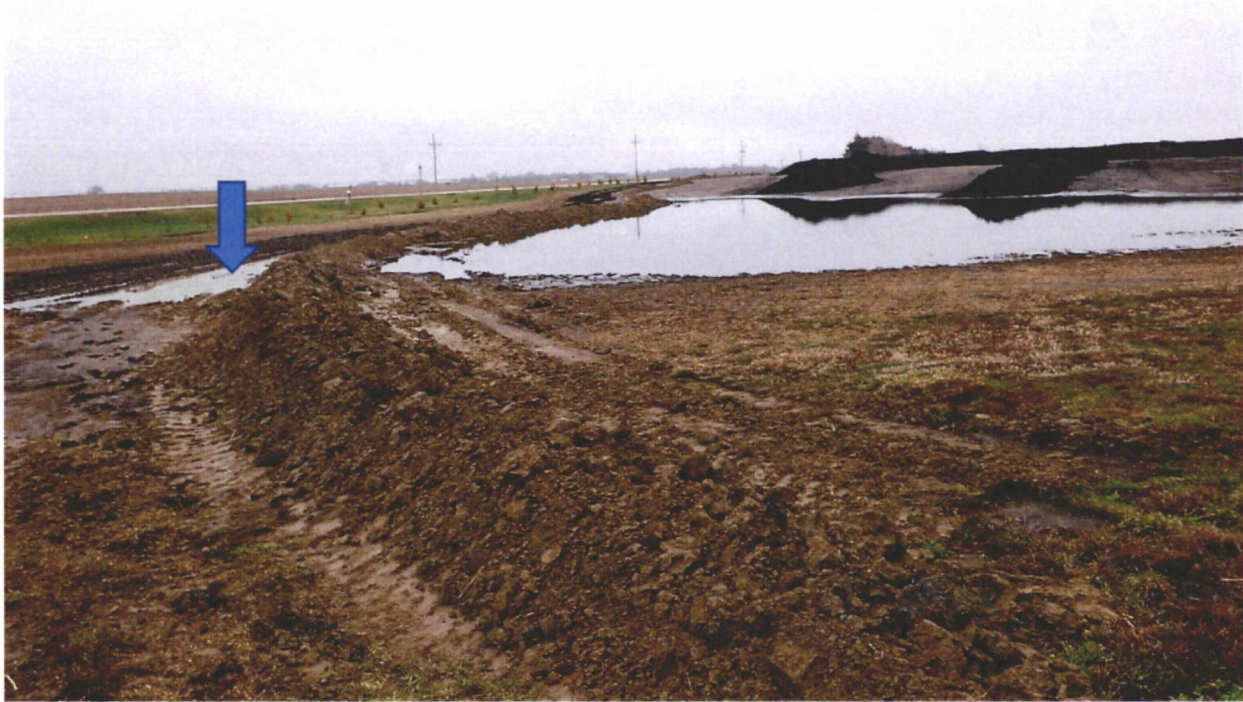
Photo: 3

Description: This photo depicts the berms north of the hoop building. There is water contained behind the berm. The water to left appears to be rain water accumulation (arrow). I did not see evidence of leaking at this time.

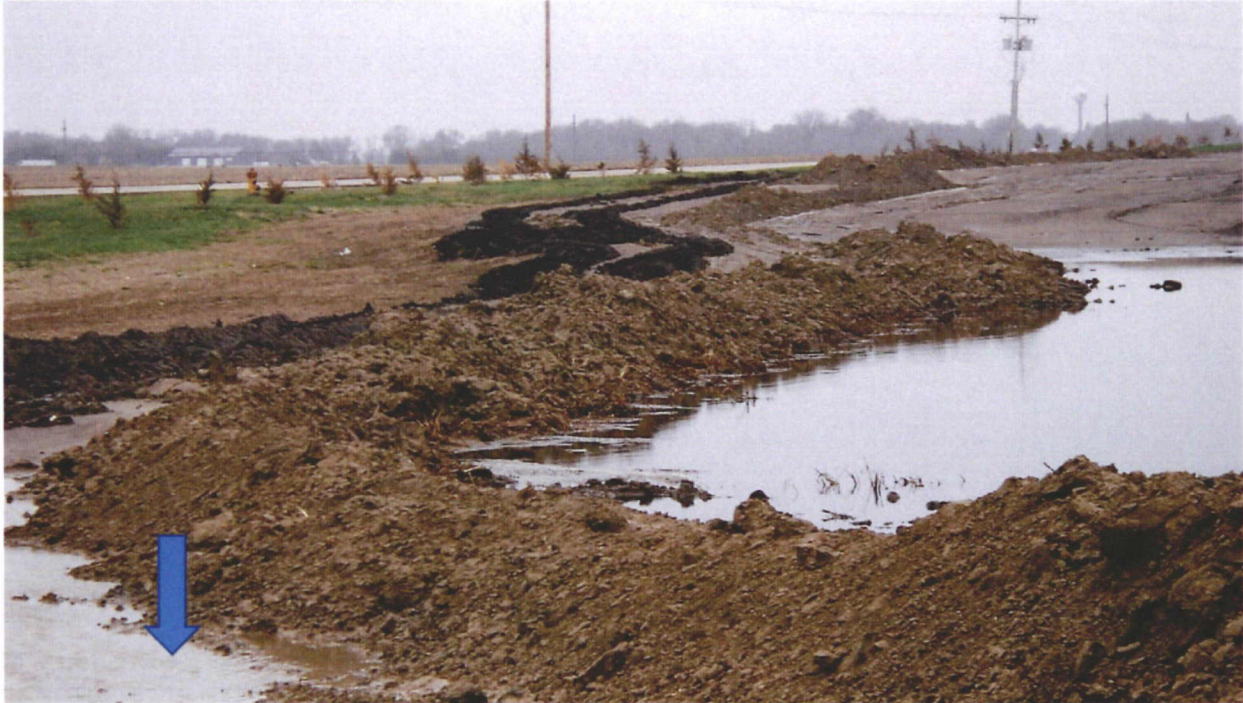
Photo: 4

Description: This is a closer photo the berm Northwest of the hoop building. There is water contained behind the berm. The water to left side appears to be rain water accumulation (arrow). I did not see evidence of leaking at this time.

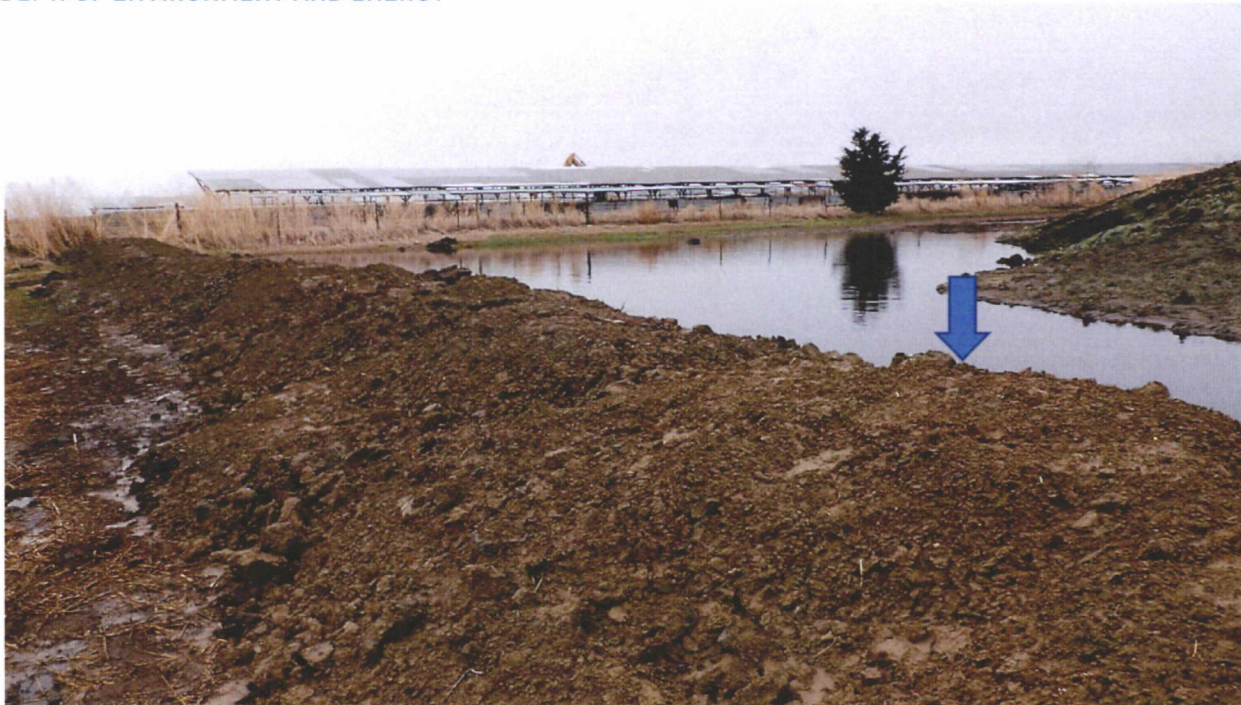
Photo: 5

Description: This photo depicts the berm containment around the east wet cake pile.

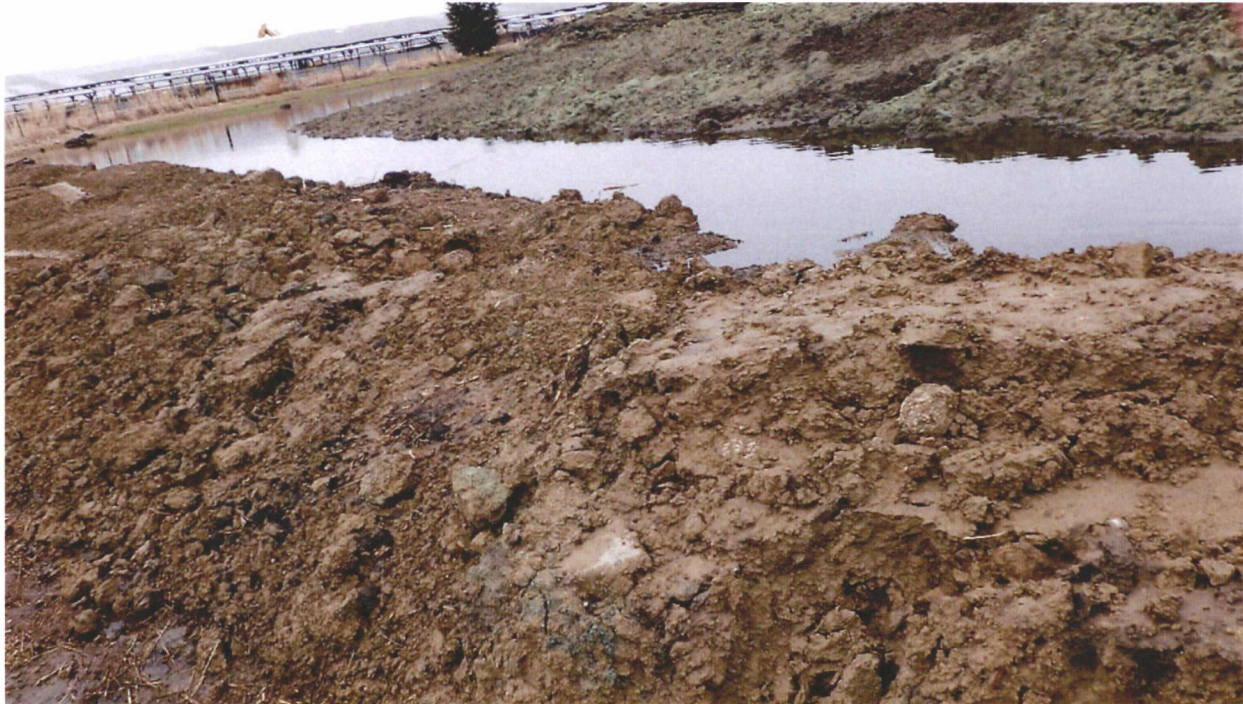
Photo: 6

Description: This photo depicts the berm containment around the east wet cake pile. The berm is not breaching at this time but is at capacity. I instructed Mr. Peterson to maintain this area by adding dirt and pumping.

- The facility has expanded the berm northeast of the administration building.
- The facility expanded the berm near the south lagoon.
- The east wet cake pile berm needs reinforcement. I pointed out the area to Mr. Peterson. Mr. Peterson agreed to add additional material. Mr. Peterson will also begin pumping.
- The facility agreed to continue monitoring the berms and provide daily emails of any changes or repairs.

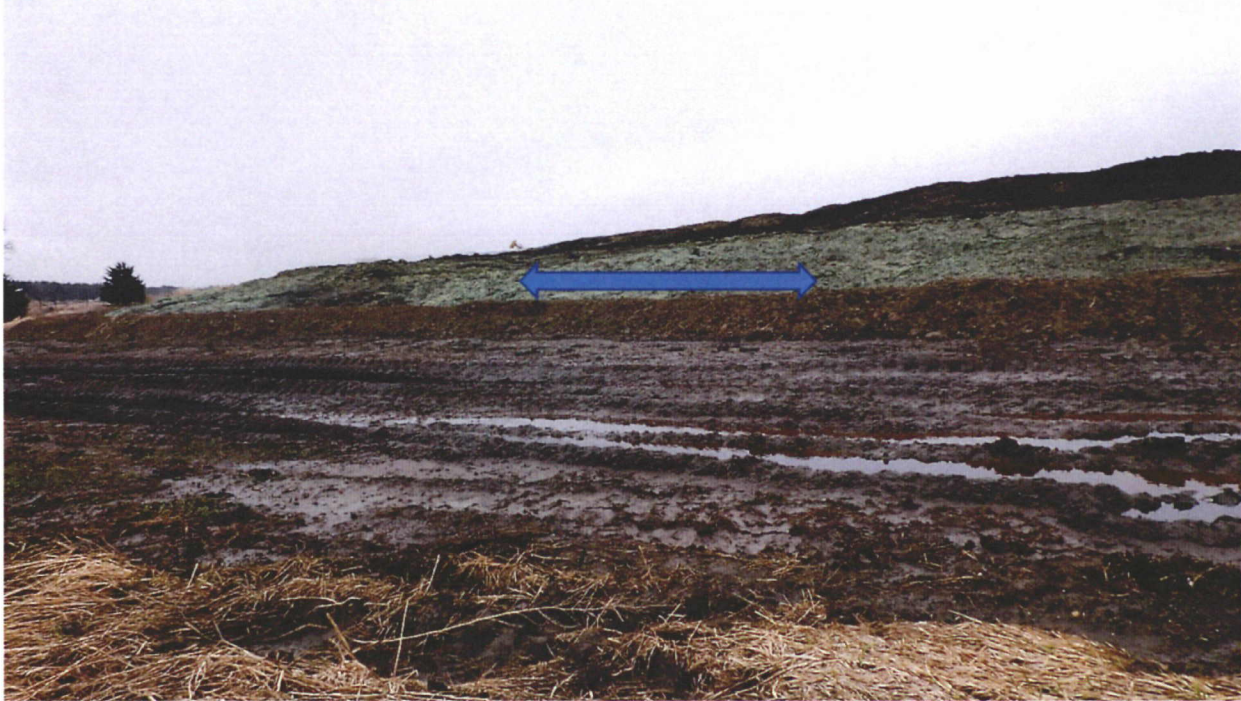
Photo: 7

Description: This photo depicts the berm containment around the east wet cake pile (arrow). The photo depicts the berm from the west side of the water way.

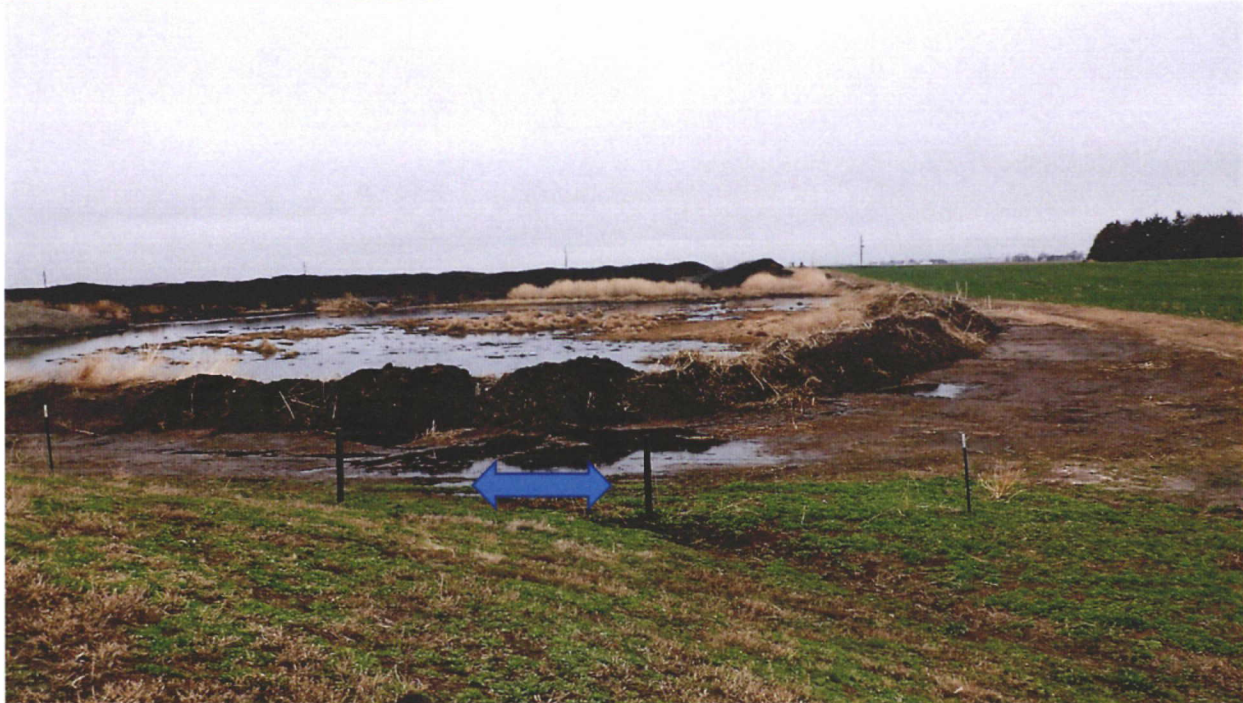
Photo: 7

Description: This photo depicts the northwest corner of the northwest lagoon. There is accumulated water inside the berm. There is also some rainwater accumulation behind the berm (arrow). There is no evidence of leaking at this time.

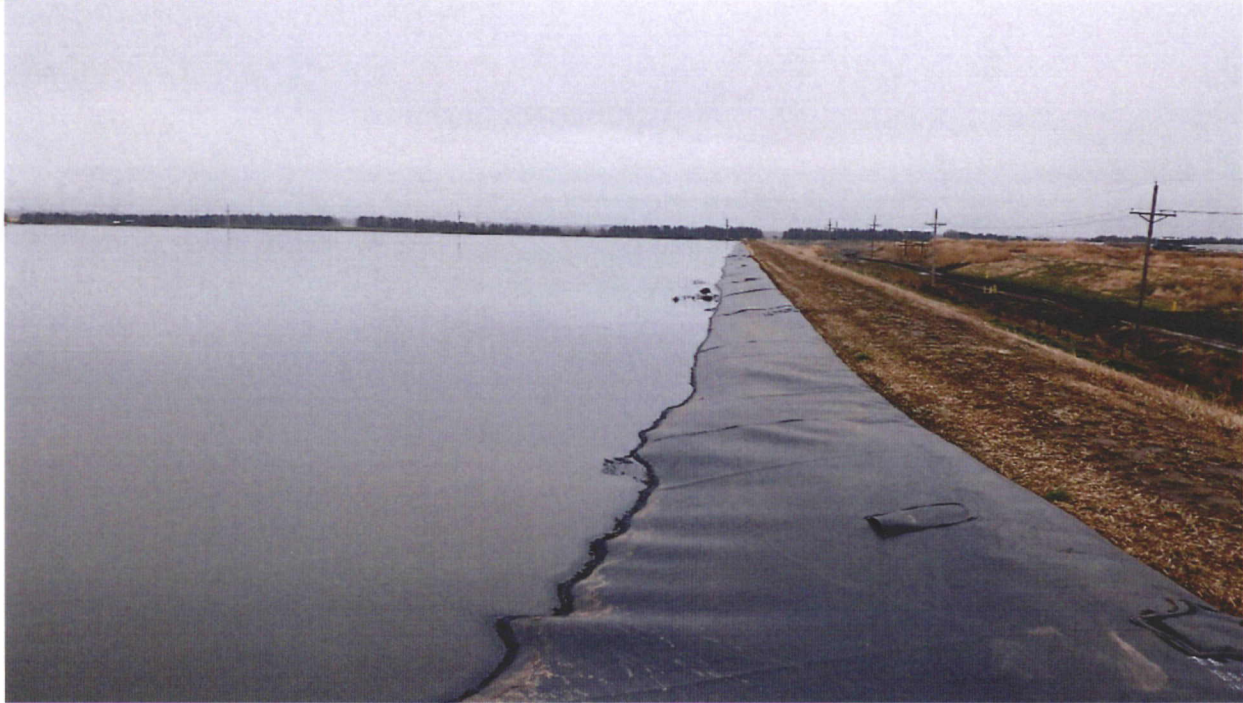
Photo: 8

Description: This photo depicts the south lagoon. The lagoon appears lower than it did on Monday March 15, 2021.

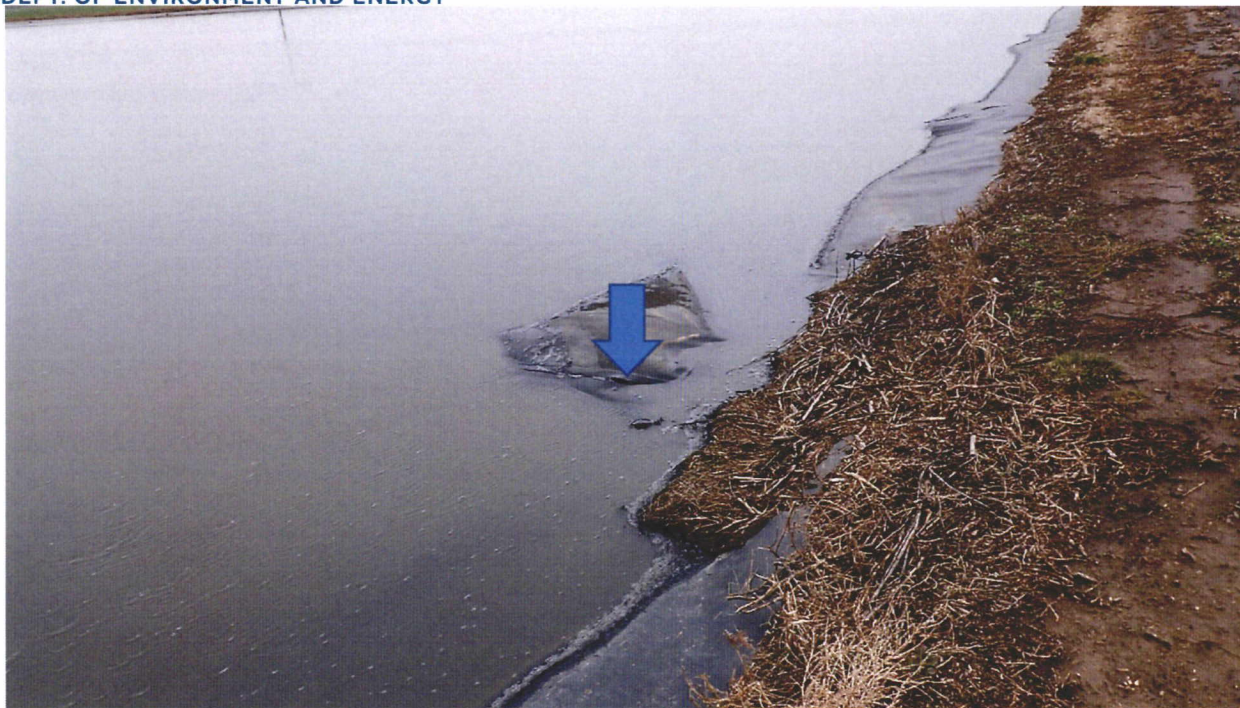
Photo: 10

Description: This photo depicts a possible tear in the south lagoon liner (arrow). This is located along the south lagoon dike.

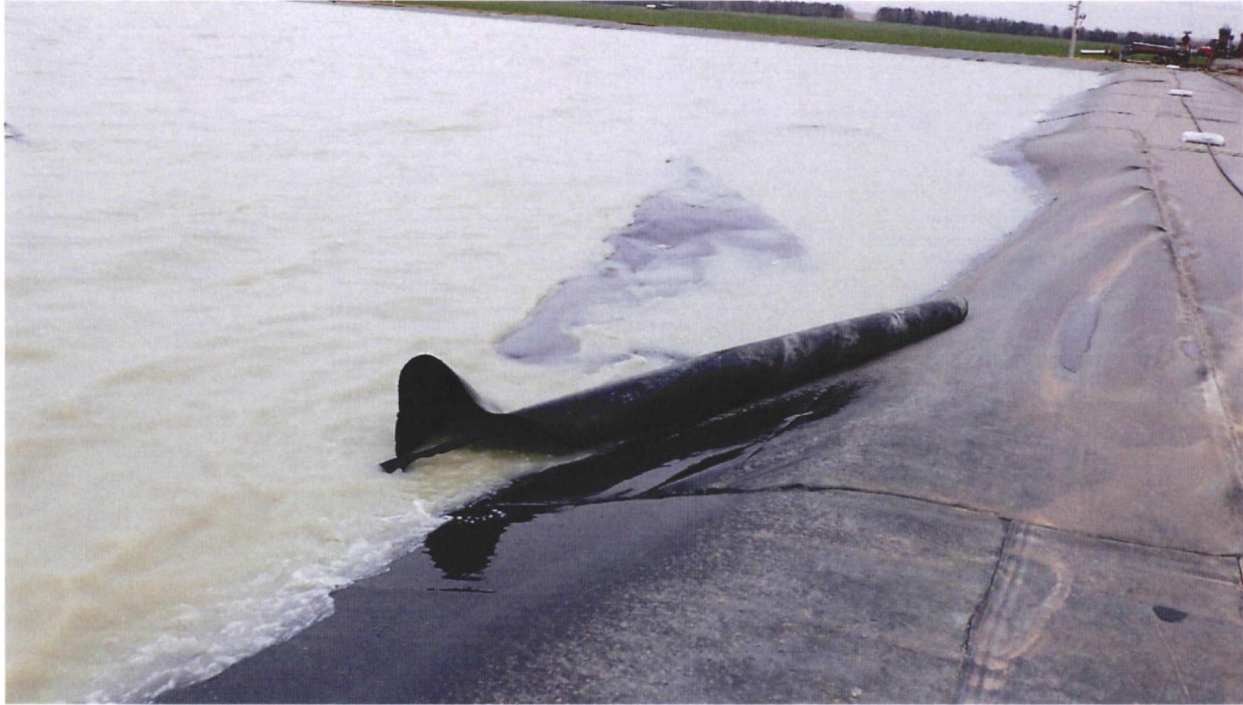
Photo: 11

Description: This photo depicts a torn liner floating against the south dike.

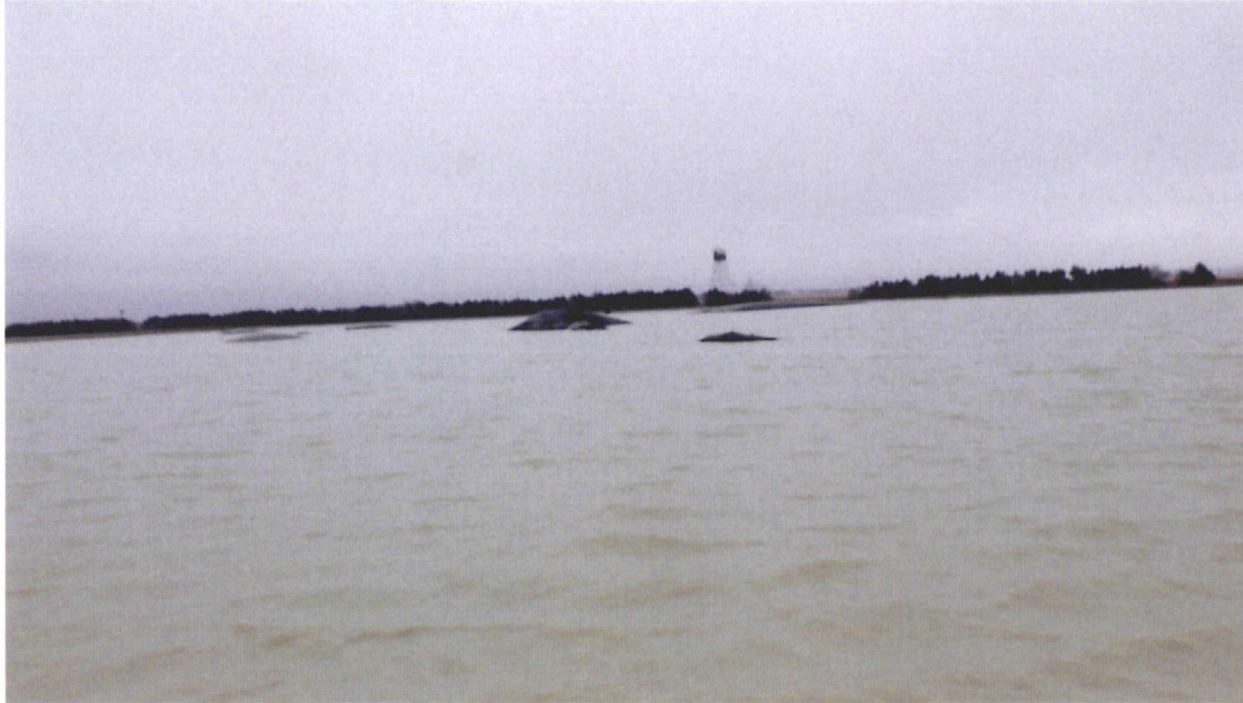
Photo: 12

Description: This photo depicts multiple whales in the northeast lagoon. The whales appear to be slightly smaller today.

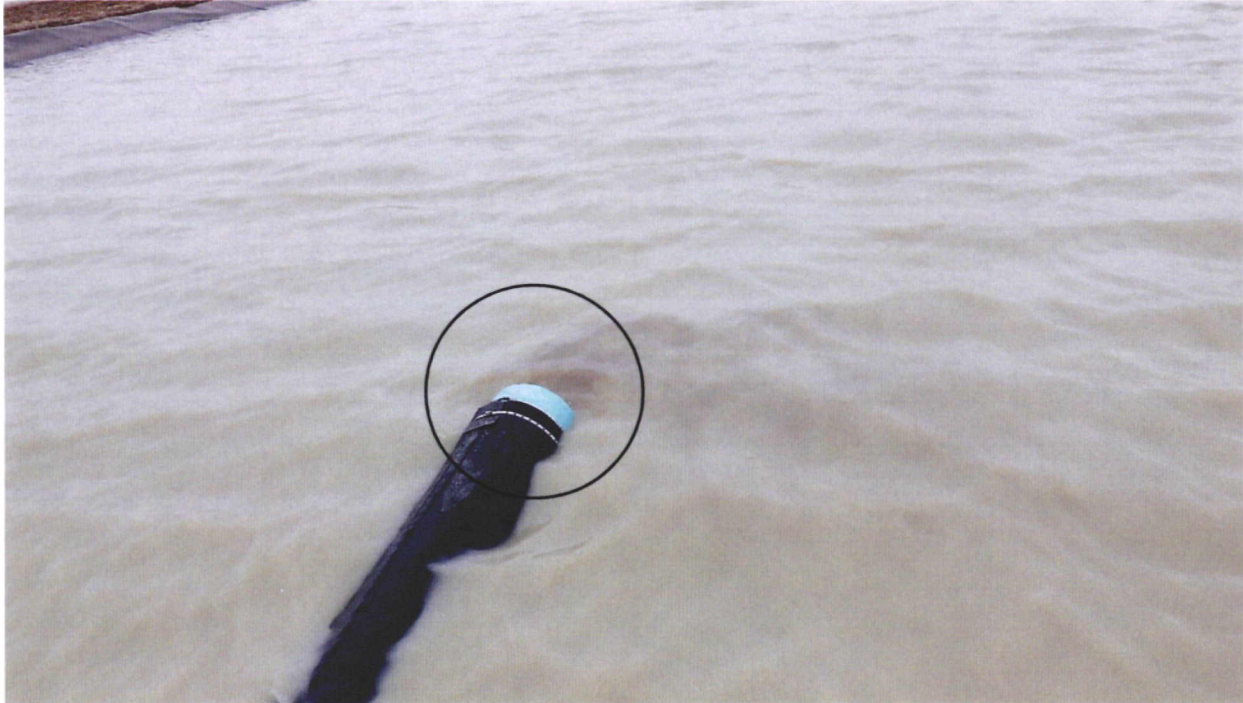
Photo: 13

Description: This photo depicts the equalization tube between the South and the Northeast lagoon. It appears that the south lagoon is flowing into the northeast lagoon. Notice the difference in color (circle).

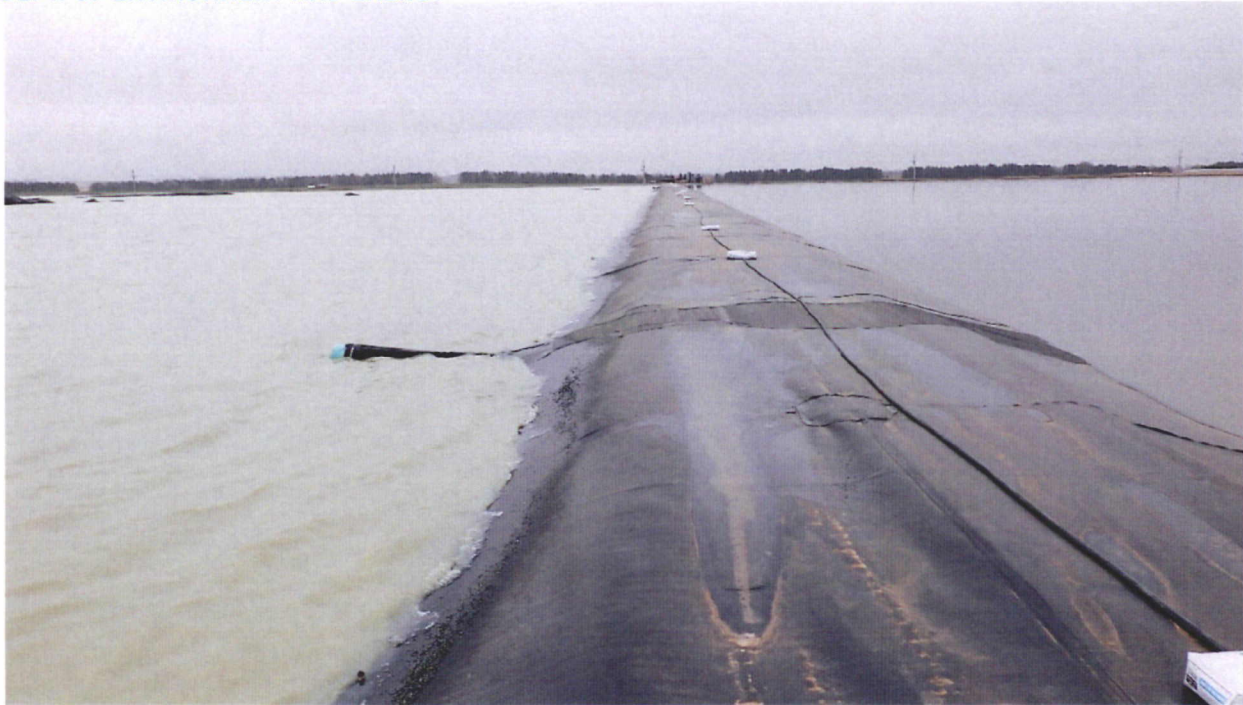
Photo: 14

Description: This photo depicts the dikes between the northeast and south lagoon. The photo also depicts the equalization tube between the two lagoons. There is lots of wave action in the northeast lagoon while the south lagoon is smooth.

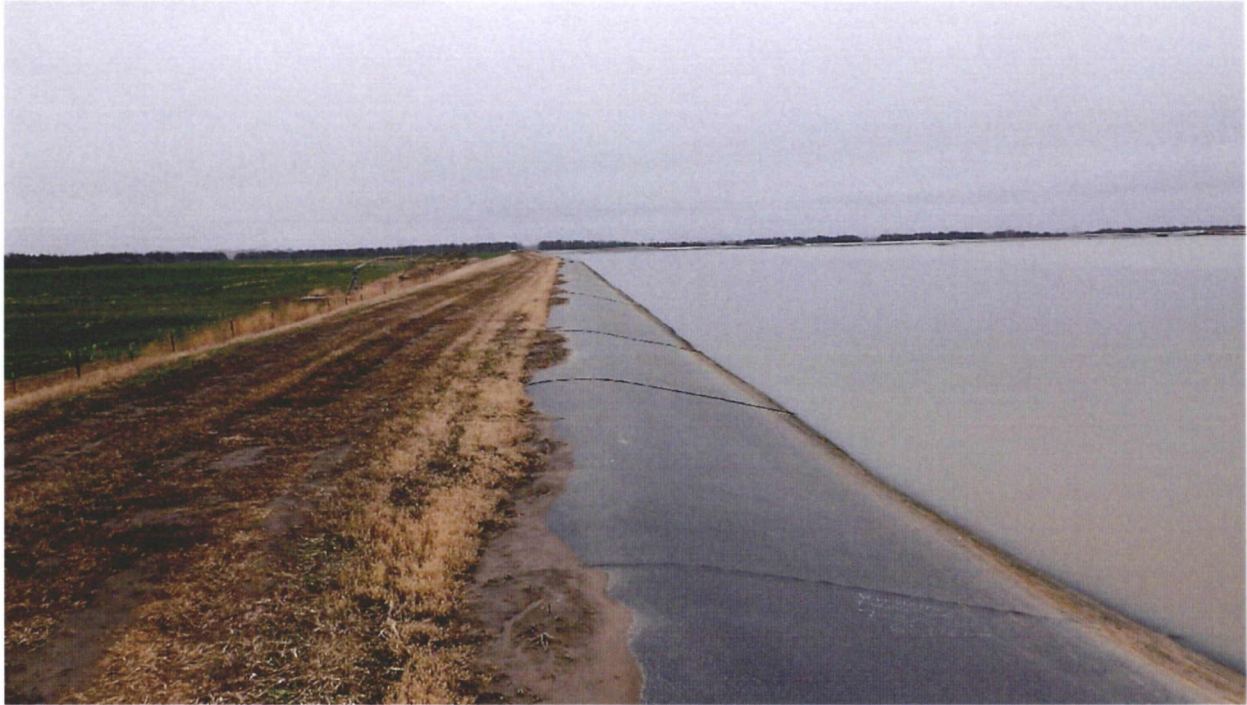
Photo: 17

Description: This photo depicts the lagoon liner and freeboard.

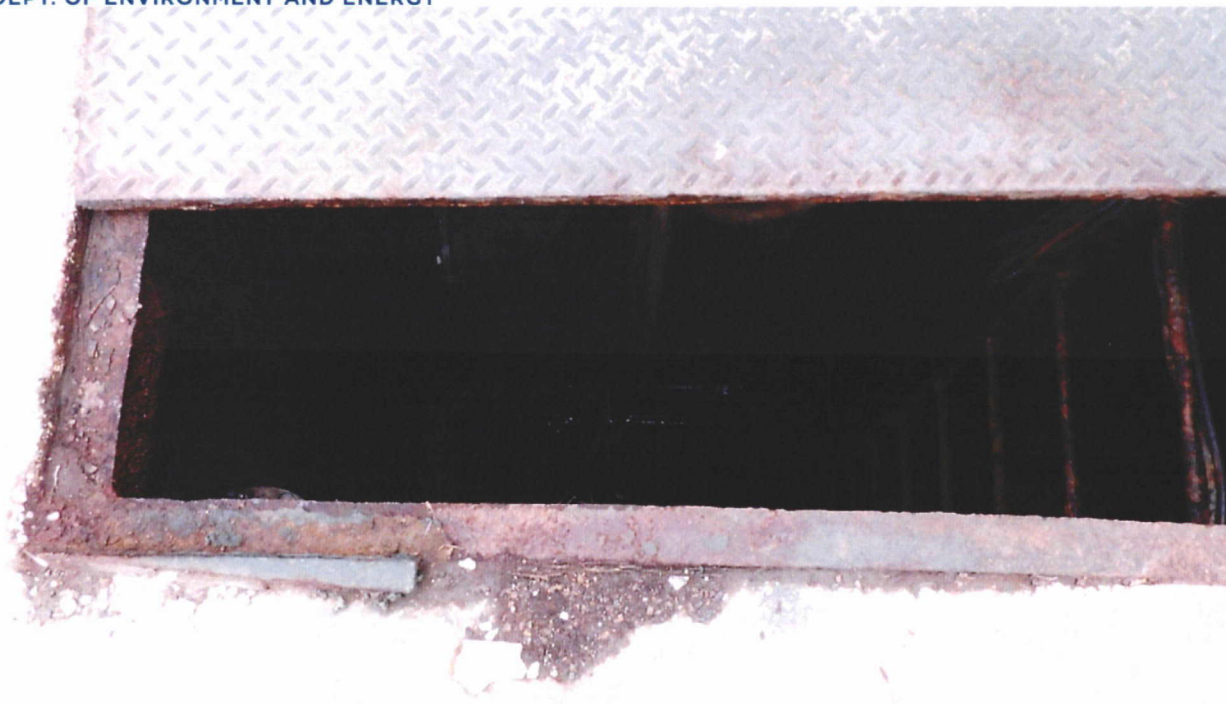
Photo: 19

Description: This photo depicts the lift station. There is very little water in the transfer box at this time. Mr. Peterson stated that storm water is conveyed through this station. Mr. Peterson also stated that one to two thousand gallons of solids from the new treatment system enters this lift station. The lift station pumps directly to the lagoon system.
