PCS 84069

AltEn Field Observations

March 8, 2021

NDEE

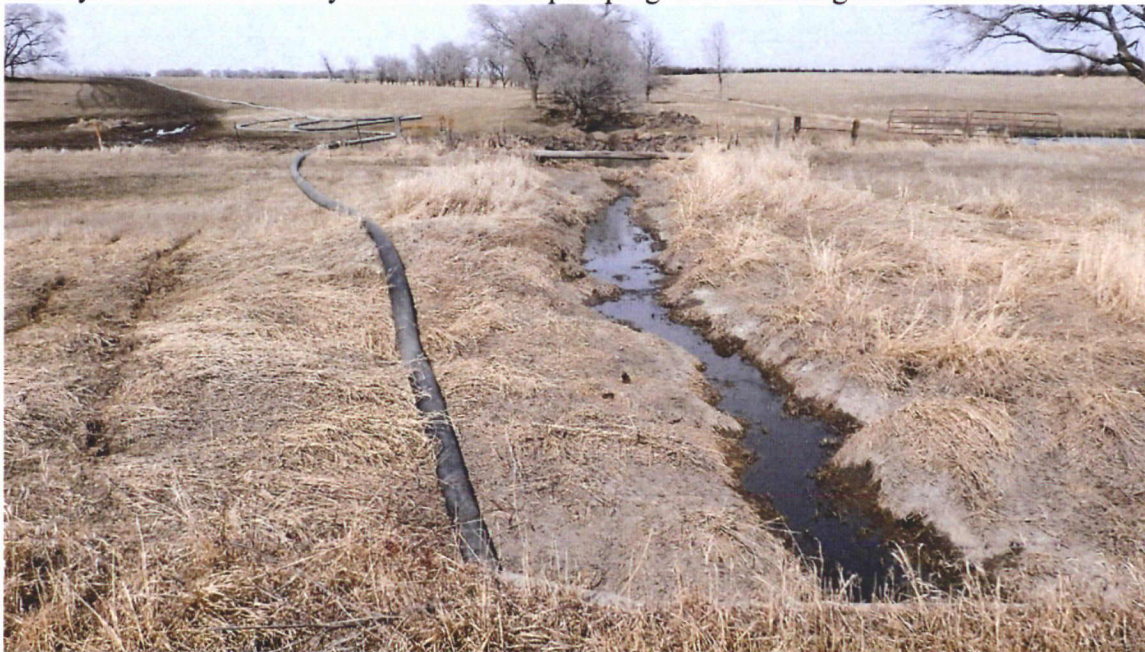
The site above Site 3 and on the north side of Highway 66 facing north. There had previously been a pump at this site pumping upstream of the berm, which is visible above the telephone pole across the drainage. The water was being pumped back to the AltEn facility. At the time of my observation no pumping was occurring at this location.

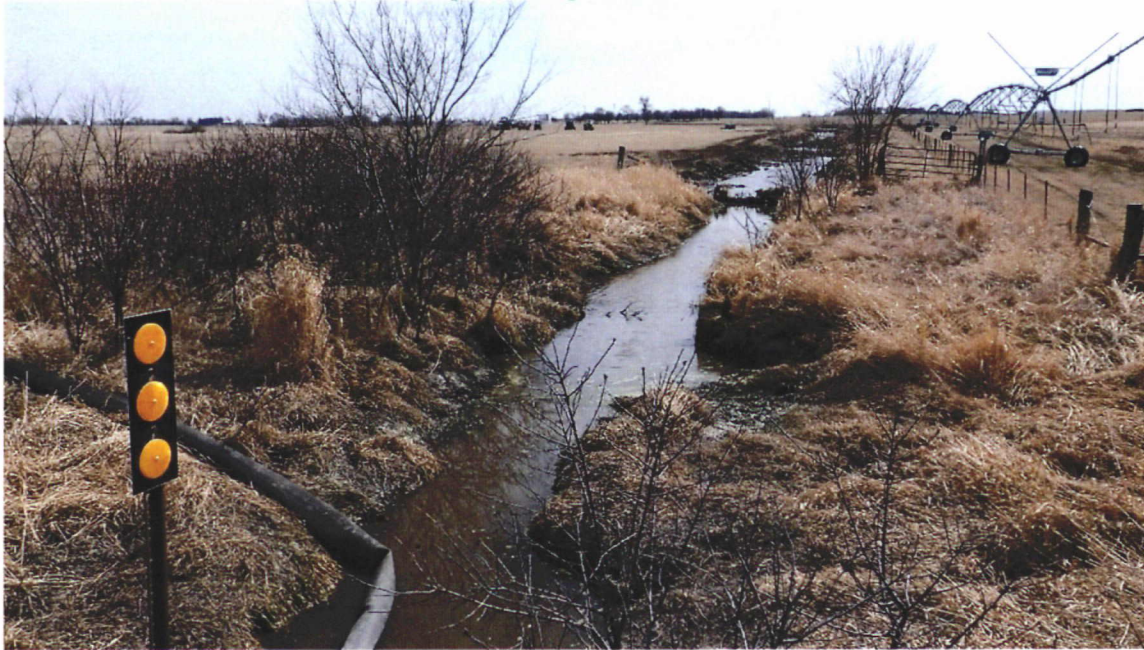
On the south side of Highway 66 facing south and above Site 3. Water is being pumped from the drainage and is going through the collapsible tubing towards the northwest back to the AltEn facility. Note collapsible tubing in lower left-hand corner of the photo. This is the same tube as is visible in the previous photo.

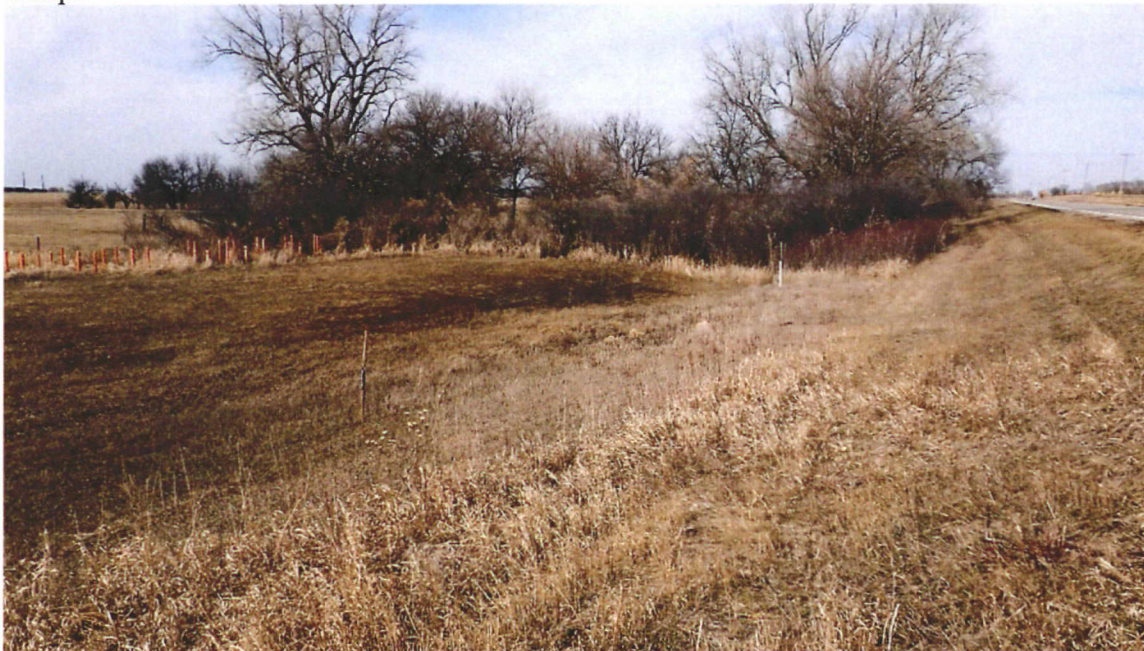
Photo of the staff gauge which was put in place on March 2, 2021. Photo is on the west side of Highway 66 facing north and on the south side of Site 3. Water level had dropped to where the drainage was in its banks and the area where the staff gauge is located is just damp.

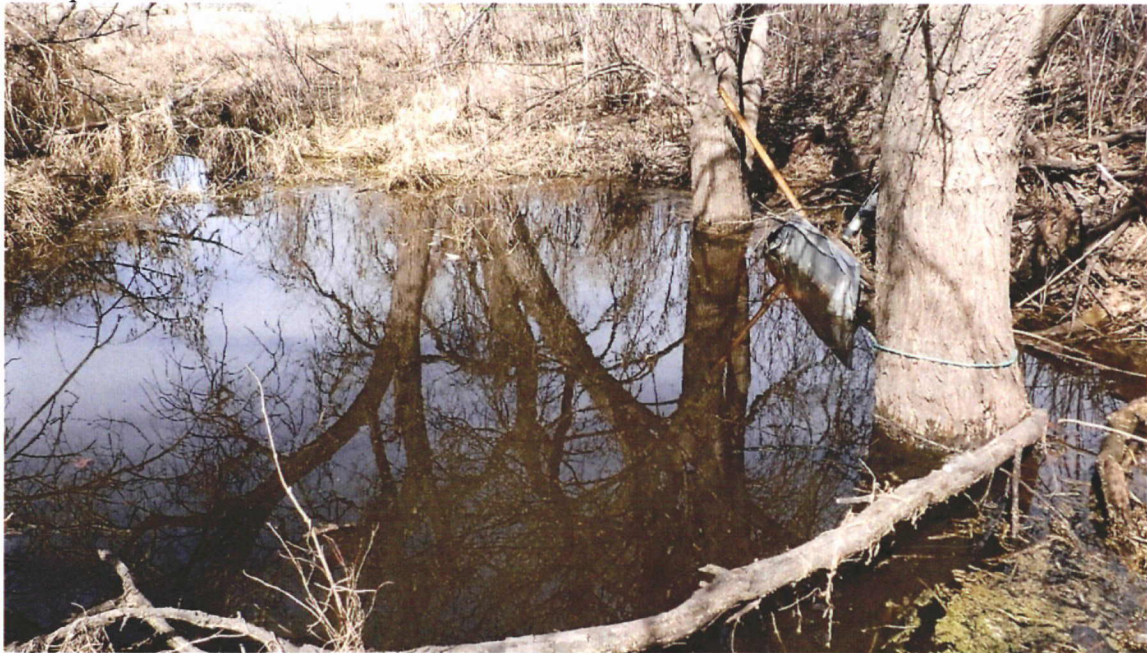
Site 3 on the west side of Highway 66, south side of the stream facing north. The cement culvert, right side of photo, is visible between the two large trees, with a balloon inside of the culvert blocked by plywood wrapped with a plastic tarp and held in place with sandbags. The top of the culvert was visible. Water temperature: 12.5 degrees C, Dissolved oxygen: 1.4 mg/l, pH: 7.1 St.Units, Conductivity: 450 Umhos/cm, Turbidity: 24.4 NTU's. Air temperature: 72 degrees F, 90% cloud cover and a south wind at 20 to 25 mph.

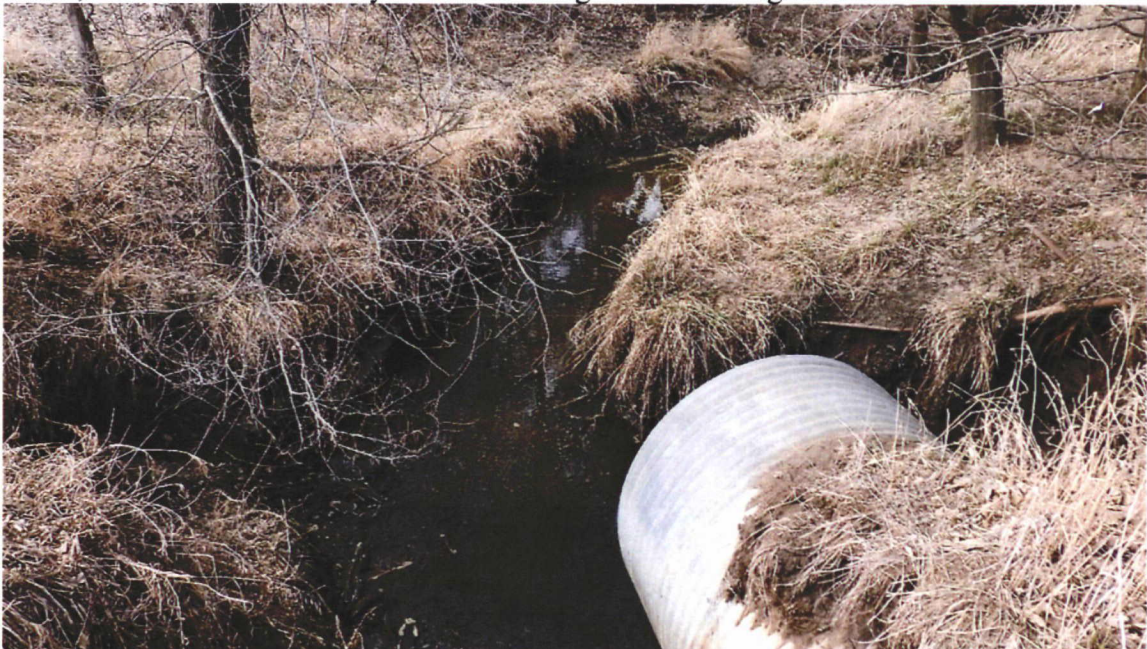
Site 2, west side of the county road and facing west. Drainage is clear of ice.

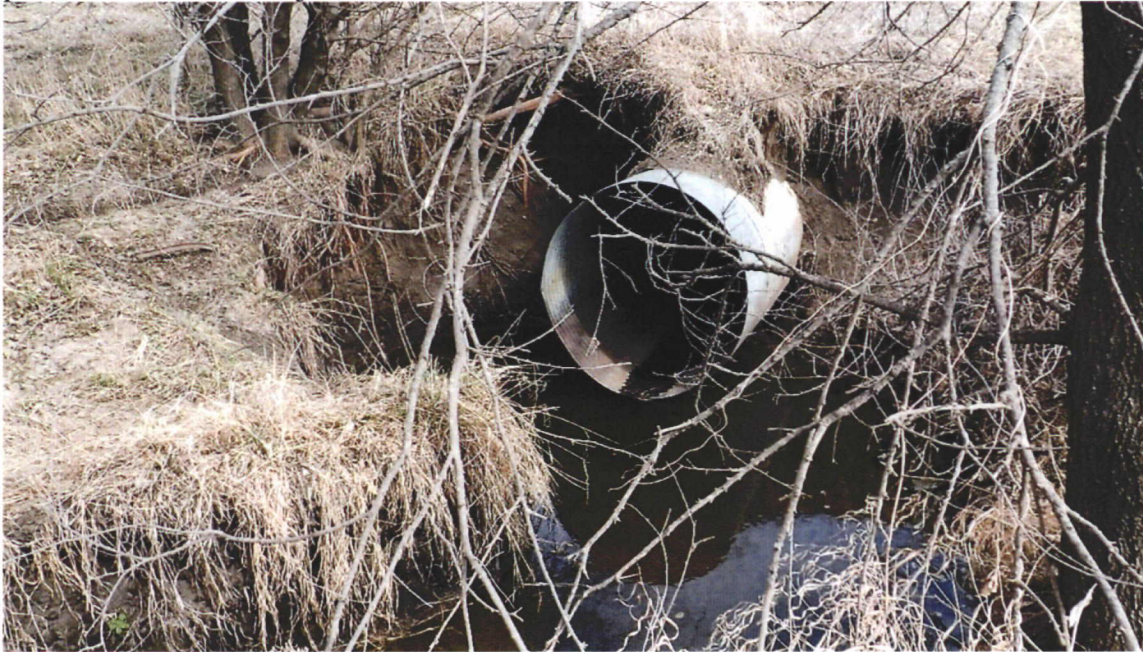
Site 2 west side of county road facing east. The same metal culvert as in the previous picture. Water level is just to the bottom of the culvert.

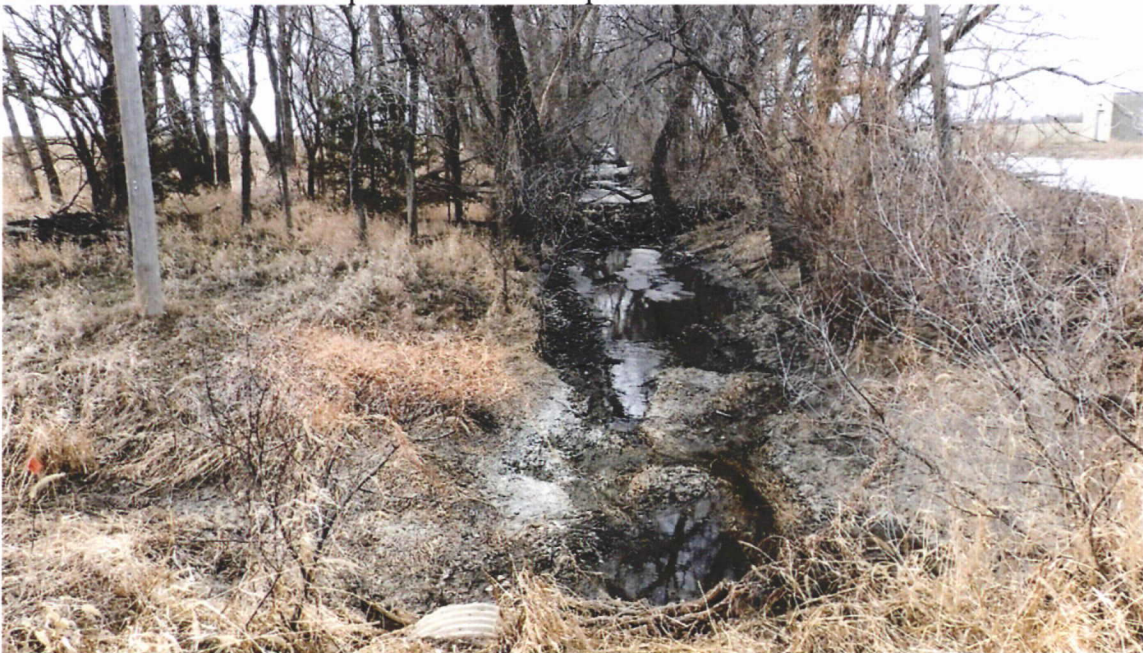
Site 4, west side of the county road facing west. Snow and ice now melted. Low to no flow due to a beaver dam upstream and some pooled areas.

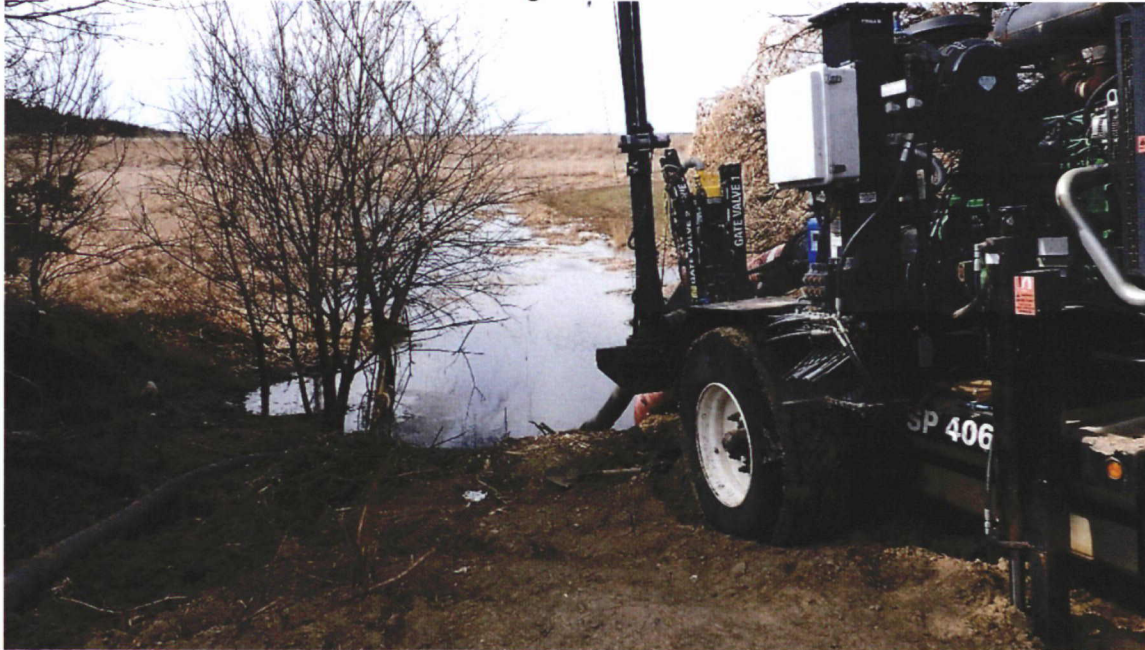
Site 5 facing west. Pump was not running.
