PCS  
84069

AltEn Field Observations.  
March 4, 2021  
Jim Borovich  
NDEE

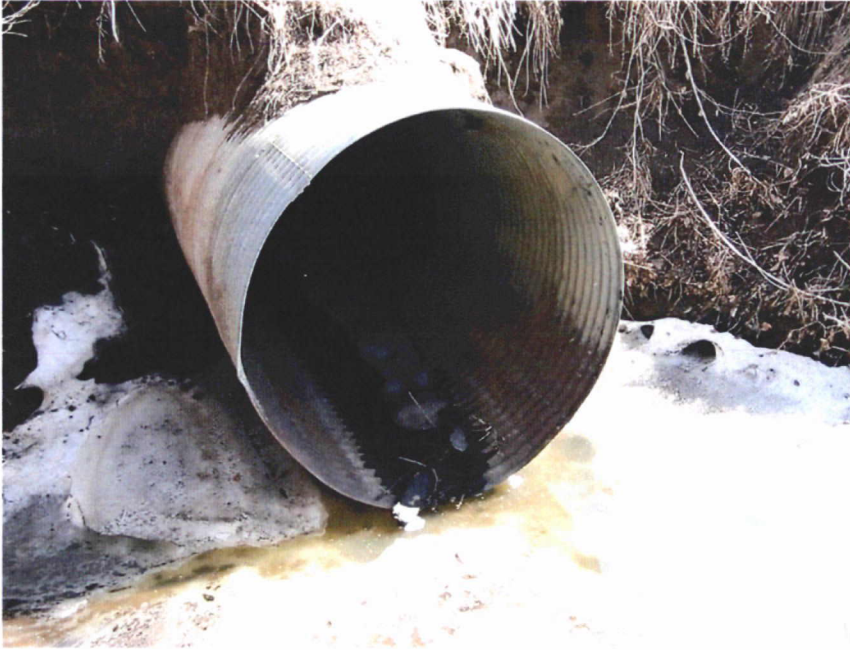
Photo 1. Looking east at culvert on west side of Road 6. Water in drainage way discolored and murky. Does not appear much water is entering culvert and water level appears lower in relation to bottom of culvert compared to Borovich's observations of 3/1/21.

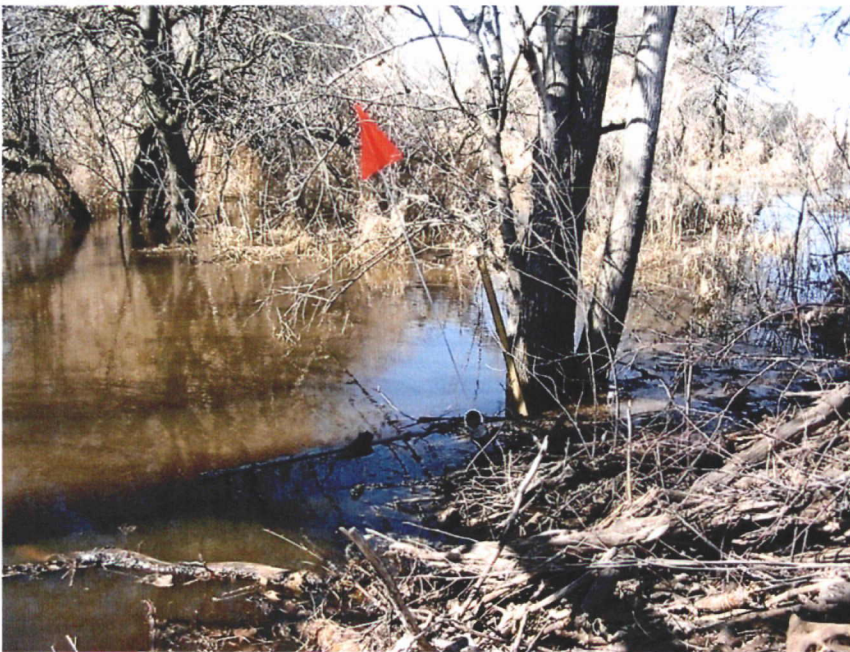
Photo 2. Looking west from west side of Highway 66. Area inundated with water. Water discolored. Red flag marks general position of culvert and makeshift dam. Water level is lower compared to Borovich's observation of this location on 3/1/21.

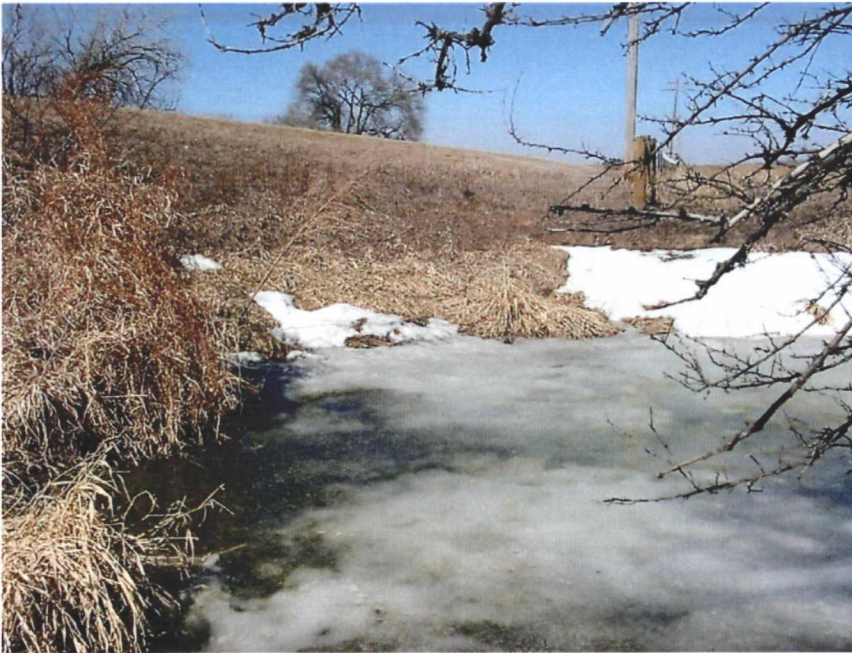
Photo 3. Looking northwest at culvert/drainage way on east side of Highway 66.

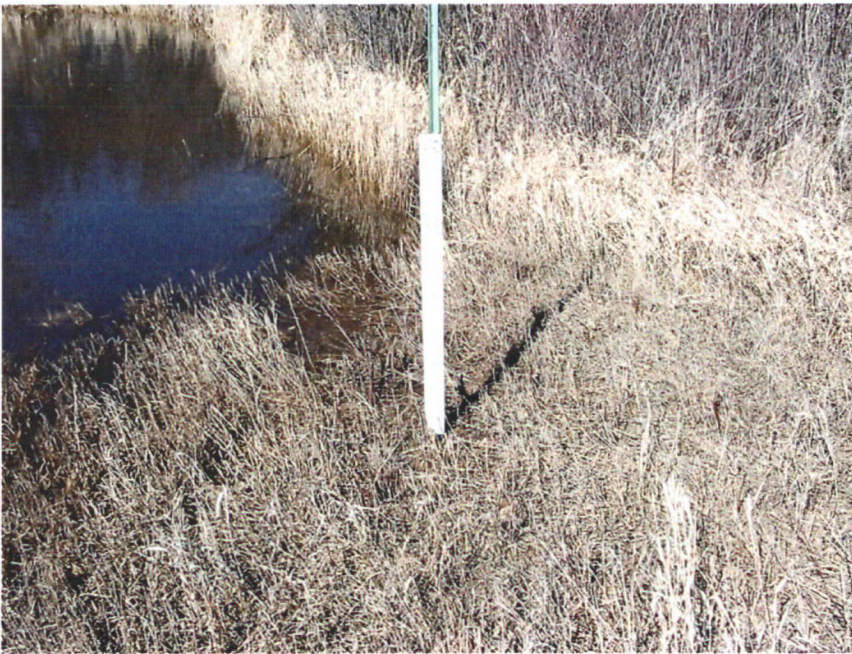
Photo 4. Looking north at water level indicator previously put in place by NDEE Monitoring Section staff. Location approx. 25 yards south of Photo 2 location.

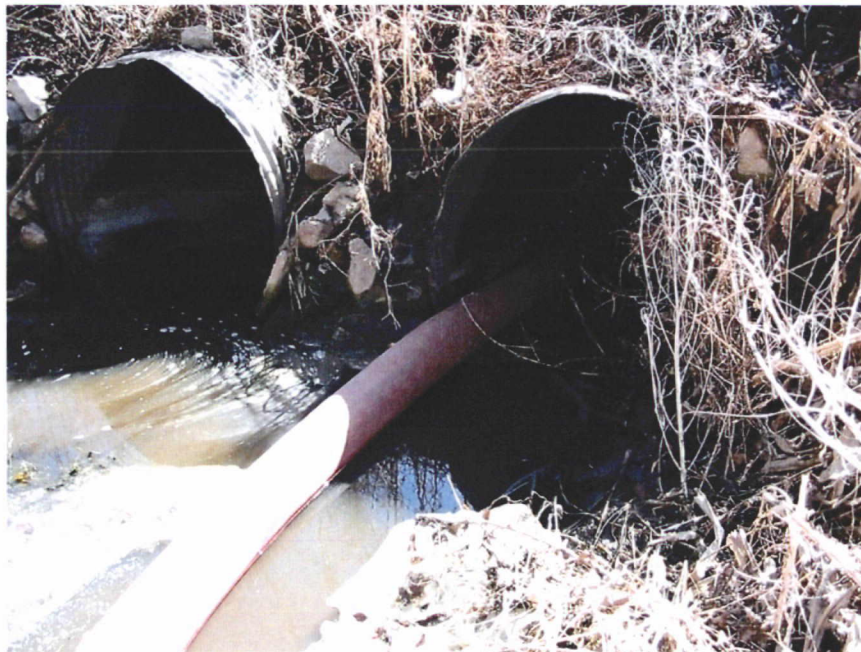
Photo 5 (designated Photo #6 in field notes). Looking south at culvert on north side of Road H. Note piping exiting culvert from pumping at previous stop.

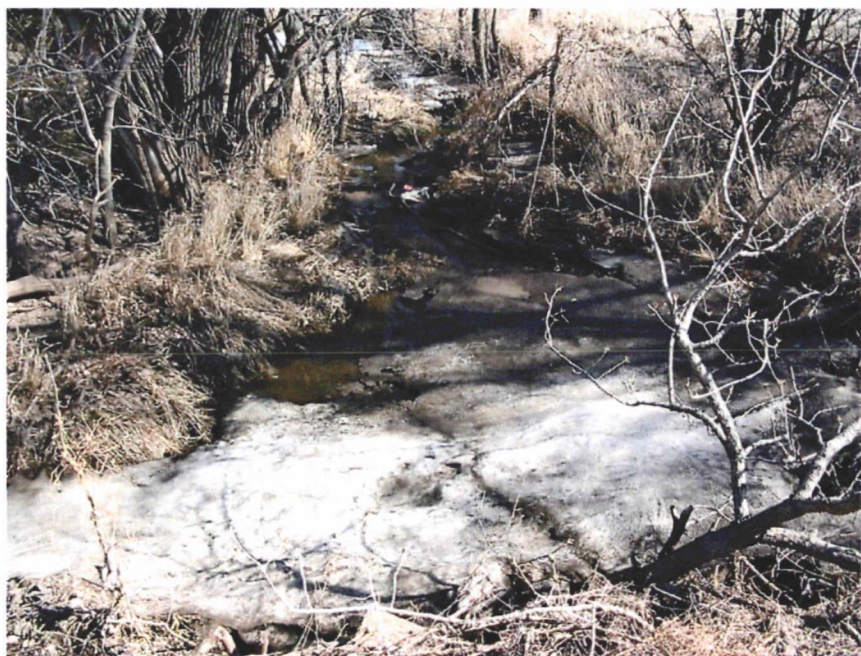
Photo 6 (designated Photo #7 in field notes). Looking east at drainage way on east side of Road 8. Water level appears to be lower compared to Borovich's observations made 3/1/21.

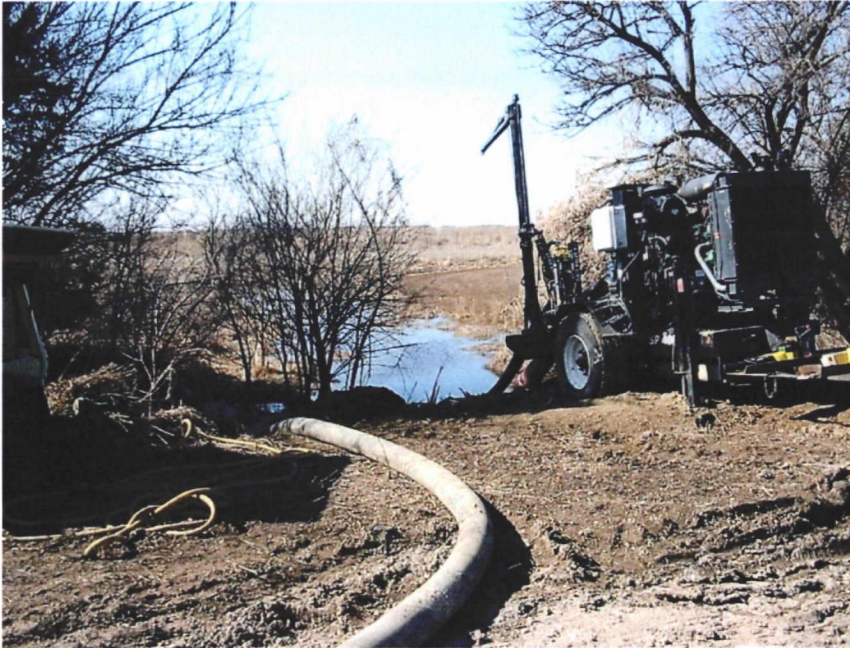
Photo 7 (designated Photo #8 in field notes). Looking west from west side of Road 9. No pumping was occurring at this location at the time of photo.

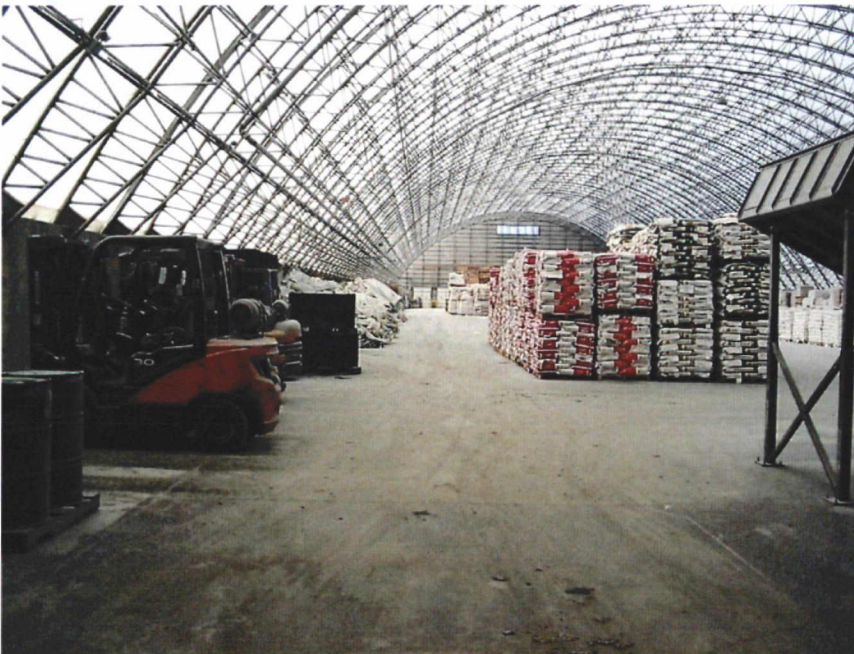
Photo 8 (designated Photo #9 in field notes). Interior of South Hoop Building, looking west. Building contains facility recyclables and palletted seed corn.

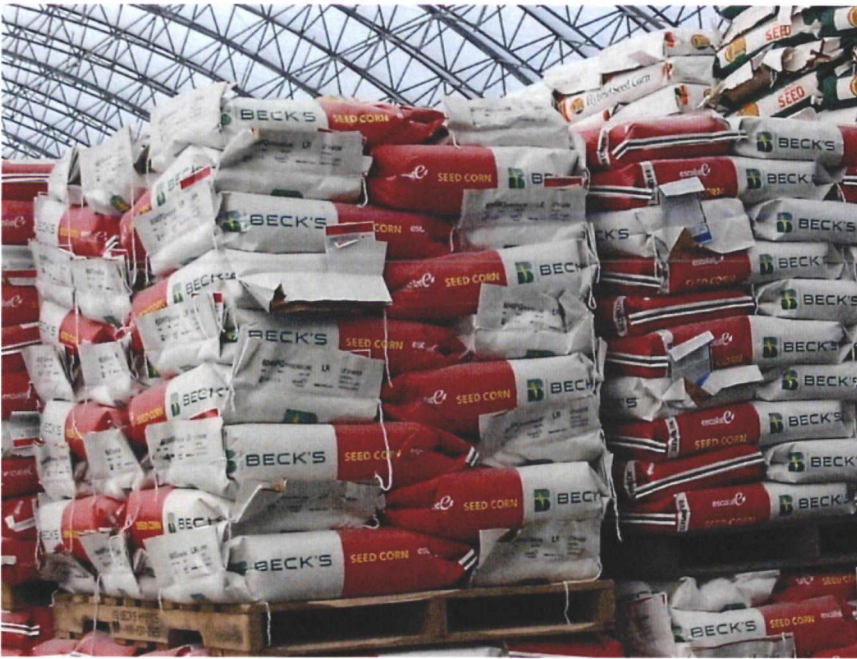
Photo 9 (designated Photo #10 in field notes). South Hoop building, looking a close-up of pallets of seed corn.

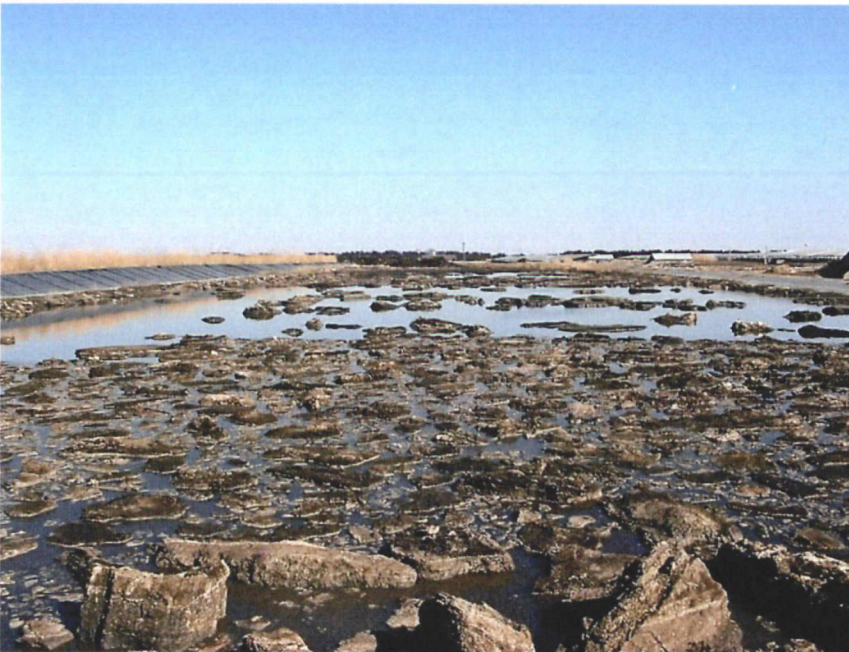
Photo 10 (designated Photo #12 in field notes). Looking east across the “Emergency Lagoon.” Material includes ice and other debris. Note dark brown “line” of material in background (middle) of photo. This is material excavated previously by Heimes Excavating, Inc. and placed in the northeast corner of the lagoon (see Photo 11).

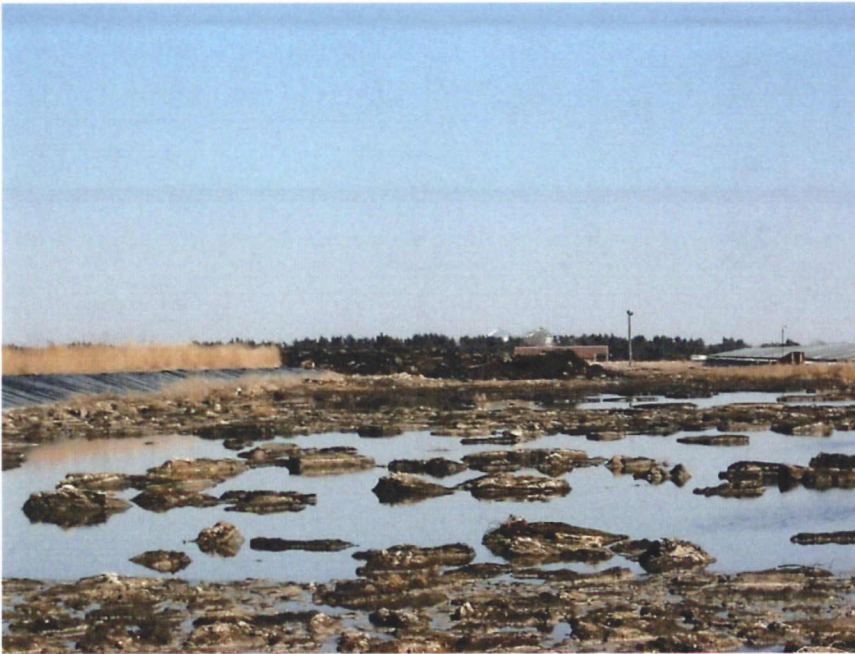
Photo 11 (designated Photo # 13 in field notes). Looking east across “Emergency Lagoon” at material previously excavated by Heimes Excavating and placed in the northeast corner of the lagoon.

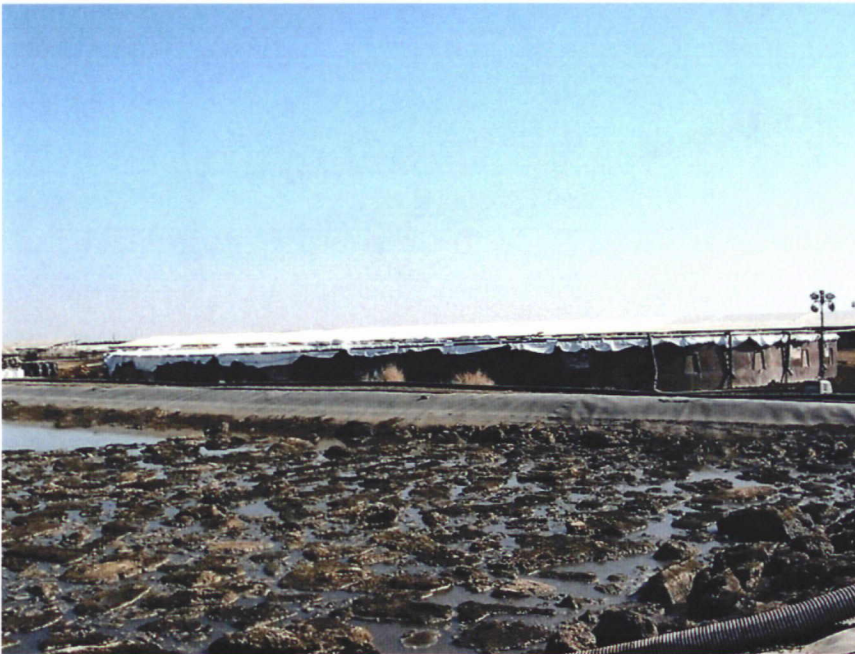
Photo 12 (designated Photo #14 in field notes). Looking southeast from same location as Photos 10 & 11 at constructed holding or field tank (one million-gallon capacity).
