AltEn: Samples at Pond below Site 2,
March 26, 2021
Dave Bubb, NDEE

On March 26, 2021 I collected water samples from a pond, owned by Stan Keiser, approximately 0.5 miles below, or east of, Site 2 on the unnamed tributary to Clear Creek.

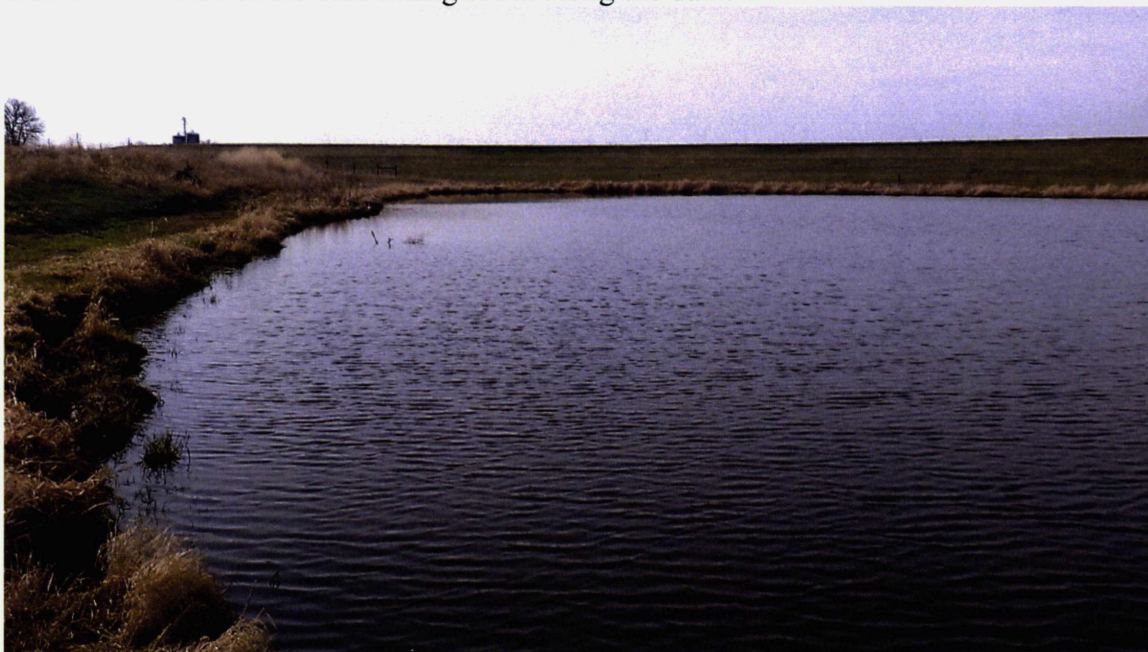
On the north side of the dam facing south along the dam.

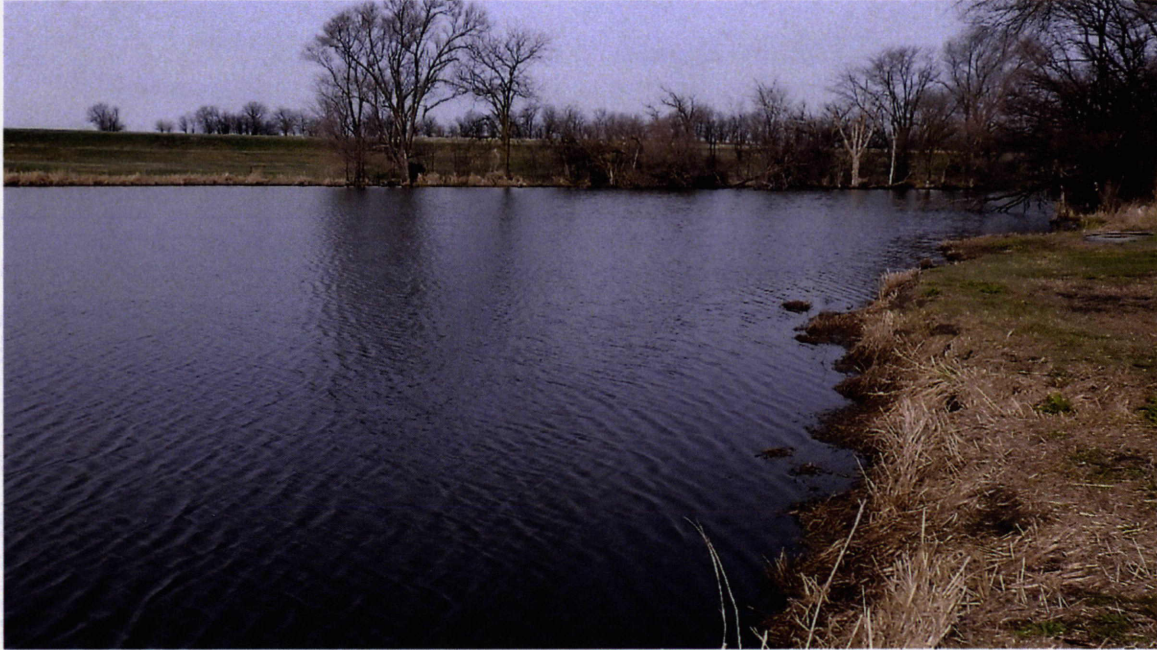
On the north side of the dam facing west/northwest

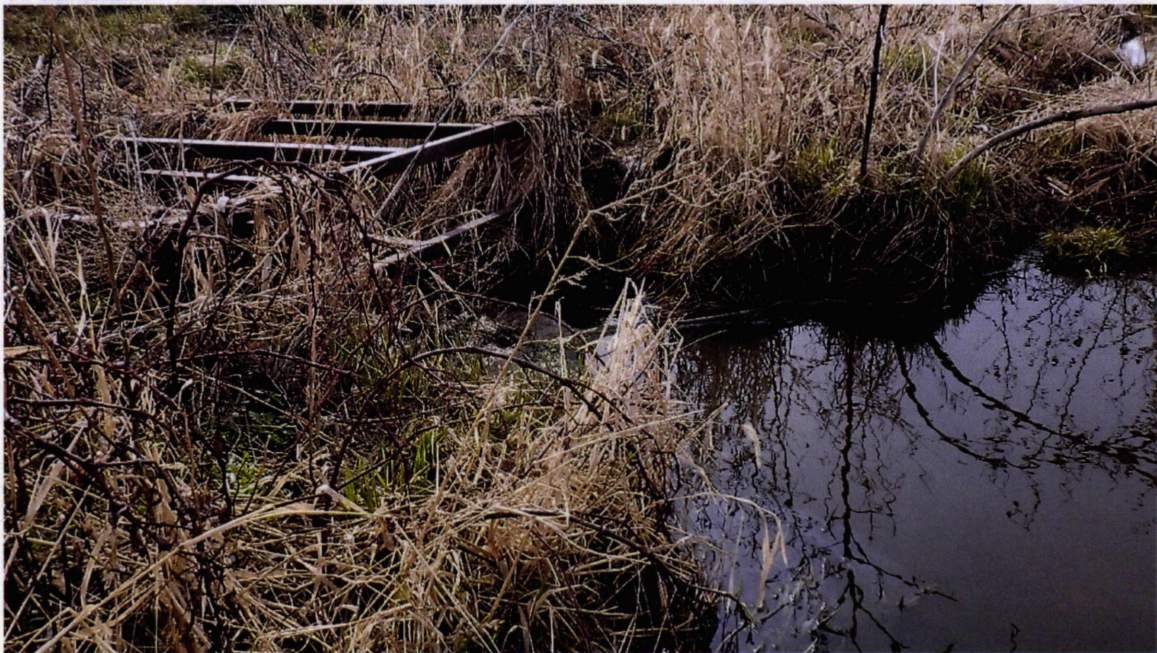
Photo is facing south/southeast and is of the outfall structure at approximately the middle of the dam.

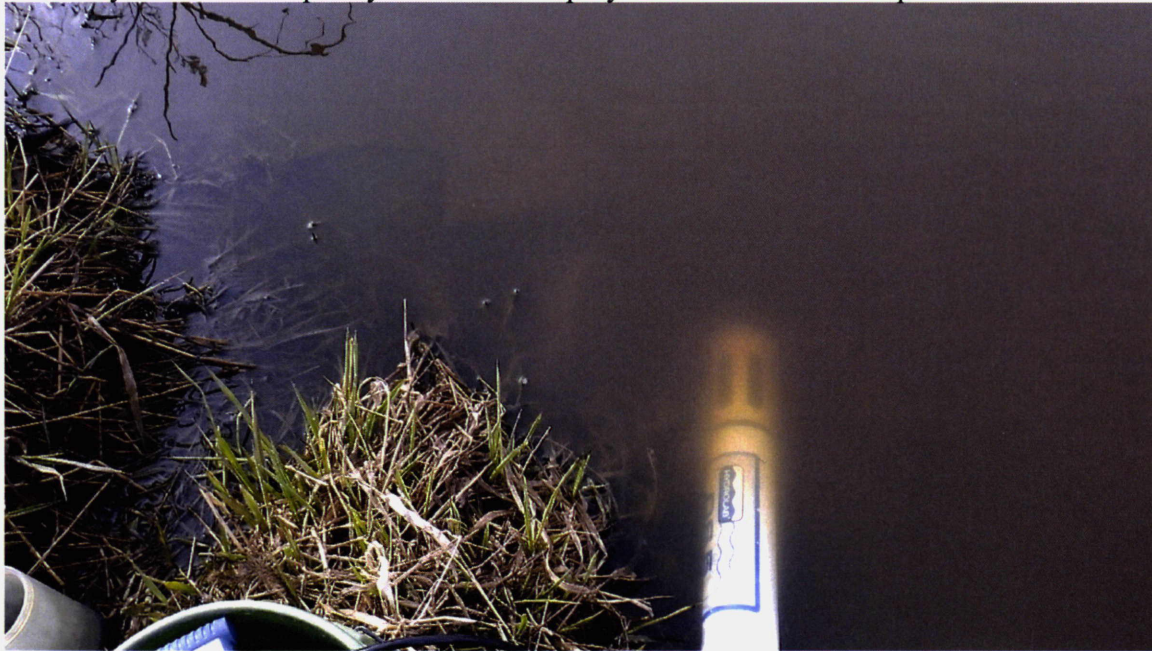
Photo taken at approximate center of dam just to the north of the outfall structure and is of the Hydrolab water quality instrument deployed to determine field parameters.

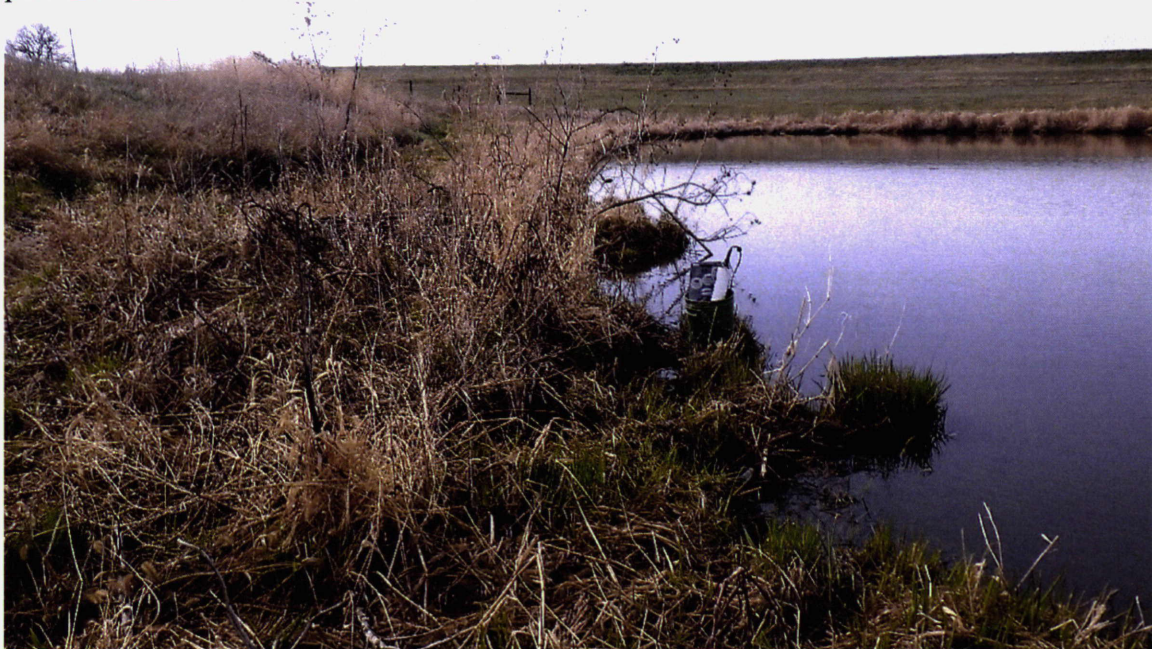
Facing south at approximate center of dam. Photo is of the green bucket which contains the Hydrolab water quality instrument and is at the site where field parameters and water samples were collected. The outfall structure is to the left of the bucket. Water temperature: 8.4 degrees C, Dissolved oxygen: 0.4 mg/l, pH: 6.7 St.Units, Conductivity: 483 Umhos/cm, Turbidity: 36.1 NTU's, Dissolved oxygen (percent saturation) 2.6 percent. Collections time was 10:20.

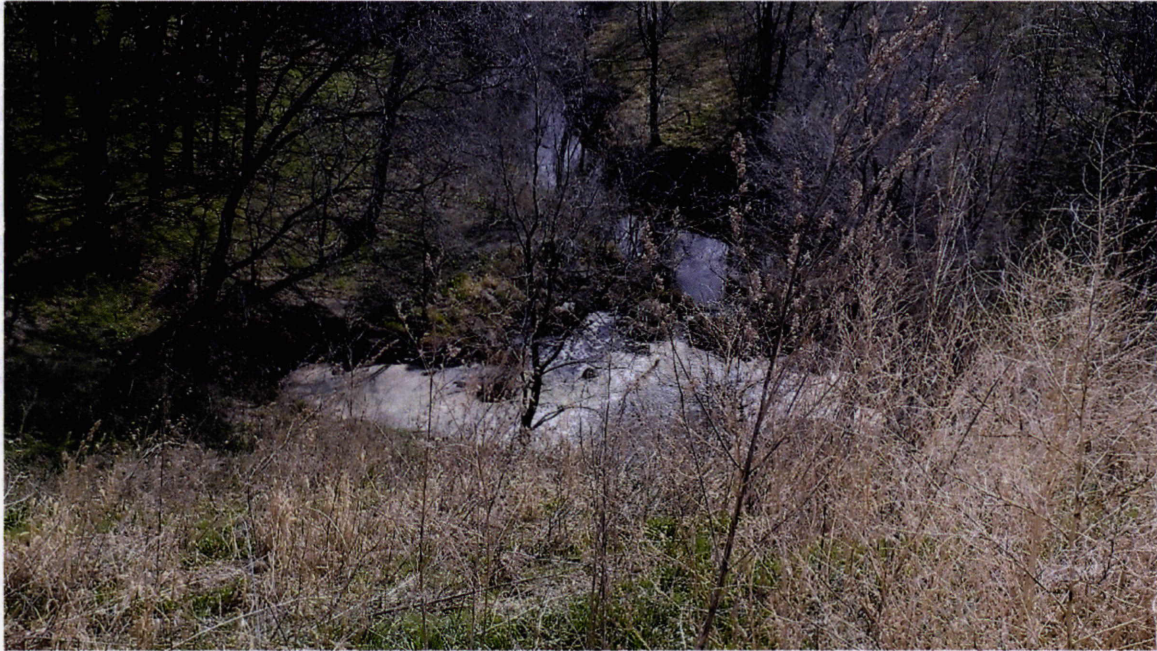
Facing east from the east side of the dam. Photo shows discharge below the dam. Water contains foam.

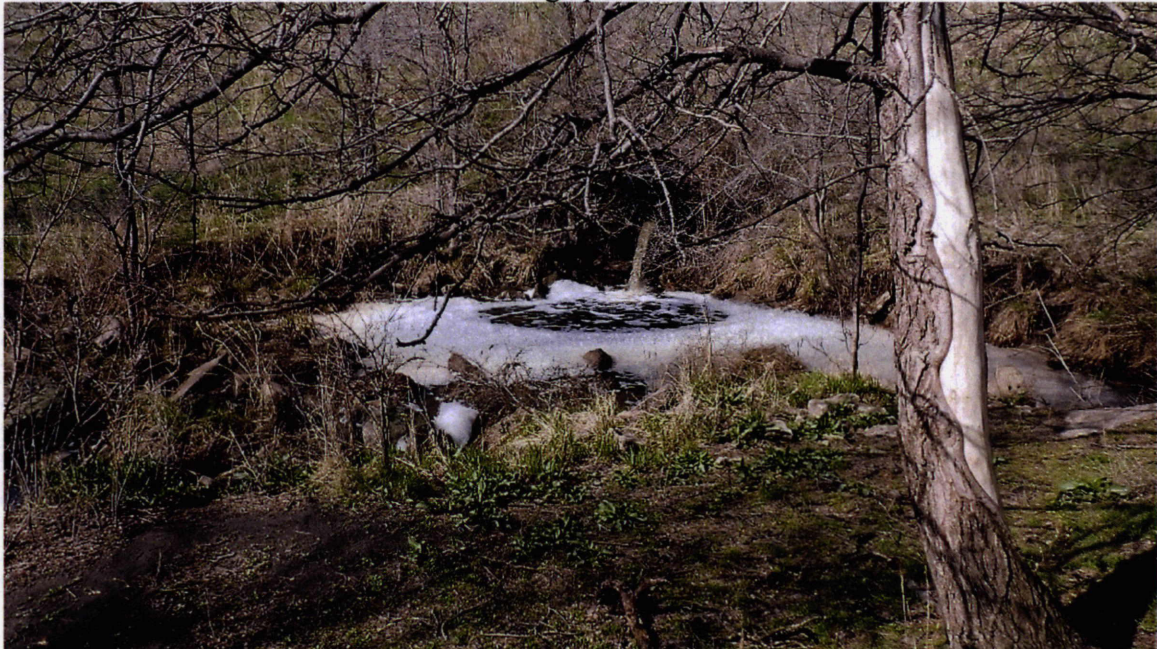
Below dam and facing west towards dam. Center of photo is discharge from pond. Considerable foam in water below discharge point.

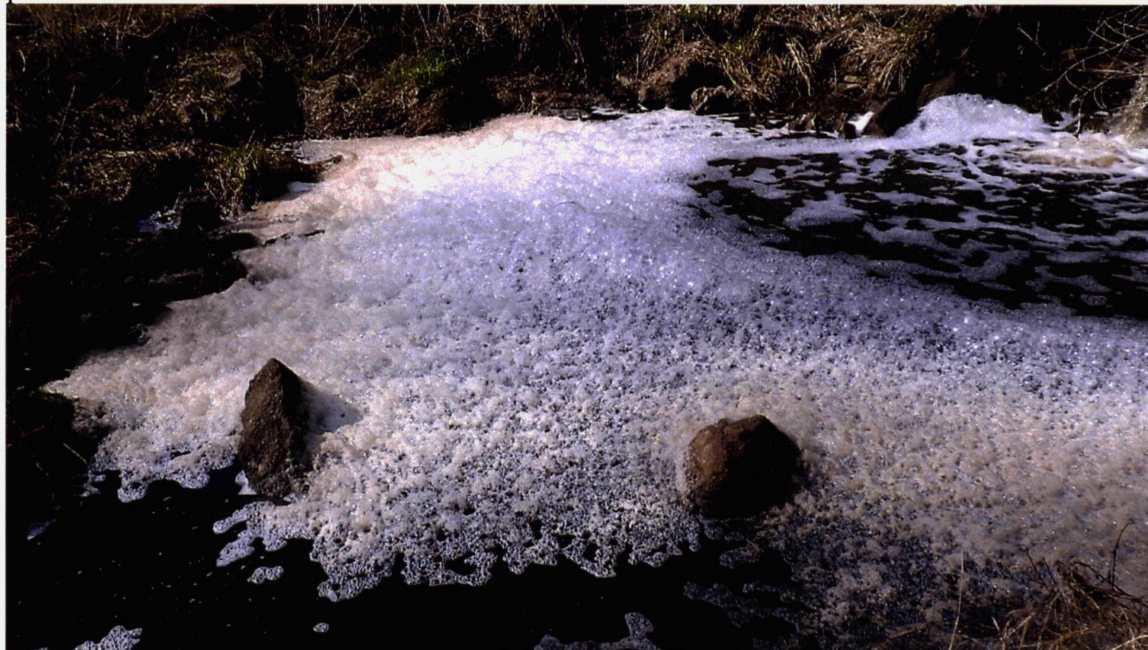
Close-up of foam from discharge below dam. Discharge point is on the right side of the photo.

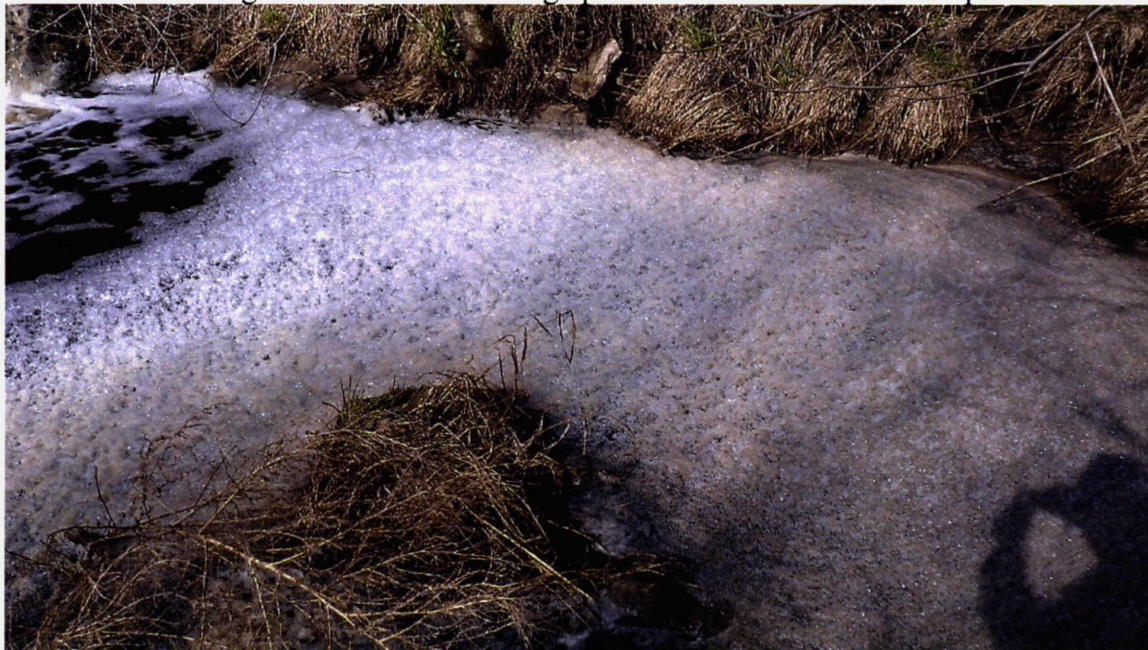
Foam near discharge below dam. Discharge point is on the left side of the photo.
