Date: August 20, 2019

RE: Complaint Investigation
AltEn, LLC
1344 County Road 10
Mead, NE 68041

NDEE ID: 84069

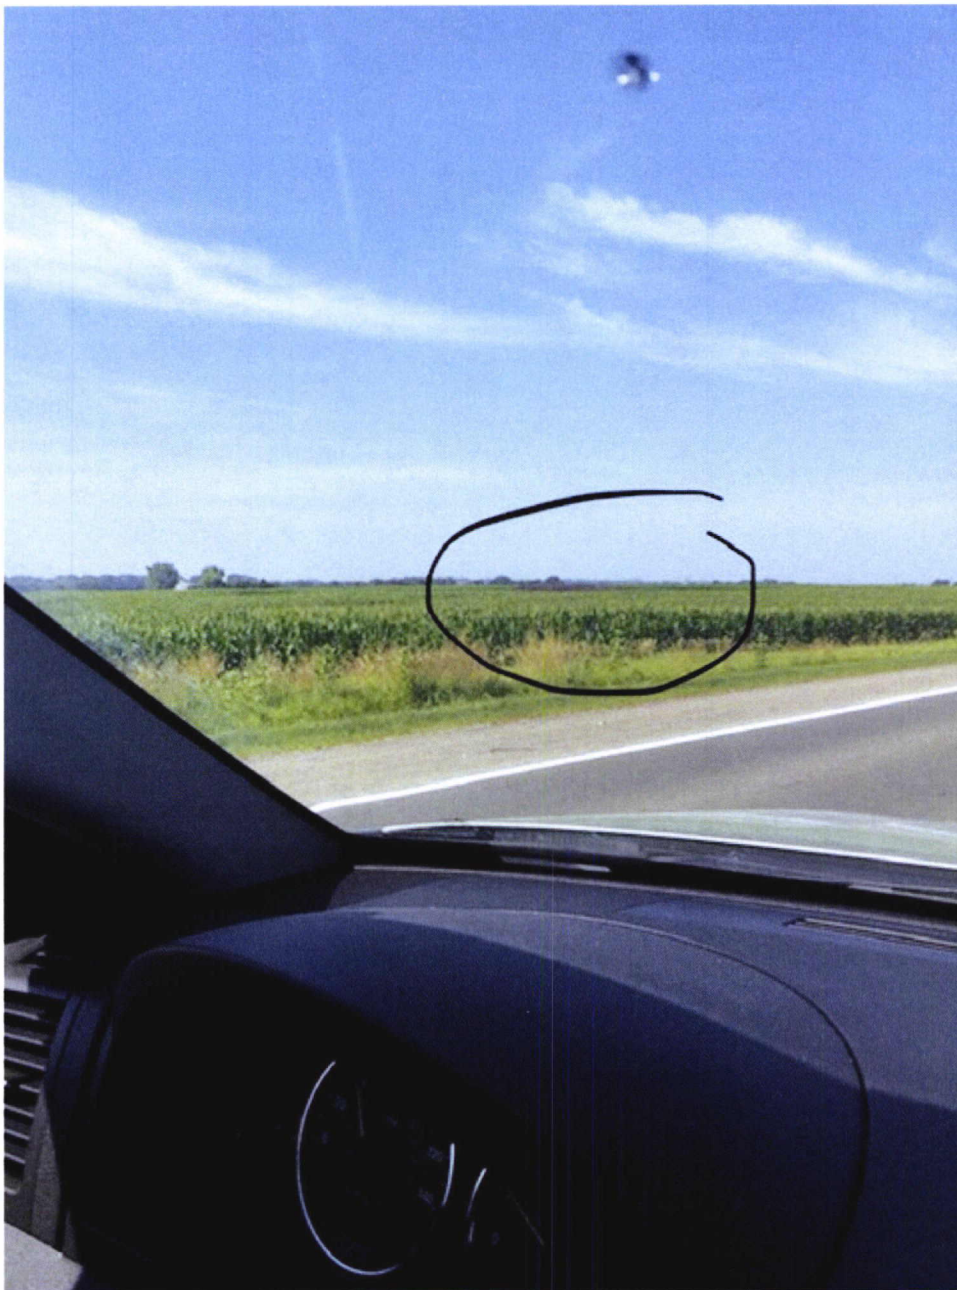
Can barely see it, can only see it going west on 92, on the south side appears in the middle of the corn field. Between the first road south after the 92/77 intersection and the second road! You will smell it before you see it

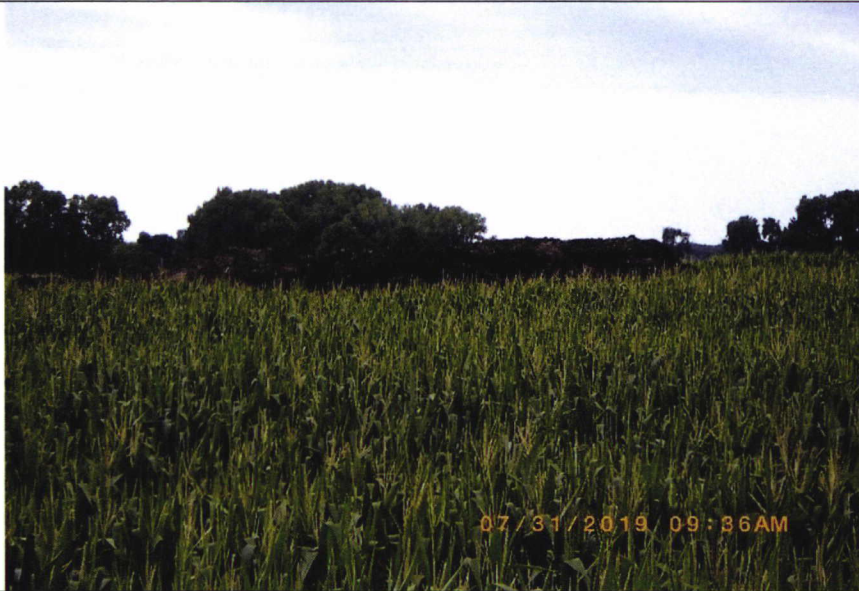
Photograph 1
Date: July 31, 2019
Photographer: Mark Pomajzl
Camera: RICOH WG-50
IIS# 84069, IWM Permit # NE0204447
Subject: AltEn, LLC Complaint Investigation

- 1) The location given by Ms. Weible, which is south of Hwy 92 and in between County Roads 18 & 19 (Photograph 1).
- 2) North of East 1st St., on the east side of Wahoo and just west of the cemetery (Photograph 2).
- 3) Northeast of the intersection of Hwy 92 and Hwy 77, located just west of Mead (Photograph 3).

Looking south, photograph showing wet cake in a field located south of Hwy 92, between County Roads 18 & 19. This is presumably the location of the complaint received by Ms. Weible.

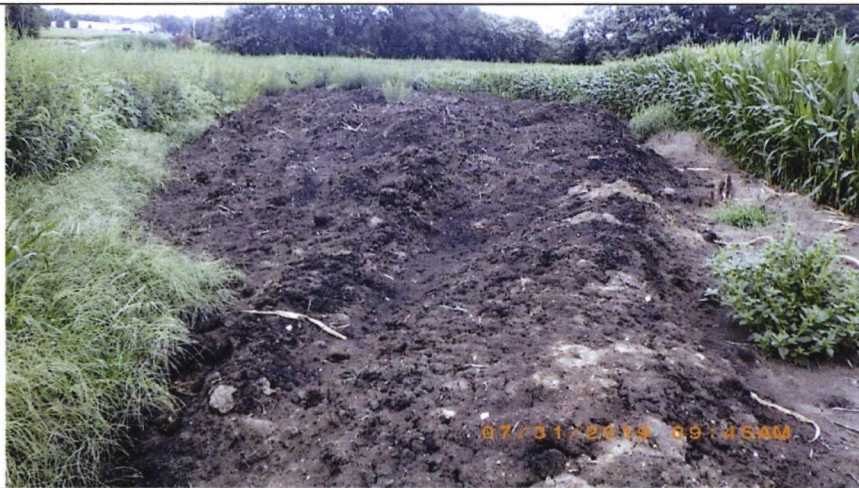
Photograph 2
Date: July 31, 2019
Photographer: Mark Pomajzl
Camera: RICOH WG-50
IIS# 84069, IWM Permit # NE0204447
Subject: AltEn, LLC Complaint Investigation

Looking west, photograph showing wet cake in a field located on the north side of East 1st St., east of Wahoo and just west of the cemetery.

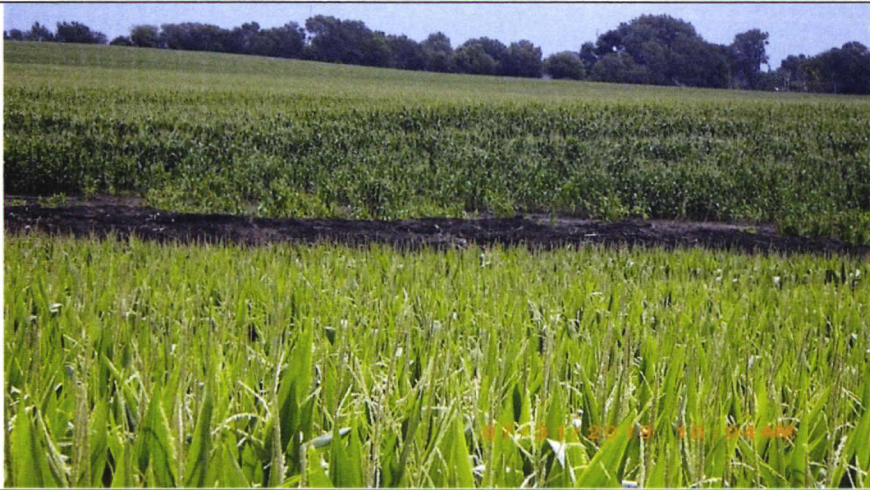
Photograph 3
Date: July 31, 2019
Photographer: Mark Pomajzl
Camera: RICOH WG-50
IIS# 84069, IWM Permit # NE0204447
Subject: AltEn, LLC Complaint Investigation

Looking east, photograph showing wet cake in a field located northeast of the intersection of Hwy 92 and Hwy 77, west of Mead.

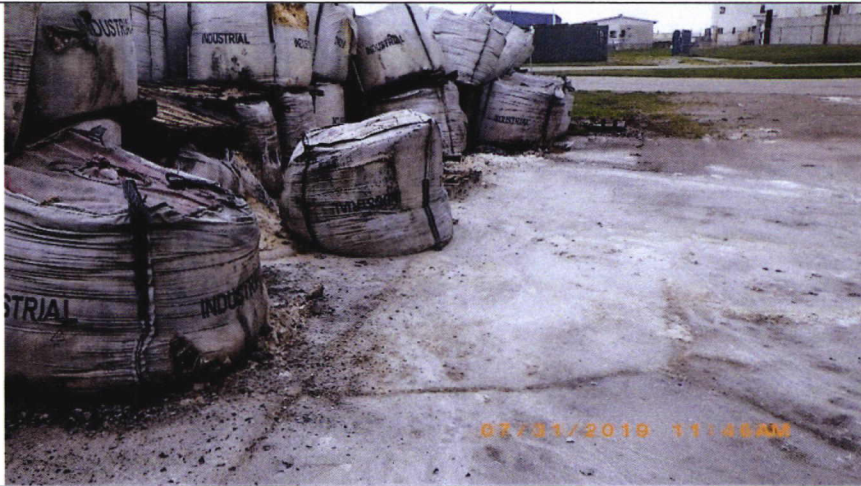
Photograph 4
Date: July 31, 2019
Photographer: Mark Pomajzl
Camera: RICOH WG-50
IIS# 84069, IWM Permit # NE0204447
Subject: AltEn, LLC Complaint Investigation

Numerous super sacks of industrial and/or food grade starch were located west of the office building. It is believed most of these sacks have been in place for approximately 2 years. Mr. Peterson said because they have gotten wet and have hardened, they could not be used in the ethanol process. He said they have talked about getting rid of it or possibly using the starch in a new process although he was not at liberty to discuss. He said a 3rd party also took some but that has ended. It was learned later that BigOx located in S. Sioux City was the 3rd party.

Numerous sacks of starch were observed split open and some of the starch had spilled and accumulated on the ground (Photographs 4-7). Other super sacks of starch were located at other locations, within the facility footprint, and were in similar condition. It was also learned that starch was being mixed in with the wet cake prior to the wet cake being delivered to the wet cake storage areas. Mr. Peterson confirmed this was happening after we questioned the white material on the ground near the wet cake load out area (Photograph 8). He was unaware how much or how often it was being done.

Photograph showing damaged sacks of starch and starch spilled on the ground. These bags were located south of the NR System building.

- 1) I requested the facility provide information on their plan for the sacks of starch to include de-clumping and addressing those sacks that were split open with some of the contents being spilled. I also requested they provide information on how much starch has been mixed in with the wet cake up to this point. I reminded Mr. Tingelhoff to provide documentation that supported his claim of the starch having nutrient value. I discussed that a new nutrient analysis will be necessary since the starch has been added to the wet cake.

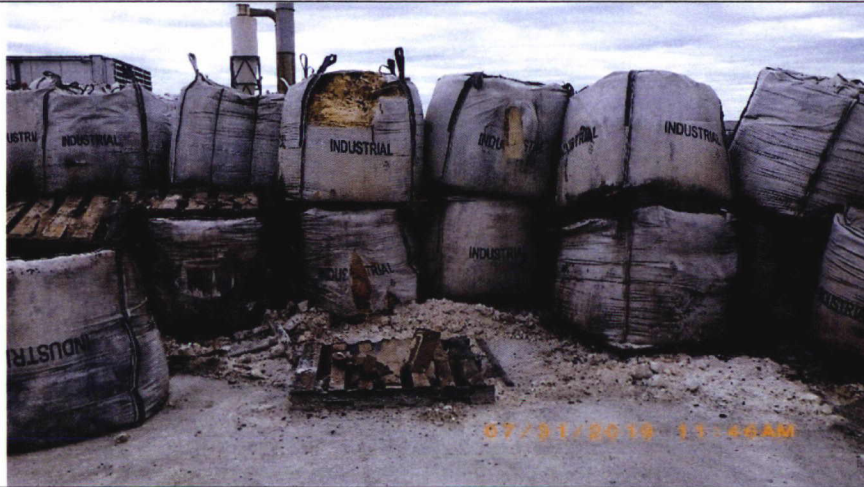
Photograph 5
Date: July 31, 2019
Photographer: Mark Pomajzl
Camera: RICOH WG-50
IIS# 84069, IWM Permit # NE0204447
Subject: AltEn, LLC Complaint Investigation

Another view of the sacks of starch located south of the NR System building and mentioned in photograph 4.

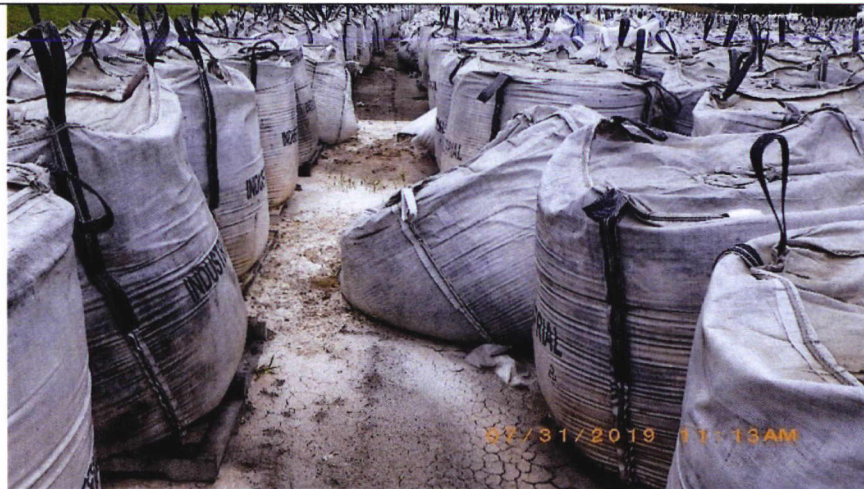
Photograph 6
Date: July 31, 2019
Photographer: Mark Pomajzl
Camera: RICOH WG-50
IIS# 84069, IWM Permit # NE0204447
Subject: AltEn, LLC Complaint Investigation

Photograph showing sacks of starch located west of the office building. Numerous sacks were split open spilling their contents on the ground.

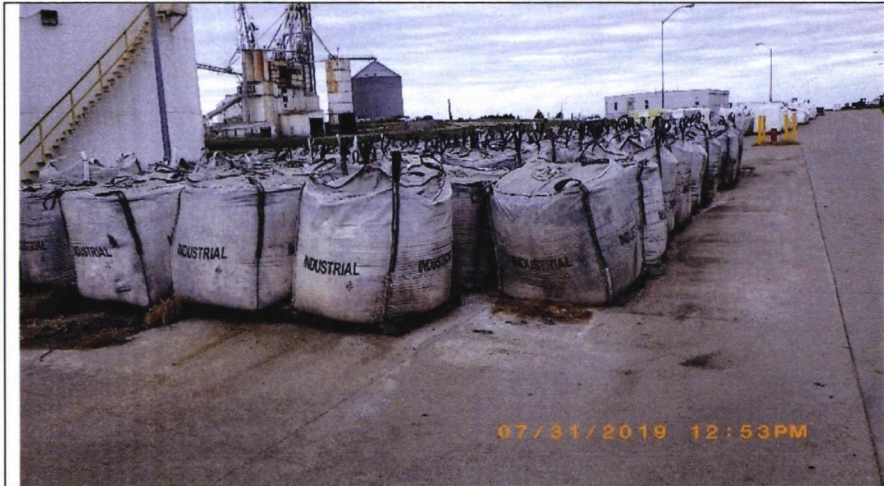
Photograph 7
Date: July 31, 2019
Photographer: Mark Pomajzl
Camera: RICOH WG-50
IIS# 84069, IWM Permit # NE0204447
Subject: AltEn, LLC Complaint Investigation

Looking west, photograph showing more sacks of starch being stored towards the northeast corner of the facility.

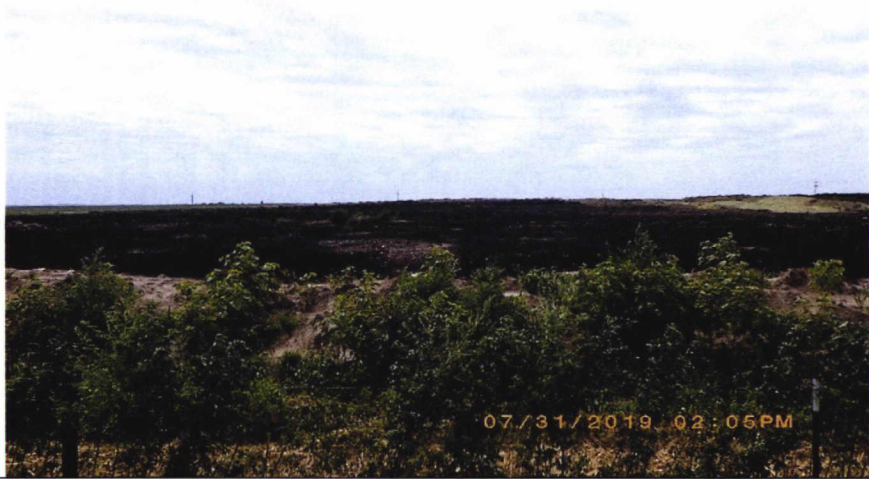
<p> Photograph 9 Date: July 31, 2019 Photographer: Mark Pomajzl Camera: RICOH WG-50 IIS# 84069, IWM Permit # NE0204447 Subject: AltEn, LLC Complaint Investigation </p> <p>Looking west, photograph showing wet cake being stored north of the hoop buildings.</p>

I asked facility representatives for an estimate of how much wet cake was currently being stored on site. Mr. Egr emailed me on August 1 and estimated a total of 26,000 tons of wet cake was being stored at the site (Attachment III). This included areas east and north of the warehouse (hoop buildings) as well as west of the compost pad (Photographs 9-12).

- 3) I explained that the facility needed to clean up the spilled treated seed corn located around the grain bin, daily.
- 4) I reminded Mr. Tingelhoff of the letter the department sent concerning management of the wet cake after the issuance of the Stop-Use and Stop-Sale order from the Dept. of Ag. Specifically, I reminded him of the department's position that since the wet cake can no longer be land applied, it is a solid waste requiring disposal at a permitted municipal solid waste facility. I requested him to submit a plan to the department if the facility was not going to dispose the wet cake at a landfill. I expressed my concerns of the facility increasing the amount of wet cake being stored with no place to go with it.

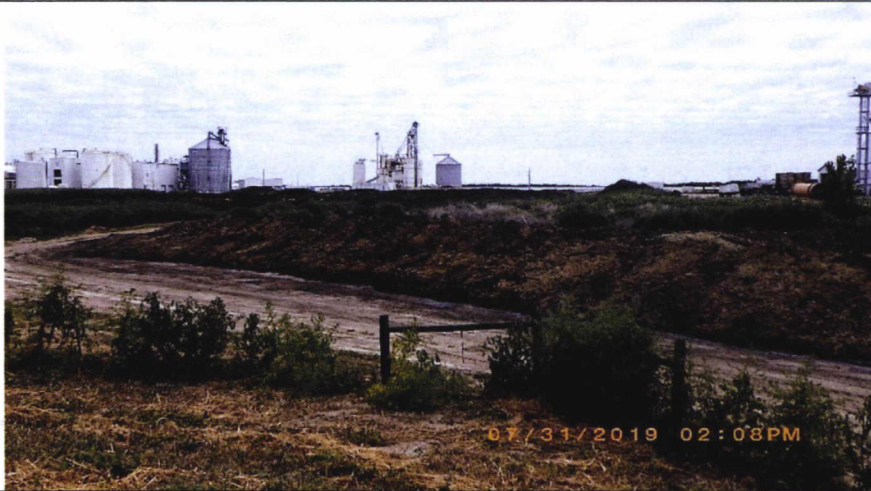
Photograph 11
Date: July 31, 2019
Photographer: Mark Pomajzl
Camera: RICOH WG-50
IIS# 84069, IWM Permit # NE0204447
Subject: AltEn, LLC Complaint Investigation

Looking south, photograph showing wet cake being stored east and northeast of the hoop buildings.

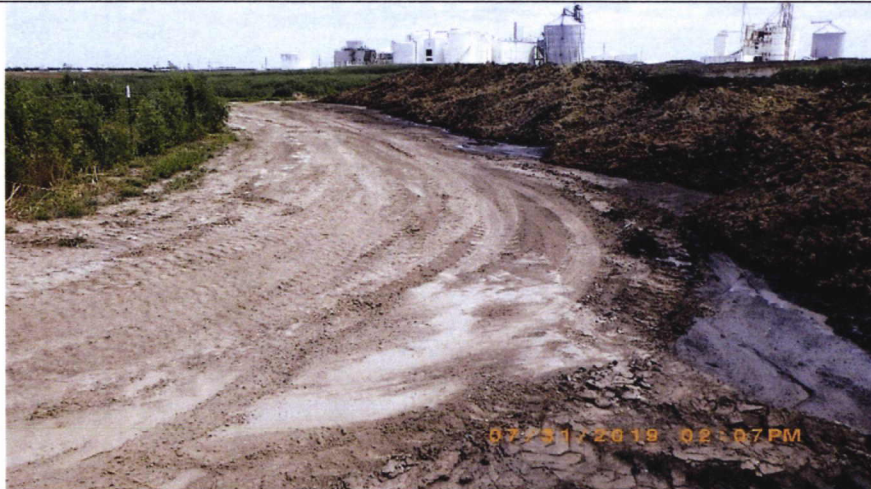
Photograph 12
Date: July 31, 2019
Photographer: Mark Pomajzl
Camera: RICOH WG-50
IIS# 84069, IWM Permit # NE0204447
Subject: AltEn, LLC Complaint Investigation

Looking southeast, photograph showing another view of the wet cake pile observed in photograph 11.

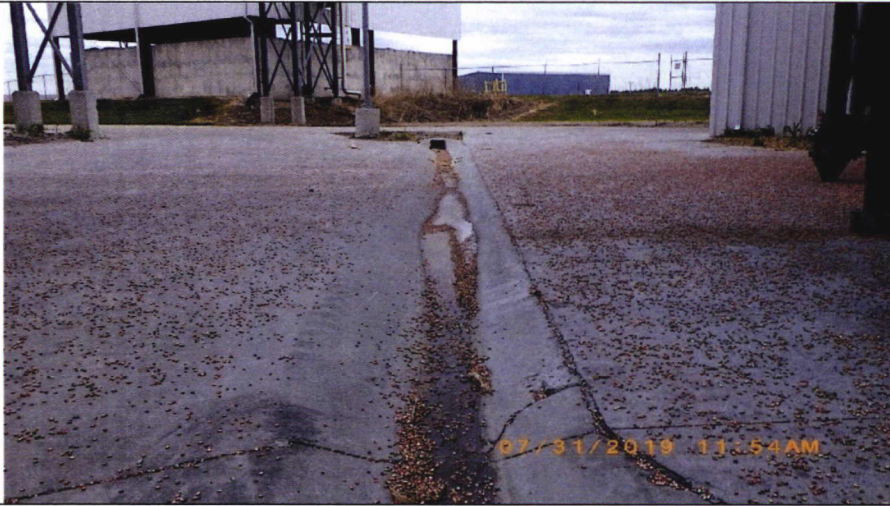
Photograph 13
Date: July 31, 2019
Photographer: Mark Pomajzl
Camera: RICOH WG-50
IIS# 84069, IWM Permit # NE0204447
Subject: AltEn, LLC Complaint Investigation

Treated seed was observed scattered along the ground around the grain bin that provided seed to the ethanol process (Photograph 13). Mr. Peterson said there were some wear sections along the conveyor that allowed seed to drop out and that this was to be fixed during the

Photograph showing treated seed corn scattered along the ground around the grain bin that provided seed to the ethanol process.

upcoming scheduled plant shutdown scheduled for the week of August 12. In the meantime, he said they will take care of the spilled seed corn and clean it up. Mr. Tingelhoff confirmed this would happen during our exit briefing.

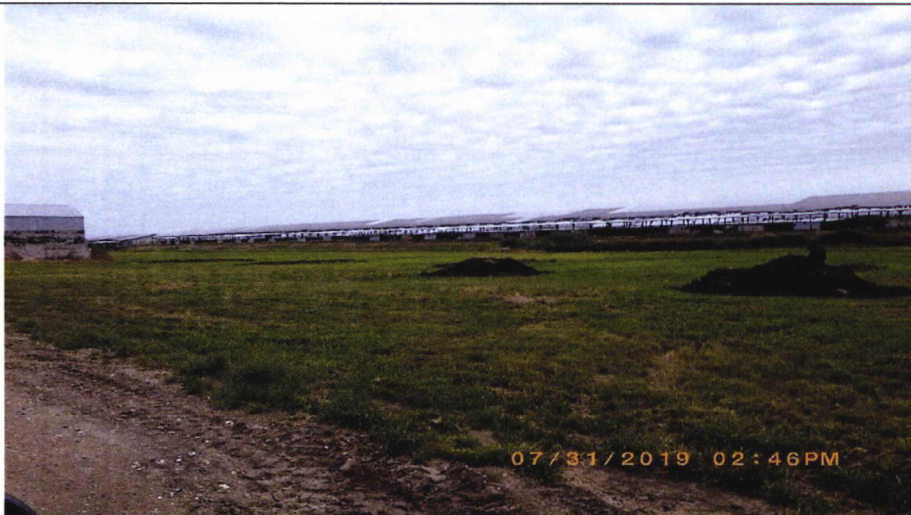
Photograph 14
Date: July 31, 2019
Photographer: Mark Pomajzl
Camera: RICOH WG-50
IIS# 84069, IWM Permit # NE0204447
Subject: AltEn, LLC Complaint Investigation

We also drove by the compost pad while on site. There were approximately 4 small windrows of wet cake (Photograph 14). These piles were observed during a previous site inspection. I reminded Mr. Tingelhoff that the material needed to be removed from the compost pad and the pad kept clear until the necessary repairs had been made.

Photograph showing some of the small windrows of wet cake located on the compost pad.

- 2) I explained to Mr. Tingelhoff that the wet cake currently on the compost pad had to be removed and the pad left empty until the necessary repairs had been made.
