INVESTIGATION REPORT

SUBJECT: ALTEN LLC
Mead, Nebraska
NDEE FACILITY - 84069
NDEE Spill Number – 021221-NH-0845

LOCATION: 1344 County Road 10, Mead, Nebraska

INVESTIGATION DATE: 13 FEB 2021 **FINAL REPORT DATE:** 17 MAR 2021
INVESTIGATOR: Kirk Morrow **REPORT BY:** Kirk Morrow

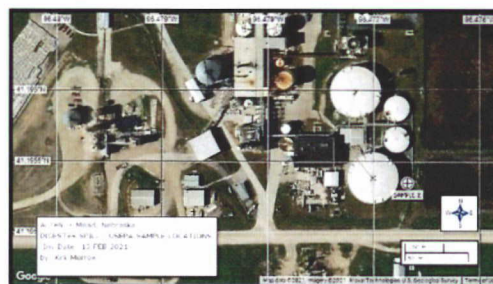
The two (2) large tanks in the photo to the right are the AltEn, LLC facility digesters. Both tanks have valving located on the east side of the tank, at the bottom of the tank, protected by a galvanized “window well.”

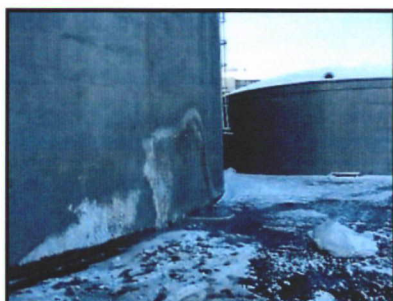
The south digester tank (photo to left) experienced a catastrophic release of its contents beginning on February 12 and was effectively emptied by the time of our arrival on February 13. The initial pressure of the release is reflected in the height of the frozen discharge on the side of the tank. Facility personnel also indicated that the spray from the release extended thirty (30) feet to the east. The “window well” that contained the valving is visible in the lower half of the photo (looking north). Spilled material was frozen to the ground throughout this area of the facility.

This area is USEPA Sample Location 2 – It was sampled at approximately 1731 hours on February 13. Two containers (one preserved) of contaminant fluid and 1 container of contaminant solid were collected. The initial summary report (March 5th E-Mail from OSC Ferguson) of the results include:

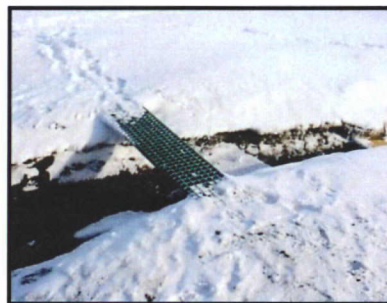
The photograph to the right (looking down and to the southeast from the southeast corner of the south digester) depicts a walkway over a drainageway from the “berm” immediately southeast of the south digester tank. It appeared that there was always drainage at this location. According to AltEn personnel, a portion of the spilled material flowed through/under this walkway and scoured the trench wider than it was previously.

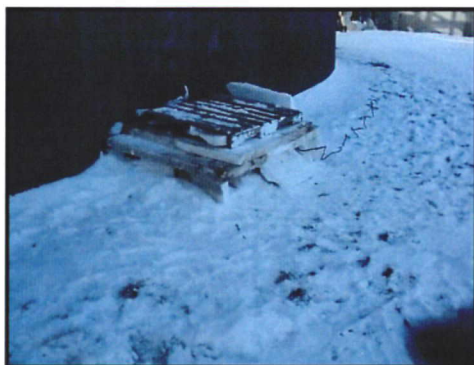
The second (north) digester tank needs to be drained. Currently, the facility has insulated the valve “window well” and placed a light inside to generate heat. This may prevent this valve from freezing/failing.

The photograph to the left (facing northwest) depicts the north digester. Visible in the photo is the insulation placed around the window well/valving. A power cord is visible that we were told powered a 75W light bulb. The intent is to produce heat and keep the valves from freezing.

- Contain the release and prevent further migration downstream.
- Recover, transport, treat and/or dispose of the spilled contaminants and affected areas as soon as possible.
- Further testing to determine the legal and available treatment and disposal options is likely necessary.
- Continue to prevent a second potential release (from the north digester)

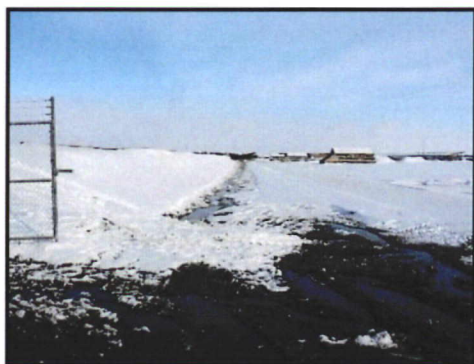
The photograph to the right is the south side of the north digester (looking up to the northwest). Visible is an ongoing “low volume” discharge from near the top of the tank.

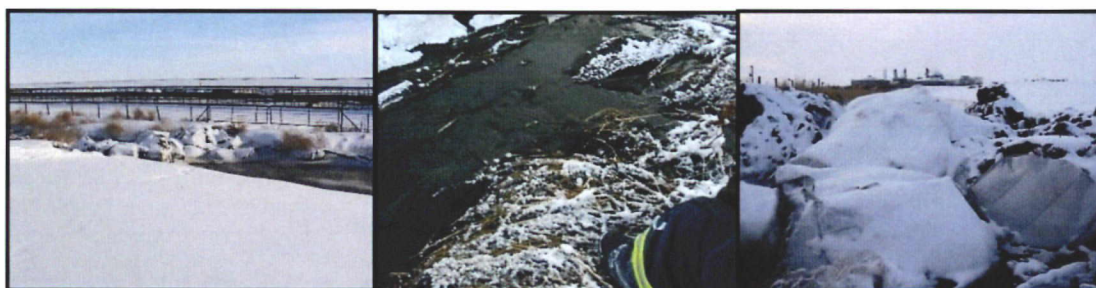
The photos below depict the area where the facility attempted to contain/divert the spill by damming the ditch with sacks of "biochar."

- The photo on the left is looking southeast at the now snow-covered sacks.
- The center photo depicts the ditch just east of the sacks. Several of the sacks were broken and the black in the photo is the biochar that leaked from the sacks (the pantleg, lower right, is that of Eric Deselich).
- The photo on the right depicts the dam looking west at it from the east (sample) side.

This area is USEPA Sample Location 1 – It was sampled at approximately 1708 hours on February 13. Two containers (one preserved) of contaminant fluid and 1 container of contaminant (not intended to be the biochar) solid were collected. The initial summary report (March 5th E-Mail from OSC Ferguson) of the results include:

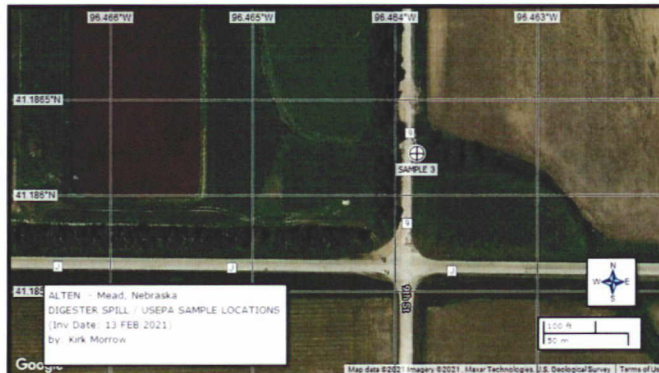
It appears that prior to our arrival the dam had been fortified with loose dirt. The photograph to the left is taken from Road 9, the “top of the dam.” The photo is looking west and depicts the general area of USEPA sample 3.

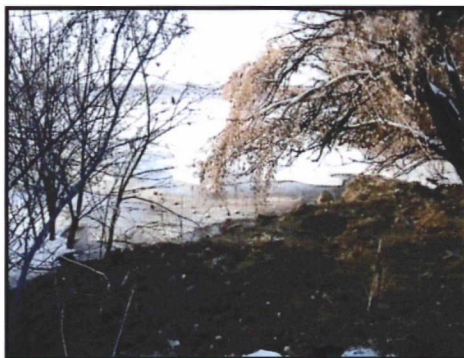
The photo to the right is again taken from Road 9, facing east and

downward. Water/contaminants continue to flow past this point at the time of our visit.

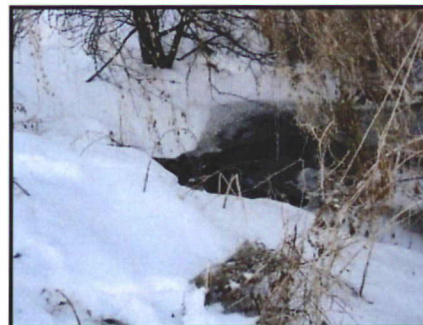
This area is USEPA Sample Location 3 – It was sampled at approximately 1755 hours on February 13. Two containers (one preserved) of contaminant fluid were collected. The initial summary report (March 5th E-Mail from OSC Ferguson) of the results include:

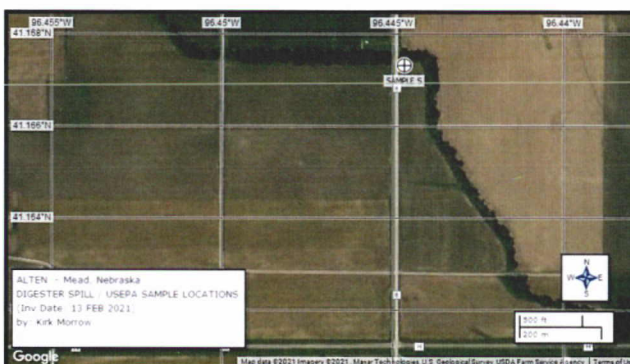
Even in darkness, contamination in this drainageway was apparent. Everything was frozen except for the areas where the waterway was thawed by the spilled material. These areas appeared as a black color from a distance.

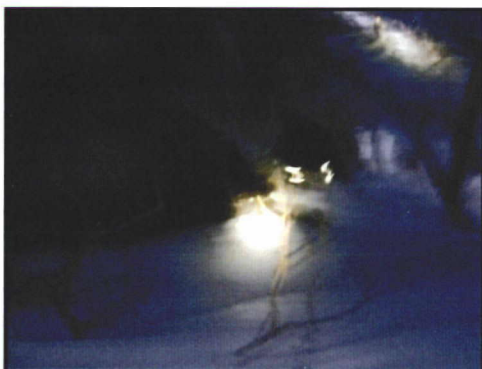
The photograph on the left is START contractor Eric Deselich as he prepares to collect a representative sample from the east side of County Road 8. The photo is taken from the east shoulder of the road, looking east.

This area is USEPA Sample Location 5 – It was sampled at approximately 1825 hours on February 13. Two containers (one preserved) of contaminant fluid were collected. The initial summary report (March 5th E-Mail from OSC Ferguson) of the results include:

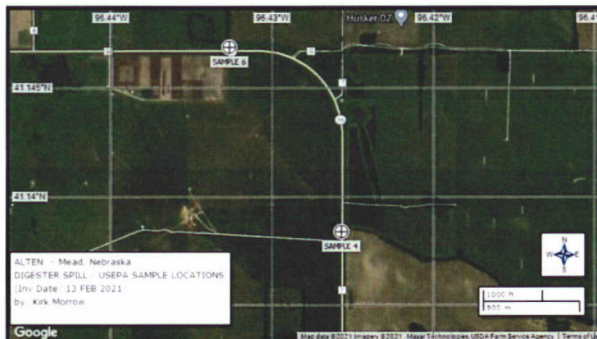
USEPA reported that visual evidence of the spill appeared at, and immediately southeast of, the sample 6 location.
