Date: May 28, 2020

RE: Complaint Investigation / NEC 051920-MP-1445

NDEE ID: 84069

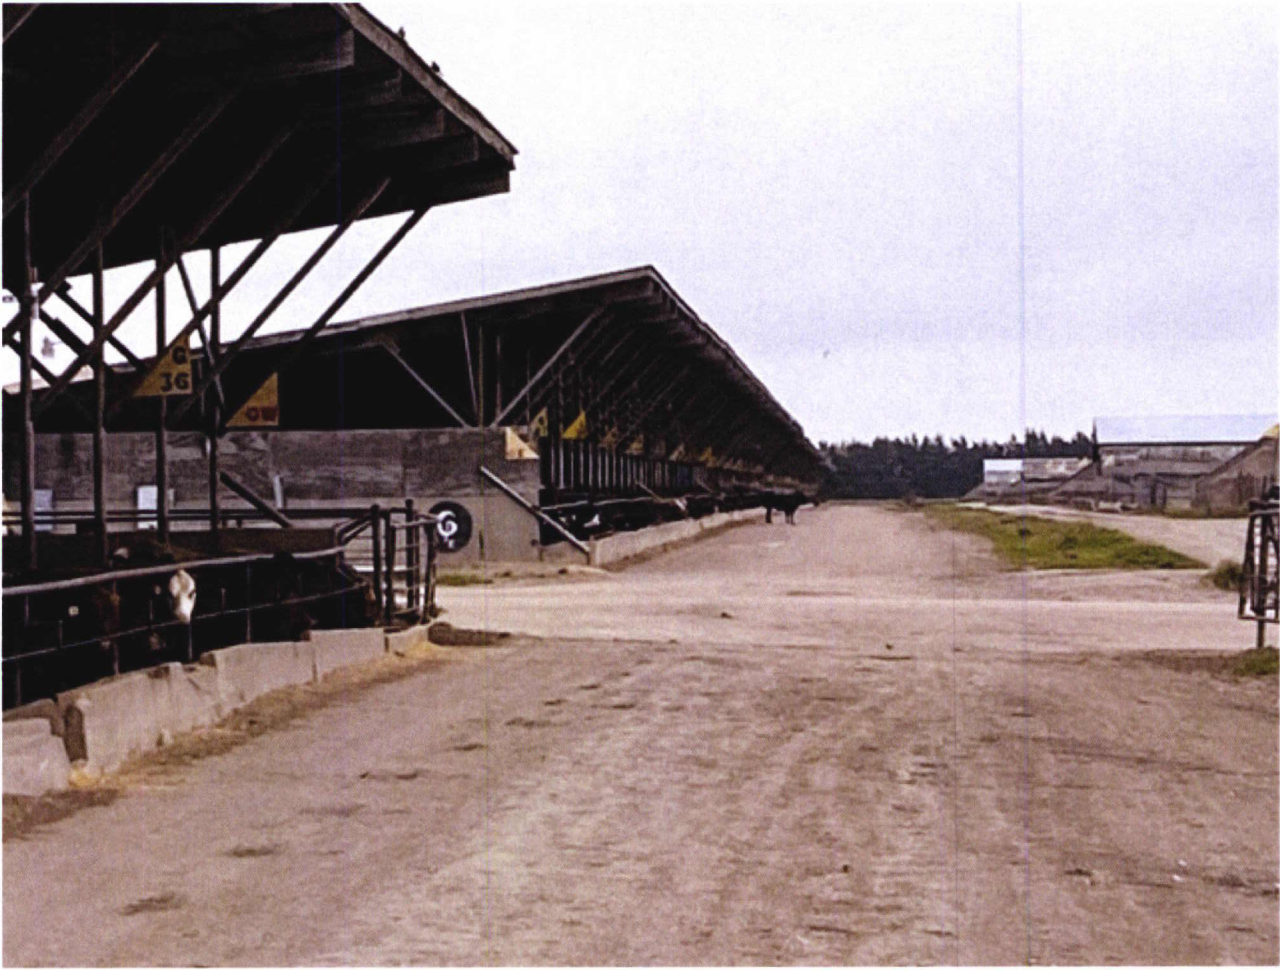
This should help you out this is a cow out of its pin not far from the pile of mash from the ethanol plant back in the mead cattle property

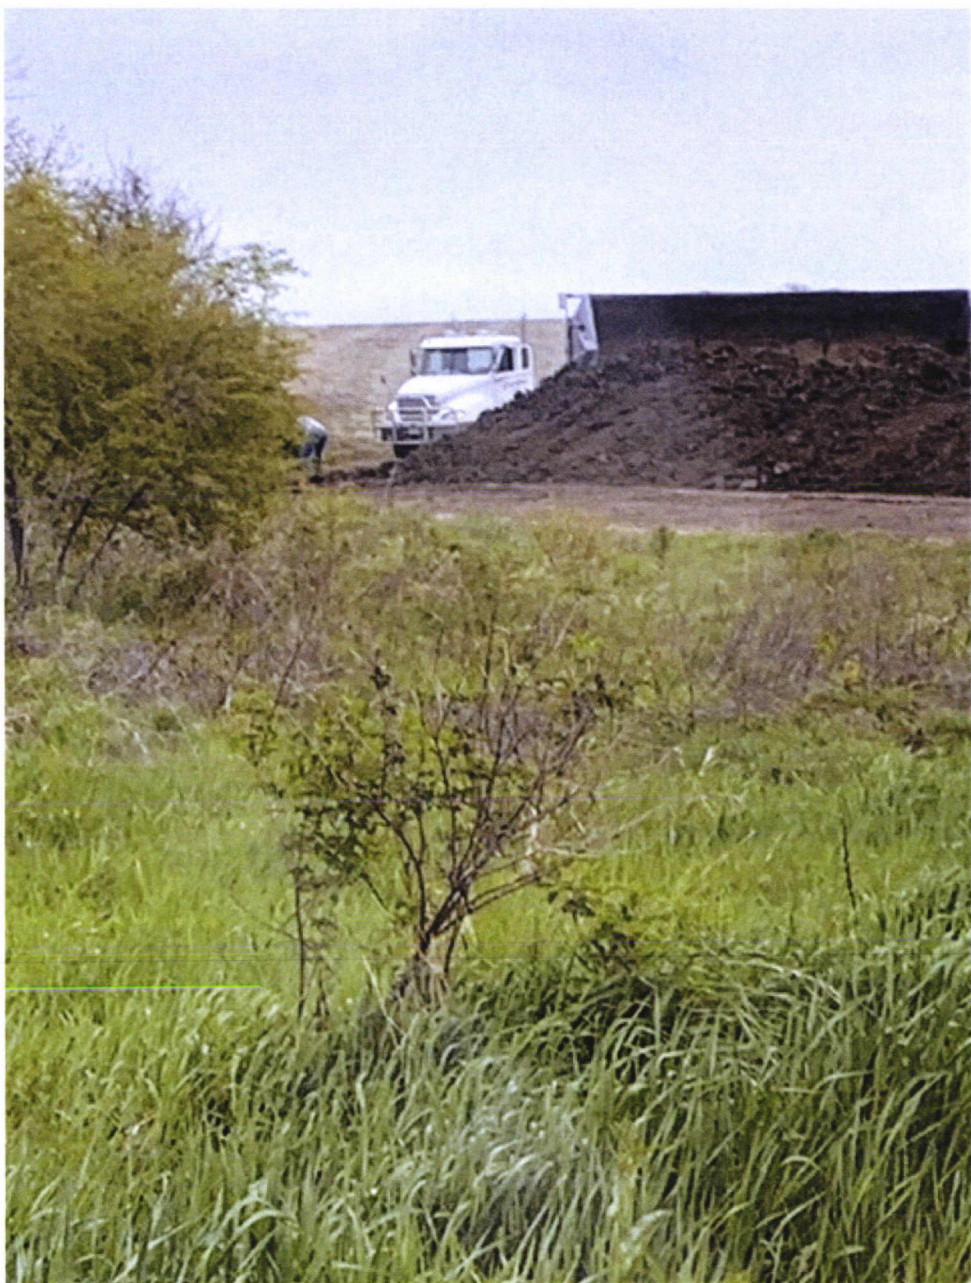
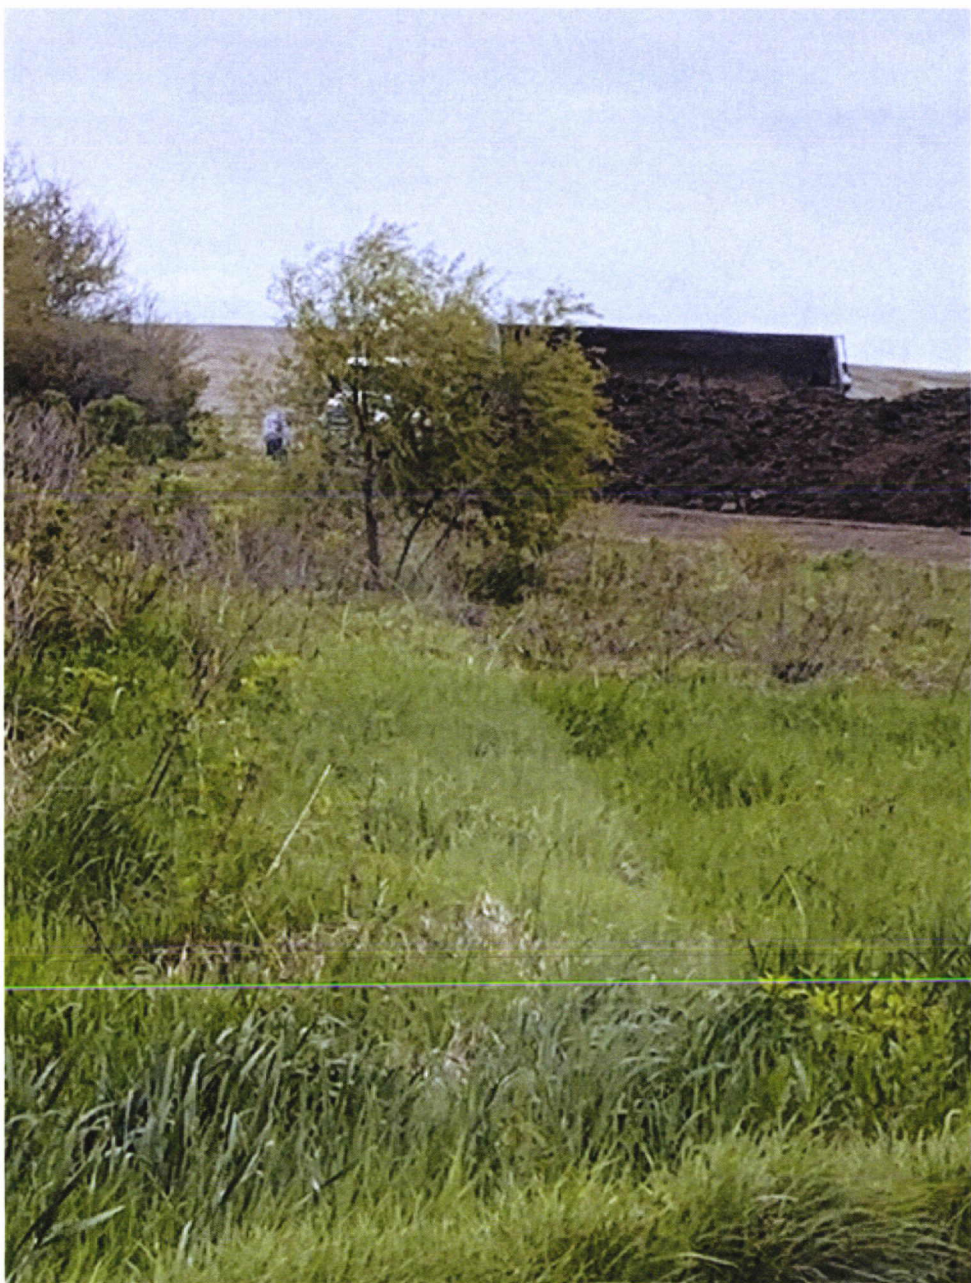
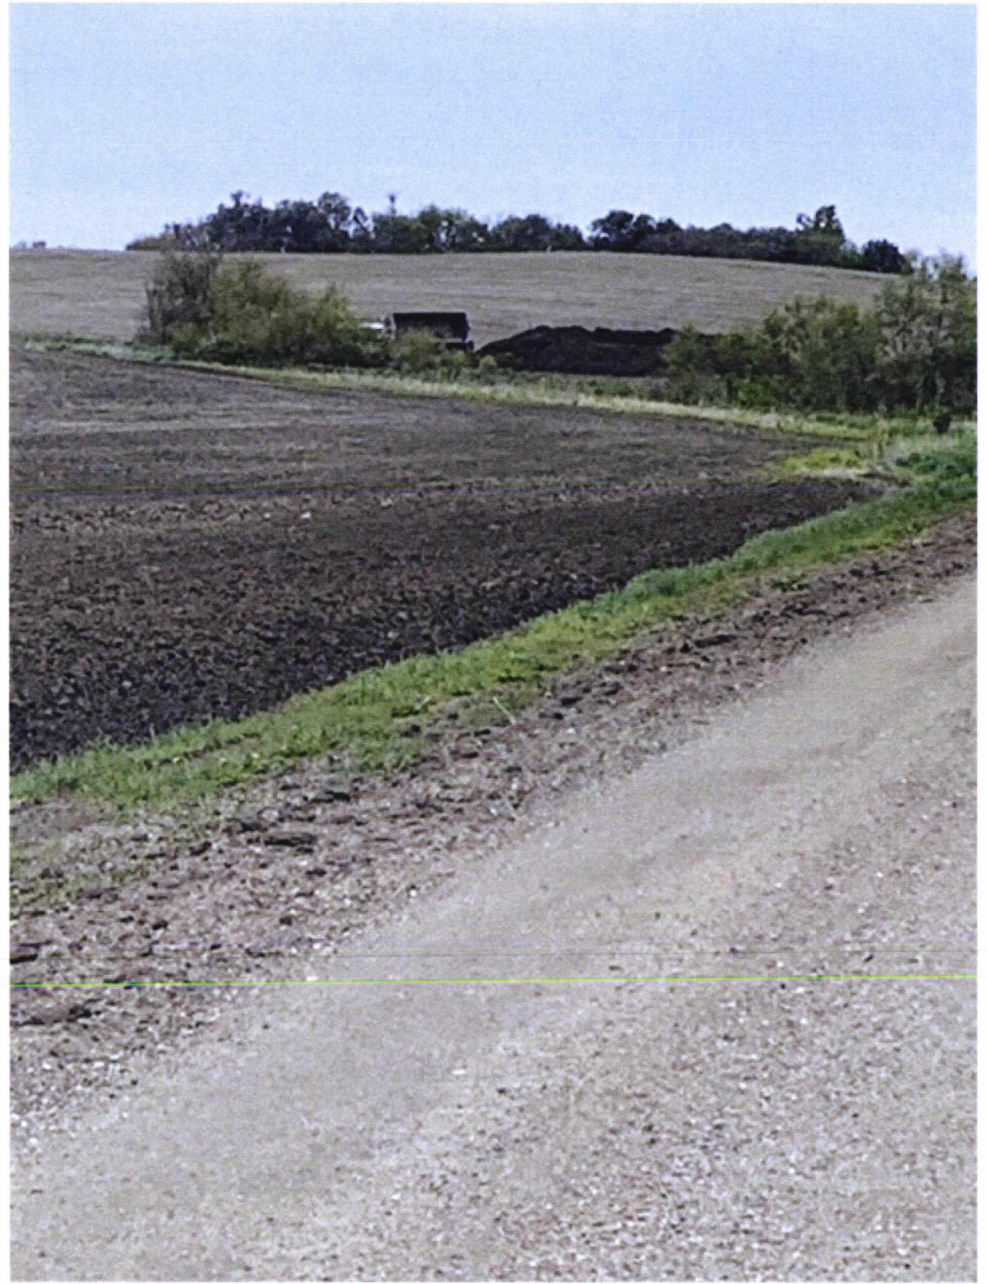
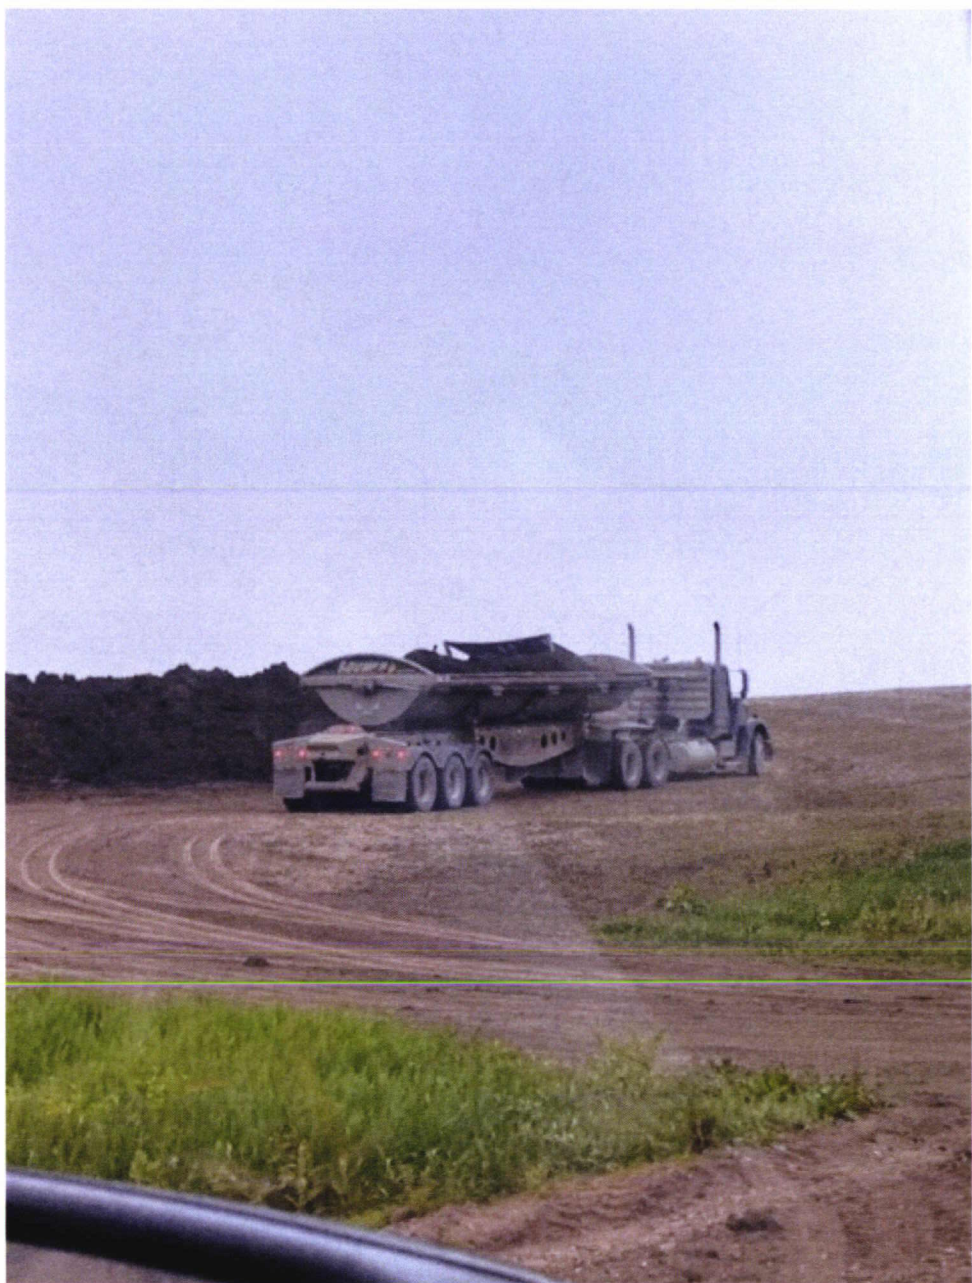
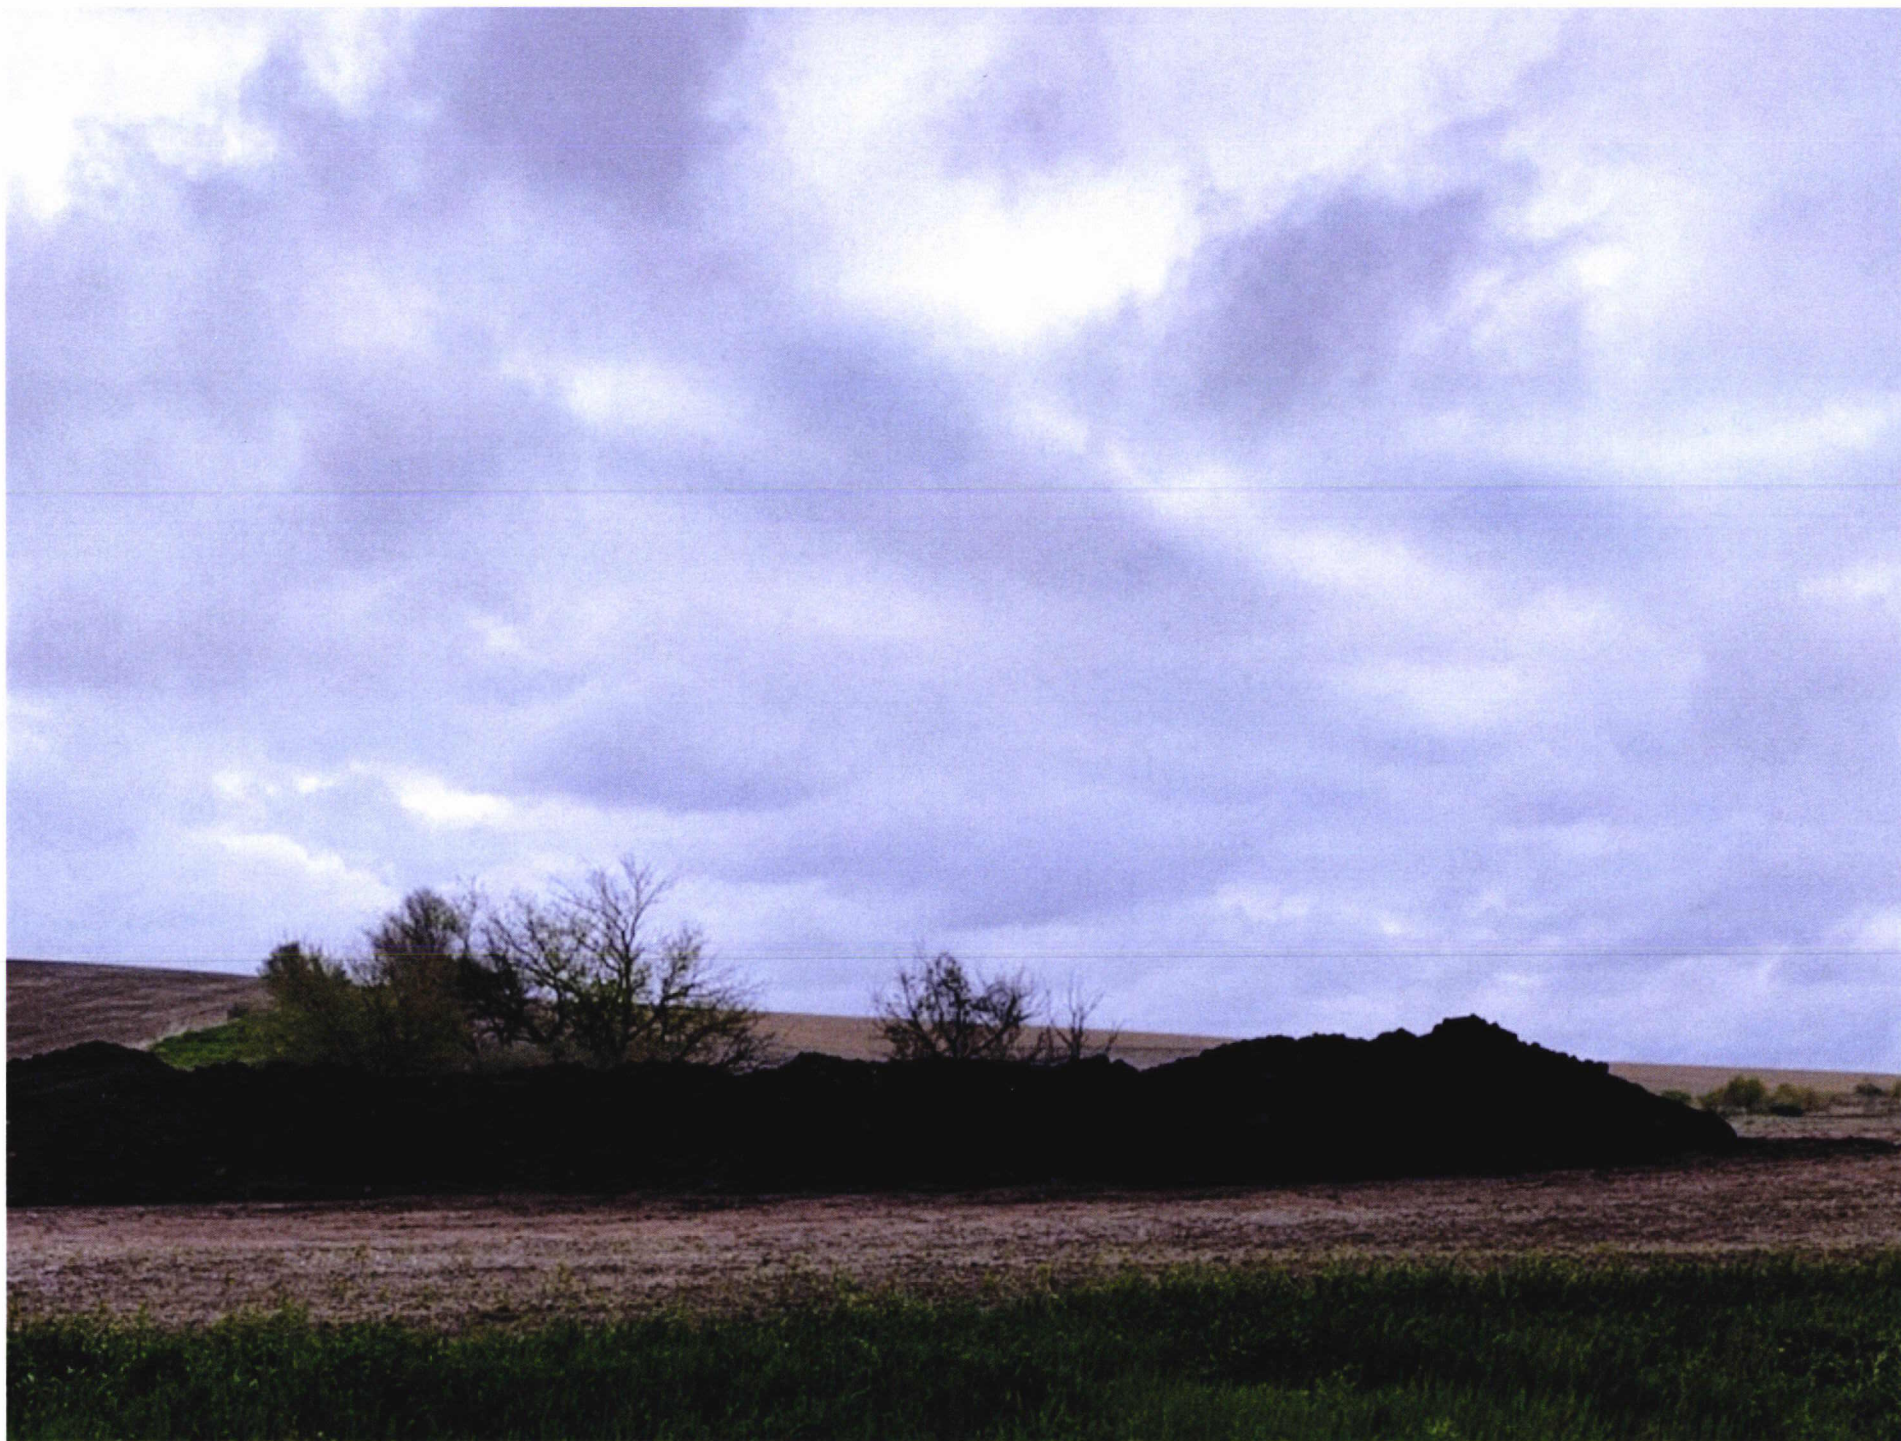
Pics taken last evening and this morning. County road 9, about 1/2 mile north of hwy 64, east side of road.

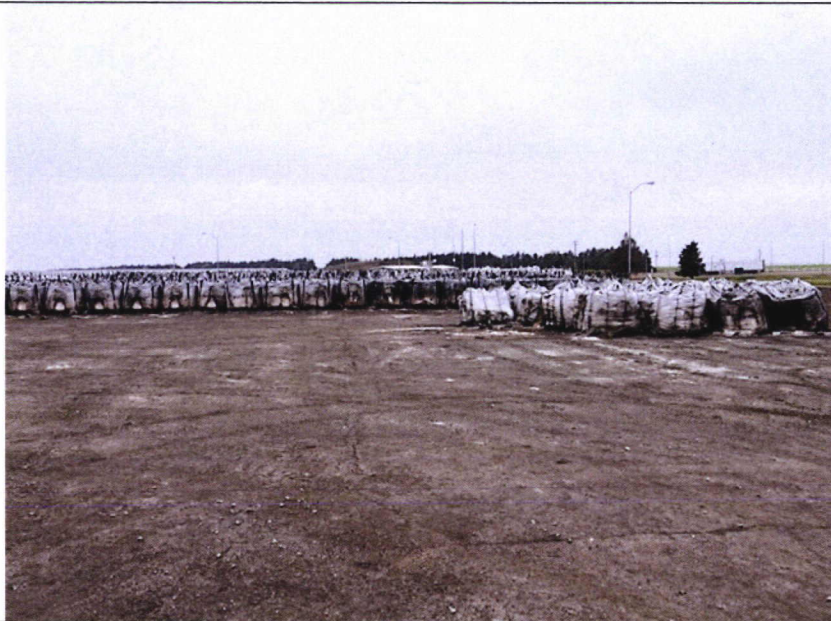
Photograph #1

Looking west, west of the office building, photograph taken to show that some of the super sacks of starch have been removed. Mr. Tingelhoff said they were moved to a location closer to the digester. I observed the sacks that were moved located east of the Biochar unit and next to super sacks of Biochar.

As we were leaving the parking lot located west of the office building, I asked about the super sacks of starch that were being stored west of the lot (Photograph 1). I noticed that there were not as many sacks as I have observed during previous site visits/inspections. Mr. Tingelhoff said that they moved some to a location closer to the digester.

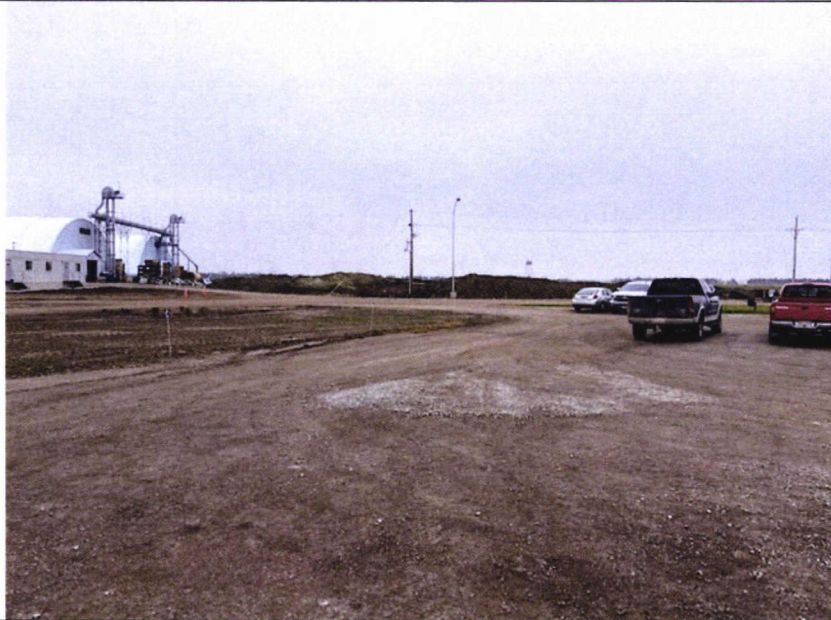
Photograph #2

Looking north, photograph taken from the parking lot located west of the office building. Photograph showing the distiller's grain being stockpiled north of the office building and east of the hoop buildings which are the white buildings located on the left side of the photo.

Finally, we proceeded to the stockpile location located north of the office building and east of the hoop buildings. It appeared that the facility has been conducting some dirt work in this area as well as consolidating piles (Photographs 2, 11-15). While at this location I stepped out of my vehicle and approached Mr. Tingelhoff's. I wanted to share with him the photographs provided by Ms. Weible. Mr. Tingelhoff denied that any distiller's grain was being taken to County Road 9, ½ mile north of Highway 64. I shared with him that it sounded as though it was manure hauled out there by Mead Cattle. I asked if he had contact information for Mead Cattle so that I could follow up with someone concerning this matter before I departed the site. He provided me a telephone number of 402-624-2995.

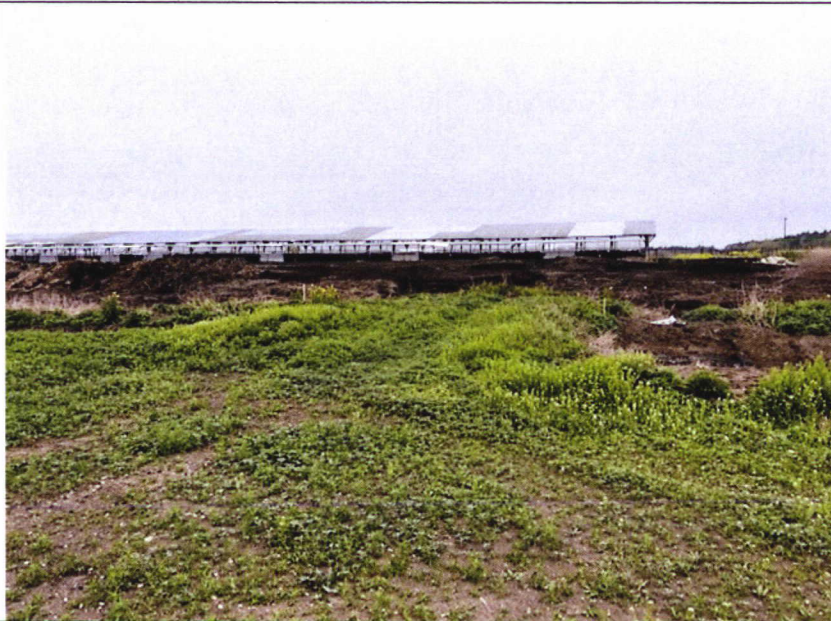
Photograph #3

Looking south, photograph showing the western edge of the distiller's grain being stockpiled west of the compost pads.

The compost pads were empty. There was a small pile of presumably cattle manure adjacent to the drive and it appeared to be off of the compost pad. Located west of the compost pads was stockpiled distiller's grain (Photographs 3-4). The pile appeared to be about the same size as I have observed during previous site visits and Mr. Tingelhoff believed nothing had been taken to or removed from this stockpile location.

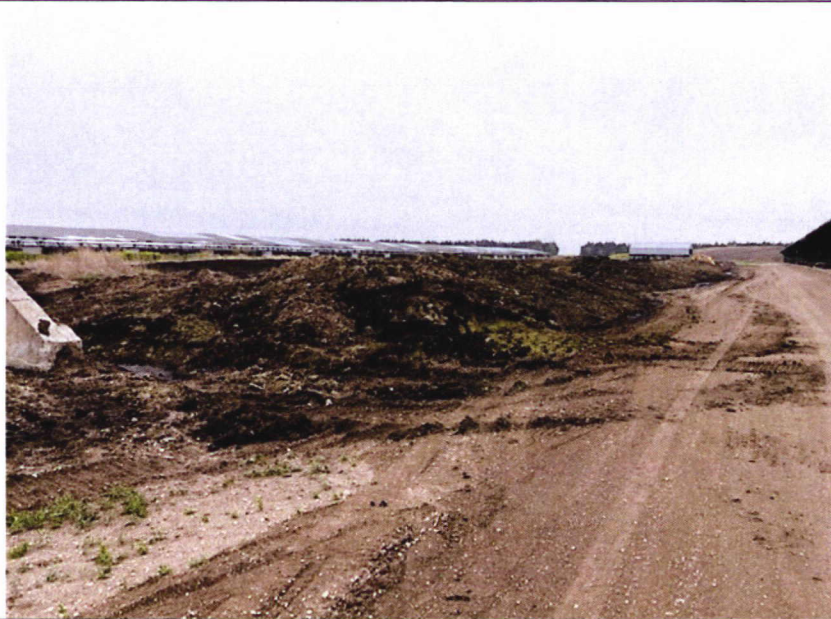
Photograph #4

Looking west, photograph showing the eastern edge of the distiller's grain being stockpiled west of the compost pads.

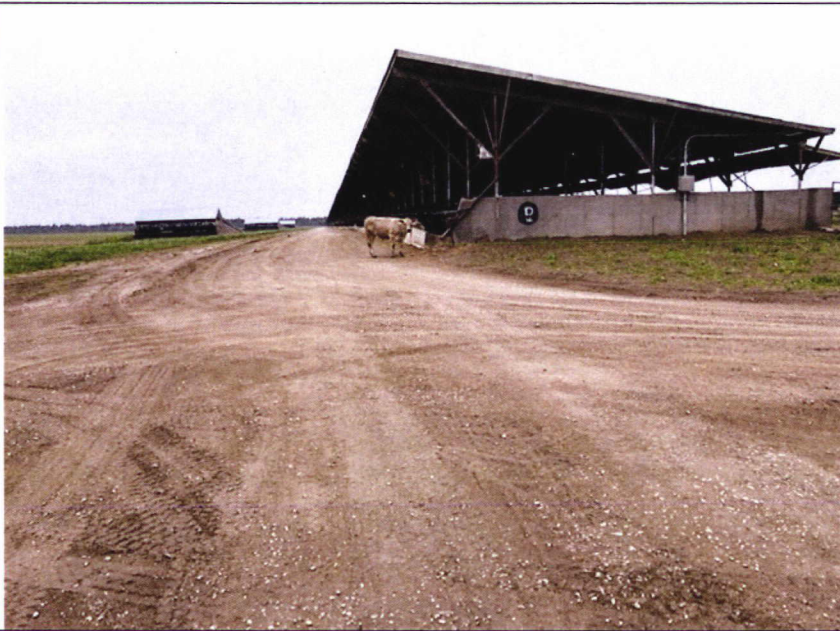
Photograph #5
Date: May 22, 2020
Photographer: Jason Holsten
Camera: iPhone SE
Facility ID#: 84069
NEC: 051920-MP-1445
Subject: AltEn Complaint Investigation

Looking west, photograph taken to show one of four cattle that were observed loose during the investigation. This steer was located near the furthest south and west cattle pen.

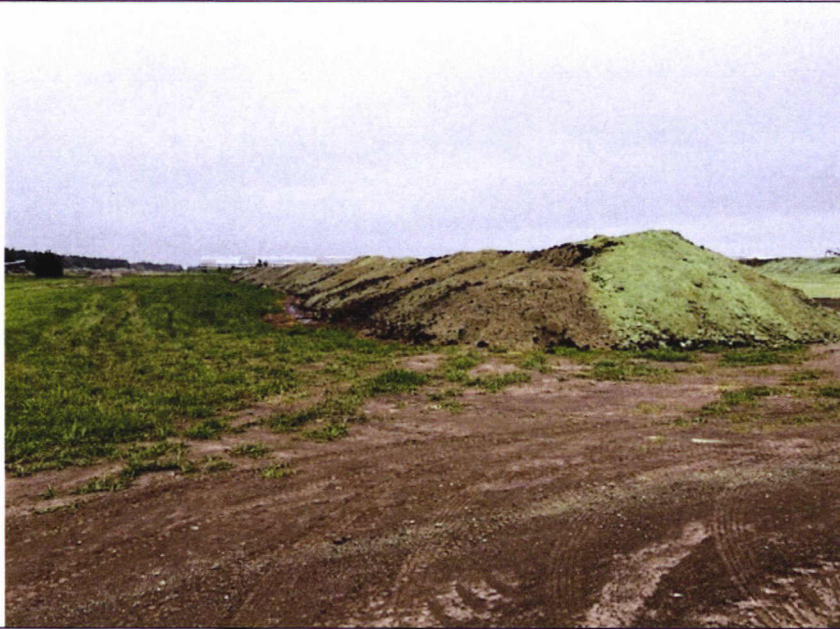
Photograph #6
Date: May 22, 2020
Photographer: Jason Holsten
Camera: iPhone SE
Facility ID#: 84069
NEC: 051920-MP-1445
Subject: AltEn Complaint Investigation

Looking south, photograph showing distiller's grain being stockpiled in a new location. According to Mr. Tingelhoff, this location was on AltEn property and was located on the northeast corner of the site and to the east of the north Mead Cattle lagoon.

We then proceeded to a new stockpile location for distiller's grain at the northeast corner of the site which was located east of the north Mead Cattle lagoon (Attachment II) (Photographs 6-10). Mr. Tingelhoff was unsure when they started using this location but thought maybe a year ago. He was also unsure how much distiller's grain had been stockpiled here but later learned from Dean Egr that approximately 4,000 tons have been placed in this location. As we departed this area, Mr. Tingelhoff shared with me that they have been applying a product called Odor X to the distiller's grain with the hope of keeping down odors. He believed it was working. He explained that the product is sprayed on the distiller's grain and can be sprayed a distance of 10-15 feet. Mr. Tingelhoff later emailed me a safety data sheet for the Odor X (Attachment III).

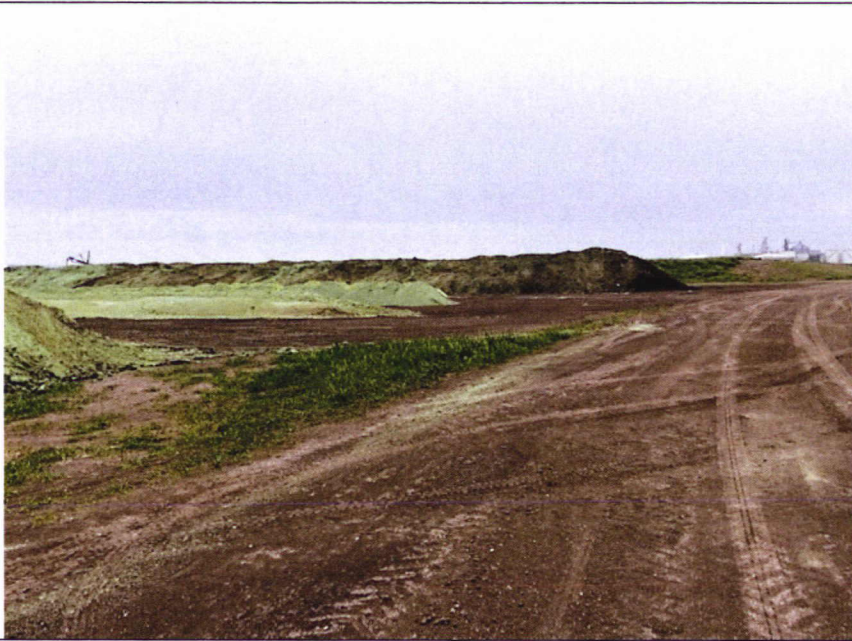
Photograph #7
Date: May 22, 2020
Photographer: Jason Holsten
Camera: iPhone SE
Facility ID#: 84069
NEC: 051920-MP-1445
Subject: AltEn Complaint Investigation

Looking west, southwest from the same vantage point as photograph 6, photograph taken showing the distiller's grain being stockpiled at this new location.

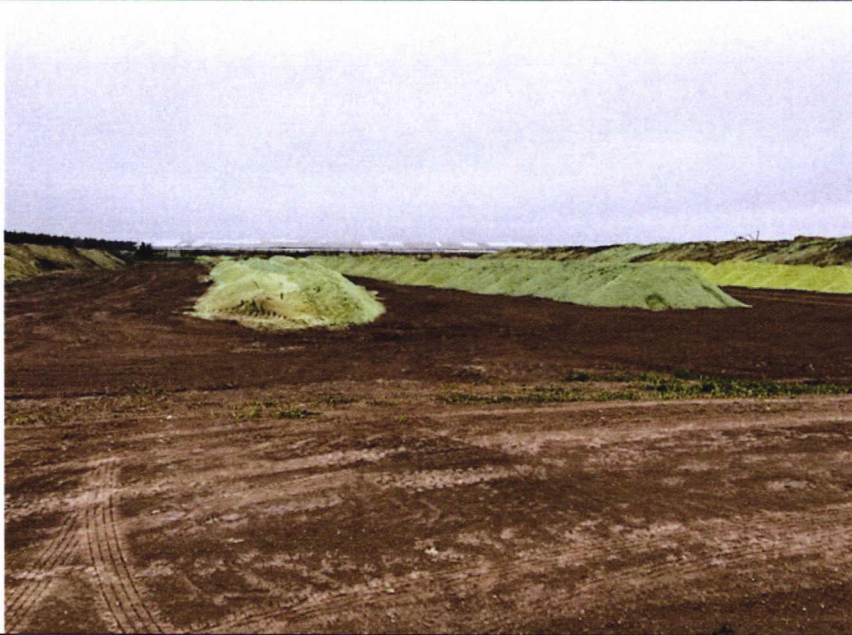
Photograph #8
Date: May 22, 2020
Photographer: Jason Holsten
Camera: iPhone SE
Facility ID#: 84069
NEC: 051920-MP-1445
Subject: AltEn Complaint Investigation

Looking south, photograph showing rows of distiller's grain located at the location mentioned in photographs 6 & 7.

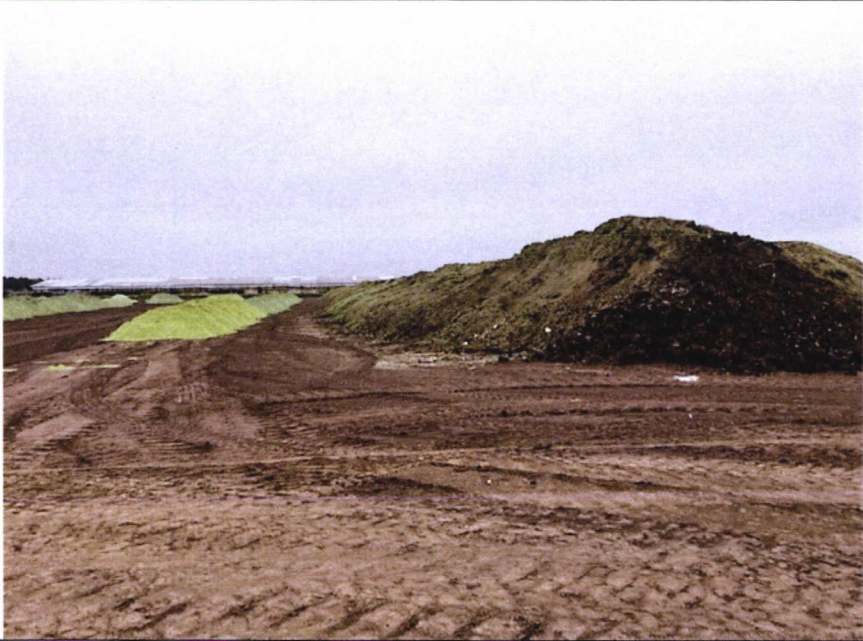
<p> Photograph #9 Date: May 22, 2020 Photographer: Jason Holsten Camera: iPhone SE Facility ID#: 84069 NEC: 051920-MP-1445 Subject: AltEn Complaint Investigation </p> <p>Looking south, photograph showing the western most rows/piles of distiller's grain located at the new storage location mentioned in photographs 6-8.</p>

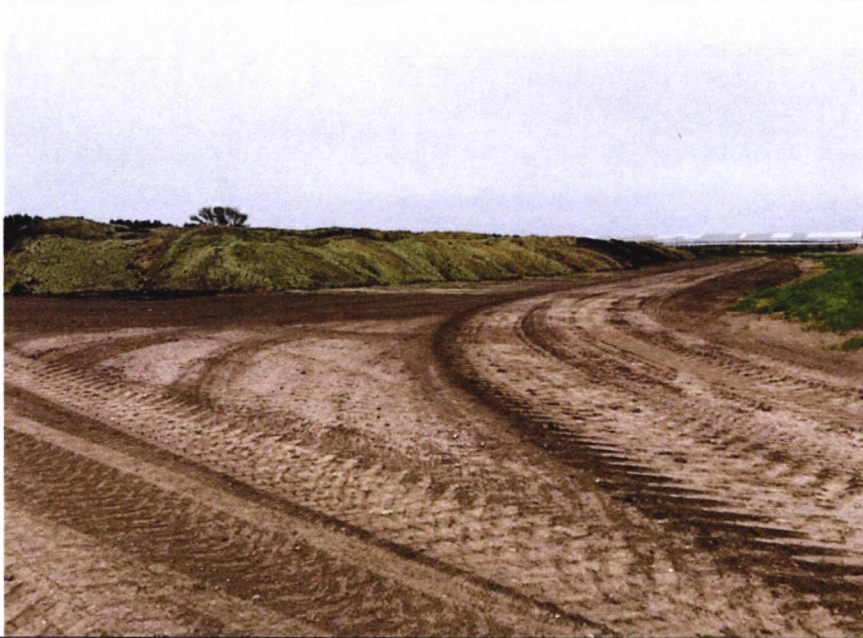
<p> Photograph #10 Date: May 22, 2020 Photographer: Jason Holsten Camera: iPhone SE Facility ID#: 84069 NEC: 051920-MP-1445 Subject: AltEn Complaint Investigation </p> <p>Looking southeast, photograph showing the western edge of the distiller's grain being stockpiled at the location mentioned in photographs 6-9.</p>

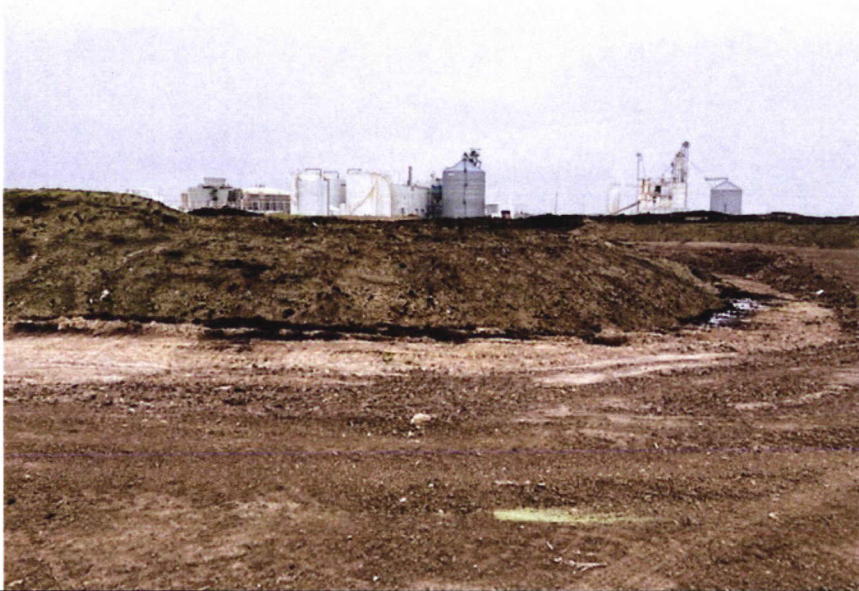
<p>Photograph #11 Date: May 22, 2020 Photographer: Jason Holsten Camera: iPhone SE Facility ID#: 84069 NEC: 051920-MP-1445 Subject: AltEn Complaint Investigation</p> <p>Looking south, photograph showing the distiller's grain being stockpiled in an area north of the office building and east of the hoop buildings. The vantage point of this photograph was near the south side of the facility's southwest wastewater lagoon.</p>

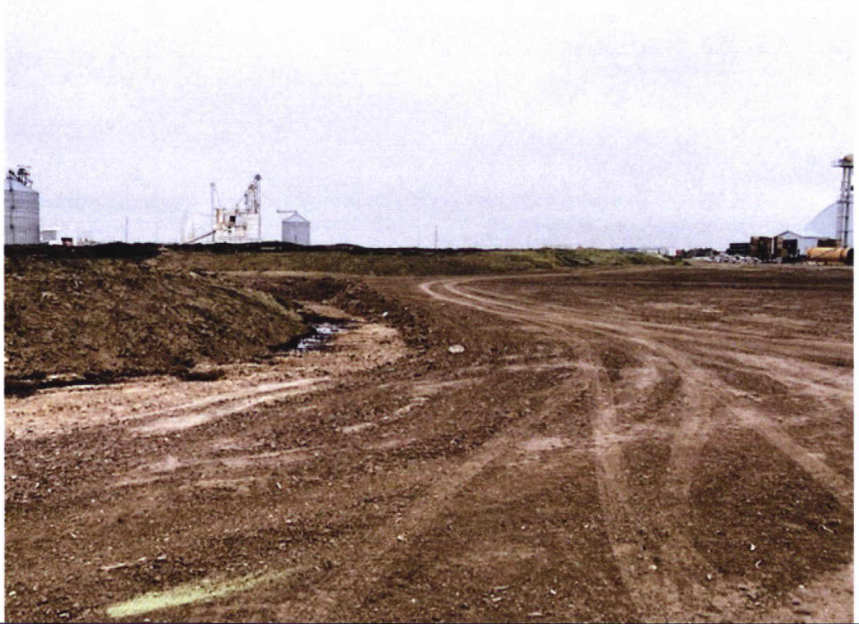
<p>Photograph #12 Date: May 22, 2020 Photographer: Jason Holsten Camera: iPhone SE Facility ID#: 84069 NEC: 051920-MP-1445 Subject: AltEn Complaint Investigation</p> <p>Looking south southwest from the same vantage point as photograph 11, photograph showing distiller's grain being stockpiled north of the office building. Also of note is recent dirt work and cleaning up of the area. Piles of distiller's grain appeared to be consolidated.</p>

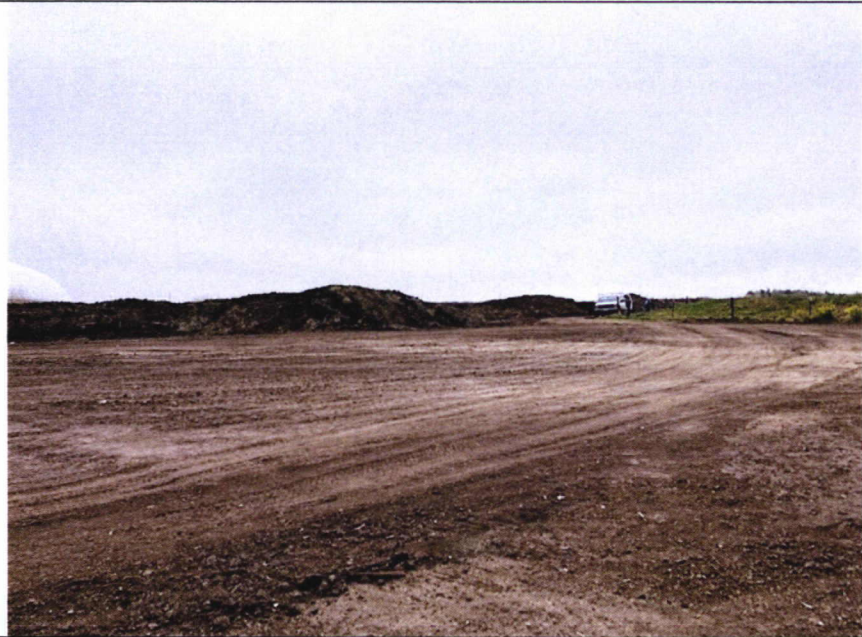
Photograph #14
 Date: May 22, 2020
 Photographer: Jason Holsten
 Camera: iPhone SE
 Facility ID#: 84069
 NEC: 051920-MP-1445
 Subject: AltEn Complaint Investigation

Looking northwest from near the same vantage point as photograph 13, photograph showing distiller's grain being stockpiled north of the north hoop building. The green area in the photograph is the southwest corner of the southwest wastewater lagoon.

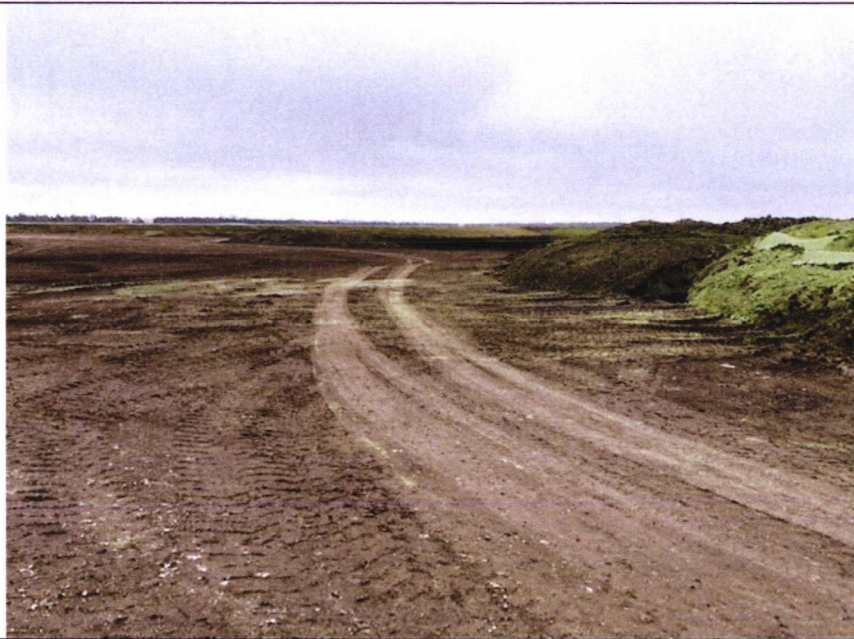
Photograph #15
 Date: May 22, 2020
 Photographer: Jason Holsten
 Camera: iPhone SE
 Facility ID#: 84069
 NEC: 051920-MP-1445
 Subject: AltEn Complaint Investigation

Looking north from near the entrance road into the distiller's grain stockpile location located north of the office building.

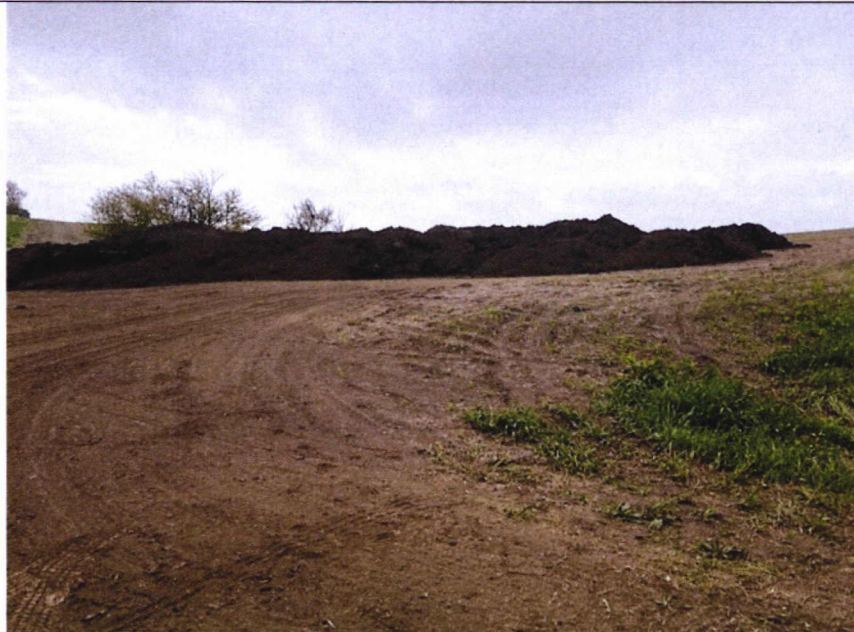
Photograph #16
 Date: May 22, 2020
 Photographer: Jason Holsten
 Camera: iPhone SE
 Facility ID#: 84069
 NEC: 051920-MP-1445
 Subject: AltEn Complaint Investigation

Looking east, photograph showing presumably soil and/or cattle manure from Mead Cattle. Location is east side of County Road 9, approximately ½ mile north of Hwy 64. Complainant alleged AltEn was hauling and dumping distiller's grain at this location. NDEE Ag section confirmed with Mead Cattle that they hauled manure to this location.

After departing AltEn, I drove to the location shared by Ms. Weible located at County Road 9, ½ mile north of Highway 64. There, on the east side of the road, I noticed a pile of what appeared to be manure and/or soil (Photograph 16). The pile did not have the same appearance of the distiller's grain generated at AltEn.
