Memo to File

RE: Site Inspection-Complaint

Address: AltEn, 1344 County Road 10, Mead, NE

Facility ID: 84069 05OWT051

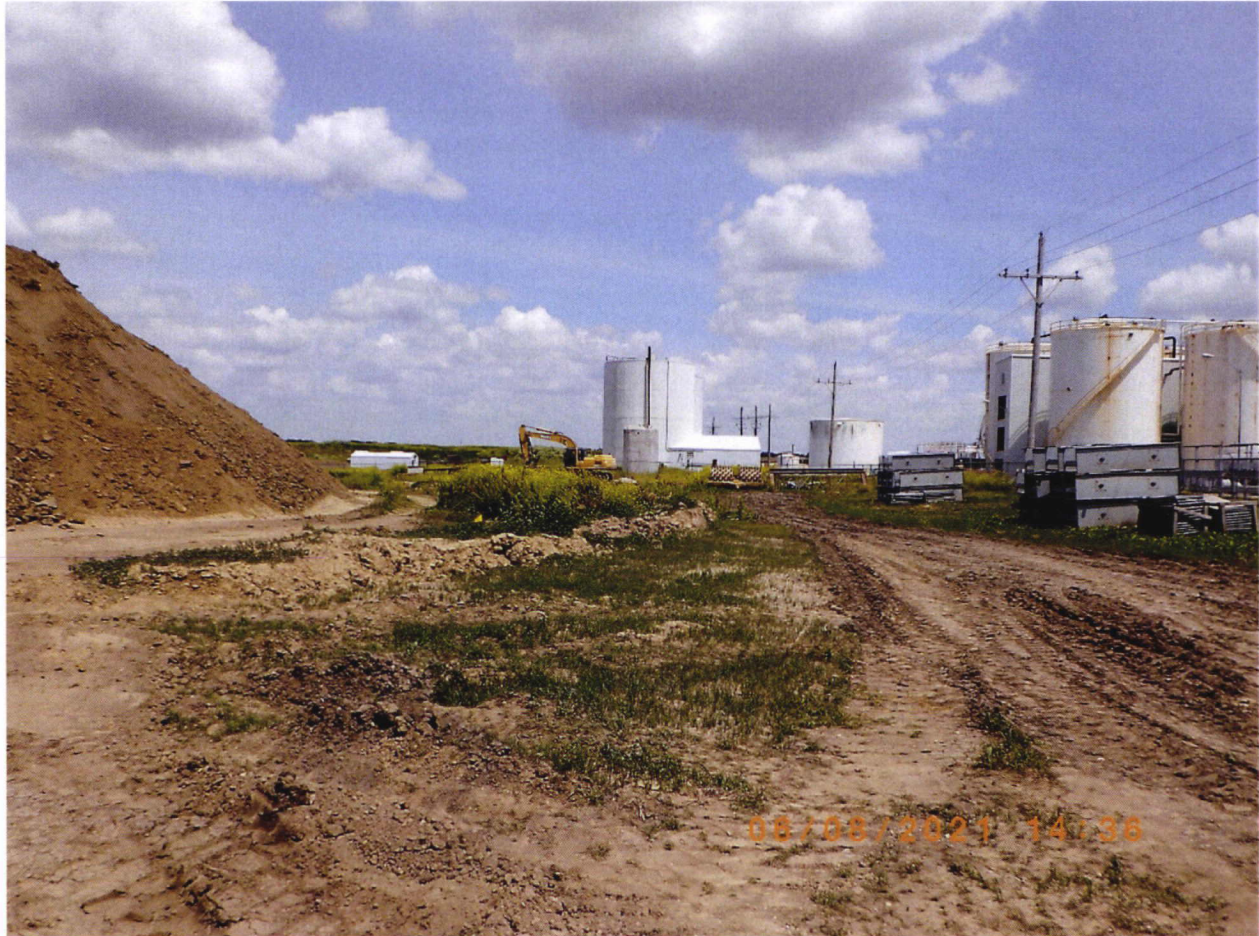
Image of excavated dirt pile. Pile is to the North East of the AltEn Administrative Building. Photo taken facing East.

The dirt pile and tall patches of vegetation were not the location of the septic system. Mr. Tinglehoff contacted Mr. Cunningham and directed us to the area where the septic system is located.

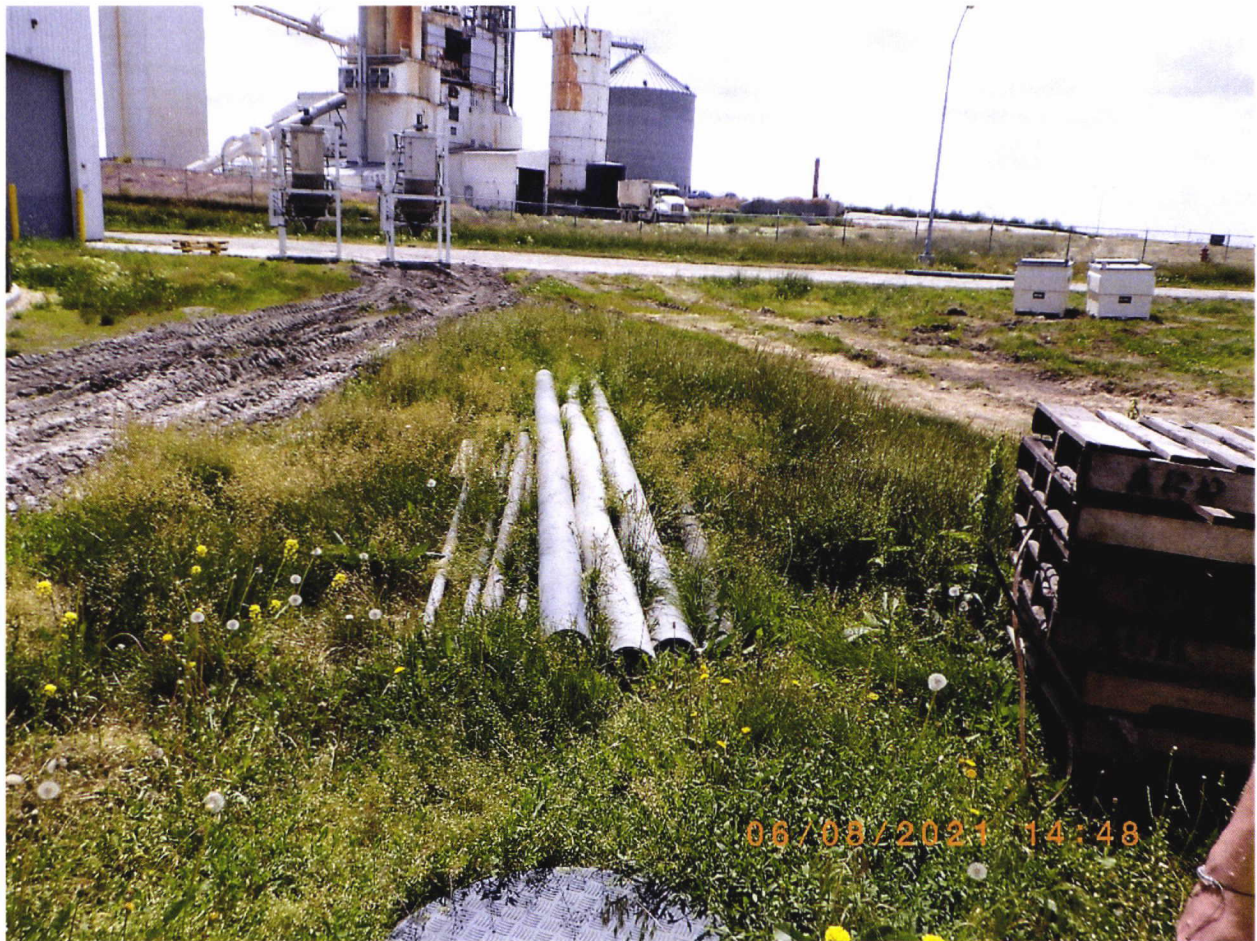
The septic system is located to the South East of the AltEn Administration building.

Septic system location. One of the tank cover lids is visible in the center foreground of the picture (in front of the pipe and to the left of the stack of pallets). Photo taken facing West (towards the AltEn Administration Building).

The area where the septic system was located was mowed. No areas of the ground were muddy or saturated from moisture. There was no evidence of plant overgrowth which could indicate issues with laterals. All areas of exposed dirt were dry.

The area where the septic tank is located does not show any evidence the system is discharging or failing.

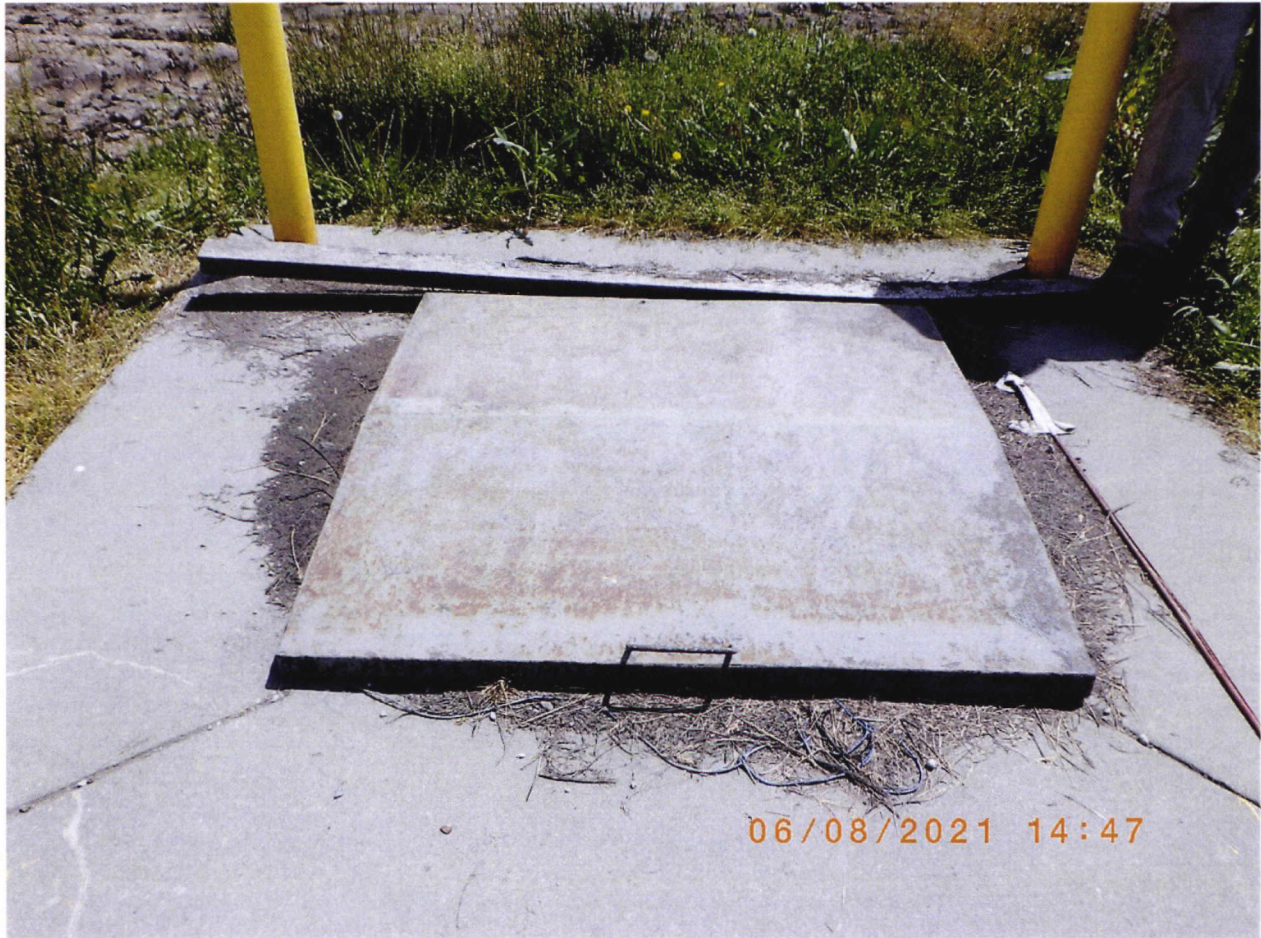
First Tank lid. Lid is secure and undamaged. Mud and plant debris accumulation is consistent with precipitation gathering in the area and is not indicative of/evidence of overflow. Photo taken facing South.

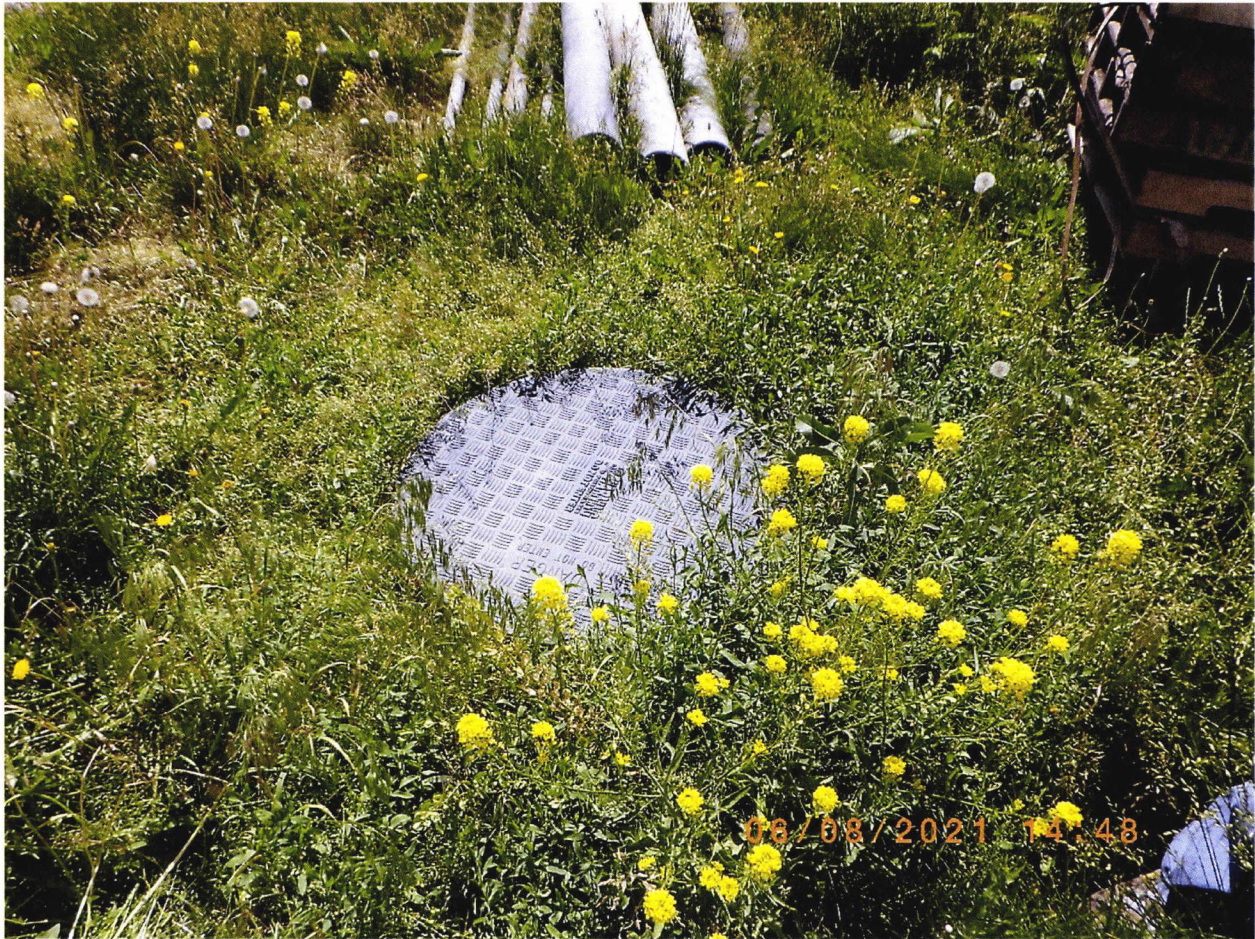
Second tank lid. Lid is secure and undamaged. No evidence of system discharge or overflow. Area is dry.

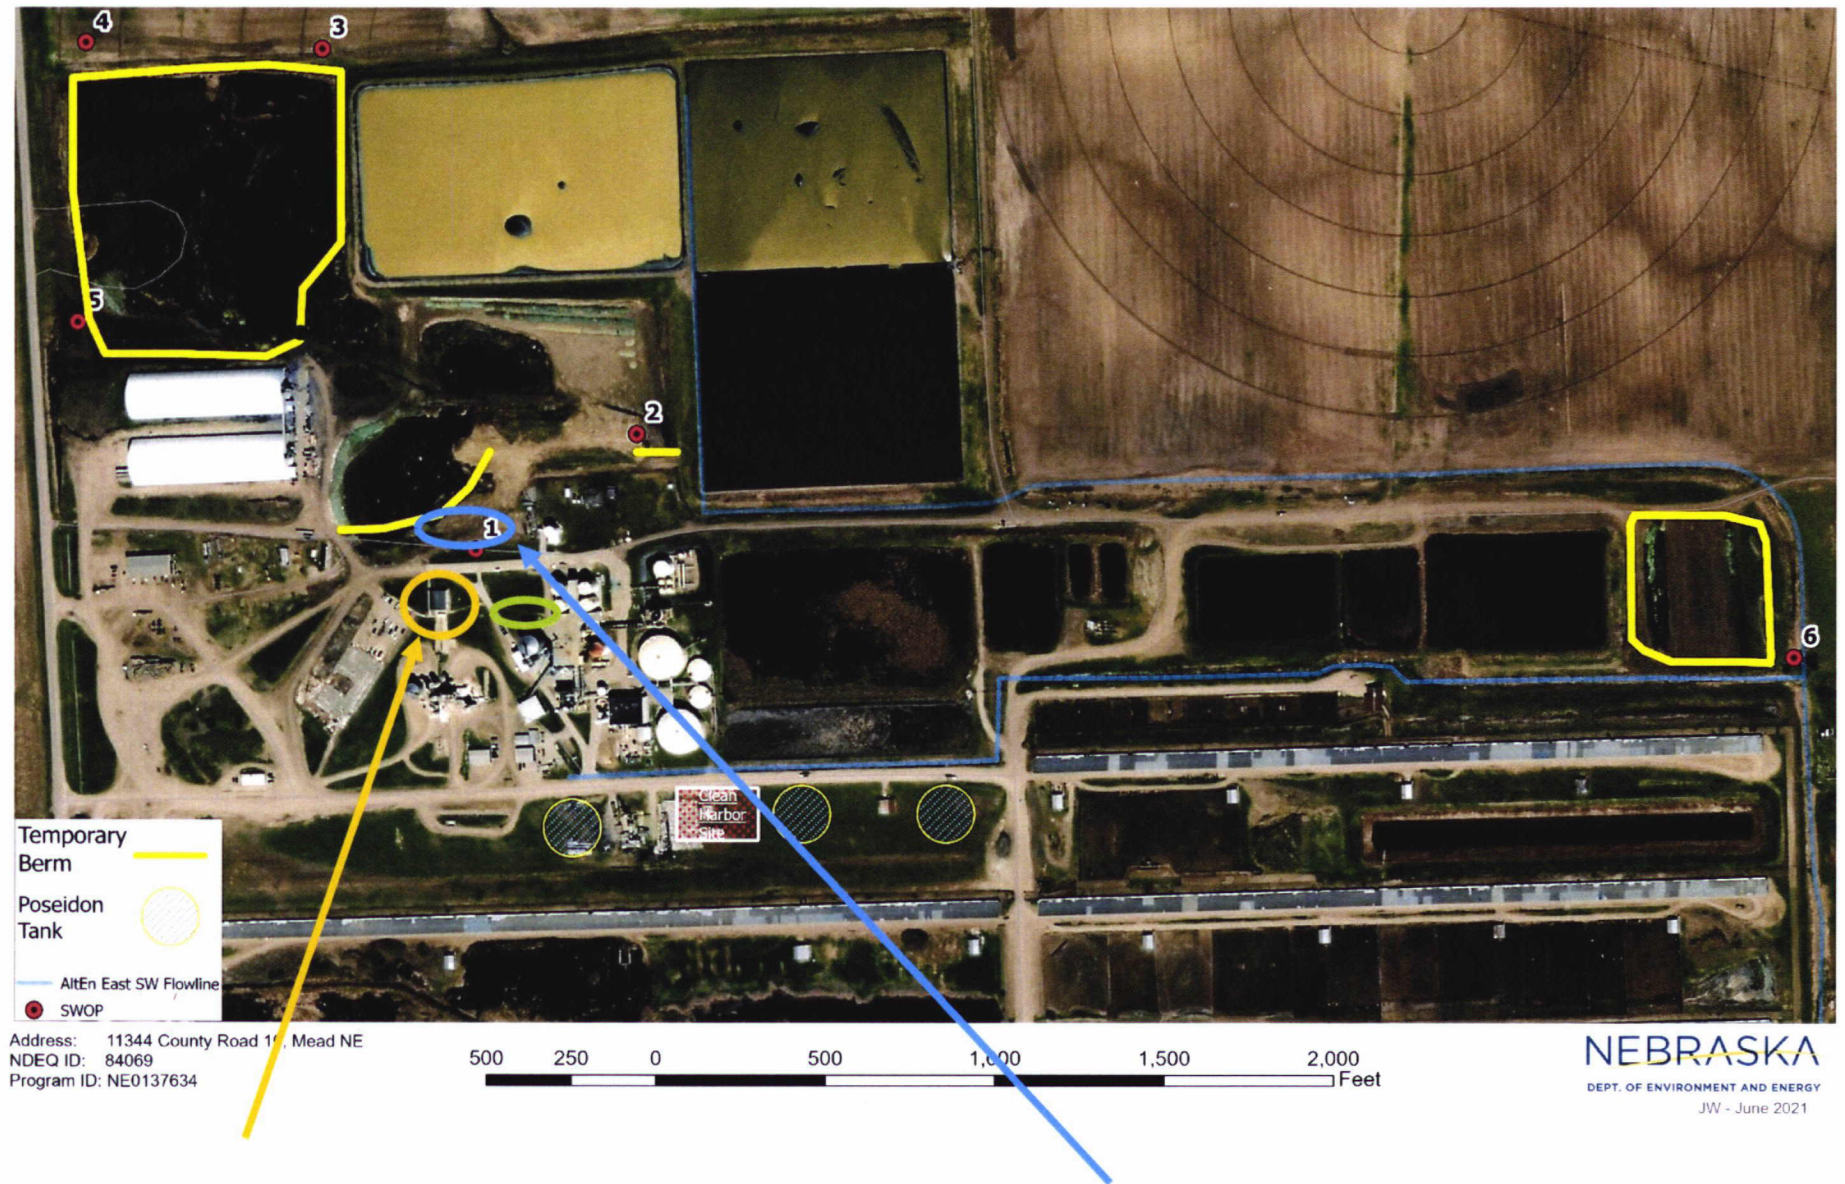
AltEn LLC - Storm Water Temporary BMP Check Map

This orange circle indicates the AltEn Admin Building. located.

The light blue circle is where the dirt pile is located. The green circle is where the septic system is
