DEPT. OF ENVIRONMENTAL QUALITY

MEMORANDUM

RE: Site visit – Mark Pomajzl, Jason Holsten

NDEQID: NE0137634 / NE0204447

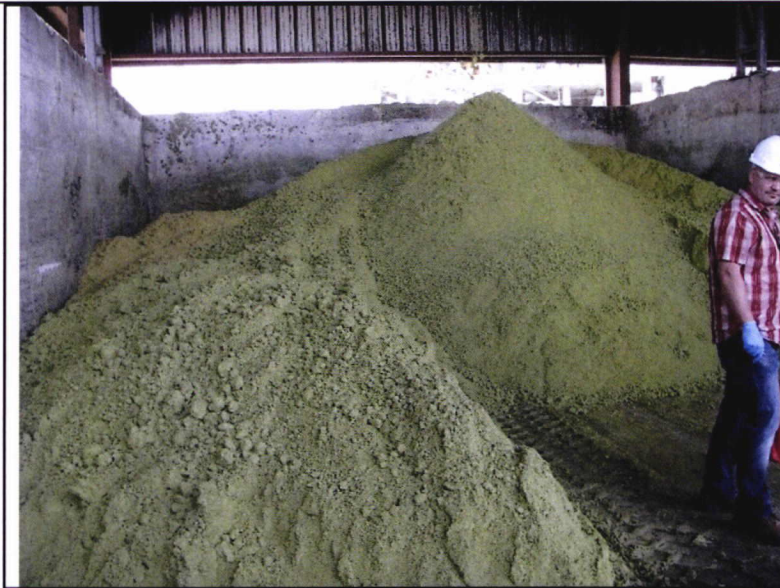
Photograph #1
Date: 8/1/2018
Photographer: Mark Pomajzl
Camera: Canon PowerShot SX100 IS
Facility Name: **ALTEN Mead**
Facility IIS number / Program ID:
IIS#84069/ NE0137634 / NE0204447
Direction Facing: East
Observation Point: 1
Description: Wet cake barn,
Conveyer distributing wet cake, composite
samples taken from this pile and the pile
below. North pile

We geared up with hardhat, protective glasses, steel-toed work boots and laboratory gloves prior to sampling. Mr. Egr provided access to the first sampling area (wet cake barn), located on the southeast portion of the property. The barn has a conveyor, which drops wet cake from the roof, creating two piles below, separated by a concrete wall. Mr. Egr stated that both piles were the same. To validate this we sampled a composite of both piles. Each sample was randomly taken from areas around the pile, filling the bottles half full from one pile and then randomly sampling from the next pile. Samples were collected, labeled with time, date and sampler, and then stored in the cooler for Midwest lab delivery and analyzed for ammonia, TOC, COD, BOD, TSS, TCLP, VOC, TCLP SVOC, TCLP Metals and TCLP Pesticides. (Photos 1, 2, 3 and GPS collected)

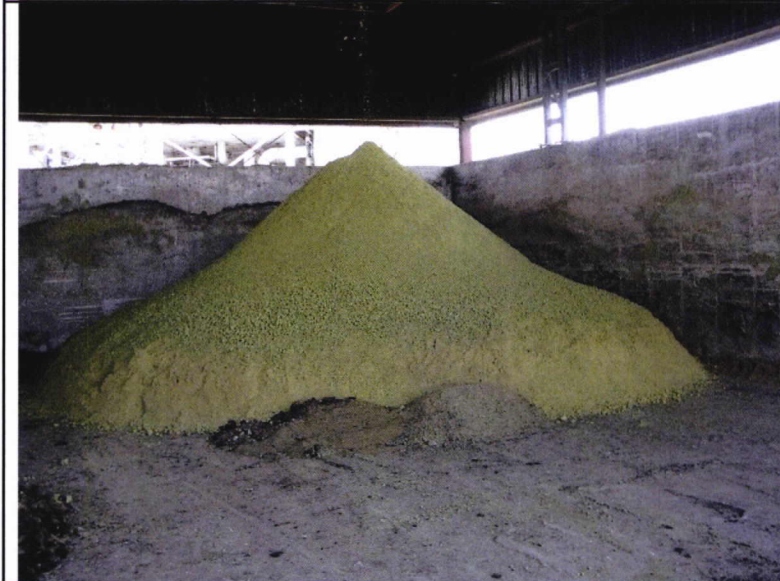
Photograph #2
Date: 8/1/2018
Photographer: Mark Pomajzl
Camera: Canon PowerShot SX100 IS
Facility Name: **ALTEN Mead**
Facility IIS number / Program ID:
IIS#84069/ NE0137634 / NE0204447
Direction Facing: East
Observation Point: 2
Description: Wet cake barn,
Conveyer distributing wet cake, composite
sample taken from this pile.

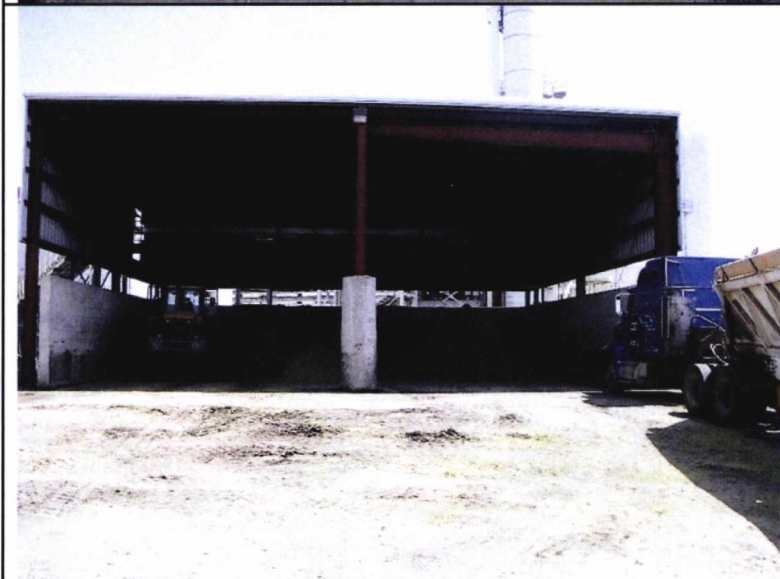
Photograph #3
Date: 8/1/2018
Photographer: Mark Pomajzl
Camera: Canon PowerShot SX100 IS
Facility Name: **ALTEN -Mead**
Facility IIS number / Program ID:
IIS#84069/ NE0137634 / NE0204447
Direction Facing: East
Observation Point: 3
Description: Wet cake barn
Conveyer distributing wet cake, composite
samples taken from this pile and the pile
below.
GPS: N 41.19568 / 096.47845 W

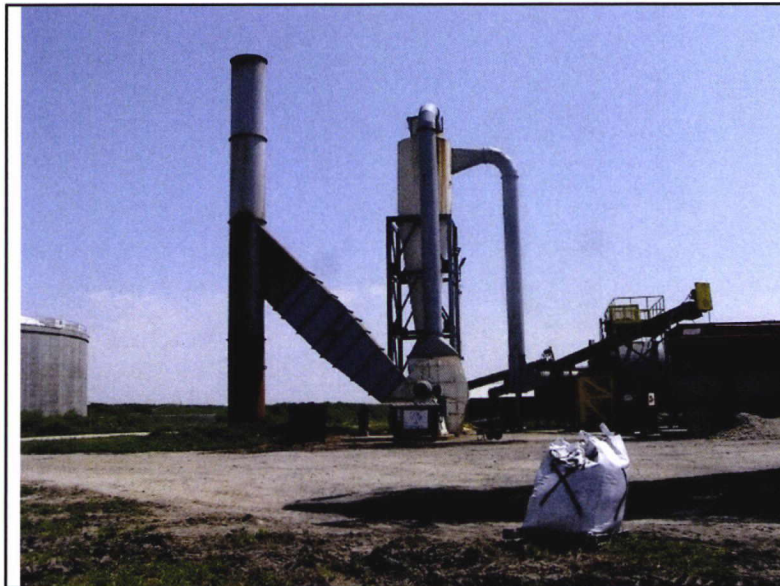
Next, we investigated the BioChar system, located south and west of the wet cake barn. We noted a white haze rising from some bags of processed biochar. When asked about this haze, Mr. Egr stated some bags were burning. Mr. Egr explained that for some unexplained reason the material at times will combust and burst the bags. Four to five bags in the area were smoldering, creating a possible fire hazard to nearby dry grass. Mr. Egr explained the possible uses of biochar, from additives to cinder blocks, absorbents and fertilizer. The process area was not currently on the facility Storm Water Pollution Prevention Plan (SWPPP). No samples were collected from this area. (Photo 4, GPS Collected)

Photograph #4
Date: 8/1/2018
Photographer: Mark Pomajzl
Camera: Canon PowerShot SX100 IS
Facility Name: **ALTEN Mead**
Facility IIS number / Program ID:
IIS#84069/ NE0137634 / NE0204447
Direction Facing: East
Observation Point: 4
Description: BioChar System
GPS: N 41.19458 / W096.47803

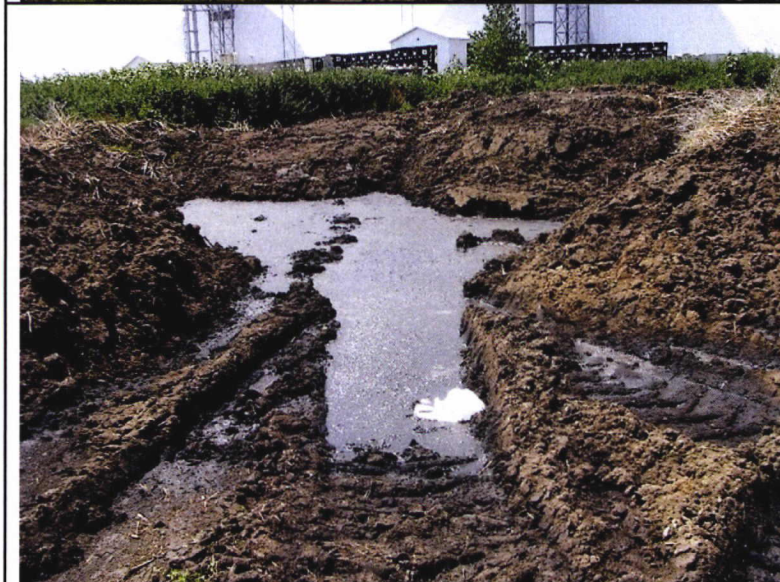
The last area sampled was from the wet cake staging area, located on the northeast portion of the property. To prevent storm water runoff and discharges, the facility constructed a berm around the wet cake pile. We located only two areas of liquefied wet cake water to sample; the storage area had dried due to recent lack of rainfall. We labeled the sample bottles with the date, time and sampler prior to collection. The first sample was collected on the east side of the pile (photo 5 and GPS collected). The laboratory did not provide preservative. The sample bottle was placed in the cooler until delivery. The second liquid sample was collected on the north portion of the wet cake staging pile (photo 6 and GPS collected). We labeled the sample bottle with the date, time and sampler prior to collection. The sample was placed in the cooler until delivery. Liquid samples were analyzed for ammonia, TOC, COD, BOD and TSS. The last sample collected was solid wet cake from random locations (composite) from the wet cake pile. We labeled the sample bottles with the date, time and sampler prior to collection. We sampled three locations, filling the sample bottles in thirds at each location (photo and GPS collected). There was no preservative provided. We placed the samples in the cooler for delivery. The wet cake solids were analyzed for TCLP VOC, TCLP SPVOC, TCLP Metals, TCLP pesticides.

Photograph #5
Date: 8/1/2018
Photographer: Mark Pomajzl
Camera: Canon PowerShot SX100 IS
Facility Name: **ALTEN Mead**
Facility IIS number / Program ID:
IIS#84069/ NE0137634 / NE0204447
Direction Facing: East
Observation Point: 5
Description: Wet cake storage area, liquid samples
GPS: N 41.19860 / W096.48050

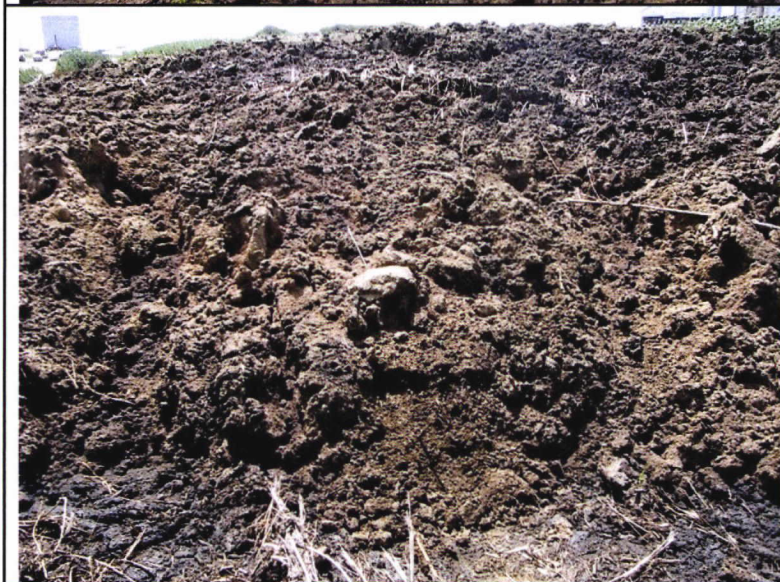
Photograph #7
Date: 8/1/2018
Photographer: Mark Pomajzl
Camera: Canon PowerShot SX100 IS
Facility Name: **ALTEN Mead**
Facility IIS number / Program ID:
IIS#84069/ NE0137634 / NE0204447
Direction Facing: East
Observation Point: 7
Description: Composite sample location
GPS: N 41.19864 / W096.47998

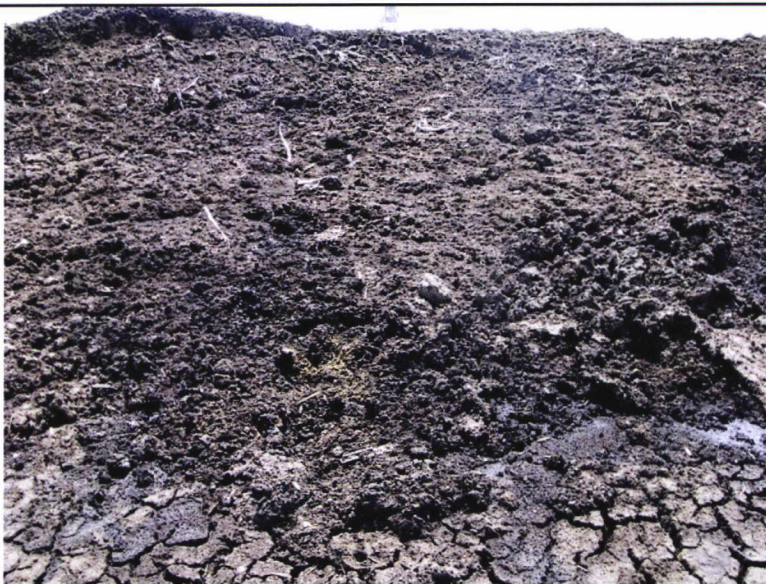
Photograph #8
 Date: 8/1/2018
 Photographer: Mark Pomajzl
 Camera: Canon PowerShot SX100 IS
 Facility Name: **ALTEN Mead**
 Facility IIS number / Program ID:
 IIS#84069/ NE0137634 / NE0204447
 Direction Facing: East
 Observation Point: 8
 Description: Composite sample location
 GPS: N 41.19884 / W096.4800

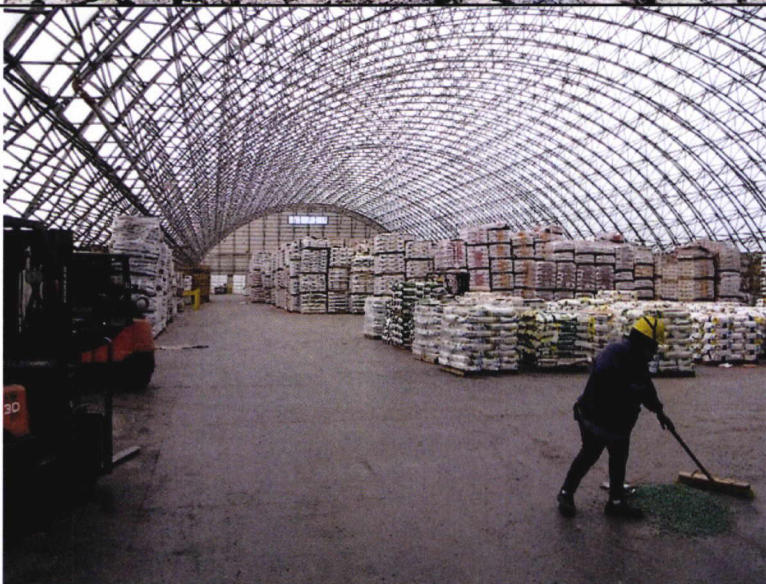
Next, we requested to see the outdated seed corn storage. Seed corn is stored in two large buildings on the northwest portion of the property. The south building stores bagged corn containing many different brands and types. The facility conveys seed to the north building where it is stored in a large pile (photos) until processed through the ethanol process. In this area, other types of seed noted included Sudan grass and sorghum.

Photograph #9
 Date: 8/1/2018
 Photographer: Mark Pomajzl
 Camera: Canon PowerShot SX100 IS
 Facility Name: **ALTEN Mead**
 Facility IIS number / Program ID:
 IIS#84069/ NE0137634 / NE0204447
 Direction Facing: West
 Observation Point: 9
 Description: Outdated seed corn storage area.
 GPS: Not collected

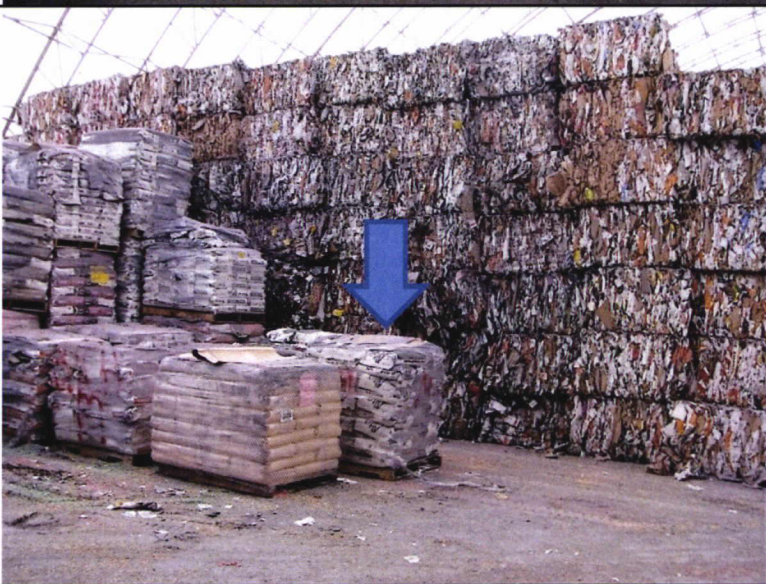
Photograph #10
 Date: 8/1/2018
 Photographer: Mark Pomajzl
 Camera: Canon PowerShot SX100 IS
 Facility Name: **ALTEN**
 Facility IIS number / Program ID:
 IIS#84069/ NE0137634 / NE0204447
 Direction Facing: West
 Observation Point: 10
 Description: Paper sacks stored in bails until recycled. The bags located in front are not seed corn but are other types of seed such as sudan grass.
 GPS: Not collected

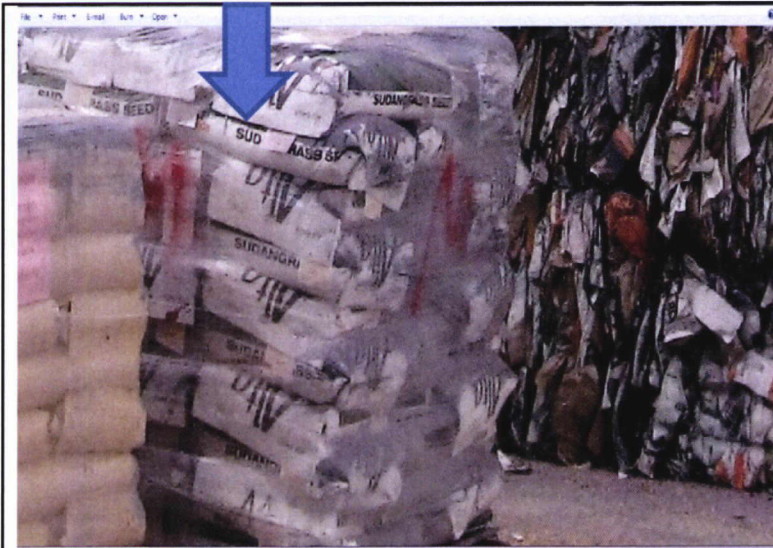
Photograph #11
 Date: 8/1/2018
 Photographer: Mark Pomajzl
 Camera: Canon PowerShot SX100 IS
 Facility Name: **ALTEN**
 Facility IIS number / Program ID:
 IIS#84069/ NE0137634 / NE0204447
 Direction Facing: West
 Observation Point: 10
 Description: Sudan grass bags.
GPS: Not collected
