MEMORANDUM

DATE: July 17, 2018
TO: AltEn LLC **FACILITY ID:** 84069
Mead Cattle Co 43238
THRU: Todd Ellis
FROM: Kyle Morton
RE: Site visit - NEC 071218-HJ-1515

On July 12, the Department received a notification of environmental concern pertaining to the AltEn plant in Mead, Nebraska. Callers alleged strong chemical odors rising from a WDGS (wet distillers grains and solubles) pile stored on the north side of the facility property, as well as farmland adjacent to the property on which the WDGS was applied.

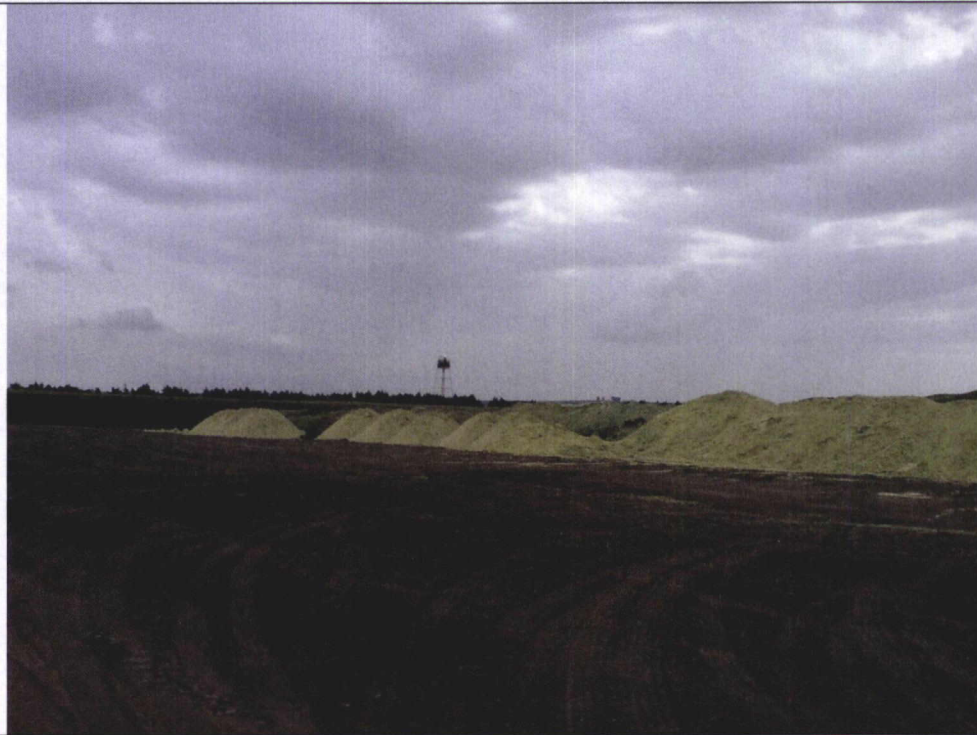
Photograph 1.

Location: North property looking northeast at possible compost or waste pile, which had yellowish coloration

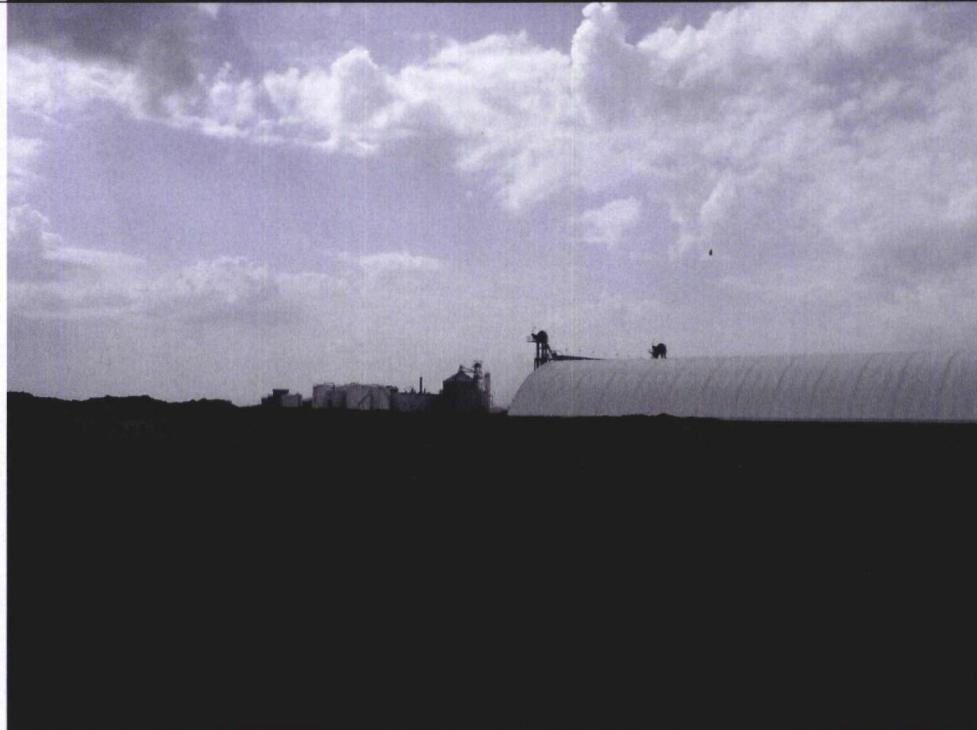
Photograph 2.

Location: North property looking southeast at possible compost or waste pile, which had brownish/dark green coloration

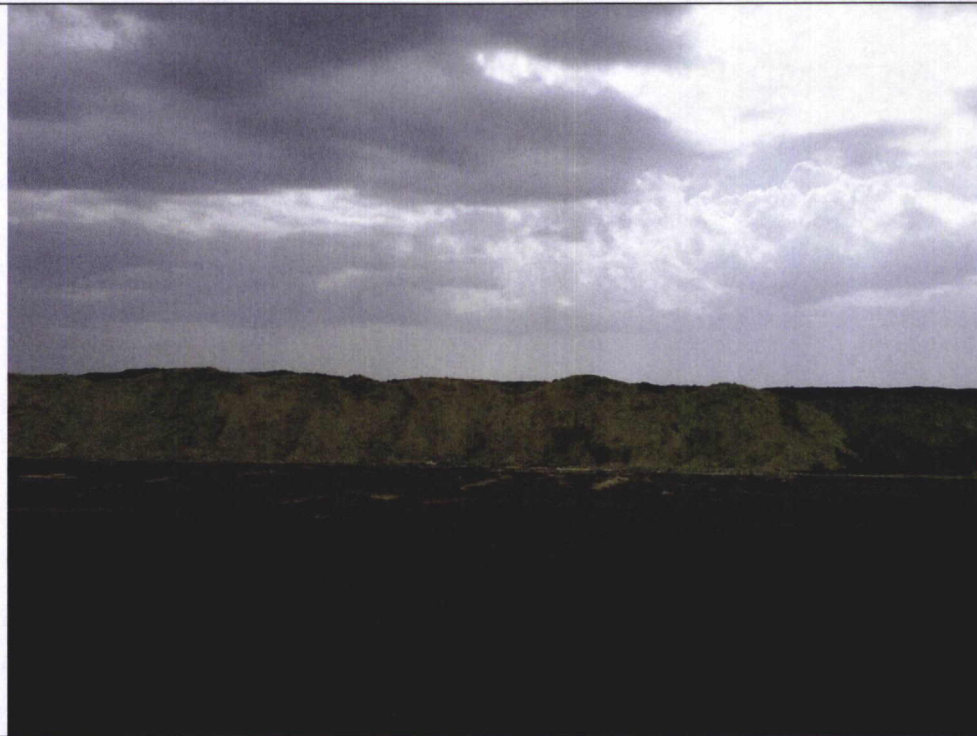
Photograph 3.

Location: North property looking east at possible compost or waste pile. Middle of pile had greenish coloration

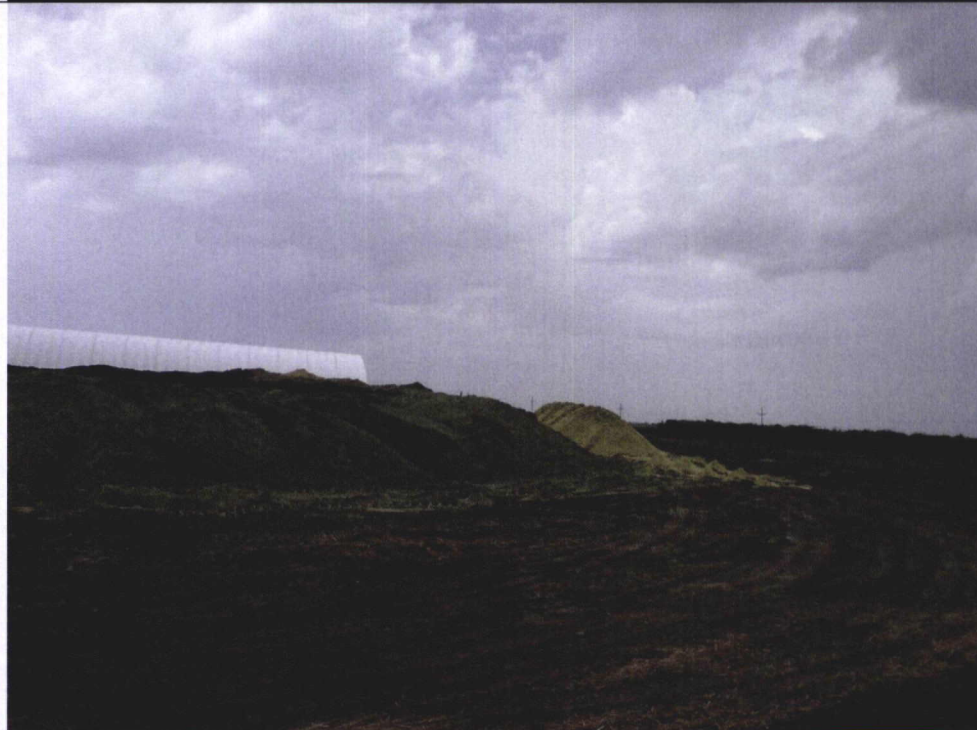
Photograph 4.

Location: North property looking south at possible compost or waste pile, which had yellowish/green coloration

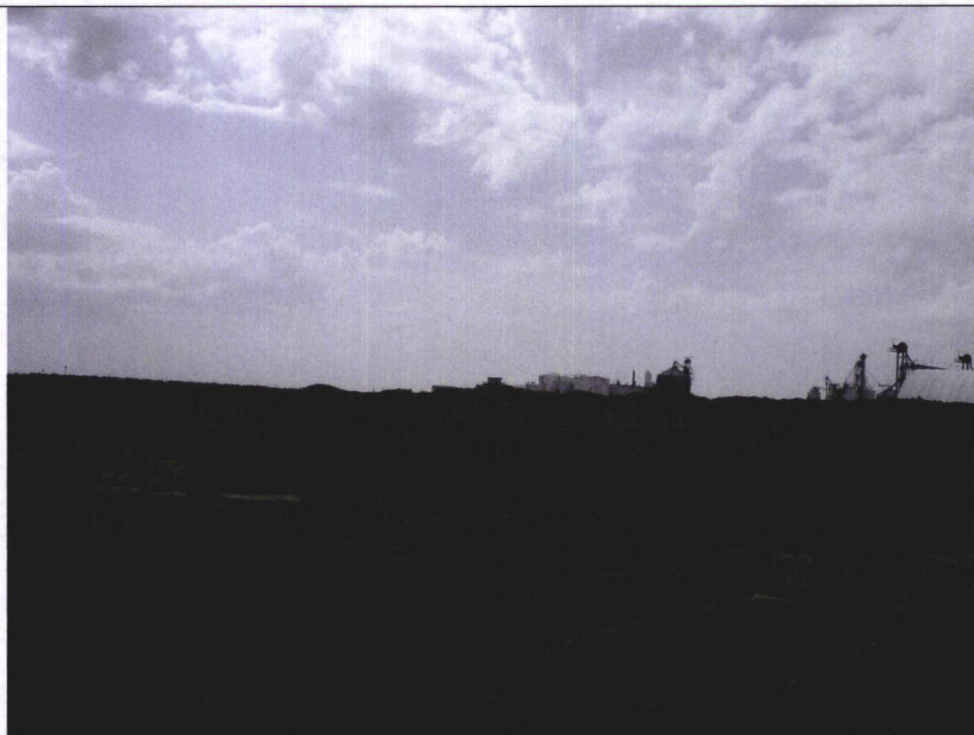
Photograph 5.

Location: North property looking southeast at possible compost or waste pile.

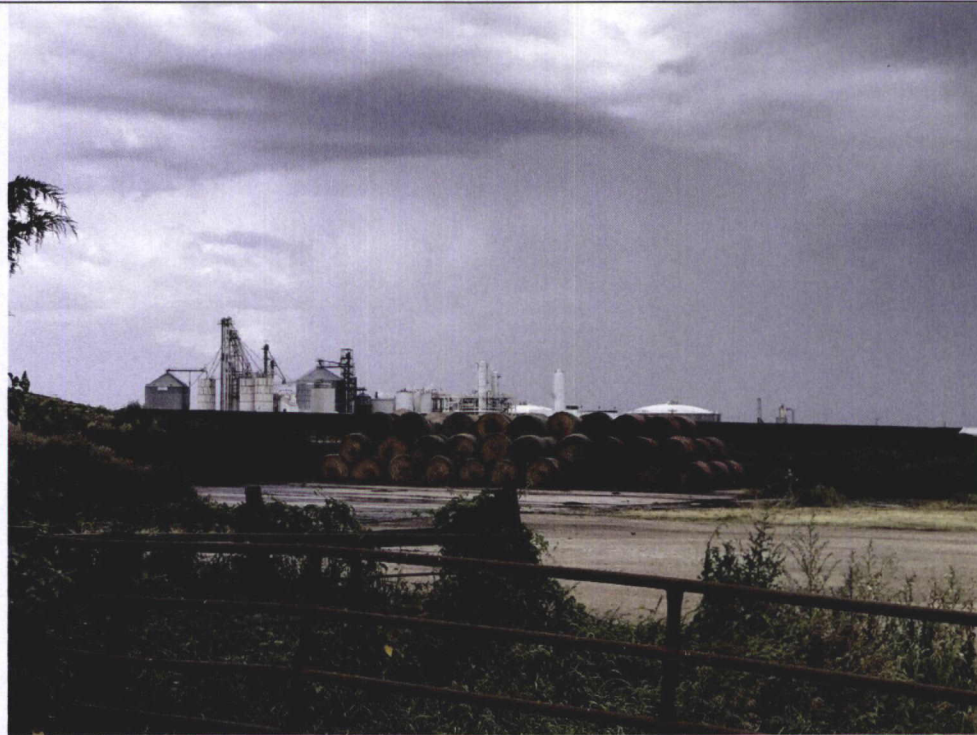
Photograph 7.

Location: Southwest of AltEn property facing northeast. Approximate view of Method 9 readings. Biochar stack can be seen toward the right side of the picture.

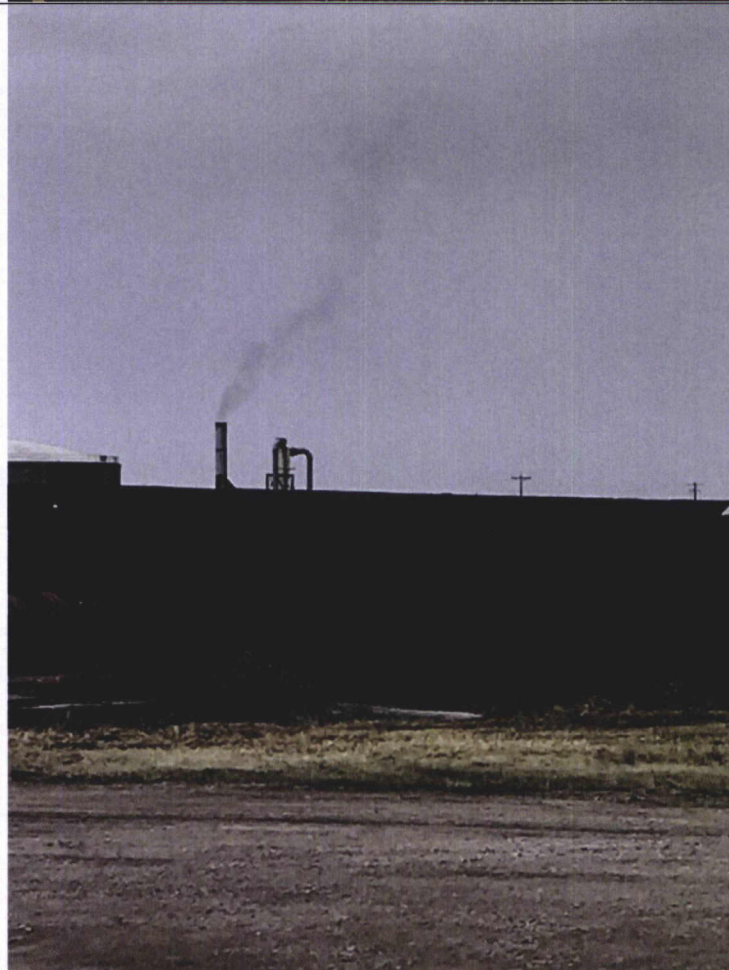
Photograph 8.

The highest 6-minute average Method 9 opacity reading I recorded was 30.4%, which exceeds the 20% opacity limit in Title 129 – Chapter 20.

Location: Method 9 reading example (35%). Peak opacity was 50% during my observation of the site.
